Research on Joint Sealant Materials to Improve Installation and Performance: Final Report

Pangil Choi, Sanjaya Senadheera, and Moon C. Won

Performed in cooperation with the Texas Department of Transportation and the Federal Highway Administration

Research Project 0-6826 Research Report 0-6826-1 http://www.techmrt.ttu.edu/reports.php

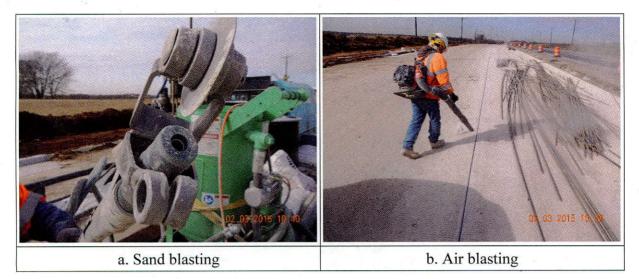
Figure 2.7 Sand blasting and air blasting

After saw cutting, joint interfaces are sandblasted to remove the residuals in the interfaces of joint as shown in Figure 2.7(a). Figure 2.7(b) shows the joint cleaning procedure using compressed air. The compressed air must be free of moisture and oil. The joint interfaces are supposed to be checked for cleanliness. If there are any dust or remaining concrete particles, then the joint must be re-blasted and blown clean. To ensure cleanliness, it is recommended that each joint interface be wiped clean with a clean rag without solvents to remove any dust remaining after sandblasting. However, this recommendation is rarely followed.

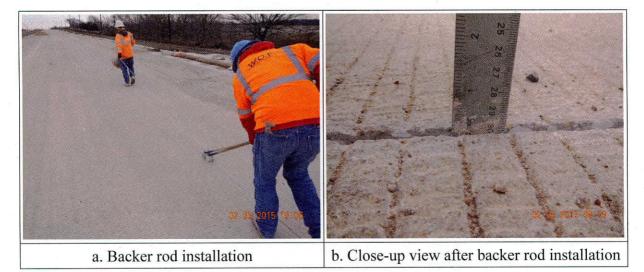
Figure 2.8 Backer rod installation

The backer rod plays a role as a bond breaker, preventing the sealant from bonding to the bottom of the joint and preventing the flow of the material through the joint itself. Backer rods consist of cylinders of compressible material, which holds the fluid sealant in place in open joints. Backer rods also prevent "three-face bonds" in the joints. This enhances the performance of joint sealant by minimizing stresses in the sealants. It should be noted that TxDOT "Concrete Paving Details Joint Seals (JS-14)" does not require a backer rod at longitudinal sawed contraction joints or longitudinal/transverse construction joints, which violates the principle of avoiding three-face bonds. However, backer rods were installed in all the joint sealing operations observed. The size of the backer rod must be at least 25% greater than the joint reservoir width (Texas Department of Transportation 2012). Figure 2.8(a) shows a backer rod installation at longitudinal sawed contraction joint and Figure 2.8(b) illustrates a close-up view after backer rod installation.

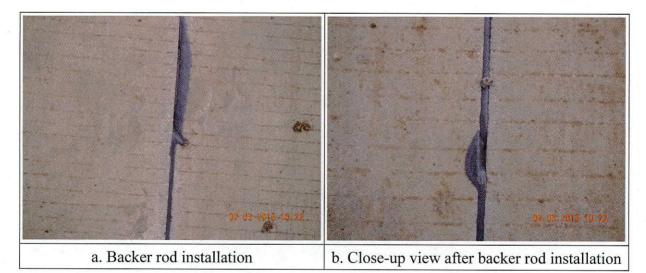
Figure 2.10 Inadequate sealant installation

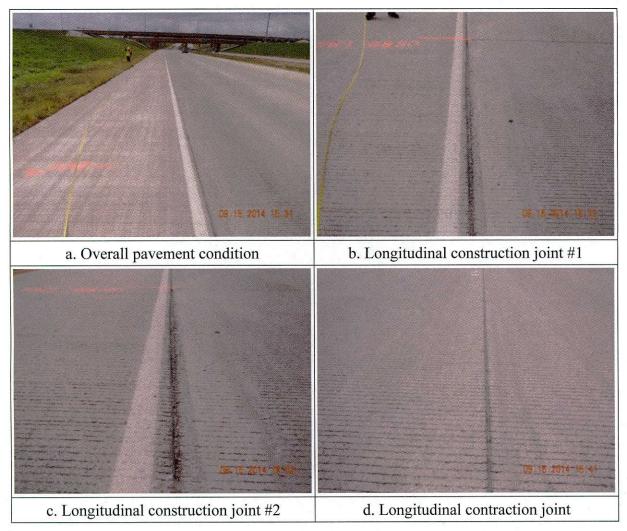
Figure 3.3 Sealant condition on US 82-LBB [NO. 29]

Figure 3.3 shows a typical sealant condition in CRCP where the pavement age is less than 10 years old. The NO at the end of the figure label indicates the project number in Tables 3.1 through 3.3. This pavement was built in 2011 in the Lubbock District. As shown in Figures 3.3(b) and (c), although the pavement is only three years old, minor distress in the form of chipping occurred due to inadequate saw cuts in longitudinal construction joints. On the other hand, the condition of the sealant at longitudinal contraction joint was excellent, as shown in Figure 3.3(d).

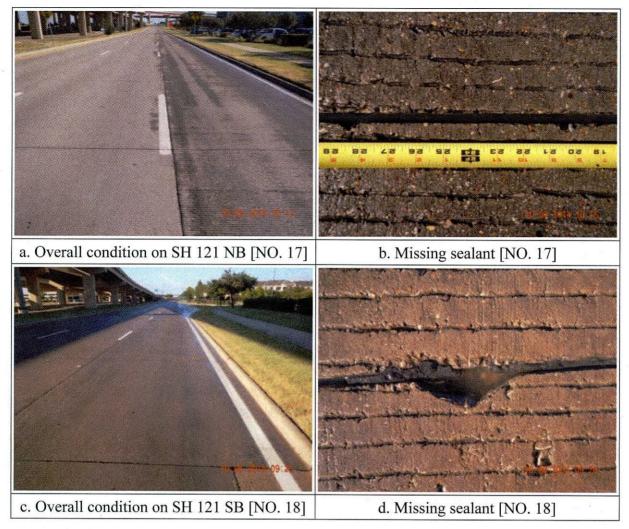
Figure 3.4 Sealant condition on SH 121-DAL [NO. 17 and NO. 18]

It was a rainy day when the section was surveyed. Water was observed in the joint areas where joint sealant was missing, which indicates that the areas seem to serve as a reservoir for rainwater. It also indicates that it is difficult for rainwater to permeate into the pavement base layer through joints even when joint sealant is missing. Figures 3.4(c) and (d) show the pavement condition on SH 121 SB. It is observed that water stayed at the joint even though sealant was missing. The overall condition of the pavement was quite good.

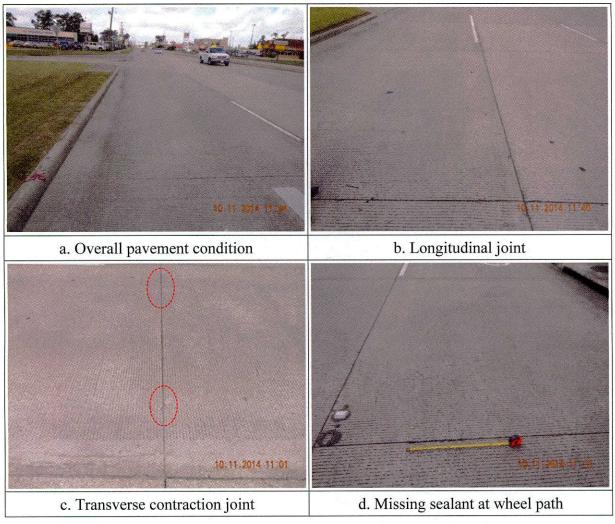
Figure 3.5 Sealant condition on US 90 BR-BMT [NO. 27]

Figure 3.5 shows the adhesion failure in the wheel paths on US 90 Business Rd in the Beaumont District. This section was completed in 2005. It is observed that the adhesion failure occurred near the wheel paths. The cause for the adhesion failure of sealant near the wheel paths is not known.

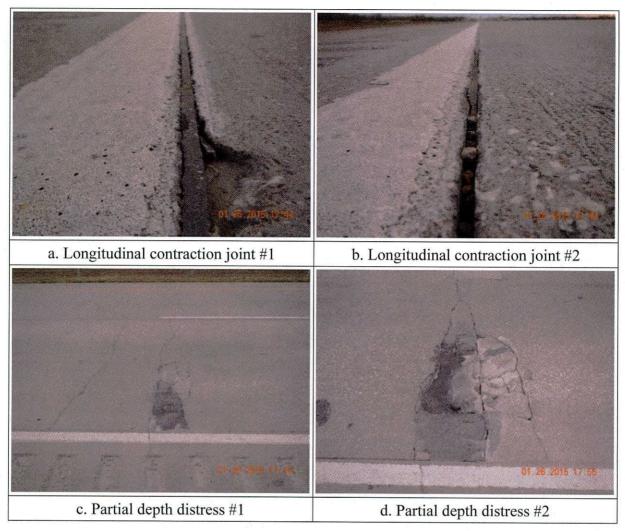
Figure 3.6 Sealant condition on IH 35-LRD [NO. 42]

Figures 3.6(a) and (b) show the sealant condition at longitudinal contraction joint on IH 35 in Webb County, Laredo District, which was built in 2002, showing adhesion failure, missing sealant, and spalling. However, distresses related to sealant issues were not observed. On the other hand, as shown in Figures 3.6(c) and (d), partial depth distresses were observed. This type of partial depth distress occurs when delamination exists at the depth of longitudinal steel. One of the reasons for delamination is an increased stress around longitudinal steel due to the applications of heavy wheel loading. The SCN of this section was estimated to be close to 0, which indicates a good sealant condition. The distress observed here is not related to the sealant condition.

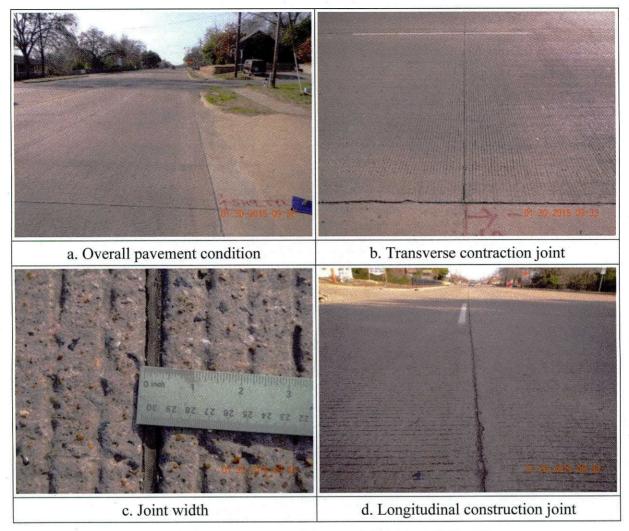
Figure 3.7 Sealant condition on SH 9-TYL [NO. 40]

SH 19 was built in May, 2003 with a 9-in CPCD over 4-in asphalt stabilized base in Van Zandt County, Tyler District. Figure 3.7(a) shows the overall pavement condition on SH 19. Figures 3.7 (b) and (c) show the transverse contraction joint and joint width, respectively. As shown in these two figures, adhesion failures were observed at transverse joints. Figure 3.7 (d) presents the longitudinal joint condition. Even though the pavement was 12 years old at the time of the condition survey, the overall joint condition was good.

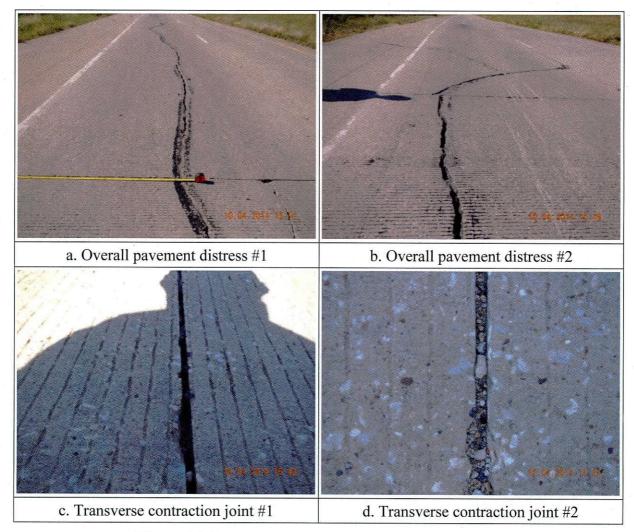
Figure 3.8 Sealant condition on SL 288-DAL [NO. 47]

Figure 3.8 shows the pavement condition on SL 288 in the Dallas District, which was built in 1999 with a 9-in CPCD. The survey was conducted on 14 October, 2014. This section was constructed with a 4-in. ASB (asphalt stabilized base) and 8-in. lime treated subgrade (LTS). Significant pavement distress was observed in the form of wide longitudinal cracks as shown in Figures 3.8(a) and (b). Most of the sealant in the transverse contraction joints were missing. However, the overall condition of the joints was good. The SCN was estimated to be at about 6, which implies the worst sealant condition. It implies a rather poor correlation between SCN and overall joint condition.

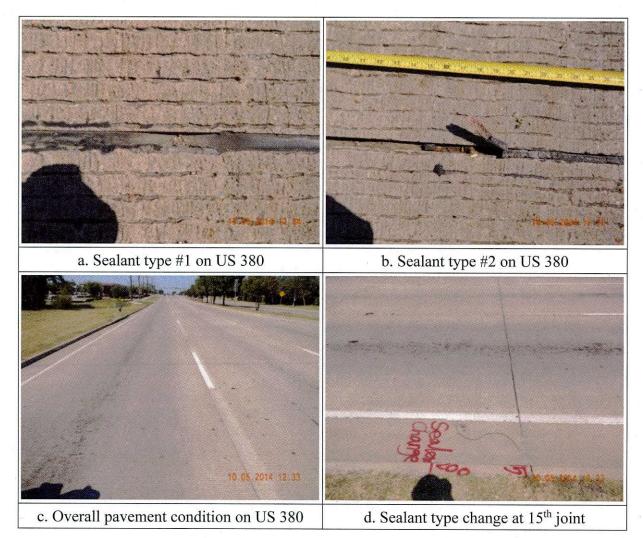
Figure 3.11 Sealant condition on US 380-DAL [NO. 39]

US 380, built in 1994 with a 9-in CPCD in the Dallas District, was investigated on 5 October, 2014. As shown in Figures 3.11(a) and (b), two types of sealant were applied when the resealing was conducted. As can be seen Figure 3.11(a), no missing sealant or adhesion failure was observed where the sealant type #1was used. On the other hand, as shown in Figure 3.11(b), missing sealant and adhesion failures were observed where the sealant type #2 was used. However, field survey results show that the overall joint and pavement condition was good regardless of sealant types, as shown in Figure 3.11(c). This result implies that the SCN and seal rating (SR) of joints may have a weak correlation with pavement performance. In other words, the mean of SCN and SR indicates only the condition of the joint sealant, not necessarily the performance of joints or pavement.

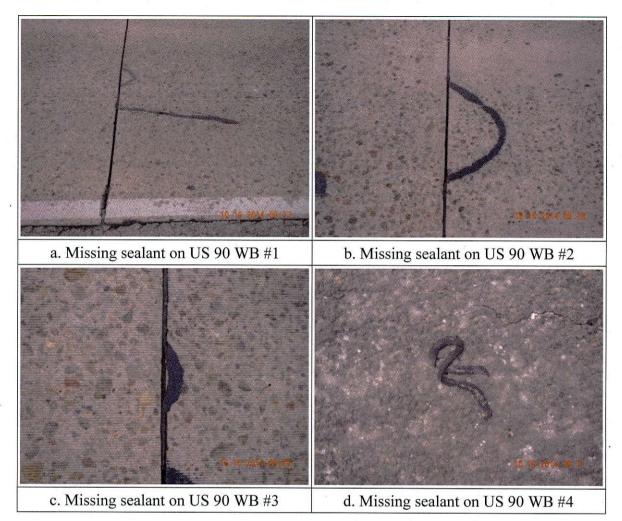
Figure 3.13 Sealant condition on US 90 WB-BMT [NO. 32]

Figures 3.13(a), (b), (c), and (d) show the missing sealants on US 90 WB. It appears that diamond grinding operation caused extrusion of the sealant.

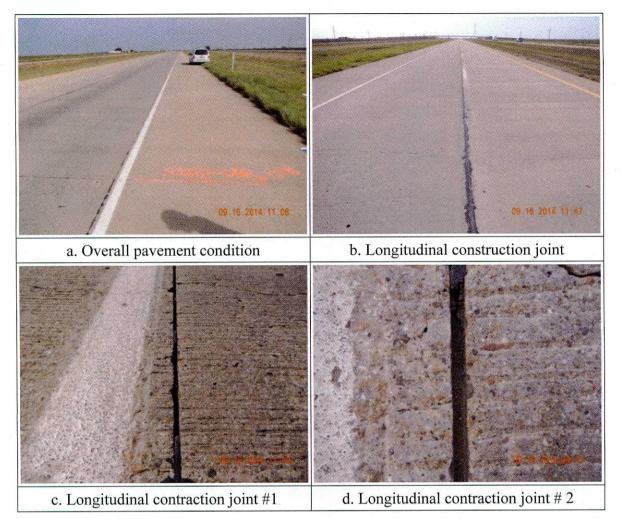
Figure 3.14 Sealant condition on IH 27-LBB [NO. 46]

Field survey results on CRCP indicate that, regardless of pavement ages, joint or pavement performance does not appear to be affected by the condition of sealants.

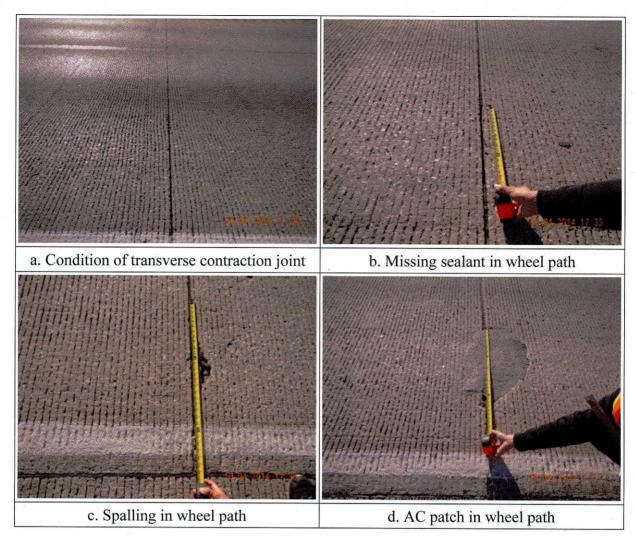
Figure 3.15 Sealant condition on IH 35-DAL [NO. 45]

Figure 3.15 shows the pavement condition on IH 35 in Denton County, Dallas District. In 1988, this section was overlaid with 11-in CPCD over 2-in asphalt interlayer, on top of existing 10-in CPCD. The original CPCD was built in 1960, which means that the 10-in CPCD provided 28 years of service before the unbounded overlay was applied. The condition of transverse contraction joints was in a good condition except for a few joints. A missing sealant was observed in the wheel paths as shown in Figure 3.15(b) and spalling was observed as shown in Figure 3.15(c). Also, an asphalt concrete patch was applied at large spalled areas in transverse contraction joints, as shown in Figure 3.15(d).

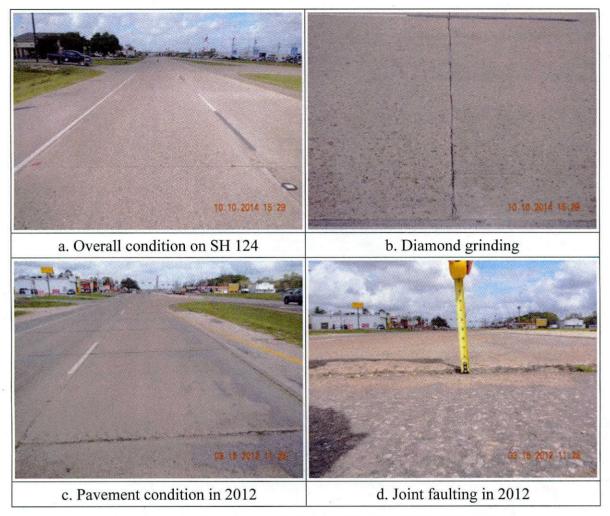
Figure 3.16 Sealant condition on SH 124-BMT [NO. 57]

SH 124 in Chambers County, Beaumont District was built in 1962 with a 10-in CPCD. The age of the pavement when the condition survey was conducted was 52 years. Dowel bars were not used in this section. Diamond grinding was done to correct joint faulting as shown in Figures 3.16(a) and (b), which also shows missing sealants. When the section was surveyed in 2012 for the rigid pavement database project (0-6274), severe faulting was observed as illustrated in Figures 3.16(c) and (d). It appears that diamond grinding was applied to correct faulting and diamond grinding might have caused the breakage of sealants.

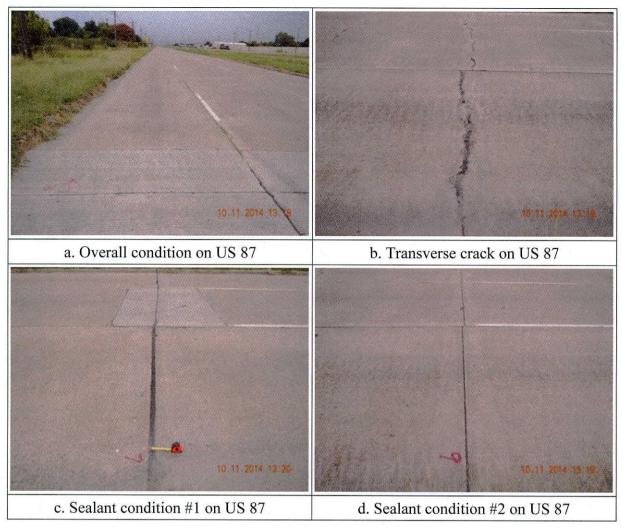
Figure 3.17 Sealant condition on US 87-BMT [NO. 61]

US 87 was built in 1951 with a 9-in JRCP in Jefferson County, Beaumont District. The age of pavement when the condition survey was conducted was 63 years. Figure 3.17(a) shows the overall pavement condition on US 87. Several concrete patches were installed at transverse expansion joints. In addition, transverse cracks occurred in most JRCP slabs and were sealed as shown in Figure 3.17(b). Figures 3.17(c) and (d) show the transverse expansion joint condition.

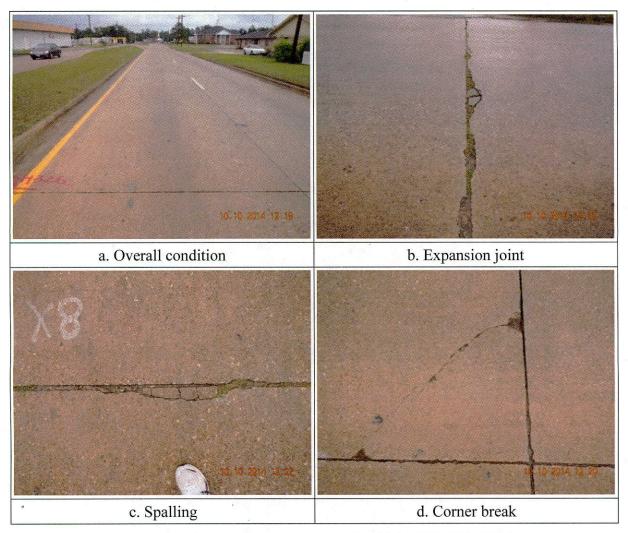
Figure 3.18 Sealant condition on SH 326-BMT [NO. 55]

SH 326 was constructed in 1967 with 10-in JRCP over 4-in cement stabilized base. The field survey was conducted on October, 2014. As shown in Figure 3.18, sealant was not present at all joints. Minor spalling was observed at some joints as shown in Figures 3.18(b) and (c), which might have occurred due to missing sealants, resulting in 'a high severity rating related to water infiltration criteria.' All the joints were also filled with dirt or other materials, which implies that the number affecting the SCN in terms of incompressible material is 'a high severity debris or stone retention rating.' Because of these two criteria for estimating the SCN, the SCN was estimated at 6.

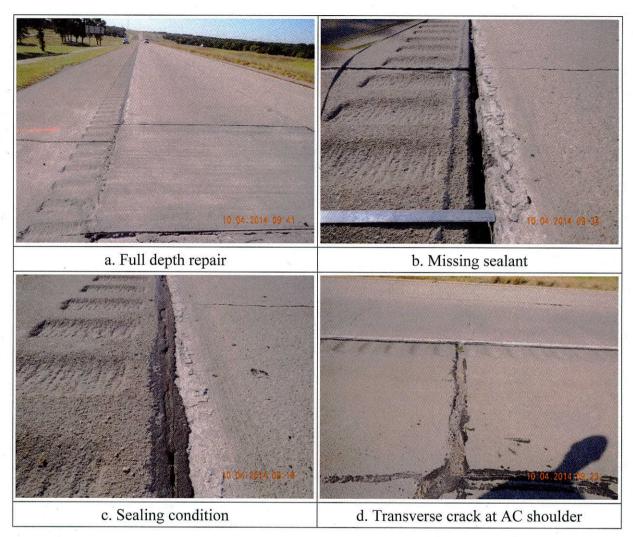
Figure 3.21 Sealant condition on US 287-WFS [NO. 51]

US 287 built in 1972 in the Wichita Falls District was investigated as shown in Figure 3.21. There were numerous Portland cement concrete patches (PCPs) observed as shown in Figure 3.21(a). This pavement was built with asphalt shoulder. Joint separations between outside lane and asphalt shoulder and resulting pumping were observed as shown in Figure 3.21(b). This magnitude of lane separation will allow water to get into layers under the concrete slab, degrading the durability of the slab support and causing pavement distress. Figure 3.21(c) shows sealing with hot pour asphalt to prevent gaps at a joint. Cracking was also observed in the asphalt shoulder as shown in Figure 3.21(d), which could allow rain water to get into the pavement system. It is important to keep the joints between concrete main lanes and asphalt shoulders as tight as possible in order to prevent or minimize water infiltration. Since there are no good means available to keep the concrete lanes and asphalt shoulders tight, the best option would be to keep the joints sealed.

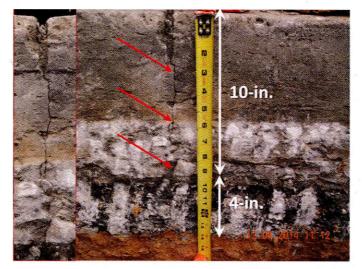
Figure 4.6 Joint condition on SH 288

little deficient; however, a crack developed under the saw cut. The overall condition of the joint was good.

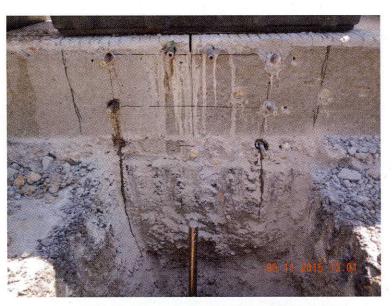
Figure 4.19 Joint condition before gage installation

Figure 4.19 shows joint condition after one day of concrete placement, which was September 11, 2015. It shows quite shallow saw cut depth at the edge of the slab. The cut is shallow because the concrete was placed with forms, and the saw cut operation was stopped a few inches away from the form. However, the saw cut depth was adequate through the joint except at the edge of pavement as shown in Figure 4.20. Figure 4.19 shows a crack already developed at the bottom of the saw cut.

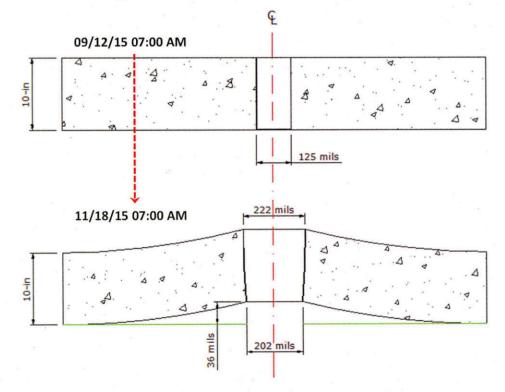
Figure 4.25 Actual joint shape at Joint #2

curing, with no built-in curling at that point. Figure 4.25 shows an increase in joint width as well as curling of the concrete slabs. Over five week period, joint widths at the top and bottom of the slab increased by about 78% and 62%, respectively. A vertical displacement was measured at 36 mils due to curling effect. It is expected that concrete will continue to shrink, increasing joint width. Whether the current extension requirement for joint sealant in TxDOT DMS-6310 is adequate will depend on how much additional drying shrinkage will take place. It is difficult to obtain information on the variations in joint width from the setting of fresh concrete. It is strongly recommended that TxDOT continue to collect data from this experiment and analyze data for the refinement of the requirements in DMS-6310.
