Pavement Repair Strategies for Selected Distresses in FM Roadways

Technical Report 0-6589-1

1. Report No. FHWA/TX-11/0-6589-1	2. Government Accession No.	3. Recipient's Catalog No.	
4. Title and Subtitle PAVEMENT REPAIR STRATEGIES FOR SELECTED DISTRESSES IN FM ROADWAYS		5. Report Date Published: June 2012

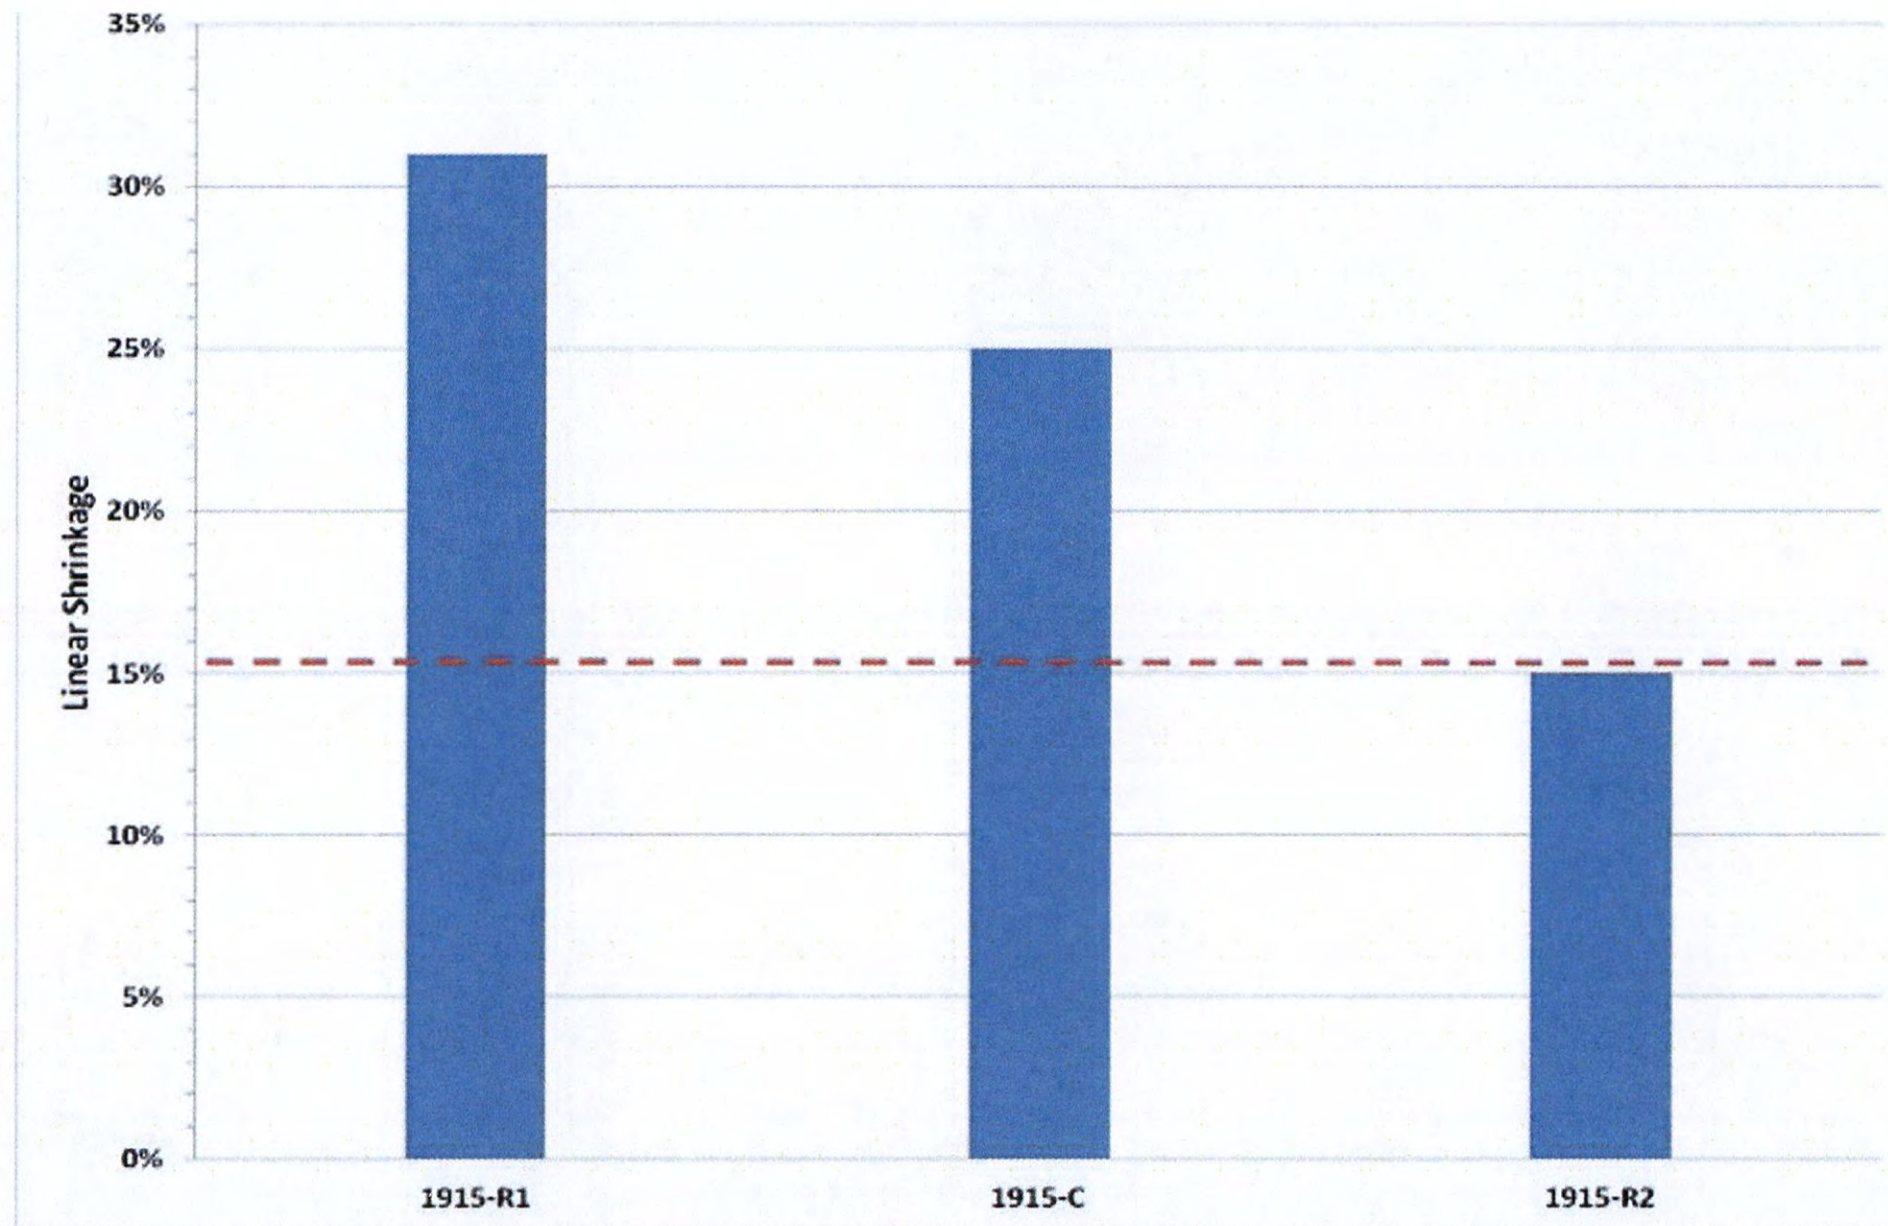
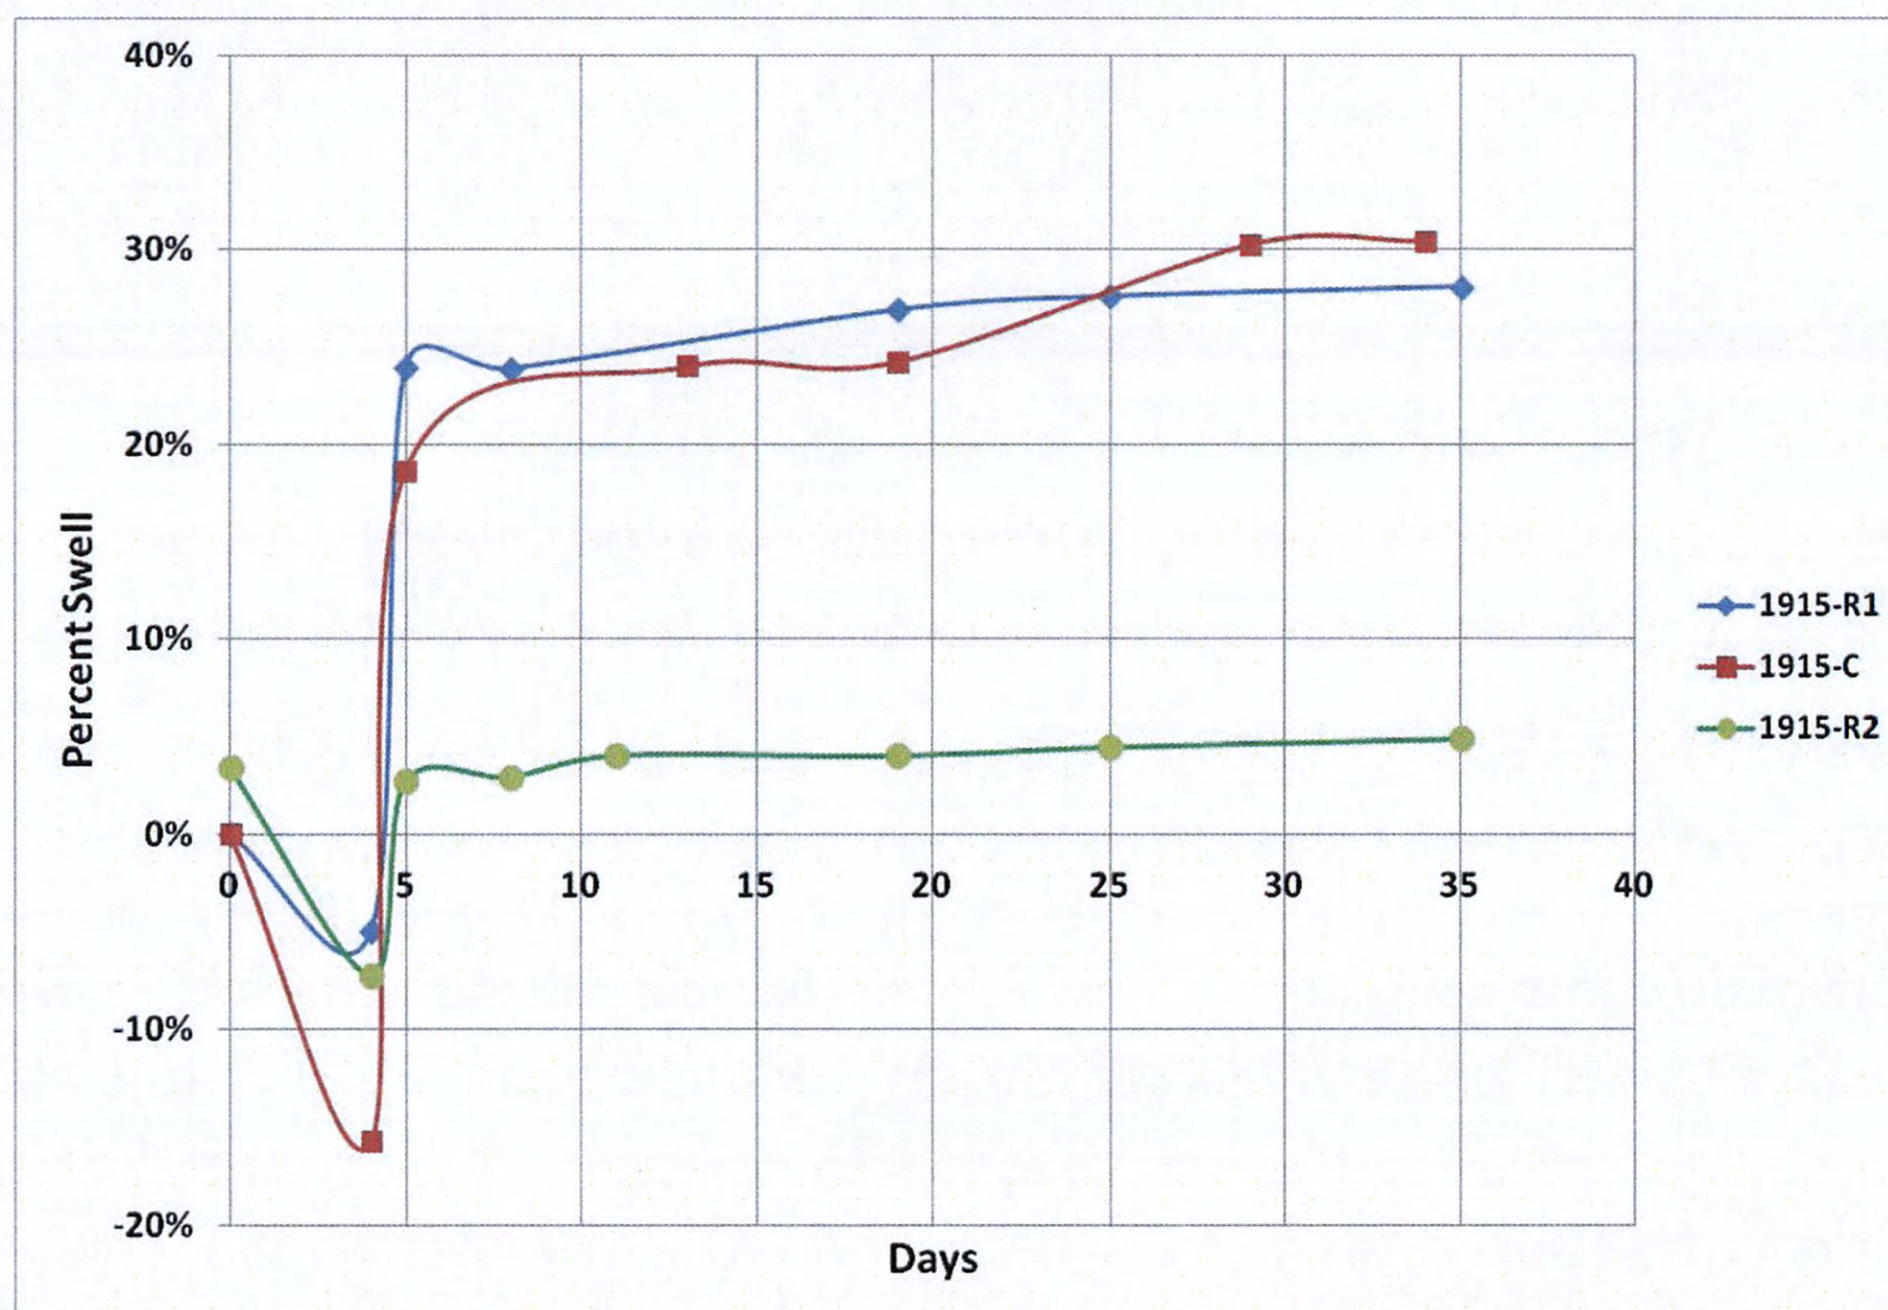
Figures 4.3 and 4.4 indicated that the subgrade of sections 1915-R1 and 1915-C was more prone to shrink in higher extent than that in section 1915-R2. This seems to be consistent with GPR data interpretation, FWD and DCP data analysis, and field visual survey. Considering the severe shrinkage potential of 1915-R1 soils, geogrid reinforcement alleviates soil movement to some extent, where a relatively lesser extent of damage was observed compared to control section. Swelling test protocol states that the lime treatment should reduce 3-D swell to 7 percent or less. From this perspective, the soils in sections 1915-R1 and 1915-C are required to be stabilized to prevent further damage.

Figure 4.3. Shrinkage Test Results of FM 1915 Subgrade.

Figure 4.4. Variation of Percent Swell versus Time of FM 1915 Subgrade.

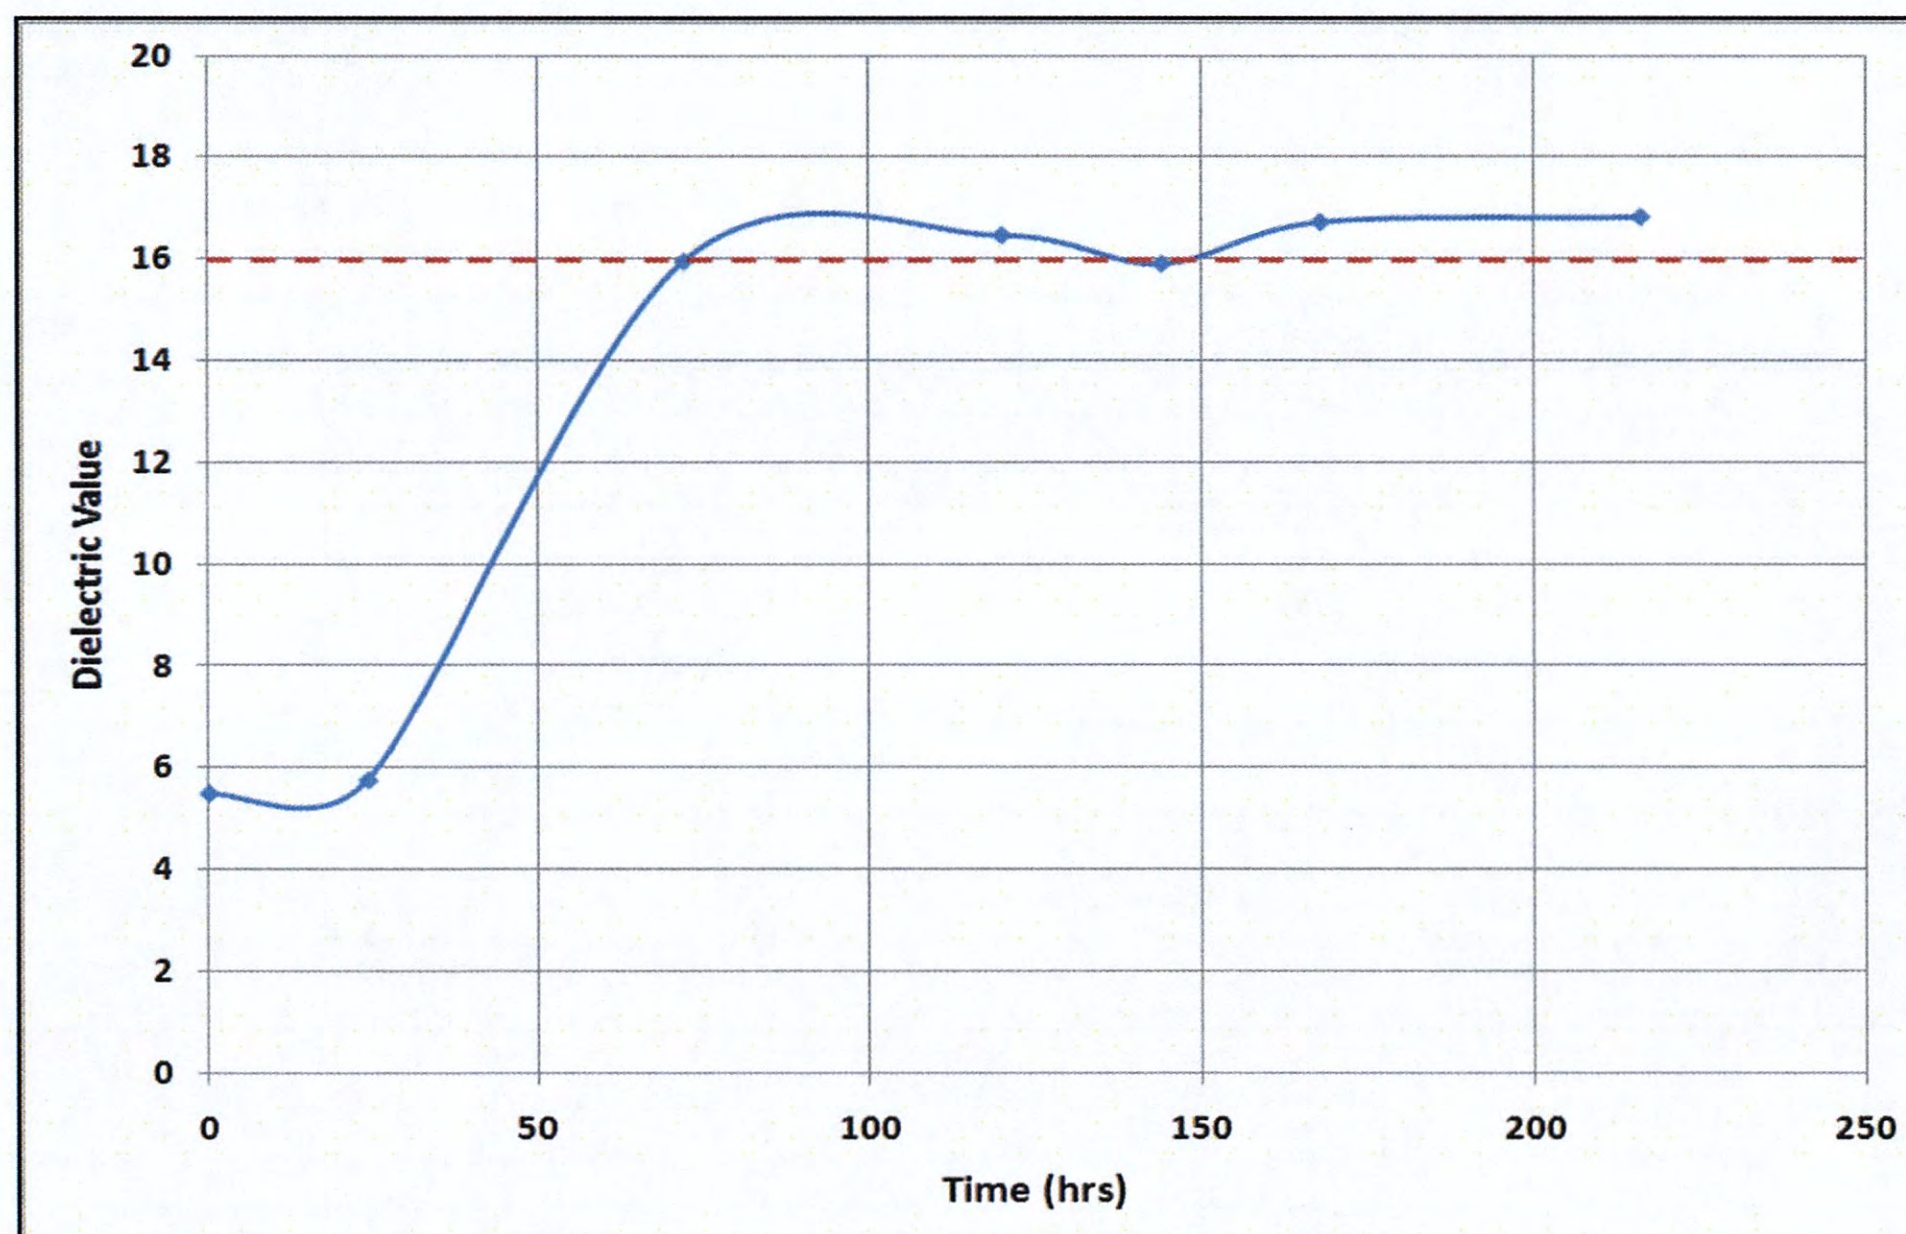
Figure 4.6. Tube Suction Test Results of FM 1915 Base.

The tube suction test on the base material revealed a dielectric value (DV) slightly over 16 after 72 hrs. of soaking as shown in Figure 4.6. This figure indicated that the base material can be classified as high moisture susceptible material according to the tentative guideline provided by Barbu and Scullion (2006).

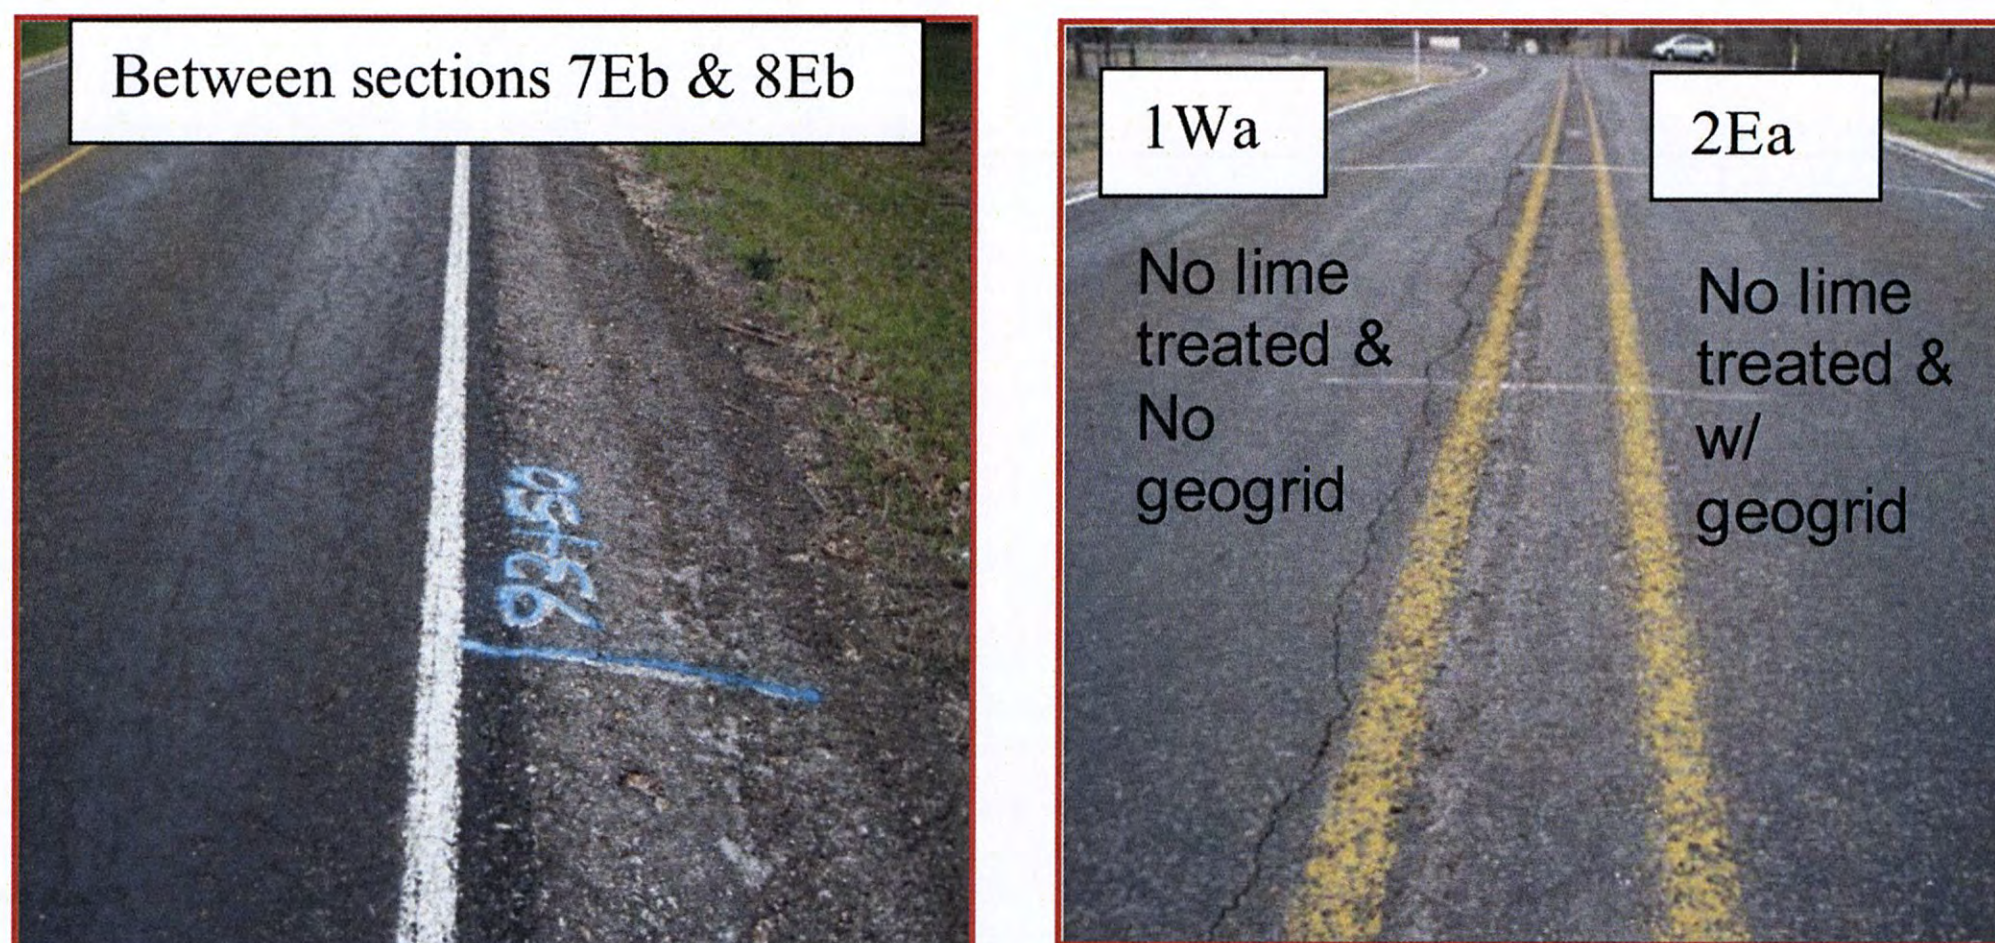
Figure 4.9. Longitudinal Cracks Detected in FM 2.

were detected at several locations (Figure 4.9), the section in both directions has performed well based on the review of video log files taken during the GPR survey and several visual surveys. Detail of the survey can be found in Appendix C. Researchers also reviewed PMIS data of corresponding segment and found that the test segment has exhibited excellent performance history since 2005 (Table 4.5).

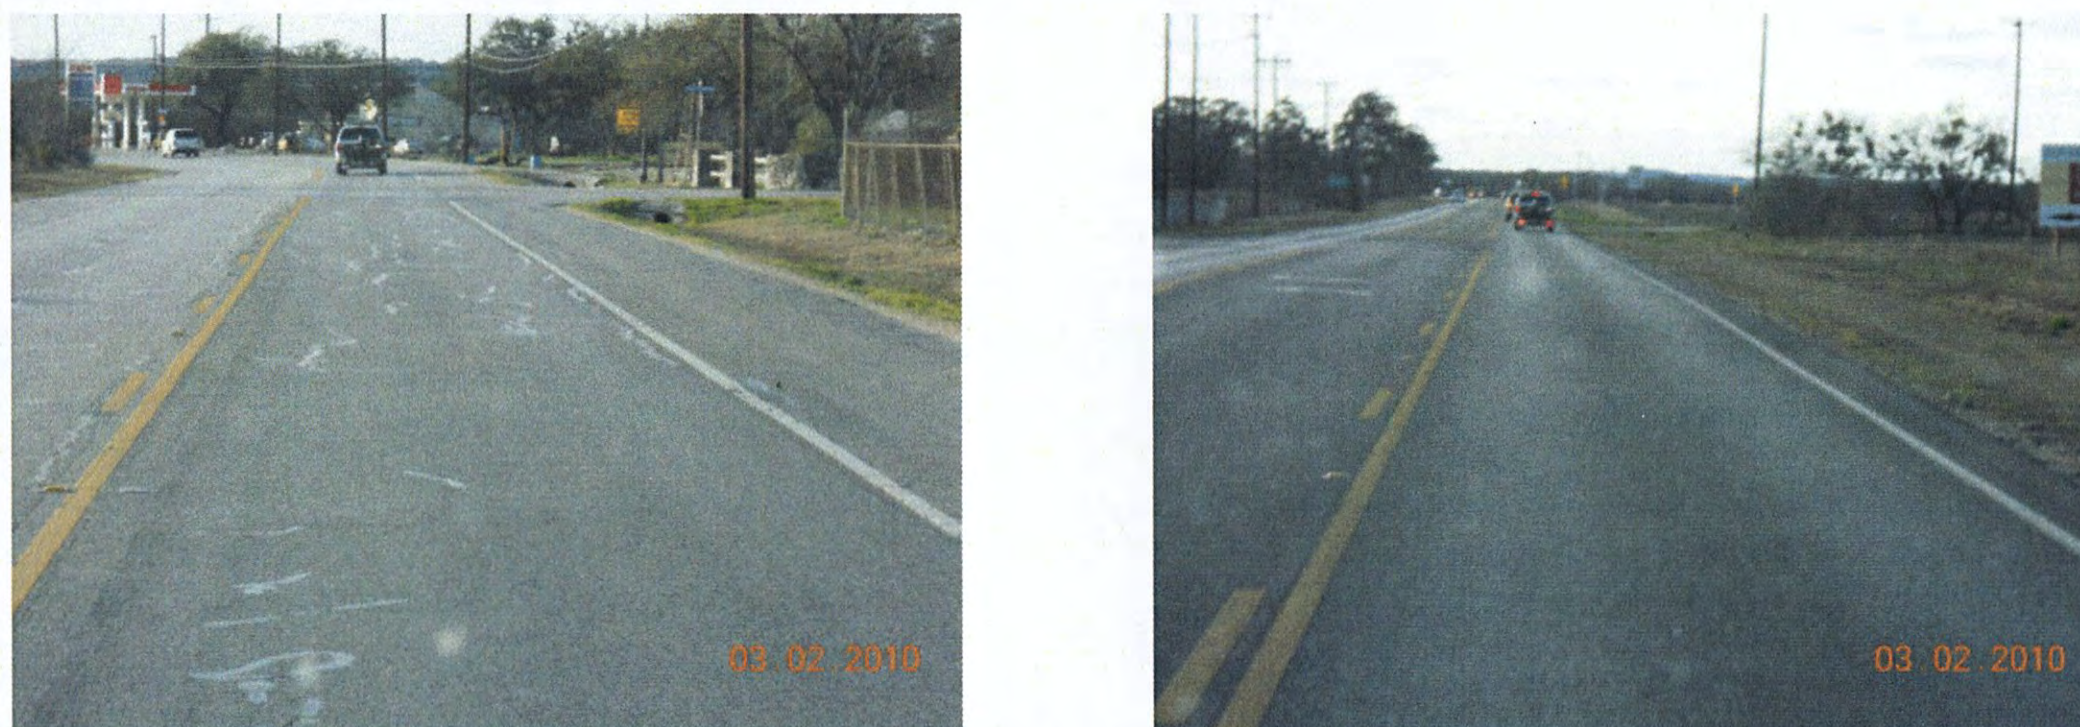
Figure 4.11. Surface Condition Showing Rutting and Cracking in the Wheel Path at the Control (left) and Distress-Free at the Reconstructed (right) Sections.

(shown in Figure 4.11) while cracks (sealed) and rutting was noticed in the control section particularly along the wheel paths.

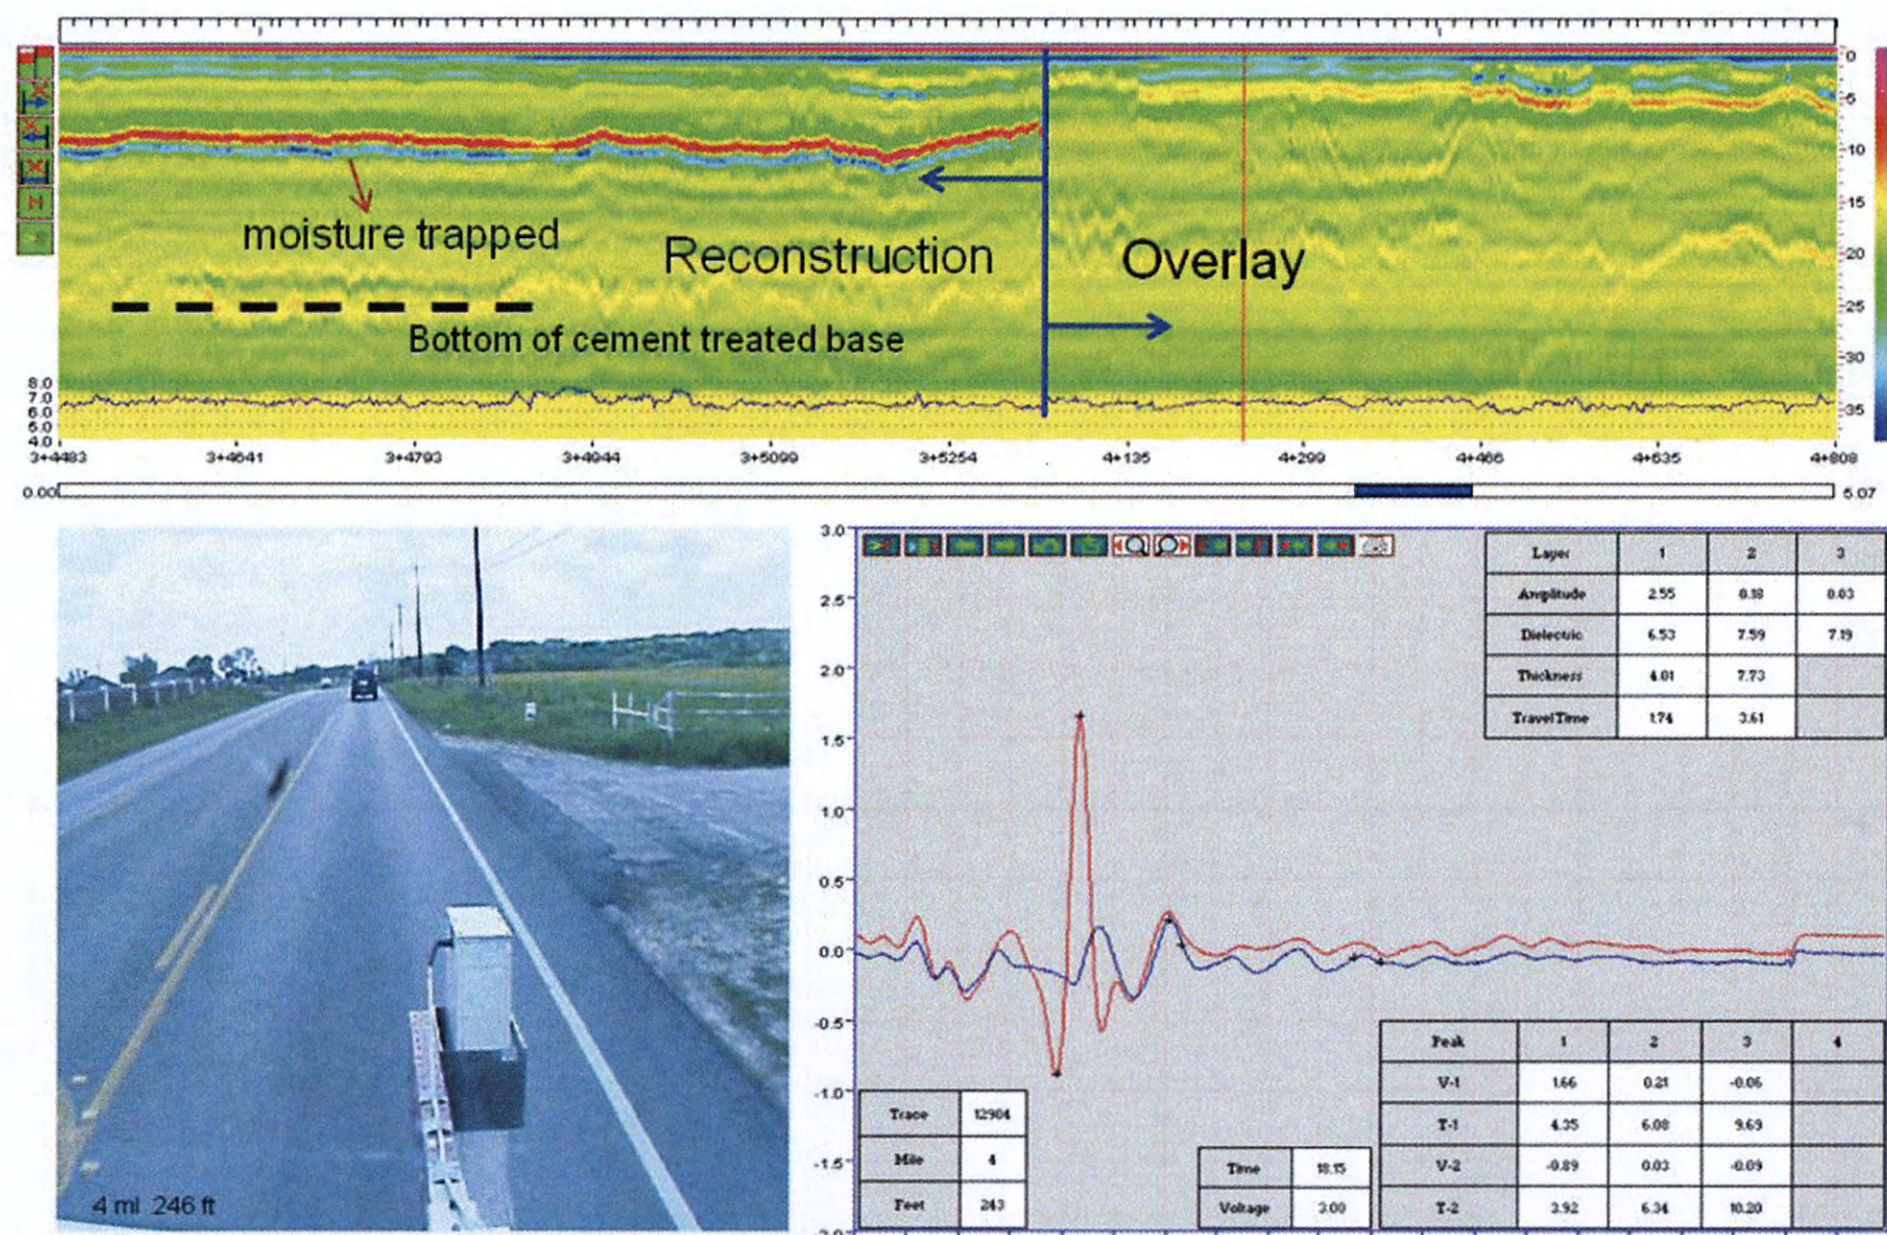
Figure 4.12. GPR Data between Reconstruction and Overlay Section.

treated base layers that may result in moisture induced damage of the asphalt pavement. There was no evidence that this damage was reflected on the surface during the field evaluation.

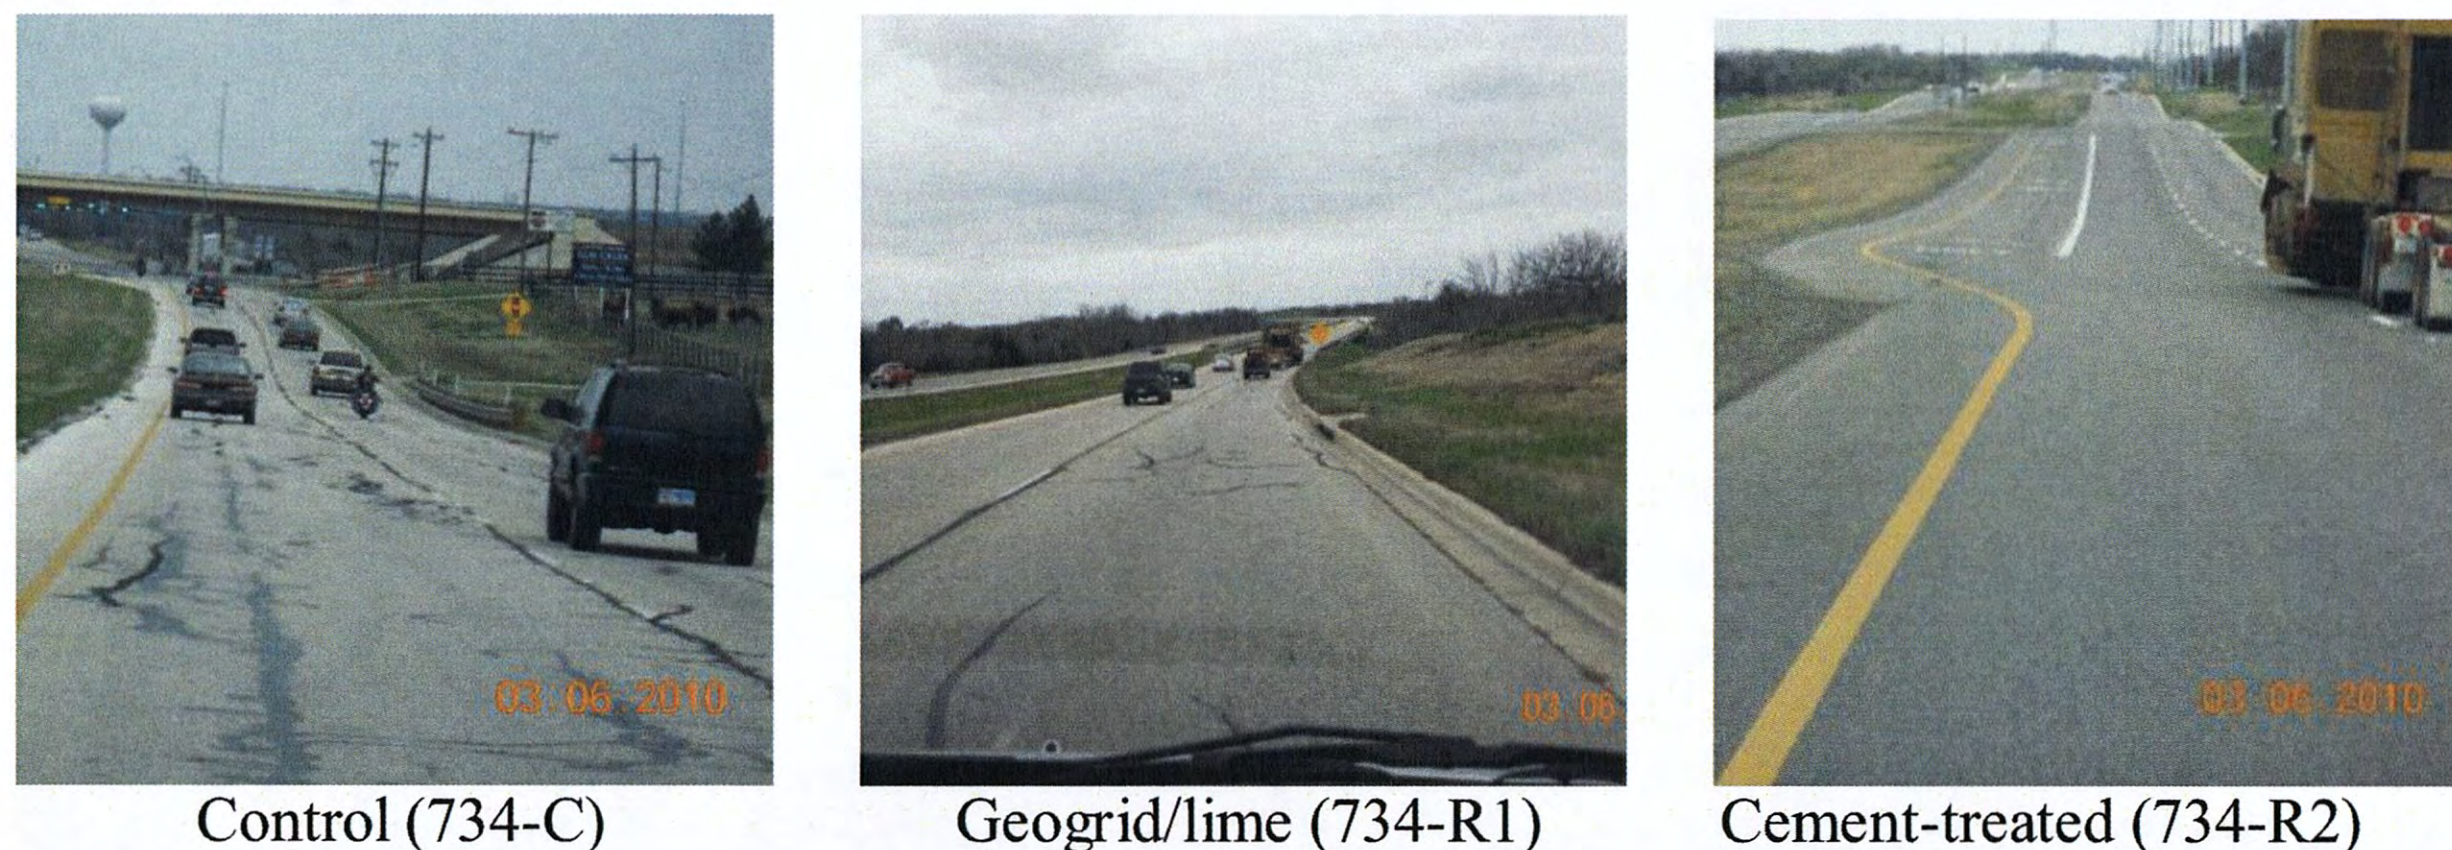
Figure 4.14. FM 734 Test Sections Surface Conditions.

Severe surface cracking is evident in the control section with poor ride quality while the geogrid section has only minor surface cracking. There was no sign of distresses at the cement treated reconstructed section as shown in Figure 4.14.

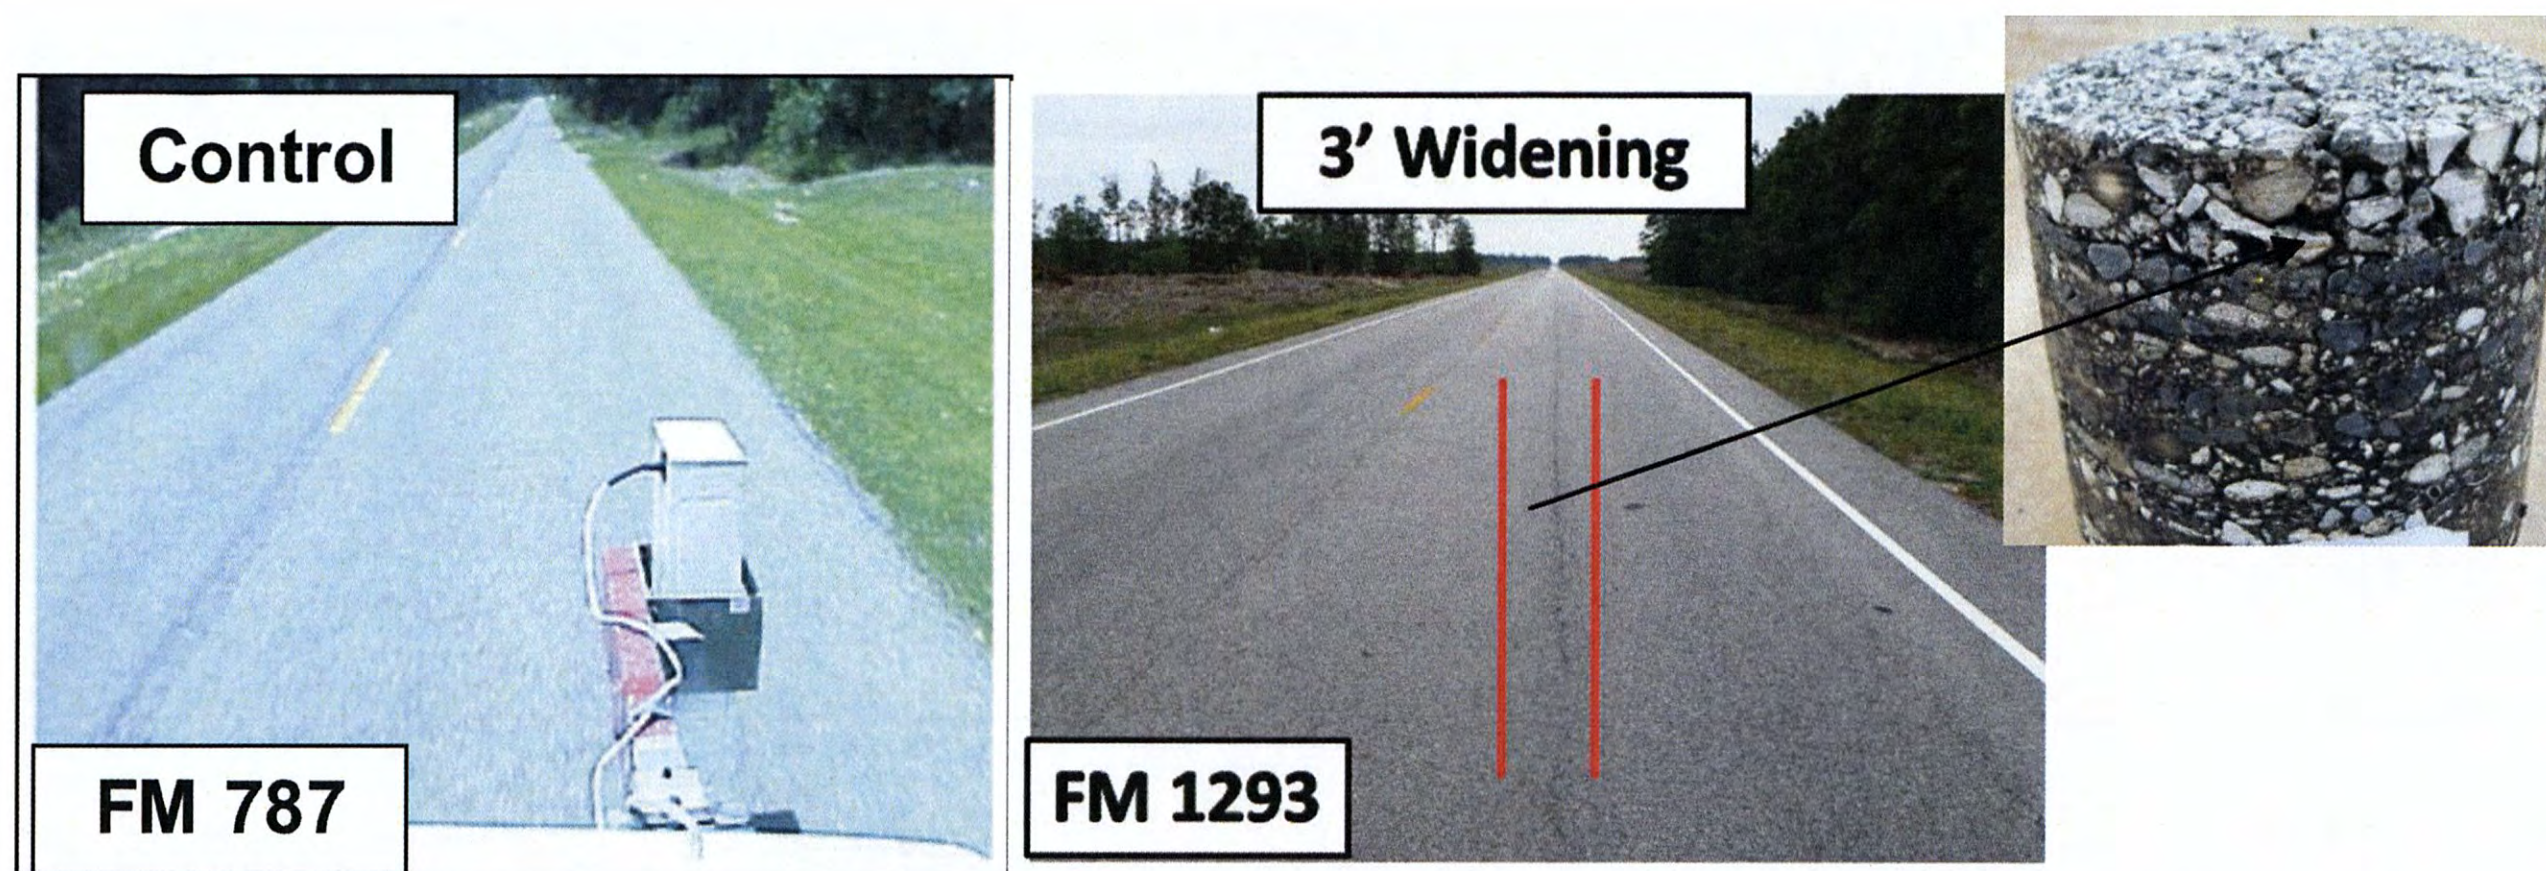
Figure 4.16. Surface Condition Indicated Distress-Free Narrow Pavement at Control Section and Longitudinal Cracking at Widened Section.

Visual survey indicated that the control section (787-C) experienced shallow rutting and fatigue cracking at the wheel path. The widened section (1283-W) experienced surface cracking that is attributed to segregation of the 1.5" overlay (Figure 4.16). No evidence of cracking in the 787-W section.

From the GPR survey, it was recognized that the widened section in FM 1293 exhibited better ride quality than the control FM 787. However, the GPR images suggested that the pavement could become rougher in the near future due to a possible moisture infiltration in the asphalt layer, as denoted by the GPR signals (Figures C-17 to C-18). The DCP was not performed in this site due to the granular nature of the base and subgrade materials. Table 4.14 shows the FWD backcalculation results. It was found that the layer moduli of 1293-W was higher than the 787-W sections. This could explain the structural-related damage in the form of rutting and fatigue cracking in the wheel path of the widened section 787-W.
