Pavement Repair Strategies for Selected Distresses in FM Roadways

Technical Report 0-6589-1

1. Report No. FHWA/TX-11/0-6589-1	2. Government Accession No.	3. Recipient's Catalog No.	
4. Title and Subtitle PAVEMENT REPAIR STRATEGIES FOR SELECTED DISTRESSES IN FM ROADWAYS		5. Report Date Published: June 2012

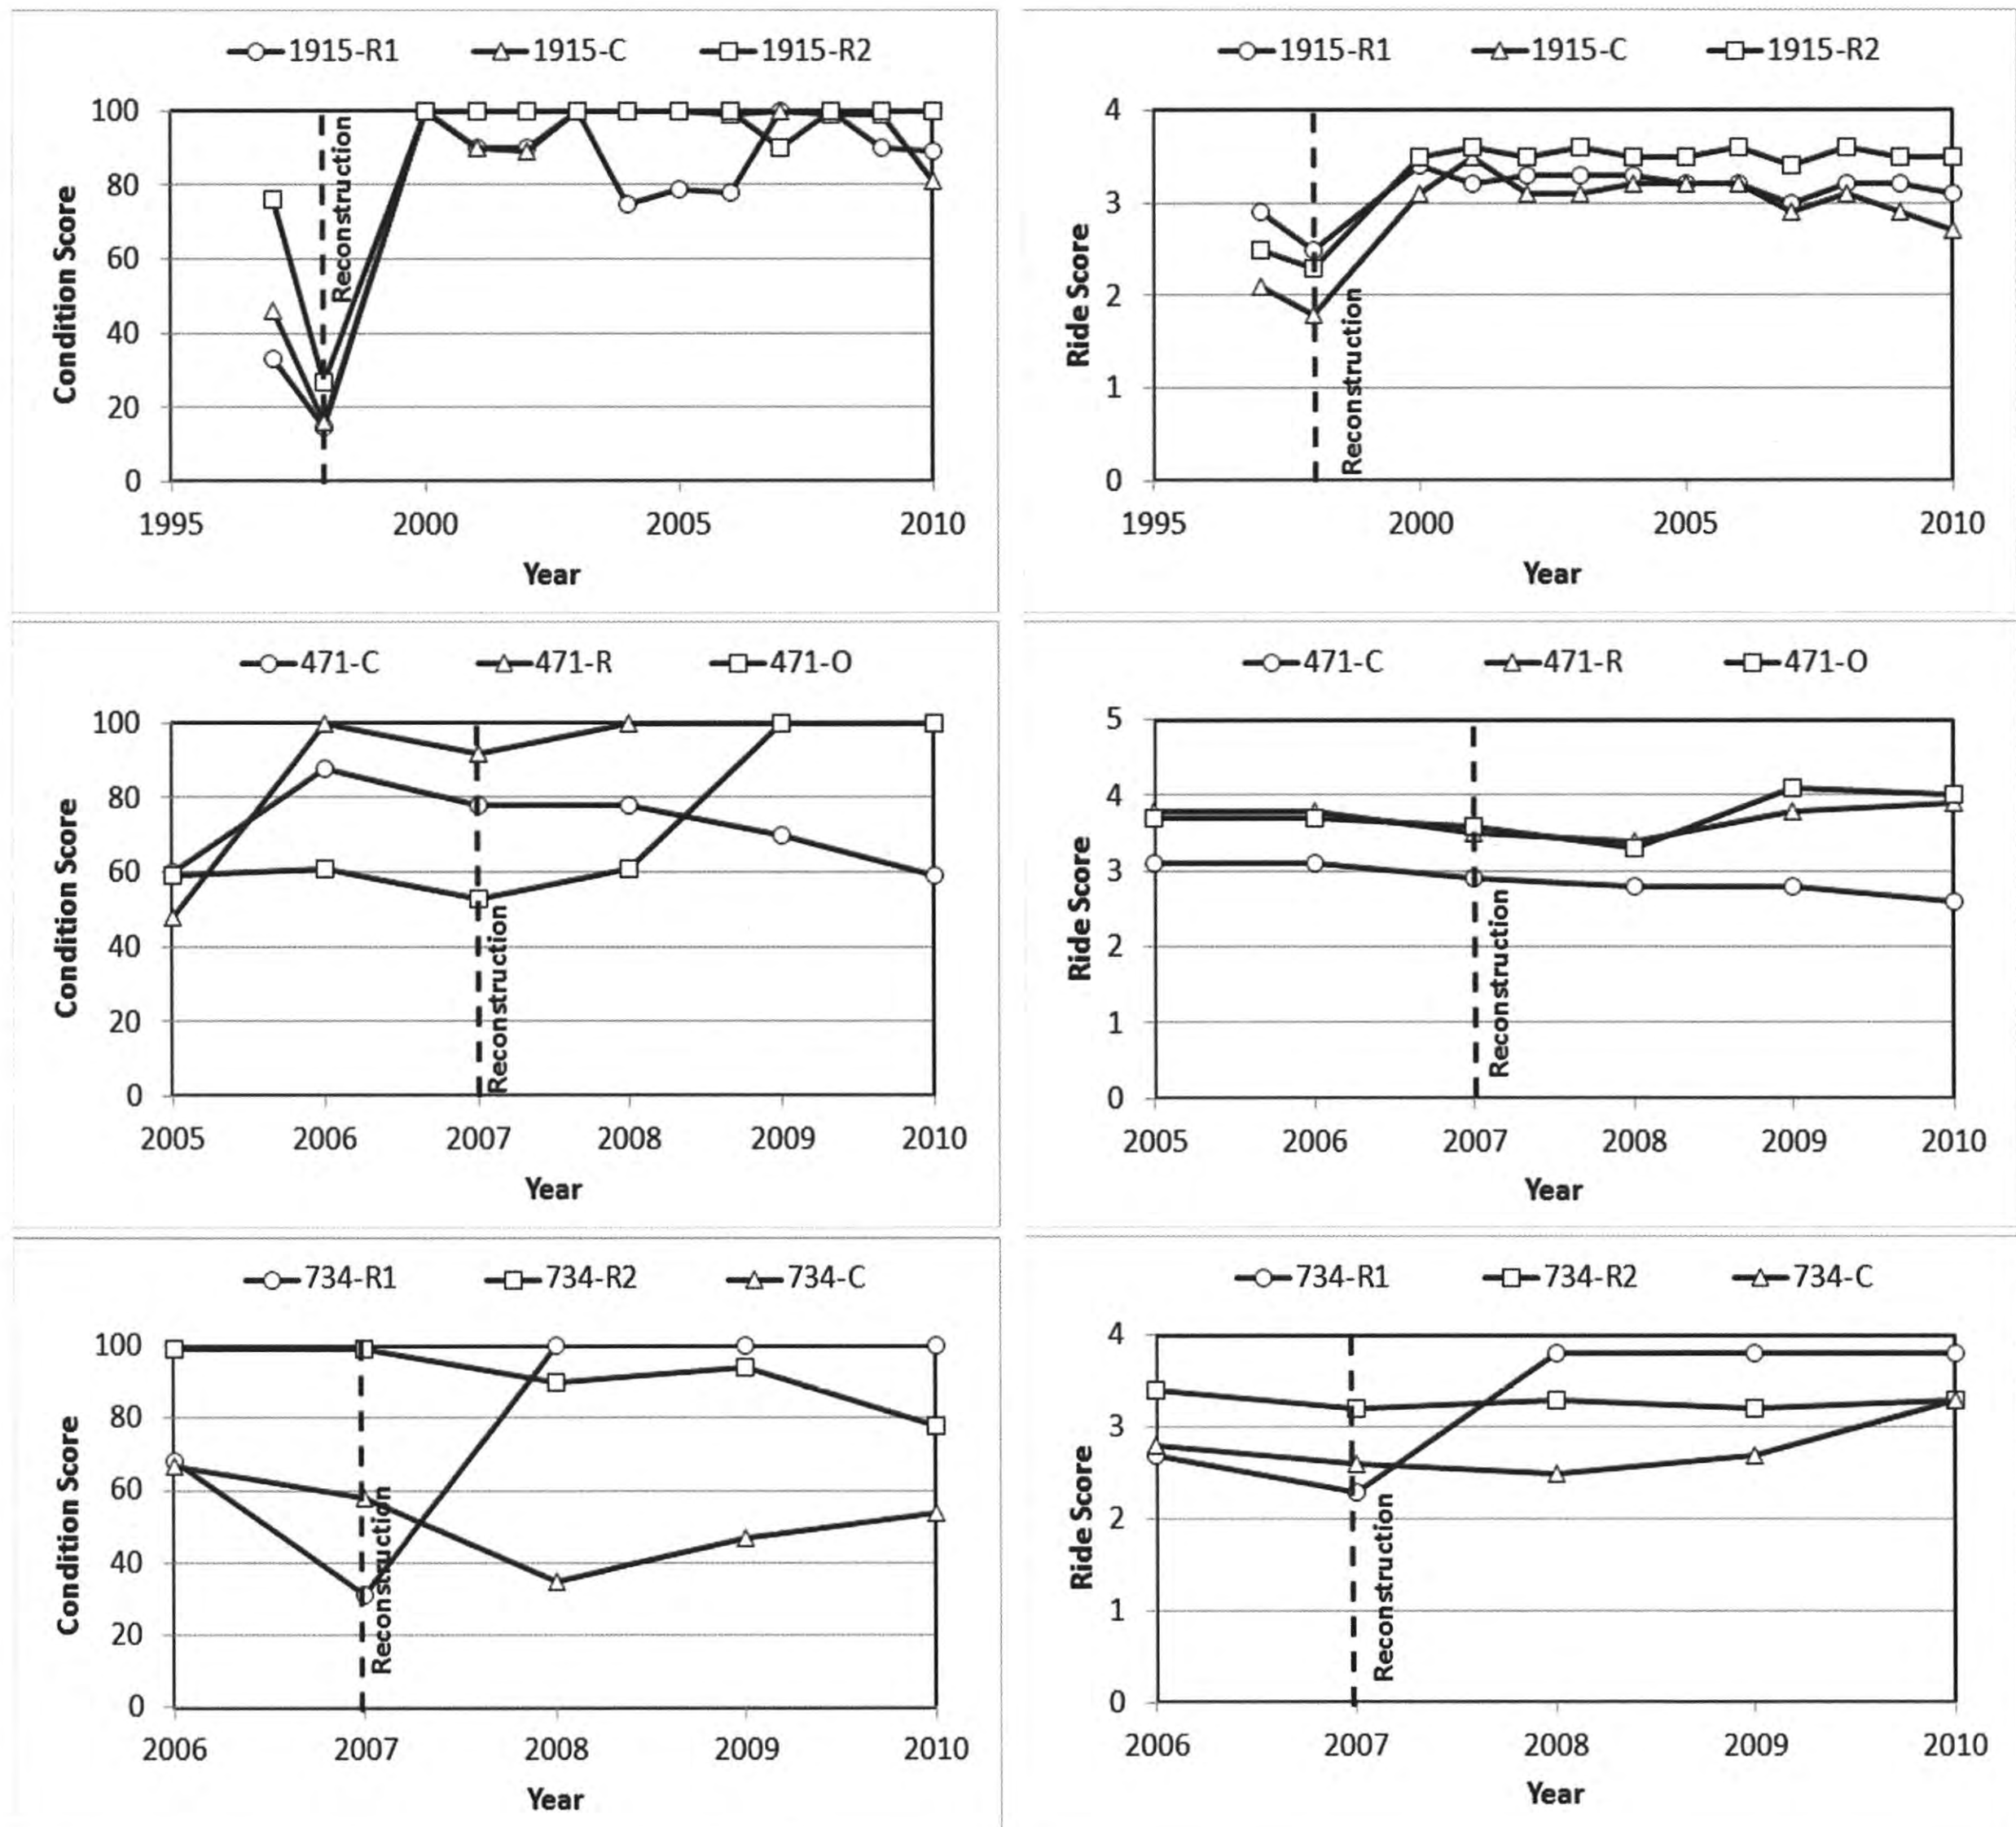
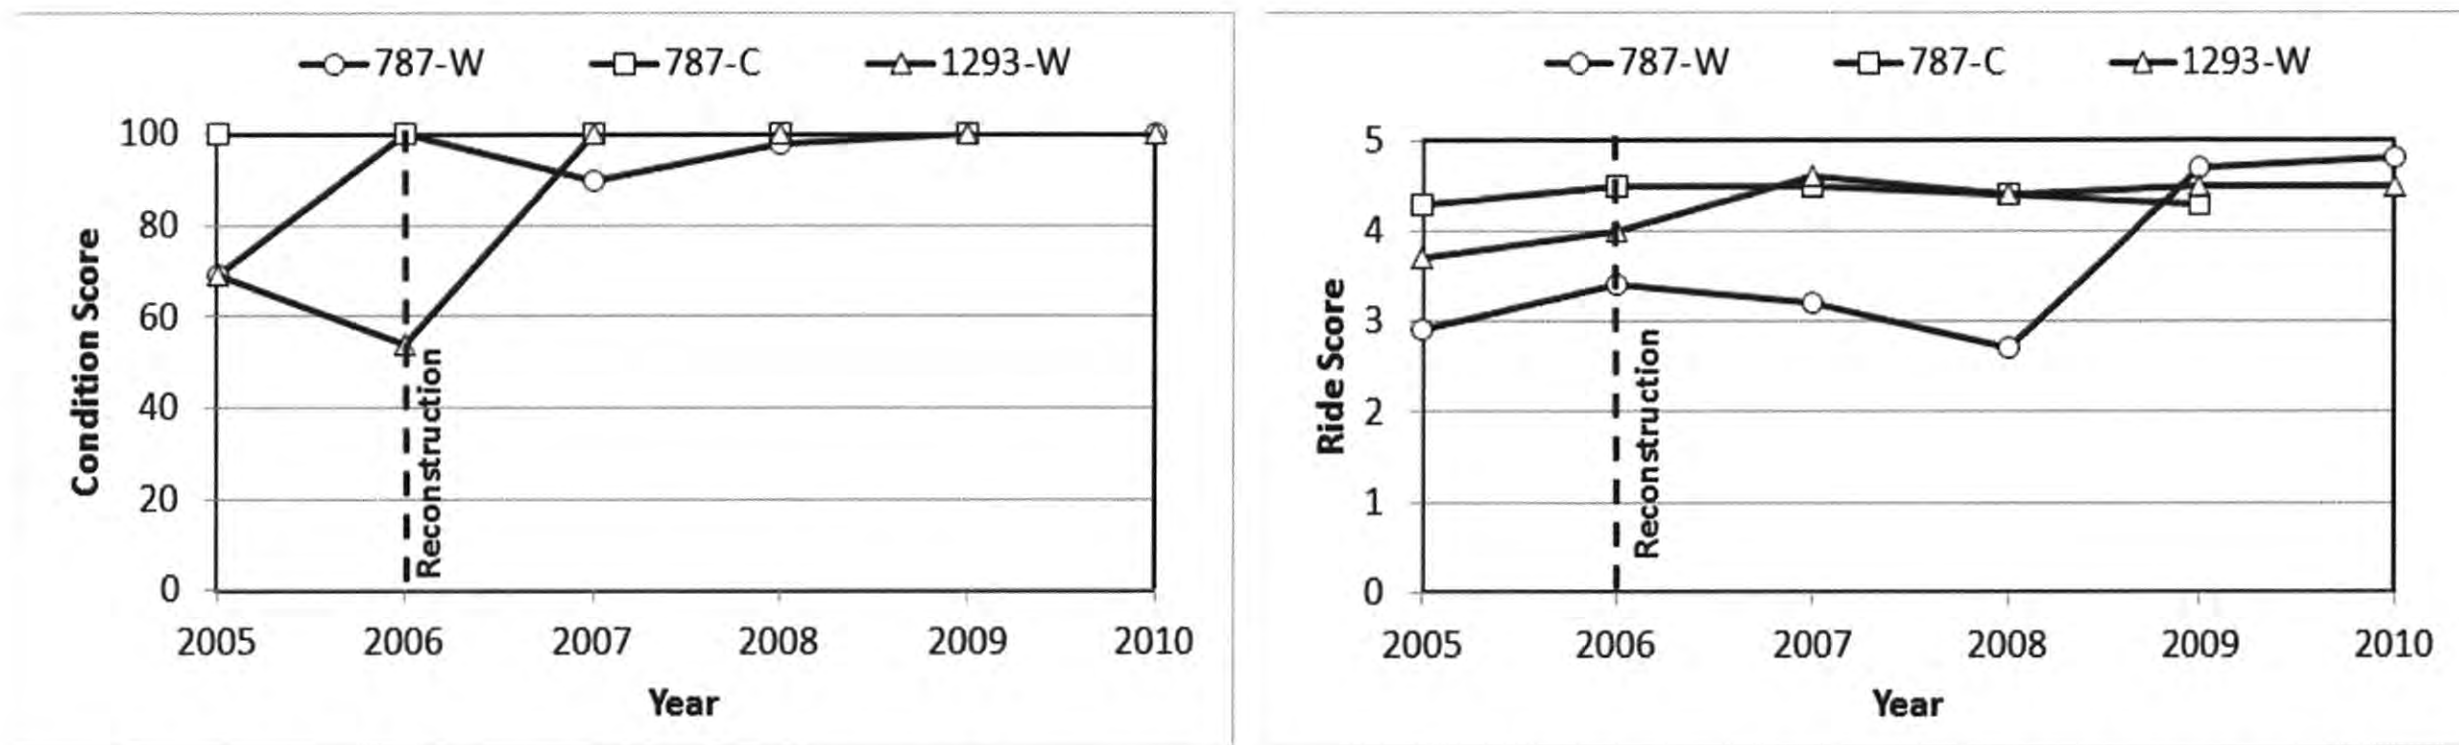
Figure 4.22. The Condition Scores and Ride Scores Before and After the Reconstruction.

Figure 4.22 suggest that the condition score and ride scores have significantly increased after the repair was taken place at each site. With regard to the expansive soil sites the treatment of cement-treated base, lime treated subgrade with geogrid and overlay were considered in this study. One can notice the effectiveness of the cement-treated base (471-R and FM 734-R2). Although this treatment was showing higher scores against the expansive soil conditions and the heavy traffic, it is a very costly repair. Geogrid at base-subgrade interface was also an effective treatment against expansive soil. Geogrid effectiveness is increased when combined with lime treated subgrade (734-R1). This repair is also costly but with less degree than in cement treatment base. On other hand, the overlay has also shown acceptable performance (471-O) and could be considered one of less costly treatments. With regard to the edge failure, only one site was investigated. It seems that incorporating the lateral support with overlay increases the performance scores of the pavement (787-W and 1293-W).

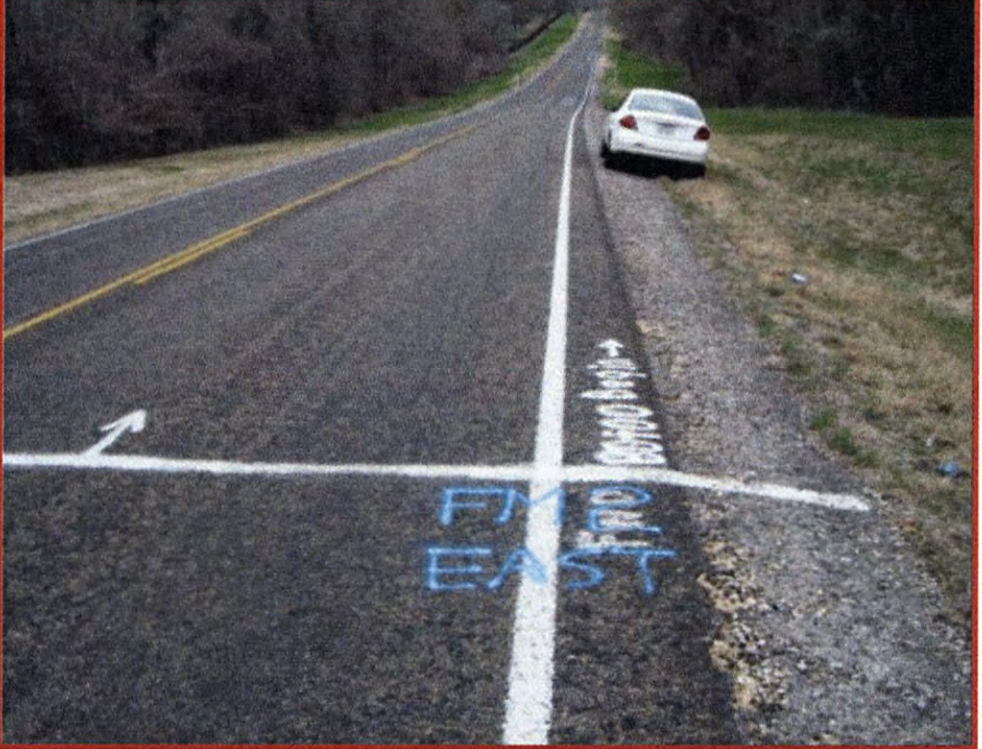
89+00 ~ 98+00	<p>Area surveyed: 5Wb: No geosynthetic w/lime treatment 6Wb: Geogrid 1 w/lime treatment 7Eb: Geogrid 2 w/lime treatment 8Eb: Geotextile w/lime treatment</p> <p>There were some longitudinal (edge) cracks which were repaired on eastbound lane, no cracks are on westbound lane.</p>
