Treatments to Reduce the Frequency of Freeway Exit Sign Hits

Technical Report 0-6120-1

1. Report No. FHWA/TX-11/0-6120-1		2. Government Accession No.		3. Recipient's Catalog No.	
4. Title and Subtitle TREATMENTS TO REDUCE THE FREQUENCY OF FREEWAY EXIT SIGN HITS				5. Report Date January 2011 Published: June 2011

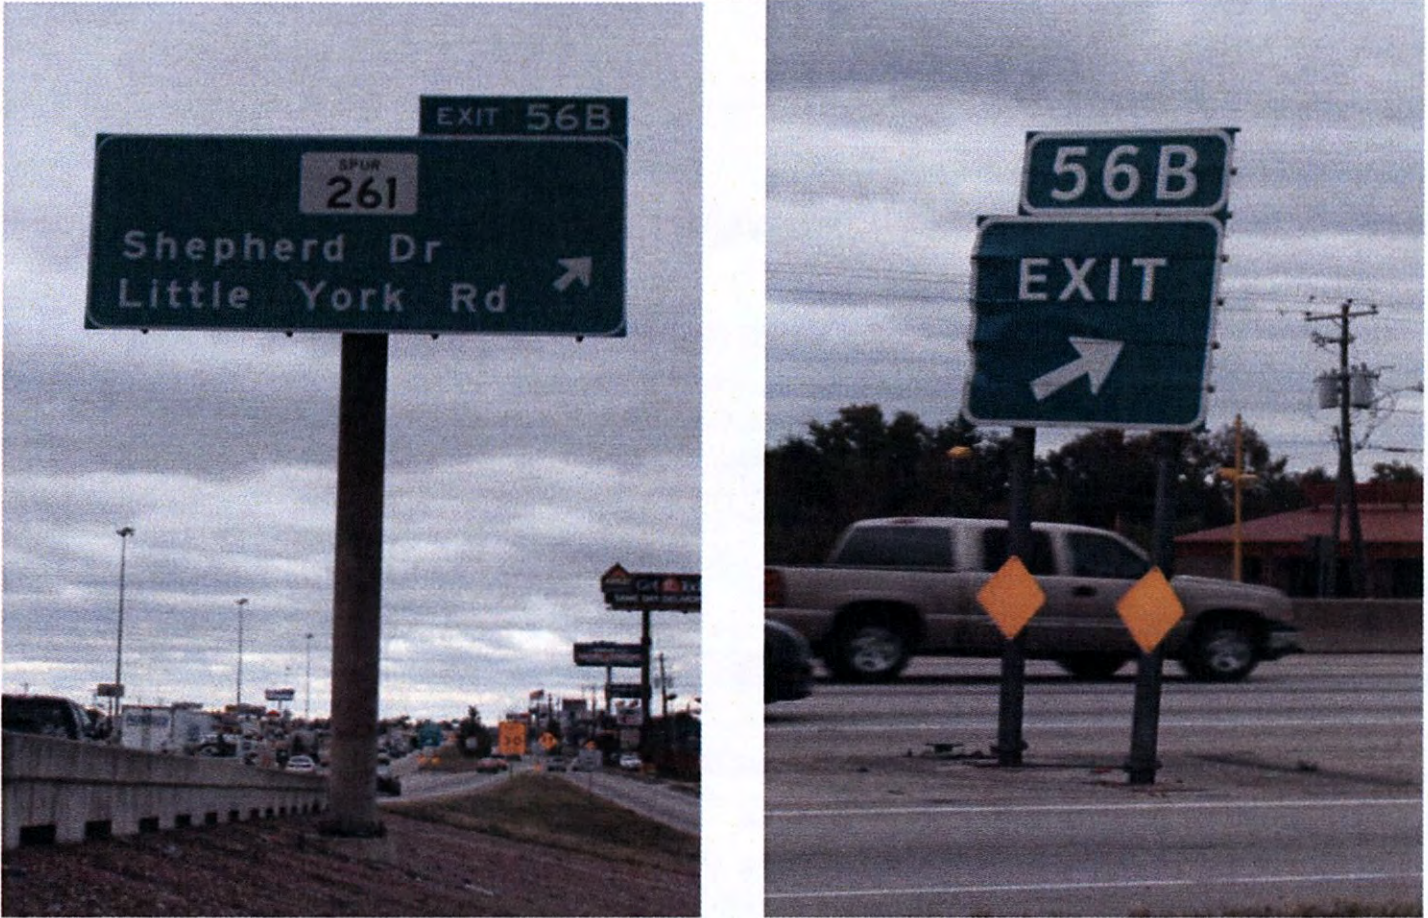
<p>Exit Direction sign shown on left. Exit Gore sign shown on right; note the use of diamond-shape reflectors on posts</p>
Key Distances from Painted Gore	
Advance Guide Sign (1/2 mi)	+2660 ft
Advance Guide Sign (METRO)	+2370 ft
Exit Direction Sign	+220 ft
Exit Gore Sign	-250 ft
Average Speeds (mph)	
Non-Exiting Traffic (lane 4)	56.5
Exiting Traffic	51.6
Speed Limits (mph)	
Main Lanes	65
Exit Ramp Advisory	30

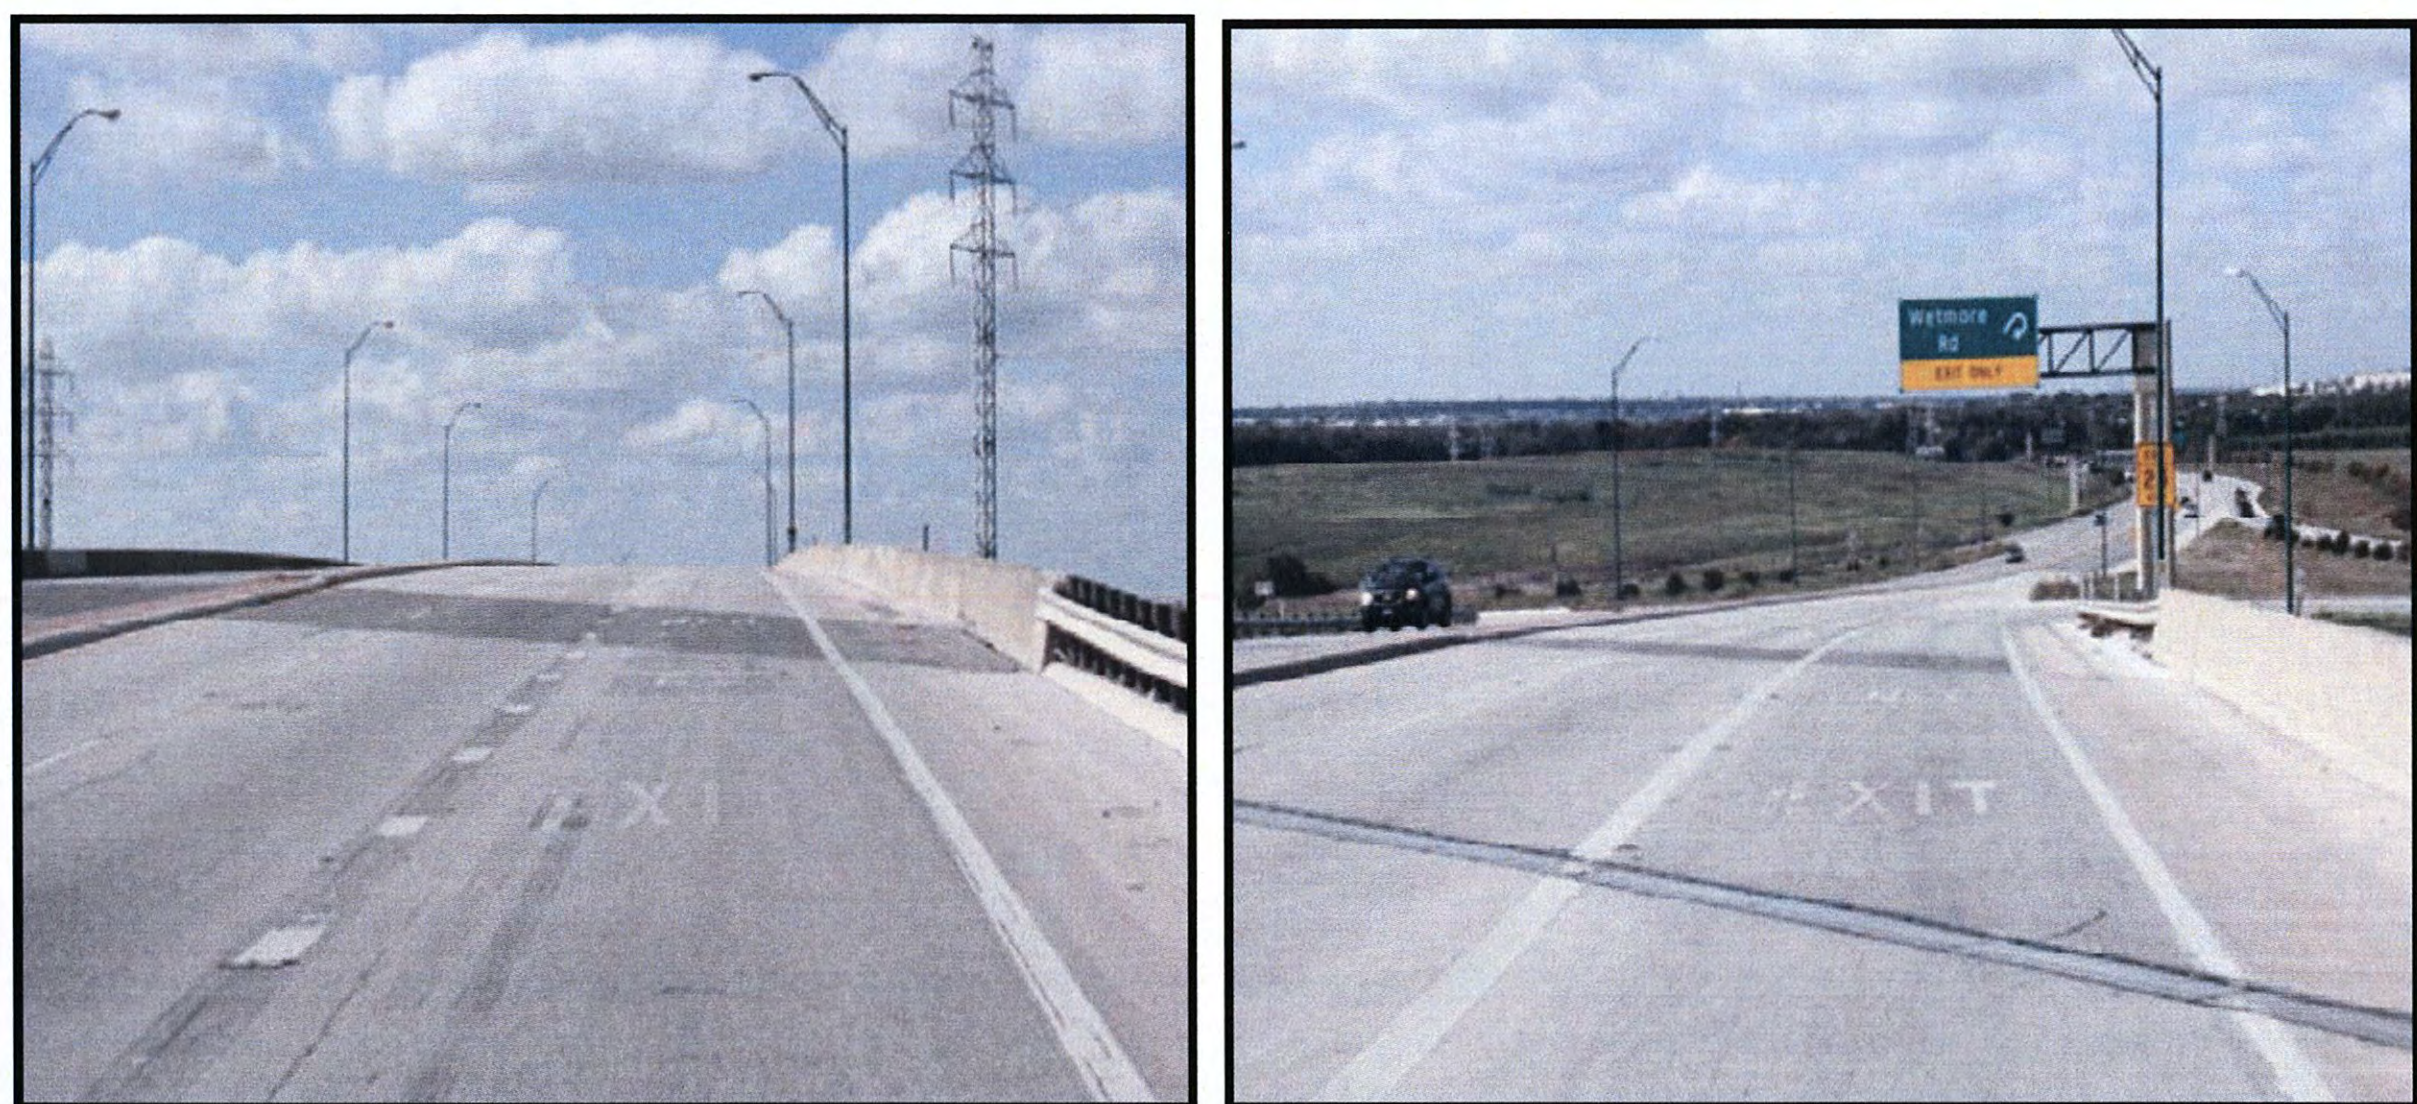
Figure 18. Example of a Potential Hazard—Steep Grade before an Exit.

Roadway conditions requiring significant deceleration were also taken into account. These include inadequate superelevation, sharp horizontal curve, steep grade, inadequate shoulder, lane drop, and lane width reductions. Figure 18 illustrates an example of a steep grade approaching an exit. Posted and advisory speeds were recorded and operating speeds were measured for each location. This allowed researchers to determine the adequacy of existing sight distances. Field staff also assessed the visibility of potential hazards at each site.

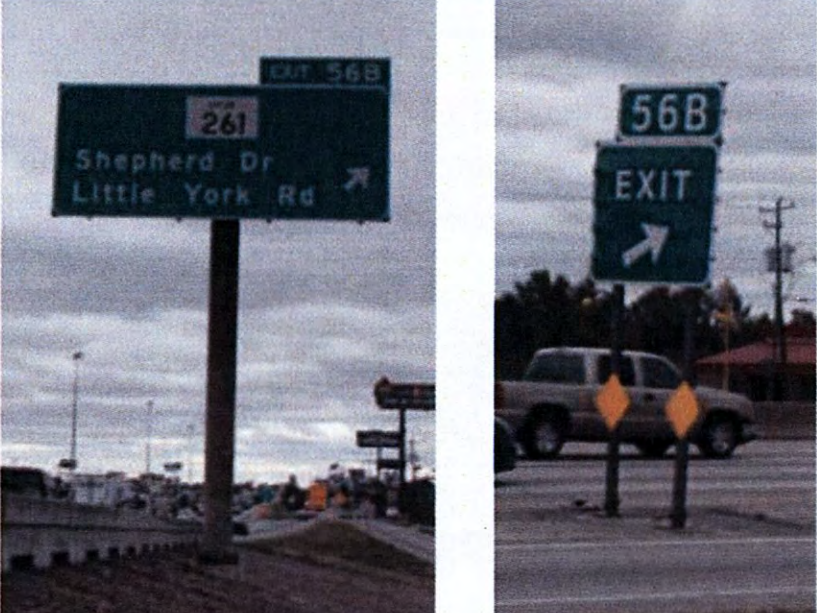
<p>Exit Direction Sign shown on left; Exit Gore Sign on right; note the use of type 1 object markers on posts</p>
<i>Key Distances from Painted Gore</i>	
Advance Guide Sign (1/2 mi)	+2660 ft
Advance Guide Sign (METRO)	+2370 ft
Exit Direction Sign	+220 ft
Exit Gore Sign	-250 ft
<i>Distance at which exit gore sign is first visible to driver</i>	+1000 ft
Average Speeds (mph)	
Non-Exiting Traffic (lane 4)	56.5
Exiting Traffic	51.6
Speed Limits (mph)	
Main Lanes	65
Exit Ramp Advisory	30

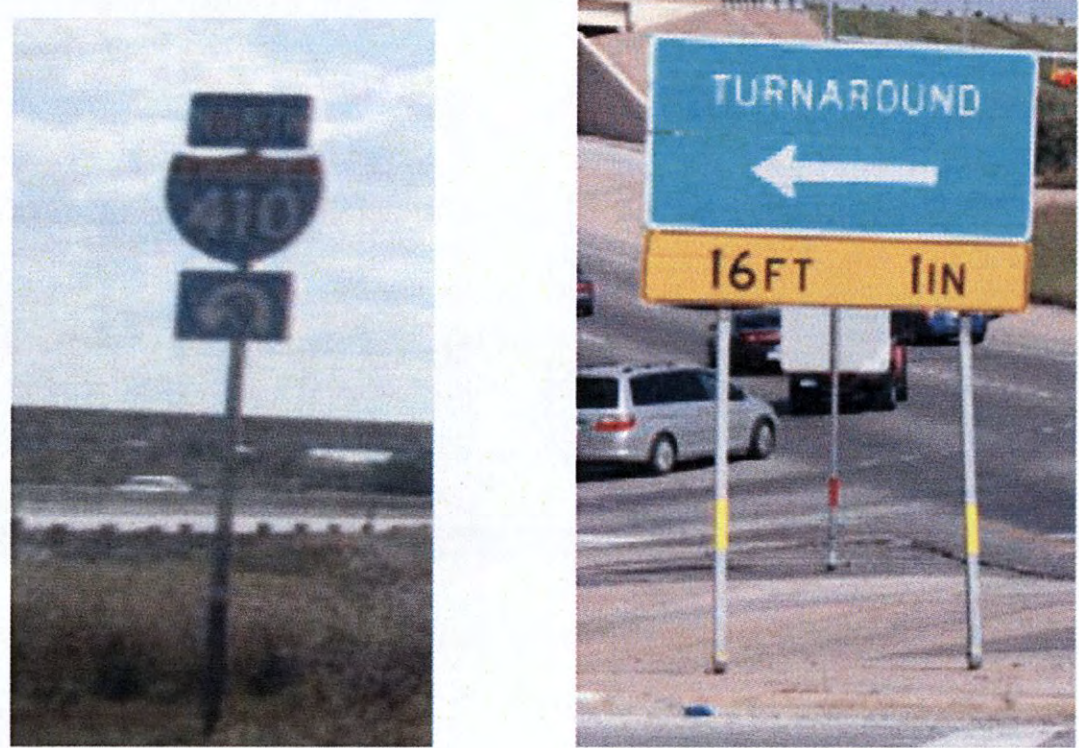
<p>Turnaround Guide Sign, Turnaround Gore Sign</p>
<i>Key Distances from Painted Gore</i>	
Turnaround Guide sign	+90 ft
Turnaround Gore sign	-181 ft
<i>Distance at which exit gore sign is first visible to driver</i>	~ 750 ft (at this distance, sign is barely visible with some visual clutter). At ~595 ft, turnaround sign is more clearly visualized with less clutter at this point
<i>Average Speeds (mph)</i>	
U-turn Exiting Traffic (at gore)	21
U-turn Traffic (upstream of gore)	28
<i>Speed Limits (mph)</i>	
Frontage Road	45
Turnaround Advisory	None
