CRASH TEST AND EVALUATION OF THE TxDOT T631 BRIDGE RAIL

Test Report 9-1002-12-10

The objective of this research was to evaluate the impact performance of the new TxDOT Type T631 bridge rail. The TxDOT Type T631 bridge rail is intended to serve as a low-cost replacement for the TxDOT Type T6 bridge rail for *MASH* TL-2 applications. The TxDOT T631 bridge rail is intended for new construction. The crash testing was performed in accordance with the requirements of *MASH* TL-2.

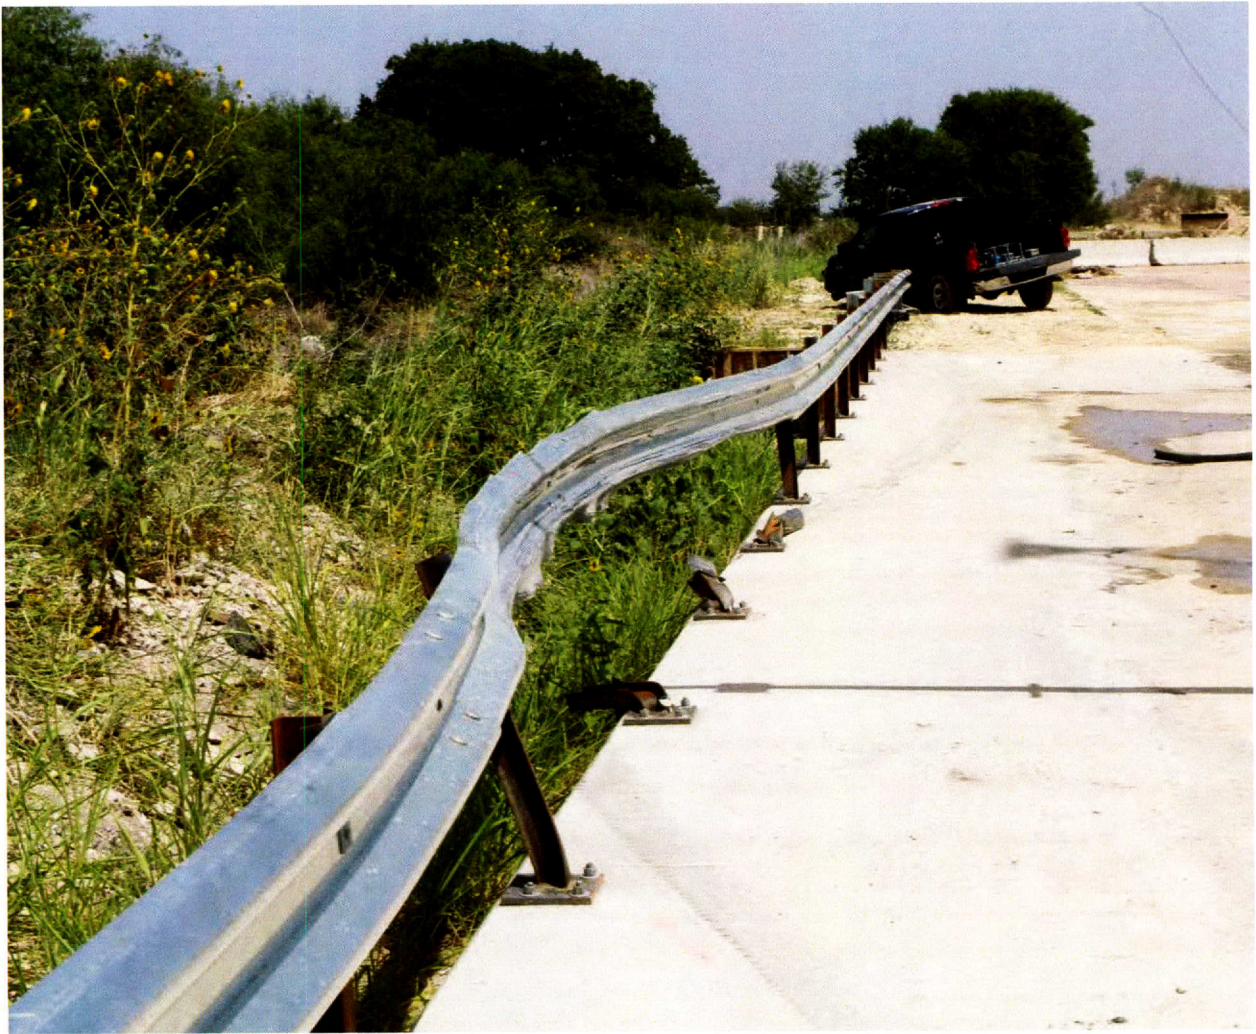
Figure 5.3. Test Article/Vehicle Positions after Test No. 490023-6-1a.

Post 1 was pulled downstream 0.25 inch, and Posts 10 and 11 were leaning toward the field side 2 degrees and 20 degrees, respectively. Posts 12 through 14 were leaning downstream 90 degrees; there was a partial tear at the base, and the rail separated from the posts. Post 15 was leaning towards the field side 5 degrees and downstream 14 degrees, and the rail separated from the post. The vehicle contacted the installation a second time at the downstream terminal post and anchor. Figures 5.3 and 5.4 show damage to the installation. The vehicle was in contact with the bridge rail 22.25 ft. Maximum dynamic deflection of the bridge rail was 25.7 inches, and permanent deformation was 21.5 inches. Working width was 30.0 inches, and vehicle intrusion was 28.8 inches.

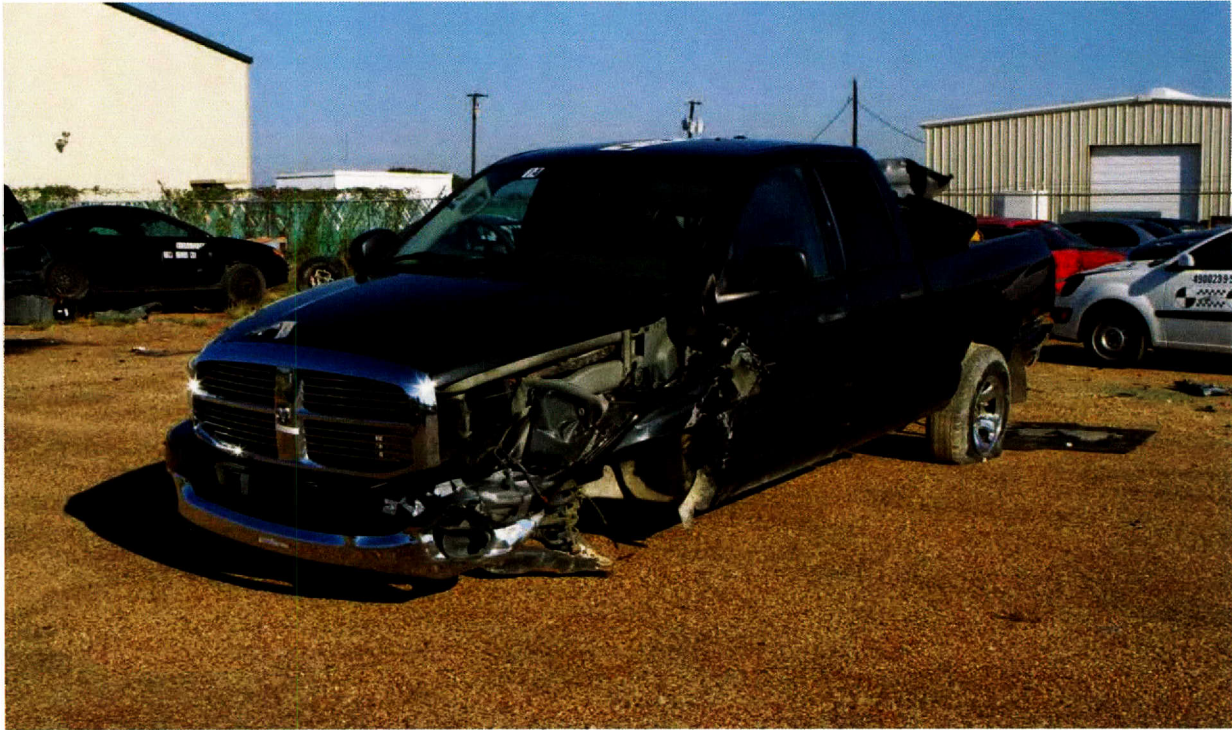
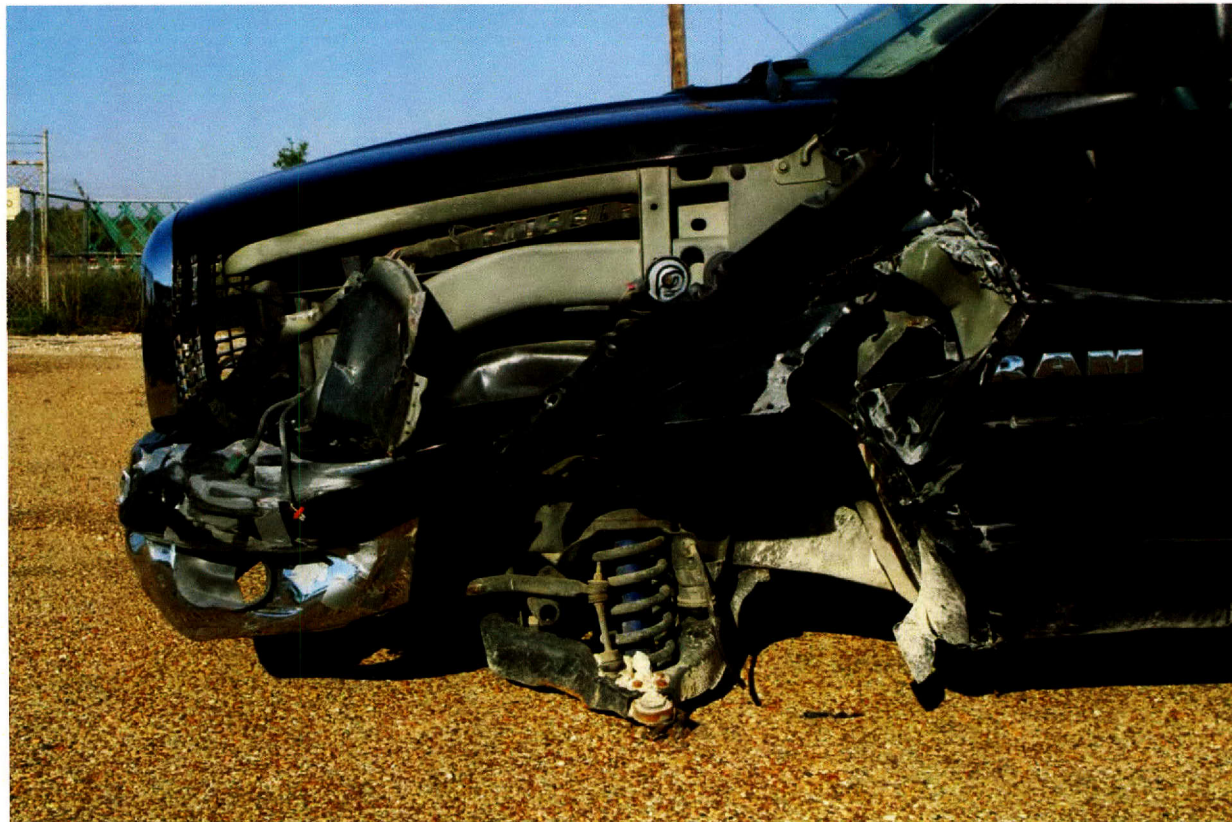
Figure 5.5. Vehicle after Test No. 490023-6-1a.

Figure 5.5 shows damage to the exterior of the vehicle. The left front wheel assembly broke from the upper and lower ball joints; the left upper and lower ball joints, A-arms, and left front tie rod end were deformed. Also damaged were the front bumper, left front fender, left front brake line, left front door, left front tire and wheel rim, left rear tire, left rear exterior bed, and the left rear bumper. Maximum exterior crush to the vehicle was 6 inches in the side plane at the left front corner at bumper height. No occupant compartment deformation or intrusion occurred. Figure 5.6 provides photographs of the interior of the vehicle. Tables C3 and C4 in Appendix C provide exterior crush and occupant compartment measurements.

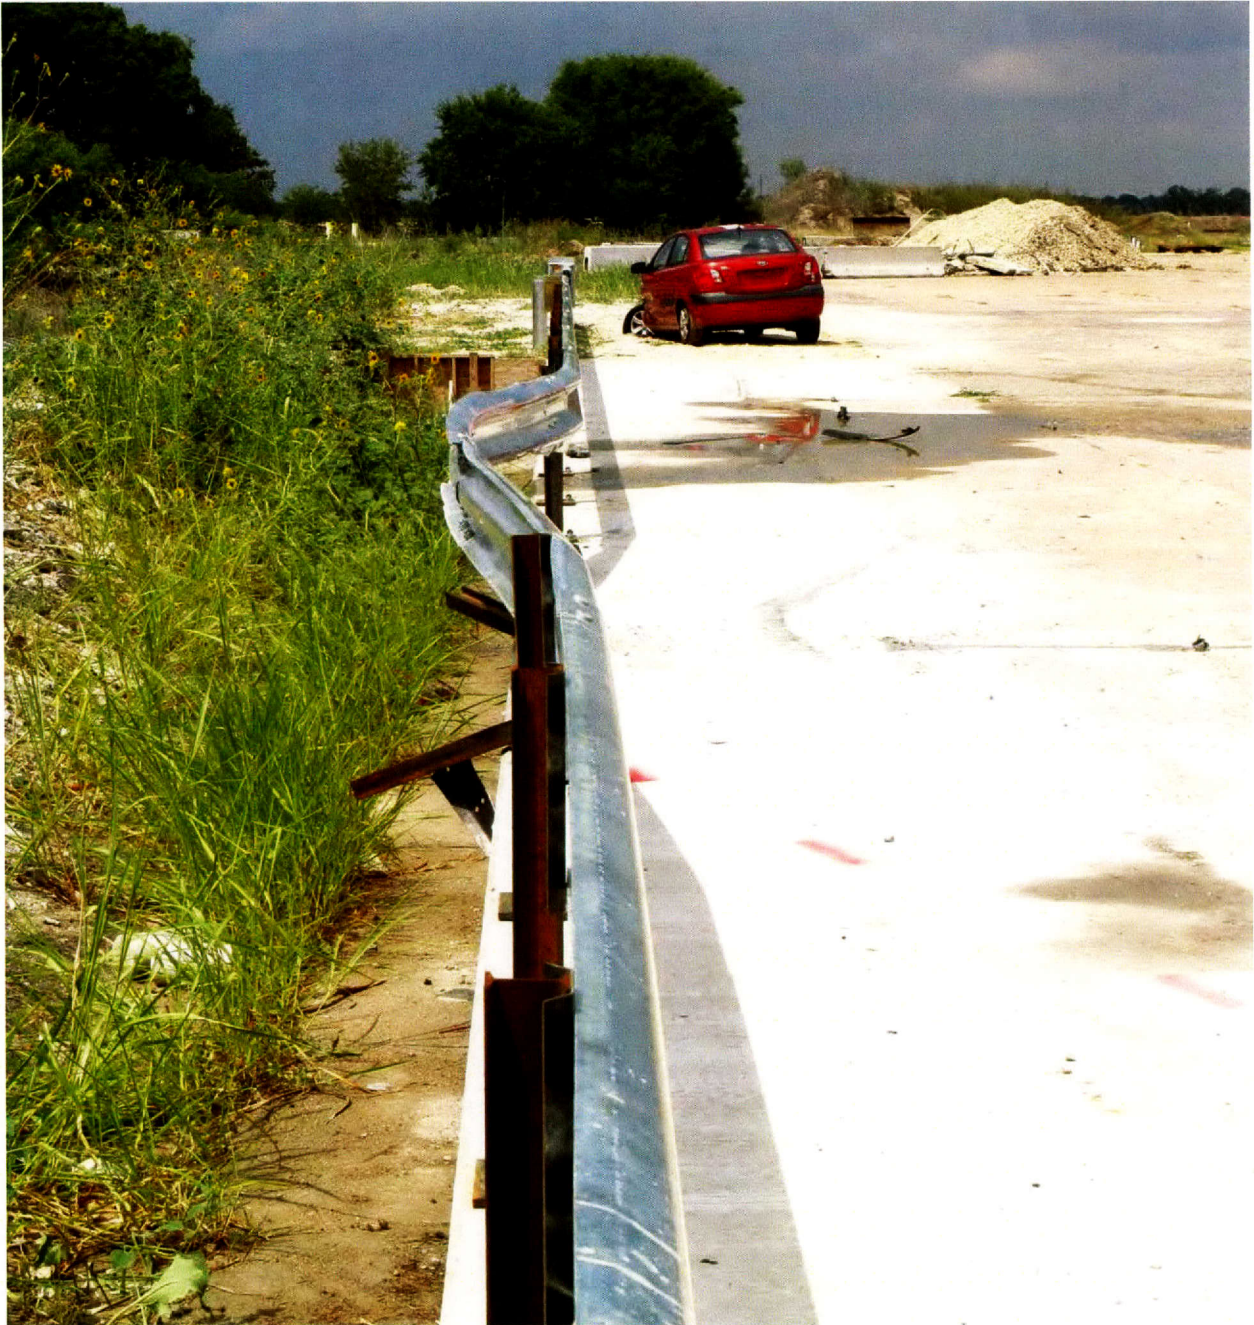
Figure 6.3. Test Article/Vehicle Positions after Test No. 490023-6-2.

Post 9 was leaning towards the field side 4 degrees. Post 10 was leaning towards the field side 95 degrees and the front flange and webbing were torn. Post 11 was leaning downstream 85 degrees and towards the field side 10 degrees; the front flange was partially torn, and the backup plate released. Post 12 was leaning downstream 85 degrees and the back flange was partially torn. Post 12 was leaning downstream 8 degrees. Figures 6.3 and 6.4 show damage to the installation. The 1100C vehicle was in contact with the bridge rail 17.8 ft. Maximum dynamic deflection of the bridge rail during the test was 22.6 inches, and maximum permanent deformation was 15.0 inches. Working width was 25.5 inches, and vehicle penetration was 30.3 inches.

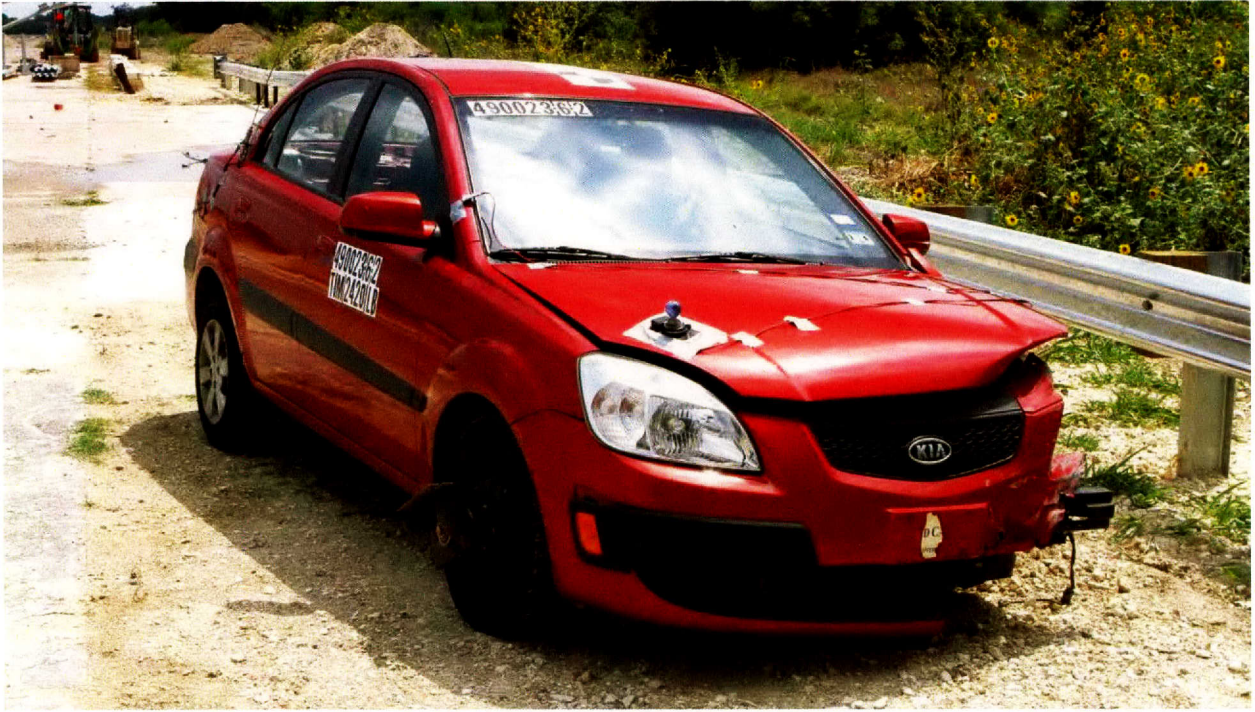
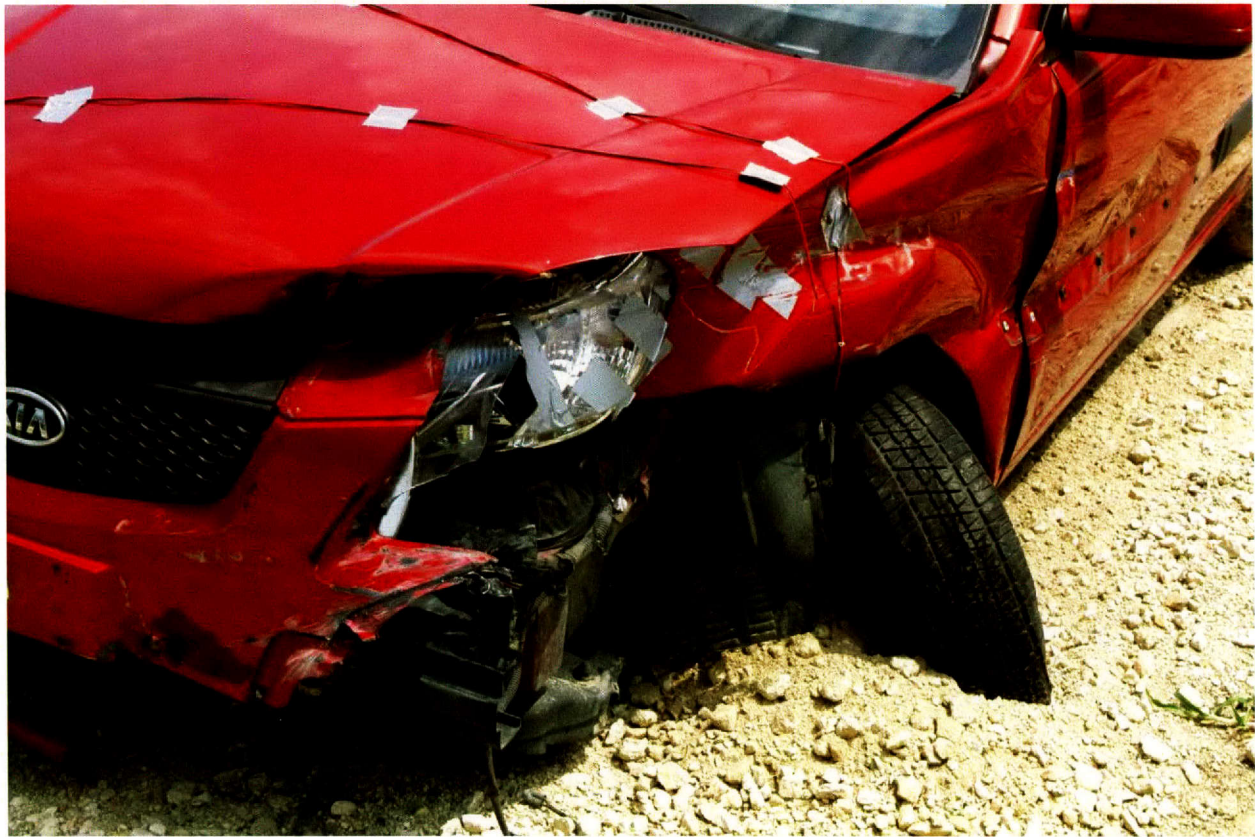
Figure 6.5. Vehicle after Test No. 490023-6-2.

Figure 6.5 shows damage to the 1100C vehicle. The left strut, strut tower, and left tie rod end were deformed. Also damaged were the front bumper, hood, left front fender, left front tire and wheel rim, and the left front door. Maximum exterior crush to the vehicle was 9.5 inches in the side plane at the left front corner at bumper height. No occupant compartment deformation or intrusion occurred. Figure 6.6 provides photographs of the interior of the vehicle. Tables D3 and D4 in Appendix D provide exterior crush and occupant compartment measurements.
