CRASH TEST AND EVALUATION OF TEMPORARY WOOD SIGN SUPPORT SYSTEM FOR LARGE GUIDE SIGNS

Test Report 9-1002-15-4

TEXAS A&M TRANSPORTATION INSTITUTE
COLLEGE STATION, TEXAS

TEXAS DEPARTMENT OF TRANSPORTATION

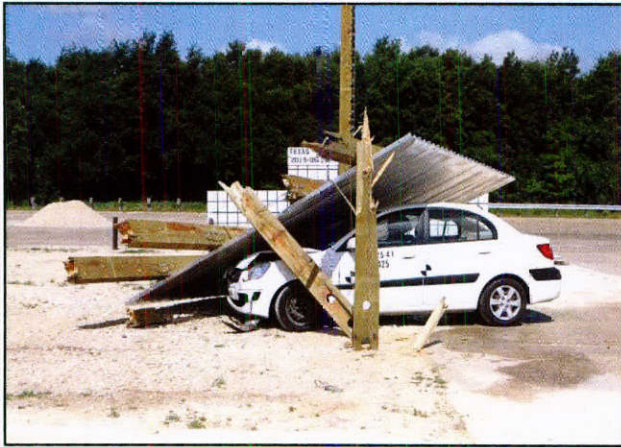
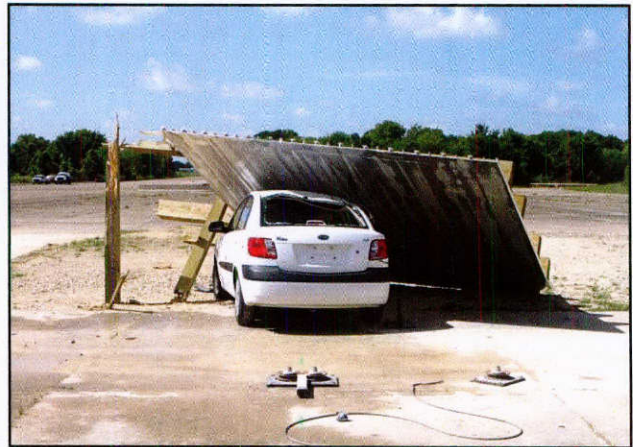
Figure 5.3. Vehicle/Installation Positions after Test No. 490025-4-1.

Figures 5.3 and 5.4 show damage to the sign support system after the test. Post 1 fractured at the hole just beneath the sign panel in a torsional manner. Post 2 fractured at all three weakening hole locations. Posts 3 and 4 both fractured at the holes near and above ground level. The sign panel remained intact and came to rest partially on top of the vehicle.

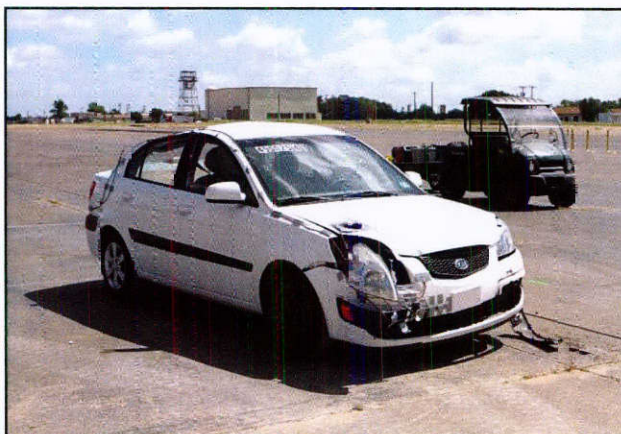
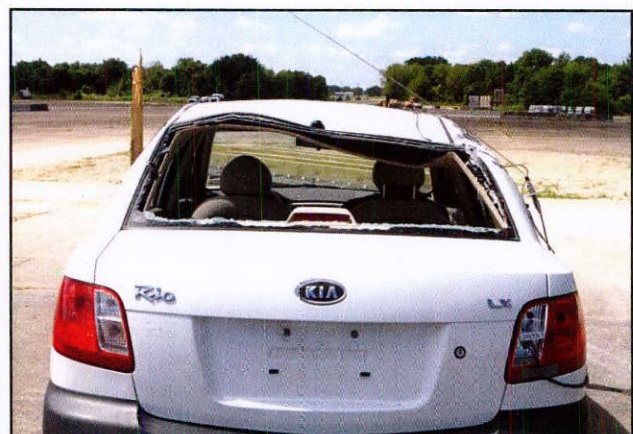
Figure 5.5. Vehicle after Test No. 490025-4-1.

Damage to the vehicle is shown in Figure 5.5. The front bumper, hood, roof, and right C-post were deformed. The windshield sustained stress cracks radiating from the right corner of the roof, and the rear glass was shattered. Maximum external crush to the vehicle was 2.5 inches in the roof and 2.0 inches in the front plane at the right front corner of the bumper at bumper height. Figure 5.6 shows the interior of the vehicle before and after the test. Maximum occupant compartment deformation was 2.5 inches in the roof. Exterior vehicle crush and occupant compartment measurements are shown in Appendix C2, Tables C.2 and C.3.

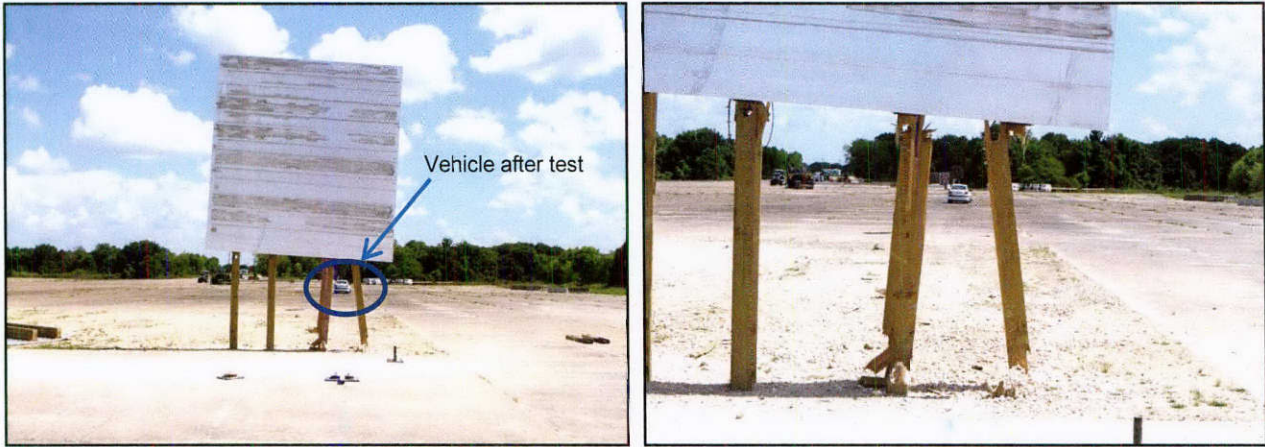
Figure 6.3. Vehicle/Installation Positions after Test No. 490025-4-2.

Figures 6.3 and 6.4 show damage to the sign support system after the test. Post 2 partially fractured at the hole just below sign panel. Posts 3 and 4 fractured at all three weakening holes as designed, and remained attached to the sign panel by the restraining cables.

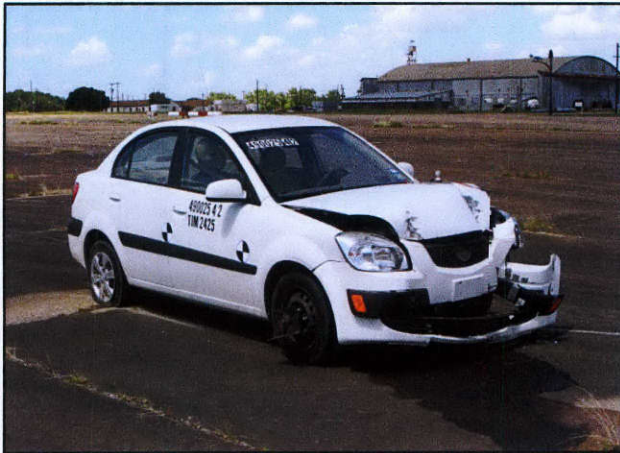
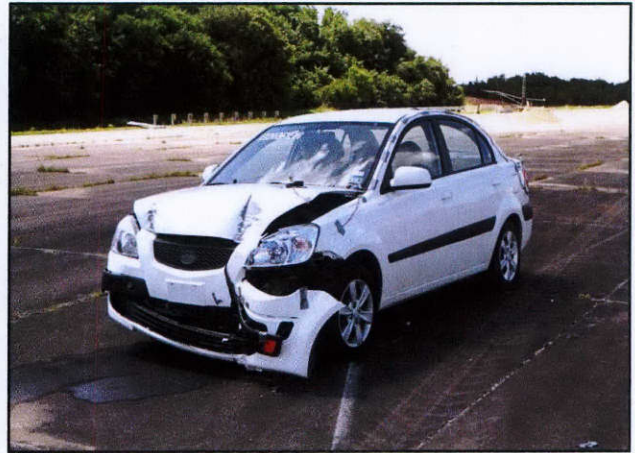
Figure 6.5. Vehicle after Test No. 490025-4-2.

Damage to the vehicle is shown in Figure 6.5. The front bumper, hood, and roof were deformed. The windshield sustained a crack radiating from the left front corner of the roof. Maximum external deformation of the vehicle was 3.26 inches in the front plane at the left quarter point of the bumper at bumper height. No occupant compartment deformation was noted. Figure 6.6 shows the interior of the vehicle. Exterior vehicle crush and occupant compartment measurements are shown in Appendix D2, Tables D.2 and D.3.
