Preservation and Maintenance Manual

DART Police Headquarters at Illinois Station/Monroe Shops

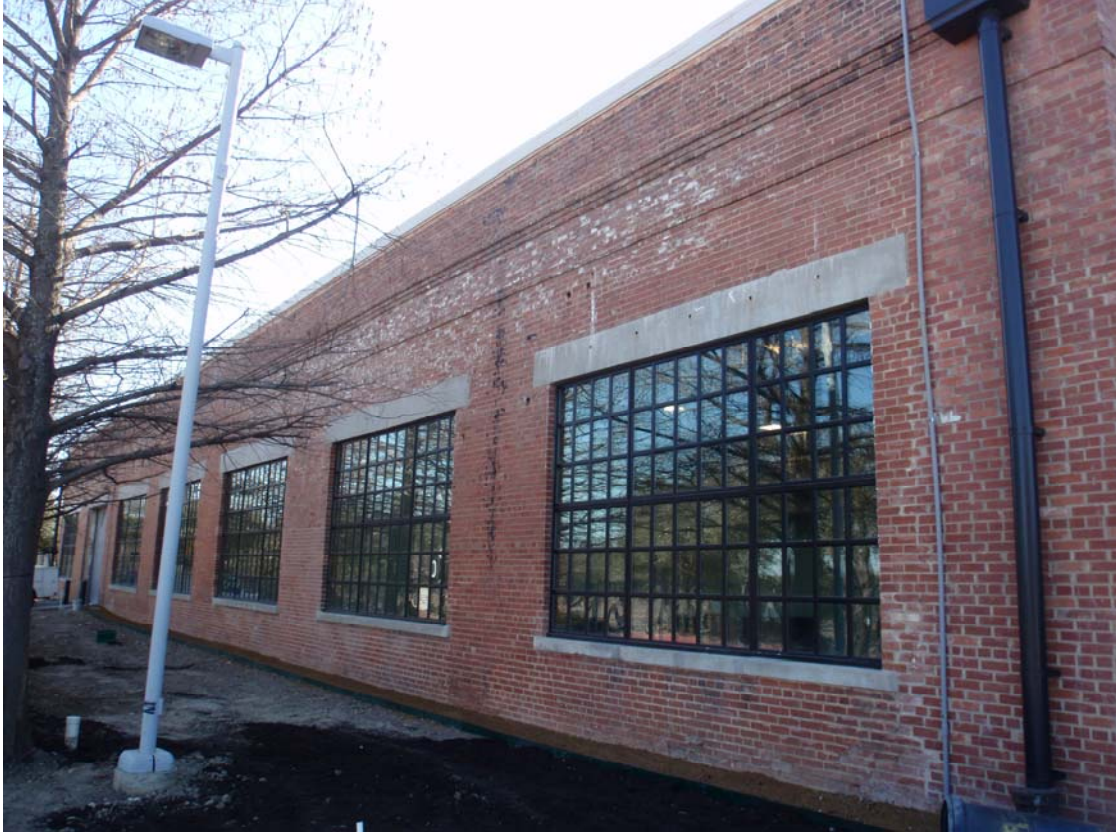
Figure 9: Replacement steel windows on east facade

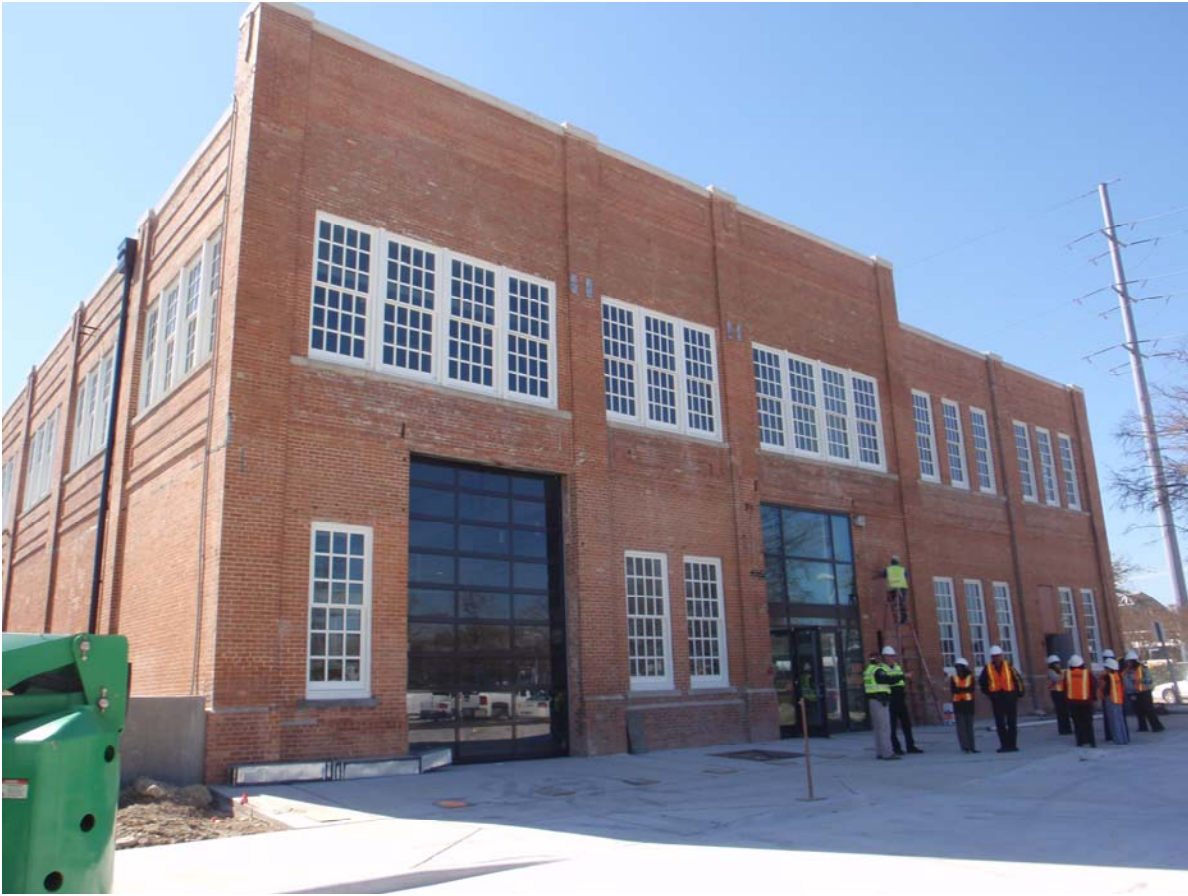
Figure 10: Replacement steel windows on north facade

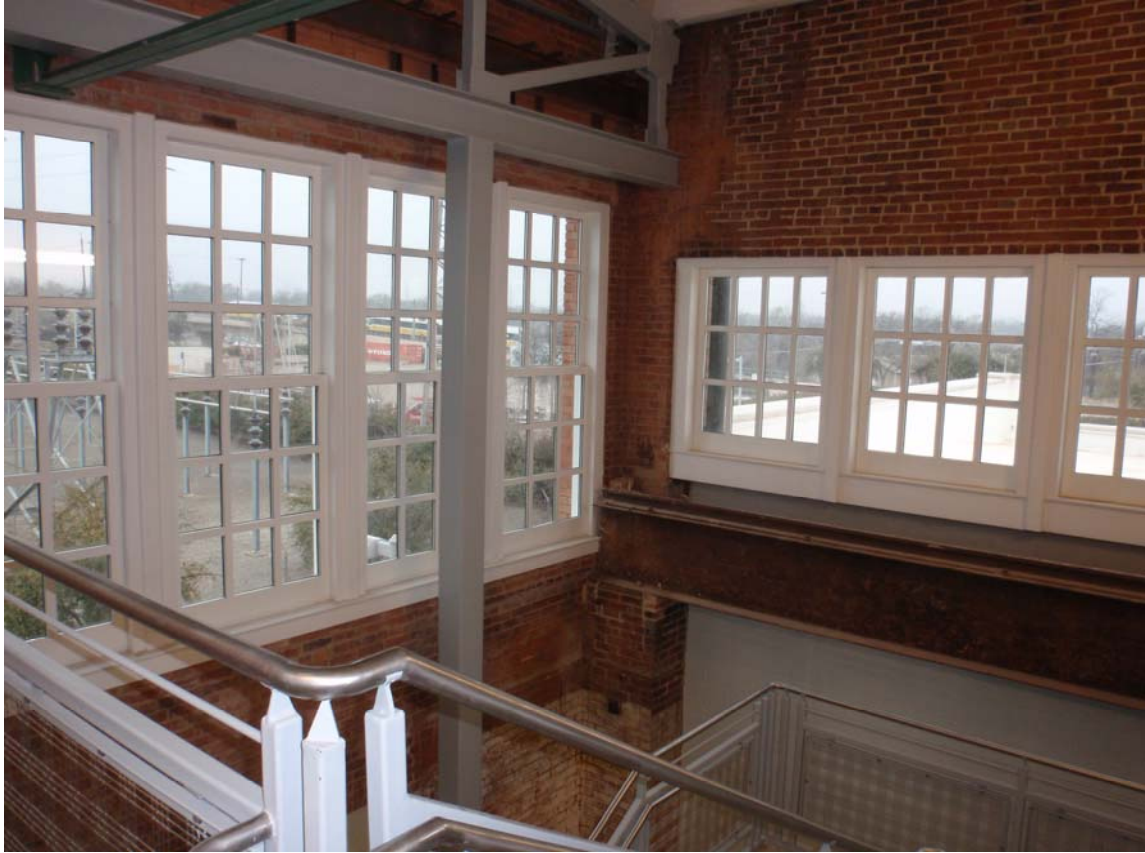
Figure 11: New interior wood window sills and surrounds

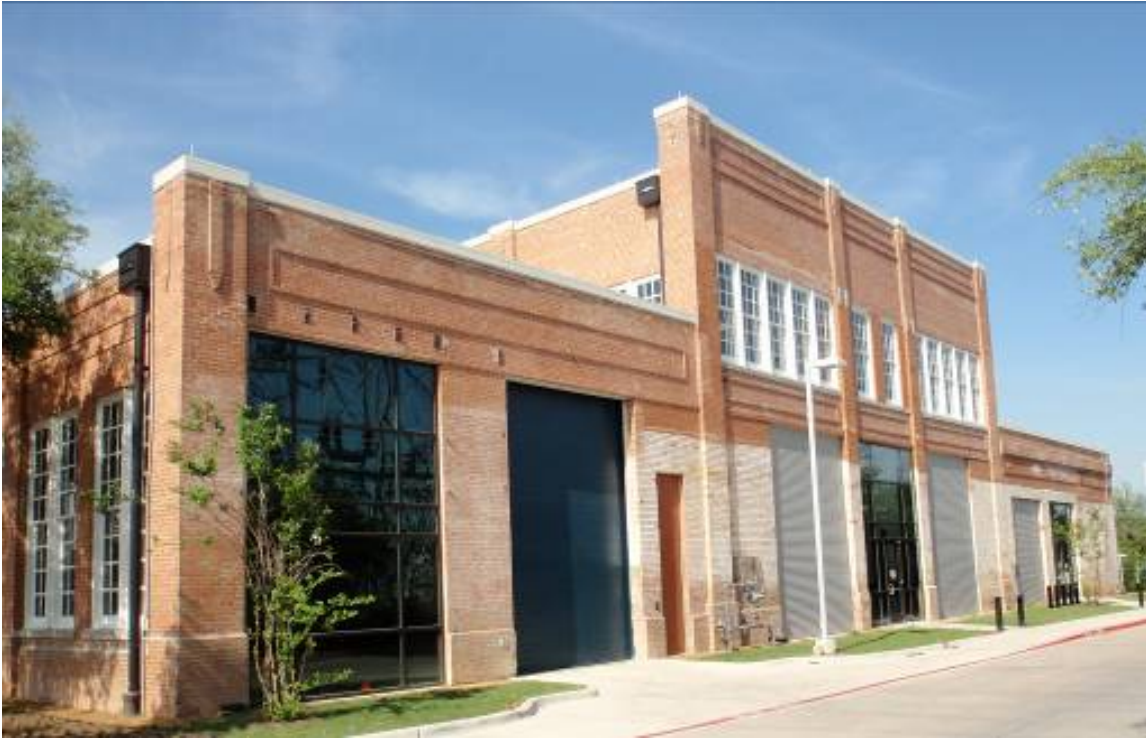
Figure 12: South façade with historic openings

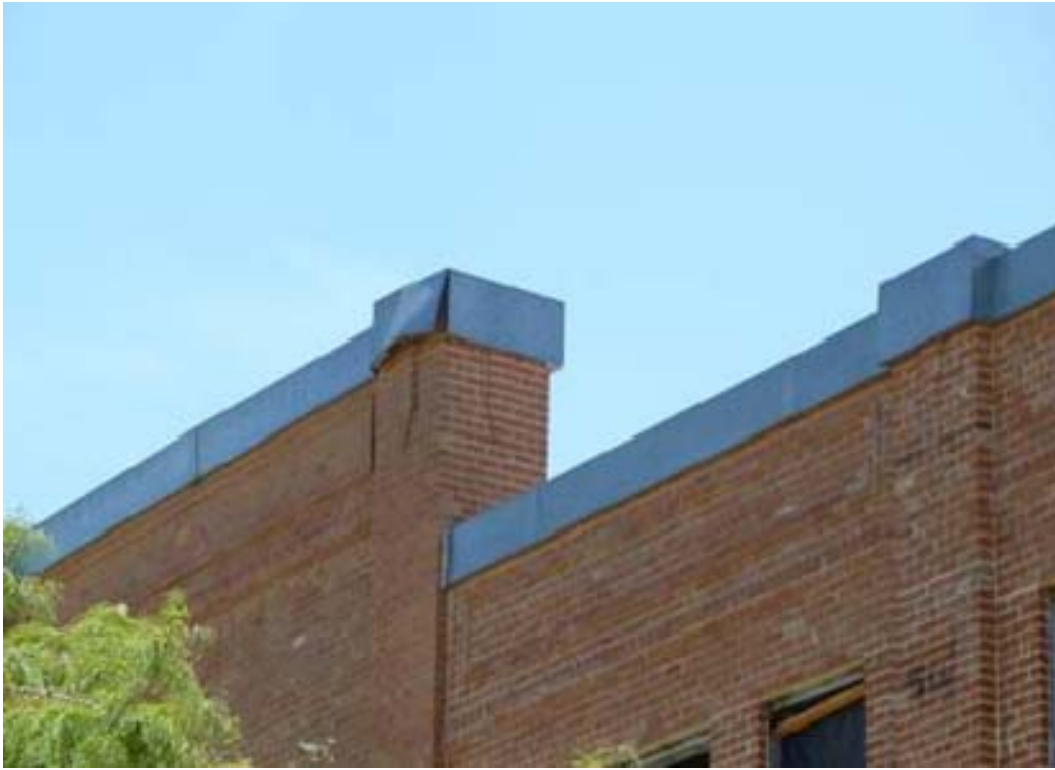
Figure 15: Parapet Cap during repair

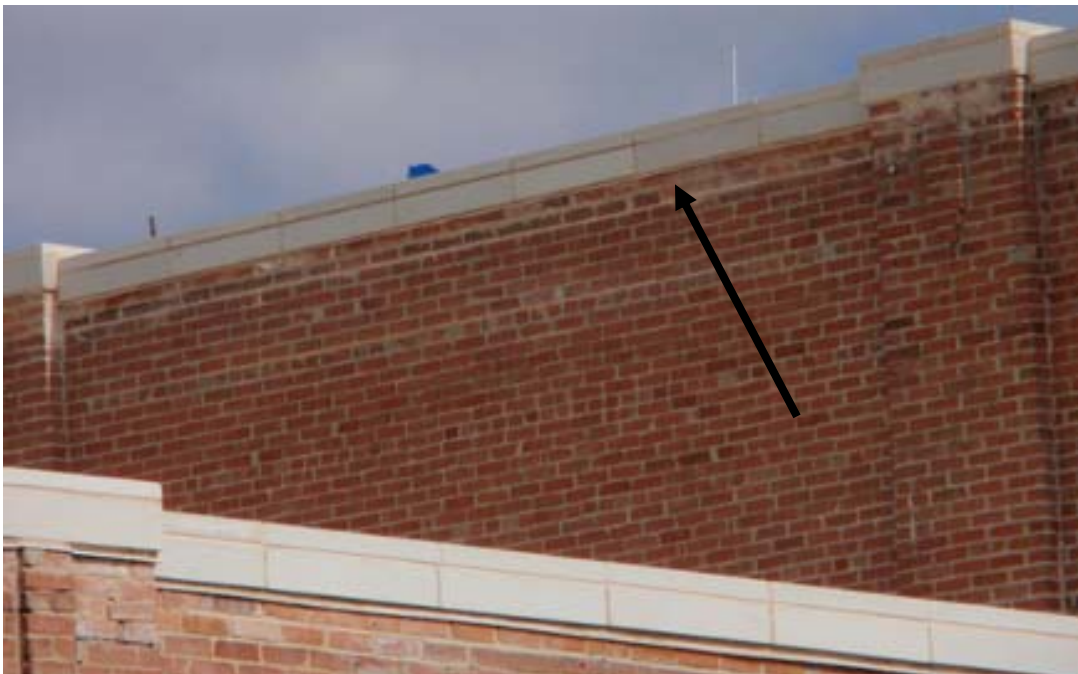
Figure 16: Parapet Cap after repair

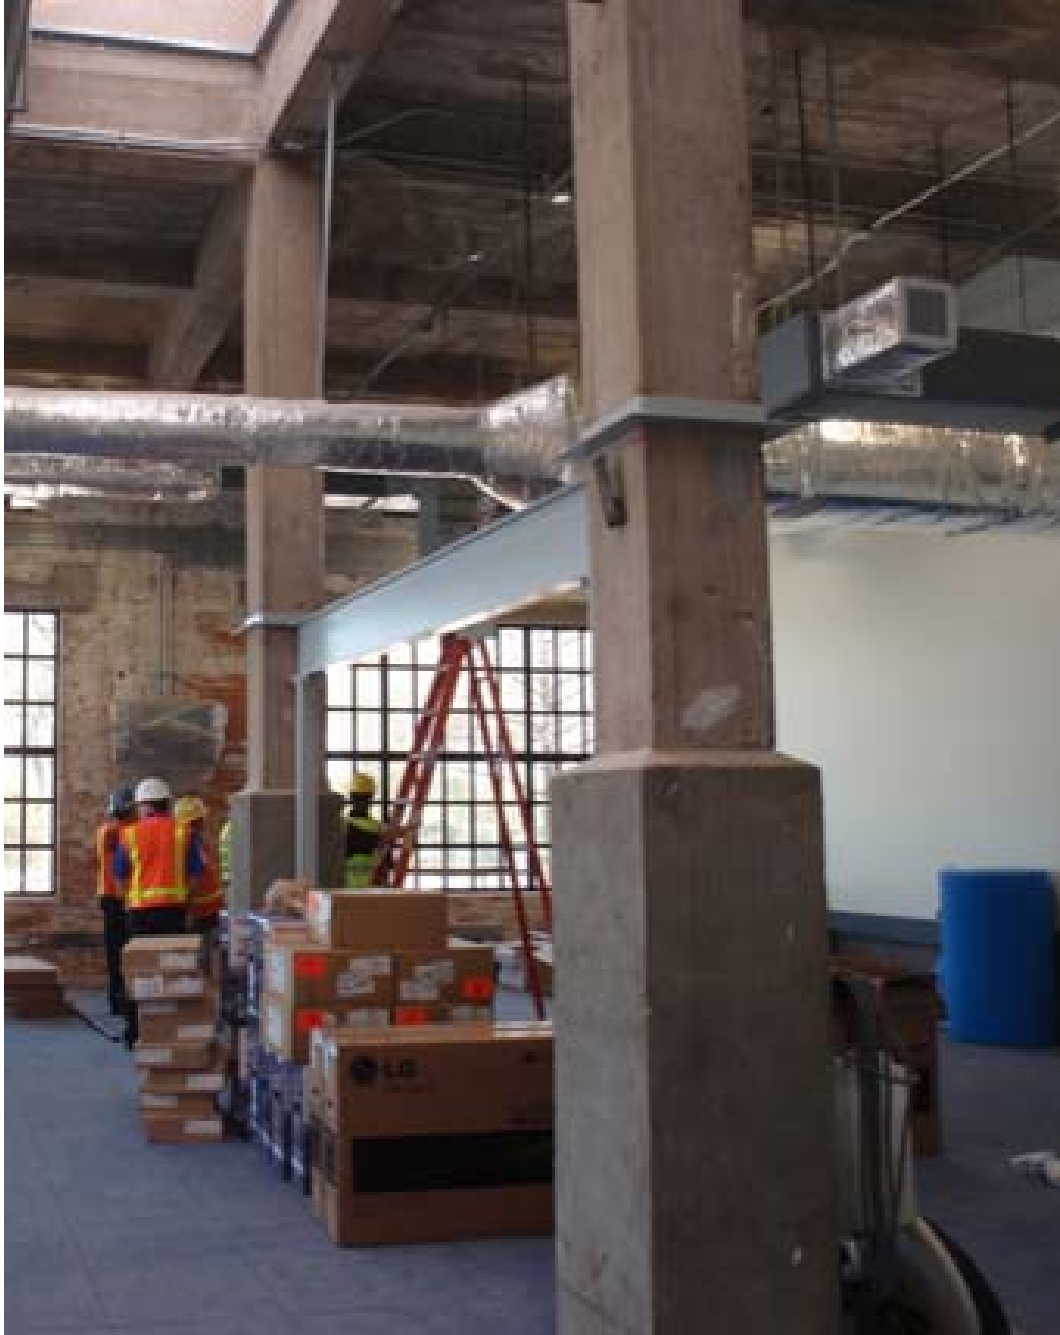
Figure 17: Columns after cleaning

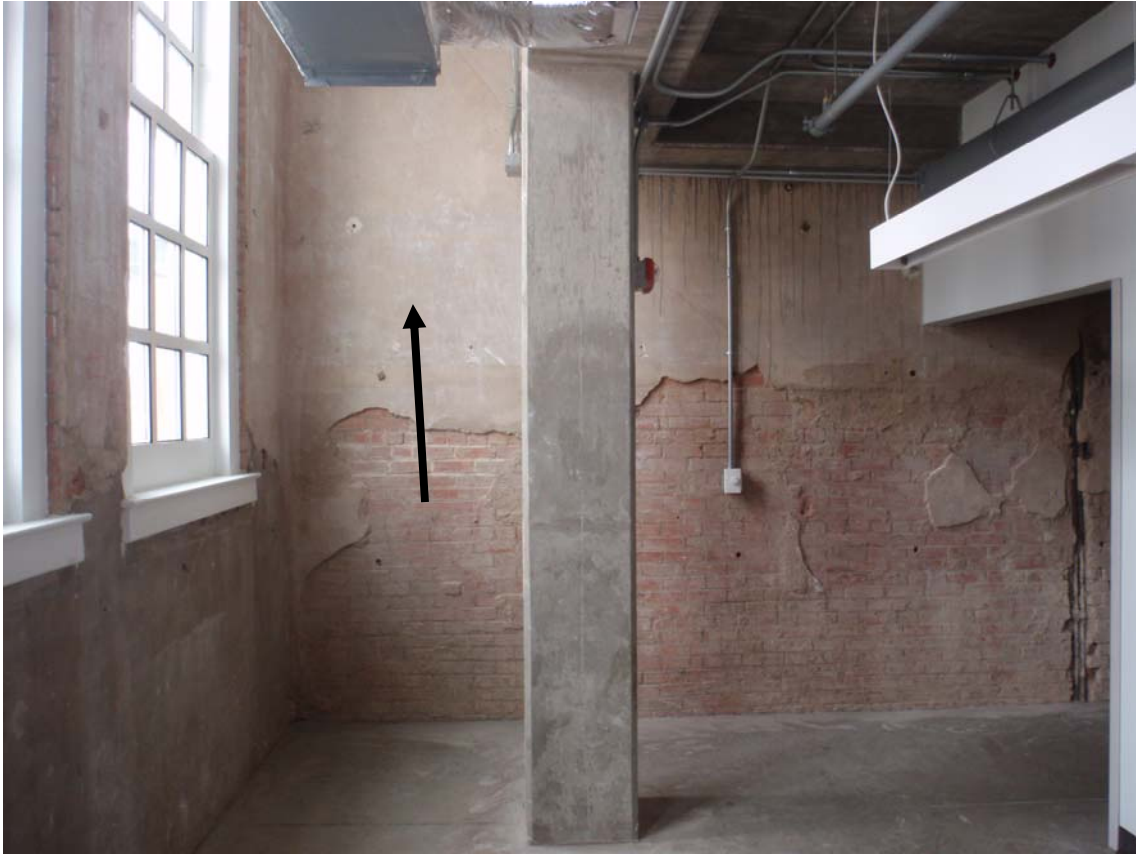
Figure 24: Historic plaster (arrow) on wall in break room at northwest end of building

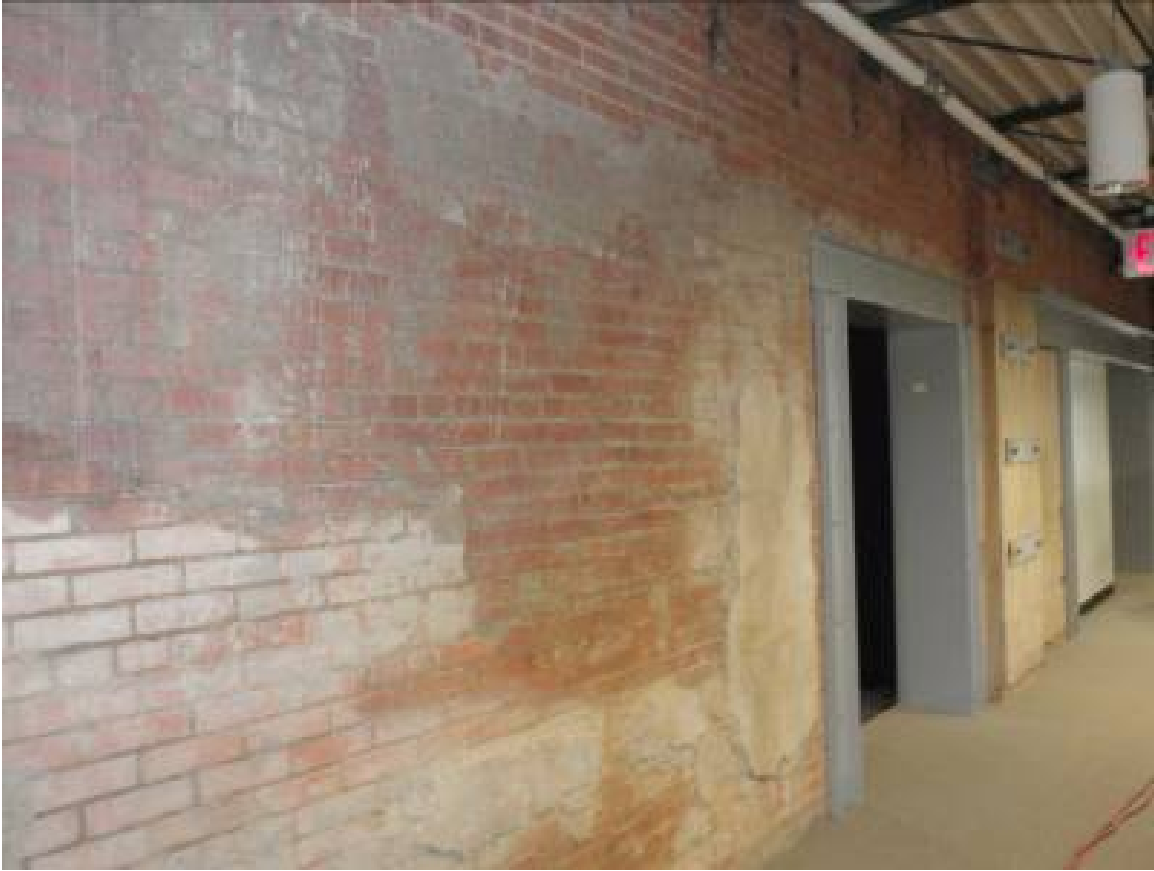
Figure 26: Historic wall on second floor runs north to south in the building

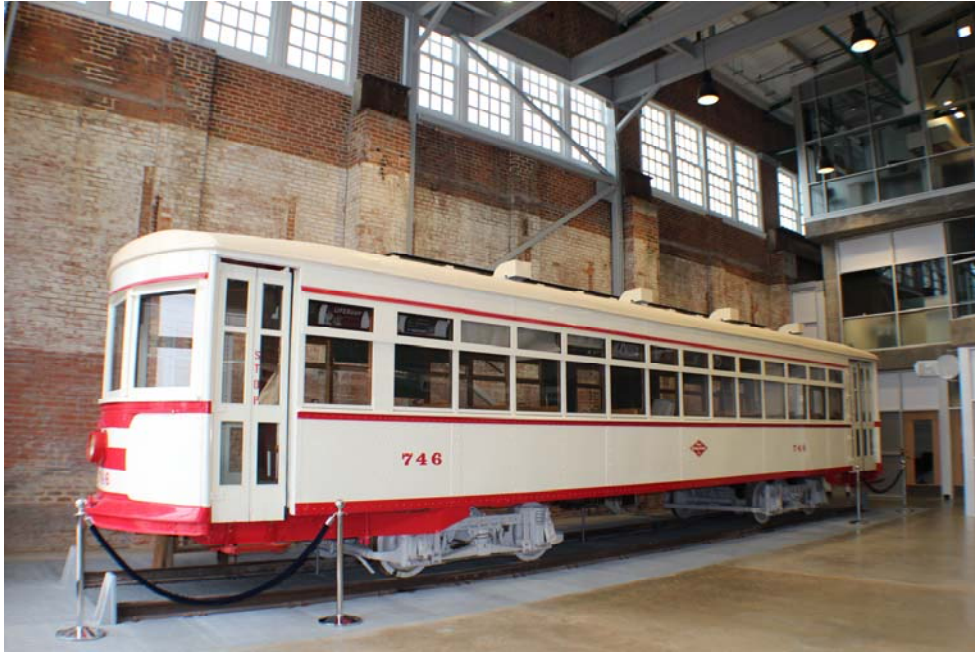
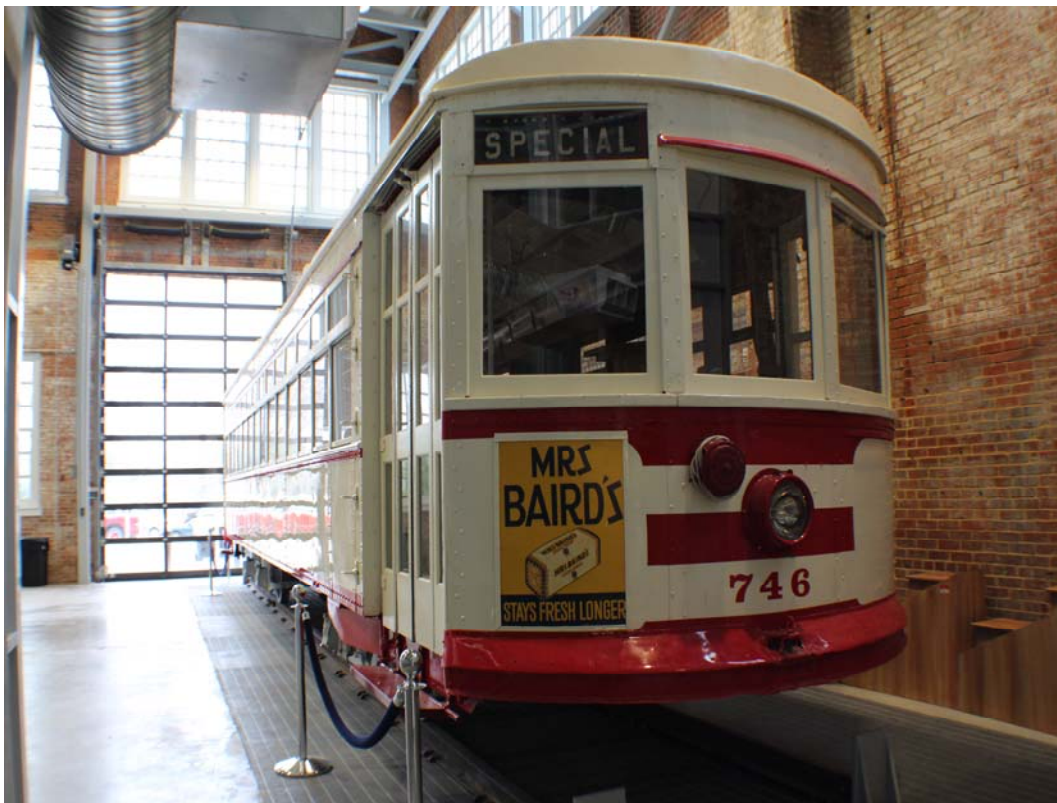
Figures 28 and 29: Historic Interurban Trolley Car #746

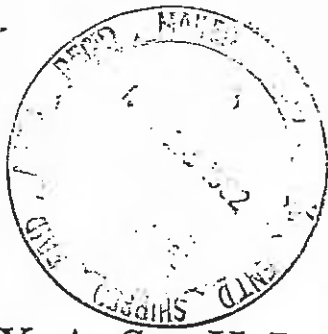
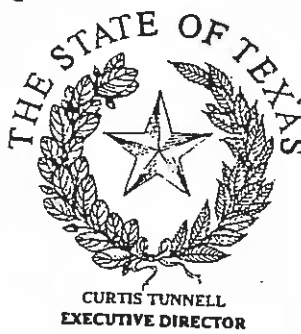
The covenant shall be a binding servitude upon the Property and shall be deemed to run with the land. Execution of this covenant shall constitute conclusive evidence that Grantee agrees to be bound by the foregoing conditions and restrictions and to perform to obligations herein set forth.

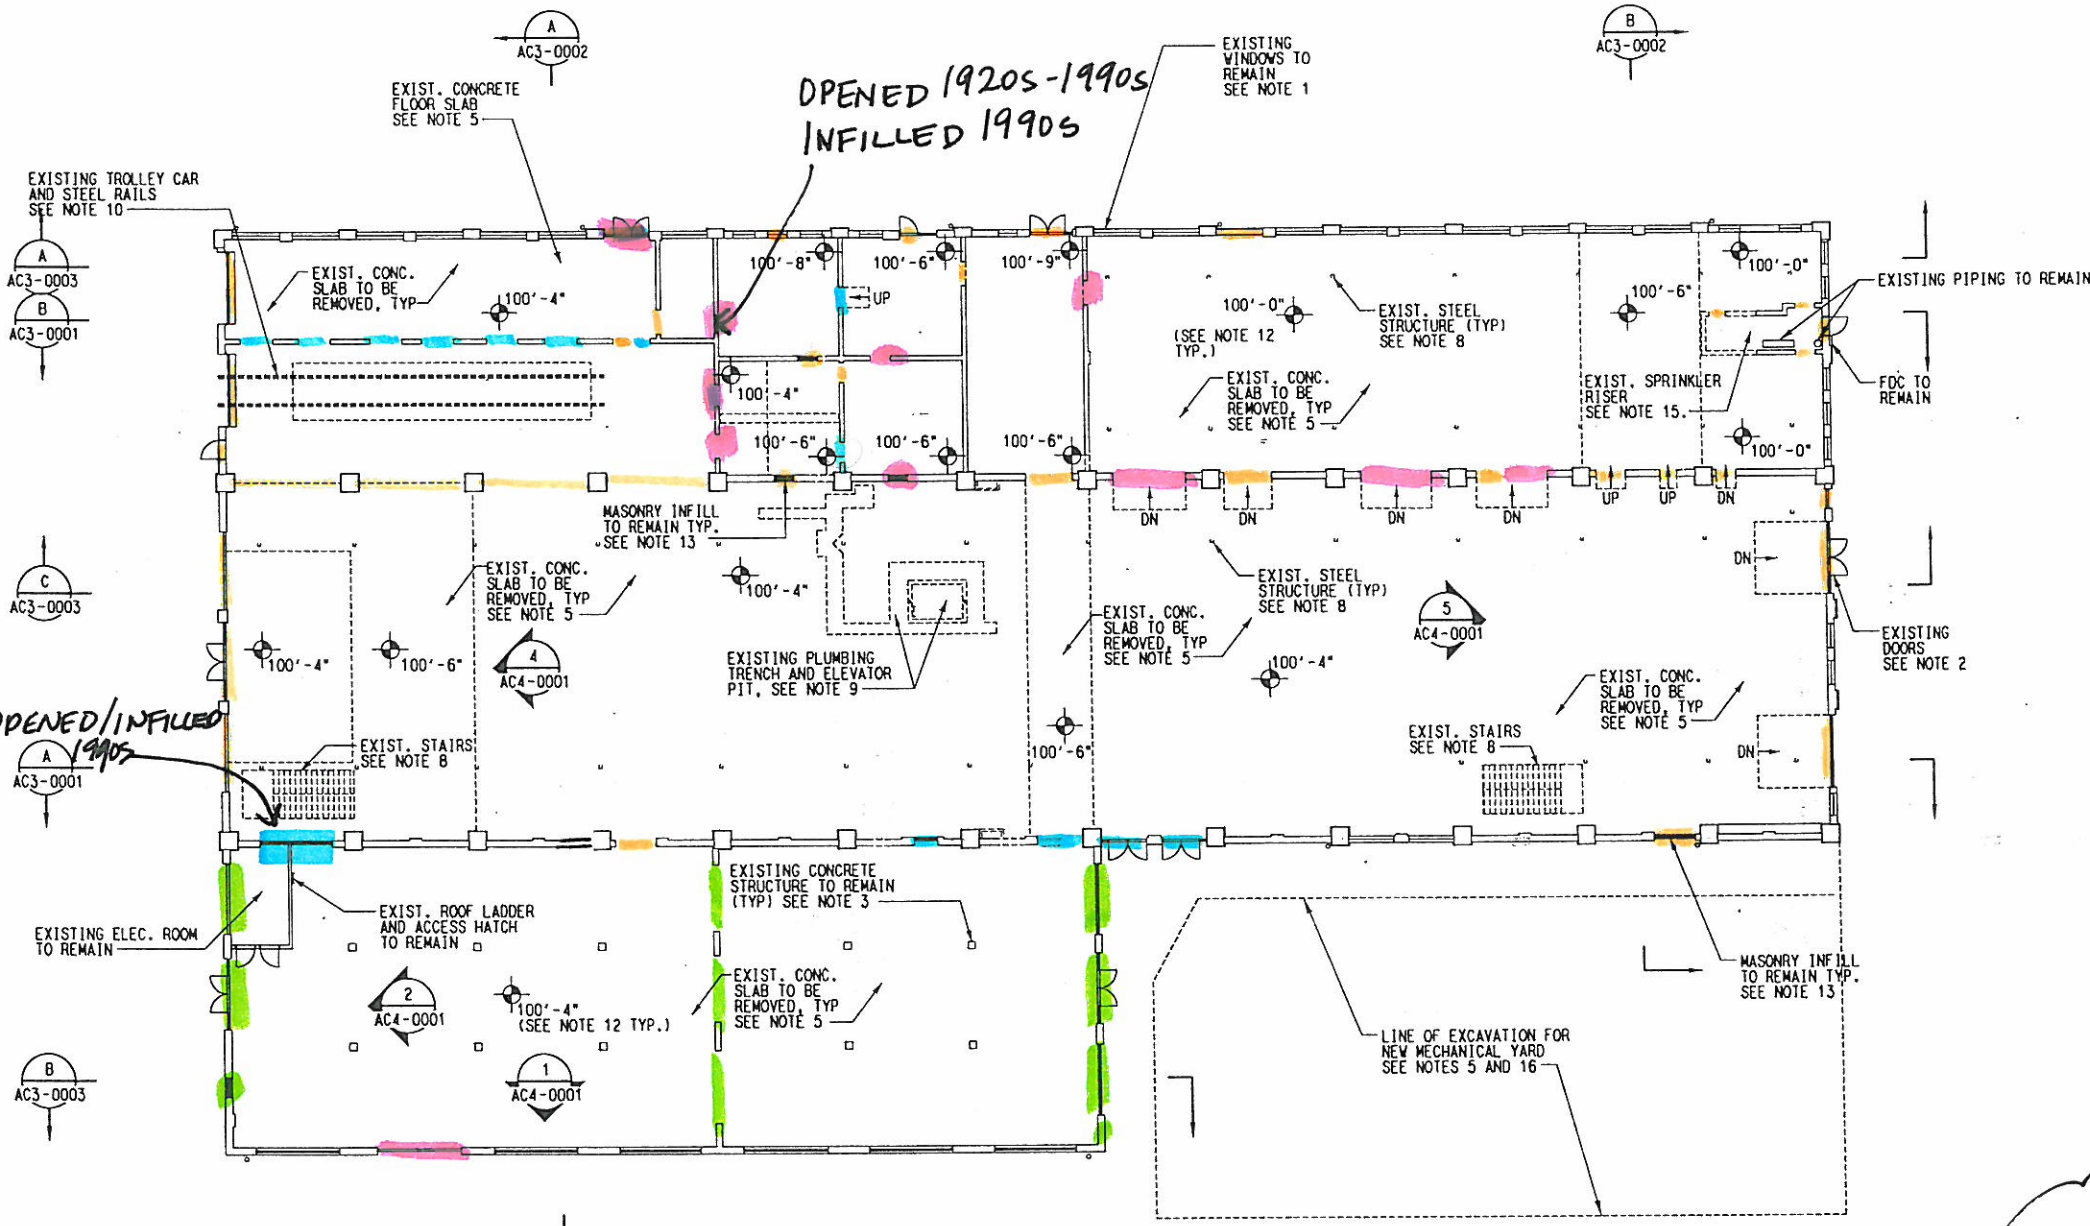
- NOTES:
- EXISTING WINDOWS AND STOREFRONTS TO REMAIN, PROTECT.
 - EXISTING DOORS TO REMAIN, PROTECT.
 - NOT USED.
 - NOT USED.
 - DEMOLISH ENTIRE INTERIOR EXISTING CONCRETE SLAB UNLESS NOTED OTHERWISE. EXCAVATE TO DEPTH OF CONCRETE OR TO ELEV. OF 99'-4" WHICHEVER IS GREATER. PRESERVE STRUCTURAL INTEGRITY OF EXISTING EXTERIOR AND INTERIOR MASONRY WALLS. NOTIFY AUTHORITY OF ANY RAILS, STEEL, OR EQUIPMENT DISCOVERED IN OR UNDER EXISTING CONCRETE SLAB. AUTHORITY TO REVIEW AND APPROVE SALVAGE.

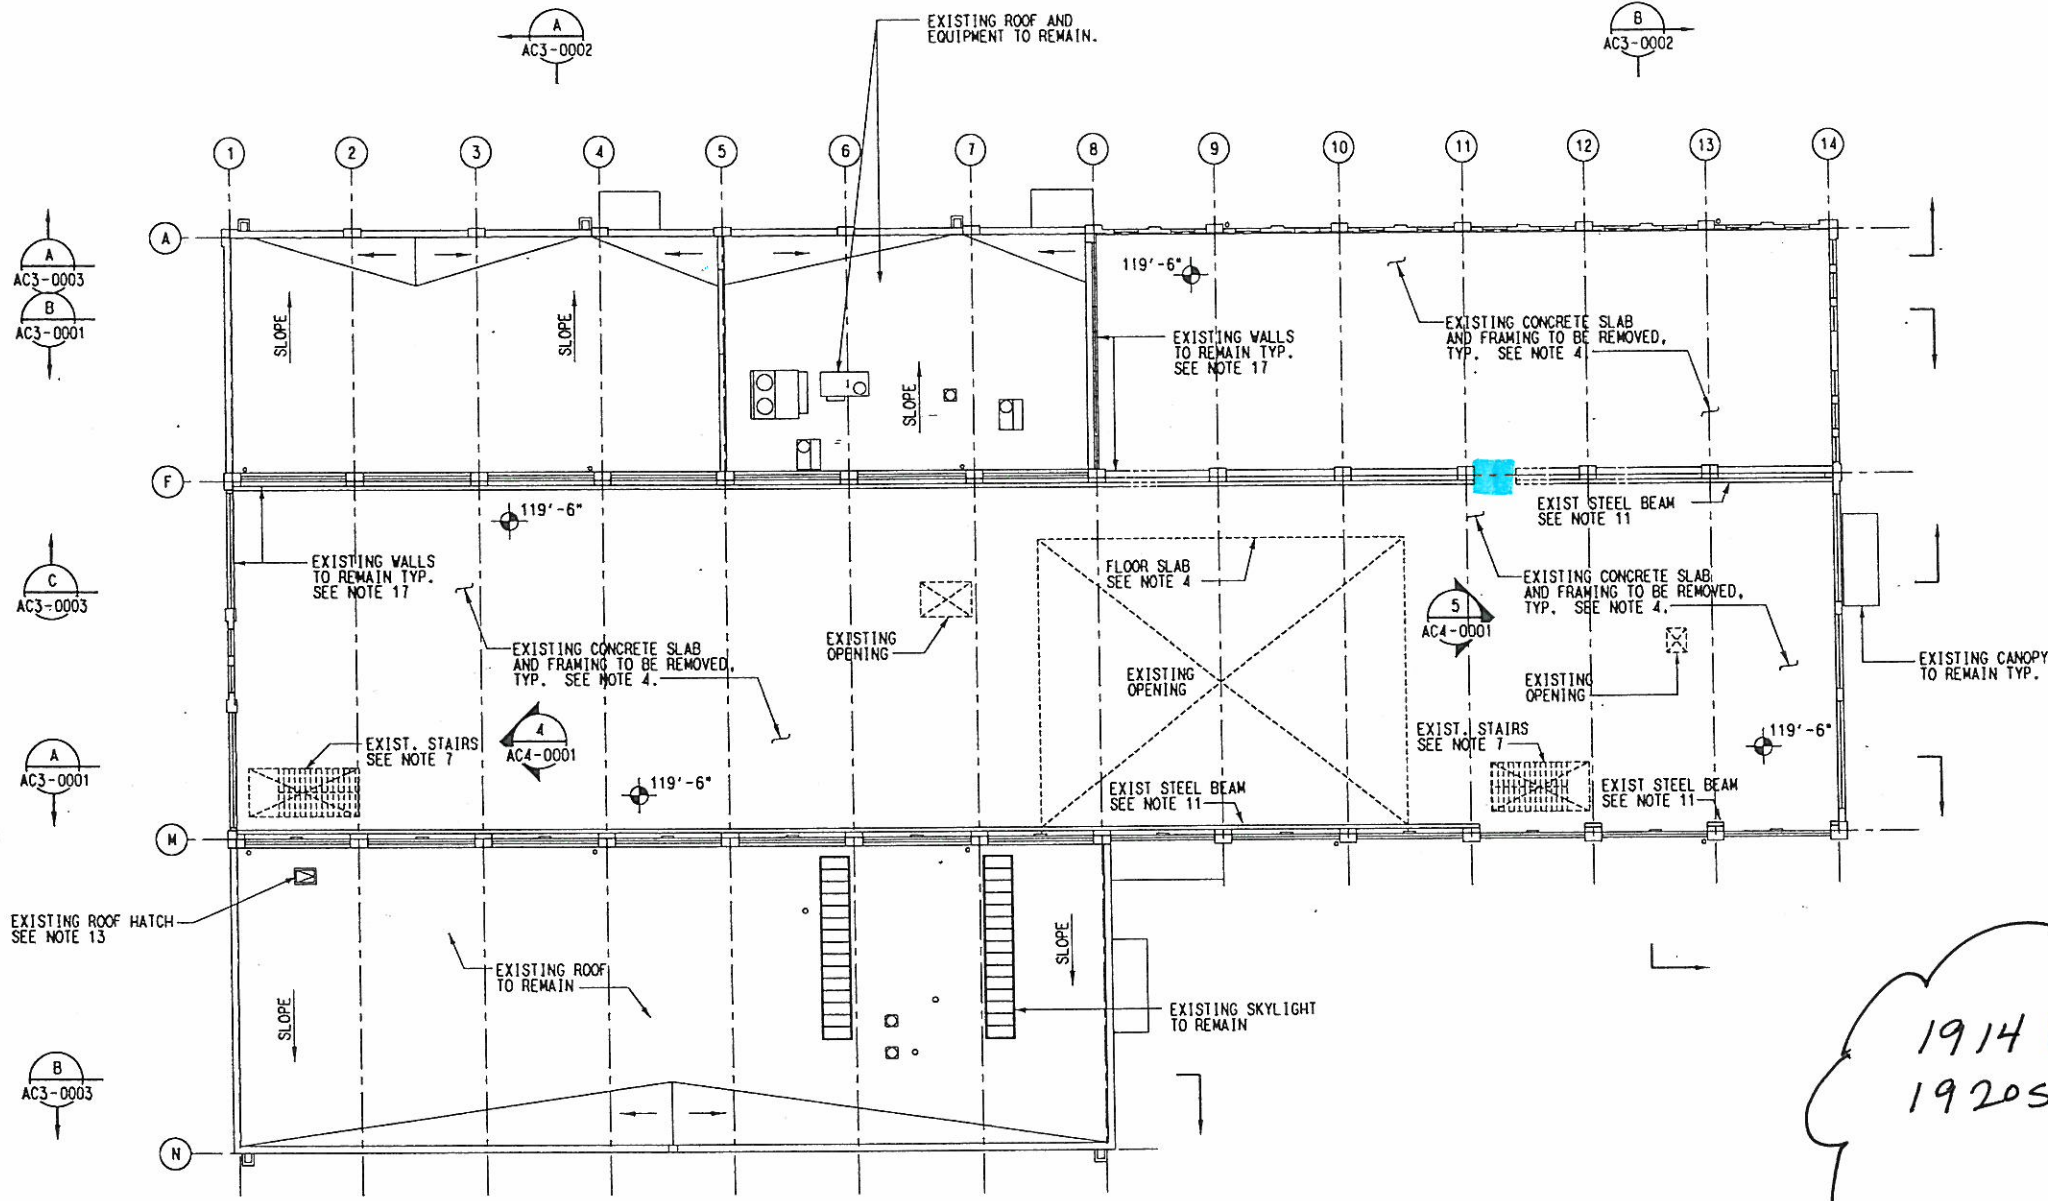
- NOTES:
1. NOT USED.
 2. NOT USED.
 3. NOT USED.
 4. DEMOLISH EXISTING UPPER LEVEL CONCRETE SLAB AND ASSOCIATED STEEL FRAMING. PROTECT EXISTING MASONRY WHERE FLOOR SLAB ABUTS. NOTIFY AUTHORITY REGARDING ANY ADVERSE CONDITIONS. AUTHORITY TO REVIEW AND APPROVE SALVAGE.
 5. NOT USED.
 6. NOT USED.
 7. REMOVE EXISTING STAIRS AND STEEL STRUCTURE RELATED TO EXISTING SECOND FLOOR.
 8. NOT USED.
 9. NOT USED.
 10. NOT USED.
 11. PROTECT AND PRESERVE EXISTING STEEL CRANE RAIL BEAM ALONG COLUMN LINES 'F' AND 'M'.
 12. NOT USED.
 13. EXISTING ROOF ACCESS HATCH TO REMAIN.
 14. NOT USED.
 15. NOT USED.
 16. NOT USED.
 17. EXISTING INTERIOR AND EXTERIOR WALLS TO REMAIN, PROTECT AND PRESERVE.
 18. FOR REMOVAL OF BRICK TO CREATE NEW OPENINGS REFER TO AC3-0004, AC3-0005, AC3-0006 AND AC3-0007.

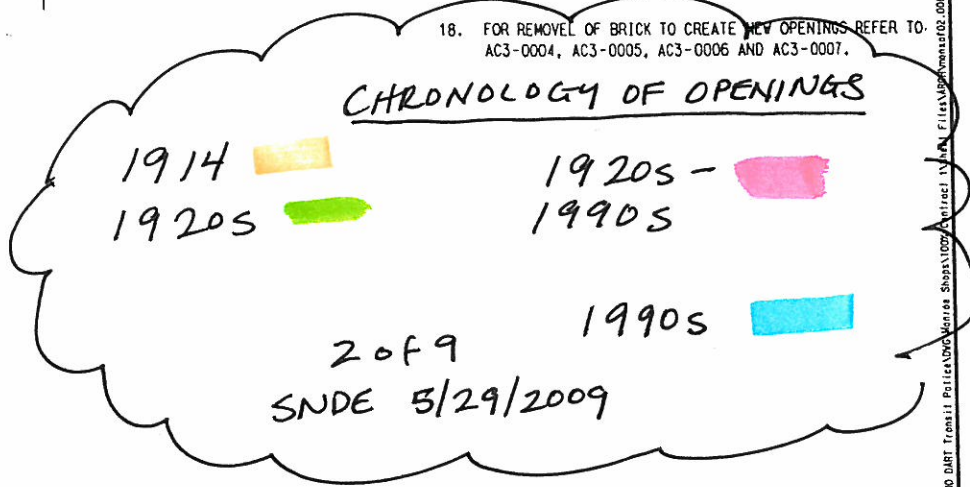
SHELL BUILDING-
DEMOLITION FLOOR PLAN
LEVEL TWO
SCALE: 1/16"=1'-0"

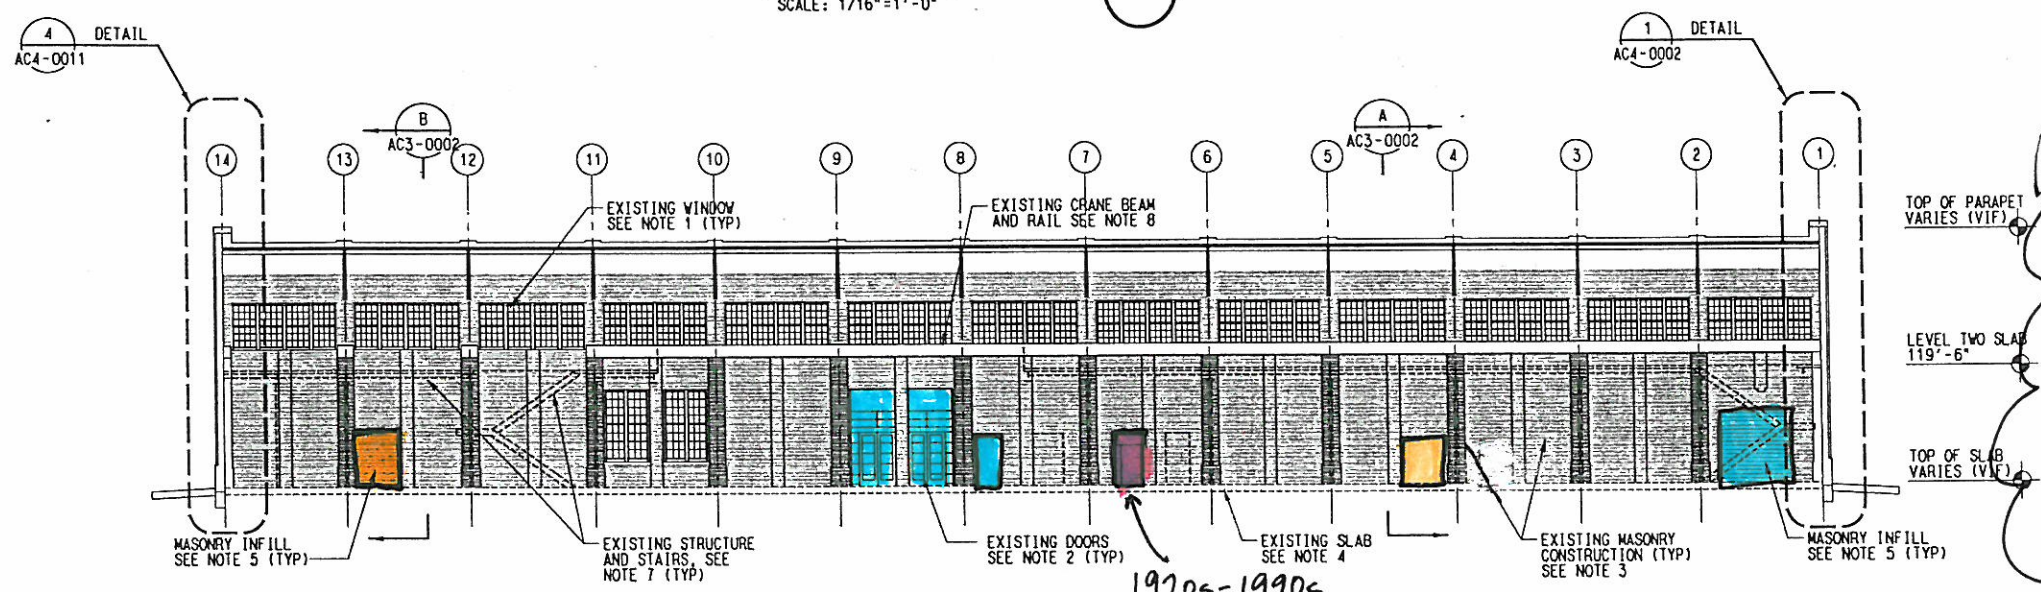
DEMOLITION BUILDING SECTION A
SCALE: 1/16"=1'-0"

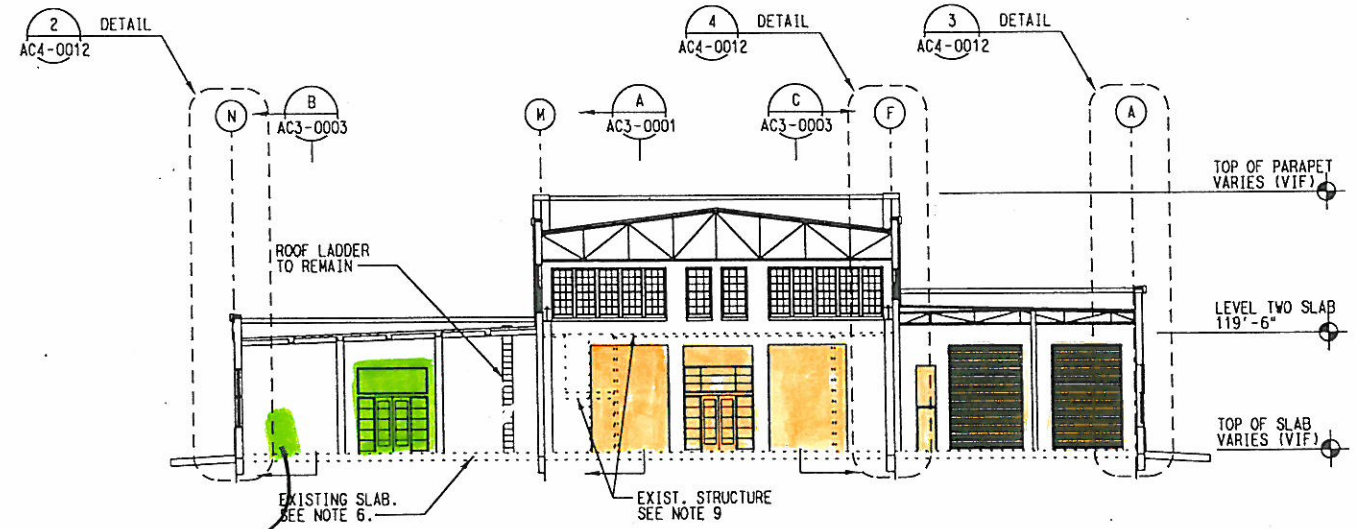
DEMOLITION BUILDING SECTION A
 SCALE: 1/16"=1'-0"
EXISTING MASONRY INFILL TO REMAIN

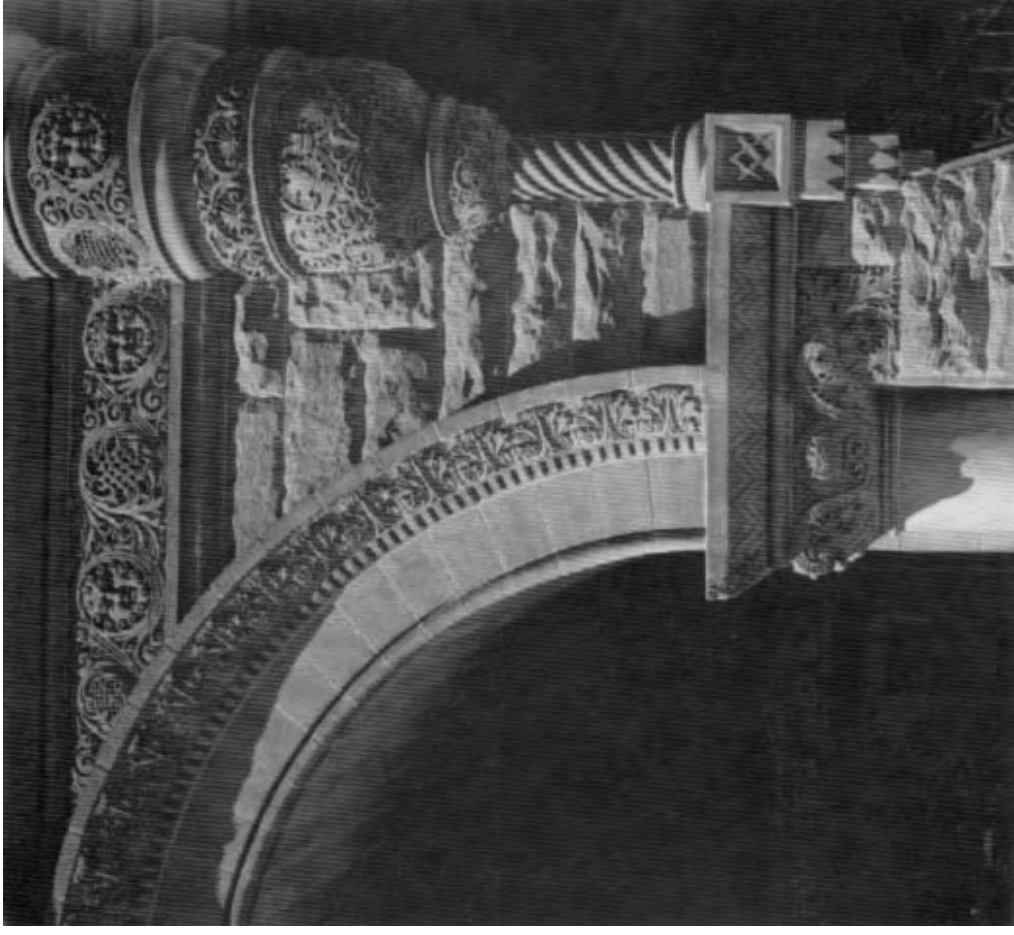
While masonry is among the most durable of historic building materials, it is also very susceptible to damage by improper maintenance or repair techniques and harsh or abrasive cleaning methods.

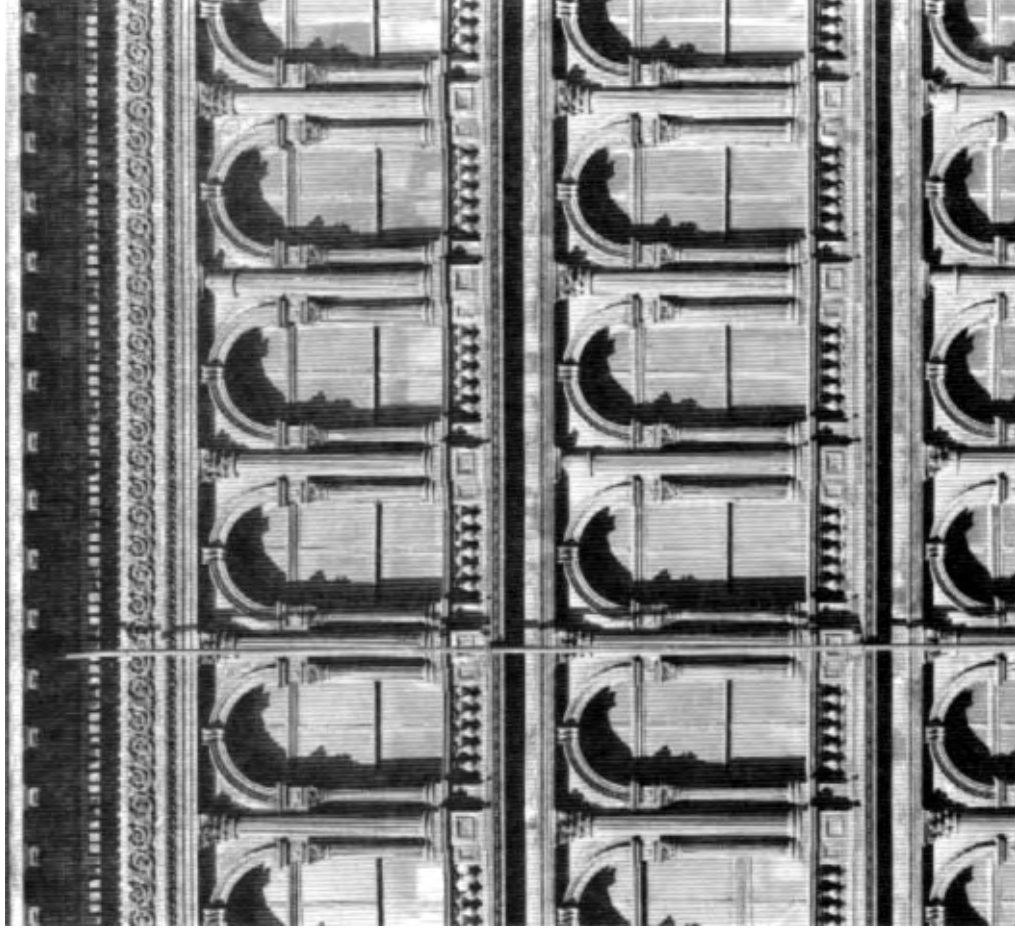
Building Exterior Features

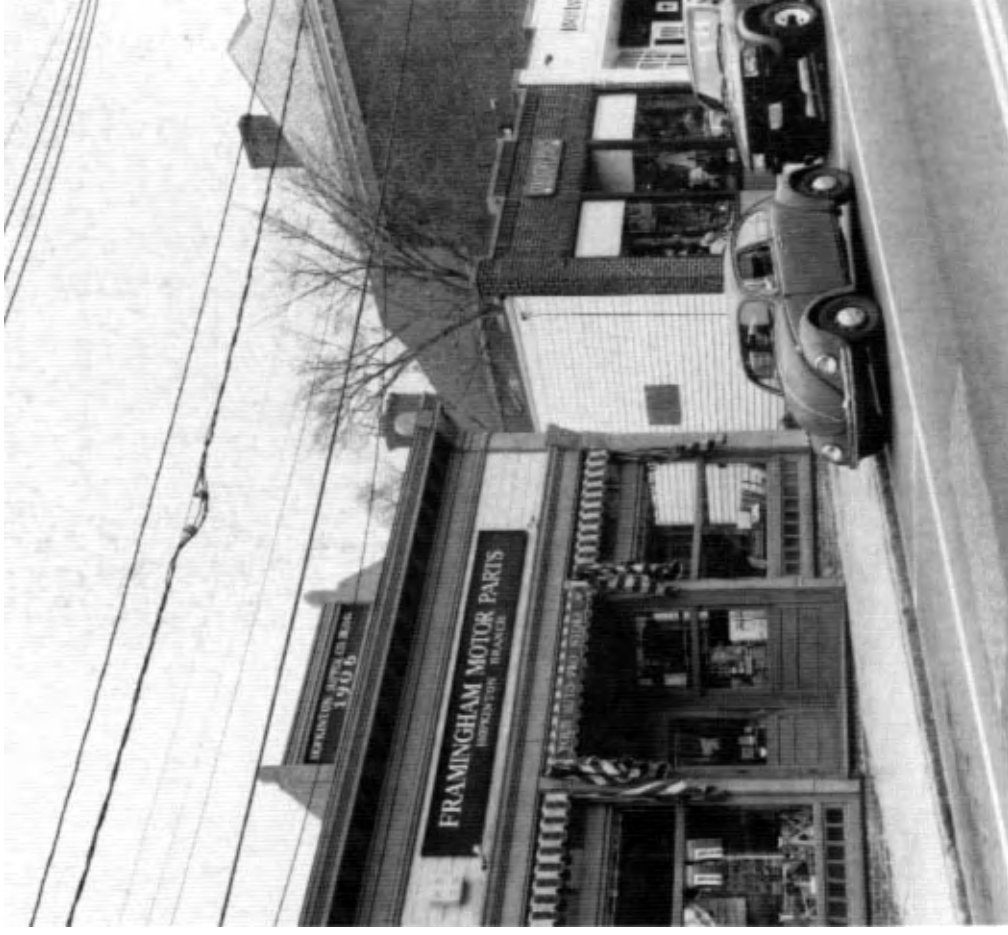
The storefront is usually the most prominent feature of a historic commercial building, playing a crucial role in a store's advertising and merchandising strategy. Although a storefront normally does not extend beyond the first story, the rest of the building is often related to it visually through a unity of form and detail. Window patterns on the upper floors, cornice elements, and other decorative features should be carefully retained, in addition to the storefront itself.

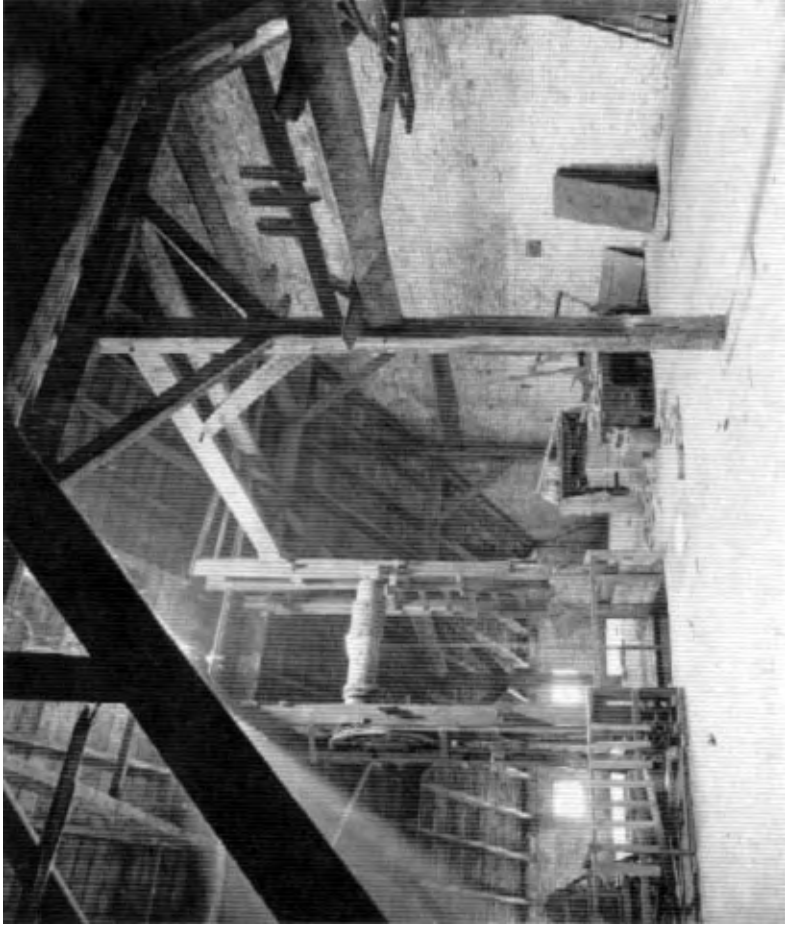
Spaces, Features, and Finishes
