Preservation and Maintenance Manual

DART Police Headquarters at Illinois Station/Monroe Shops

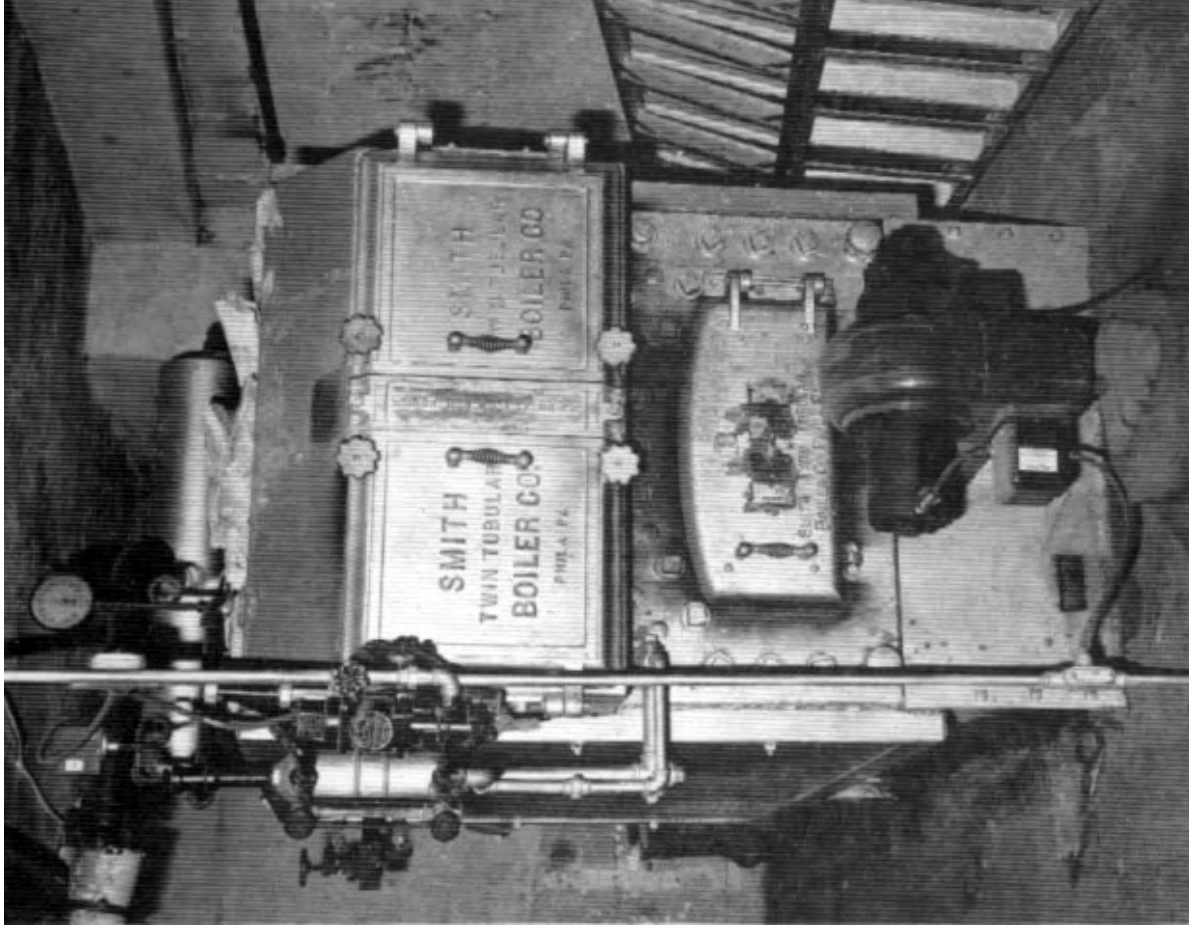
The visible decorative features of historic mechanical systems such as grilles, lighting fixtures, and ornamental switchplates may contribute to the overall historic character of the building. Their identification needs to take place, together with an evaluation of their physical condition, early in project planning. On the other hand, mechanical systems need to work efficiently so many older systems, such as compressors and their ductwork, and wiring and pipes often need to be upgraded or entirely replaced in order to meet modern requirements.

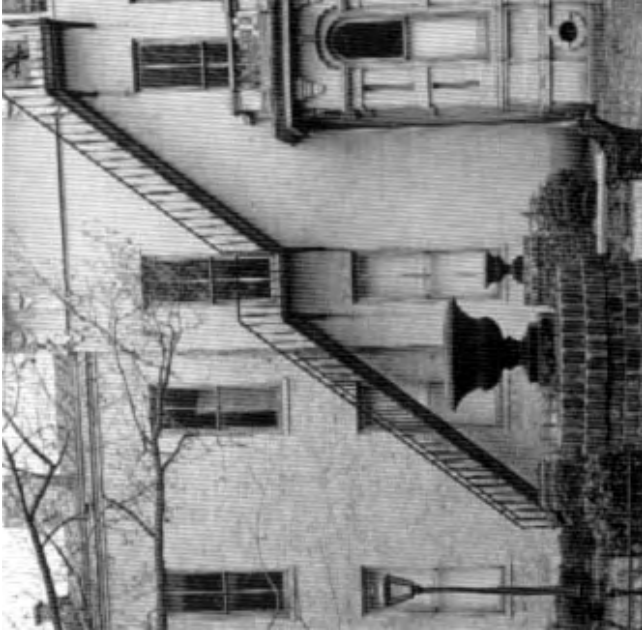
Standards for Preservation & Guidelines for Preserving Historic Buildings

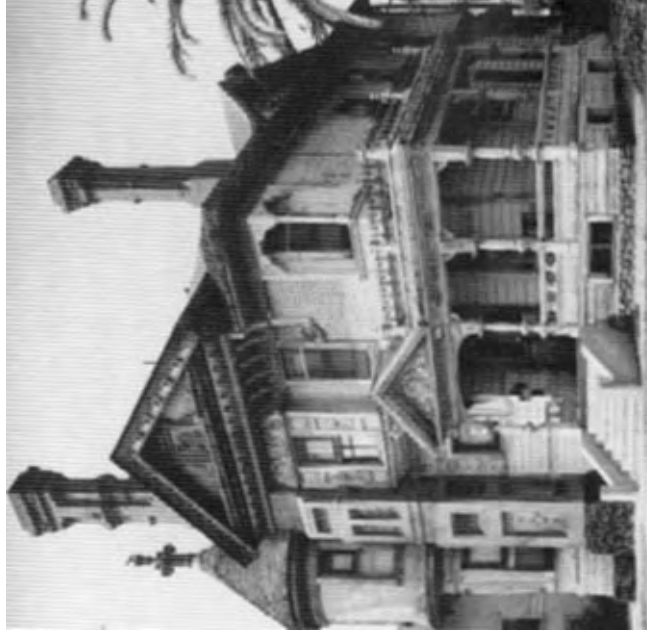
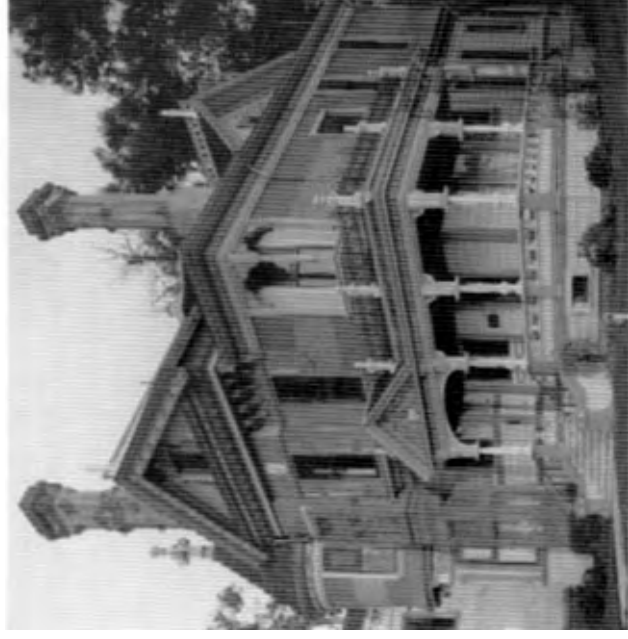
Standards for Preservation

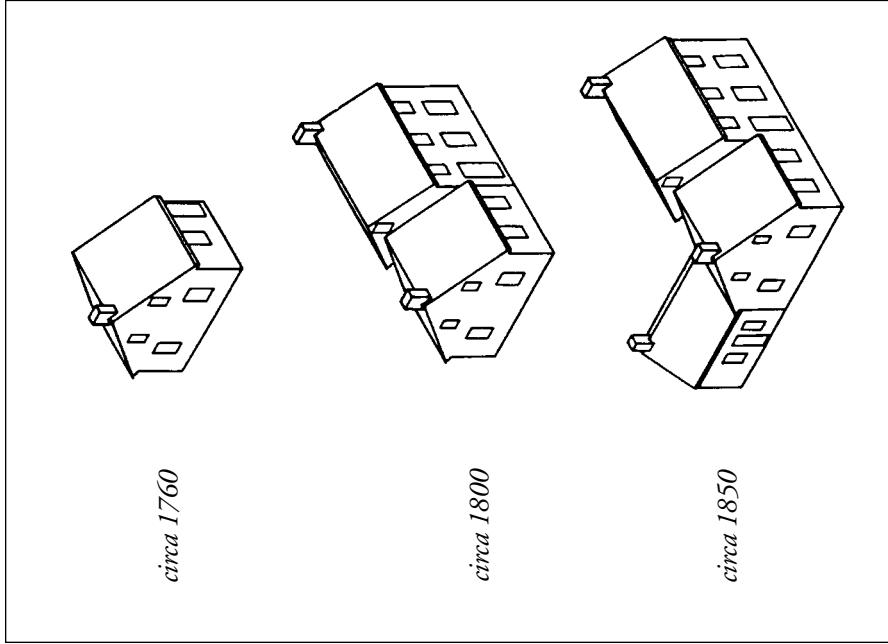
This three-part drawing shows the evolution of a farm house over time. Such change is part of the history of the place and is respected within the treatment, Preservation. Drawing: Center for Historic Architecture and Engineering, University of Delaware (adapted from Preservation Brief 35: Understanding Old Buildings).

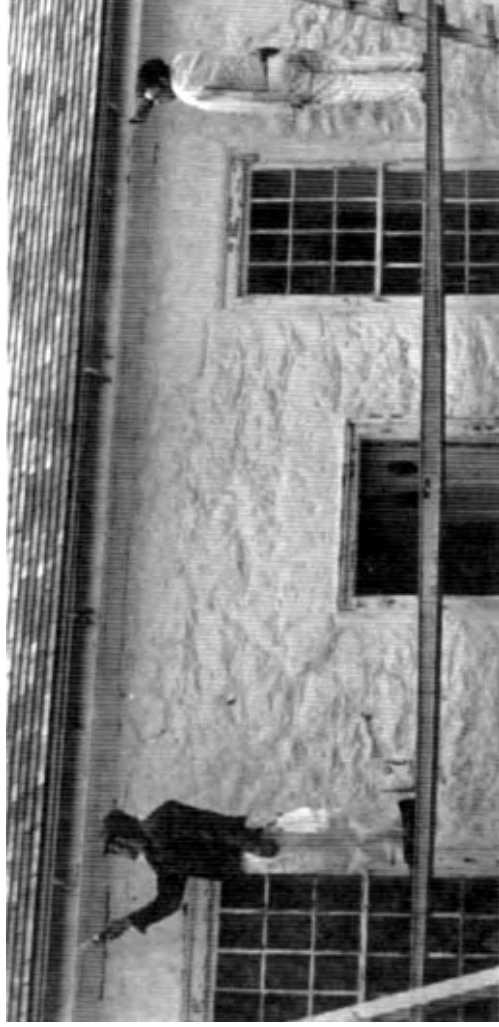
Adequate protection and maintenance of a historic building is an ongoing commitment. Here, two workers are priming and repainting exterior stone and wood trim. If surface treatments are neglected, more extensive repair and replacement will be required. Each loss further undermines a building's historic integrity.

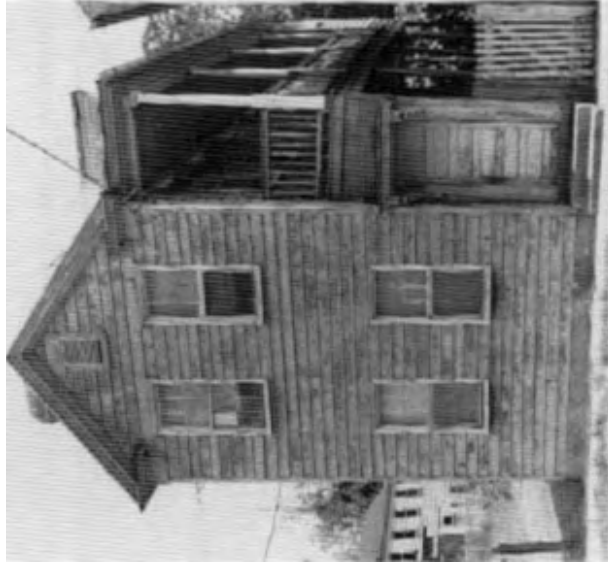
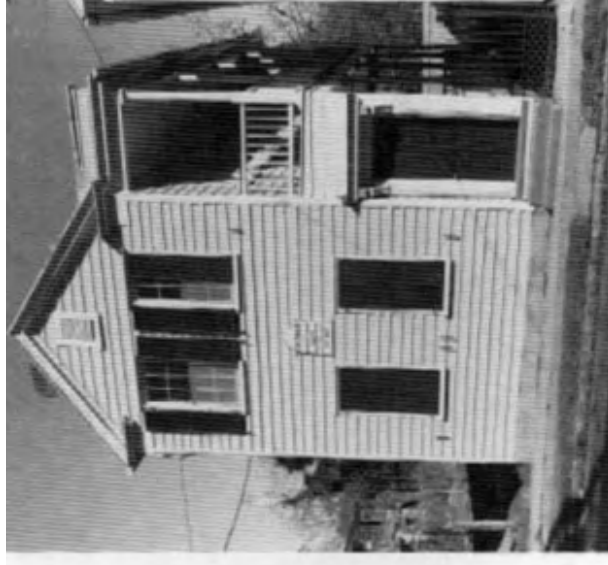
Maximizing retention of historic materials and features is the primary goal of Preservation as demonstrated here in these “before” and “after” photographs. Aside from some minor repairs and limited replacement of deteriorated material, work on this house consisted primarily of repainting the wood exterior. Photos: Historic Charleston Foundation.

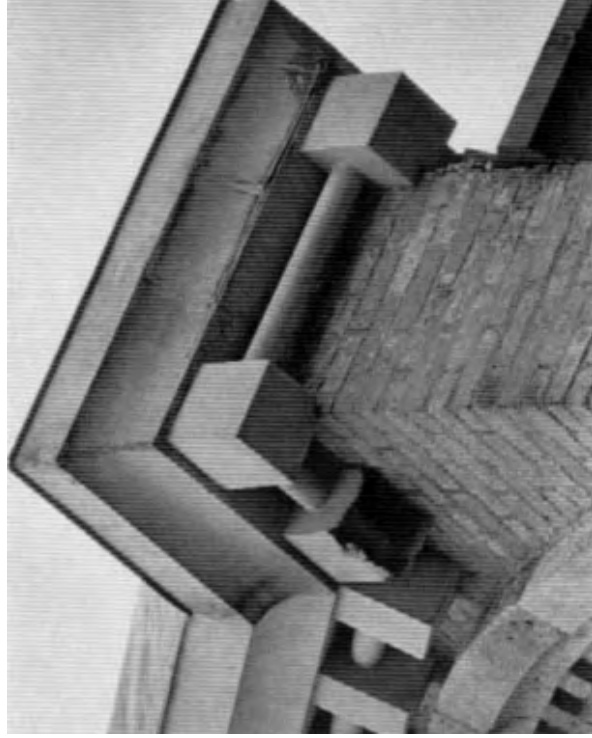
Repairing architectural metal features by patching, piecing-in, or otherwise reinforcing the metal using recognized preservation methods. The new work should be unobtrusively dated to guide future research and treatment.

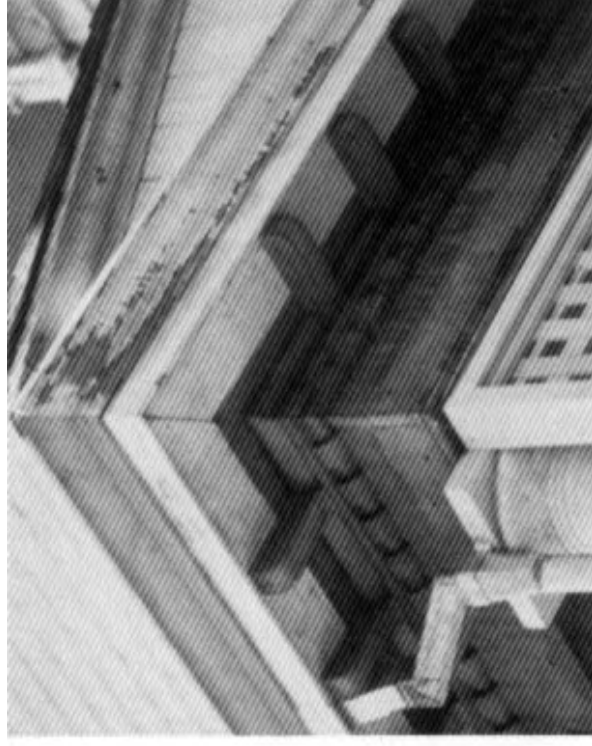
Two examples of “limited replacement in kind” point out an appropriate scope of work within the treatment, Preservation. (a) One metal modillion that has sustained damage from a faulty gutter will need to be replaced; and (b) targeted repairs to deteriorated wood cornice elements (fascia board and modillions) meant that most of the historic materials were retained in the work.

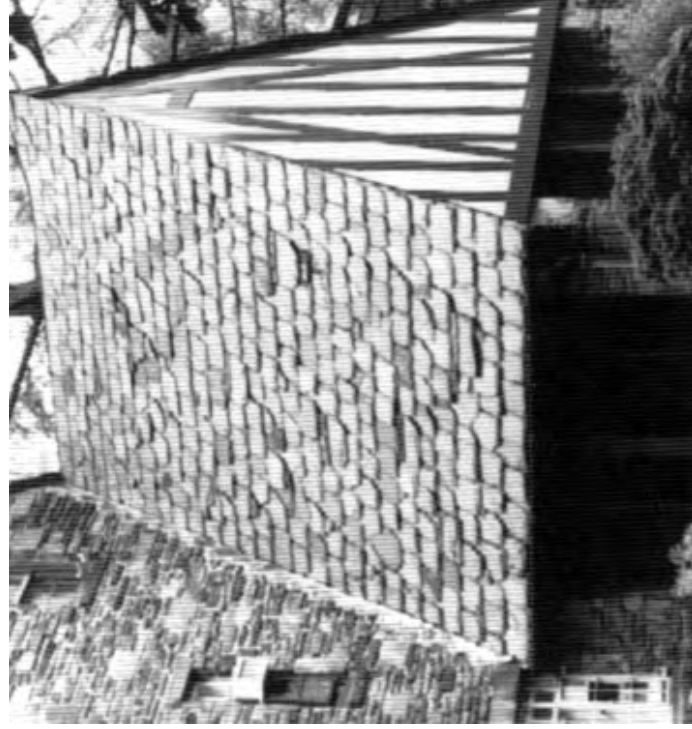
Stabilizing deteriorated or damaged roofs as a preliminary measure, when necessary, prior to undertaking appropriate preservation work.

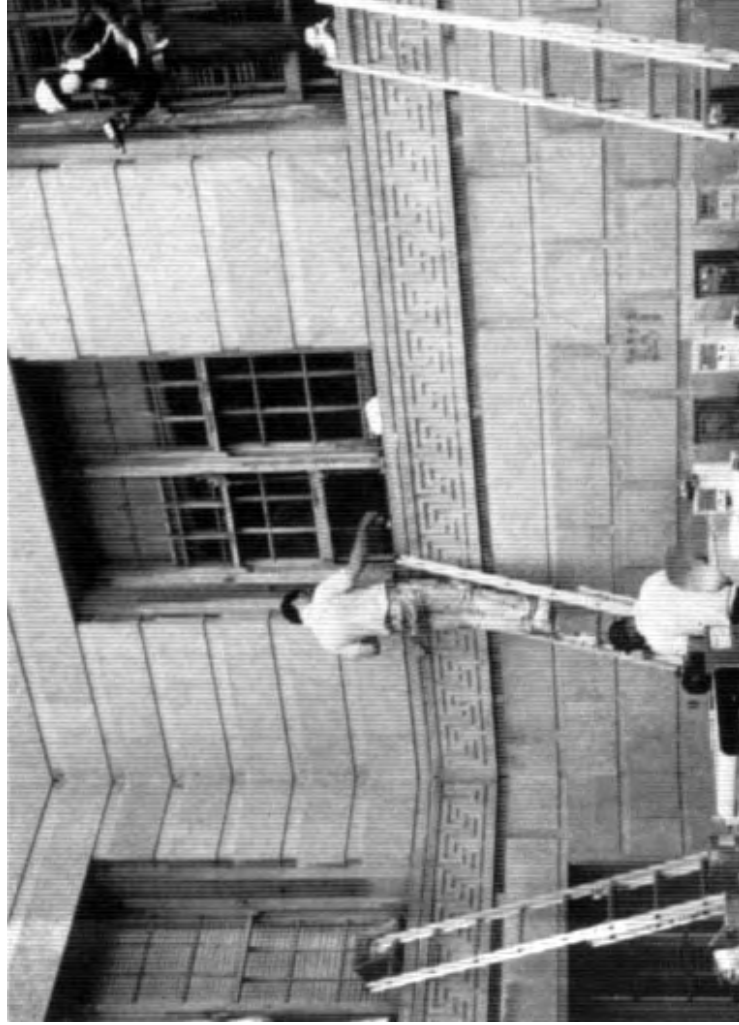
Preserving a building's historic windows generally involves scraping, sanding, and re-painting. While some repair work will most likely be undertaken within the scope of work on this institutional building, replacement of the window units is usually not an appropriate preservation treatment. Photo: Chuck Fisher.

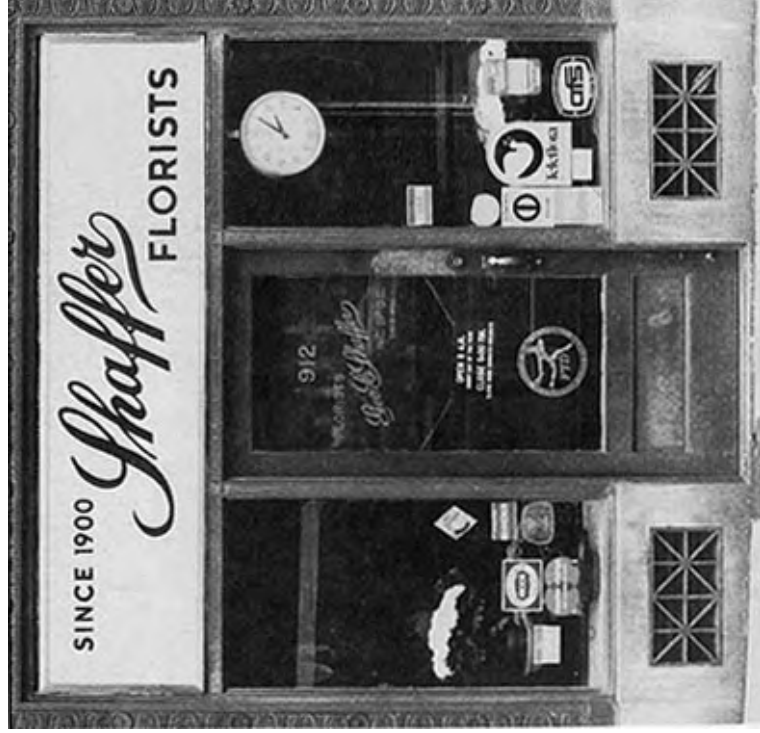
The original form and features of this 1920s storefront have been retained through Preservation. Photo: David W. Look, AIA.

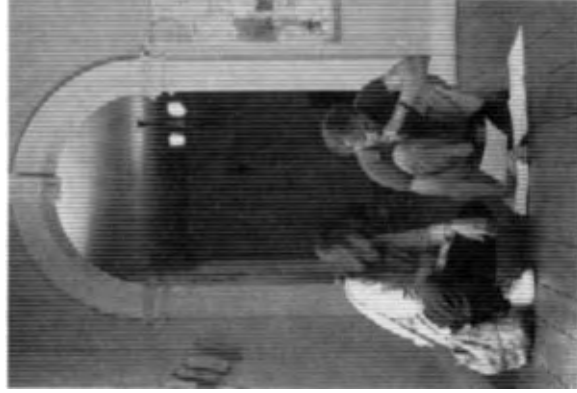
Careful documentation of a building's physical condition is the critical first step in determining an appropriate level of intervention. (a) This may include relating the historical research to existing materials and features; or (b) documenting a particular problem such as this cracked ceiling. Photo (a): Jean E. Travers; Photo (b): Lee H. Nelson, FAIA.

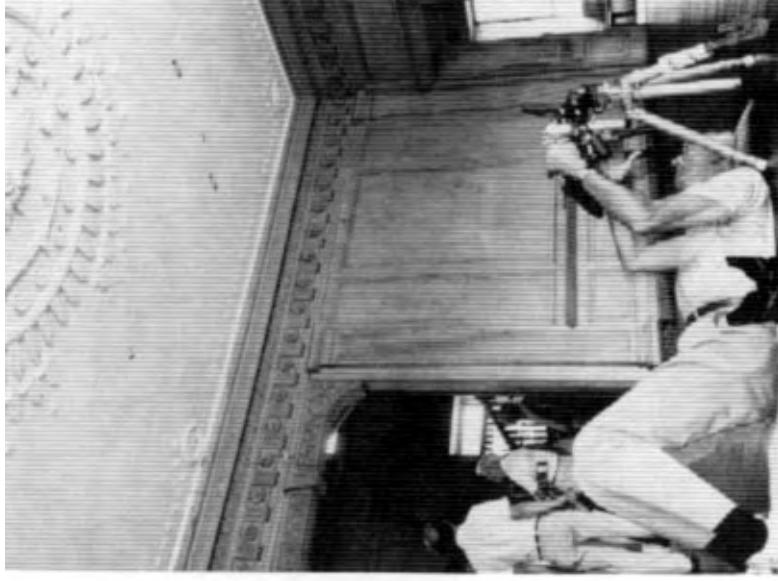
Altering a floor plan or interior spaces—including individual rooms—which are important in defining the overall historic character of the building so that, as a result, the character is diminished.

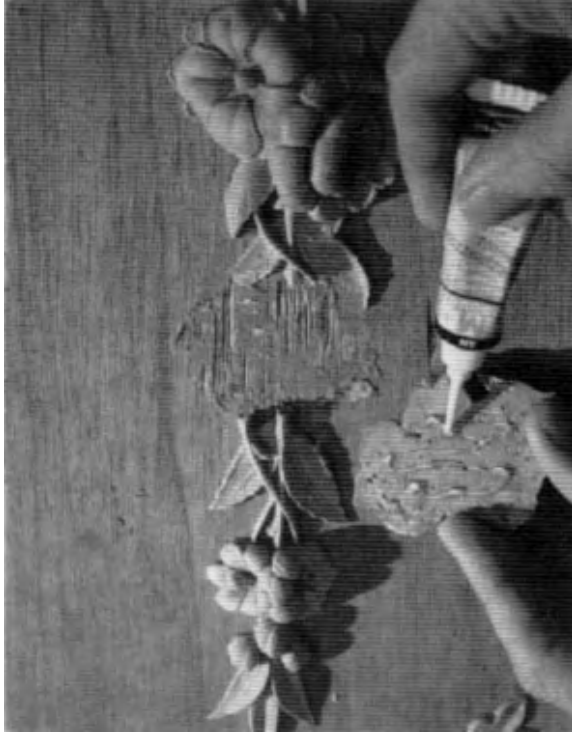
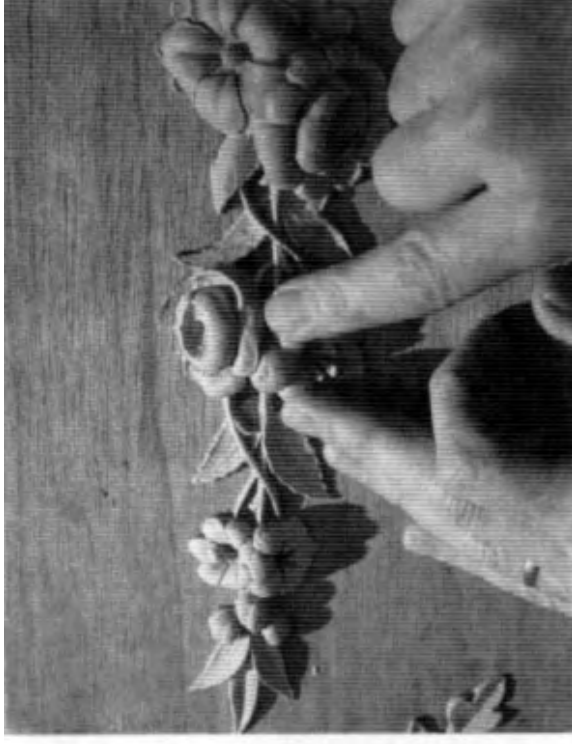
In Preservation, an appropriate level of intervention is established prior to work in order to maximize retention of historic materials.
(a) A conservator is applying adhesive to 19th century composition ornament that has delaminated from its wood substrate.
(b) The compo fragment is carefully held in place until the quick-setting adhesive takes hold. Photos: Jonathan Thornton.

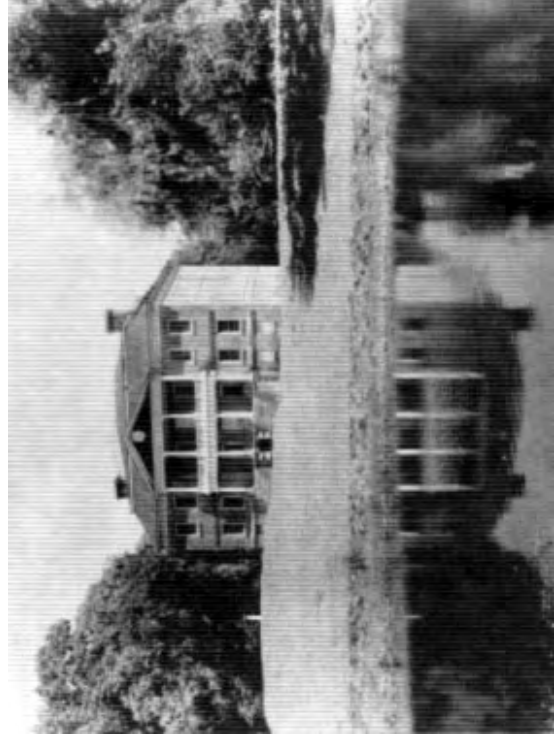
Stabilizing deteriorated or damaged building and site features as a preliminary measure, when necessary, prior to undertaking appropriate preservation work.

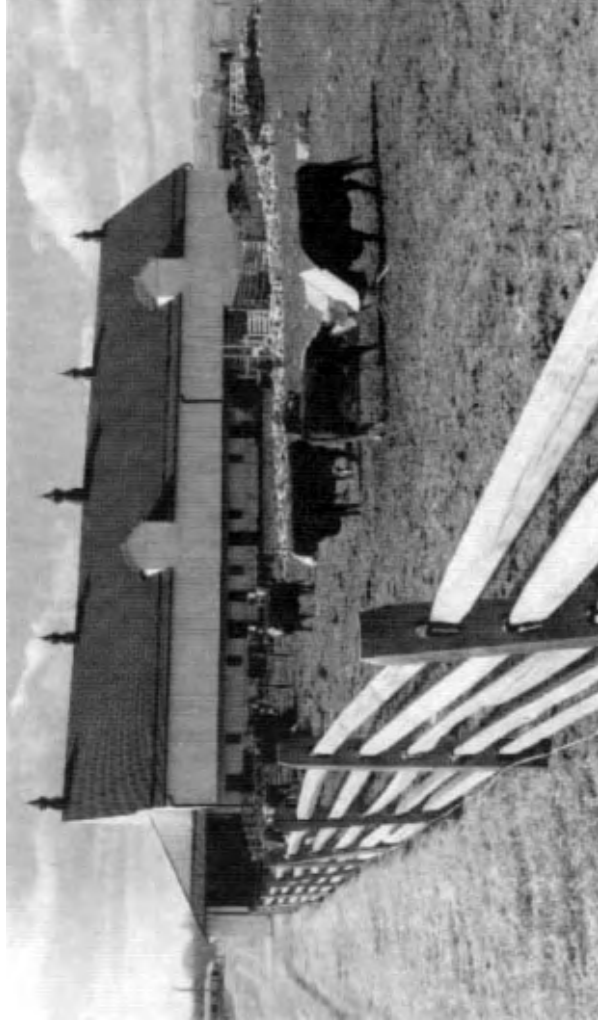
The goal of Preservation is to retain the historic form, materials, and features of the building and its site as they have changed—or evolved—over time. This bank barn was built in the 1820s, then enlarged in 1898 and again in 1914. Today, it continues its role as a working farm structure as a result of sensitive preservation work. This included foundation re-grading; a new gutter system; structural strengthening; and replacement of a severely deteriorated metal roof. Photo: Jack E. Boucher, HABS.

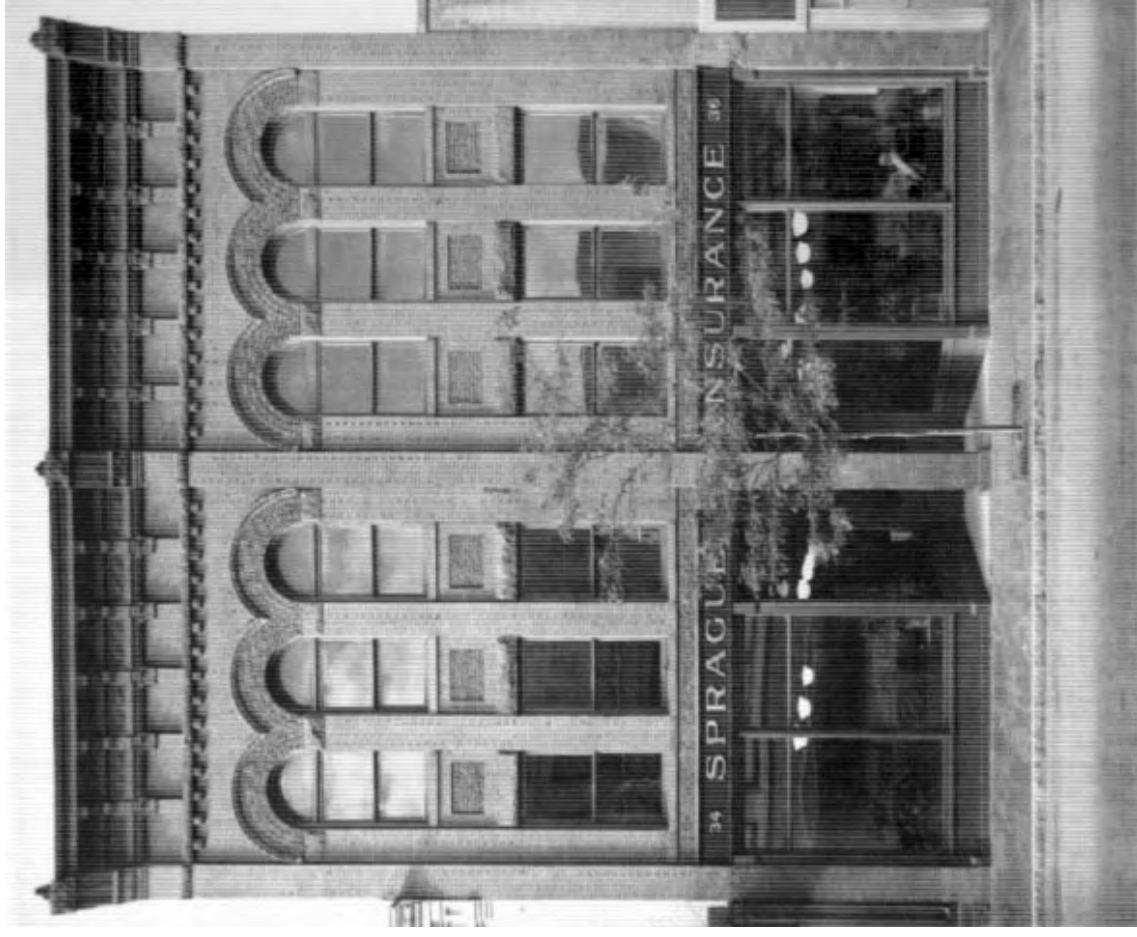
Standards for Rehabilitation

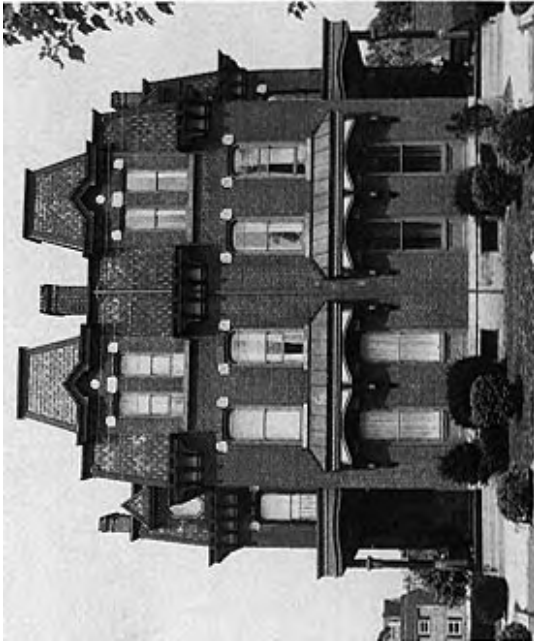
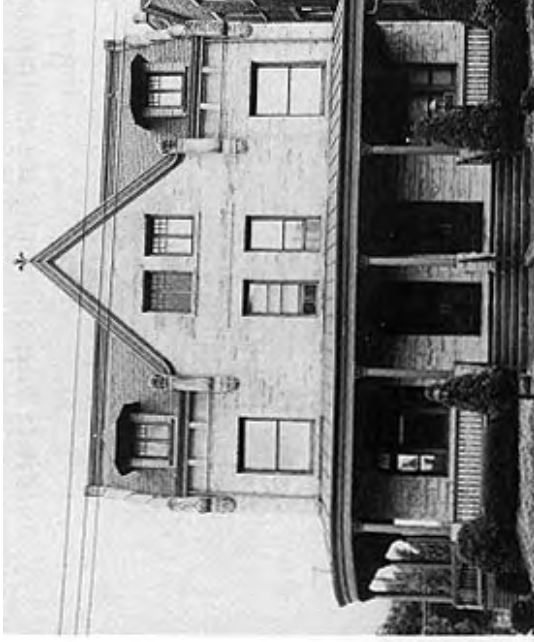
Originally built as single-family, semi-detached duplexes, these houses were rehabilitated for a new use as rental apartments. While some alteration to non-significant interior features and spaces was necessary in each one, the exteriors were essentially preserved. Photos: Mistick, Inc.

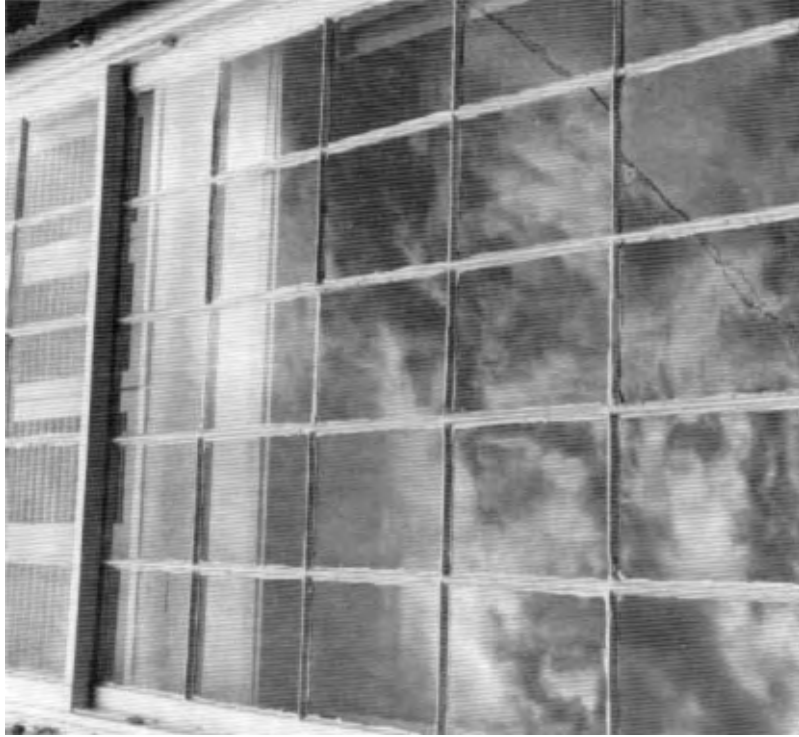
According to the Standards for Rehabilitation, existing historic materials should be protected, maintained and repaired. In an exemplary project, the windows and shutters of this historic residence were carefully preserved.

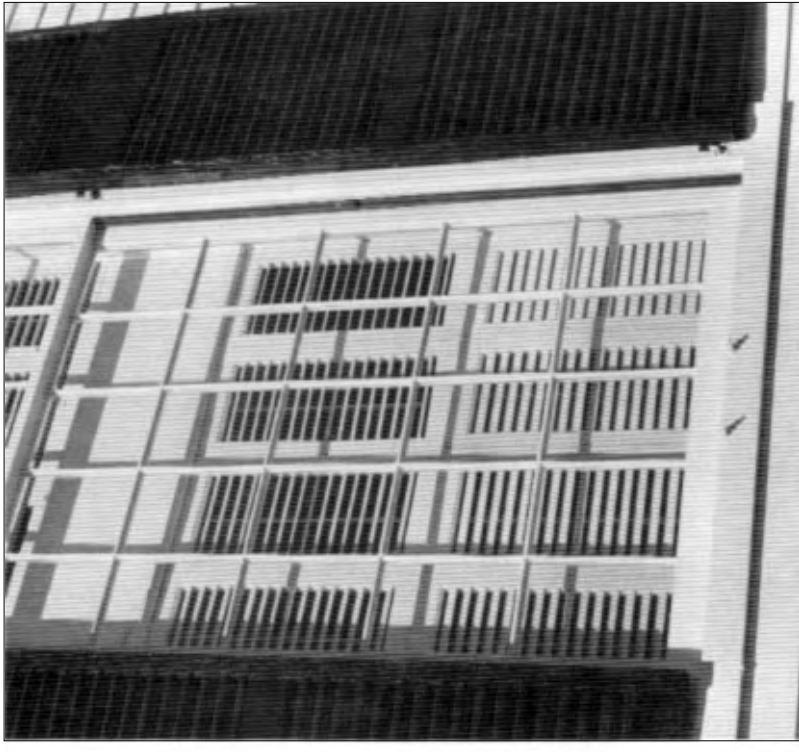
In an exemplary project, the

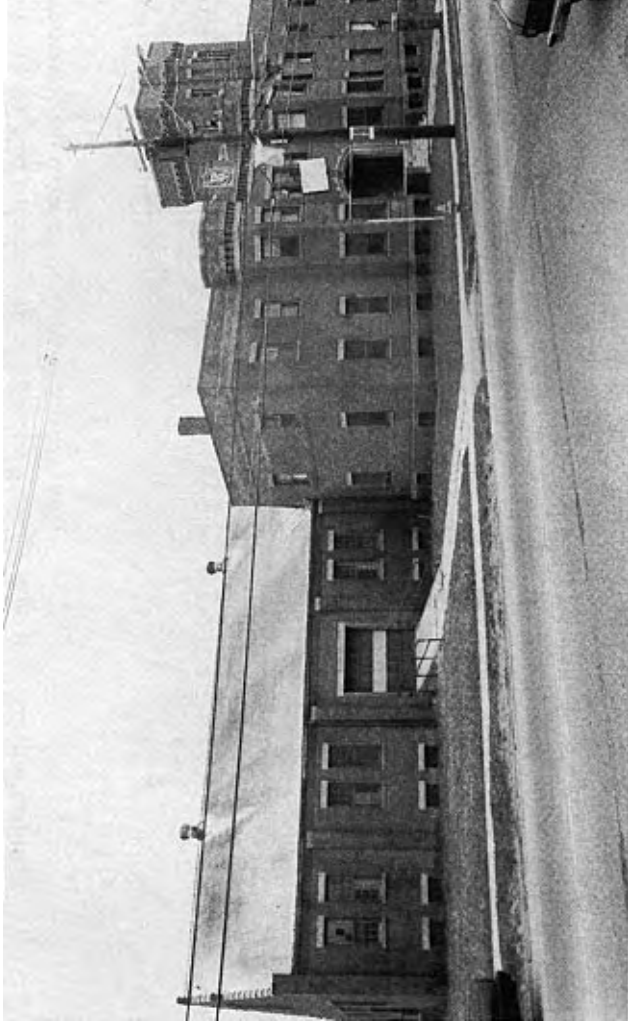
Inserting new floors or furred-down ceilings which cut across the glazed areas of windows so that the exterior form and appearance of the windows are changed.

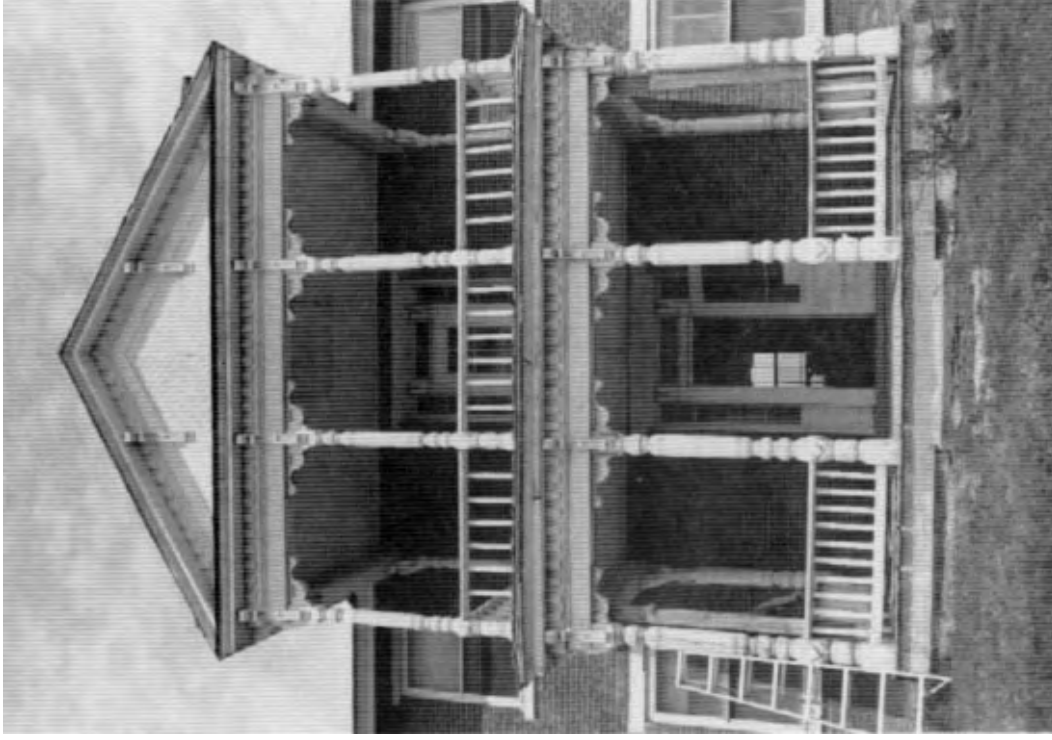
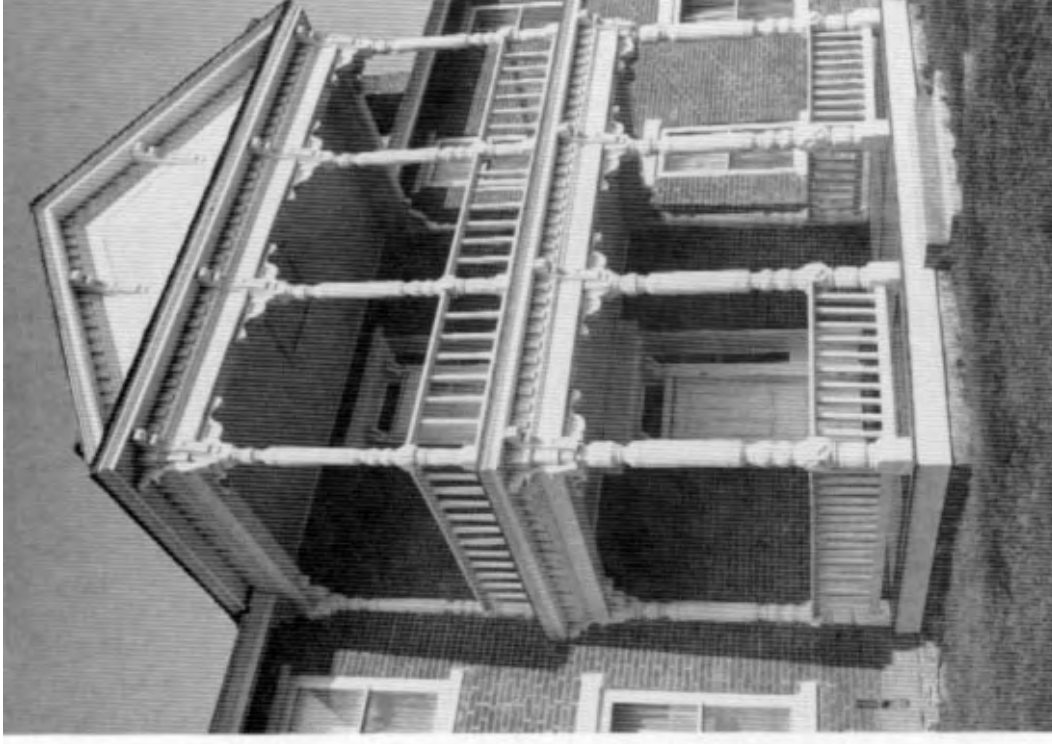
In Rehabilitation, deteriorated features should be repaired, whenever possible, and replaced when the severity of the damage makes it necessary. Here, a two-story porch is seen prior to treatment (left). The floor boards are rotted out and the columns are in a state of collapse, supported only by crude, temporary shafts. Other components are in varying stages of decay. Appropriate work on the historic porch (right) included repairs to the porch rails; and total replacement of the extensively deteriorated columns and floor boards. Some dismantling of the porch was necessary.

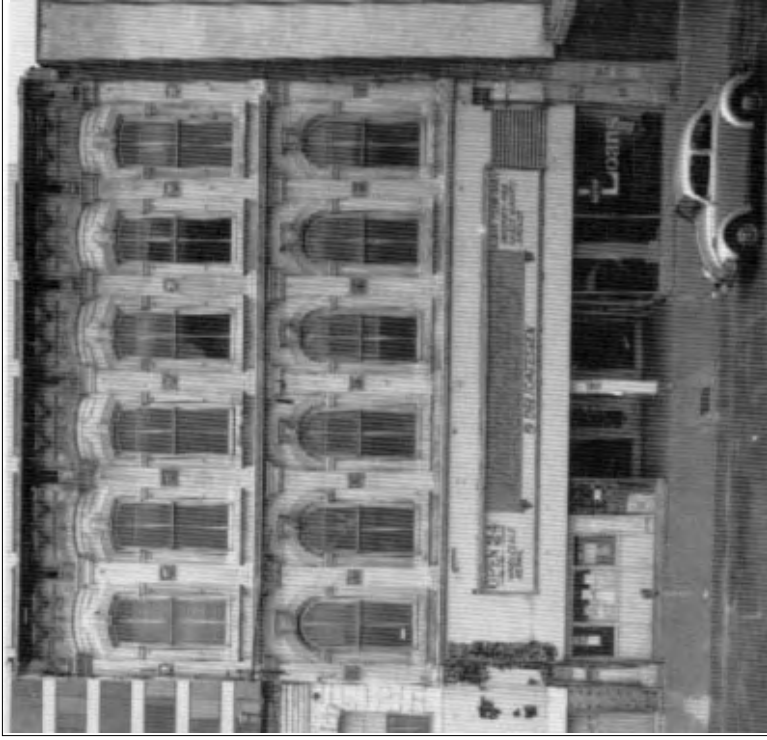
Using inappropriately scaled signs and logos or other types of signs that obscure, damage, or destroy remaining character-defining features of the historic building.

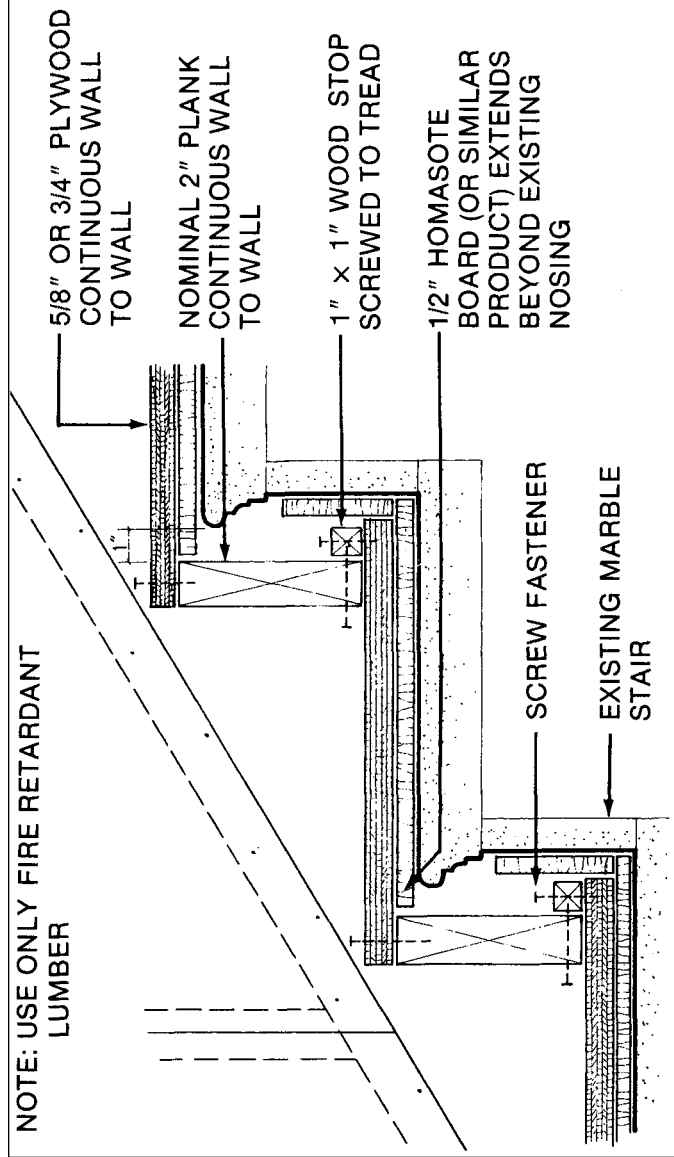
Historic features that characterize a building should always be protected from damage during rehabilitation work. The drawing shows how a resilient, temporary stair covering was applied over the existing marble staircase. Drawing: National Park Service staff, based on material originally prepared by Emery Roth and Sons, P.C.

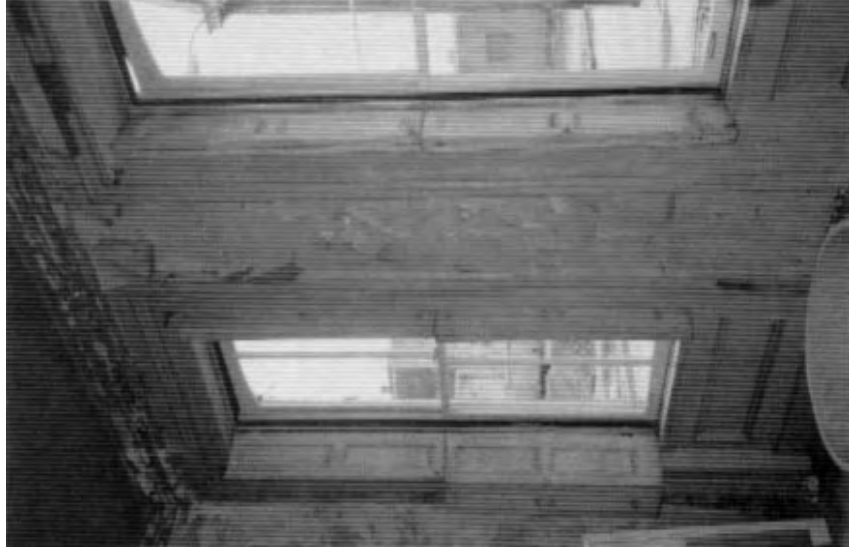
Removing a character-defining feature or finish that is unrepairable and not replacing it; or replacing it with a new feature or finish that does not convey the same visual appearance.

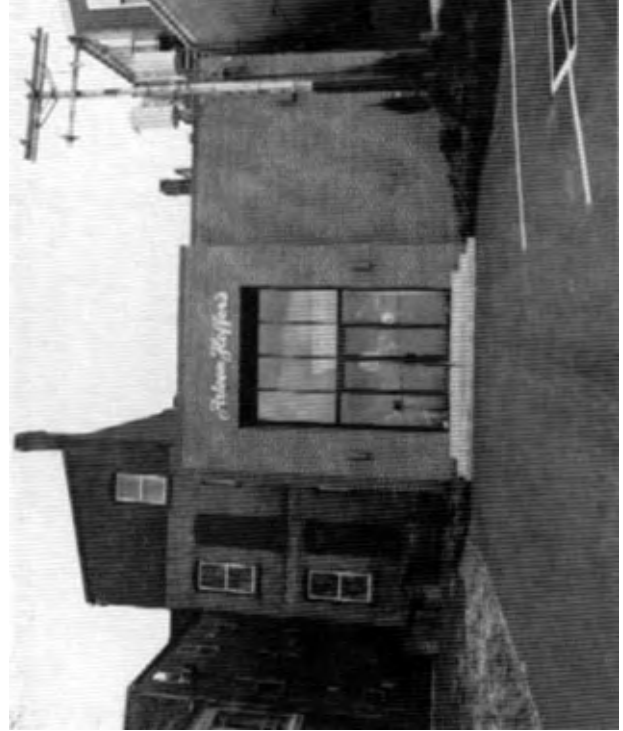
If a rear elevation of a historic building is distinctive and highly visible in the neighborhood, altering it may not meet the Standards. (a and b) This 3-story brick rowhouse featured a second story gallery and brick kitchen wing characteristic of other residences in the district which backed onto a connecting roadway. (c) In the rehabilitation, the wing and gallery were demolished and a large addition constructed that severely impacted the building's historic form and character.

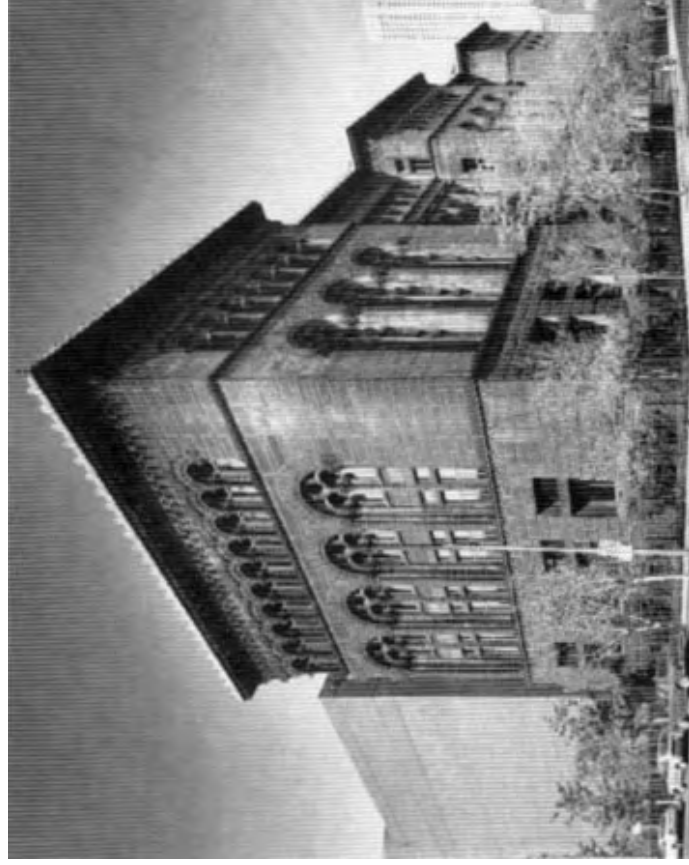
Rehabilitation, like Preservation, acknowledges a building's change over time; the retention and repair of existing historic materials and features is thus always recommended. However, unlike Preservation, the dual goal of Rehabilitation is to—respectfully—add to or alter a building in order to meet new use requirements. This downtown Chicago library was expanded in 1981 when additional space was required with light and humidity control for the rare book collection. The compatible 10-story wing was linked to the historic block on side and rear elevations. Its simple design is compatible with the historic form, features, and detailing; old and new are clearly differentiated.
Photo: Dave Clifton.

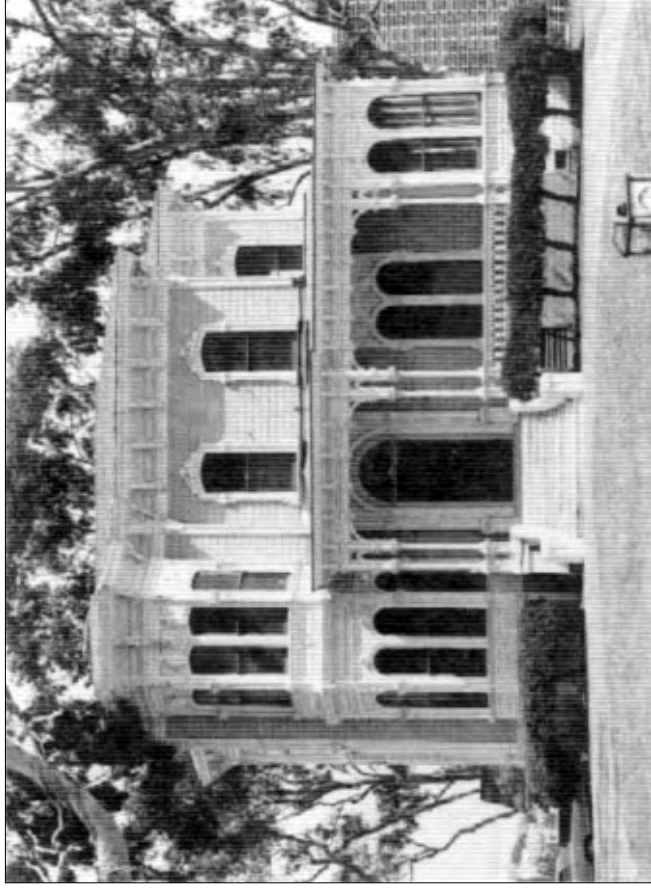
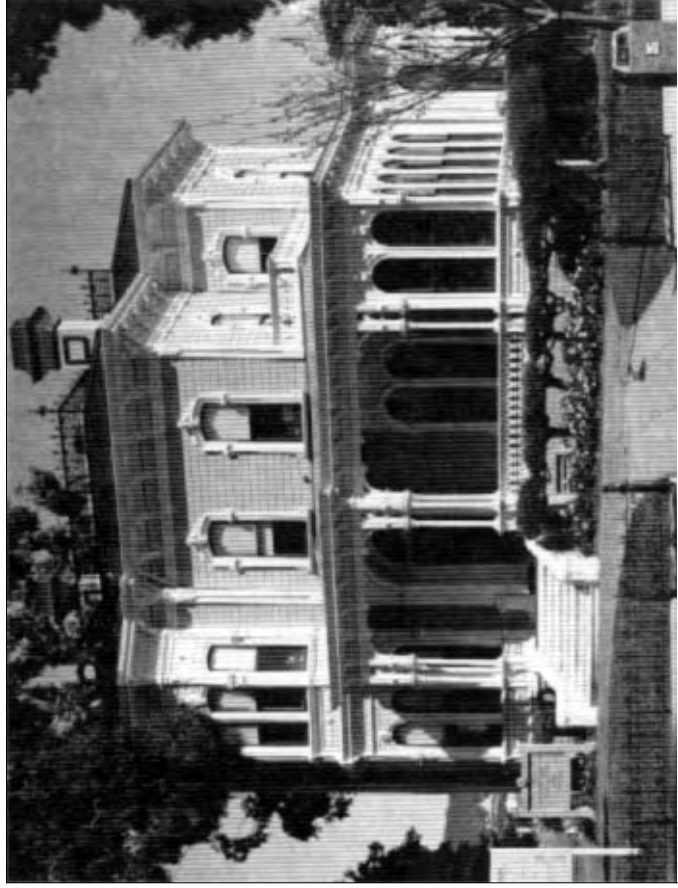
Standards for Restoration

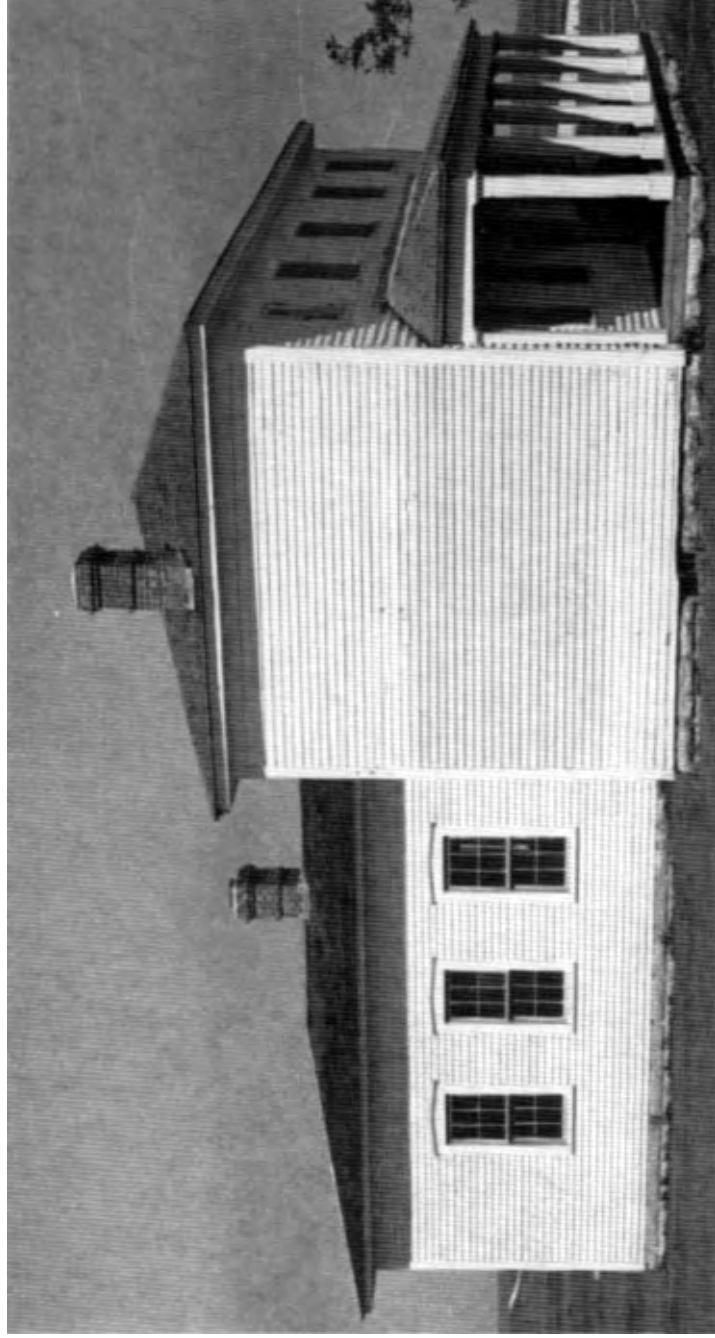
In a project at Fort Hays, Kansas, the wood frame officers' quarters were restored to the late 1860s—their period of significance. This included replacing a missing kitchen ell, chimneys, porch columns, and cornice, and closing a later window opening in the main block. The building and others in the museum complex is used to interpret frontier history.

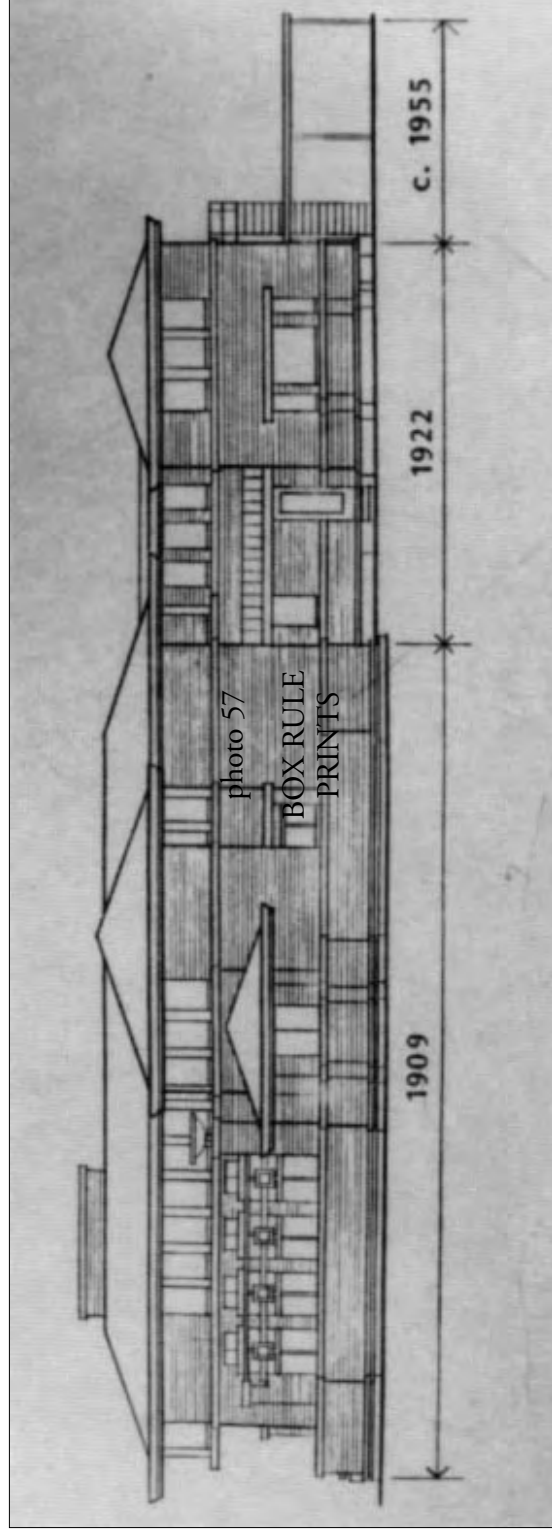
The Meyer May House in Grand Rapids, Michigan, was designed by Frank Lloyd Wright and built in 1909. In 1922, May added to the house for an expanding family. After the May occupancy, the house was altered for use as apartments, with a carport added in 1955. In the 1980s restoration, the Wright's original design was deemed more significant than May's later changes, and, as a result, the additions were removed and the house returned to its 1909 appearance. Drawing: Martha L. Werenfels, AIA.
