Preservation and Maintenance Manual

DART Police Headquarters at Illinois Station/Monroe Shops

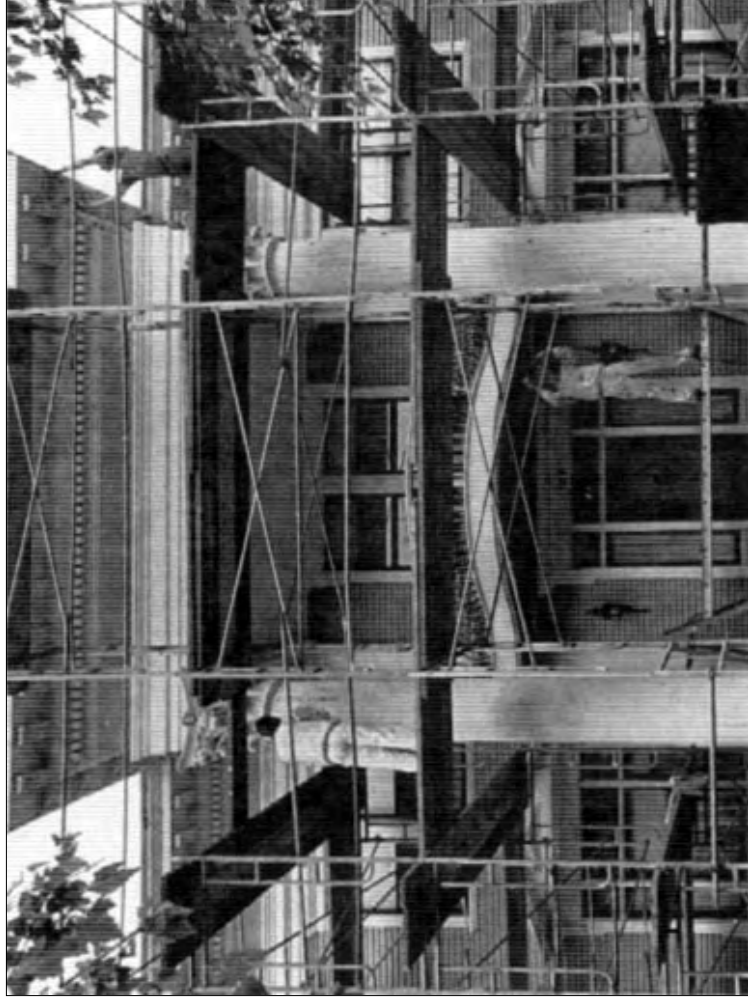
Ongoing work at this house focuses on the maintenance and repair of exterior wood features from the restoration period. After scraping and sanding, the wood was painted in colors documented to the Restoration period. Photo: ©Mary Randlett, 1992.

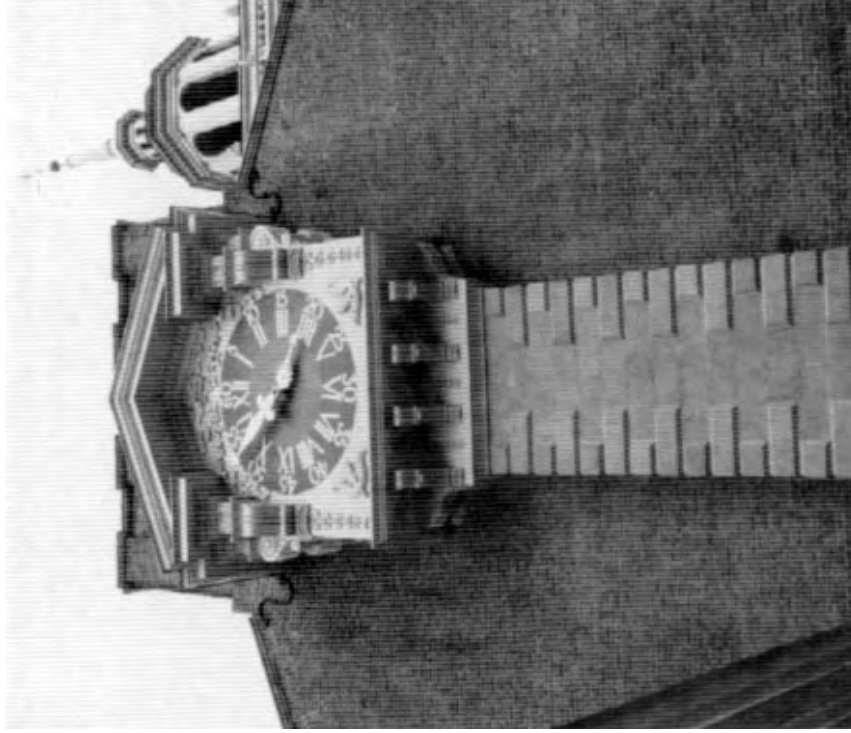
The Standards for Restoration call for the repair of existing features from the restoration period as well as the re-creation of missing features from the period. In some instances, when missing features are replaced, substitute materials may be considered if they convey the appearance of the historic materials. In this example at Philadelphia's Independence Hall, the clock was re-built in 1972-73 using cast stone and wood with fiberglass and polyester bronze ornamentation. Photo: Lee H. Nelson, FAIA.

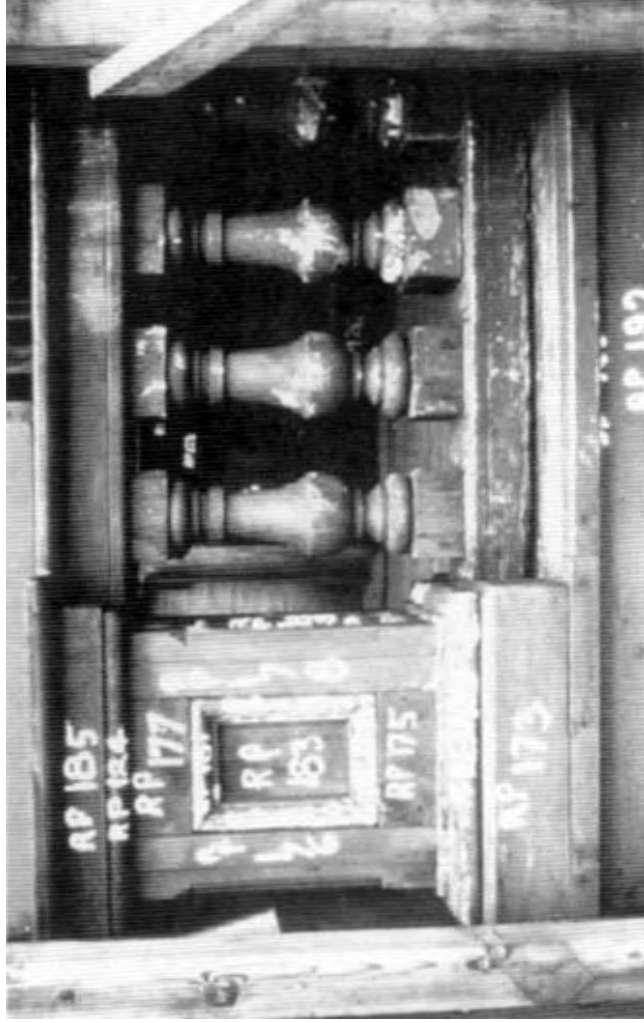
Portions of the small porch on an Italianate mansion were carefully numbered prior to Restoration. Some original elements were restored in place, while others had to be removed for repair, then reinstalled. Any element too deteriorated to save was replaced with a new one replicated to match the original design. Photo: Morgan W. Phillips.

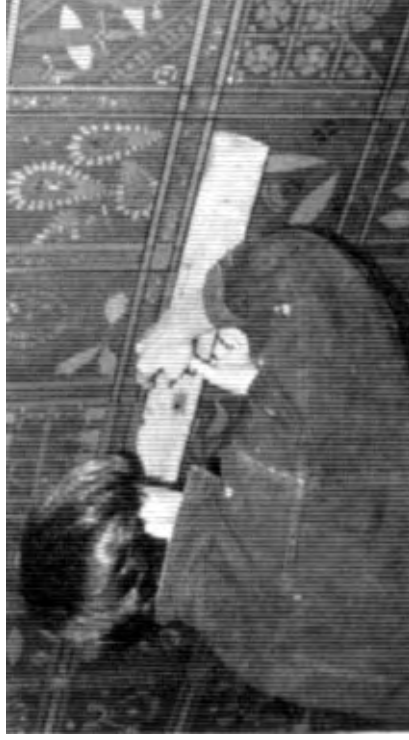
A complete paint investigation often needs to be conducted during Restoration. Paint samples are carefully collected onsite. In the laboratory, an ultra violet light is used to identify pigment and binding media. Paint samples are then photographed. Physical evidence documented through laboratory research provides a sound basis for an accurate restoration of painted finishes, such as the complex stencilling pictured here. Photo left: Courtesy, Alexis Eliza; Photo right: Courtesy, Andrea Gilmore.

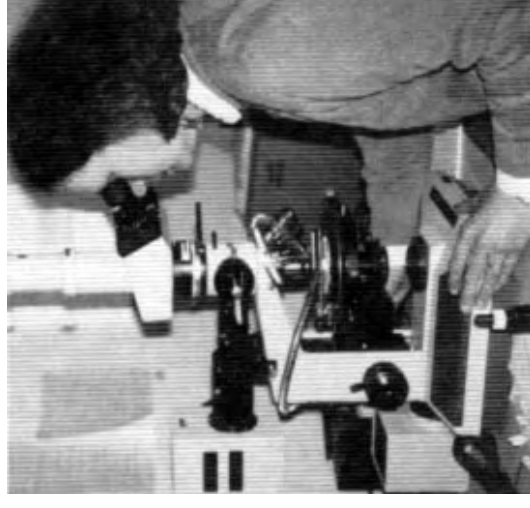
The following Restoration work is highlighted to indicate that it involves the removal or alteration of existing historic interior spaces, features, and finishes that would be retained in Preservation and Rehabilitation treatments; and the replacement of missing interior spaces, features, and finishes from the restoration period using all new materials.

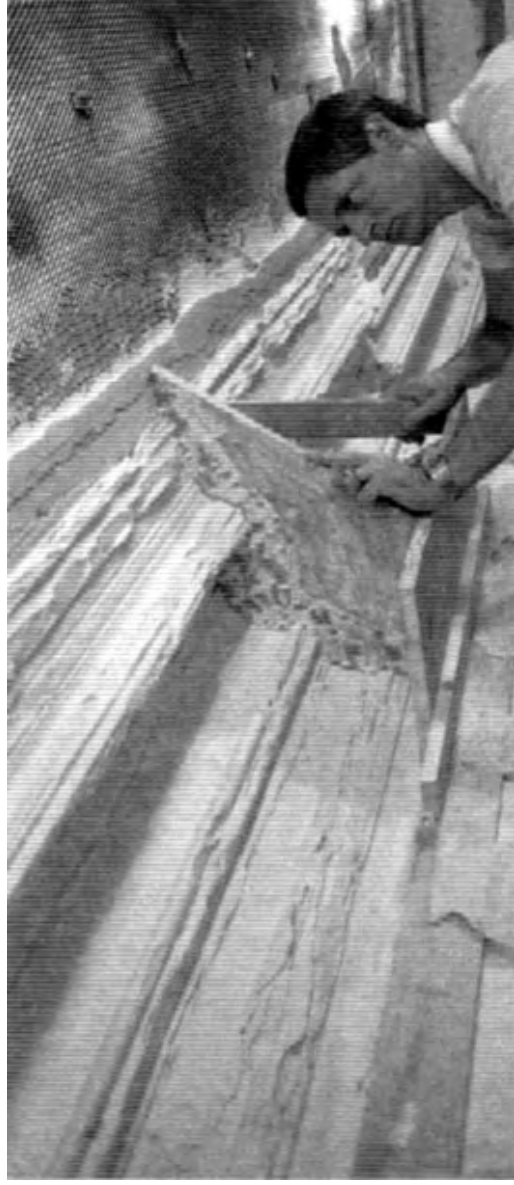
*The missing plaster cornice was restored as part of an overall project to return a residence to its original appearance. The traditional method of producing a cornice is unchanged today.
Photo: Old-House Journal.*

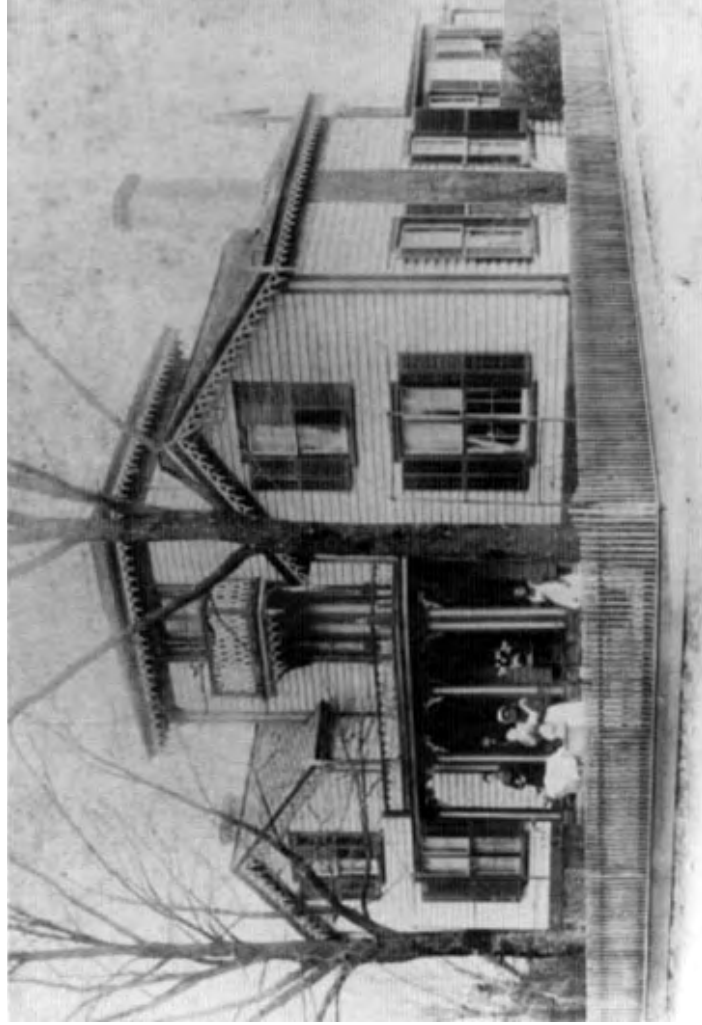
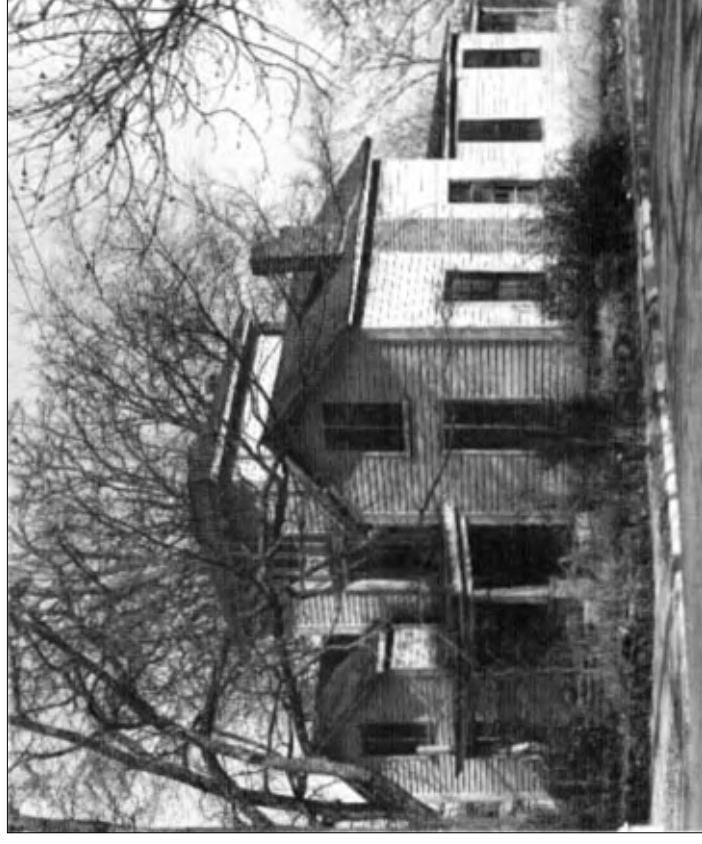
This ca. 1900 photograph (left) would be invaluable to guide restoration of the deteriorated house (right) to its documented earlier appearance, complete with decorative trim, shutters, polychromed exterior, and fencing. Photos: Courtesy, North Carolina Department of Archives and History.

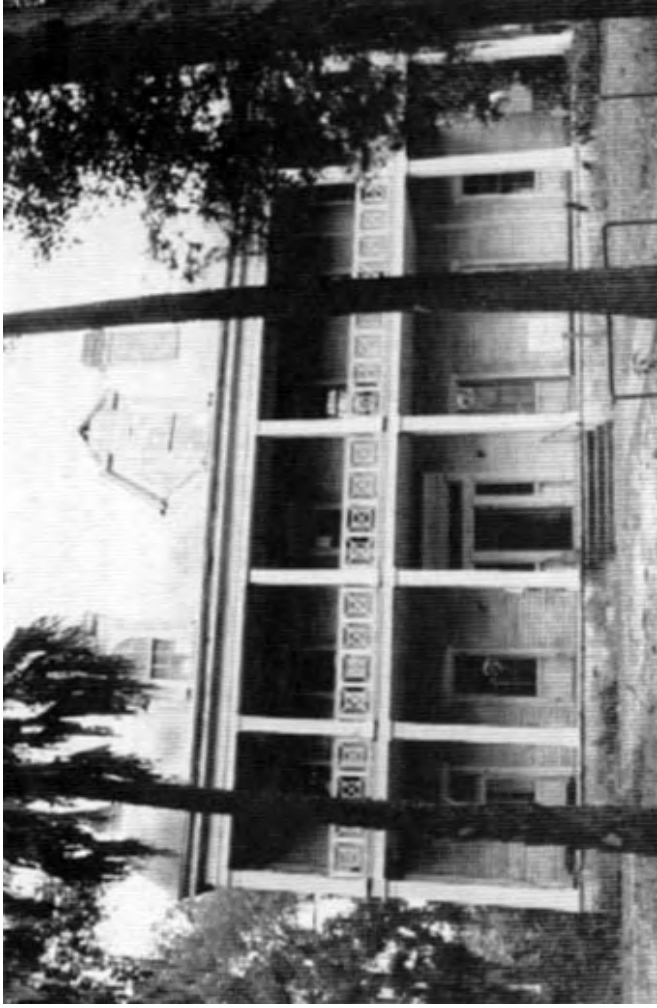
The Bronson-Mulholland House in Palatka, Florida, ca. 1845, is shown (a) before and (b) after the treatment, Restoration. Over the years the east (far right) side of the veranda had been filled in as a sixth bay. During the restoration, this later infill was removed and the east veranda, together with its flooring, stairs, and foundation, restored. Photo: City of Palatka, Community Development Department.

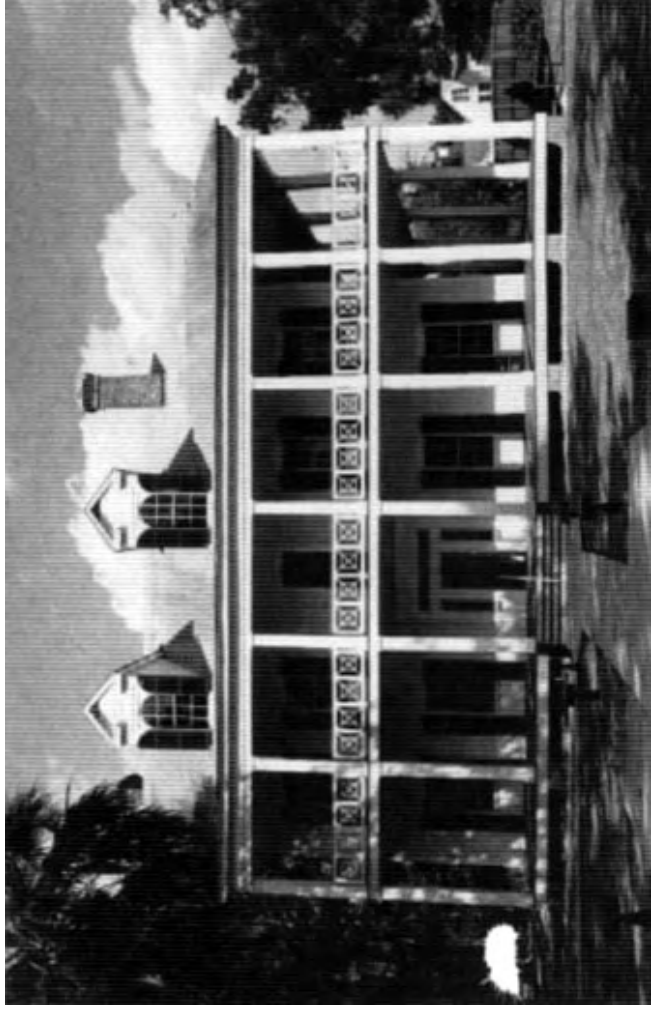
Although the work in the following sections is quite often an important aspect of restoration projects, it is usually not part of the overall process of preserving features from the restoration period (protection, stabilization, conservation, repair, and replacement); rather, such work is assessed for its potential negative impact on the building's historic appearance. For this reason, particular care must be taken not to obscure, alter, or damage features from the restoration period in the process of undertaking work to meet code and energy

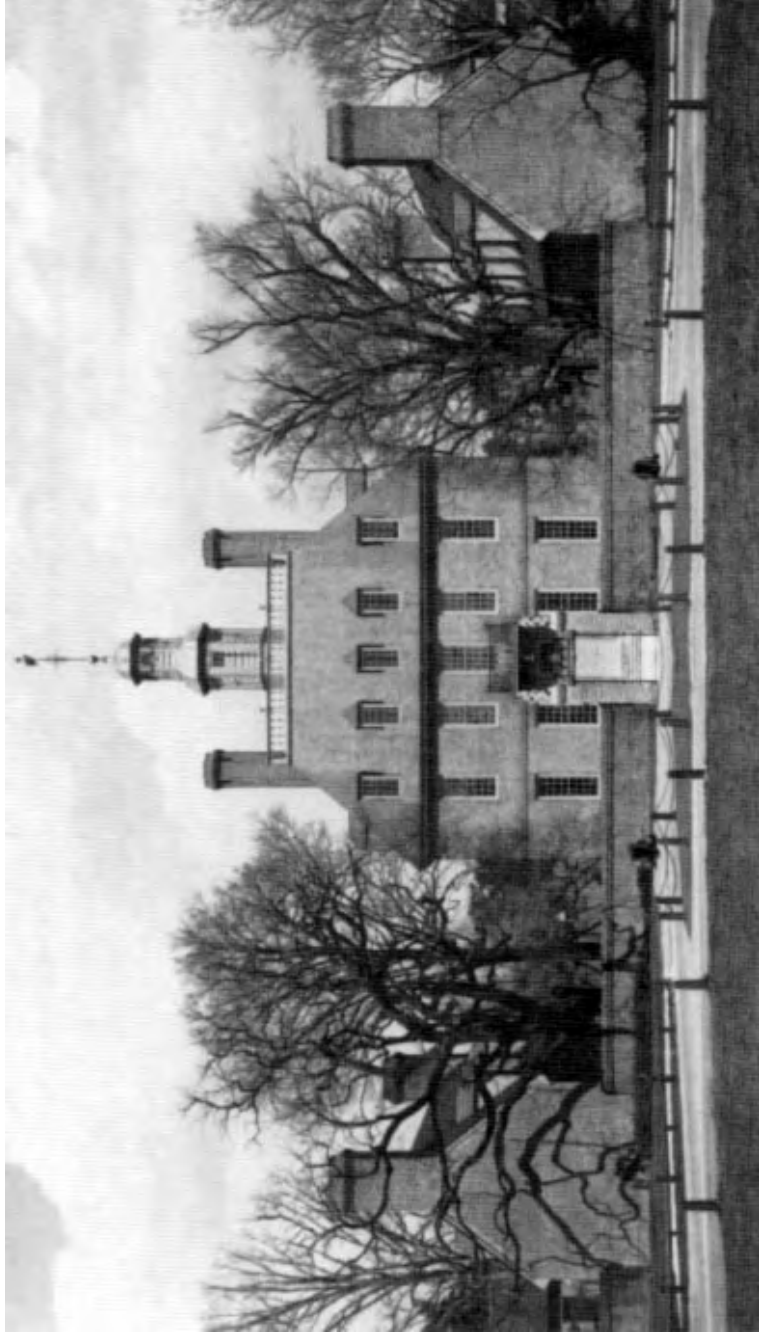
*In the 1930s reconstruction of the 18th century Governor's Palace at Colonial Williamsburg, Virginia, the archaeological remains of the brick foundation were carefully preserved in situ, and serve as a base for the reconstructed walls.
Photo: The Colonial Williamsburg Foundation.*

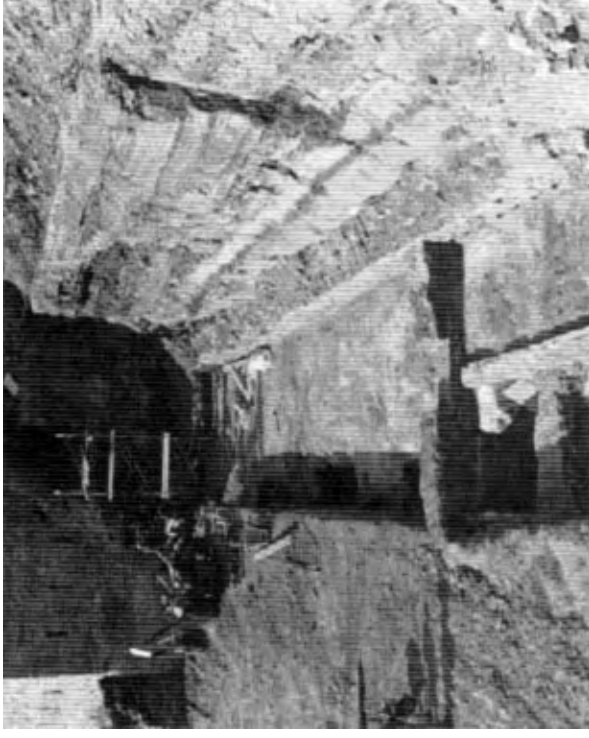
Reconstruction should generally be based on an extensive archeological investigation, as was done here to re-create a non-surviving commissary building at Fort Snelling.

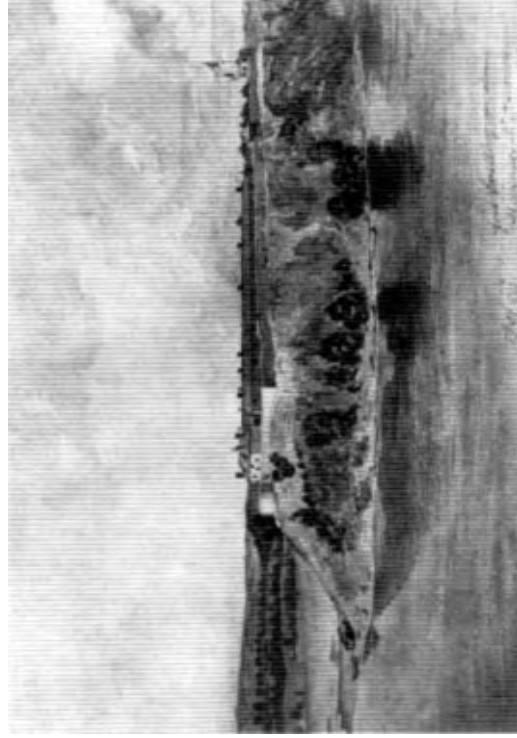
Jean Baptiste Wengler's watercolor rendering of Fort Snelling, Minnesota, in 1857, is aesthetically pleasing, but the overall view does not constitute adequate documentary evidence for a Reconstruction. Oral histories are also unreliable sources of documentation for treatment.

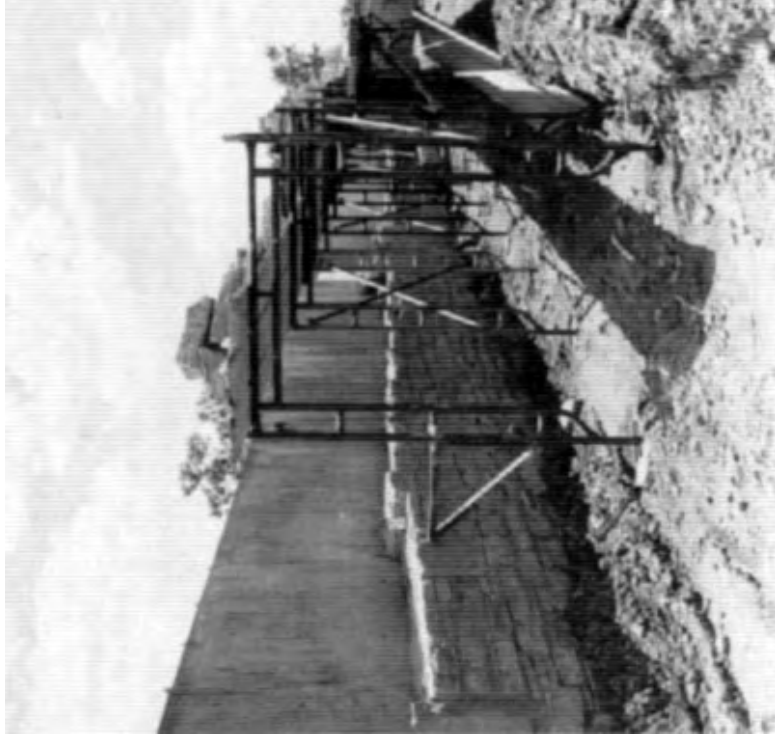
(a) and (b). Two photos illustrate the use of contemporary construction materials and techniques within the treatment, *Reconstruction*. Because Reconstruction is employed to portray a significant earlier time, usually for interpretive purposes, substitute materials may be appropriate if they are able to convey the historic appearance.

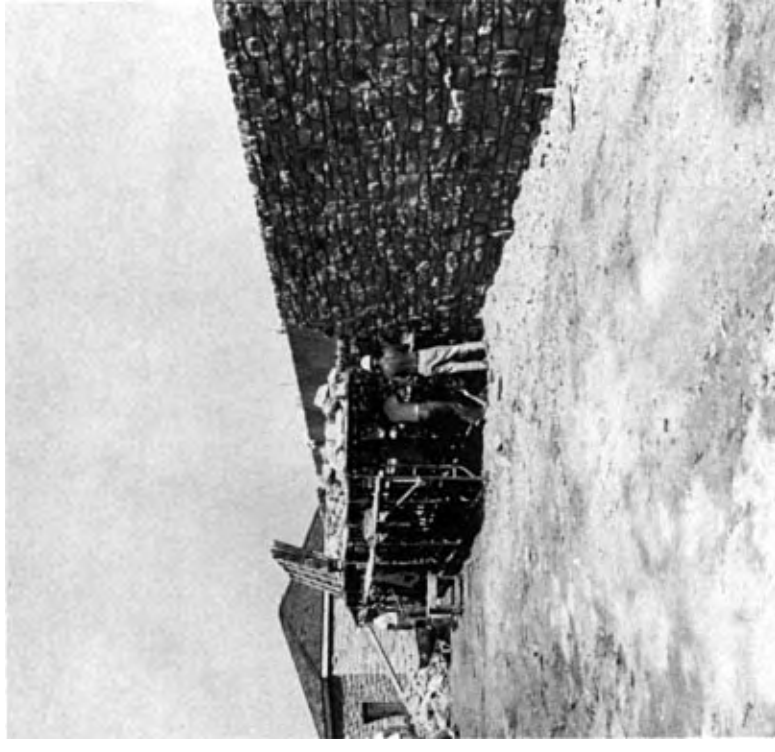
Basing a reconstruction on conjectural designs or the availability of different features from other historic buildings.

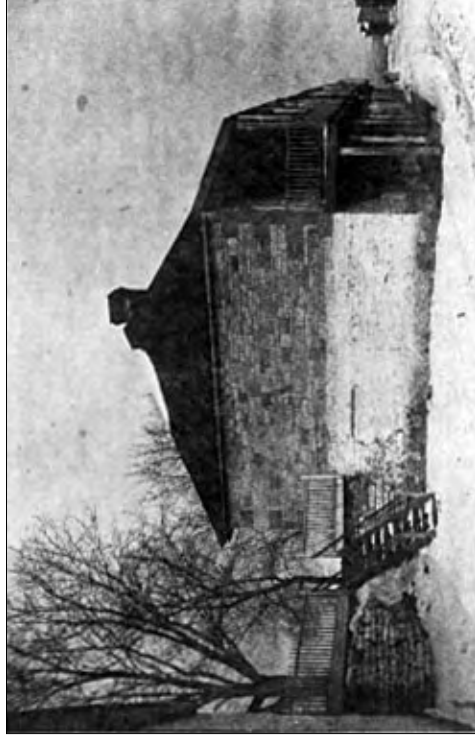
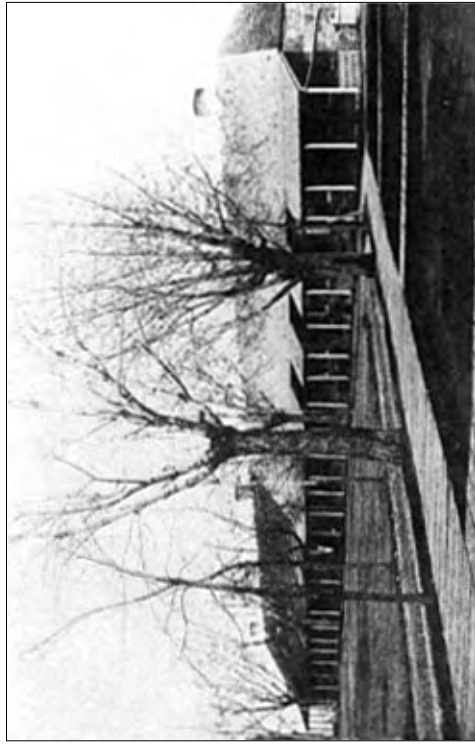
(a) and (b). Two views of the Officers' Quarters at Fort Snelling (ca. 1885 to 1900) not only provide information on the materials and form of the historic block, they document the wooden walkways and other landscape features such as stairs, railings, and tree placement. Historical and pictorial evidence would need to be combined with specific physical evidence in order to make the case for Reconstruction as a treatment.

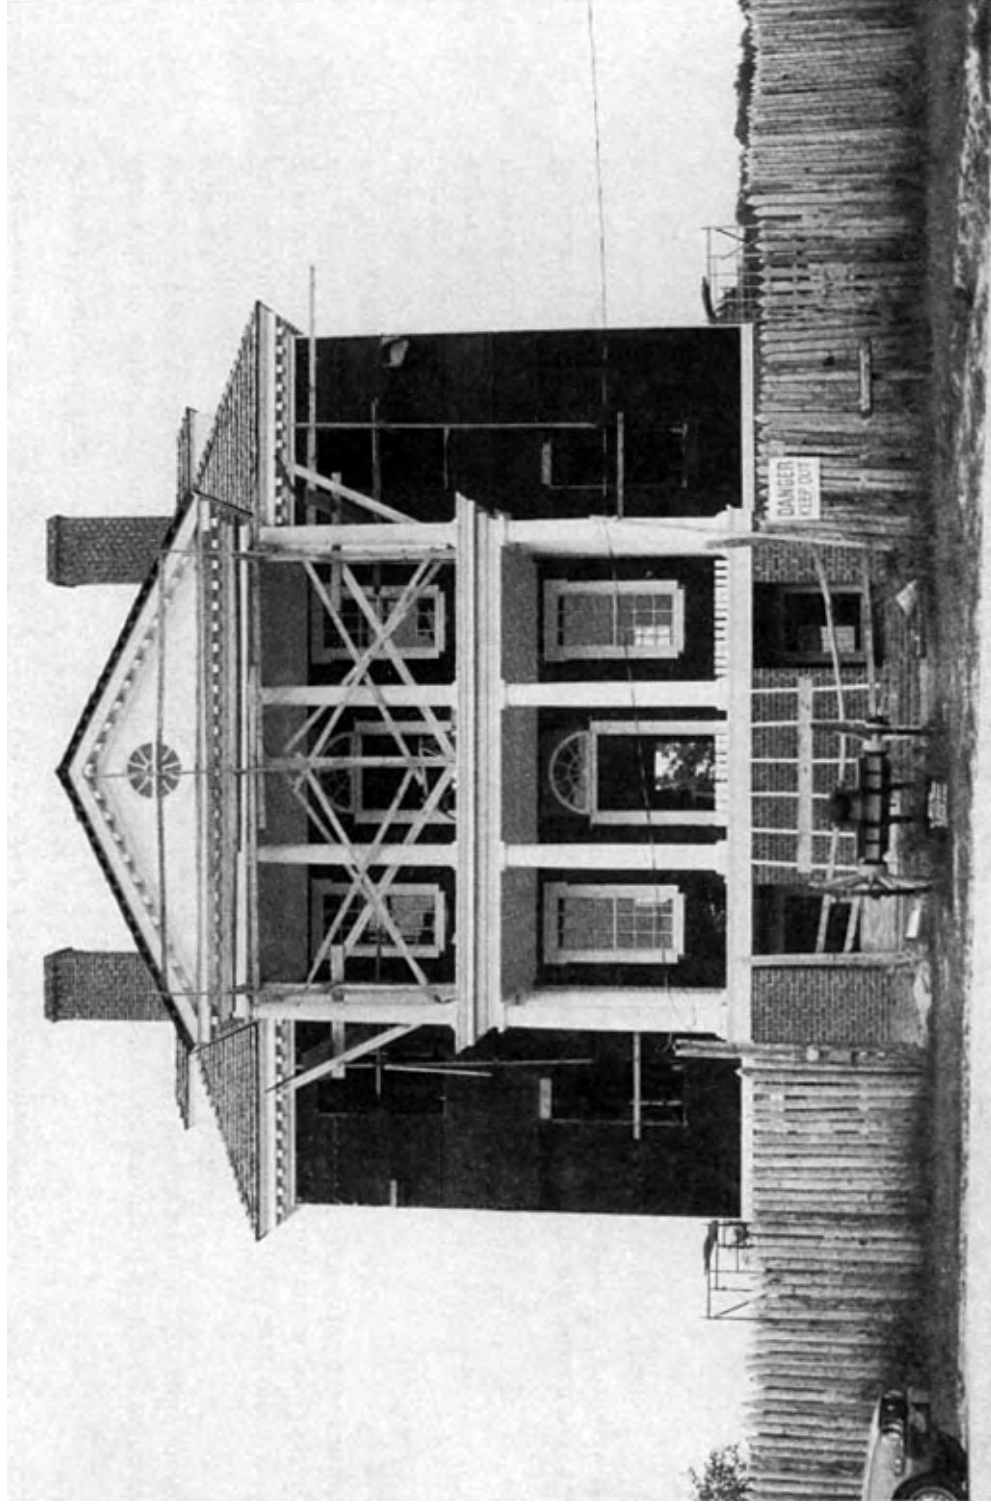
The 1778 Kershaw House, which served as British Headquarters during the Revolutionary War, was burned by Union troops in 1865. In the early 1970s, the house was reconstructed as part of Camden Battlefields, Camden, South Carolina. Built expressly for interpretive purposes, it serves as an illustrative reminder of a past event of national significance. The Standards for Reconstruction call for any re-created building to be clearly identified as a contemporary depiction. This is most often done by means of an exterior sign or plaque, or through an explanatory brochure or exhibit. A guide may inform visitors as well. Photo: Richard Frear.

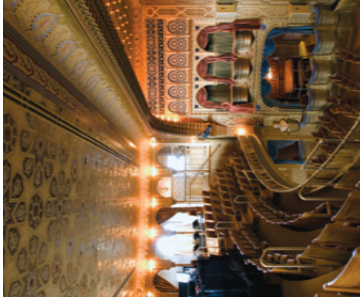
All photographs and drawings included here not individually credited have been selected from National Park Service files.

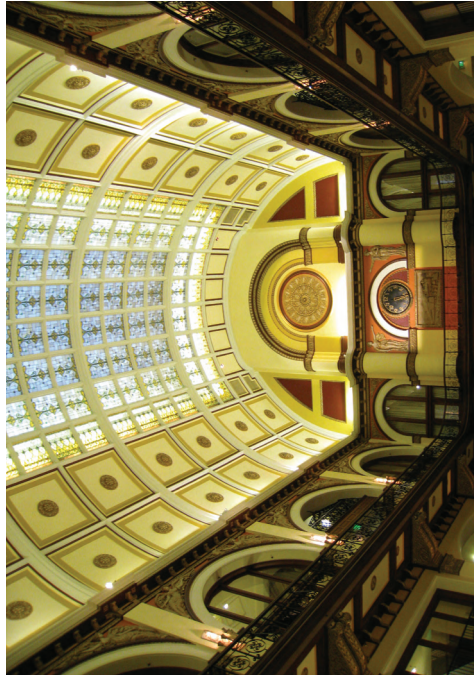
[1] Stained glass skylight provides natural light in a historic train station.

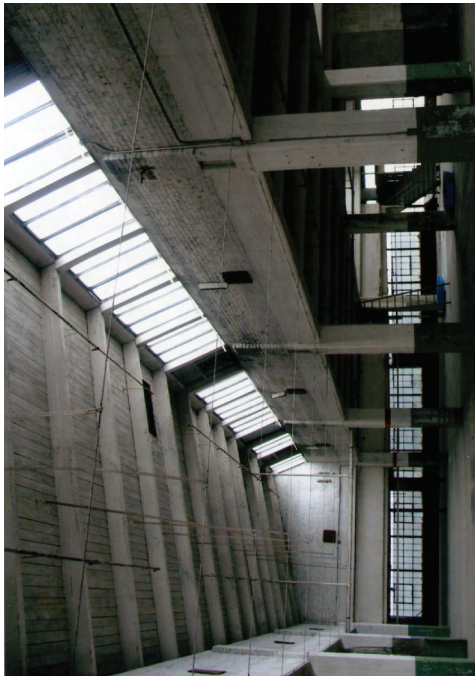
[2-3] Clerestory windows provide natural light in a historic industrial building.

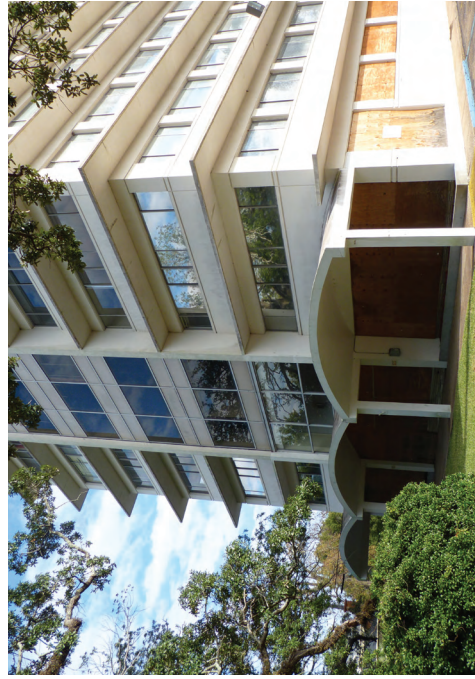
[4] Covered walkways and horizontal sun screens are distinctive and sustainable features in some mid-century modern office buildings.

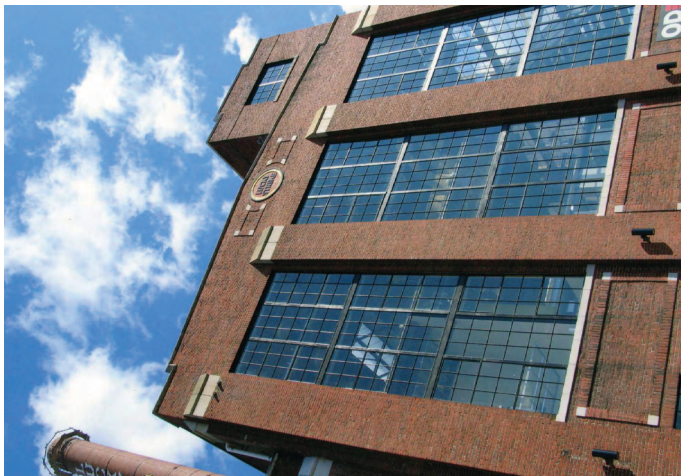
The Secretary of the Interior’s Standards for Rehabilitation

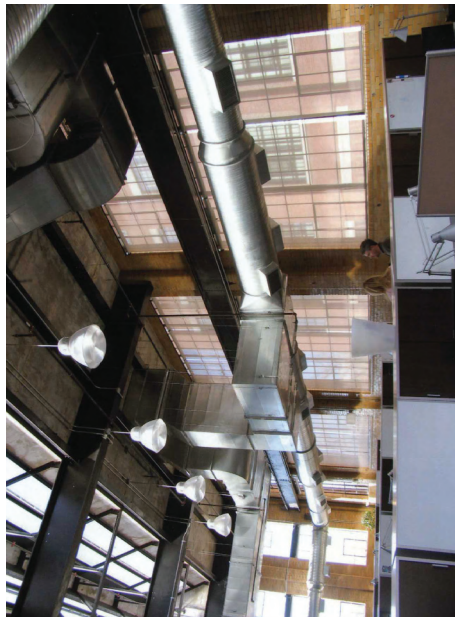
[5-6] Large windows and a roof monitor provide natural illumination in a historic industrial building.

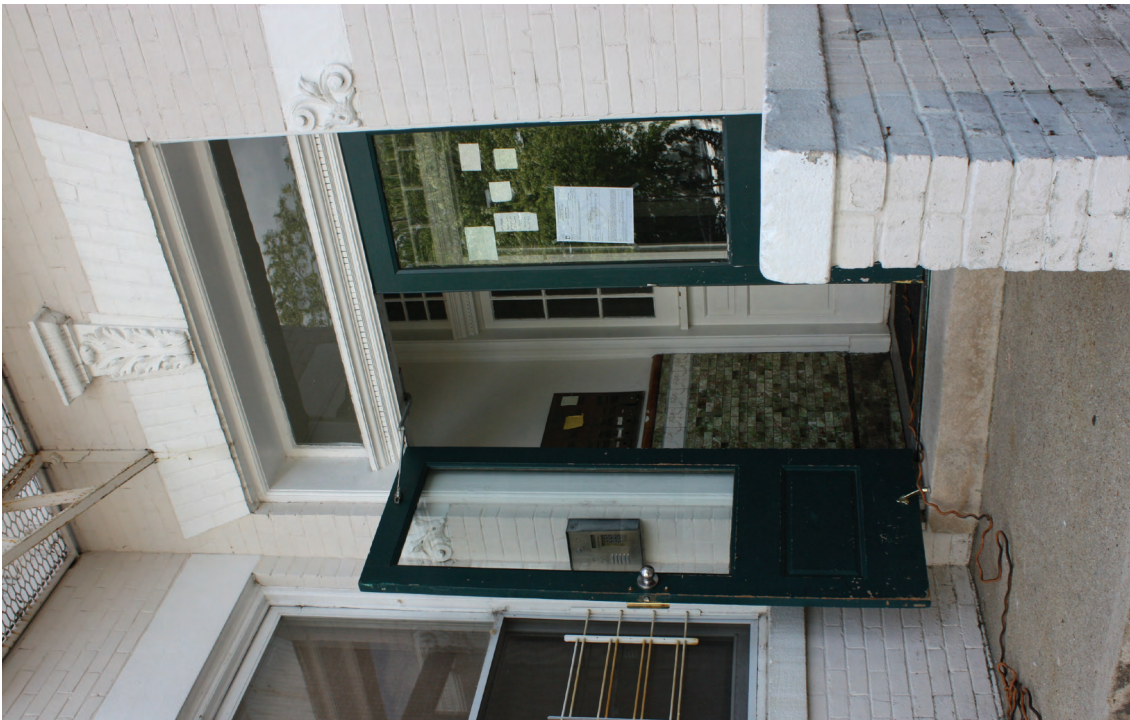
[11] A vestibule helps retain interior conditioned air in the living space in this historic row house.

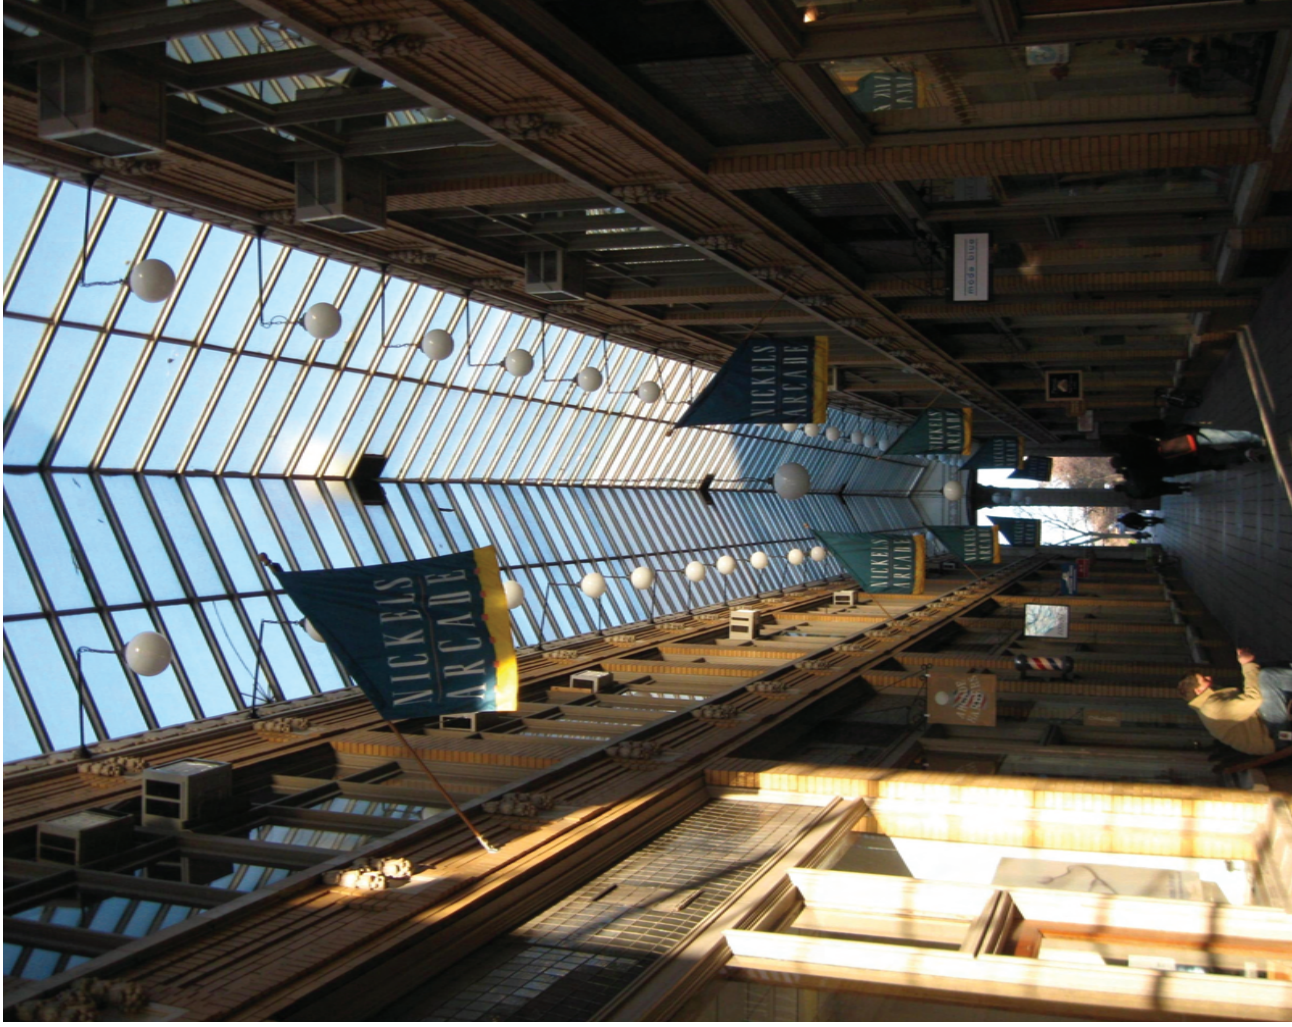
[15] Glass skylight illuminates historic shopping arcade.

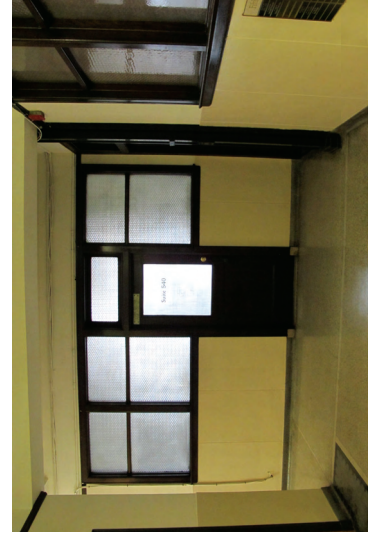
[16-18] Inherently sustainable features of historic buildings: Shutters and a deep porch keep the interior cool in a historic house in a warm climate (top); a skylight provides natural light to the interior of this mid-20th century house (center); partially glazed partitions and doors allow natural light into the corridor of a historic office building (bottom).

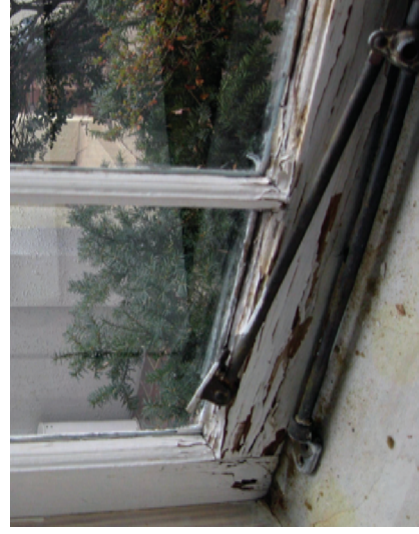
Not Recommended: [21-22] The peeling paint on an exterior window sill and on the interior of a window indicates that these features have not received regular maintenance. The broken casement window hardware also needs to be repaired to make the window operable.

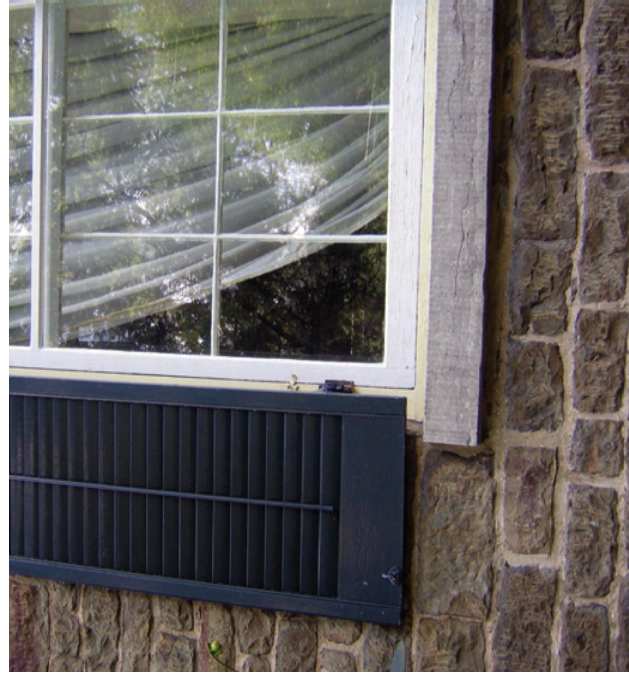
Recommended: [23-25] Historic exterior storm windows have been well maintained and continue to perform as intended.

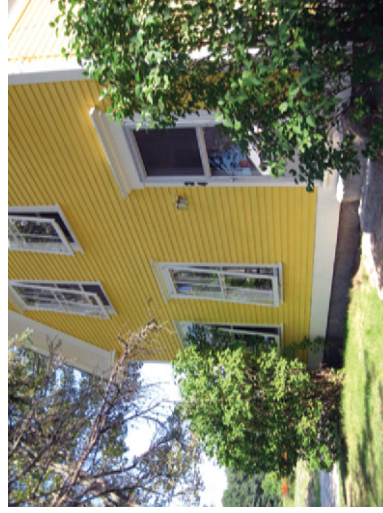
Not Recommended: [27] A broken sash cord can be repaired easily and does not justify replacement of the window.

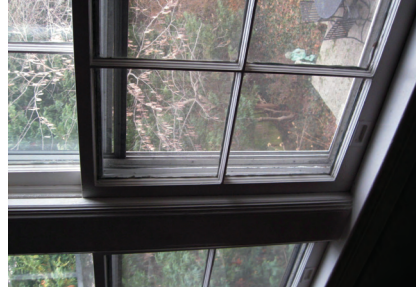
Not Recommended: [31-32] Ill-fitting exterior aluminum storm windows viewed from both inside and outside are clearly not energy efficient.

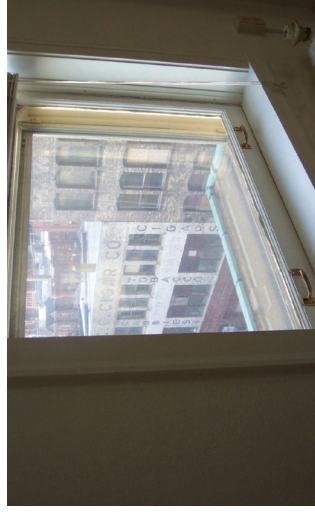
Recommended: [28-29] These exterior storm windows match the pane configuration of the historic interior windows in a residence and in a multi-story hotel building.

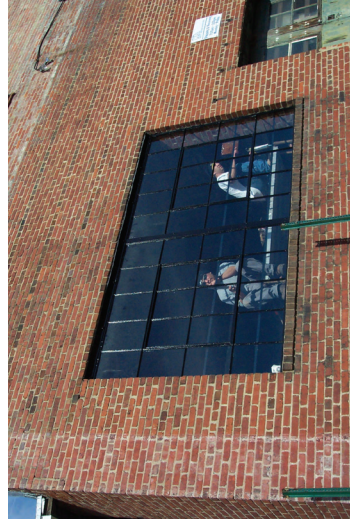
Recommended: [33-35] Original metal windows were appropriately repaired as part of the rehabilitation of this historic industrial building.

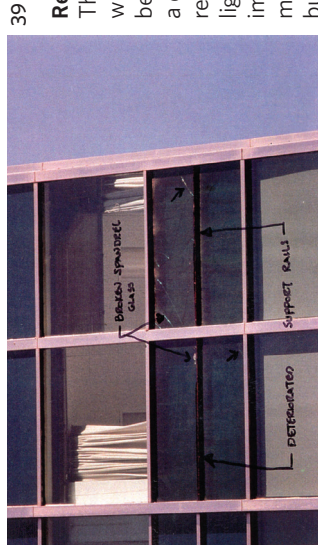
Covering or removing existing transoms.

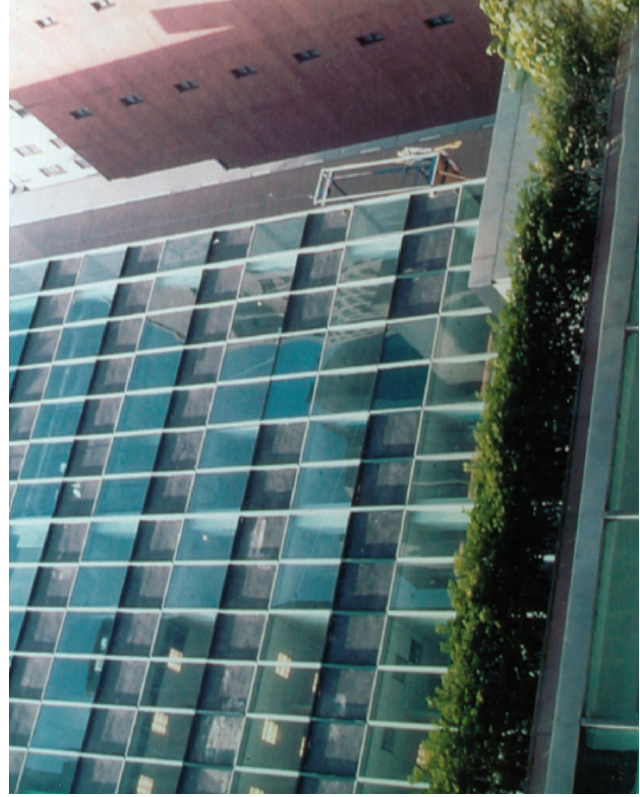
Recommended: [39-40] The original windows, which were deteriorated beyond repair, featured a dark tint. They were replaced with a slightly lighter-tinted glazing to improve daylighting in this mid-century modern office building.

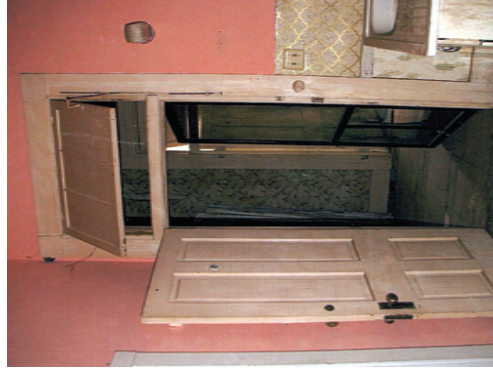
Recommended: [41] Traditional canvas awnings should be retained when they exist on historic buildings.

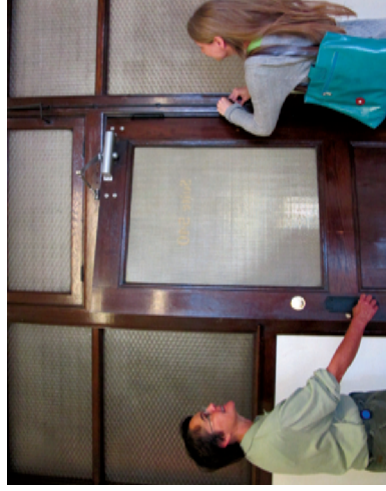
Recommended: [42] Transoms and screen doors are distinctive and practical features that provided cross ventilation in this historic hotel.

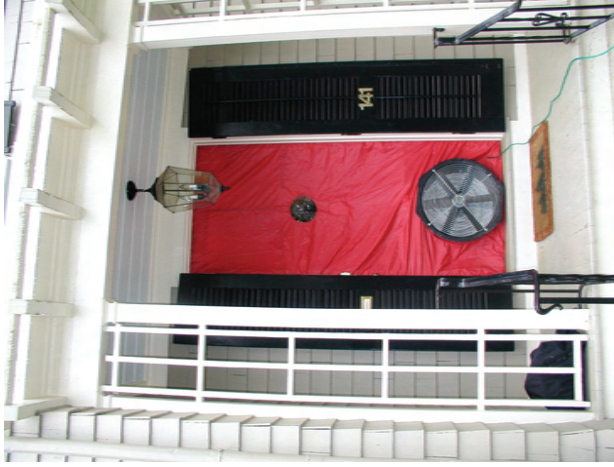
Recommended: [44-45] A blower door test is a useful tool to help identify air infiltration in a historic building before undertaking weatherization or retrofit treatments. Top Photo: Robert J. Cagnetta, Heritage Restoration, Inc.

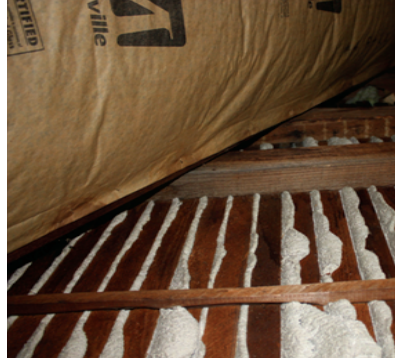
Recommended: [47-48] Insulation should be installed first in unfinished areas such as attics, crawl spaces and basements of residential buildings.

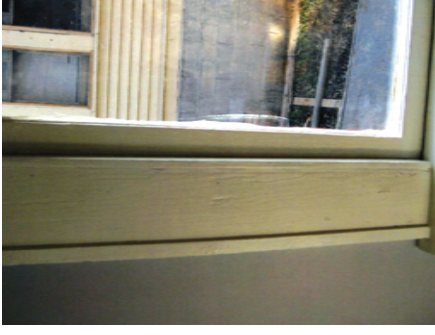
Recommended: [52-53] The original proportion and relationship of the wall to the windows and trim, which is important in defining the character of these historic interior spaces, has been retained here.

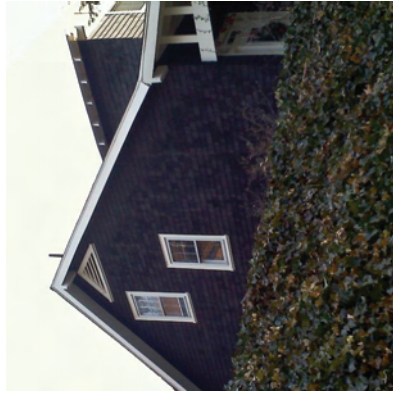
Recommended: [55-57]
Wood vents in the gable ends of a historic house and a barn and cast-iron oval vents in a masonry foundation traditionally helped air circulate.

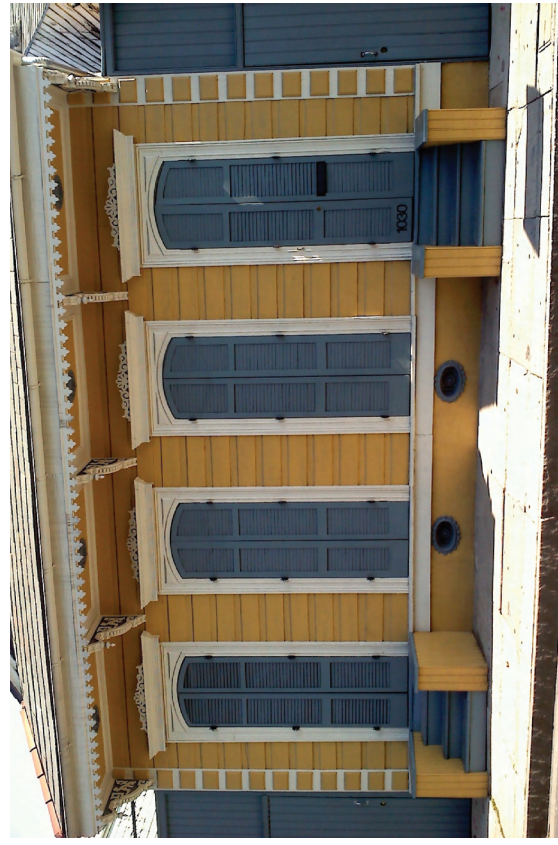
HEATING, VENTILATING AND AIR CONDITIONING (HVAC) AND AIR CIRCULATION

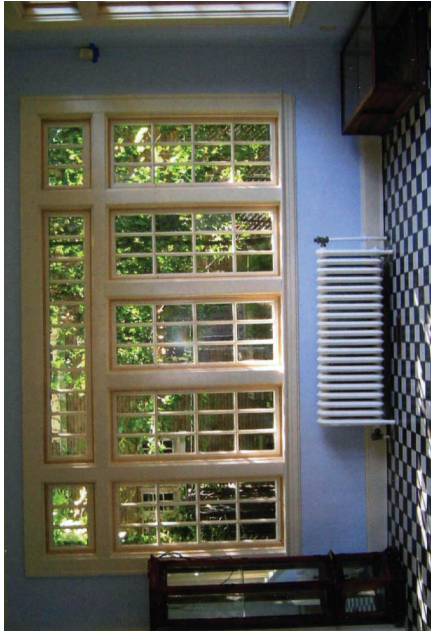
Recommended: [60] Original radiators that are still functional and efficient were retained in the rehabilitation of this historic house.

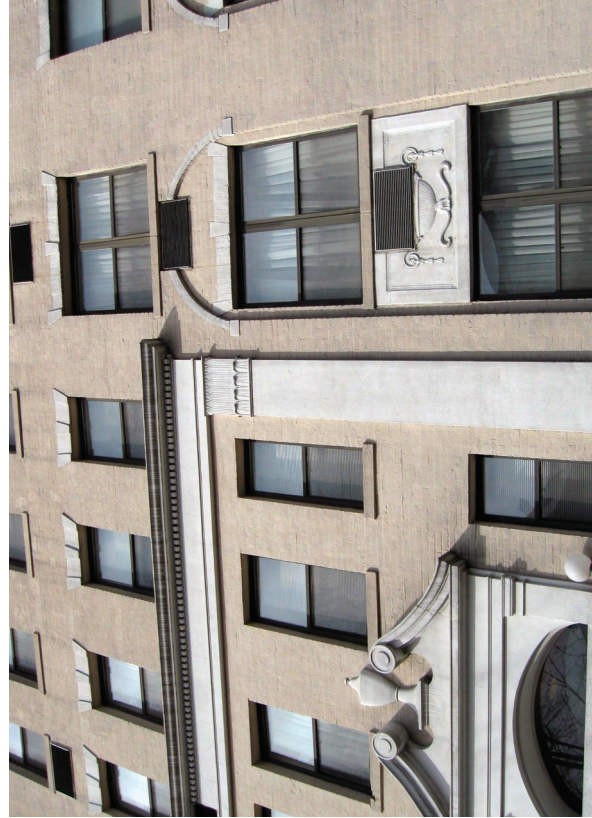
Not Recommended: [61] The cuts made in the brick and the decorative stone trim to install through-the-wall air conditioners have not only destroyed building material, but have also negatively impacted the character of this historic apartment building.

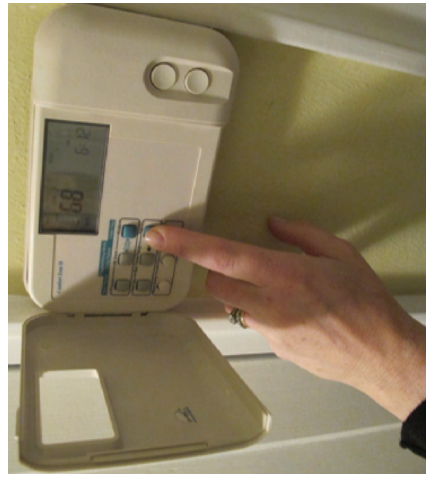
Recommended: [59] Installing a programmable thermostat can help existing systems to operate more efficiently.

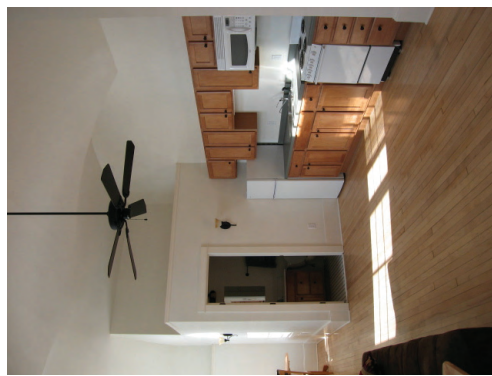
Recommended: [58] Ceiling fans enhance the efficiency of HVAC systems in historic buildings.

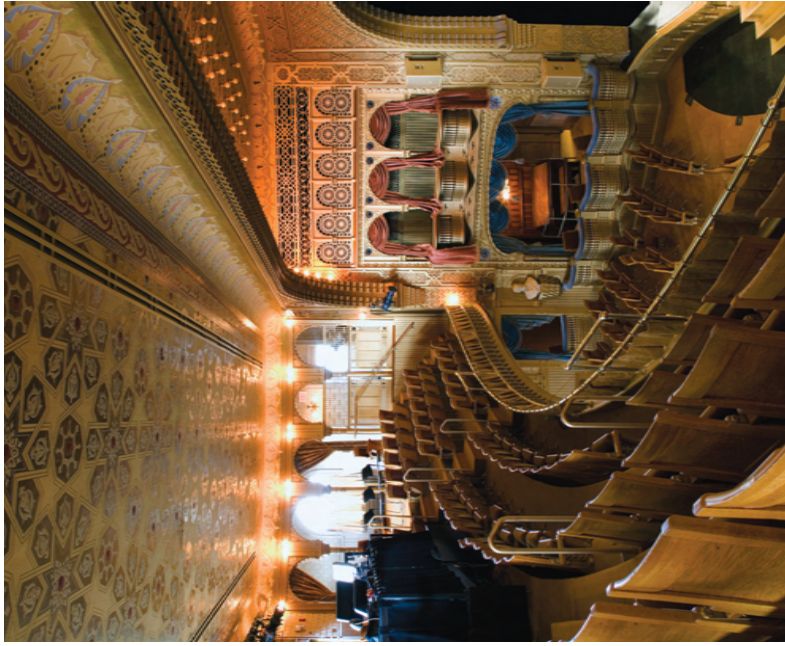
HEATING, VENTILATING AND AIR CONDITIONING (HVAC) AND AIR CIRCULATION
