Preservation and Maintenance Manual

DART Police Headquarters at Illinois Station/Monroe Shops

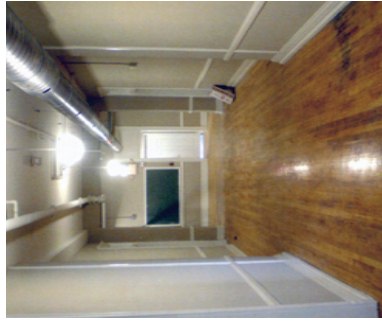
Recommended: [62-63] Carefully installed new mechanical ductwork is barely visible in the elaborately decorated ceiling of this historic theater.
 [64] The ductwork has been left unpainted which is compatible with this historic industrial interior.
 [65] To avoid damaging the metal ceiling, the ductwork was left exposed and it was painted to minimize its impact, thus preserving the historic character of this former bank.

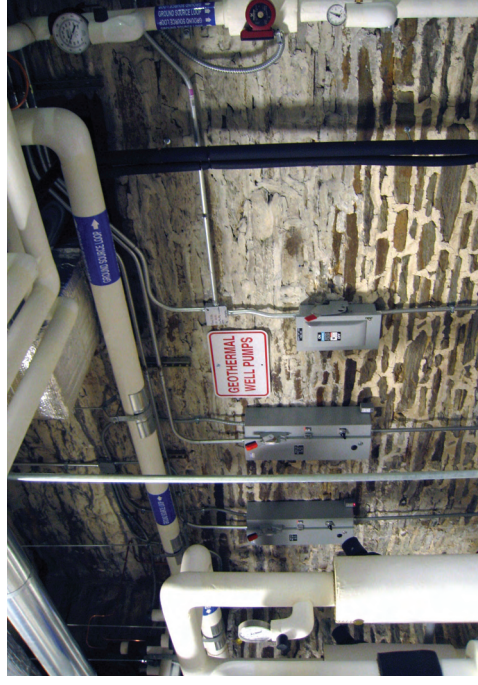
Recommended: [70-71] A geothermal system was installed on the property of this historic mansion, but only after an archeological investigation was conducted of the grounds.

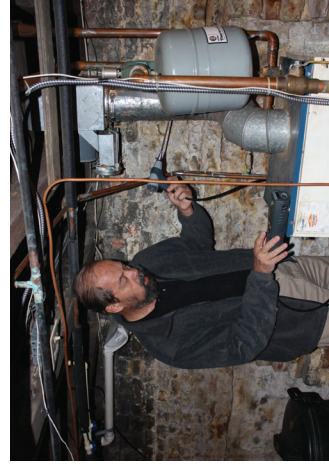
Recommended:[67] A professional energy auditor analyzes the performance of an existing furnace to ensure it is operating efficiently.

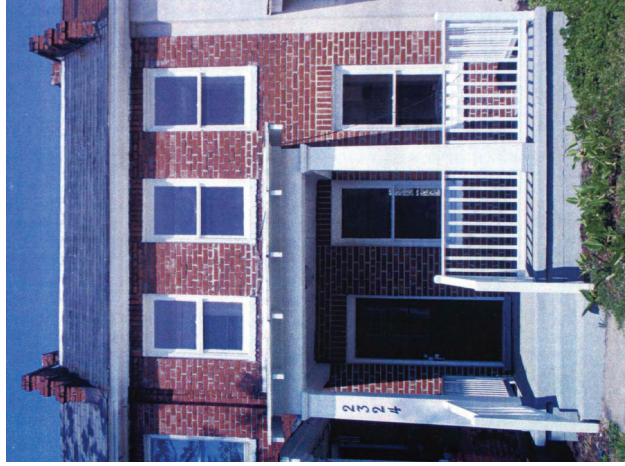
Recommended: [72-73] Solar panels were installed appropriately on the rear portion of the roof on this historic row house that are not visible from the primary elevation.

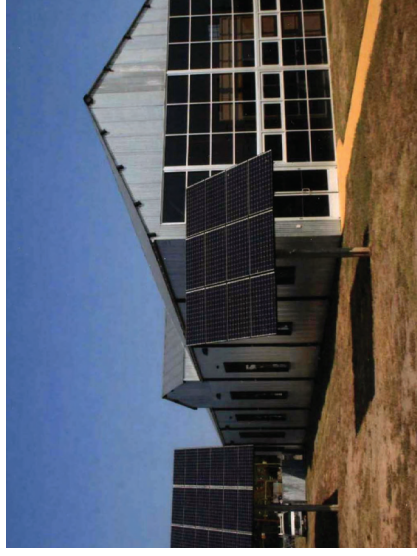
Recommended: [74] Free-standing solar panels have been installed here that are visible but appropriately located at the rear of the property and compatible with the character of this industrial site.

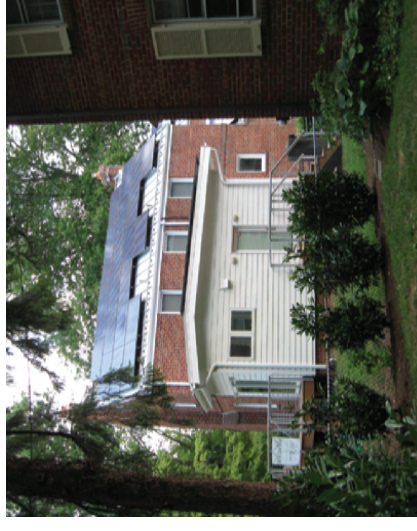
Not Recommended: [75] Solar roof panels have been installed at the rear, but because the house is situated on a corner, they are highly visible and negatively impact the character of the historic property.

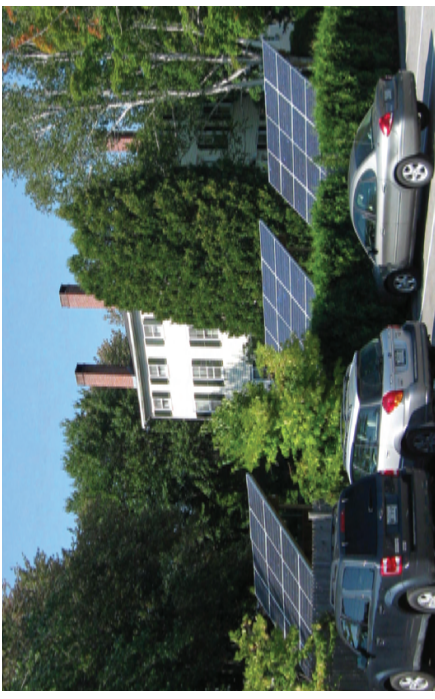
Not Recommended: [79] Although installing solar panels behind a rear parking lot might be a suitable location in many cases, here the panels negatively impact the historic property on which they are located.

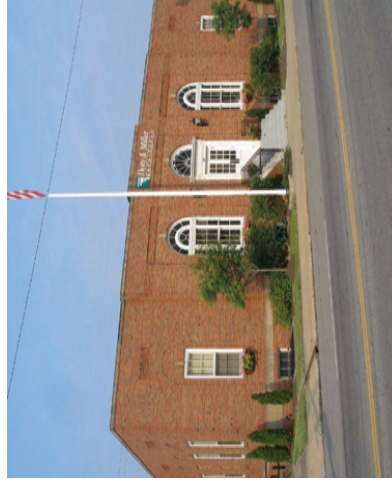
WIND POWER—WIND TURBINES AND WINDMILLS

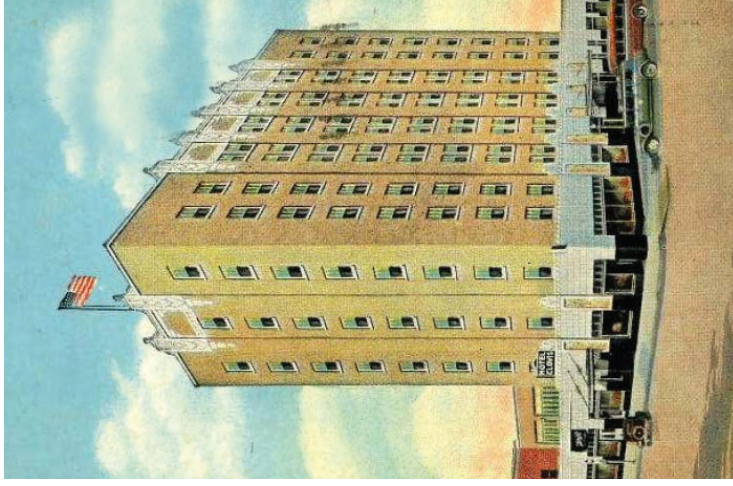
RECOMMENDED	NOT RECOMMENDED
Installing wind-powered equipment on the historic building without damaging the roof or walls or otherwise negatively impacting the building's historic character.	Installing wind-powered equipment on the historic building in a manner that damages the roof, compromises its structure or negatively impacts the building's historic character.
	Removing historic roof features to install wind-powered equipment, such as wind turbines.
	Installing wind-powered equipment on the historic building that is not reversible.
	Installing wind-powered equipment on the primary façade of a historic building or where it is highly visible.
Investigating off-site, renewable energy options when installing on-site wind-power equipment would negatively impact the historic character of the building or site.

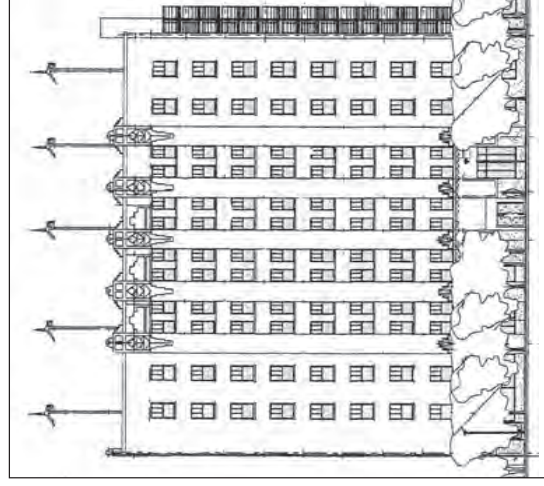
Not Recommended: [83-84] This historic hotel is a prominent and highly visible local landmark, and the wind turbines proposed to be added on the roof would negatively impact its historic character.

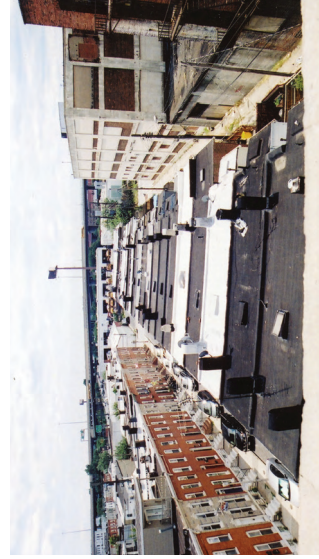
Recommended: [85-86] A cool or green roof is best installed on a flat roof where it cannot be seen from the public right of way and will not negatively impact the character of the historic building.

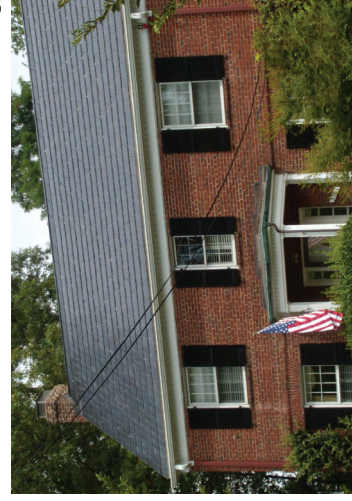
Not Recommended: [87] Historic roofing materials in good condition should be retained rather than replaced with another material perceived as more sustainable, such as, in this case, solar roofing shingles.

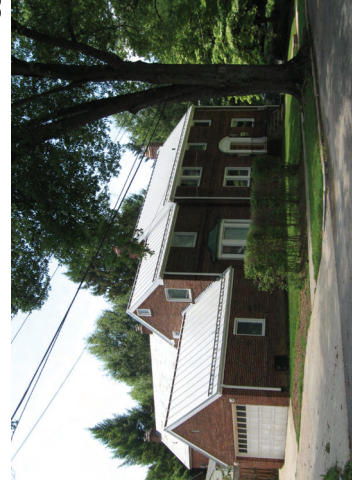
Not Recommended: [88] This new, cool white metal roof is not an appropriate material or color for this historic mid-20th century house.

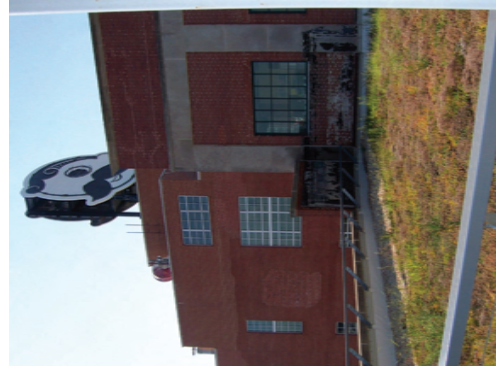
Recommended: [89-92] Low-scale and sustainable native plants are appropriate for these roof gardens on historic buildings.

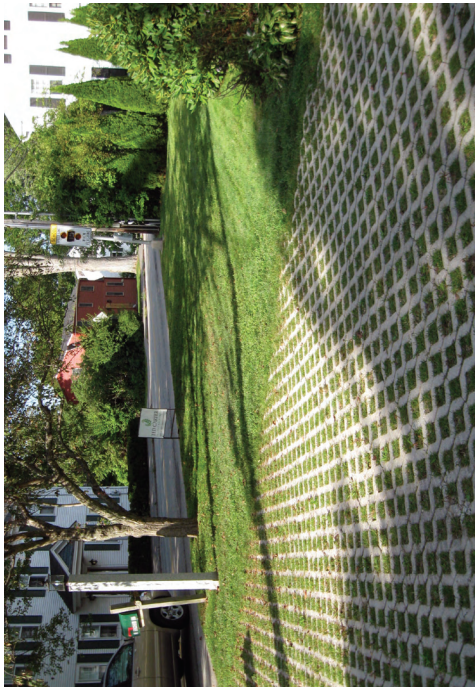
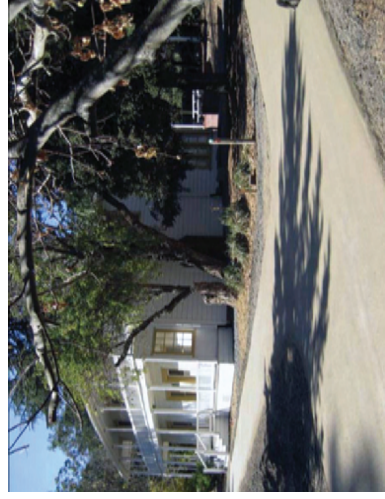
Recommended: [94-95] Permeable pavers were used at this historic residential property for a driveway and parking (above) and a hard-packed, construction aggregate provides environmentally-friendly paths for visitors at this historic site (below).

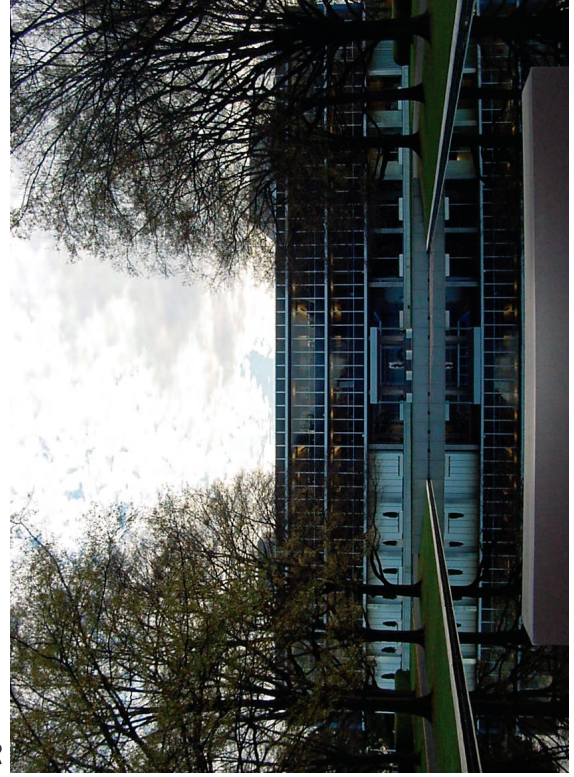
SITE FEATURES AND WATER EFFICIENCY

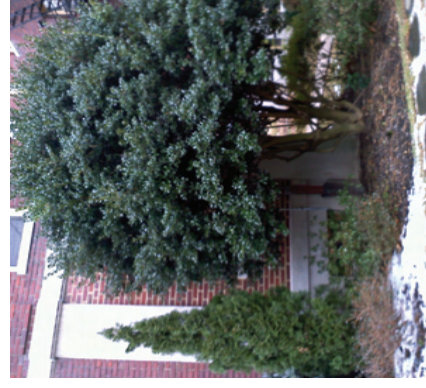
Not Recommended: [97] This tree, which was planted too close to the building, has caused the masonry wall to retain moisture that damaged the mortar and required that the brick be repointed in this area.

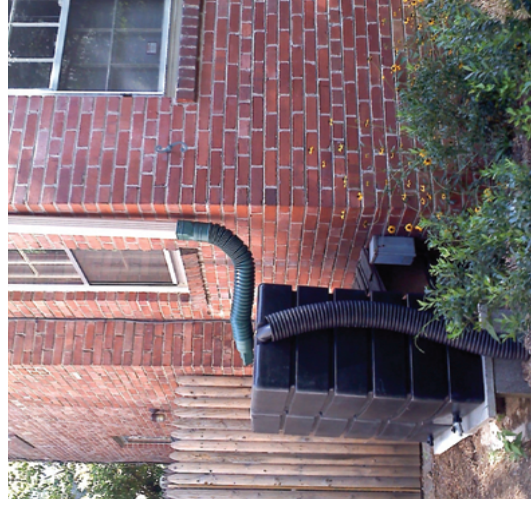
Recommended: [98-100] Rain gardens and rain-water collection tanks are features that may be added to a historic property to improve storm-water management and increase on-site water use.

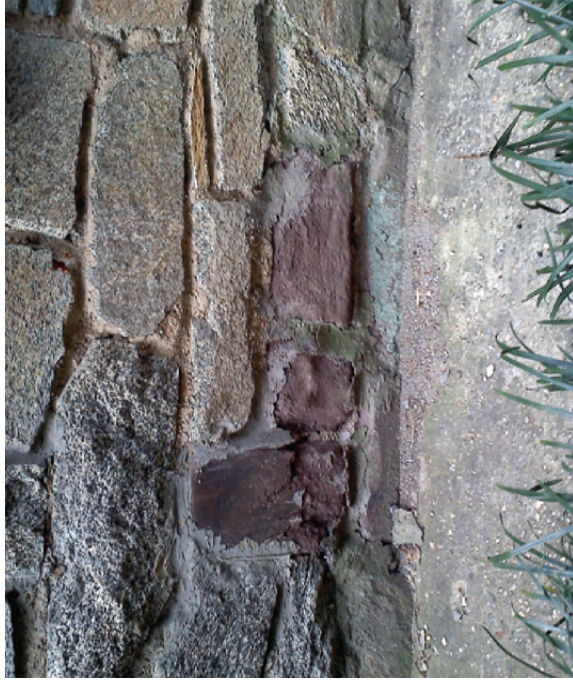
Not Recommended: [101] Splash back from the impermeable concrete paving next to the foundation is damaging these stones.

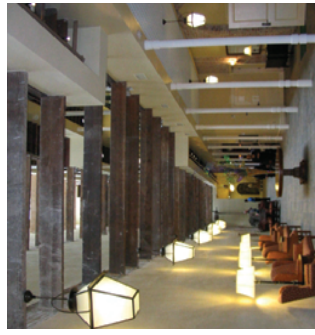
Recommended: [102-103]
Small, covered atriums that are compatible with the character of these historic warehouses have been inserted to light the interior.

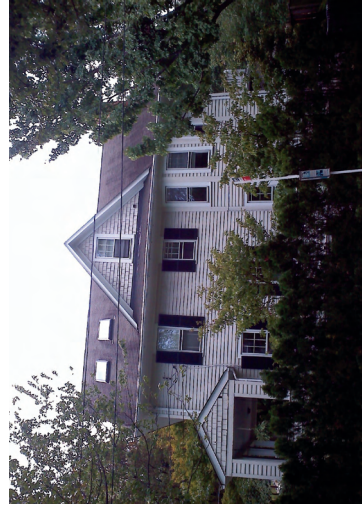
Not Recommended: [104-106]
Skylights added on a primary roof elevation negatively impact the character of these historic houses.

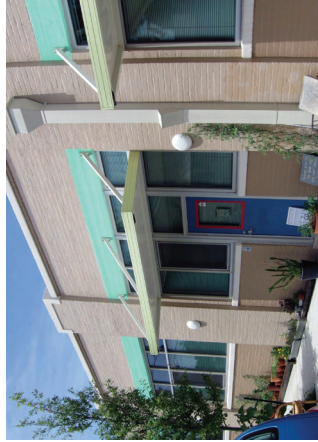
Recommended: [107] Traditional canopies compatible with the industrial character of this former factory building were installed when it was converted for residential use.

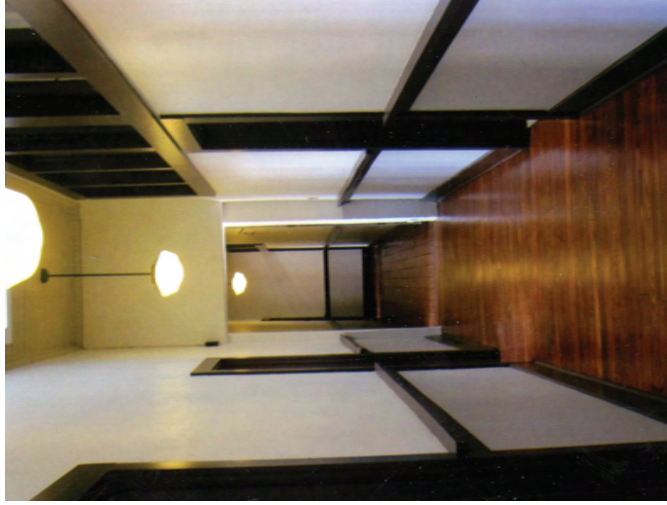
[108-109] The original, partially-glazed doors and office partitions, as well as skylights, that let natural light into the corridors were retained as part of the rehabilitation of this early-20th century building.

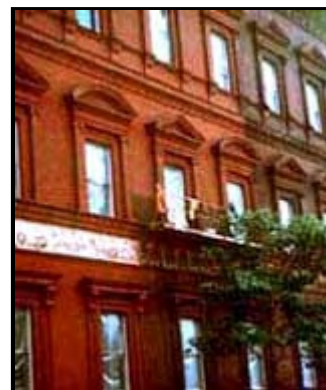
A NOTE TO OUR USERS: The web versions of the **Preservation Briefs** differ somewhat from the printed versions. Many illustrations are new, captions are simplified, illustrations are typically in color rather than black and white, and some complex charts have been omitted.

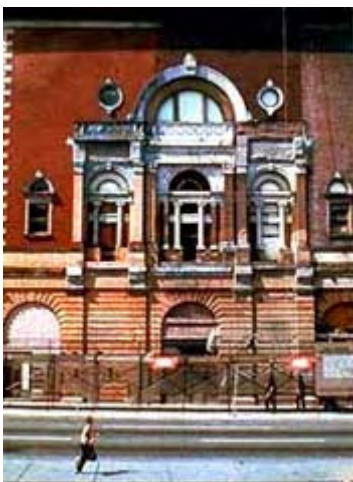
Ninety years of accumulated dirt and pollutants are being removed from this historic theater using an appropriate chemical cleaner, applied in

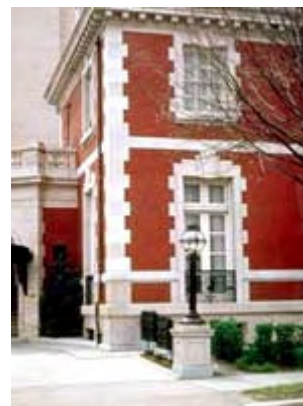
The decorative trim on this brick building is architectural terra-cotta intended to simulate the limestone foundation. Photo: NPS files.

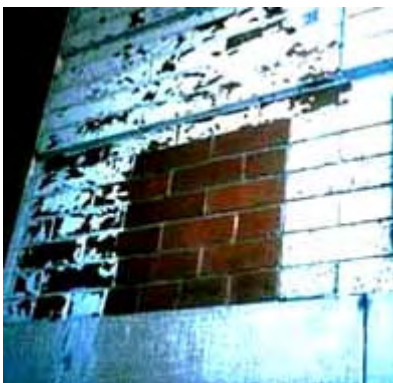
Any cleaning method should be tested before using it on historic masonry. Photo: NPS files.

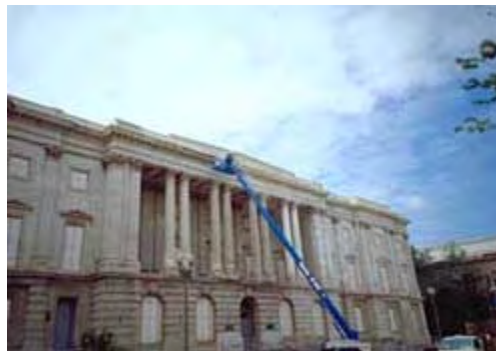
Low-to-medium-pressure steam (hot-pressurized water washing) is a gentle method of softening heavy soiling deposits and cleaning historic marble. Photo: NPS files.

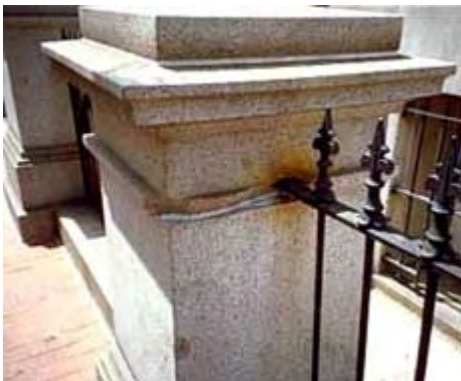
The iron stain on this granite post may be removed by applying a commercial rust-removal product in a poultice.
Photo: NPS files

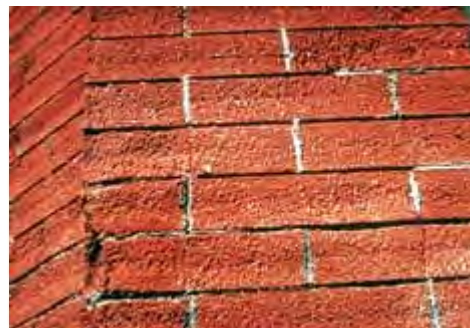
Sandblasting has permanently damaged this brick wall. Photo: NPS files

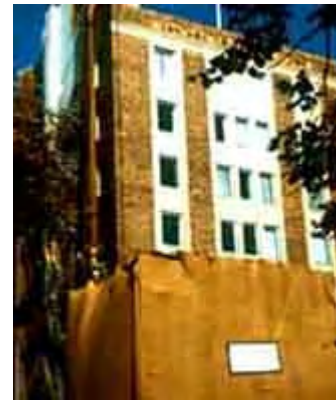
The lower floors of this historic brick and architectural terra-cotta building have been covered during chemical cleaning to protect pedestrians and vehicular traffic from potentially harmful overspray. Photo: NPS files.

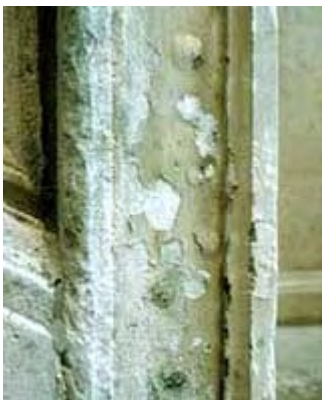
This clear coating has failed and is pulling off pieces of the stone as it peels. Photo: NPS files

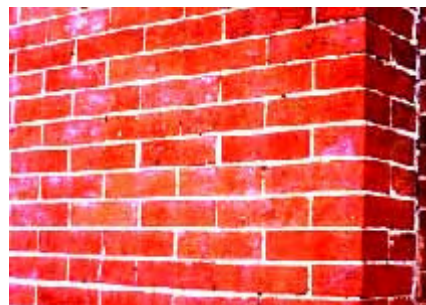
masonry buildings. These coatings are often quite shiny which can greatly alter the appearance of a historic masonry surface, and they are not always effective. Generally, other ways of discouraging graffiti, such as improved lighting, can be more effective than a coating. However, the application of anti-graffiti coatings may be appropriate in some instances on vulnerable areas of historic masonry buildings which are frequent targets of graffiti that are located in out-of-the-way places where constant surveillance is not possible.

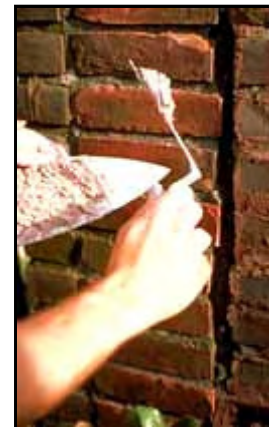
A NOTE TO OUR USERS: The web versions of the **Preservation Briefs** differ somewhat from the printed versions. Many illustrations are new, captions are simplified, illustrations are typically in color rather than black and white, and some complex charts have been omitted.

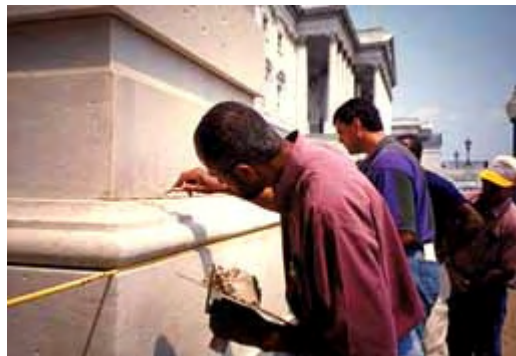
Masons practice using lime putty mortar to repair historic marble. Photo: NPS files.

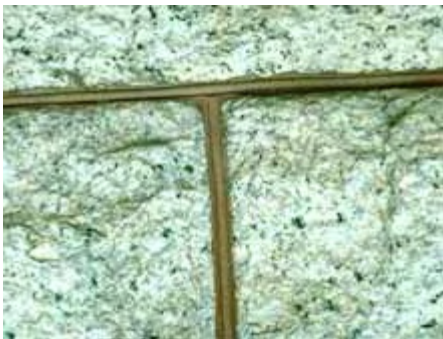
This late 19th century granite has recently been repointed with the joint profile and mortar color carefully matched to the original. Photo: NPS files.

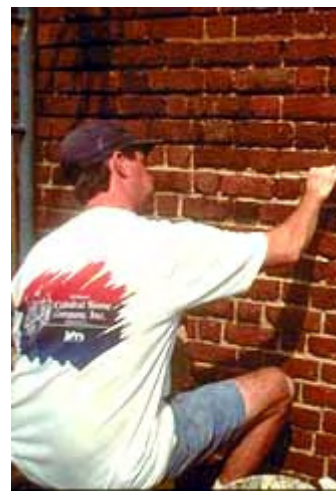
This early 19th century building is being repointed with lime mortar. Photo: Travis McDonald.

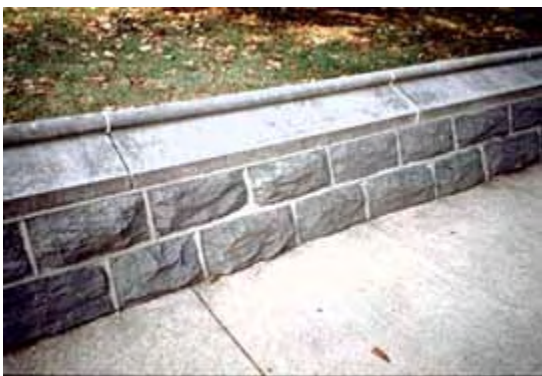
Caulking was inappropriately used here in place of mortar on the top of the wall. As a result, it has not been durable. Photo: NPS files.

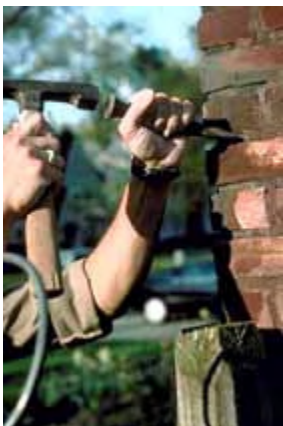
Here, a hammer and chisel are being correctly used to prepare a joint for repointing. Photo: John P. Speweik.

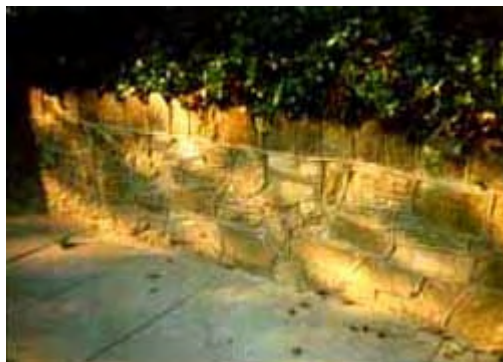
When repairing this stone wall, the mason matched the raised profile of the original tuckpointing. Photo: NPS files.

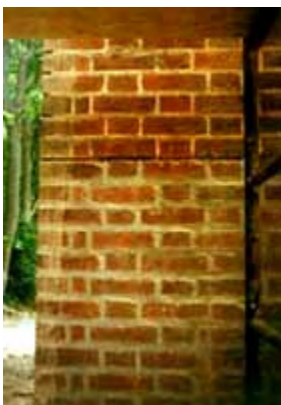
Contractor Selection

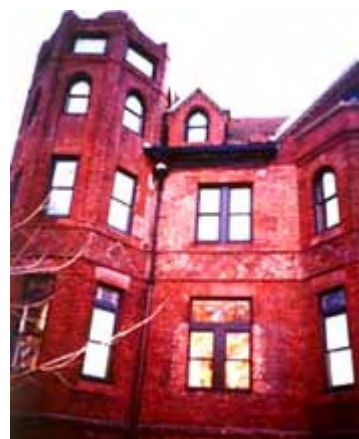
Unskilled repointing has negatively impacted the character of this late-19th century building. Photo: NPS files.

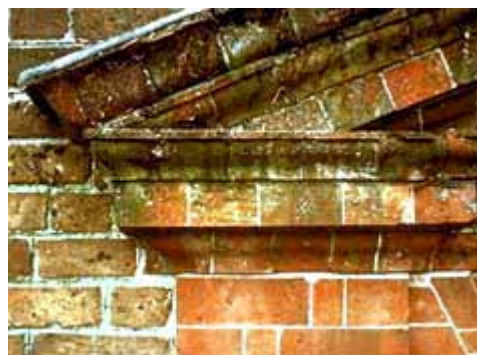
This 18th century pediment and surrounding wall exhibit distinctively different mortar joints. Photo: NPS files.

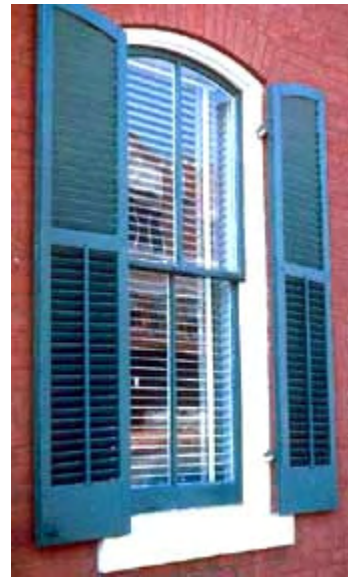
Shutters can be used to minimize the problem of summer heat gain by shading the windows. Photo: NPS files.

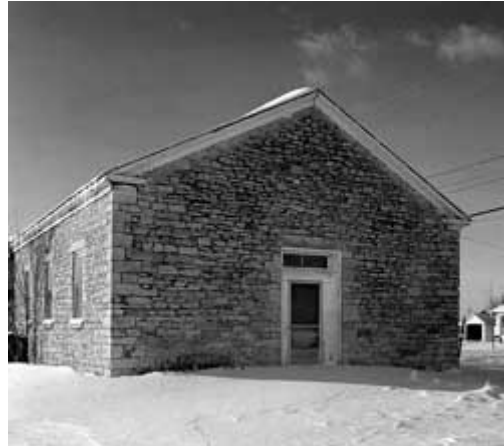
Heavy masonry walls and few windows serve to maximize warmth inside. Photo: HABS collection, NPS.

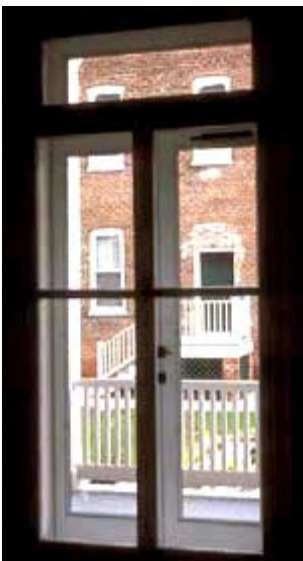
Storm doors have been added on the inside of this historic building as an energy-conserving device. Photo: NPS files.

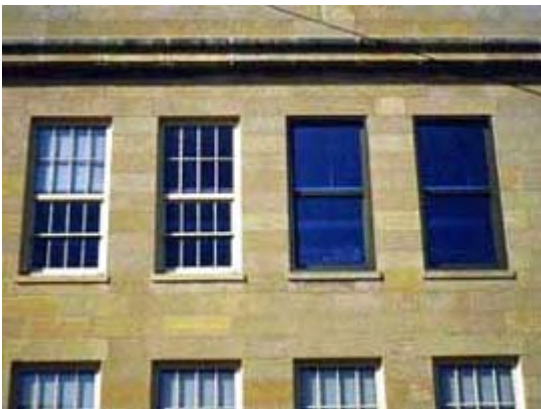
Tinted glazing has jeopardized the character of this historic office building and is, thus, not a recommended approach. Photo: Mike Jackson.

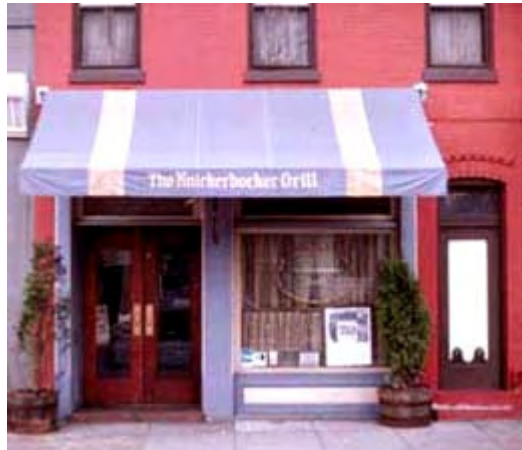
Awnings reduce heat gain in the summer and, when they are raised in the winter, radiant heat from the sun provides free supplementary heat. Photo: NPS files.

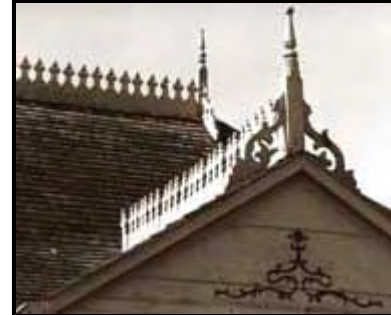
A NOTE TO OUR USERS: The web versions of the **Preservation Briefs** differ somewhat from the printed versions. Many illustrations are new, captions are simplified, illustrations are typically in color rather than black and white, and some complex charts have been omitted.

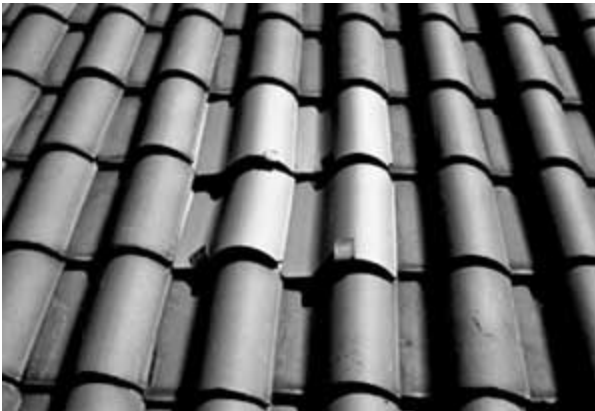
Repairs on this pantile roof were made with new tiles held in place with metal hangers. Photo: NPS files.

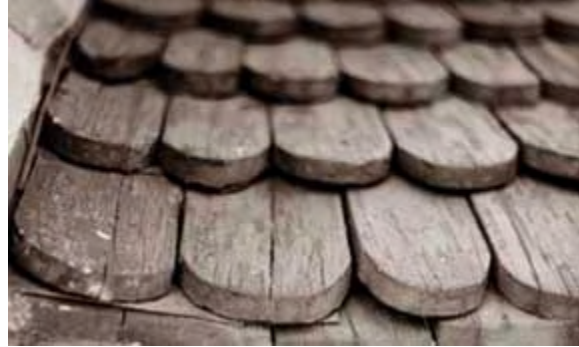
Replacement of particular historic details is important to the individual historic character of a roof, such as this rounded butt wood shingle roof. In the restoration, the drainage around a dormer was improved by the addition of carefully concealed modern metal flashing. Photo: NPS files.

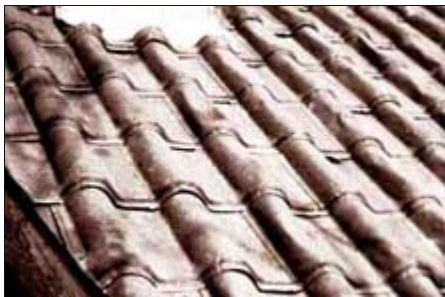
Galvanized sheet-metal shingles imitating the appearance of pantiles remained popular from the second half of the 19th century into the 20th century. Photo: NPS files.

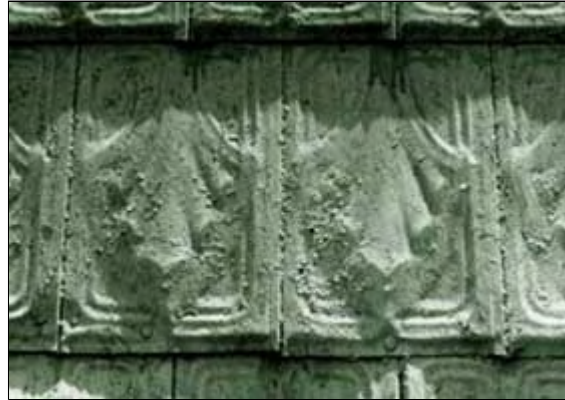
Tin shingles, commonly embossed to imitate wood or tile, or with a decorative design, were popular as an inexpensive, textured roofing material. Photo: NPS files.

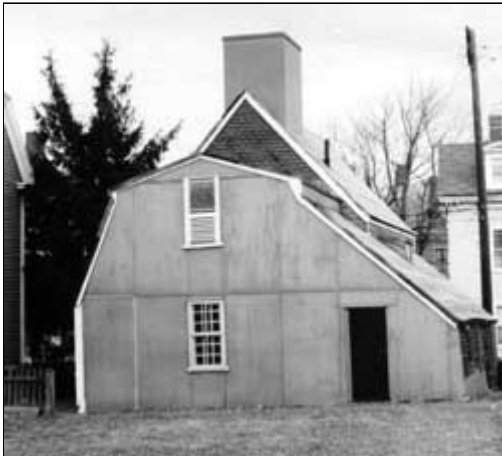
Temporary stabilization or "mothballing" with materials, such as plywood and building paper, can protect the roof of a project until it can be properly repaired or replaced. Photo: NPS files.

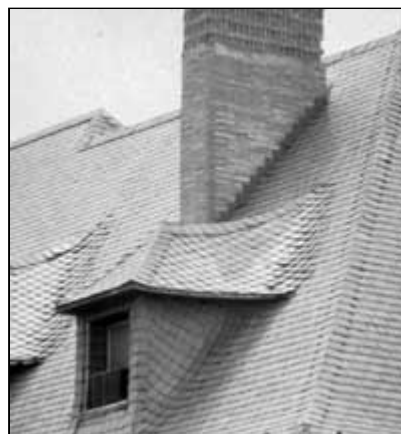
Because of the roof's visibility, the slate detailing around the dormers is important to the character of this structure. Photo: NPS files.

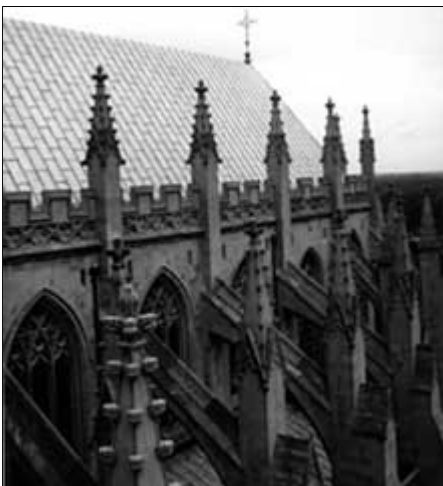
Good design and quality materials for the roof surface, fastenings, and

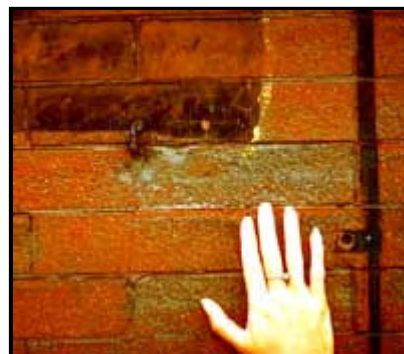
A NOTE TO OUR USERS: The web versions of the **Preservation Briefs** differ somewhat from the printed versions. Many illustrations are new, captions are simplified, illustrations are typically in color rather than black and white, and some complex charts have been omitted.

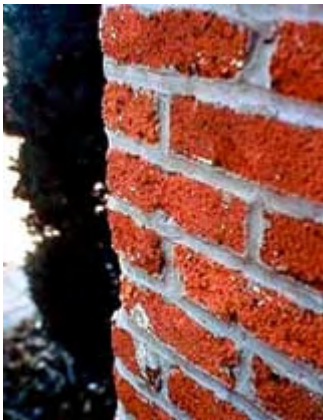
Abrasive cleaning can cause permanent damage to historic fabric, such as this brick wall. Photo: NPS files.

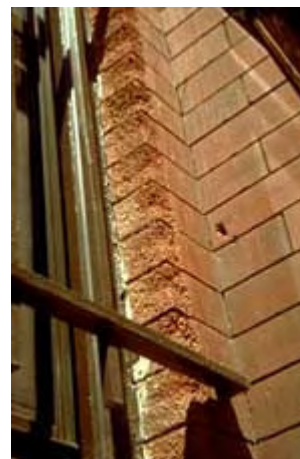
Brick molding next to the window has been severely abraded by sandblasting to remove paint. Photo: NPS files.

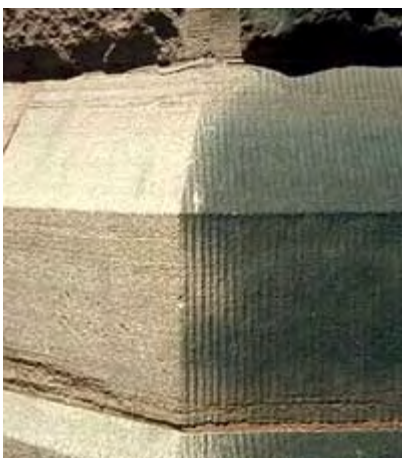
On the left, grit blasting has obliterated the vertical tooling marks from granite, a very dense stone. Photo: NPS files.

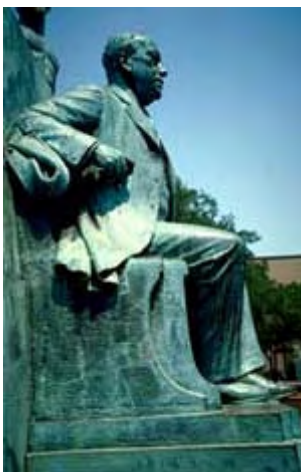
Bronze statuary may be cleaned gently using crushed walnut shells.
Photo: NPS files.

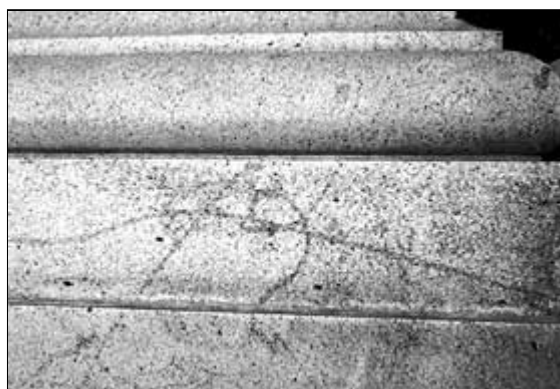
Very high-pressure water has scarred this granite. Photo: NPS files.

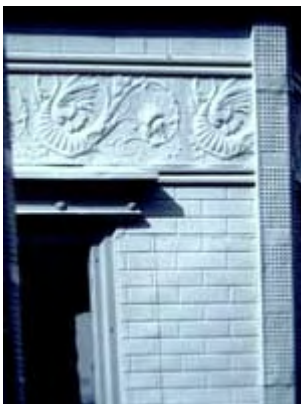
Decorative pressed metal interior or exterior features should not be cleaned abrasively. Photo: NPS files.

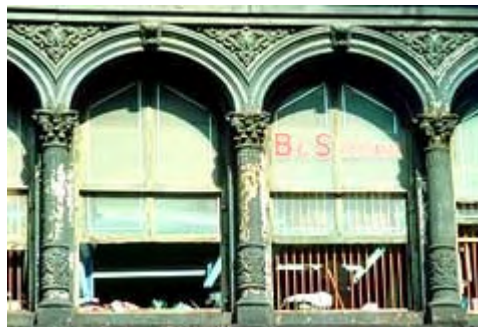
Cast iron may be abrasively cleaned, but must be painted immediately to prevent rust. Photo: NPS files.

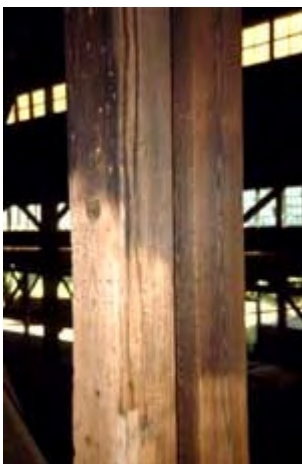
Industrial interiors that are not finely milled may be abrasively cleaned, in some instances. Photo: NPS files.

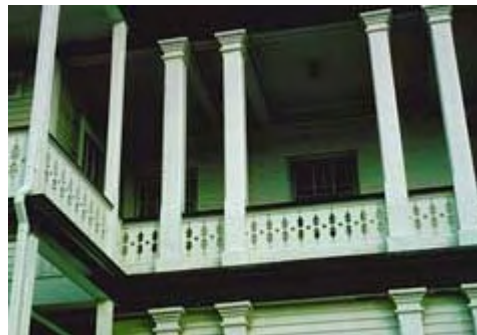
Decorative wood exterior or interior features should not be cleaned abrasively. Photo: NPS files.

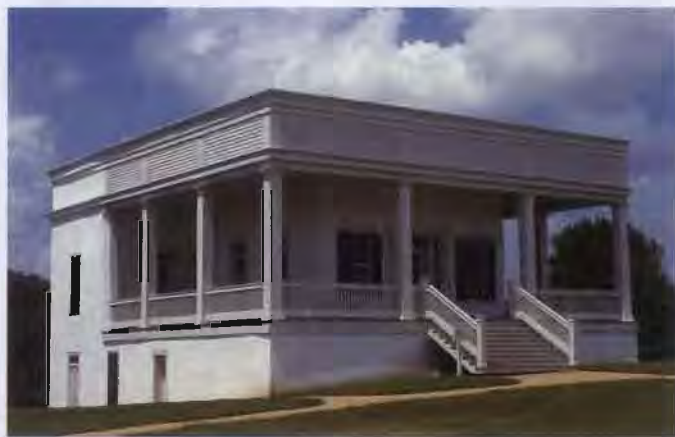
Figure 1. The Sebastopol House in Seguin, Texas, is an 1856 Greek Revival-style house constructed of lime concrete. Lime concrete or "limecrete" was a popular construction material, as it could be made inexpensively from local materials. By 1900, the town had approximately ninety limecrete structures, twenty of which remain. Photo: Texas Parks and Wildlife Department.

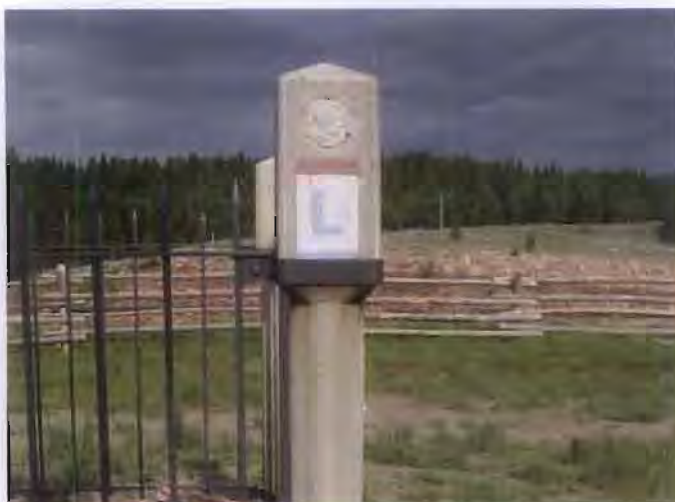
Figure 3. The Lincoln Highway Association promoted construction of a high quality continuous hard surface roadway across the country. The Boys Scouts of America installed concrete road markers along the Lincoln Highway in 1928.

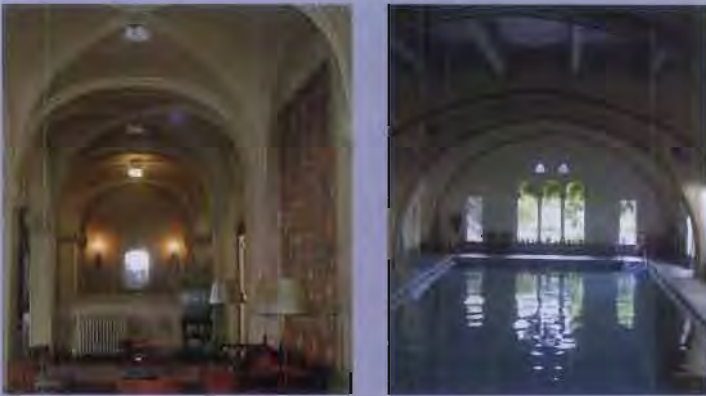
Figure 10. The Berkeley City Club has significant interior spaces and features of concrete construction, including the lobby and pool. Photos: Una Gilmartin (left) and Brian Kehoe (right), Wiss, Janney, Elstner Associates, Inc.

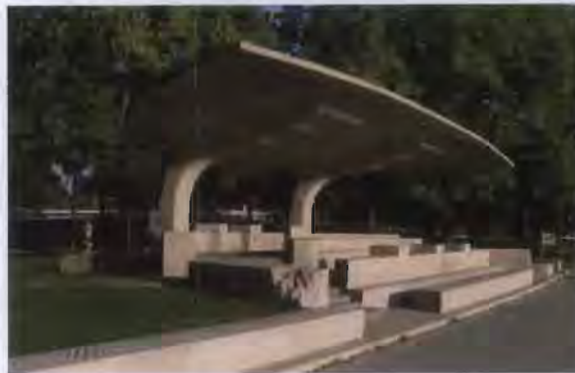
Figure 8. The Chess Pavilion in Chicago's Lincoln Park was designed by architect Morris Webster and constructed in 1956. The pavilion is a distinctive landscape feature, with its reinforced concrete cantilevered slab that provides cover for chess players.

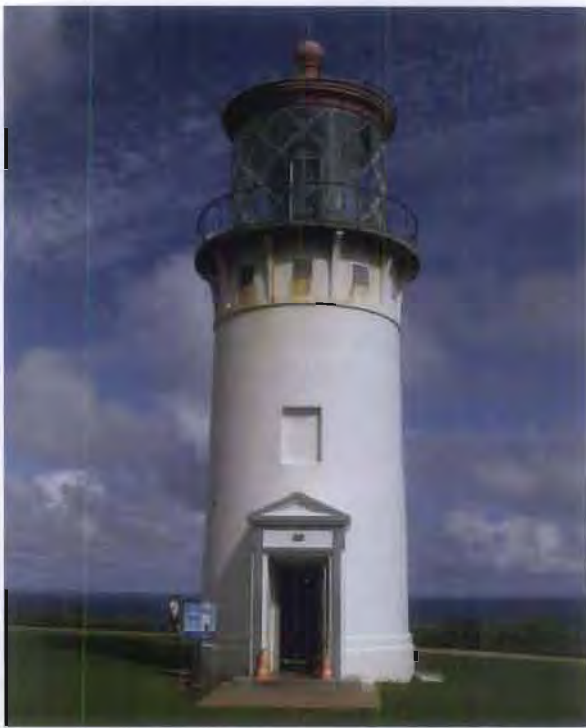
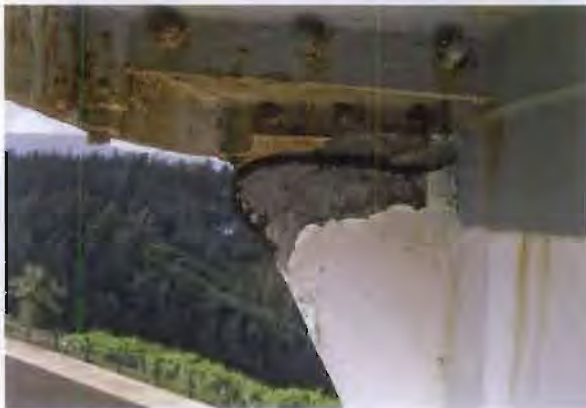
Figure 12. The concrete lighthouse at the Kilauea Point Light Station, Kilauea, Kauai, Hawaii, was constructed circa 1913. The concrete, which was a good quality, high strength mix for its day, is in good condition after almost one hundred years in service. Deterioration in the form of spalling related to corrosion of embedded reinforcing steel has occurred primarily in areas of higher ornamentation such as projecting bands and brackets (see close-up photo).

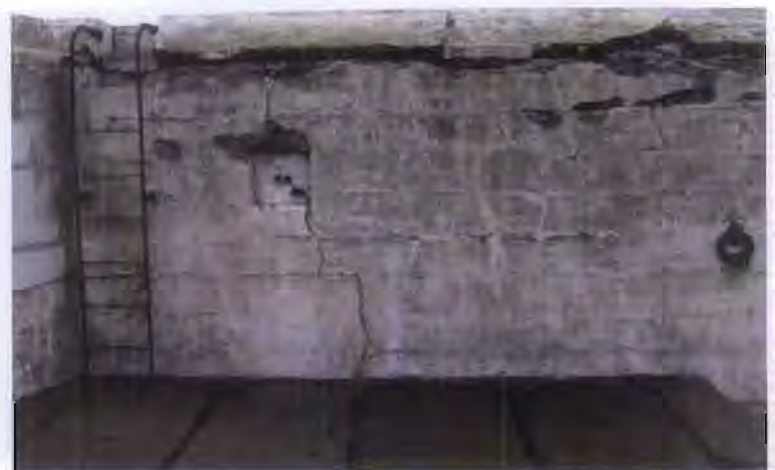
Figure 13. Fort Casey on Admiralty Head, Fort Casey, Washington, was constructed in 1898. The lift lines from placement of concrete are clearly visible on the exterior walls and characterize the finished appearance.

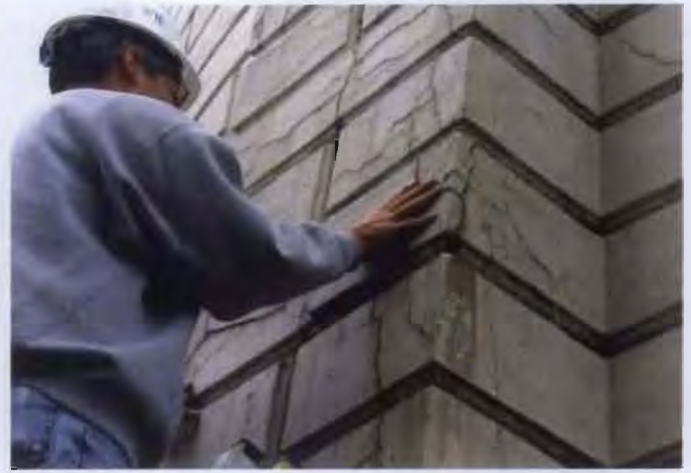
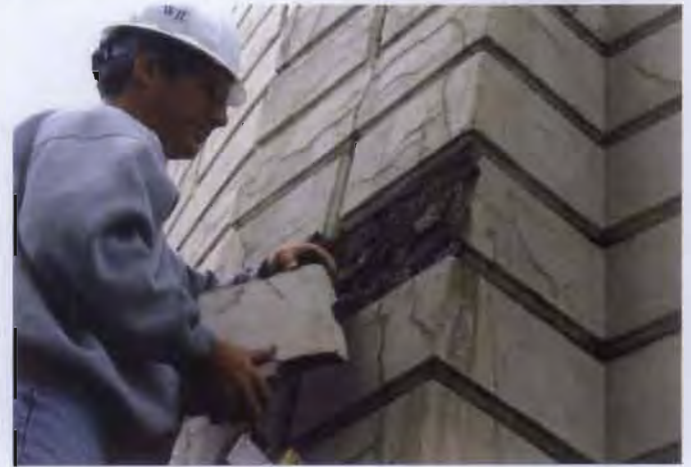
Figures 14. Layers of architectural concrete that have debonded (spalled) from the surface were removed from a historic water tank during the investigation performed to assess existing conditions. Photos: Anita Washko, Wiss, Janney, Elstner Associates, Inc.

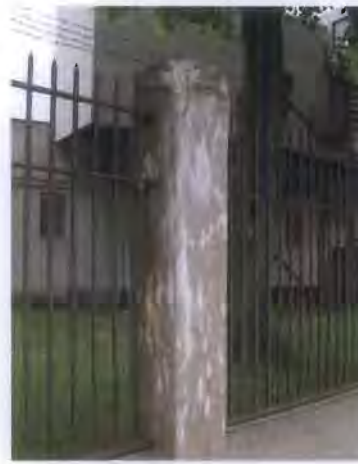
Figure 15. Evidence of moisture movement through concrete is apparent in the form of mineral deposits on the concrete surface. Cyclic freezing and thawing of entrapped moisture, and corrosion of embedded reinforcement, have also contributed to deterioration of the concrete column on this fence at Crocker Field in Fitchburg, Massachusetts, designed by the Olmsted Brothers.

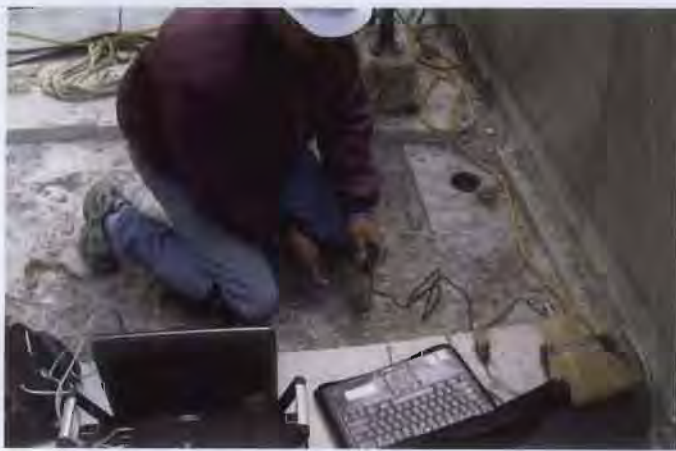
Figure 16. Impact echo testing is performed on a concrete structural slab to help determine depth of deterioration. In this method, a short pulse of energy is introduced into the structure and a transducer mounted on the impacted surface of the structure receives the reflected input waves or echoes. These waves are analyzed to help identify flaws and deterioration within the concrete.

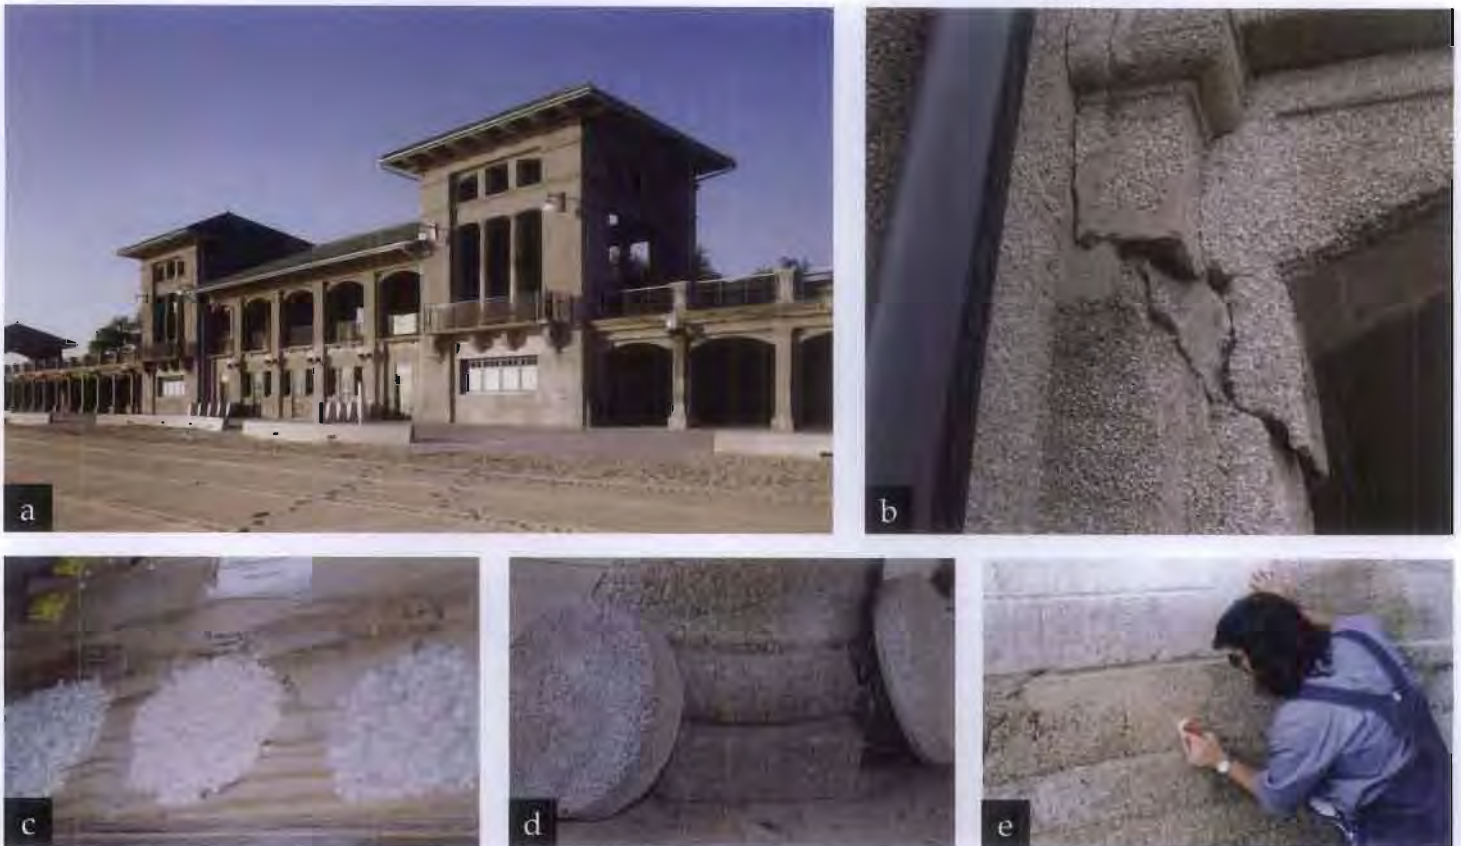
Sealants are an important part of maintenance of historic concrete structures. Elastomeric sealants, which have replaced traditional oil-resin based caulks for many applications, are used to seal cracks and joints to keep out moisture and reduce air infiltration. Sealants are commonly used at windows and door perimeters, at interfaces between concrete and other materials, and at attachments to or through walls or roofs, such as with lamps, signs, or exterior plumbing fixtures.

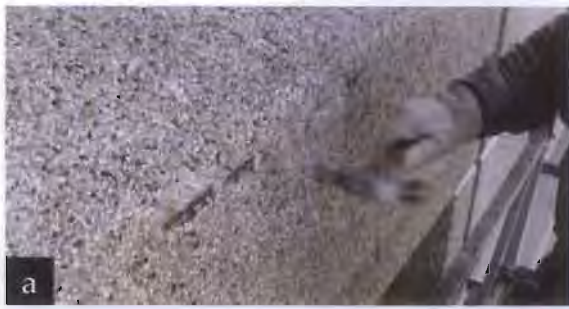
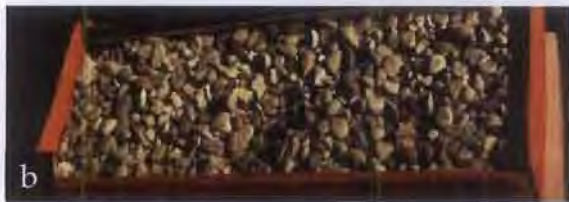
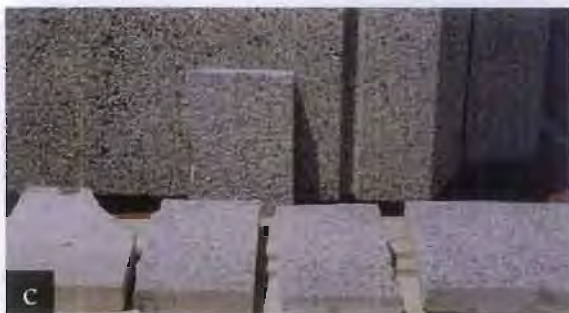
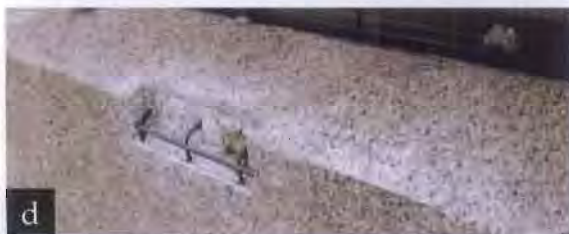
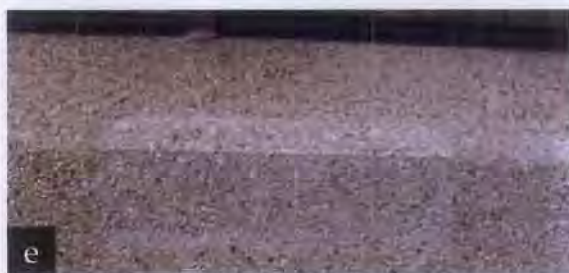
The concrete's durability, or resistance to deterioration, and the materials and methods selected for repair depend on its composition, design, and quality of workmanship. In most cases, a mix design for durable replacement concrete should use materials similar to those of the original concrete mix. Prepackaged materials are often not appropriate for repair of historic concrete. The concrete patching material can be air entrained or polymer-modified if subject to exterior exposure, and should incorporate an appropriate selection of aggregate and cement type, and proper water content and water
