Preservation and Maintenance Manual

DART Police Headquarters at Illinois Station/Monroe Shops

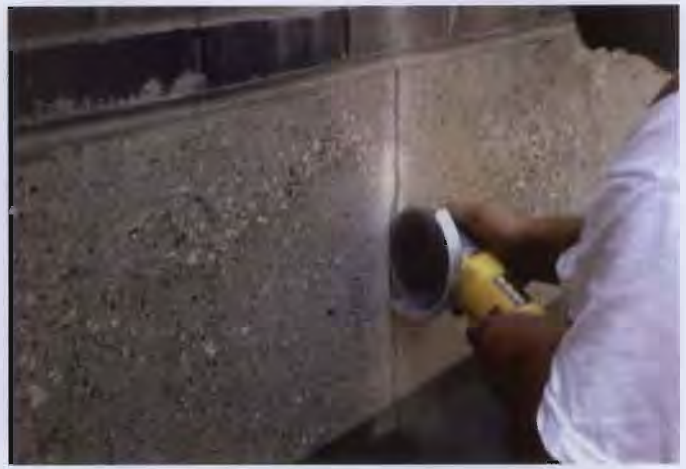
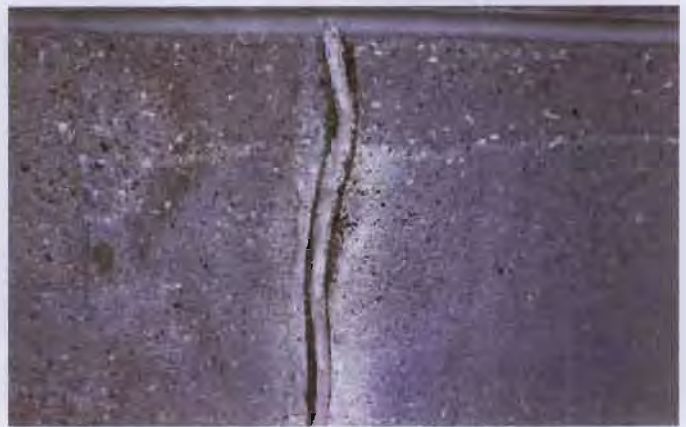
Figure 19. A high-speed grinder is used to widen a crack in preparation for installation of a sealant. This process is called "routing." After the crack is prepared, the sealant is installed to prevent moisture infiltration through the crack. Although sealant repairs can provide a durable, watertight repair for moving cracks, they tend to be very visible.

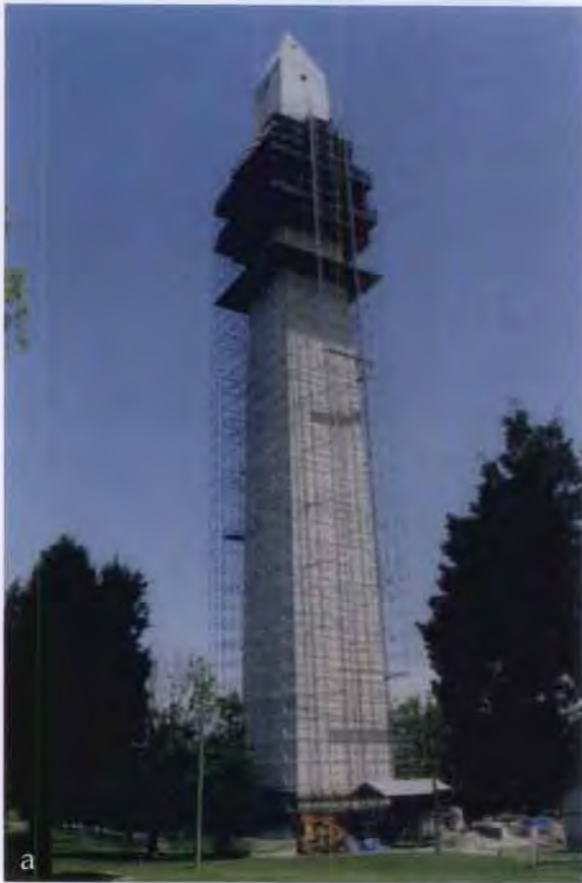
Coatings and Penetrating Sealers. Protection systems such as a penetrating sealers or film forming coating are often used with non-historic structures to protect the concrete and increase the length of the service life of concrete repairs. However, film-forming coatings are often inappropriate for use on a historic structure, unless the structure was coated historically. Film-forming coatings will often change the color and appearance of a surface, and higher build coatings can also mask architectural finishes and ornamental details. For example, the application of a coating on concrete having a formboard finish may hide the wood texture of the surface. Pigmented film-forming coatings are also typically not appropriate for use over exposed aggregate concrete, where the uncoated exposed surface contributes significantly to the historic character of

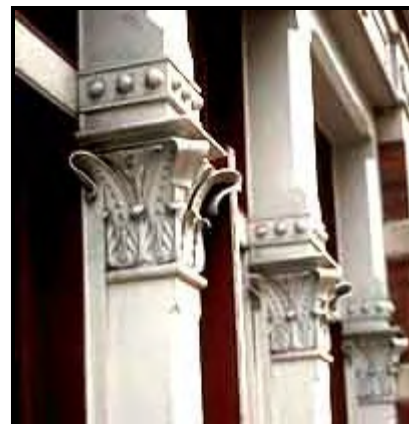
A NOTE TO OUR USERS: The web versions of the **Preservation Briefs** differ somewhat from the printed versions. Many illustrations are new, captions are simplified, illustrations are typically in color rather than black and white, and some complex charts have been omitted.

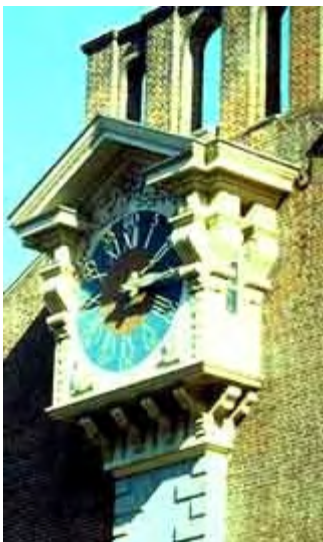
In the reconstruction of the clock tower at Independence Hall, the substitute materials used were cast stone and wood with fiberglass and polyester bronze ornamentation. Photo: NPS files.

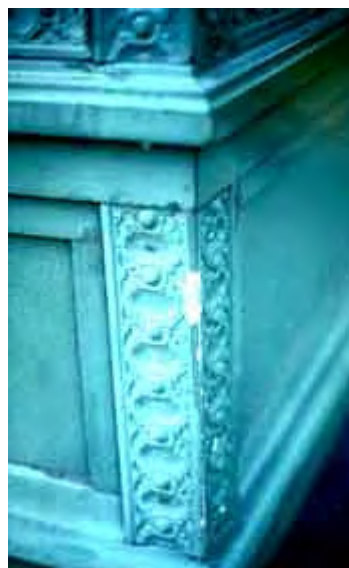
Substitute materials need to be located with care to avoid damage. The fiberglass column base has chipped, whereas the historic cast iron would have remained sound. Photo: NPS files.

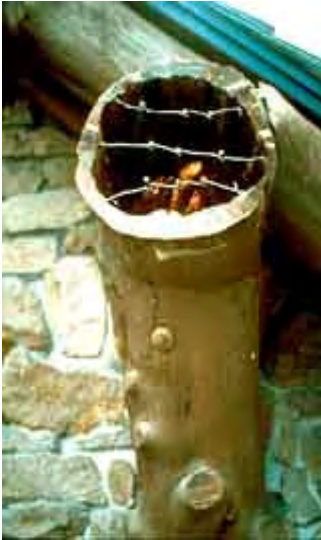
The core of a deteriorated wood outrigger was first drilled out. Photos (left and right): Courtesy, Harrison Goodall.

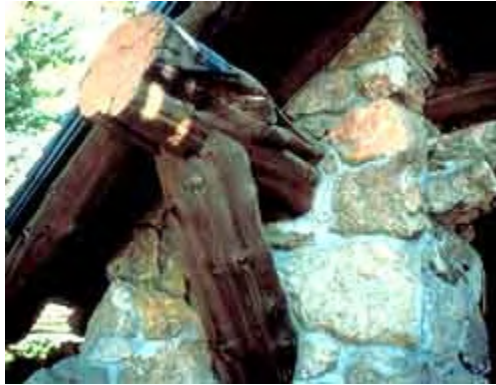
An inert material was injected into the hollow outrigger, permitting the outer wood to be retained and preserved.

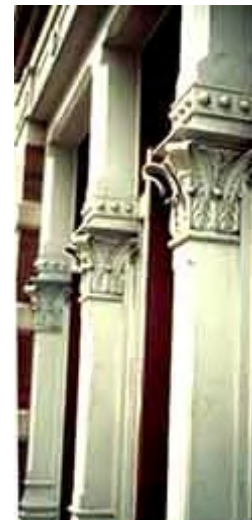
Cast aluminum has been used as a replacement material for cast iron. Photo: NPS files.

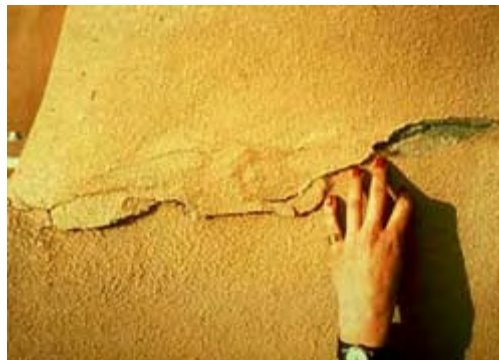
A waterproof coating is an inappropriate substitute material to apply to adobe as it seals in moisture and may result in spalling. Photo: NPS files.

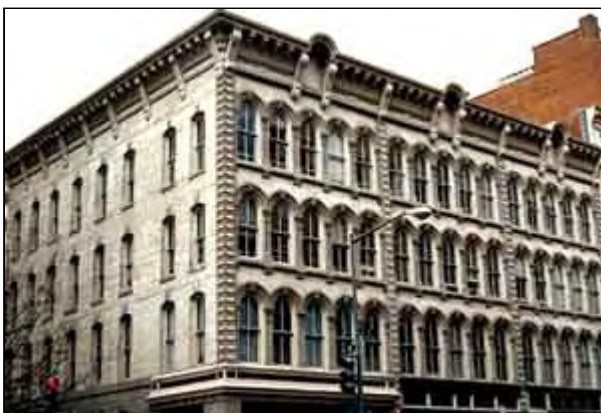
The historic cornice was successfully replaced with a fiberglass cornice. Photo: NPS files.

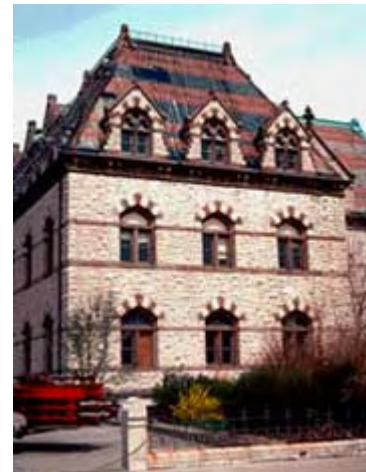
Overall Visual Character: Roof and Related Features

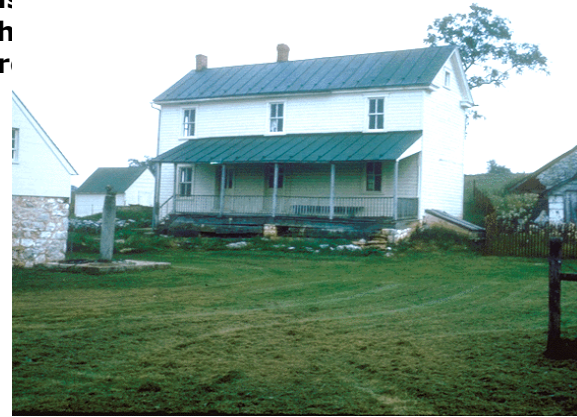
projecting porch or balcony can be very important to the overall visual character of almost any building and to the district in which it is located. Despite the size of this building (3-1/2 stories), and its distinctive roofline profile, and despite the importance of the very large window openings, the lacy wrap-around iron balcony is singularly important to the visual character of this building. It would seriously affect the character to remove the balcony, to enclose it, or to replace it with a balcony lacking the same degree of detail of the original material.

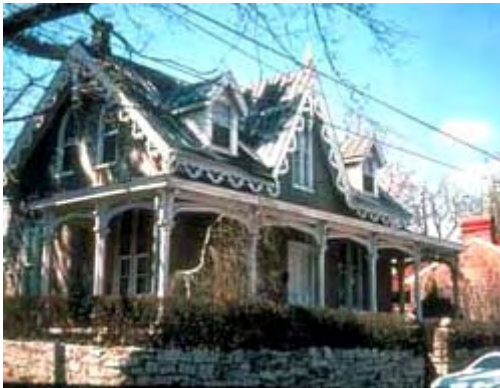
If one were to analyze the overall shape or form of this building, it would be seen that it is a gable-roofed house with dormers and a wrap-around porch. It is similar to many other houses of the period. It is the wooden **trim** on the eaves and around the porch that gives this building its own identify and its special visual character.

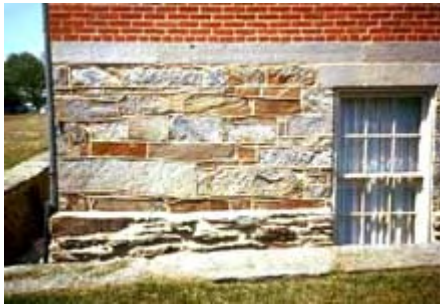
At arm's length, the visual character is most often determined by the surface qualities of the **materials** and craftsmanship; and while these aspects are often inextricably related, the original choice of materials often plays the dominant role in establishing the close range character because of the color, texture, or shape of the materials.

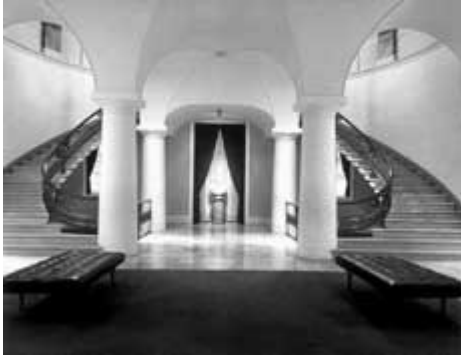
the quality of the materials in the floor and in the stairs. If the ceiling were to be lowered to provide space for heating ducts, or if the stairways were to be enclosed for code reasons, the shape and character of this space would be damaged, even if there was no permanent physical damage. Such changes can easily destroy the visual character of an individually important interior space. Thus, it is important that the visual aspects of a building's interior character be recognized before planning any changes or alterations.

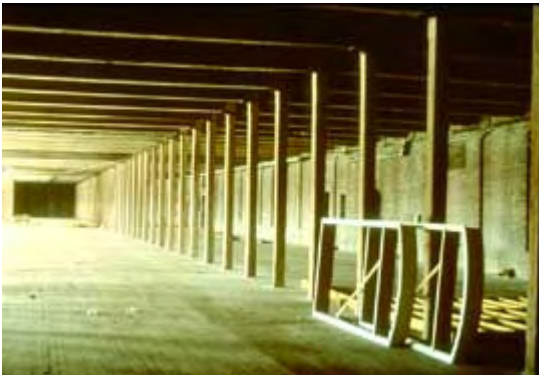
If features of the **structural system** are exposed, such as loadbearing brick walls, cast iron columns, roof trusses, posts and beams, vigas, or stone foundation walls, they may be important in defining the building's interior visual character.

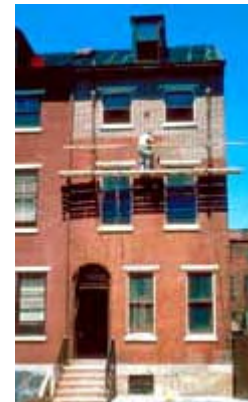
These qualities could be easily damaged by painting the brick, by raking out the joint with power tools, or repointing with a joint that is too wide. As seen here during the process of repointing, the visual character of this front wall is being dramatically changed from a wall where the bricks predominate, to a wall that is visually dominated by the mortar joints.

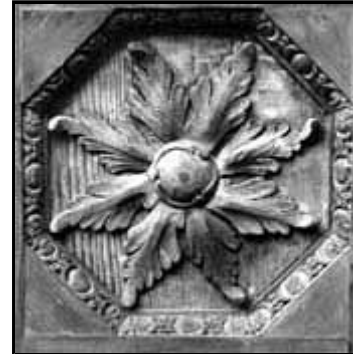
A NOTE TO OUR USERS: The web versions of the **Preservation Briefs** differ somewhat from the printed versions. Many illustrations are new, captions are simplified, illustrations are typically in color rather than black and white, and some complex charts have been omitted.

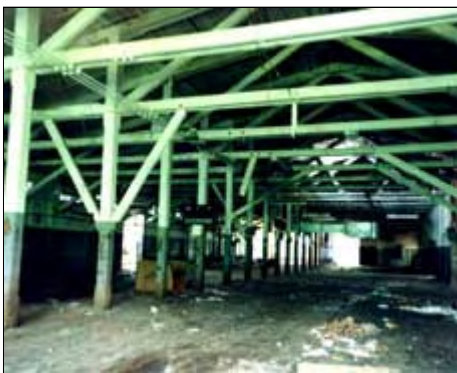
The interiors of mills and industrial buildings are frequently open, unadorned spaces with exposed structural elements. While these spaces can serve many new uses, the floor to ceiling height and exposed truss system are character-defining features that should be retained in rehabilitation.
Photo: NPS files.

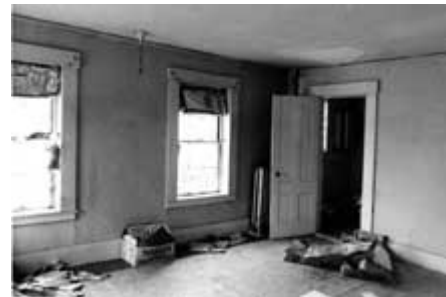
The interior of this 19th worker's house has not been properly maintained, but it may be as important historically as a richly ornamented interior. Its wide baseboards, flat window trim, and four-panel door should be carefully preserved in a rehabilitation project. Photo: NPS files.

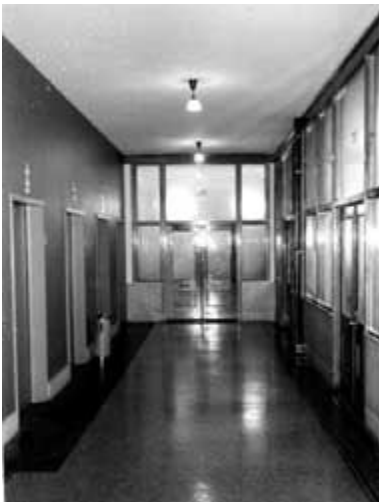
This corridor has glazed walls, oak trim, and marble wainscoting, typical of those found in the late 19th and early 20th century office buildings. Corridors such as this, displaying simple detailing, should be a

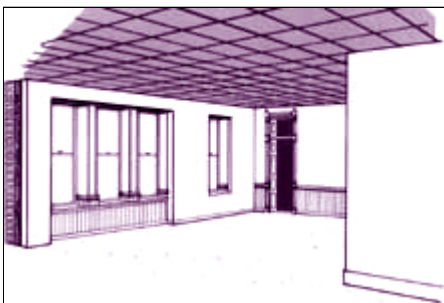
Furring out exterior walls to add insulation and suspending new ceilings to hide ductwork can change a room's proportions and cause interior features to appear fragmented. The interior character of this school classroom that was converted to apartment use has been destroyed.
Drawing: Neal A. Vogel

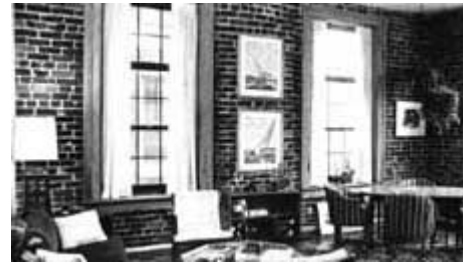
Plaster has been removed from perimeter walls, leaving brick exposed. The plaster should have been retained and repaired, as necessary. Photo: NPS files.

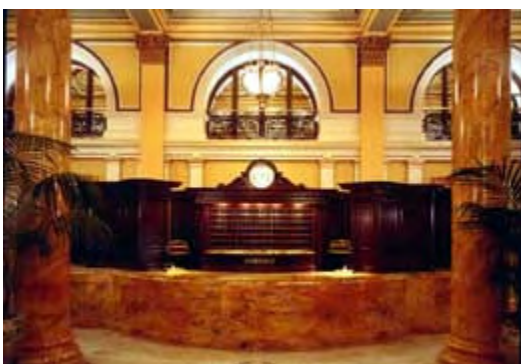
After rehabilitation, this severely deteriorated space was returned to its original elegance. Plaster was repaired and repainted; scagliola columns were restored to match marble; and missing decorative metalwork was re-installed in front of the windows. Photo: Carol M. Highsmith.

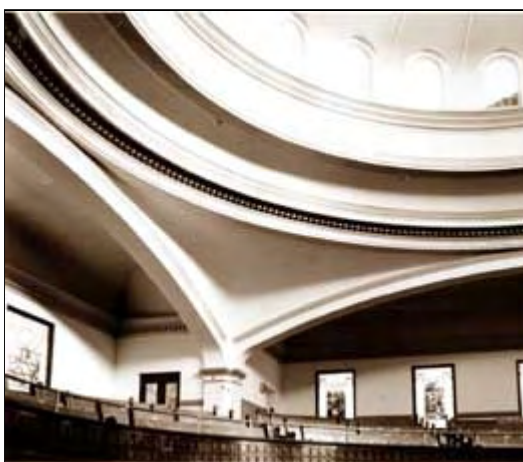
Plaster was used as the interior surface

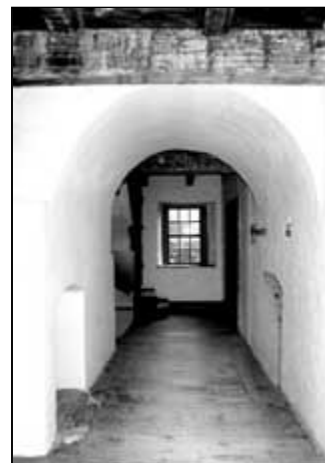
Schifferstadt, a simple house of German origin that dates to 1756, utilized plaster for both flat and curved walls. The building is located in Frederick, Maryland Photo: NPS files.

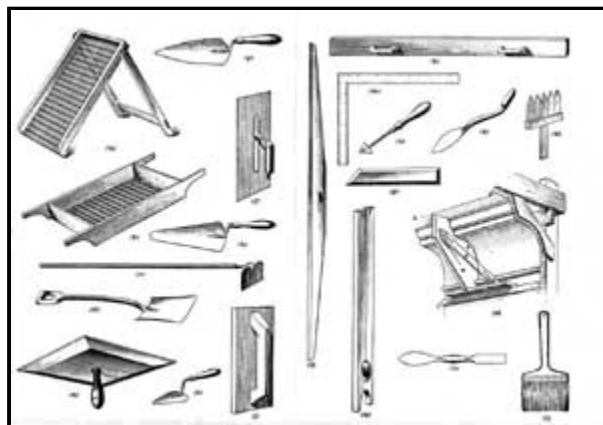
Many of these traditional plastering tools are still used today. Drawing: NPS files.

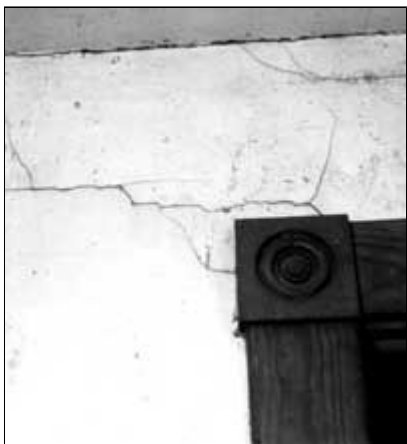
Stress cracks in plaster over a kitchen door frame can be repaired using fiberglass mesh tape and joint compound. Photo: NPS files.

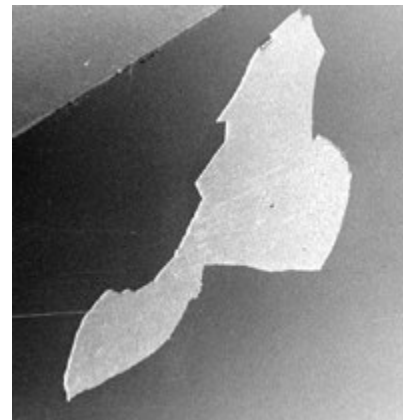
The smooth-trowled lime finish has delaminated from the brown coat underneath. Photo: Marylee MacDonald.

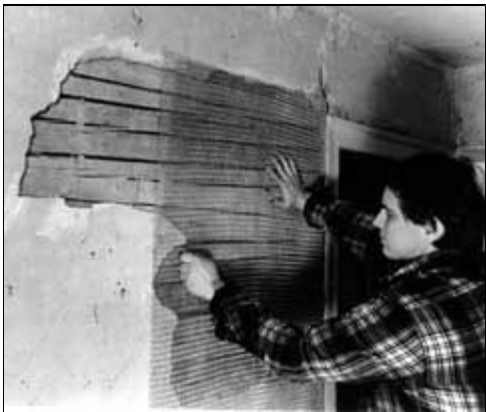
In this New Hampshire residence dating from the 1790s, the original plaster was a single coat of lime, sand, and horsehair applied over split lath. A one-coat repair, in this case, is appropriate. Photo: John Leeke.

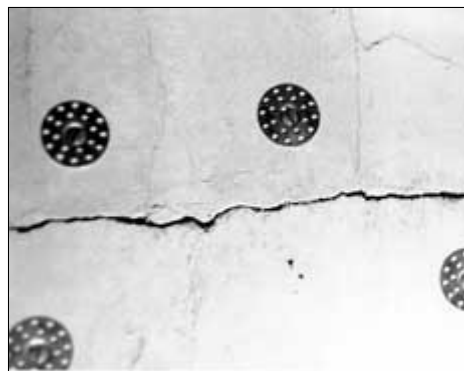
Flat-head wood screws and plaster washers were used to reattach loose ceiling plaster to the wood lath. After the crack is covered with fiberglass mesh tape, all will be skim-coated with a patching compound. Photo: John Obed Curtis.

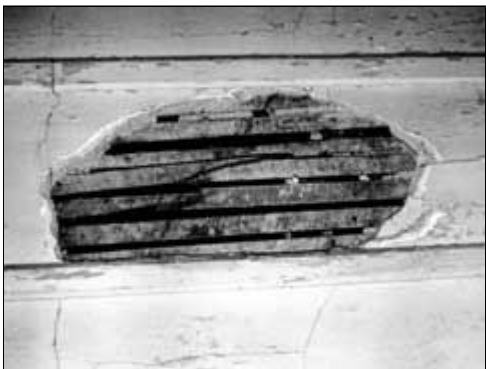
This beaded ceiling in one of the bedrooms of the 1847 Lockwood House, Harpers Ferry, West Virginia, is missing portions of plaster due to broken keys. Photo: NPS files.

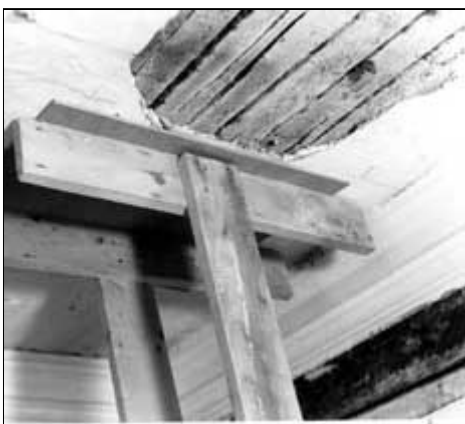
When ceiling repairs are made with wet plaster or with an injected adhesive mixture, the old loose plaster must be supported with a plywood brace until re-keying is complete. Photo: John Leeke.

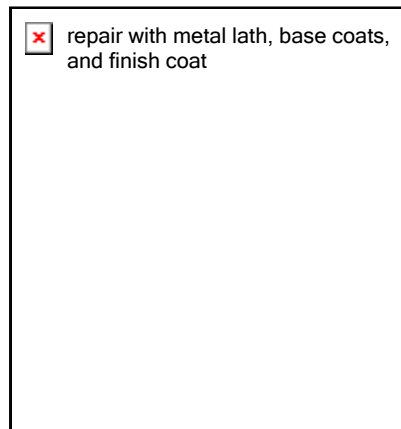
Repairs are being made to the historic plaster. Expanded metal lath is cut to fit the hole, then attached to the wood lath with a tie-wire. Two ready-mix gypsum coats are applied, then a smooth-trowled coat of gauged lime. Photo: Walter Jowers.

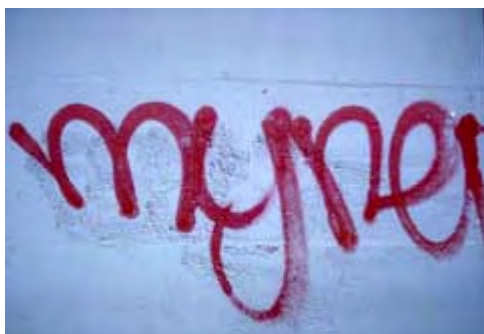
Inappropriate abrasive blasting to remove the graffiti has permanently etched the graffiti into the stone. Photo: NPS files.

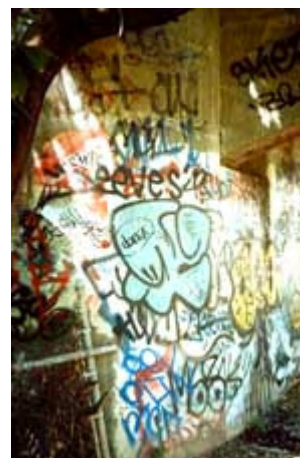
Removing this densely painted graffiti will require several applications of paint remover. Photo: NPS files.

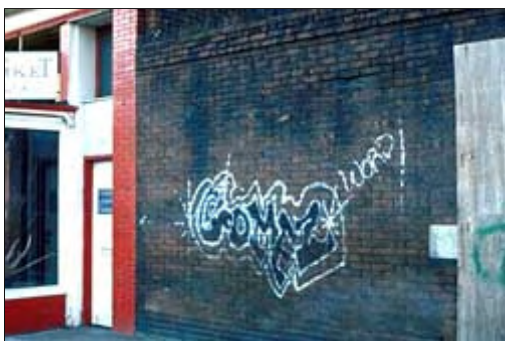
Spray painted graffiti defaces this historic brick building. Photo: NPS files.

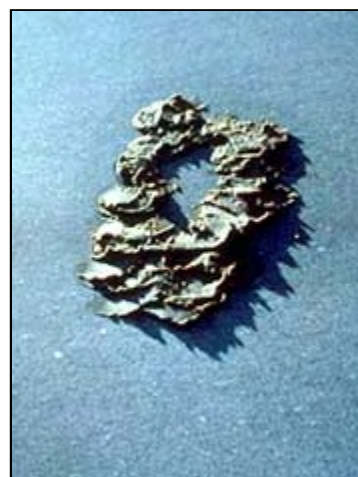
A poultice is often the preferred method of graffiti removal.
Photo: NPS files.

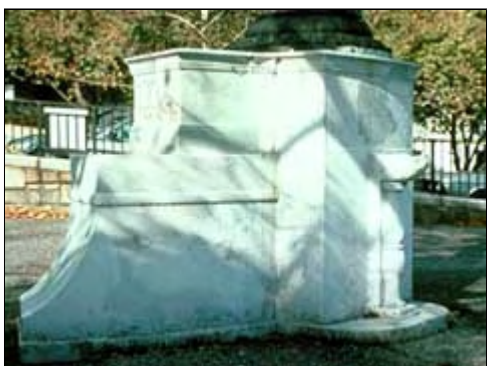
Painting over graffiti on stone is not a recommended maintenance treatment.
Photo: NPS files.

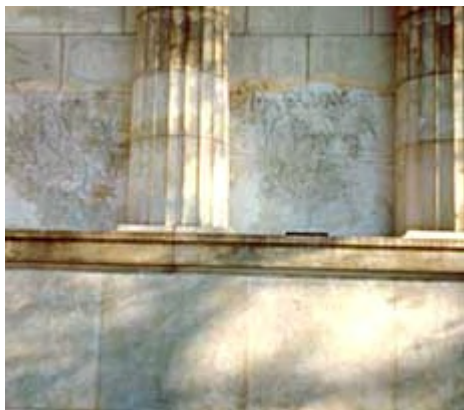
Damaging graffiti removal methods have scarred the marble. Photo: NPS files.

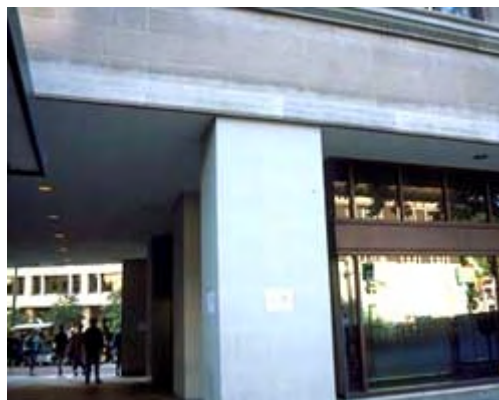
The difference in color between the bottom and the top of the stone spandrel is the only clue to the presence of a clear barrier coating. Photo: NPS files.

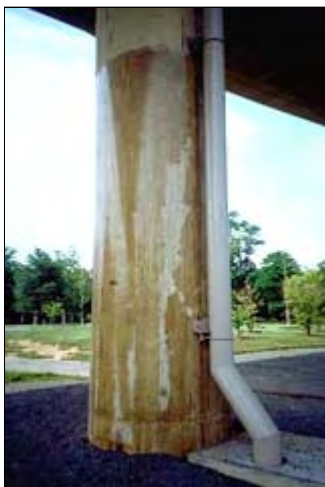
This formerly clear barrier coating is very shiny and has discolored as it has aged. Photo: NPS files.

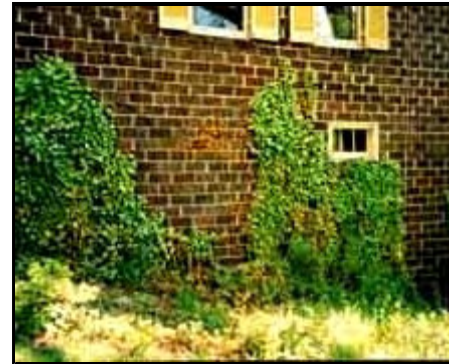
A NOTE TO OUR USERS: The web versions of the **Preservation Briefs** differ somewhat from the printed versions. Many illustrations are new, captions are simplified, illustrations are typically in color rather than black and white, and some complex charts have been omitted.

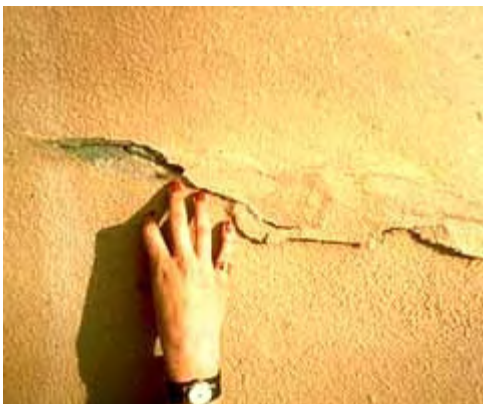
Applying a waterproof coating to an above-ground masonry wall can trap moisture underneath, causing further damage to the historic material. Photo: NPS files.

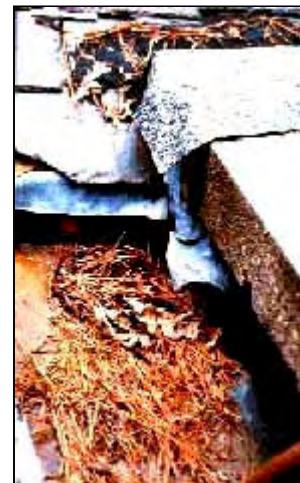
Debris will impede the normal flow of water from the roof's gutter and downspout system to the ground and result in moisture problems. Photo: NPS files.

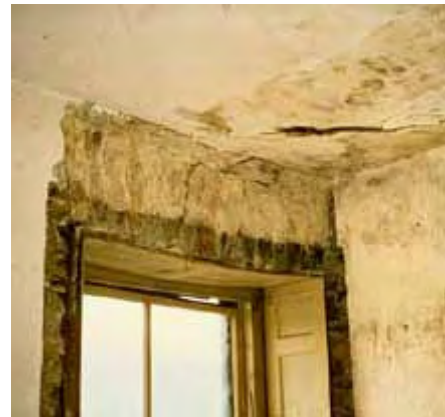
Damp interior plaster around windows generally indicates moisture has entered from the outside. Photo: NPS files.

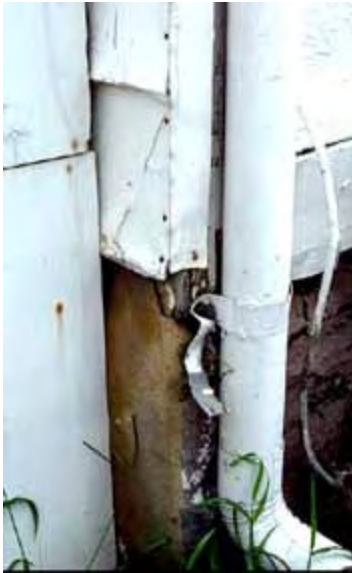
A clogged or broken downspout causes the water to pour directly into the ground. NPS files. Photo: NPS files.

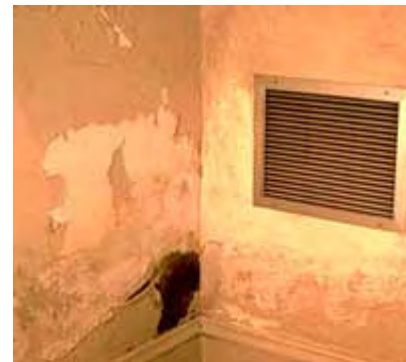
If adequate ventilation is installed,

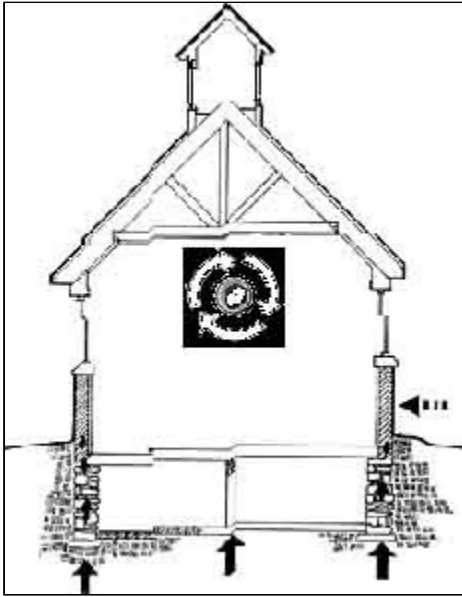
The dynamic forces that move air and moisture through a building are important to understand, particularly when selecting a treatment to correct a moisture problem. This drawing shows how moisture can invade "inward" from the exterior; "upward" from the ground; and be generated from "within" the interior. All have damaging effects. Drawing: NPS files.

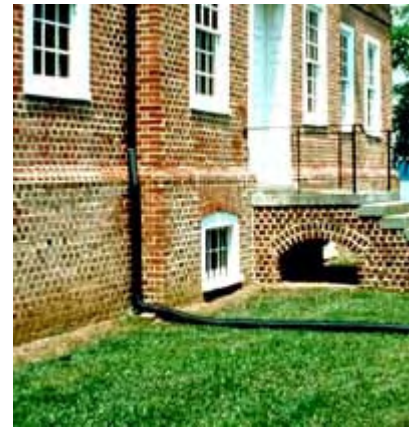
The owner used long black extender pipes to test a theory that it was faulty roof drainage causing the problem. Photo: NPS files.

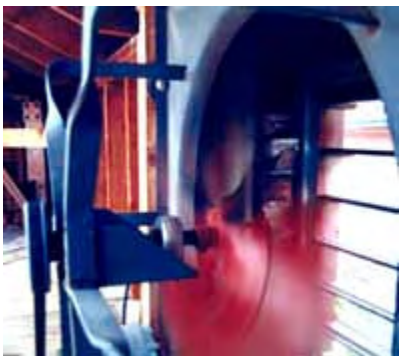
Installing ventilating fans can improve damp conditions or reduce cooling loads. Photo: NPS files.

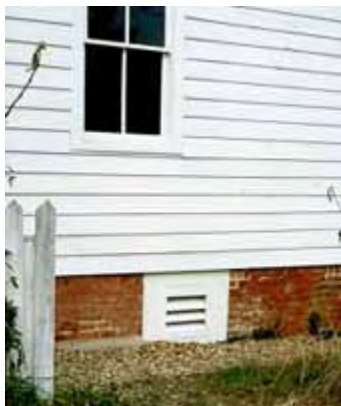
A vent may be added if there is none. Close grilles in the summer, if hot humid air is getting into air conditioned spaces. Photo: NPS files.

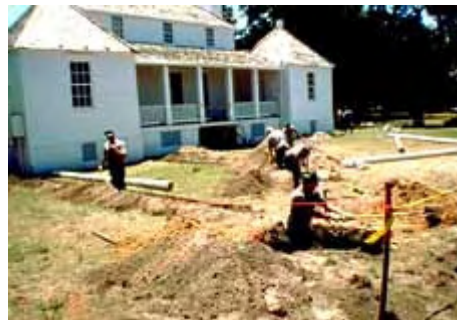
New drainage systems for roof run-off may be installed in order to remove
