Repair Systems for Deteriorated Bridge Piles:

Final Report

University of Houston

Texas Tech University (TechMRT)

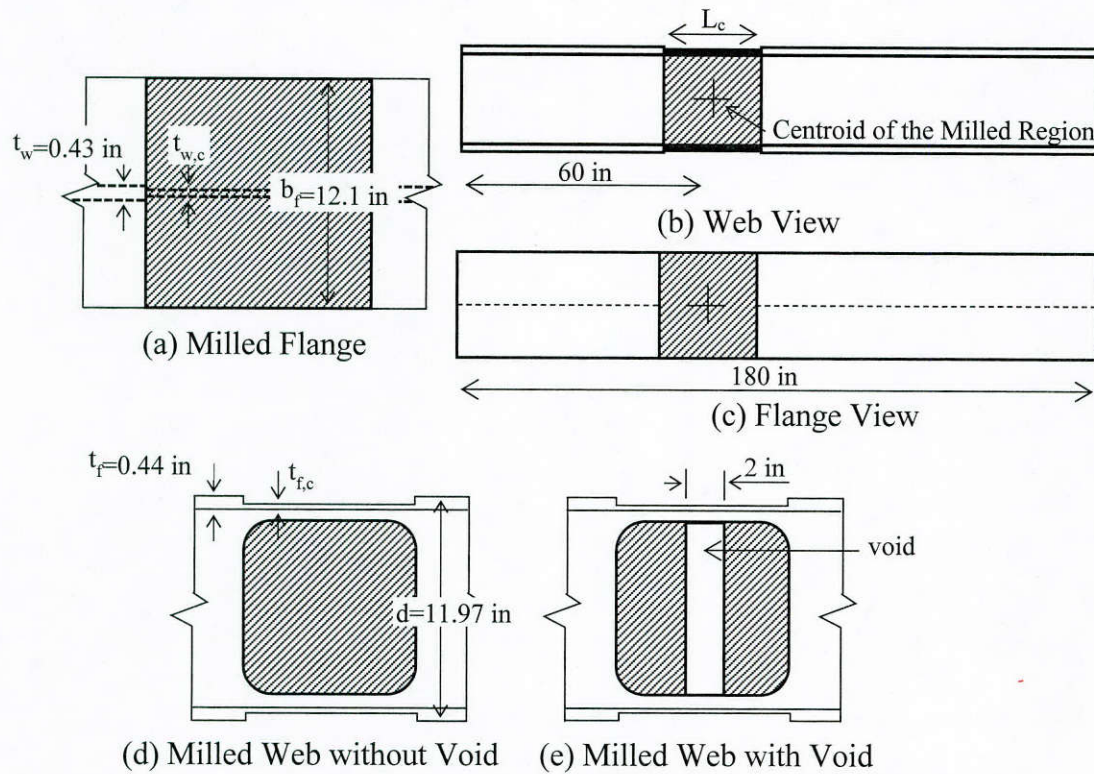
For the piles that were observed in the field the corrosion was located closer to one of the points of inflection than the other. To represent this trend, the centroids of the corroded regions were located at 5 ft. from one end of the piles, that is, at the 1/3 length.. Figure 4.3 shows the schematic drawing of the corroded region. The nominal levels of reduction in the flange thicknesses were 0%, 40%, and 80%. The thicknesses of the webs were reduced by 20% and 60% distributed evenly between the two faces of the webs. As shown in Figure 4.3, one pile had a 2 in. through-web void. The extent of the corroded region was 12 in. for five piles and 36 in. for one pile.

Figure 4.3: Schematic drawing of the location and geometry of the milled region

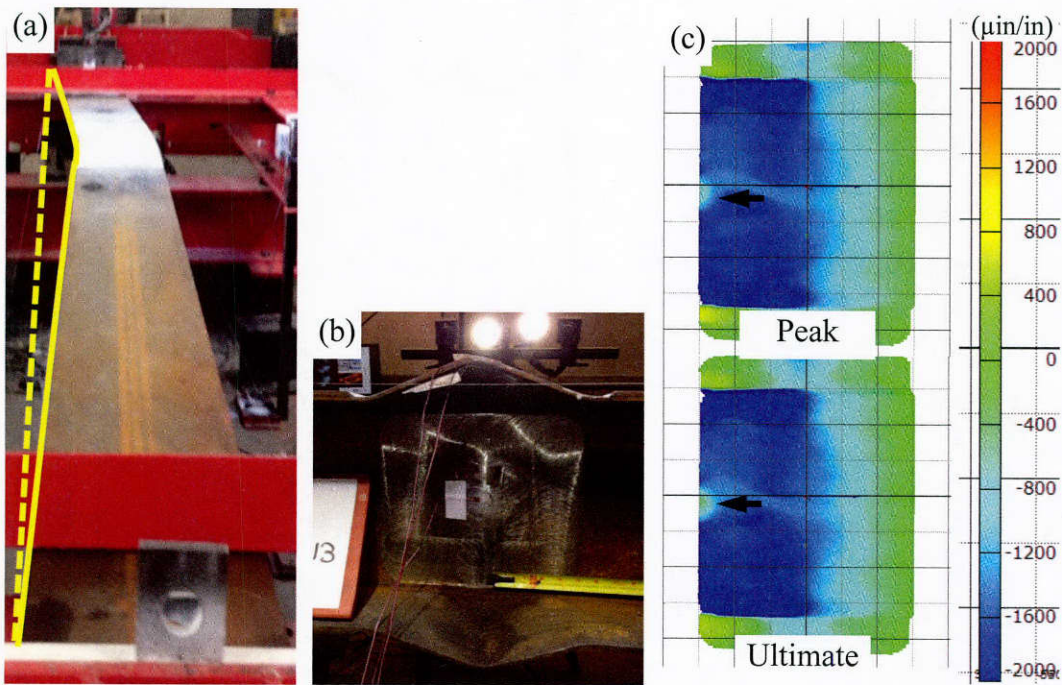
After applying one loading cycle up to 99 kips to seat the specimen, the pile 40/20 was loaded up the peak load monotonically. No visible signs of deformation were observed during the test up to the peak load. After attaining the peak load of 435 kips, the load began to drop gradually. At the load level of 413 kips, the axial load suddenly dropped to 79 kips due to flange local buckling followed by global lateral deformation of the pile. Figure 4.12(a) and (b) show the global deformation and flange local buckling of the tested pile, respectively. Longitudinal strain contours at peak load within the corroded flange, as shown in Figure 4.12(c), suggest the initiation of flange local buckling at the locations of with strain concentration, although at this stage no sign of deformation was observed. Strain contours at the ultimate loading stage indicate strain relief on edge of the corroded flange where the local buckling was observed.

Figure 4.12: Global deformation, local deformation, and strain contours of pile 40/20

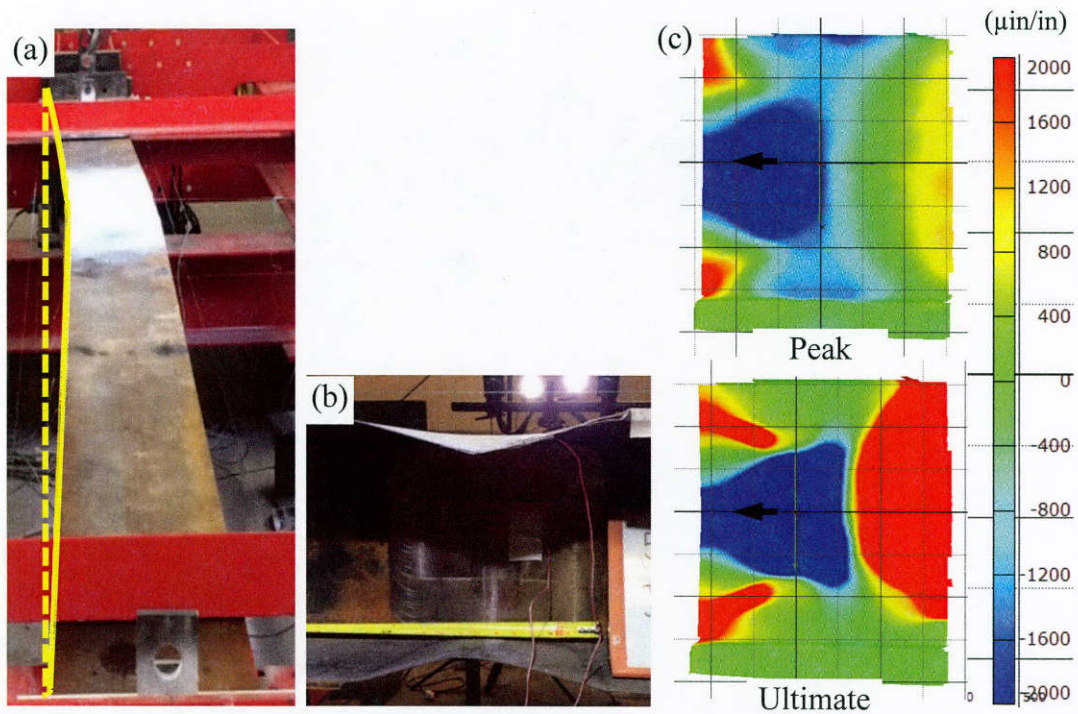
The pile 80/60 was subjected to a seating load of 45 kips. Then, it was loaded up the peak load monotonically. No visible signs any deformation were observed during the test up to the peak load. After attaining the peak load of 182 kips, the load began to drop gradually. At the load level of 164 kips, the axial load suddenly dropped to 102 kips due to flange and web local buckling followed by global deformation. Figure 4.18(a) and (b) show the global deformation and flange and web local buckling of the tested pile, respectively. Longitudinal strain contours at measured at the peak load on the top surface of the top flange within the corroded region, shown in Figure 4.18(c), indicate initiation of flange local buckling at the locations of strain concentrations, although at this stage no sign of deformation was observed. Strain contours at the ultimate loading stage indicate strain relief on edge of the corroded flange where the local buckling occurred.

Figure 4.18: Global deformation, local deformation, and strain contours of pile 80/60

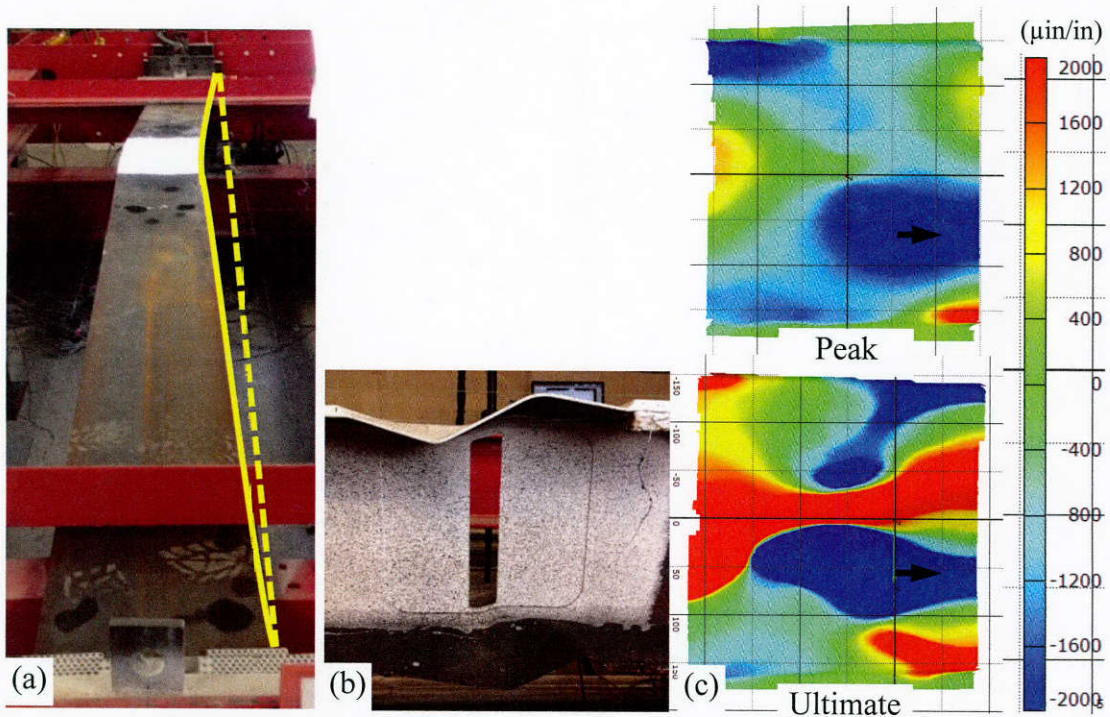
After applying one loading cycle up to 25 kips to seat the specimen, pile 80/60/V was loaded up to the peak load monotonically. The axial load-deflection response of the pile exhibits a notable reduction in stiffness at a load level of 109 kips. This was attributed to the initiation of localized bending of the bottom flange which was confirmed by strain gauge measurements as discussed below. After attaining the peak load of 125 kips, the load began to drop gradually to 52 kips at which point the test was terminated due to excessive axial deformation of the pile. The pile failed due to localized one-way bending of the flanges on either side of the void rather than in the two-way plate bending mode that is commonly associated with local buckling. Figure 4.21(a) and (b) show the global deformation and flange localized bending of the tested pile, respectively. Longitudinal strain contours at peak load within the corroded flange, as shown in Figure 4.21(c), indicate initiation of flange localized bending at the spots with strain concentration, although at this stage no sign of deformation was observed.

Figure 4.21: Global deformation, local deformation, and strain contours of pile 80/60/V

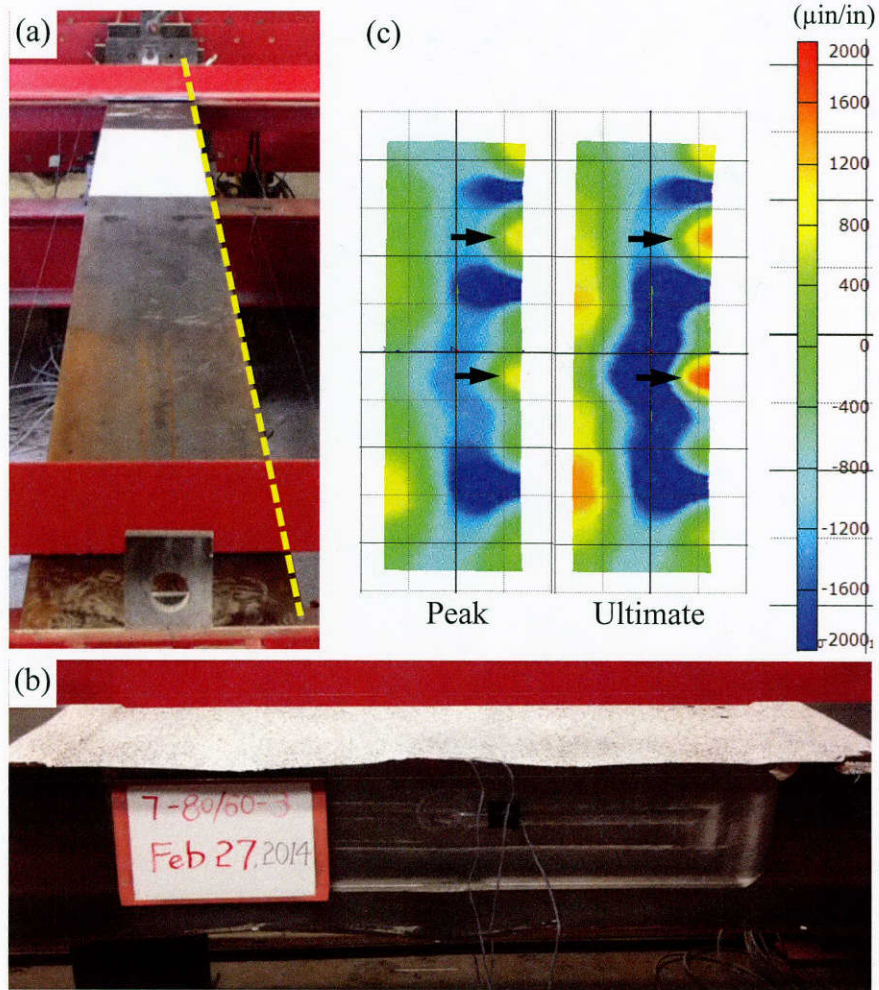
The pile 80/60/3 was loaded up to the peak load monotonically. No visible signs of any deformation were observed during the test up to the peak load. After attaining the peak load at 159 kips, the load began to drop gradually to 132 kips at which point the test was terminated. The pile failed by flange and web local buckling followed by global lateral deformation. Figure 4.24(a) and (b) show the global deformation and flange and web local buckling of the tested pile, respectively. Longitudinal strain contours at the peak load on the top surface of the top flange within the corroded region, shown in Figure 4.24(c), indicate initiation of flange local buckling at the locations with strain concentrations, although at this stage no sign of deformation was observed. Strain contours at the ultimate loading stage indicate strain relief on edge of the corroded flange where the local buckling happened.

Figure 4.24: Global deformation, local deformation, and strain contours of pile 80/60/3

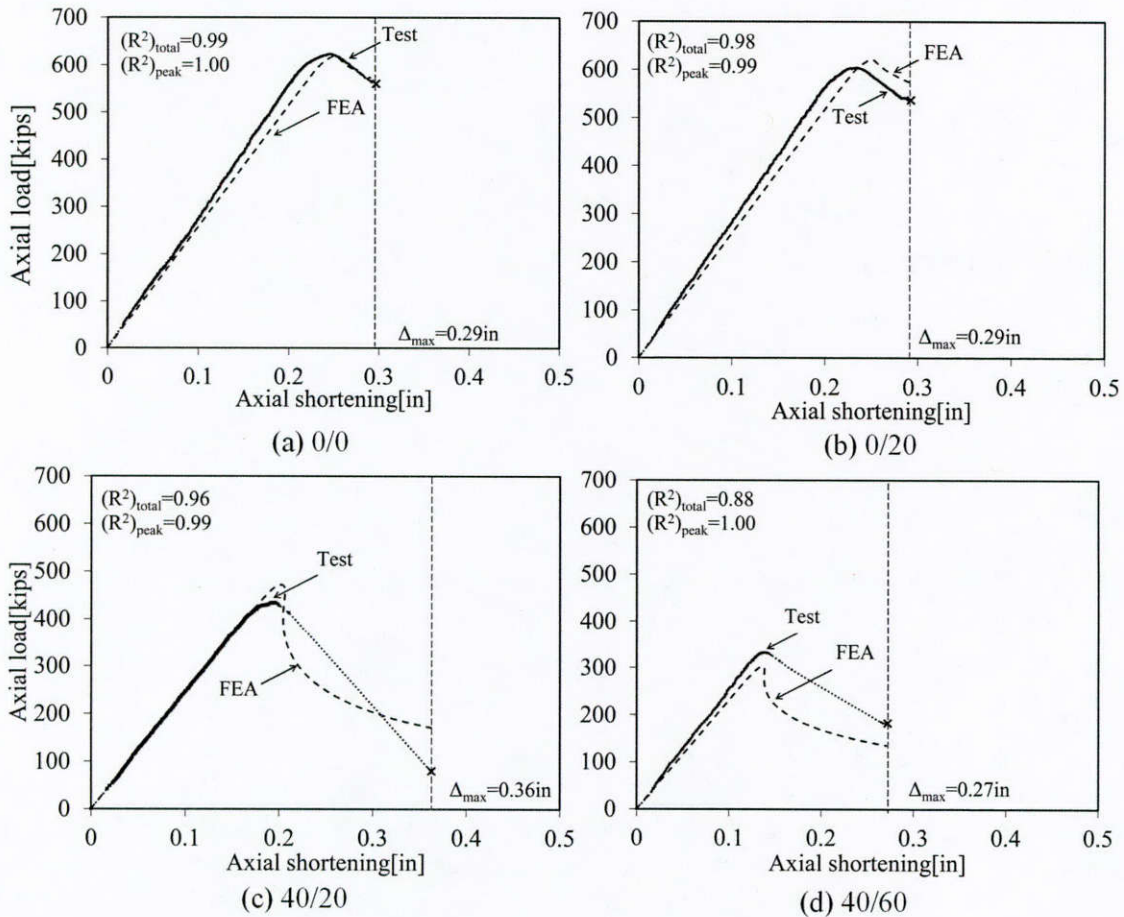
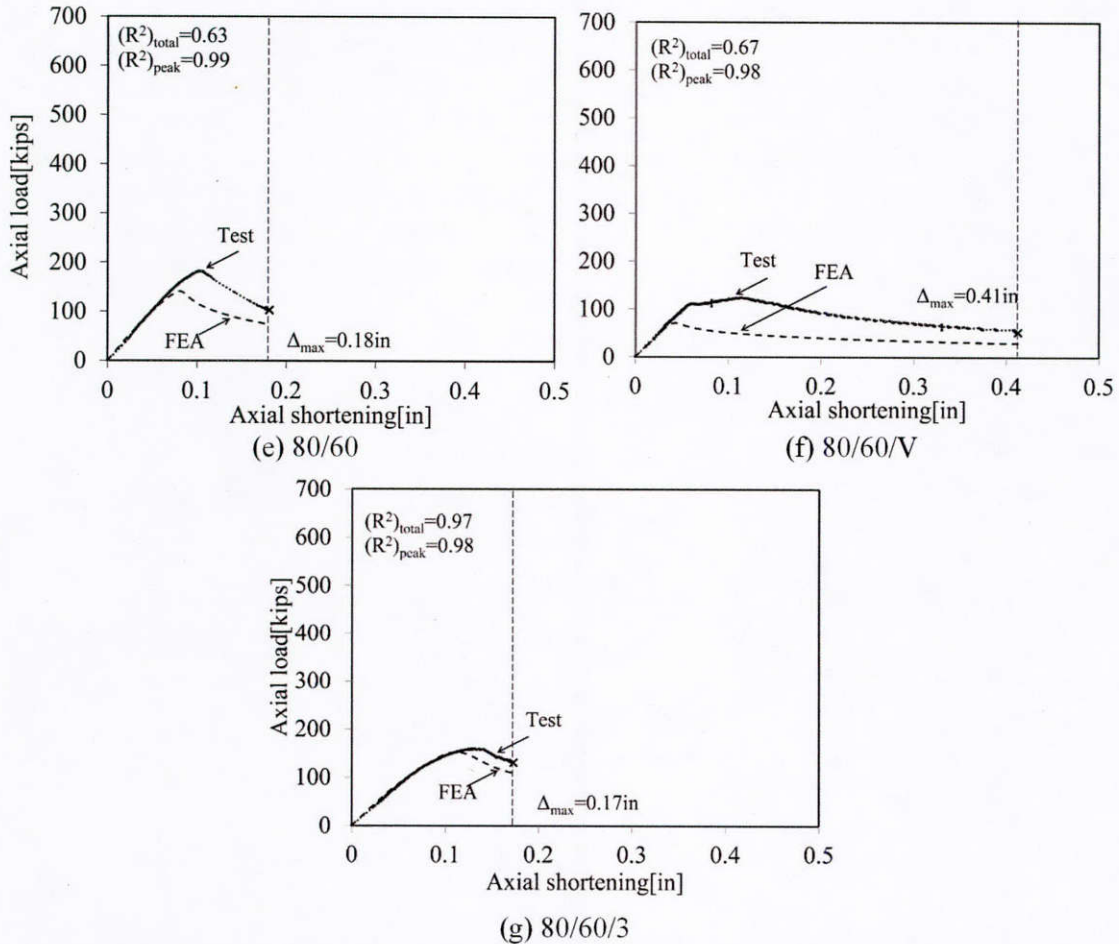
accurately predicted the full axial load-deformation responses for these piles. For piles 40/20 and 40/60, the post-peak measured response exhibited a sudden drop of capacity. Consequently, there are very few measured data points in the post peak range for these piles and the trend does not closely match the predicted response. The FEA under-predicted the post-buckling capacity of pile 80/60, 80/60/V, and 80/60/3 compared to the measured response. The discrepancies between the measured and predicted axial load-displacement relationships was attributed to four possible causes: (1) unintentional eccentricity of the applied load during testing; (2) uncertainty of the magnitude and pattern of the residual stresses; (3) conservativeness of the assumed magnitude and pattern of initial imperfections; (4) effect of the fillet at the junction of flange and web.

Figure 6.10: Comparison of axial load-deformation responses from test and FEA of HP12×53

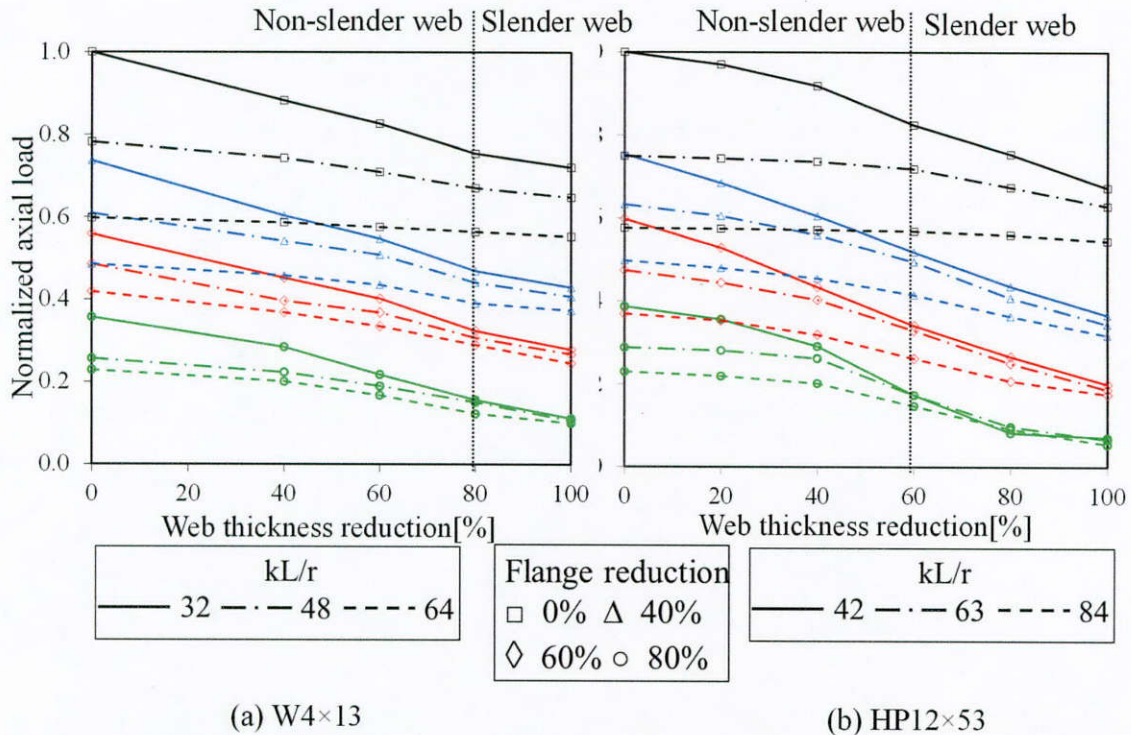
Figure 6.11 shows the effects of flange and web corrosion on the predicted axial capacities of corroded W4×13 and HP12×53 piles with different slenderness ratios, kL/r , where k is the effective length factor, L is the clear length of the member, and r is the radius of gyration of the cross section about the axis of bending. The horizontal and vertical axes illustrate the degree of the reduction of the web thickness and the normalized axial capacity, respectively. For W4×13 shown in Figure 6.11(a), the axial load was normalized with respect to the capacity of the un-corroded pile, 0/0, with a slenderness ratio of 32. For HP12×53 shown in Figure 6.11(b), the axial load was normalized with respect to the capacity of the un-corroded pile, 0/0, with a slenderness ratio of 42. The points in the figure indicate the predicted peak loads of the simulated piles, and they are connected by lines for visual convenience. The marker styles indicate the degrees of flange thickness reduction. The line styles indicate pile slenderness ratios of 32, 48, and 64 for W4×13 (Figure 6.11(a)), 42, 63, and 84 for HP12×53 (Figure 6.11 (b)).

Figure 6.11: Axial peak loads for piles with different reduction on flange and web

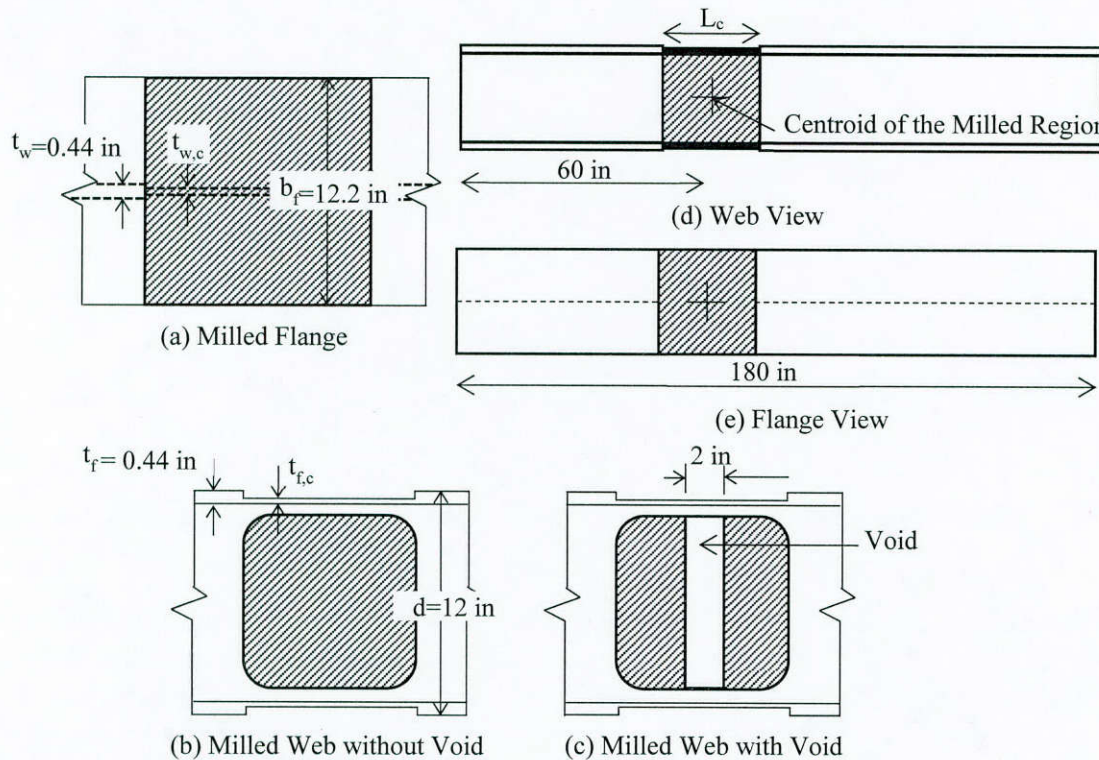
The corrosion patterns for the tested piles were created by milling the thickness of flanges and web to a certain level to increase the slenderness of these elements and make them susceptible to local buckling. Figure 8.1 presents a schematic of the corroded regions for the tested piles. The length of the piles was 15 ft., and the centroid of the corroded region was located at 5 ft. from one end of the piles. Three levels of nominal reduction of the flange thickness were considered: 0%, 40%, and 80%. The thickness of the web was reduced symmetrically by either 20% or 60%. One pile in each group had a 2 in. through-web void as illustrated in Figure 8.1. The extent of the corroded region, L_c , was 12 in. for six of the piles while one pile in each group had a 36 in. extent of the corroded region, L_c .

Figure 8.1: Schematic drawing of the location and geometry of the milled region

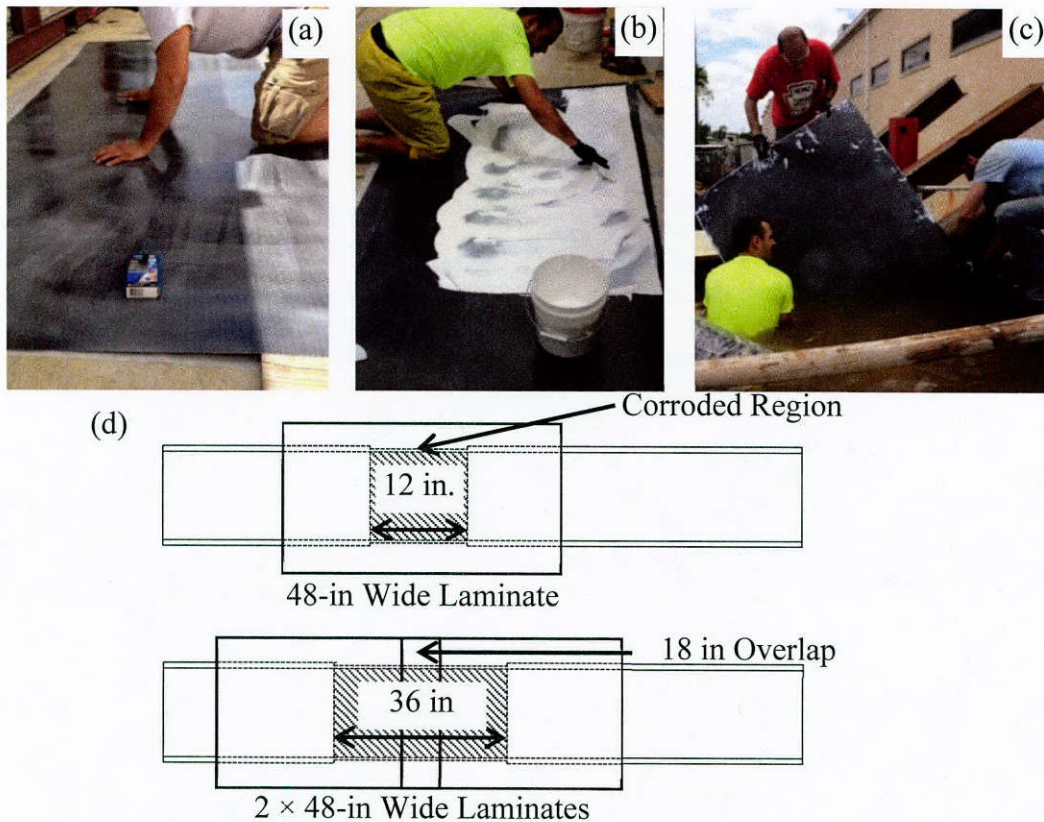
Figure 8.6 shows the process of installing the F1-type FRP jackets. The FRP laminate for the F1 repair system was pre-cut to the desired length and shipped to the laboratory by the manufacturer. As shown in Figure 8.6(a), the laminate was hand sanded with 60 grit sand paper to roughen the surface and wiped clean with a piece cotton cloth. Figure 8.6(b) shows the application of an underwater-curing epoxy to the surface of the laminate. After applying the epoxy the laminate was immediately transferred to the tank, wrapped around the pile, and pressed against the end-cap as shown in Figure 8.6(c). A 10 ft. long laminate was wrapped completely around each pile twice (providing a jacket with two layers of CFRP) with a minimum of 8-in of overlap length at the end of the wrap. For the piles with degradation along 12 in., of the pile in the longitudinal direction, a 48 in. long repair was implemented resulting in load introduction lengths of 18 in. above and below the corroded regions. For the pile with a 36 in. long corroded region, two 48 in. wide laminates were provided with an 18 in. overlap located at the center of the milled region resulting in a total repair length of 78 in. (see Figure 8.6(d)). The installation of the jackets on the seven piles required one day of labor by one experienced representative from the manufacturer and two graduate student assistants. The jacket installations were achieved using hand tools and minimal power tools and did not require any heavy equipment. The epoxy cured for a week before casting the grout. The jacket installation was done in May 2014 when the average temperature and relative humidity were 75°F and 65%, respectively.

Figure 8.6: Installing FRP jacket for F1 FRP-based repair system

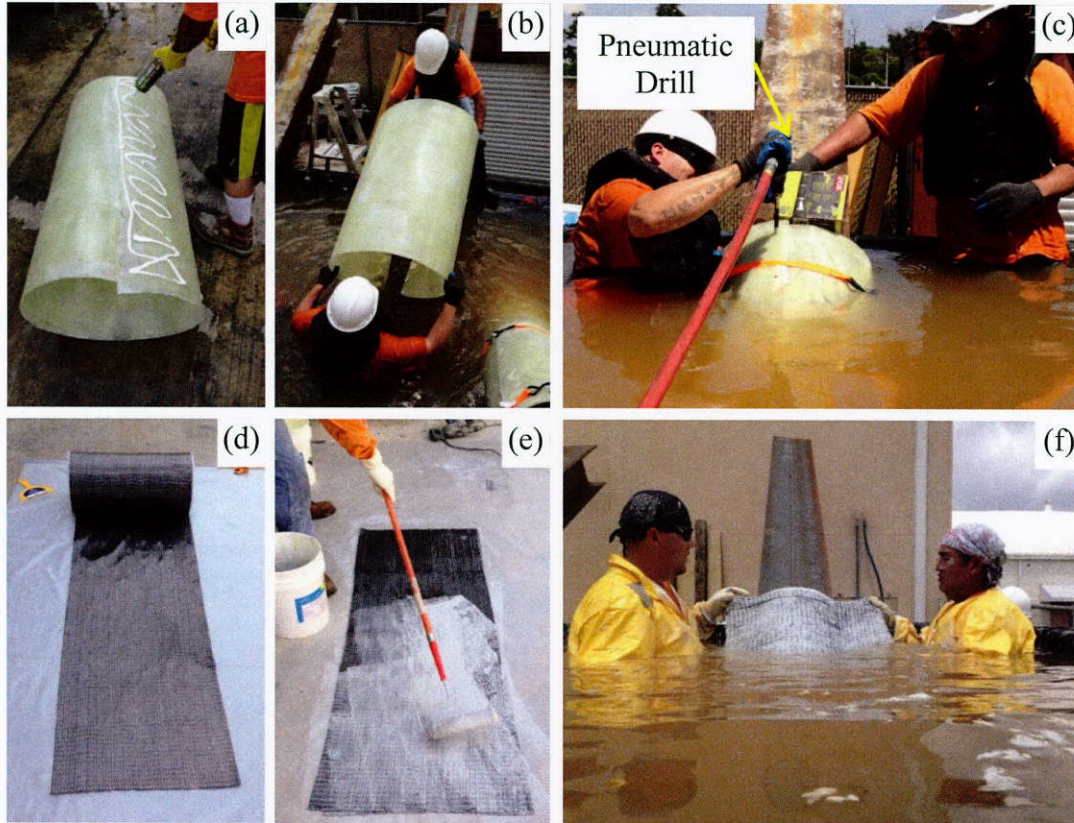
was completed using basic hand and power tools and did not require any heavy equipment. The epoxy cured for a week before casting the grout. The jacket installation was done in July 2014 when the average temperature and relative humidity were 86°F and 71%, respectively.

Figure 8.7: Installing FRP jacket for F2 FRP-based repair system

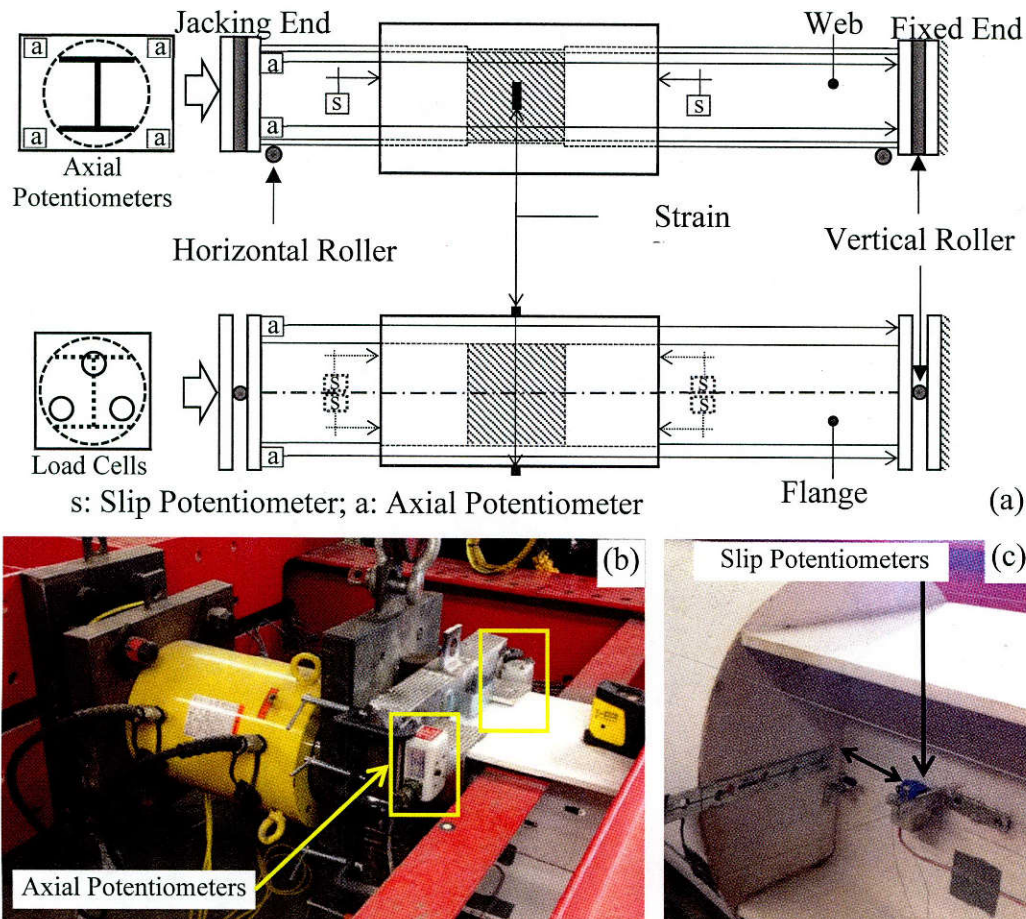
A similar instrumentation scheme was adopted for measurement of the repaired piles as that used in the measurements of the un-repaired, corroded control piles. The axial load was measured using three load cells, each with a capacity of 200 kips. The load cells were installed in a triangular configuration located behind the jack as shown in Figure 8.12(a). The axial shortening of the piles were measured by taking the average of the four linear string potentiometers that were mounted symmetrically at the four corners of the tested piles between the two end plates, as Figure 8.12(a) and (b) show. Four linear potentiometers were mounted on both ends of the grout cylinder, to measure the slip between the steel pile and grout cylinder, as shown in Figure 8.12(c), to measure the slip between the steel pile and grout cylinder. Two electrical resistance strain gauges were installed to measure the hoop strains in the FRP jacket at the center of the repair system. The gauges were installed on either side of the web as illustrated in Figure 8.12(a).

Figure 8.12: Instrumentation of repaired corroded piles

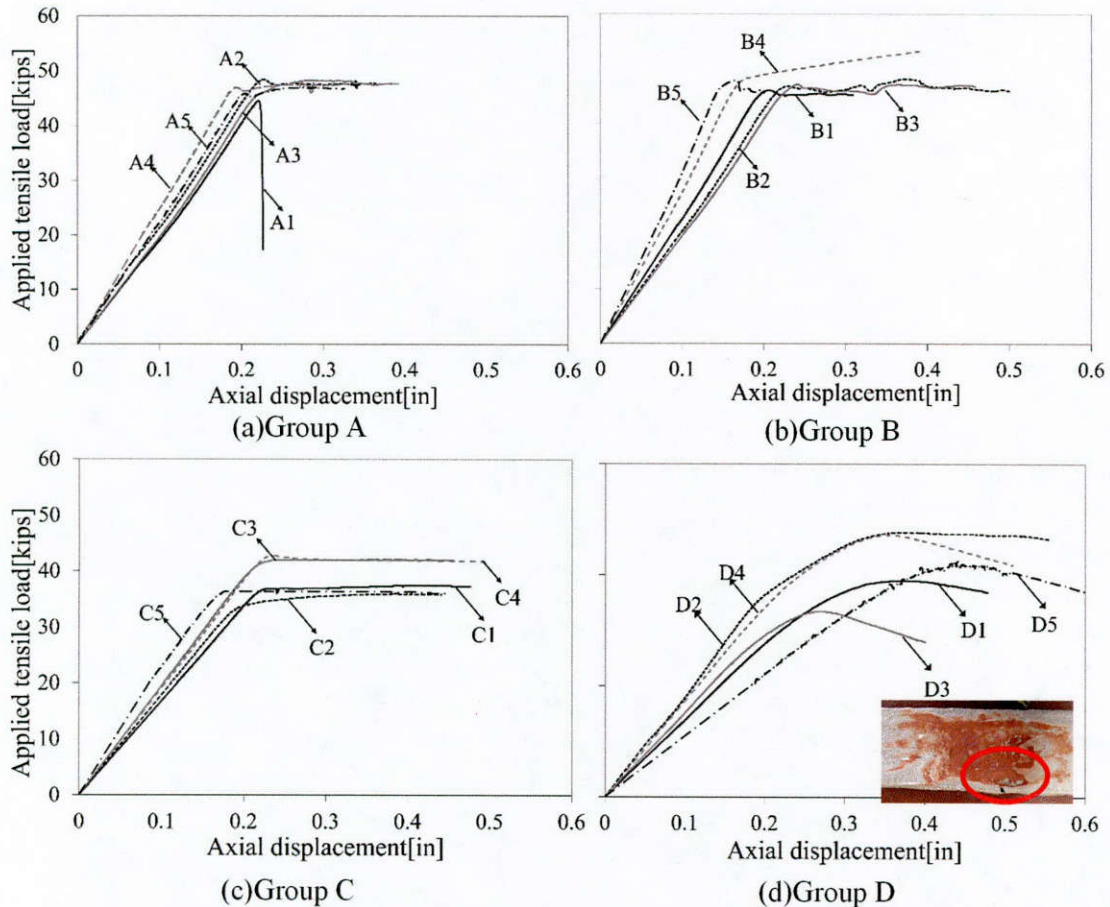
Figure 8.14 shows the measured load-displacement relationships from each group. The figure indicates that Group A, B, and C exhibited similar behavior with a constant load plateau after the initiation of slipping as expected. However, specimens in Group D exhibited softening behavior with softening behavior after reaching the peak load. This this was attributed to the failure of the Armor plate 360 coating, as shown in the bottom right portion of Figure 8.14.

Figure 8.14: Load-slip relationships from slip resistance tests

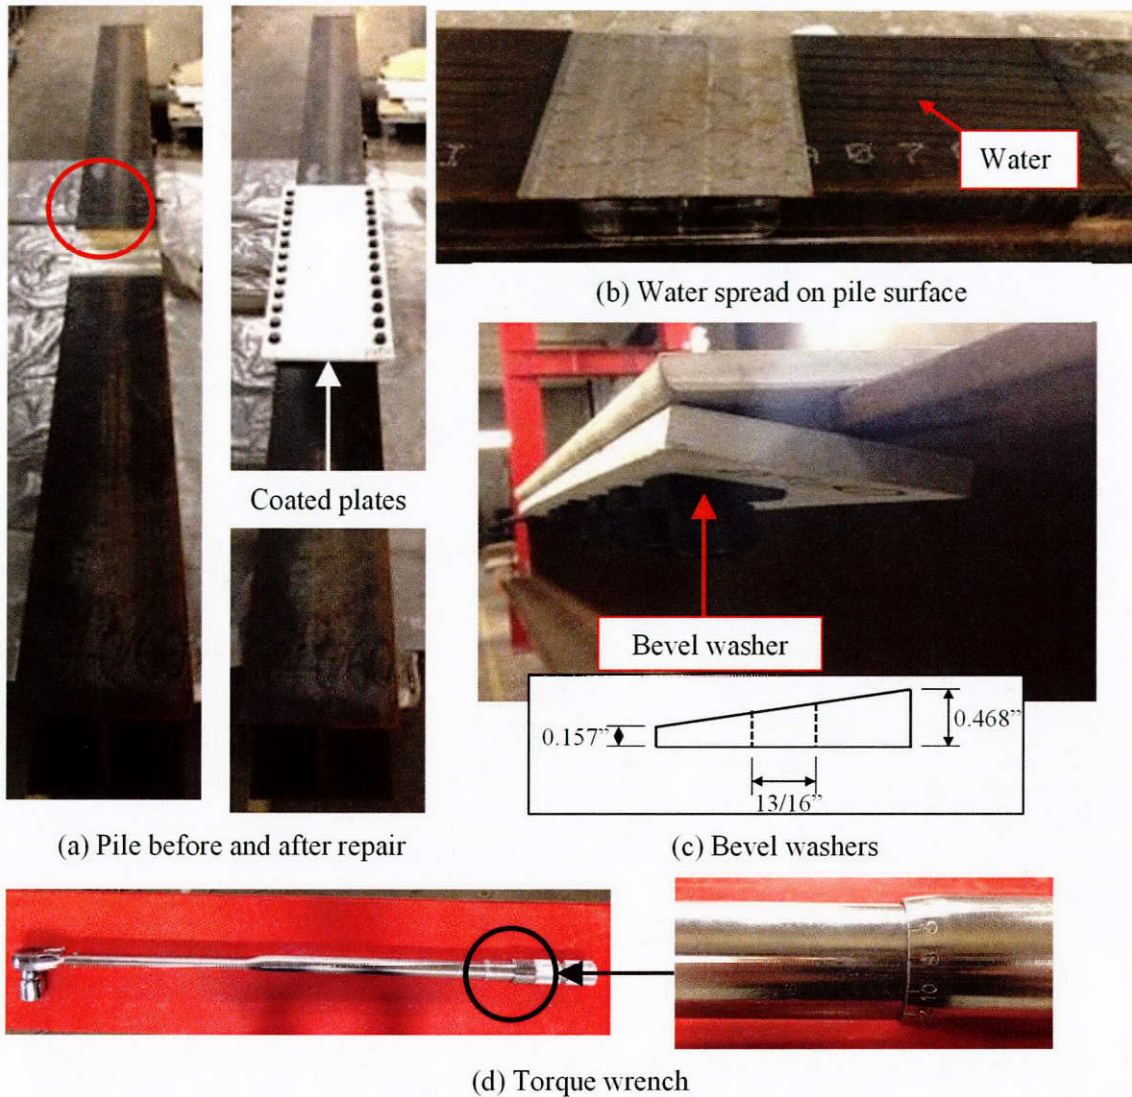
Figure 8.15 illustrates the sequence used in the fabrication of the repair system. First, a CNC mill was used to reduce the thickness of the flanges and webs, to simulate the corrosion effects as shown in Figure 8.15(a). The measured reduced thicknesses of the flanges and webs are summarized in Table 8.9. The steel repair plates (main plates and clamping plates) were grit blasted and coated with the two coatings by the manufacturer and allowed to cure. Water was sprayed on the original pile before placing the steel repair plates to simulate fabrication “in-the-wet”, as shown in Figure 8.15(b). All bolts were tightened using a calibrated torque wrench, as shown in Figure 8.15(d), to reach the minimum pretension for a slip-critical connection specified in AASHTO (2012), which is 28 kips for $\frac{3}{4}$ in A325 bolts. In all specimens except 40/60-S, bevel washers were used to balance the angle between the main plate and the clamping plate to keep the bolts straight, as shown in Figure 8.15(c).

Figure 8.15: Fabrication of the repair system

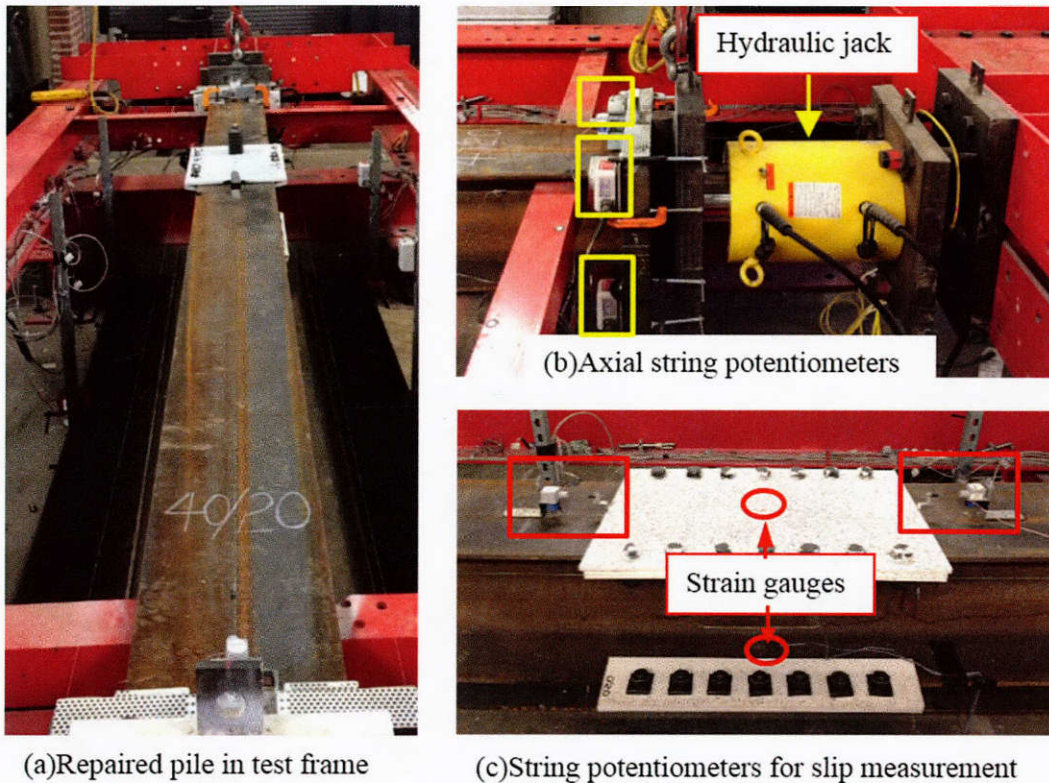
Figure 8.16(c). The values obtained from strain gauges indicated the axial load distribution between the original pile and the repair system.

(a) Repaired pile in test frame

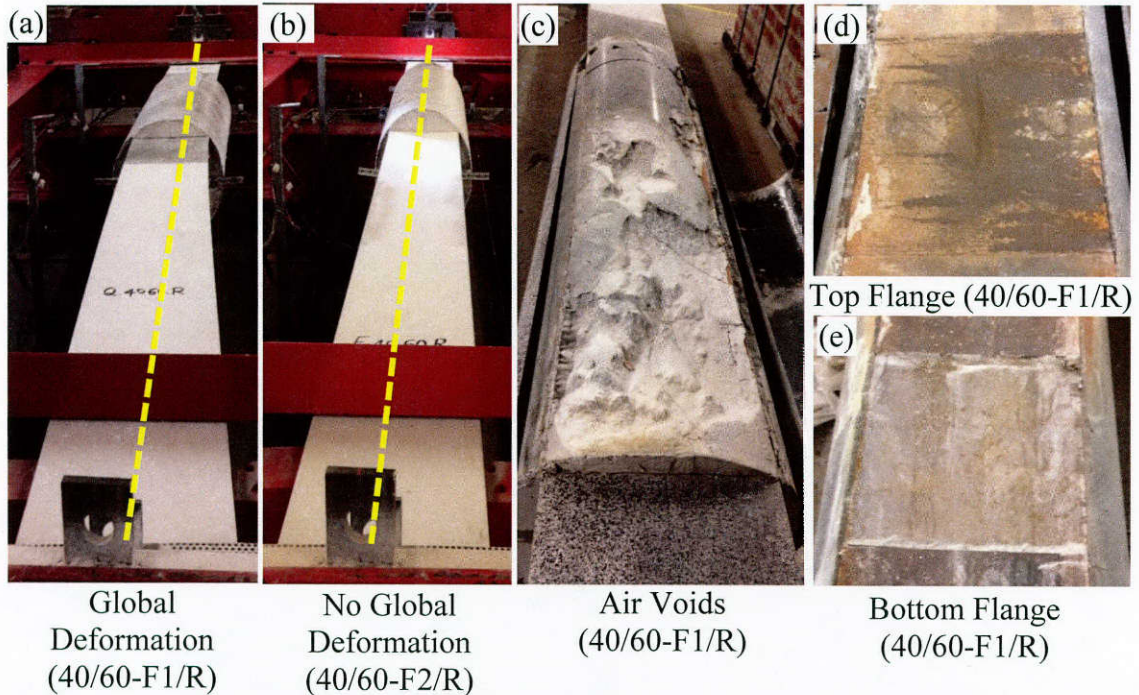
The axial load-shortening response of the repaired piles remained linear up to 562 kips and 607 kips for the 40/60-F1/R and 40/60-F2/R piles, respectively. Testing of the pile 40/60-F1/R was terminated when the load decreased to 504 kips after a short plateau and visible lateral deformation as shown in Figure 8.26(a). However, no post peak response was obtained for the pile 40/60-F2/R due to limitation of capacity of the hydraulic loading system. Figure 8.26(a) shows pile 40/60-F1/R which failed by global buckling. However, no failure was observed for the pile 40/60-F2/R as shown in Figure 8.26(b).

Figure 8.26: Piles 40/60 repaired with the F1 and F2 repair systems after testing

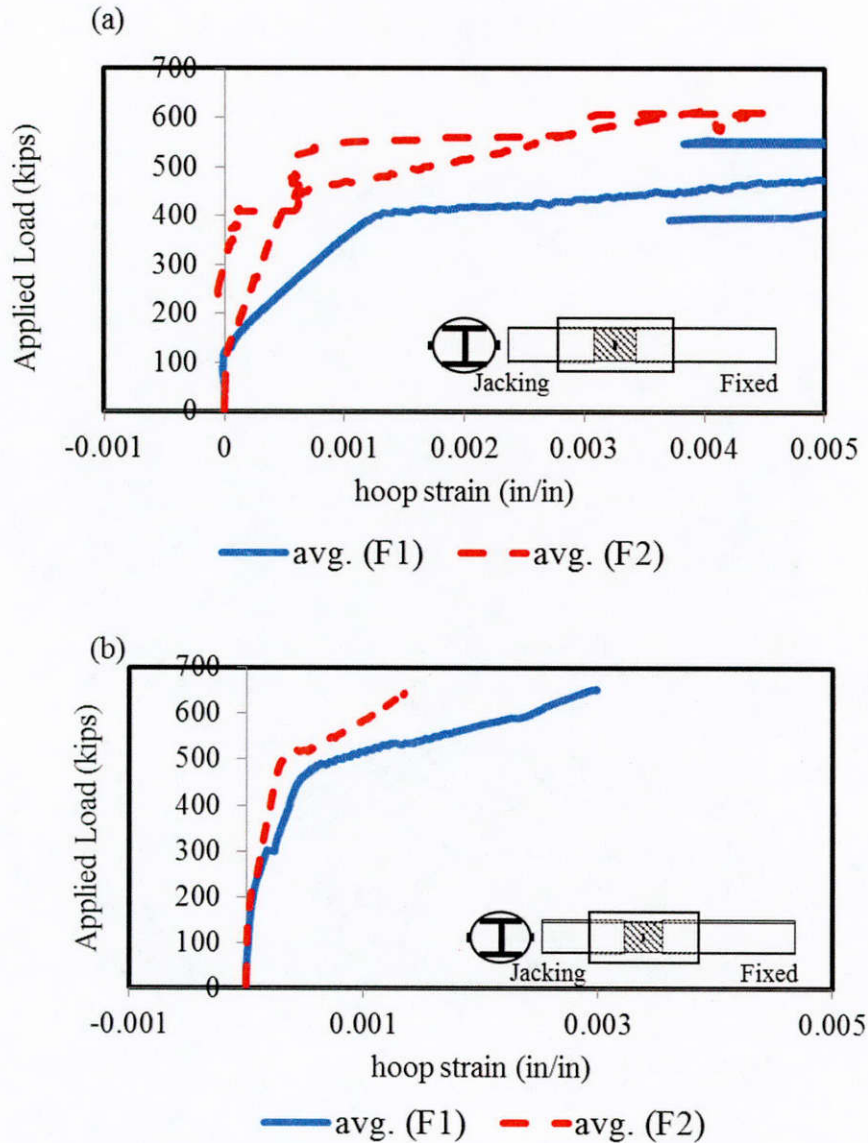
Figure 8.31 shows the relationship between the axial load and hoop strain in FRP jacket of the 80/60 repaired pile group. The hoop strain in the F1 jacket is higher than that in the F2 jacket at the same load due to lower stiffness of the F1 jacket relative to the F2 jacket. Further, comparing Figure 8.31 (a) and (b) indicates that the presence of the mechanical anchors in the load introduction region helped to reduce the hoop strains in the FRP jackets at a given load for both types of jacket.

Figure 8.31: Comparing FRP hoop strain of 80/60 repaired piles

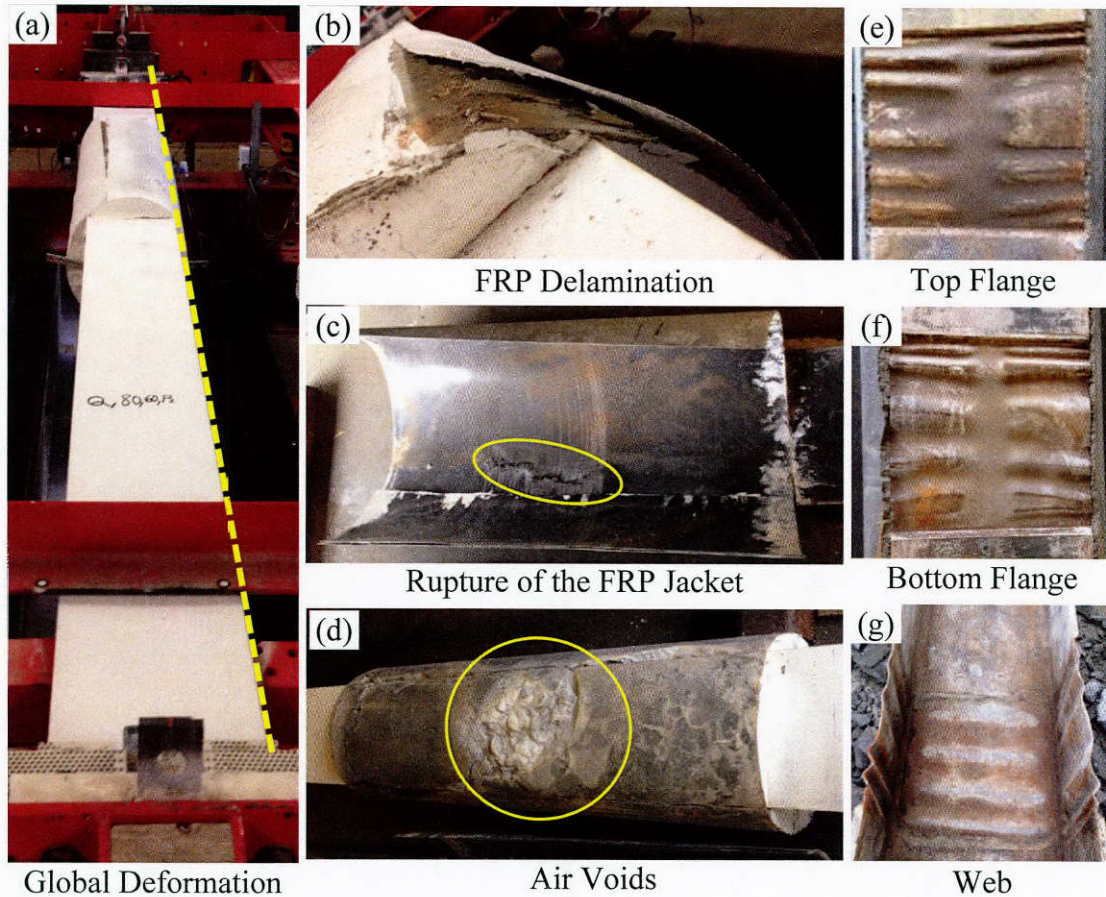
This mode is distinguished from local buckling primarily based on the restraining effect of the repair system.

Figure 8.32: Pile 80/60(1)-F1/R after testing

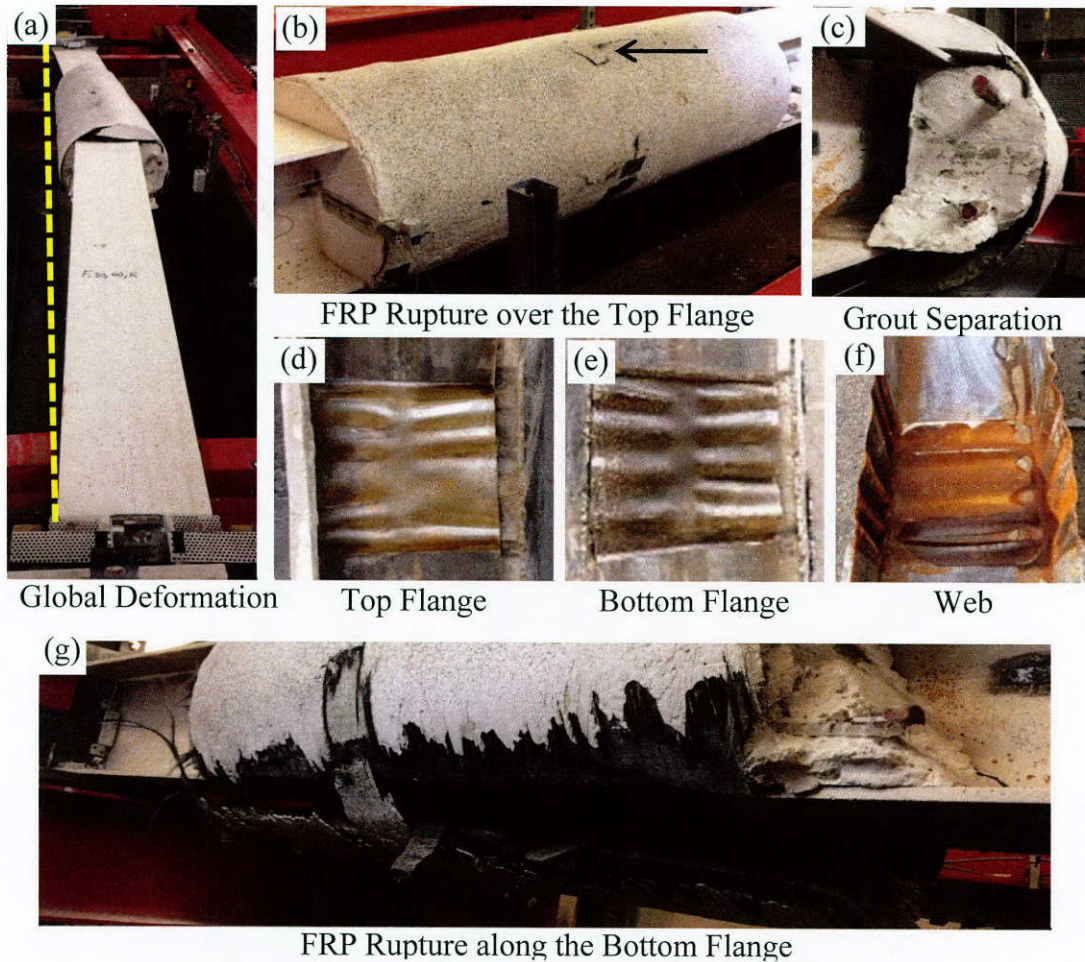
Figure 8.33(a) shows the failure mode of the tested 80/60(1)-F2/R pile. The pile failed by rupture of FRP jacket which first occurred partially near the top corroded flange (see Figure 8.33(b)). Subsequently, another FRP rupture was initiated and propagated near the bottom flange which was followed by separation of the grout from the steel pile as shown in Figure 8.33(c) and (g). After the test, the repair materials were removed from the pile. It was observed that the flanges and web demonstrated localized crumpling deformation within the corroded region as shown in Figure 8.33(d) - (f).

Figure 8.33: Pile 80/60(1)-F2/R after testing

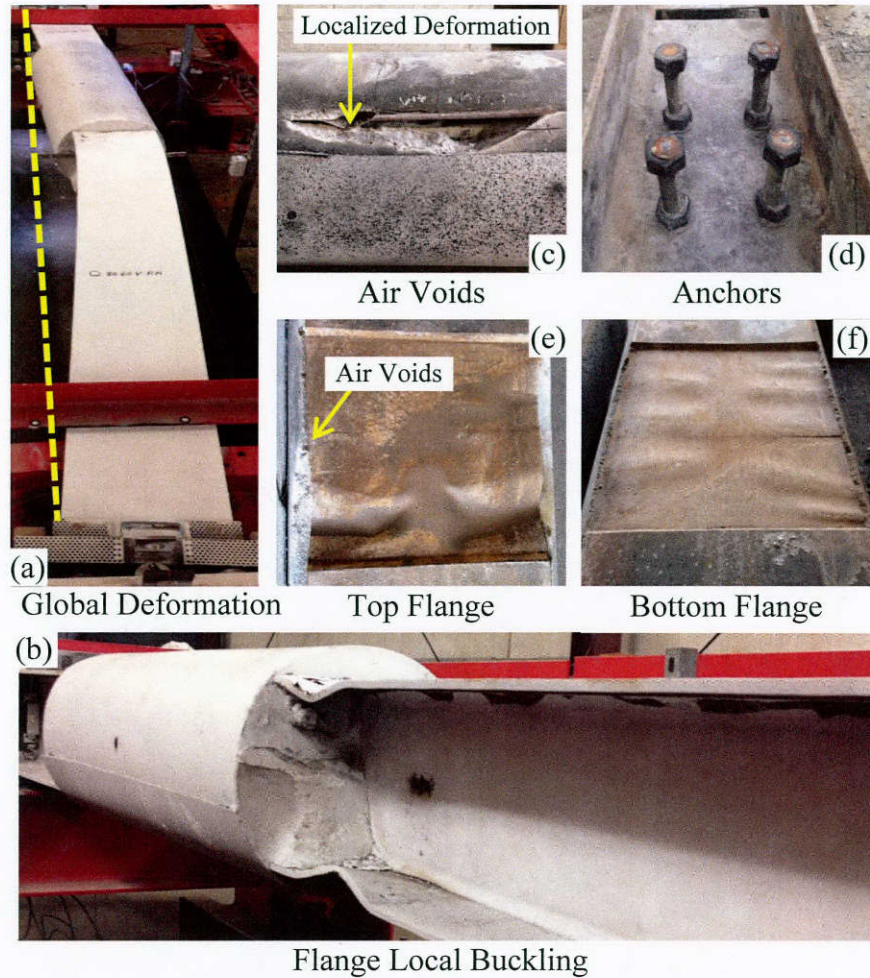
Figure 8.39(a) shows the tested 80/60/V-F1/RA pile which failed by local buckling of the flanges just beyond one end of the repaired region as shown in Figure 8.39(b). Figure 8.39(c) shows air voids in the grout adjacent to the top flange that were observed after removing the FRP jacket. These caused the top flange to demonstrate a different pattern of local deformation from the bottom flange as shown in Figure 8.39(e) and (f). No visible sign of damage was observed in the headed-stud anchors as indicated in Figure 8.39(d).

Figure 8.39: Pile 80/60/V-F1/RA after testing
