Repair Systems for Deteriorated Bridge Piles:

Final Report

University of Houston

Texas Tech University (TechMRT)

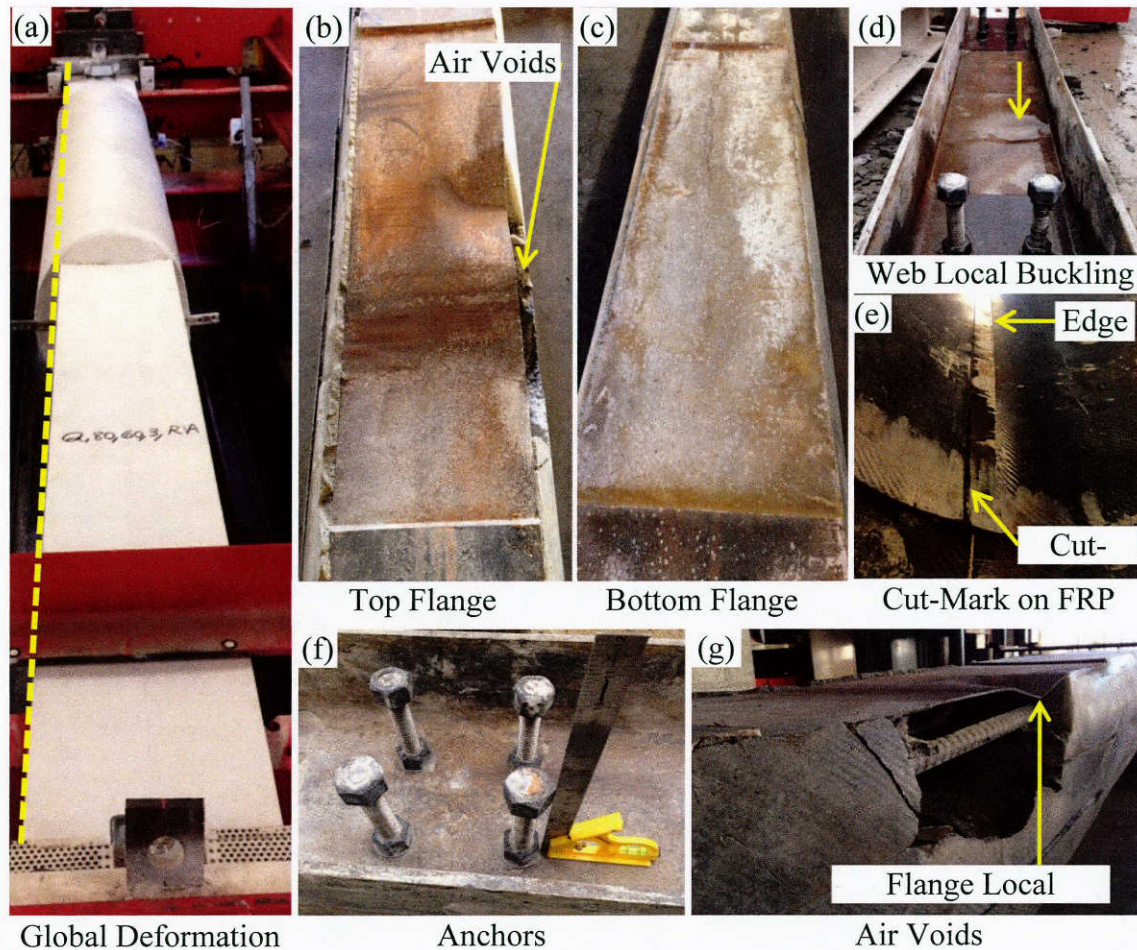
Figure 8.44(a) shows the tested 80/60/3-F1/RA pile which demonstrated no failure. After removing the FRP jacket, air voids were observed in the grout which caused localized deformation in the adjacent slender flange as indicated in Figure 8.44(b) and (g). The bottom flange and headed-stud anchors demonstrated no visible deformation as shown in Figure 8.44(c) and (f). Figure 8.44(d) shows localized deformation in the web that occurred adjacent to the air voids in the grout. Figure 8.44(e) shows a longitudinal cut mark on the internal layer of the FRP jacket due to abrasion from the edge of the corroded flange. This highlights the importance of proper placement of protective spacers between the FRP jacket and the corroded pile during construction.

Figure 8.44: Pile 80/60/3-F1/RA after testing

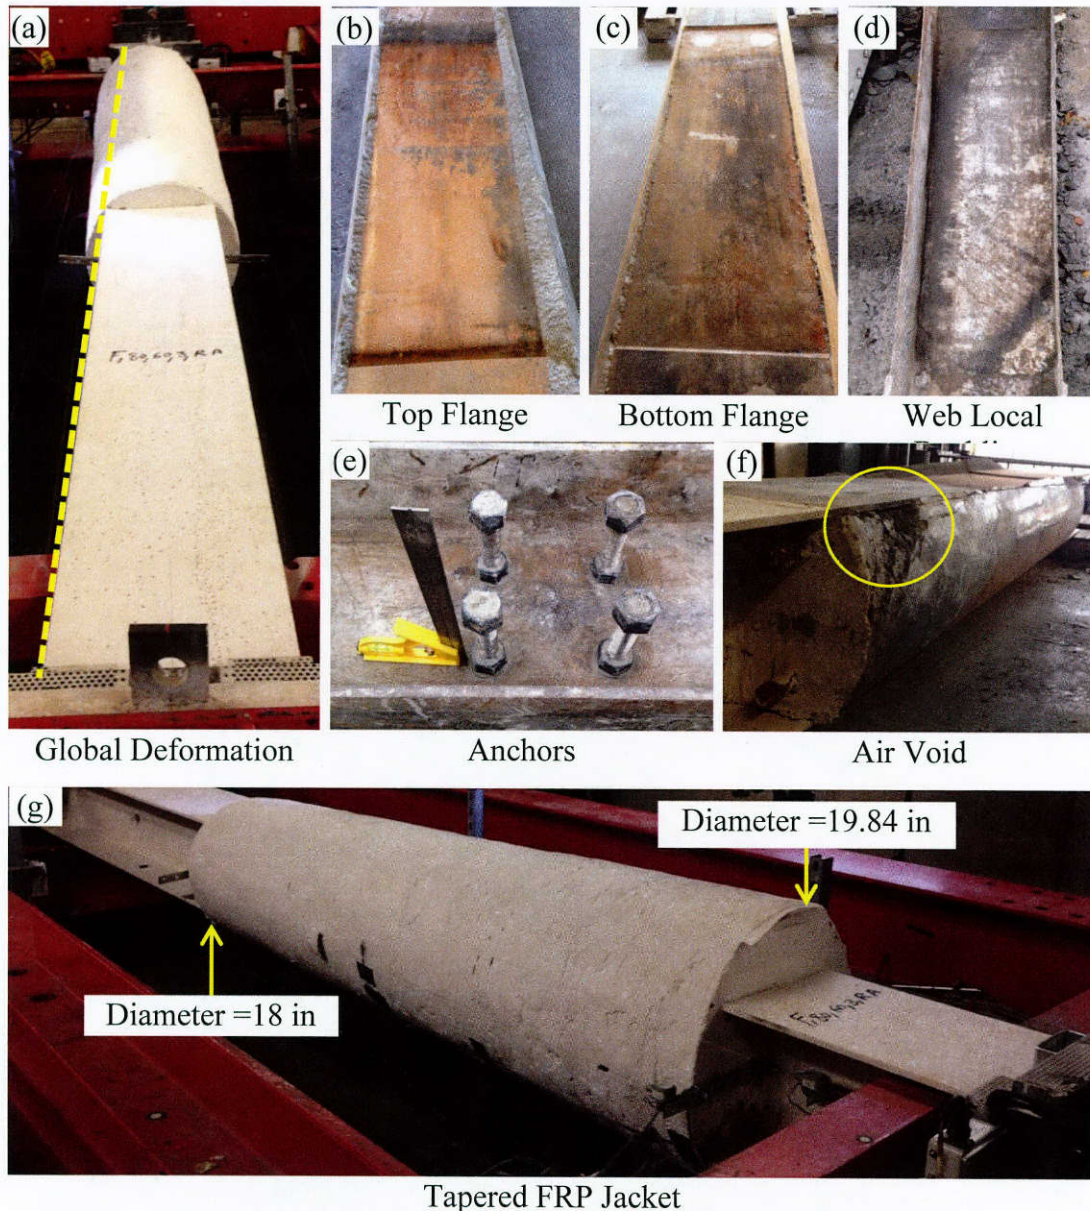
Figure 8.45(a) shows the tested 80/60/3-F2/RA pile which demonstrated no failure. The repair system was removed after the test for more detailed investigation. As shown in Figure 8.45(f), there were air voids in the grout located outside of the corroded region. No sign of deformation was observed in the flanges or web as can be seen in Figure 8.45(b) - (d). Also, no deformation was observed in the headed-stud anchors (see Figure 8.45(e)). Figure 8.45(g) shows that the jacket diameter was 1.9 in. larger at one end compared to the other end

Figure 8.45: Pile 80/60/3-F2/RA after testing

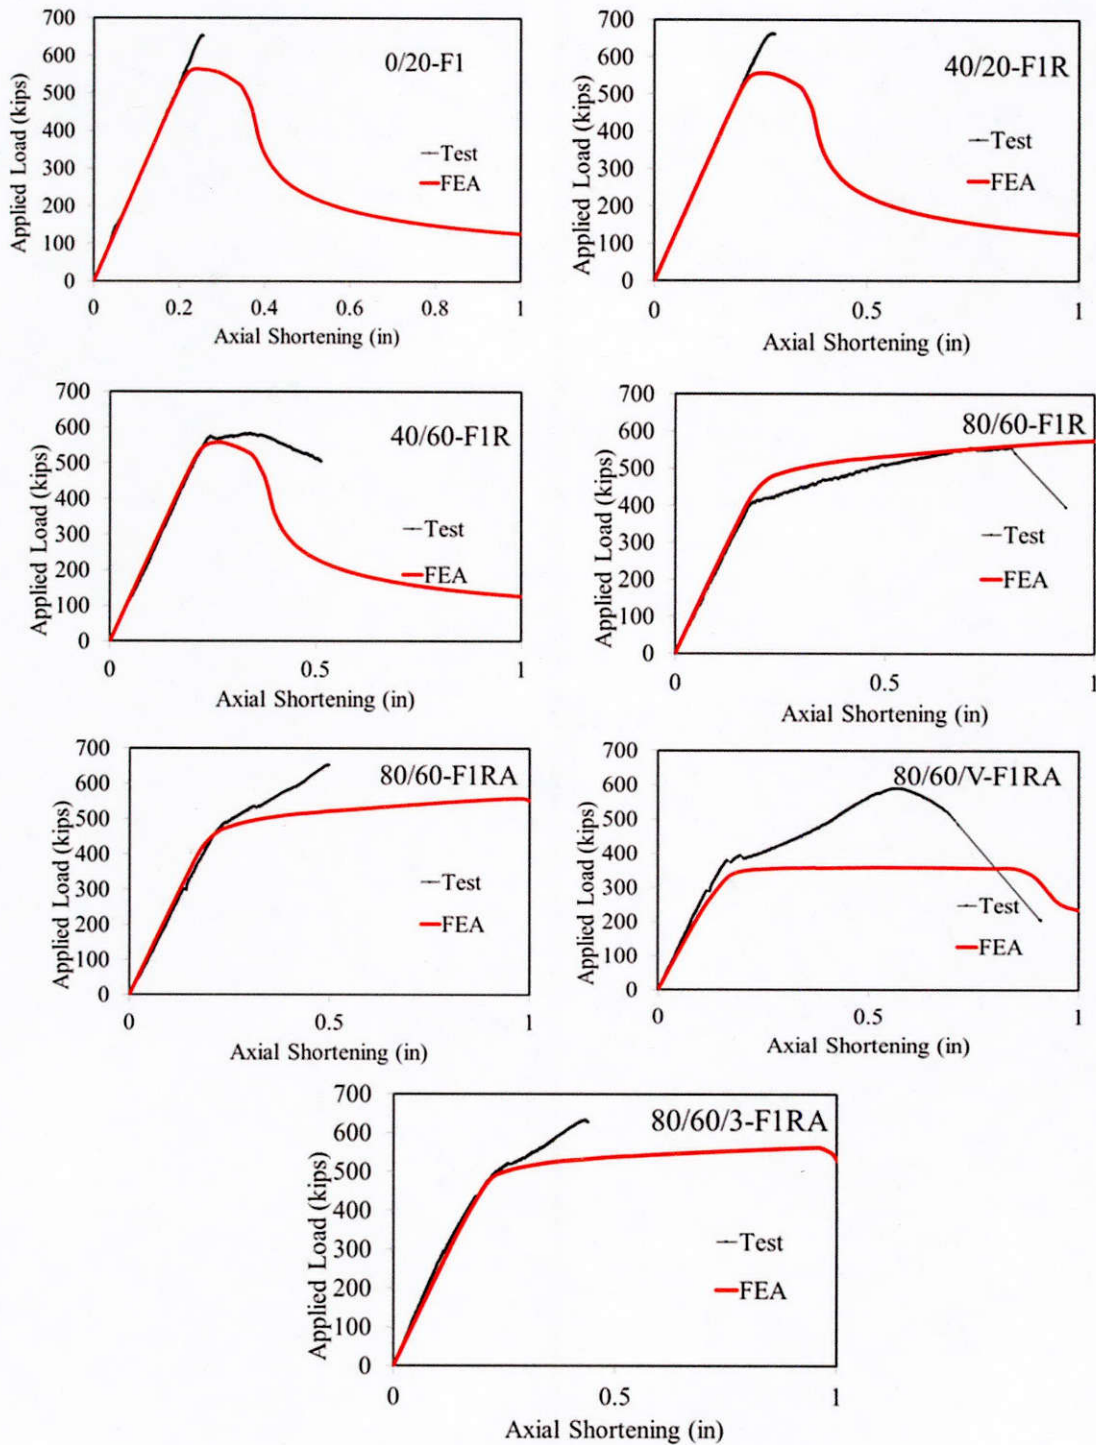
the predicted second-slope stiffnesses were 65% and 75% lower than the measured values for piles 80/60-F1/R and 80/60-F2/R, respectively. Comparing the predicted to measured inelastic stiffness after cohesive bond failure for the piles with mechanical anchors, piles 80/60(2)-F1/RA, 80/60(2)-F2/RA, 80/60/V-F1/RA, 80/60/V-F2/RA, 80/60/3-F1/RA, and 80/60/3-F2/RA, shows that the errors are even higher. This may have been due to the fact that the anchors were modeled using truss elements that were only effective in their axial directions and did not have any shear or flexural stiffness.

Figure 9.17: Comparison of the test and FE load-shortening response for the piles repaired with F1 jacket

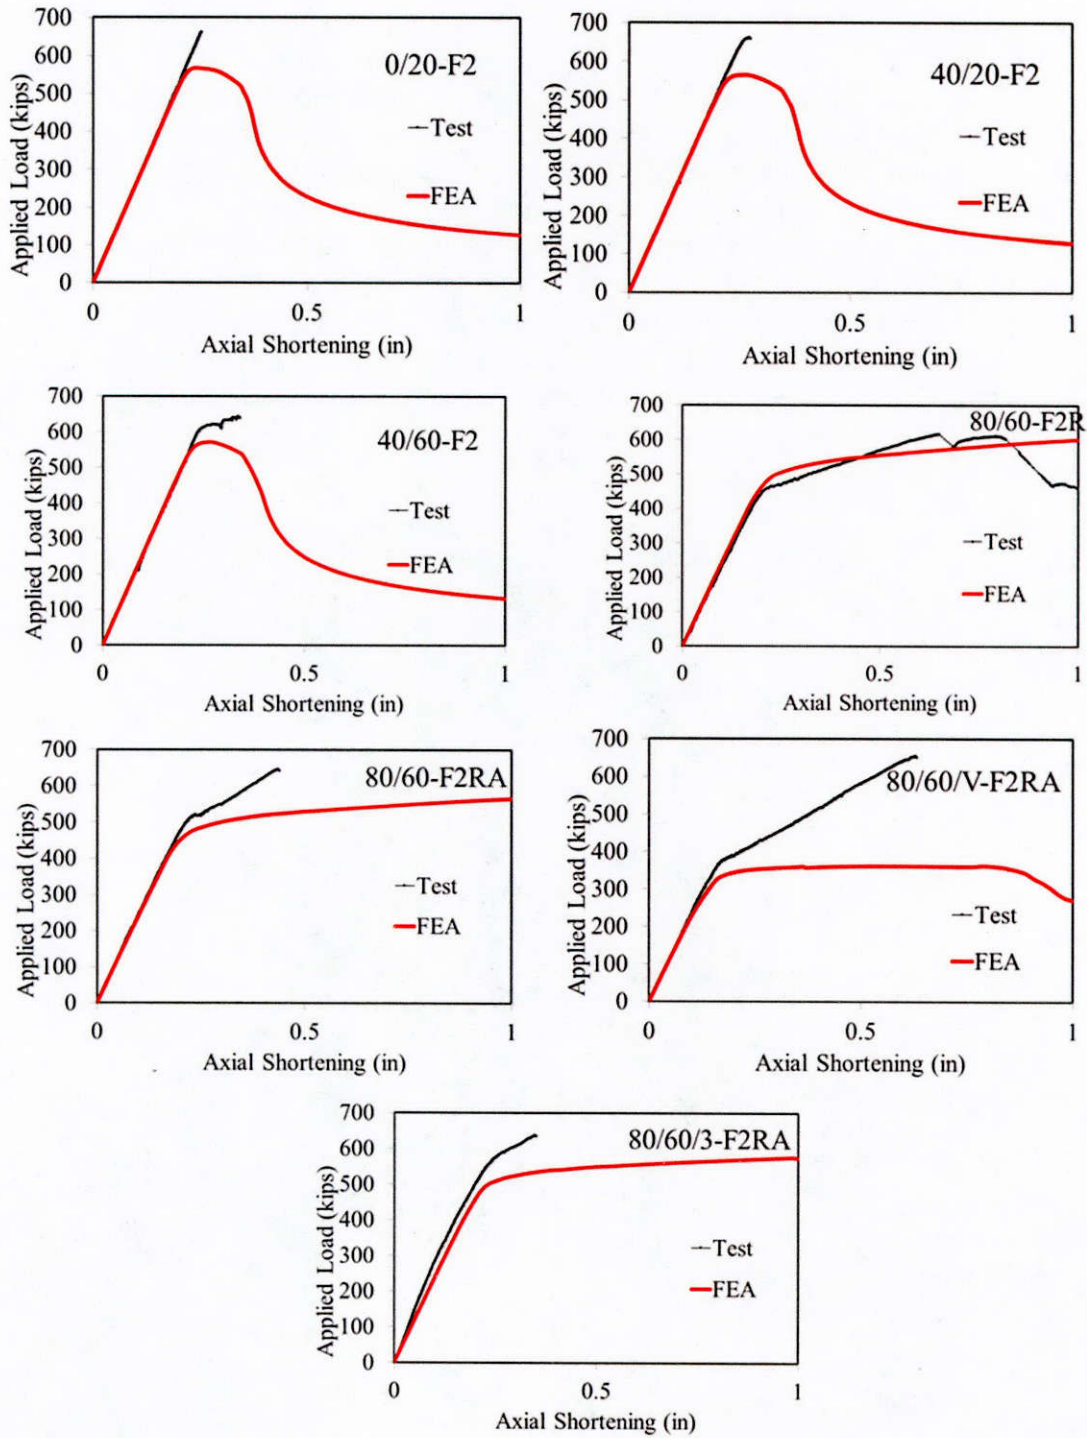
Figure 9.18: Comparison of the test and FE load-shortening response for the piles repaired with F2 jacket

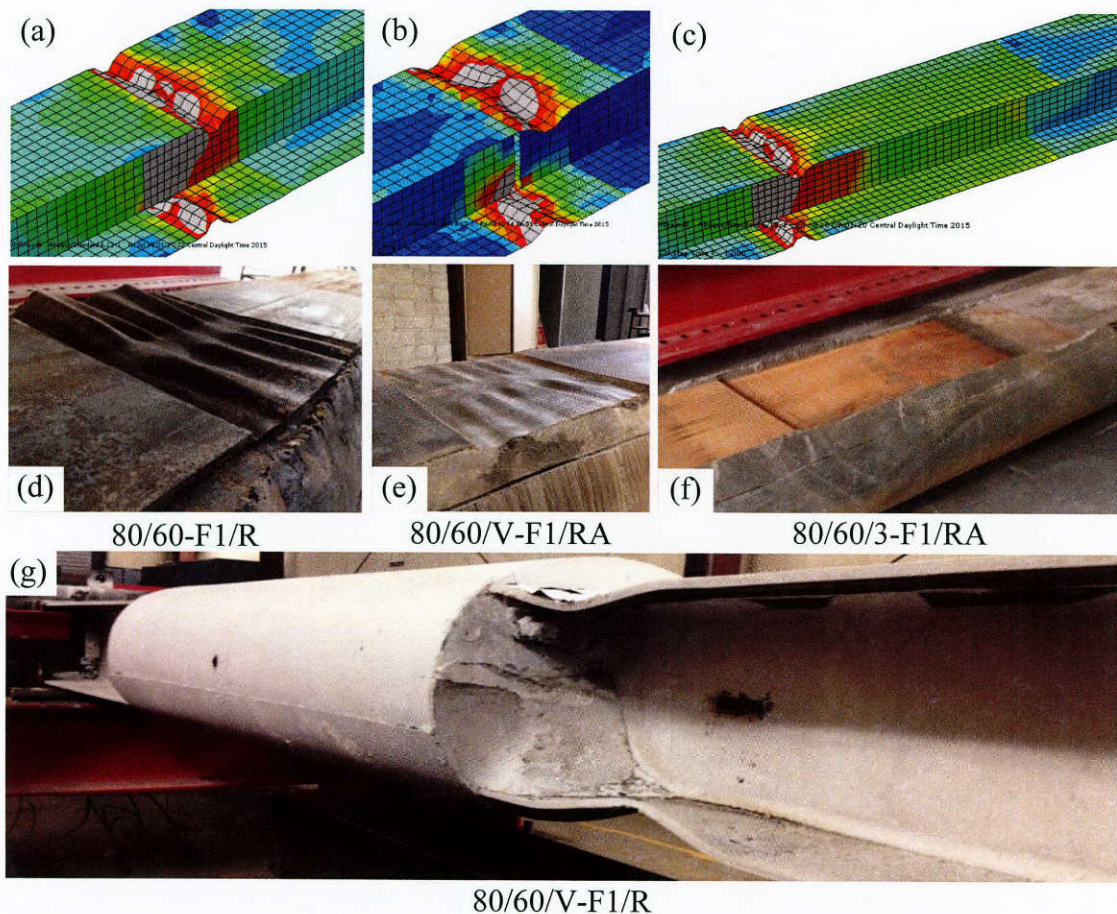
Pile 80/60/V-F1/RA demonstrated flange local buckling followed by global lateral deformation during the test as shown in Figure 9.20(g), while the modeled 80/60/V-F1/RA failed by flange local buckling within the corroded region. HP 12×53 piles are very close to having slender flanges and a minor reduction of the flange thickness for the tested pile may have induced local buckling of the pile outside of the repair region, modified the predicted failure mode, and reduced the predicted capacity slightly. Due to the limitation of the loading system, no localized deformation or failure was observed in the pile 80/60/3-F1/RA as shown in Figure 9.20(f):

Figure 9.20: Comparison of the deformation of the tested and modeled piles with 80% reduction of the flange thickness

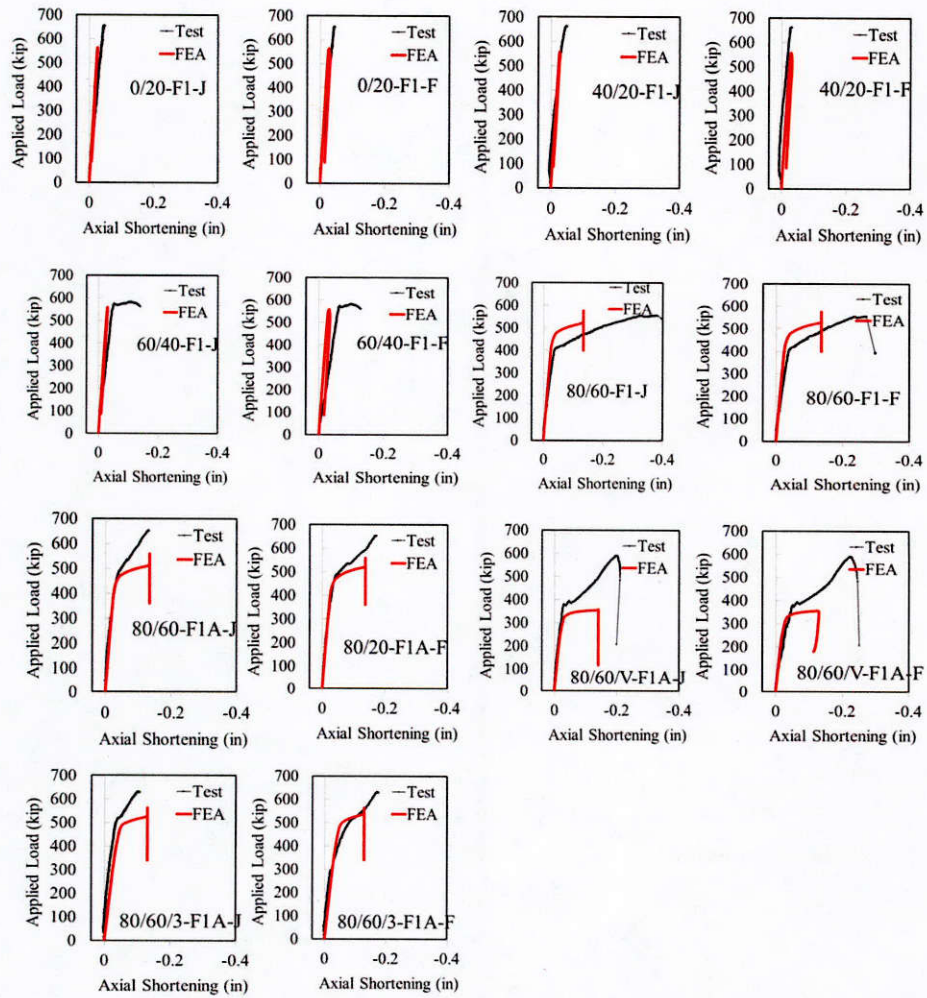
Figure 9.22: Comparison of measured and predicted slip at grout/steel interface for the piles repaired with F1 jacket

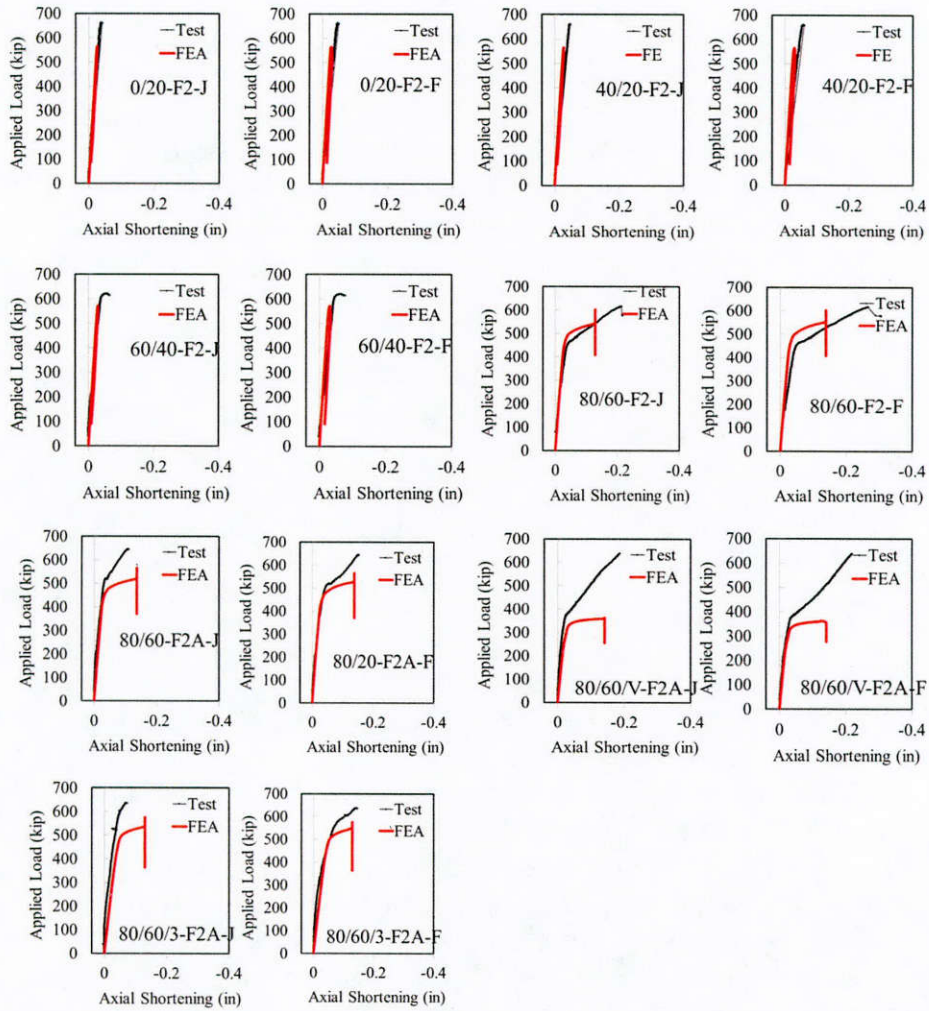
Figure 9.23: Comparison of measured and predicted slip at grout/steel interface for the piles repaired with F2 jacket

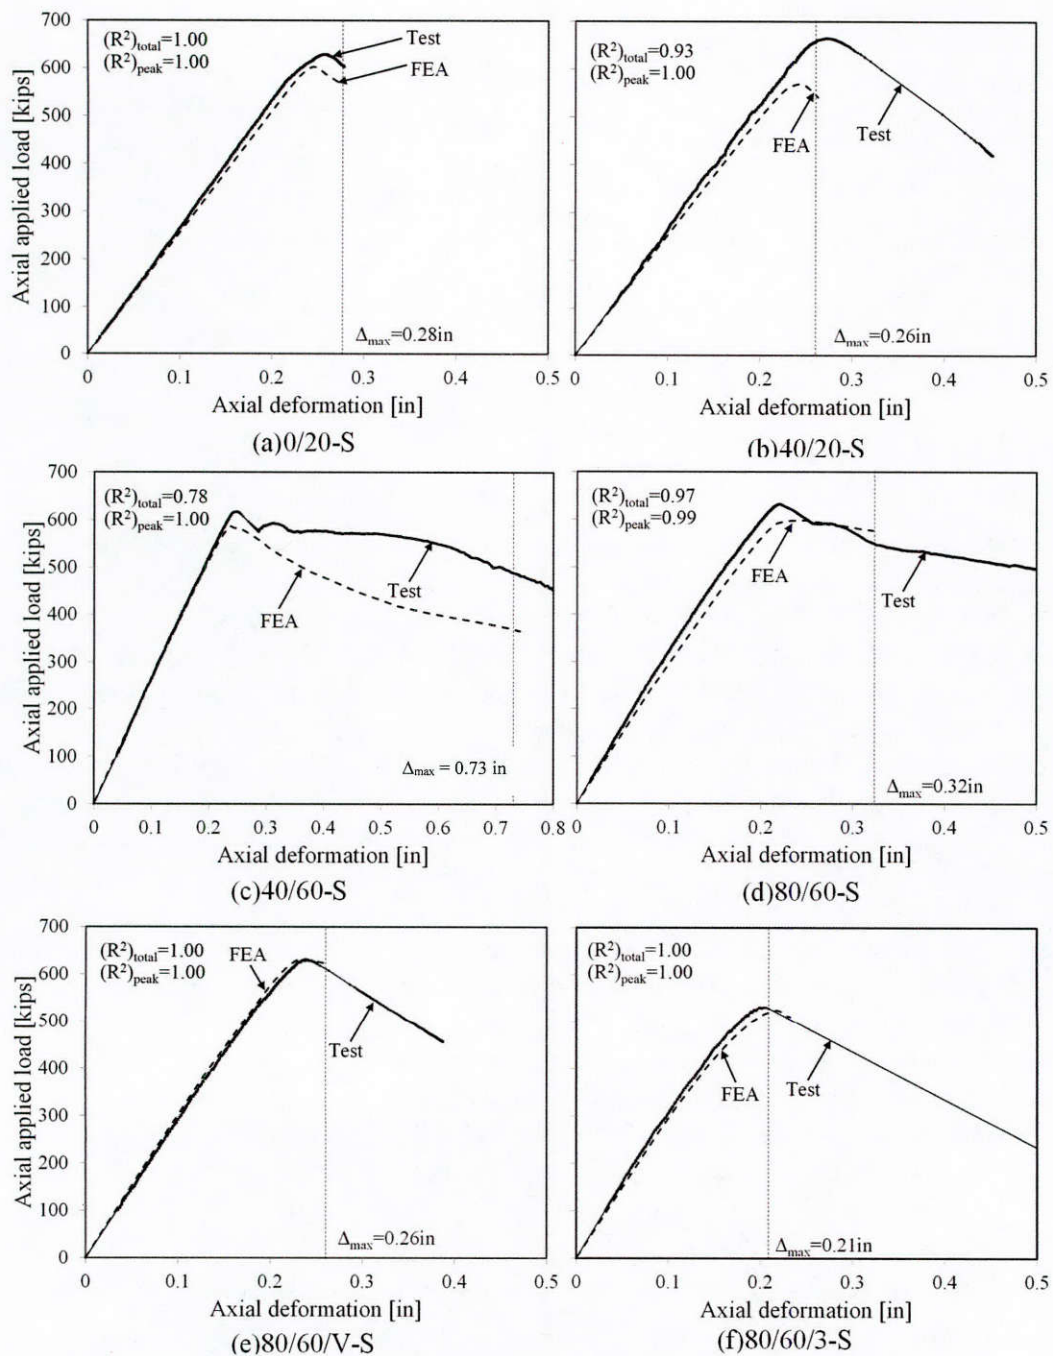
Figure 9.26: Axial load-deformation responses of repaired piles from tests and FEA

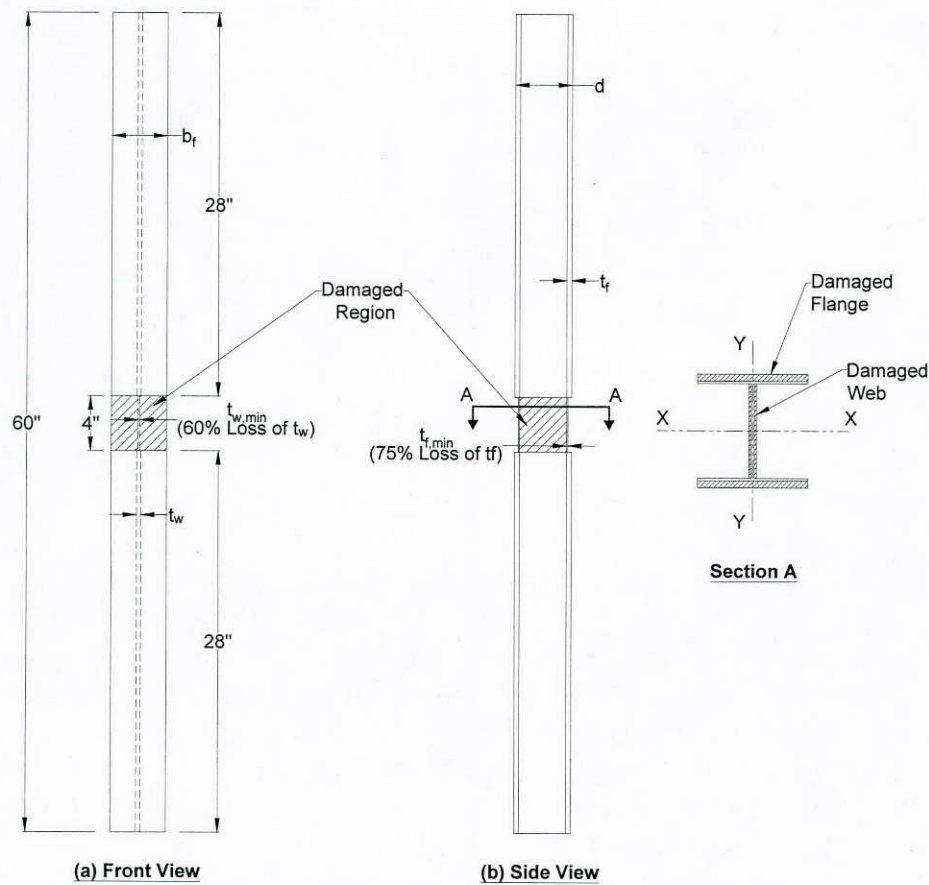
Figure 10.1: Damage level for minor repair case

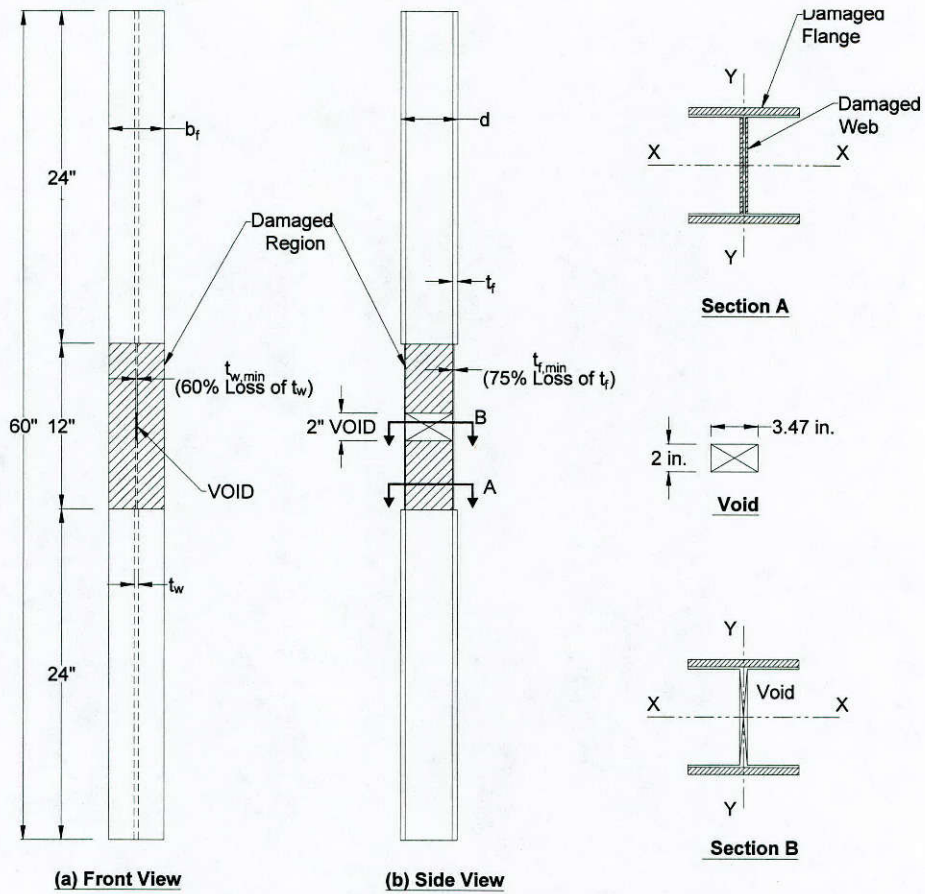
Figure 10.2: Damage level for major repair case

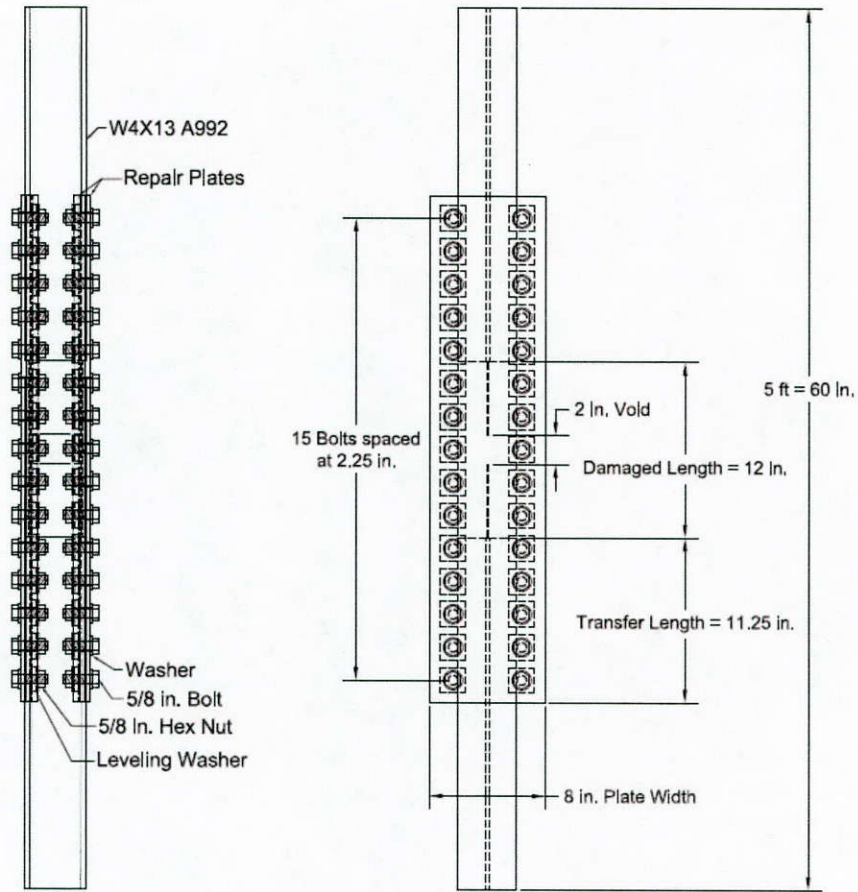
Figure 10.8: Design of Repair System 3 for the major repair

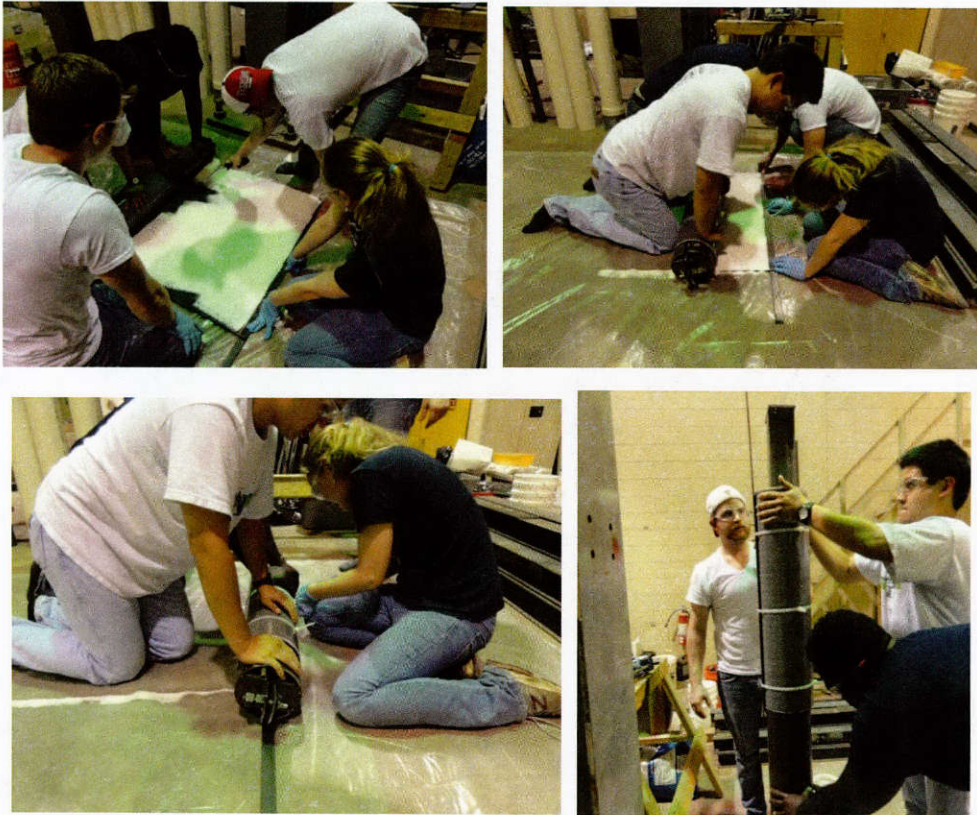
Figure 10.10: Fabrication of FRP jackets for Repair System 1

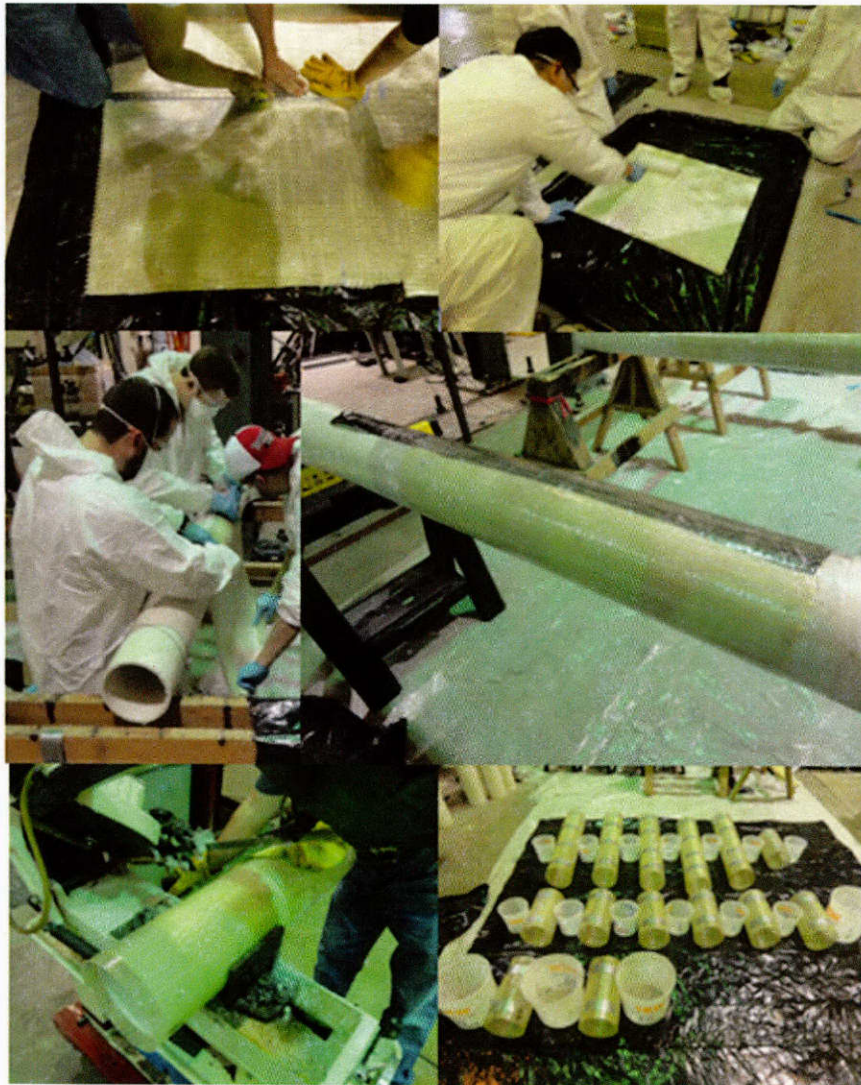
Figure 10.13: Fabrication of cylindrical GFRP shells

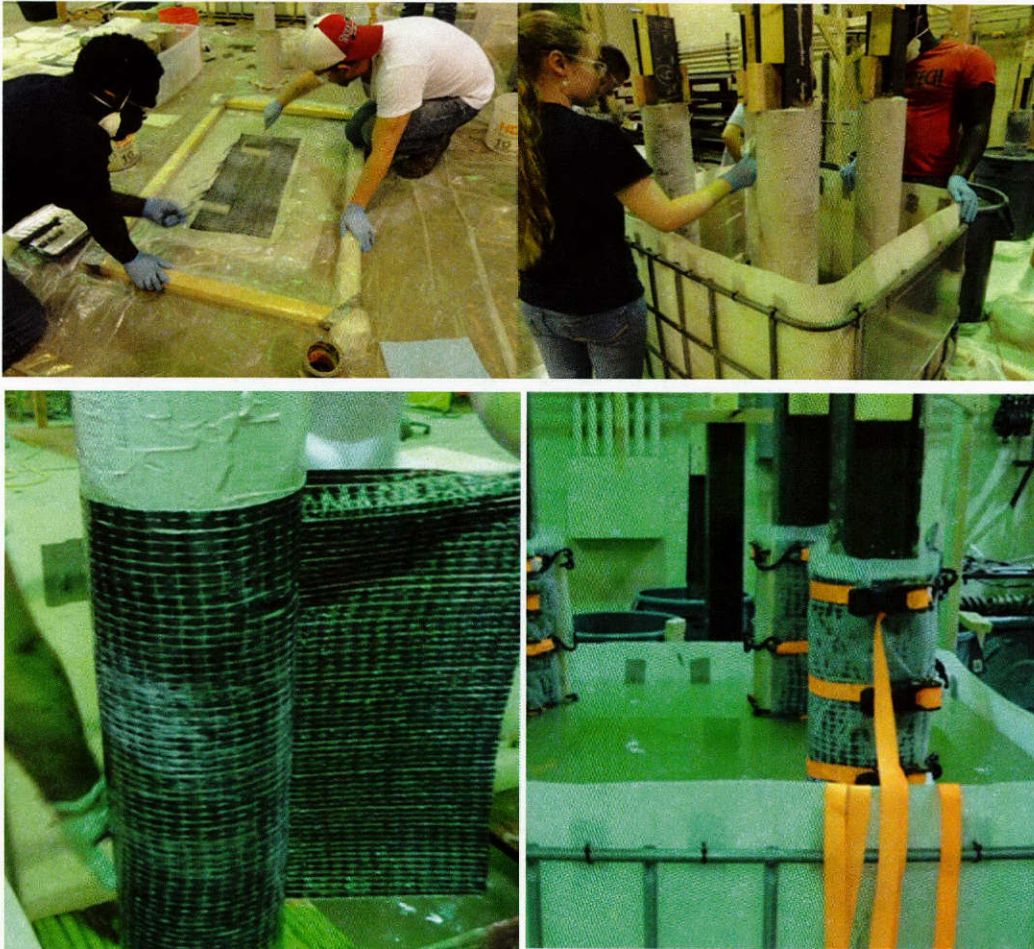
Figure 10.16: Application of CFRP Sheets using wet lay-up technique

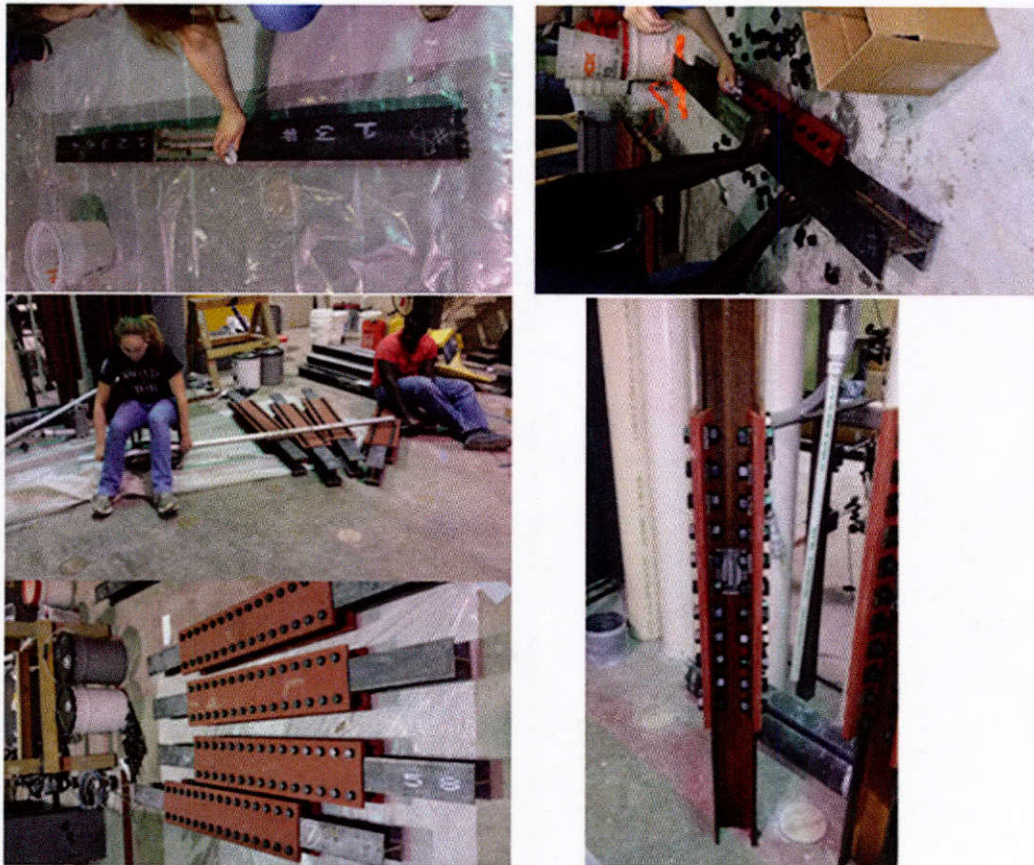
Figure 10.17: Fabrication of Repair System 3

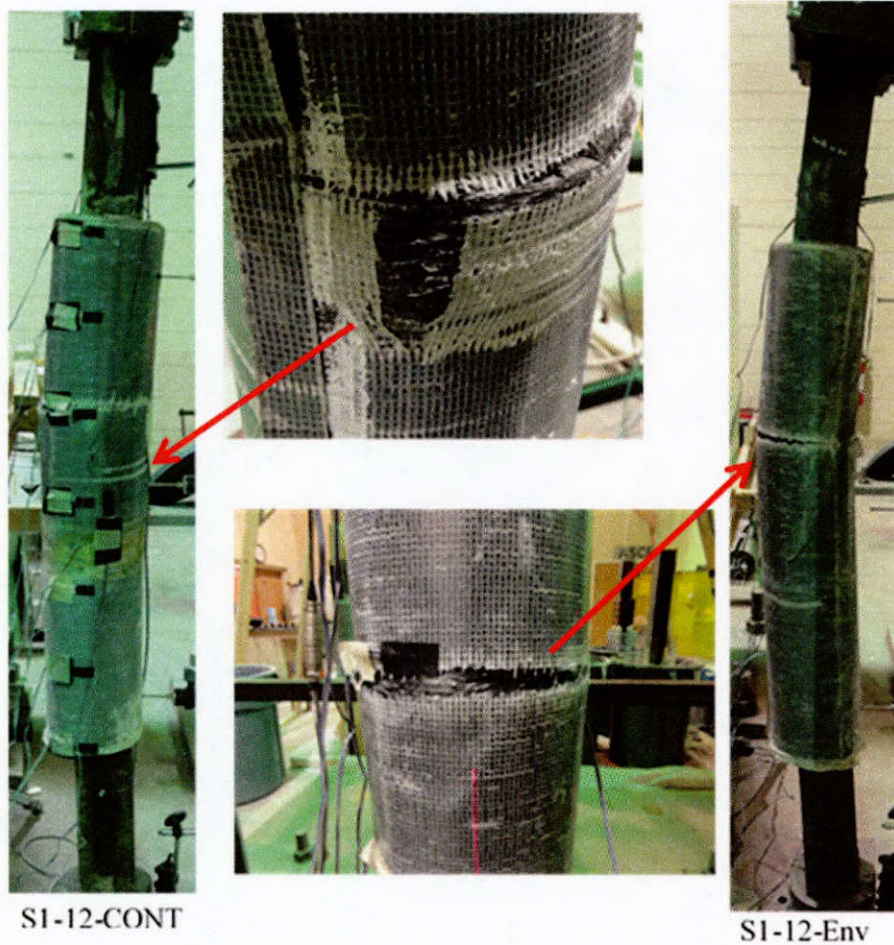
Figure 10.28: Failure of 12-in damaged piles repaired with Repair System 1 (S1-12-CONT and S1-12-Env)

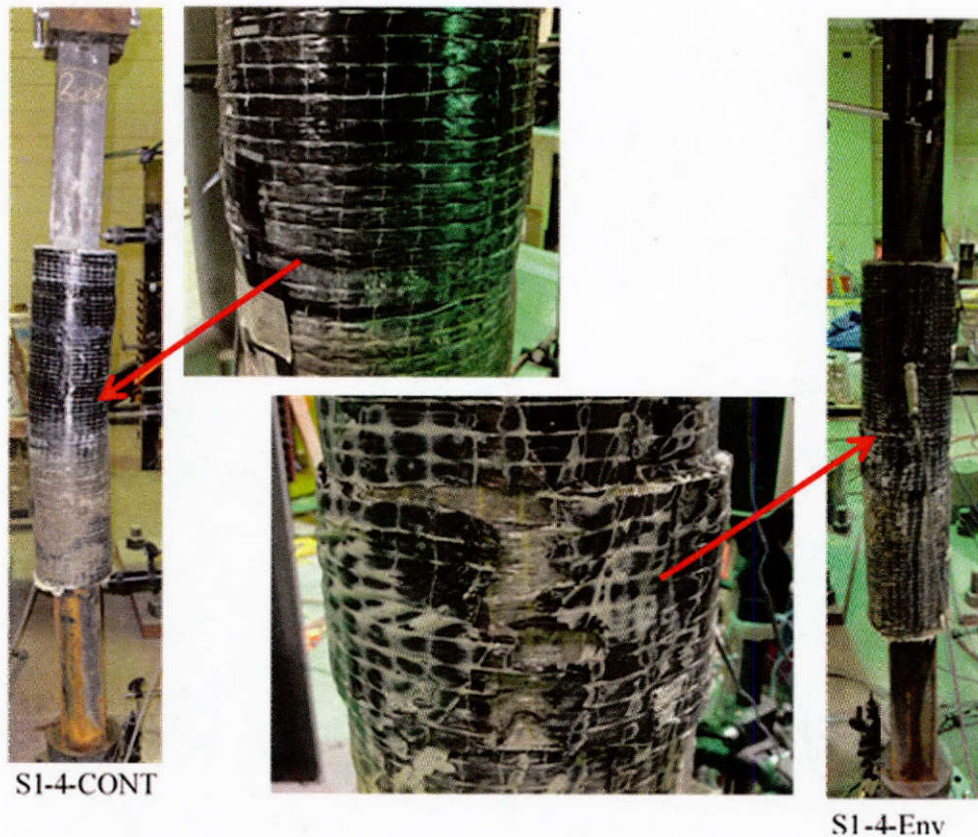
Figure 10.29: Failure of 4-in damaged piles repaired with Repair System 2 (S2-4-CONT and S2-4-Env)

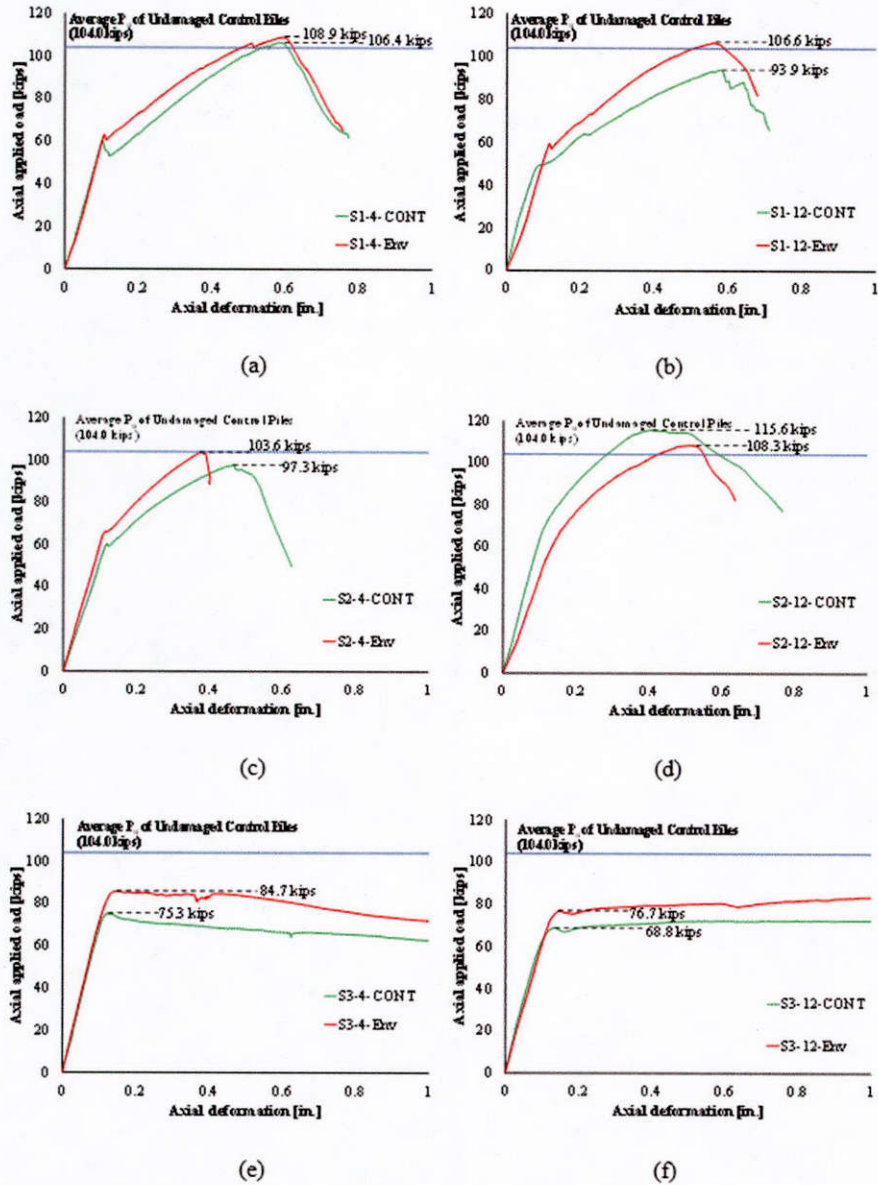
Figure 10.40: Comparisons of the performance of the repaired piles with/without being exposed to the environmental cycles

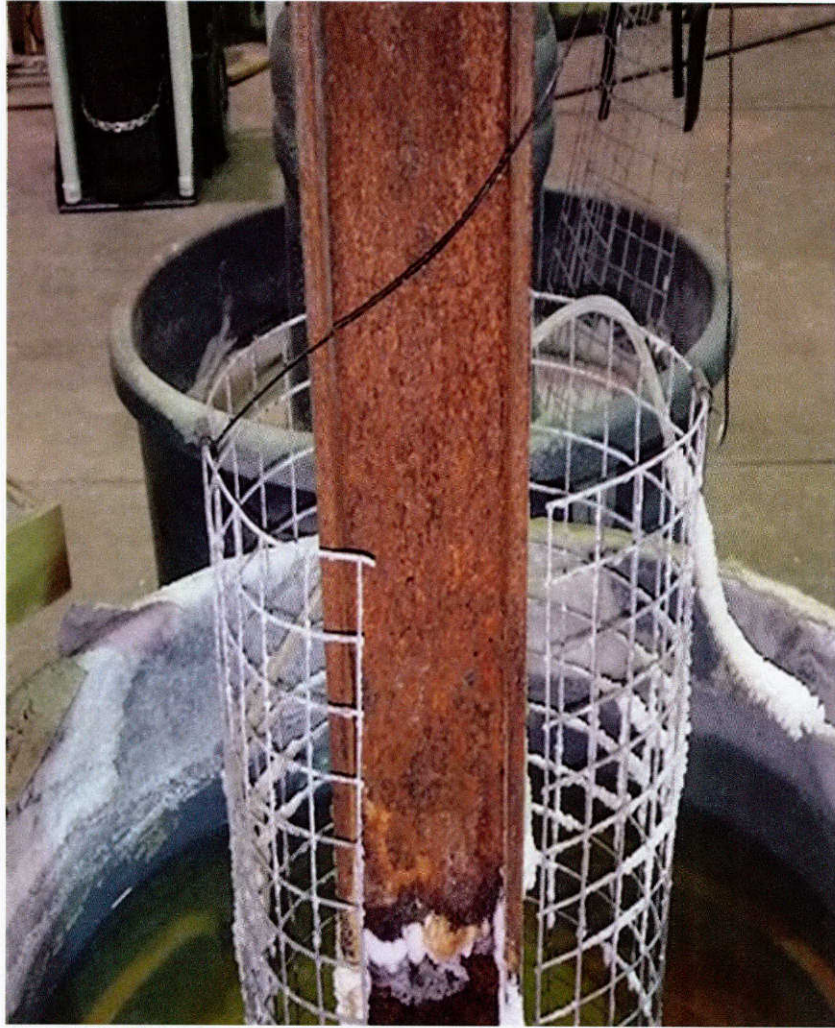
Figure 10.41: Undamaged pile (CONT-Cor) showing the rust build-up

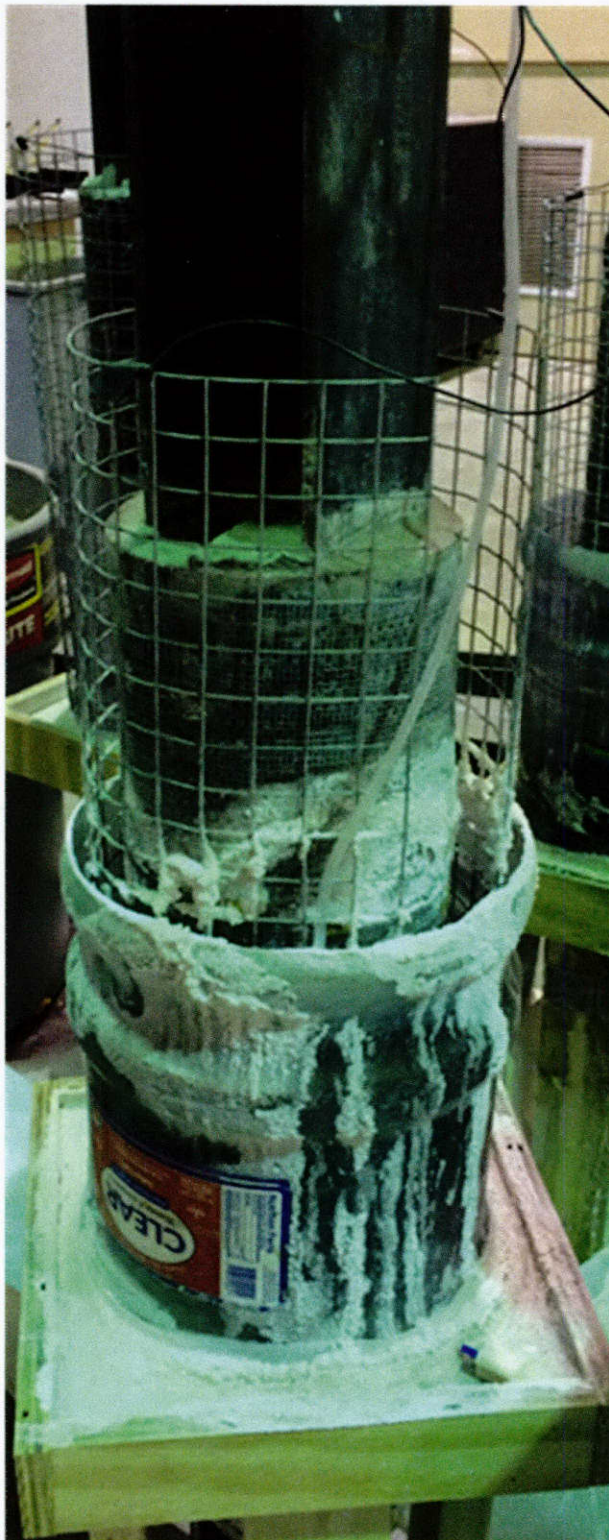
Figure 10.42: A damaged pile repaired with Repair System 1 (S1-4-Cor) showing no evidence of corrosion

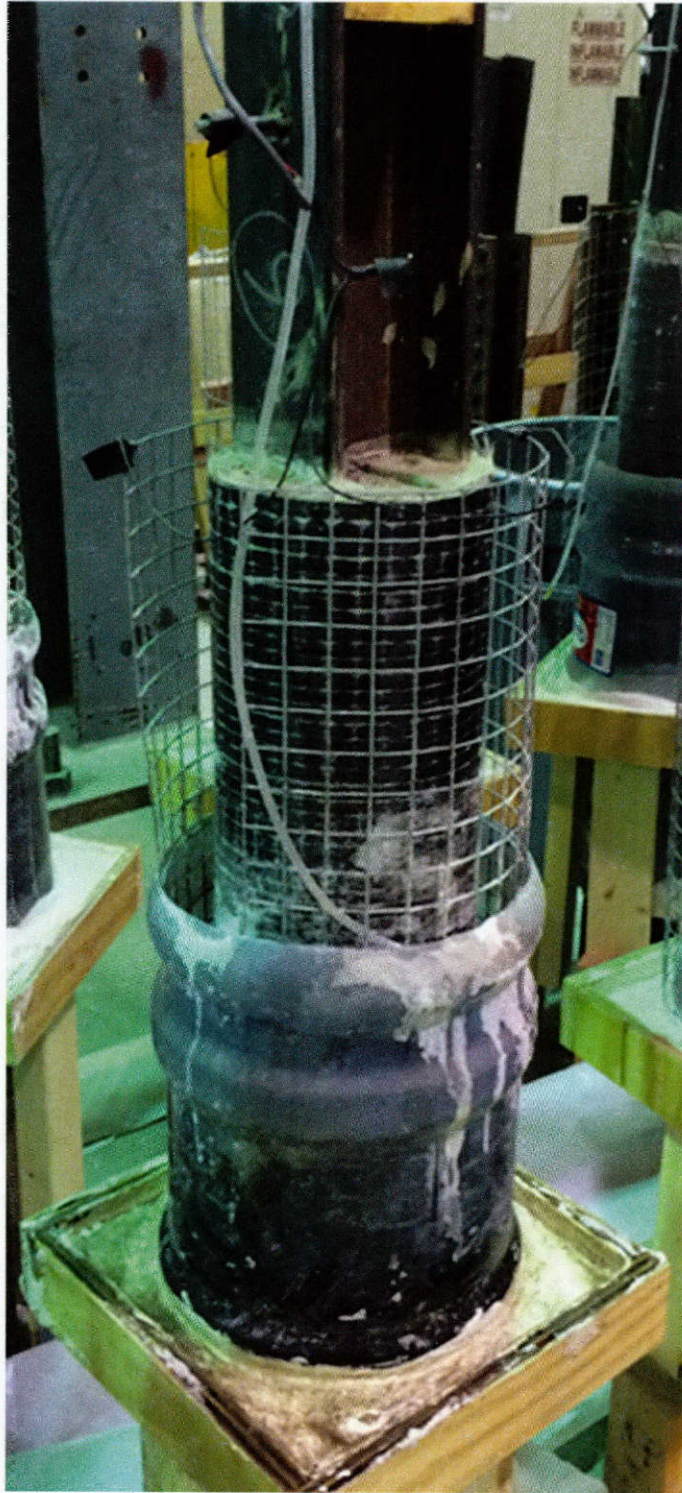
Figure 10.43: A damaged pile repaired with Repair System 2 (S2-12-Cor) showing no evidence of corrosion
