Repair Systems for Deteriorated Bridge Piles:

Final Report

University of Houston

Texas Tech University (TechMRT)

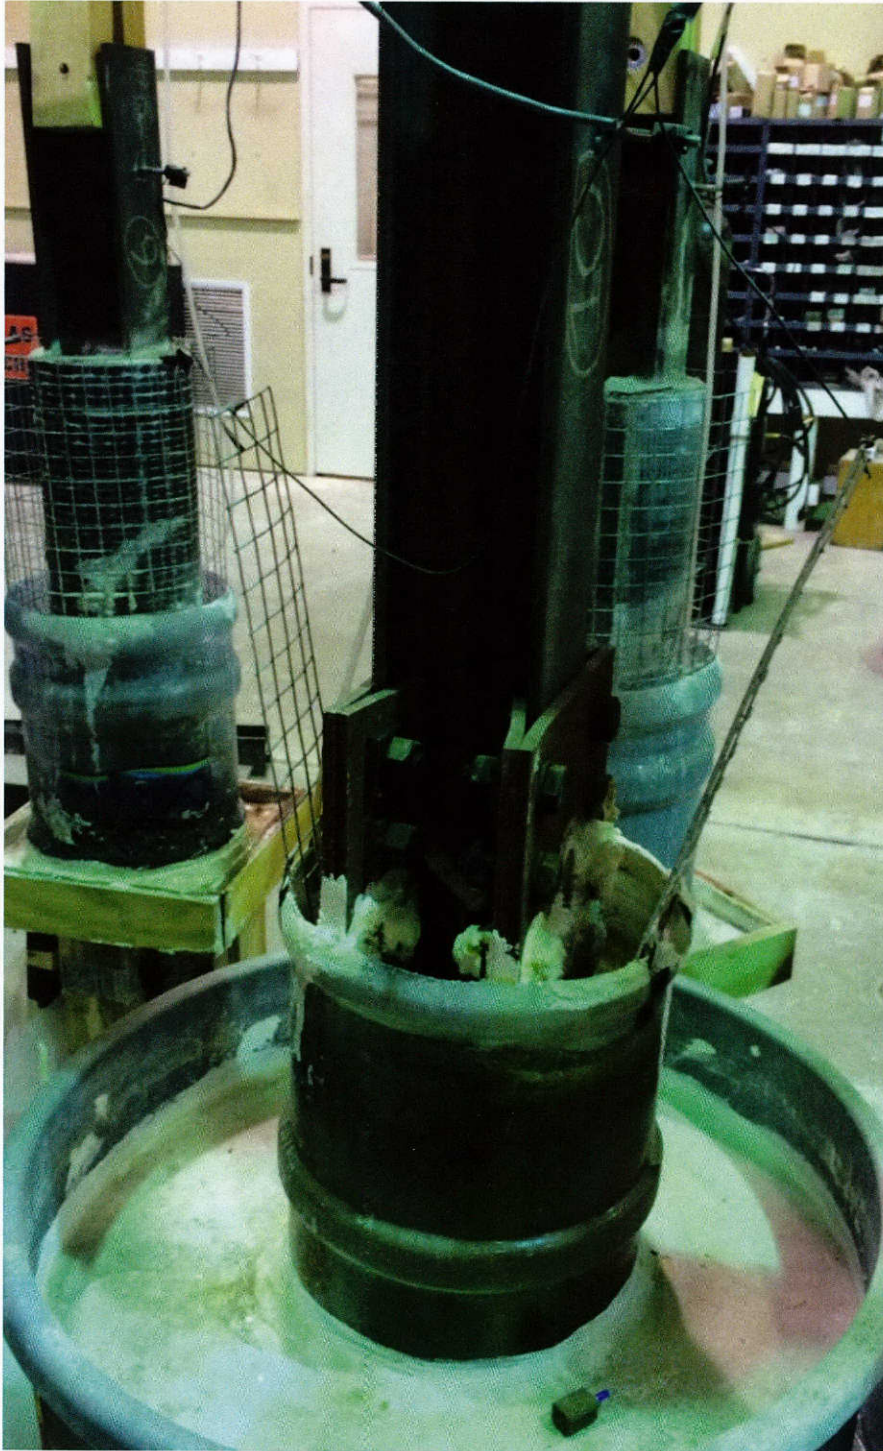
Figure 10.44: Accelerated corrosion test set-up for the piles repaired with System 3 (S3-4-Cor)

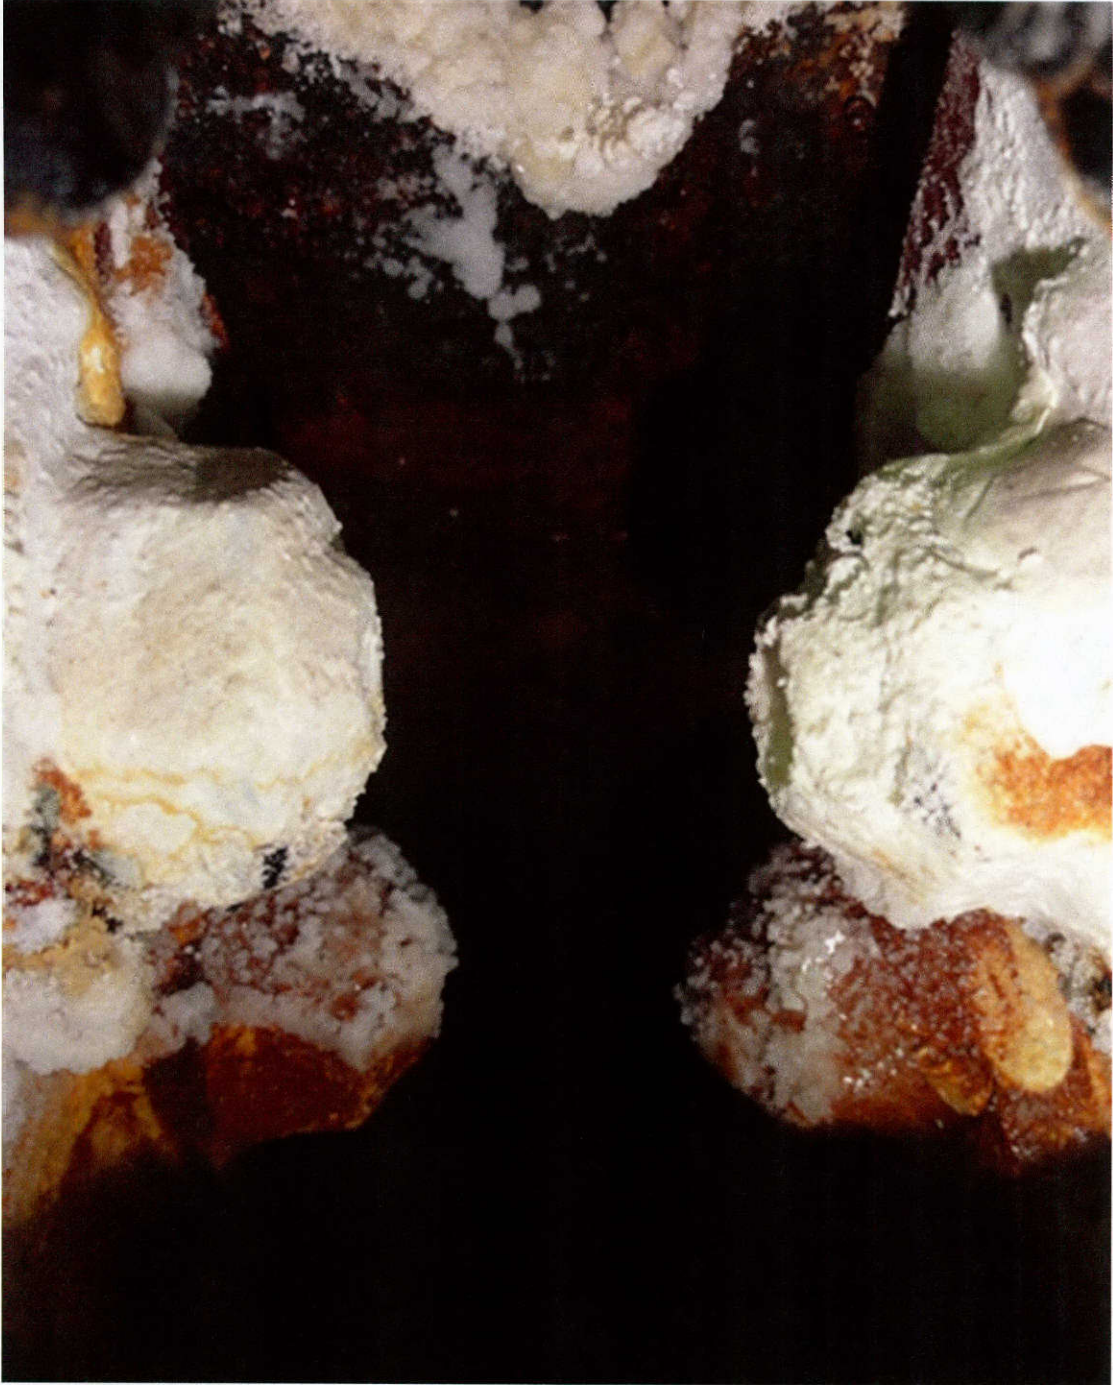
Figure 10.45: Bolt and web corrosion of Repair System 3 (S3-4-Cor)

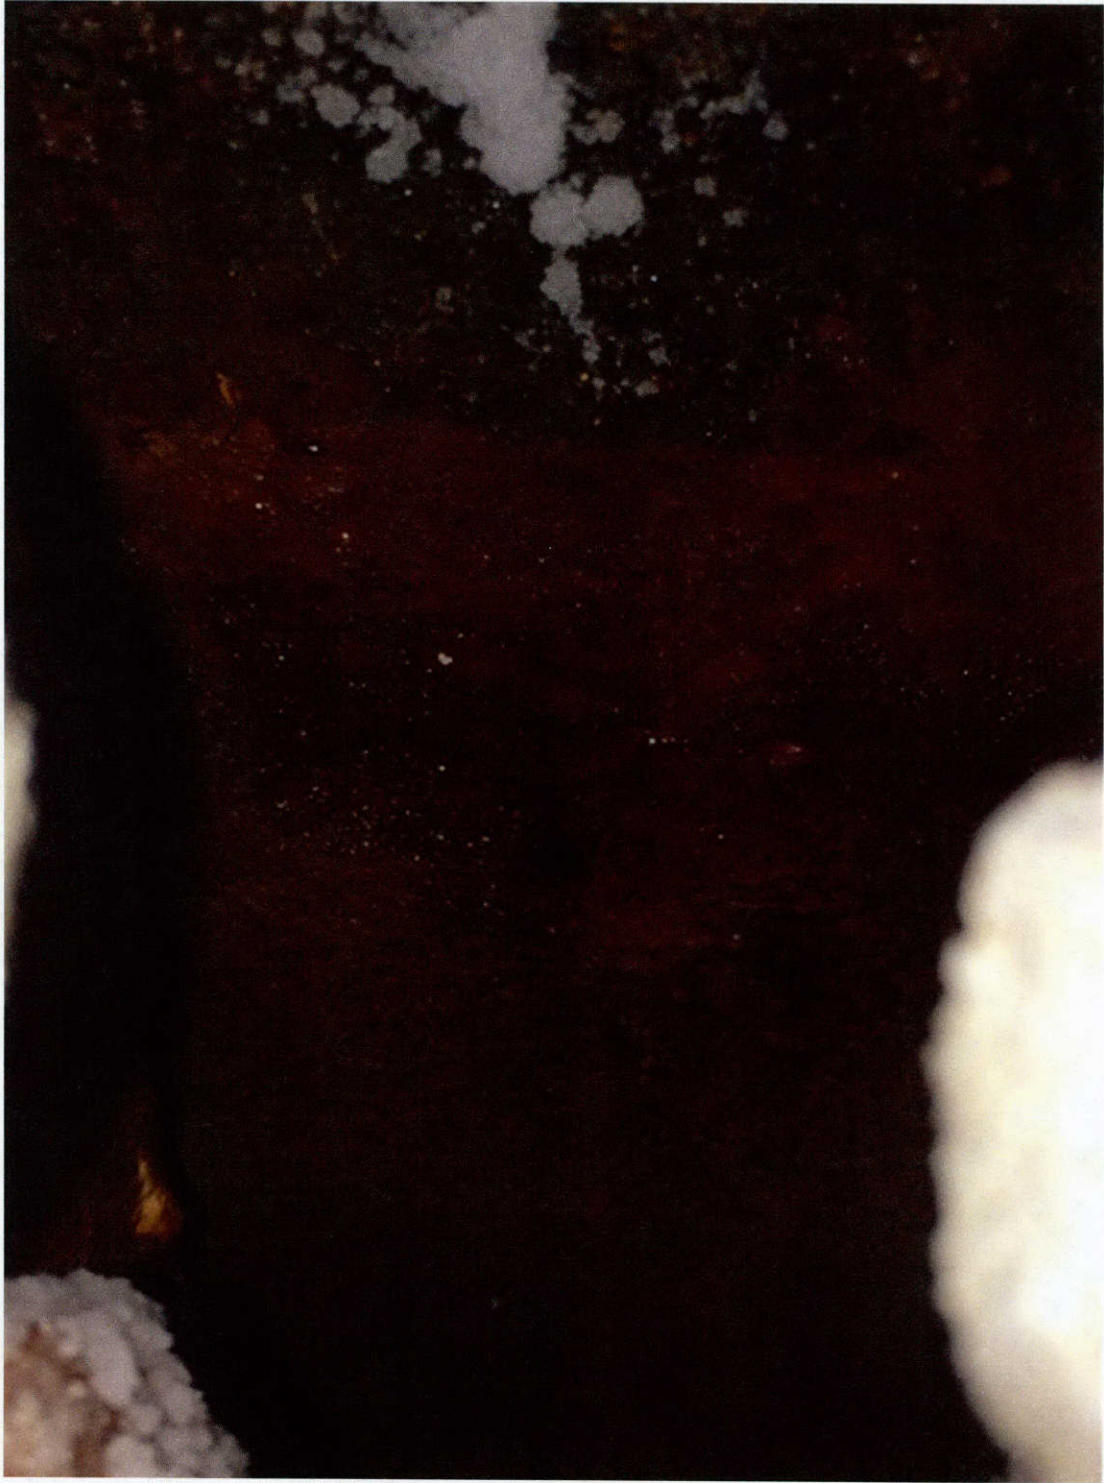
Figure 10.46: Web corrosion of Repair System 3 (S3-4-Cor)

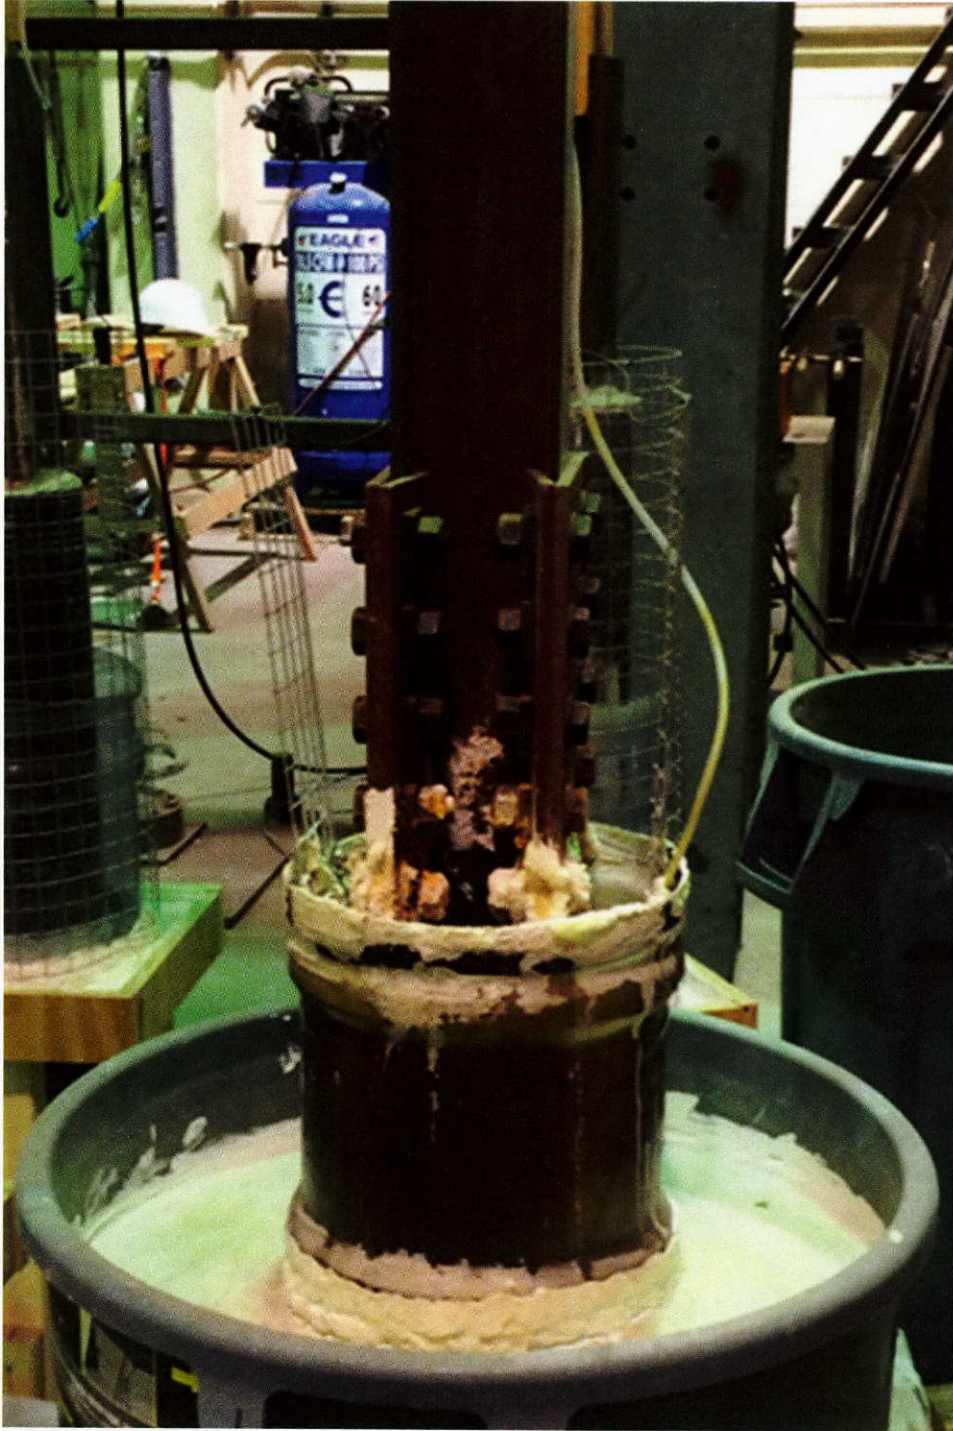
Figure 10.47: Accelerated corrosion test set up for Repair System 3 (S3-12-Cor)

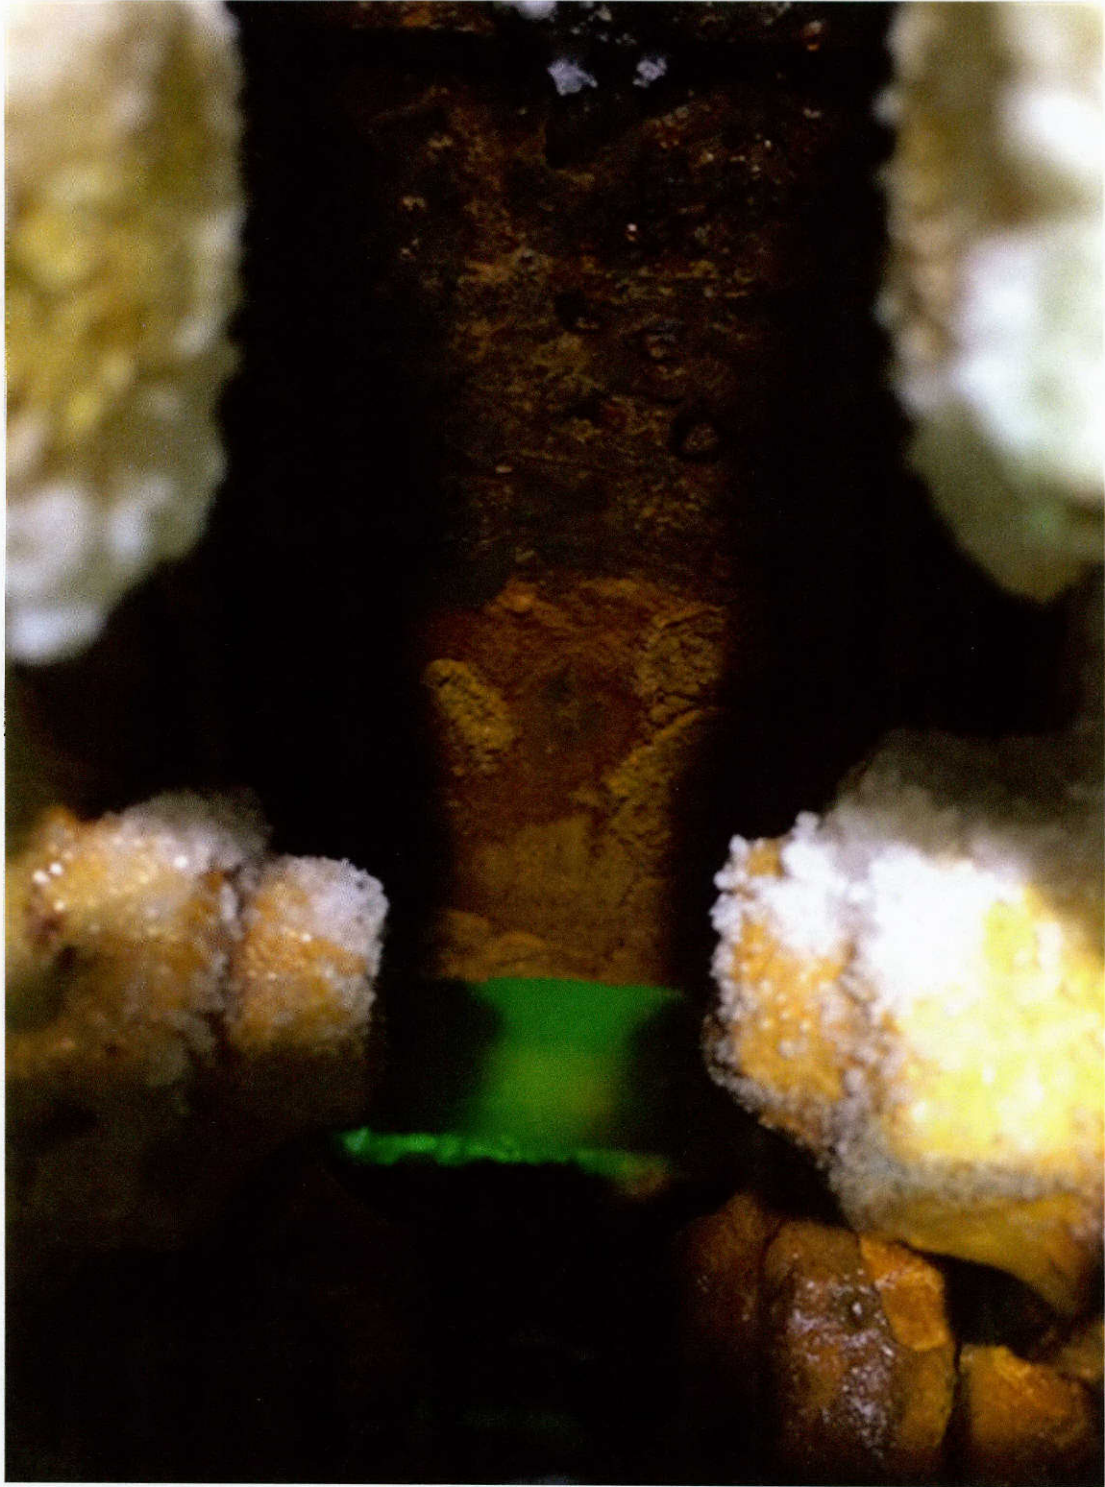
Figure 10.48: Web and bolt corrosion for Repair System 3 (S3-12-Cor)

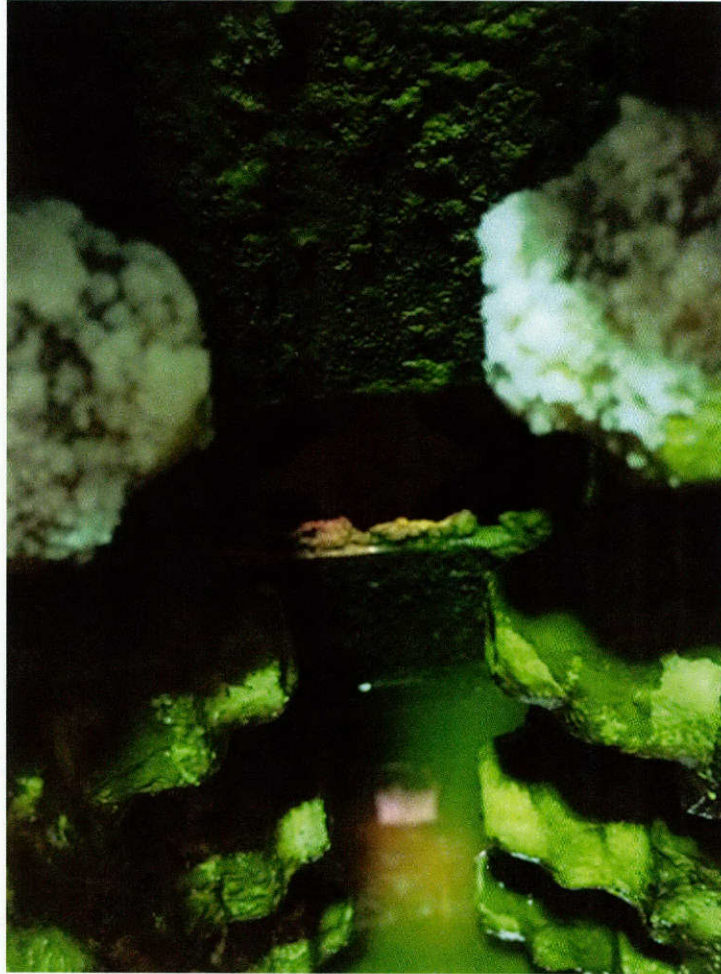
Figure 10.49: Web and bolt corrosion of Repair System 3 (S3-12-Cor)

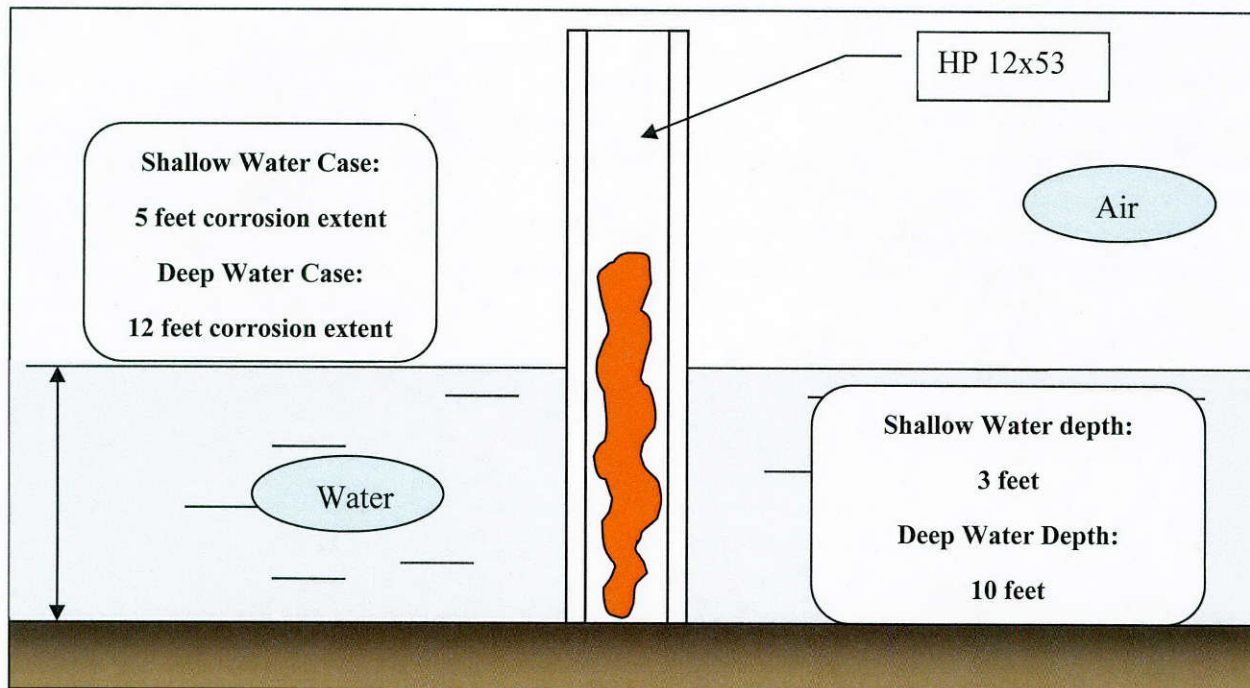
Figure 11.1: Corroded Steel Bridge Piles (Deep Water Case and Shallow Water Case)

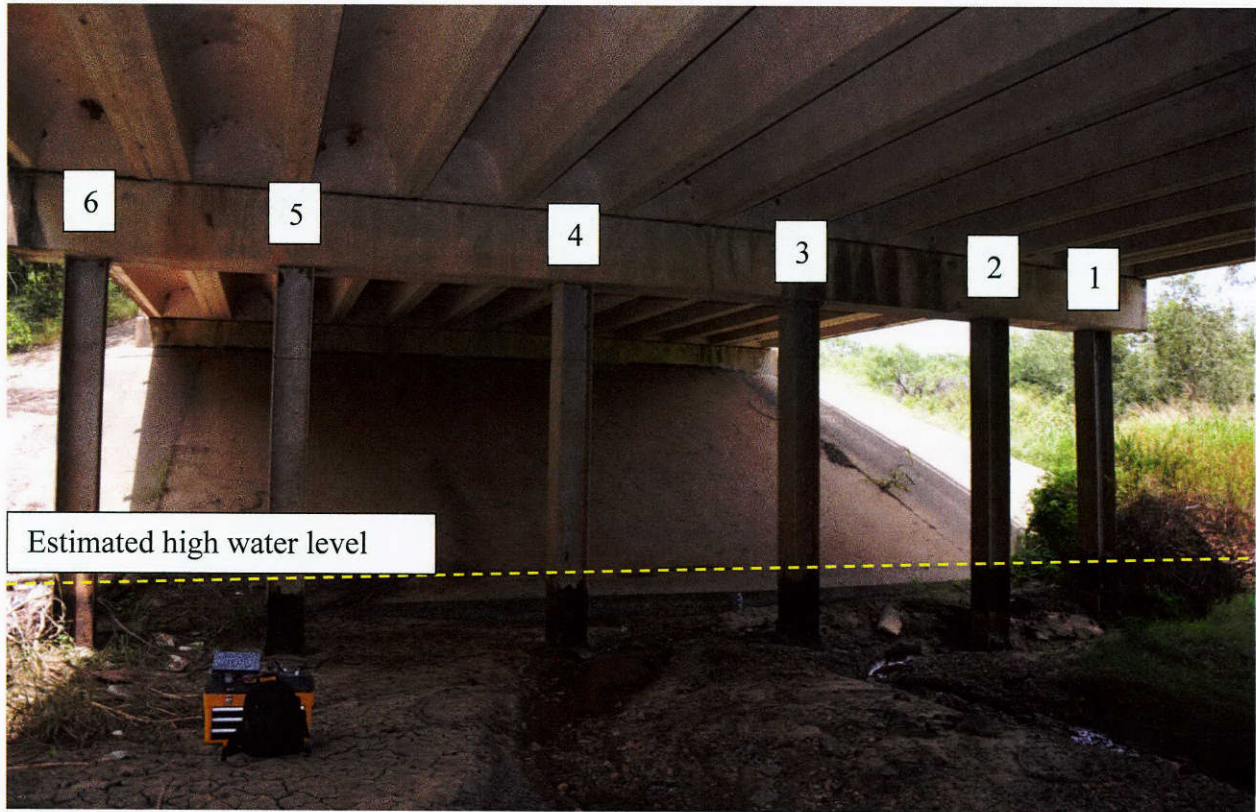
Figure 12.1: Candidate piles at bent 2 from northeast abutment, view towards northeast.

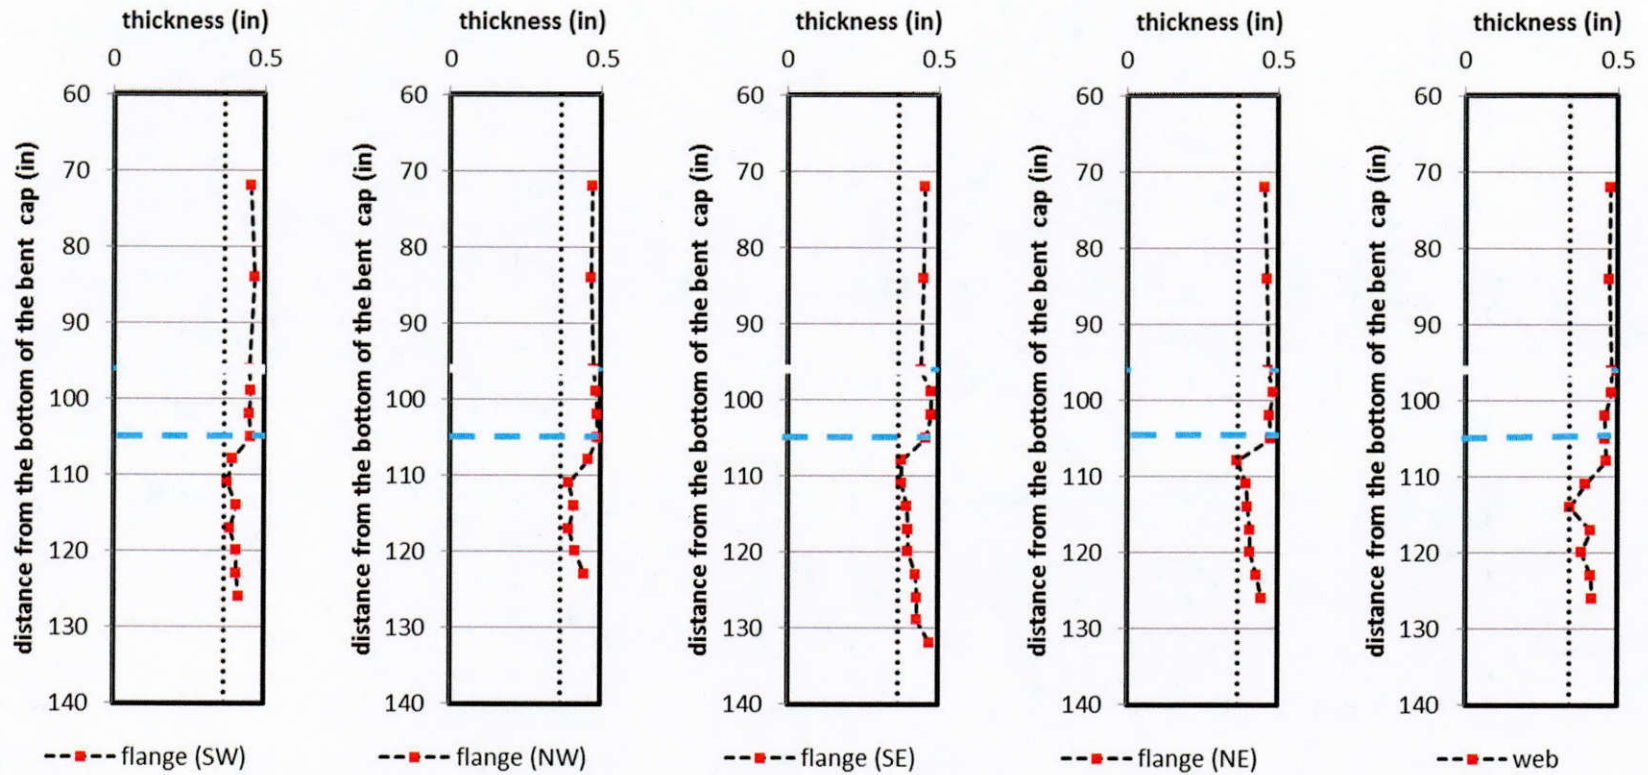
(a) Measured thickness profile for elements of pile 3

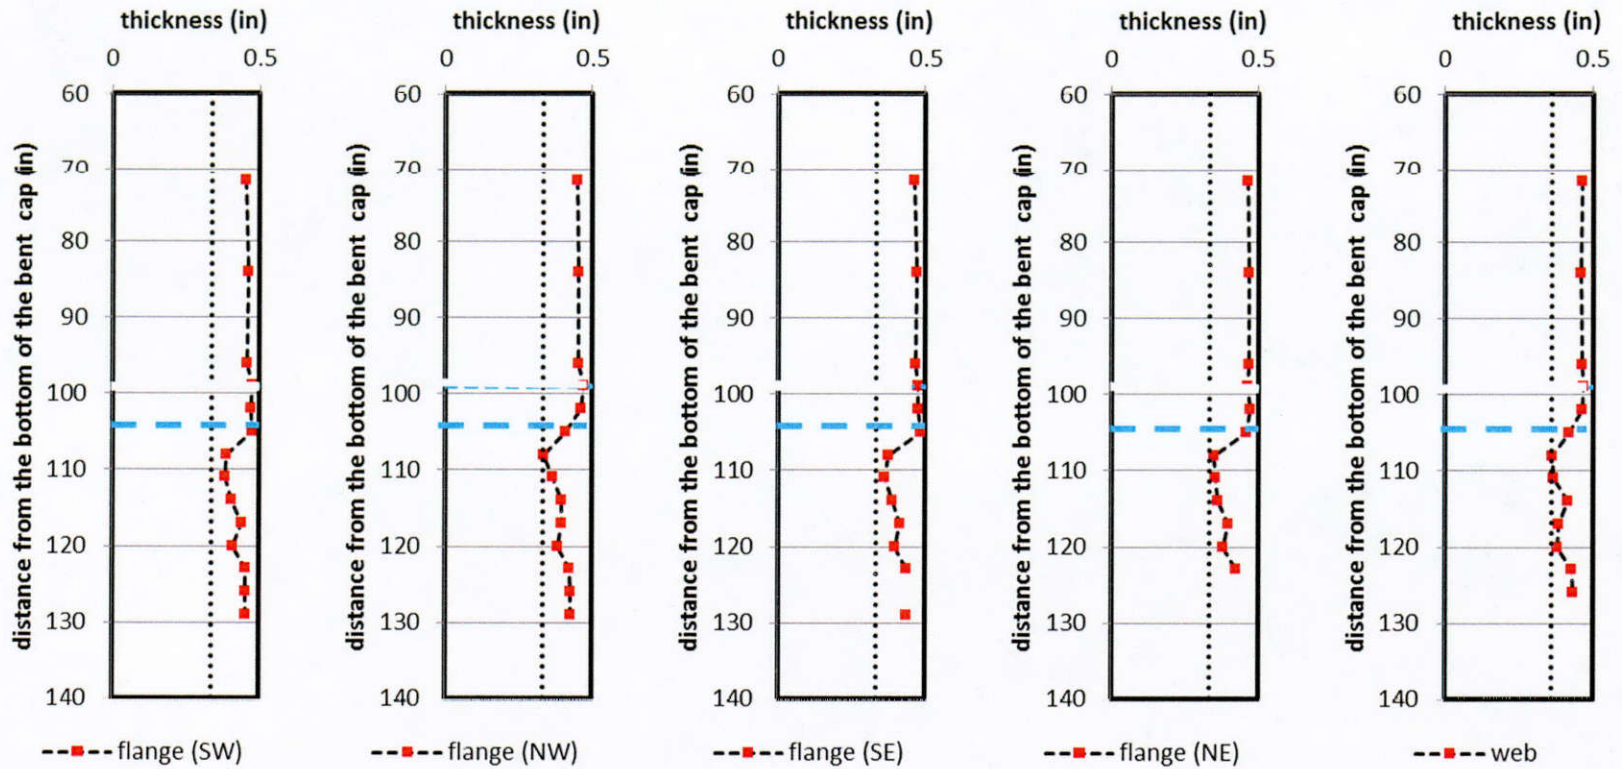
(c) Measured thickness profile for elements of pile 5

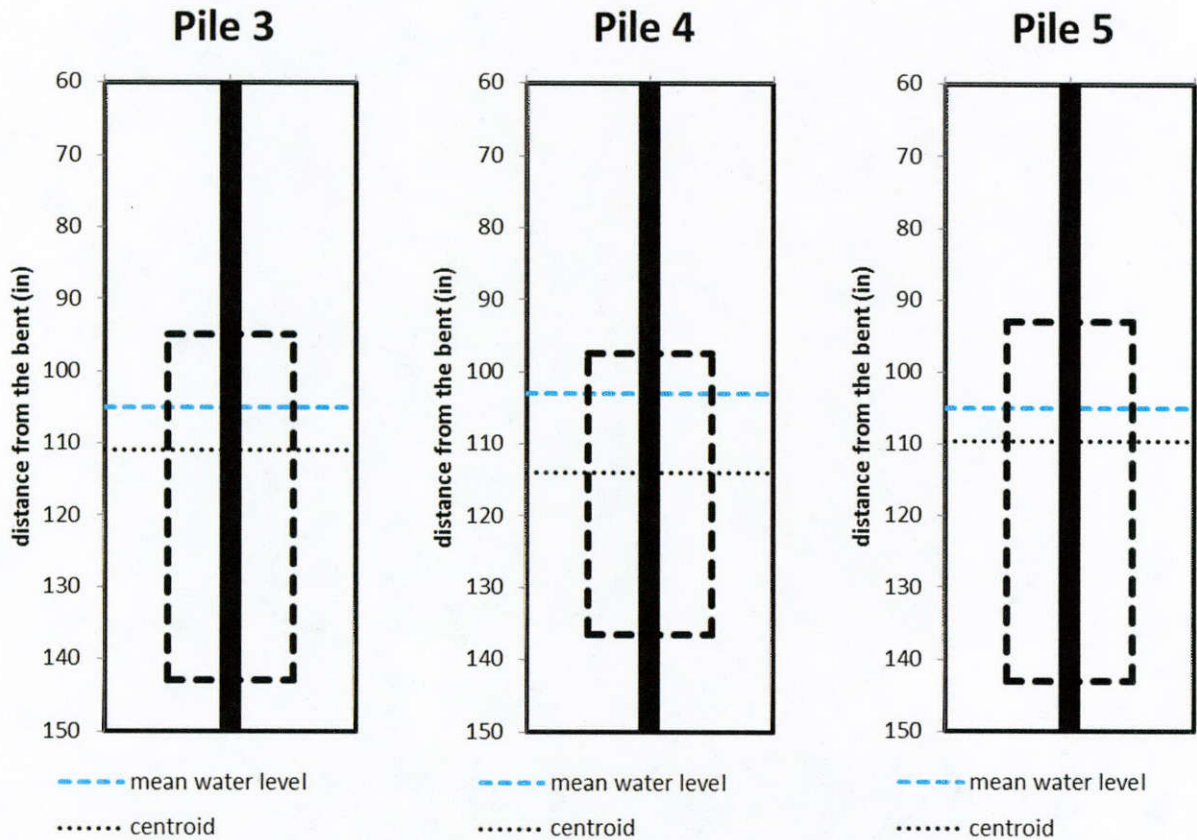
Figure 12.4: Updated high water levels and relative repair system positions

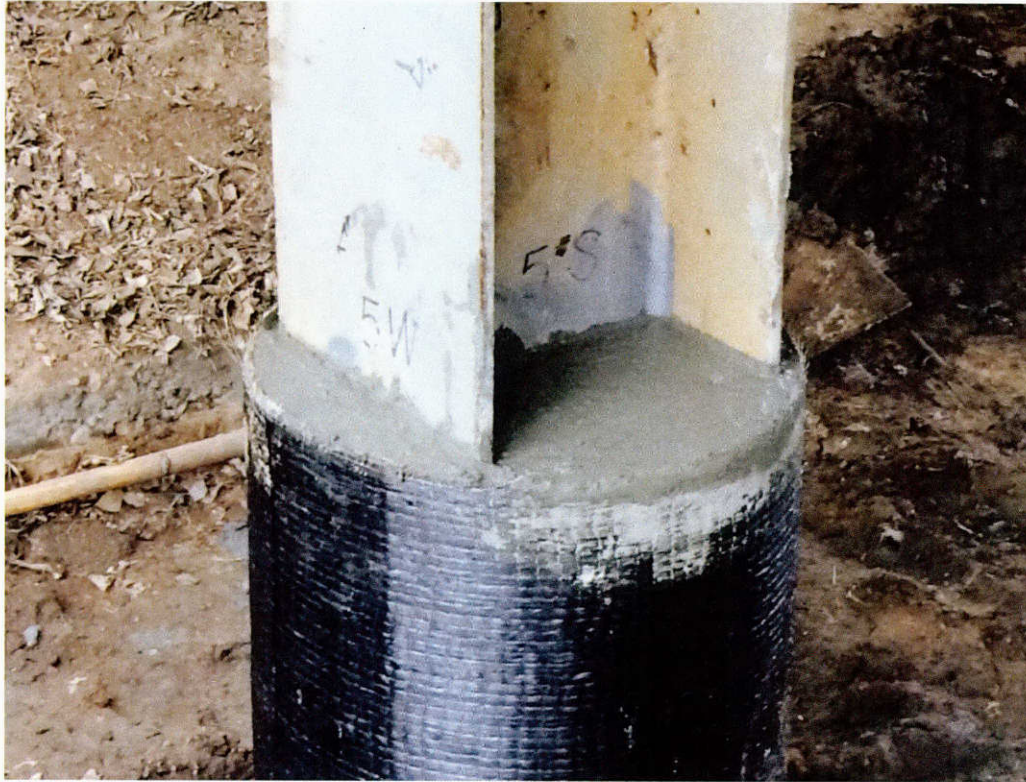
Figure 12.8: Completed installation of grouted FRP-jacket
