TEXAS DEPARTMENT OF TRANSPORTATION

Historical Studies Report No. 2011-01

Guidelines for Assessing the NRHP Eligibility of
Commercial Historic Districts in Crossroads Communities
in Northwest-Central Texas

Prepared by David W. Moore, Jr.

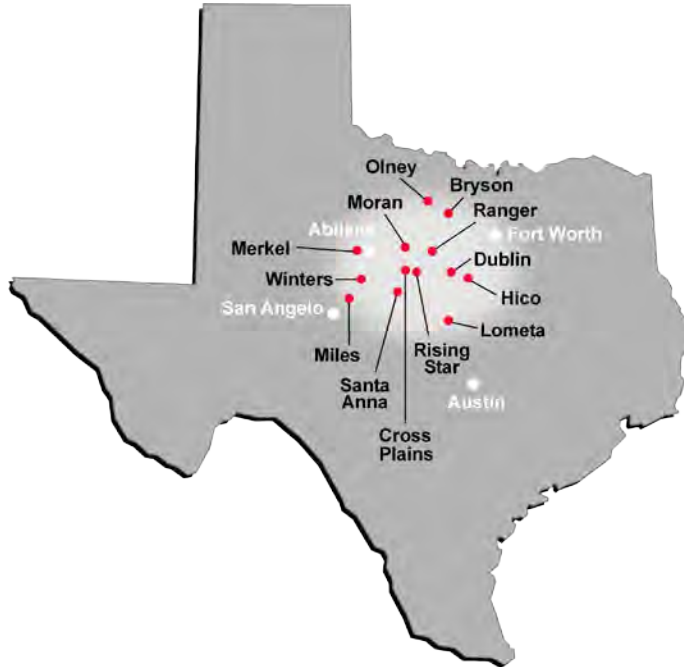
Figure 1-1. Crossroads communities visited in northwest-central Texas.

The 12 downtowns visited for this project provide a cross section of the kinds of commercial nodes and types of buildings, structures, and objects typically found in such settings (Figure 1-1). These communities were selected following an analysis that considered their location, size, periods, and rates of growth of the towns within the context of primary historical themes of the region. Results from limited field investigations provided the foundation for defining property types found in crossroads communities and for developing a process with which to assess downtowns for potential NRHP eligibility and district designation. The Property Types section identifies the most common kinds of buildings that exist in the downtowns of the crossroads communities. The classification system used in the Property Types section relies principally on the plan or form of the building but also considers architectural style, movements, and traditions. This method of classifying buildings is consistent with approaches developed by architectural historians Richard Longstreth in *The Buildings of Main Street* and W. Dwayne Jones in *A Field Guide to Gas Stations in Texas*. The NRHP evaluation process applies National Park Service (NPS) guidelines to the kinds of buildings and downtowns that exist in crossroads communities in the region. The approach outlined in this report could easily be adapted to other parts and settings in the state.

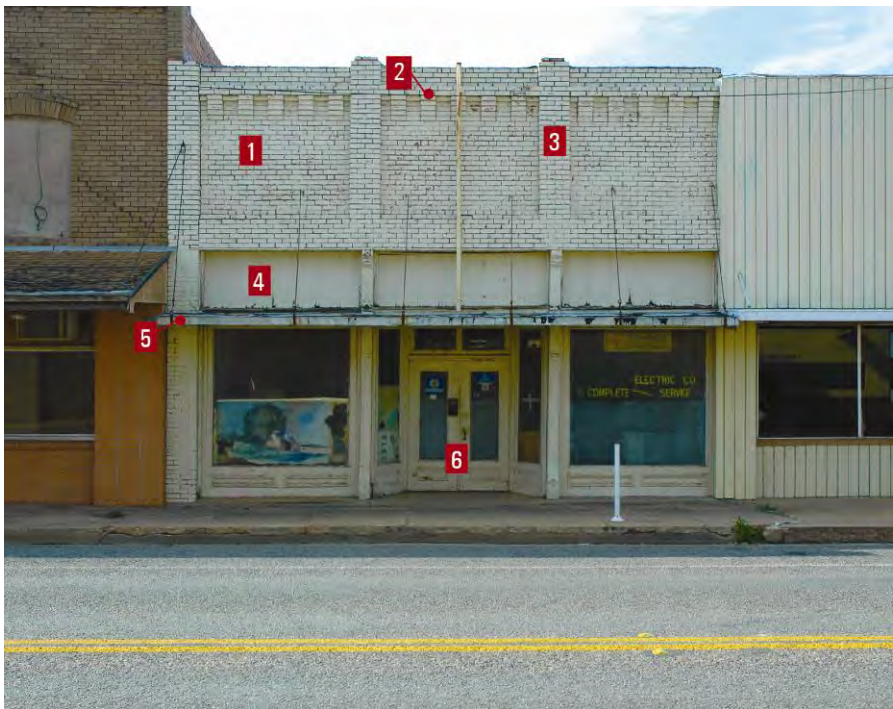
- 1 Brick parapet with recessed panels
- 2 Corbelled brickwork in cornice
- 3 Brick pilasters define bays
- 4 Row of fixed-light transom window openings
- 5 Canopy across the front suspended with metal rod-and-chain supports
- 6 Three-part storefront with a recessed double-door entrance and flanking large wood-frame plate-glass windows

Figure 3-2. One-Part Commercial Block building in the 100 block of S. Main Street, Winters.

This store retains its character-defining features to a noteworthy degree.

This building in Winters is an outstanding and well-preserved example of a *One-Part Commercial Block* building (Figure 3-2). The store retains its original three-bay storefront with a recessed double-door primary entrance and angled display windows. Engaged cast-iron columns define the entrance bay. The three-part configuration at the pedestrian level extends to the parapet, which features recessed panels and brick piers. The cornice displays corbelled brickwork that is common to many *One-Part Commercial Block* buildings from the late nineteenth and early twentieth centuries. Alterations include the covering of the transoms and the application of paint over the original brick finish. These changes diminish, but do not compromise, the integrity of *Materials* and *Feeling*. Otherwise, the building retains all of the qualities that distinguish it as a good example of its subtype. Note how the application of metal siding onto the exterior of the adjoining building on the right, and the replacement of the display windows have compromised the building’s historic character.

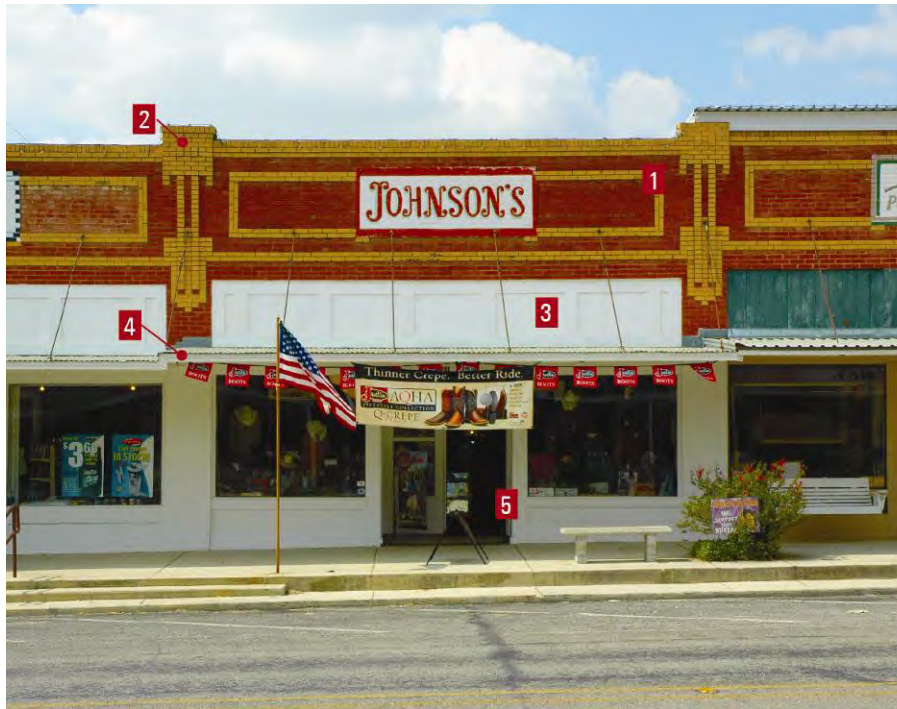
- 1 Dark-red brick parapet with tan-colored brick detailing creates contrast and sense of horizontality
- 2 Brick decorative motif on piers featuring geometric designs are suggestive of the Prairie School
- 3 Row of large fixed-light transom windows boarded
- 4 Canopy across the front suspended with metal rod-and-chain supports
- 5 Three-part storefront with a recessed double-door entrance and flanking plate-glass windows

Figure 3-3. One-Part Commercial Block buildings in the 100 block of N. Main Street, Cross Plains.

This store displays brickwork in the parapet that is suggestive of the Prairie style.

The west side of the 100 block of N. Main Street in Cross Plains includes a series of nearly identical *One-Part Commercial Block* buildings (Figure 3-3). Each has a three-bay storefront and a decorative parapet with noteworthy masonry work. The common scale, configuration, and aesthetic qualities that these buildings share strongly contribute to a strong sense of cohesiveness. The building in the center is representative of the entire group, and it exhibits many of the signature features that identify it as a *One-Part Commercial Block* subtype. The pedestrian zone includes a centrally placed, double-door entrance and large display windows on either side. Metal rods support the suspended canopy, and a row of fixed-light transoms rise above the canopy. However, the application of paint on brick surfaces, the covering of the transom windows, and the installation of new windows and doors at the storefront level detract from its historic character. The building is not significant on an individual basis, but it still retains enough of its salient physical features to contribute to the downtown's historic character.

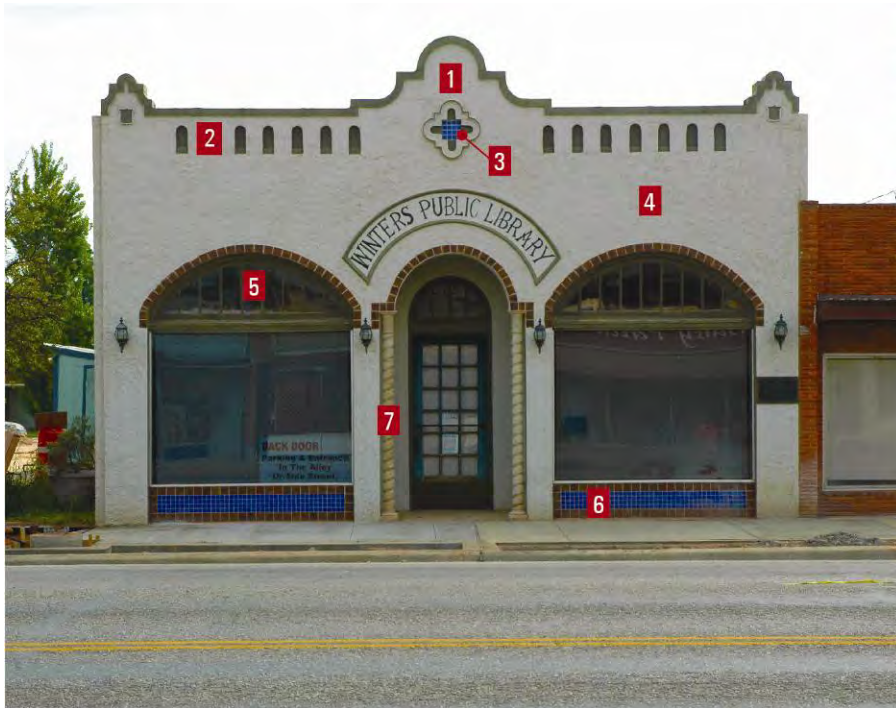
- 1 Mission parapet
- 2 Row of small arched niches
- 3 Central quatrefoil adornment with inlaid tile
- 4 Stucco finish
- 5 Round-arched transom above plate-glass windows
- 6 Inlaid tile
- 7 Spiral columns

Figure 3-4. One-Part Commercial Block building at 120 N. Main Street (US 83), Winters. This building presents architectural ornamentation that is indicative of the Spanish Colonial Revival style.

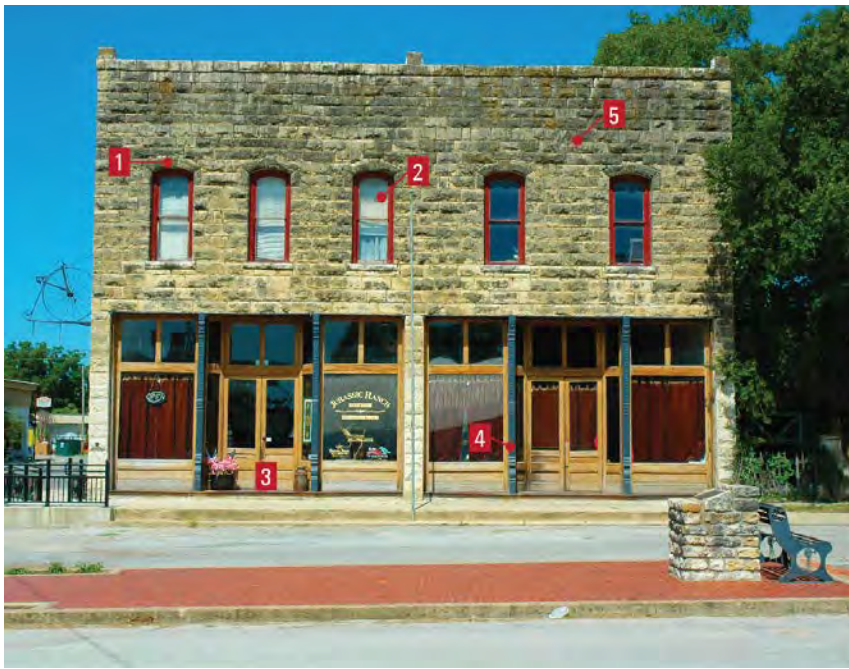
- 1 Segmental-arched openings on second floor with stone lintels
- 2 Double-hung wood-sash windows with one-over-one lights
- 3 Three-part storefronts on each side
- 4 Cast-iron columns and thresholds
- 5 Masonic Lodge dedication stone

Figure 3-5. Two-Part Commercial Block building at 224 N. Pecan Street, Hico.

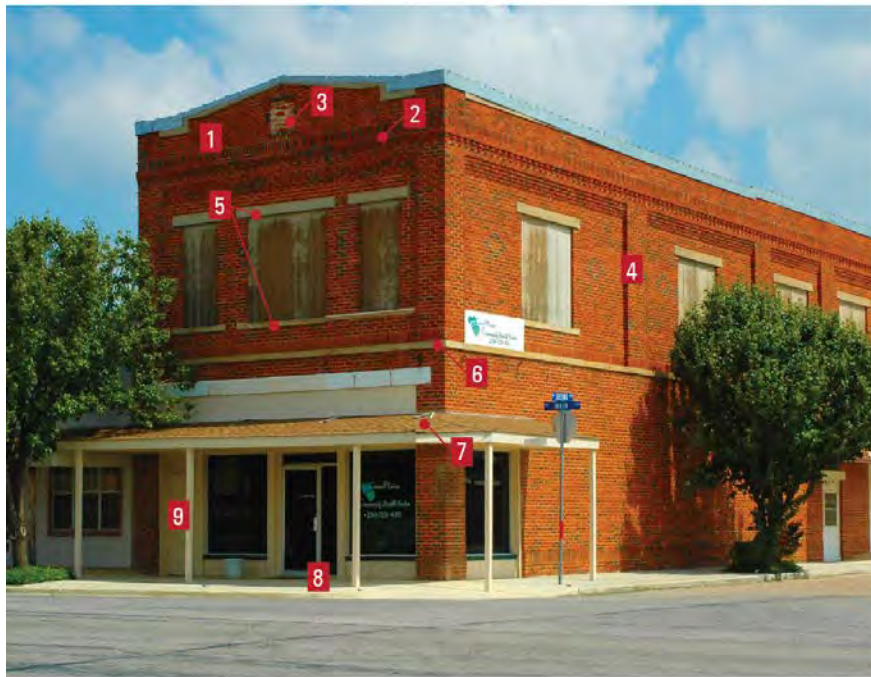
- 1 Brick parapet with pediment and entablature form
- 2 Stacked bricks forming dentils
- 3 Remains of embellishment embedded in the center of pediment
- 4 Brick pilasters
- 5 Cast-stone lintels and sills on second-story windows
- 6 Cast-stone string course
- 7 Wrap-around canopy rests atop metal freestanding columns
- 8 Storefront on the ground floor with an entrance flanked by large frame windows
- 9 Secondary independent entrance to second floor

Figure 3-7. Two-Part Commercial Block building at the northeast corner of N. Main Street and Second Street, Cross Plains.

This building in Cross Plains features two distinct zones on the primary, west-facing façade that identify it as a *Two-Part Commercial Block* building (Figure 3-7). It exhibits a pediment parapet and other architectural features that reflect an influence of the Classical Revival style. This movement enjoyed widespread popularity during the early twentieth century. A number of alterations diminish some of the building’s ability to convey a sense of the past. Examples include the replacement windows and doors at the ground level, the installation of a new canopy across the front and a portion of the south wall, and the covering of second-floor window openings. Nevertheless, the building has cast-stone lintels above the second floor and dentil-like brickwork in the parapet and recessed panels in the side elevation. The exposed square-shape area in the pediment likely contained a decorative panel – probably a logo for a lodge that once met in the upper floor and used a separate entrance that led to the upstairs meeting hall. Although it is a good local example of its subtype and contributes to the overall historic character of the downtown, the building lacks sufficient integrity to be individually eligible for the NRHP. The covering of the second-floor windows, changes to the storefront, and roof covering diminish its integrity of *Materials, Design, and Feeling*.

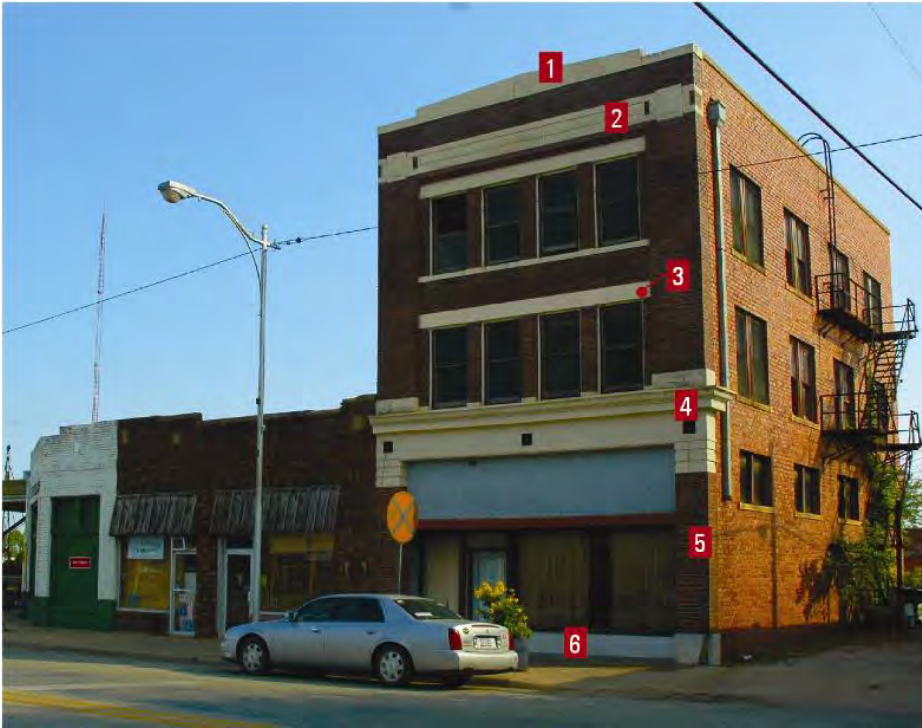
- 1 Parapet reinforces a sense of horizontality
- 2 Cast-stone frieze
- 3 Stone lintels sit above second- and third-floor windows
- 4 Cast-stone facing divides the upper and lower zones of the front façade
- 5 Brick pilasters
- 6 Storefront on the ground floor with off-center single-door entrance and large plate-glass windows

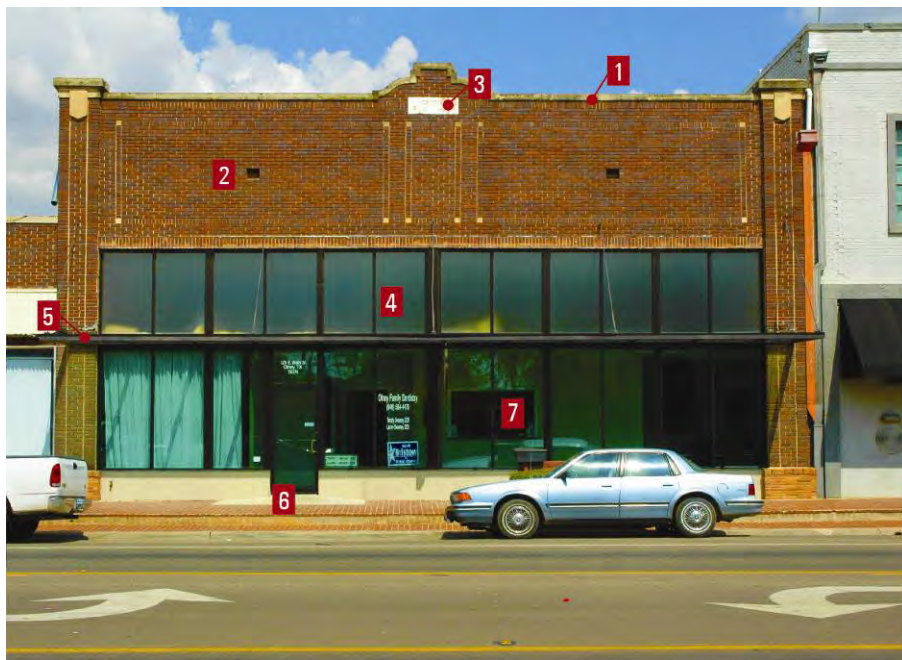
- 1** Cast-stone coping
- 2** Brick decorative motif on piers and parapet featuring geometric designs
- 3** Embedded glazed terra cotta plaque notes date of construction and original occupant
- 4** Row of large fixed-light transom windows
- 5** Canopy across the front suspended with metal rod supports
- 6** Storefront extends across nearly the entire length of the primary façade
- 7** Large metal-frame plate-glass windows

Figure 3-9. Enframed Window Wall building in the 100 block of W. Main Street, Olney. Despite alterations to the storefront, this building possesses all of the signature traits of an *Enframed Window Wall* building.

This is an example of an *Enframed Window Wall* in Olney (Figure 3-9). Almost the entire pedestrian level features large expanses of glass in display windows, transoms, and doors, and are indicative of this form. The parapet displays a modest influence of Prairie School architecture, which enjoyed a degree of popularity in the downtowns of many crossroads communities in the study area. The installation of anodized aluminum window and door frames, as well as the use of tinted glass, diminishes the building’s ability to convey significance as an example of this property subtype classification. The negative effect these changes have to integrity of *Materials*, *Workmanship*, and *Feeling* disrupt its ability to convey significance as an example of this architectural plan type. However, it retains, albeit marginally, sufficient integrity to contribute to the historic character of the downtown.

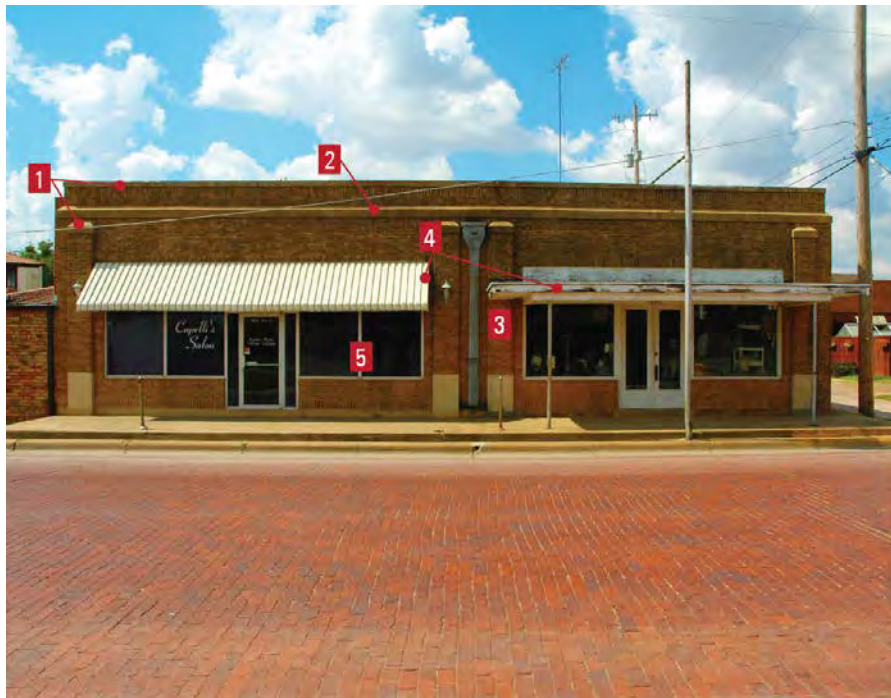
- 1 Cast-stone coping along parapet
- 2 Cast-stone string course reinforces sense of horizontality
- 3 Engaged piers frame each storefront
- 4 Separate canopies across each storefront
- 5 Storefronts with central entrances flanked by plate-glass windows

Figure 3-10. *Enframed Window Wall* building in the 100 block of Avenue C, Olney.

This building in Olney has two separate storefronts, both of which feature large expanses of glass that are framed on each end by prominent brick piers, a signature trait of an *Enframed Window Wall* (Figure 3-10). Side by side, these storefronts provide an opportunity to show how changes can affect the historic character and integrity of a building. The store on the north (right) side retains most of its original features and materials, but the one on the south (left) side has been subject to some modification. The display windows and door on the south side are replacements that utilize metal framing that contrasts with the wood-frame units on the north side. The metal-covered shed canopy on the south obscures the transoms and has become a visually prominent physical feature that detracts from the historic character of the storefront. Despite these changes, the building retains most of its important architectural features and remains a typical example of a relatively common building type. The modifications detract but do not compromise integrity of *Materials*, *Design*, and *Feeling*. While not individually significant, the building contributes to the historic character of the downtown.

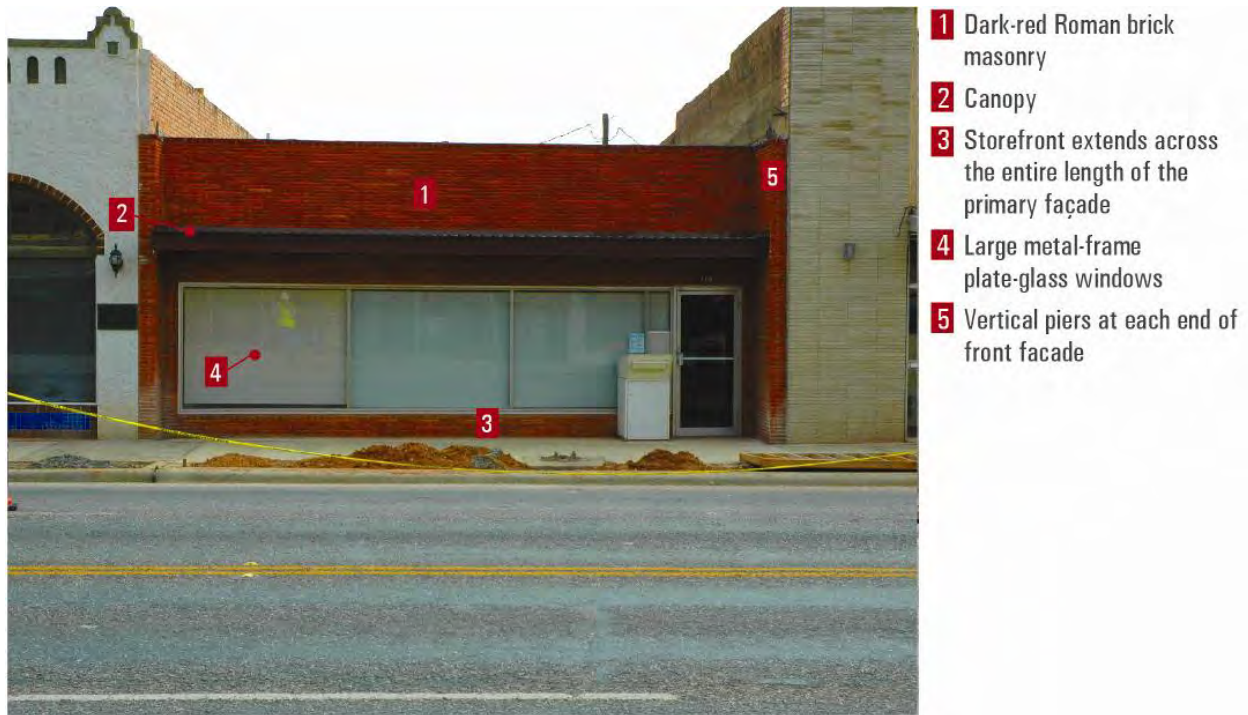
- 1 Dark-red Roman brick masonry
- 2 Canopy
- 3 Storefront extends across the entire length of the primary façade
- 4 Large metal-frame plate-glass windows
- 5 Vertical piers at each end of front facade

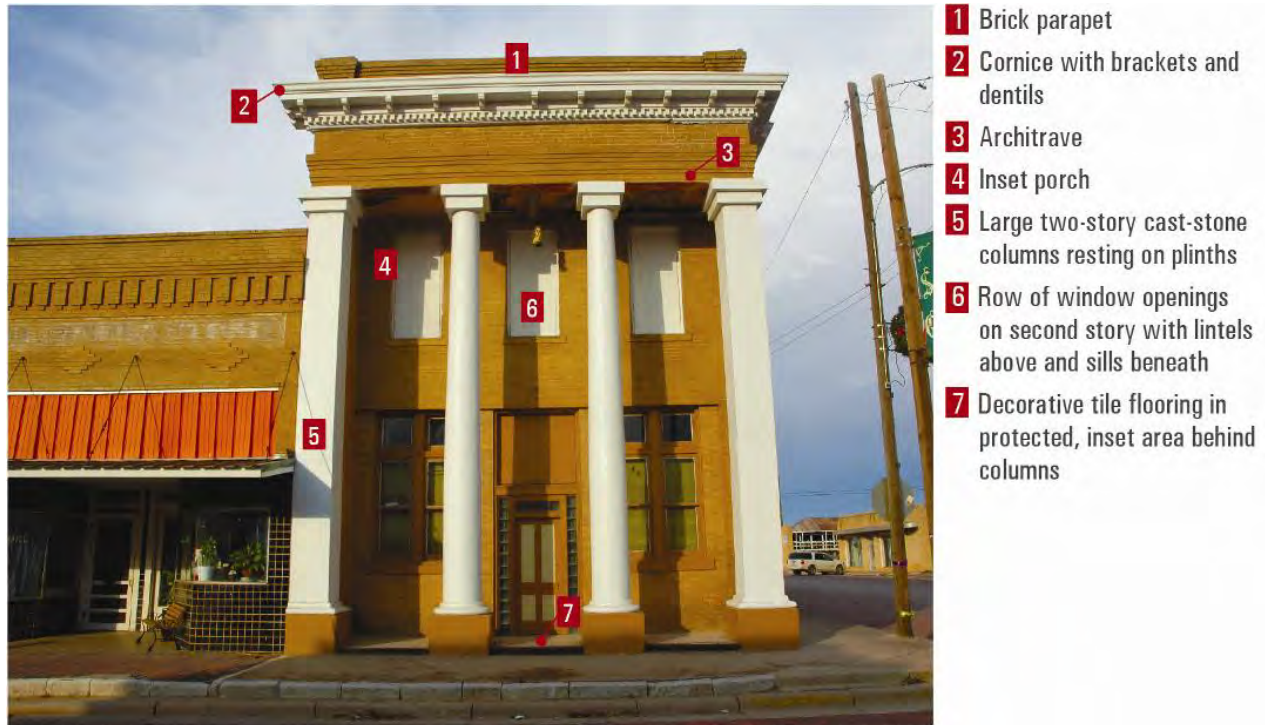
Figure 3-12. Temple Front building at the southwest corner of Edwards Street and N. Second Street, Merkel. This former bank is a good example of Temple Front building and features Classical Revival detailing.

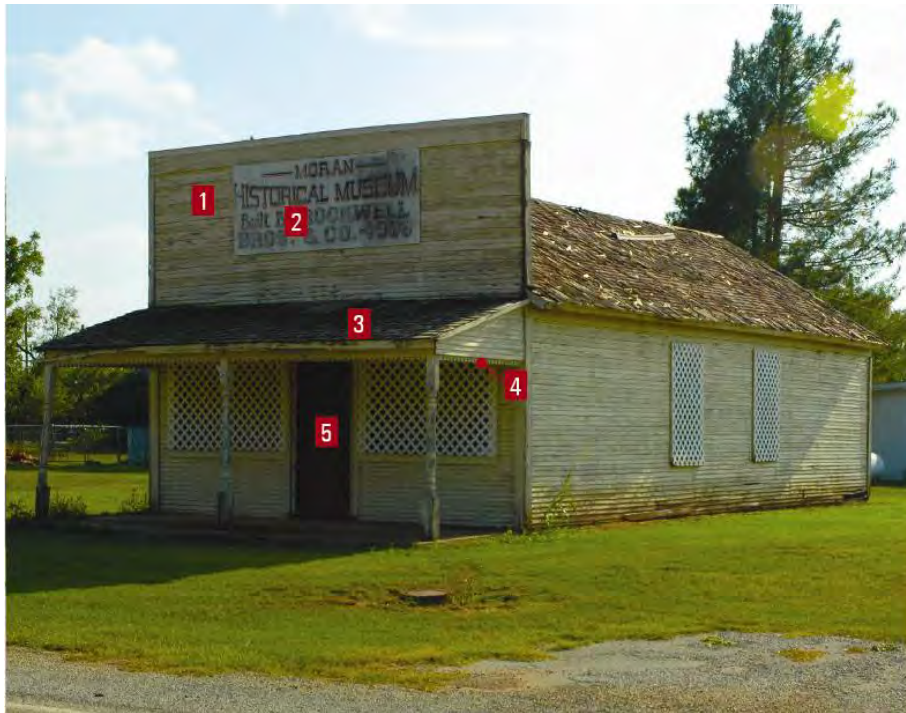
- 1 Large parapet conceals front-gabled roof
- 2 Painted sign mounted on parapet
- 3 Canopy across front with turned columns
- 4 Decorative trim
- 5 Symmetrical arrangement of central entrance flanked by large window openings

Figure 3-13. False Front building in the 300 block of Ground Street (FM 880), Moran.

This building presents a façade composition that is often associated with “boomtowns” in western states, including Texas (Figure 3-13). Extant examples are found in several of the crossroads communities documented for this study. The broad false front largely obscures the gabled roof and makes the building appear to be grander and more substantial than it actually is. The sign in the parapet notes that the building was constructed by “Rockwell Bros. & Co. - 1906.” The turned-wood columns rest on a concrete slab that is not original to the building. The building is located about a half block from the historic downtown and likely was moved to its current site at an unknown time. Despite its relocation and being set back from the nearby highway, the building retains many of its salient features that are indicative of the *False Front* subtype. The lattice panels over the windows are easily reversible alterations that detract minimally from the building’s historic character. The most significant change is the building’s new site, which compromises its integrity of *Location* and *Setting*.

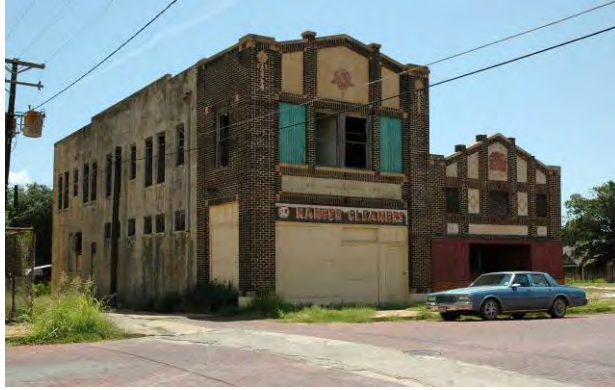
**Figure 3-14 (left).
Vacant buildings in the
100 block of S. Austin
Street, Ranger.**

These buildings date to the oil boom era of Ranger and show how important the discovery of oil was to the community and the downtown. These buildings are in poor condition but retain many of the physical attributes and qualities that add to the ability of the downtown to convey significance.

The buildings in Figure 3-14 are among several vacant buildings in downtown Ranger. The *Two-Part Commercial Block* building on the left was a store, while the *One-Part Commercial Block* building on the right was a theater. Both have been abandoned for many years. Most of the openings have been covered with sheets of plywood or corrugated plastic panels, and several of the second-floor windows on the two-story building are exposed, leaving the interior vulnerable to decay and water damage. While the store and theater fronts are covered, most of the original façades are still visible and retain their ability to convey a sense of the past despite each building's overall deteriorated condition. While they lack sufficient integrity to be significant on an individual basis, they retain sufficient integrity of *Design, Materials, Workmanship, and Feeling* to add to the historic character of the downtown and would be considered contributing resources within a district.

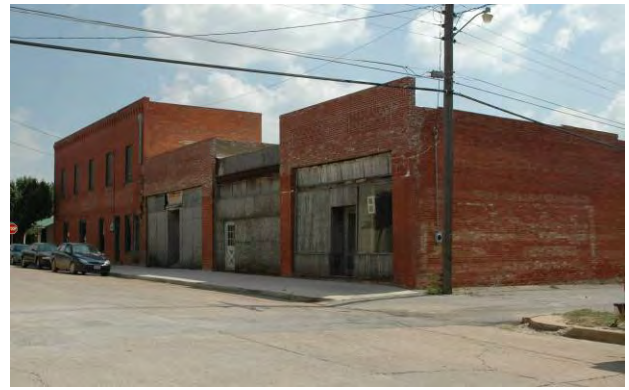
The buildings are clearly historic but their deteriorated condition interferes with their ability to convey a sense of the past.

The buildings in Figure 3-15 are abandoned and in a deteriorated state. They are located just off Main Street and display many of the physical attributes that are common throughout Cross Plains' historic downtown. However, large plywood and particleboard panels cover the window and door openings and affect the ability of each building to convey a sense of the past. Although the fenestration and original window and door features may be intact underneath, they are completely obscured by the panels. Water seepage and deteriorated mortar in the masonry walls have also caused damage to the structural stability and integrity of the buildings. Portions of the brick parapet of the building in the foreground have been rebuilt. The buildings present a degree of their historic character, but their deteriorated condition compromises integrity of *Feeling, Materials, and Design* to such an extent that they no longer add to the ability of the downtown to convey significance.

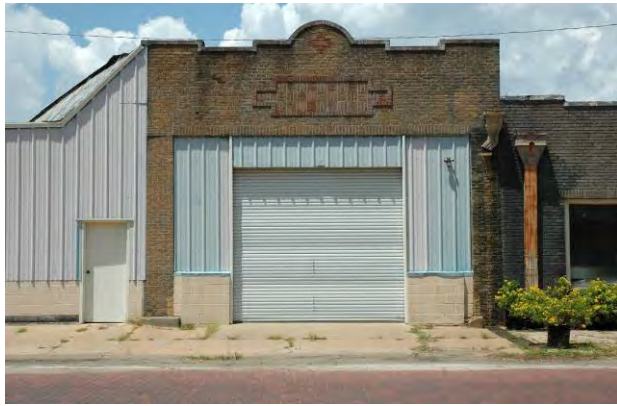
**Figure 3-16 (left).
Garage in the 100 block
of S. Austin Street,
Ranger.**

Sanborn maps note that this building was a garage and was built in the 1920s. The building retains some of its historic qualities, yet the introduction of new materials at the street level overwhelm its historic character. Only a small portion of the building's original exterior finish is visible.

The building in Ranger presented in Figure 3-16 exemplifies the kind of changes that occur in crossroads communities. The building's form and massing remain intact. In addition, the parapet displays brick masonry work that distinguishes the building and showcases the skills of its builder. However, modifications at the street level, such as the entrance and the application of metal panels, do not date from the downtown's period of significance and have a negative effect on the building's historic character. Street-level changes represent about two-thirds of the surface area of the front. The combined effect of these alterations is substantial enough to compromise the building's integrity of *Design, Feeling, Setting, and Materials*. While vestiges of the building's original exterior remain visible, a large amount of the surface area on the primary façade no longer retains its historic finishes, and the building lacks sufficient integrity to be individually eligible or even be a contributing resource within a district.

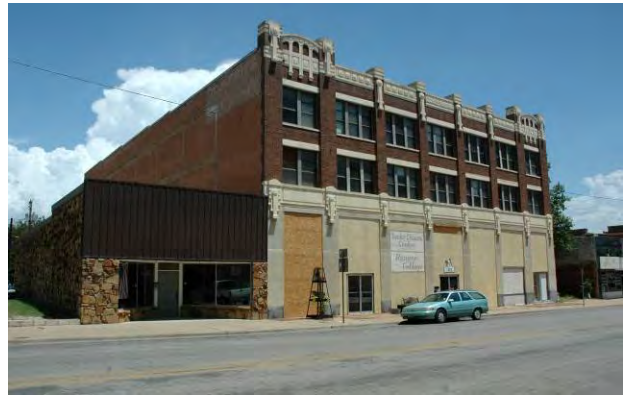
The Hodges-Neal Building is noteworthy within Ranger because it displays a high level of architectural design and ornamentation that reflects the city's prosperity during the oil boom of the late 1910s and 1920s (Figure 3-17). Like the previous illustration, however, the building has experienced severe changes at the pedestrian level. The enclosure of the windows and doors and the removal of the canopy negatively affect the building's historic character and integrity. However, the vertical piers, though difficult to discern in this image, still divide the street level portion of the building into seven bays. They are also consistent with the original fenestration pattern, which remains intact on the upper floors. Pedestrian-level changes diminish the building's integrity of *Materials, Design and Feeling* to a degree, but the rest of the building is largely intact and still retains the ability to convey its significance as a noteworthy building from the oil boom era. It contributes to the historic character of the downtown but lacks sufficient integrity to be individually eligible in its current state.

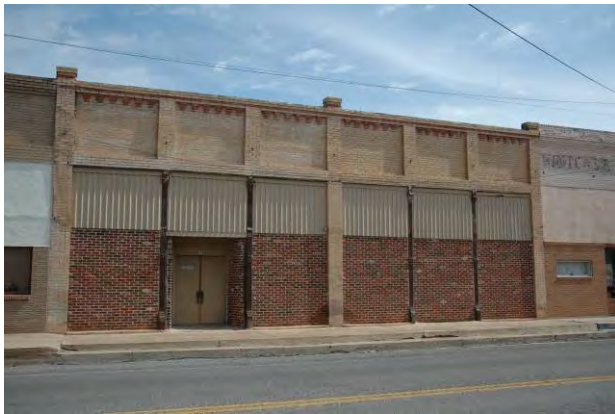
**Figure 3-18 (left).
Building in the 100
block of W. Dale Street,
Winters.**

This *One-Part Commercial Block* building retains some of its character-defining features, but changes to the fenestration overpower the building's ability to convey its historic character.

Changes to the arrangement and rhythm of window and door openings (fenestration) represent one of the most common types of changes to resources within the *Commercial Buildings* property type category. The building shown in Figure 3-18 provides graphic documentation of the effect changes to fenestration can have to a building and how such alterations affect multiple aspects of integrity. While the rhythm of the bay openings is maintained by the presence of the brick and cast-iron engaged columns, the bricked-in windows and doors and the placement of corrugated metal panels over the transoms change the character of the building. Besides disrupting the fenestration pattern and integrity of *Design, Feeling, and Workmanship*, the introduction of non-historic materials compromise the building's integrity of *Materials*. In contrast, the upper part of the building (parapet) remains virtually unaltered; however, changes at the pedestrian level overwhelm the building's overall ability to convey a sense of the past. This illustration also demonstrates how important fenestration is to a *One-Part Commercial Block* building. Although the parapet is a distinctive part of the front, the pedestrian zone represents a far greater percentage of the façade surface area and is more directly associated with the way people perceive and experience the building and the businesses operating inside. The building clearly has potential to be rehabilitated, but in its present state, changes to the fenestration diminish the building's ability to convey its significance individually or as part of a district.

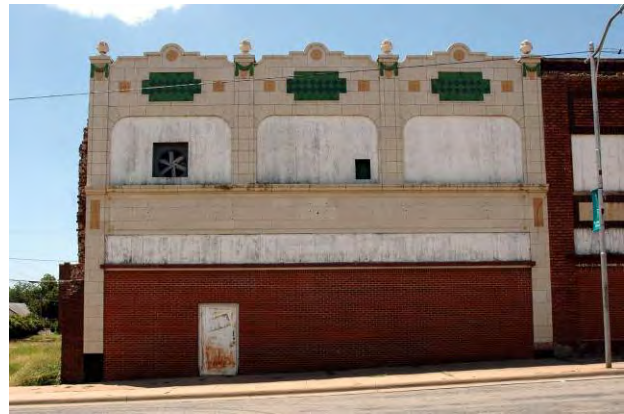
**Figure 3-19 (right).
Building in the 400
block of W. Main
Street, Ranger.**

Despite severe alterations at the pedestrian level, this building retains some of its most important architectural features.

Figure 3-19 provides another opportunity to show how important fenestration is to a building. This *Two-Part Commercial Block* building features noteworthy craftsmanship and detailing as well as terra cotta and tiled exterior finishes that make the building noteworthy within downtown Ranger. Despite the distinctive architectural ornamentation, the complete enclosure of the fenestration on the ground floor represents a major alteration that diminishes multiple aspects of integrity (*Design, Materials, Workmanship, and Feeling*). Despite the severity of these changes as well as the covering of transoms and upper-floor window openings with plywood panels, the building still retain sufficient integrity, albeit minimally, to contribute to the ability of the downtown to convey significance. It clearly lacks sufficient integrity to be individually eligible.

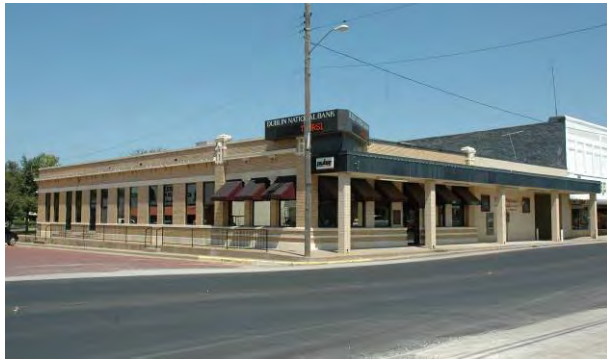
Figure 3-20 (left).
Dublin National Bank
Building at 128 S.
Patrick Street, Dublin.

All of the historic windows and doors on this building have been replaced. Although some of the original architectural ornament is intact, the multitude of changes to the exterior disrupts the building's integrity and historic character.

The Dublin National Bank building is a prominent architectural landmark in downtown Dublin (Figure 3-20). With a strong horizontal emphasis and distinctive ornamentation, the building exhibits a stylistic influence of the Prairie School, which enjoyed a degree of popularity in many crossroads communities in the study area during the 1910s. Although the bank possesses significance for these qualities, the window and door replacements, along with the new canopy and sign, disrupt integrity of *Materials*, *Design*, and *Feeling*. Their overall impact to the building's historic character and ambiance is so severe that the building lacks sufficient integrity to convey significance for its physical attributes. When viewed from the front, the building's noteworthy architectural qualities are no longer discernible. The side elevation retains more of its historic fabric, but the effect of the window replacements is even more pronounced. The bank and its continued operation provides a link to, and continuity with, the period in which the downtown achieved significance; however, changes to the windows and doors as well as other alterations diminish its contributions to the downtown's historic character.

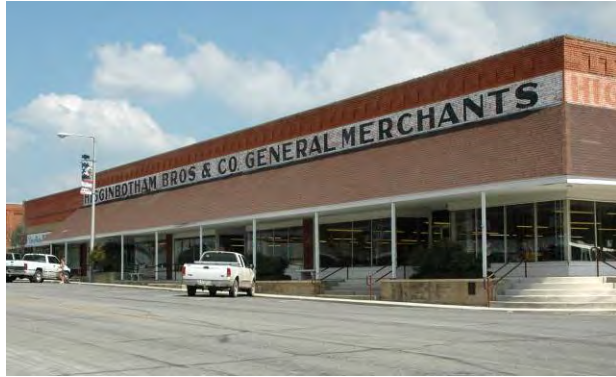
Figure 3-22 (top left). Higginbotham Store, Cross Plains.

The existing canopy is a strong visual element that encompasses much of the exterior surface of the building.

Canopies are an often overlooked architectural element of resources in the *Commercial Buildings* property type category; however, they are a prominent part of the composition and organization of the façade and are important visual element. They also separate pedestrian/street-level zone from the rest of a building. The removal of a canopy or the replacement with non-historic materials and/or different profile, shape, or size can change the aesthetic quality of a historic commercial building. Figure 3-22 presents a good example. This building has a broad, shed-roofed, composition-shingle-covered canopy that extends across the front and continues to the side. It constitutes almost 50 percent of the surface area of the front façade. Although the corbelled brick and historic painted sign in the parapet are noteworthy, the canopy visually overwhelms these features and much of the building's historic fabric. Compared with the historic photograph (Figure 3-23), it is clear that the present canopy changes the character of the building. Other changes at the street level including the replacement of windows and doors as well as sidewalk alterations disrupt the building's historic character, but the canopy is the biggest factor and detracts from integrity of *Design, Materials, and Feeling*.

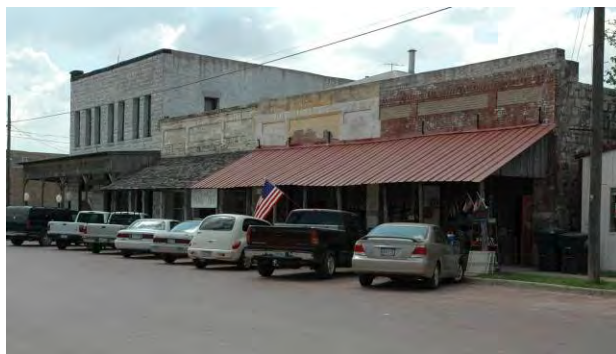
The replacement canopies are less obtrusive than those on the Higginbotham Store in Cross Plains.

The row of *One-Part Commercial Block* buildings in Miles includes three separate stores with replacement canopies (Figure 3-24). In contrast to the general store in Figure 3-22, the canopies do not represent as massive a visual and architectural feature and are less obtrusive. They clearly diminish the ability of the buildings to evoke a sense of the past, but are not as severe as the building in Cross Plains. In addition, the storefronts on these buildings retain their original configuration and have been subject to fewer changes. These buildings lack sufficient integrity to be individually eligible but retain enough of their historic fabric to be contributing to a downtown historic district.

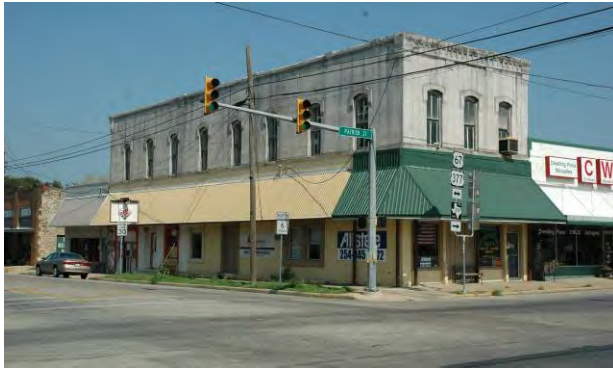
Figure 3-25 (left). Two-Part Commercial Block building in the 100 block of N. Patrick Street, Dublin.

Multiple changes to this historic building diminish its ability to convey significance. Some character-defining features are visible, but the combined effect of alterations compromises the building's integrity.

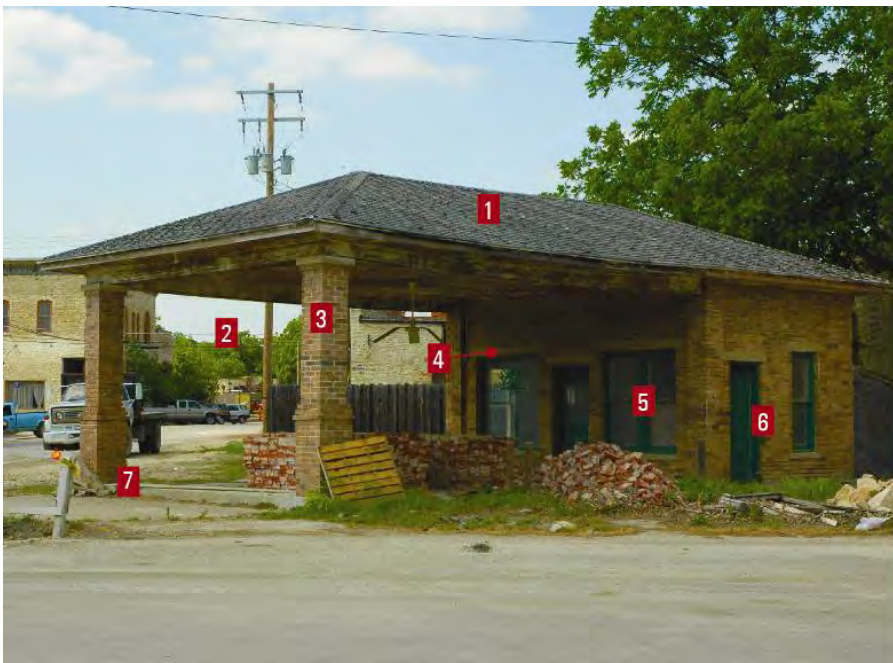
Figure 3-27. House with Canopy building at the northeast corner of First Street and Elm Street, Hico.

- 1 Hipped roof
- 2 Open service bay
- 3 Brick columns with corbelling at corners of canopy
- 4 Cast-stone lintels above windows and doors
- 5 Wood-frame, double-hung windows
- 6 Small office at rear of building
- 7 Oblique orientation of edifice on corner lot

Despite the construction debris on the lot, this gas station retains the salient features that identify it as a *House with Canopy* subtype, including the hipped roof and open service bay (Figure 3-27). It occupies a corner lot that fronts onto two streets at the outskirts of the downtown, and the building's angled orientation makes it easily accessible from two sides. In addition, the office still has wood-frame double-hung windows and wood-paneled doors with glazing. The open service bay has pressed metal ceiling tiles. The most obvious alterations are the absence of gas pumps and the lack of a concrete driveway. This *Gas Station* type was common throughout the study area during the early years of the automobile age, but this building is one of the intact and least-altered illustrations. Although it is no longer used as a gas station, which diminishes its integrity of *Association*, the building retains all other aspects of integrity. It still possesses the ability to convey significance as a good local example of its subtype, both individually and as part of a district.

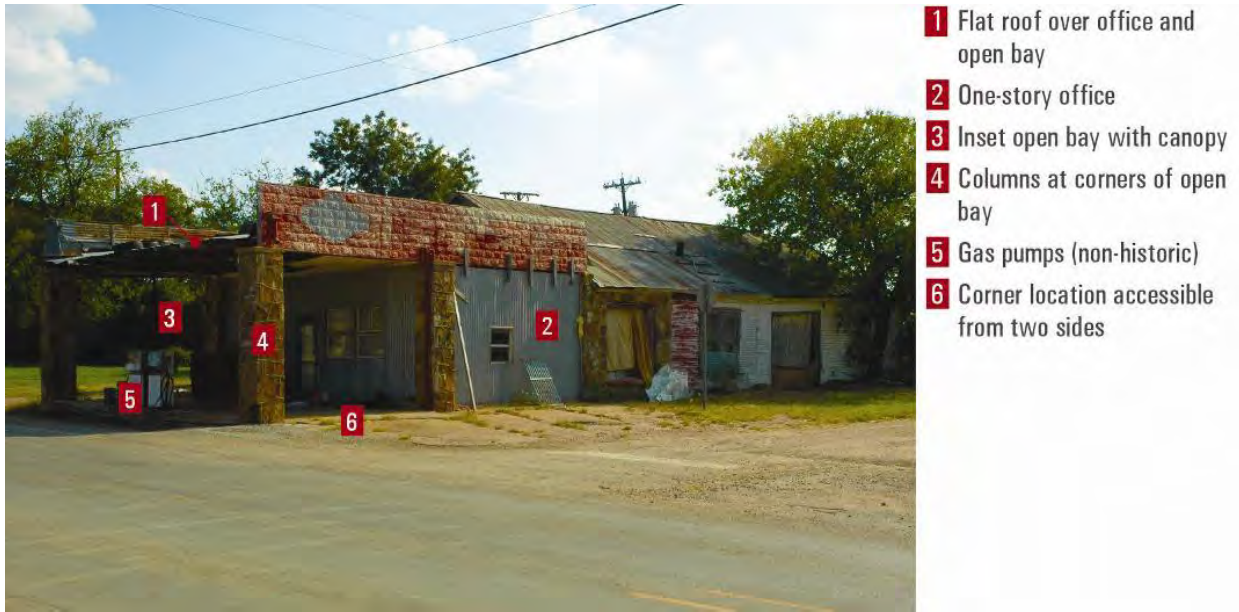
Figure 3-28. Box with Canopy building in 400 block of Ground Street, Moran.

This severely altered gas station is one of the few examples of a *Box with Canopy* subtype observed in the communities visited for this study.

This is the only example of a *Box with Canopy* gas station subtype documented for this study (Figure 3-28). Located in Moran, it presents a box-like massing that is the most distinctive physical characteristic of this subtype. The additions, introduction of new materials, and overall condition diminish the building’s integrity of *Materials, Feeling, Design, and Workmanship*. Furthermore, the gable-roofed rear addition changes the building’s overall massing and form and greatly diminishes some of the most important features that define this gas station within this property subtype. Since this building has been subject to extensive alterations that interfere with the gas station’s integrity, it no longer retains the ability to convey its significance, either individually or as part of the historic downtown. Nonetheless, it is noteworthy, albeit marginally, as the only extant example of a *Box with Canopy* gas station in the crossroads communities documented in this study.

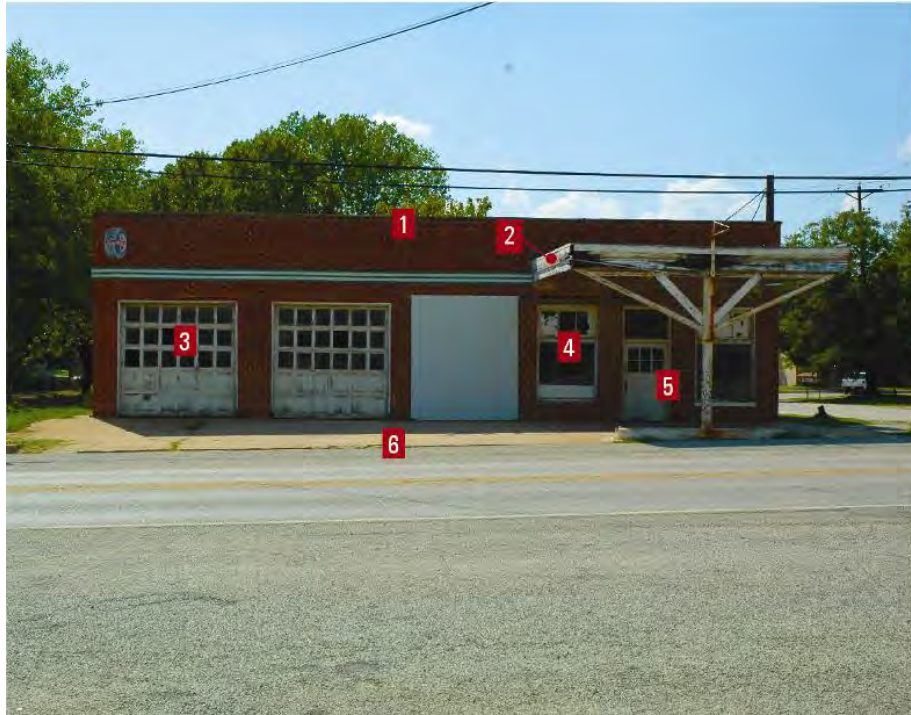
Figure 3-29. Oblong Box with Canopy building in the 100 block of N. Main Street (US 183), Rising Star.

- 1 Flat roof
- 2 Partial width, flat-roofed canopy
- 3 Overhead doors with glazing
- 4 Large plate-glass windows
- 5 Off-center office with single-door entrance
- 6 Corner location with concrete driveways

This building in Rising Star is an example of a mid-century gas station (Figure 3-29). Located on the north end of the downtown, the gas station marks the southbound entrance into Rising Star’s historic commercial center along US 183. The building has been subject to some change, most notably the removal of gas pumps and the placement of an overhead metal door in one of the garage bay openings. However, the building retains other salient features of an *Oblong Box with Canopy* gas station including its elongated plan and canopy over the pumping area. Other noteworthy features include the wood paneled garage doors with glazing and the original wood-frame windows, transoms, and doors. The building is presently vacant, which affects its integrity of *Association* and to a lesser degree integrity of *Feeling*, but it still retains other aspects of integrity and contributes to the historic character of the downtown.

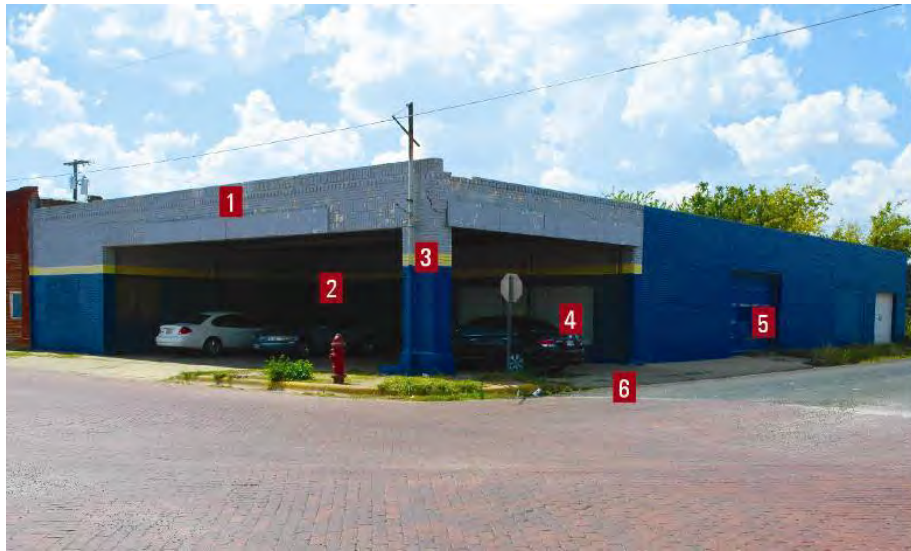
Figure 3-30. One-Part Commercial Block building at the southwest corner of Avenue C and E. Elm Street, Olney.

- 1 Massing and form similar to commercial building
- 2 Large inset open bay
- 3 Prominent masonry pier at corner
- 4 Large plate-glass windows
- 5 Overhead doors to garage/service bay
- 6 Corner location accessible from two sides

This building in Olney is a good example of a *One-Part Commercial Block* building, and remains largely recognizable as a gas station despite the removal of pumps (Figure 3-30). The open service bays and corner location are among the most distinctive features of this subtype. Although not visible in this photograph, the ceiling in the open service bay has pressed metal tiles, again another common architectural element of this form. The application of paint over the brick exterior service, removal of gas pumps, and rear additions diminish integrity of *Materials* and *Design*. However, it retains other aspects of integrity to sufficient levels to contribute to the historic character of the downtown. Furthermore, its massing, form, and setback are consistent with those attributes of the vast majority of other commercial buildings in the downtown.

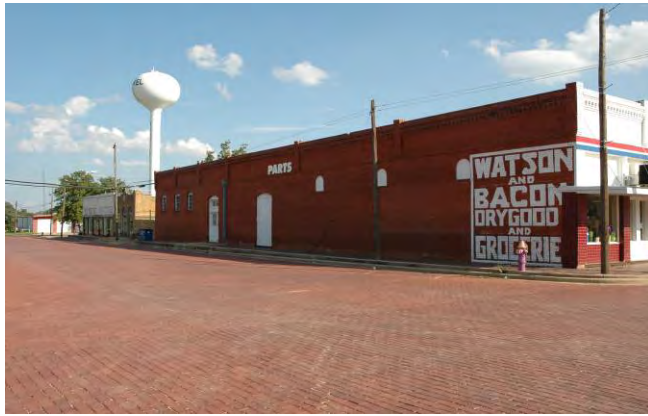
Figure 3-31 (left). Brick-paved street in 900 block of N. Second Street, Merkel.

Increased popularity of automobiles in the 1910s and 1920s led many towns, such as Merkel, to install brick paving in downtowns.

Brick-paved streets – an infrastructural improvement dating from the early twentieth century (Figure 3-31). Many of the crossroads communities still retain their brick-paved streets, and this feature may be a significant physical attribute that contributes to the downtown’s historic character. Common alterations that can affect integrity include covering or patching brick paving with non-historic materials.

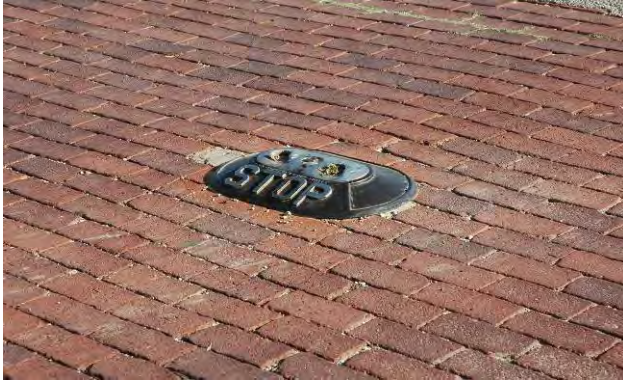
**Figure 3-36 (left).
Embedded stop sign in
Merkel.**

Many of the crossroads communities have similar kinds of objects that are a vivid reminder of the early years of the automobile era. This sign was manufactured by George C. Christopherson of Wichita, Kansas, likely from the late 1910s. Ghost marks showing the outline of such objects are still visible at street intersections in some cities, such as Miles.

Embedded stop signs – objects used to control vehicular traffic within the downtowns (Figure 3-36). Some crossroads communities still retain antiquated traffic stop signs that are embedded at busy intersections, usually in the middle of secondary streets. They typically are in locations where the historic brick paving remains intact. These signs are of metal construction and have the word “STOP” in large raised letters that can be seen, at least in theory, by drivers. They were designed to be noticed, not to impede traffic. The practice of using such devices soon lost its appeal, as they no doubt proved to be ineffective. Although they were used for a relatively short time during the early years of the automobile era, they can enhance the ability of a downtown to convey a sense of the past.
