TEXAS DEPARTMENT OF TRANSPORTATION

Historical Studies Report No. 2011-01

Guidelines for Assessing the NRHP Eligibility of
Commercial Historic Districts in Crossroads Communities
in Northwest-Central Texas

Prepared by David W. Moore, Jr.

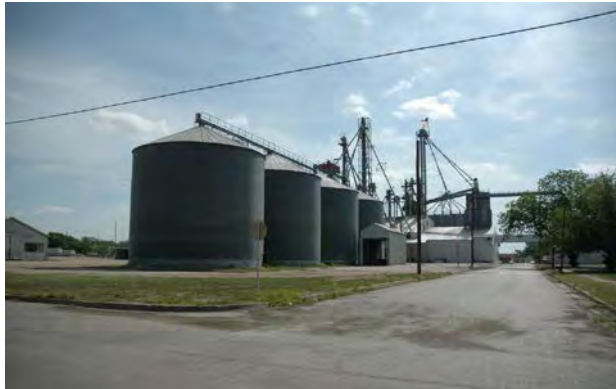
Figure 3-38 (left). Grain mill and elevator in Winters.

This industrial complex supports the local agriculture-based economy.

Grain mills and elevators and feed mills – part of an industrial complex used to store, process, and ship grain (Figure 3-38). Since farming and the cultivation of wheat, among other crops, historically represent fundamental aspects of the agricultural-based economies of many crossroads communities and surrounding areas, grain mills and elevators are a common resource type. They typically are located adjacent to and have direct access to railroads. They are often grouped in industrial zones, usually located on the opposite side of the tracks of commercial and retail areas or, as is the case in Winters, between the downtown and the railroads. These industrial operations typically include one or more offices, as well as a series of large multi-story concrete cylinders and

groupings of metal silos or storage bins. A complex system of conveyors moves and distributes grain within the complex.

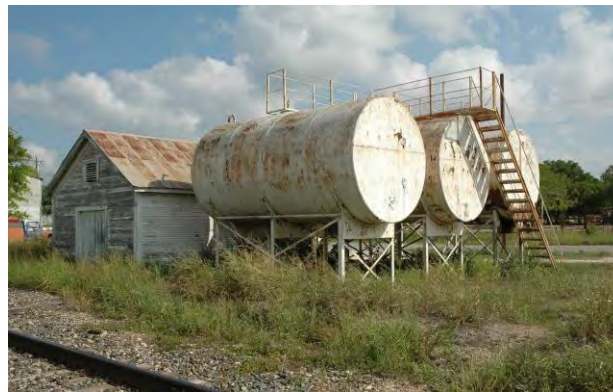
Figure 3-40 (bottom). Oil tanks in railroad right-of-way, Lometa.

This complex, which also includes an associated warehouse/office, is a common resource type built along railroad right-of-ways.

Oil tanks – above-ground cylindrical metal storage tanks placed on metal stands, typically located adjacent to railroad tracks (Figure 3-40).

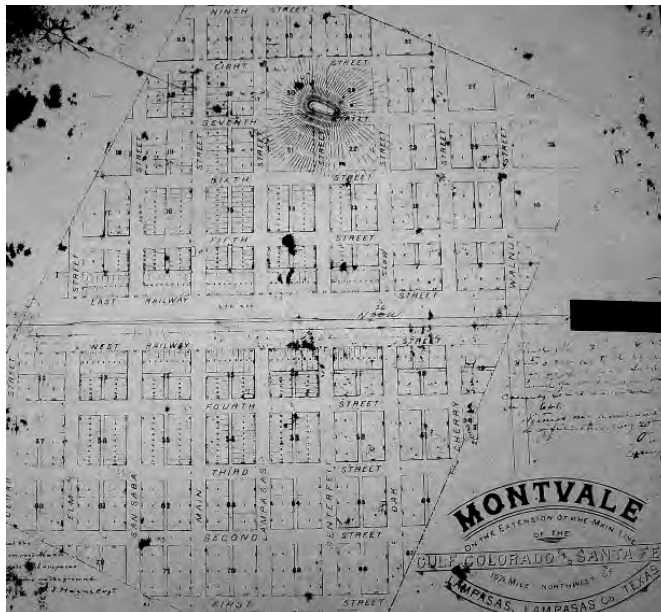
Figure 4-9 (left). Montvale Town Plat, Office of the County Clerk, Lampasas County Courthouse Annex, Lampasas.

The original name for Lometa was Montvale, and it was established by the Gulf, Colorado and Santa Fe Railway. Note the narrow and deep commercial lots on most property fronting onto the railroad. This configuration established the pattern for subsequent patterns of development.

Legal records and plat maps are public records that can be copied at the county courthouse, tax office, or tax appraisal district and can be reviewed during the field investigation phase of a survey. Unless a fire or other calamity destroyed records at the courthouse, the original town plat and/or subdivision maps should either be available in deed records or plat map file cabinets at the county clerk's office (Figure 4-9). The original plat maps delineate blocks, lots, and streets and graphically depict original or intended patterns of development and uses of property. For example, narrow yet deep lots typically indicate that the property is targeted for commercial use. The number of blocks with such lots reveals how large the town founder(s) envisioned the downtown to be and the relative size of the community. Comparing existing concentrations of historic commercial buildings identified through field investigations with the original plat shows how the town grew and evolved (Figure 4-10).

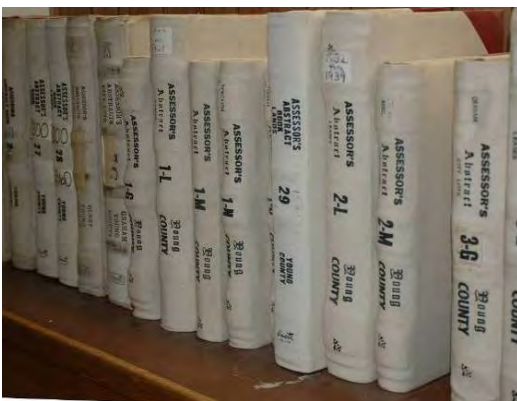
Figure 4-11 (left).
Assessor's Abstracts,
Young County, Office of
the Tax Assessor-
Collector, Young County
Courthouse, Graham.

These records provide a year-by-year list of all property in the county. Property evaluations can indicate improvements to a lot and can also serve as a barometer of the local economy.

Tax abstracts are county records that present a year-by-year valuation of property based on the legal descriptions (Figures 4-11 and 4-12). Compiled in large, bound volumes similar in size to deed records, they contain tax information for a multi-year (usually a five-year) period. The county tax office maintains these records, which are used so infrequently that county staff

sometimes is unaware that they exist or know little about them. However, tax abstracts are very useful for historians and researchers because they identify property owners, track improvements through increases in property values, and note sales and transactions of properties. Such records are more useful for intensive-level surveys, but a quick review of these materials can provide vital site-specific information for a reconnaissance-level survey as well as general construction activity and trends of development over time. Since they are organized by legal description rather than the name of the property owner (ad valorem tax records, copies of which are available at the Texas State Library and Archives), they are an invaluable tool for historians not only when evaluating downtowns in crossroads communities, but also for undertaking any type of historic resources surveys.

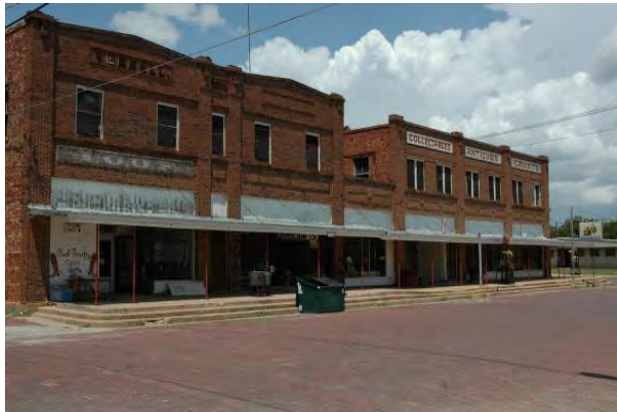
Figure 4-20 (left). Buildings with significance under Criterion C, 100 block of N. Rusk, Ranger.

These buildings are among the best and most intact collections of early twentieth century commercial architecture in the study area. They retain most of their original physical qualities and features, which distinguishes them as noteworthy architectural landmarks in the community.

A historic district may also possess significance because of the cohesive qualities of its resources, which may lack distinction on an individual basis but are noteworthy when considered collectively as a single unit and/or grouping of resources. The following provide guidance for assessing a historic district that derives significance from the physical qualities of its design and/or association with the work of a master (Figures 4-20 and 4-21).

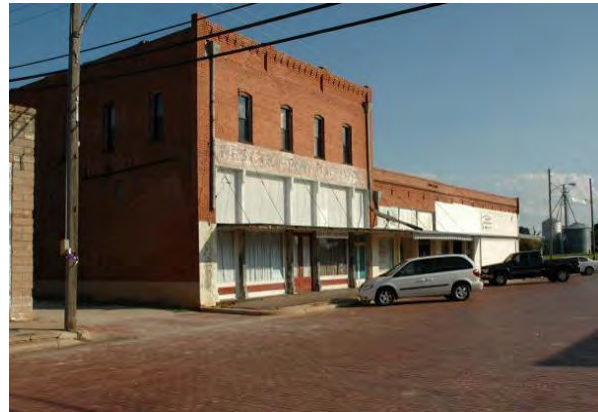
Figure 4-21 (right). Buildings with significance under Criterion C, 100 block of Edwards, Merkel.

The buildings in this image do not possess sufficient significance or integrity to be eligible for the NRHP under Criterion C on an individual basis. However, they illustrate how buildings lacking significance for their own merits can be noteworthy as a grouping because of their physical attributes.

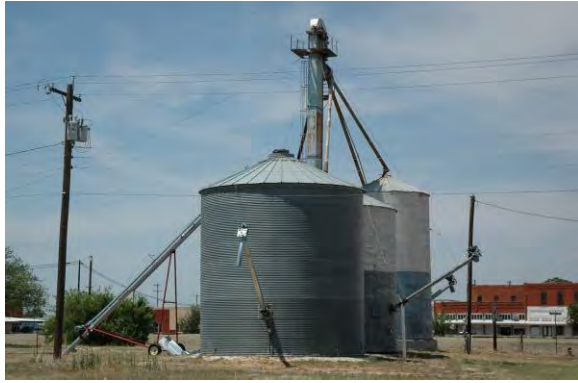
Figure 4-28. (left) Agricultural-processing businesses near downtown Merkel.

The grain silo in the foreground is one of several light industrial operations that served area farmers. Tracks of the Union-Pacific Railroad, originally part of the Texas and Pacific Railway system, extend between the silo and the downtown (in the right background). Merkel's success was largely dependent on this and other similar agriculture-related processing operations.

- *Industry*. The district includes a collection of light industrial buildings near the railroad tracks whose operations contributed directly not only to the local economy but also specifically to the downtown (Figure 4-28). For a downtown to have significance in the area of *Industry*, it must derive a large degree of its importance from the establishment and operation of industries within its boundaries. When assessing significance in the area of *Industry*, consider the following:

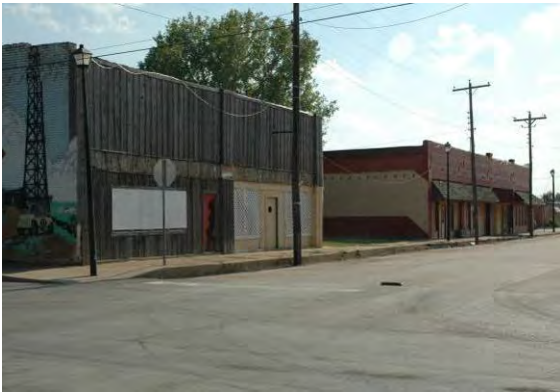
Figure 4-34 (left). 300 block of Fisher Street, Moran.

The combined effect of changes to these buildings renders the historic downtown of Moran unable to retain its integrity of *Design*. Alterations include the covering of window and door openings, the application of paint over original brick surfaces, and the removal of canopies, as well as vacant lots that disrupt the historic rhythm of the downtown and diminish other aspects of integrity (*Materials, Feeling, Setting, and Craftsmanship*).

contrast, a commercial historic district eligible under Criterion A or B need not retain its integrity of *Design* to as high a standard. However, it still must remain recognizable to the period in which it attained significance and convey a strong sense of the past (Figure 4-34). The kinds of changes and alterations that can affect integrity of *Design* of historic resources in a district can include but are not necessarily limited to:

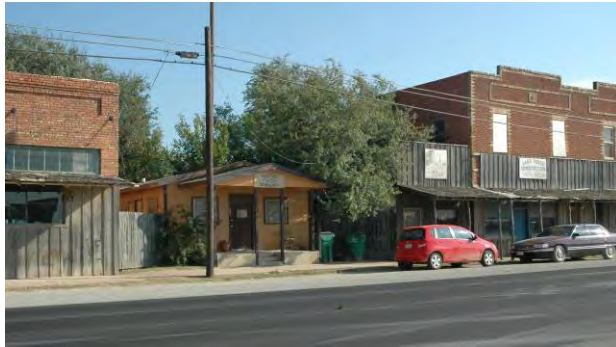
Figure 4-38. 100 block E. Dempsey Street (US 380), Bryson.

The application of board-and-batten siding obscures original building materials that largely defined the historic physical and architectural character of this block. The existing appearance bears little resemblance to the time when the downtown enjoyed its primary period of significance. The wood siding also affects integrity of *Workmanship* and *Feeling*.

- Installation of stucco, aluminum, or other materials over original exterior finishes, or materials that postdate the period of significance (Figure 4-38);

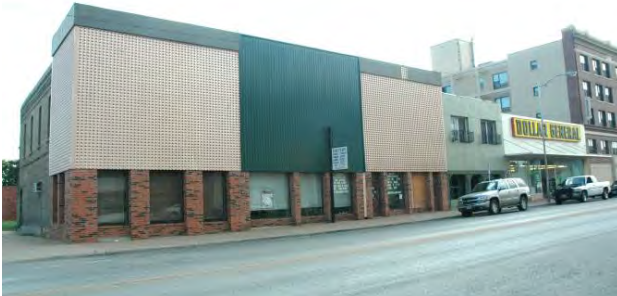
Renovations from the 1960s and 1970s to this grouping of buildings obscure noteworthy architectural embellishment. While the changes reflect a changing dynamic in the mid-century local oil-dependent economy, the renovations completely overwhelm the original historic character of the buildings. They also compromise integrity of *Workmanship*, as well as other aspects of integrity.

Figure 4-39. 200 block of W. Main Street, Ranger. Renovations from the 1960s and 1970s to this grouping of buildings obscure note-worthy architectural embellishment. While the changes reflect a changing dynamic in the local oil-dependent economy during the mid-century, The renovations completely overwhelm the original historic character of the buildings. They also compromise integrity of *Workmanship*, as well as other aspects of integrity. 4-32

- Removal of architectural ornamentation/embellishment on wall surfaces and in windows, doors, canopies, storefronts and drive-thrus;
- Replacement or installation of architectural ornamentation with modern or anachronistic elements (Figure 4-39); and
- Use of stucco and other materials to cover architectural features that display noteworthy craftsmanship, such as corbelled brickwork in the cornice (Figure 4-40).

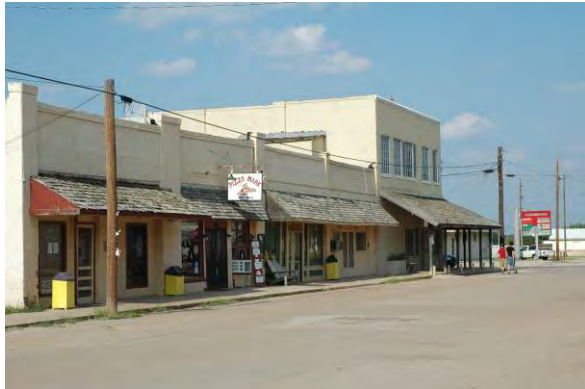
Figure 4-41 (left). 300 block of Fisher Street, Moran.

The community of Moran enjoyed its greatest prosperity during the early twentieth century as a regional agricultural processing and shipping point for area farmers. The community's slow decline for the last several decades is evident by the existing character of the downtown, which diminishes its integrity of *Feeling*.

Figure 4-41. 300 block of Fisher Street, Moran. The community of Moran enjoyed its greatest prosperity during the early twentieth century as a regional agricultural processing and shipping point for area farmers. The community’s slow decline for the last several decades is evident by the existing character of the downtown, which diminishes its integrity of *Feeling*. 4-33

Integrity of *Feeling* is measured by the degree to which the aesthetic and historic character of a resource is conveyed. A property that retains its integrity of *Feeling* closely resembles its appearance at the time it achieved significance and remains in a good state of repair. Integrity of *Feeling* can be compromised by minimal changes that by themselves are not particularly severe, but when combined may have a significant effect on a resource's historic character. A resource that no longer retains other aspects of integrity, such as *Design, Materials, Setting, and Workmanship*, will no longer possess integrity of *Feeling*. If the majority of the buildings in a district lack such qualities, the district likewise does not retain sufficient integrity of *Feeling* to meet NPS standards. The introduction of new infrastructural improvements or the creation of public spaces on former building sites may also detract from this aspect of integrity for a district. A historic downtown area in a crossroads community that possesses its integrity of *Feeling* conveys that the area served as the local center for retail and wholesale operations and visually communicates that role and historical association. As such, integrity of *Feeling* is a fundamental part of the integrity analysis process. The many kinds of changes (Figures 4-41 and 4-42) that can affect integrity of *Feeling* include:

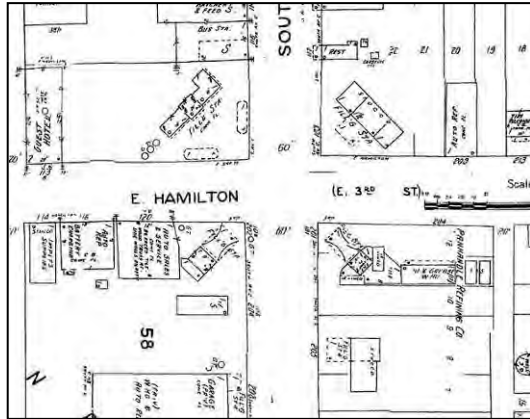
**Figure 4-43 (left).
Intersection of S. Avenue C (formerly SH 79) and E. Hamilton Street, Olney.**
This intersection once marked the northbound entrance into Olney. It contained gas stations at each corner that catered to the high volume of traffic that passed through this once strategic and important intersection in Olney during the oil boom era of the 1920s and 1930s.

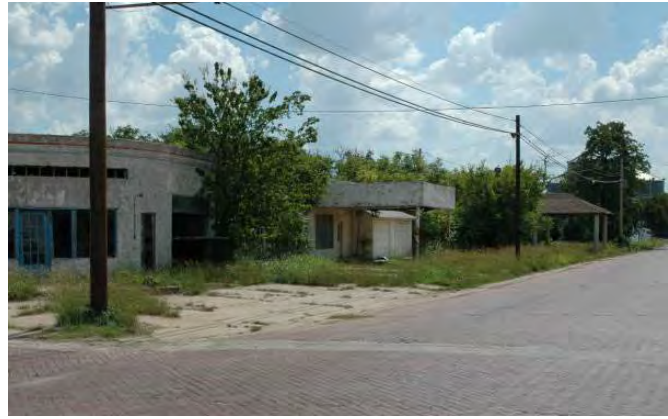
**Figure 4-44 (right).
Abandoned gas stations in 100 block of S. Avenue C, Olney.**
In 1939, the re-routing of SH 79 two blocks to the east shifted traffic and activity away from this block and led to a gradual decline of the area. The abandoned gas stations underscore the importance of the city as a crossroads community and its dependence on transportation. However, their deteriorated state and abandonment negatively affects the downtown's integrity of *Association*.

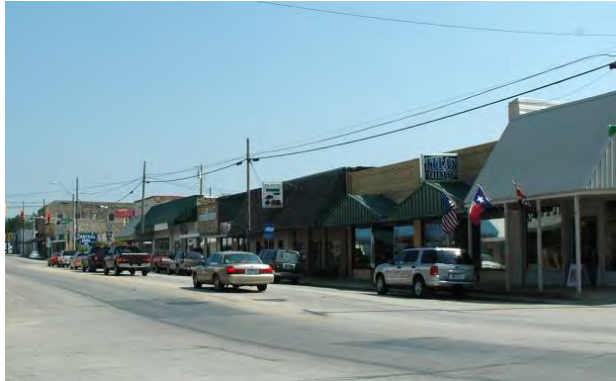
Figure 5-1 (left). 100 block of Patrick Street (US 377), Dublin.

Downtown Dublin continues to be an active hub of commercial and retail activity with a constant flow of local and out-of-town traffic.

The historic downtown of Dublin (Figure 5-1) remains at the juncture of two regionally important highways: US 377 and SH 6. Unlike many other crossroads communities in the study area, Dublin does not have a bypass highway to relieve traffic congestion in the downtown. Many local businesses continue to occupy most of the historic commercial buildings. While the area's commercial viability remains strong and stable and retains its integrity of *Association* to an exceptional degree, most buildings have been subject to extensive alterations that diminish the downtown's overall historic character. The overall effect of these modifications compromises other aspects of integrity (*Materials, Design, Workmanship, and Feeling*).

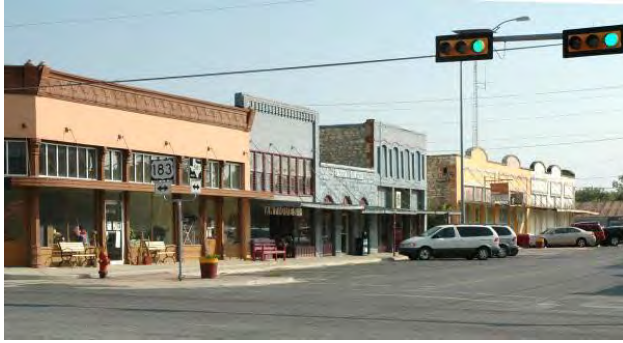
Figure 5-3 (left). 100 block of W. Main Street (FM 581), Lometa.

The commercial buildings in this block illustrate Lometa's primary period of development. The relative lack of alterations to the buildings contributes to the ability of the downtown to convey a strong sense of the past.

The buildings in downtown Lometa (Figure 5-3) reflect the community's role as a regional retail and distribution center in northwestern Lampasas County. Most of the extant buildings date from the late nineteenth and early twentieth centuries when Lometa gained significance as a shipping point for locally produced cotton, pecan, and other crops, as well as for shipment of mohair and wool. The buildings in this image and others nearby reflect the downtown's importance from a well-defined and easily recognizable period of time and are tangible links to distinct historical patterns and trends.

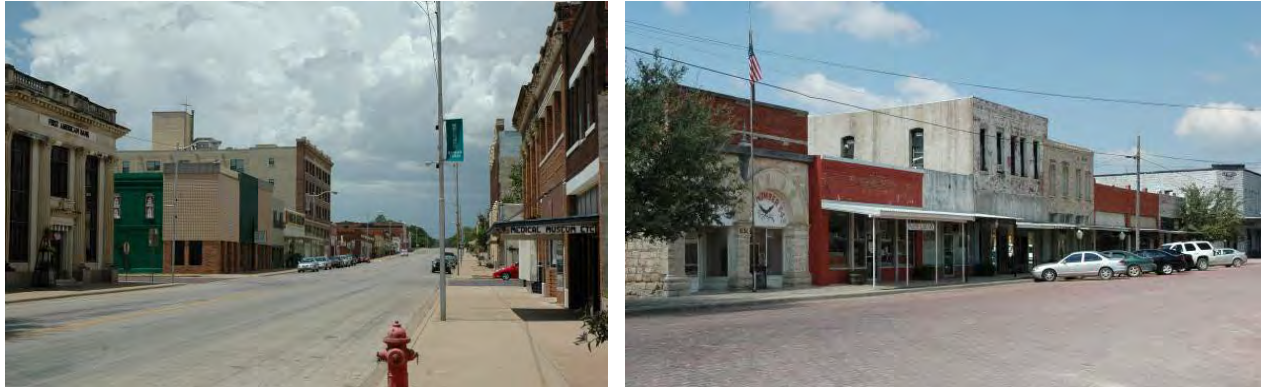
Figure 5-5 (left). 100 - 200 blocks of W. Main Street (RR 101), Ranger.
The majority of buildings in downtown Ranger date to the oil-boom era of the late 1910s and 1920s and represent the community's most prosperous period of development.

Figure 5-6 (right). 100 block of Robinson Street, Miles.
Downtown Miles developed during the late nineteenth and early twentieth century and served area farmers and ranchers.

Ranger is a community that experienced unprecedented growth following the 1917 discovery of oil in the region. During the next several years, most of the extant buildings in the downtown were constructed. The oil boom brought great wealth to the community and its residents, but that prosperity lasted for only a brief time. The city was in decline by 1930. The buildings in Figure 5-5 provide a tangible link to this period and are a vivid reminder of the community's significance as a regional oil-producing center through much of the 1920s. Many of the buildings in downtown Ranger exhibit a scale and level of craftsmanship and detail that stand out among other downtowns documented in the study area. The equally dramatic bust in the local oil industry in the 1930s triggered by overproduction and poor management of resources had a profound effect on the downtown. Many of the buildings were simply abandoned and left to deteriorate. Today, empty lots mark the locations of stores and offices erected during the oil boom and many buildings stand vacant in dilapidated condition.

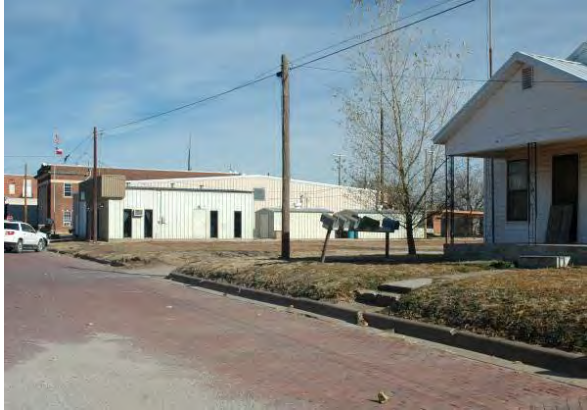
Figure 5-7 (left). 200 block of Grand Avenue, Olney.

A transitional area south of the City Hall (far left) separates the downtown from an adjoining residential neighborhood.

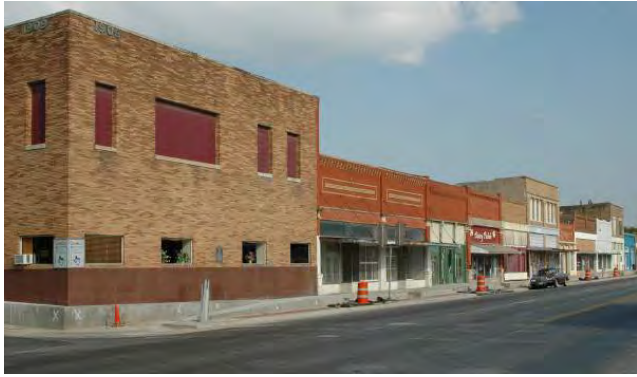
Figure 5-9 (left). 100 block of N. Main Street (US 83), Winters.

This block has no empty lots to disrupt the rhythm and uniformity of this part of the downtown.

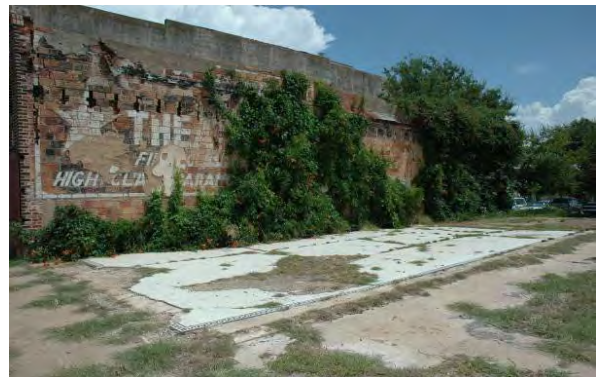
Figure 5-10 (right). 100 block of S. Austin Street, Ranger.

Figure 5-10. 100 block of S. Austin Street, Ranger. Foundations and flooring mark the sites of former commercial buildings and disrupt the cohesive quality of the block. . 5-11

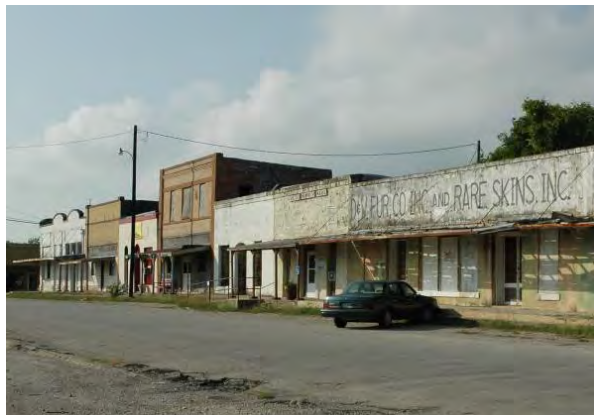
Figure 5-11 (left). 400 block of W. Railway Street, Lometa.

This streetscape presents an uninterrupted block with uniform setbacks that adds to the cohesive quality of the downtown.

The grouping of buildings in Figure 5-11 fronts onto railroad tracks that extend through the city. Each building maximizes the amount of frontage they have on the road that runs parallel to and directly abuts the railroad. This property likely was the most valuable during the city's period of significance. The uniform setbacks enhance the cohesive quality of the downtown and are fundamental aspects to the downtown's sense of time and place. Despite their current state, they nevertheless contribute, albeit marginally, to the historic character of the downtown. Their overall condition and abandonment diminish their integrity of *Association*, *Design*, *Materials*, and *Feeling*, but they retain enough of these qualities to help the downtown convey its significance.

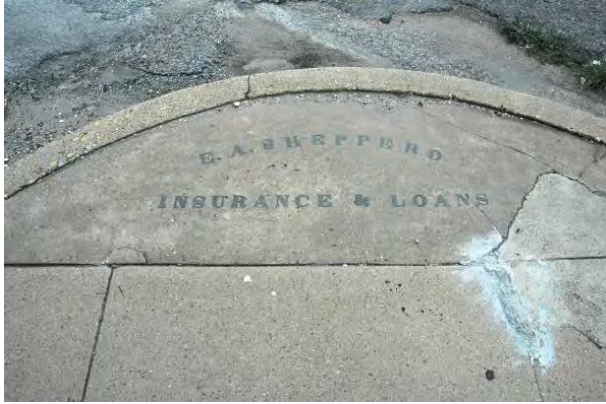
Figure 5-13 (left). 100 block of W. Dale Street (Texas Loop 438), Winters.

A distinctive sidewalk feature in downtown Winters that dates from the period of significance.

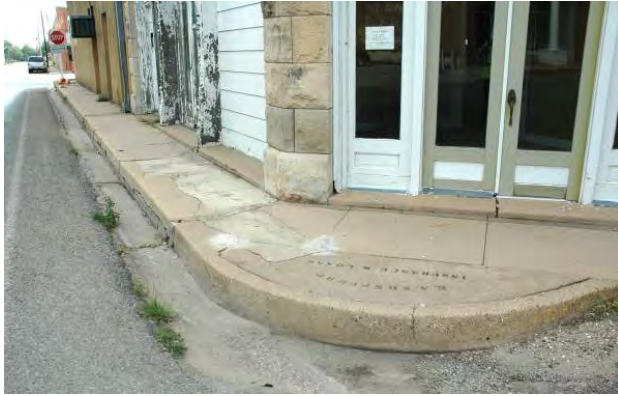
Figure 5-15 (left). 100 block of W. Dale Street (Texas Loop 438), Winters.

The continuous concrete curbing along this block adds to the downtown's overall historic character and is a contributing feature.

The curbing shown in Figure 5-15 is representative of the kind of continuous concrete curbing found in crossroads communities throughout the study area. The segment of curbing in this image remains in good condition and retains its salient features to a noteworthy degree. In other downtowns, the curbing has often deteriorated over time or has been repaired or patched with in-kind material. The curbing shown in this image contributes to the ability of the downtown to convey a sense of place from the period of significance.

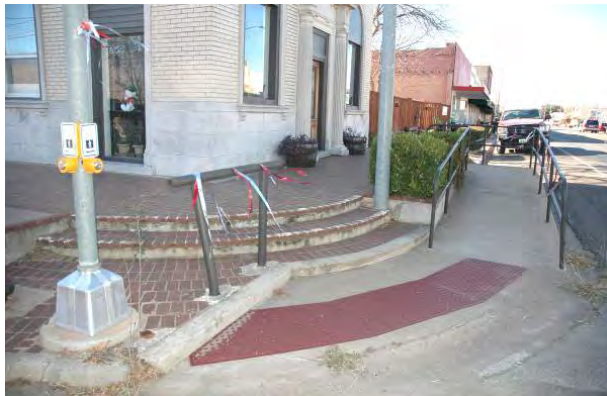
Figure 5-17 (left). Southwest corner of E. Main Street and Avenue C, Olney.

A reconfigured sidewalk and ramp at an important intersection in downtown Olney.

- Figure 5-17. Southwest corner of E. Main Street and Avenue C, Olney.** A reconfigured sidewalk and ramp at an important intersection in downtown Olney. 5-19

As seen in Figure 5-17, the extension of ramps into the street changes the layout of the street intersection and alters the relationship between the nearby building and the street corner. Efforts to revitalize downtowns through sidewalk improvement projects and to provide ADA-compliant ramps sometimes can have a negative effect on the historic character of a downtown.

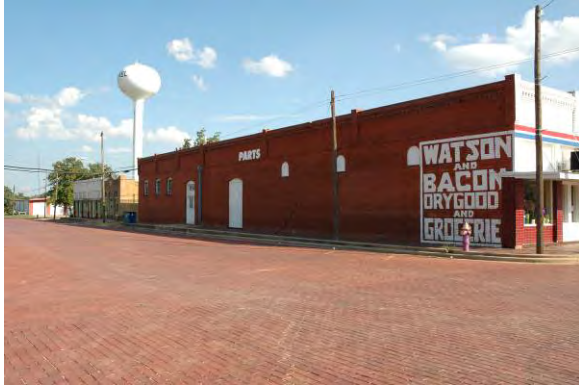
Figure 5-19 (left). 900 block of N. Second Street, Merkel.

Most of downtown Merkel retains its historic brick paving, which enhances the area's ability to convey a sense of the past from the period of significance.

Among all of the crossroads communities visited for this study, Merkel retains the highest percentage of its historic brick-paved surfaces (Figure 5-19). The brick streets contribute to a sense of cohesiveness and function as a physical and aesthetic link to the red brick masonry buildings that comprise much of the downtown.

In contrast to downtown Merkel, Cross Plains retains little of its original historic brick-paved streets. Figure 5-20 shows how the covering of brick paving with asphalt takes away some of the historic qualities of a historic downtown, as is evident when compared with Figure 5-19. While the buildings in this block are historic and retain their integrity to varying degrees, they would convey a stronger sense of cohesiveness if the original brick paving was intact and visible.

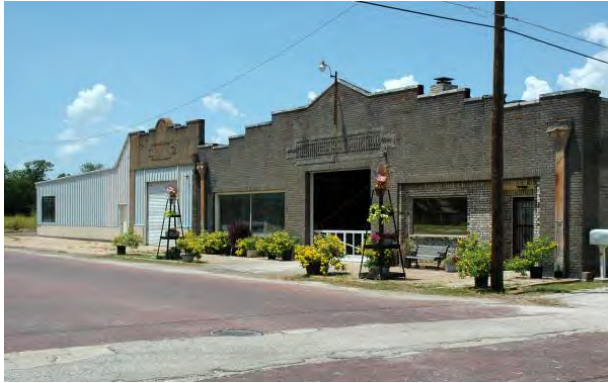
Figure 5-21 (left). 100 block of S. Austin Street, Ranger.

A group of altered buildings in downtown Ranger.

The buildings in Figure 5-21 show how changes at the pedestrian level can overwhelm the historic character of a streetscape. The brickwork in the parapets of both historic buildings is particularly noteworthy and is indicative of commercial architectural trends in the region during the early twentieth century. While the upper zones of the buildings retain much of their original historic character, the introduction of new materials, the partial enclosure of window openings, and the installation of modern overhead sliding garage doors are major alterations that have a negative effect on each building's character-defining features. While the buildings are recognizable to the period when Ranger enjoyed its most prosperous era as an oil-boom town, the combined effect of these modifications detracts from the downtown's historic character and integrity.

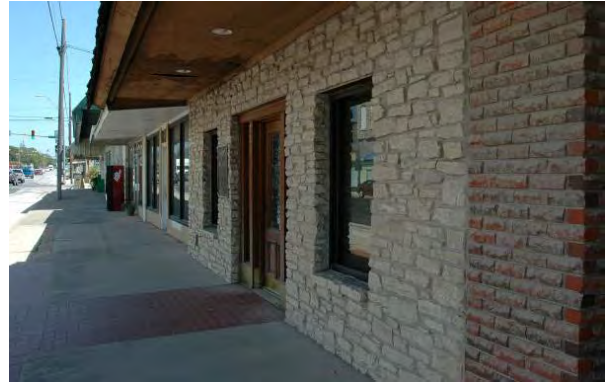
Figure 5-22 (right). 100 block of S. Patrick Street (US 377), Dublin.

Altered storefronts within the pedestrian zone.

The storefronts depicted in Figure 5-22 have been subject to extensive alterations. The introduction of new materials that are unlike those used during the period of significance greatly diminishes the original historic character and aesthetic quality of the downtown when it achieved significance. Other changes include new windows and doors and the reconfigured fenestrations of several buildings. This block retains few of the qualities that reflect the downtown's historic character.

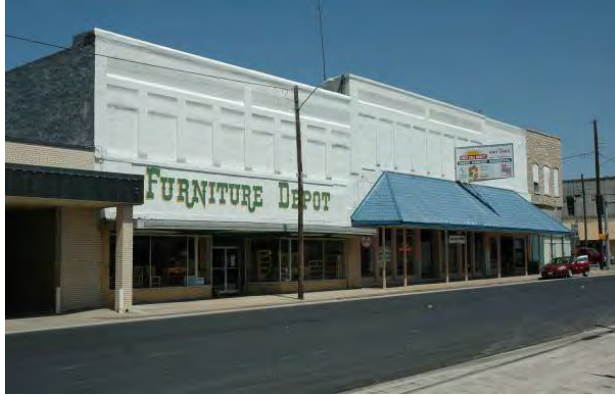
Figure 5-23 (left). 100 block of S. Patrick Street (US 377), Dublin.

A group of altered historic buildings in downtown Dublin.

All of the buildings in Figure 5-23 date from the late nineteenth or early twentieth centuries and present a scale and proportion that typify contemporaneous commercial architectural design in other crossroads communities throughout the study area. While the upper floor bays remain discernible, the fenestration on all but the stone building at the far right has been compromised due to the application of stucco onto exterior surfaces and window openings. The stucco covers many of the buildings' most important architectural features and diminishes their aspects of integrity. In addition, alterations at the pedestrian level also detract from the buildings' historic character. Aluminum-frame plate glass windows and doors, covered transom windows, and new canopies are among the most common kinds of changes in Dublin. The combined effect these alterations have to the buildings diminishes almost all aspects of integrity to such an extent that the downtown lacks the ability to convey significance under any National Register Criteria.

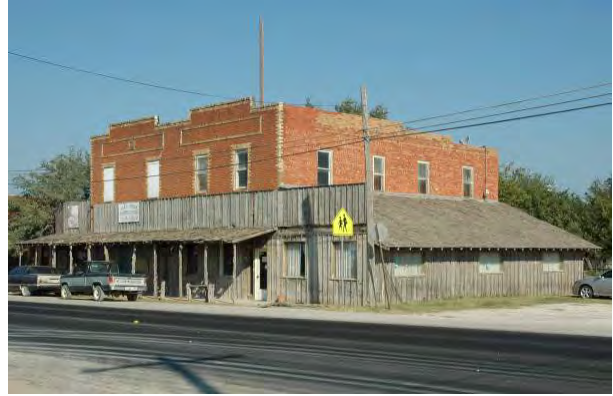
Figure 5-24 (right). 100 block of E. Dempsey Street (US 380), Bryson.

A group of one- and two-story brick and wood-frame commercial buildings in downtown Bryson.

- Figure 5-24. 100 block of E. Dempsey Street (US 380), Bryson.** A group of one- and two-story brick and wood-frame commercial buildings in downtown Bryson. 5-25

The grouping of buildings in the small crossroads community of Bryson (Figure 5-24) illustrates how the use of non-historic materials can affect the historic character and integrity of a streetscape. The building at the far left of the picture is a one-story board-and-batten building that may be the oldest of all the buildings. The application of board-and-batten siding to the two-story brick building creates a more unified, rustic effect at the pedestrian level. However, this appearance is not consistent with the historic character of the two-story brick building. While the upper floor retains much of its original fabric, the visual impact of the board-and-batten siding and other changes at the pedestrian level compromise the historic character to such an extent that integrity is lost and the building no longer retains the ability to convey significance.

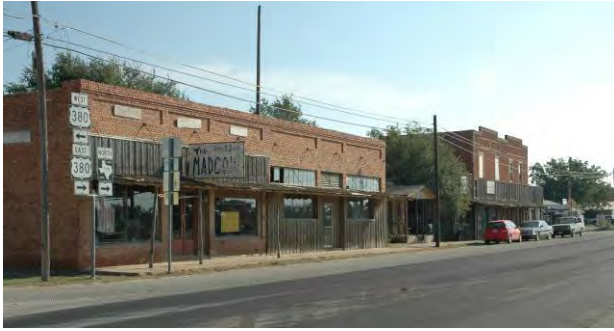
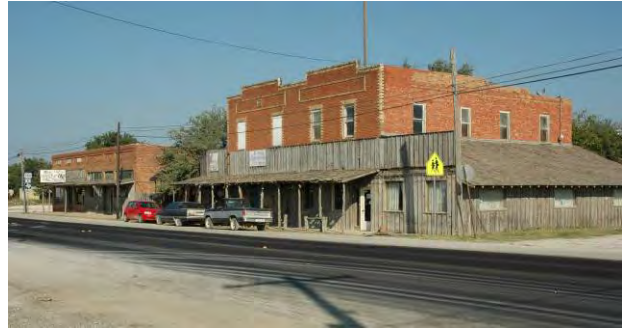
Figure B-1 (left). 100 block of E. Dempsey Street (US 380), Bryson.
North side of the block looking northeast.

Figure B-2 (right). 100 block of E. Dempsey Street (US 380), Bryson.
North side of the block looking northwest.

In 1903, the Chicago, Rock Island, and Gulf Railway line arrived in Bryson. The tracks, however, are not shown on the 1906 plat map of the town. It depicts Bryson as a 9-block site on 13 acres with only four named streets – Dempsey, North, West (Depot) and East streets. Narrower lots for commercial development were planned on Dempsey Street between present-day College and Boland streets. West Street led south to the depot at Clayton Street. The small town was utilized by area cattle ranchers as a center for trade and education.

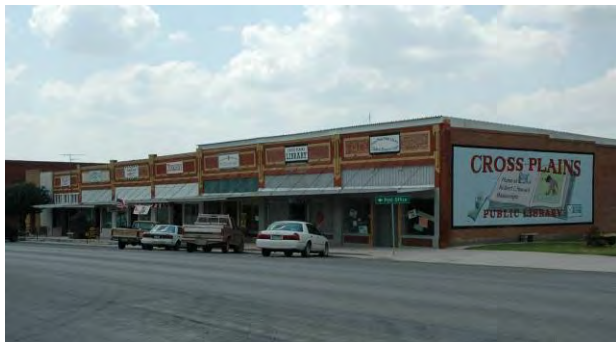
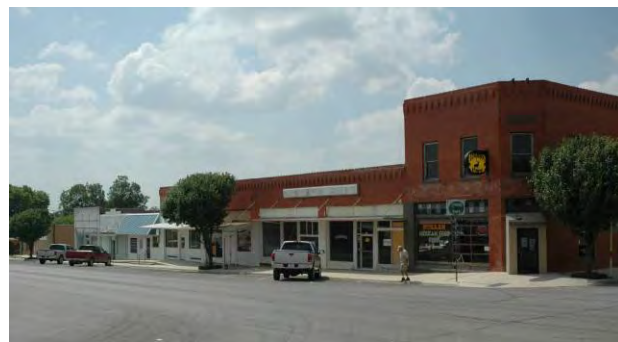
Figure B-3 (left). 100 block of N. Main Street, Cross Plains.

Figure B-4 (right). 100 block of S. Main Street, Cross Plains.

Cross Plains, in the southeast corner of Callahan County, is situated at the intersection of State Highways 36 (Fifth Street) and 206 (Main Street) (Figures B-3 and B-4). The town was originally settled at and named after Turkey Creek, which presently runs through Treadway Park at the western edge of Cross Plains. Cross Plains was founded as a post office in 1877 and named due to its location at the crossing of stage coach and military roads. One of these was the Fort Mason-Camp Cooper Military Road leading to those outposts at present day Mason (Mason County) and Throckmorton (Throckmorton County), respectively. Between 1880 and 1910, Cross Plains' population grew from 25 to 600.

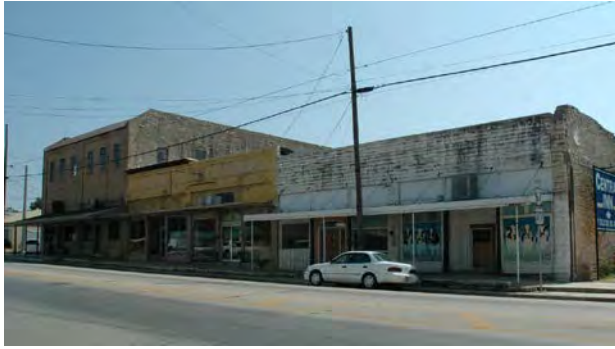
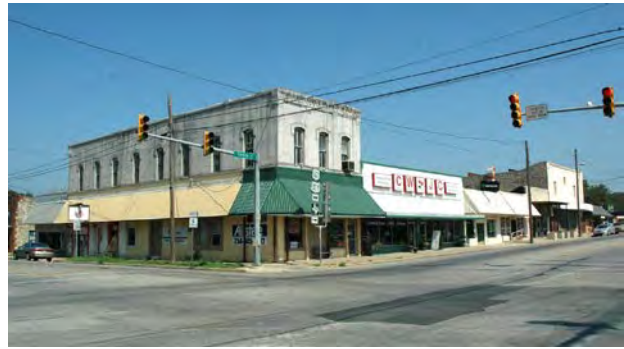
Figure B-5 (left). 100 block of N. Patrick Street (US 377 and US 67), Dublin.

Figure B-6 (right). 100 block of N. Patrick Street (US 377 and US 67), Dublin.

Dublin is located in the west-central portion of Erath County (Figures B-5 and B-6). It is positioned at the intersection of US 67 and 377 (Patrick Street) and SH 6 (Blackjack Street). Old Dublin was founded in 1854 and experienced growth in the mid-1870s with the acquisition of a stagecoach line and post office. New Dublin was formed in 1881 when the Texas Central Railroad built tracks through to Mount Airy; the new town was formed on the rail line four miles southwest from Mount Airy and had 45 businesses within a year. An additional rail line, the Fort Worth and Rio Grande, which was completed to Stephenville in 1889, was also present west of Post Oak Street. The new town's growth around the rail lines spurred economic progress as cotton farmers now had better access to eastern markets.

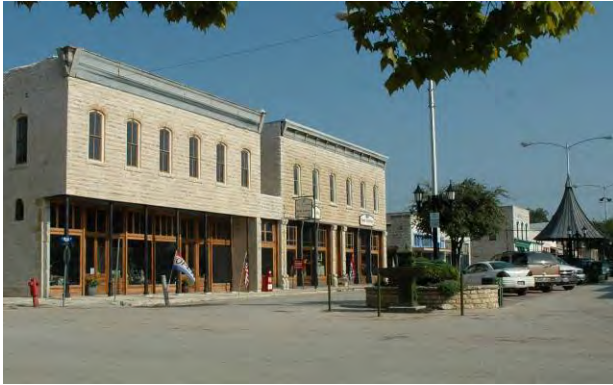
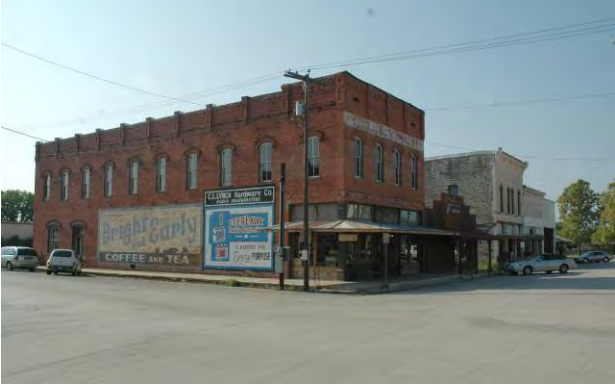
Figure B-7 (left). 100 block of S. Pecan Street, Hico.

Figure B-8 (right). 100 block of S. Pecan Street, Hico.

Hico is located at the crossroads of US 281 and SH 6 and 220 in the northeastern corner of Hamilton County (Figures B-7 and B-8). The old town was founded in 1856 on Honey Creek, two-and-a-half miles south of its present location. It had eight businesses in 1874. In 1880, Old Hico was moved to access the line of the Texas Central Railroad. Hico’s agricultural economy relied on some cotton production but mostly cattle and horses.

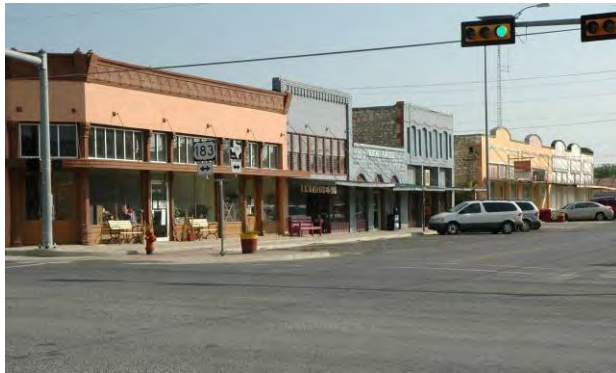
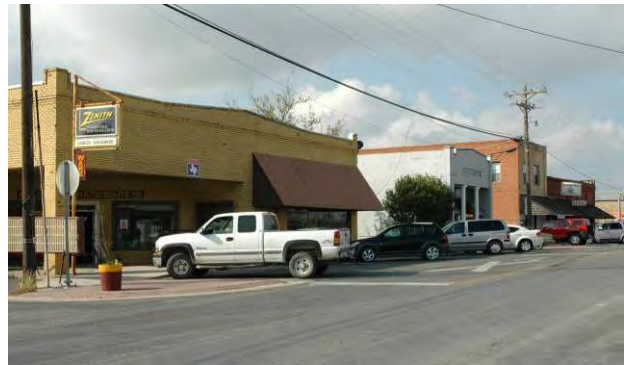
Figure B-9 (left). 100 block of W. Main Street, Lometa.
North side of the block looking northeast.

Figure B-10 (right). 100 block of W. Main Street, Lometa.
South side of the block looking southwest.

Lometa is located at the intersection of US 183 (Fourth Street, formerly US 190 and 284) and Ranch Road 581 (Main Street) in south-central Lampasas County (Figures B-9 and B-10). The town was founded at the site of the Frank Longfield Ranch in 1885 on the Santa Fe Railway line as it extended from Lampasas, 15 miles to the east. Longfield deeded the required 100-foot right-of-way in June and sold an additional 2,000 acres to the railroad for the development of a town the following month. Originally platted as Montvale in May 1886, the town’s name change occurred in July with the application for a post office. Early commercial development in Lometa included businesses that relocated from the village of Senterfitt three miles to the west in order to be on the railroad line. Agricultural production in the outlying areas included cattle, sheep, wool, cotton, grain, and pecans; farmers and ranchers utilized the railroad at Lometa to ship their livestock and produce. Lometa’s commercial area developed around Main and Fourth streets, just west of the railroad.

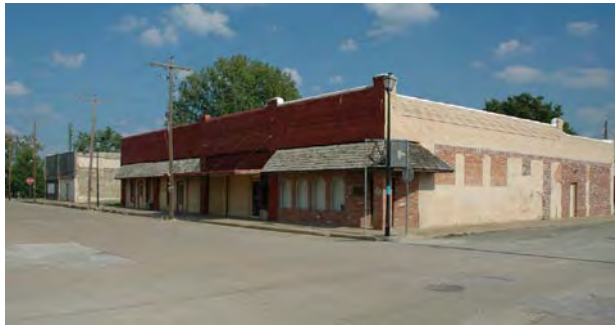
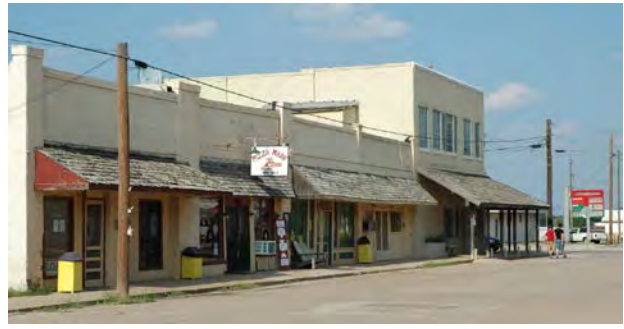
Figure B-13 (left). 300 block of Fisher Street, Moran.

Figure B-14 (right). 300 block of Fisher Street, Moran.

Moran is located at the intersections of SH 6, FM Roads 880, 576, and 2408 in the southeast corner of Shackelford County (Figures B-13 and B-14). The town was founded in 1882 with the construction of the Texas Central Railroad. Early commercial growth of the small town was influenced by Moran's position as a center from which area farmers and ranchers shipped their goods.

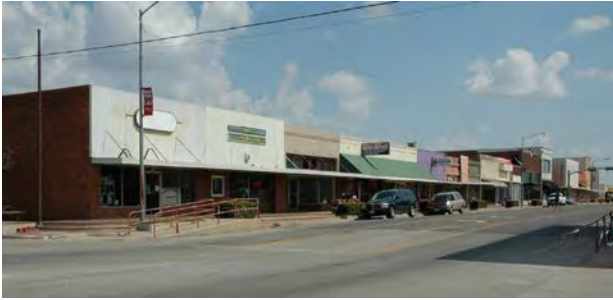
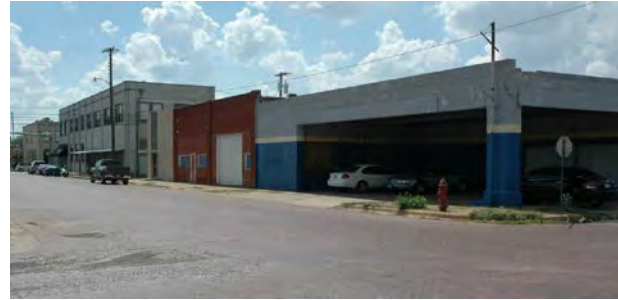
Figure B-15 (left). 100 block of W. Main Street (SH 114), Olney.

Figure B-16 (right). 100 block of N. Avenue C, Olney.

Olney is located in north-central Young County at the crossroads of SH 79 and 114 (Main Street), FM 210 (Spring Creek Road) and 1768 (Hall Road), and SH Loop 132 (Avenue M) (Figures B-15 and B-16).

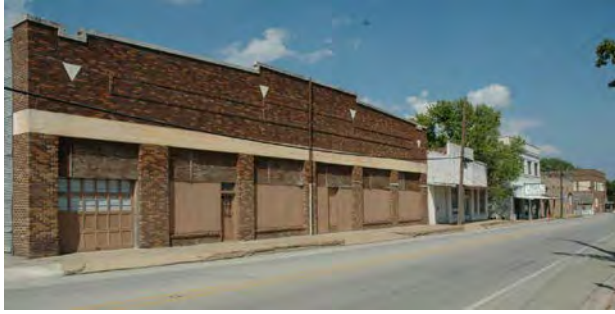
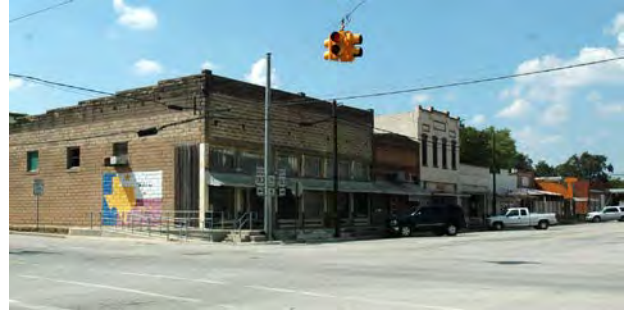
Figure B-19 (left). 100 block of W. College Street (SH 36), Rising Star.

Figure B-20 (right). 100 block of N. Main Street (US 183), Rising Star.

Rising Star is located at the crossroads of US 183 (Main Street, formerly US 283) and SH 36 (College Street) in the southwestern portion of Eastland County (Figures B-19 and B-20). The area was settled in 1876. A post office was established in 1878 with the town named Copperas Creek, the body of water between the forks of which it was located. Rising Star received its present name in the early 1880s.

In the spring of 1911, a fire destroyed much of the southeast portion of the town. As a result, the wood-frame buildings that dominated downtown were replaced with masonry buildings. Most of them were one-story with iron column structural systems. Also in that year, the Missouri, Kansas, and Texas Railroad was built through Rising Star on its path from Cross Plains (Callahan County) to De Leon (Comanche County), which significantly affected the growth of Rising Star's commercial district. The line extended along Mills Street, one block north of the town's crossroads intersection. The arrival of the railroad brought additional economic opportunities for those involved in agricultural endeavors in outlying rural areas, particularly cotton farmers and buyers. Formerly, cotton farmers shipped their freight by wagon to Cisco or Brownwood, two- and three-day roundtrips, respectively, because of the distance and the poor conditions of the roads. With the instigation of rail service, Rising Star became an increasingly important center of commerce and trade as area farmers bought their cotton to town for sale. Buyers used the railroad to transport cotton to markets elsewhere. A 1914 boll weevil infestation ruined cotton crops throughout the area, forcing farmers to learn to cultivate other crops such as peanuts. Though Rising Star's economy was affected by these changes, the town continued to grow. Rising Star's 1919 plat map and the 1921 Sanborn Fire Insurance Company Map illustrate dense commercial development extending from the intersections of Main and College streets after the fire and the development of the railroad.

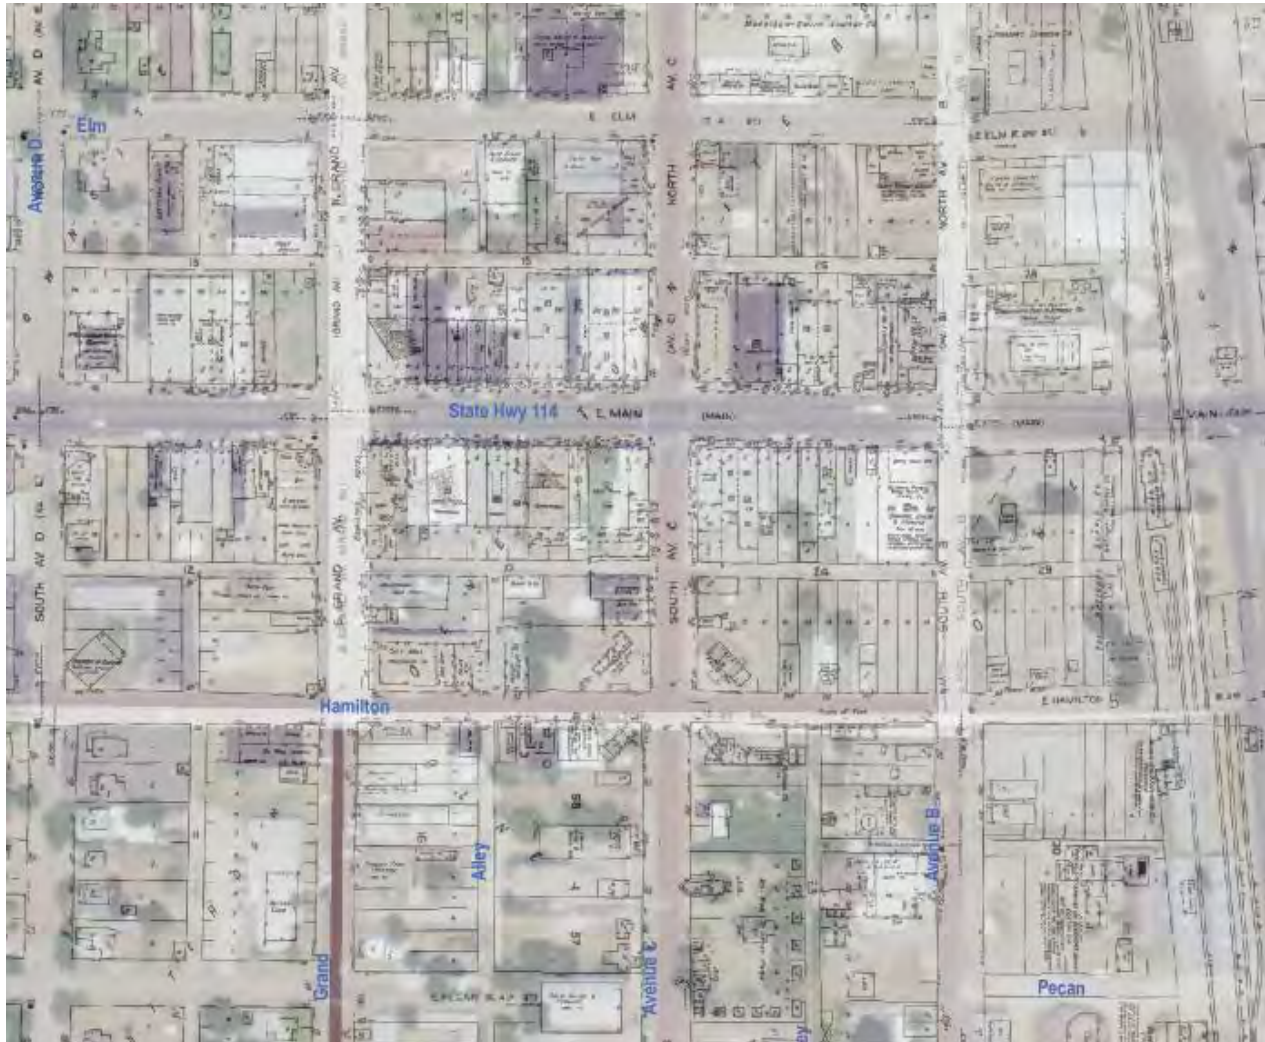
Figure C-18. Overlay of downtown Olney.

This composite view includes the 1948 update of fire insurance maps published by the Sanborn Map Co. and a current aerial from TNRS.

Over 75 percent of the extant resources in the downtown predate 1942, the year marking the end of the period of significance as determined through historical research, according to an analysis of Sanborn maps (Figure C-18) and information obtained through tax roll research and from field investigations.

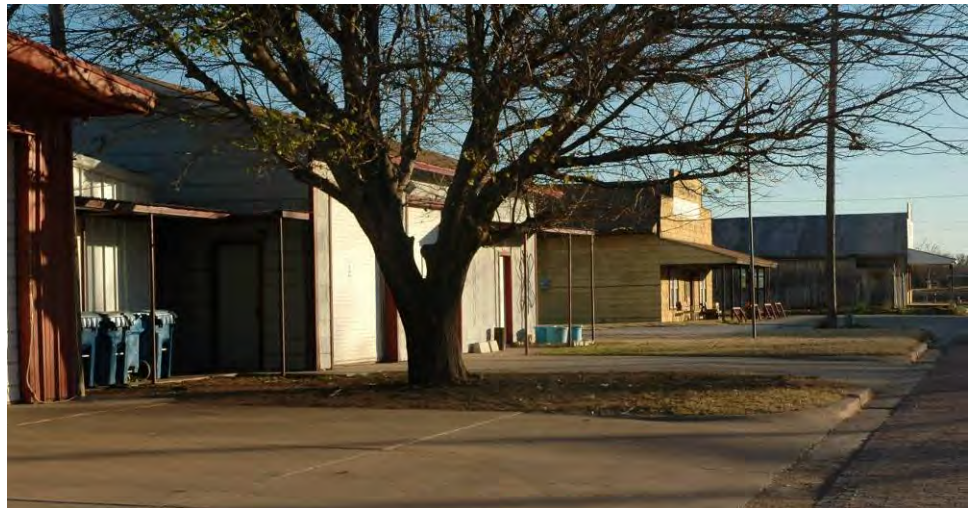
**Figure C-20 (middle).
100 block of Lamar
Street, Merkel.**

The streetscape is immediately east of downtown Merkel and exhibits few of the physical traits of buildings in the downtown.

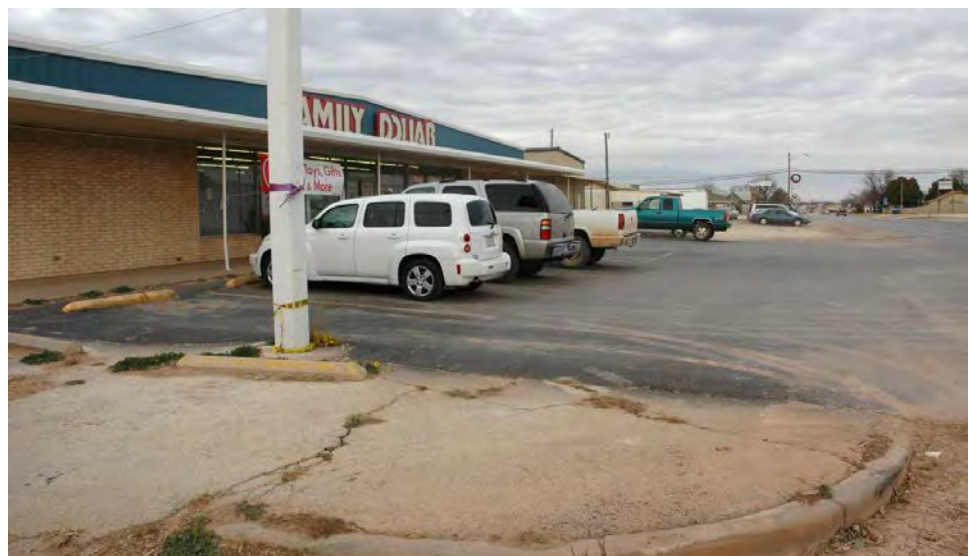
**Figure C-21 (bottom).
200 block of Kent
Street, Merkel.**

This block has commercial development that postdates the period of significance of the downtown.

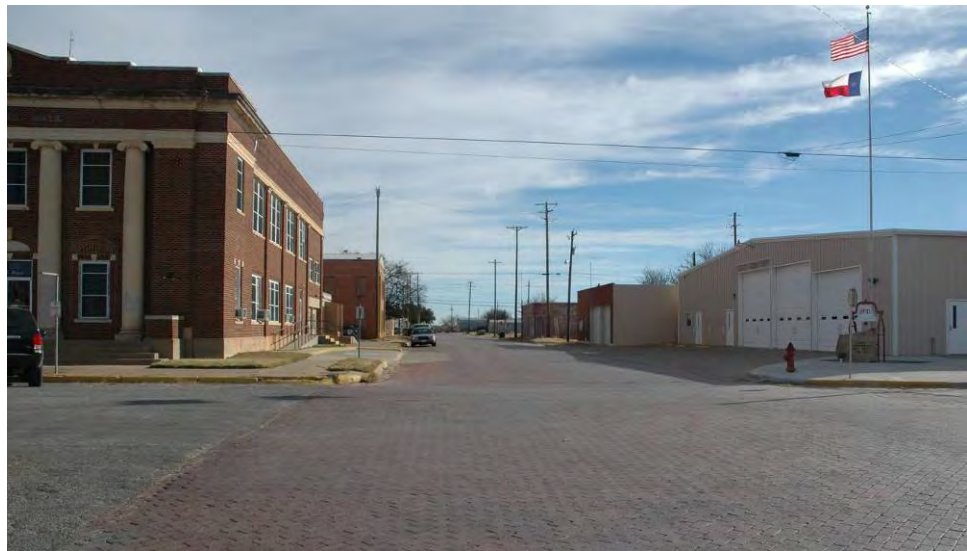
Figure C-22. 100 block of W. Hamilton Street, Olney.

The Olney City Hall is on the left, and the Volunteer Fire Department is on the right. The scale, type, and materials of buildings on the right (south) share few of the physical characteristics of the downtown.
