TEXAS DEPARTMENT OF TRANSPORTATION

Historical Studies Report No. 2011-01

Guidelines for Assessing the NRHP Eligibility of
Commercial Historic Districts in Crossroads Communities
in Northwest-Central Texas

Prepared by David W. Moore, Jr.

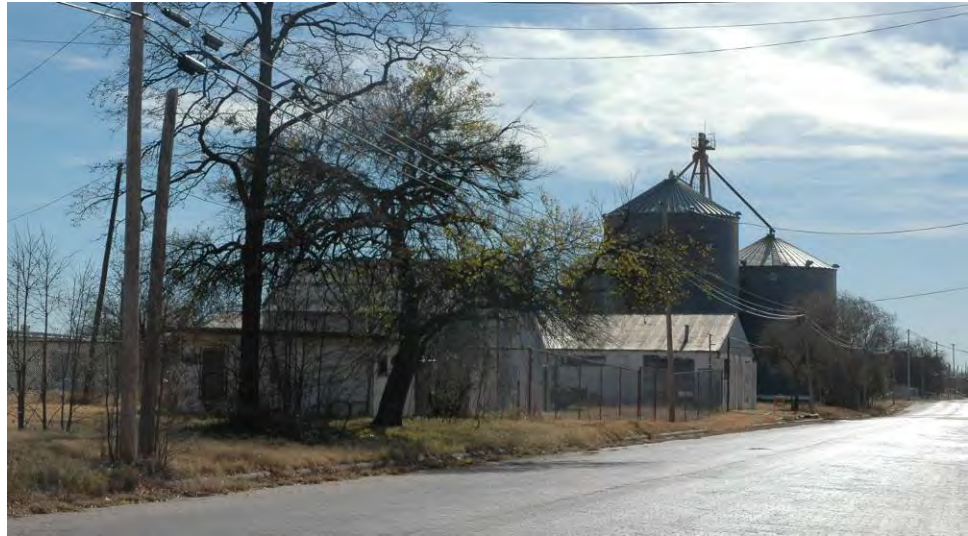
Figure C-23 (top). 200-300 blocks of S. Avenue C, Olney.

This view shows the types of buildings in the industrial zone south of the downtown.

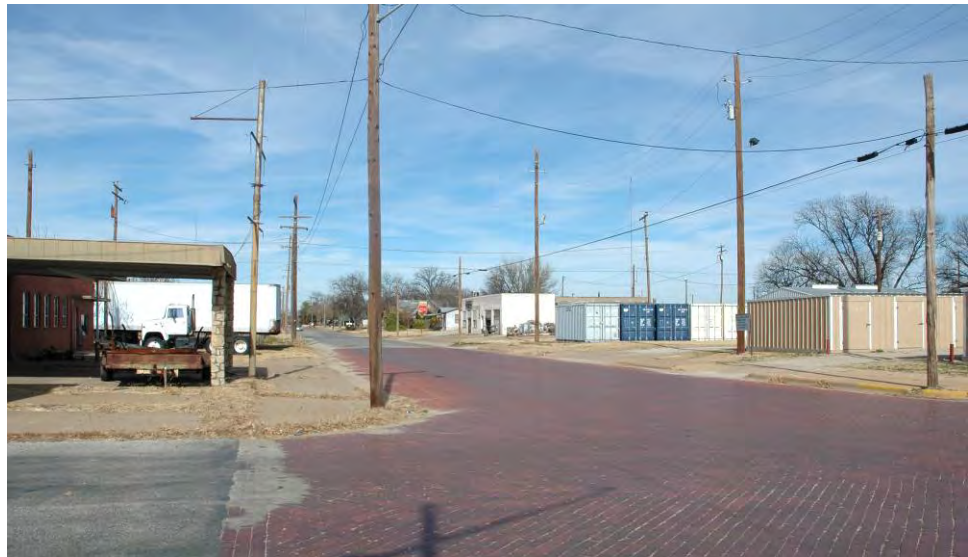
Figure C-24 (middle). 200 block of N. Avenue C, Olney.

This area is north of downtown. The new complex of metal storage units marks a sharp break from the historic downtown

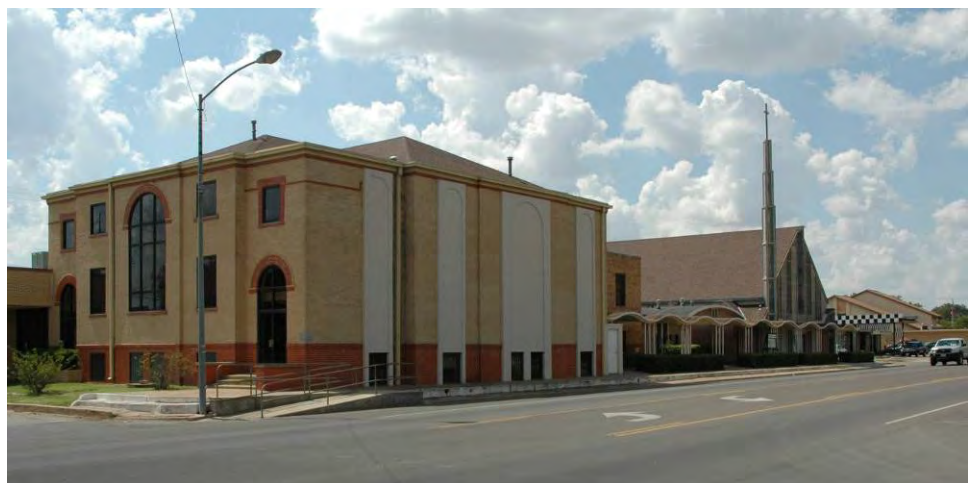
Figure C-25 (bottom). 300 block of W. Main Street, Olney.

Just beyond the western limits of the historic downtown, a number of churches functions as a buffer between the city's commercial center and residential neighborhoods.

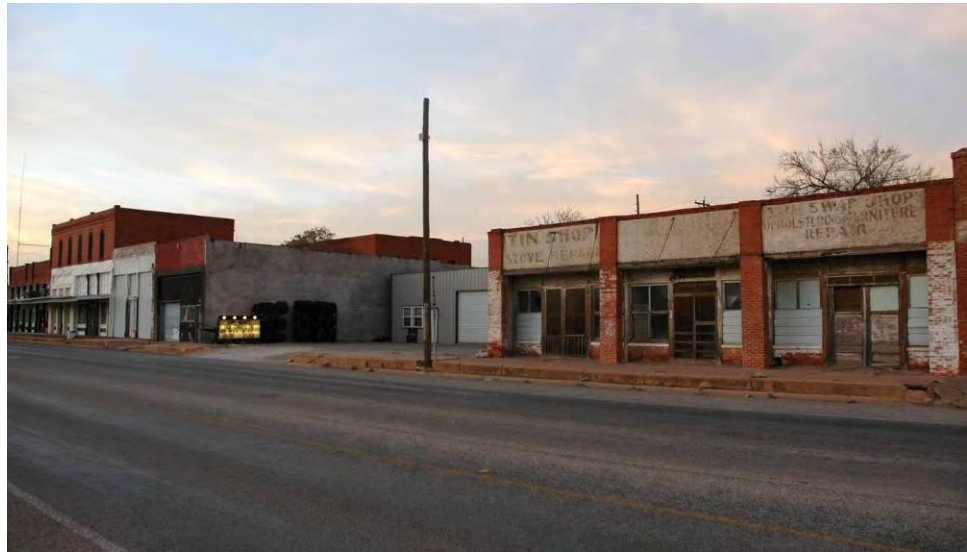
Figure C-26. 900 block of N. First Street, Merkel.

The non-historic garage in the middle of the block disrupts the cohesive character and rhythm of this streetscape.

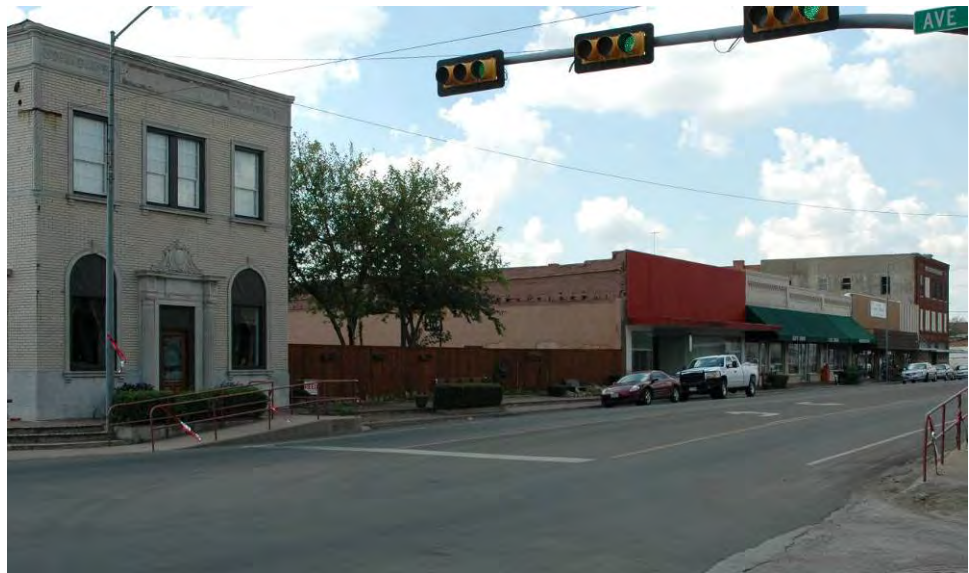
Figure C-27. 100 block of W. Main Street, Olney.

The vacant lot in the left center of this image diminishes the historic character of this block.

Buildings fronting onto the 100 block of W. Main Street present an almost continuous series of historic buildings with uniform setbacks. The only exception is the vacant lot adjacent to the bank building at the southwest corner of Main Street and Avenue C (Figure C-27). Other blocks within downtown have multiple vacant lots that diminish some of the important qualities that distinguish the downtown. Examples include the park and gazebo at the northwest corner of W. Main Street and Grand Avenue, the entire west side of S. Grand Avenue, and both sides of the 100 block of W. Hamilton Street. Sanborn maps confirm that buildings stood at these locations during the period of significance, and their absence detracts from the downtown's overall historic character. The only block that retains a noteworthy concentration of historic buildings with minimal interruptions is the 100 block of W. Main Street. Based on this analysis, vacant lots and construction outside the period of significance have had a negative effect on the downtown's integrity of *Setting*, *Design*, and *Feeling*. The only area that is minimally affected by these changes is the 100 block of W. Main Street.

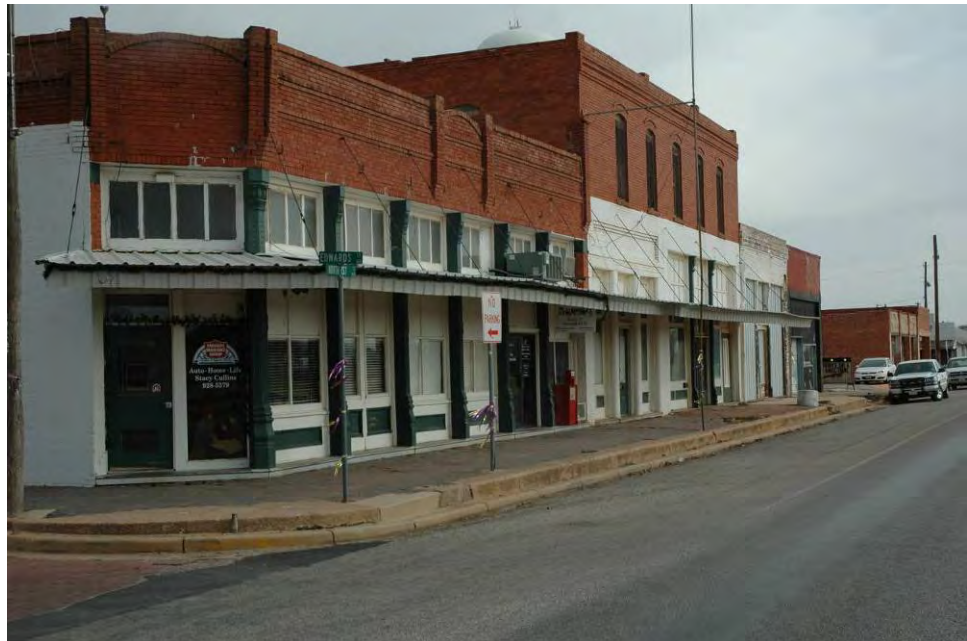
Figure C-28. 900 block of N. Front Street, Merkel.

The uniform setbacks contribute to the sense of cohesiveness within the downtown.

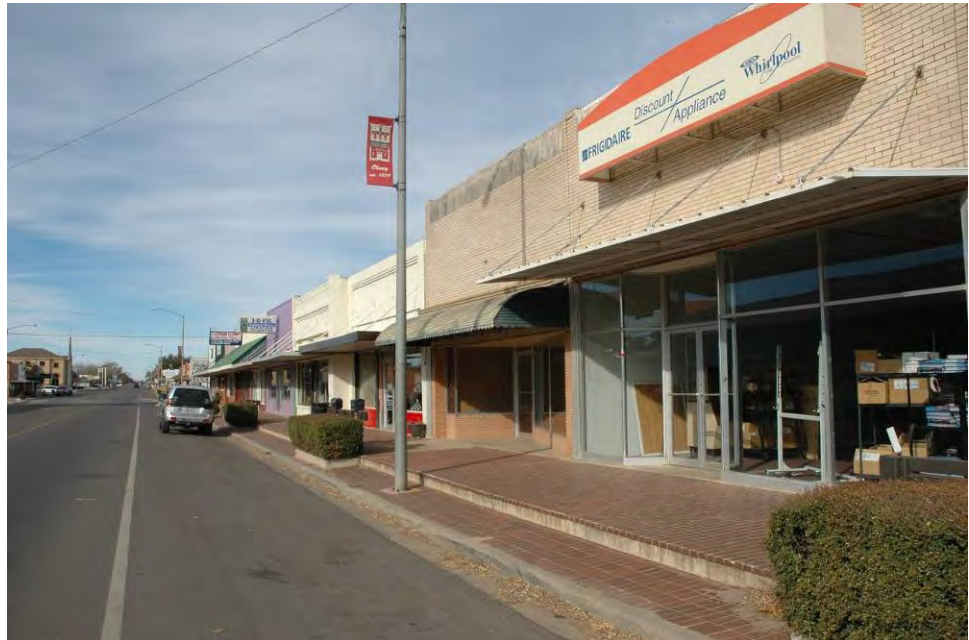
Figure C-29. 100 block of W. Main Street, Olney.

This row of historic commercial buildings on the north side of the block presents a uniform grouping of buildings with the same setback from the street.

Downtown Olney includes significant concentrations of buildings with uniform setbacks. The highest percentage is along the 100 block of W. Main Street, where mostly One-Part Commercial Block buildings line both sides of the thoroughfare (Figure C-29). The area marks the historic core of the downtown and retains the strongest sense of cohesiveness in the downtown area. That continuity breaks down on side streets, including Avenue C and Grand Avenue. While the One-Part Commercial Block gas station at the southwest corner of Avenue C and Elm Street maintains the consistent setback, the gas station at the opposite side, as well as an adjacent 1950s detached office building, disrupts the uniformity of the building placement. Based on this analysis, the 100 block of W. Main Street contains the most significant concentration of buildings with even setbacks, which enhances the downtown's integrity of *Setting, Feeling, and Design*.

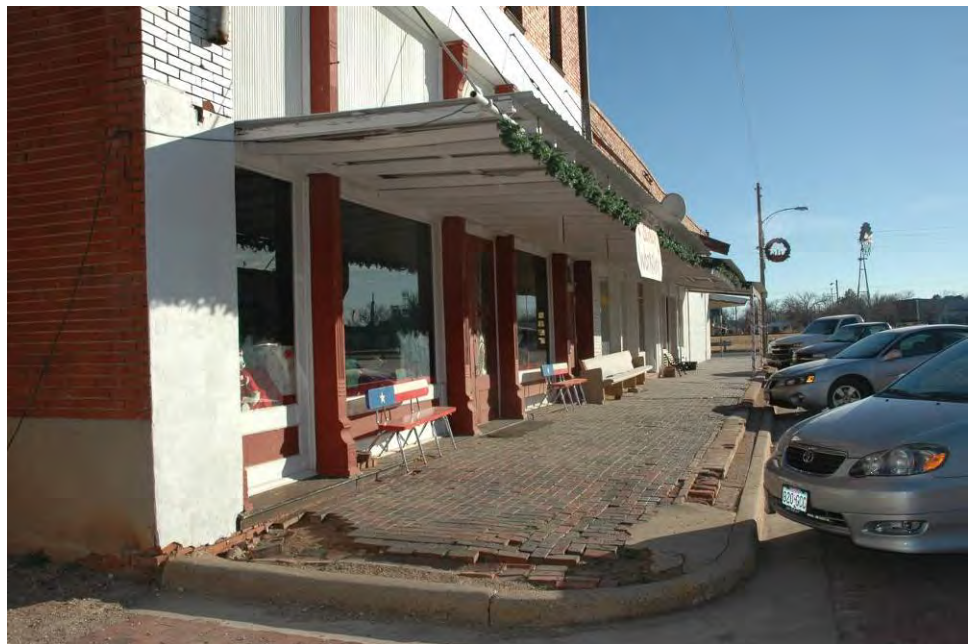
Figure C-30. 100 block of Edwards Street, Merkel.

The brickwork in the sidewalk in this downtown block is in poor condition and is a hazard for pedestrians. These are Thurber bricks, but other sidewalks in Merkel have modern brick pavers that present a very different character and feel.

Sidewalks in Merkel utilize a wide range of materials and are at varying levels of condition and disrepair. Most of the sidewalks are undistinguished concrete panels with expansion joints; however, a significant number of buildings have sidewalks with brick pavers (Figure C-30). While the effect may have been intended to provide a visual link with the brick-paved streets, the appearance is not based on historical precedent, and the uneven surface and poor condition actually detract from the downtown’s historic character. The inconsistent aesthetic quality of the use of different materials in the sidewalks detracts from the downtown’s integrity of *Materials* and *Setting*.

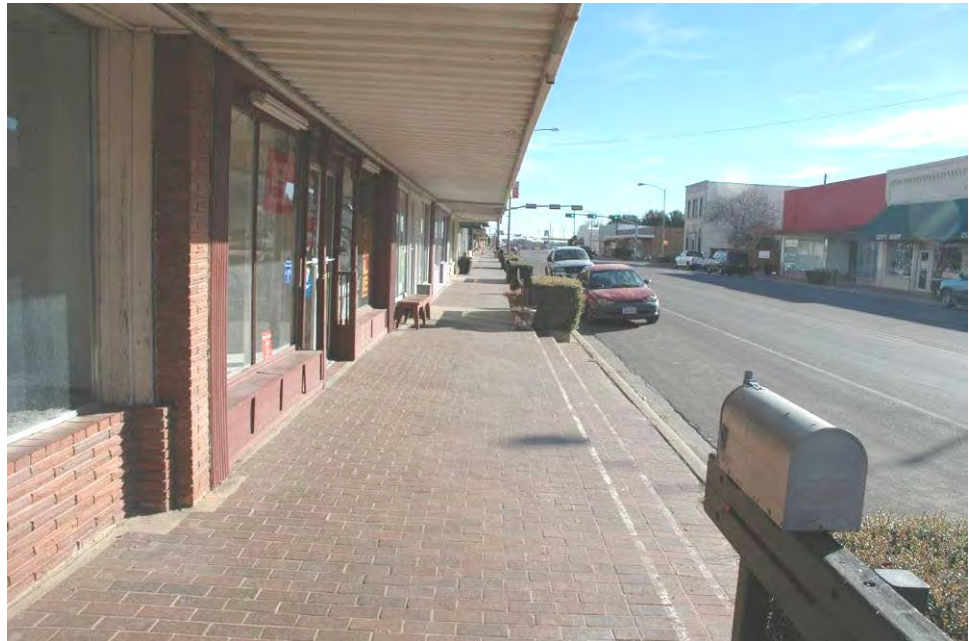
Figure C-31. 100 block of W. Main Street, Olney.

Most of the sidewalks in downtown Olney have brick-paved sidewalks similar to that seen in this image.

Main Street has been subject to a sidewalk improvement program that has introduced new sidewalk paving materials that are not consistent with the downtown's historic character. Specifically, the 100 block of W. Main Street, which contains the greatest concentration of historic resources and represents the core of the downtown, has brick-paved sidewalks that are an intrusive visual element (Figure C-31). Most of the other sidewalks in the town utilize concrete that dates from the period of significance. Since the sidewalks in front of the most important concentration of historic buildings have sidewalk materials that postdate the period of significance, the downtown's integrity of *Materials* and *Setting* are diminished.

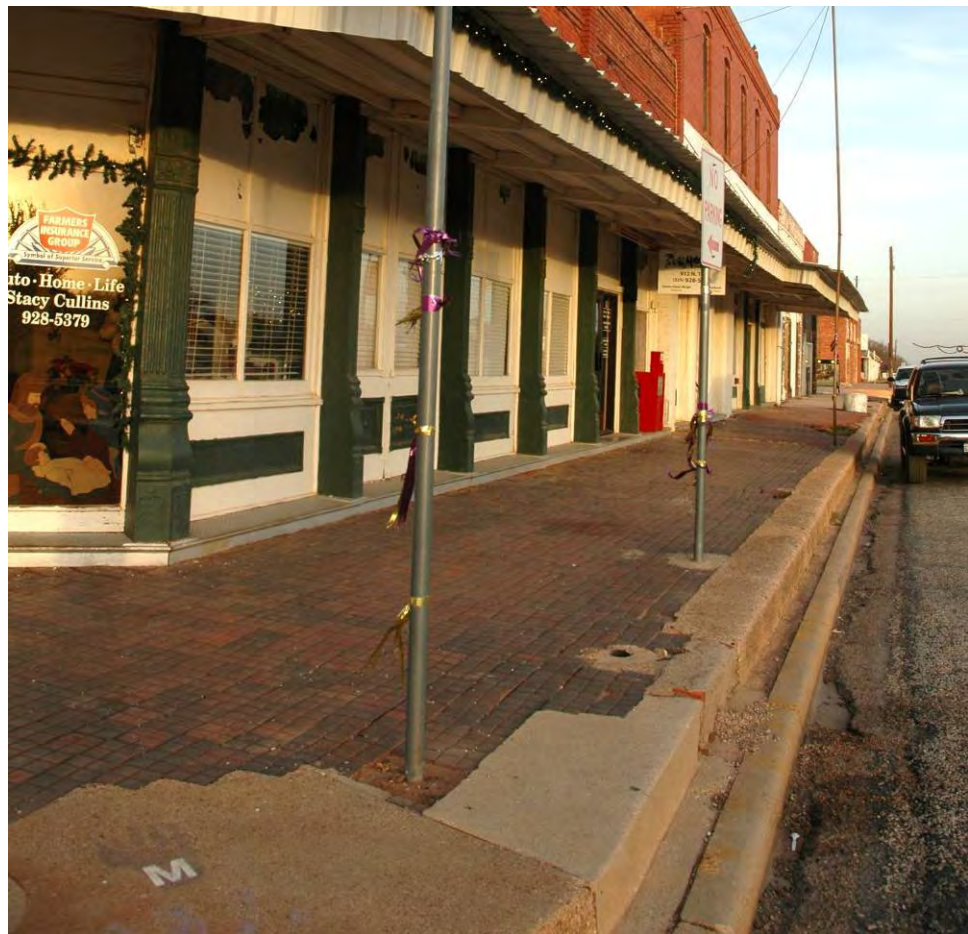
Figure C-32. 900 block of N. Front Street, Merkel.

The concrete curbing in this block is in stable condition.

Stone and concrete are the two kinds of curbing used in downtown Merkel (Figure C-32). With few exceptions, the curbing is continuous and features materials that date from the period of significance. Notable exceptions include driveway cuts for several buildings that face onto N. First Street (BI 20-P) such as the new auto-repair shop in the 900 block, the city hall/library in the 1000 block, and the gas station in the 1100 block. The stone curbing is the older of the two materials used but its placement is not known. Research has not determined the date or period when the concrete curbing was installed; however, the curbing likely was part of the brick-paved street improvement program that probably was undertaken in the 1920s. Most of the curbing in the downtown is in good condition and dates to the period of significance; therefore, it contributes to the downtown's integrity of *Materials, Setting, and Feeling*.

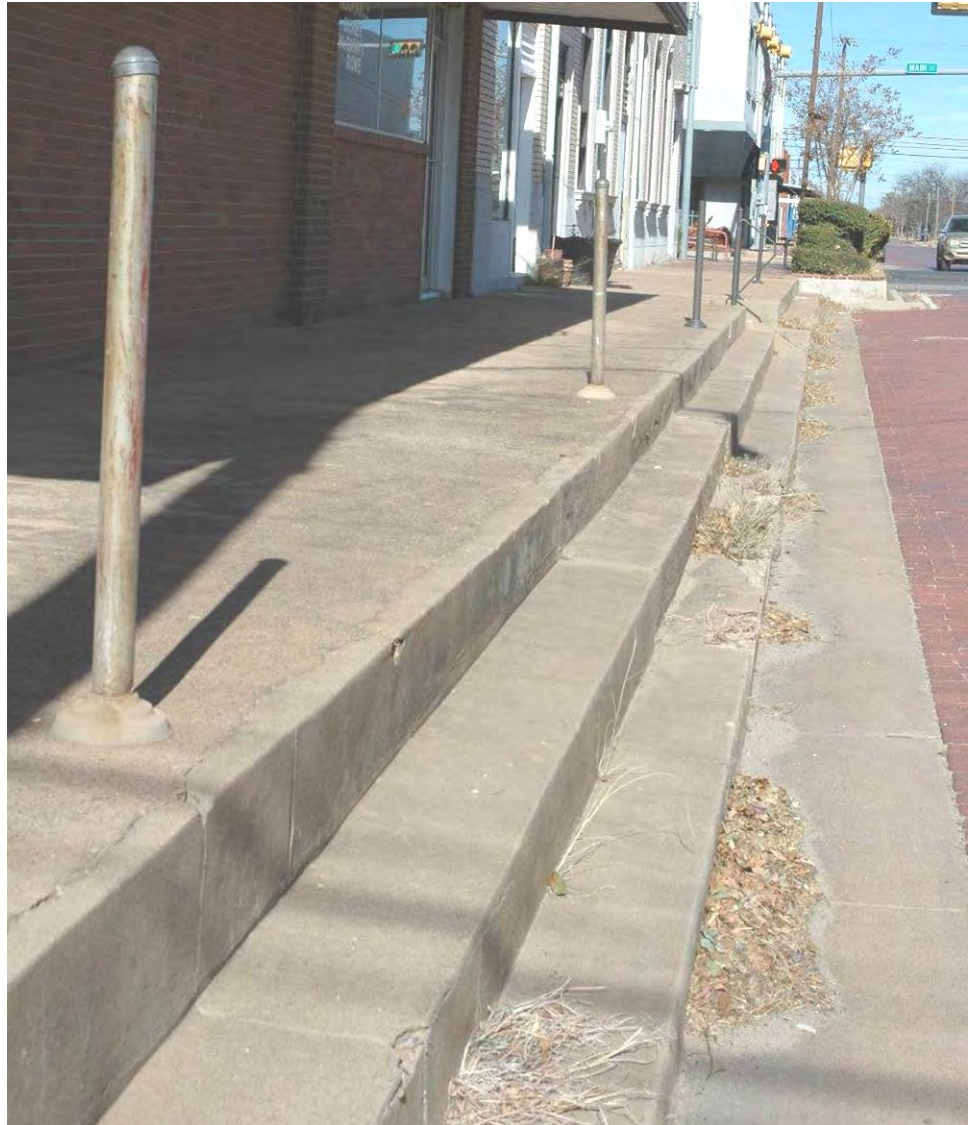
Figure C-33. 100 block of S. Avenue C, Olney.
The curbing in this block typifies conditions throughout downtown Olney.

The streets of downtown Olney retain concrete curbing that likely dates from the period of significance (Figure C-33). The lack of disruptions or breaks to the curbing adds to the downtown's overall historic character and sense of cohesiveness and enhances its integrity of *Materials*, *Setting*, and *Feeling*.

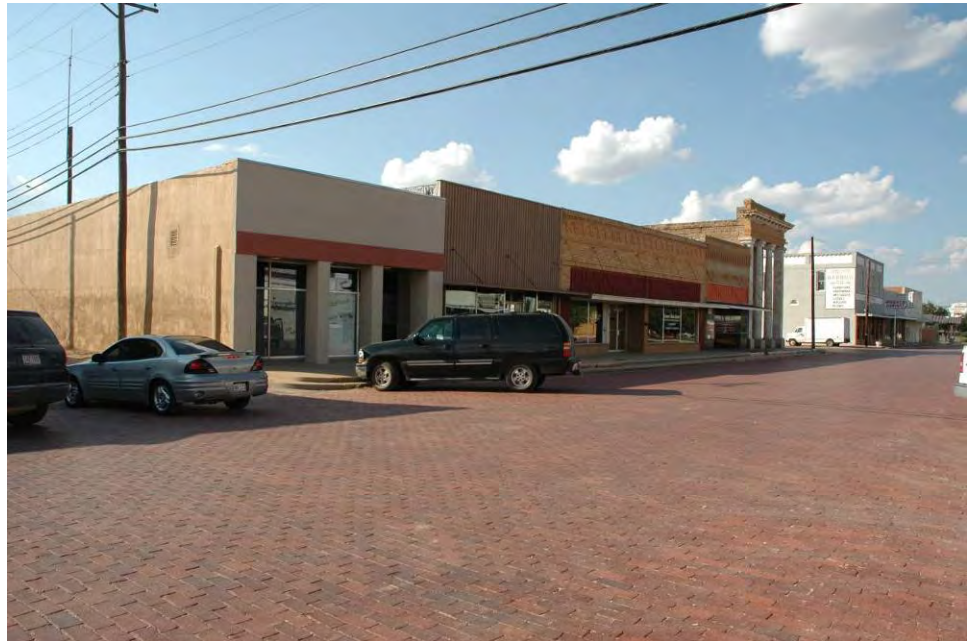
Figure C-36. 100 block of Edwards Street, Merkel.

Most of the streets in downtown Merkel retain their brick-paved surfaces. They remain in good condition and contribute to the historic character of the area.

Field investigations noted most streets in downtown Merkel with historic brick-paved surfaces, which are an important physical attribute of the area (Figure C-36). The most notable exception is N. First Street, which is also designated as BI 20-P. Since it is part of the federal and state highway systems, it has asphalt paving in part to meet highway safety standards. The brick streets remain in very good condition with minimal changes or interruptions. They add much to the downtown’s historic character and are considered as a single contributing resource. Aerial photographs provide graphic evidence of their visual and aesthetic contributions to defining the limits of the downtown, which independently confirm the limits of field investigations for the survey. The historic paving enhances to the downtown’s integrity of *Materials, Design, Workmanship, Association, and Setting*.

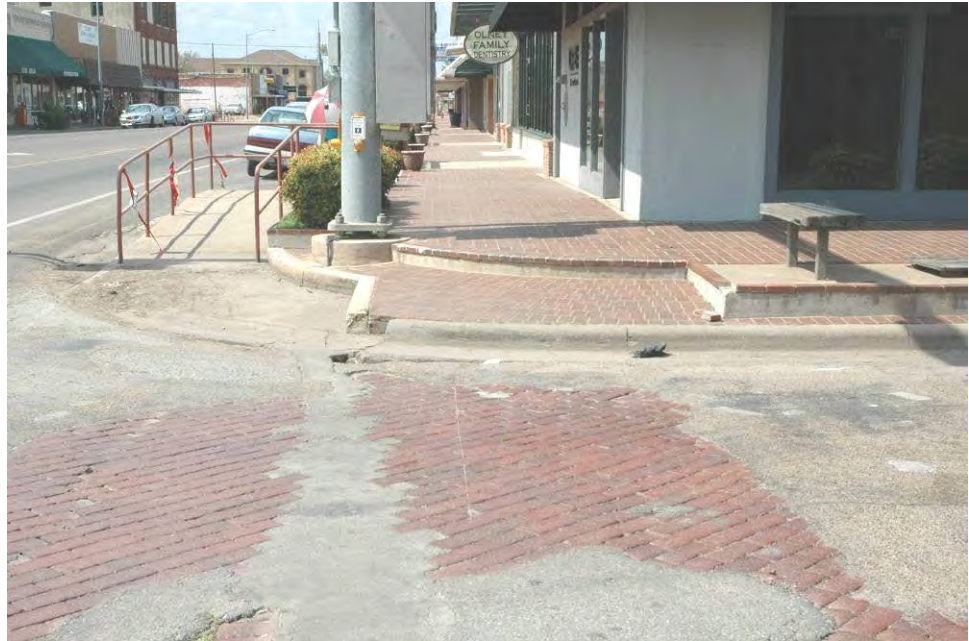
Figure C-37.
**Intersection of Main
Street and Avenue C,
Olney.**

Some of the original brick paving is exposed, but repairs diminish its integrity and ability to contribute to the downtown's historic character.

Olney has multiple brick streets in the downtown, but the main thoroughfare, Main Street, where the greatest concentration of historic resources is found, has asphalt paving material. The brick paving on side and secondary streets (Grand Avenue, Avenue C, Elm Street, and Hamilton Street) is largely intact, but repairs using different kinds of materials diminish the brick streets' contributions to the historic character of the downtown (Figure C-37). The inconsistent character of the street paving materials in the downtown have a negative effect on the downtown's integrity of *Materials, Design, Workmanship, Association, and Setting*.

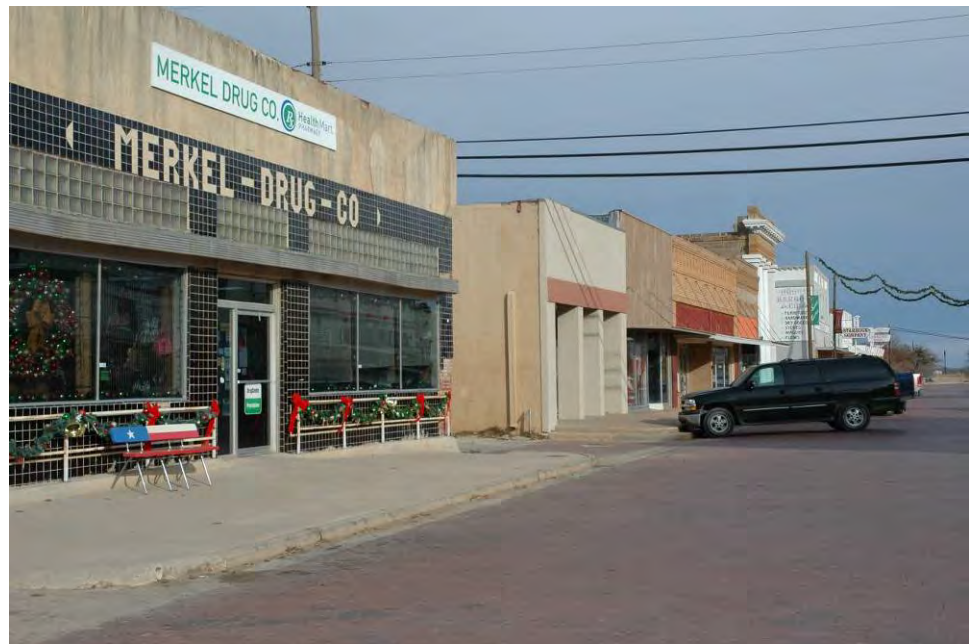
Figure C-38. 100 block of Edwards Street, Merkel.

Although storefront alterations to the Merkel Drug Store date from the mid-1940s and contribute to the downtown's historic character, alterations to the majority of other storefronts in this image have a negative effect on character-defining features of the One-Part Commercial Block buildings that prevail.

Most of the buildings in downtown Merkel have been subject to varying degrees of change and modifications (Figure C-38 through C-41). Most of these alterations are at the pedestrian level, where owners replaced windows and doors and removed or installed new canopies. In particular, the west sides of the 100 block of Kent Street and the 200 block of Edwards include cohesive groupings of One- and Two-Part Commercial Block buildings that have been altered to such an extent that their collective historic character has largely been compromised. In contrast, some streetscapes have been subject to less severe changes at the street level, including the 100 block of Edwards Street, the north side of the 900 block of Front Street, and the south side of the 900 block of N. Second Street. A small number of the buildings have been severely altered and are no longer recognizable to the period of significance; however, these are exceptions. The fenestration of the majority of the buildings is intact and some, such as the Merkel Drug Store, have remodeled storefronts that have become an important part of the physical character of the building. Since these kinds of alterations date to the period of significance, they contribute to the historic character of the building and the downtown as a whole.

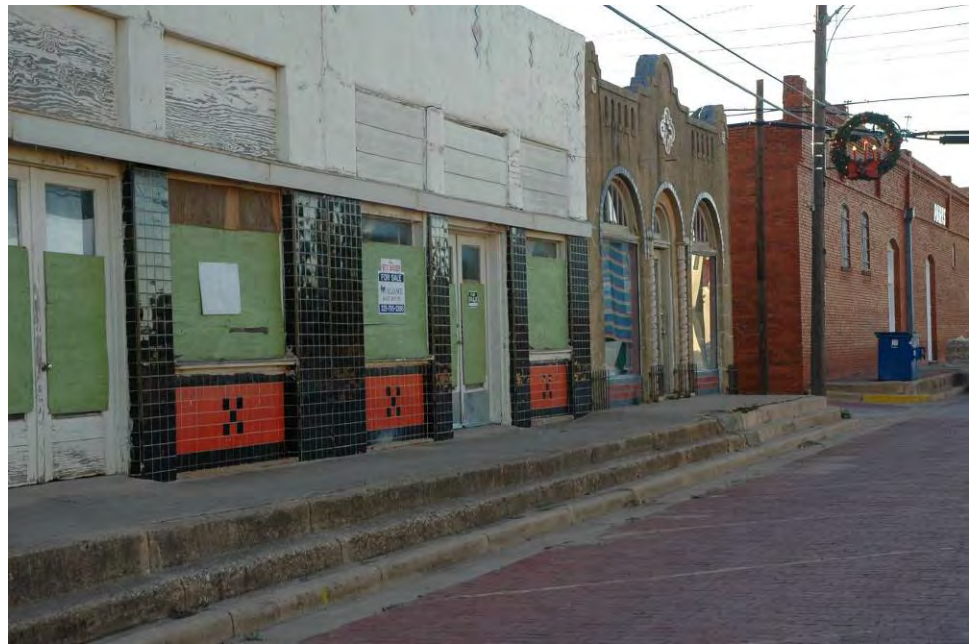
Figure C-39 (top). 900 block of N. Second Street, Merkel.

The stores in this block present storefronts that date from the period of significance. The building in the foreground has a tiled exterior finish that is similar to that seen on the Merkel Drug Store in the previous image.

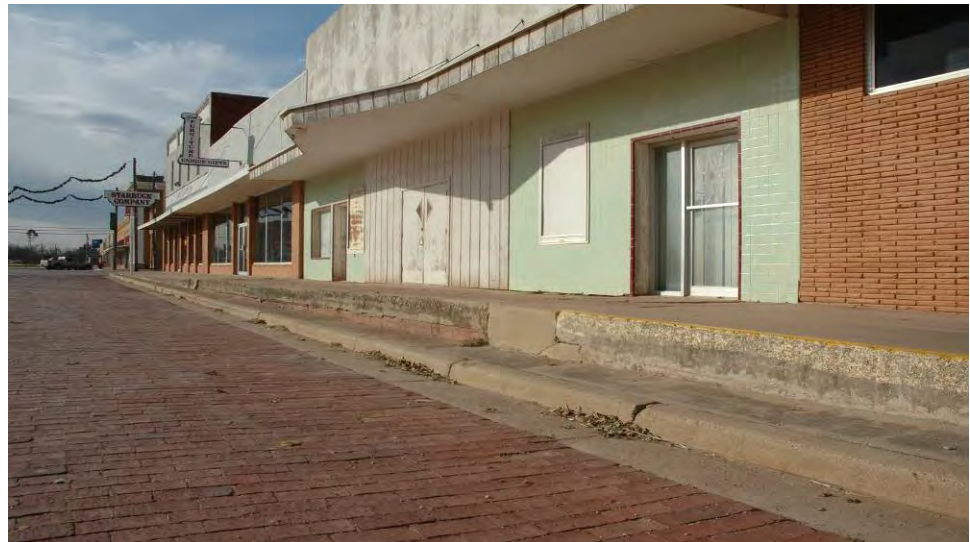
Figure C-40 (middle). 200 block of Edwards Street, Merkel.

The storefronts in this block have been subject to severe alterations that do not date from the period of significance. The overall effect detracts from the district's historic character.

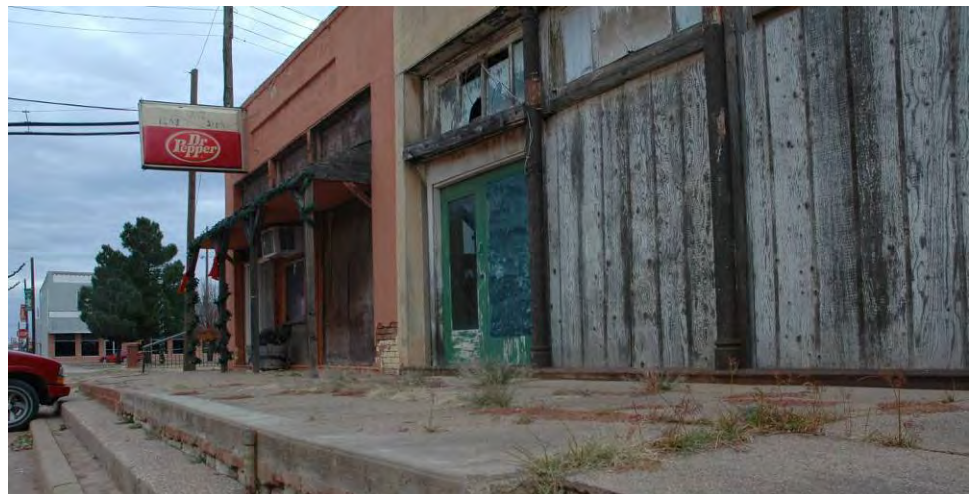
Figure C-41 (bottom). 900 block of N. Second Street, Merkel.

While the historic fenestration pattern is still evident, the deteriorated condition, covering of window openings, and the introduction of new materials diminish the ability of these buildings to convey significance from the past.

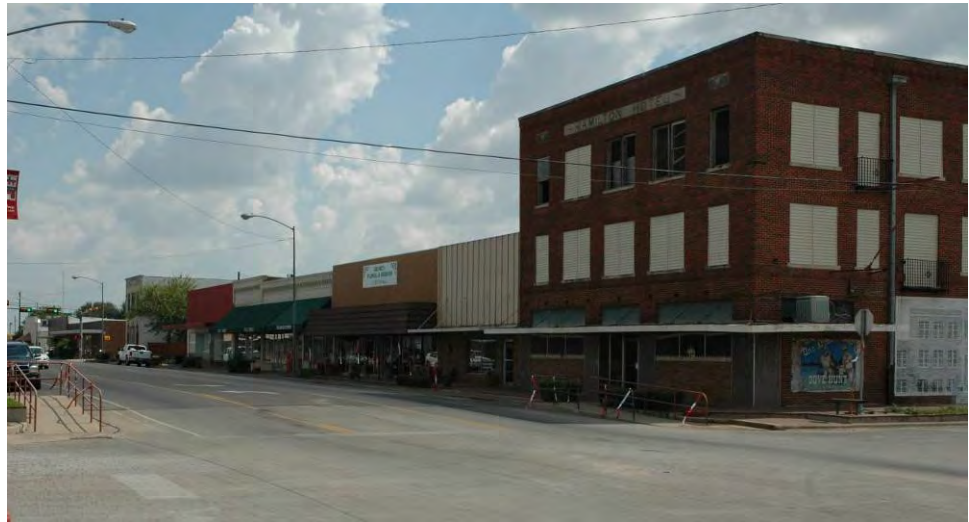
Figure C-42 (top). 100 block of W. Main Street, Olney.

The storefronts on all of the buildings on the south side of the block have been extensively modified. The combined effect of these changes disrupts the downtown's historic character.

Alterations at the pedestrian level to most of the buildings in the 100 blocks of E. and W. Main Street compromise character-defining features of the One- or Two-Part Commercial Block buildings that line the street. Not only have most of the original windows and doors been replaced and canopies removed, many of the storefronts have been reconfigured and fenestration patterns have been changed. About half of the historic buildings on the side streets (Grand Avenue, Avenue C, Hamilton, and Elm Street) have been so severely altered at the pedestrian level that their historic storefronts are no longer recognizable. The introduction of new materials and finishes and reconfigured storefronts not only disrupts the historic character of the buildings but compromises the ability of the downtown to convey a sense of the past (Figure C-42 through C-46).

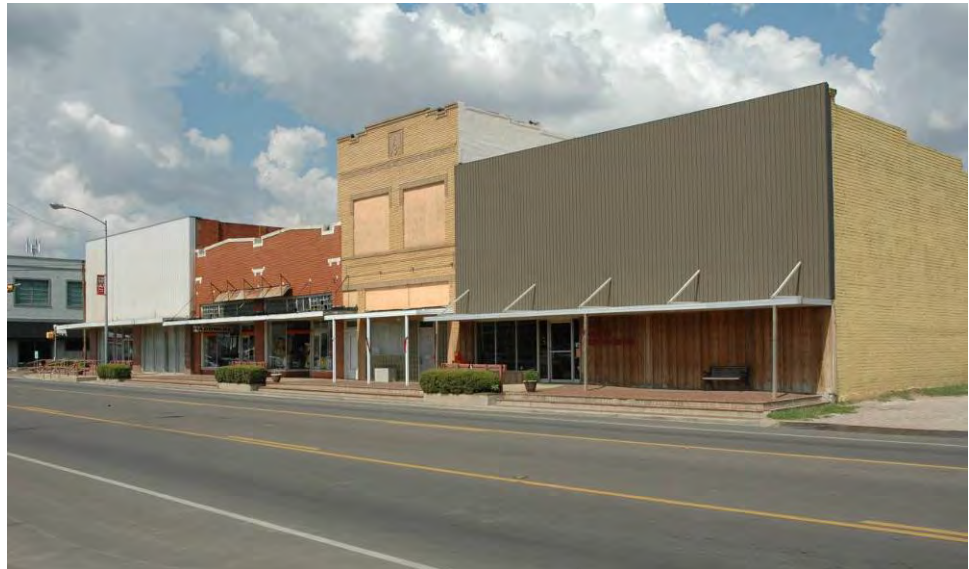
Figure C-43 (bottom). 100 block of E. Main Street, Olney.

Although the two middle buildings retain much of their historic storefronts, the buildings on either side have been severely altered and convey little of their historic character from the period of significance.

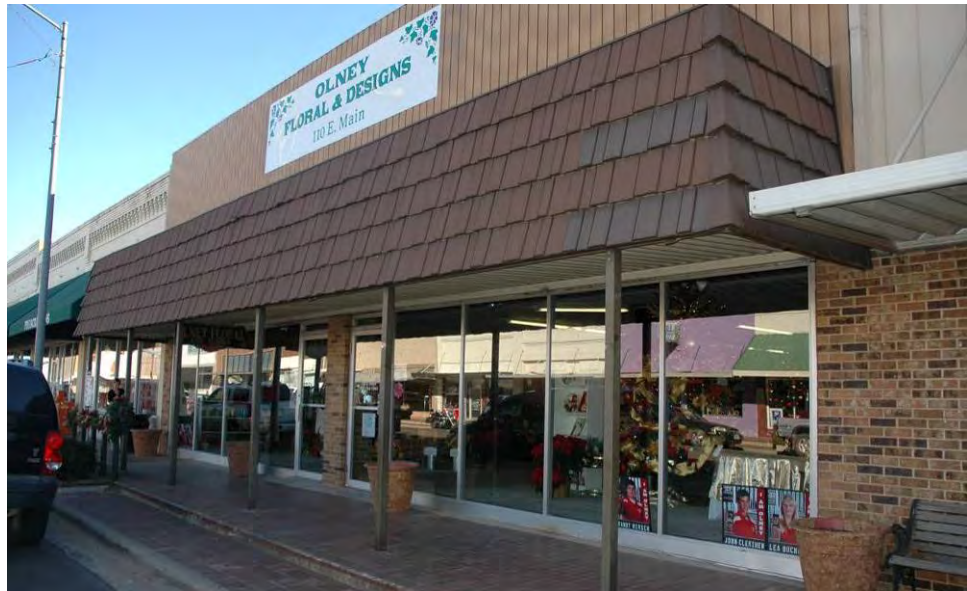
Figure C-44 (top). 100 block of W. Main Street, Olney.

The storefront typifies the kinds of changes that have been made to many of the commercial buildings in the downtown. Hardly any of the historic fabric or character survives.

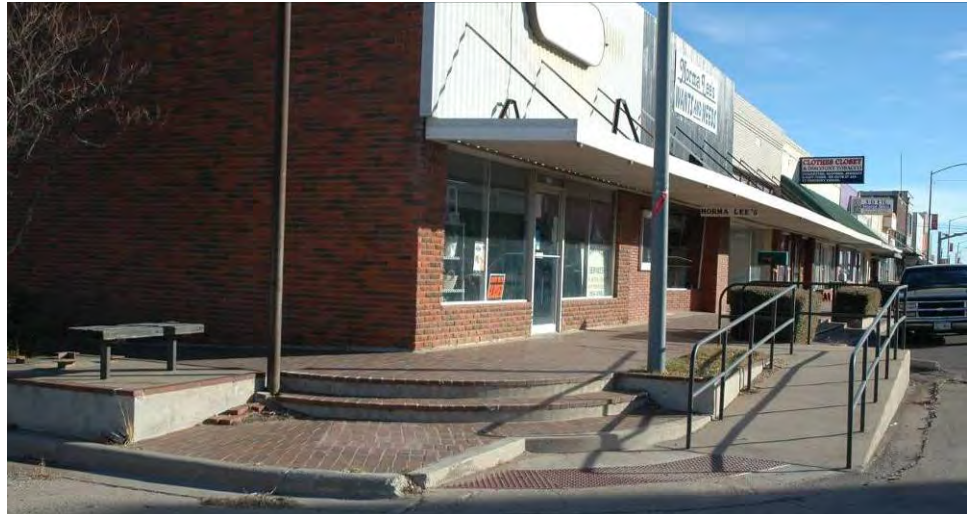
Figure C-45 (middle). 100 block of W. Main Street, Olney.

Most of the storefronts have been altered on a moderate to severe level.

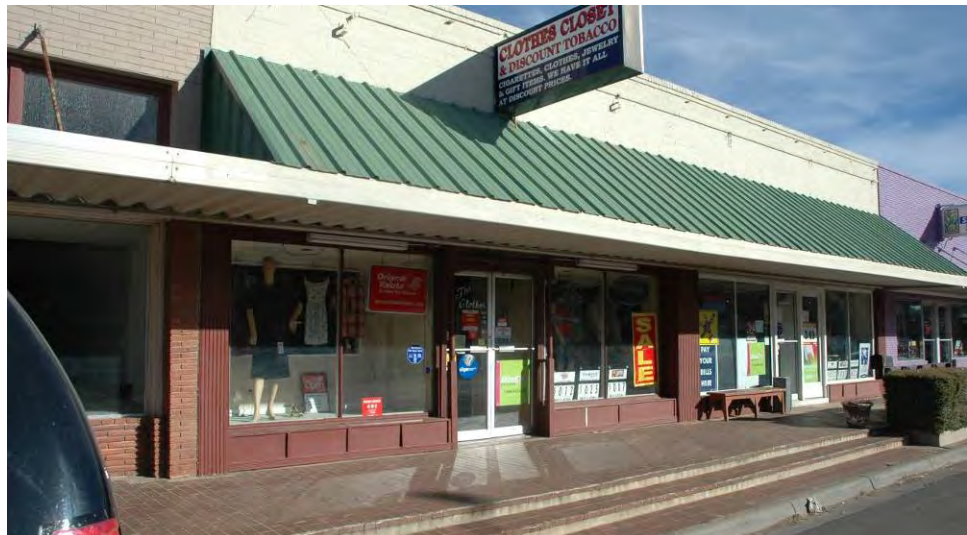
Figure C-46 (bottom). 100 block of W. Main Street, Olney.

While the historic fenestration pattern is intact, new materials and the canopy diminish the ability of the building to convey a sense of the past.
