TEXAS TECH UNIVERSITY

Rational Use of Terminal Anchorages in Portland Cement Concrete Pavements

1. Report No. FHWA/TX-12/0-6326-1	2. Government Accession No.	3. Recipient's Catalog No.	
4. Title and Subtitle Rational Use of Terminal Anchorages in Portland Cement Concrete Pavements		5. Report Date February 2012

Project Report 0-6326-1

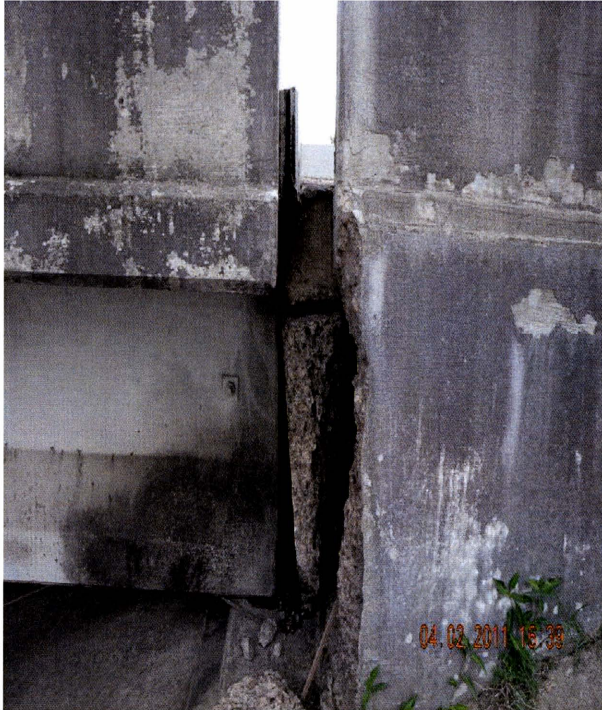
Figure 2.1 Damage in the abutment

The bridges on US69 in the Beaumont District showed some of the most severe damage observed by the research team. Brian Merrill, P.E., of the Bridge Division informed the research team of the expansion of the pavement and resulting damage to the bridge structures. Figure 2.1 illustrates the damage in the abutment due to the approach slab pushing the armor joint. Figure 2.2 shows that the approach slab pushed the armor joint seven inches.

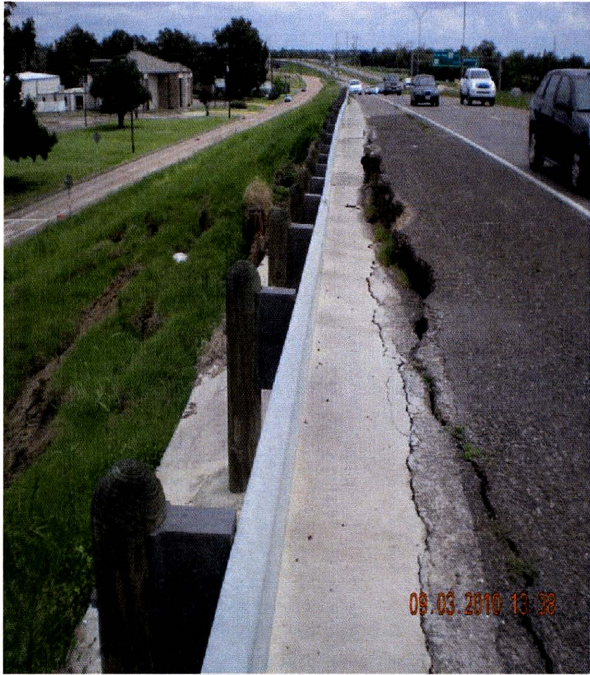
Figure 2.3 Slope failure in the embankment area

During the field visit to this site in September 2010, it was observed that there were slope failures near the bridge approach slabs, as shown in Figure 2.3. The slope failure was repaired in April 2011, as shown in Figure 2.4, and embankment materials were collected from various locations. The embankment materials were high PI clay, with PI values over 50. It is not known

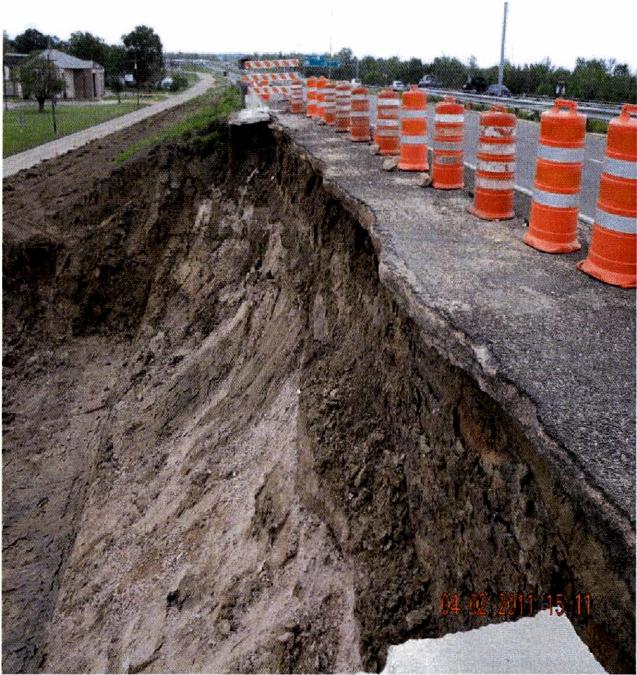
Figure 2.4 High PI clay in the embankment

at this point whether the volume changes in the embankment and/or natural soil under the pavement contributed to the approach slab being pushed by seven inches.

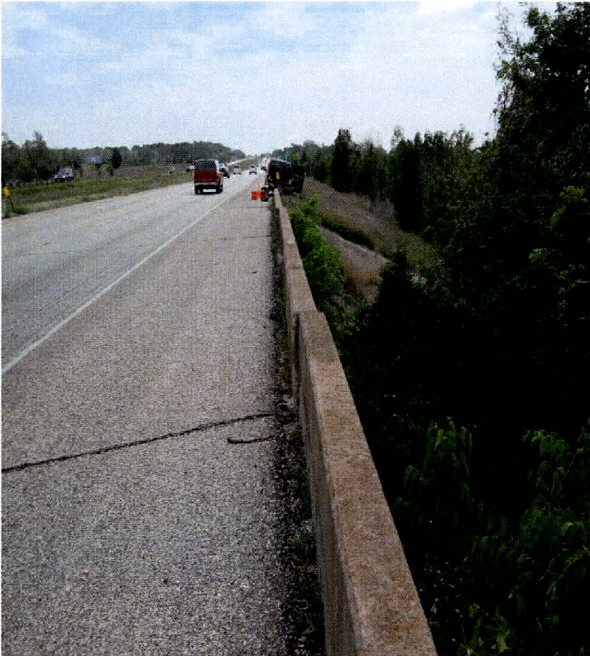
Figure 2.9 Misalignment of the traffic rails

A bridge on IH 10 between mile post 676 and 677, three miles east of Schulenburg experienced distresses in the form of misaligned traffic rails, as shown in Figure 2.9. The pavement is AC overlay on CRCP. The terminal system used in this bridge is not known. Field evaluations indicated no damages to the bridge approach slabs or any other signs of distress in the bridge structures, except for the damages in the rail due to the relative movements between rails, as shown in Figure 2.10. It does not appear that the pavement was pushing the bridge structures, since distresses to this extent would have been observed in the bridge approach slabs.

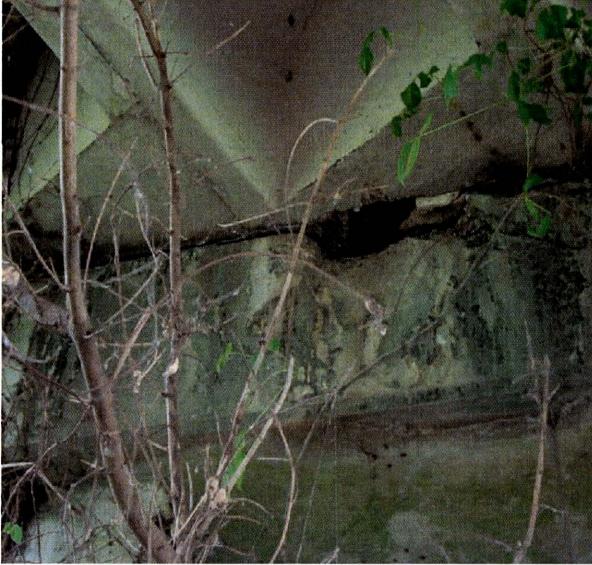
Figure 2.11 Damage in bent cap

Figure 2.11 indicates the relative displacement between girders and a bent cap. It appears that there were dowels or tie bars that caused the beams and bent cap to behave as one unit. The relative displacements resulted in spalling of the concrete in the bent cap. It is not known whether the beams or the bent cap initiated the relative movement.

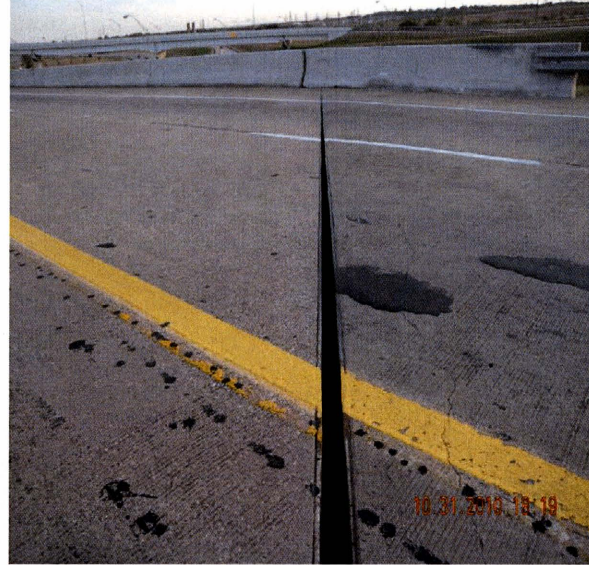
Figure 2.12 Variations in armor joint width

Figure 2.12 shows a variation in the widths of an armor joint in a bridge on IH 20 near IH 820 West. The terminal type was an expansion joint system, and the pavement is CRCP with a 10 in thick slab. The large variation in the armor joint is indicative of either rotation of the abutment or pavement slab sliding. Figure 2.13 shows the misalignment of the traffic rail at the side of the roadway where the armor joint is closed. Figure 2.14 indicates that (1) the armor joint is completely closed up, (2) the approach slab slid toward the right side with respect to the bridge deck, and (3) there was a separation between the bridge approach slab and the traffic rail. Based on these observations, it is likely that the rotation of the abutment is a plausible cause for the variation in the joint width.

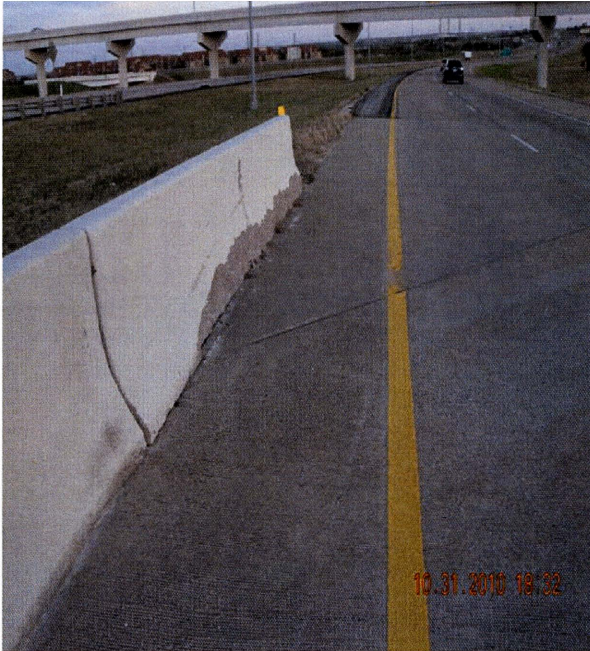
Figure 2.15 Damage in traffic rail

Figure 2.15 illustrates the relative displacements between the approach slabs and traffic rail. This picture shows the other side of the bridge shown in Figure 2.13. It's interesting to note that the damage in the rail is limited to the bridge approach slab portion only. In other words, the rail and the bridge deck behaved as a single unit, while the rail and the approach slab did not. Figure 2.16 illustrates damage in the bridge superstructure. The abutment could have rotated, or the pavement could have pushed the approach slab. At the time of this visit, the expansion joint between the pavement and the approach slab was not closed up, even though it should be recognized that this evaluation was done in October, when the air temperature was not high.

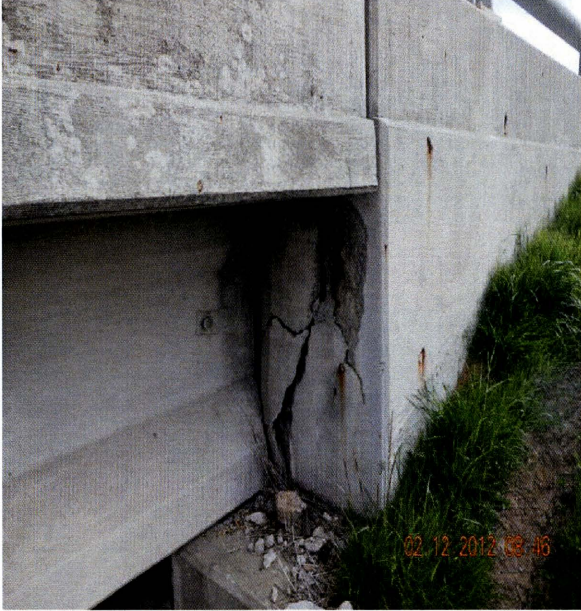
Figure 2.17 Damages in abutment

Figure 2.17 shows damage in the abutment, and Figure 2.18 illustrates the condition of armor joint and distresses in the bridge approach slab. Both distresses are quite common in bridge structures in Texas. The transverse cracks shown in Figure 2.18 are a good indicator of voids under the bridge approach slab behind the abutment. The portion of the concrete between armor joint and transverse cracks in Figure 2.18 nearly coincides with the width of the abutment.

The fact that there are damages in the bridge approach slab and abutment in a bridge where CPCD abuts the bridge indicate that these damages are due to the volume changes and/or consolidation of embankment materials.

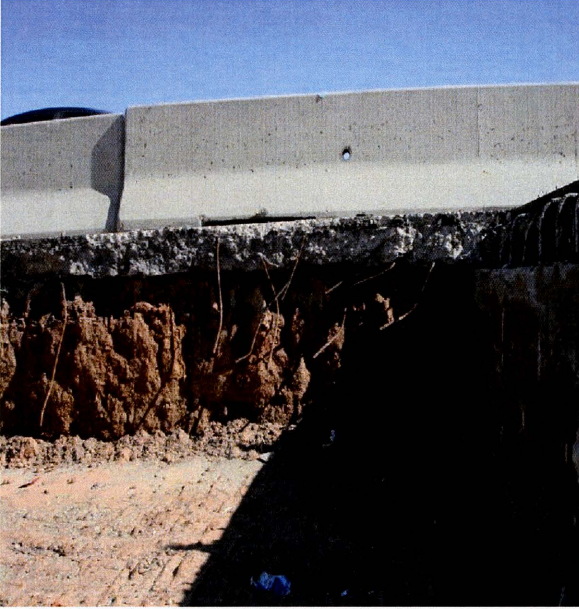
Figure 2.19 Bridge embankment and abutment

During a widening project on IH 35W in the Fort Worth District , the side of the roadway, including bridge embankments, was cut and excavated. This provided a good opportunity to observe the condition of the embankment materials. The bridge was over Altamesa Blvd, between mile post 44 and 45. The pavement was 13 inches CRCP with an expansion joint terminal system. Figure 2.19 shows the side of the bridge embankment, approach slab and abutment.

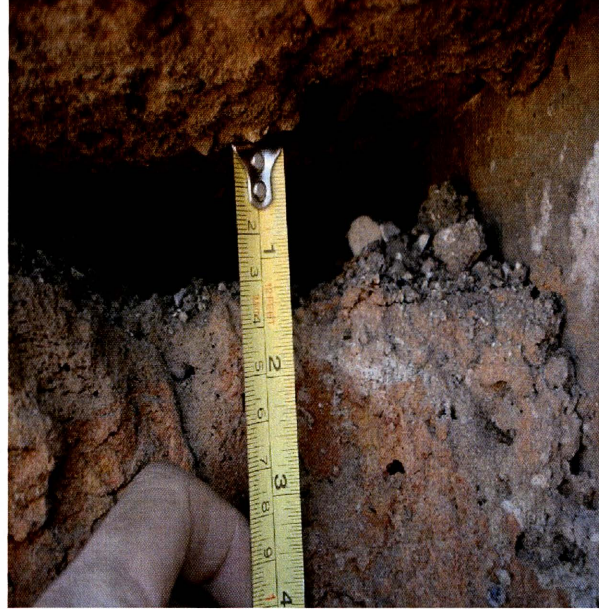
Figure 2.20 Void under bridge approach slab

Figure 2.20 shows a void of more than one inch under the bridge approach slab near the abutment, apparently due to the continued consolidation of the embankment materials. Figure 2.21 shows the undersealing material used in an effort to raise the bridge approach slab. Undersealing of the bridge approach slabs is quite frequent in Texas, indicating that there is an issue of continued consolidation of the embankment materials and voids under bridge approach slabs. Figure 2.22 illustrates transverse cracks in the bridge approach slab at the armor joint, which were apparently caused by the voids underneath. These cracks look similar to those cracks in Figure 2.18. It's interesting to note that the more than one in void under the bridge approach slab caused minor transverse cracks only under heavy traffic. One reason for the good performance of the bridge approach slab with the voids underneath could be due to the heavy reinforcement in the 13-inch slab. The longitudinal reinforcement in the bridge approach slabs is 1.5 percent, which is almost 2.5 times that of CRCP. The armor joint in Figure 2.22 is closed up, even though the expansion joint was in good condition as shown in Figure 2.23, indicating that the pavement did not push the approach slab. The condition of this armor joint indicates that the variations in the armor joint width are not caused by the expansion of the pavement; rather, they

could be due to the displacements of the approach slabs caused by volume changes in the embankment materials.

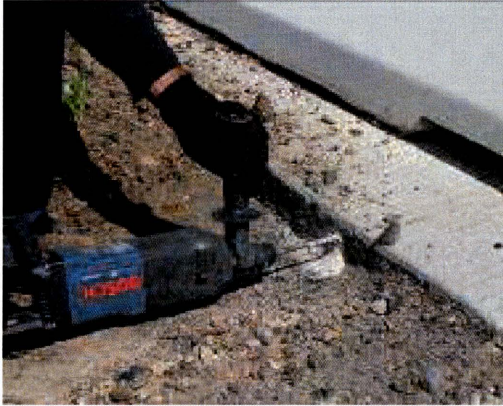
Figure 4.1 Drilling of transverse hole to install a groutable anchor

For this study, a transverse hole was drilled on the edge of the pavement slab to install the sensor anchor. The vertical location of the hole was located about two inches to three inches below the surface of the slab as shown in Figure 4.1. To anchor the crackmeter to the fixed point, a vertical hole was drilled on the ground about three inches away from the edge of the pavement slab as shown in Figure 4.2. The depth of the vertical hole should be deep enough to go through any stabilized subbase. The three-ft long invar, which has minimum thermal expansion, was inserted

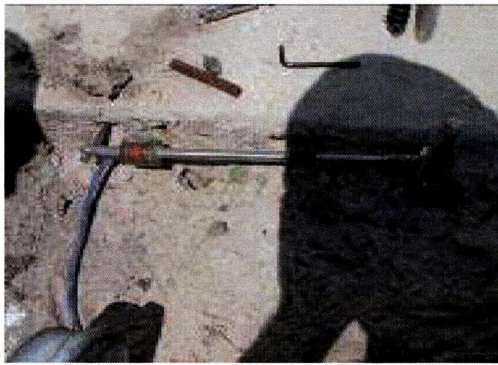
Figure 4.3 One end of crackmeter is connected to groutable anchor and the other to the invar

into the ground through the vertical hole. One end of the crackmeter was connected to the sensor anchor and the other to the invar as shown in Figure 4.3. This system measures the longitudinal movement of the slab relative to the ground. After installing the crackmeter, a protective metal cover box was installed to ensure the long-term stability of the measurement system. Wires from the crackmeter were connected to the data logger. Figure 4.4 shows a one-channel datalogger used in this study.

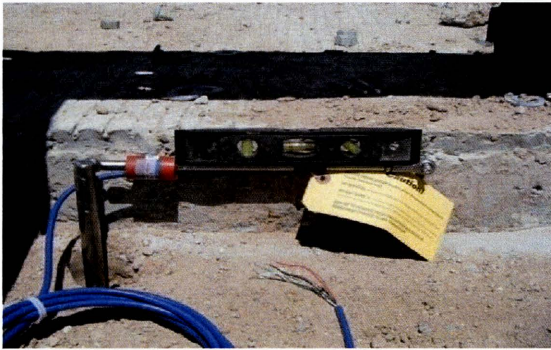
Figure 4.14 Installation of the crackmeter

The El Paso site was located at Spur 601 in El Paso. EJ was used as the terminal system to accommodate concrete slab movement. The slab thickness of the concrete pavement was 13 inches. The length of pavement was 0.80 mile. Subbase type used was three inches ASB. Aggregate type was LS. Crackmeters were installed at this site on April 21, 2009. Figures 4.12 and 4.13 show the location of the bridge and the crackmeter position. A protection box was used to protect the crackmeter and the datalogger as shown in Figures 4.14 and 4.15.

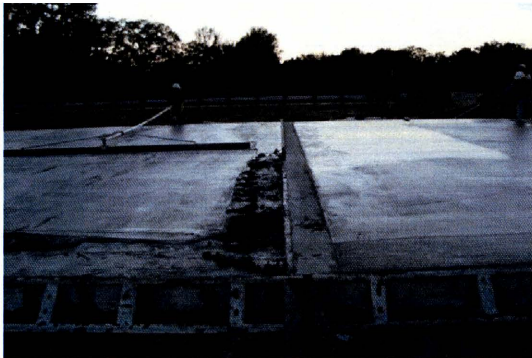
Figure 4.24 WF system placed

pavement was 13 inches. The length of pavement was greater than a mile. Subbase type was open graded 4 inches ASB. Aggregate type was SRG. The construction and placement of WF system are shown in Figures 4.21, 22, 23 and 24. A crackmeter was installed at this site on October 1, 2009. Figure 4.25 shows the installation of a crackmeter near the WF at the end of pavement. A protection box was also placed to protect the crackmeter and the datalogger as shown in Figures 4.26. The construction was completed on October 1, 2009 as shown in Figure 4.27.

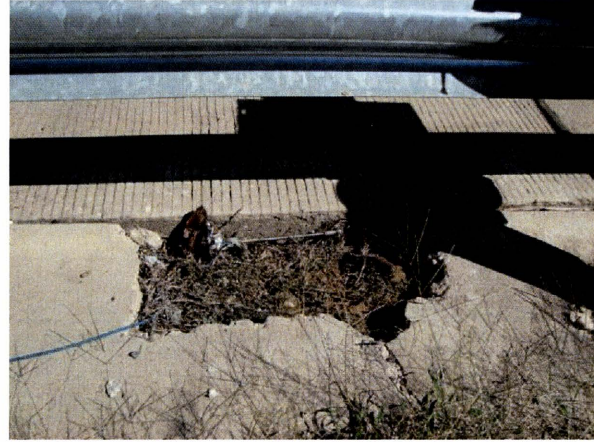
Figure 4.34 Crackmeter installation

The Texarkana site was located on LP 151 as shown in Figure 4.33. This pavement is not a new section. An AL system was used as the terminal system to restrain movements. The slab thickness of the concrete pavement was 13 inches. The length of pavement was 0.45 mile. Subbase type was four inches ASB. Aggregate type was SRG. A crackmeter was installed at this site on May 22, 2007 as shown in Figure 4.34. Figures 4.35 and 4.36 show the datalogger setup at the guardrails and the overview of the pavement where the crackmeter was installed, respectively.

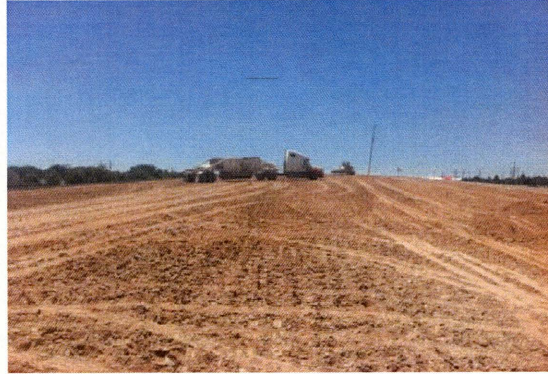
Figure 4.41 Subbase type 6 inches CSB

The Lubbock 2 site was located on Loop 289 as shown in Figure 4.40. An AL system consisting of four anchor lugs was used as the terminal system. The slab thickness of the concrete pavement was 10 inches. The length of pavement was 0.45 mile. Subbase was Type D one-inch ASB plus six inches CSB as shown in Figures 4.41 and 4.42. Aggregate type used was LS.

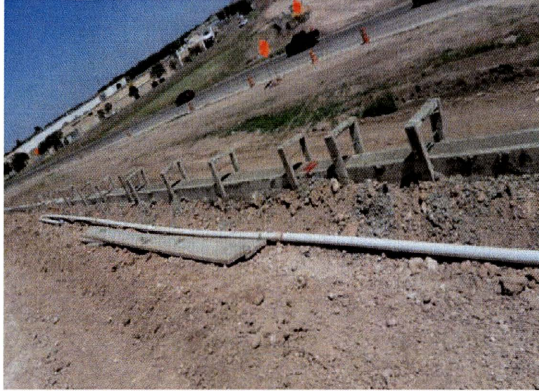
Figure 4.44 Pipes to protect gage cables

The nearest (AL1: anchor lug 1) and farthest (AL4: anchor lug 4) anchor lugs from the bridge approach slab were selected as the instrumentation area in the test section as shown in Figures 4.43 and 4.47. As there was no place for installing the datalogger box in the area of the pavement, it was decided to use PVC conduits to send the cables of the gages and to arrange the datalogger box at the bottom of the retaining wall. Figure 4.44 shows the arrangement of the pipes towards AL1 and AL4.

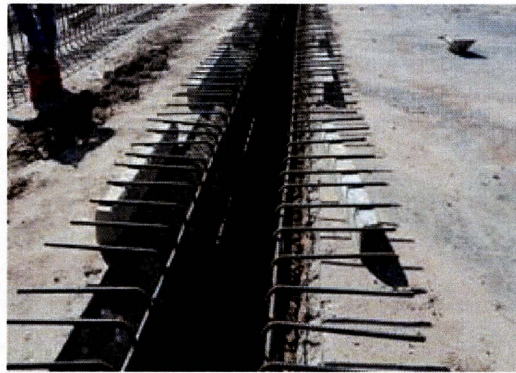
Figure 4.46 Cage tied and placed in the excavated area

Figure 4.45 shows the anchor lugs area excavated on August 31, 2009. In the night of August 31, all gages were brought to the site, and the cables were sent through the PVC conduit. On September 1, the steel cages were assembled at the job site as shown in Figure 4.46. Wooden planks were used to fix the gages in position. Eight VWSGs were installed in the two lugs. Figure 4.47 illustrates the section and gage installation scheme. Two pressure cells were installed in opposite directions in the AL4, which is away from the bridge as shown in Figures 4.47 and 4.50. All the VWSGs were installed eight ft from the retaining wall. To ensure a good contact of pressure cells to the soil, the surface of the walls were flattened, and a thin layer of plaster of Paris was applied as shown in Figure 4.48. Figure 4.49 shows the gages installed in the AL near the bridge (AL1). Concrete was poured in this lug in the morning of September 2, 2010 (Figures 4.51 and 4.52). The two pressure cells were installed 13 ft from the edge of the retaining wall. The main lane paving was done on September 30, 2010 as shown in Figure 4.53. The concrete placement started at 11 am. Concrete strain gages in the pavement slab (L1, L2, R1, and R2 in Figure 4.47) were installed in the CRCP at this time. The two crackmeters were also installed on November 8, 2010 when the shoulder was placed as shown in Figure 4.54. The shoulder was placed with concrete at 1 pm as shown in Figure 4.55.

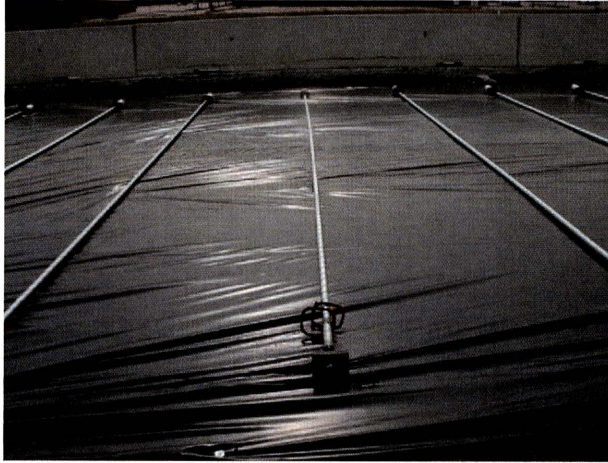
Figure 4.56 Polyethylene sheet placed between subbase and CRCP

Cast-in-place concrete post-tensioned concrete pavement was constructed on IH 35 in Hillsboro in the Waco District from 2007 to 2009. To investigate the effect of subbase friction on slab movement, the information on the slab movement of this pavement section was utilized. The slab thickness of the pavement was nine inches. The length of the pavement slab between armor joints was 300 ft. Subbase type was four inches ASB. Aggregate type was LS. Two layers of polyethylene sheet were placed between the subbase and concrete slab to reduce the friction of the slab as shown in Figures 4.56 and 4.57. Figure 4.58 shows the concrete placement.

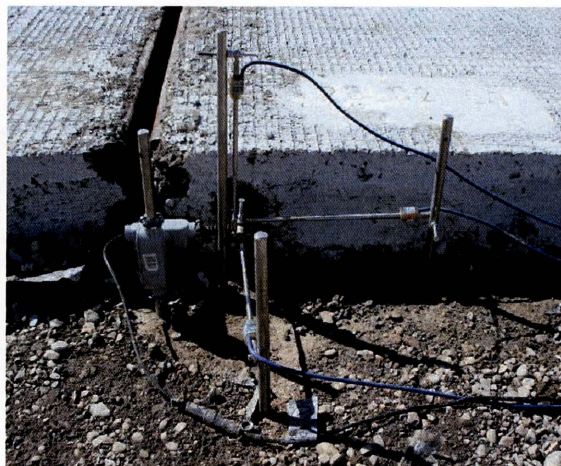
4.59 Installation of crackmeter

Crackmeters were installed at this site on February 23, 2009 as shown in Figure 4.59. At the free edge of the slab, five crackmeters were installed at different distances from the slab center as shown in Figure 4.60.

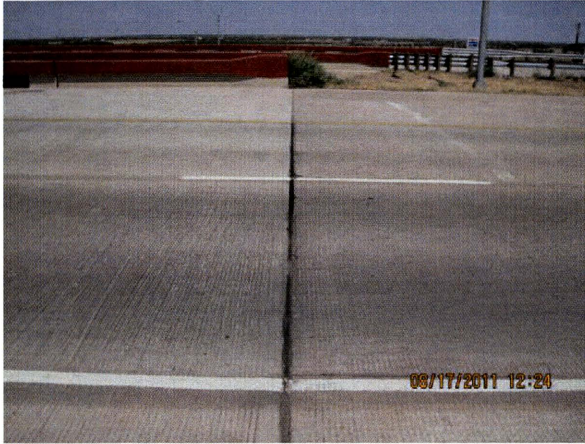
Figure 5.6 Expansion joint at the west end of the CRCP

Air temperature was quite high in the summer of 2011. The widths of expansion joints were measured on August 17, 2011. The air temperature was 106 °F. The joint widths varied from 0.90 to 1.25 inches in the west end, and from 1.25 to 1.50 inches in the east end (Figures 5.6 to 5.9). Since the initial joint width during the construction was about 1.5 inches, the slab expansions varied approximately from zero to 0.6 inches.
