**CENTER FOR TRANSPORTATION RESEARCH
THE UNIVERSITY OF TEXAS AT AUSTIN**

TECHNICAL REPORT 0-6357-1

MONITORING OF EXPERIMENTAL SECTIONS USING A WEB-BASED DATABASE

Jose Pablo Aguiar-Moya
Andre de Fortier Smit
Jorge A. Prozzi

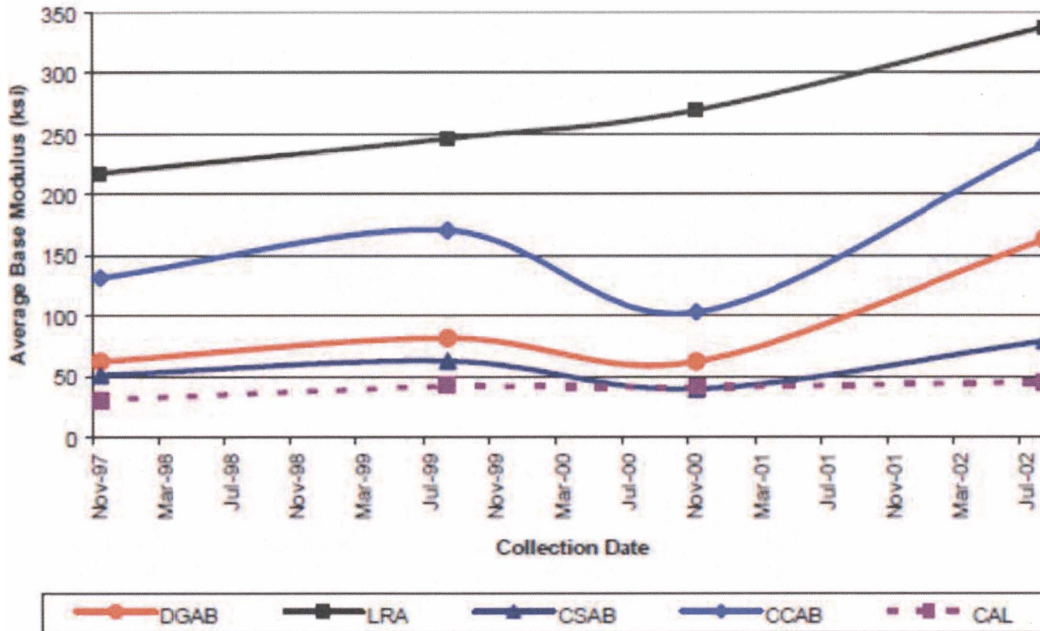
Figure 2.2: Base layer moduli for US 281 sections over time

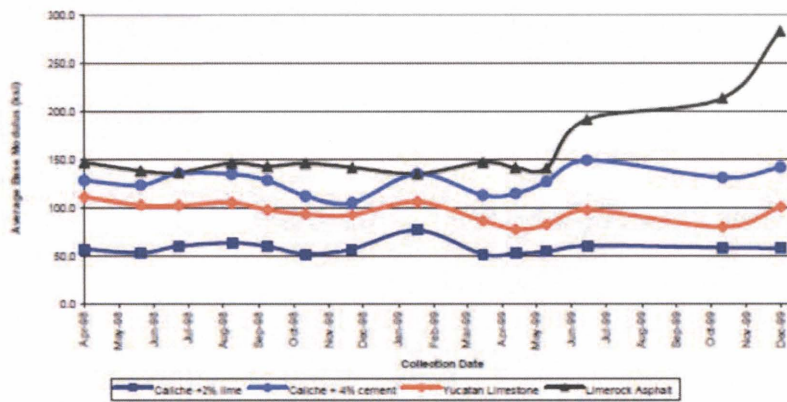
Figure 2.3: Base layer moduli on US 77 from 1998 to 1999

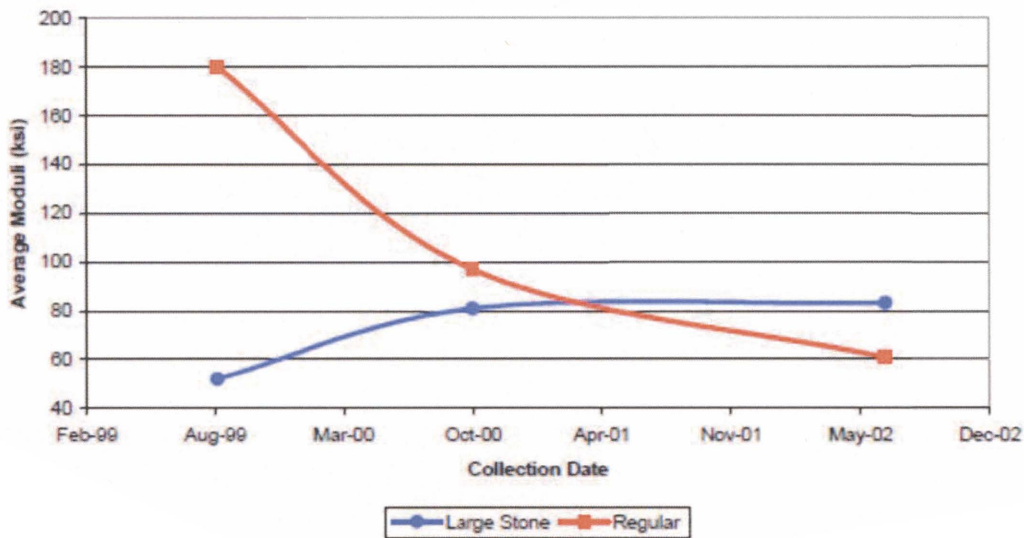
Figure 2.5: Base layer moduli on FM 1810 from 1999 to 2002.

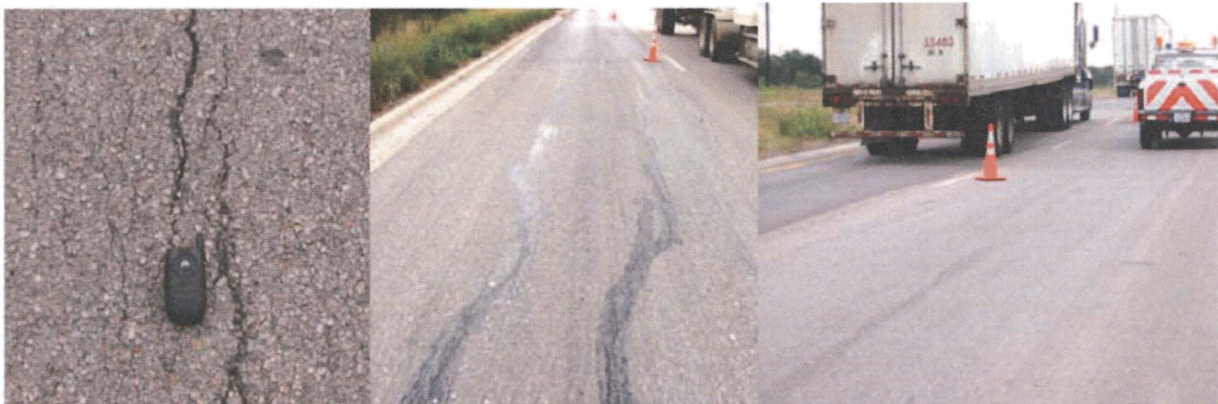
Figure 2.8: Shrinkage cracking distress on FM 734

The pavement on FM 734 (Parmer Lane) from Samsung Road to Harris Branch in the Austin District experienced severe distresses (shown in Figure 2.8). Frequent swells and dips were evident, due to sulfate heave and seasonal expansive soil swelling. In addition, the pavement was experiencing longitudinal shrinkage cracking with cracks as wide as 1 inch and deeper than 5 feet caused by shrinkage of expansive soil during the drought in 2006.

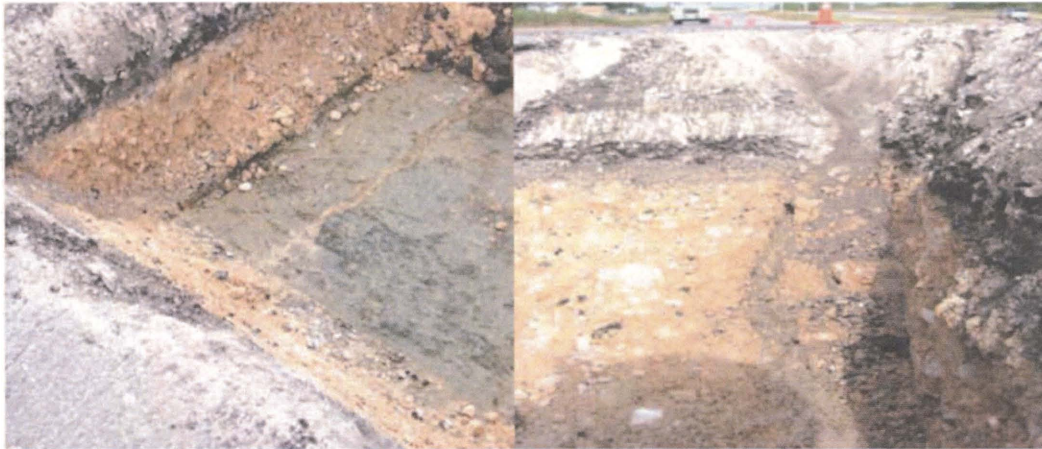
Figure 2.9: Reflective shrinkage cracking seen in test pit

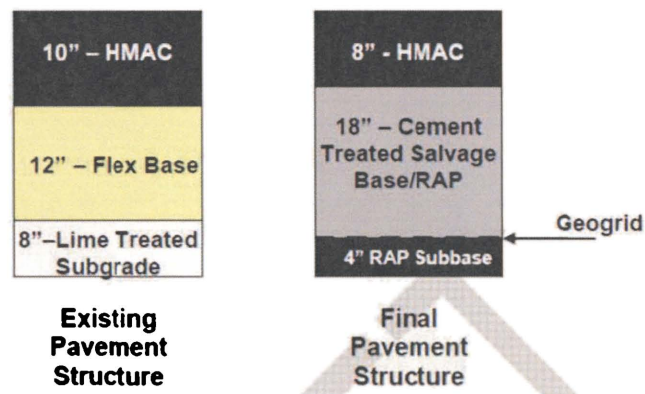
Figure 2.10: FM 734 pavement redesign

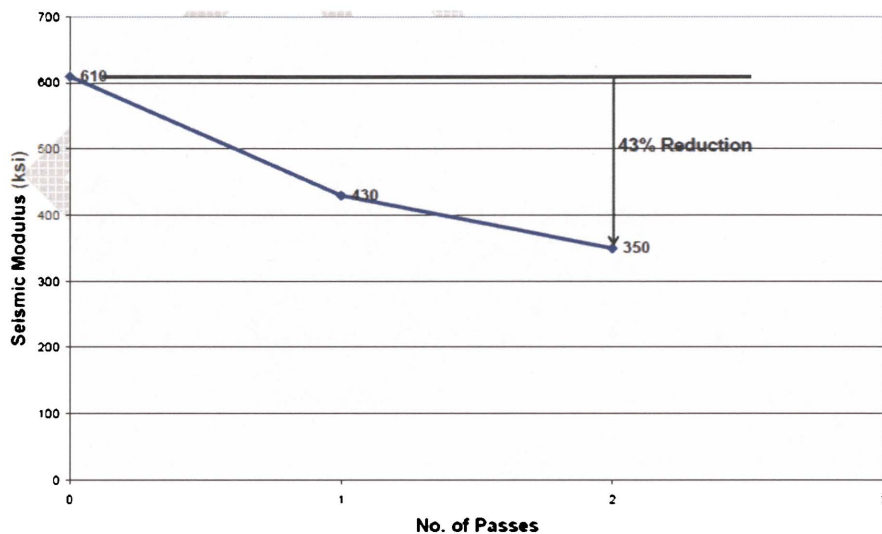
Figure 2.11: Reduction of base modulus with micro-cracking

stiffness of the base increases over time, with a substantial increase in modulus 14 days following the micro-cracking.

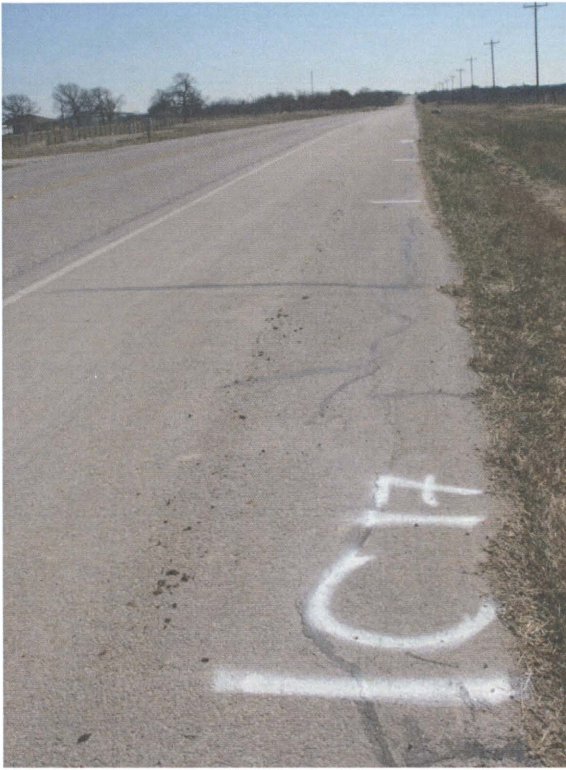
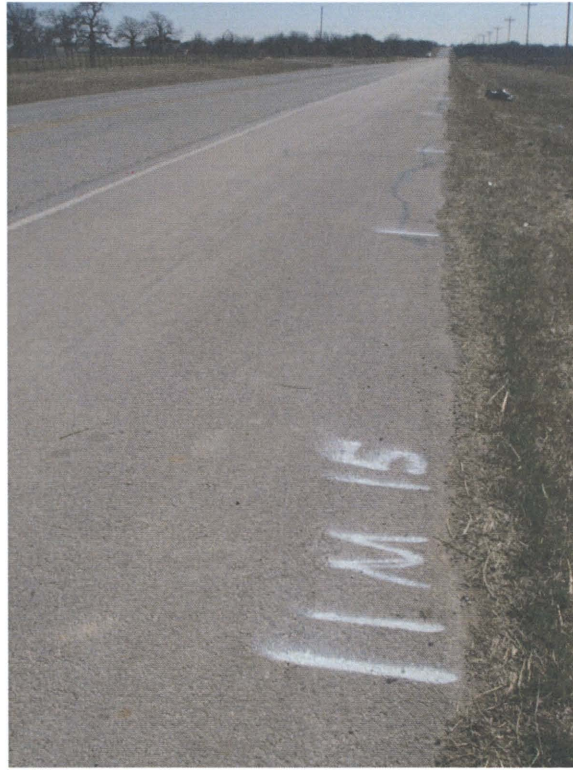
(a) Control Plot

(b) Dairy Manure as compost

Figure 2.13: Use of compost to reduce shoulder cracking

More recently, Texas has also used compost materials as a means to reduce shoulder cracking as Figure 2.13 shows. The reader should refer to Kirchoff et al (2002) for details on the process.

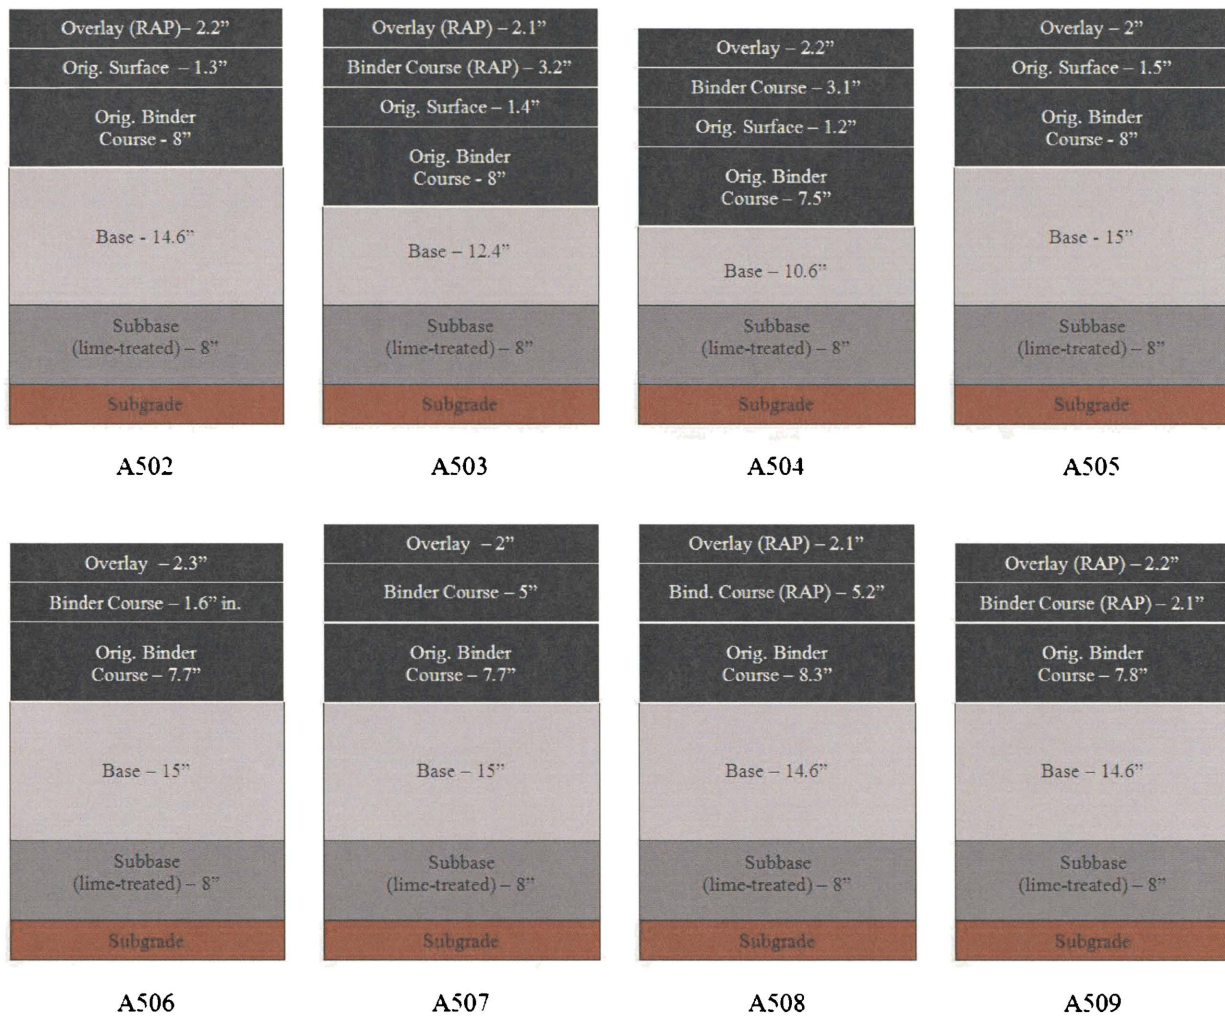
Figure 4.1: Texas SPS-5 pavement structures

- A501 (Control, no treatment),
- A502 (Thin overlay—recycled HMA mix),
- A503 (Thick overlay—recycled HMA mix),
- A504 (Thick overlay, virgin mix),
- A505 (Thin overlay, virgin mix),
- A506 (Thin overlay, virgin mix, with milling),
- A507 (Thick overlay, virgin mix, with milling),
- A508 (Thick overlay, recycled mix, with milling), and
- A509 (Thin overlay, recycled mix, with milling).

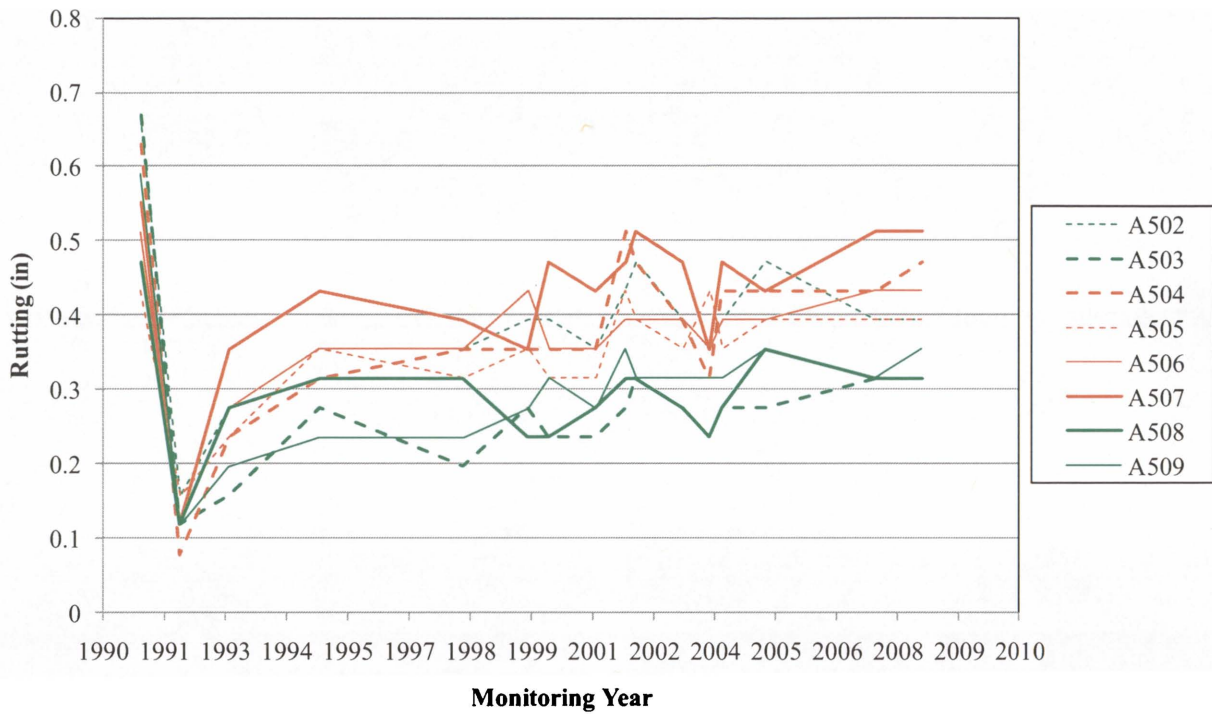
Figure 4.2: Rutting of Texas SPS-5 pavement structures

The field performance of the Texas SPS-5 sections in terms of rutting and cracking is shown in Figures 4.2 through 4.6. As expected, three of the sections with RAP (thick overlay with and without milling, and thin with milling) outperform the sections with no RAP in terms of rutting resistance. However, note that the average difference in rutting between the sections with RAP and the sections with no RAP is only in the order of 0.07 in. All sections, in general, performed well. Nonetheless, regardless of the difference in rutting between the sections with and without RAP, a clear distinction exists between the performances of the two types of mix.

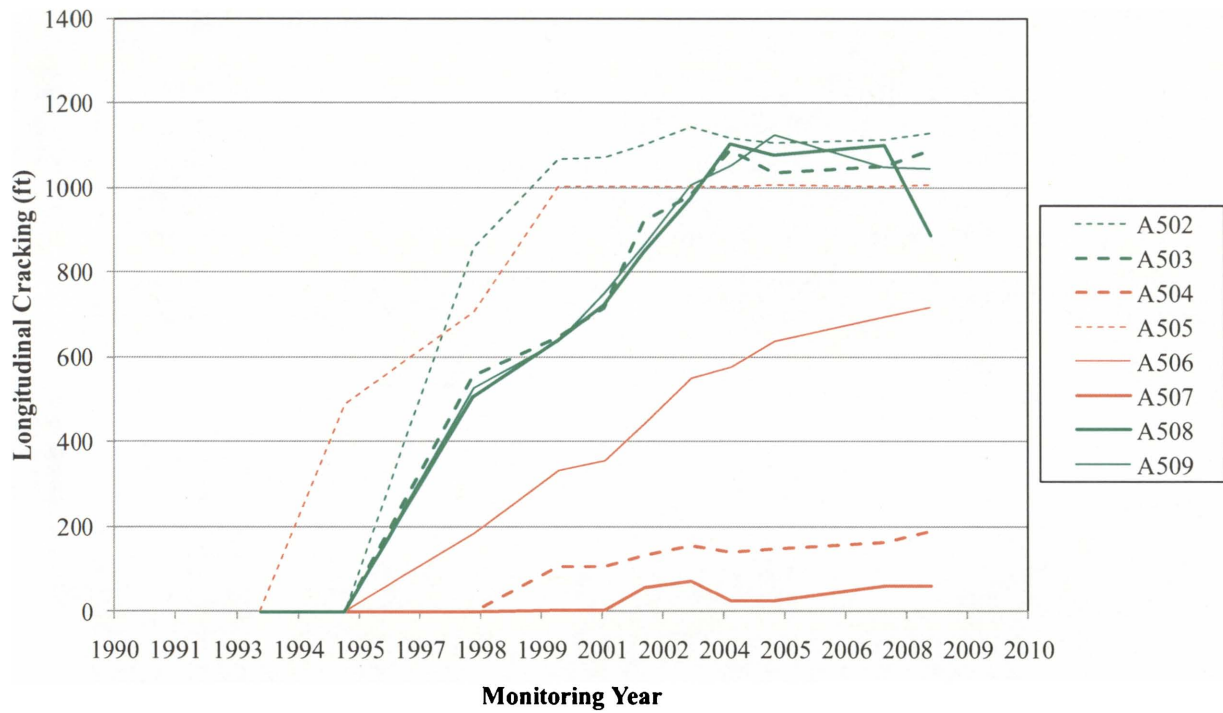
Figure 4.4: Longitudinal cracking of Texas SPS-5 pavement structures

Contrary to the case of rutting, Figures 4.3 through 4.5 illustrate that the pavement sections with RAP consistently exhibit earlier cracking initiation (alligator, longitudinal, and transverse cracking) and a higher rate of cracking progression, as compared to pavement sections where RAP was not included. In the case of fatigue cracking, two of the pavement sections with no RAP (thin overlay with and without milling) did not develop alligator cracking during the entire observation period. Similarly, in the case of transverse cracking, three of the pavement sections with no RAP (thick overlay with and without milling, and thin with milling) have developed very few transverse cracks at a slower rate than the remaining pavement sections that include RAP.

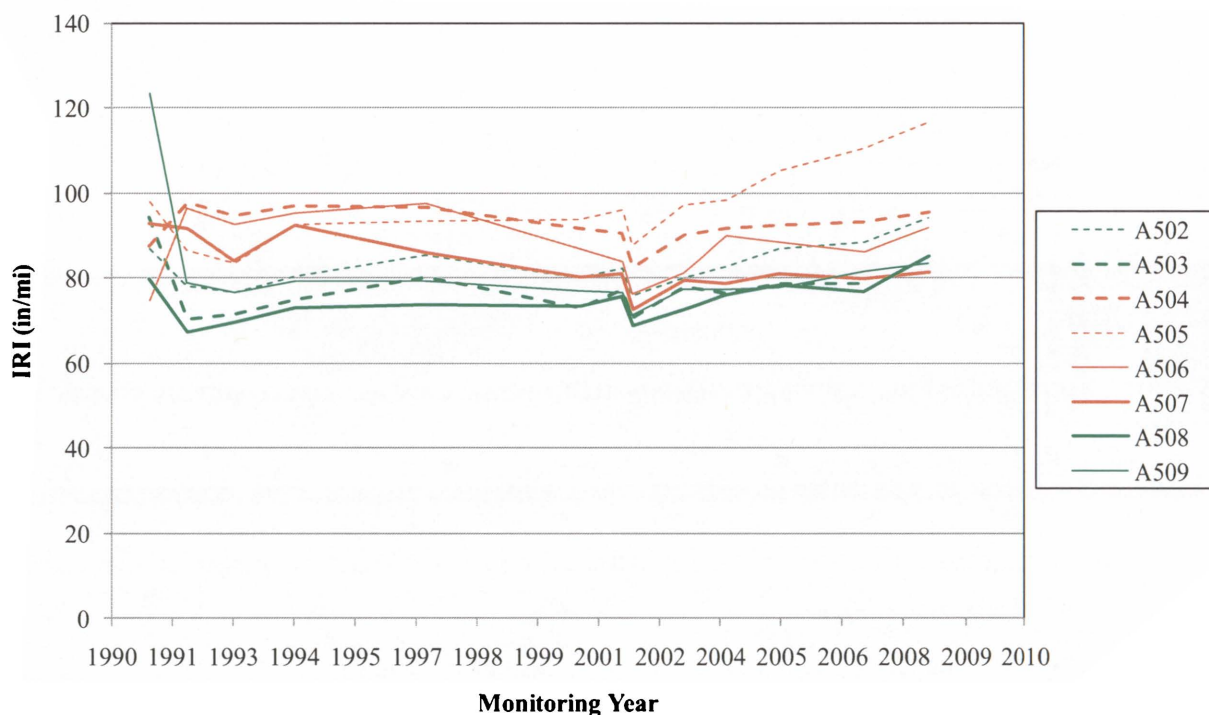
Figure 4.6: Roughness of Texas SPS-5 pavement structures

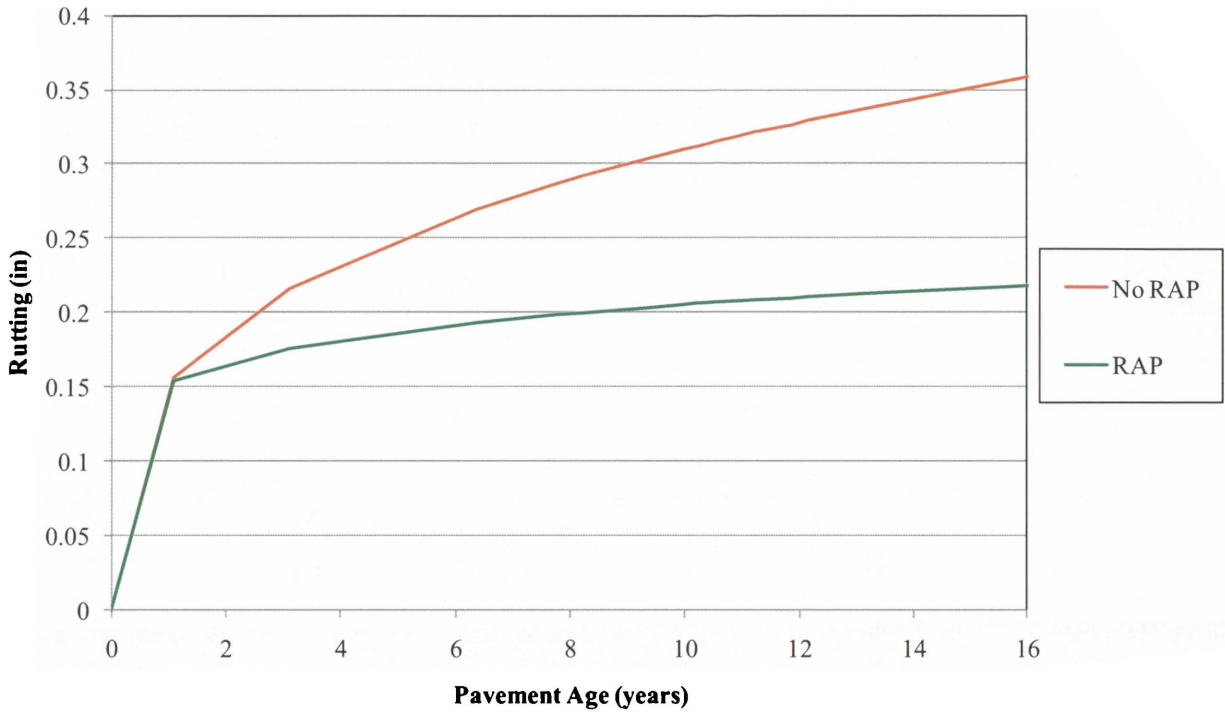
Figure 4.7: Rutting progression on a pavement with a thick overlay (with milling prior to overlaying)

From the model estimates, the researchers concluded that the effect of milling (β_2) is not significant at the 95 percent level of confidence. On the other hand, the thickness of the overlay is significant based on the previous level of confidence. However, based on the model estimates, the use of RAP has the highest effect on the rutting progression of the pavement structure. Figure 4.7 shows a comparison of the performance predicted by the model for a pavement section with and without RAP.

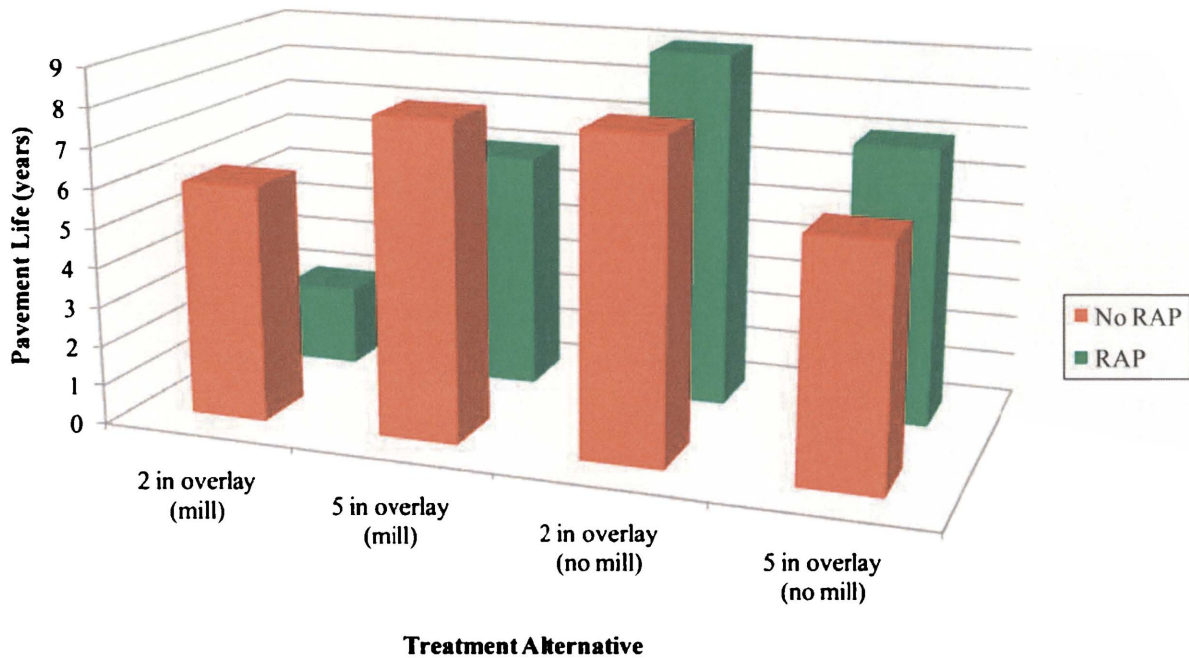
Figure 4.9: Estimated pavement life of analysis pavement sections

Based on the previously defined deterioration models and failure criteria, the estimated life of the pavement sections of interest can be summarized in Figure 4.9. Note that milling prior to overlaying increases the life expectancy of the pavement structure when no RAP is used in the mix. In the case where RAP is used, the effect of milling is reversed. Furthermore, the expected increasing trend of pavement life as a function of overlay thickness can be verified for the case of pavement where RAP was used. The reverse trend is observed in pavements with no RAP (however, this trend can be verified by observing the actual field cracking and rutting on the SPS-5 sections in Figures 4.2 through 4.5).

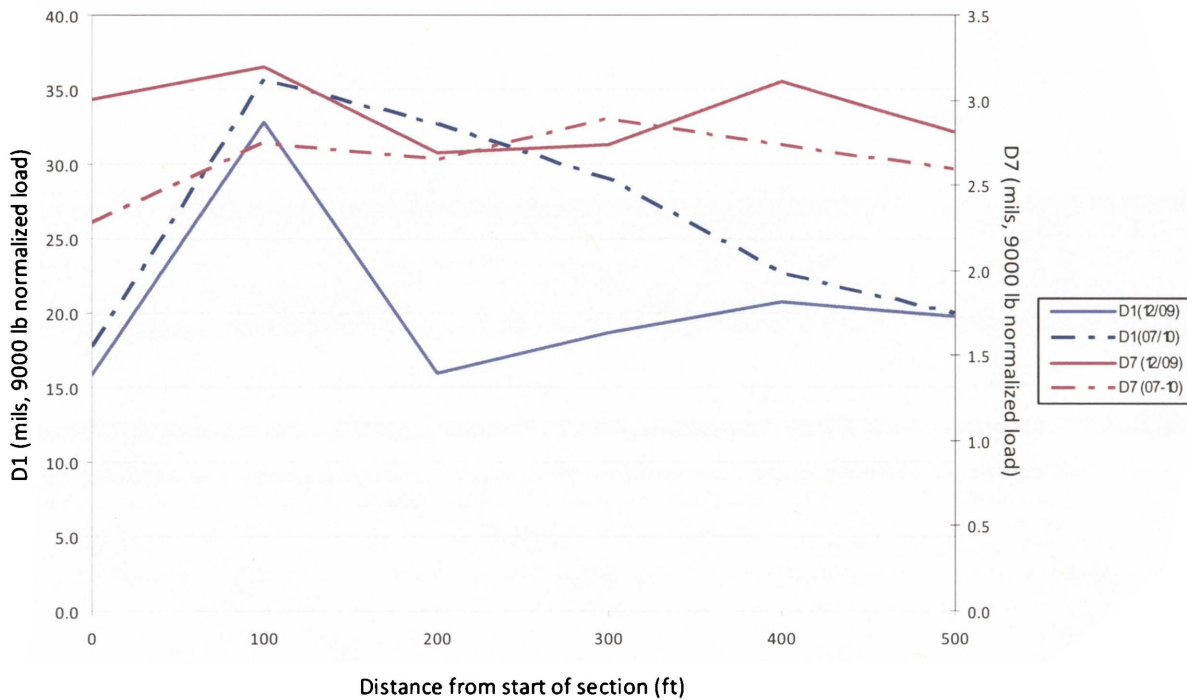
Figure 6.3: Deflections along WMA (Advera) in FM 324, Lufkin (LFWMA1AS)

As an example of the data that were collected, the performance data for one WMA section are shown in Figures 6.3–6.7. Please note that Figure 6.7 shows no transverse cracking. The data correspond to the WMA with Advera placed on the southbound lane of Loop 368 (LFWMA1AS).

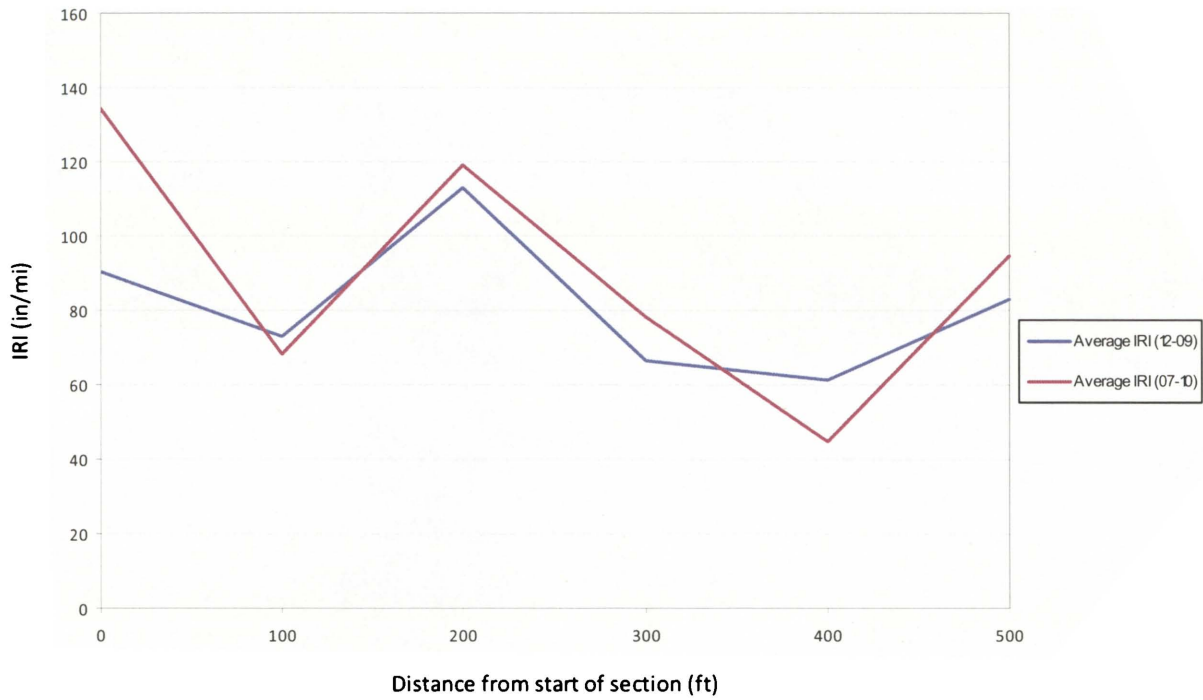
Figure 6.4: Roughness along WMA (Advera) in FM 324, Lufkin (LFWMA1AS)

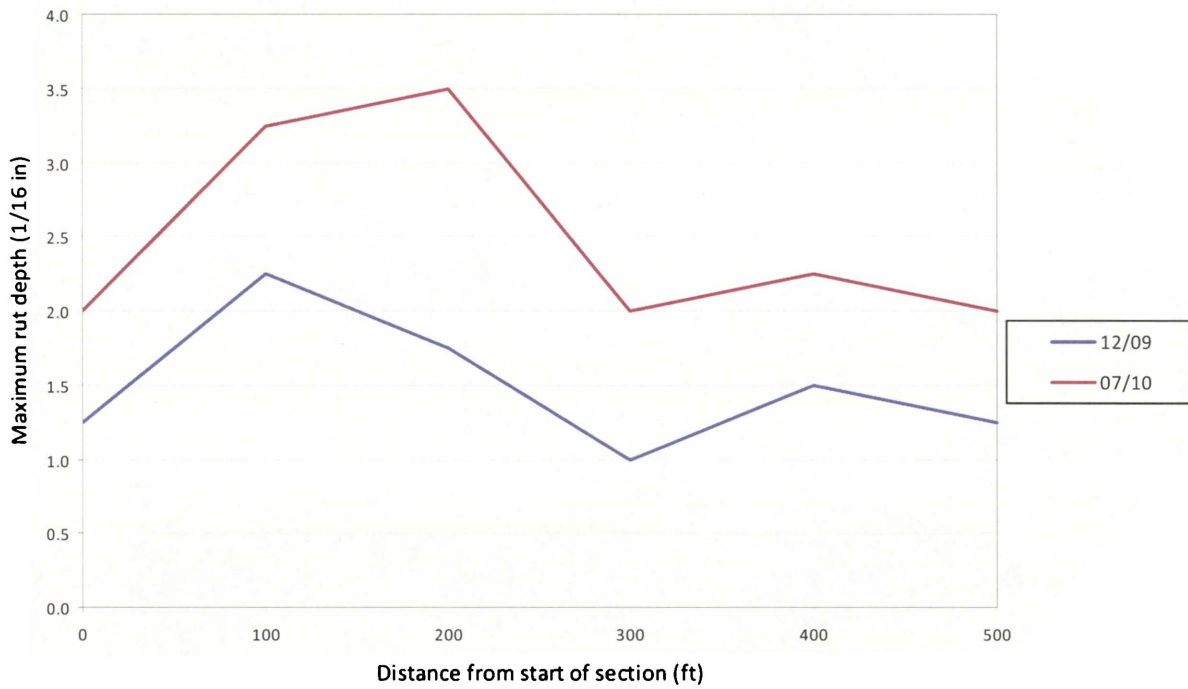
Figure 6.5: Rutting along WMA (Advera) in FM 324, Lufkin (LFWMA1AS)

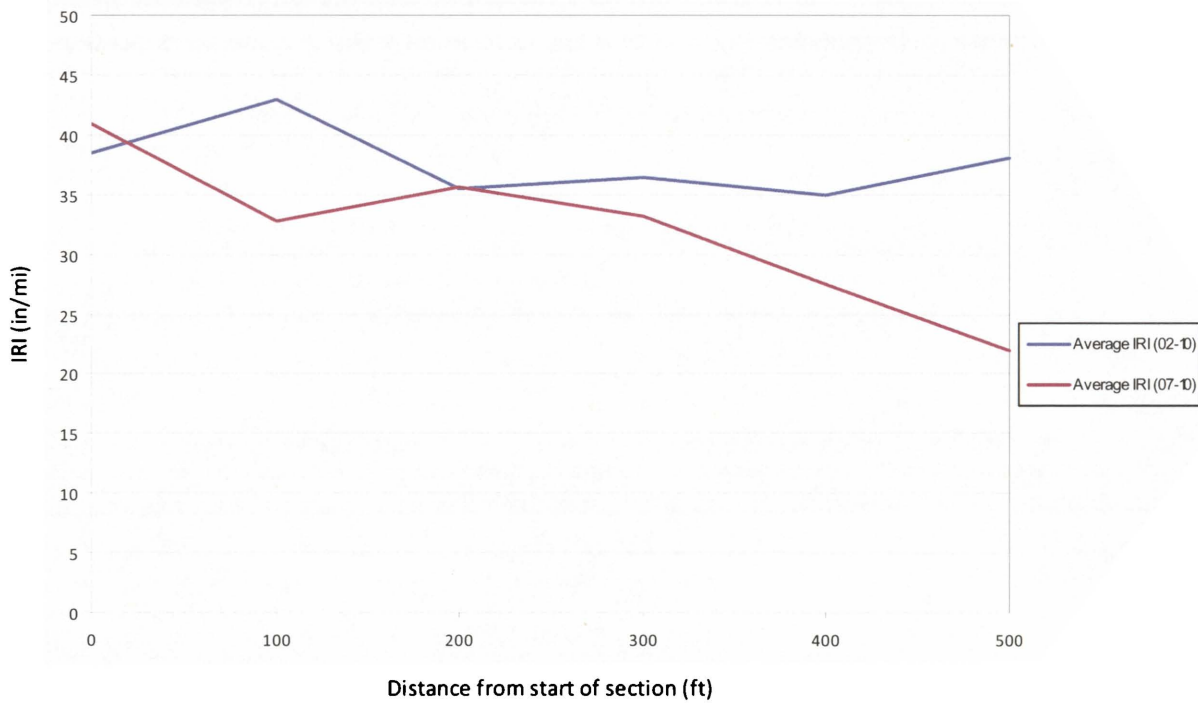
Figure 7.3: Roughness along perpetual pavement structure, R1, Fort Worth (FWPERP1E)

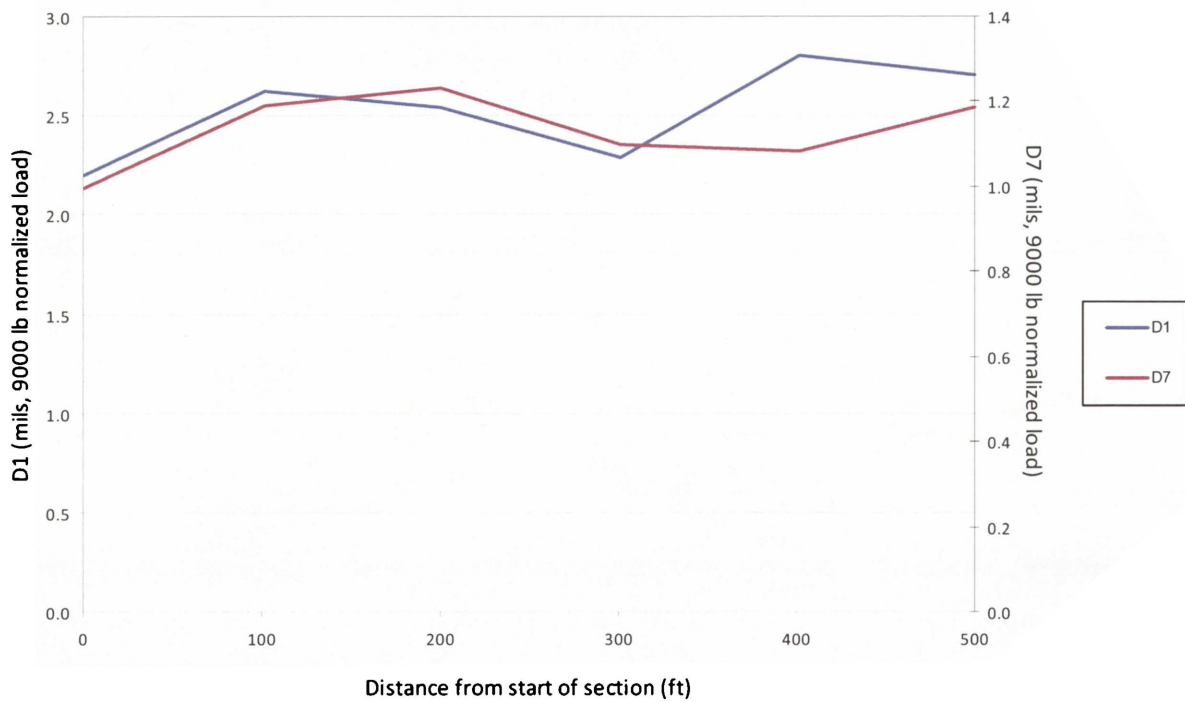
Figure 7.10: Deflections along perpetual pavement structure, R1, IH 35 (LAPERPIN)

Figures 7.10–7.12 provide an example of the collected data: the performance of one of the northbound perpetual pavement sections (LAPERP1N). The data corresponds to the outside lane (R1). Notice that Figure 7.12 displays the average rut depth for the left and right wheel path, 2/16 and 1/16 in., respectively. Data are also available for the remaining four sections. To access the information, please refer to:

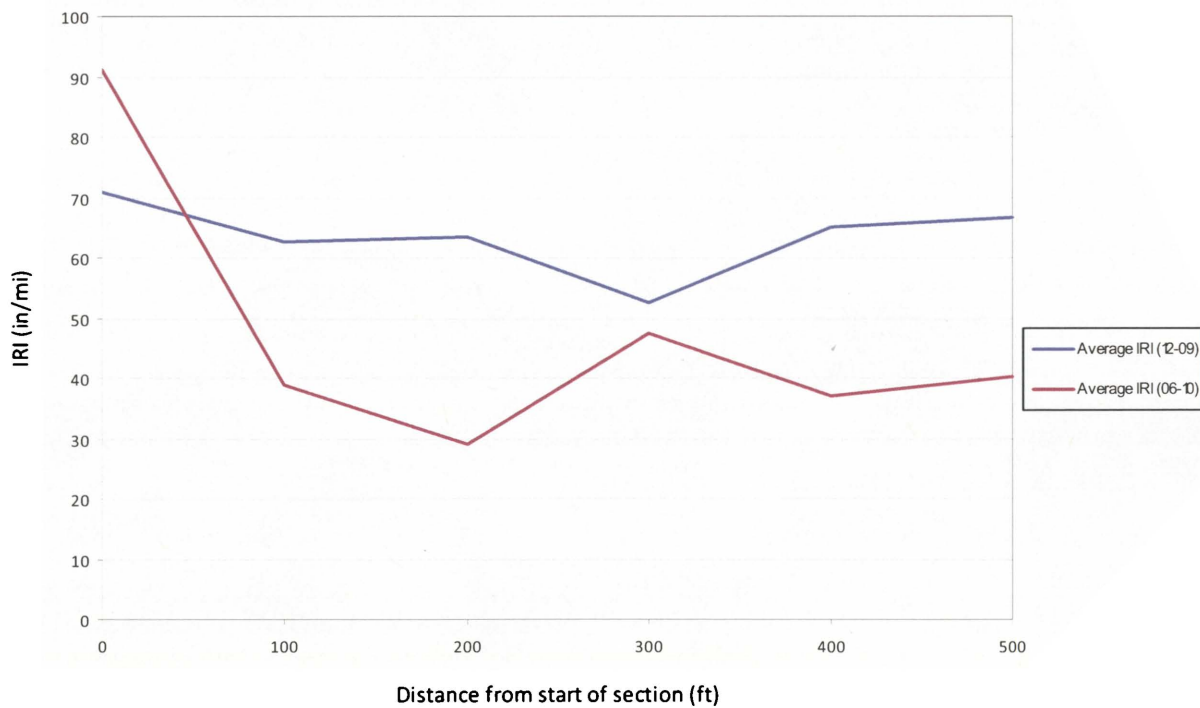
Figure 7.11: Roughness along perpetual pavement structure, R1, IH 35 (LAPERPIN)

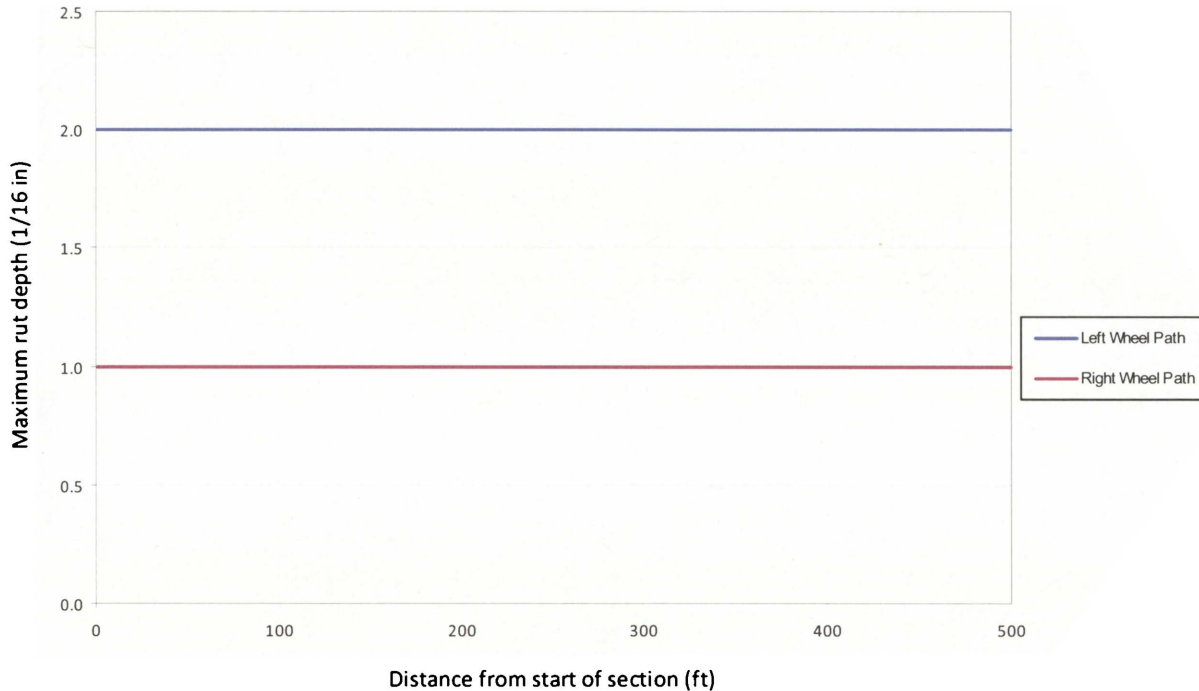
Figure 7.12: Rutting along perpetual pavement structure, R1, IH 35 (LAPERPIN)

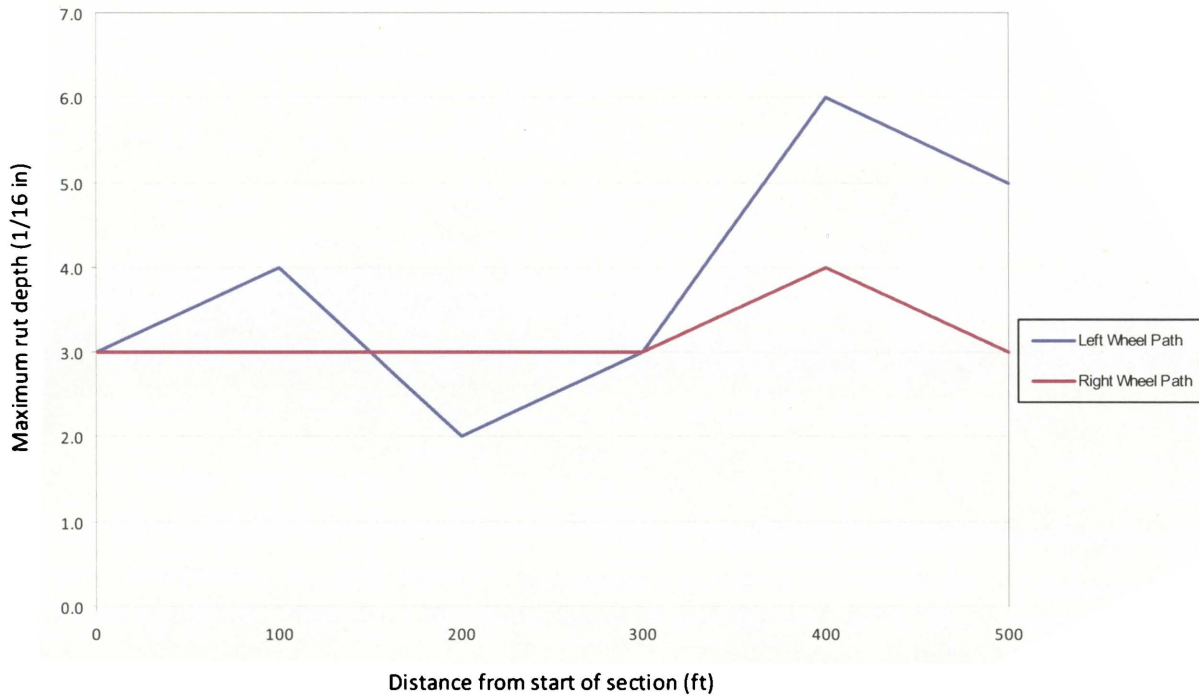
Figure 8.2: Rutting along CAM section on LP 20, Laredo (LACAM1W)

As an example, the following figures display the performance data for the Laredo section (Loop 20). Figure 8.1 shows the location of the surface CAM pavement section, and Figure 8.2 shows rutting along the section.

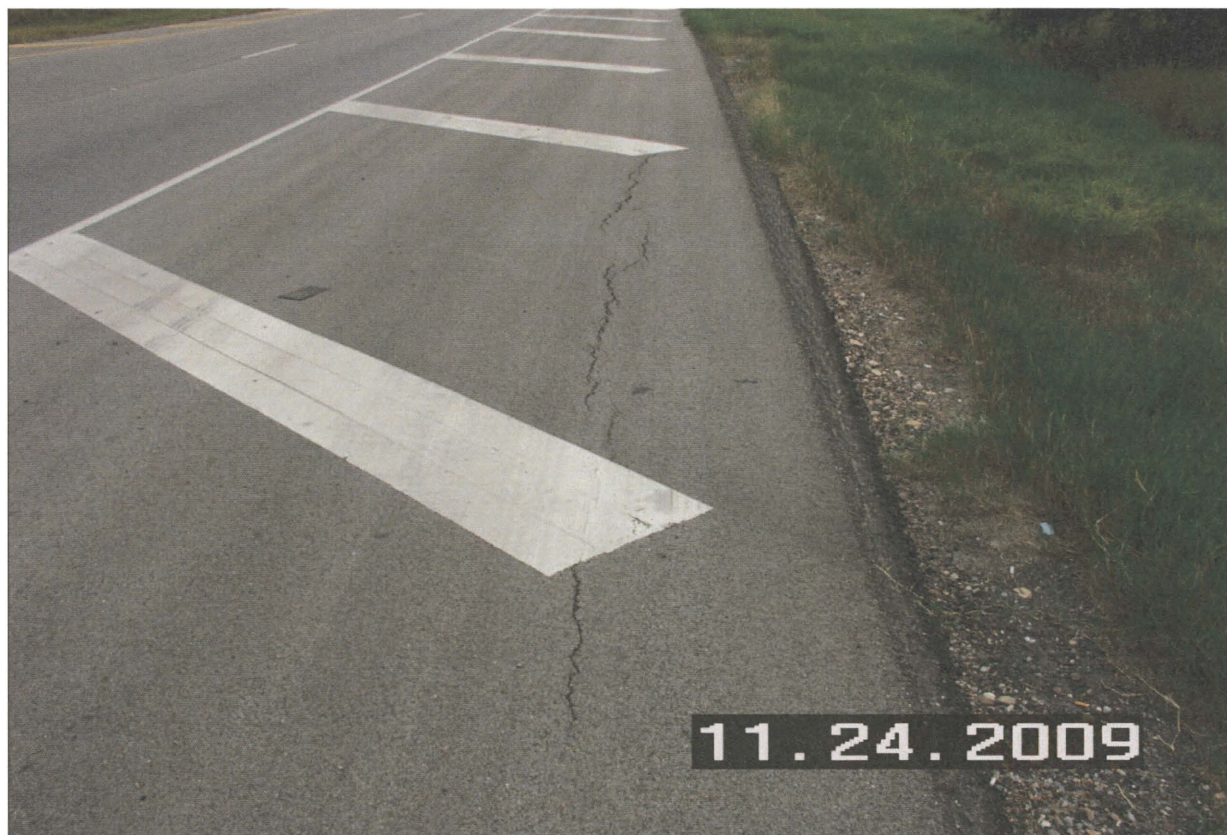
Figure 8.3: Cracking along pavement shoulder in CAM section on Loop 20, Laredo

The poor performance of the CAM mixtures both in terms of rutting and cracking as observed from the sections monitored in the study is reason for concern. The CAM sections are still relatively new constructions but are showing early signs of distress, suggesting the improper application of these mixtures. In other sections of Texas CAM mixes have been used successfully.

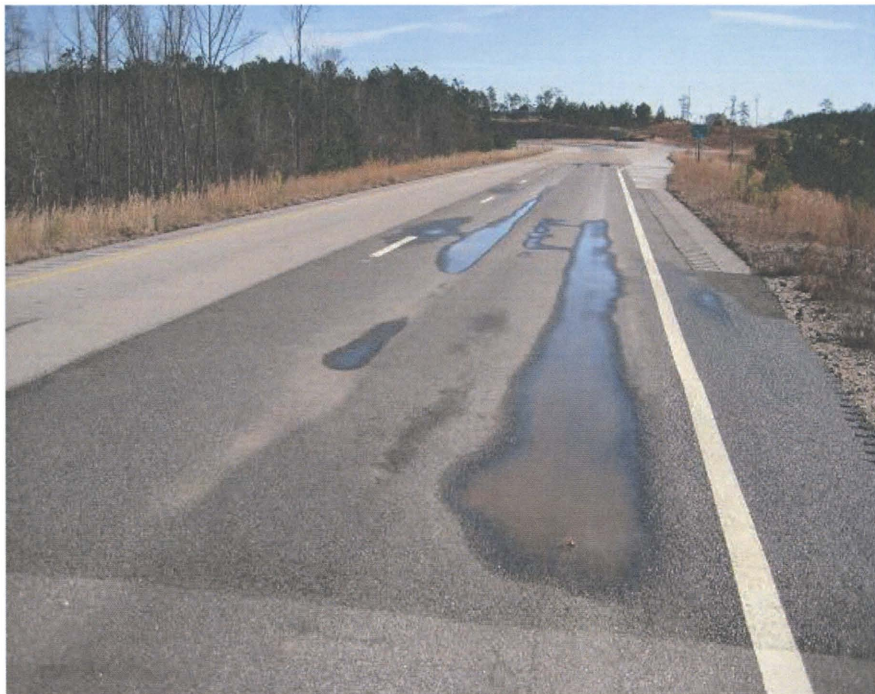
After the NCAT experiment ended (10 million ESALs according to NCAT's own estimation) the pavement section exhibited considerable rutting (1.02 in. [26 mm] of surface rutting). The rutting was attributed to poor construction that resulted in binder contents in the Type D mix in excess of 1.3 percent from the design AC value. The rutting allowed for water ponding, as Figure 8.4 shows.
