1. Report No. FHWA/TX-10/0-6100-1		2. Government Accession No.		3. Recipient's Catalog No.	
4. Title and Subtitle DEVELOPMENT OF A PRECAST BRIDGE DECK OVERHANG SYSTEM				5. Report Date February 2010 Published: February 2011

DEVELOPMENT OF A PRECAST BRIDGE DECK OVERHANG SYSTEM

Report 0-6100-1

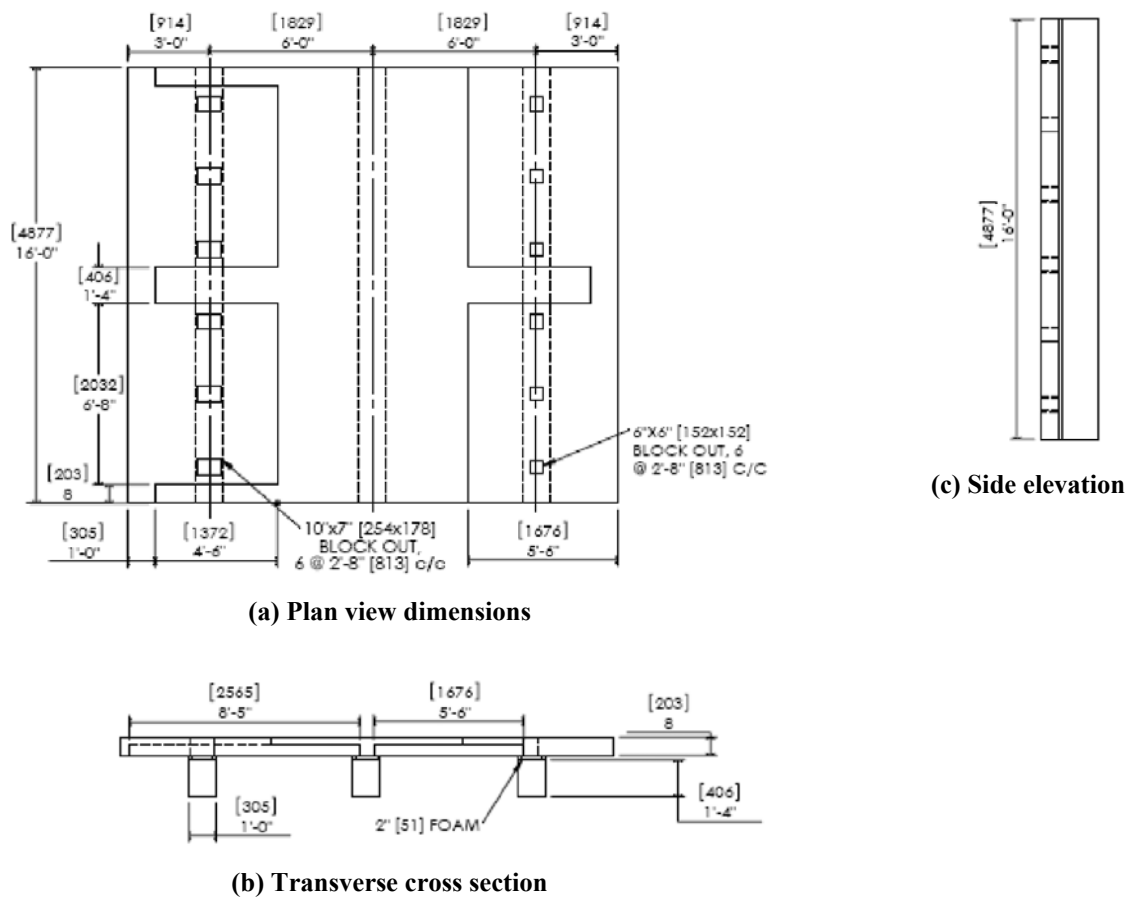
Figure 2-4. Various Views and Layout of Specimen 2.

Specimen 2 was designed and tested with the objectives of (1) confirming the findings of the precast overhang system tested on Specimen 1 and (2) investigating an alternative approach for constructing full-depth overhang panels. The latter objective was achieved by constructing a conventional panel system with a “second stage” concrete placement to achieve a full-depth overhang panel. Figure 2-4 shows a general layout for Specimen 2. The reinforcement details for this system are similar to the precast overhang system, with the exception that the prestressing strands are replaced with conventional reinforcement in the “first stage” cast. As with the conventional overhang system, #4 (#13M) mild steel reinforcing bars were placed at

6-in. (152 mm) centers. The shear connections for this system were similar to the Specimen 1 connectors with the exception of the pockets, which were reduced from 10 × 7-in. (254 × 180 mm) pockets to 6-in. (152 mm) square pockets. Smaller composite pockets allowed for the main top steel over the cantilever portion to be spaced closer to 6-in. (152 mm) uniform spacing. It was anticipated that by evaluating the lab-cast panels, information could be obtained on the effect of the prestress in the bottom layer.

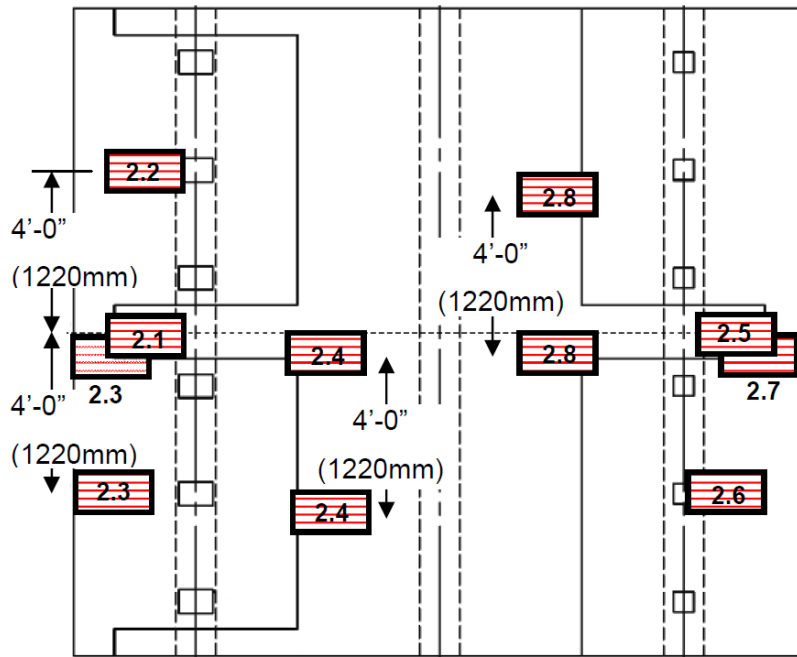
Figure 2-6a illustrates the load cases tested on Specimen 1. Load Cases 1.1 and 1.2 are the required AASHTO factored load at the longitudinal midpoint (or seam), and the longitudinal quarter-point (center of a panel), respectively. For the overhang, this positioned the center of the load plate 6 in. (152 mm) off the beam face, resulting in 2 in. (51 mm) of the load plate bearing over the grout bed (haunch). This load location is referenced in Section 3.6.1.3 of the AASHTO LRFD [Bridge Design Specifications \(2007\)](#). Load Case 1.3 is the edge failure load, where the wheel load edge is on the edge of the panel. This may be representative of a crash load, with an increased moment due to the overturning force from the barrier resistance. The shear force will be the same as the AASHTO required load point; however, a greater moment at the beam face makes it more critical. Load Cases 1.3 and 1.4 are similar to 1.1 and 1.6, while Load Case 1.5 differs from Load Case 1.3, as it is on the seam edge. Load Case 1.7 is an axle load at the midpoint of each panel. Load Case 1.8 is the interior failure load for an axle. Axle wheel loads are spaced at 6-ft (1.8 m) centers.

Load Case 1.7 was loaded to 120 kips (534 kN) per wheel load. All other load cases were loaded to failure. Load Cases 2.1, 2.2, 2.5 and 2.6 were loaded up to 60 kips (267 kN). All other load cases were loaded to failure. Load Cases 1.1, 1.2, 1.4 and 1.5 were loaded up to 60 kips (267 kN).

Figure 2-6b shows loading for Specimen 2. The overhang loading on the lab-cast side was the same as Specimen 1 for the conventional and precast overhang to allow direct comparison of results. The failure load on the precast side was a trailing wheel load on the same panel as shown in Figure 2-6b. Load Case 2.4 was a trailing wheel load on one panel. Load Case 2.8 is similar; however, one wheel load is on the adjacent panel, closest to the seam. The trailing wheel load is 4 ft (1.2 m), whereas in Specimen 1, Load Cases 1.7 and 1.8 represent a total axle load with the two wheel loads spaced 6 ft (1.8 m) apart.

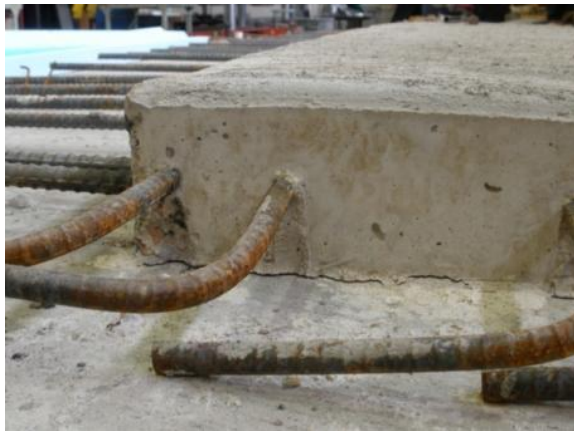
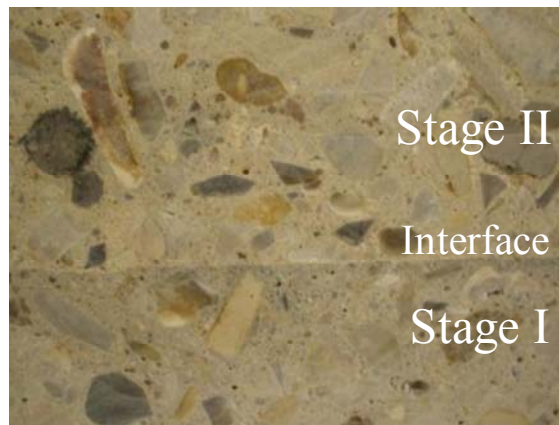
Figure 2-7. Photographs Showing Cracking in between Concrete Lifts and Good Consolidation between Concrete Lifts.

As noted, the panels were constructed in two stages. Stage I concrete was broom-finished to provide enhanced friction between the Stage I and II interface. Delivered panels exhibited signs of cracking between the Stage I and II concrete placements, likely due to differential shrinkage or curling of the panels. Cracks propagated approximately 2 ft (0.6 m) in both directions from the corner, as shown in Figure 2-7a. Figure 2-7b shows that satisfactory compaction was achieved at other locations between the two concretes placed in different stages.

(a) Cracking between Stage I and II

(b) Cross section of Stage I and II concrete

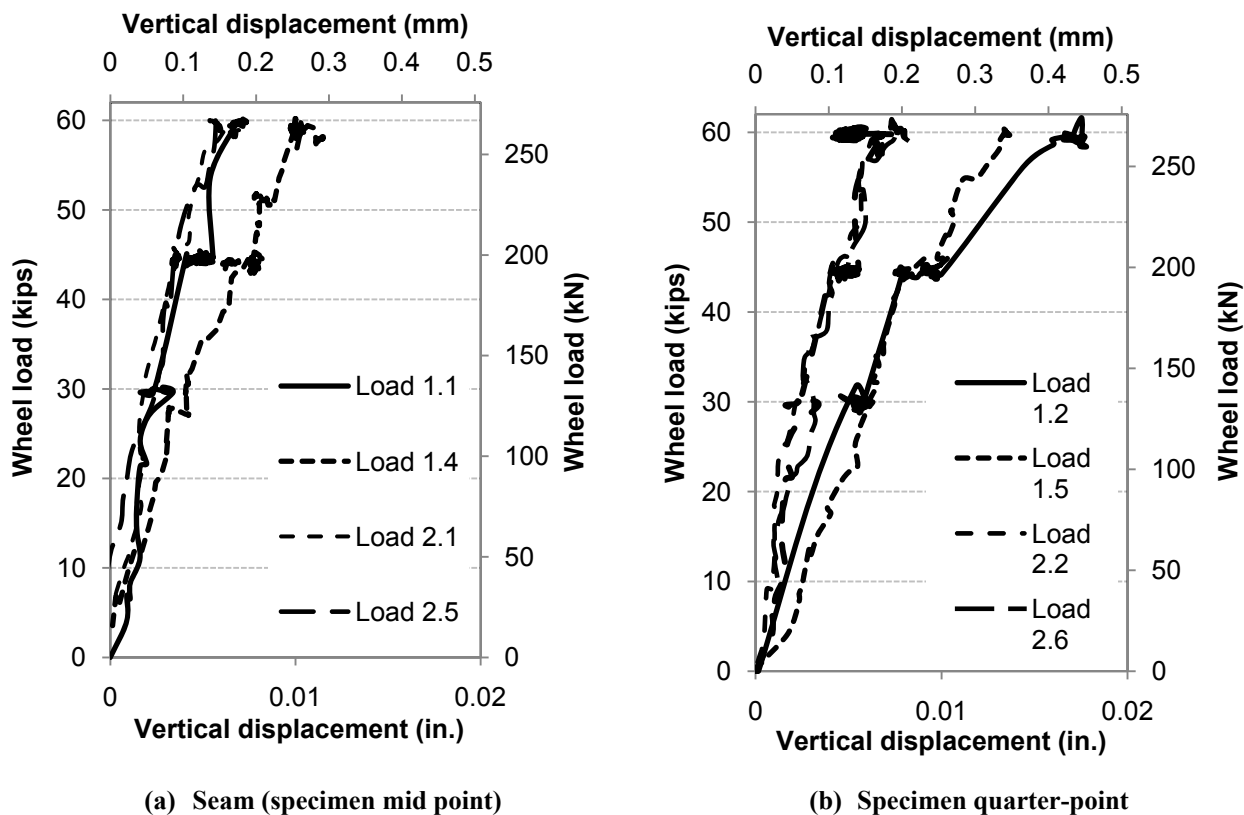
Figure 2-9a presents the results for the AASHTO overhang wheel load at the longitudinal midpoint of the bridge deck (the seam between precast panels). Vertical displacements obtained were small, with the largest displacement being approximately 0.012 in. (0.3 mm), corresponding to a slab transverse rotation of 0.002 radians at the beam face.

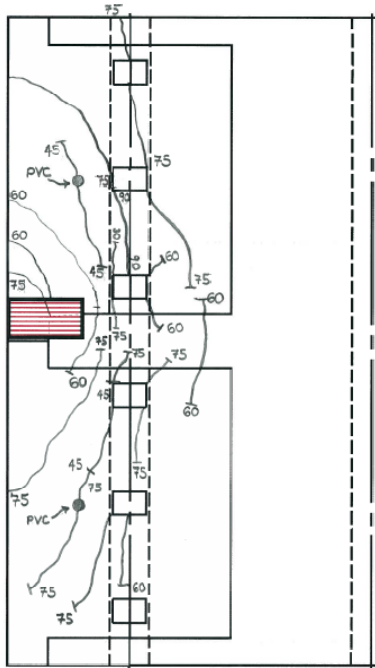
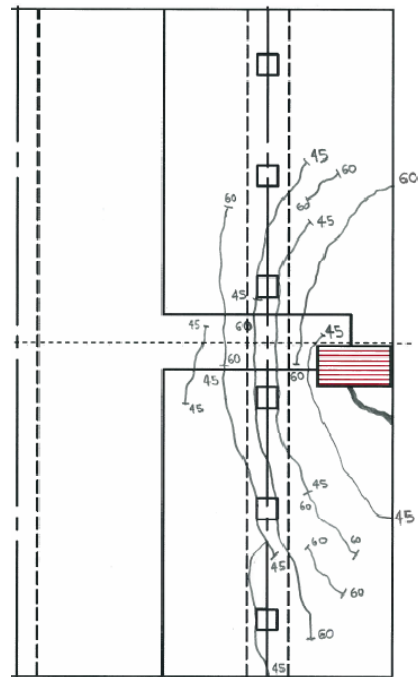
Figure 2-10. Crack Mapping of Overhang Failure Loads.

Cracks were mapped at selected loads based on the force-deformation data during the experiment. [Figure 2-10](#) shows the cracks that were observed during the experiments on the top deck surface. [Figure 2-11](#) shows photographs taken at the time of failure. The conventional overhang failure was close to symmetrical about the load plate. For the precast loads, cracks were observed in the panel adjacent to the panel loaded.

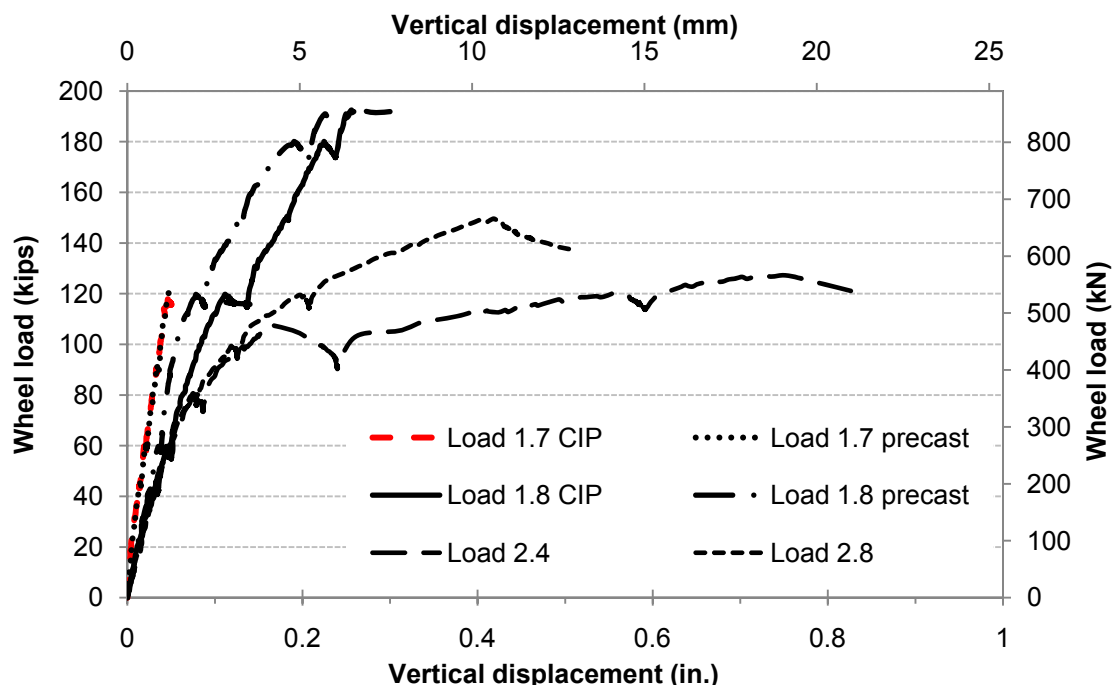
[Figure 2-15](#) shows the results of all interior failure loads (Load Cases 1.8, 2.4, and 2.8) as well as quarter-point loads (Load Case 1.7). It is evident that Load Case 2.4 is the critical case in the trailing wheel load over a single panel. However, the initial stiffness in all load cases is comparable up to approximately 70 kips (311 kN) for loading near the seam. Note that this is in excess of the maximum factored AASHTO load (~45 kips [200 kN]). Behavior beyond 70 kips (311 kN) is still satisfactory, with a moderate degree of ductility (failure warning) exhibited.

Load Case 1.7 precast and Load Case 1.7 conventional (Specimen 1 trailing axle load), Load Case 1.8 precast and conventional (Specimen 1 trailing axle load), Load Case 2.4 (Specimen 2 trailing wheel load single panel loaded), Load Case 2.8 (Specimen 2 trailing wheel load straddling lab-cast seam). NOTE: Load Case 1.7 conventional underlies Load Case 1.7 precast.

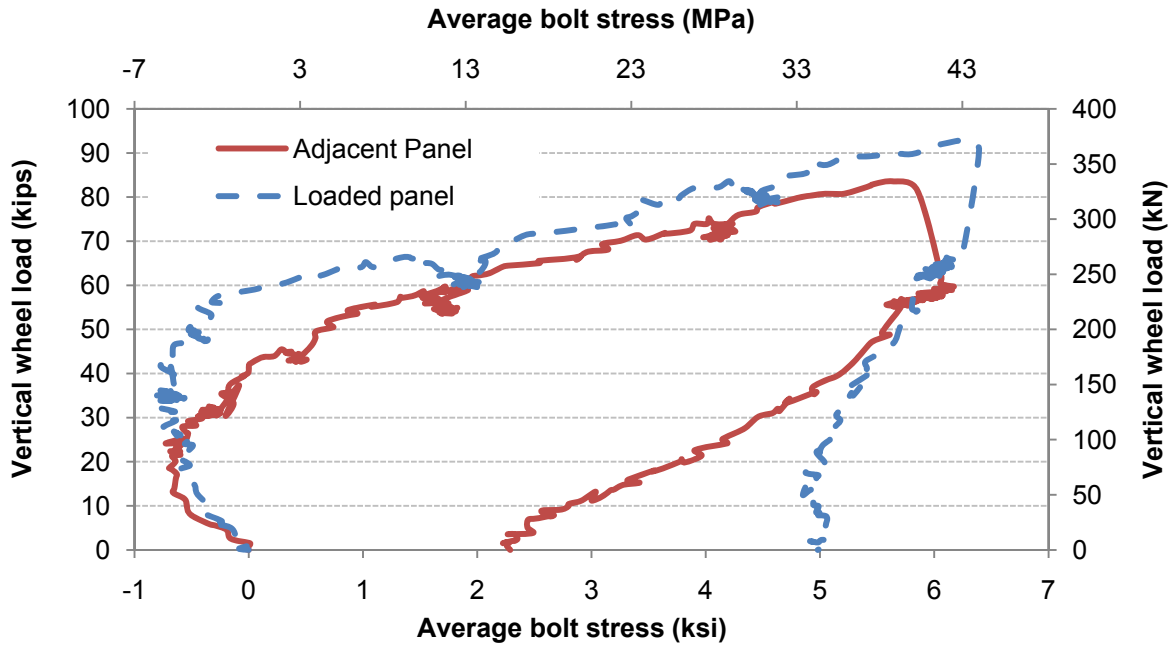
Figure 2-16. Shear Connector Stress for Specimen 1 Overhang Failure Load Case 1.6.

In the pocket closest to the seam, for both precast overhang panels, strains in one shear connector were recorded. Figure 2-16 presents the stresses in the rod from the overhang Load Case 1.6. The maximum tensile stress recorded was 6.4 ksi (44 MPa), a minimal value for a rod with yield stress of 105 ksi (724 MPa). Figure 2-17 shows the strain observed on the #4 (#13M) top transverse reinforcement. The yield strain was 0.00217 in./in. (mm/mm). Hence, at the 60 kip (267 kN) load, the bars remained elastic (~55 percent of yield) over the beam centerline. The ultimate load yielded the bar from the beam centerline to approximately 15 in. (381 mm) beyond the interior beam face. Based on an evaluation of the strains and load deformation behavior, it is apparent that a full failure mechanism did not form until the load reached approximately 78 kips (347 kN).

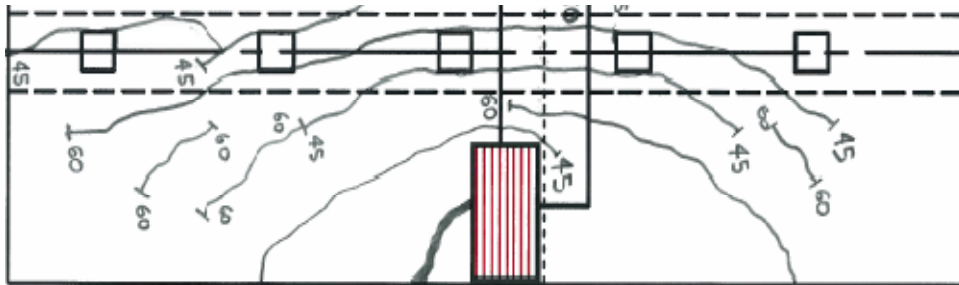
(b) Surface cracks on prestressed-precast overhang. Load increments in kips. Failure load 68 kips (302 kN)

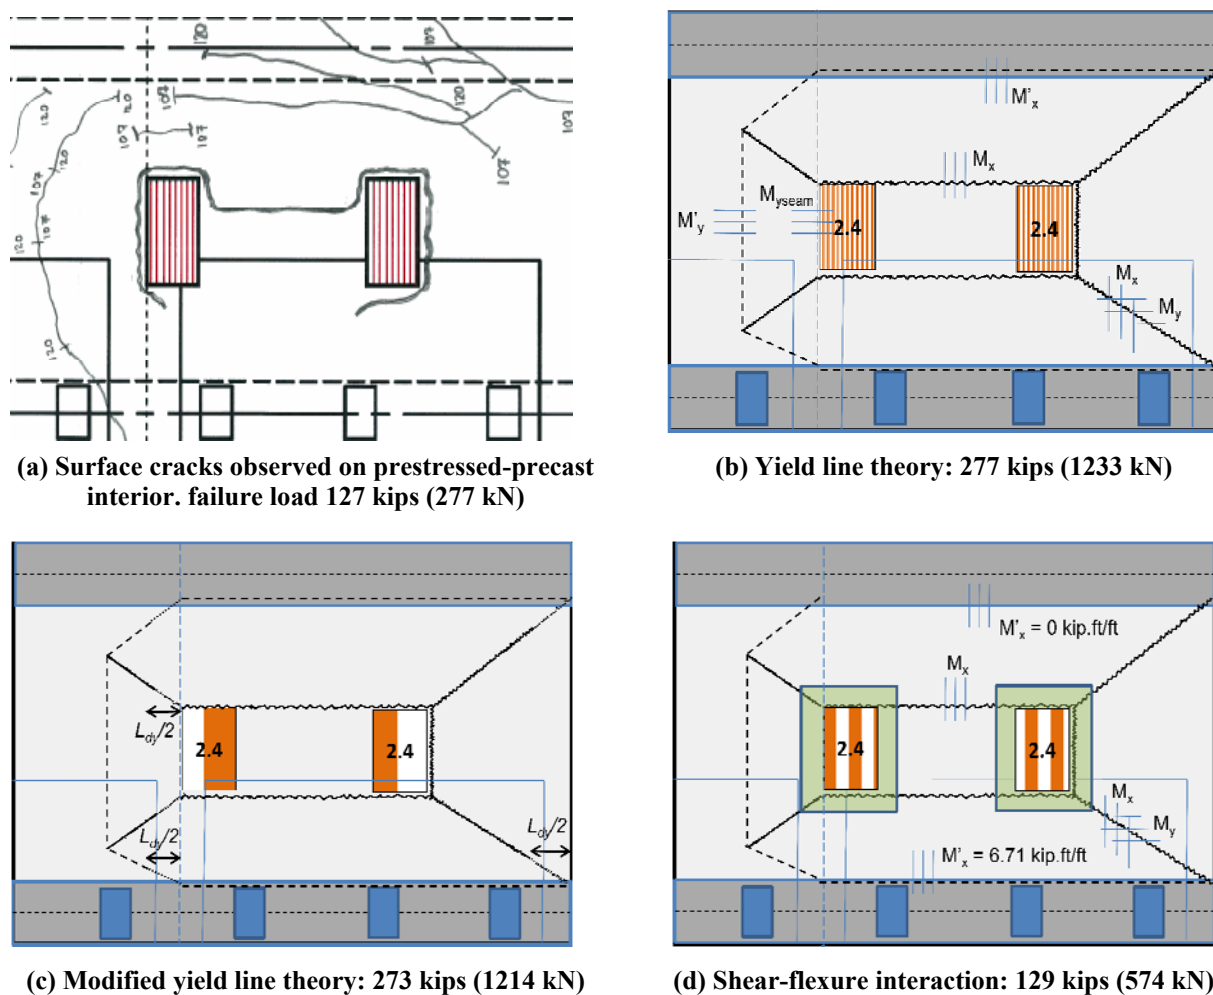
Figure 2-34. Load Case 2.4; Credible Failure Modes for Precast Interior with Trailing Wheel Load on Single Panel.

Punching-shear occurs over the top 4 in. (102 mm) CIP deck. This failure load was added to that from the flexural capacity of the bottom panels. The theoretical failure load was predicted to be 129 kips (574 kN), a factor of 1.02 times greater than the experimental failure load of 127 kips (565 kN). This theory compares well with the experimentally observed data. The crack pattern of Figure 2-34a is similar to the assumed yield line cracks of Figure 2-34b. The surface cracks along the face of the exterior beam (with pockets) were difficult to capture as existing cracks were present from the overhang failure load (Load Case 2.3). Cracks were observed on the underside of the deck to be like that of Figure 2-34b; however, safety restricted access under the deck as failure of the slab became likely. The final failure was in punching-shear of the top deck around the load plates, as drawn in Figure 2-34a. A full flexural mechanism could not form due to the high pressures at the plate, and delamination between the two concrete layers occurred.

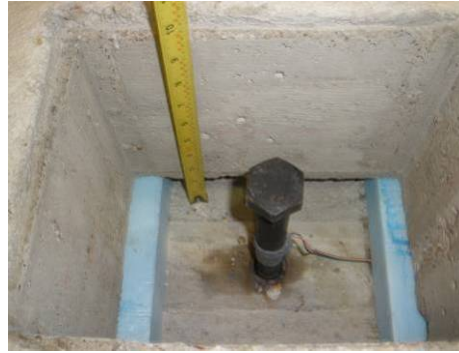
Figure 3-6. Photograph of BC Pre-Installed Shear Connections Specimens.

As an alternative pre-installed connector, a 1.0-in. (25 mm) diameter high-strength bolt (SAE Grade 8) in a coupler (BC) was also evaluated. Figure 3-6 shows a photograph of a BC specimen.

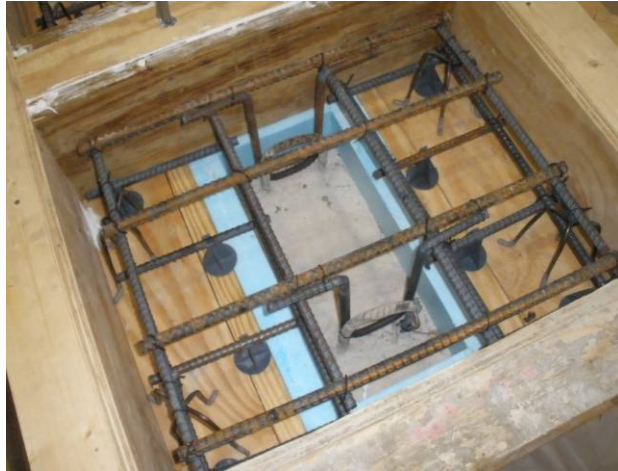
Figure 3-9. Photograph of Typical Reinforcing Layout of a CIP Shear Test Deck Specimen.

The deck reinforcing details of the four CIP specimens are similar to the precast shear deck specimens described above, but there were two key differences required because the CIP specimens model the shear connection of the interior girders. First, all of the bars were evenly spaced along the length of the beam (i.e., the pockets did not limit the location of the connectors). Second, the bottom transverse steel was not continuous, simulating the edges of the two partial-depth precast panels resting on the girder. See [Figure 3-9](#) for a photograph of the deck reinforcing of a typical CIP specimen.

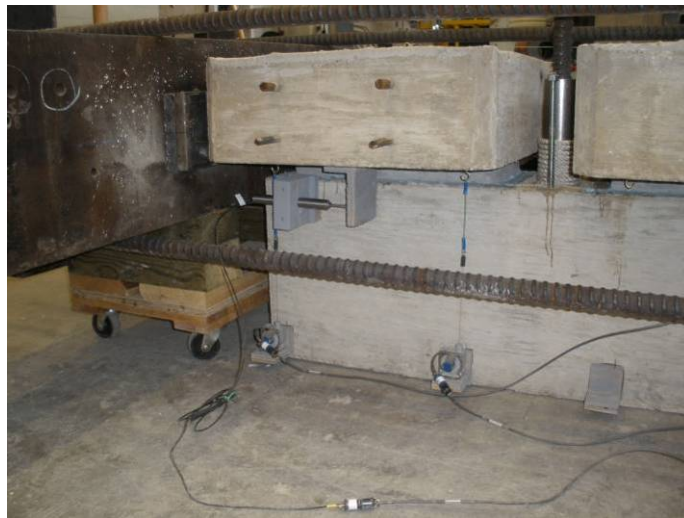
Figure 3-10. Photograph of LVDTs and String Potentiometers Connected to a Shear Test Specimen.

The key measurement that must be acquired from the shear tests is the displacement of the shear test deck specimen relative to the shear test beam. This was accomplished with a linear variable differential transducer (LVDT) mounted on each longitudinal face of the shear test beam pushing against a reaction angle mounted to the bottom of the shear test deck specimen and aligned with its transverse centerline. By utilizing an LVDT on each side, the amount of skew that the shear test deck specimen experiences during loading can be assessed. Two string potentiometers were attached to the vertical face of the shear test beam and attached to the side of the beam; these were connected to the soffit of the deck panel unit under test. These potentiometers indicate the degree of uplift and rotation of the deck panel unit with respect to the support beam. [Figure 3-10](#) shows a photograph of the instrumentation on the specimen.

A 2000-kip (8896 kN) capacity load cell was attached in series to the actuator to provide accurate measure of the actual load applied to the shear test frame and shear test specimen. The half-bridge strain gauges were attached to one of the threaded rods or stirrup legs to provide information on the tensile force and strain on the shear connector during the test.

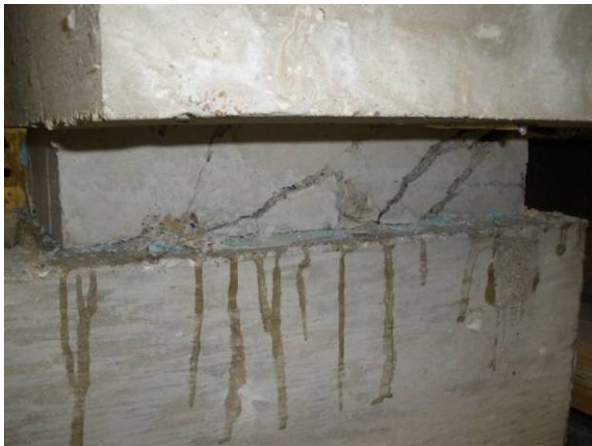
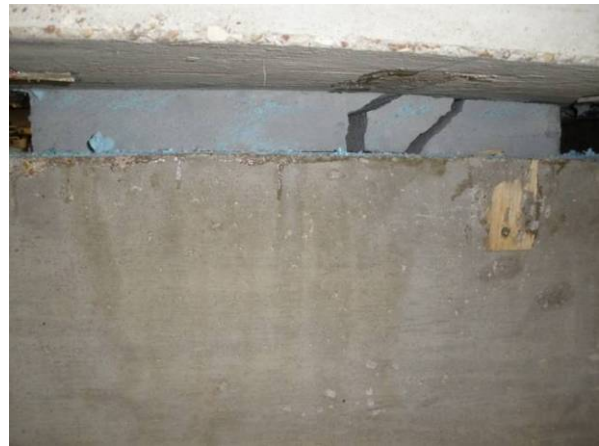
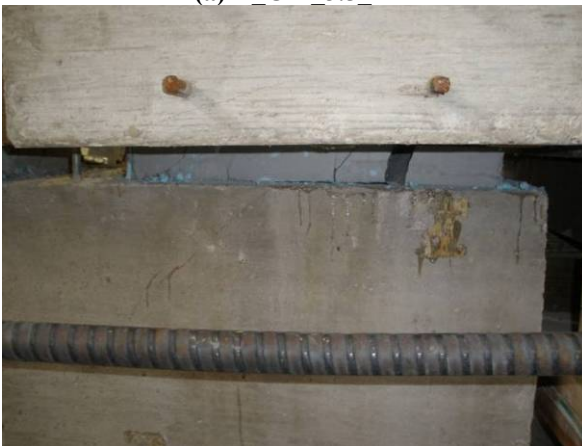
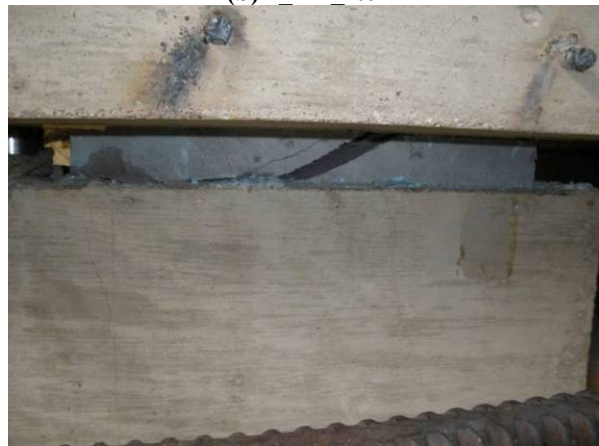
Figure 3-28. Examples of Specimens that Exhibited a Sliding Shear Failure Mechanism.

From shear testing, three classical failure mechanisms were observed: 1) sliding shear, 2) beam failure, and 3) cone pullout. The first and most common was sliding shear. Typically, the rear third of the haunch separated and the yielding shear connector(s) clamped the deck down to the beam through the front two-thirds of the haunch, sliding with significant ductility. [Figure 3-28](#) contains photographs of several of the specimens that exhibited this sliding shear failure mechanism. Several of the sliding shear specimens also exhibited complete shearing of the connector(s). [Figure 3-29](#) and [Figure 3-30](#) show photographs of two such specimens.

(a) 4_CIP_3.5_A

(b) 1_KB_2.0

(c) 1_TRS_2.0

(d) 1_BC_2.0_B

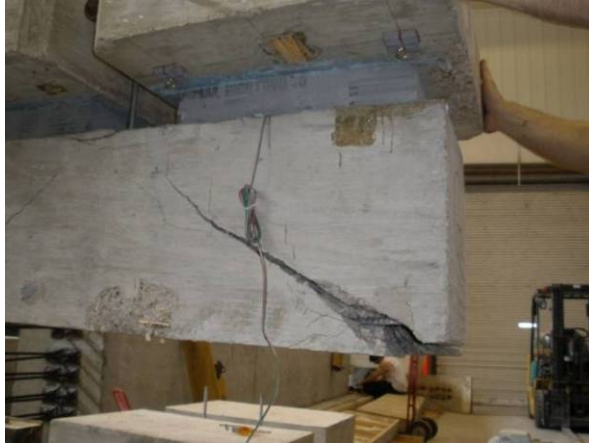
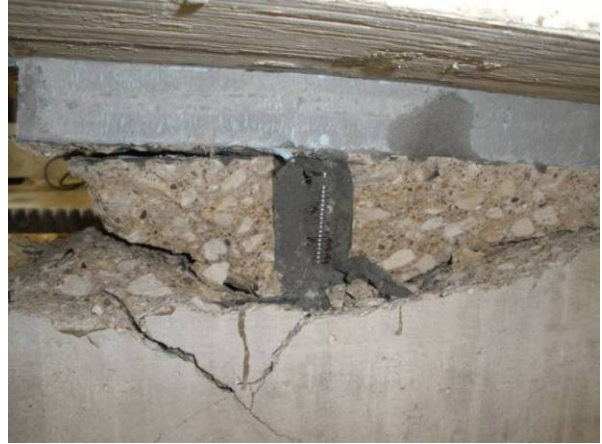
Figure 3-31. Photographs of Shear Test Specimens that Exhibited a Brittle Beam Failure.

The second most common failure mechanism observed was brittle beam failure. This mechanism typically occurred suddenly at a low lateral load relative to the yield strength of the connectors because of insufficient hoopsets in the beam, as explained in [section 3.8.7](#). Thus, this failure mode exhibits a low strength and very little ductility. [Figure 3-31](#) contains photographs of two of the specimens that exhibited this brittle beam failure mechanism.

(a) 2_TR_3.5_B

(b) 2_TRS_2.0_Rough

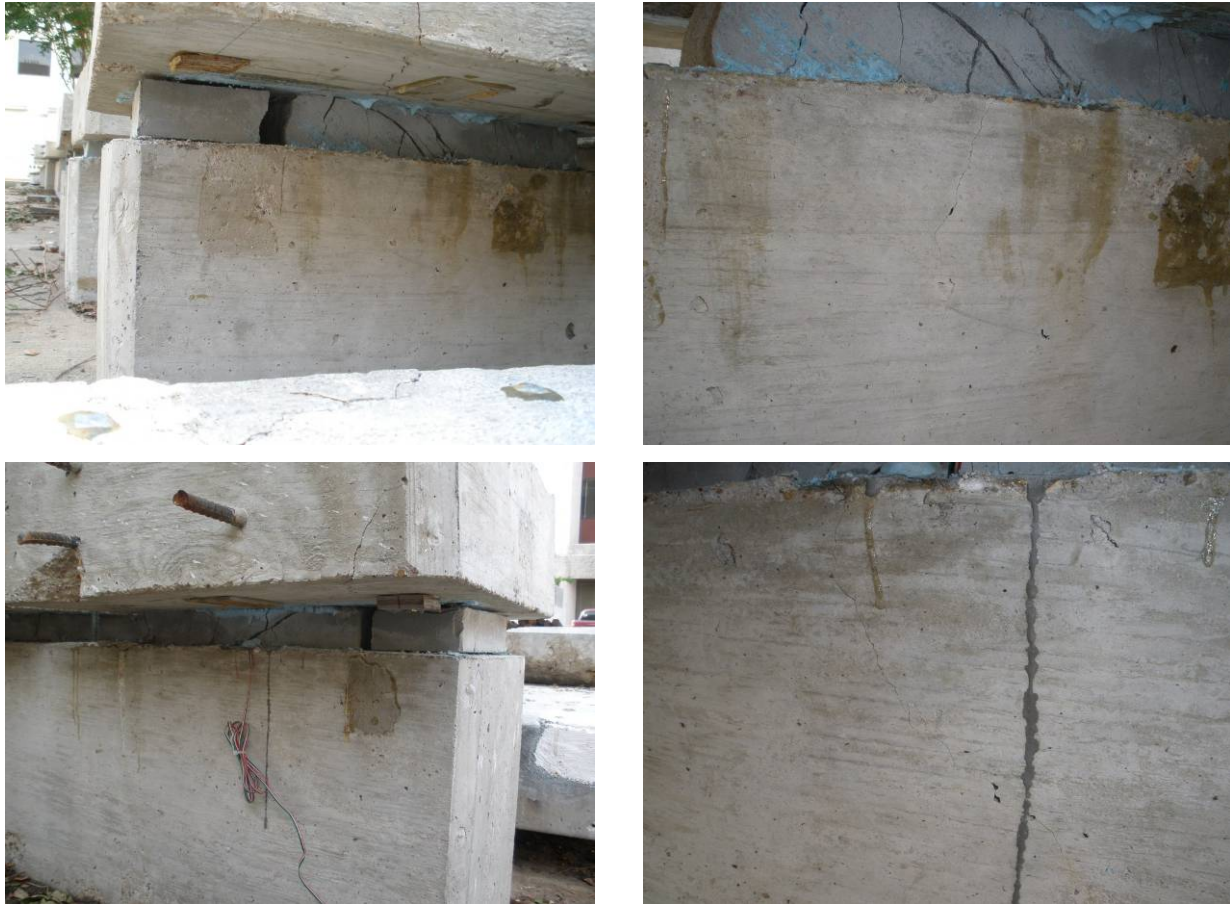
Figure 3-33. Photographs of 2_TR_2.0_B after Testing.

Figure 3-32 shows the force-displacement plot comparing 2_TR_2.0_A (not intentionally roughened), 2.0_TR_2.0_B (not intentionally roughened), and 2_TRS_2.0_Rough. Specimen 2_TRS_2.0_Rough exhibited a different failure mechanism. Figure 3-33 shows photographs of the failure mechanisms revealed from 2_TR_2.0_B. Observing this performance supports the need for adequate shear reinforcement in the beam to avoid this brittle beam failure. The final failure mechanism observed was a cone pullout failure. This failure mechanism is similar to the brittle beam failure mechanism but exhibits significantly higher strength and more ductility prior to failure. Figure 3-34 shows several photographs from one of the specimens that exhibited a cone pullout failure.

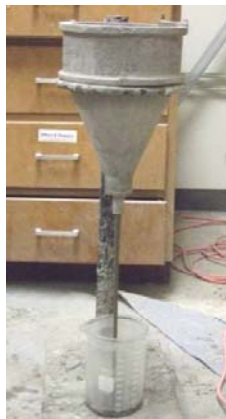
Figure 4-1. Efflux Cone Test.

An optimum level of flowability is required for precast panel construction, as a high plastic viscosity is required to allow the grout to freely flow and consolidate within the haunch. However, the grout mixture must be cohesive enough to maintain a homogenous profile while moving through the haunch zone. The consistency can be indirectly measured using an efflux cone apparatus in accordance with Tex-437-A, *Test for Flow of Grout Mixtures (Flow Cone Method 2)*, a modified version of ASTM C939-02, *Flow of Grout for Preplaced-Aggregate Concrete*. This test is used to provide an indirect measure of the grout's consistency by measuring the time for 33.8 fl oz. (1000 mL) of fresh grout material to pass through a defined opening or orifice. [Figure 4-1](#) shows the apparatus used to evaluate the grout consistency. To put this test into perspective, the efflux time of water is three seconds, whereas thick syrup would have an efflux time close to 15 seconds.

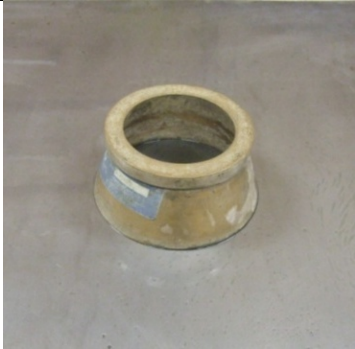
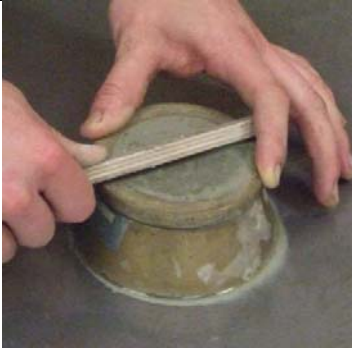
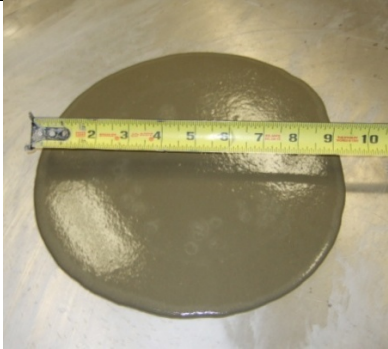
Figure 4-2. Testing Procedures for the Flow Cone Test.

from the test procedure. Figure 4-2 shows the three-step procedure to carrying out this modified test. To obtain the loss of flowability with time relationship, a mix was batched and divided evenly into five buckets and left to set in a room of known temperature and humidity. Each sample was left undisturbed until the time of testing, and then it was promptly mixed for 10 seconds and tested. Readings were taken at 15-minute intervals and the grouts were discarded after use.

<p style="text-align: center;">Step 3</p>
<ul style="list-style-type: none"> • Lay a flat steel sheet of metal measuring no less than 15 × 15 in. (381 × 381 mm) on the ground so that it is level in both planes. • Wet and clean the flow cone approximately 1 minute before use and allow to stand and dry. • Wipe down the metal surface with a damp cloth approximately 30 seconds prior to use and place the flow cone in the center. • Place cone on flat sheet. 	<ul style="list-style-type: none"> • Fill the cone with grout so that it is flush with the top of the cone and strike off any excess grout with a flat surface. • Ensure that the area around the flow cone is clean. 	<ul style="list-style-type: none"> • Swiftly lift the cone vertically and hold slightly above the flowing grout to allow any excess to drip while the grout spreads in a circular pancake-like shape. • Once the grout has stopped flowing, take two perpendicular readings of the circle's diameter to the closest 0.25 in. (6 mm). • If grout continues to spread, this is an indication that either the grout has not been properly mixed because there is free water present, or that the w/p is too high.

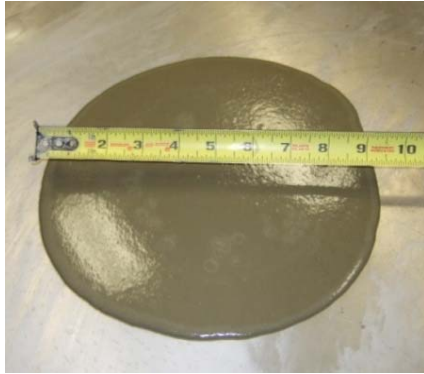
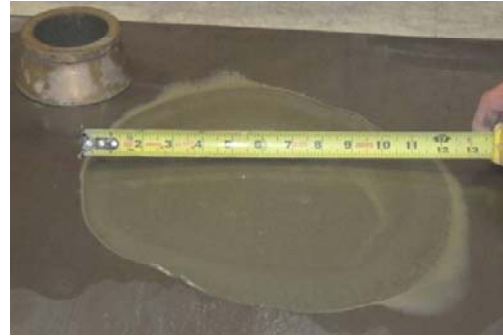
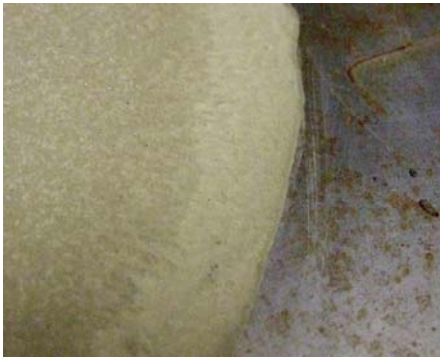
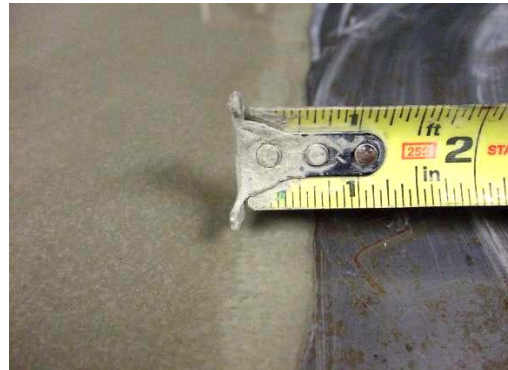
Figure 4-3. Examples of Good Flow Cone Tests and Tests that Show Clear Signs of Segregation.

to segregation will separate into two layers when performing a flow cone test; the sand and grout will be deposited in the center of the circle while the free water will flow freely at the edge of the grout circle, leaving a distinct lighter zone at the edge of the circle as shown in the examples of [Figure 4-3](#).

(a) Flow cone displaying good consistency

(b) Flow cone showing signs of segregation

(c) Close up of segregated edge

(d) Example of a 0.5 in.(12.7 mm) VGSI

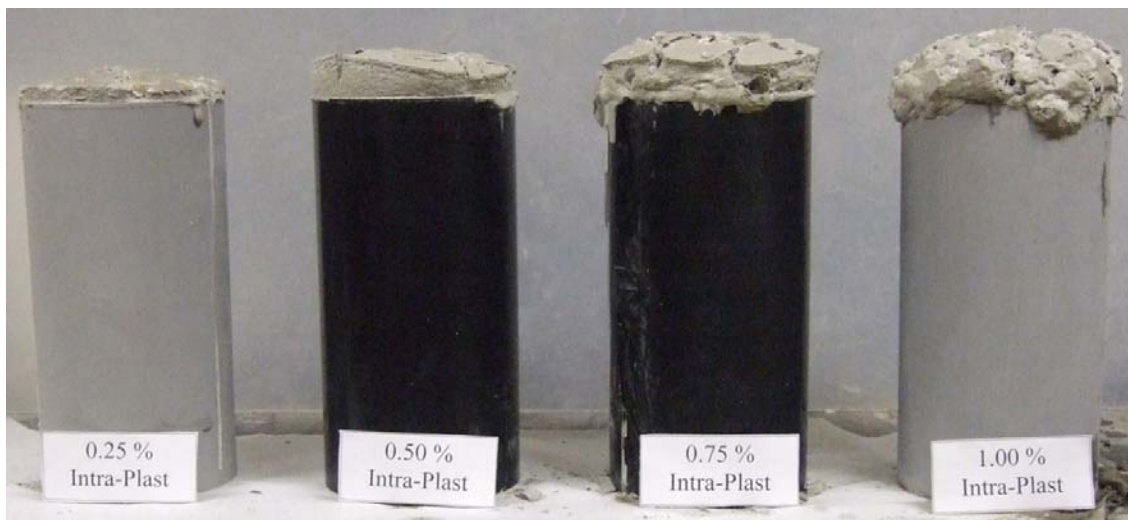
Figure 4-12. Effects of Increasing Dosages of Grout Expanding Aid.

In order to assess the performance of the grout expanding aid (here-in referred to as GEA) a trial batch of mixes was cast with varying percentages of GEA by weight of the cementitious material. The mixture tested consisted of a 0.40 w/c, 25 percent replacement of fly ash by weight of cement with no sand or superplasticizer, the percentages of GEA started from the recommended dosage of 1 percent (for Intraplast N) reducing in 0.25 percent increments. [Figure 4-12](#) shows the excessive amounts of expansion exhibited by the grouts containing GEA dosages higher than 0.25 percent of cementitious materials.

Cylinders are 2 × 4 in. in size.

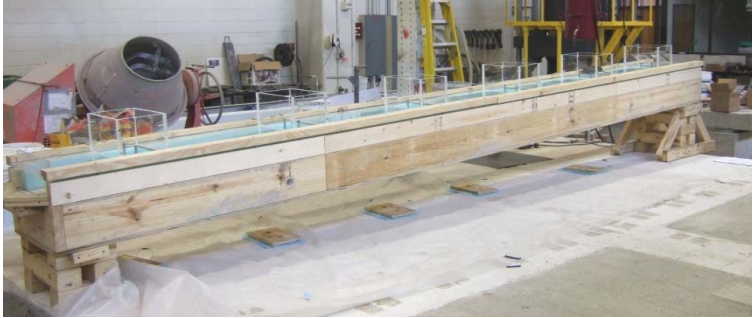
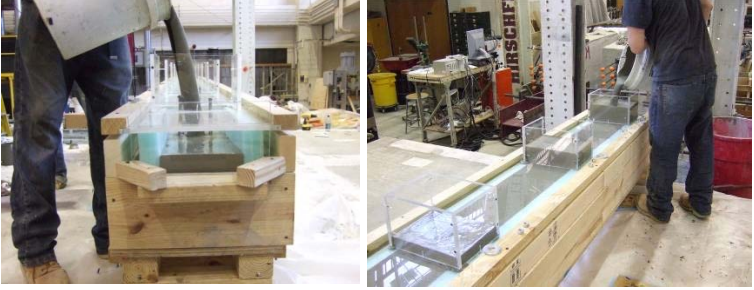
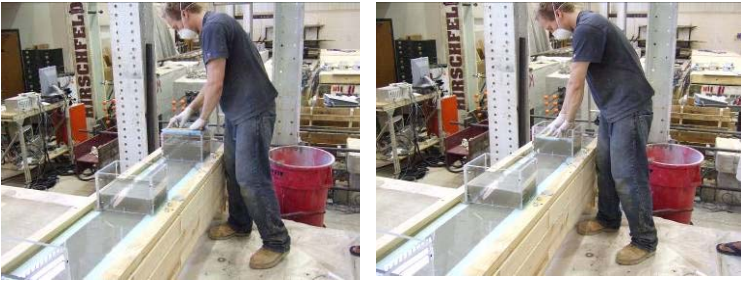
<p>A full-scale model of the bridge haunch for two panels (16 ft [5 m] in length) was built to illustrate the recommended placement method of steps 1 to 3 for a precast bridge with a 4% grade. This testing confirmed that the recommended prepackaged grout mixture is flowable through both a 0.5- and 3.5-in. (13 and 89 mm) haunch height.</p>

<p>Step 1: Place grout into first pocket.</p>

<p>Step 2: Fit and secure pocket cover to first pocket.</p>

<p>Step 3: Fit and secure pocket covers to the remaining pockets.</p>

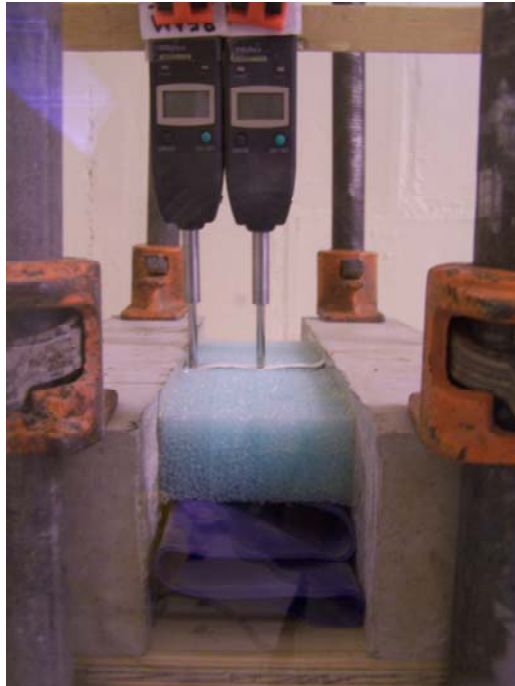
Figure 4-19. Experimental Setup for the Lateral Pressure Test.

This test examines the pure lateral pressure capacity of a foam and adhesive combination by using an inflated air bag to simulate the lateral pressure from a fluid grout or concrete. In this test the air bag is monitored with a pressure gauge, and adjustments in pressure are made with a regulatory valve. The specimens are supported on their side on a wooden table, and the concrete blocks are fixed to the table using pipe clamps. The air bag is then placed between the foam and the table. [Figure 4-19](#) shows the test setup. Care must be taken to ensure that the air bag applies uniform pressure on the foam. Deflection gages were used to measure the deflection at the edge and center of the specimen.

The specimens were measured at regular intervals starting at 1.5 psi (10 kPa) and increasing by 1 psi (7 kPa) until a maximum pressure of 6.5 psi (45 kPa) was reached. At each pressure interval the loading is paused for 1 minute to allow the deflection of the system to stabilize. The value of 6.5 psi (45 kPa) was chosen because it was the capacity of the air bag equipment used in the testing and is also a reasonable upper bound on the amount of pressure that one might see from a gravity placement of concrete or grout. This would roughly correspond to 6.5 ft (2 m) of concrete head. [Figure 4-20](#) shows an example of a failed specimen.
