1. Report No. FHWA/TX-10/0-6271-1		2. Government Accession No.		3. Recipient's Catalog No.	
4. Title and Subtitle FIELD AND LABORATORY INVESTIGATIONS FOR FULL DEPTH RECLAMATION PROJECTS				5. Report Date November 2009 Resubmitted: January 2011 Published: March 2011

**FIELD AND LABORATORY INVESTIGATIONS FOR  
FULL DEPTH RECLAMATION PROJECTS**

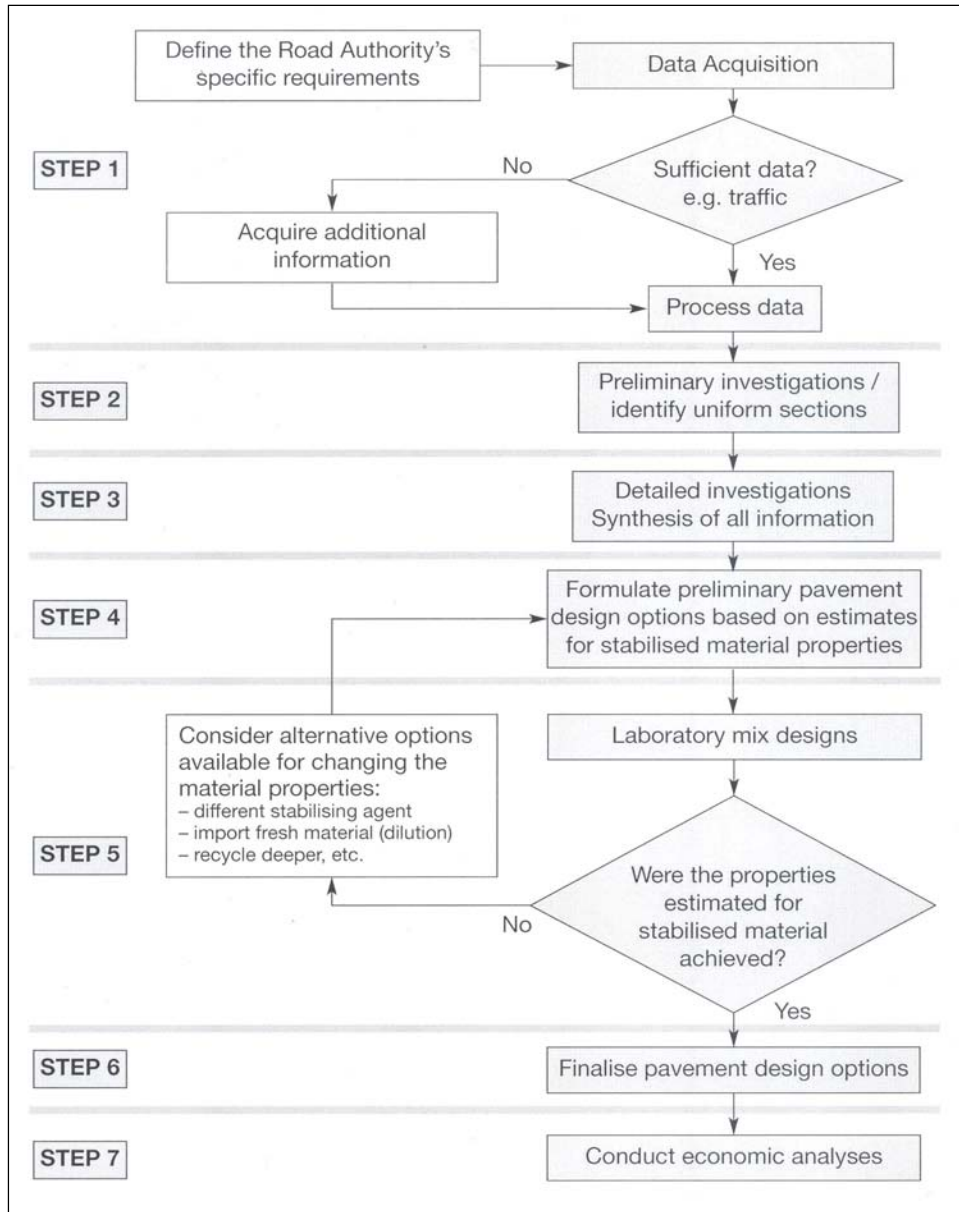
**Figure 1.1. Pavement Investigation and Design Process from Wirtgen (7).**

Getting more detailed, Figure 1.1 illustrates the strategy recommended to develop options for pavement rehabilitation.

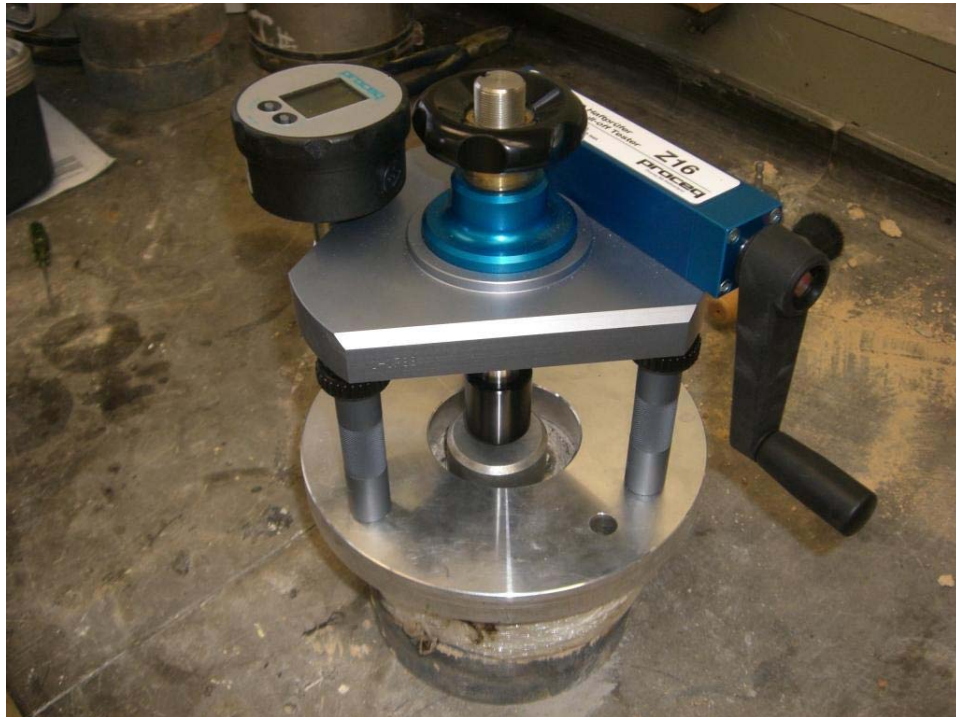
**Figure 2.3. Photo of Direct Tensile Bond Test Apparatus.**

The Direct Tensile Bond Test (ASTM C 1583) shown in Figure 2.1 is being used to assess the adhesion of surface treatments to different types of recycled base materials using different stabilizers cured under different climatic conditions. This test method was originally developed for use as an indicator of the adequacy of concrete surface preparation before applying a repair or overlay material. It is performed on the surface of the overlay material and determines the bond strength to the substrate or the tensile strength of either the overlay or substrate, whichever is weaker. When the test is performed on the surface of the material applied to the substrate, the measured strength is controlled by the failure mechanism requiring the least stress (Figure 2.2). A photo of the test device being used for the laboratory evaluation is shown in Figure 2.3.

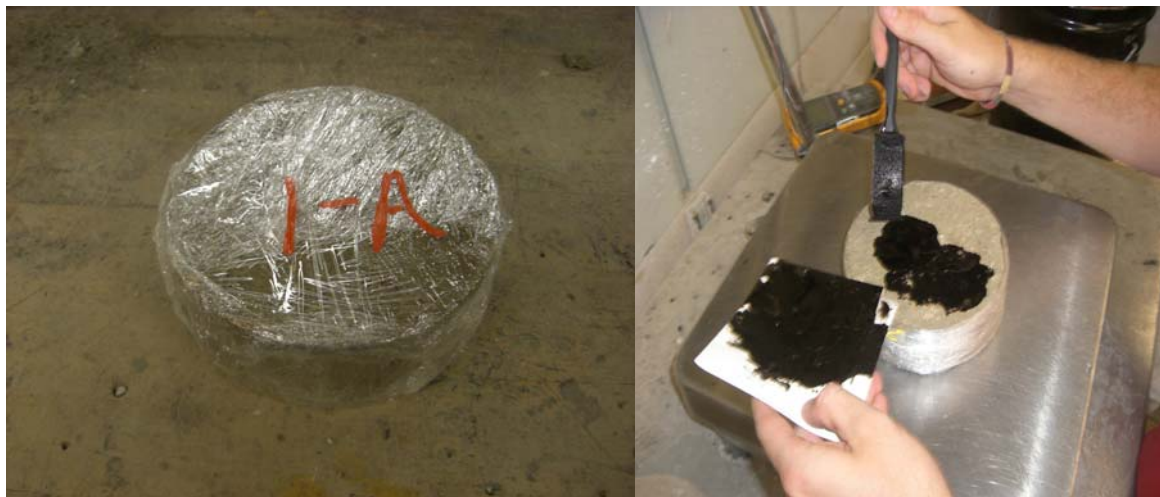
Step 3. Cover entire sample with plastic wrap for 1 hr. After 1 hr remove sample from plastic wrap and re-wrap the sample with plastic leaving only the top surface exposed. Apply prime material at predetermined application rate to the specimen surface (Figure 2.4).

**Figure 2.4. Application of Prime to Base Sample.**

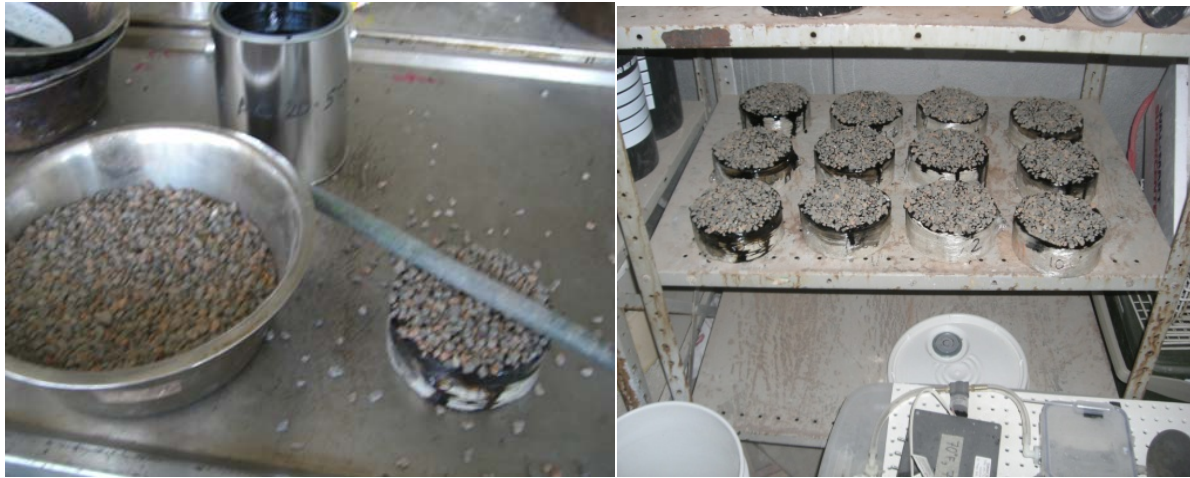
Step 5. Apply surface treatment to samples and place in 110°F oven overnight (Figure 2.5).

**Figure 2.5. Application of Surface Treatment to Primed Base Samples.**

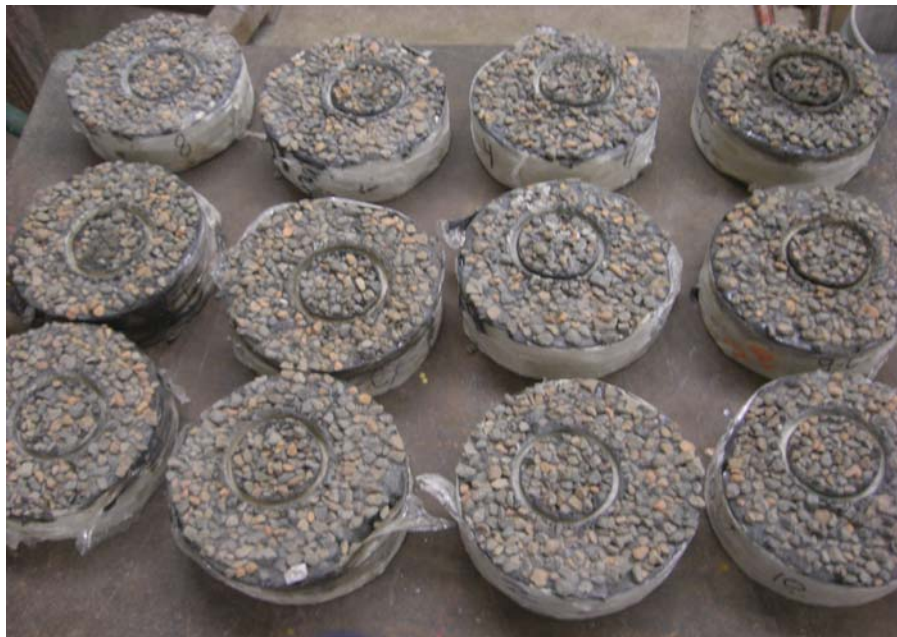
Step 6. Removed from oven, allow to cool for 1 hr and then core (dry) with a 2-in. diameter core-barrel to a depth just below the asphalt material (approximately  $\frac{1}{2}$  in.). See Figure 2.6.

**Figure 2.6. Surface Treatment Samples after Coring to a Depth of  $\frac{1}{2}$  Inch.**

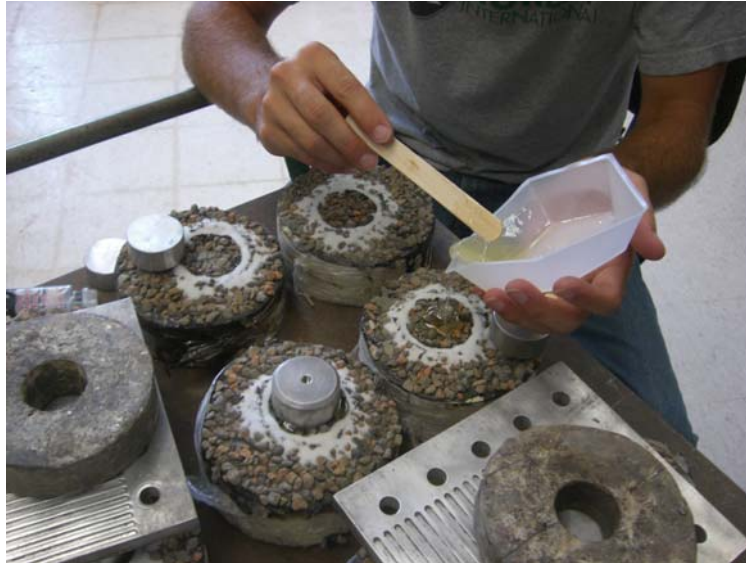
Step 7. After coring, apply epoxy glue to the metal disks and place on to the cored section of the samples. Place sand into the cored ring to prevent epoxy from penetrating into the ring. Allow glue to dry overnight (Figure 2.7).

**Figure 2.7. Gluing Metal Disks to Surface Treated Base Samples.**

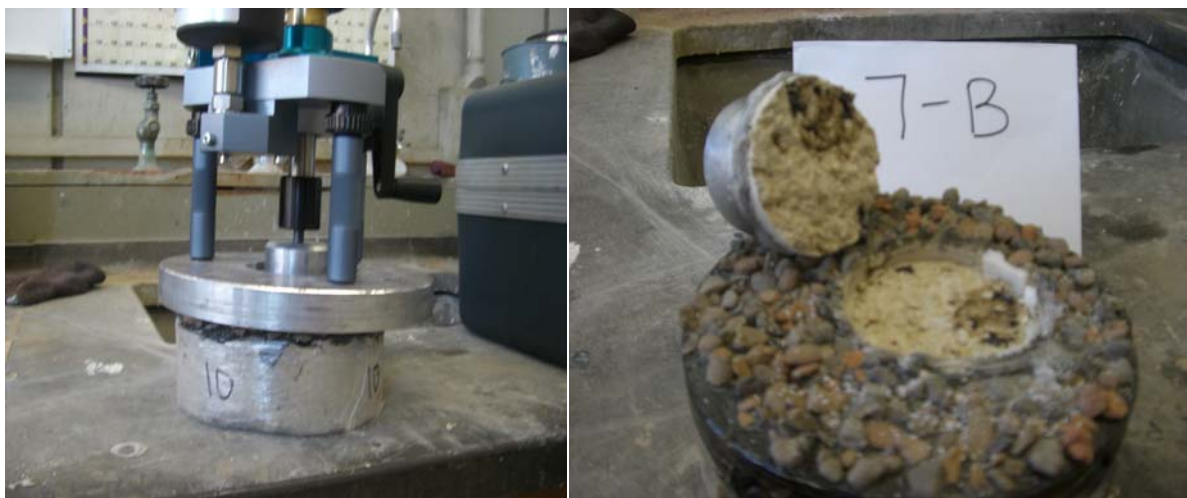
Step 8. Test Sample in Direct Tension Bond Test Apparatus and record the ultimate breaking strength in lbf and identify the plane where failure occurred; i.e., in the surface treatment, interface between prime and surface treatment, within the penetrated portion of the prime, beneath the prime and into the base (Figure 2.8).

**Figure 2.8. Sample in Testing Apparatus and after Failure.**

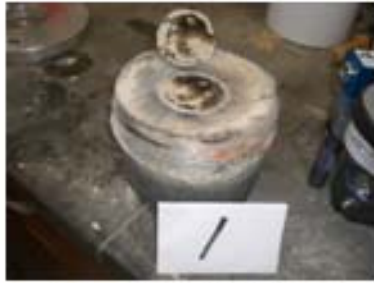
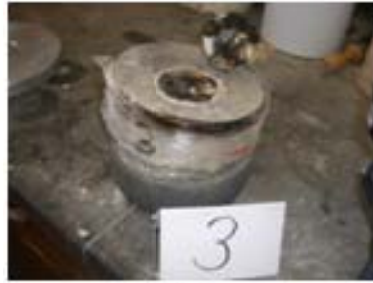
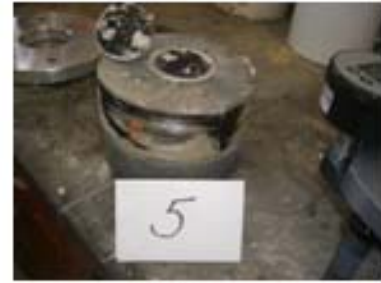
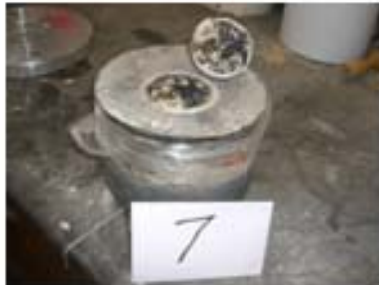
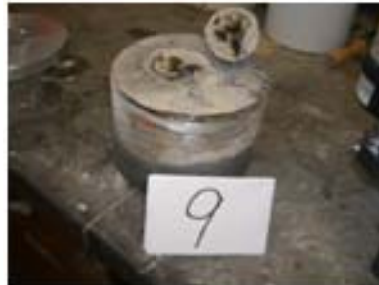
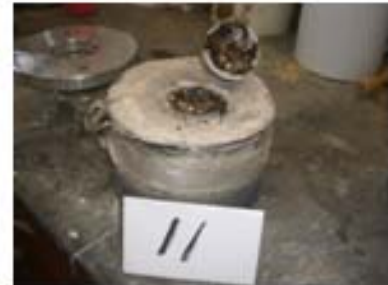
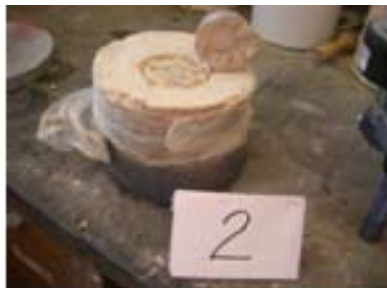
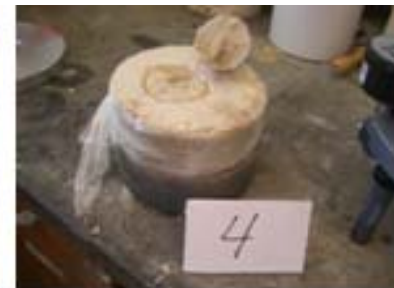
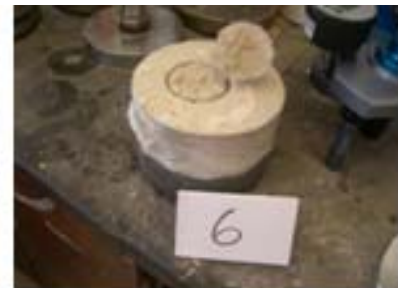
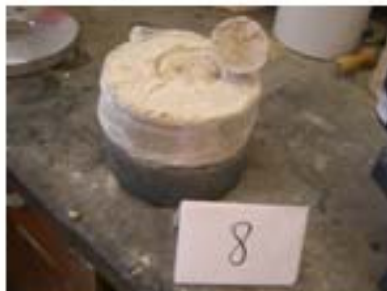
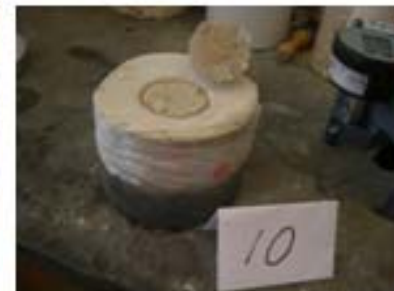
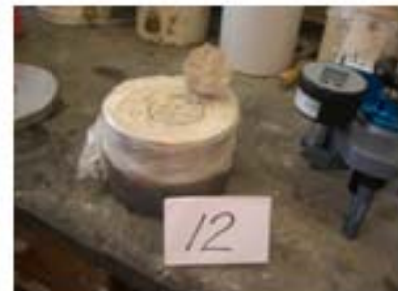
**Figure 2.9. Tensile Bond Strength Test Results with Steel Disk Glued on Top of Cement Treated Base for Both Primed and Unprimed Specimens.**

Test results are presented in Figure 2.9. In this figure, a photograph of the failed surface is shown for each specimen and the breaking strength for that specimen is noted under the photograph. The average tensile strength results for the primed and unprimed specimens are as follows:

Mean Pull-Off Strength of all 6 samples: 118 lb  
Standard Deviation: 52 lb

Mean Pull-Off Strength of all 6 samples: 62 lb  
Standard Deviation: 41 lb

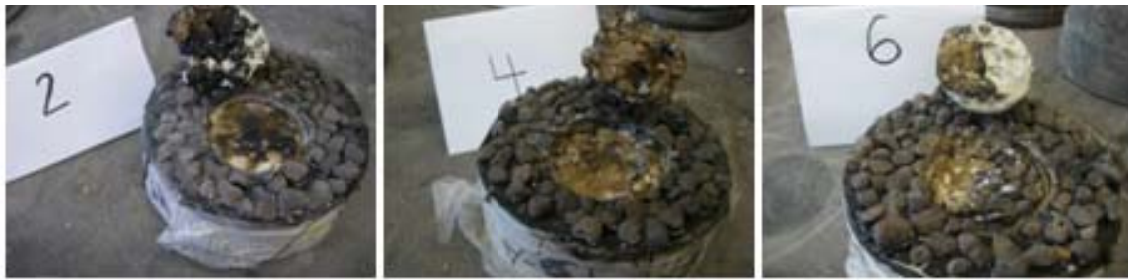
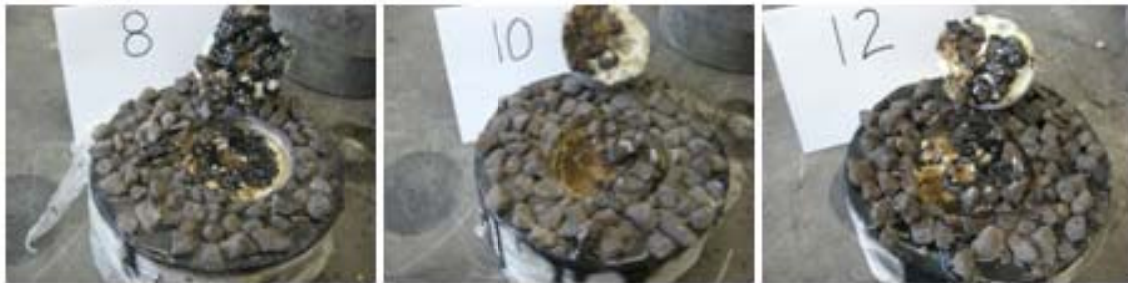
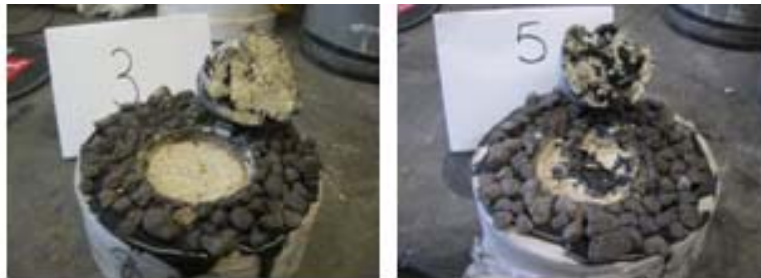
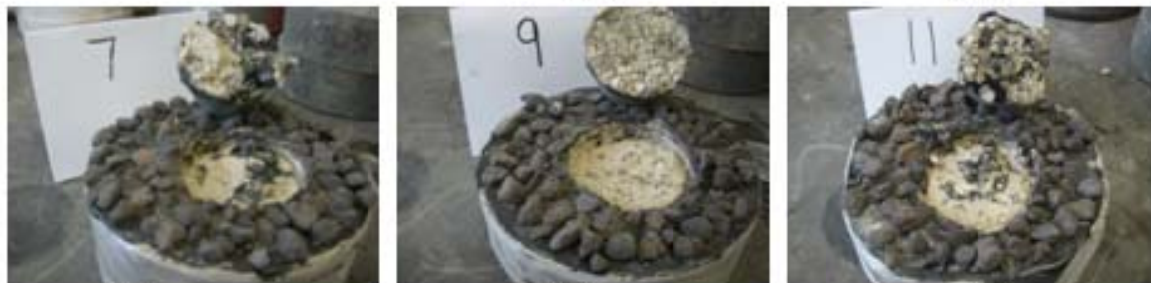
**Figure 2.10. Tensile Bond Strength Test Results with Steel Disk Glued on Top of Grade 4 Surface Treatment for Both Primed and Unprimed Specimens.**

- *Testing Sequence 2.* In this experiment, base samples were prepared as previously described and half were treated with MC-30 and the other half with no prime. After the 3-day cure, all 12 specimens were surfaced with a surface treatment consisting of AC-205TR and Grade 4 lightweight as explained in Appendix A. Samples were again placed in the oven overnight and then allowed to cool for an hour. Coring was performed as described previously and the metal disks were glued to the surface of the specimens and tested as before. These results are presented in Figure 2.10 and can be summarized as follows:

Primed Base: Mean Tensile Strength = 39 lb, Std Dev = 19 lb  
Unprimed Base: Mean Tensile Strength = 30 lb, Std Dev = 13 lb

As shown in Figure 2.10, several of the specimens failed at the interface between the glue and the surface treatment. In addition, the surface irregularities created by the Grade 4 surface treatment aggregate made it difficult to glue the metal disk such that it was level.

Mean Pull-Off Strength of all 6 samples: 39 lb  
Standard Deviation: 19 lb

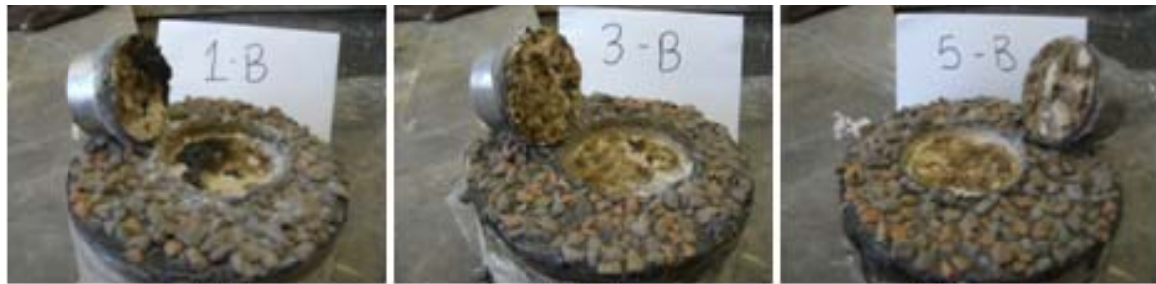
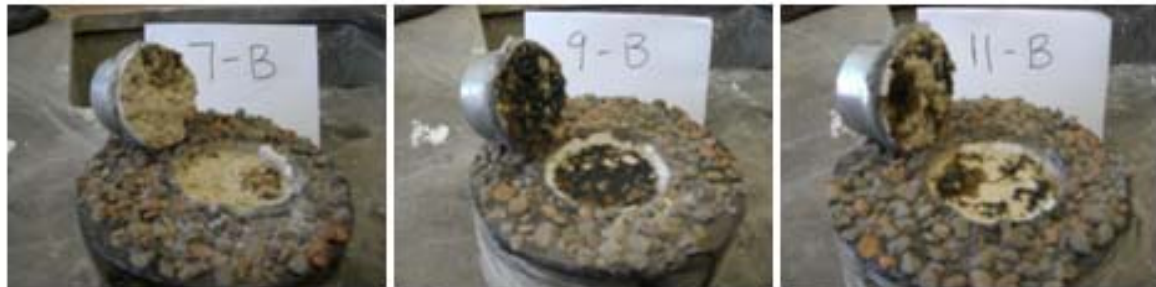
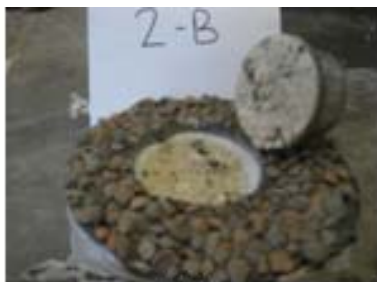
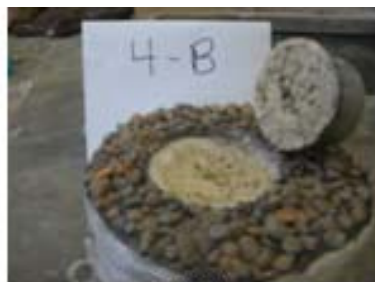
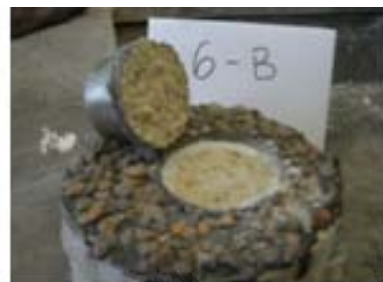
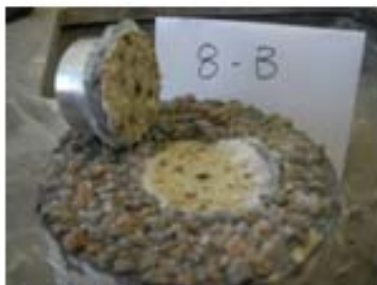
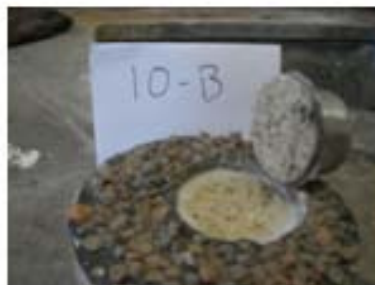
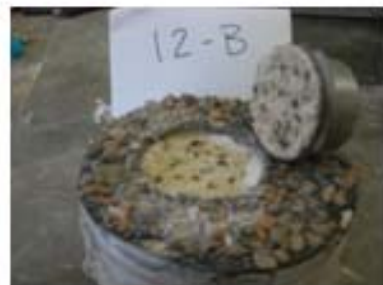
***CTB with No Prime and Grade 5 Surface Treatment***

Primed Samples: Mean Tensile Strength = 133 lb, Std Dev = 28 lb  
Unprimed Samples: Mean Tensile Strength = 49 lb, Std Dev = 12 lb

These results indicate that the test procedure can measure a difference between primed and unprimed stabilized bases and that the bond provided by a primed base course is significantly greater than without a prime coat. Additional testing is underway to evaluate different prime materials and recycled base courses.

Mean Pull-Off Strength of all 6 samples: 118 lb

Standard Deviation: 45 lb

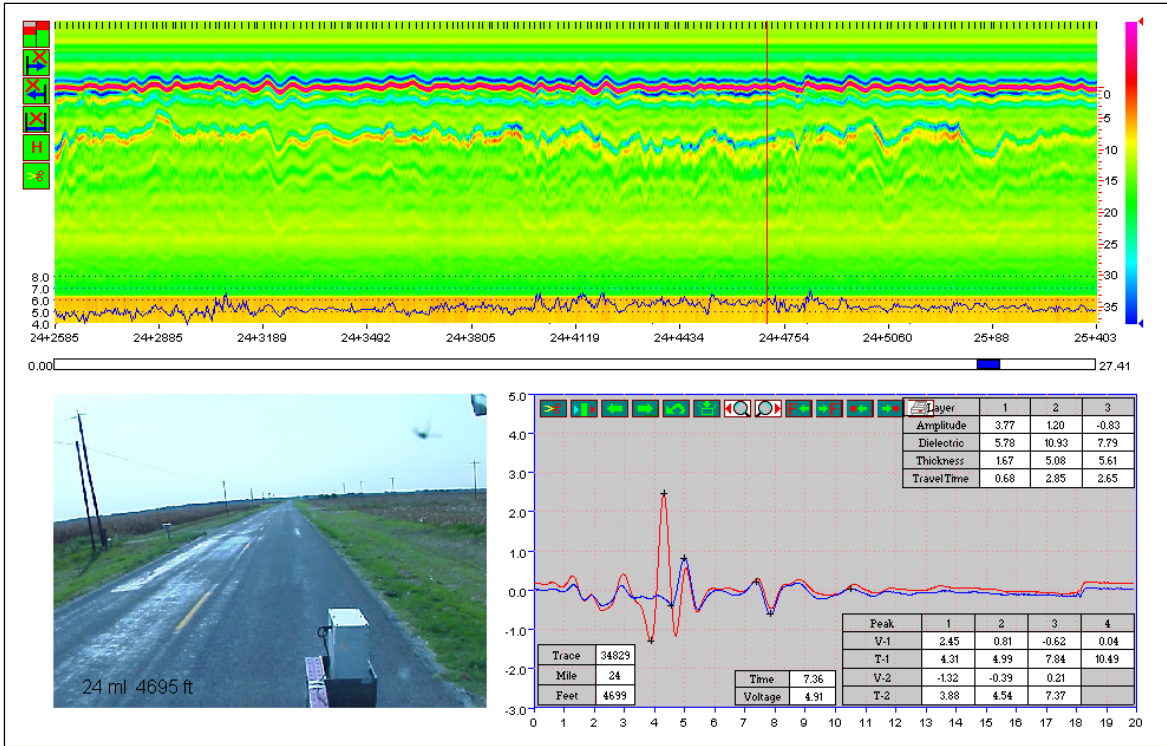
A GPR survey conducted to quickly investigate the pavement structure indicates the section is quite uniform in structure. The GPR indicates the pavement is probably built on another pavement structure. Figure 3.2 shows typical GPR data from the section. There are some surface patches and a few isolated locations (50 to 75 ft long) of deep patches as Figure 3.3 shows. With the exception of the deep patches, the maximum thickness of bituminous surfacing was approximately 5 in., which occurred at some locations of maintenance surface patches.

Figure 3.2. Typical GPR on FM 487.

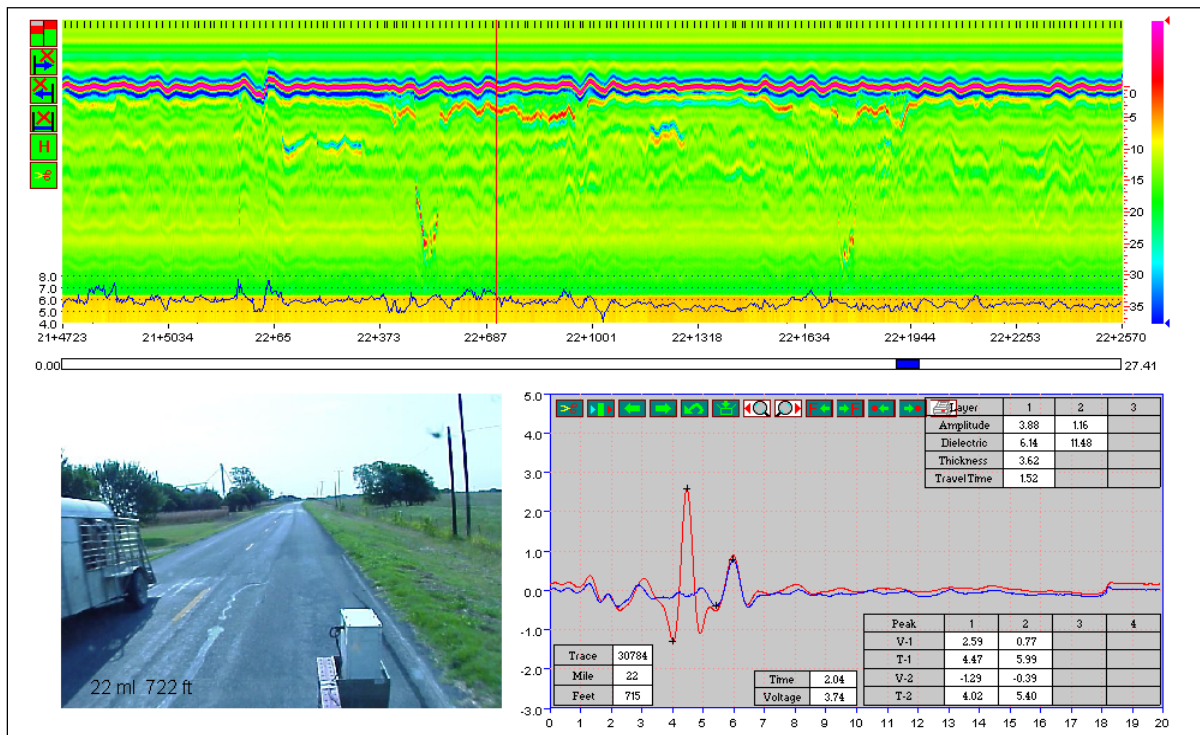
Figure 3.3. Surface Patches and Deep Repairs in GPR Data.

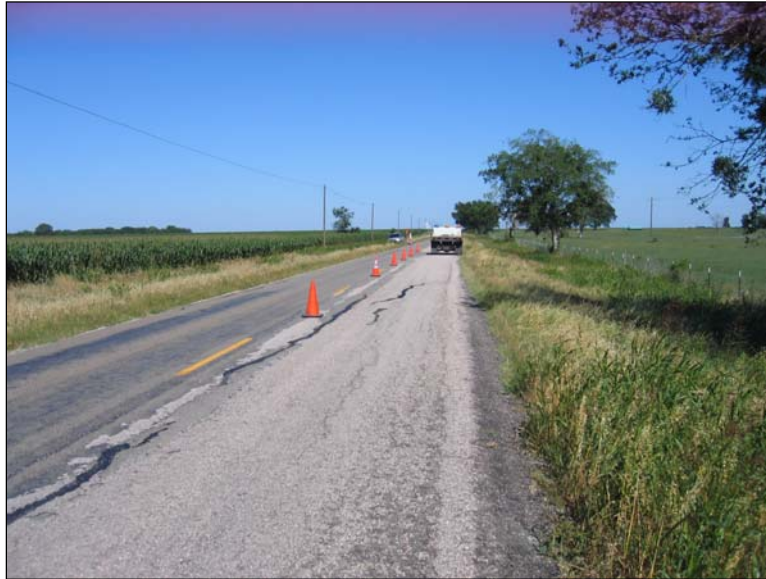
**Figure 3.4. FM 487 Sampling Locations in Maintenance Location 7.**

Three core locations were selected for validation of the pavement structure and for collecting materials for laboratory testing. These locations were in the eastbound direction and were in sections selected by the maintenance office identified as sections 7, 8, and 10. Figures 3.4 through 3.6 show the locations.

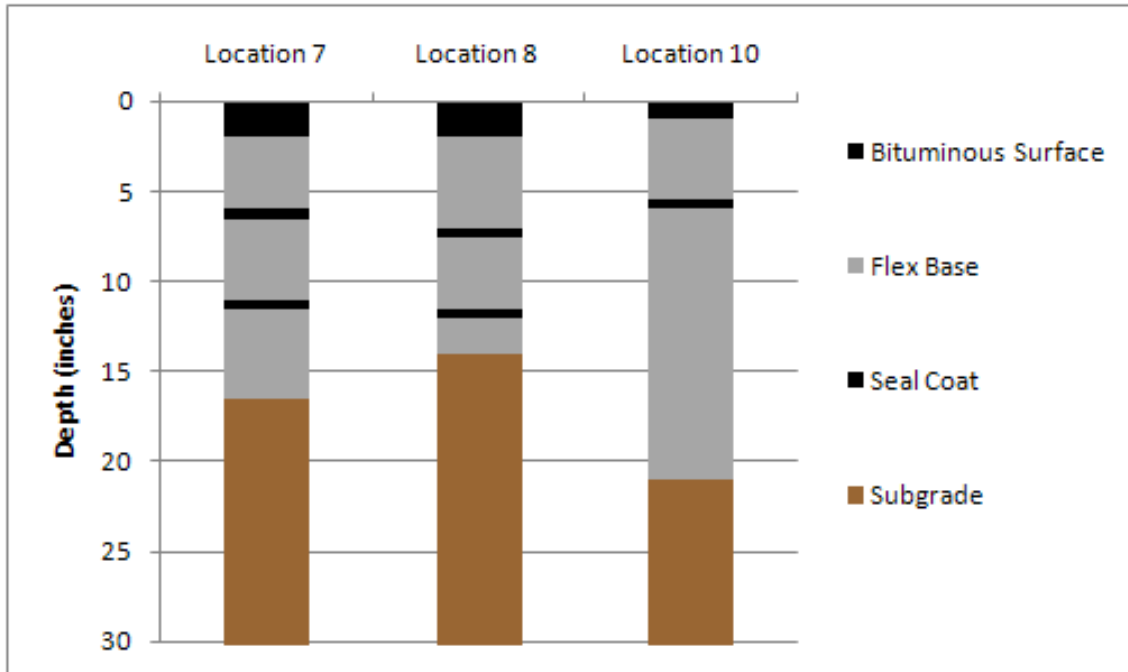
TTI used an auger rig to verify the pavement structure to the subgrade and collect material samples. Figure 3.7 illustrates the structures observed at the three sampled locations.

**Figure 3.7. Pavement Structures on FM 487 Sample Locations.**

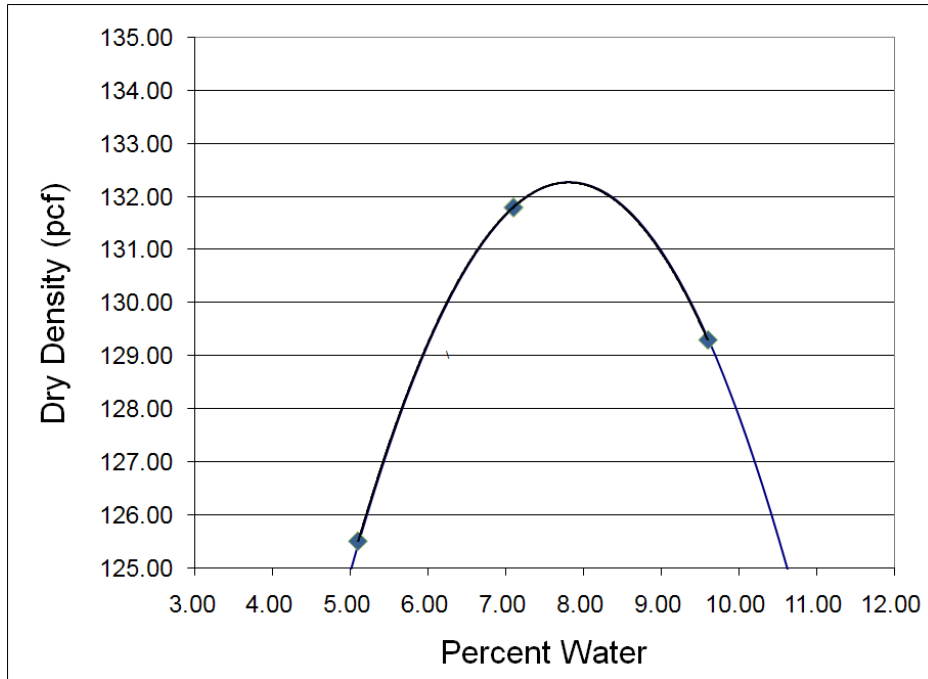
**Figure 3.9. Moisture-Density Curve for FM 487.**

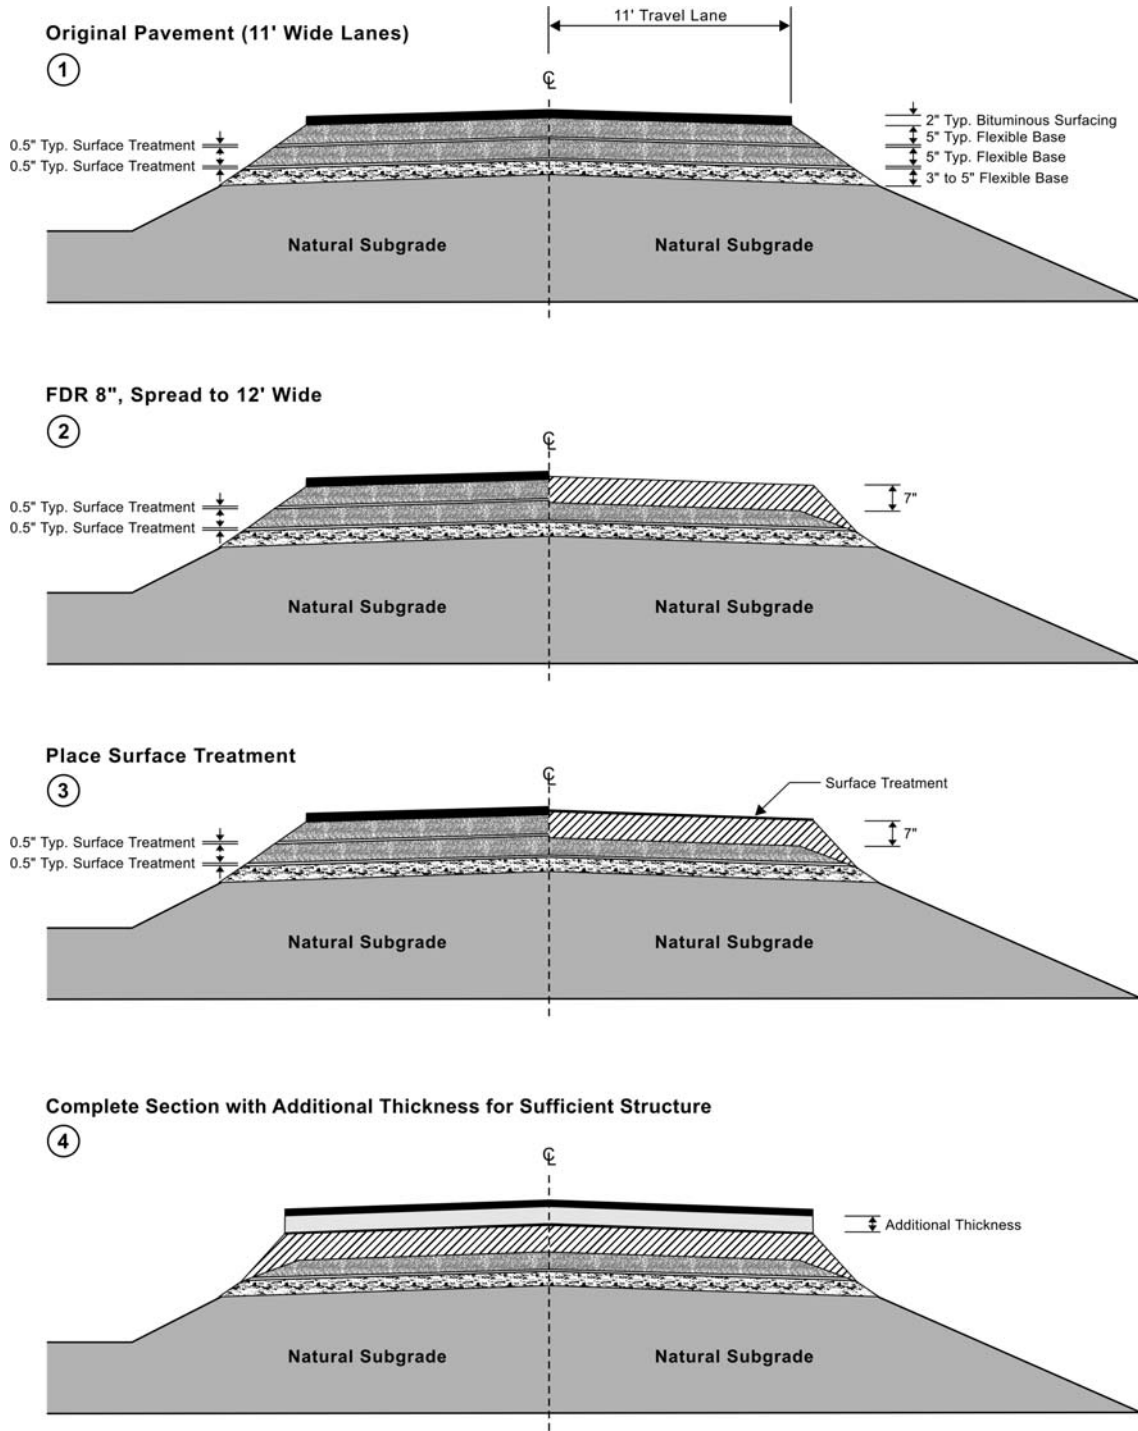
The FDR layer can be sealed then additional thickness added based upon the traffic loading requirements of the pavement. Traffic data were not available at the time of this report, so FPS verification is not presented for this pavement. However, the lab design and pavement design must coordinate with each other. For example, with this pavement if 8 in. treatment depth resulted in elevation problems due to the additional thickness required, consideration could be given to increasing the treatment depth (so long as no more than 50 percent RAP is contained in the FDR mixture and the subgrade is not cut into) to reduce the amount of additional thickness.

**Figure 3.10. Proposed Sequence for FDR on FM 487.**

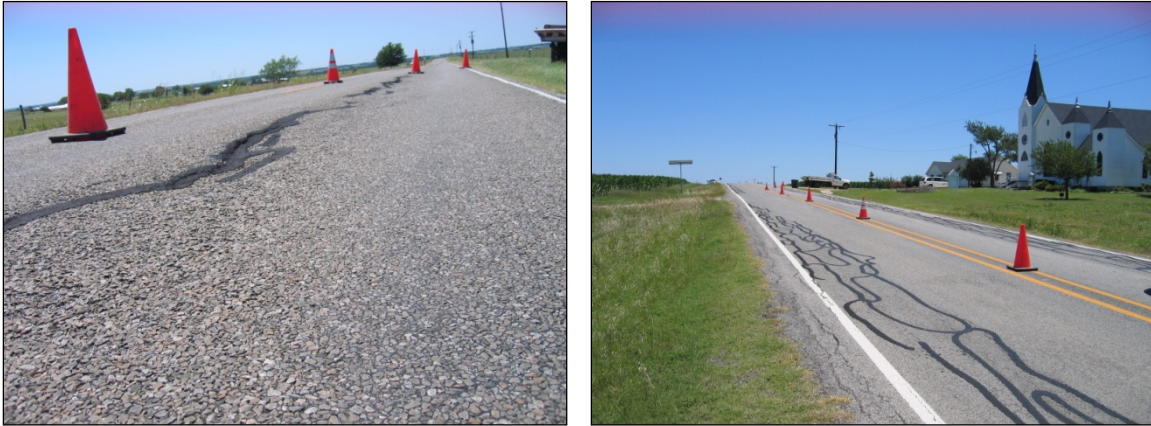
The primary distress is longitudinal cracking and faulting as Figures 5.6 and 5.7 show.

**Figure 4.6. Pavement Distress on FM 112.**

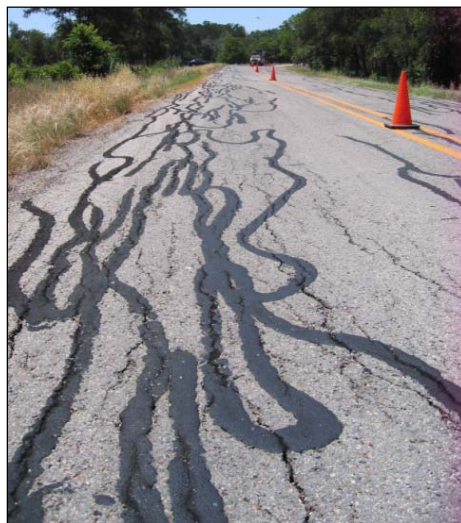
**Figure 4.7. Longitudinal Cracking on FM 112.**

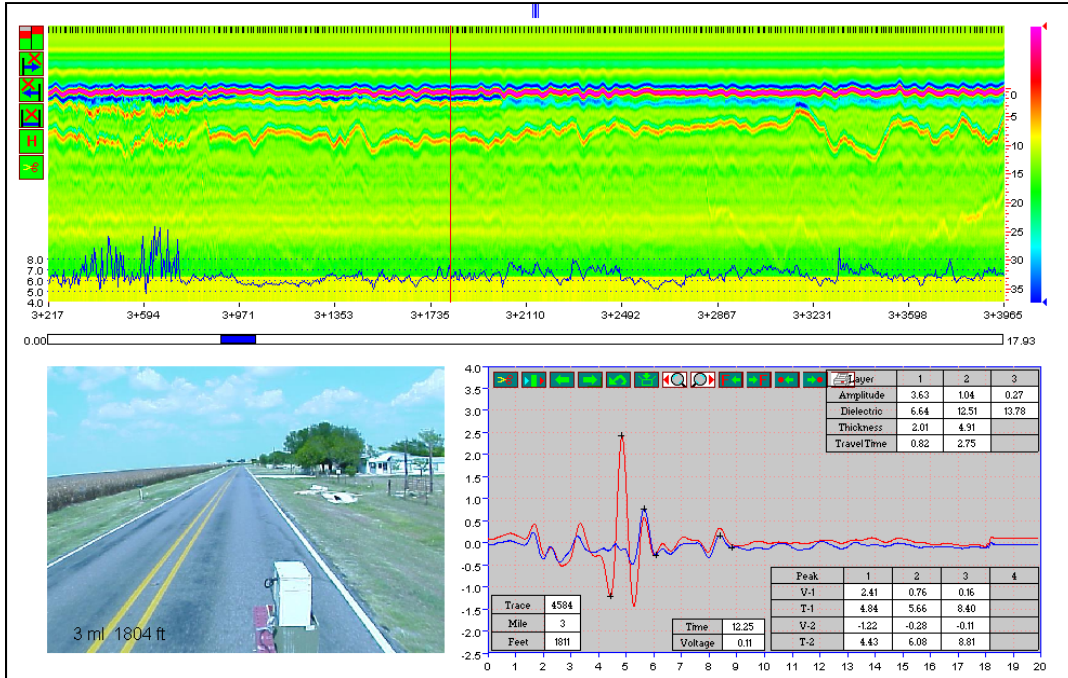
Figure 4.8. FM 112 Sampling Location 1.

A GPR survey conducted to quickly investigate the pavement structure indicates the pavement is probably built on another pavement structure. Numerous locations of maintenance activities also exist. Figures 4.8 through 4.12 show the GPR data from locations selected for coring. Figure 4.13 shows how the pavement condition improves, and the structure is quite uniform, after the location shown in Figure 4.12. The basic pavement structure consists of a thin surfacing with a thin layer of flexible base (typically 4 to 6 in.) on top of an existing roadbed.

Five core locations were selected for validation of the pavement structure and for collecting materials for laboratory testing. These locations were in the southbound direction and shown previously in Figures 4.8–4.13. TTI used an auger rig to verify the pavement structure and collect material samples. Figure 4.14 illustrates the structures observed at the sampled locations.

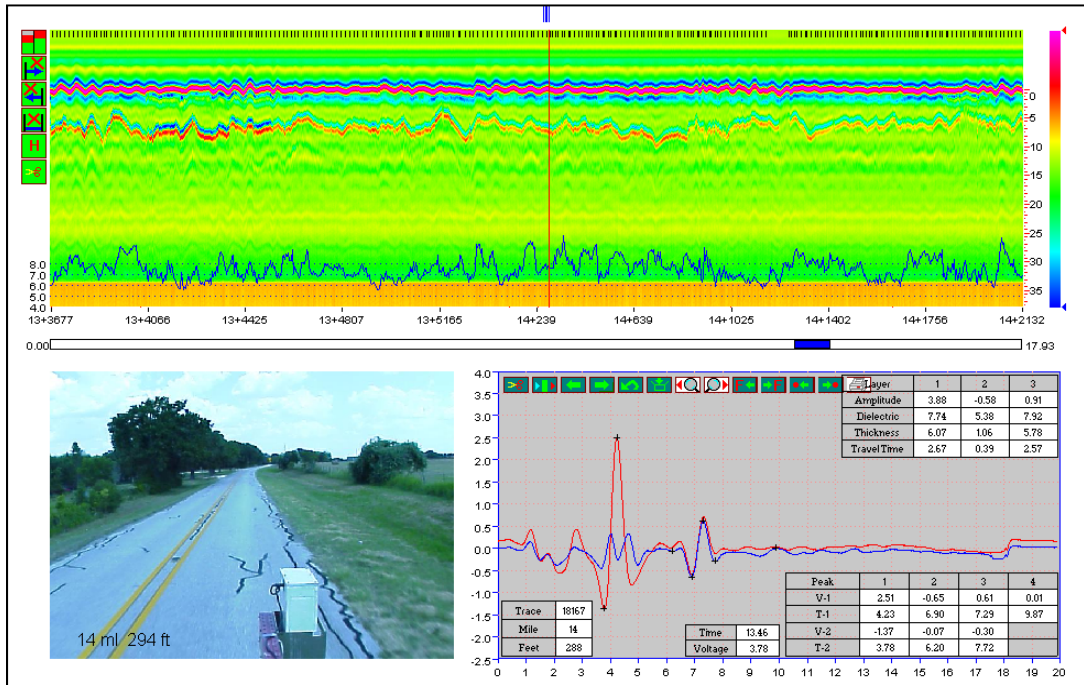
Figure 4.13. Typical FM 112 GPR Profile after Sampling Location 5.

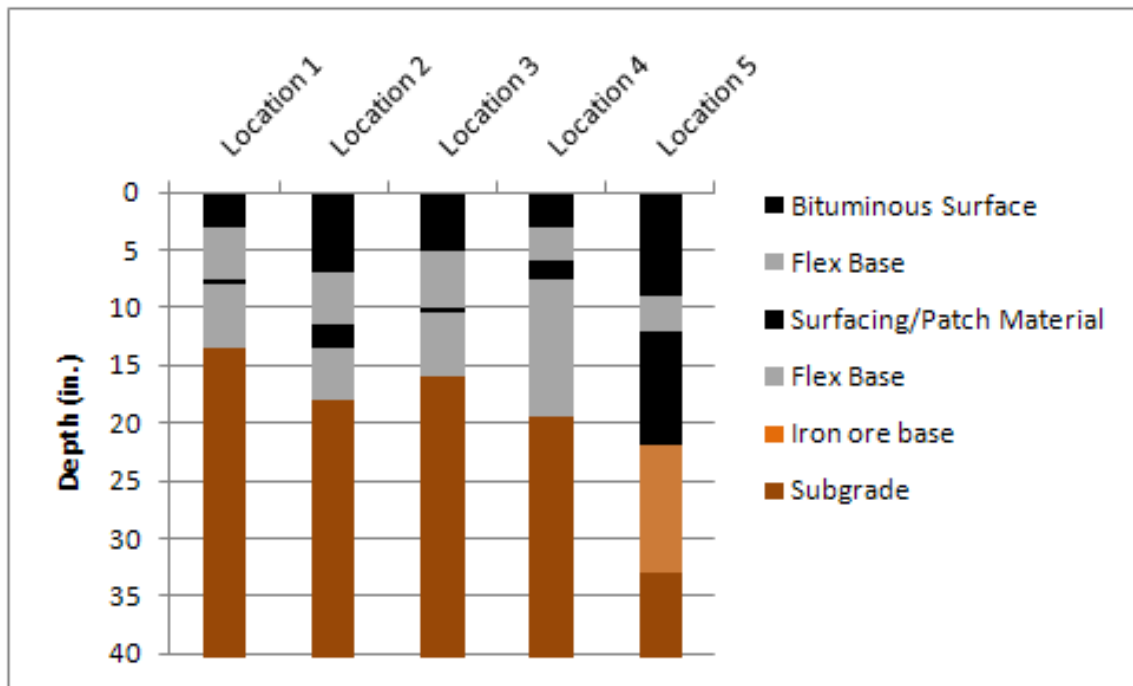
**Figure 4.14. Pavement Structures on FM 112 Sample Locations.\***

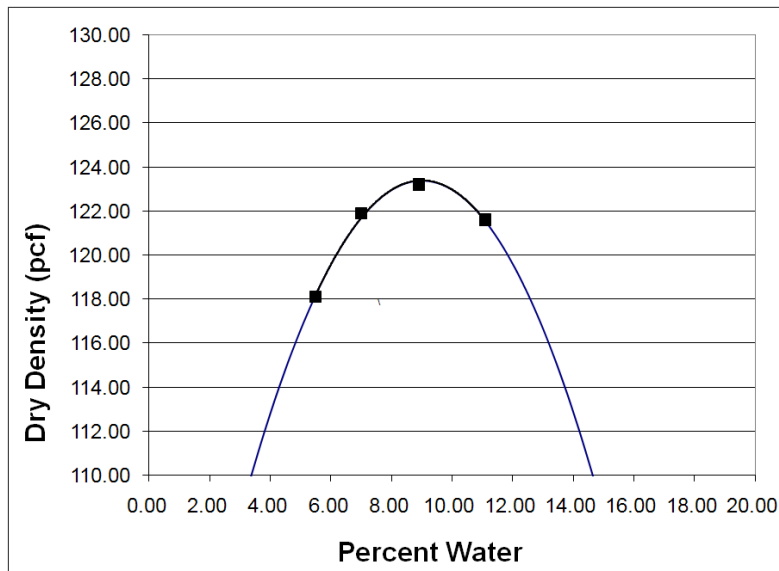
**Figure 4.15. Moisture-Density Curve from FM 112 Material.**

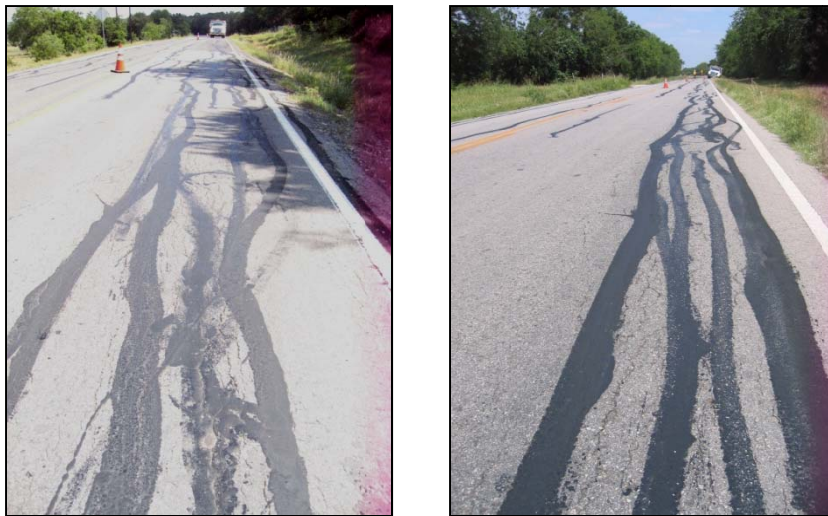
The primary distress is longitudinal cracking, with some edge faulting. Figure 5.1 illustrates the typical pavement condition.

**Figure 5.1. Typical Distress on FM 969.**

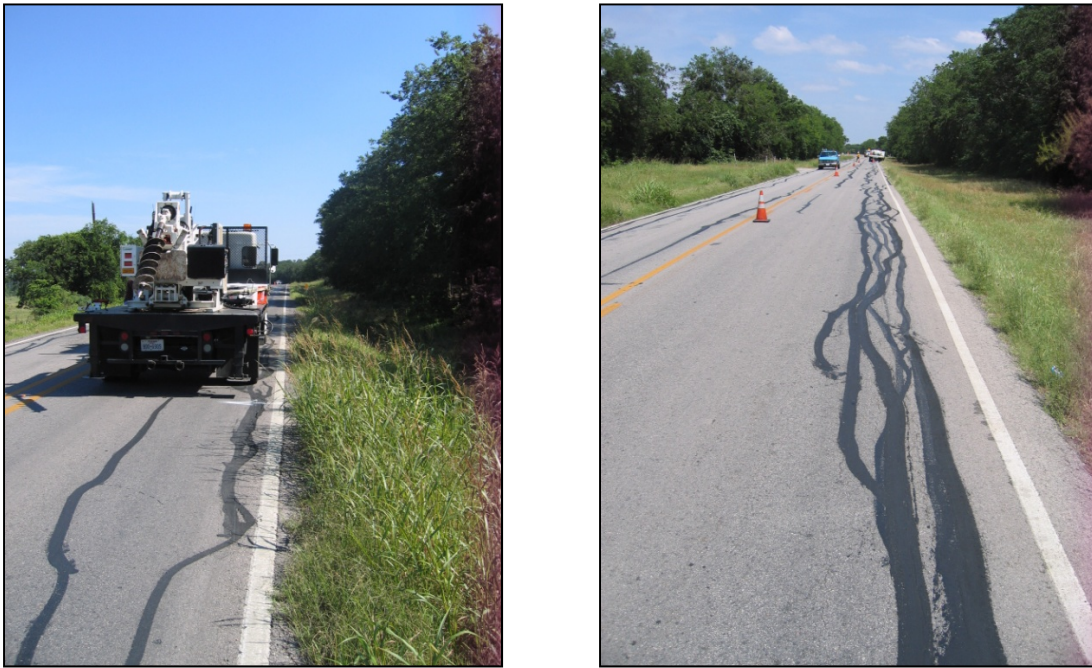
**Figure 5.4. FM 969 Sampling Locations 1 (Left) and 2 (Right).**

Two sampling locations were selected for validation of the pavement structure and for collecting materials for laboratory testing. These locations were in the westbound direction at distances of 2667 ft, and 3 miles + 2892 ft, from the county line. Figures 5.2 and 5.3, respectively, showed the GPR data at sampling locations 1 and 2. Figure 5.4 shows the sampling locations, and Figure 5.5 illustrates the steep side slopes present at sampling location 1.

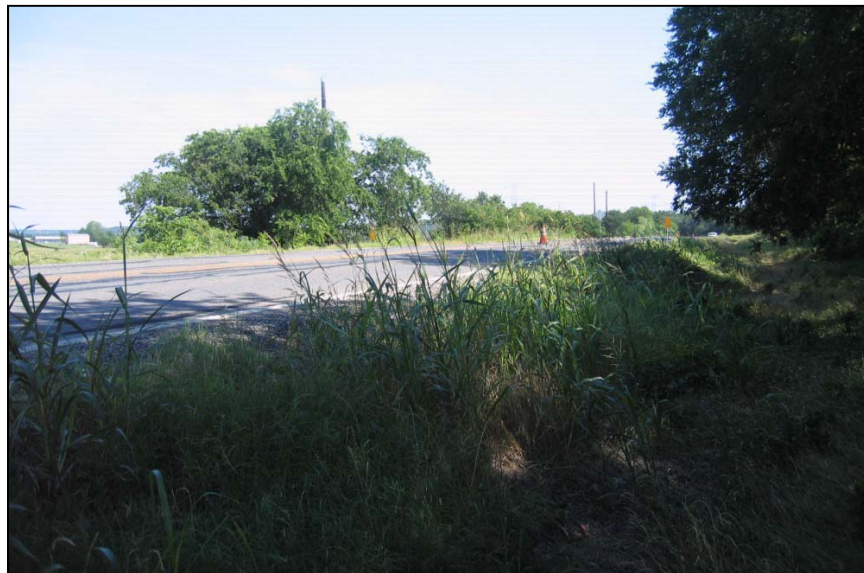
**Figure 5.5. Steep Side Slopes at FM 969 Sampling Location 1.**

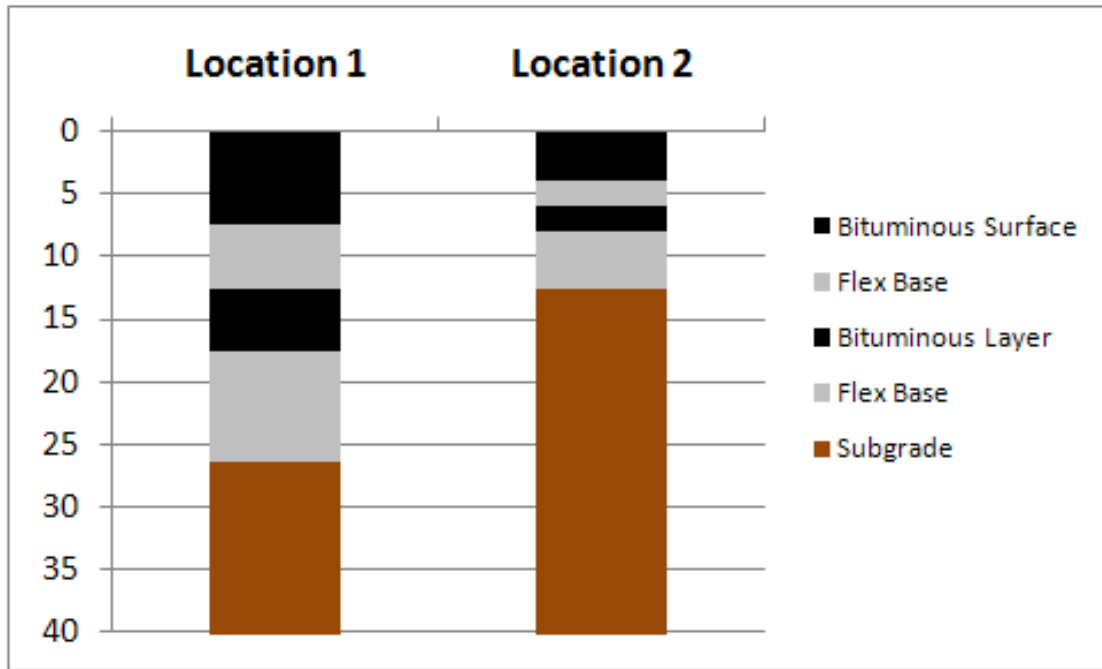
TTI used an auger rig to verify the pavement structure and collect material samples. The majority of materials were collected from Location 2 since the GPR indicated this location was most representative of the typical structure. Figure 5.6 illustrates the structures observed at the two sampled locations.

**Figure 5.6. Pavement Structures on FM 969 Sample Locations.**

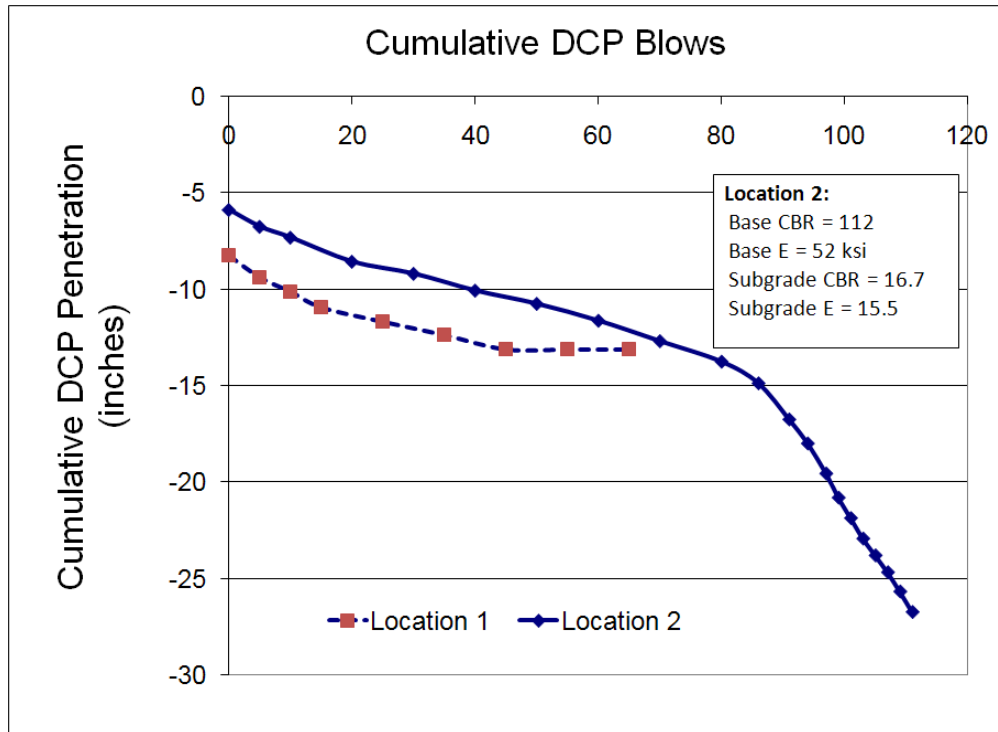
DCP profiles were collected at both sampling locations; Figure 5.7 presents the DCP data. At location 1, the DCP encountered refusal in the buried bituminous layer. At location 2, the DCP data indicate good base and subgrade support. According to correlations by Van Till (1972), the base would be a Texas Triaxial Class 1, and the subgrade approximately 4.0. At the time of testing, however, the area had been experiencing drought conditions. Given the plasticity index of the soil at this location, it is suspected during normal weather conditions the DCP results would not have been as favorable for the subgrade.

**Figure 5.7. DCP on FM 969.**
