1. Report No. FHWA/TX-10/0-6271-1		2. Government Accession No.		3. Recipient's Catalog No.	
4. Title and Subtitle FIELD AND LABORATORY INVESTIGATIONS FOR FULL DEPTH RECLAMATION PROJECTS				5. Report Date November 2009 Resubmitted: January 2011 Published: March 2011

**FIELD AND LABORATORY INVESTIGATIONS FOR  
FULL DEPTH RECLAMATION PROJECTS**

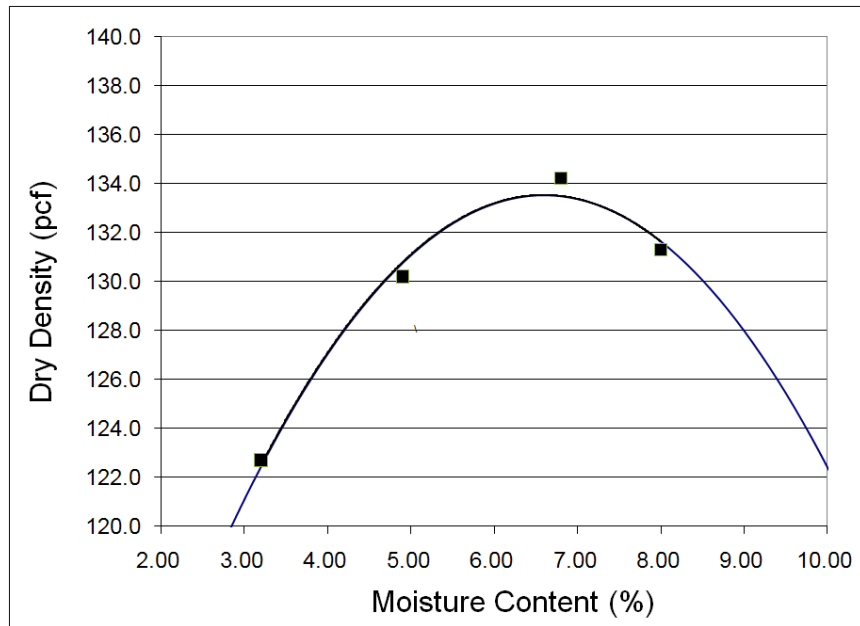
**Figure 5.8. Moisture-Density Curve of FM 969 Material.**

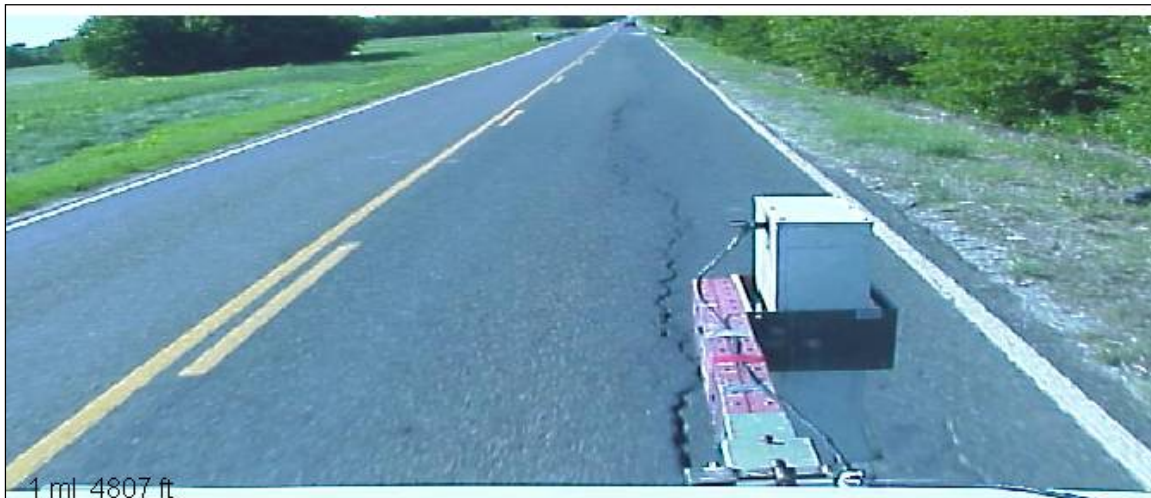
Figure 6.1 shows the current pavement condition, where the primary distress is longitudinal cracking with edge faulting.

**Figure 6.1. Pavement Distress on Business (US) 289.**

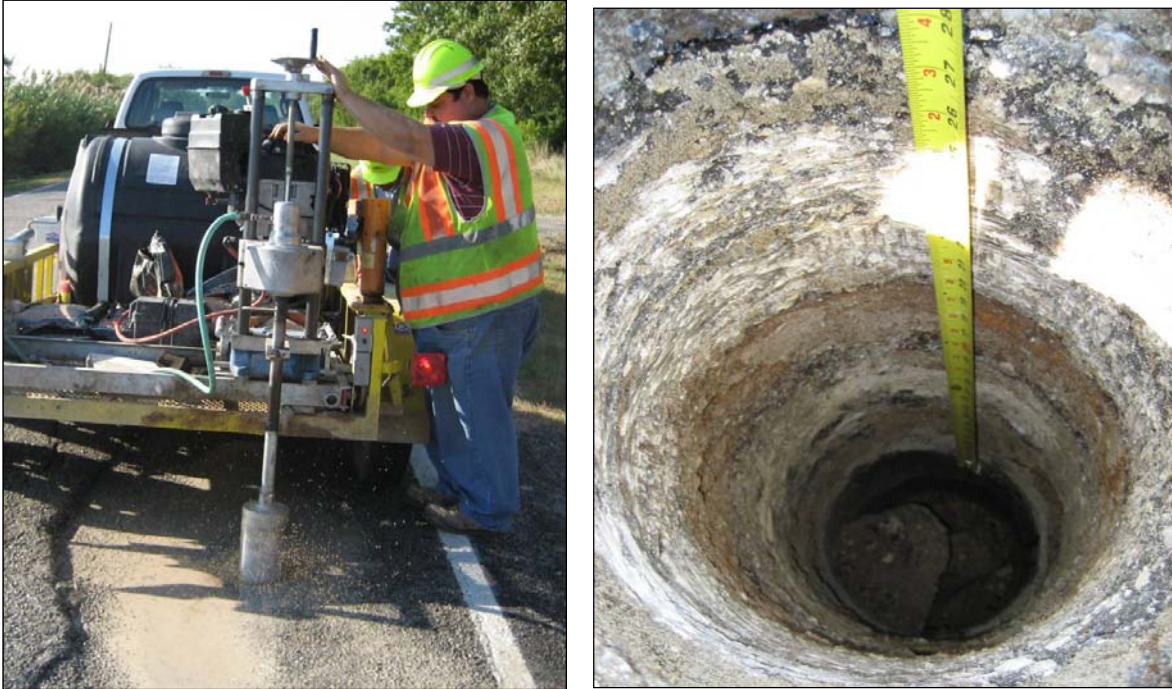
**Figure 6.2. Coring on Business (US) 289.**

A GPR and coring program revealed a thick pavement structure, with 27 in. of thickness above the subgrade. Figure 6.2 shows the field coring in progress, and Figure 6.3 illustrates the typical existing pavement structure, which consists of:

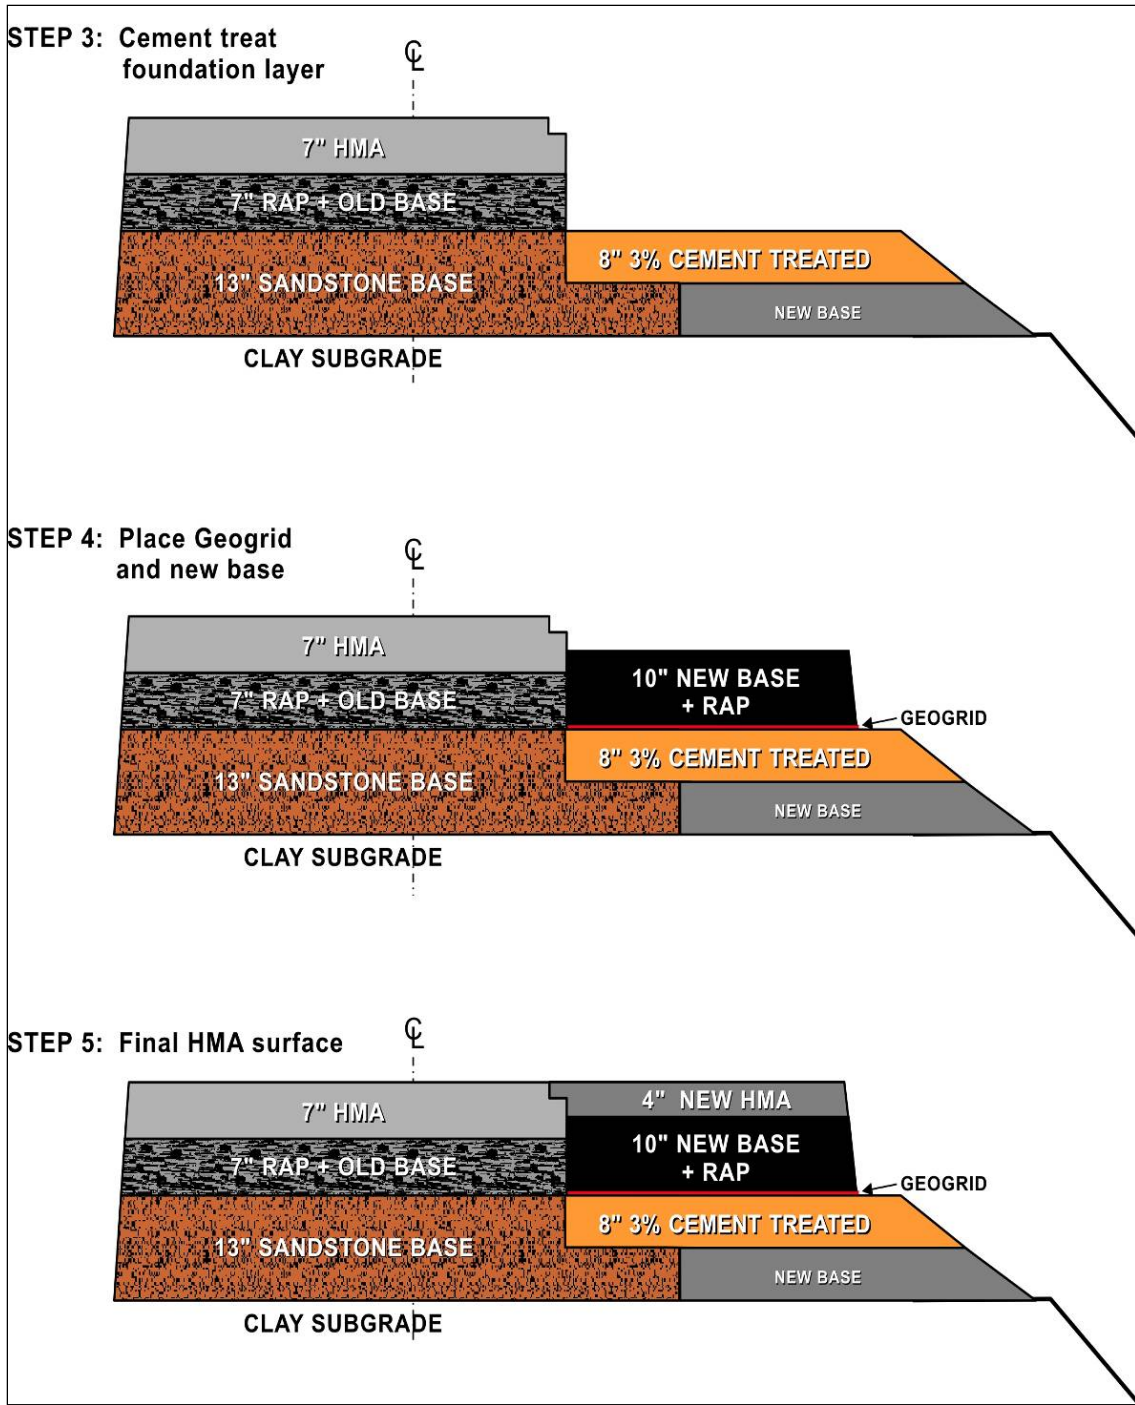
This is the most complicated and extensive repair option. It includes widening the pavement, creating a stiff foundation layer and installing a geogrid and new flexible base to minimize reflection cracking. This option has mostly been used in FDR treatments where the full roadway gets treated, but the approach may also be successful when applied as a partial-width treatment. Figure 6.4 illustrates the construction sequence for the partial-width FDR approach.

**Figure 6.4. Partial-Width FDR Option on Business (US) 289.**

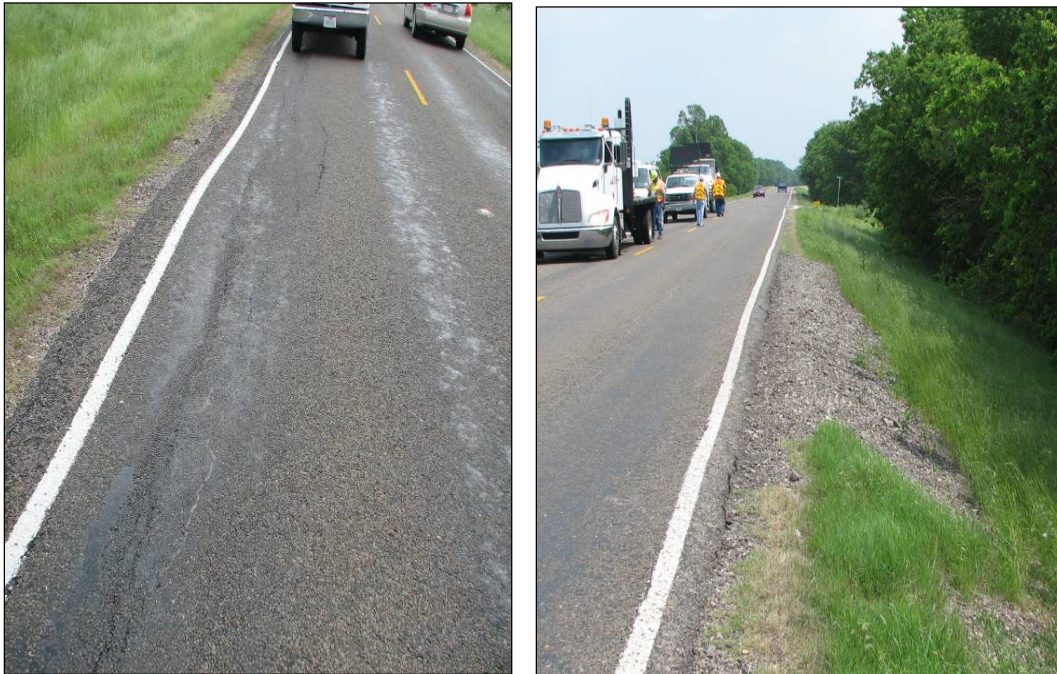
**Figure 7.1. Typical Edge Failure on FM 148.**

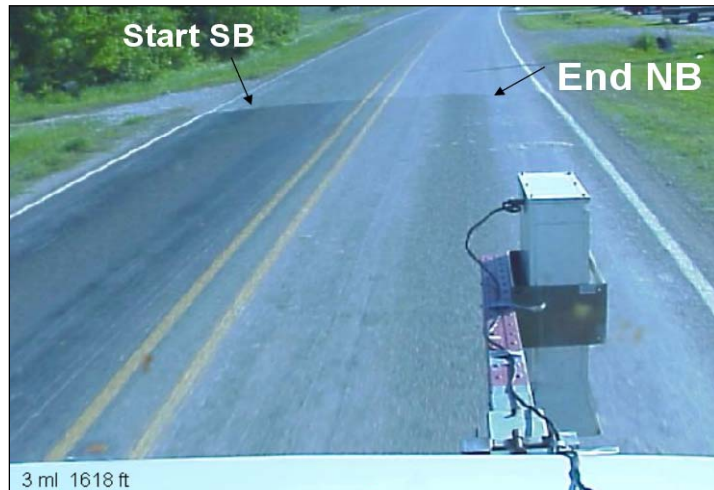
**Figure 7.4. Start Location of SB GPR Run on FM 148.**

Table 7.2 shows the detailed thickness results for the SB. Figure 7.4 shows the start location of the southbound run.

Based on the need for a uniform support layer the milling and construction treatments shown in Table 7.6 are recommended for this project. The zero location is the start of the section in the SB direction shown earlier in Figure 7.4. The typical sequence shown in Figure 7.9 will be used in all areas where the HMA is 8 in. thick. Where the HMA is only 5 in. no milling will be performed and a total of 8 in. recycled. For very thick HMA sections a mill followed by a new base overlay is proposed.

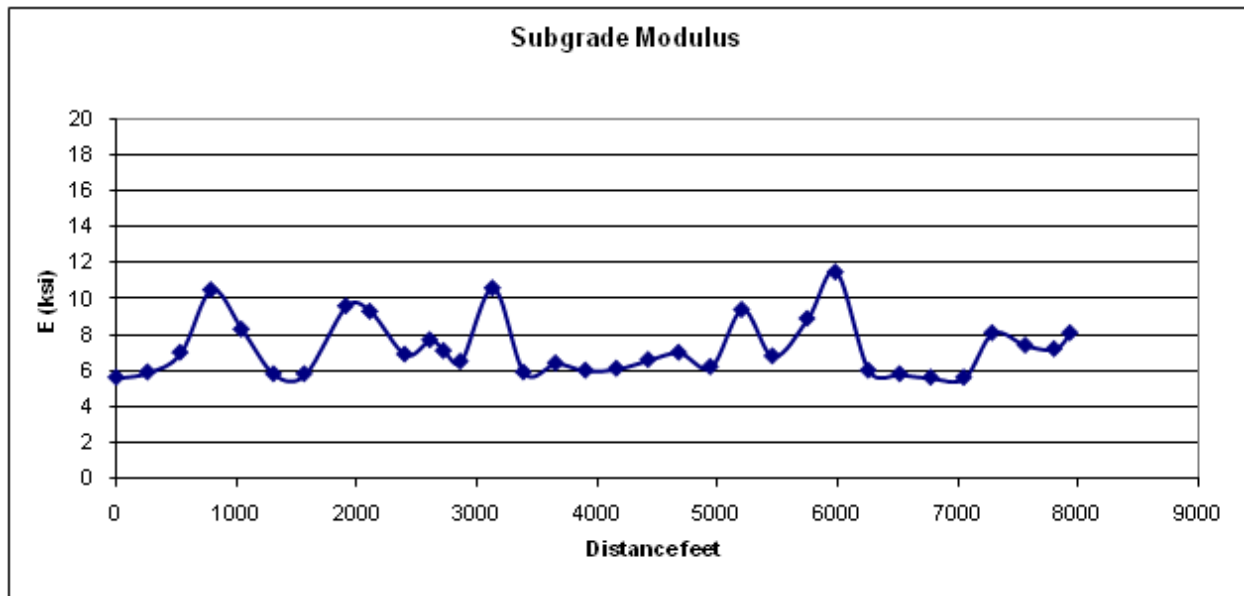
**Figure 7.5. FWD Subgrade Modulus from Adjacent Section of FM 148.**

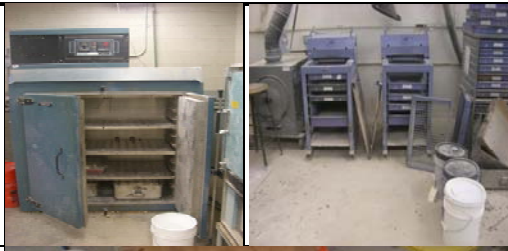
2. Sieve the material over sizes: 1 1/4, 7/8, 5/8, 3/8, #4, Pan. and separate into specific labeled buckets.

• Re-sieve the 5/8 over sizes: 3/4, 3/8, Pan. to separate the 5/8 size rocks. Discard or store all material greater than 3/4 size.

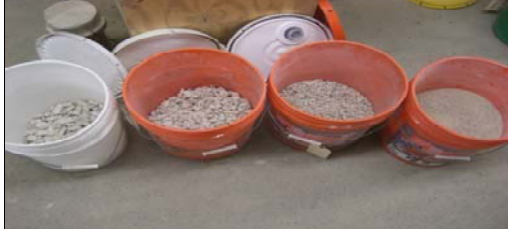
3. Weigh out total mass of material and determine the percentages of the various material sizes for preparation of the sample.

Using these percentages, the cumulative masses of each size can be found to make a specimen.

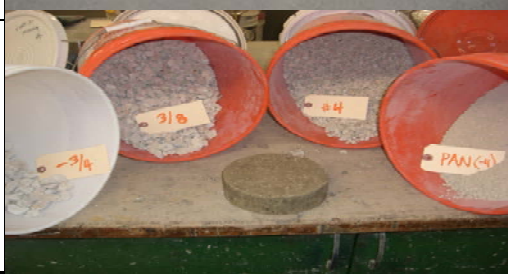
4. Using predetermined percentages of each aggregate fraction, weigh-up samples to prepare for molding.

5. Optimum moisture is found using the TxDOT weigh-up sheet given for this material.

(total weight x opt moisture % = water weight added)

6. In this example, 3% cement will be used as a stabilizer. Using the total sample weight, calculate 3% of total weight to be used as added cement weight. (total weight x 3% = cement weight added)

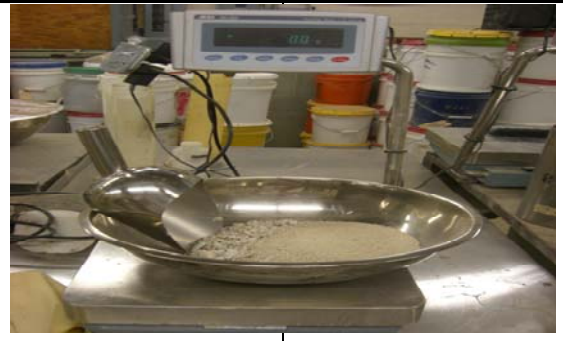
7. Place an aggregate sample in mixing pan and mix thoroughly with amount of required water.

- Cover with foil and weight pan with sample.
- Record the weight and allow the mixture to sit for an hour.

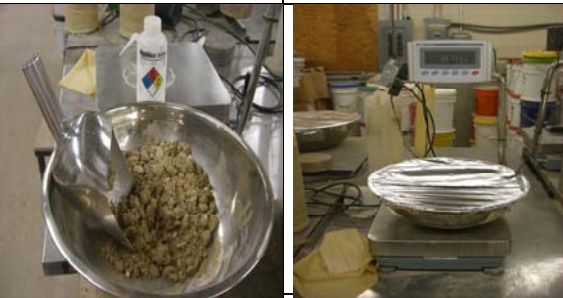
8. Upon return:

- Re-weigh the sample and replenish lost water due to evaporation
- Add allotted amount of cement to mixture
- Mix thoroughly.

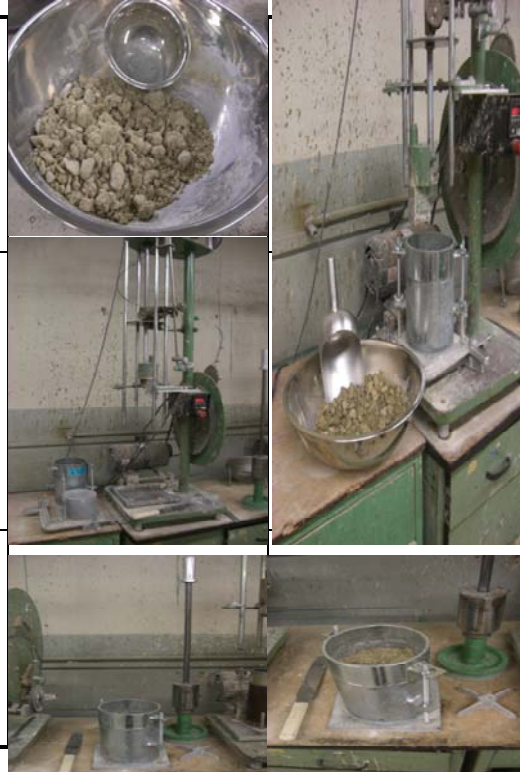
5. Compact the 6-inch x 2-inch in one layer using the standard compaction effort (Tex-113-E): 10-lb hammer, 18-inch drop, 50 blows/layer.

6. Once compacted, scarify the surface using a spatula.
  - Finish off the sample by using 10 blows from a raw-hide hammer and a small level to flatten the surface.

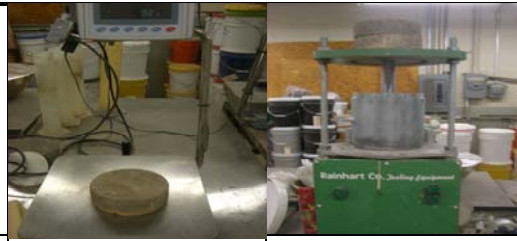
10. Record the sample weight and height.

11. Proceed to cover the entire sample with saran wrap and label it.

- Leave the samples covered for about an hour to allow them to harden.

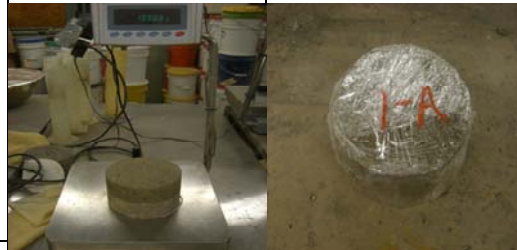
13. Choose the best side (top or bottom) and re-wrap the sample with plastic wrap to expose only the side chosen for prime coat.

- Nine grams of prime should be applied to entire open area of each sample. This amount would be adjusted depending on the prime material and desired application rate.

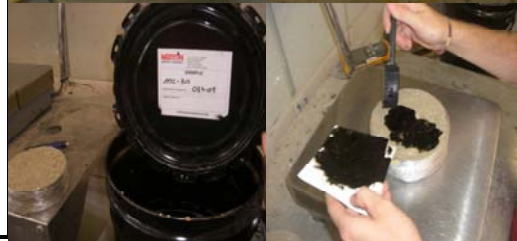
14. Once prime is applied, place samples in the 110 °F room for 3 days.

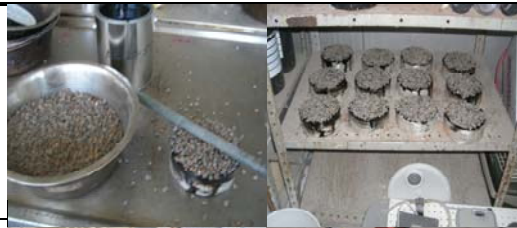
15. After the 3-day cure, apply surface treatment. For this example, an AC-20-5TR asphalt binder was used with a lightweight aggregate.

- Thirty grams of asphalt is applied to the tops of every sample and a Grade 4 or 5 seal-coat is immediately added.
- A metal pipe is used to roll the stone in place, then all 12 samples are placed back in the 110 °F room.

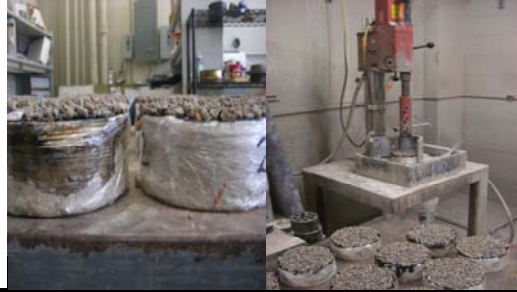
16. After leaving samples in the oven overnight, the samples are removed and allowed to cool for an hour before being cored.

- Core to a depth of ½-inch or just below the asphalt layer when you can see original base material. Exercise care to not tear up seal-coat layer when coring.

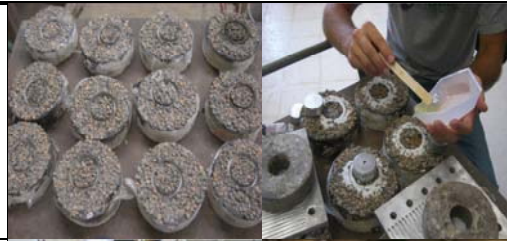
17. After coring, epoxy glue is applied to the metal pullers and stuck onto the cored section of the samples. Sand is placed in the cored ring so when the epoxy flowed it contacted the free sand instead of the outside of the sample. Small weights may also be applied to the disks to aid in the adhesion process.

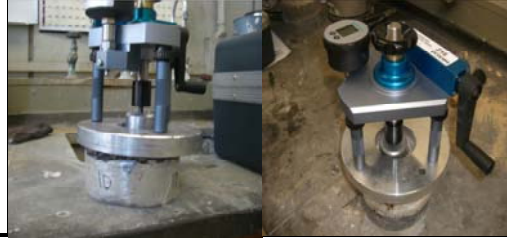
18. Once the glue has set, place sample in the testing apparatus and perform tensile test until sample fails.

- Record the breaking force in lb and identify where the failure plane occurred within the specimen.
