1. Report No. FHWA/TX-11/0-6590-2		2. Government Accession No.		3. Recipient's Catalog No.	
4. Title and Subtitle Materials Selection for Concrete Overlays: Final Report			5. Report Date October 2011, Published July 2012

## **Materials Selection for Concrete Overlays: The Final Report**

CTR Technical Report:	0-6590-2
Report Date:	October 2011
Project:	0-6590
Project Title:	Materials Selection for Concrete Overlays
Sponsoring Agency:	Texas Department of Transportation
Performing Agency:	Center for Transportation Research at The University of Texas at Austin

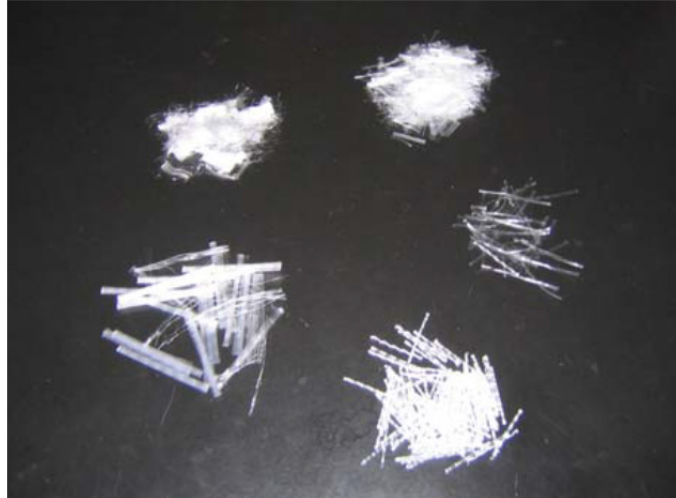
*Figure 2.3: Different forms of polypropylene fibers*

Polypropylene microfibers are produced either as cylindrical monofilaments or fine fibrils with a rectangular cross section. Polypropylene microfibers can be in monofilament, multifilament, or fibrillated form (Figure 2.3).

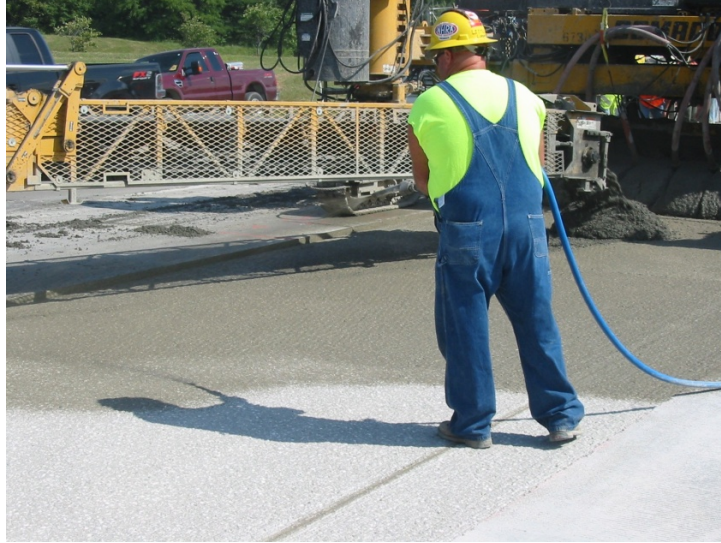
*Figure 2.5: Spraying grout immediately ahead of paver*

Figure 2.5 shows that immediately before paving, a grout can be uniformly broomed over the full width of the prepared surface. The prepared surface must be in SSD condition. Typically water-to-cement ratio of the grout is around 0.62 to 0.70 by weight, or approximately seven gallons of water per sack of cement [27].

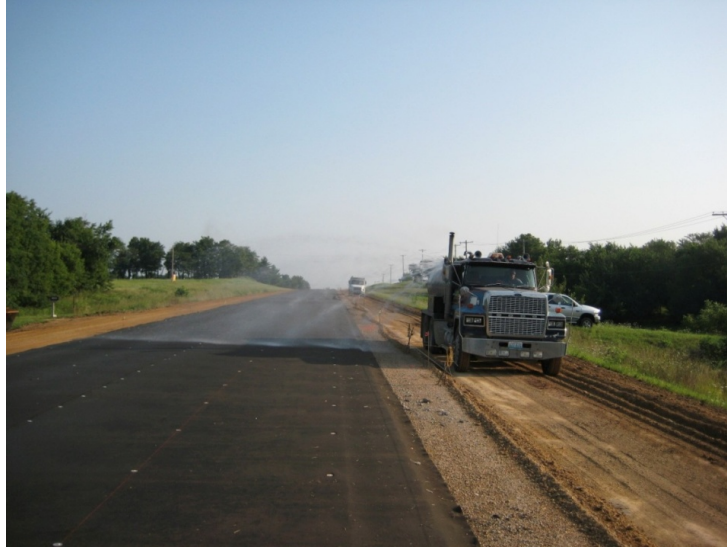
*Figure 2.7: Cooling down the prepared surface before placement*

White pigmented curing can be used to cool the existing pavement prior to pouring. This curing compound reflects heat and prevents heat build-up in the dark surface, reducing shrinkage cracking in the concrete and potential paving problems due to a soft surface [8, 24]. Water fogging is another method that can reduce the asphalt temperature. Figure 2.7 shows a way to cool down the prepared surface by spraying with water. It is good practice to water fog if the asphalt surface heat makes it uncomfortable to touch with an open palm [37]. It was found that mix water in the fresh concrete overlay was absorbed into the dry substrate, reducing the amount of water available to fully hydrate the cement paste at the bonding interface [38].

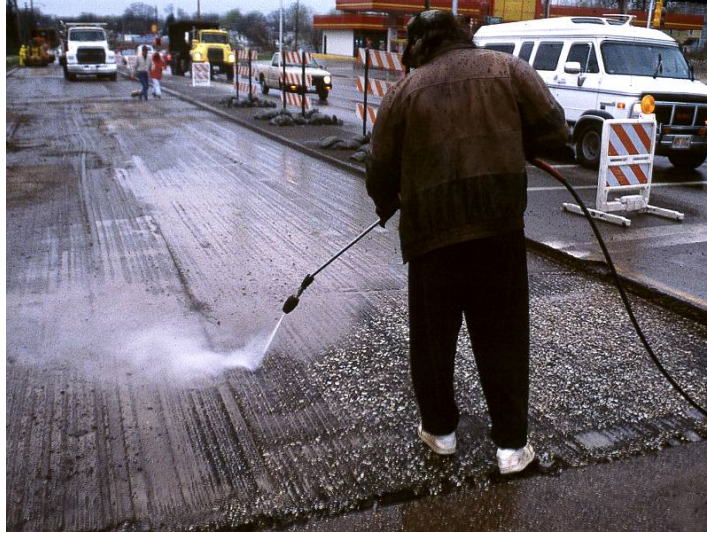
*Figure 2.8: Cleaning the surface with hydro cleaning equipment*

After the surface preparation operations are finalized and the reinforcing steel is in place, the last cleaning of the surface is done by air blasting just before concrete placement. It should be noted that air blasting and water blasting should be used only as supplementary cleaning procedures for loose material and debris elimination from the surface after milling, shotblasting, or sandblasting, because these methods are not capable of removing paint stripes, tire marks, or grout matrix. Air blasting is to be used just before overlaying to thoroughly remove debris from milling or shotblasting operations. It is important not to leave a large time lag between the final surface cleaning and paving in order to prevent the contaminants from resettling. Figure 2.8 shows hydro cleaning as a way to clean the prepared surface.

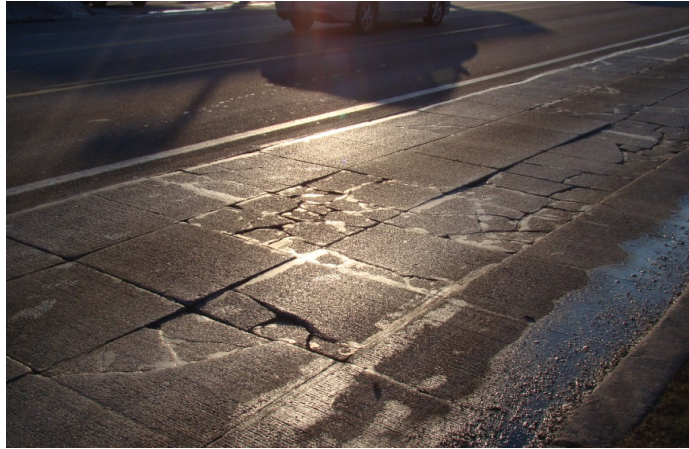
*Figure 2.10: Failed joints in wheel path*

- The timing of joint sawing is critical. Sawing too early can cause excess raveling, and sawing too late can result in shrinkage stress causing uncontrolled random cracking.
- ACPA recommends that joint spacing be about 12 to 15 times the slab thickness.
- Joint spacing has a significant effect on the rate of corner cracking. Short joint spacing, common on thin concrete overlays, reduces load-related stresses, because the slabs are not long enough to develop as much bending moment [8]. The joint location is also important to avoid concentrated loads. For example, 4-ft. by 4-ft. panels on a 12-ft.-wide lane would put truck tires on the edge of the panels, and significant distress would occur if the thin concrete overlays became de-bonded from the existing pavement [9]. Figure 2.10 is a good example of failed joints in wheel paths.

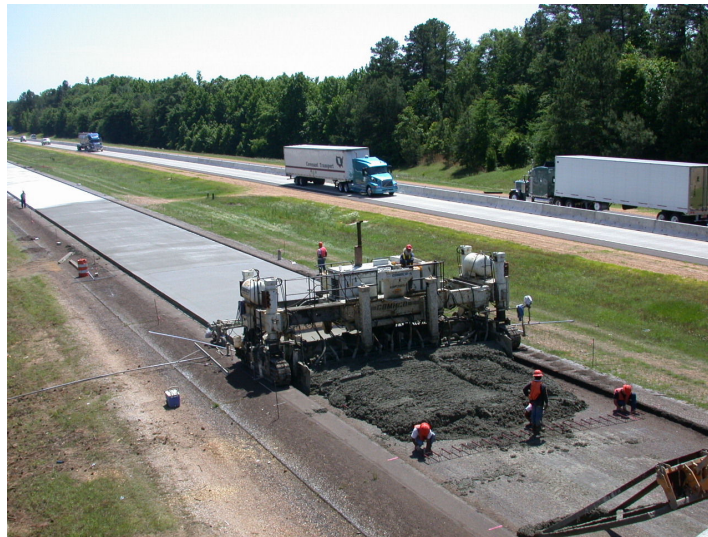
*Figure 2.11: Prompt curing following the paver*

The importance of proper curing can never be understated. Proper curing procedures are essential in preventing excessive moisture loss at early ages that can result in plastic shrinkage and loss in tensile strength capacity at the surface. Curing should begin as soon after placement and finishing as possible to minimize loss of bleed water. Figure 2.11 shows the curing crew following the paving machine closely. For concrete overlays, It is recommended that a double application of the curing compound be used [5, 32].

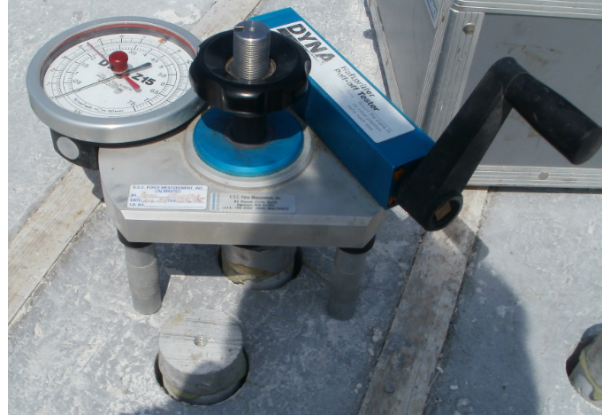
*Figure 4.9: Pull-off testing*

Bond strength of the 3-in. concrete overlays was measured in accordance with ASTM C1583, and 2-in. diameter cores were tested in tension at 3, 7, and 28 days. A Dyna pull-off tester from Humboldt was used to measure the bond strength. It was made certain that each core was drilled at least 3.5 in. deep, well past the 3-in. depth of the interface for these concrete overlays. After the tops of the cored surfaces were cleaned off and dried, a thin layer of 3000-psi epoxy was applied, and the aluminum caps were then glued to the tops of the cores. After sufficient time had passed for the epoxy to cure, the pull-off test was performed to measure bond strength.

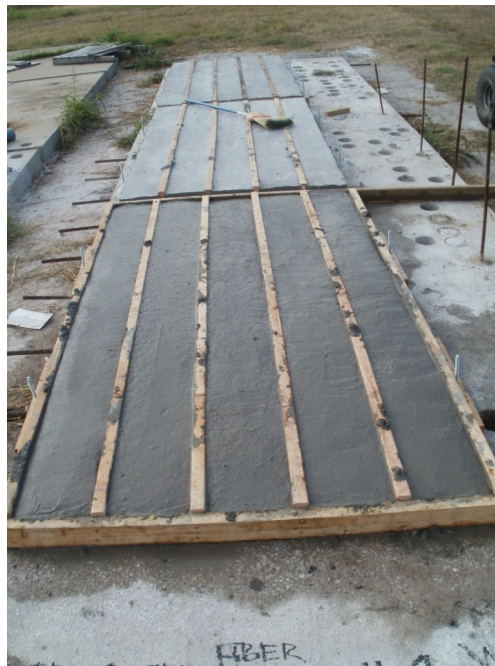
*Figure 4.10: Customized Restrained Shrinkage Slabs*

Initial plan of the research was to perform restrained shrinkage tests according to ASTM C1581 – 09a “Standard Test Method for Determining Age at Cracking under Restrained Shrinkage” as a part of the laboratory testing phase. However, based on the past experiences with the unreliability of the test procedures, equipment, and the results at CMRG, a customized test to measure restrained shrinkage cracking was developed. To more closely simulate the dimensional constraints on typical roadways, long and thin bonded concrete overlay slabs (9-in. by 3-in. by 8-ft.) were placed on cured concrete substrates outside as seen in Figure 4.10. This geometry induces transverse cracks in the specimens by making the specimens long and thin and restrained to the existing slab.

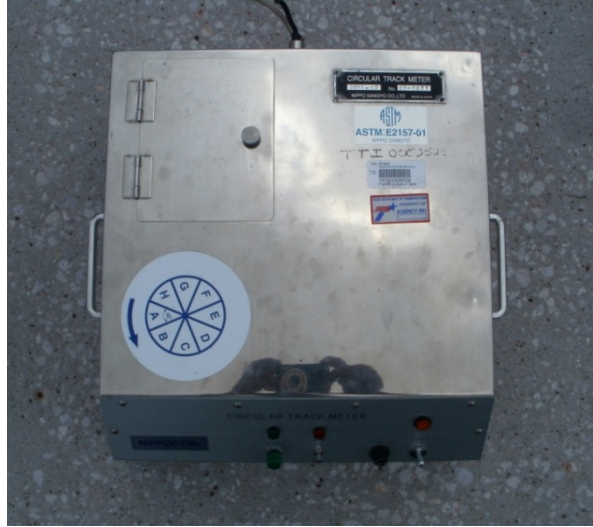
Figure 4.13: Circular Track Meter (CT Meter)

After shotblasting was finished, a Circular Track Meter (CT Meter) was used to measure the depth and consistency of the surface texture profile as shown in Figure 4.13. This test procedure is presented in ASTM E2157 – 09 “Standard Test Method for Measuring Pavement Macrotexture Properties Using the Circular Track Meter.” The CT Meter uses a laser to measure the profile of a circle 11.2 in. in diameter or 35 in. in circumference. The profile is divided into eight segments of 4.4 in. The average mean profile depth (MPD) is determined for each segment of the circle. The reported MPD is the average of all eight segment depths. The test was run at different locations in order to find an average MPD of all the areas tested. The data collected was then put through computer software called “C.T.Meter” that produces a plot and MPD. MPD found using a CT Meter is highly correlated to mean texture depth (MTD), which is a measurement of the depth of the prepared surface texture. Figure 4.14 shows a plot of test results that were performed at five different locations (shown by five different colored graphs). The letters on the top represents the eight segments of the circle, and the numbers on the left represents the profile depth. As shown, the graphs are consistent to each other with an exception to a peak at Segment F. This means that the surface texture is mainly consistent except in a small area.

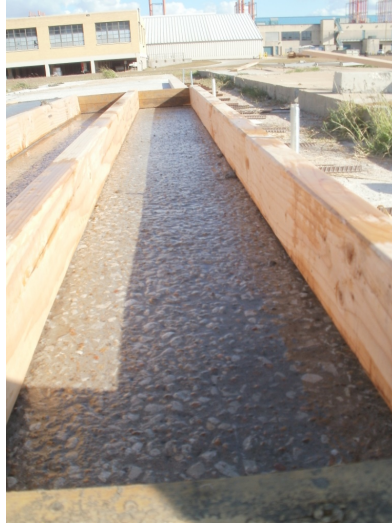
*Figure 4.15: Exposed CA shown in the prepared surface in SSD condition*

After determining that the MTD was satisfactory, the surface was cleaned and dampened to reach SSD condition just before the placement of concrete as shown in Figure 4.15.

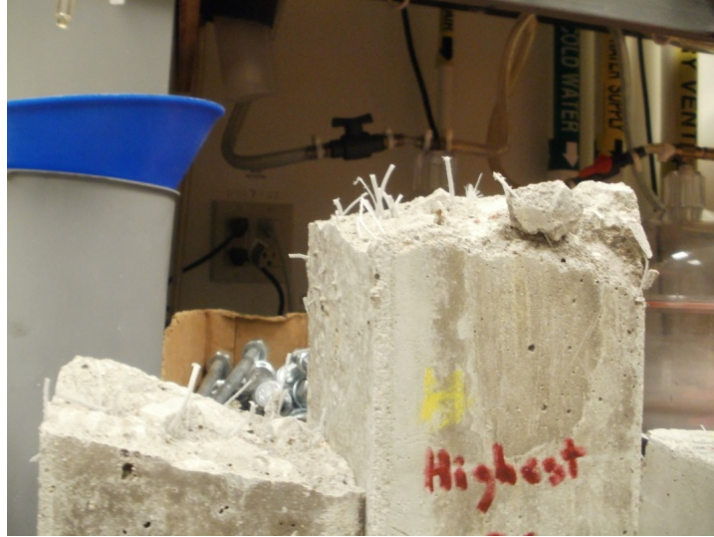
*Figure 4.27: Failed interface of the specimen with highest ARS*

Specimens that had larger amounts of fibers present at the interface gave higher ARS compared to the specimens with lower amount of fibers at the interface. Figure 4.27 shows significantly more fibers present at the interface while Figure 4.28 shows significantly less. Consequently, the specimen in Figure 4.27 had the highest ARS, and the specimen in Figure 4.28 had the lowest ARS.

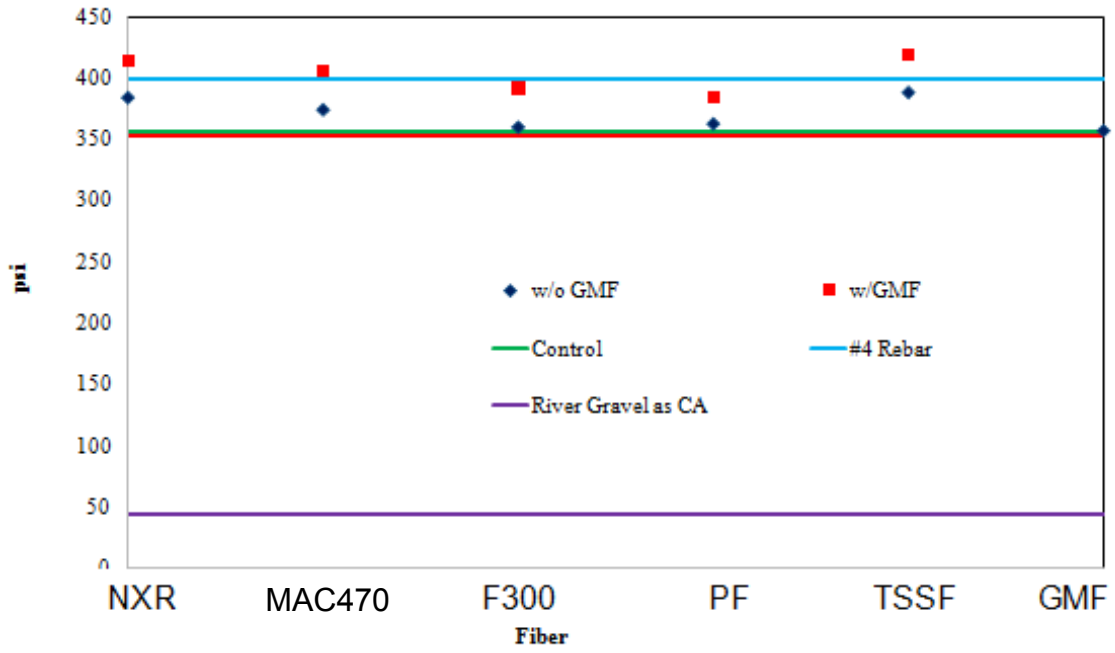
Figure 4.29: Bond strength with fibers

The results are shown in Figure 4.29. Fibers increased bond strength, and blending microfibers with either macro or steel fibers increased bonded strength even more. The specimens with river gravel as CA produced very poor bond strength due to its high CTE and induced high stress at the interface. No. 4 reinforcement bars produced very high bond strength because they effectively controlled the strain at the interface and then reduced in stress. Using reinforcement bars are still less expensive than using fibers.

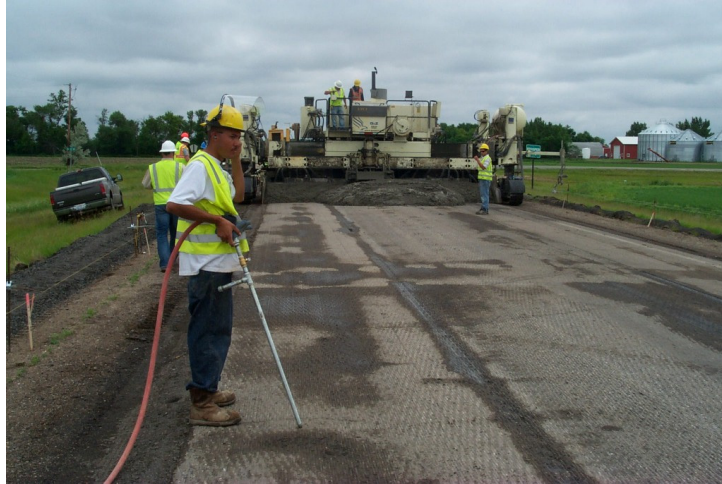
*Figure 7.5: Use of an air hose to clean the surface and spread pooled water just ahead of the paver*

Immediately prior to placing concrete, the prepared and textured surface should be thoroughly cleaned of all dust and loose particles by vacuum, air blowing, and/or by hydro blasting. During cleaning the surface should be dry, and thoroughly cleaned of all vegetation, dirt, mud, and other contaminants. Figure 7.5 shows a worker using an air hose to clean the surface and spread pooled water just ahead of the paver.

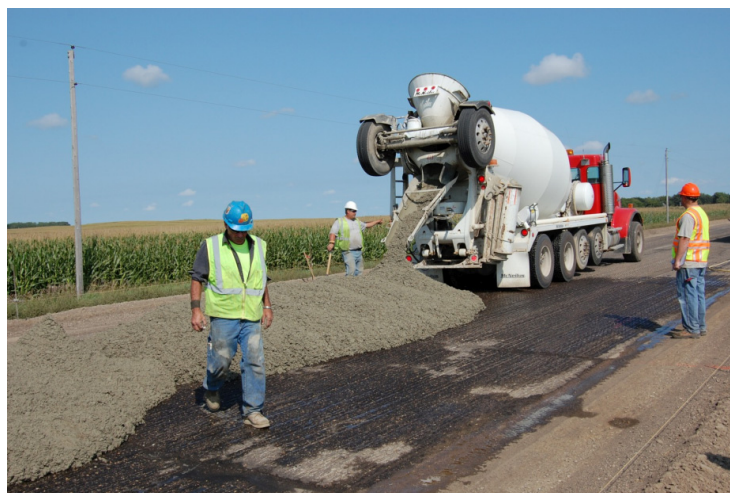
*Figure 7.6: Wetted surface and dried surface*

The goal is to achieve saturated surface dry (SSD) condition on the cleaned surface in order to lower the surface temperature and prevent moisture loss from the fresh overlay to the existing pavement. The surface should be adequately wetted (but free of puddled water) immediately before the placement. Pooling of water must be avoided since the excessive water may introduce weakened planes at the interface and hinder bond strength. Figure 7.6 shows a surface that has been wetted but beginning to dry.

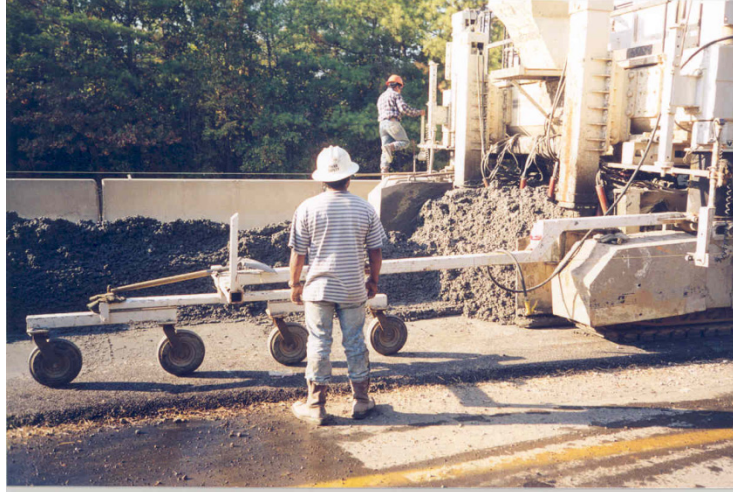
*Figure 7.9: Existing pavement, 2-in. thick asphalt separation layer, and concrete overlay placement*

A separation layer is essential to isolate the unbonded concrete overlay from the existing concrete pavement, to minimize reflective cracking, and to provide a smooth and level surface. Typically, an asphalt layer is placed about 1-in thick. Some states have used a 2-in. asphalt layer. For whitetoppings that are intended to be unbonded, no separation layer is required. However, the substrate surface should be level and provide a uniform strength platform. Figure 7.9 shows construction of an UBCO.

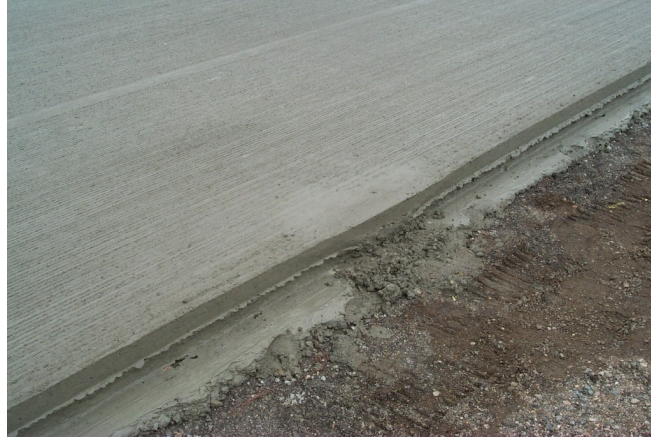
*Figure 7.10: Carpet dragged surface texture*

The use of a burlap drag is not recommended for finishing fiber-reinforced concrete overlays, because it can result in a poor finish due to the fibers becoming entangled in the burlap, leading to other fibers and coarse aggregate being pulled from the surface of the pavement. An unweighted carpet drag is an alternative option to provide an acceptable finish. Figure 7.10 shows a finished surface with carpet dragged surface texture.

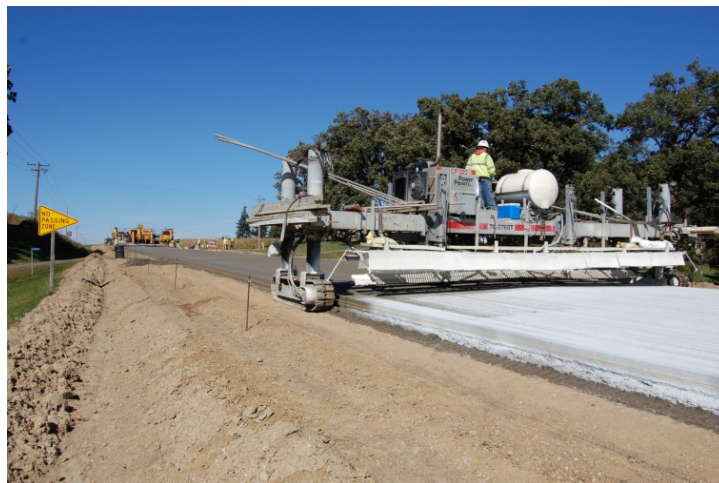
*Figure 7.11: Curing compound being promptly applied following paving operation*

Curing prevents moisture loss and thereby reduces early age shrinkage, leading to higher tensile strength at the onset of normal drying shrinkage. Simultaneously, other advantages are gained: reduced risk of cracking, higher strength, improved durability, and better wear resistance [11]. Curing compound should be applied promptly following paving operation. Figure 7.11 shows curing compound being promptly applied following paving operation.
