Construction of New Profiler Certification Tracks

Technical Report 5-9047-01-1

TEXAS A&M TRANSPORTATION INSTITUTE
COLLEGE STATION, TEXAS

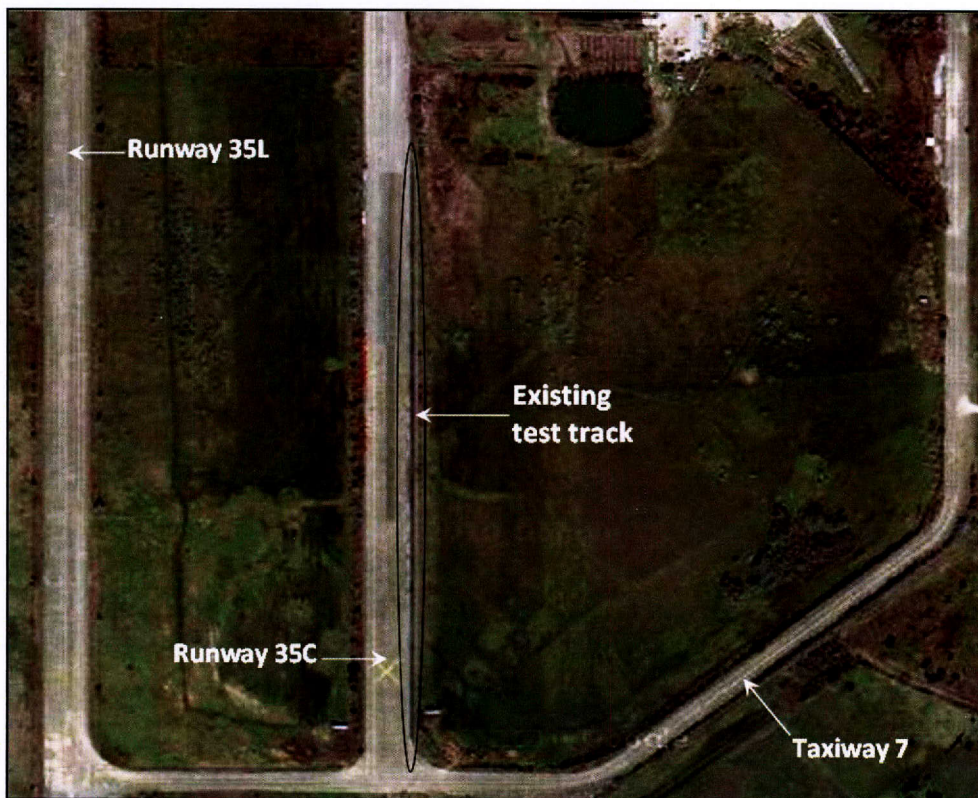
Figure 1. Existing Test Track Used for Inertial Profiler Certifications.

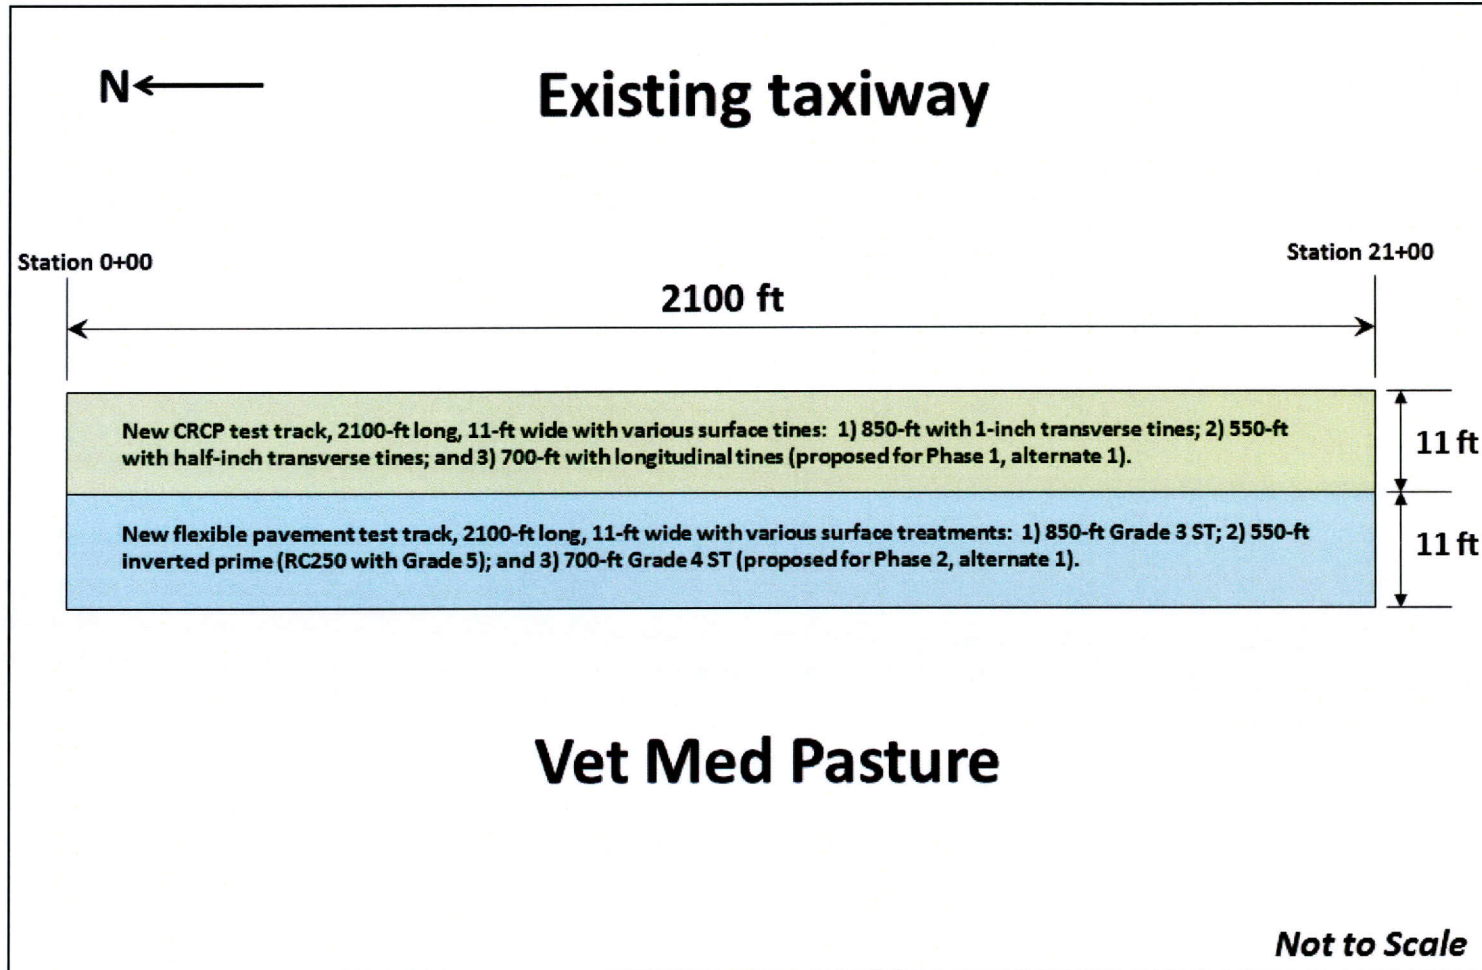
Figure 5. Plan View of Proposed New Test Tracks.

In addition to the construction of test tracks in Phase I and Phase 2, researchers included an alternate third phase covering placement of access ramps to the test tracks. Contractors were also asked to submit bids for this Phase 3 work according to the plans and specifications given in this chapter.

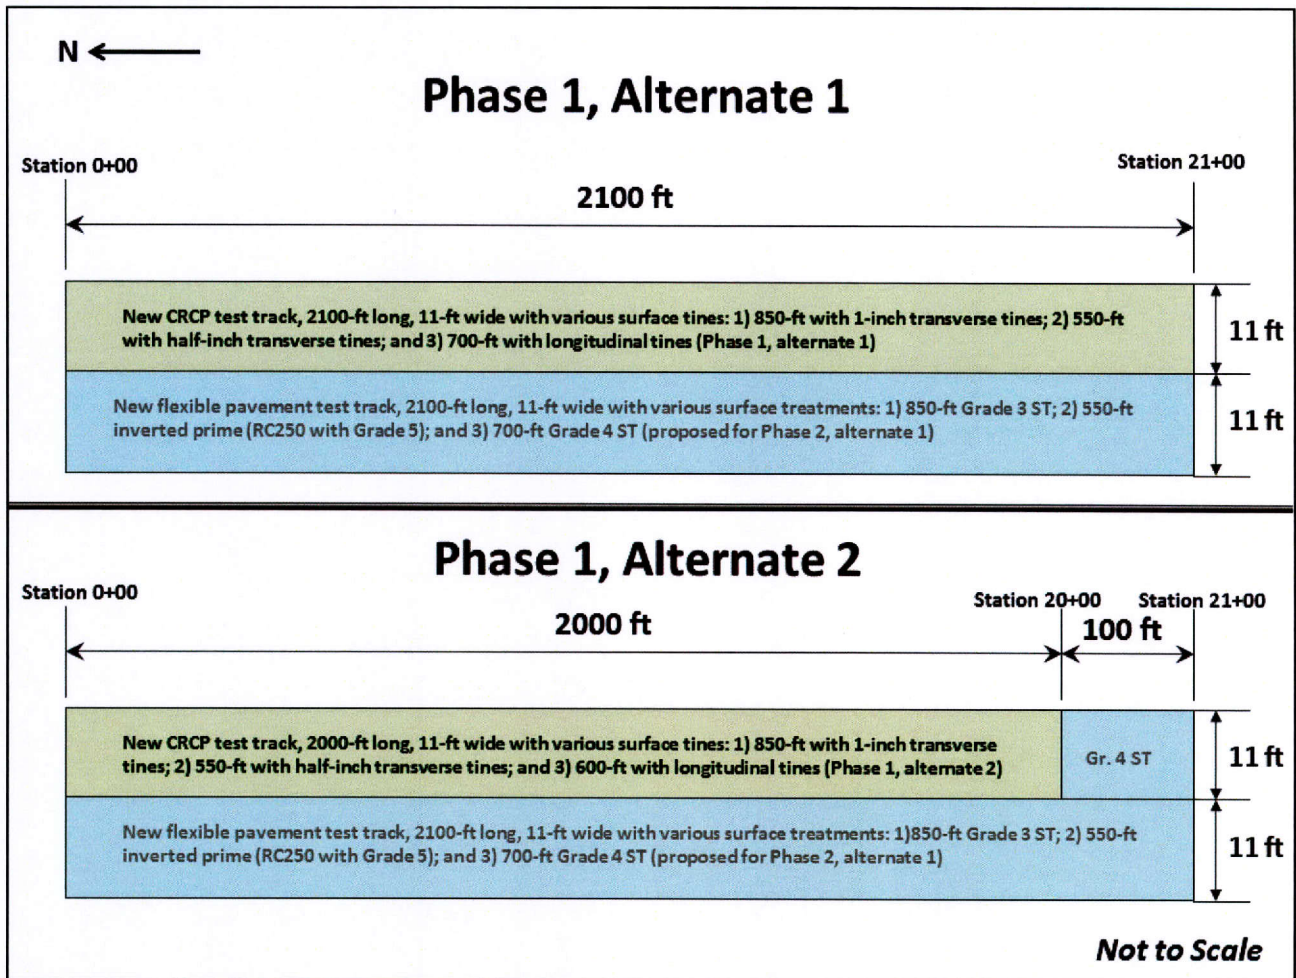
Figure 6. Plan View of Alternates for Construction of CRCP Test Track in Phase 1.

Figure 6 shows the two alternates for constructing the CRCP test track in Phase 1. Figure 7 shows the cross-section for this test track while Figure 8 illustrates the reinforcement details for the slab. Plans and specifications for the Phase 1 construction are presented in this section.

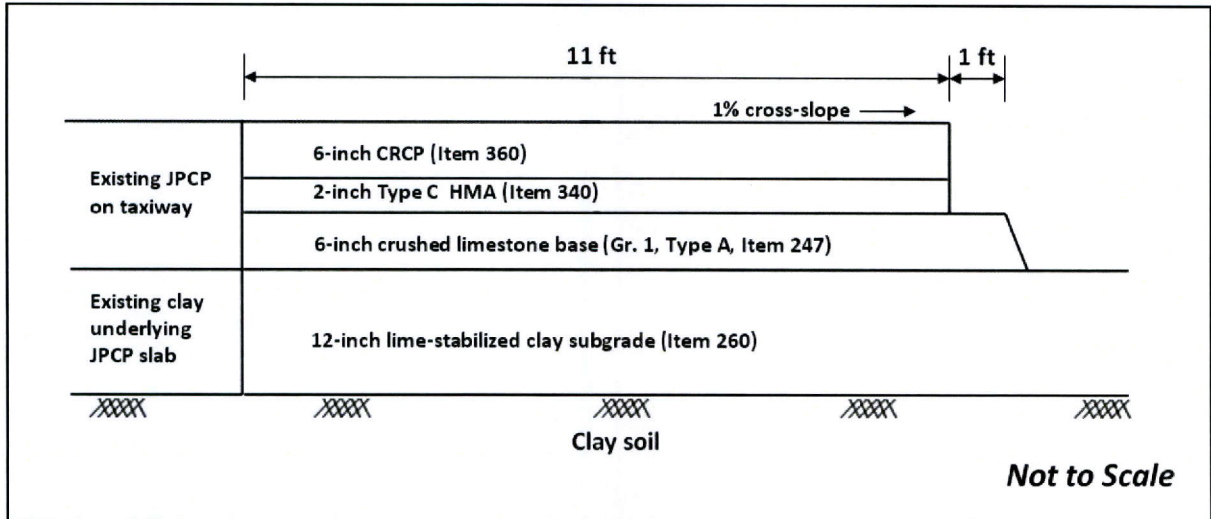
Figure 7. Typical CRCP Cross-Section.

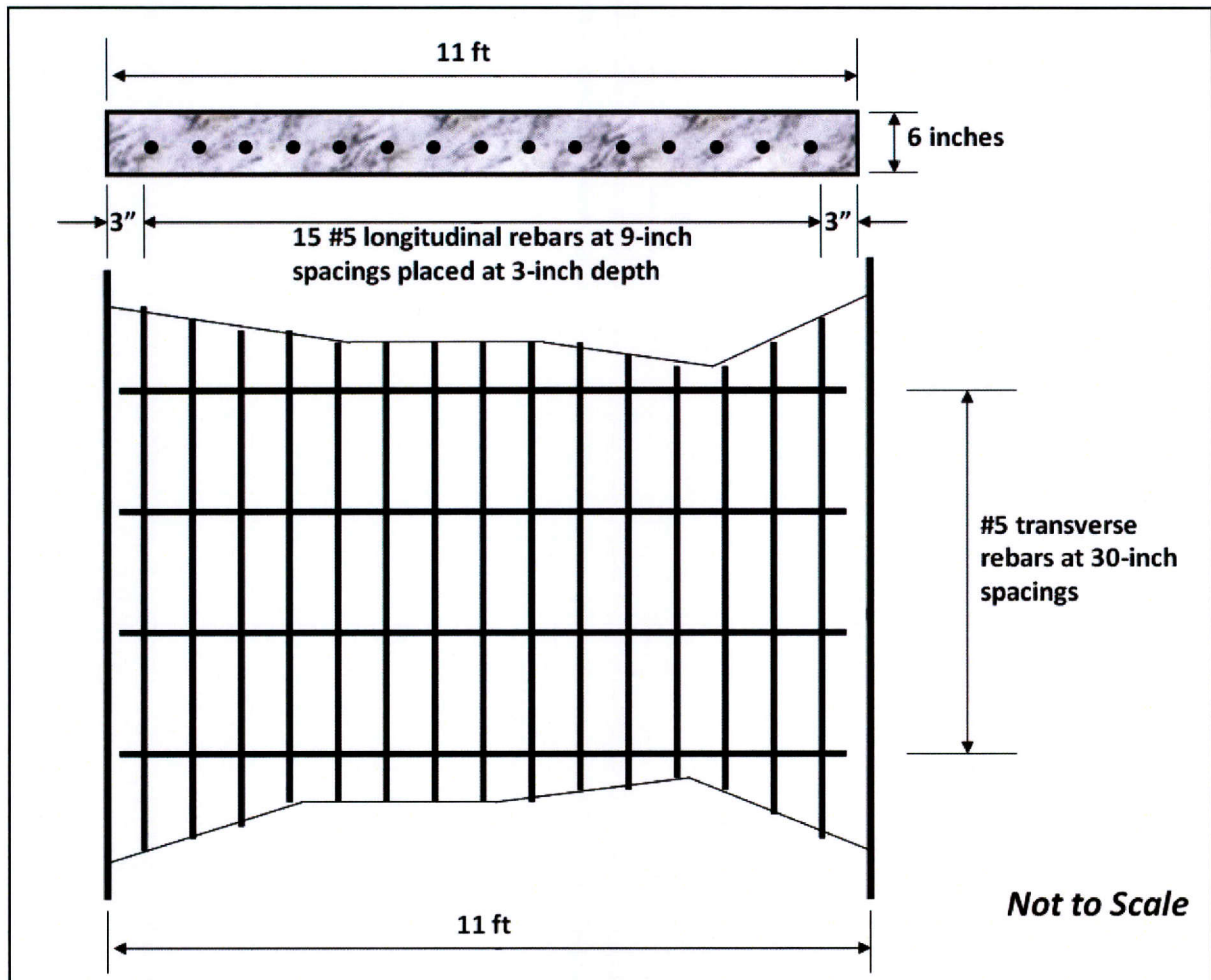
Figure 8. Concrete Slab Reinforcement Details.

Once the forms were in place, the contractor began laying out the CRCP reinforcement according to the details given in Figure 8 of Chapter 3. A TTI technician monitored this work, and verified that the reinforcement was placed according to the plans. Figure 36 shows the reinforcement that the contractor placed before the concrete was poured for the CRCP test track.

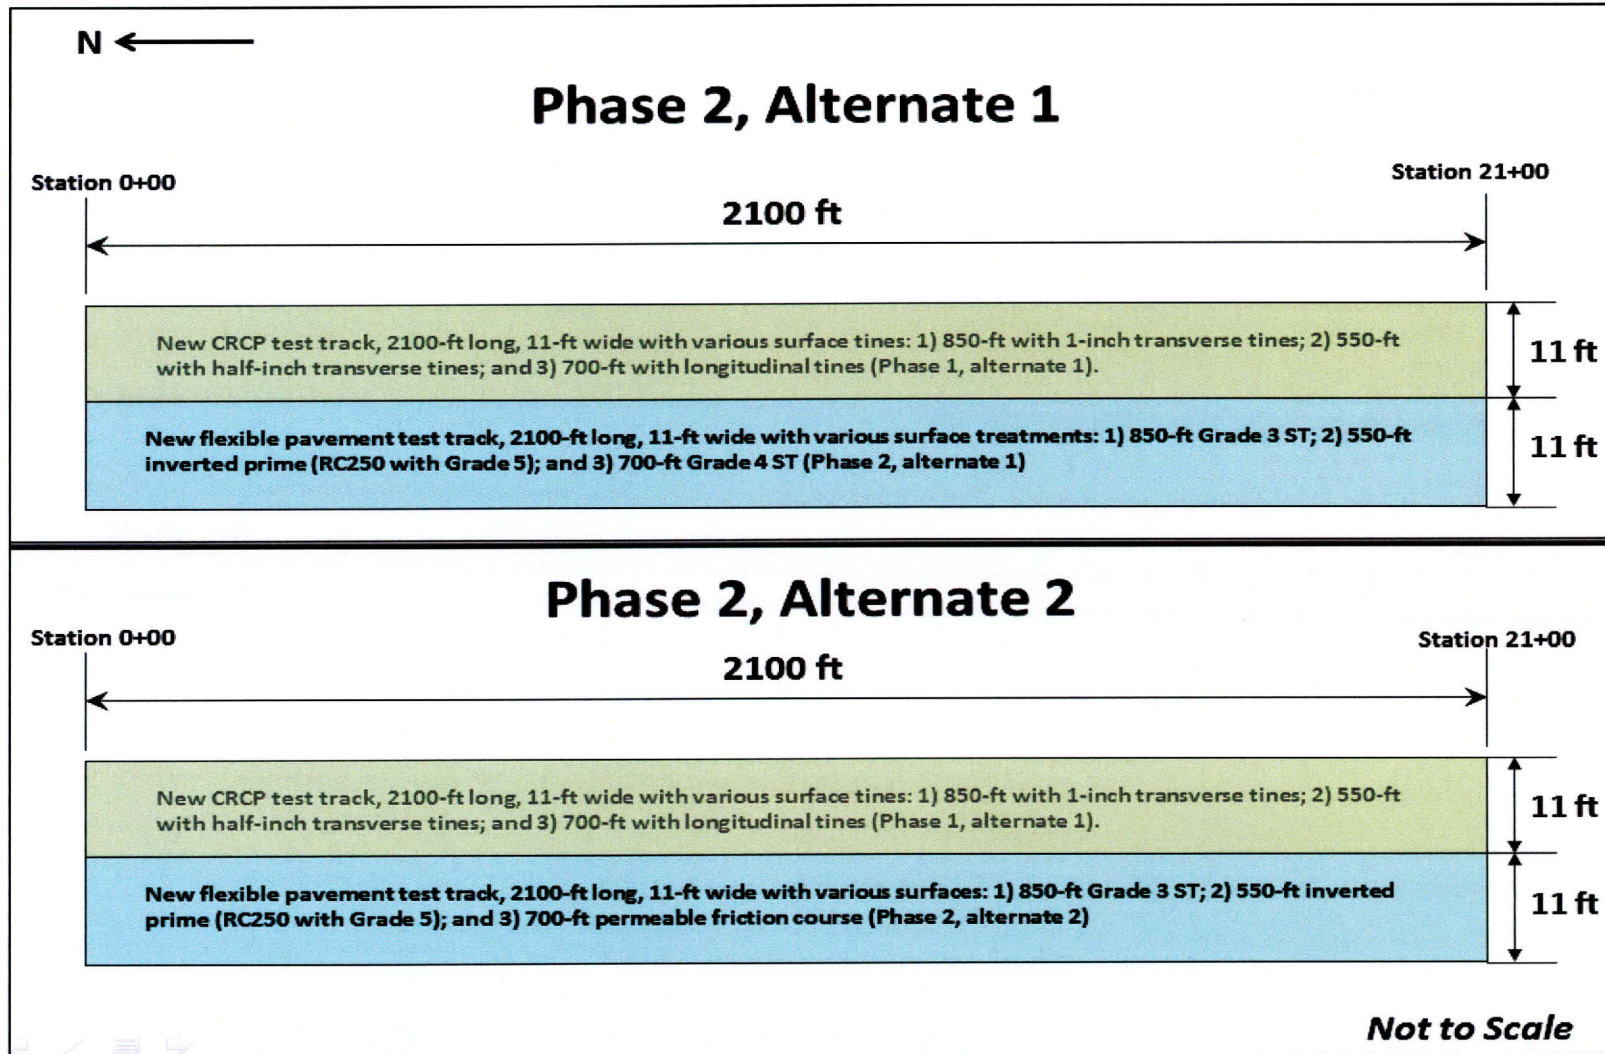
Figure 9. Plan View of Two Alternates for Construction of Flexible Pavement Test Track in Phase 2.

The second alternate, with a PFC section, will be considered only if a 2100-ft CRCP test track is built in Phase 1 (alternate 1). If a 2000-ft CRCP test track is built (Phase 1, alternate 2), the flexible pavement test track will be constructed using alternate 1 in Phase 2 (see Figure 10). The following additional notes are provided to supplement the plans and specifications given in Figures 9 to 15 in connection with the Phase 2 construction of the flexible pavement test track.

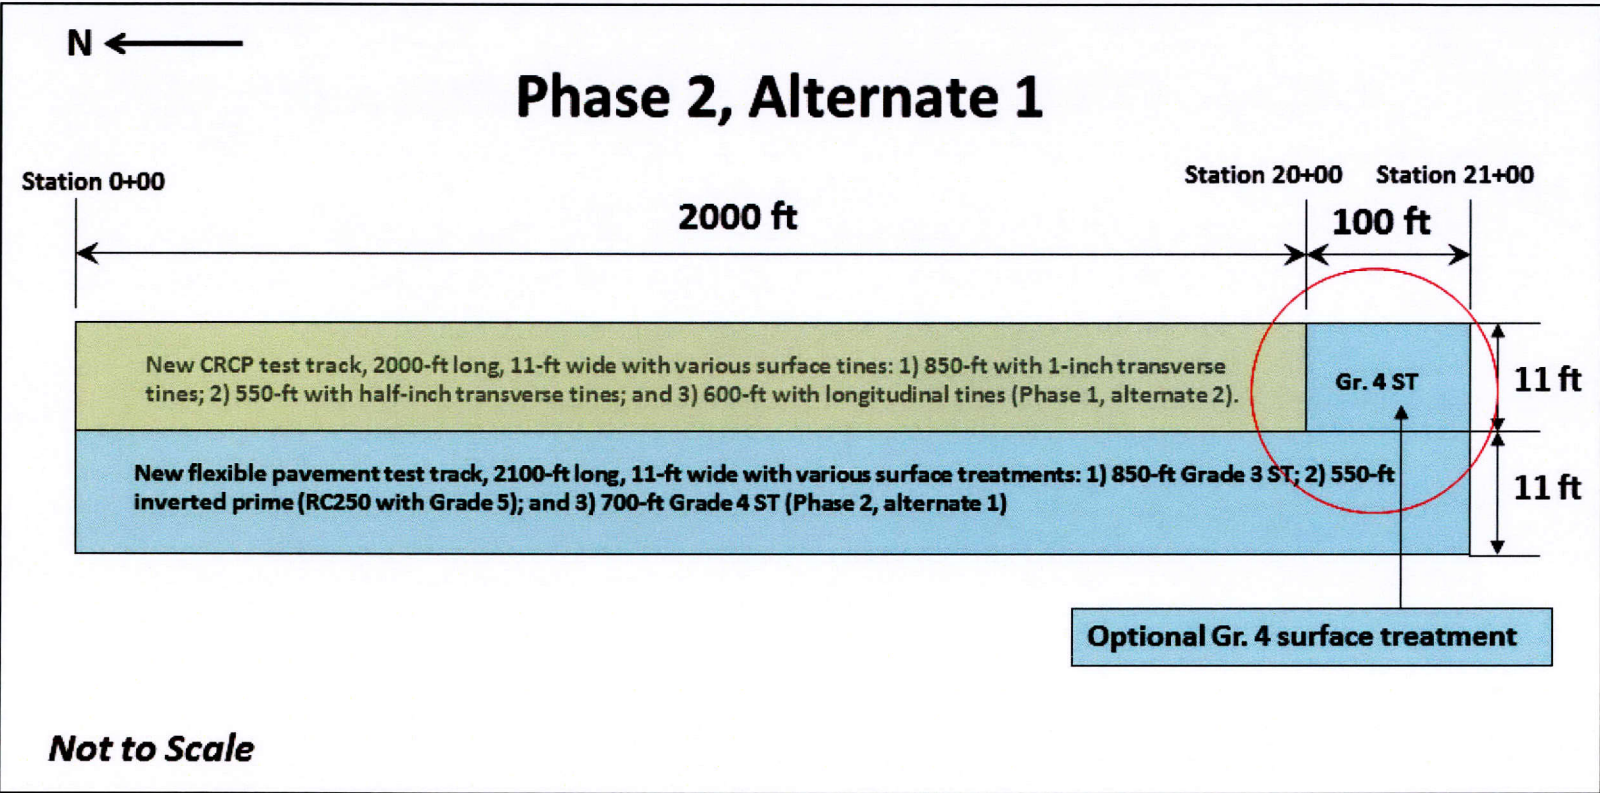
Figure 10. Plan View of Phase 2 Construction of Flexible Pavement Test Track Using Alternate 1, and Construction of Optional Grade 4 Surface Treatment at South End of 2000-ft CRCP Test Track Built under Phase 1, Alternate 2.

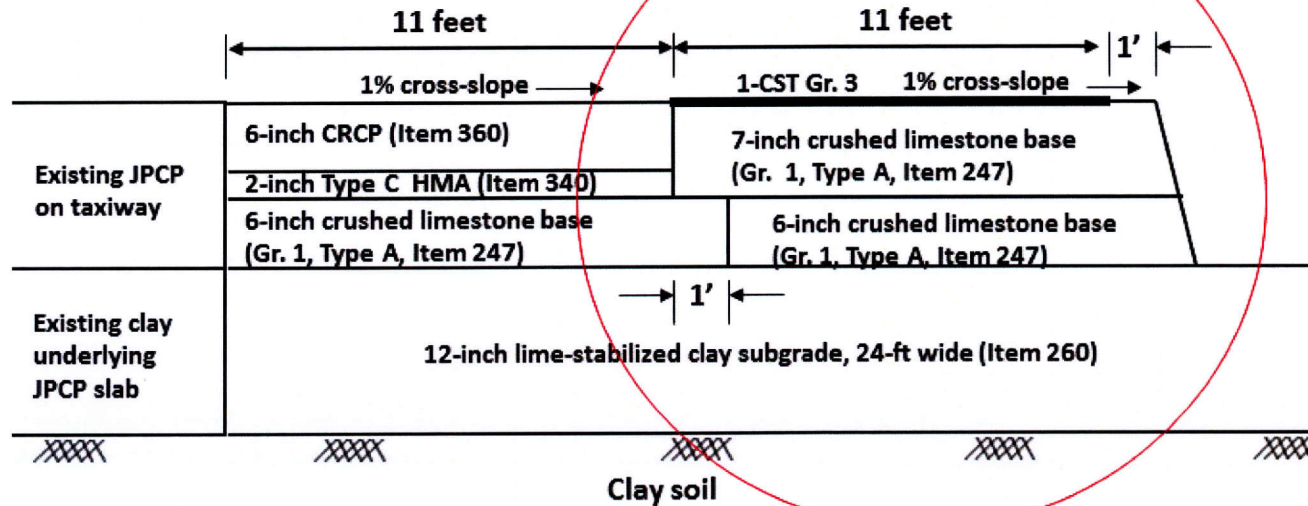
PAVEMENT CROSS-SECTIONS: 00+00 to 08+50

Notes on Placement of Grade 3 Surface Treatment:

Surface Treatment: AC-20-5TR at 0.4 gal/yd² with Grade 3 aggregate PB or PL at 95 yd²/yd³.

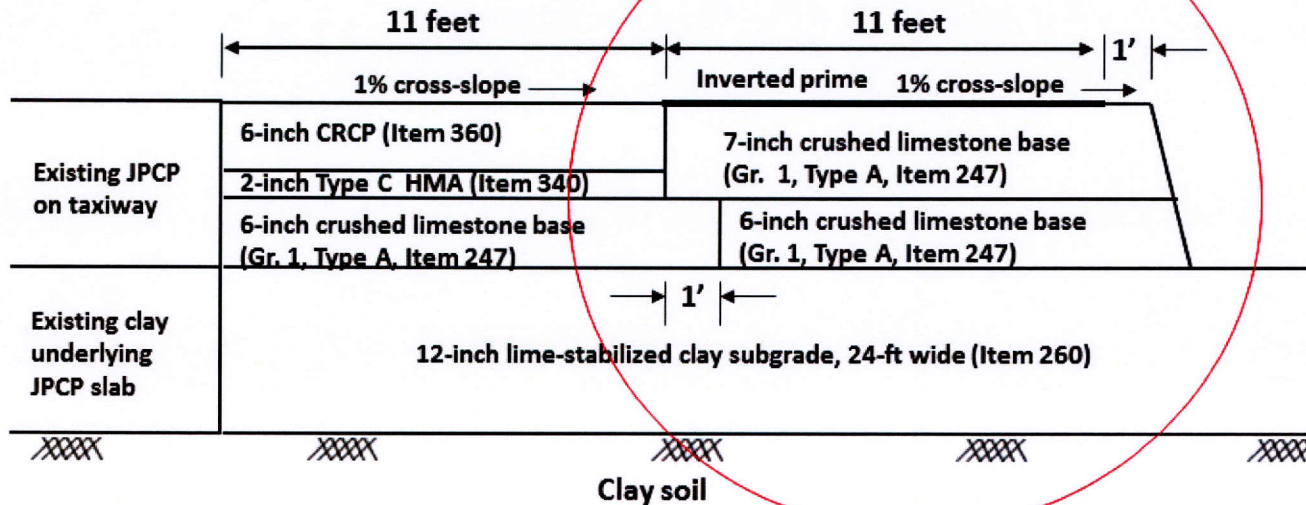
PAVEMENT CROSS-SECTIONS: 08+50 to 14+00

Notes on Placement of Inverted Prime:

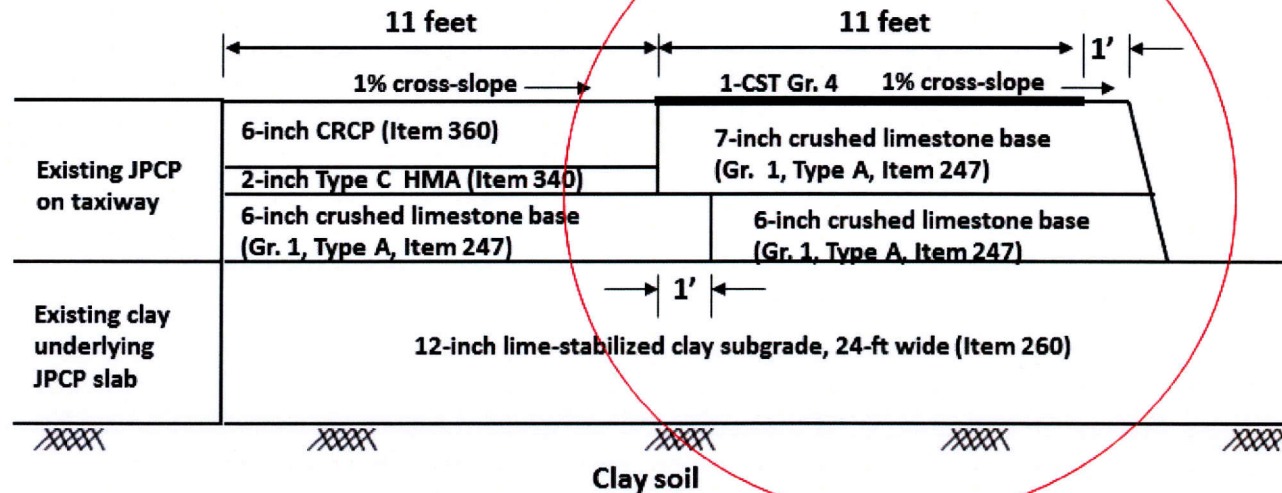
PAVEMENT CROSS-SECTIONS: 14+00 to 21+00

Notes on Placement of Grade 4 Surface Treatment:

Surface Treatment: AC-20-5TR at 0.4 gal/yd² with Grade 4 aggregate PB or PL at 125 yd²/yd³.

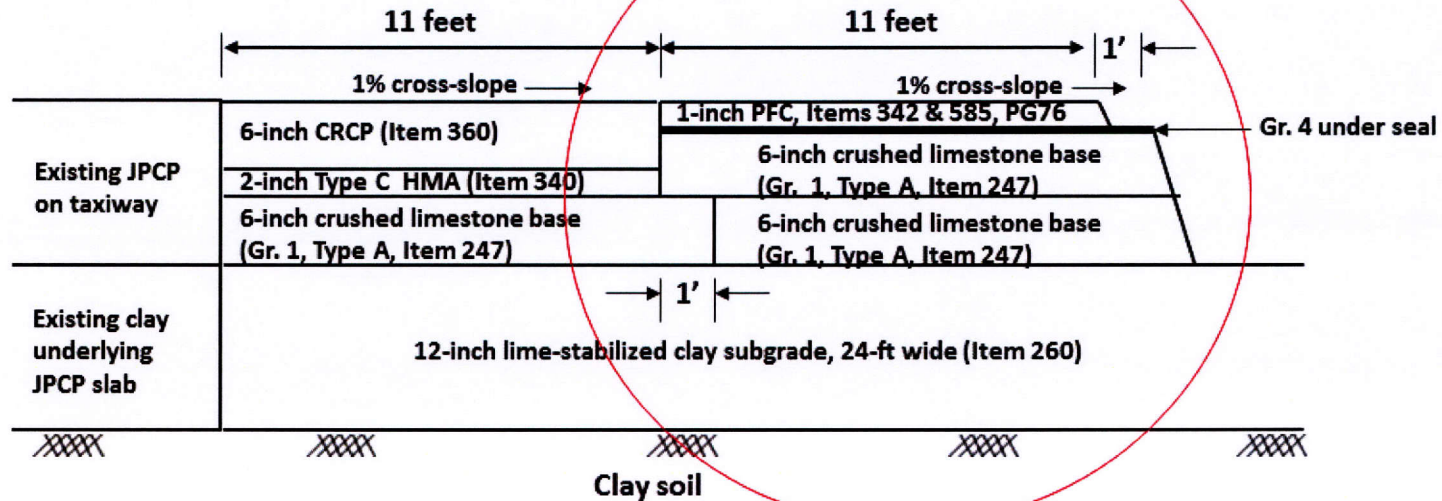
PAVEMENT CROSS-SECTIONS: 14+00 to 21+00

Notes on Placement of Grade 4 Under Seal beneath PFC:

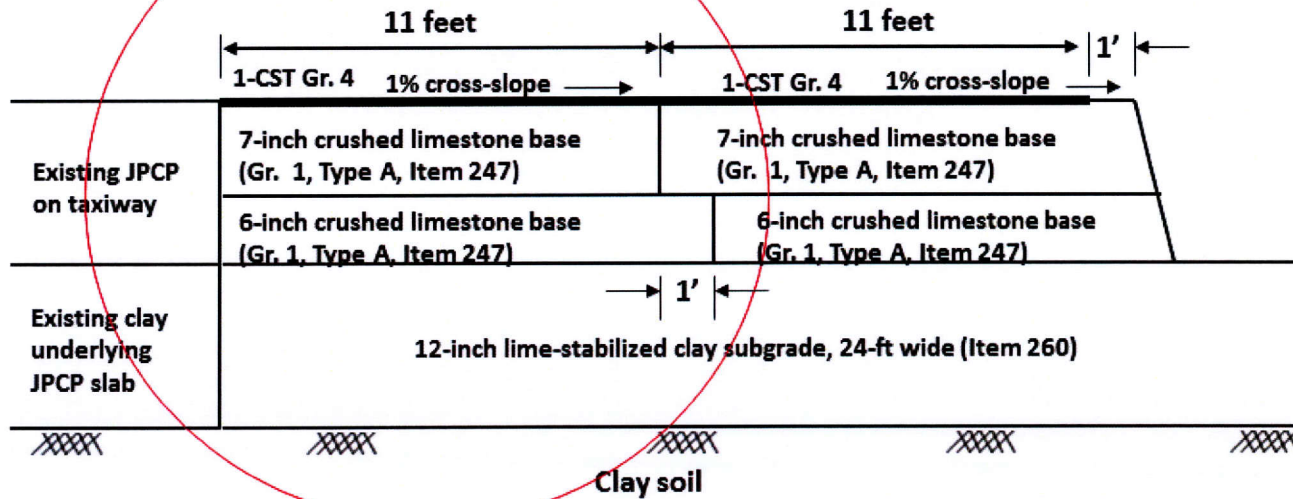
PAVEMENT CROSS-SECTIONS: 20+00 to 21+00

Notes on Placement of Grade 4 Surface Treatment at south end of CRCP Test Track:
 Surface Treatment: AC-20-5TR at 0.4 gal/yd² with Grade 4 aggregate PB or PL at 125 yd²/yd³.
 Material specification Items 300 & 302.
 Construction specification Item 316.

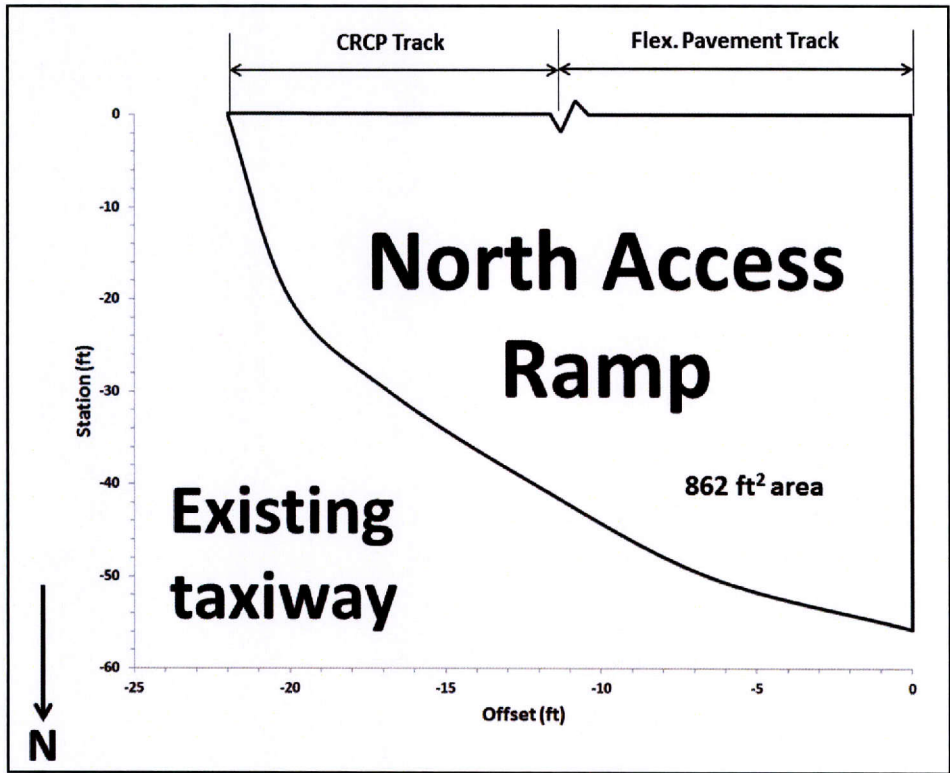
Figure 16. North Access Ramp for Test Tracks.

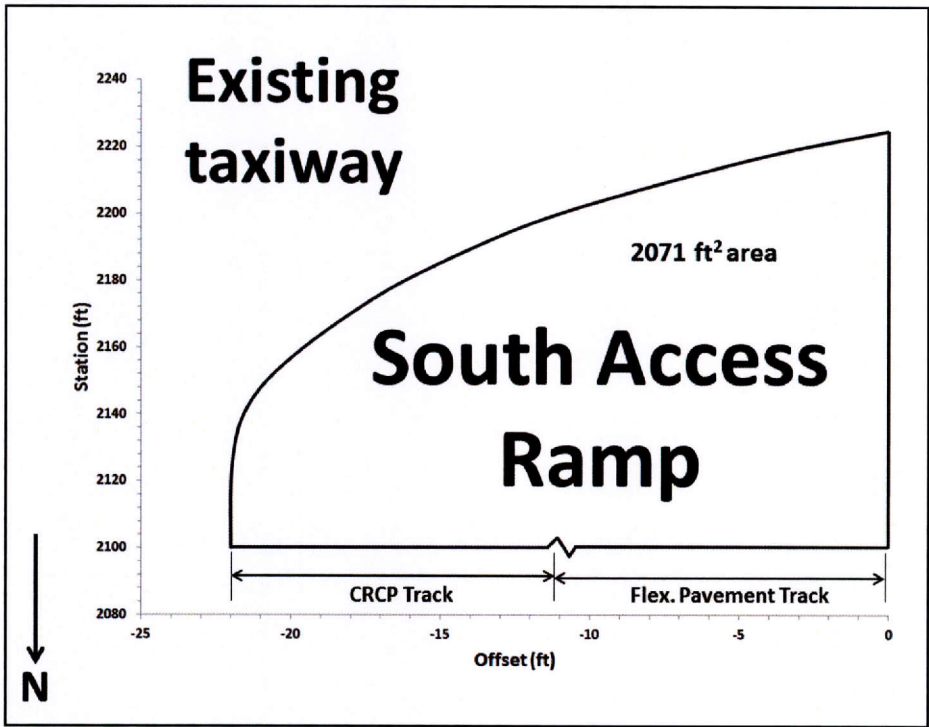
Figure 17. South Access Ramp for Test Tracks.

3-S2b	Lime stabilize existing soil 12-inch deep within the 2071 ft ² South Access Ramp area shown in Figure 14.
3-S3b	Place Grade 1 Type A flexible base in two 6-inch lifts within the South Access Ramp area.
3-S4b	Place the Grade 4 over Grade 3 two-course surface treatment within the South Access Ramp area.

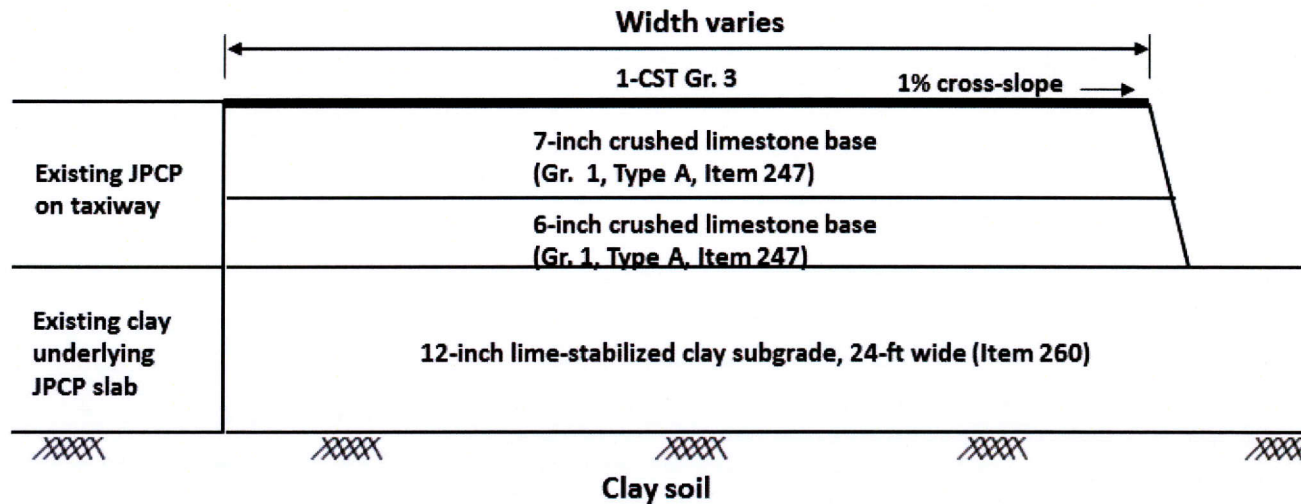
NORTH ACCESS RAMP TYPICAL CROSS-SECTION

Notes on Placement of Grade 3 Surface Treatment at North Access Ramp:
 Surface Treatment: AC-20-5TR at 0.4 gal/yd² with Grade 3 aggregate PB or PL at 95 yd²/yd³.
 Material specification Items 300 & 302.
 Construction specification Item 316.

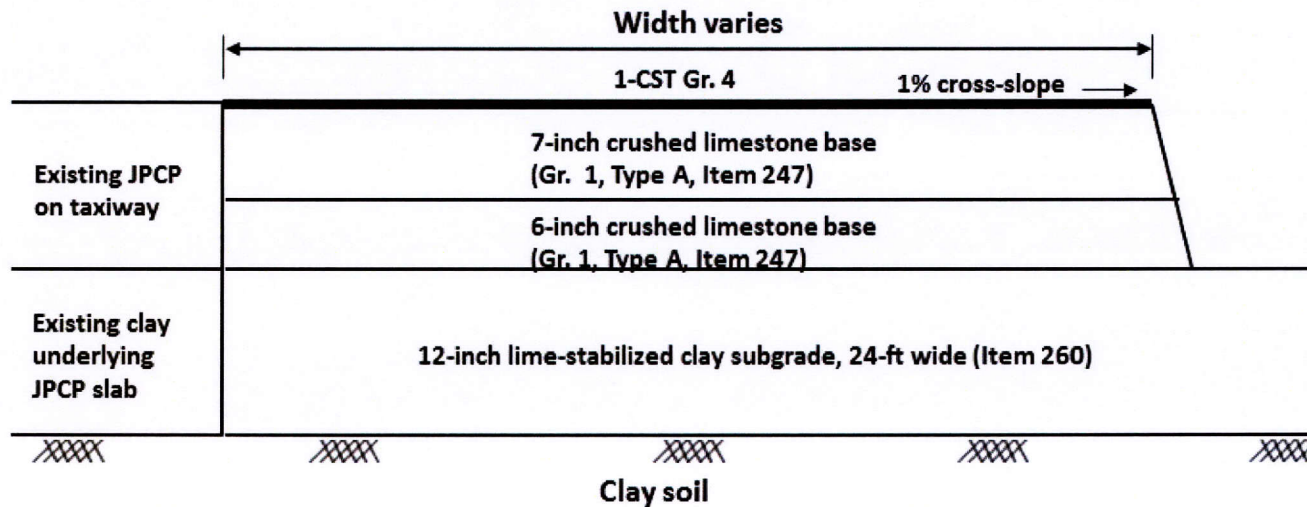
SOUTH ACCESS RAMP TYPICAL CROSS-SECTION (ALT. 1)

Notes on Placement of Grade 4 Surface Treatment at South Access Ramp (alt. 1):
 Surface Treatment: AC-20-5TR at 0.4 gal/yd² with Grade 4 aggregate PB or PL at 125 yd²/yd³.
 Material specification Items 300 & 302.
 Construction specification Item 316.

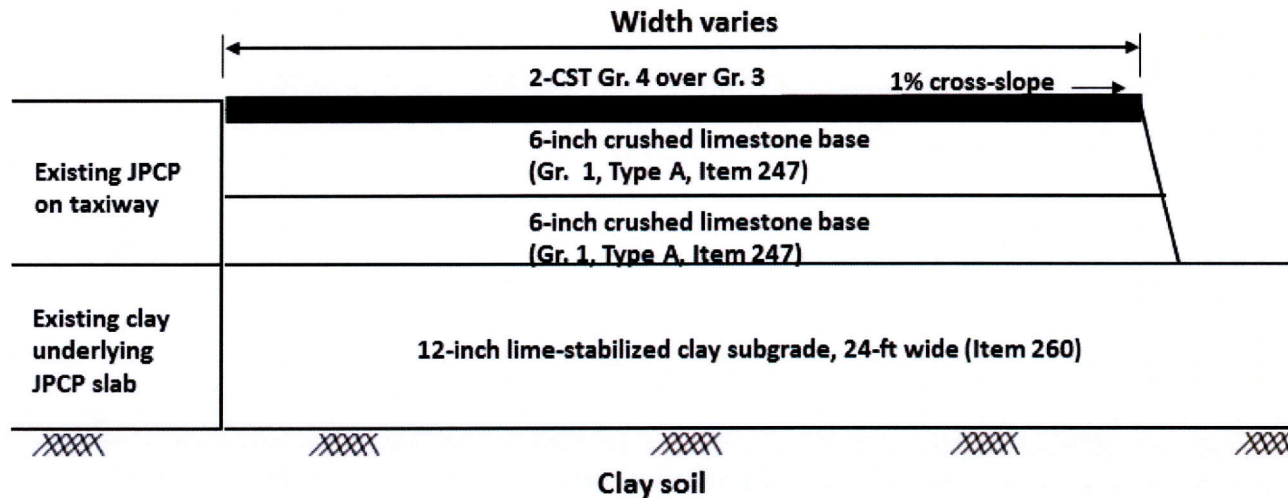
SOUTH ACCESS RAMP TYPICAL CROSS-SECTION (ALT. 2)

Notes on Placement of 2-CST Gr. 4 over Gr. 3 Surface Treatment at South Access Ramp (alt. 2):

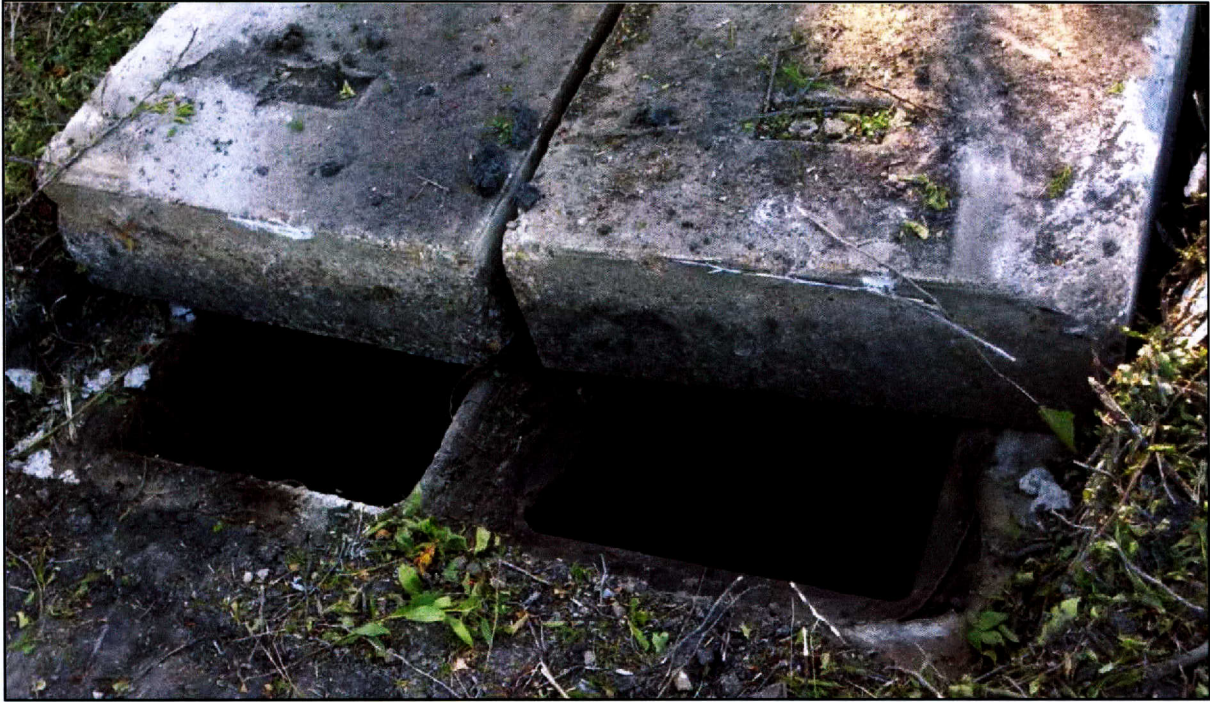
Figure 23. Utility Box Found within Construction Site.

In addition, other items required special attention. One such item was an old utility box found at around station 1+50 after the contractor cleared the site of vegetation. This utility box, illustrated in Figure 23, contained cables that might have been used for power or communication at a time when the Riverside Campus was an active U.S. Army airfield base. The contractor removed the utility box and filled the hole after TTI Facilities ascertained with Texas A&M's Utilities and Energy Management (UEM) that this action can be taken.

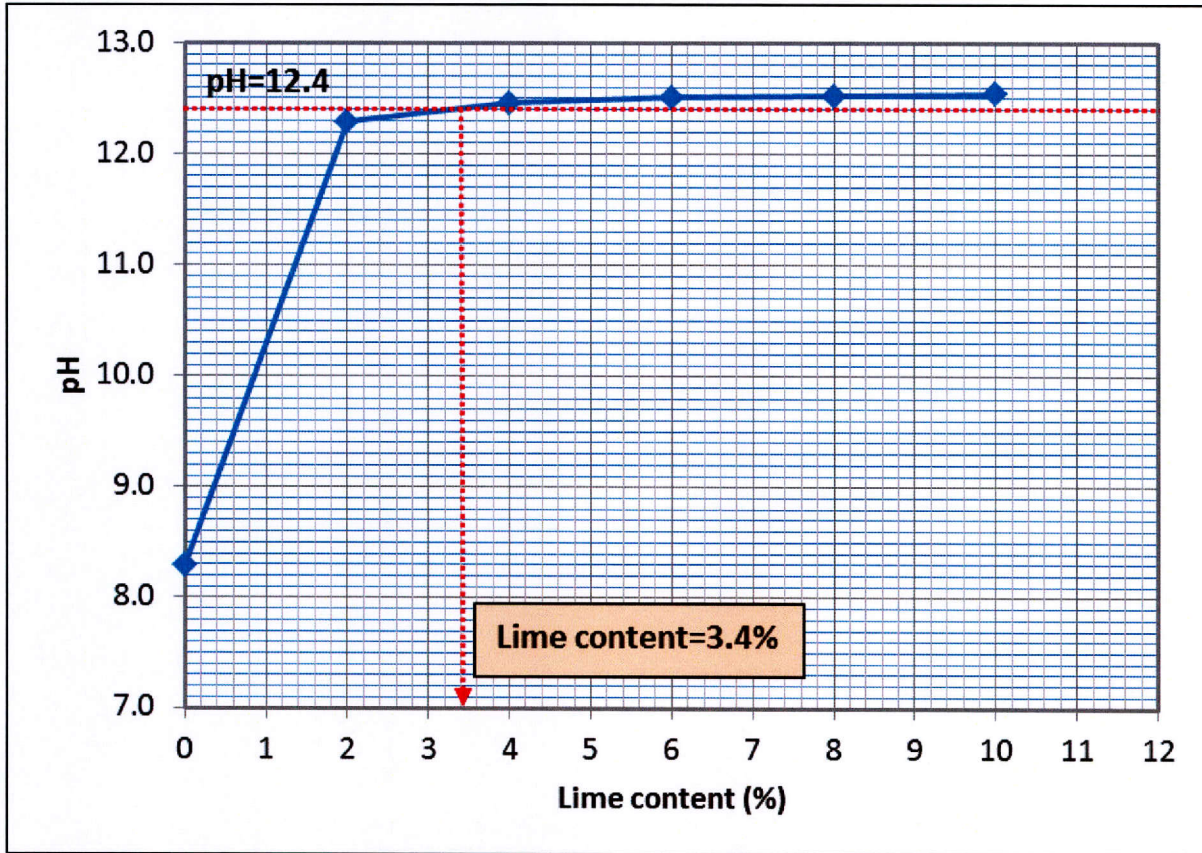
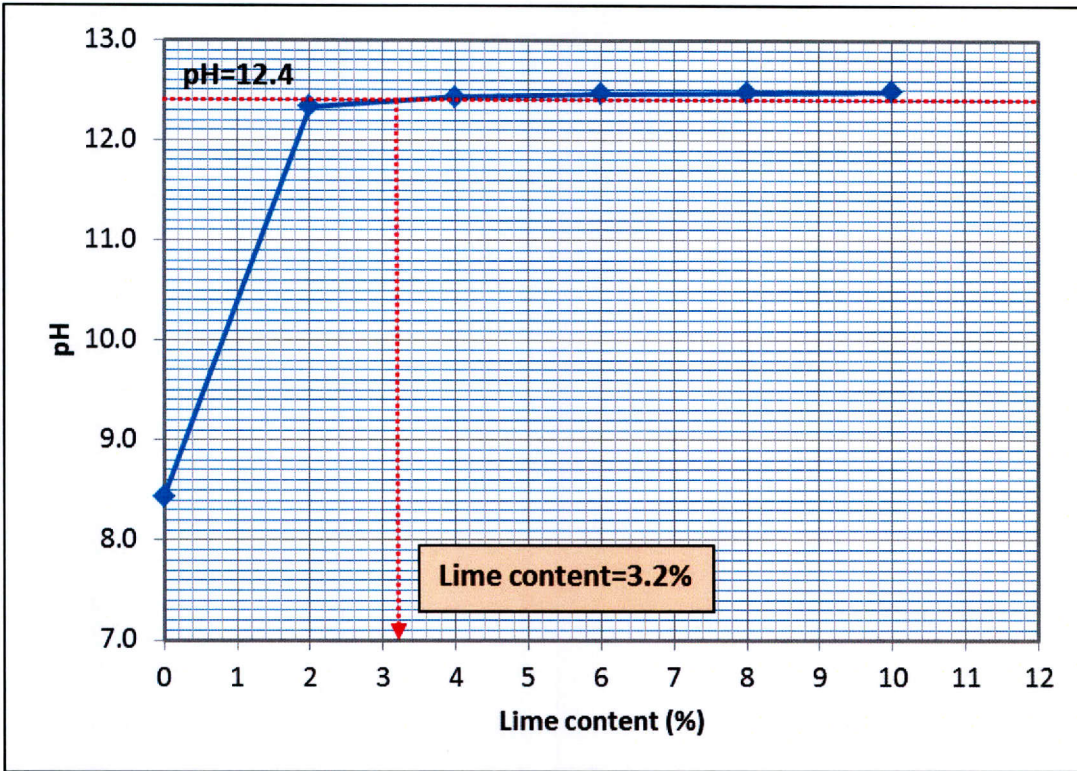
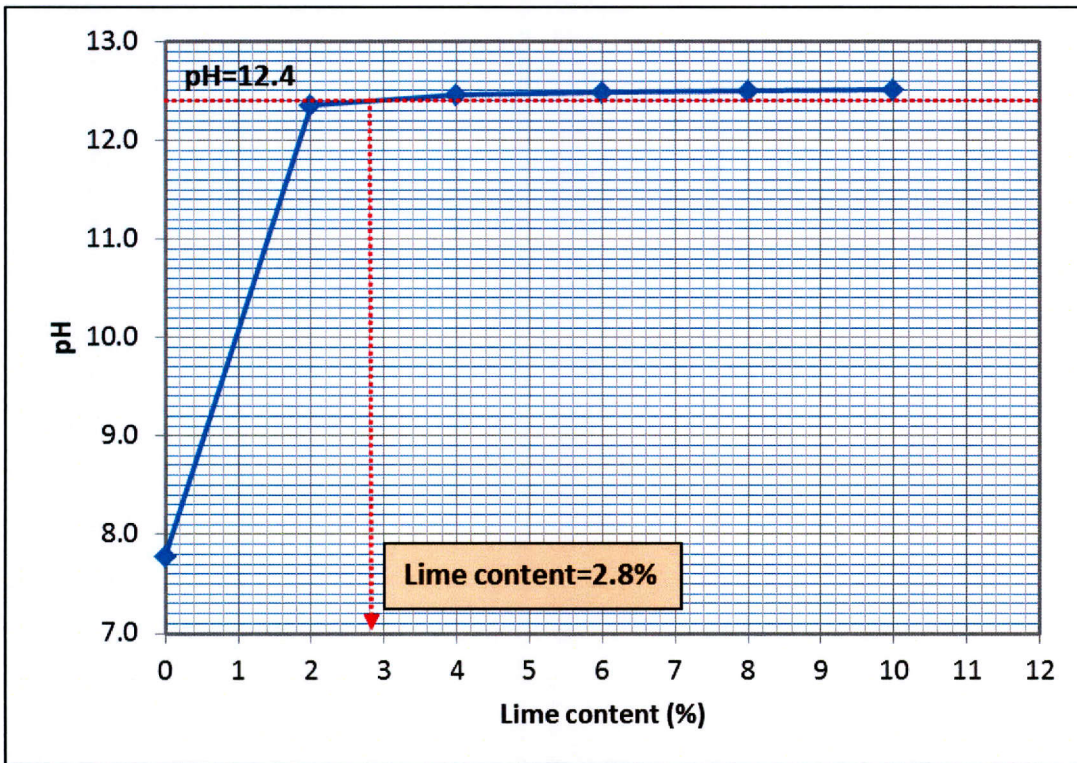
Figure 24. Tex-121-E Test Results Using Clay Samples from Station 4+25.

Figure 25. Tex-121-E Test Results Using Clay Samples from Station 11+25.

Figure 26. Tex-121-E Test Results Using Clay Samples from Station 17+50.

TTI technicians used Part III of TxDOT Test Method Tex-121-E to determine the minimum lime content for stabilizing the clay soil at the construction site. This test is based on determining the minimum percent of lime needed for the soil-lime mixture to attain a pH of 12.4 at which cation exchange occurs. TTI technicians ran tests on samples of the clay material taken at three different locations along the site. From these tests, the minimum lime content was found to vary from 2.8 to

3.4 percent (see Figures 24 to 26). Based on these results, the contractor decided to use 4 percent lime to stabilize the clay soil, requiring about 117 tons of pebble quicklime.

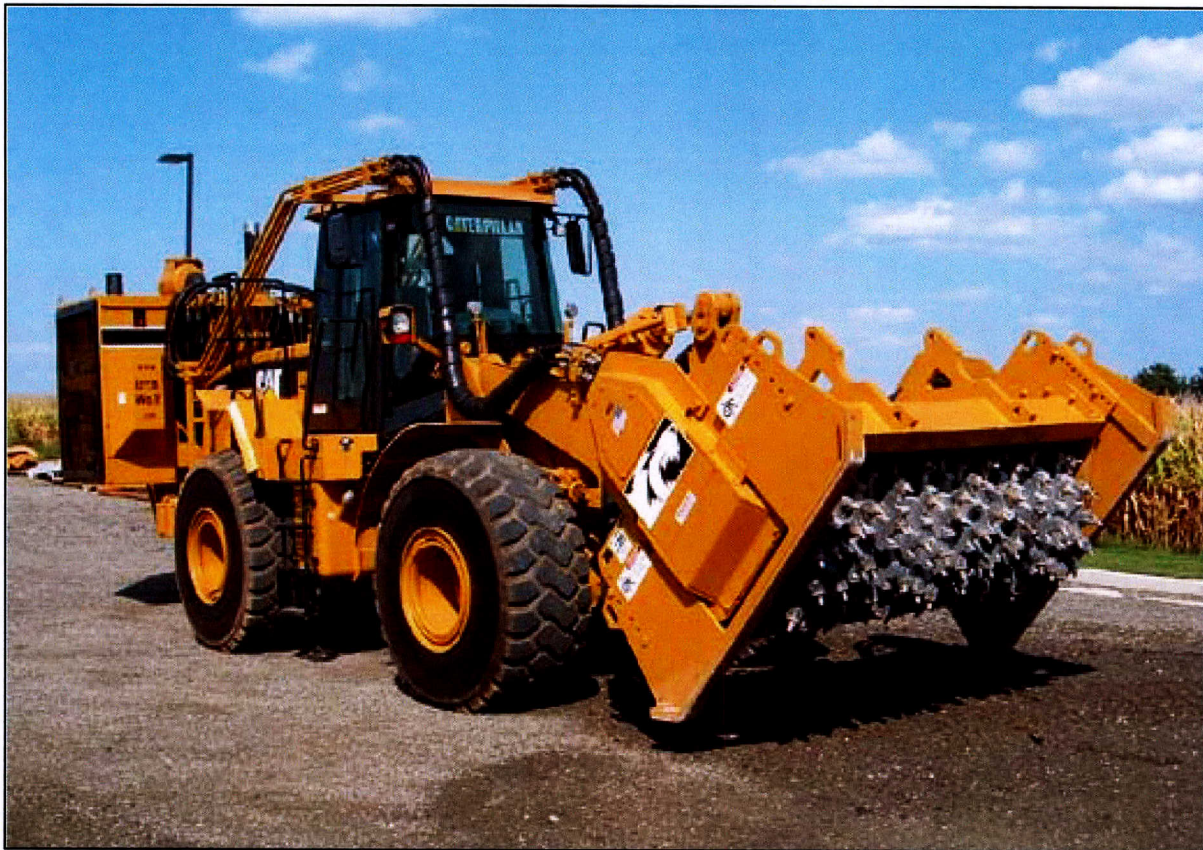
Figure 27. Equipment Used to Mix Soil with Lime.

Pneumatic tanker trailers delivered the lime in windrows. The contractor then used a motor grader to spread pebble quicklime on the surface of the subgrade to be stabilized. Water was then added to hydrate the lime. The contractor then started mixing the soil with lime using a Caterpillar SS250 soil stabilizer. During this process, the contractor added water as necessary to achieve complete hydration and thorough mixing of the soil, water, and lime. Figure 27 illustrates the type of mixer that he used.
