Construction of New Profiler Certification Tracks

Technical Report 5-9047-01-1

TEXAS A&M TRANSPORTATION INSTITUTE
COLLEGE STATION, TEXAS

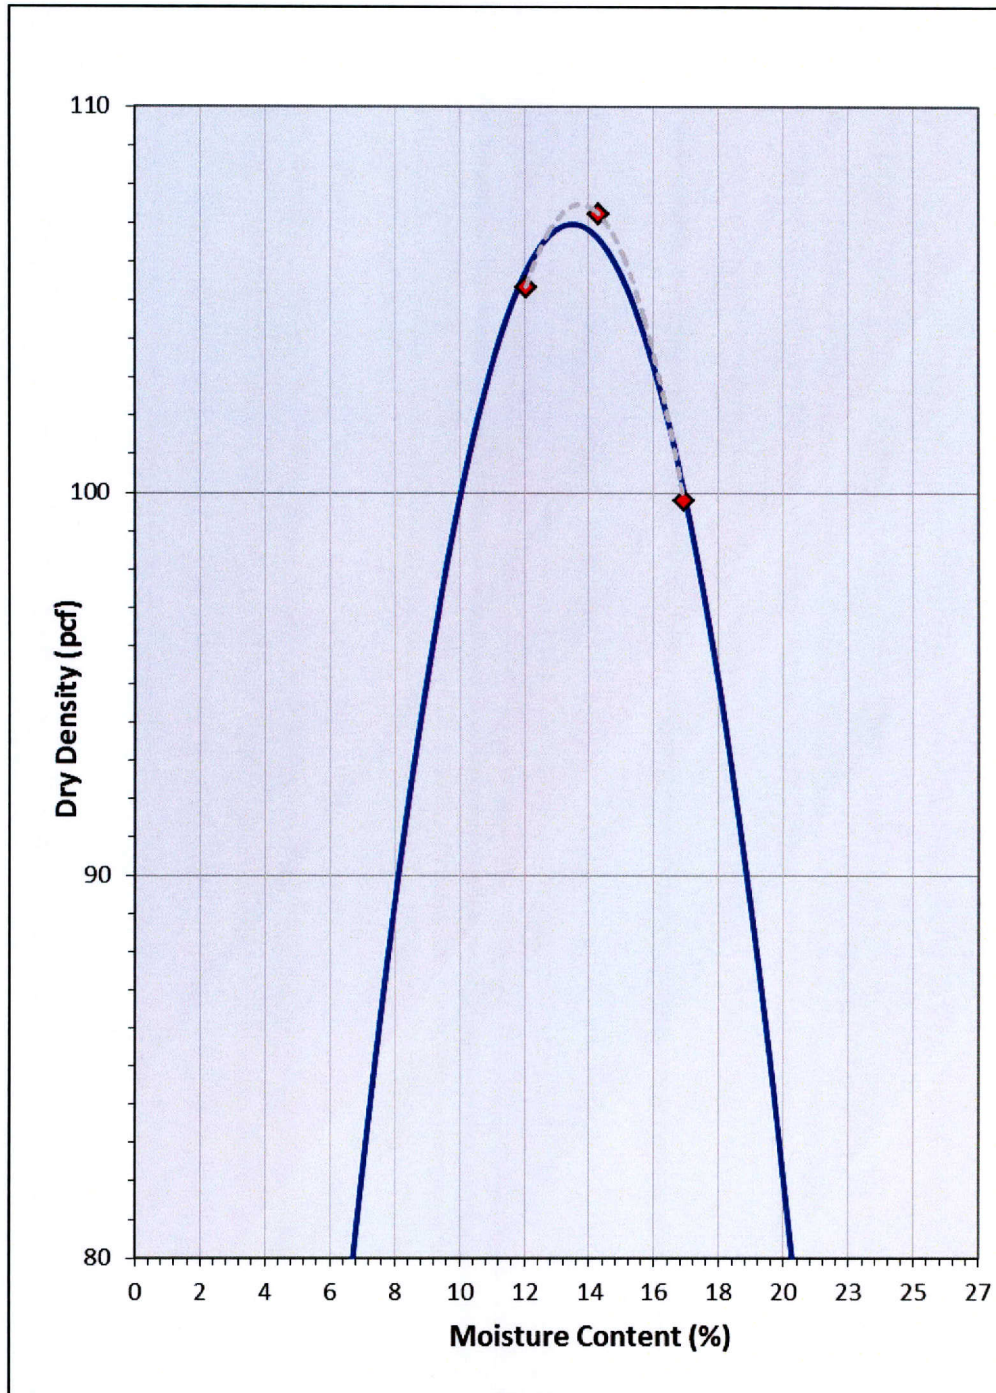
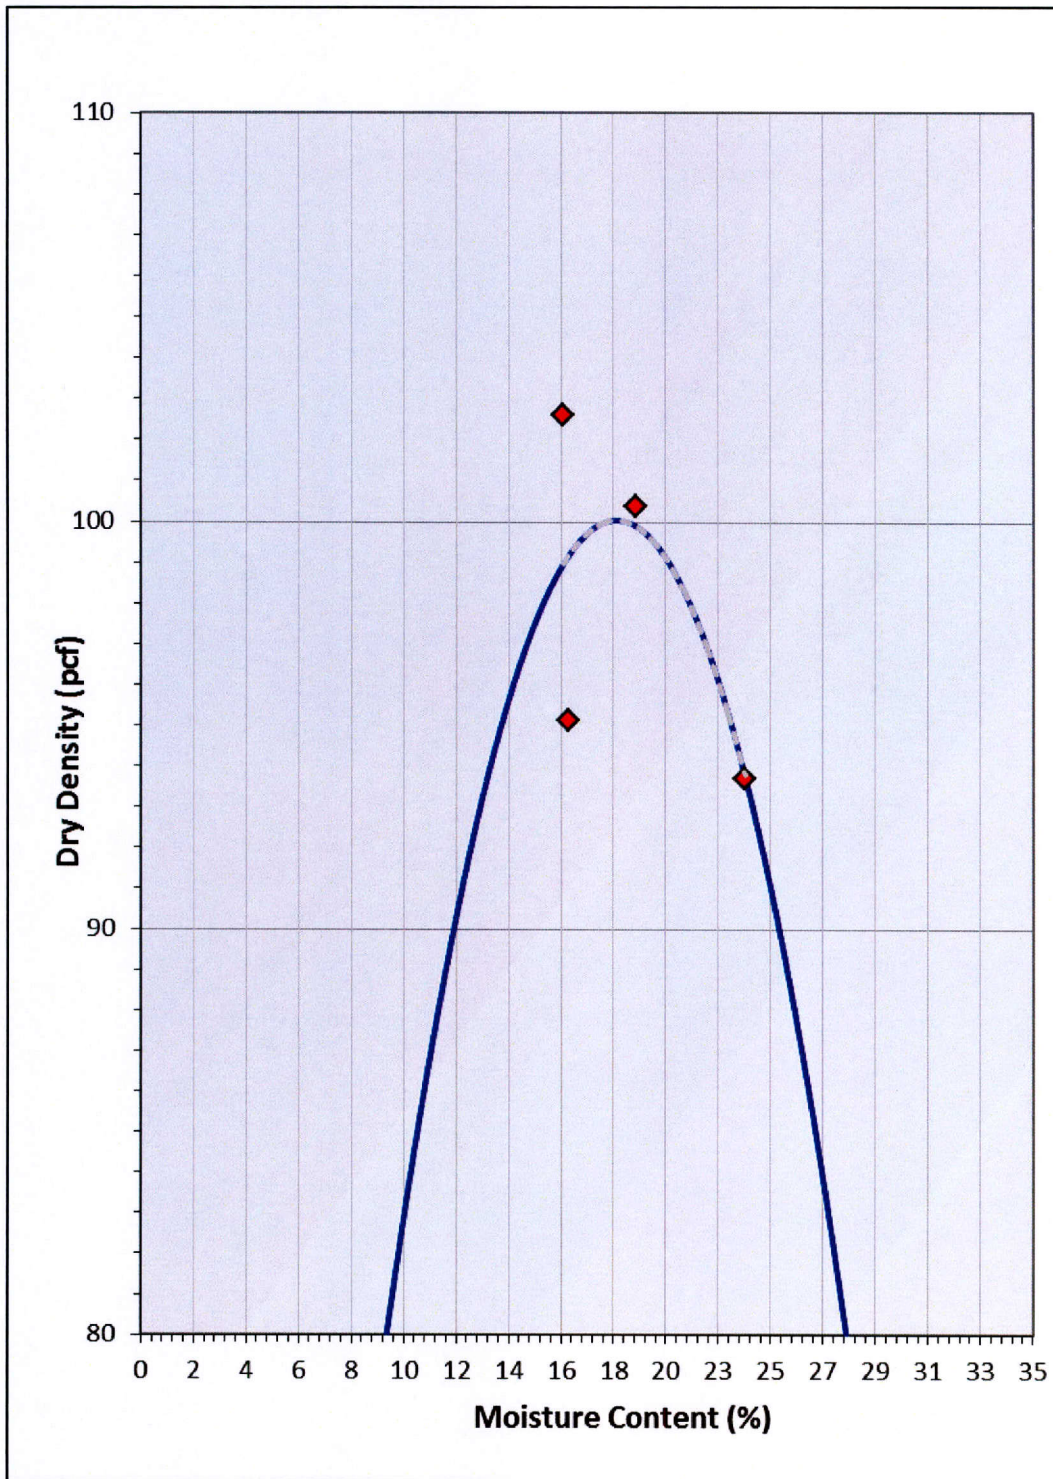
Figure 28. Moisture-Density Curve for Soil-Lime Mixture Sampled at Station 2+00.

Figure 29. Moisture-Density Curve for Soil-Lime Mixture Sampled at Station 12+00.

different locations to determine the moisture-density curves shown in Figure 28 and Figure 29. The corresponding maximum densities were then used to check the level of compaction achieved at different stations along the job site. Table 6 summarizes the results from these density tests. As shown, the contractor met the density required in the plans.

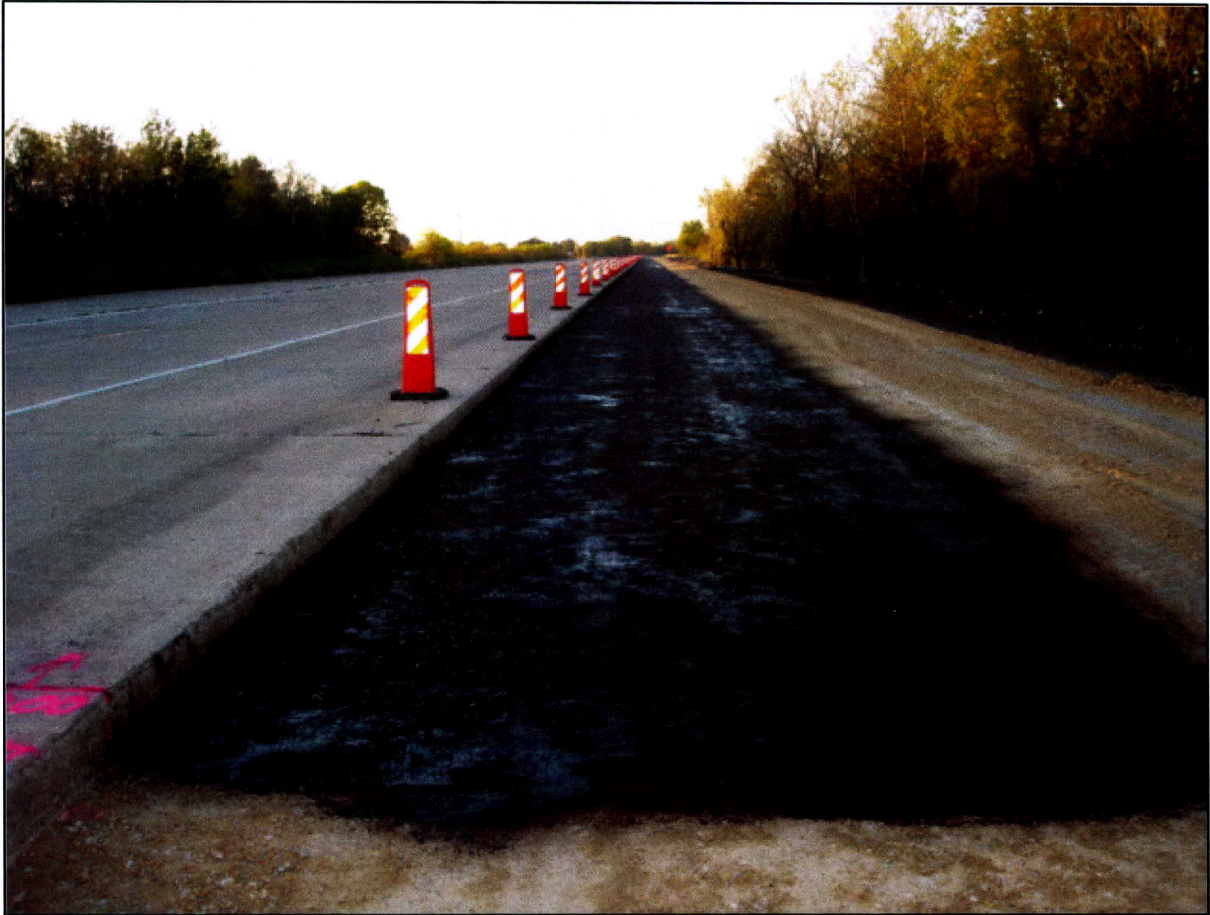
Figure 30. Tack Coat Applied to Flexible Base.

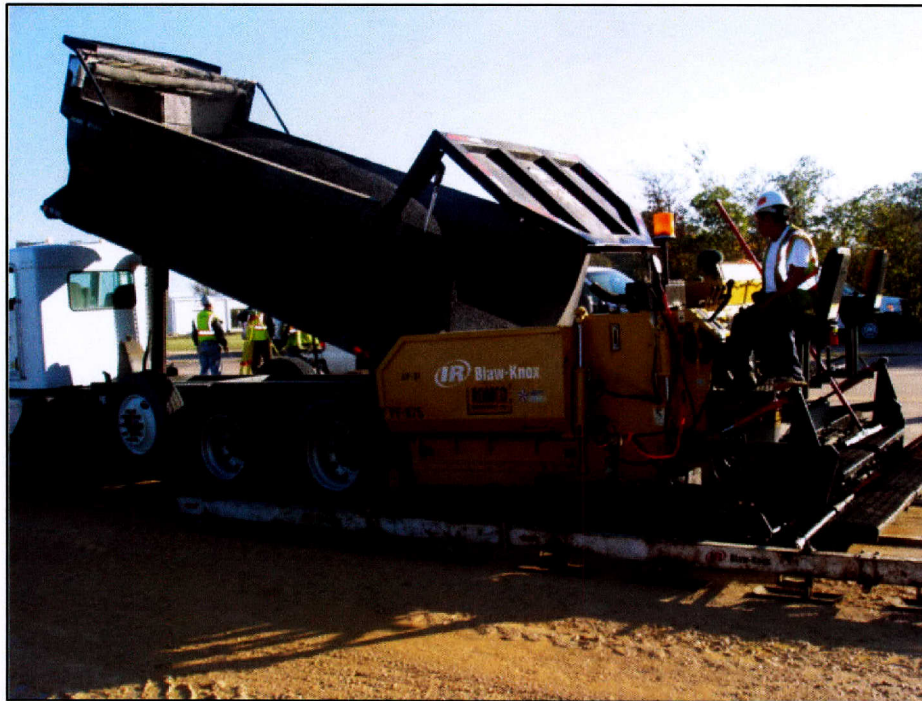
Figure 31. Paving Machine Used to Place Type C Mix.

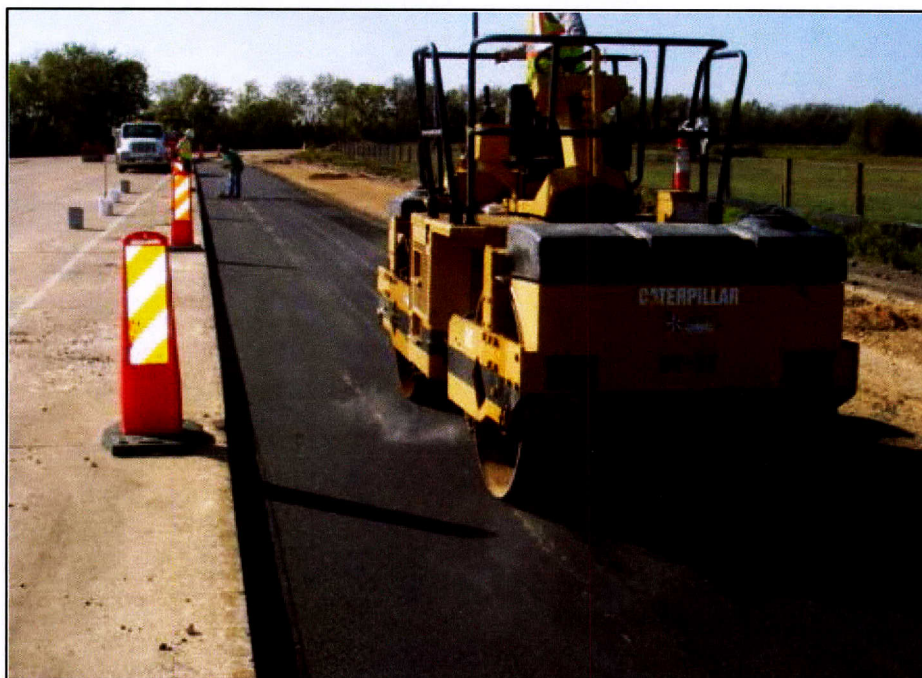
Figure 32. Steel Wheel Roller Used to Compact Type C Mix.

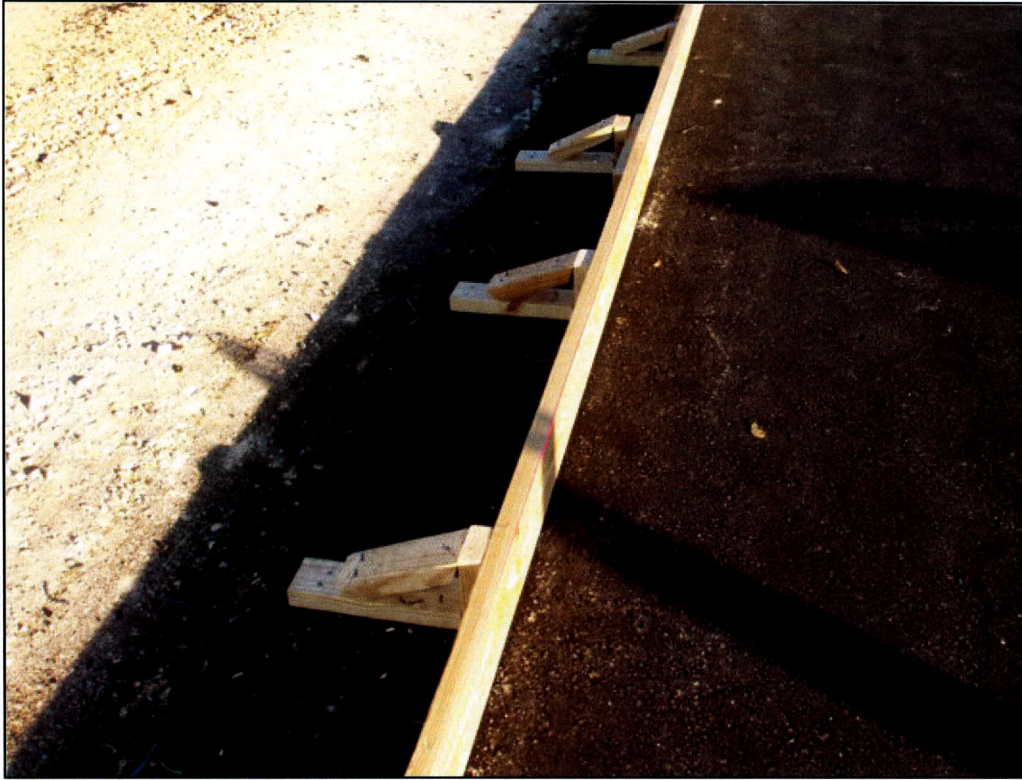
Figure 33. Form along West Side of Type C Base to Place CRCP.

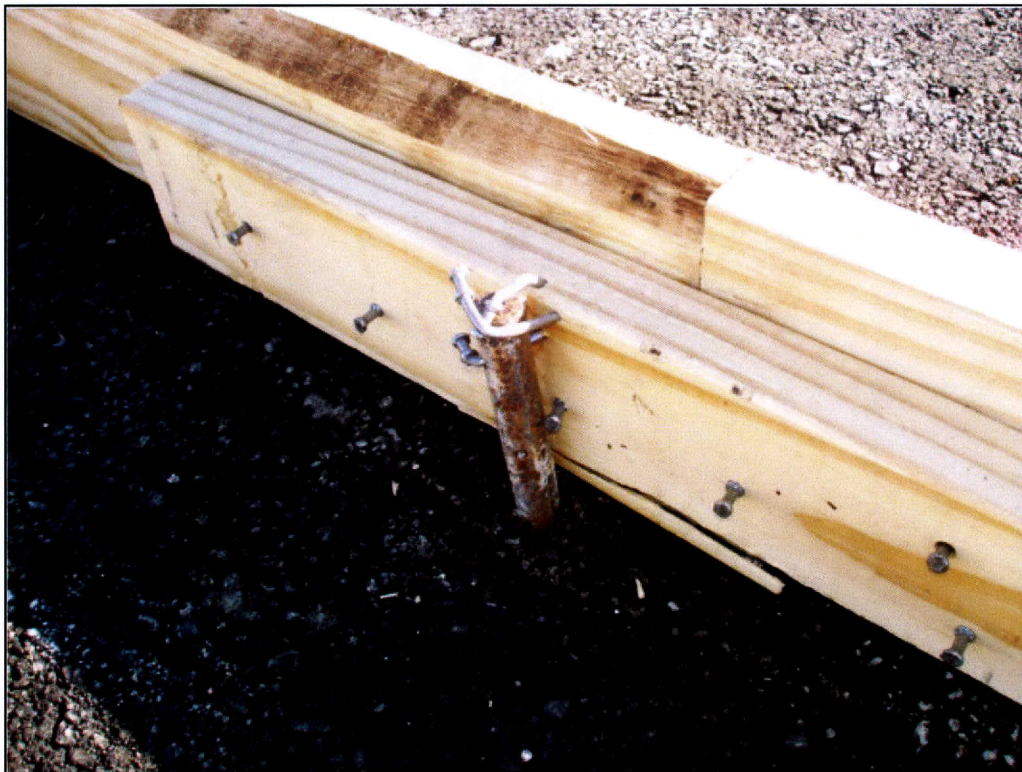
Figure 34. Joint between Form Segments on West Side of Type C Base.

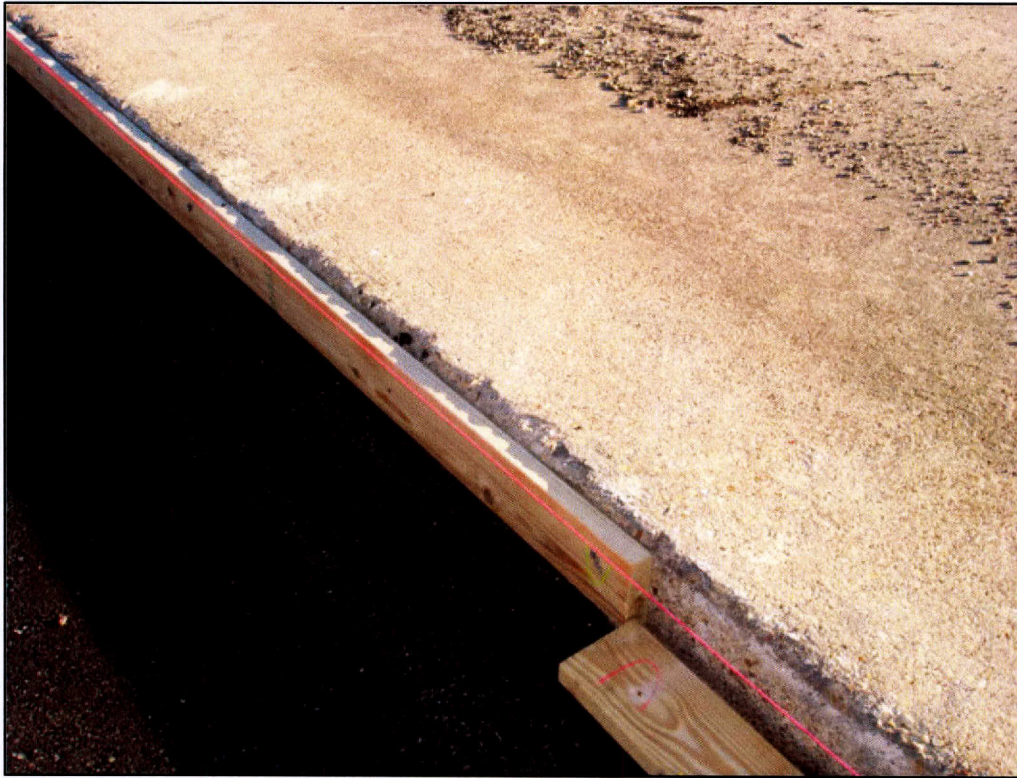
Figure 35. Placement of Form along East Side of Type C Base.

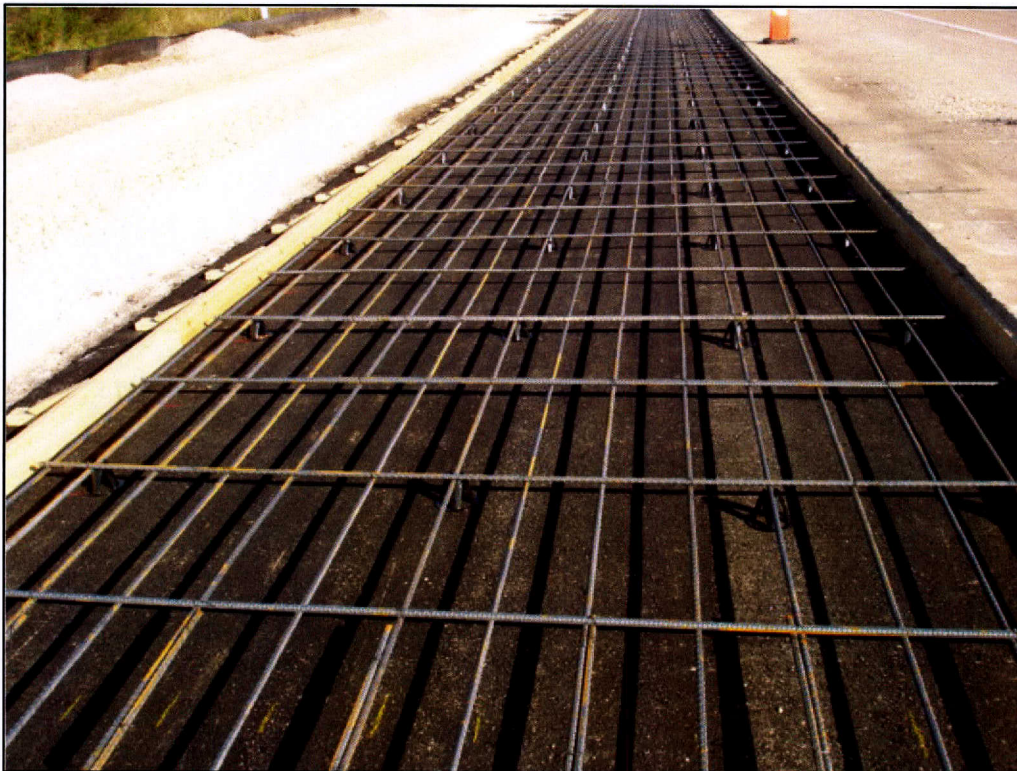
Figure 36. Reinforcement Placed for CRCP Test Track.

Once the forms were in place, the contractor began laying out the CRCP reinforcement according to the details given in Figure 8 of Chapter 3. A TTI technician monitored this work, and verified that the reinforcement was placed according to the plans. Figure 36 shows the reinforcement that the contractor placed before the concrete was poured for the CRCP test track.

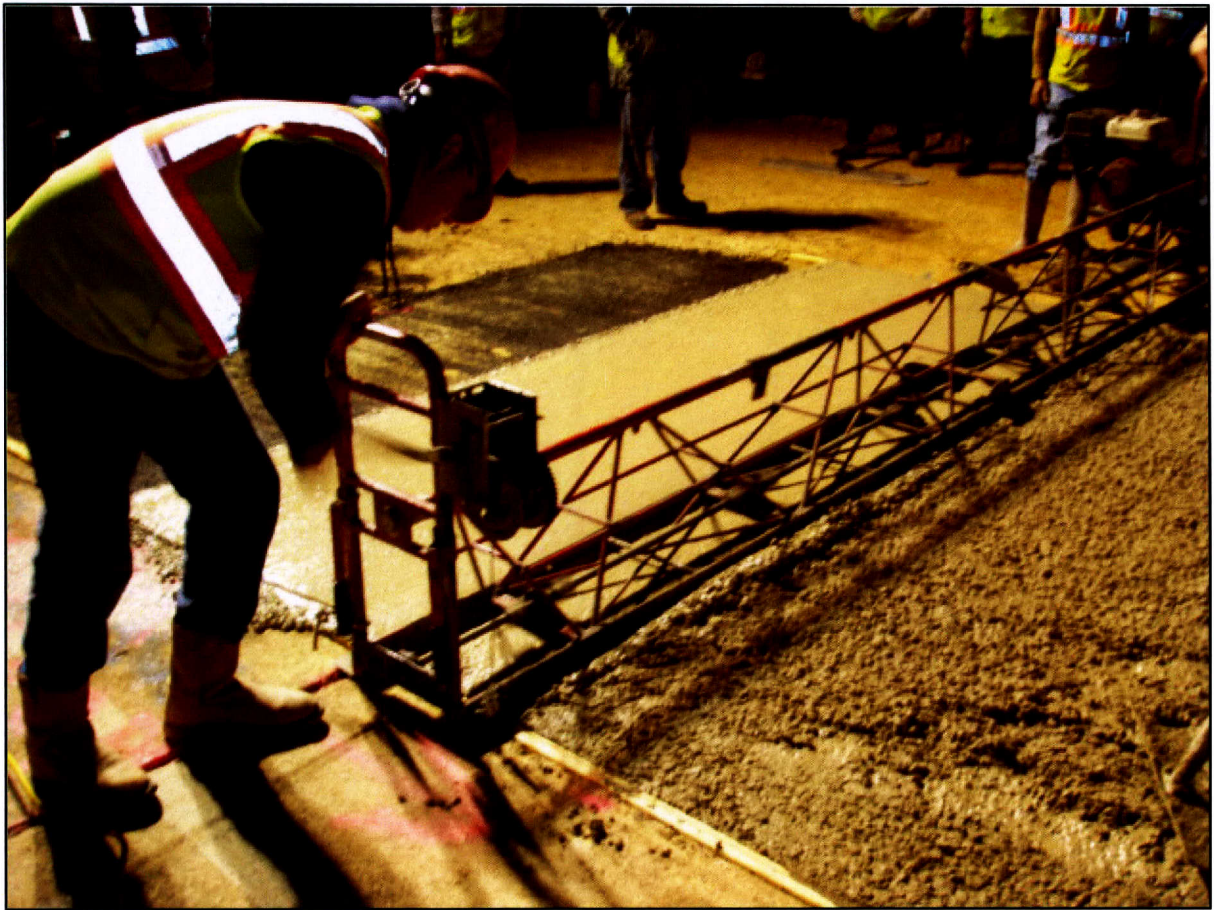
Figure 37. Vibrating Screed Used to Place the Concrete Mix.

The contractor scheduled placement of the concrete for the CRCP test track on November 9, 2012. He had his crew and equipment on the job site at midnight that day. TTI technicians were also at the site to monitor the work. The contractor initially sprayed the concrete forms with a releasing agent to facilitate removal of the forms after the concrete was placed. Figure 37 shows the contractor placing his vibrating screed on the form when the concrete pour began. This picture was taken at the south end of the track where the contractor started pouring concrete.

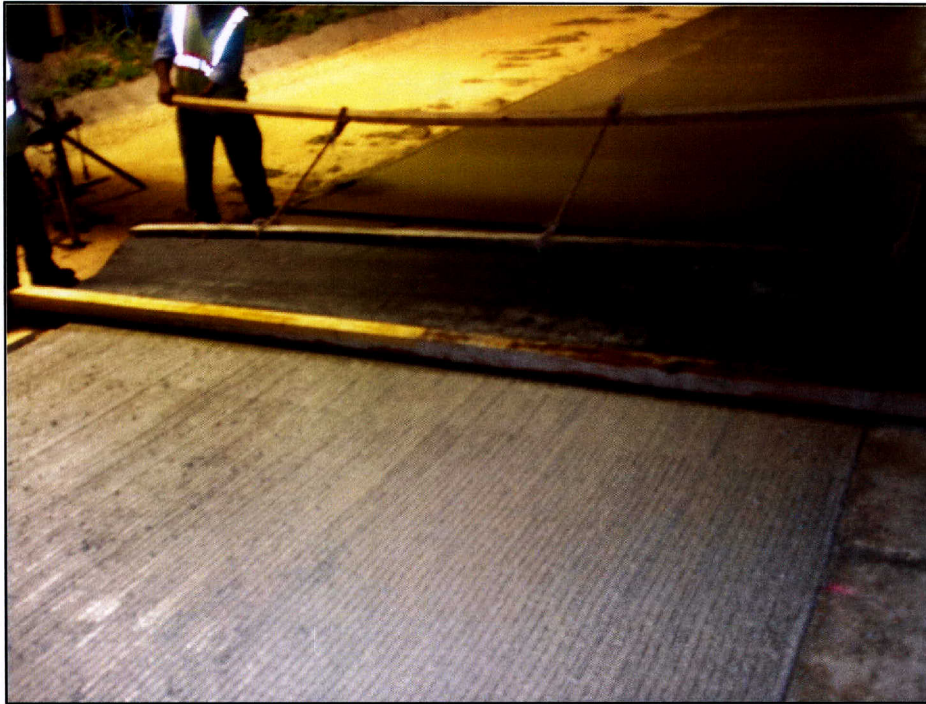
Figure 38. Concrete Surface Textured with Carpet Drag.

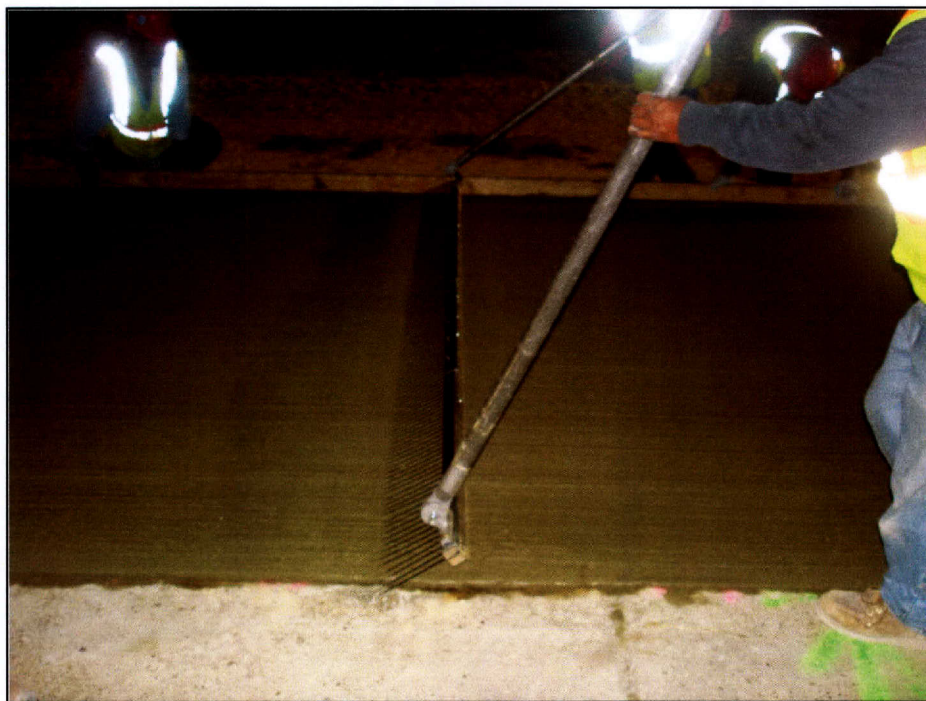
Figure 39. Concrete Surface Textured with Longitudinal Tines.

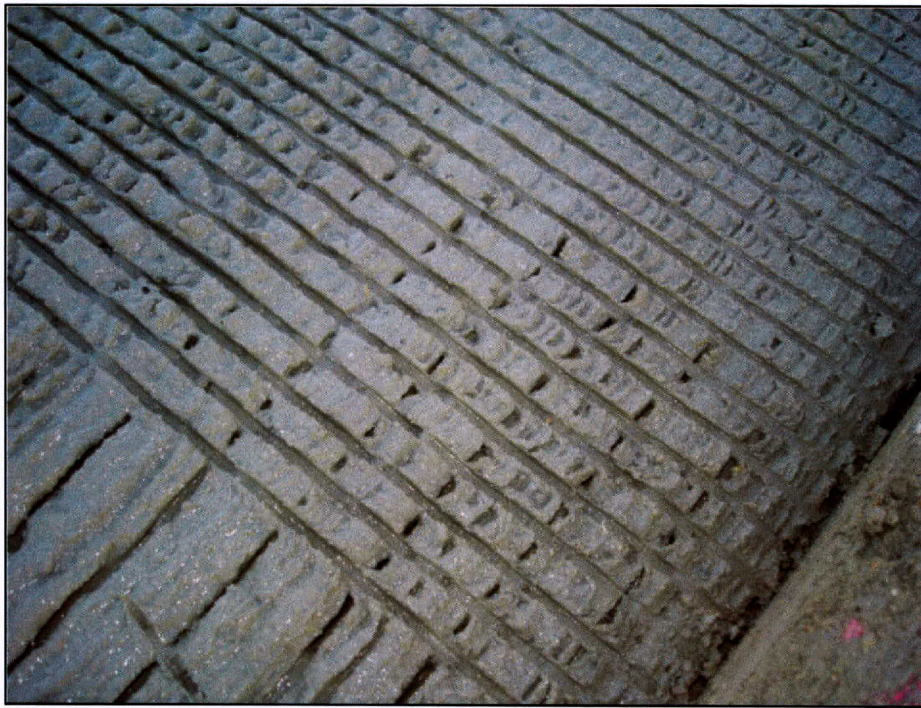
Figure 40. Change from Longitudinal Tines to ½-inch Transverse Tines.

Figure 40 shows a close-up view of the change from the longitudinally tined section to the half-inch transversely tined section. This photograph was taken at station 14+00. Figure 41 shows the change from the half-inch to the one-inch transversely tined section at station 8+50. The contractor placed 1-inch tines as illustrated in Figure 42. As may be observed in the figure, it was already morning when this picture was taken. The entire process of placing the CRCP—from the time the concrete pour began to the time the concrete was completely tined—took about 12 hours. The contractor imprinted 09-11-12 (dd-mm-yy) as the date of concrete placement at the northwest corner of the CRCP test track.

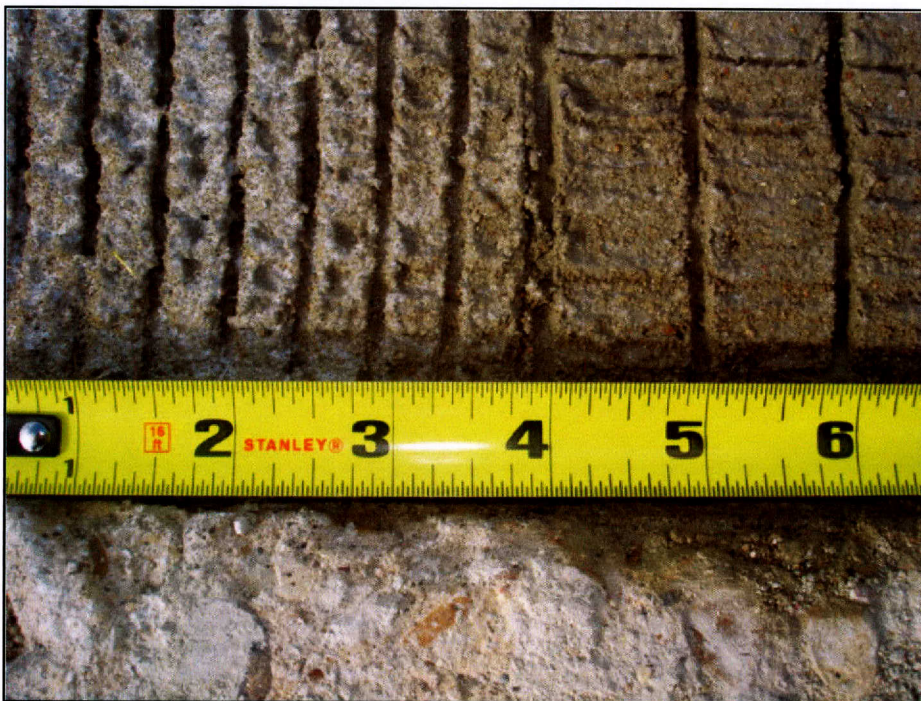
Figure 41. Change from ½-inch to 1-inch Transverse Tines.

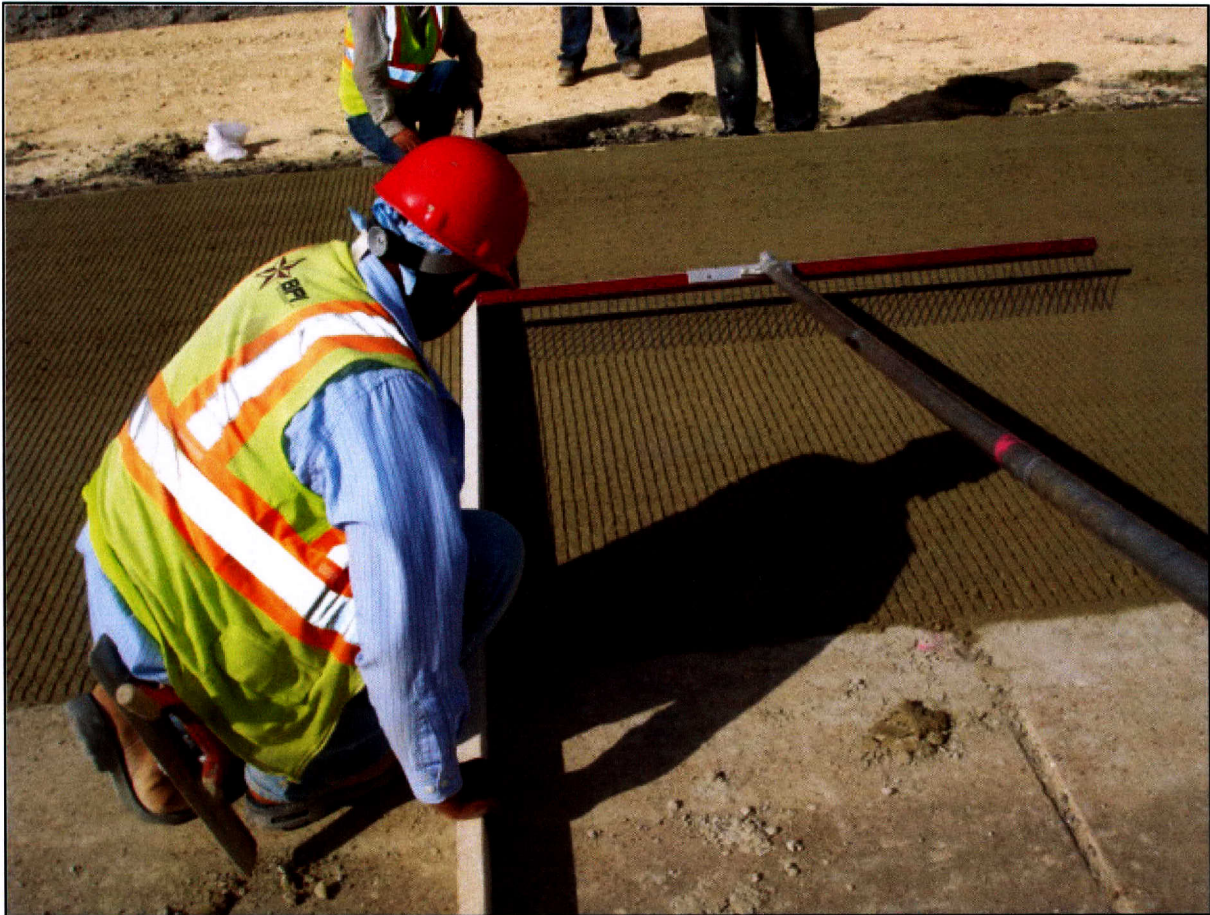
Figure 42. Concrete Surface Texture with 1-inch Transverse Tines.

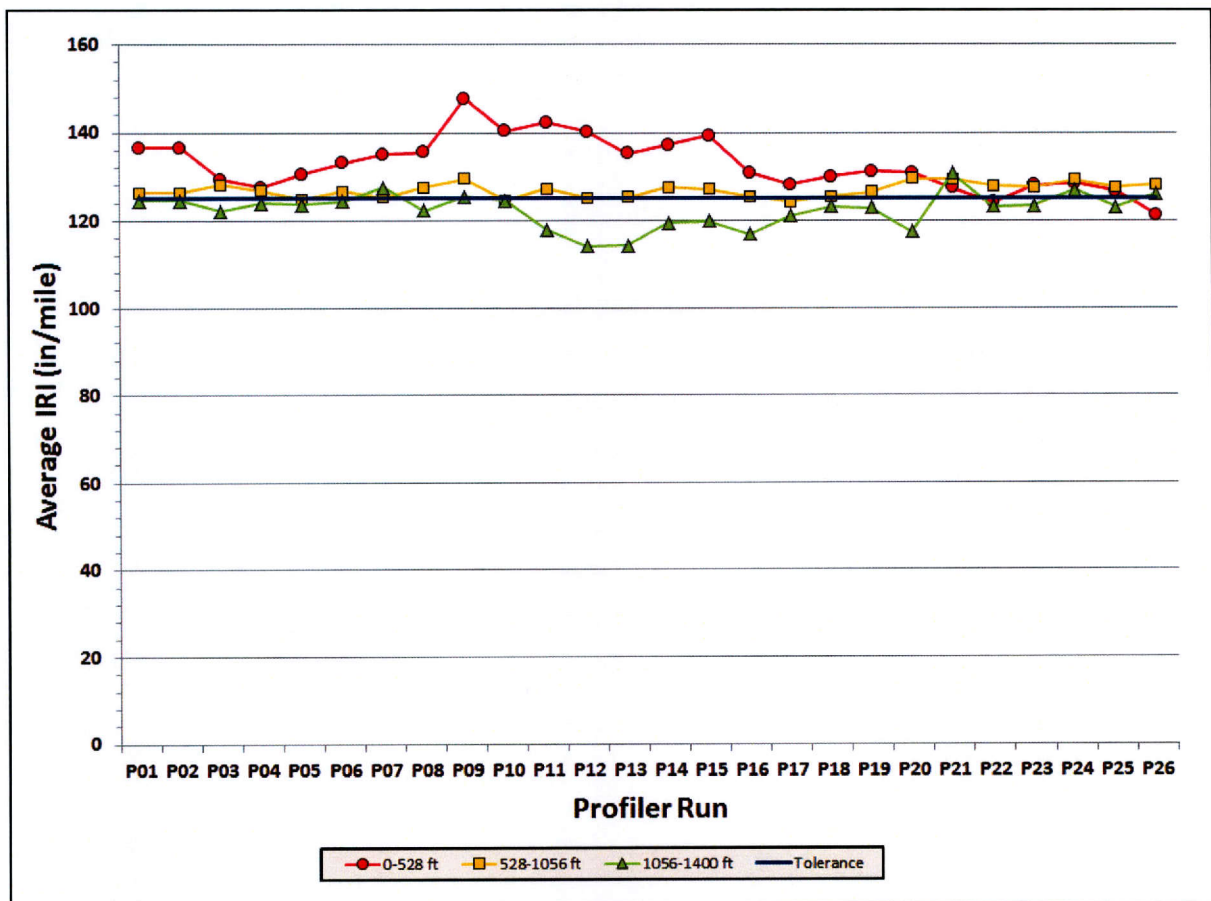
Figure 43. Results from Profile Tests to Check Ride Quality of Flexible Base.

The plans also called for checking the ride quality of the flexible base where the Grade 3 and inverted prime sections would be placed. These sections cover the first 1400 ft of the flexible pavement test track. The contractor spent much time trying to meet the ride quality requirement of TxDOT SP247-011. After placing the CRCP, the contractor found that he had limited space to use equipment with automated grade controls to achieve the required smoothness on the flexible base, and be within 125 inches/mile on the average IRI. Thus, corrections had to be done manually. TTI project staff assisted the contractor in this process by

providing profile measurements and suggesting areas where corrective work should be made. This process required a lot of iterations as can be inferred from Figure 43, which plots the average IRIs with the number of profile runs made to check the ride quality of the flexible base. Most of the work was spent on the first 528 ft of the project. After the 26th profile test, the research supervisor deemed the average IRIs to be acceptable. This decision was based on the overall weighted average of the IRIs, which was determined to be 125 inches/mile. With this work behind him, the contractor proceeded to place the surface treatments shown in the plans.

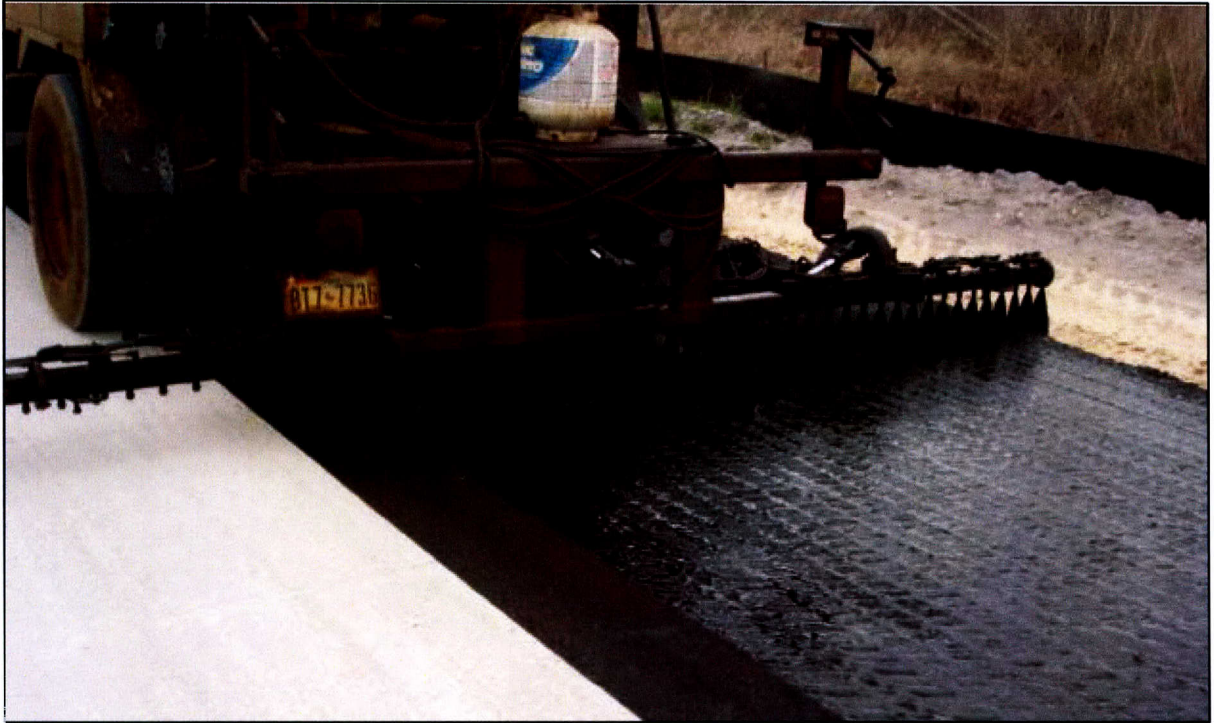
Figure 44. Asphalt Sprayed on Flexible Base for Surface Treatment.

The subcontractor hired to place the surface treatments avoided tracking the flexible base wheel paths when he applied the asphalt and aggregates. He was concerned about affecting the profile of the flexible base. Thus, he used the CRCP to place the surface treatments. Figure 44 illustrates how the subcontractor applied the asphalt on the flexible base. His operator drove the distributor truck such that the driver-side tires were on the CRCP, and the right side tires were between the wheel paths of the flexible base. Asphalt was then applied on the base over a 10-ft width. The distributor truck was then driven on the concrete to shoot asphalt over the remaining 1 ft of flexible base (see Figure 45).

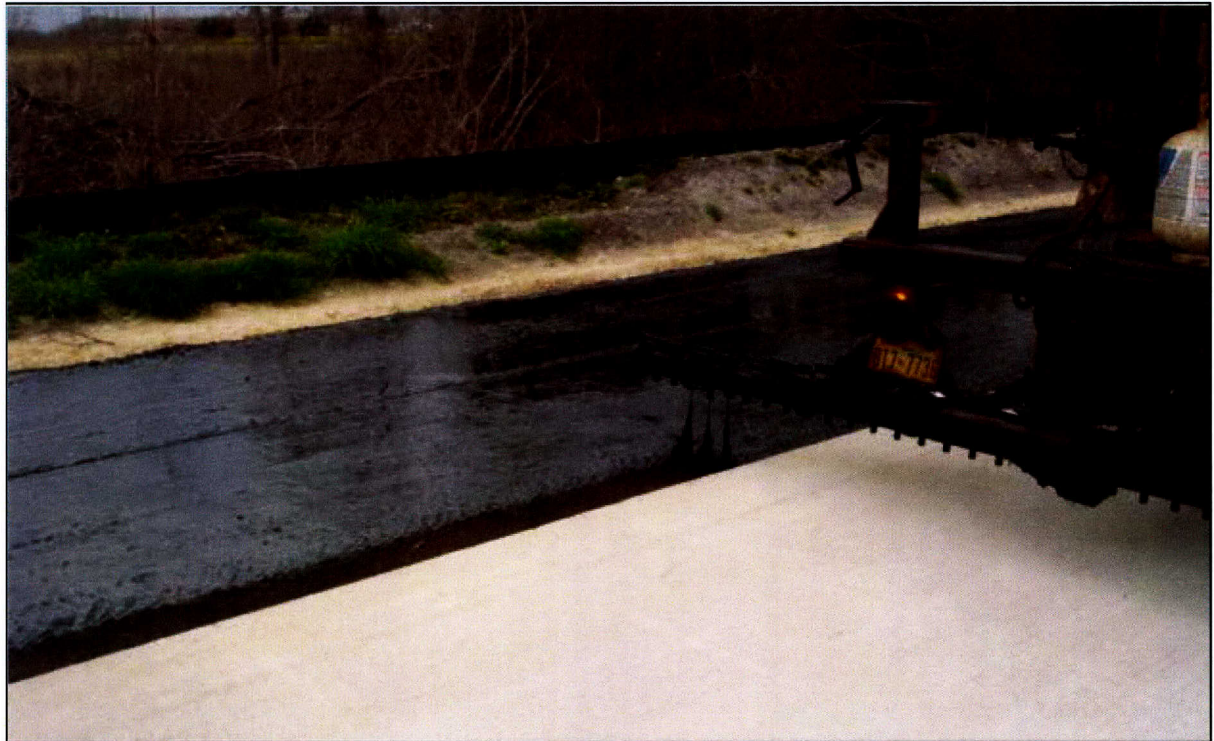
Figure 45. Finishing Asphalt Application on Flexible Base for Surface Treatment.

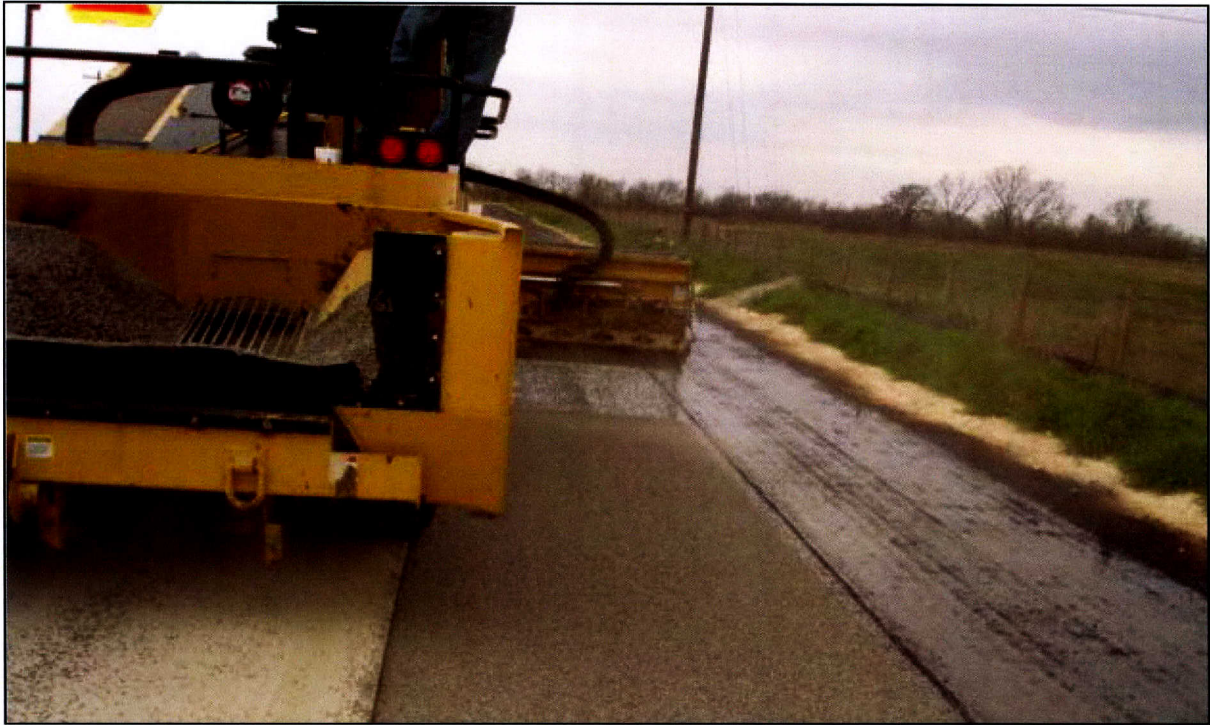
Figure 46. Chip Spreader Applying Grade 5 on Inside Half of Inverted Prime Section.

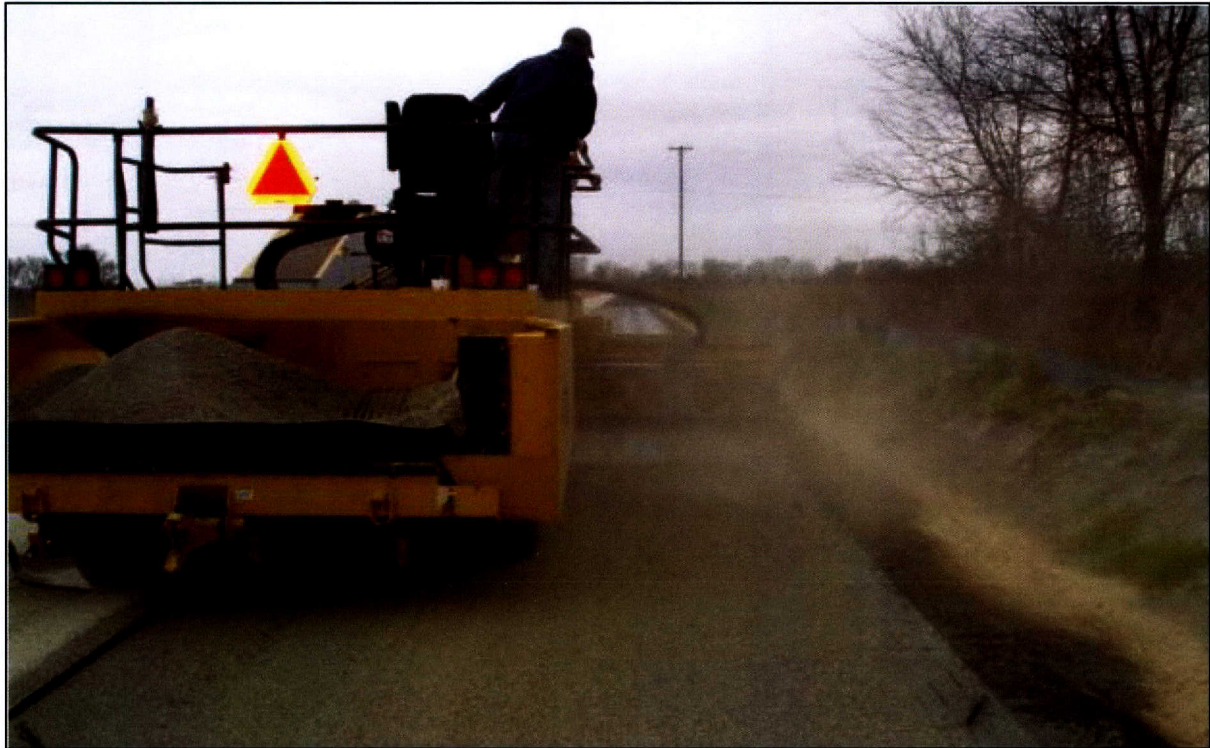
Figure 47. Chip Spreader Applying Grade 5 on Outside Half of Inverted Prime Section.

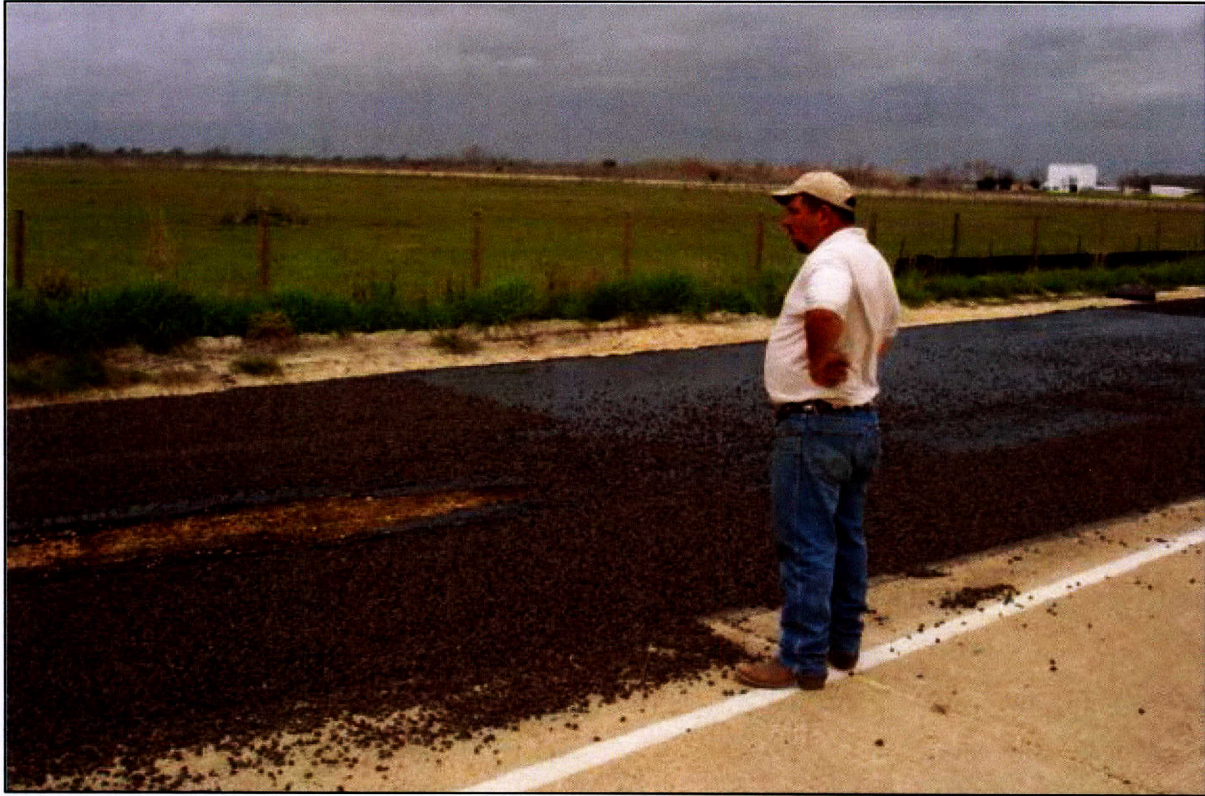
Figure 48. Strip of Grade 3 Course that Peeled Off at South Access Ramp.

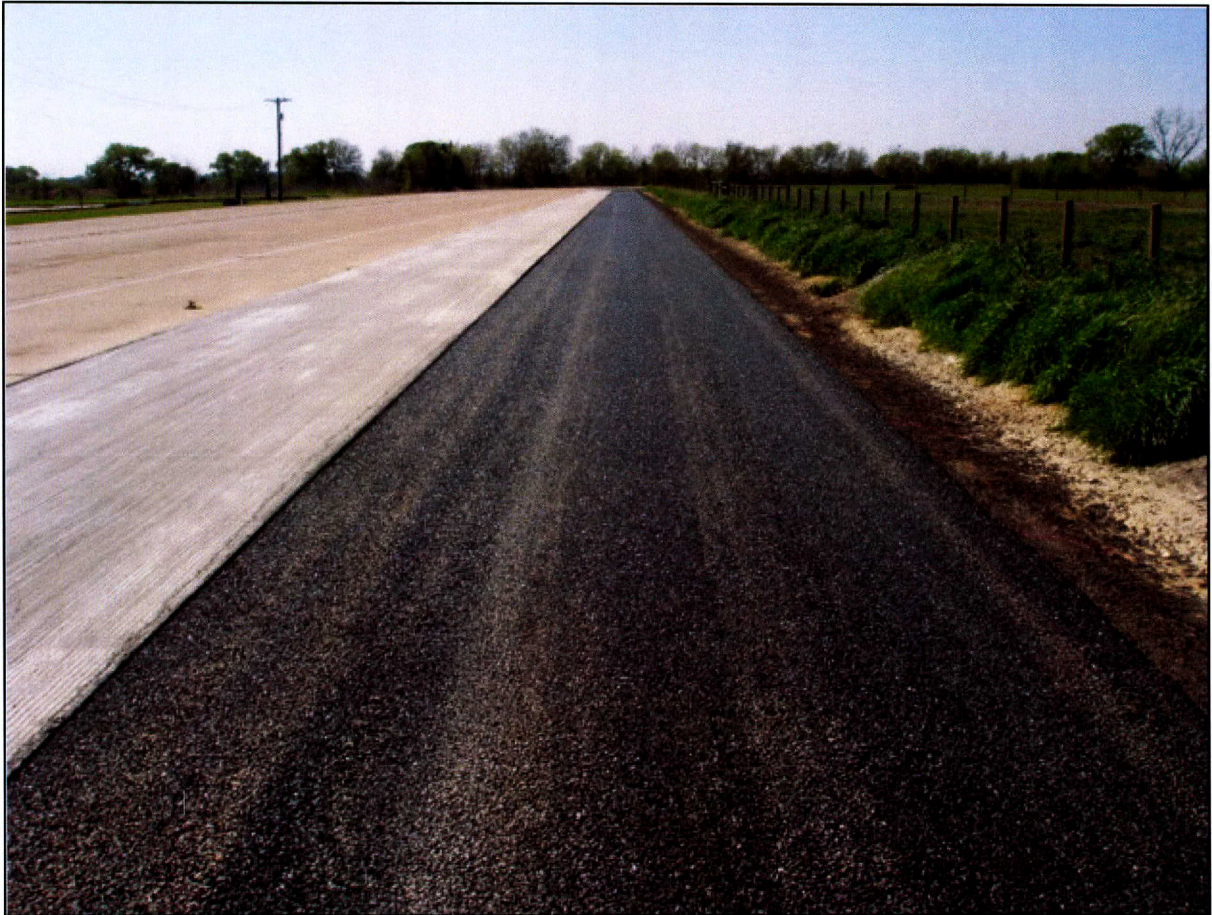
Figure 49. PFC Section Adjacent to Longitudinally Tined CRCP Section.

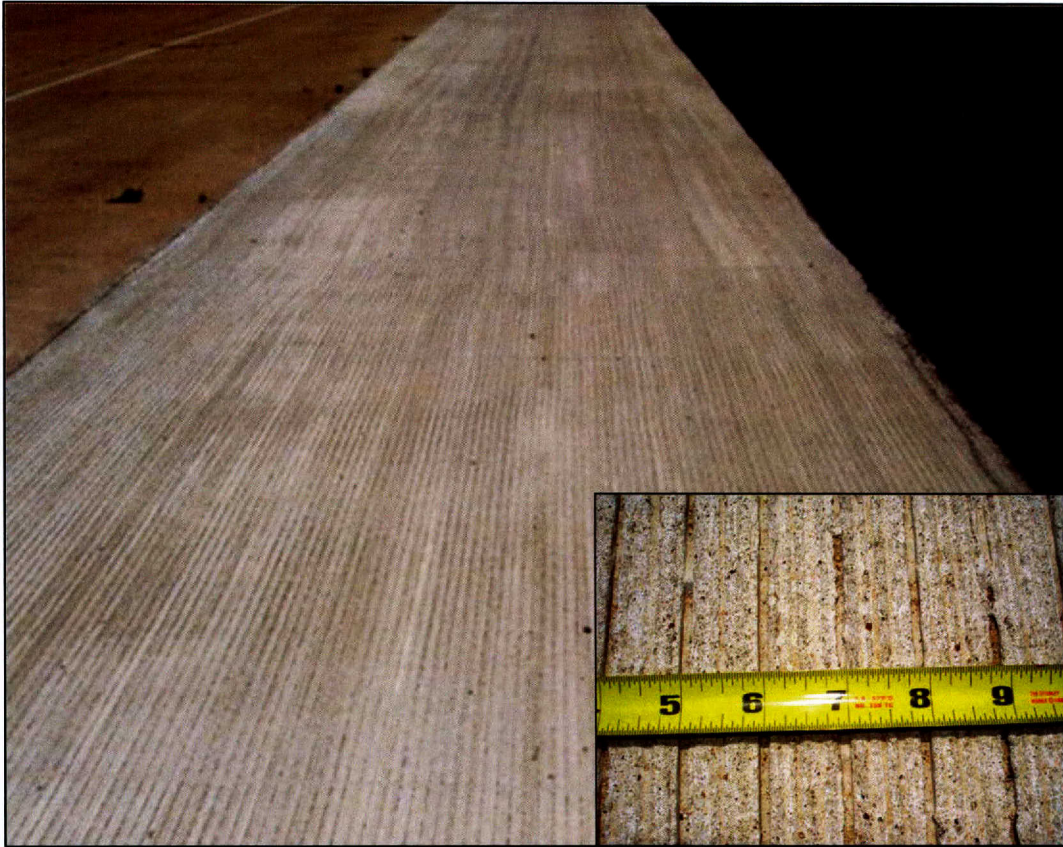
Figure 51. One-inch Longitudinally Tined CRCP Section.
