Construction of New Profiler Certification Tracks

Technical Report 5-9047-01-1

TEXAS A&M TRANSPORTATION INSTITUTE
COLLEGE STATION, TEXAS

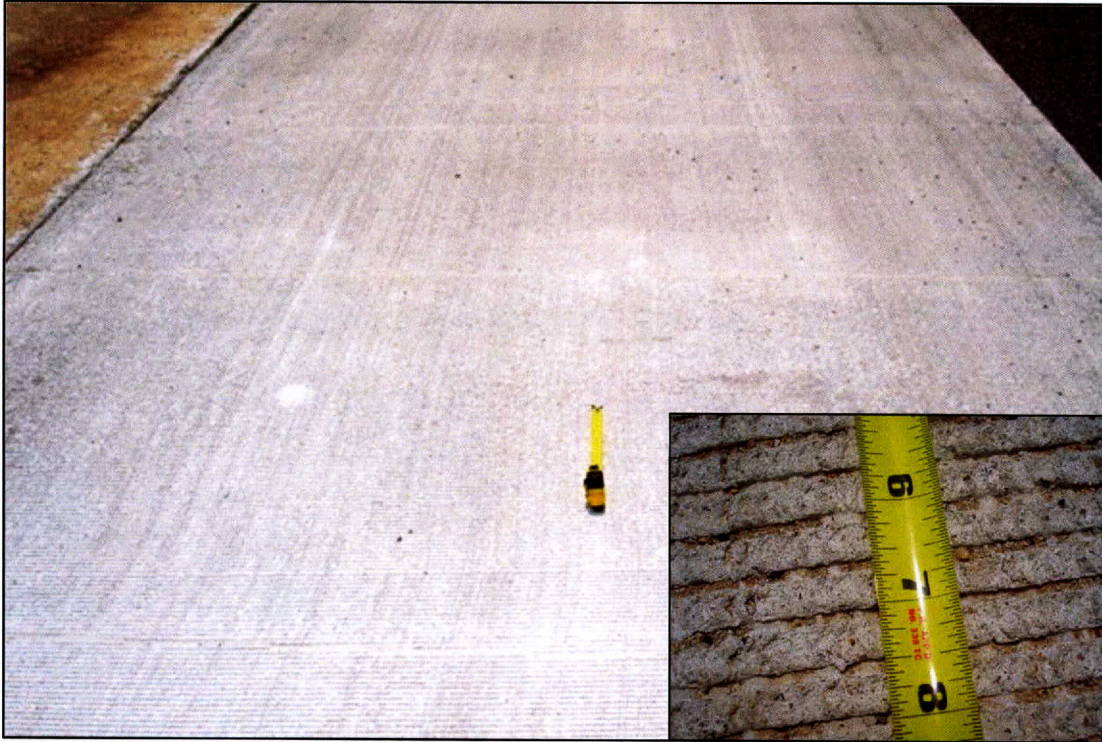
Figure 52. Half-inch Transversely Tined CRCP Section.

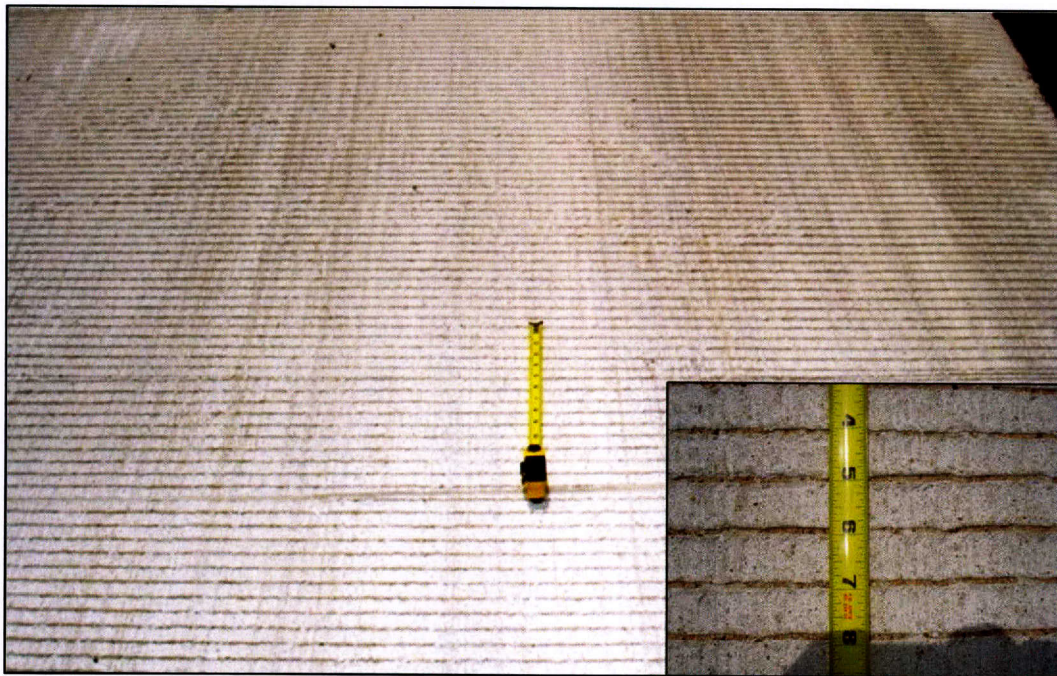
Figure 53. One-inch Transversely Tined CRCP Section.

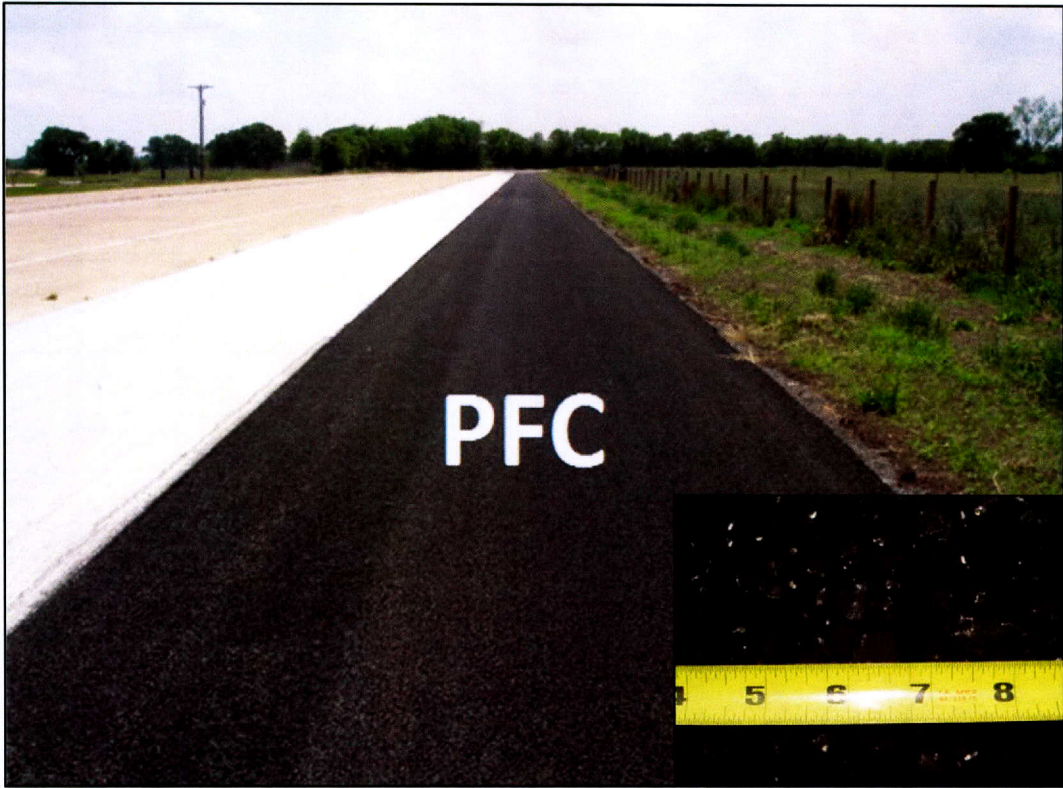
Figure 54. Permeable Friction Course Section.

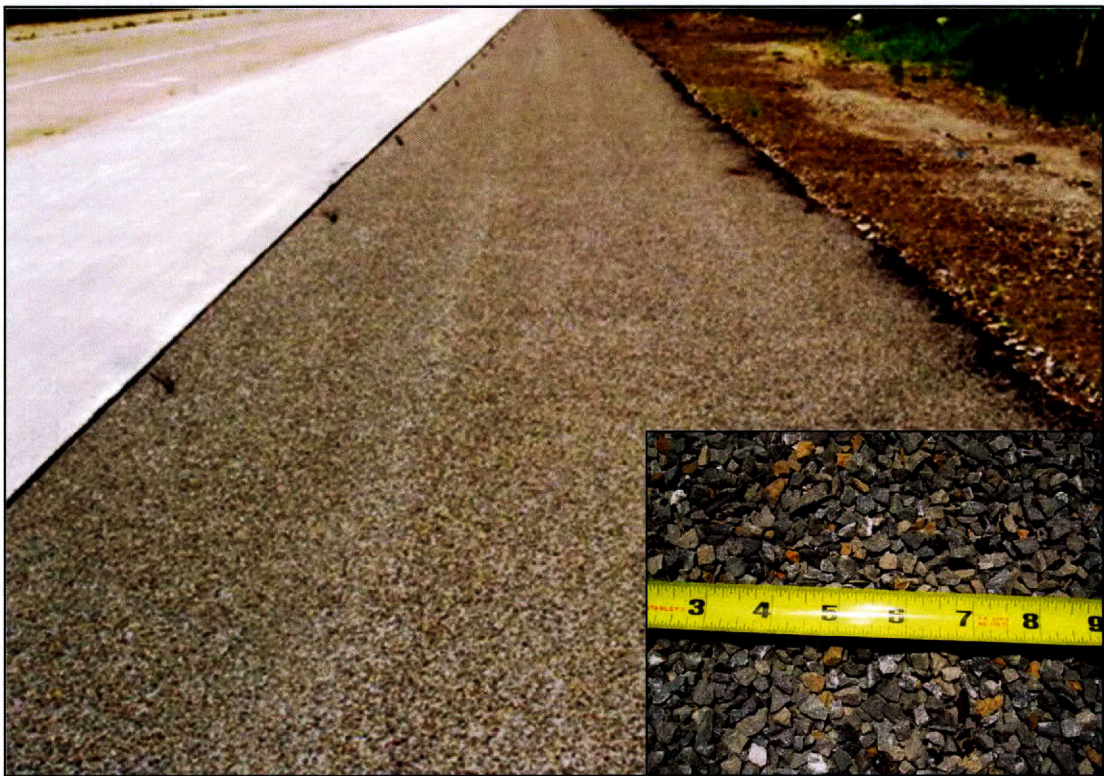
Figure 55. Inverted Prime Section.

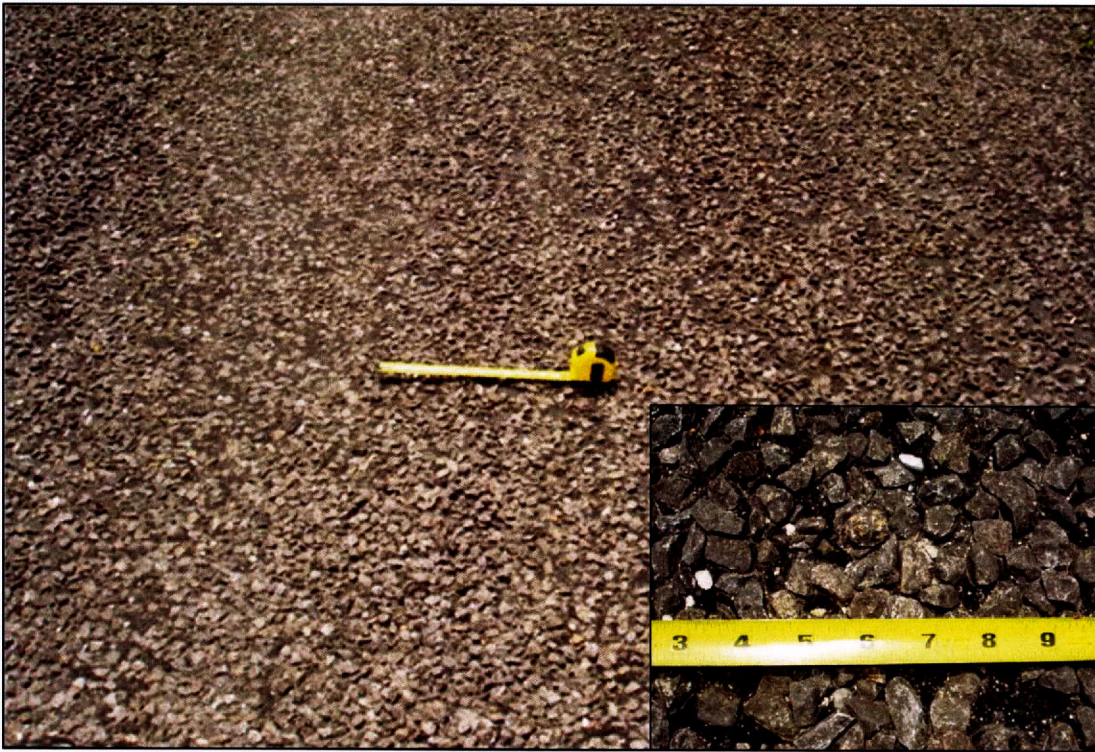
Figure 56. Grade 3 Chip Seal Section.

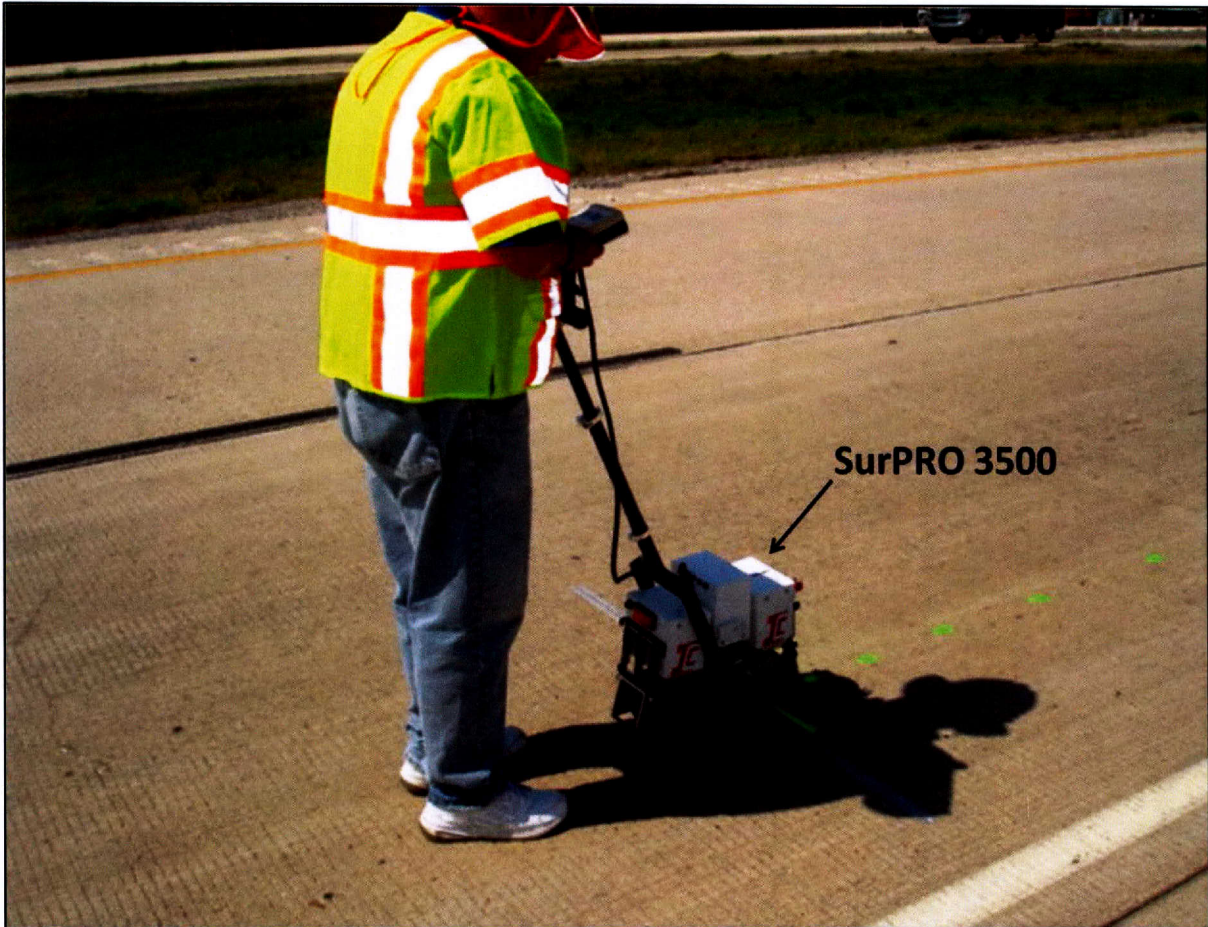
Figure 57. Instrument Used to Measure Reference Profiles.

Reference profile measurements were collected using the SurPRO 3500 profiler illustrated in Figure 57. This reference profiler is a product of the Federal Highway Administration (FHWA) pooled fund study TPF-5(063), which conducted an evaluation that assessed the accuracy and repeatability of profiles collected with three different systems provided by equipment developers who participated in that study. Based on the results, FHWA recommended using the SurPRO for evaluating profile measurements collected with inertial profilers. The SurPRO 3500 is the same profiler used to collect reference data on the existing profiler certification track that TTI maintains.

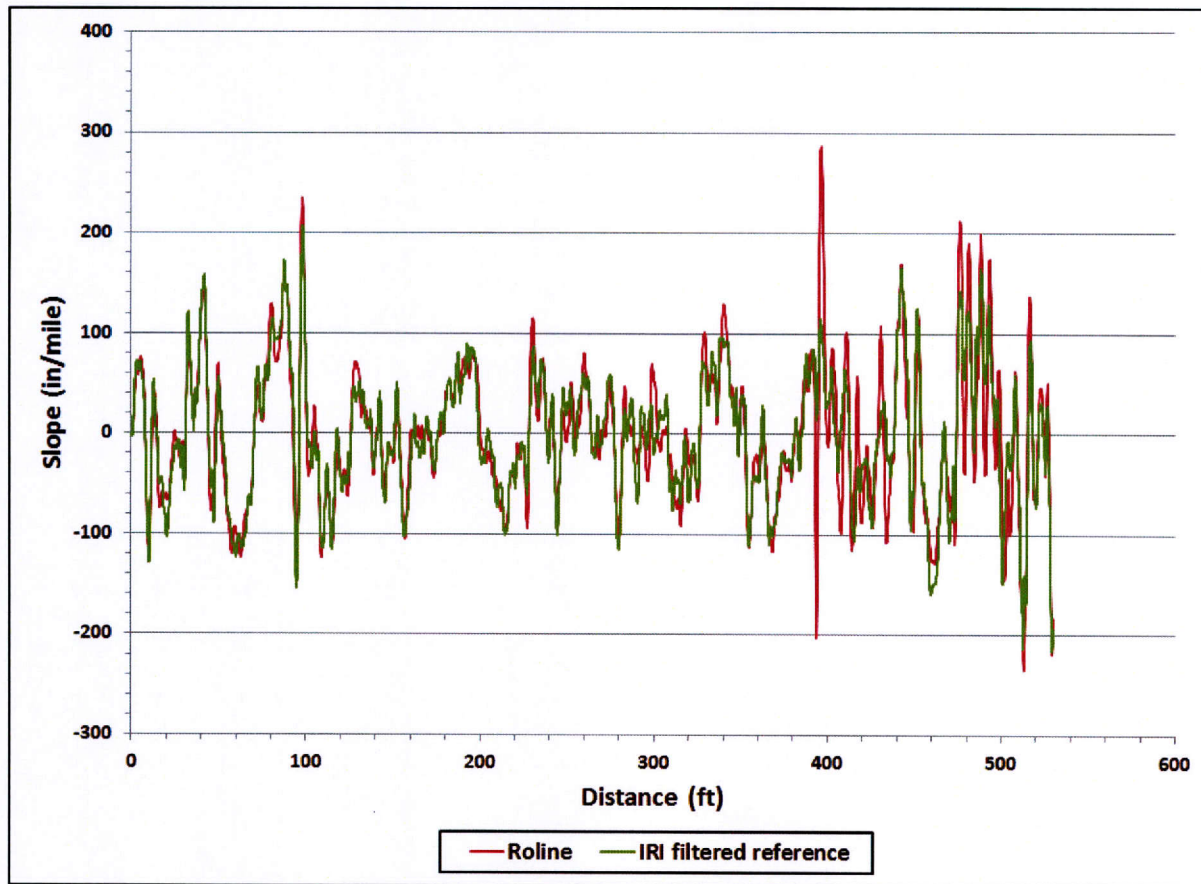
Figure 58. Comparison of IRI Filtered Profiles on a Section of CRCP Test Track.

There is evidence from test data that the ½-inch transverse tines affected the Roline measurements on the right wheel path. Figure 58 compares the IRI filtered profile from one of the runs on the CRCP track with the corresponding IRI filtered reference profile along the same interval. The IRI filtered profiles are observed to track each other quite well up to about 390 ft of the measured interval. Thereafter, the IRI filtered Roline profile shows more deviations from the IRI filtered reference profile. Researchers note that the pavement surface changes from 1-inch longitudinal tines to ½-inch transverse tines at about 390 ft on the chart. Within the first 390 ft, the cross-correlation between the IRI filtered profiles is 95 percent. If the cross-correlation is determined over the whole test interval, the cross-correlation drops to 84 percent.

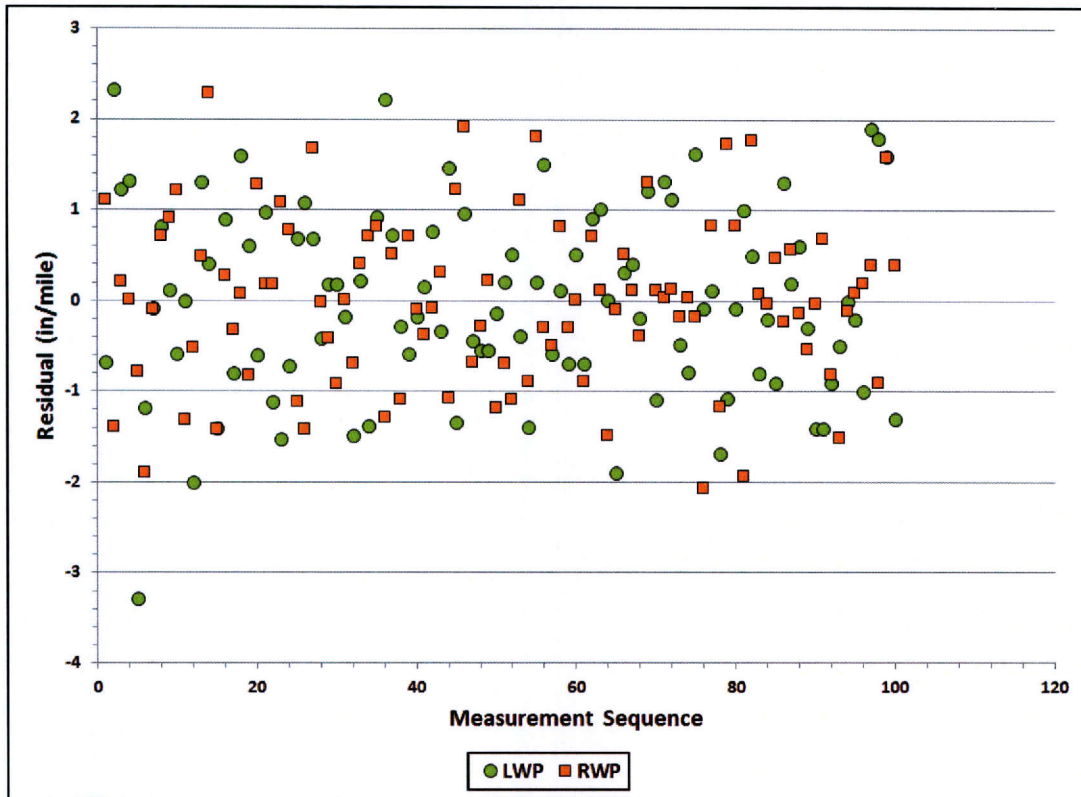
Figure 59. Results of Residual Analysis on 1/2-inch Transversely Tined Section IRIs.

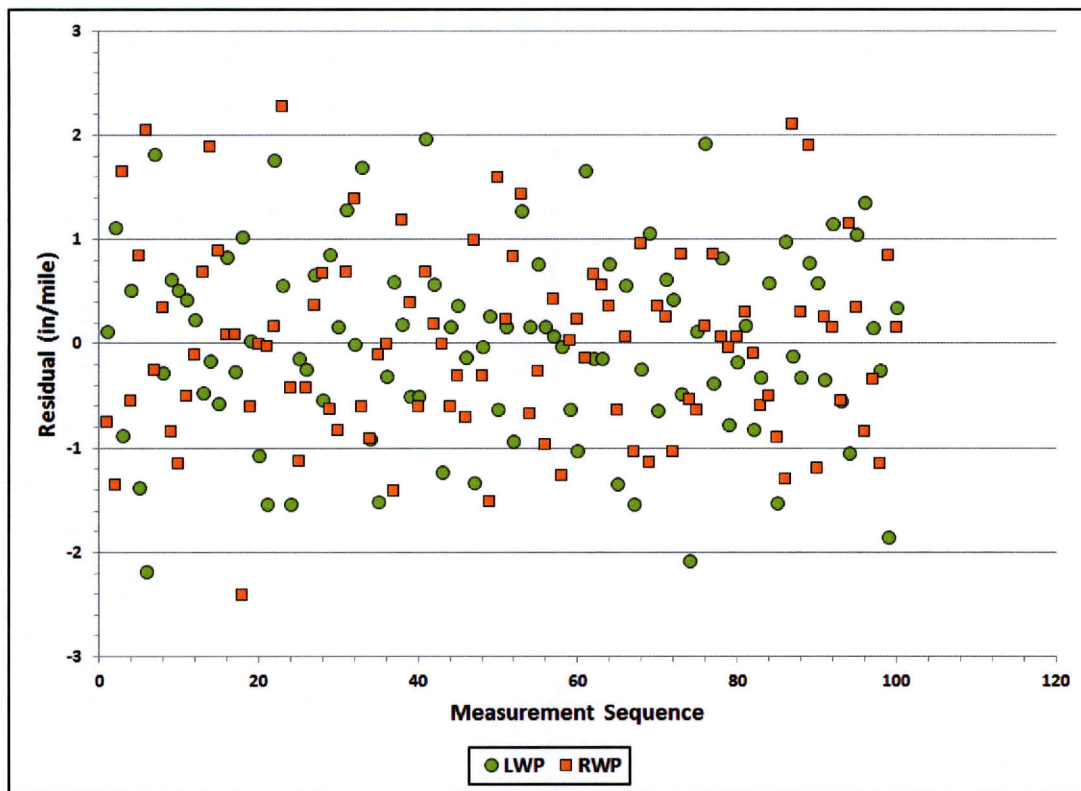
Figure 60. Results of Residual Analysis on 1-inch Transversely Tined Section IRIs.
