DEVELOPMENT AND TESTING OF A NON-PINNED LOW-PROFILE END TREATMENT

Test Report 9-1002-12-7

Cooperative Research Program

**TEXAS A&M TRANSPORTATION INSTITUTE
COLLEGE STATION, TEXAS**

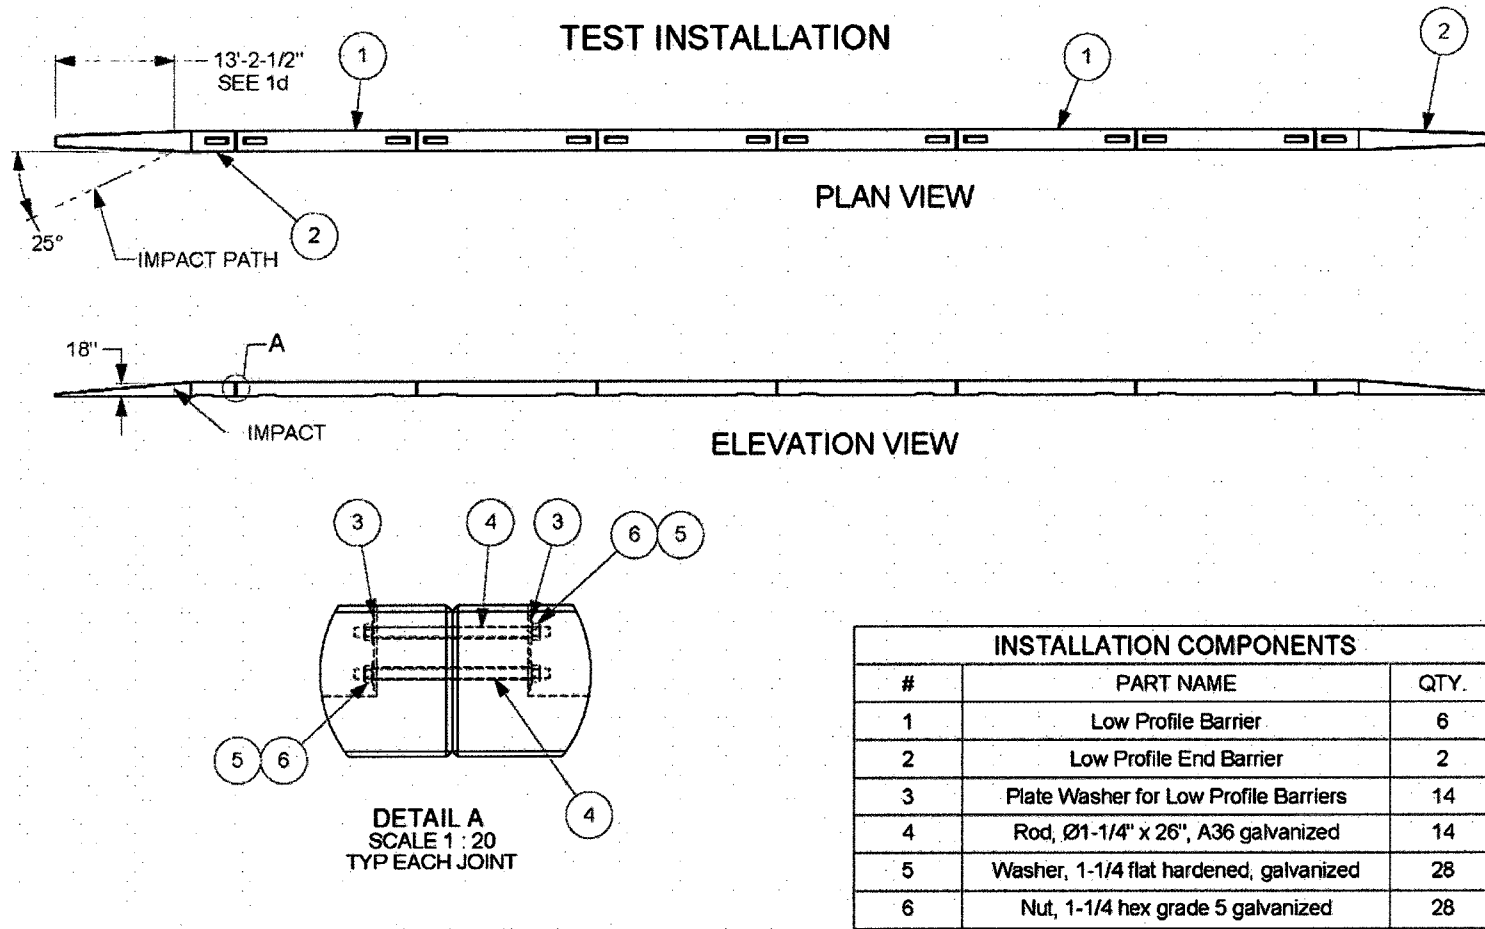
Figure 2.1. Layout of the Non-pinned Low-Profile PCB Installation.

- 1a. See the attached TxDOT drawing for component details.
- 1b. The installation will be placed free-standing (not anchored) on concrete.
- 1c. The Ø1-1/4" A36 rod used at interior connections shall have threads (6 per inch, NC) minimum 4" long at each end.
- 1d. 13'-2-1/2" dimension is approximate. Impact at 18" barrier height. 25° impact angle is from interior barriers, not angled face of end barrier.

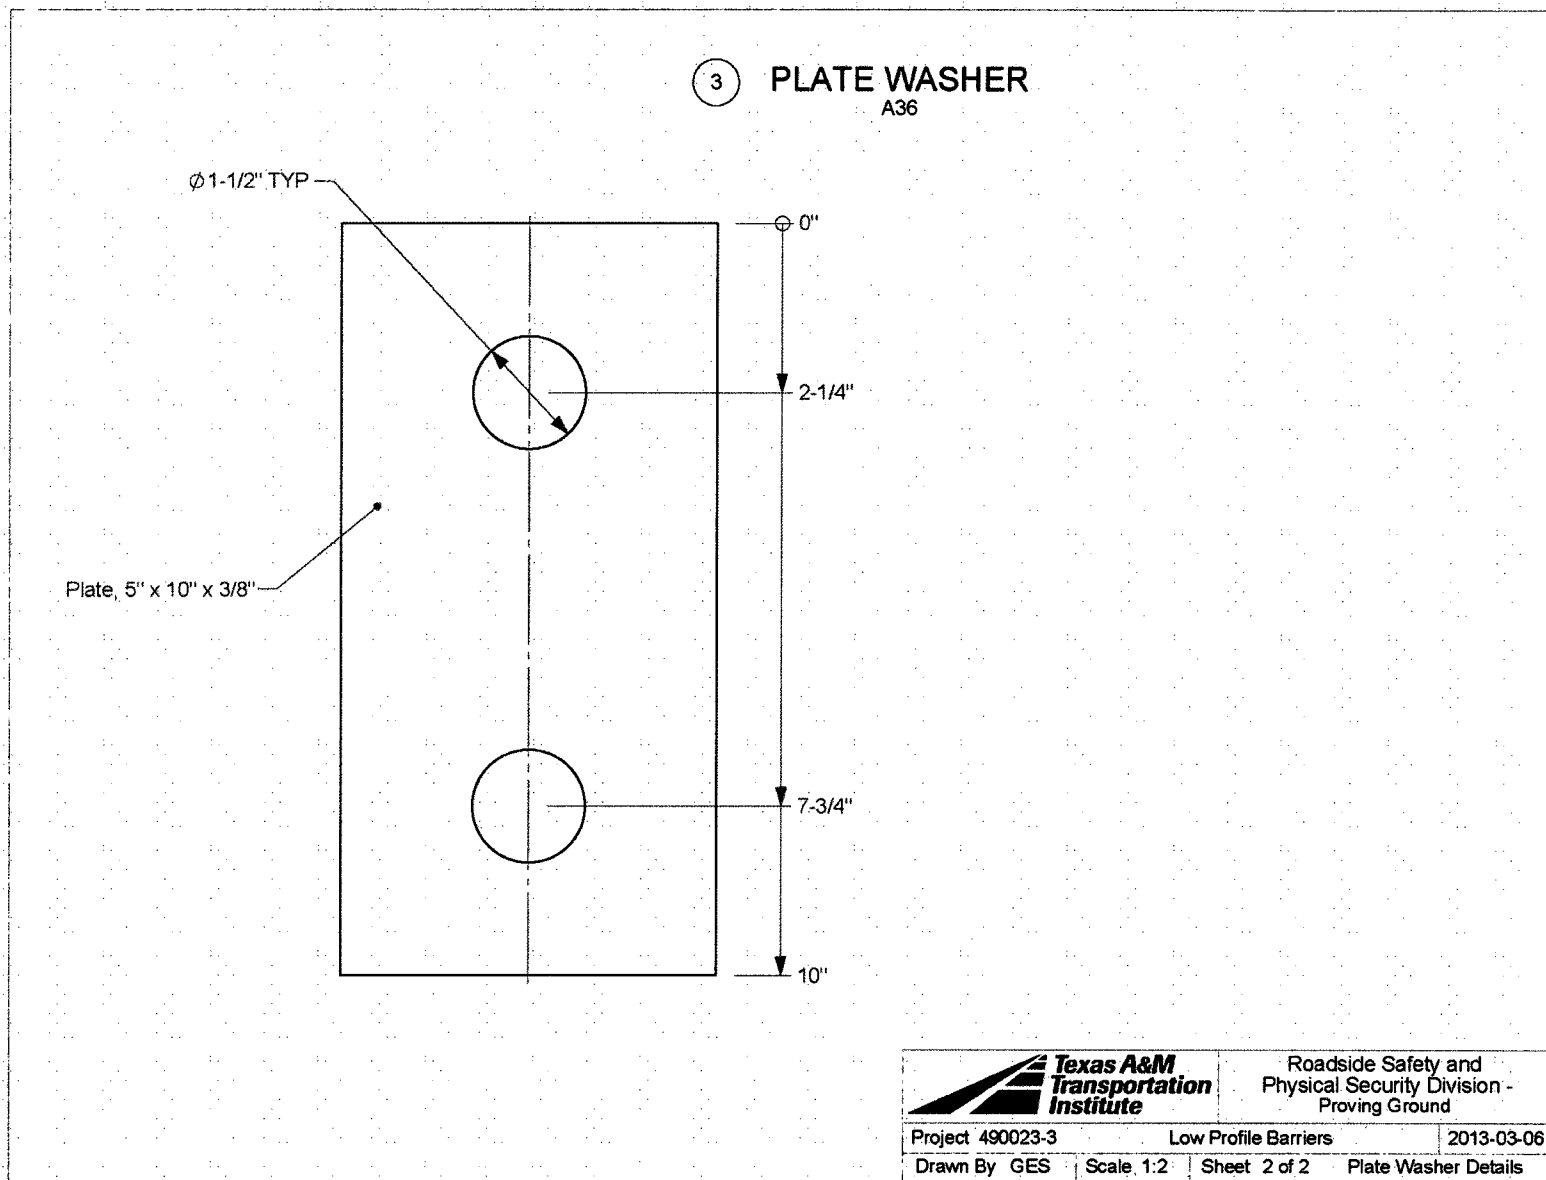
Figure 2.2. Details of the Plate Washer Used with the Non-pinned Low-Profile PCB.

To enhance the flexural rigidity of these connections, special plate washers with two symmetrically placed holes spaced to fit over both bolts were installed. These plate washers met the minimum specifications according to ASTM A36 material. For the tests presented herein, these plate washers were not hot-dip galvanized.

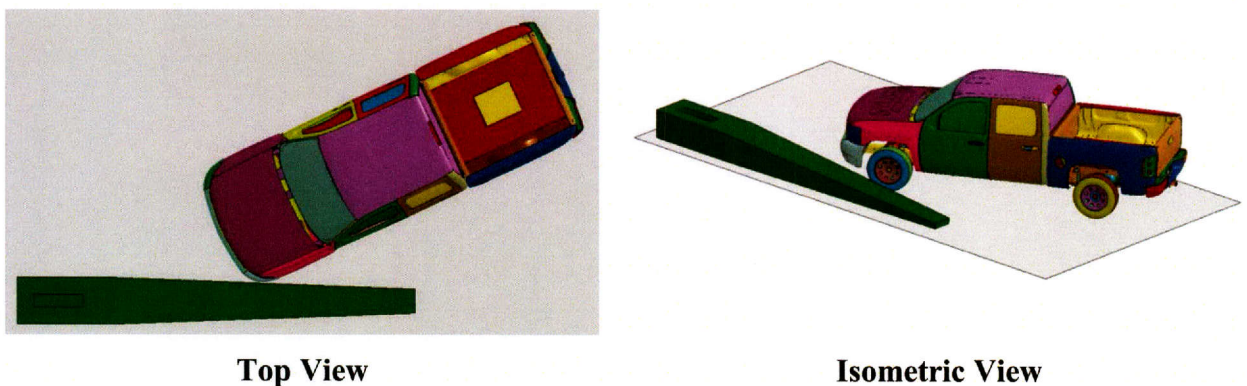
Figure 3.1. FE Model of Non-pinned Low-Profile End Treatment for Determining CIP.

For each FE analysis, a single Low-Profile end treatment was modeled using rigid material. These elements had no material failure or deformation capabilities. The end treatment was restrained from translational and rotational movements. It was the authors' intent to limit displacement and deformation of the end treatment to determine the CIP. It is reasonable to assume limiting displacement and deformation provides the worst case scenario to determine the CIP. The vehicle model used in the FE analyses was a Chevrolet Silverado that the National Crash Analysis Center (NCAC) developed. This model is available in the public domain and meets the specification criteria for the *MASH* 2270P design vehicle. Additionally, this vehicle model incorporated various modifications that TTI made to improve its performance and fidelity. Figure 3.1 shows the FE model described.

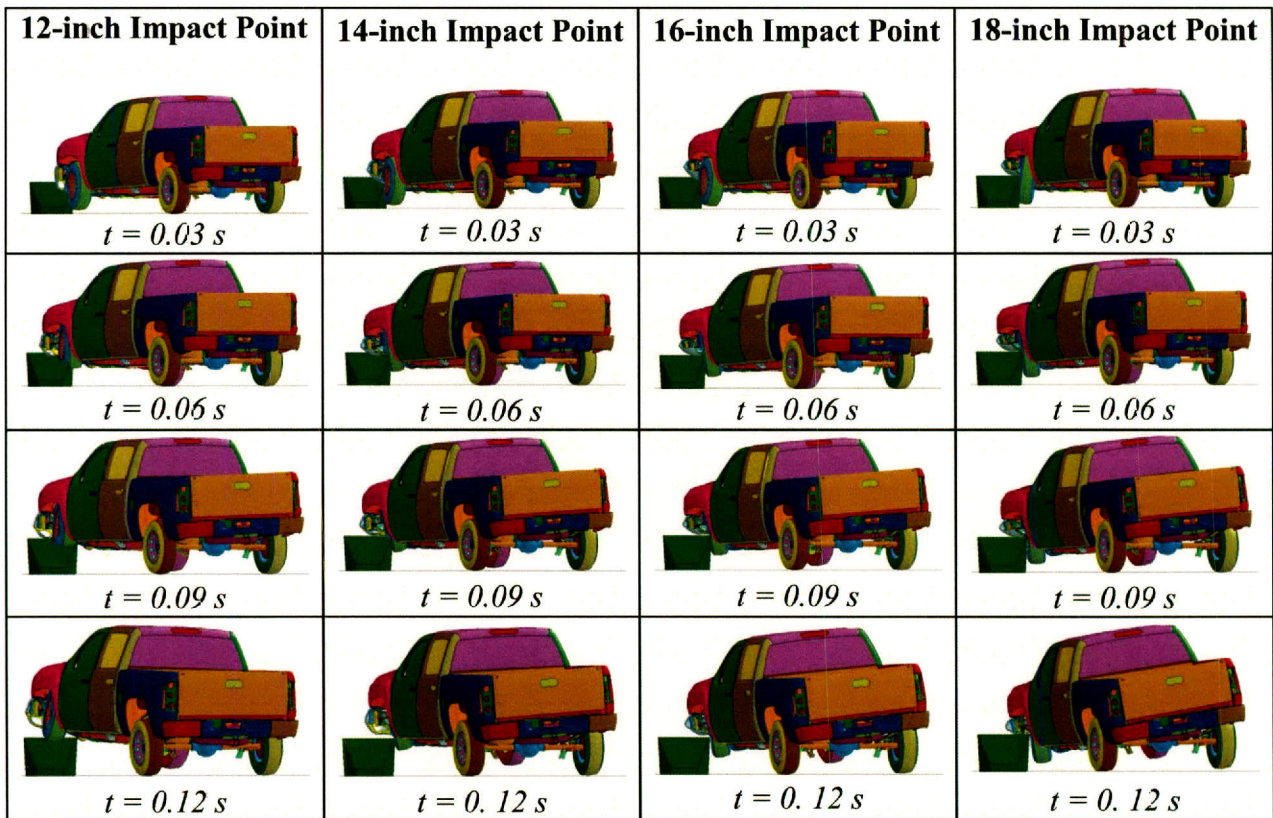
Figure 3.2. Sequential Results from FE Analyses for Different Impact Points.

All FE analyses were performed according to the criteria for *MASH* Test 2-35 involving the 2270P design vehicle impacting the end treatment at 25 degrees and 44 mi/h at the aforementioned impact points. Figure 3.2 below shows the result of this FE matrix.

As seen in Figure 3.2, a vehicle that impacts the Low-Profile end treatment at 12 or 14 inches in height will gate.

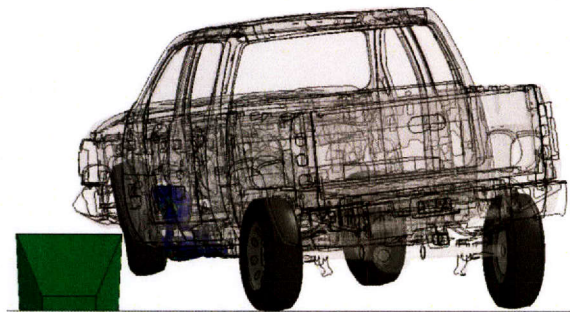
16-inch Impact Point at $t = 0.125$ s

While both the 16- and 18-inch high impact points appear to redirect the vehicle (see Figure 3.3), the latter maximizes the opportunity to redirect the vehicle and thus provides the maximum load condition on the end treatment-PCB connection. This impact point was selected as the CIP and located approximately 13 ft 2.5 inches upstream from the tip of the end treatment. A full-scale crash test was subsequently performed at this impact point, and the details are presented in the following chapters.

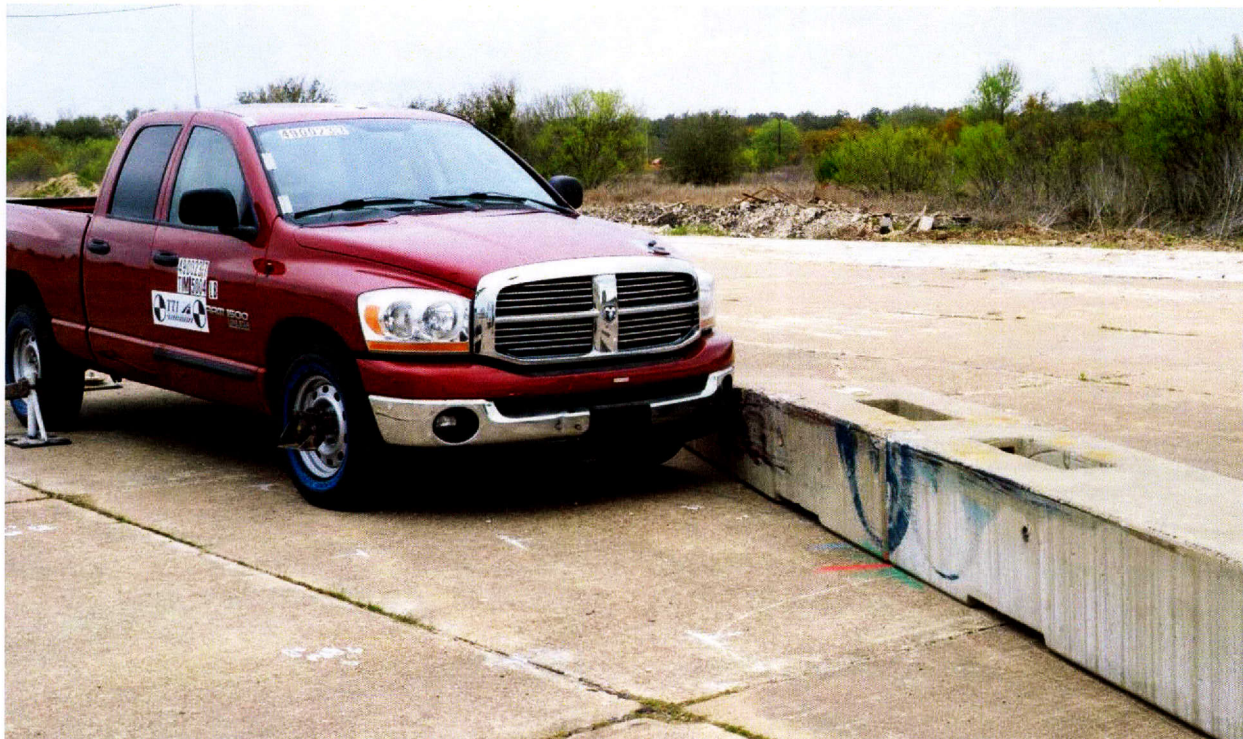
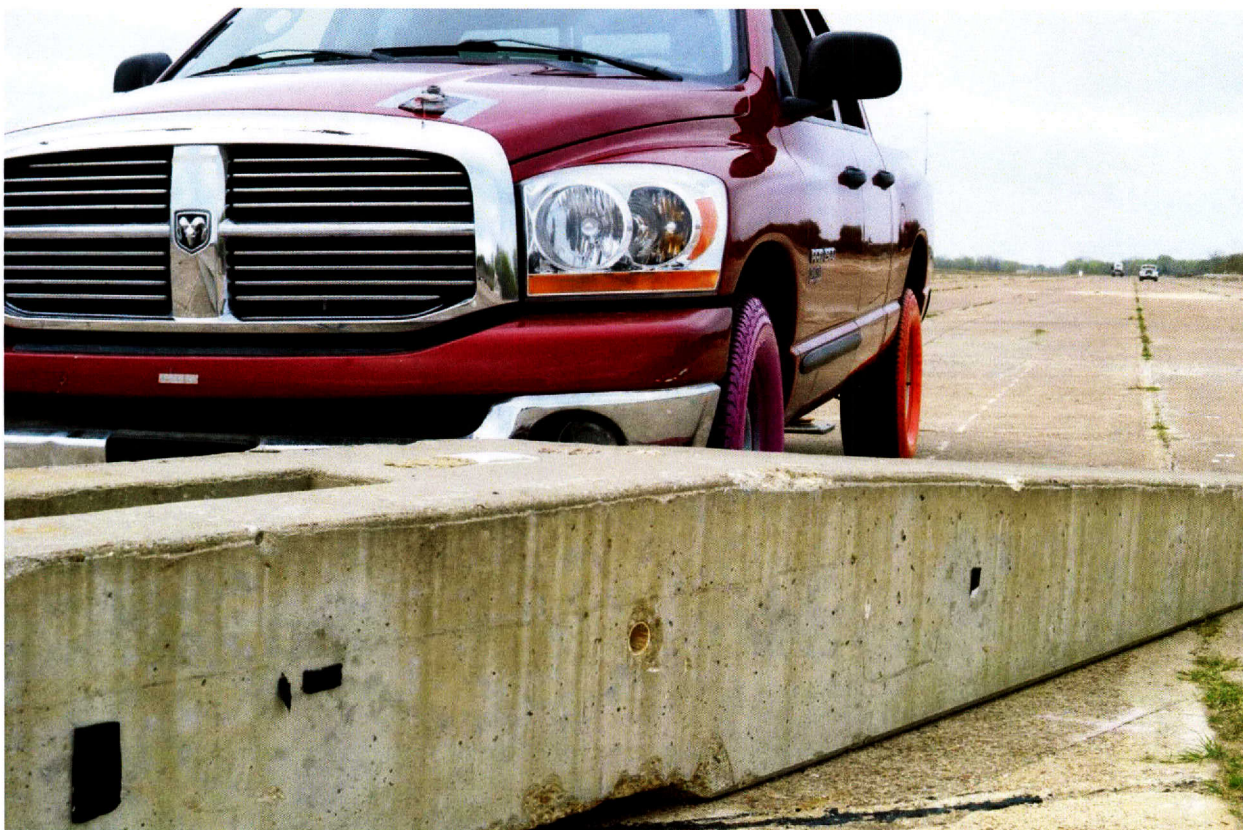
Figure 5.1. Vehicle/Installation Geometries for Test No. 490023-7.

The 2006 Dodge Ram 1500 pickup truck, traveling at an impact speed of 45.0 mi/h, impacted the non-pinned Low-Profile end treatment 78 inches upstream of the splice at an impact angle of 25.3 degrees. At approximately 0.013 s, the vehicle began to redirect, and at 0.036 s, the end of the terminal began to deflect toward the field side. The vehicle was traveling parallel with the barrier at 0.297 s, and the rear of the vehicle contacted the barrier at 0.348 s. As the vehicle continued forward, it left the view of the overhead high-speed camera, and exit speed and angle were not obtainable. However, judging from tire tracks, the vehicle exited the barrier at approximately 10 degrees, and came to rest 160 ft downstream of impact and 171 ft toward traffic lanes. Figures C1 and C2 in Appendix C show sequential photographs of the test period.

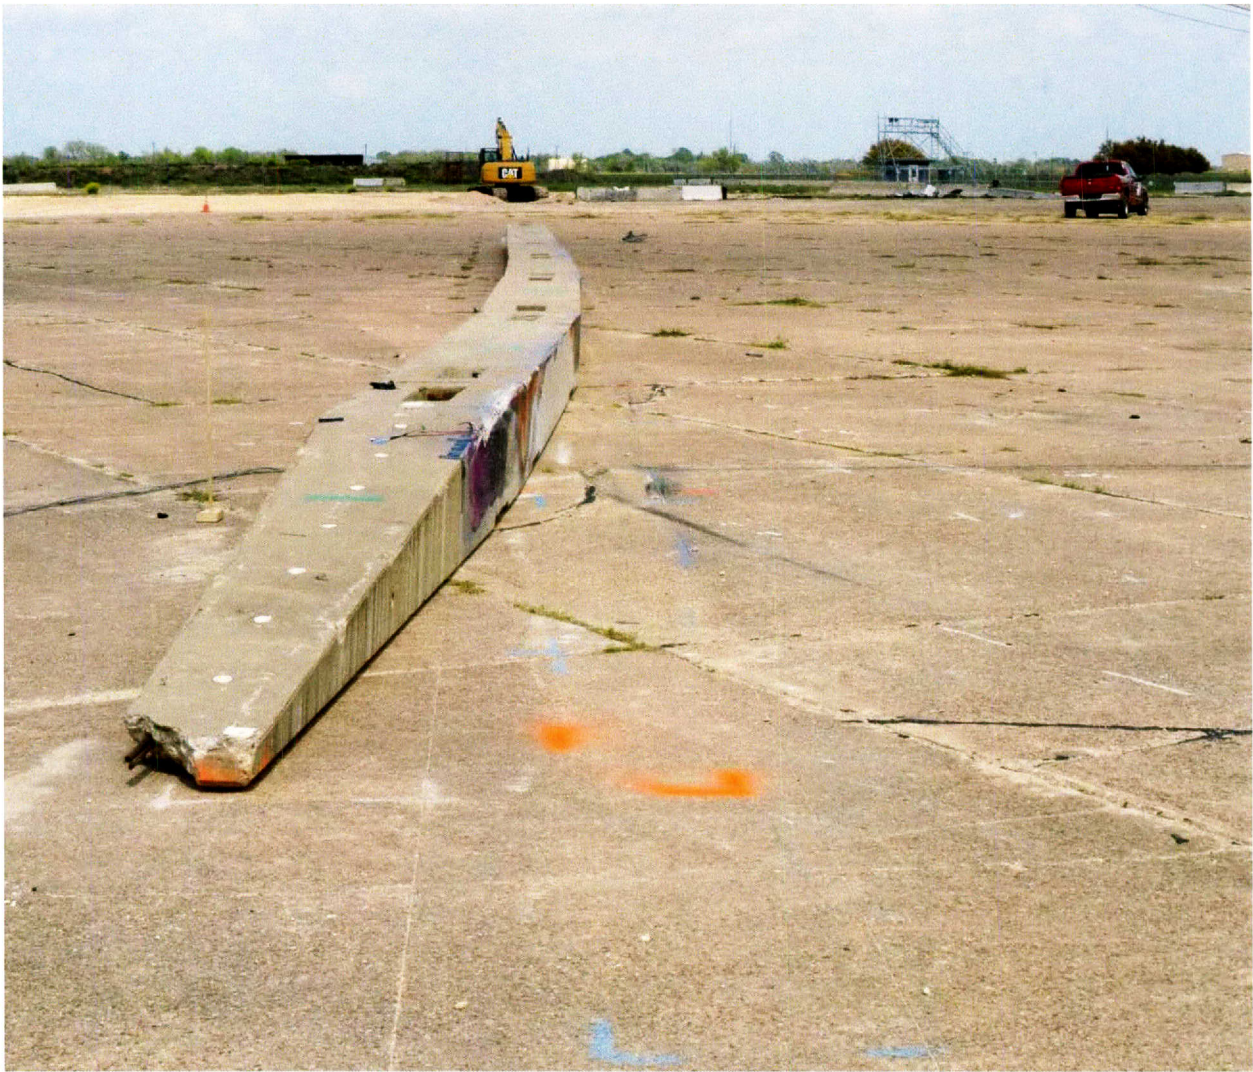
Figure 5.3. Installation/Vehicle Positions after Test No. 490023-7.

Figures 5.3 and 5.4 show damage to the installation, with tire marks and concrete spalling along the impact area on the traffic side and concrete spalling at joint 2-3 on the field side. Movement of the end treatment was 44 inches toward the field side at the upstream end, 25 inches toward the field side at joint 1-2, 9 inches toward the field side at joint 2-3, 2 inches toward the field side at joint 3-4 and 1 inch toward traffic lanes at joint 4-5. The 2270P vehicle remained in contact with the barrier for 29 ft-3 inches. Working width during the test was 55.0 inches, and vehicle intrusion was 27.7 inches. Maximum dynamic deflection during the test was 42.4 inches toward the field side, and maximum permanent movement was 42.4 inches toward the field side at the upstream end of the terminal section.

The non-pinned Low-Profile end treatment contained and redirected the 2270P vehicle. The vehicle did not penetrate, underride, or override the installation. Maximum dynamic deflection of the barrier was 42.4 inches measured at the end treatment nose. No detached elements, fragments, or other debris from the barrier were present to penetrate or show potential for penetrating the occupant compartment, or to present hazard to others in the area. No deformation or intrusion of the occupant compartment occurred. The 2270P vehicle remained upright during and after the collision event. Maximum roll and pitch angles were 15 degrees and 4 degrees, respectively. Occupant risk factors were within the preferred limits specified in *MASH*. The 2270P vehicle came to rest 171 ft downstream of impact and 14 ft toward traffic lanes.

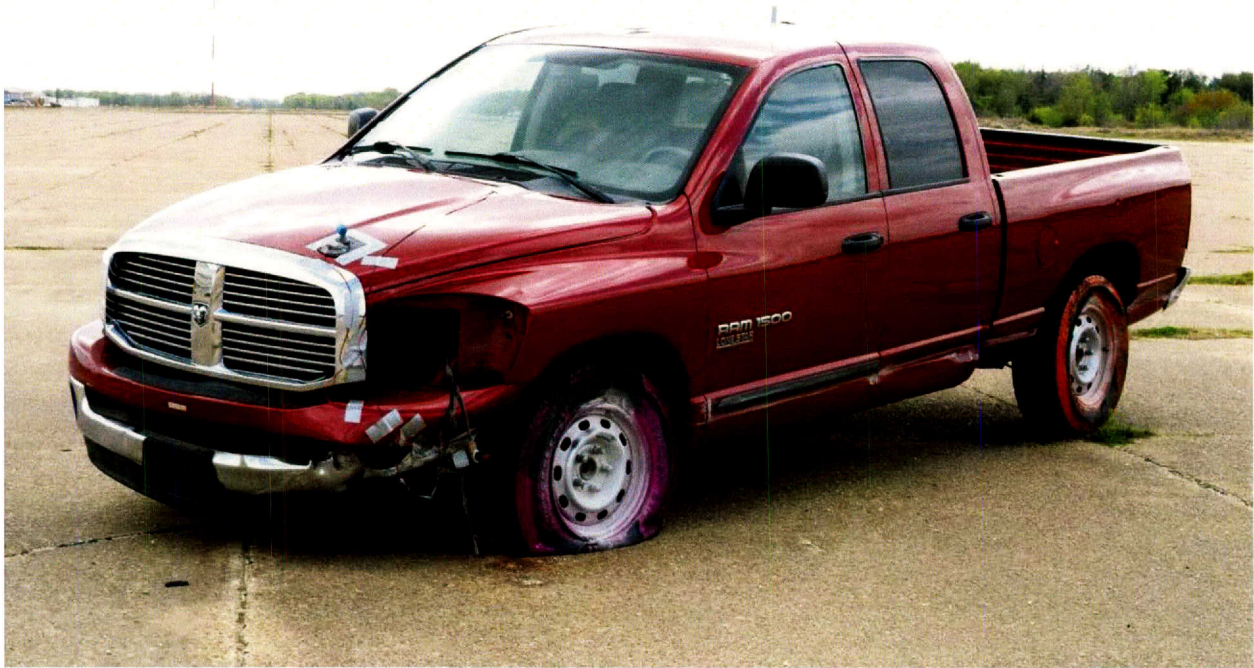
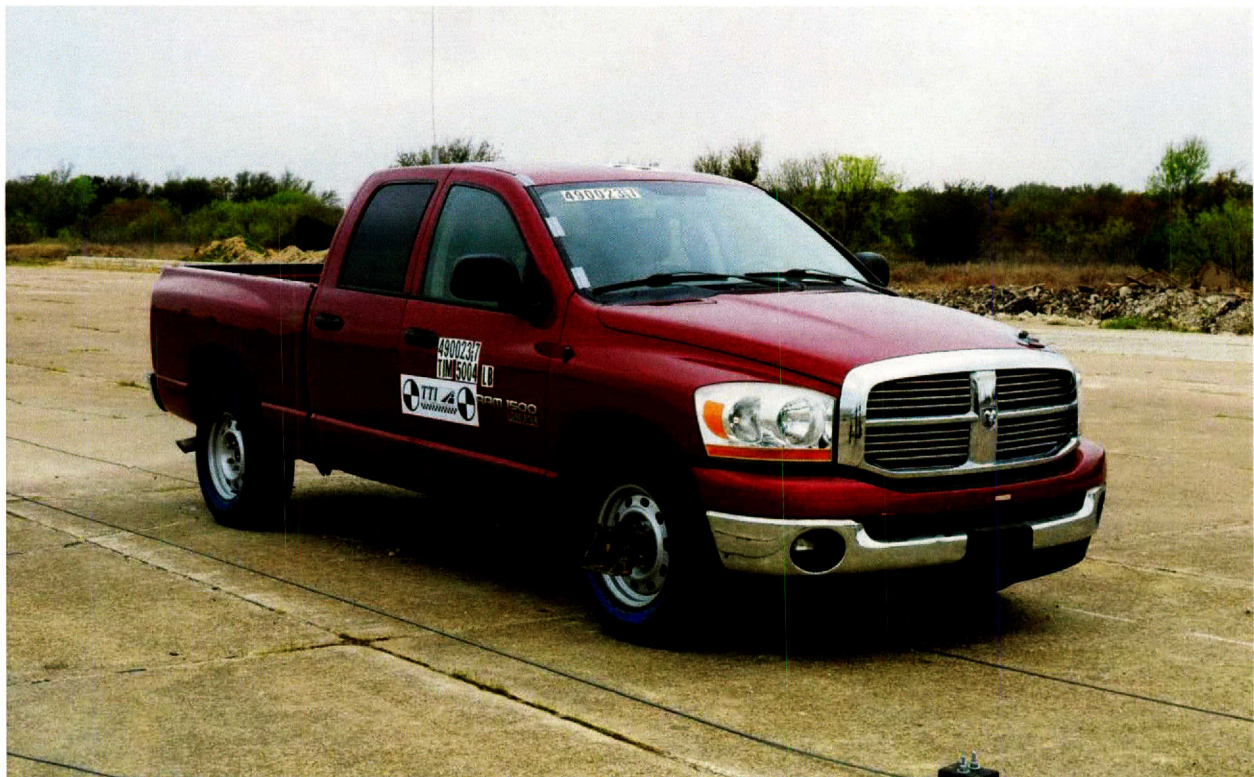
Figure 5.5. Vehicle after Test No. 490023-7.

Figure 5.5 shows damage to the vehicle. The left lower control arm was deformed. The front bumper, left front fender, left front tire and wheel rim, left front and rear doors, left rear of the cab, left exterior bed, left rear front tire and wheel rim, left front and rear doors, left lower corner of the cab, left rear exterior bed, left rear wheel rim, and the rear bumper were damaged. Maximum exterior crush to the vehicle was 14.0 inches in the front plane at the left front corner at bumper height. No occupant compartment deformation occurred. Figure 5.6 has photographs of the interior of the vehicle. Appendix C, Tables C3 and C4 show details of the exterior crush and occupant compartment.

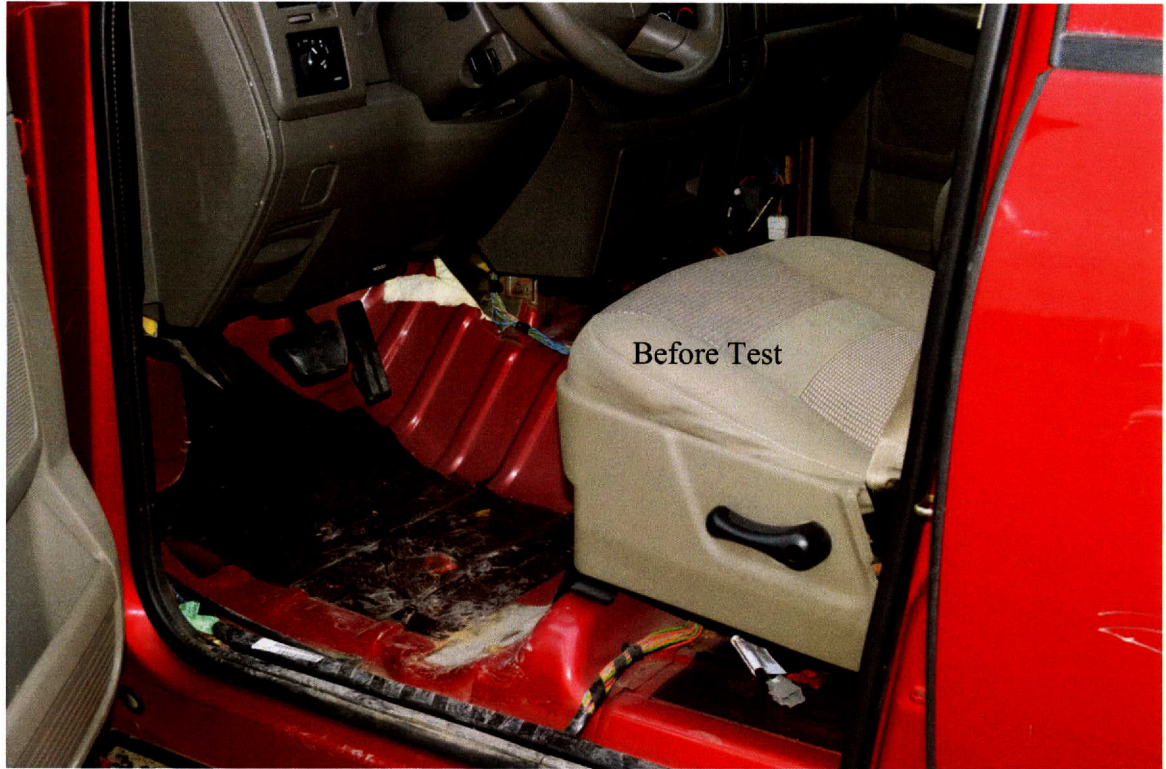
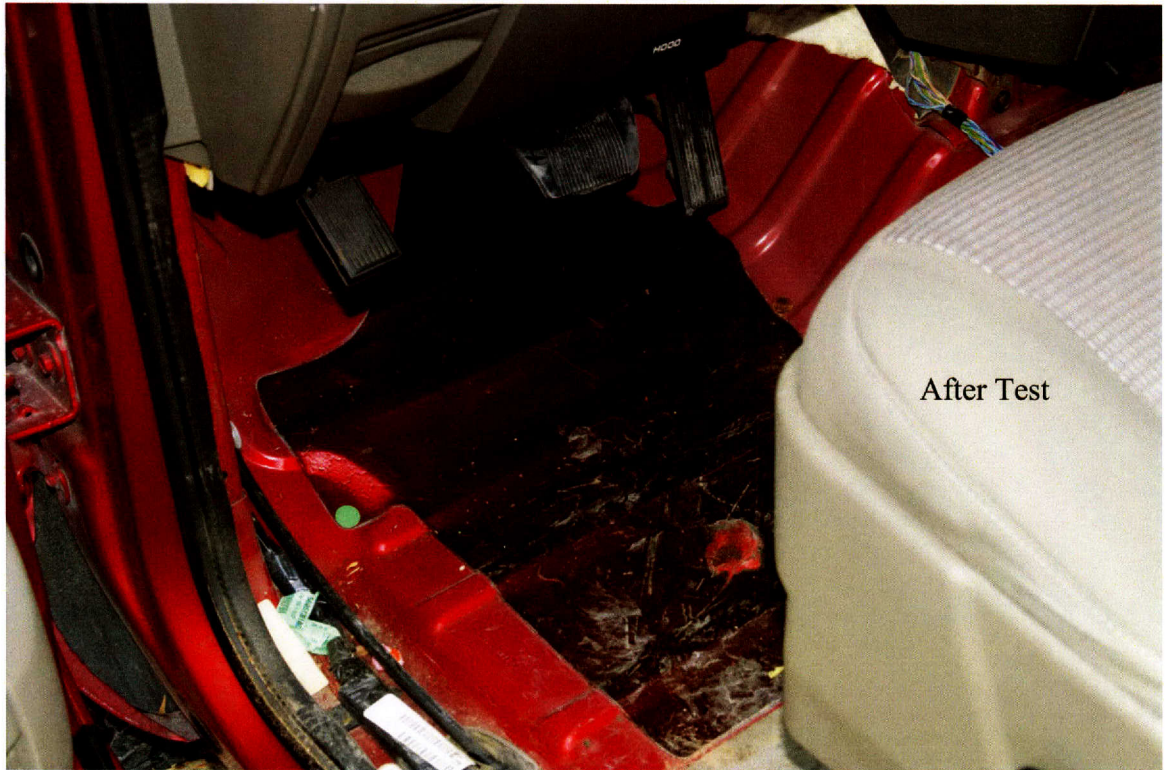
Figure 5.6. Interior of Vehicle for Test No. 490023-7.

Results: No detached elements, fragments, or other debris was present to penetrate or to show potential for penetrating the occupant compartment, or to present hazard to others in the area. (PASS)
No deformation or intrusion into the occupant compartment occurred. (PASS)

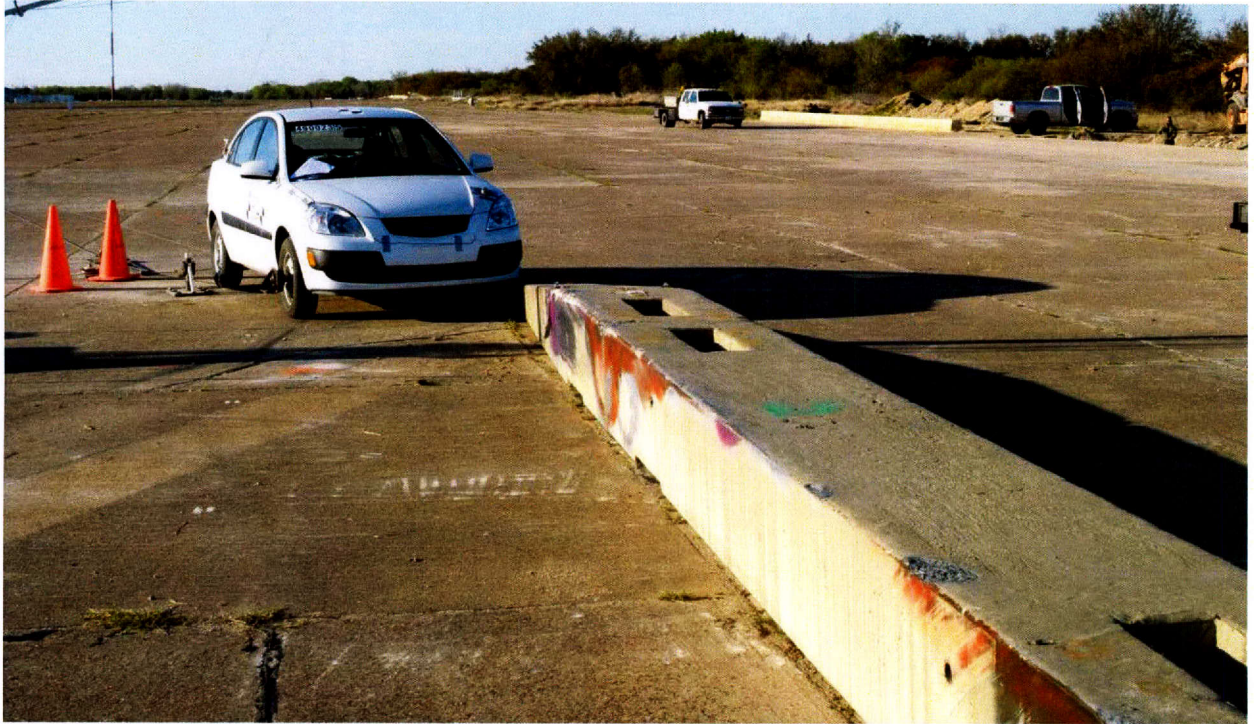
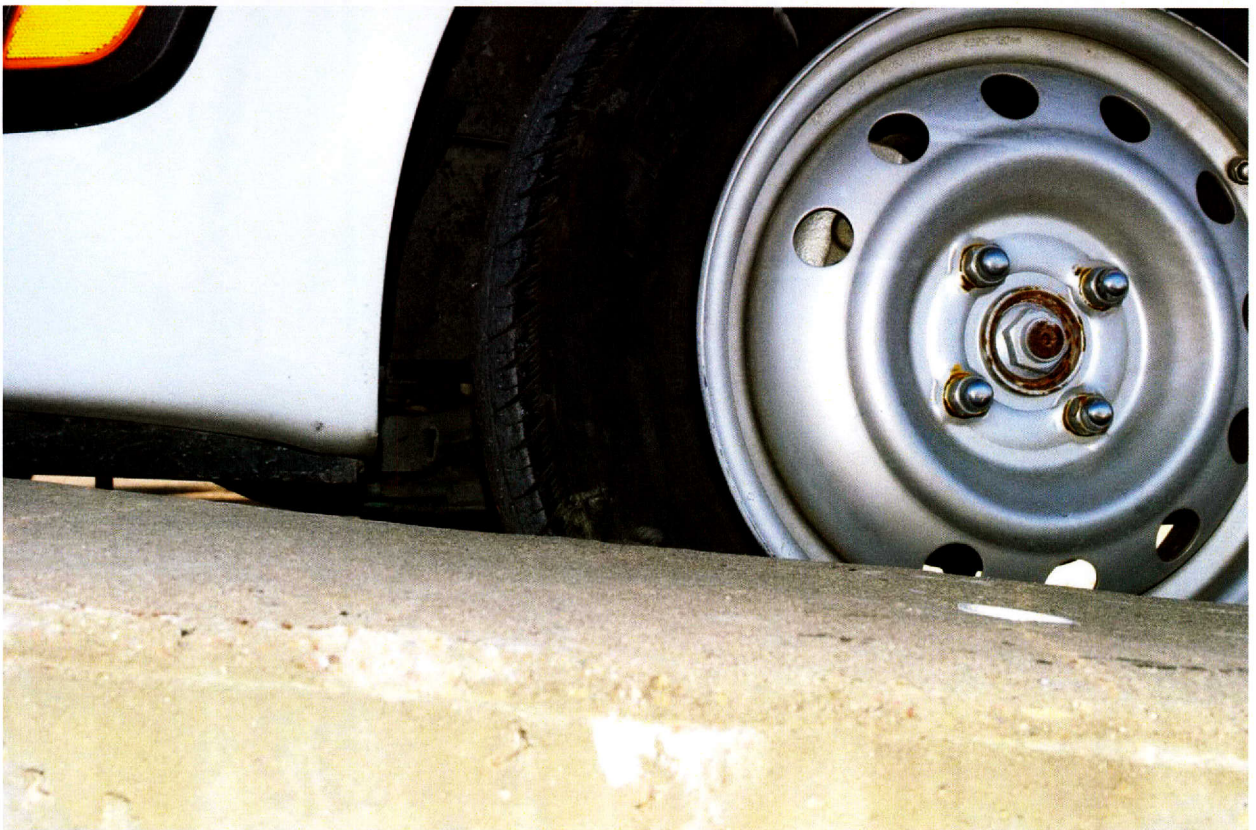
Figure 6.1. Vehicle/Installation Geometrics for Test No. 490023-5.

The 2008 Kia Rio, traveling at an impact speed of 43.9 mi/h, impacted the non-pinned Low-Profile end treatment 33.0 inches downstream from the tip at an impact angle of 15.2 degrees. At approximately 0.020 s, the left front tire began to ride up the traffic face of the end treatment, and at 0.029 s, air began to escape from the tire around the edge of the wheel rim. The left front wheel rim reached the top of the end treatment at 0.042 s, and the vehicle began to redirect at 0.048 s. At 0.084 s, the left front tire was on top the end treatment, and at 0.095 s, the left rear tire contacted the end treatment. The left rear tire climbed on top the end treatment at 0.178 s, and the vehicle was traveling parallel with the barrier at 0.576 s. As the vehicle continued forward, the vehicle rode over the end treatment and came to rest on the field side of the barrier. Figures C1 and C2 in Appendix C show sequential photographs of the test period.

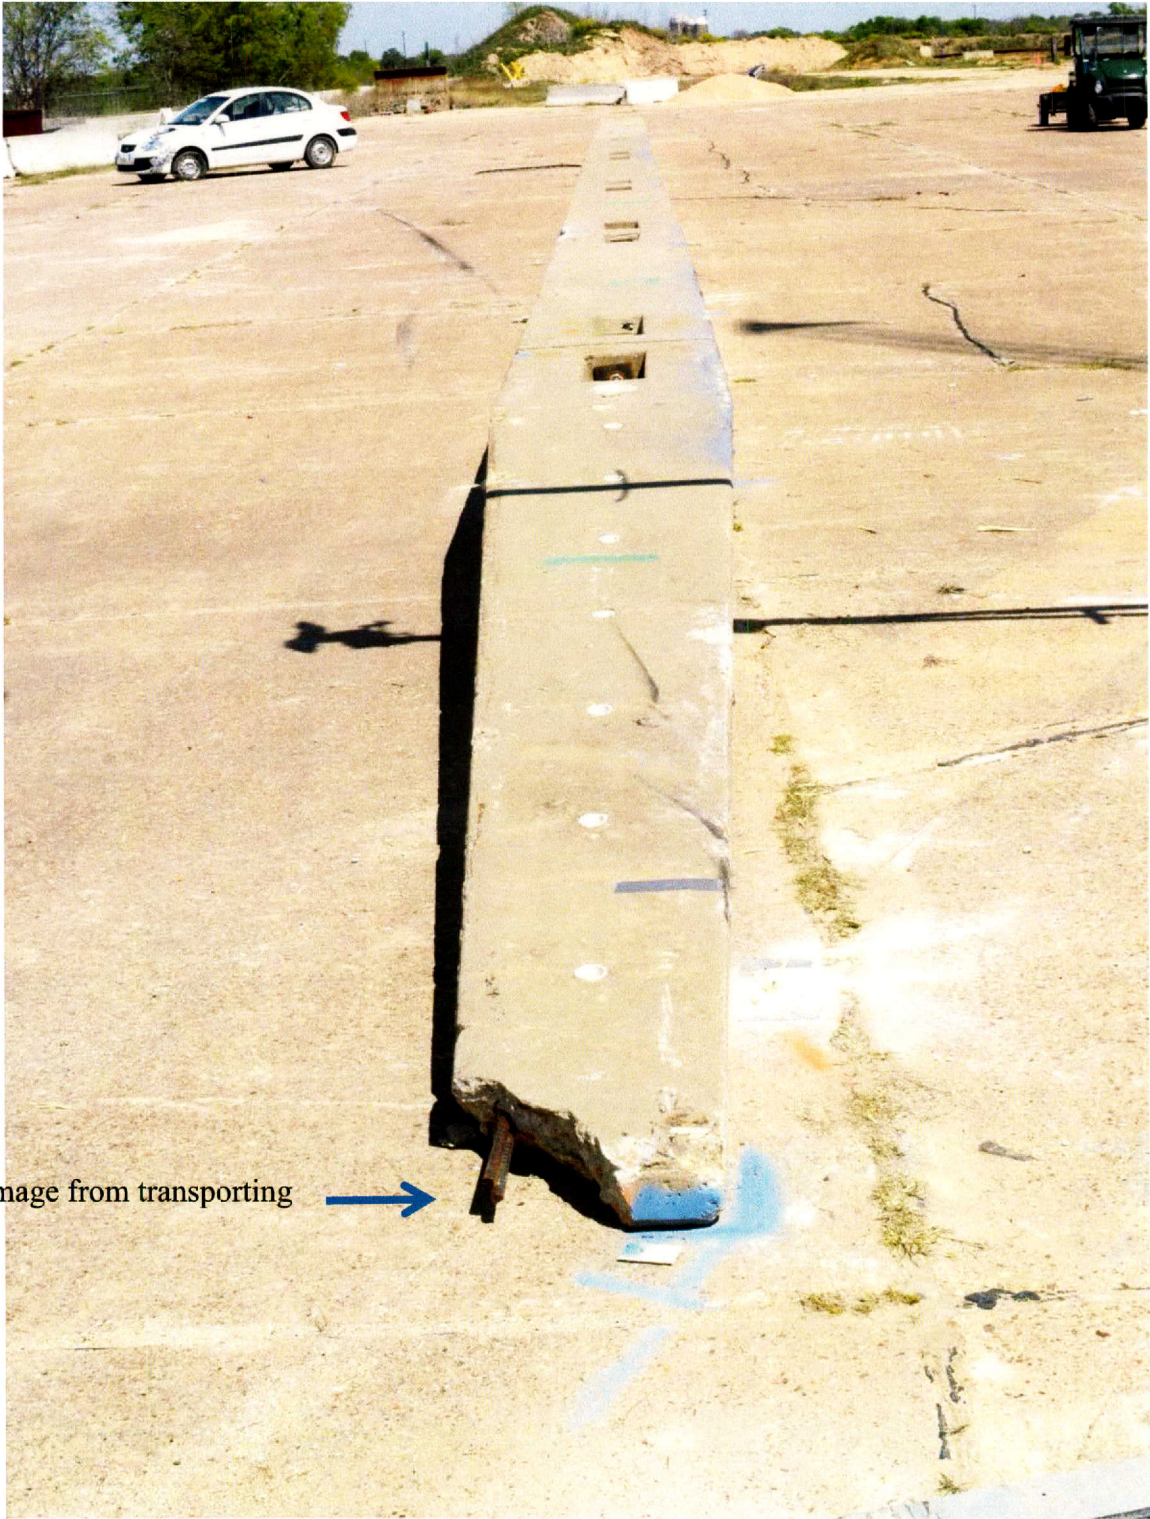
Figure 6.3. Installation/Vehicle Positions after Test No. 490023-5.

Figures 6.3 and 6.4 show damage to the installation, which was mostly cosmetic in nature with tire marks and concrete spalling along the impact area and tire marks only on the top surface of the barrier. Working width during the test was 28.75 inches, and vehicle intrusion was 32.3 ft. Maximum dynamic deflection during the test was 0.75 inch toward the field side, and maximum permanent movement was 0.75 inch toward the field side at the upstream end of the terminal section.

The non-pinned Low-Profile end treatment slowed the 1100C vehicle by allowing the vehicle to gate over the end. Maximum dynamic deflection of the barrier was 0.75 inches measured at the end treatment nose. No detached elements, fragments, or other debris was present to penetrate or to show potential for penetrating the occupant compartment, or to present hazard to others in the area. No deformation or intrusion into the occupant compartment occurred. The 1100C vehicle remained upright during and after the collision event. Maximum roll and pitch angles were 51 degrees and 9 degrees, respectively. Occupant risk factors were within the preferred limits specified in *MASH*.

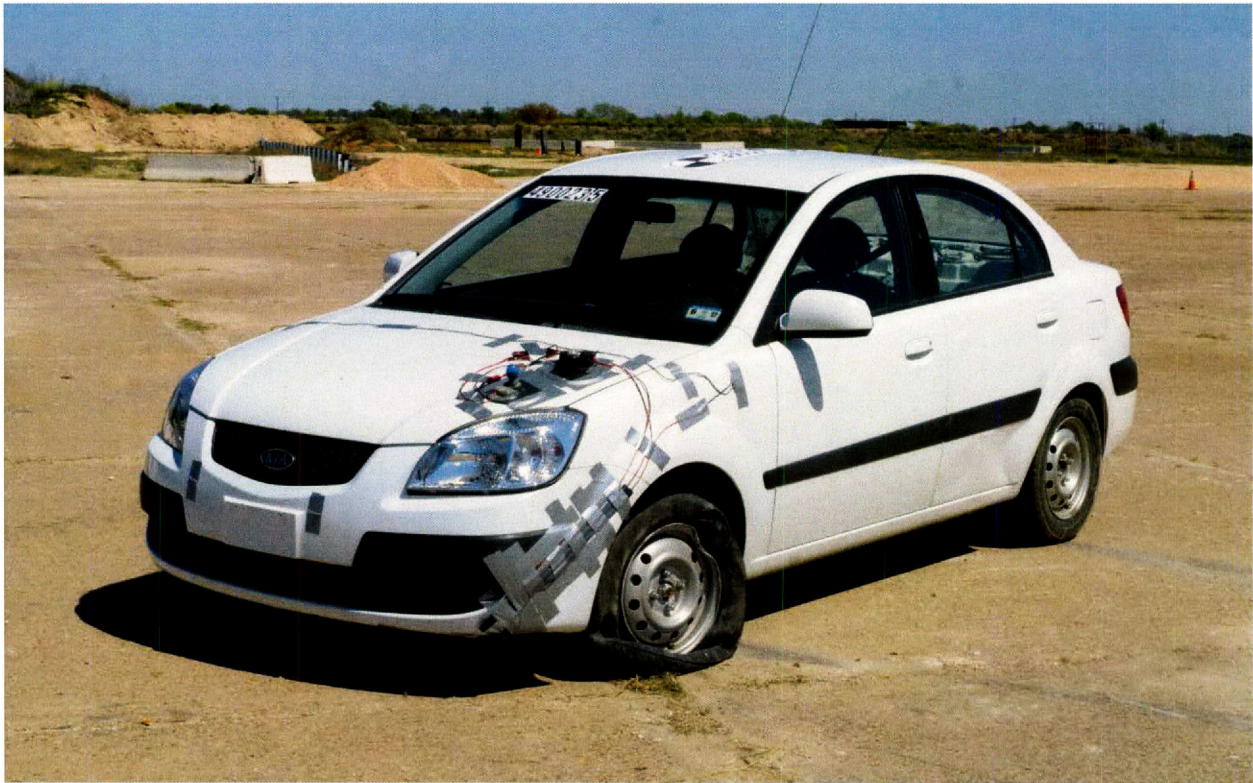
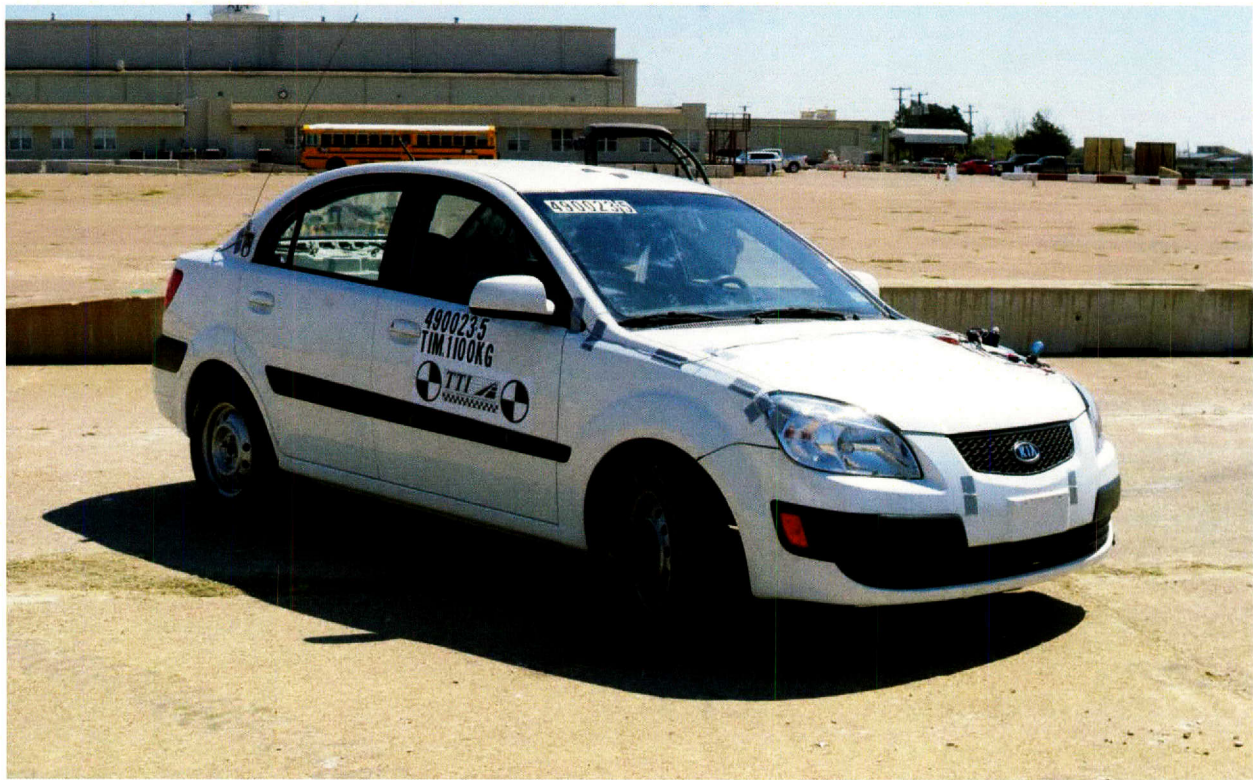
Figure 6.5. Vehicle after Test No. 490023-5.

Figure 6.5 shows damage to the vehicle. The left and right ends of the tie rod and the right lower control arm were deformed. Also, the left front tire and wheel rim and left rear wheel rim were damaged. No measureable exterior crush to the vehicle was noted, nor was there evidence of occupant compartment deformation or intrusion. Photographs of the interior of the vehicle are shown in Figure 6.6. Appendix C, Tables C3 and C4 show the details of the exterior crush and occupant compartment.

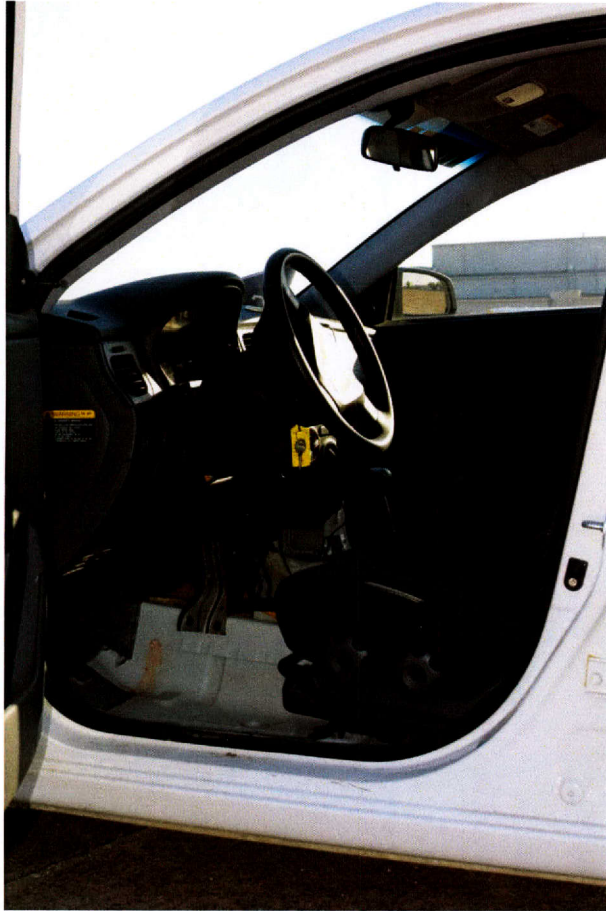
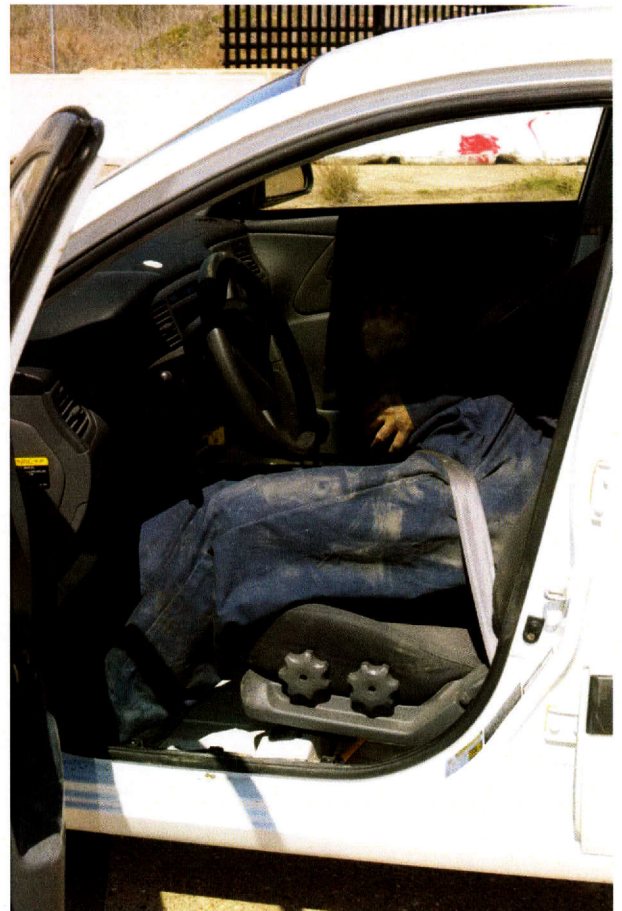
Figure 6.6. Interior of Vehicle for Test No. 490023-5.

Results: No detached elements, fragments, or other debris was present to penetrate or to show potential for penetrating the occupant compartment, or to present hazard to others in the area. (PASS)
No deformation or intrusion into the occupant compartment occurred. (PASS)

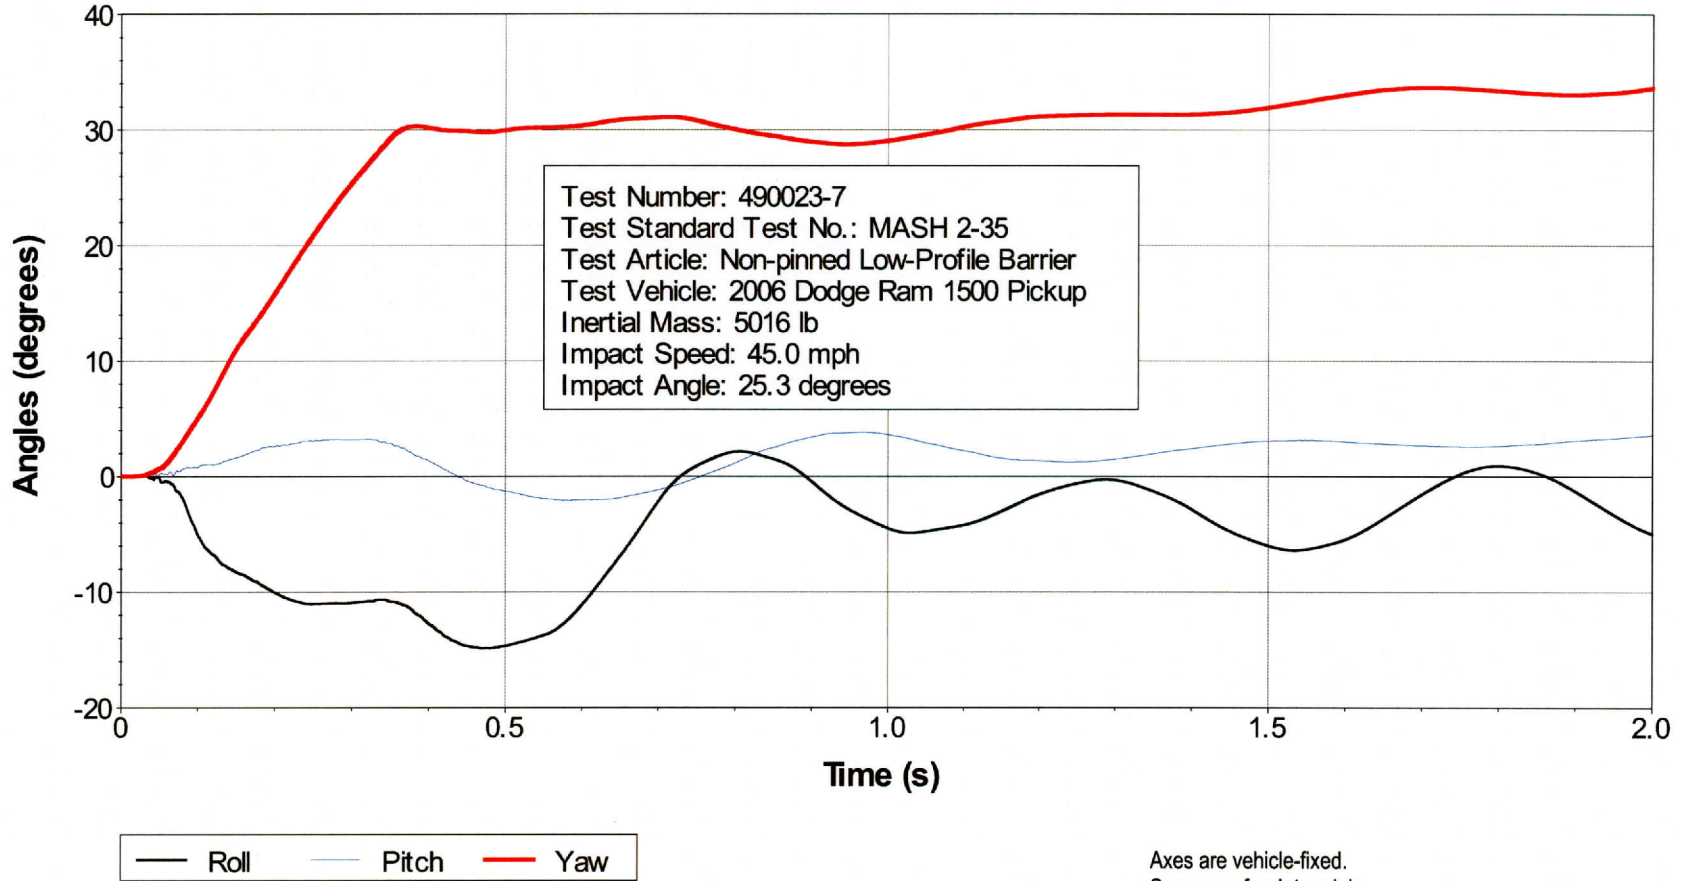
Figure C3. Vehicle Angular Displacements for Test No. 490023-7.

Axes are vehicle-fixed.
Sequence for determining orientation:

1. Yaw.
2. Pitch.
3. Roll.
