DEVELOPMENT AND TESTING OF A NON-PINNED LOW-PROFILE END TREATMENT

Test Report 9-1002-12-7

Cooperative Research Program

**TEXAS A&M TRANSPORTATION INSTITUTE
COLLEGE STATION, TEXAS**

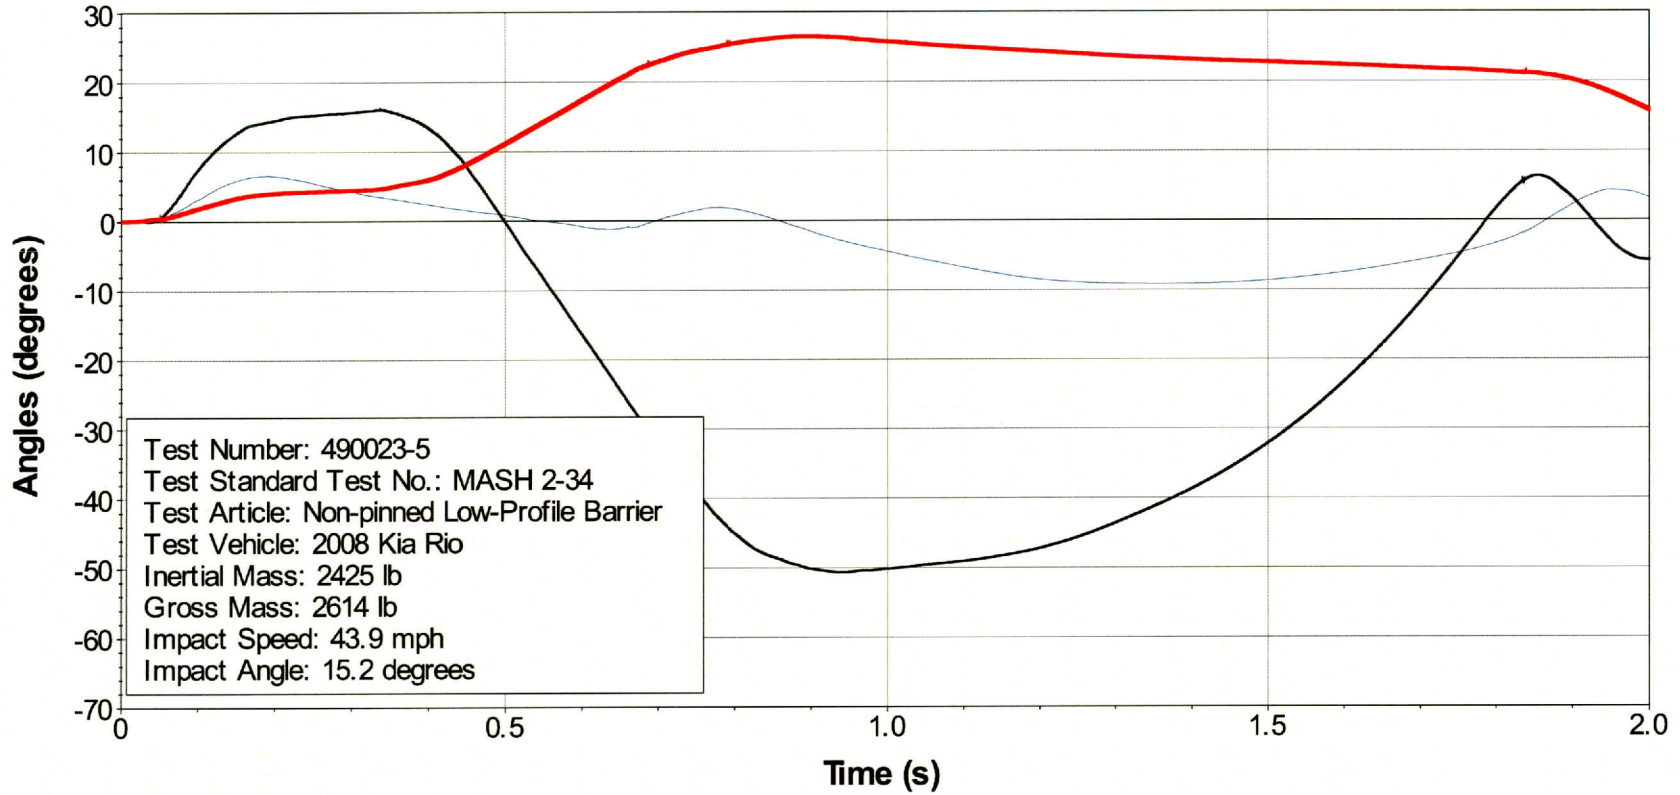
Figure D3. Vehicle Angular Displacements for Test No. 490023-5.

Test Number: 490023-5
 Test Standard Test No.: MASH 2-34
 Test Article: Non-pinned Low-Profile Barrier
 Test Vehicle: 2008 Kia Rio
 Inertial Mass: 2425 lb
 Gross Mass: 2614 lb
 Impact Speed: 43.9 mph
 Impact Angle: 15.2 degrees
