Improving DMS 9210 Requirements for Limestone Rock Asphalt - Final Report

Technical Report 0-6686-2

IMPROVING DMS 9210 REQUIREMENTS FOR LIMESTONE ROCK ASPHALT – FINAL REPORT

Report 0-6686-2
Project 0-6686

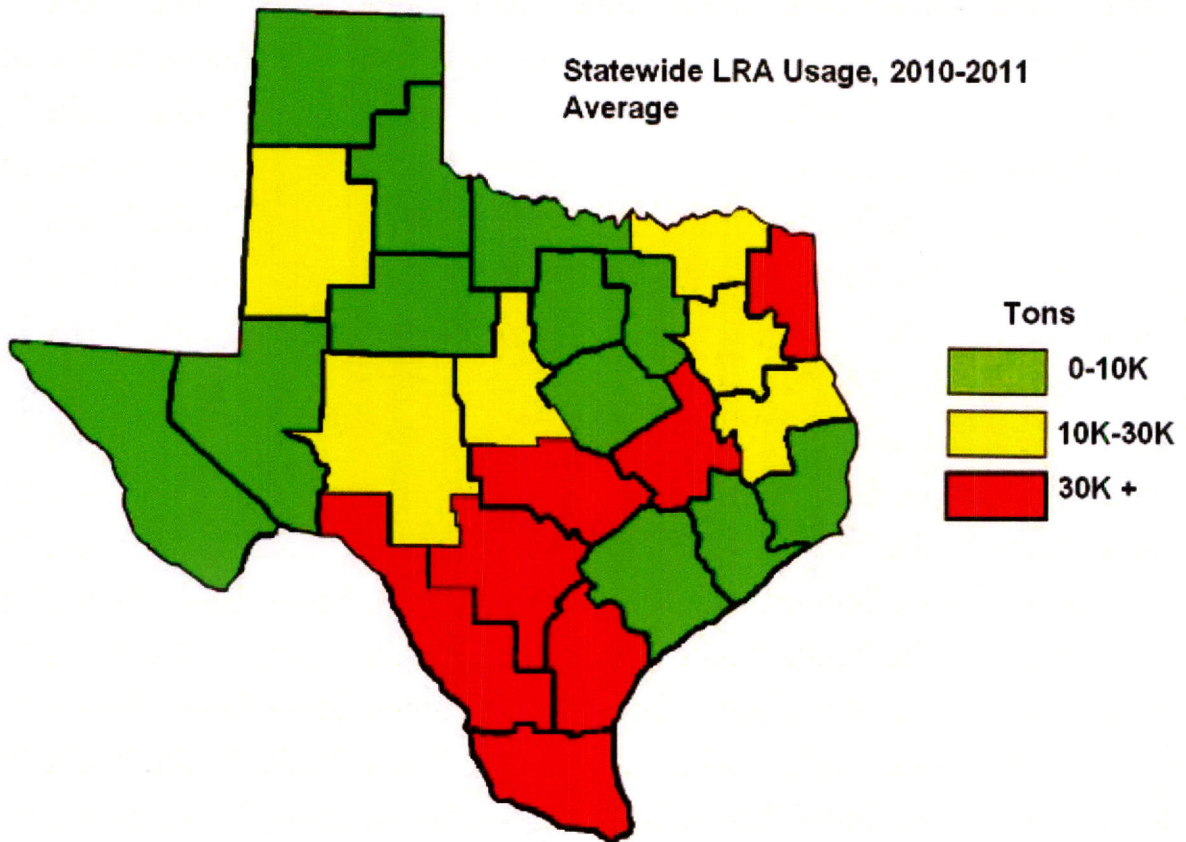
Figure 1. Statewide LRA Usage, FY 2010–2011 Average (as Purchased through Smartbuy).

use it at ambient temperature makes it very versatile. Its use seems to be more predominant in the southern districts (closest to where it is produced in Uvalde); however, it is used statewide as shown in Figure 1 through Figure 3.

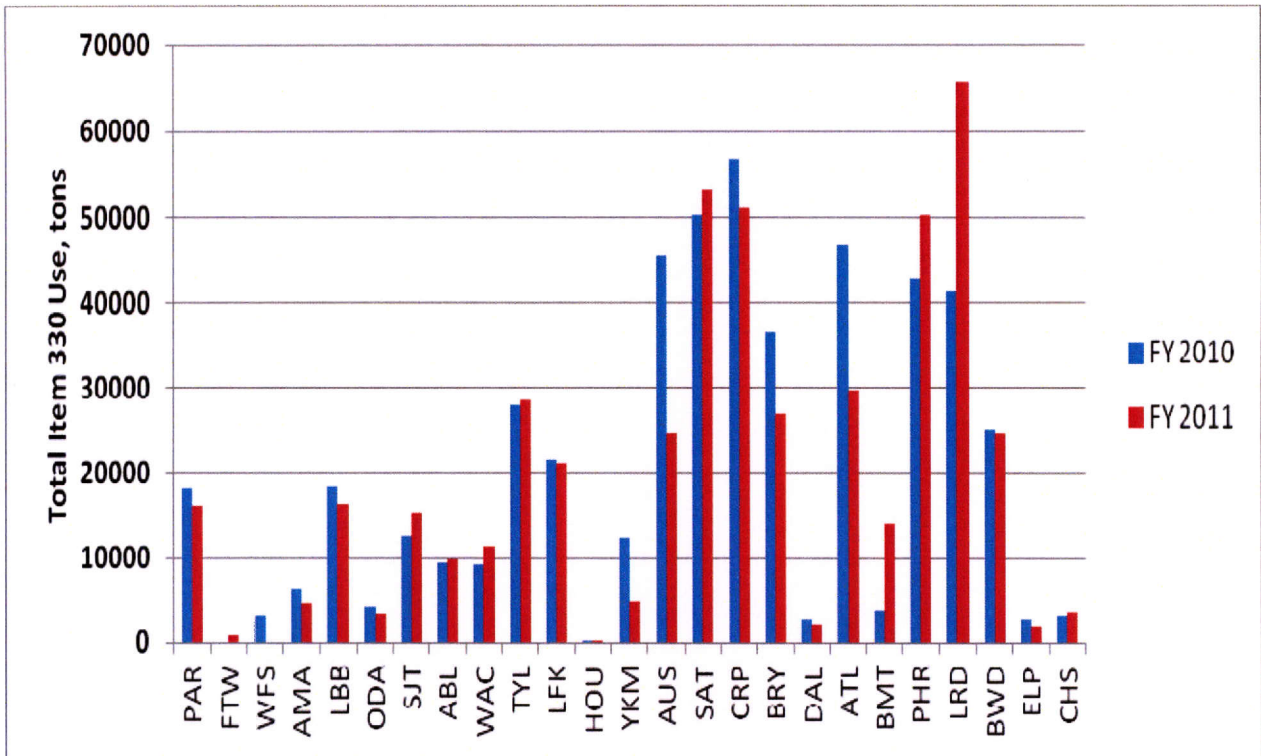
Figure 2. District Use of LRA in FY 2010 and 2011 (as Purchased through Smartbuy).

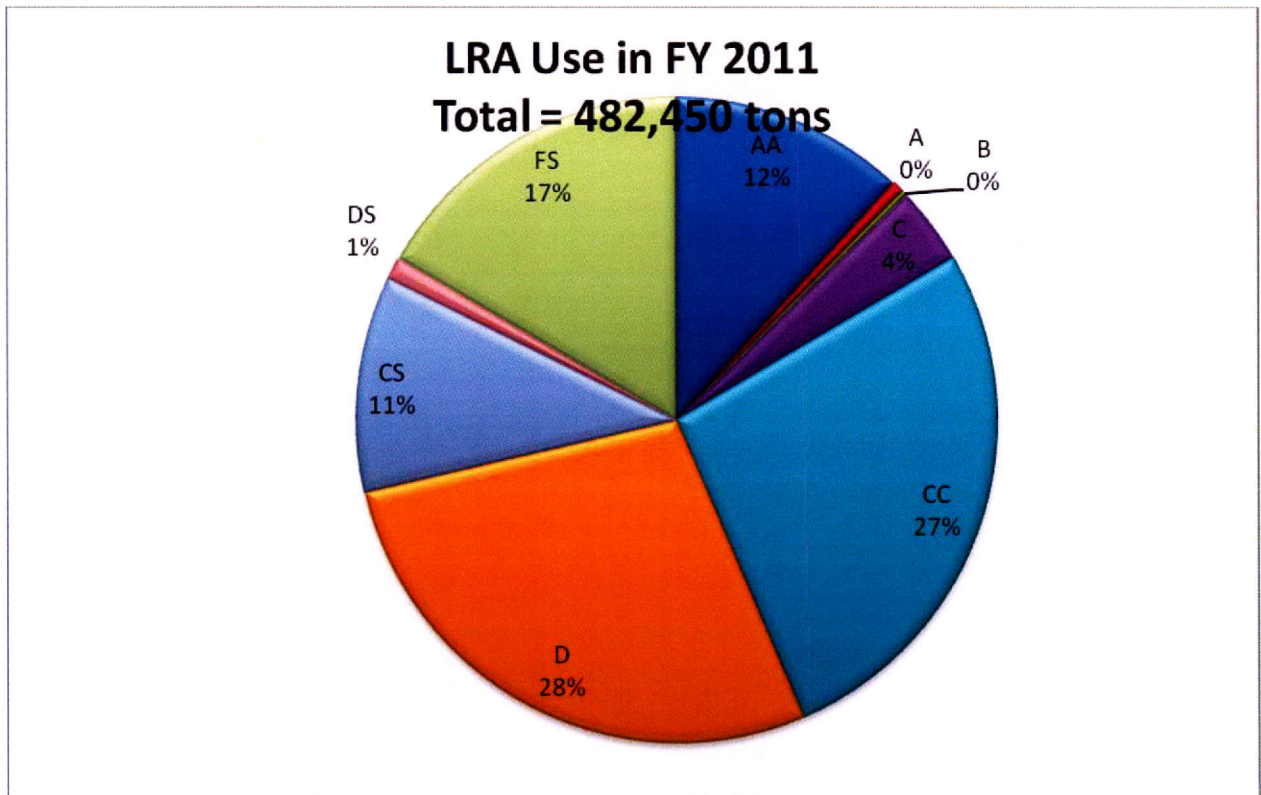
Figure 3. Use of LRA in FY 2011 by Item 330 Type.

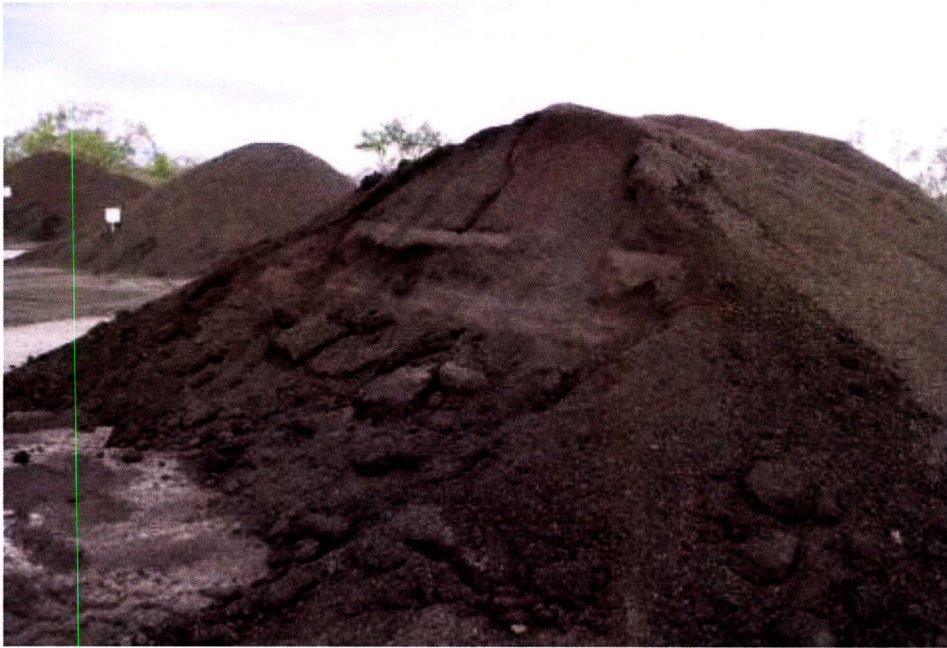
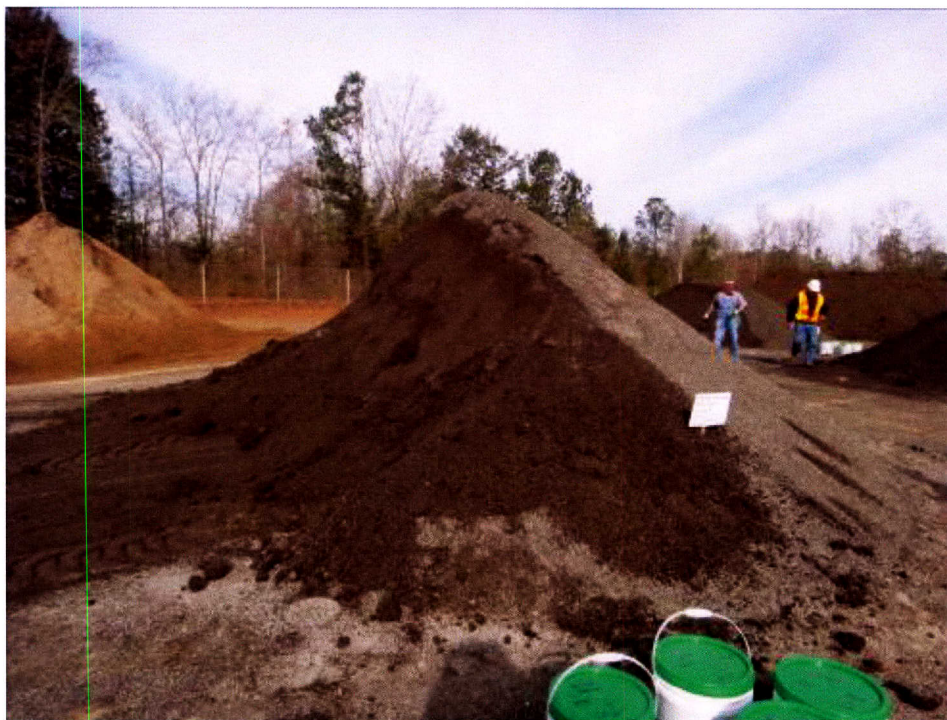
(a) San Antonio District – Uvalde Maintenance.

(b) Atlanta District – Jefferson Maintenance.

Figure 5. Four Stockpiles of Material (Two per Supplier) Shipped to Four Districts.

- Worked with TxDOT to obtain shipments of materials from Martin Marietta and Vulcan to be sent to four different districts (Figure 5)
 - San Antonio.
 - Childress.

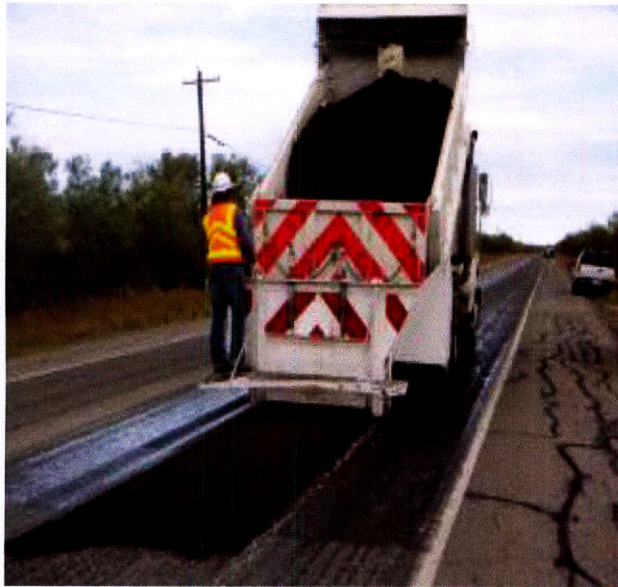
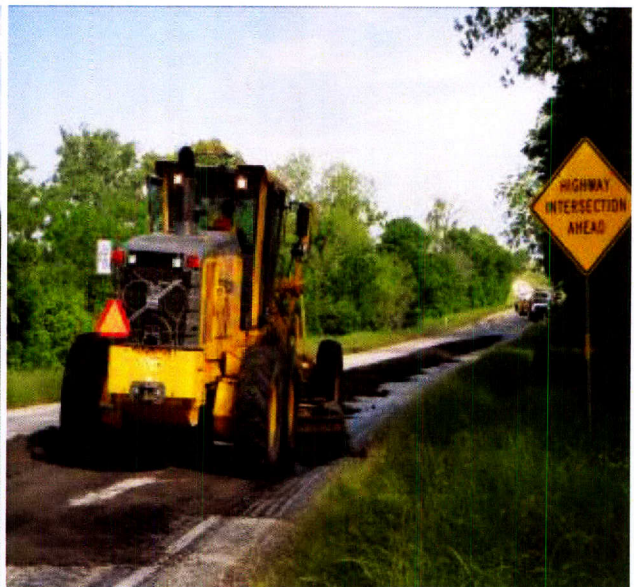
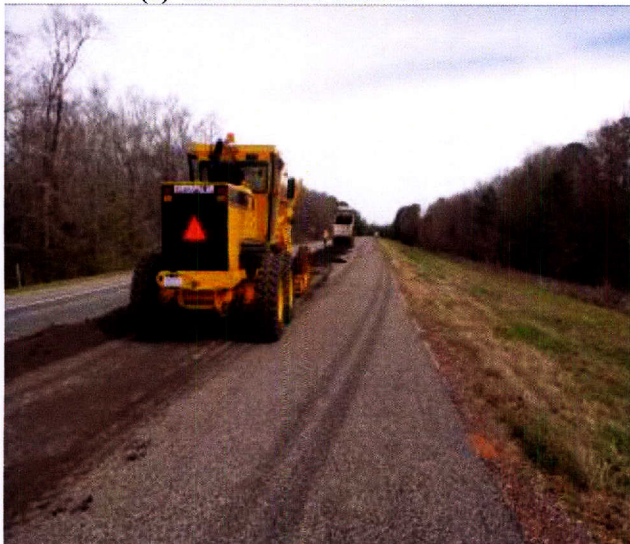
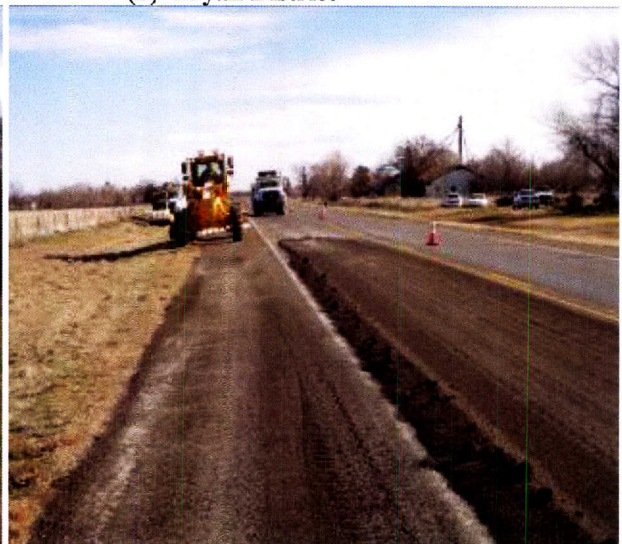
(a) San Antonio District

(b) Bryan District

(c) Atlanta District

(d) Childress District

Figure 6. Test Section Construction in Four TxDOT Districts.

- Bryan.
 - Atlanta.
- Worked with each district to place, document construction and monitor performance of test sections placed in both winter and spring (total of 28). See Figure 6.

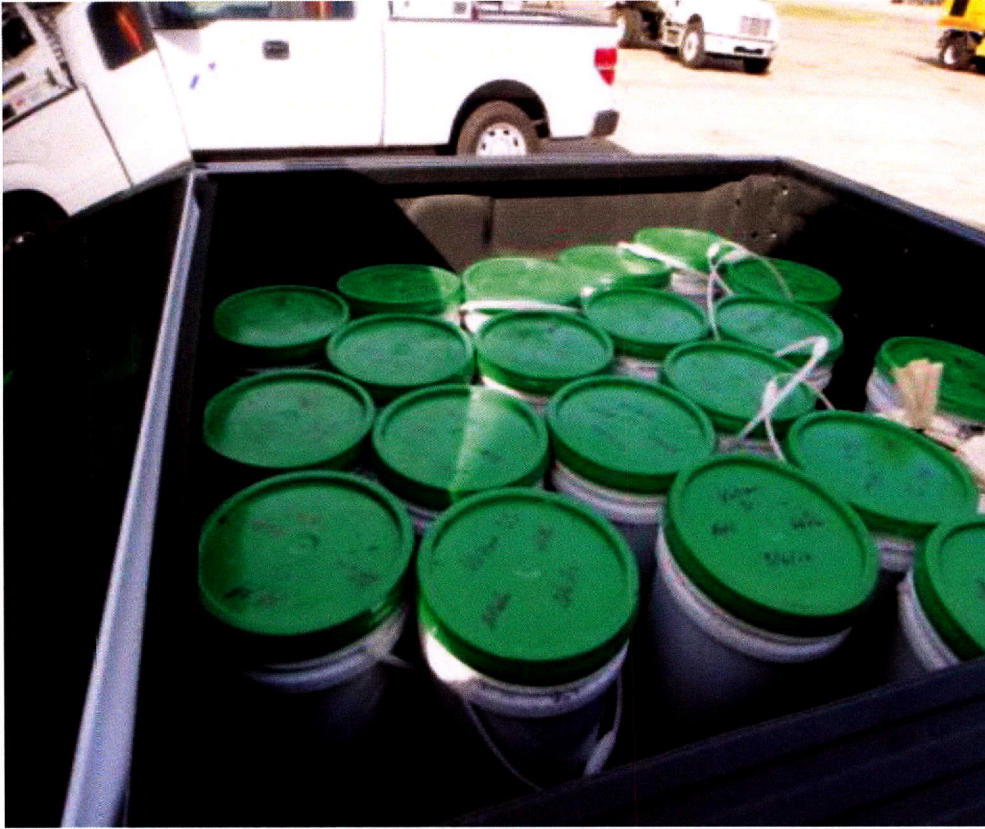
Figure 7. Five Buckets of Each of the Four Stockpiles per District Were Sampled for Further Lab Testing at TTI.

- Obtained samples of material from all 16 stockpiles for the lab testing program (Figure 7).
- Conducted the following lab tests from the field-sampled stockpiles:

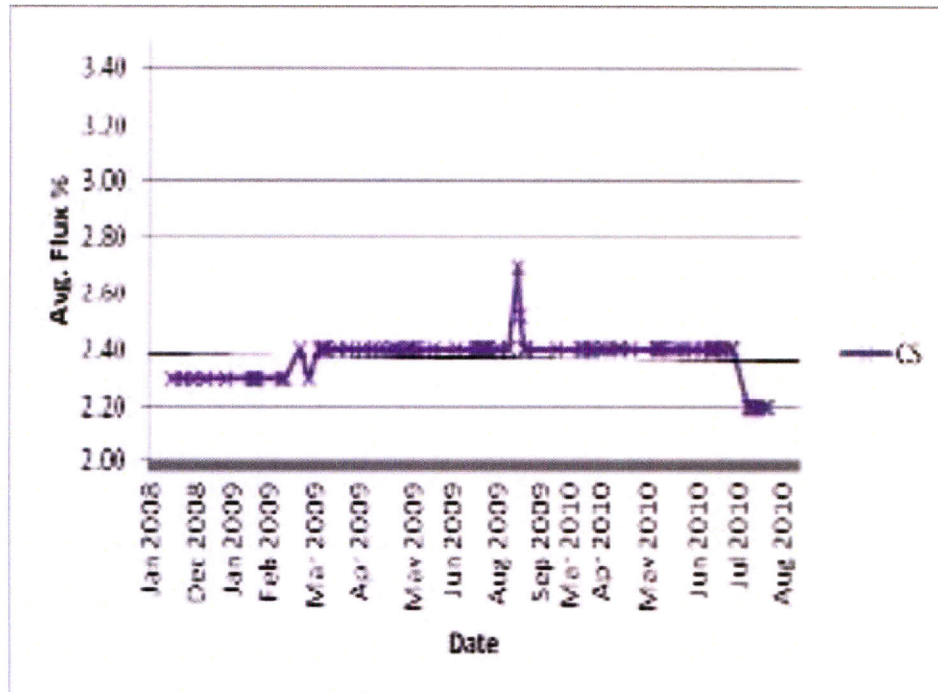
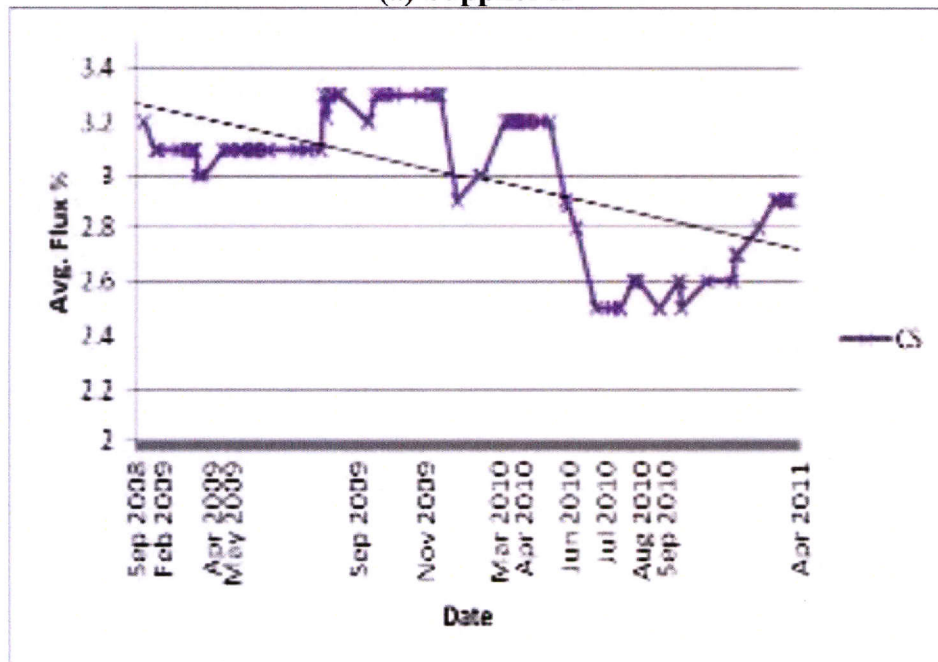
(a) Supplier A

(b) Supplier B

Figure 8. Item 330, Type CS Mixture Production Data, Average Flux Oil Content, % by Wt.

TTI processed and graphed the production data from the data cards from 2009 through 2011 and the main conclusion from this was that one of the suppliers was altering the production process by making significant changes to the amount and possible type of flux oil. This variation in flux oil was noted for all of the LRA mixture types coming from this supplier during the time-frame in question. An example of the difference in the two suppliers is shown in Figure 8 for LRA Type CS.

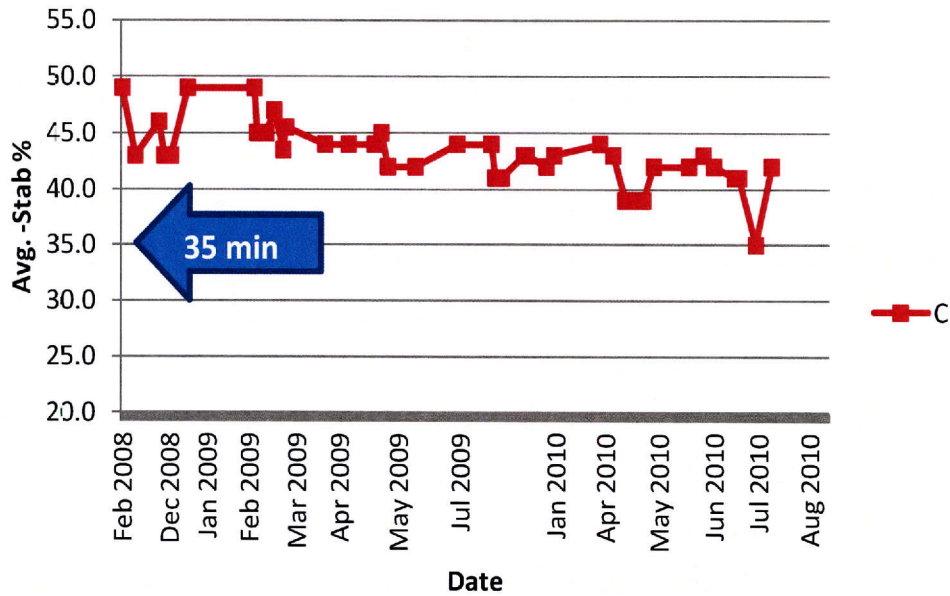
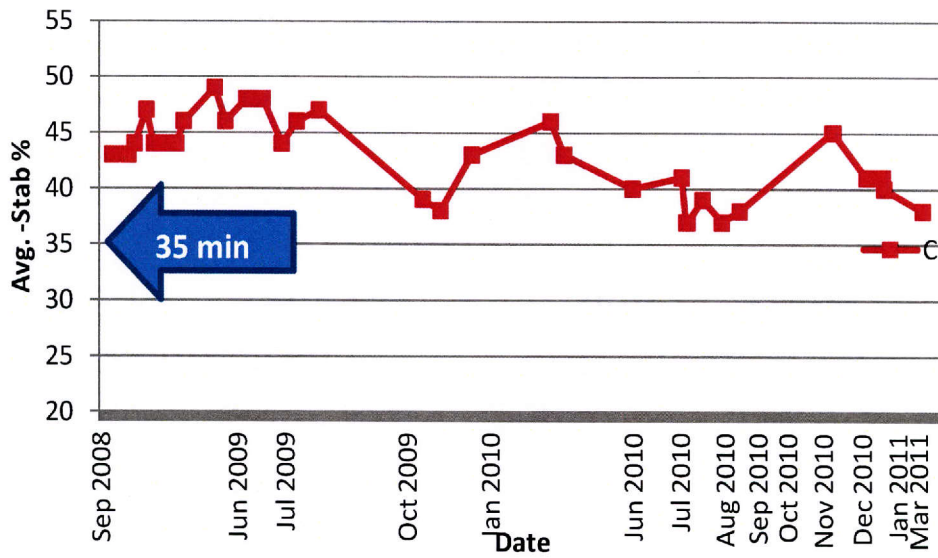
Supplier A

Supplier B

Figure 9. Item 330 Type C, Mixture Production Data, Hveem Stability, %.

- All of the materials passed current specification requirements.
- Hveem stability detects mixes, which are prone to rutting but cannot identify a mix that is too dry and prone to raveling (Figure 9).
- TxDOT needs a new performance-related test and specification requirement to identify mixes, which are too dry and susceptible to raveling.

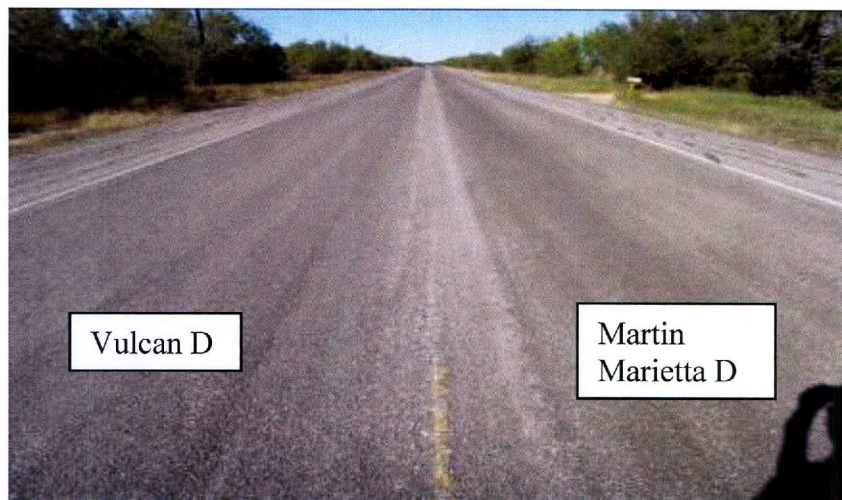
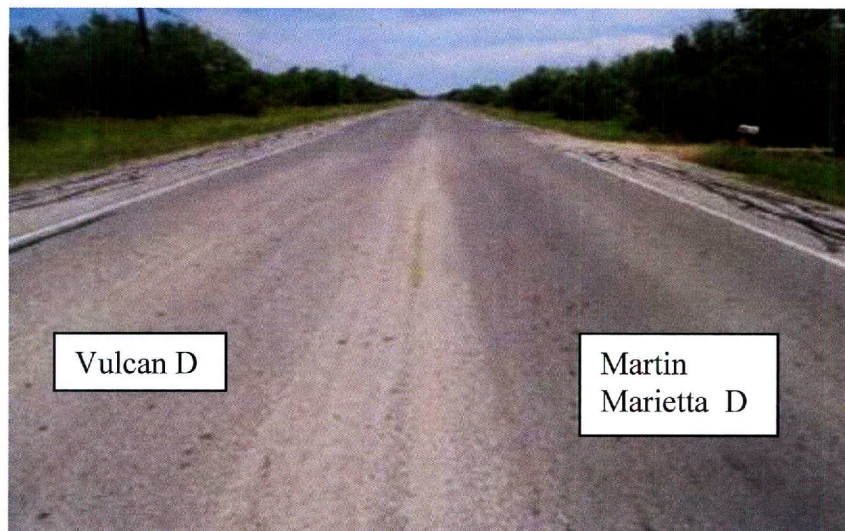
(a) Age One Day

(b) Age Six Months

Figure 10. Uvalde Test Patches Typical of Acceptable Performance in All Test Sections.

- No performance problems were identified throughout 2011 and 2012.
- Twenty-eight test sections were constructed in four districts, fall 2011 and spring 2012 construction.
 - Martin Marietta D.
 - Martin Marietta DS.
 - Vulcan D.
 - Vulcan DS.
- All exhibited minor raveling in day 1.
- No major performance problems after 12+ months in service (see Figure 10).
- District survey in fall 2012 identified no new field performance problems.

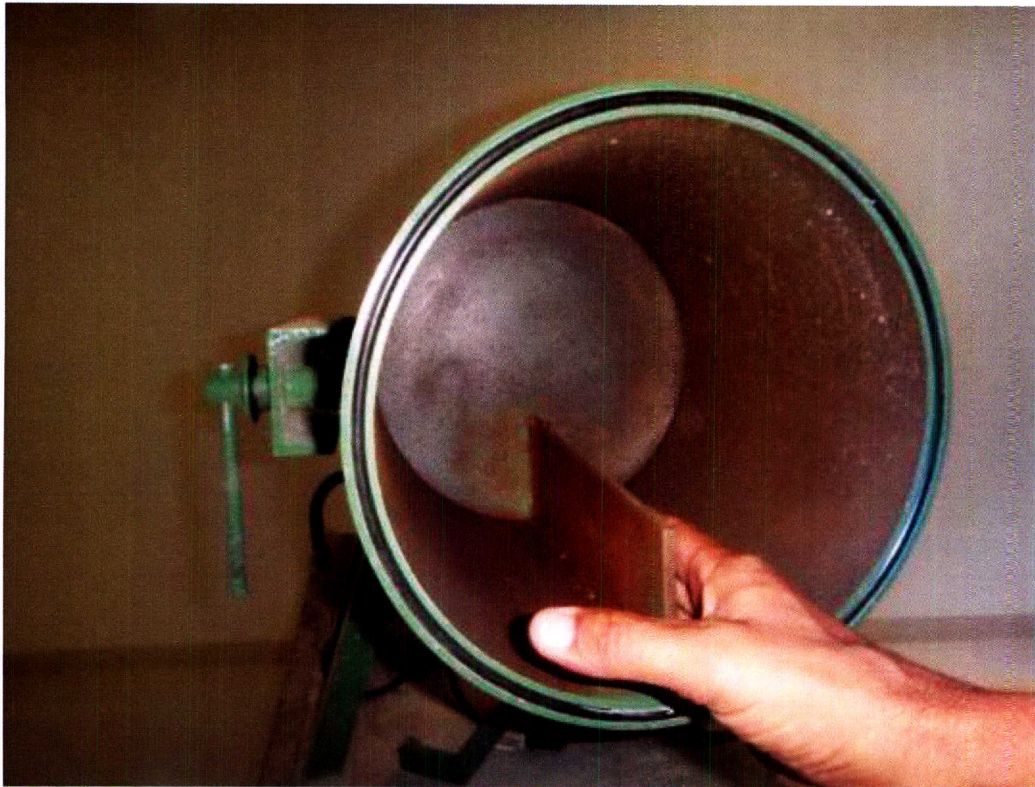
Figure 11. Inside of Wet Ball Mill Drum.

It was initially hoped that the wet ball mill equipment could be used (similar in nature to the Cantabro test but on a small scale) as a potential specification parameter. Numerous tests were conducted on dry and wet conditioned samples; however, the wet ball mill equipment could never induce enough damage to the specimens to be conclusive. This equipment is shown in Figure 11.

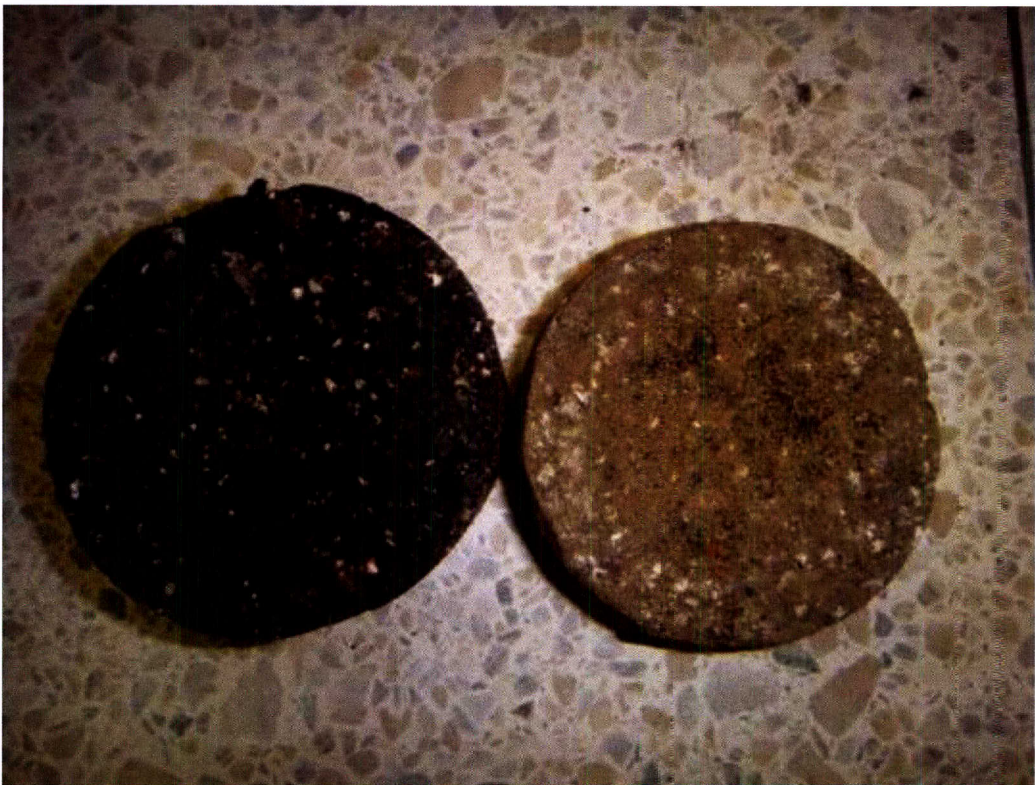
Figure 12. Texas Gyratory Specimen of LRA before and after Tumbling in Wet Ball Mill Machine.

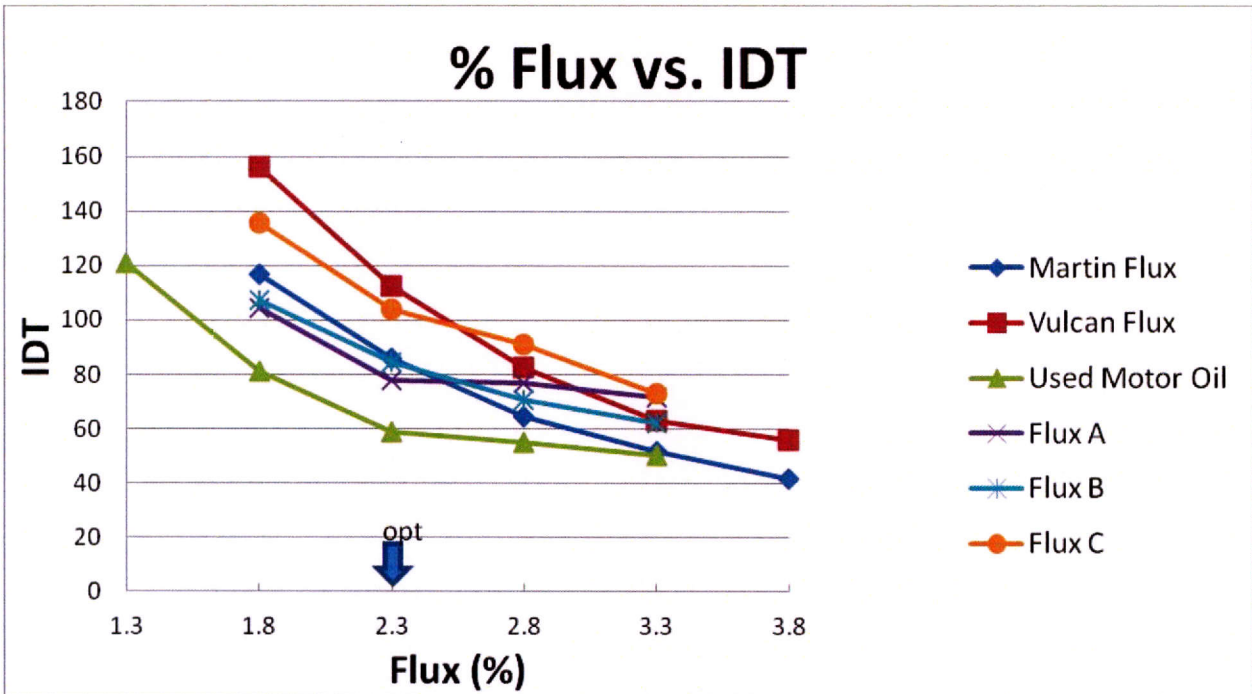
Figure 13. Indirect Tensile Strength at Different Flux Oil Contents.

Indirect tensile strength testing consistently showed decreasing strength with increasing flux oil content but did not seem to distinguish between good and bad flux oils (Figure 13 and Figure 14). The Cantabro Test equipment is shown in Figure 15. A Texas Gyrotory sample is shown before and after Cantabro in Figure 16. Additional Cantabro-tested specimens are shown in Figure 17 showing that the specimen experiences more loss in material as flux oil content decreases (as expected).

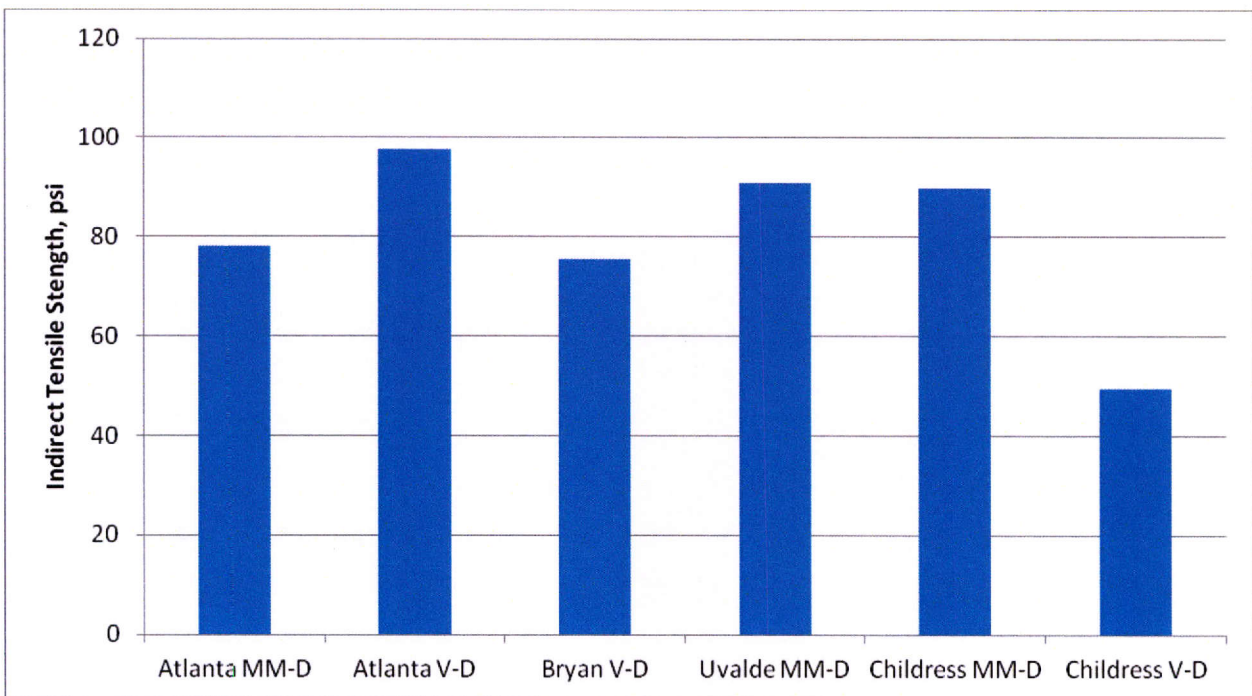
Figure 14. Indirect Tensile Strength of Field Test Section Mixes.

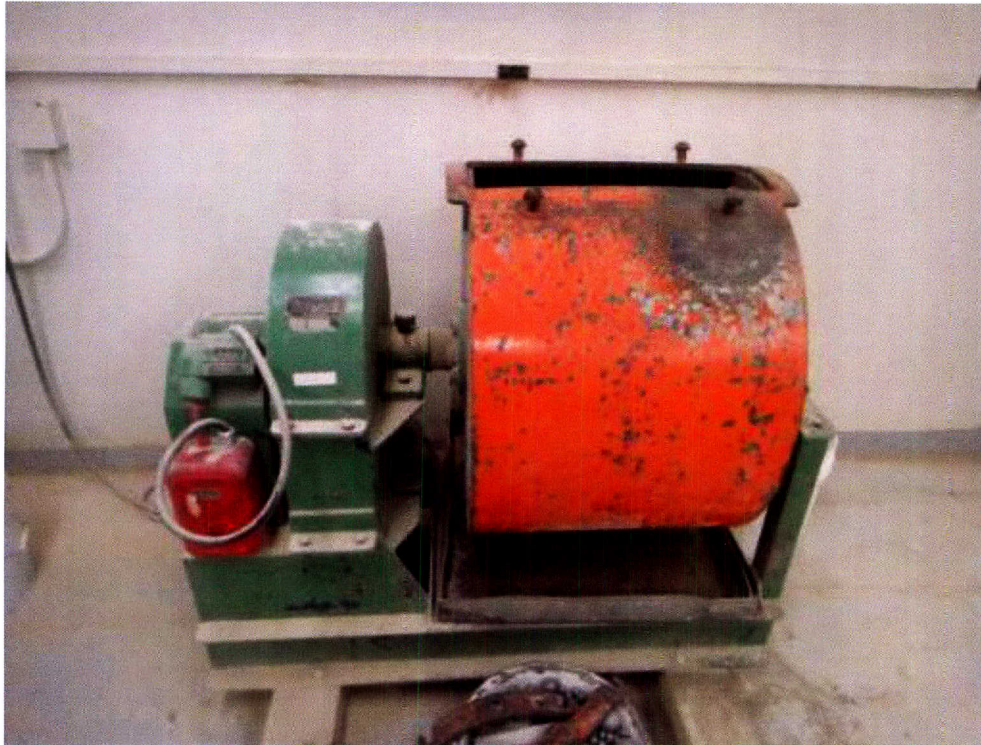
Figure 15. Los Angeles Abrasion Machine Used for Cantabro Test.

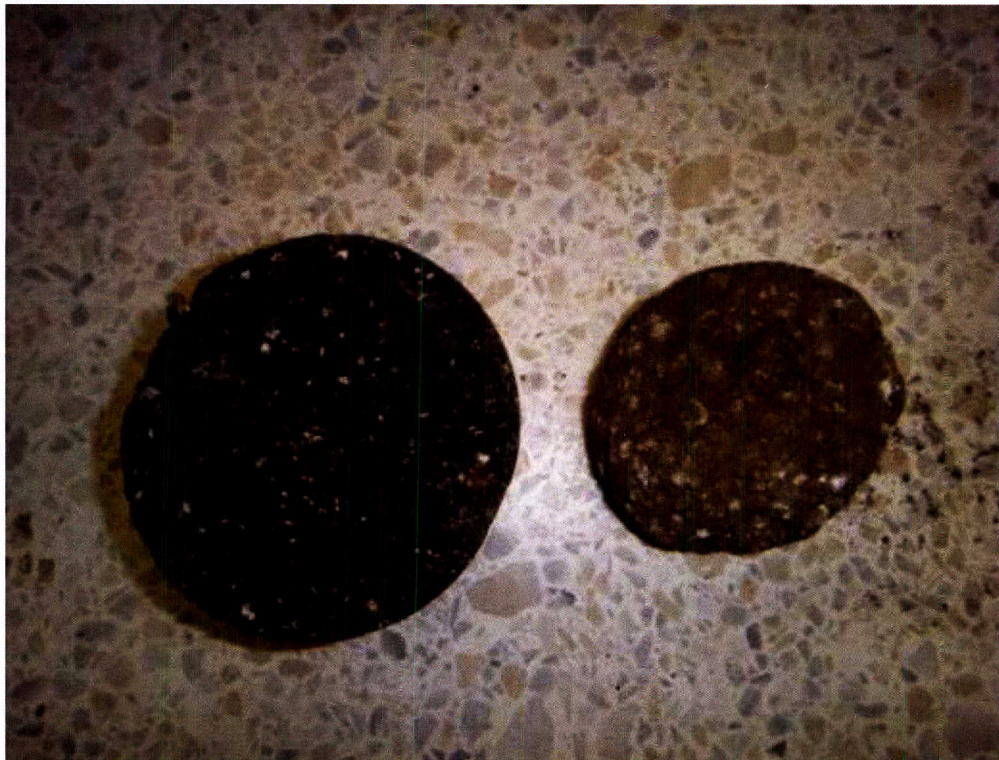
Figure 16. Texas Gyratory LRA Specimen before and after Cantabro Test.

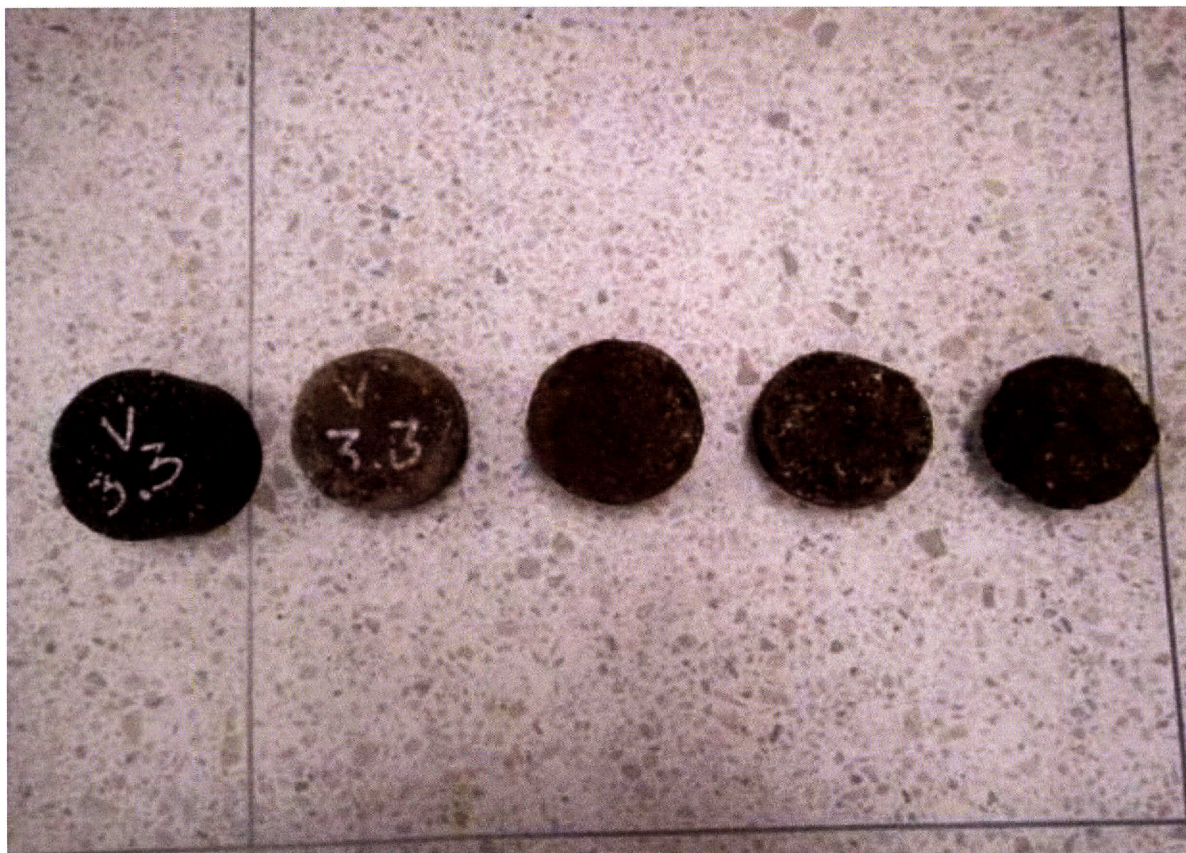
Figure 17. Cantabro-Tested Specimens at Decreasing Flux Oil Contents from Left to Right.

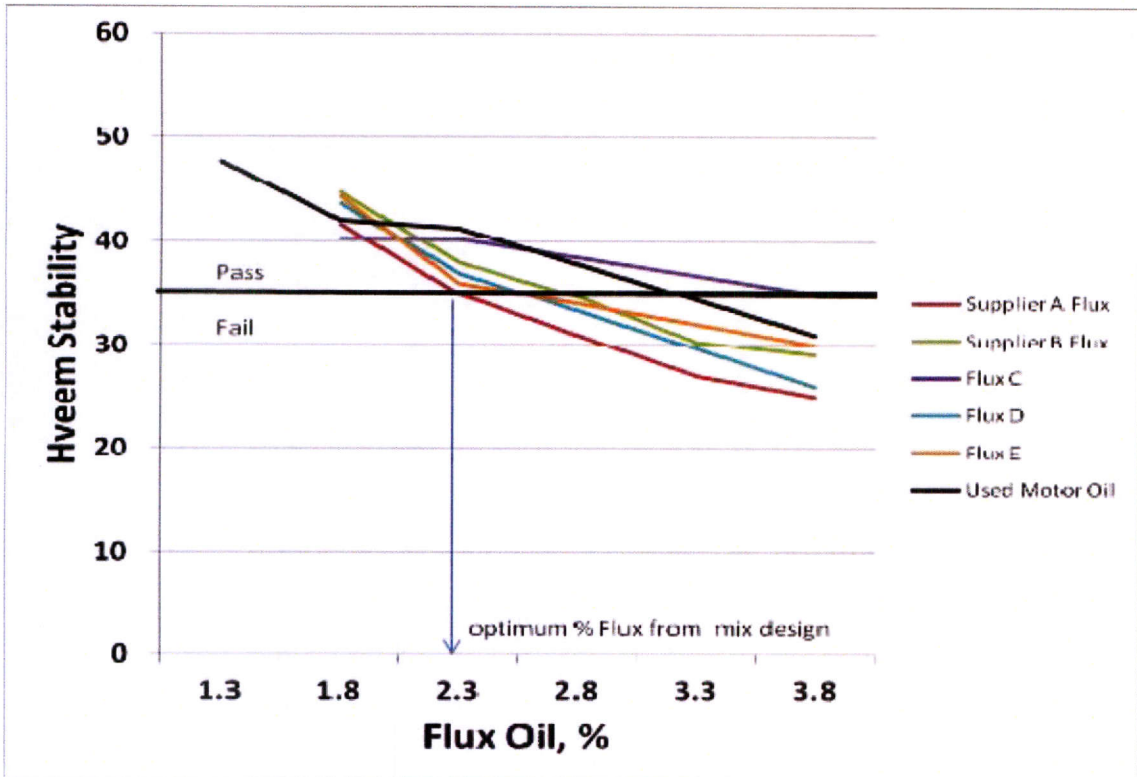
Figure 18. Hveem Stability at Different Flux Oil Contents and Types.

The Hveem stability test results and Cantabro results are shown in Figure 18 and Figure 19, respectively. As flux oil content increased, the Cantabro loss generally decreased for most of the flux oils (except the used motor oil) as shown in the attached figure. This is as expected since more binder added to the mix should prevent raveling. In addition, the Cantabro test was able to distinguish between a good and bad flux oil. The used motor oil provided very little cohesion and binding capabilities to the mix and note in the following graphs that the Cantabro Loss was over 40 percent regardless of the quantity used.

The Hveem stability is a good test to determine rutting resistance of LRA but it does not indicate when a mix is too dry. In fact, the drier the mix, the better the Hveem stability (see attached figure). Given that used motor oil was used as one of the flux oils, one could assume that potentially anything that meets viscosity requirements for the flux could be used as the additive to LRA and still pass the Hveem stability requirements, yet give very poor field performance in terms of raveling.

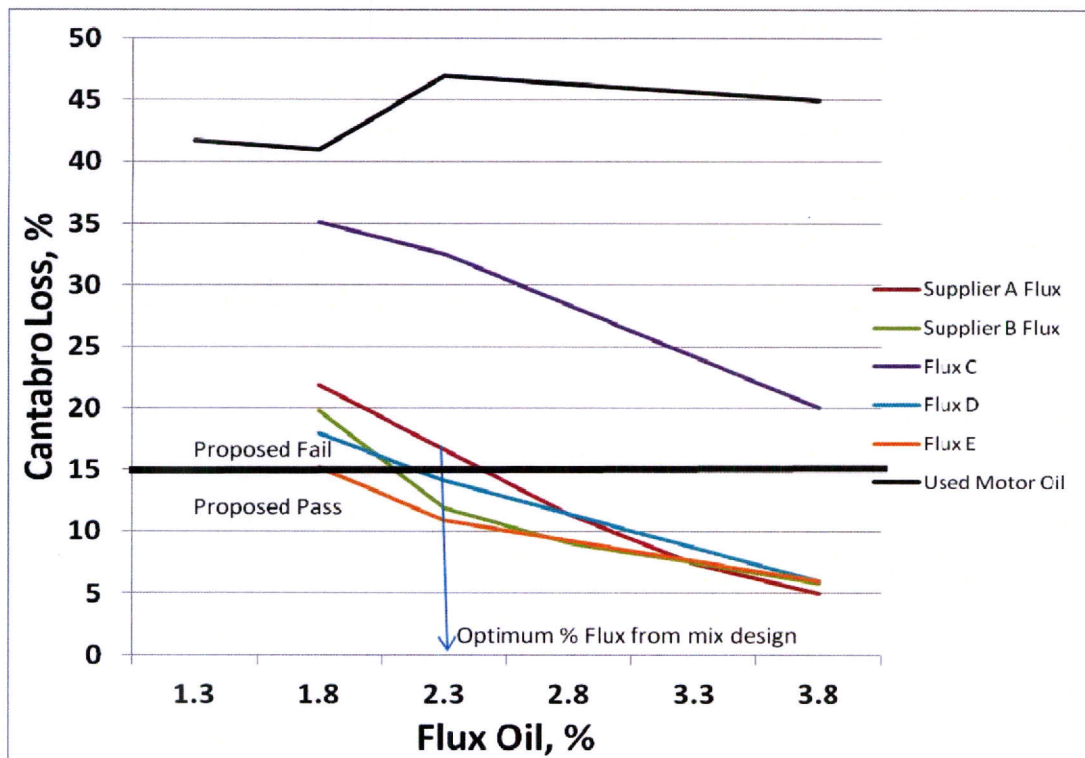
Figure 19. Cantabro Loss at Different Flux Oil Contents and Types.

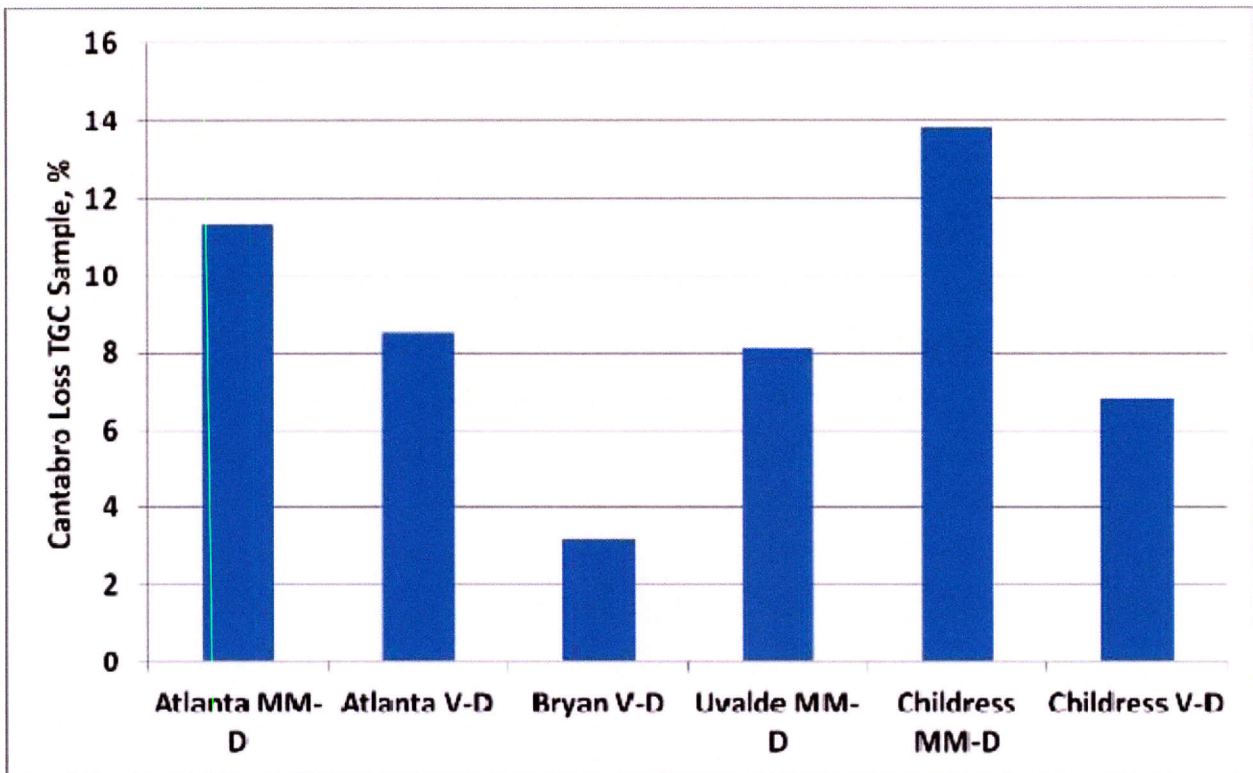
Figure 20. Cantabro Loss of Samples from Field Test Sections.

A proposed Cantabro loss of 15 percent maximum is being proposed as a specification limit due in part to the results shown in Figure 20 of all of the test section materials that are known to have good field performance and are all below 15 percent loss on the Cantabro Test.

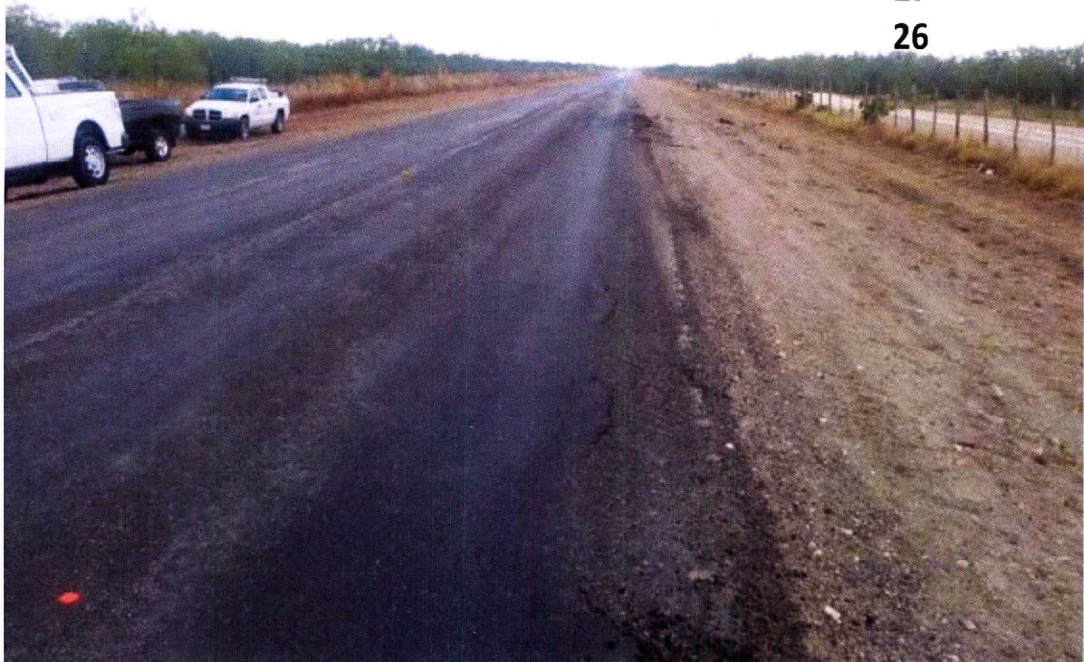
TTI Hveem Stability on Remolded Millings

Figure 21. Rutting Failure of LRA Overlay in Dimmit County, Laredo District.

- Hveem stability is still good detector of unstable mix as was evidenced in Dimmit County in the Laredo District where the LRA mix rutted but TTI's tests on the millings from the surface indicated the mix failed Hveem stability (Figure 21).

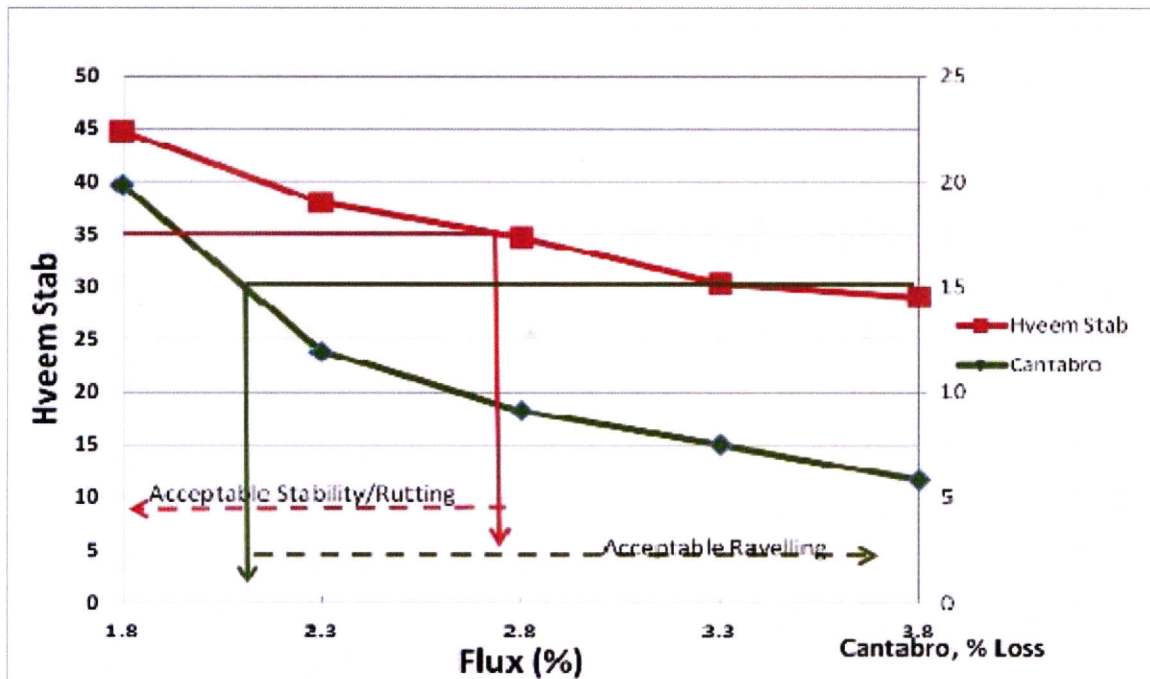
Figure 22. Approach to Balance Hveem Stability and Cantabro Loss Requirements to Achieve Acceptable Field Performance of LRA.

- Balancing both a Hveem stability test and Cantabro Loss test, both rutting and raveling performance requirements should be met (Figure 22).

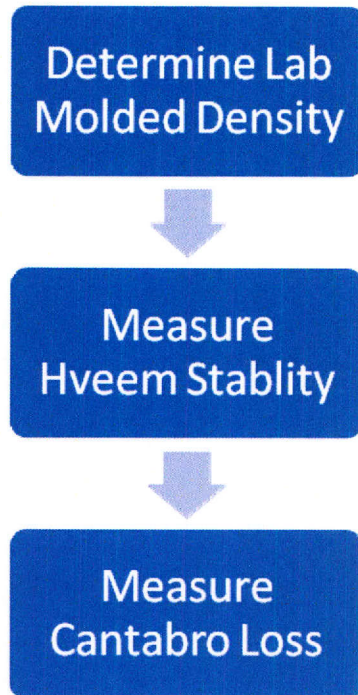
Figure 23. Proposed Testing Sequence for Single Texas Gyratory Molded Specimen.

The testing sequence to be performed on a single Texas Gyrotory Molded sample is shown in Figure 23.
