Research on Joint Sealant Materials to Improve Installation and Performance: Final Report

Pangil Choi, Sanjaya Senadheera, and Moon C. Won

Performed in cooperation with the Texas Department of Transportation and the Federal Highway Administration

Research Project 0-6826 Research Report 0-6826-1 http://www.techmrt.ttu.edu/reports.php

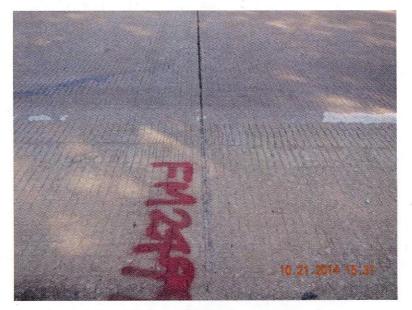
Figure 2.3 Low level of stone intrusion

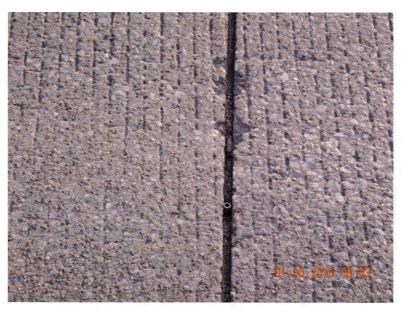
Figure 2.4 Medium level of stone intrusion

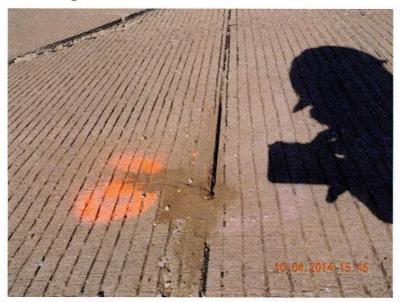
Figure 2.5 High level of stone intrusion

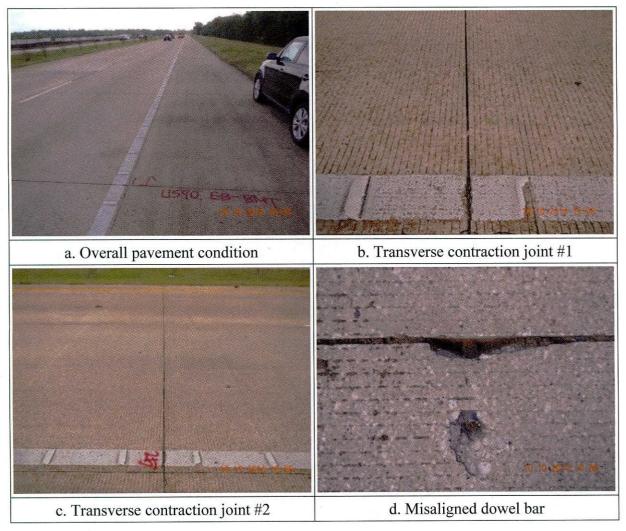
Figure 3.12 Sealant condition on US 90 EB-BMT [NO. 32]

US 90 EB was built in 2000 with a 10-in CPCD. The overall pavement condition including joint condition was very good except for a few missing sealants within the surveyed section. Figure 3.12(a) shows the overall pavement condition. Figures 3.12(b) and (c) show the condition of a typical transverse contraction joint. The misaligned dowel bar was observed as shown in Figure 3.12(d). However, there were no structural distresses observed in the span of 14 years in this area, which implies that one or two misaligned dowel bars may not affect the transverse contraction joint performance in CPCD.

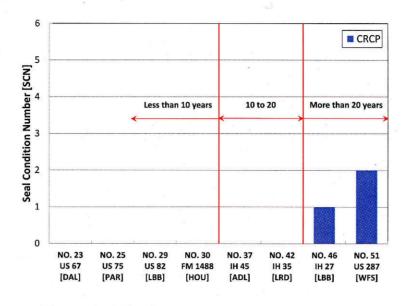
Figure 3.19 shows the SCN result for CRCP. The SCNs for all the sections with pavement age less than 20 years are 0 and the other two sections with pavement age more than 20 years are 1 and 2. The results show that joint sealants have been maintained in a good condition. In CRCP, whether longitudinal contraction/construction joints or transverse construction joints, concrete movements are severely restricted by reinforcements. It appears that small concrete movements attributed to the good sealant performance.

Figure 3.19 CRCP seal condition number [SCN]

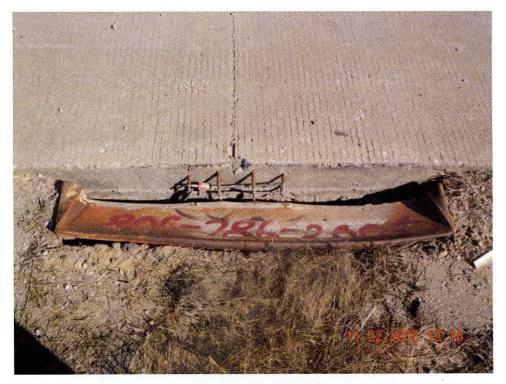
However, the gage protection boxes were destroyed during the full depth repair (FDR) for adjacent CPCD slabs as shown in Figure 4.12. The gage analysis results showed that the protection boxes were broken on April 16, 2015, and data obtained since that point were not reasonable.

Figure 4.12 Destroyed gages during the FDR on SH 288

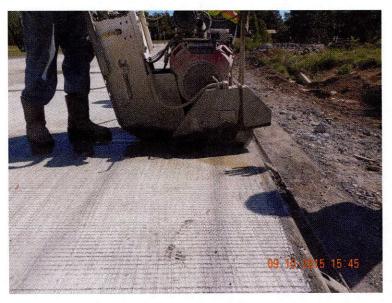
Figure 4.19 shows joint condition after one day of concrete placement, which was September 11, 2015. It shows quite shallow saw cut depth at the edge of the slab. The cut is shallow because the concrete was placed with forms, and the saw cut operation was stopped a few inches away from the form. However, the saw cut depth was adequate through the joint except at the edge of pavement as shown in Figure 4.20. Figure 4.19 shows a crack already developed at the bottom of the saw cut.

Figure 4.20 Sawcut at pavement edge

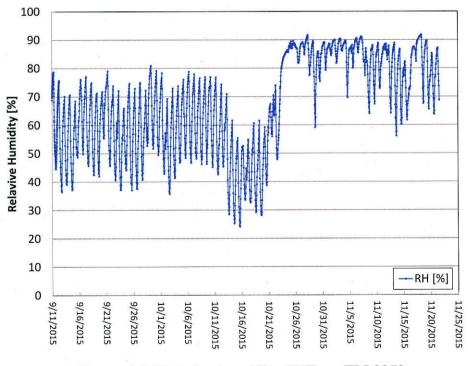
Figure 4.27 Relative humidity (RH) on FM 2253

Figure 4.26(a) and (b) illustrate the joint displacements in the vertical direction at Joint 1 and Joint 2, respectively. The joint displacement in the vertical direction increased up to 85 mils within the 42 days age for both Joint 1 and Joint 2, and decreased with temperature drop and swelling effect due to rain after the 42 days of concrete placement, which was on October 23, 2015. Figure 4.27 shows the relative humidity (RH) variation with time. The graph clearly indicates that it was rainy on October 23, 2015, and the RH of air has maintained quite high until November 21, 2015.

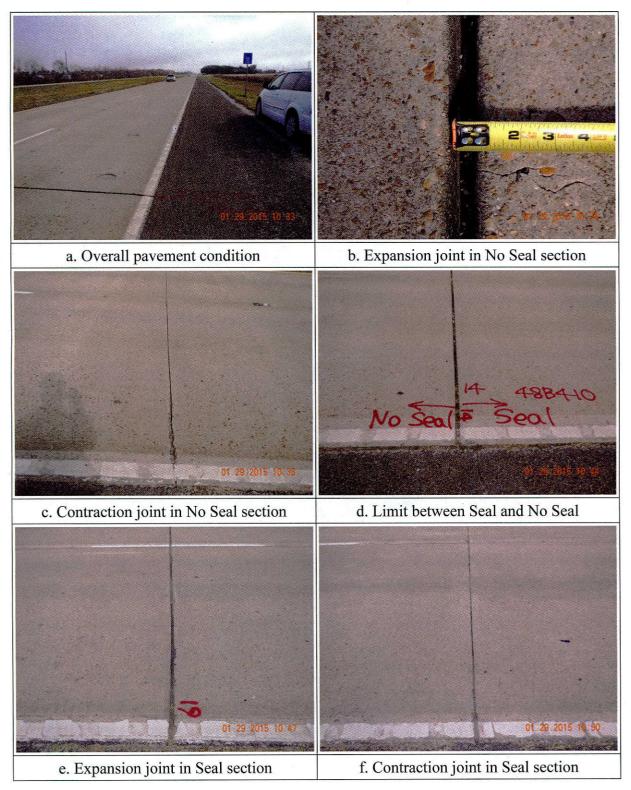
Figure 5.4 Joints conditions on US 90

Field performance survey was conducted on January 29, 2015. A total of 26 expansion joints were investigated; fourteen joints in the unsealed section and twelve joints in sealed section, as shown in Figure 5.4.

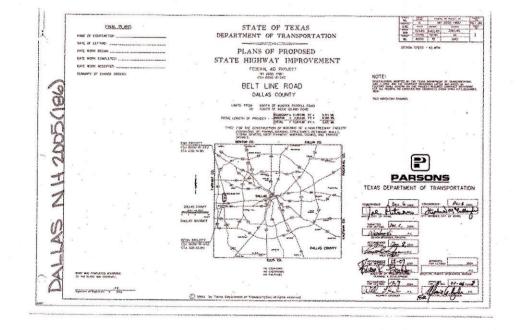
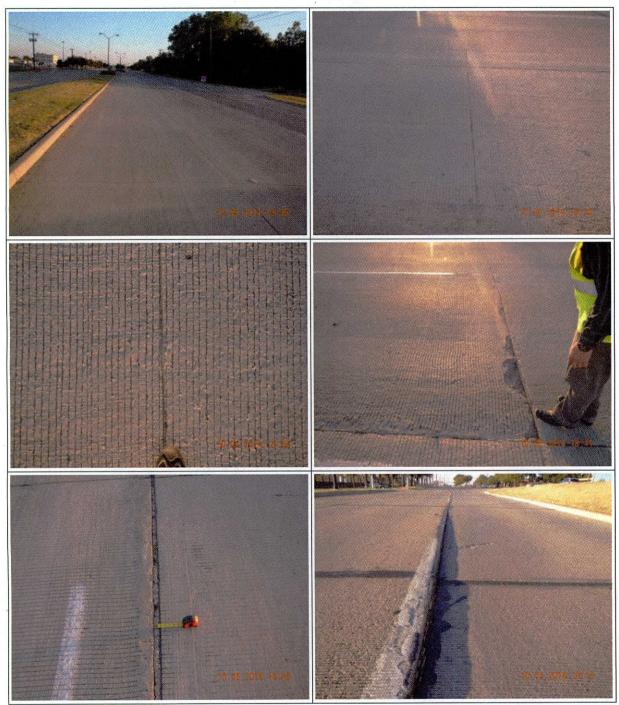
No.1 Belt Line Road (CSJ 0850-18-042)

Attribute	Information	Special Note
CSJ	8050-18-042	
County	Dallas	
Reference Marker		
GPS Coordinates		
Construction Year	2009	
Pavement Type	CPCD	
Slab thickness	10-in.	
Shoulder Type	Mono curb	
Base Type	4-in. ASB [TY-B]	
Subgrade Type	6-in. LTS	
Drainage Type		
Coarse Aggregate Type		
Con. Pavement Details	CPCD-94

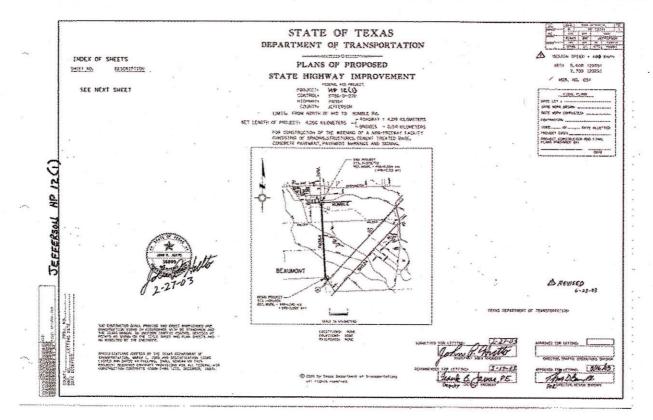
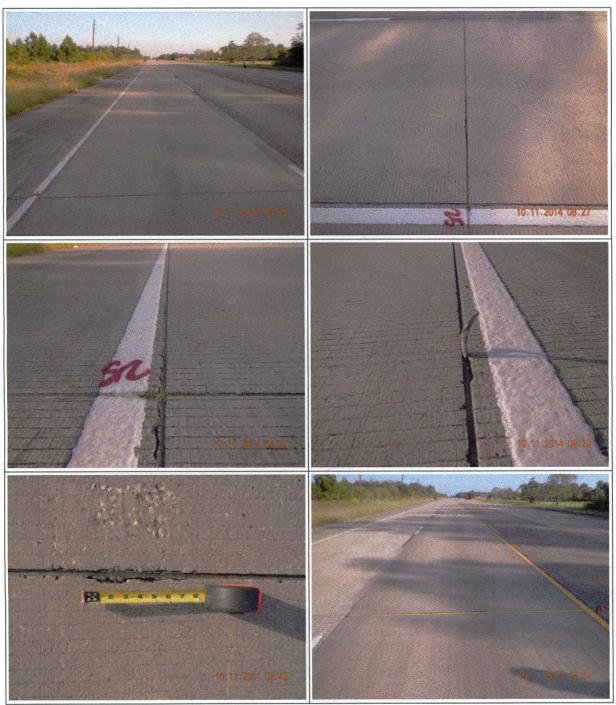
No.2 FM 364 (CSJ 0786-01-070)

Attribute	Information	Special Note
CSJ	0786-01-070	
County	Jefferson	
Reference Marker	RM 446+0.85 - 449+0.54	
GPS Coordinates		
Construction Year	2005	
Pavement Type	CPCD	
Slab thickness	12-in.	
Shoulder Type	Tied Concrete	
Base Type	1-in AC+6-in CSB	
Subgrade Type	6-in. LTS	
Drainage Type		
Coarse Aggregate Type		
Con. Pavement Details

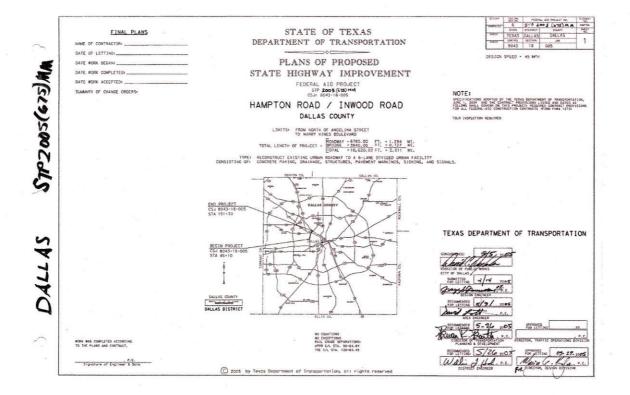
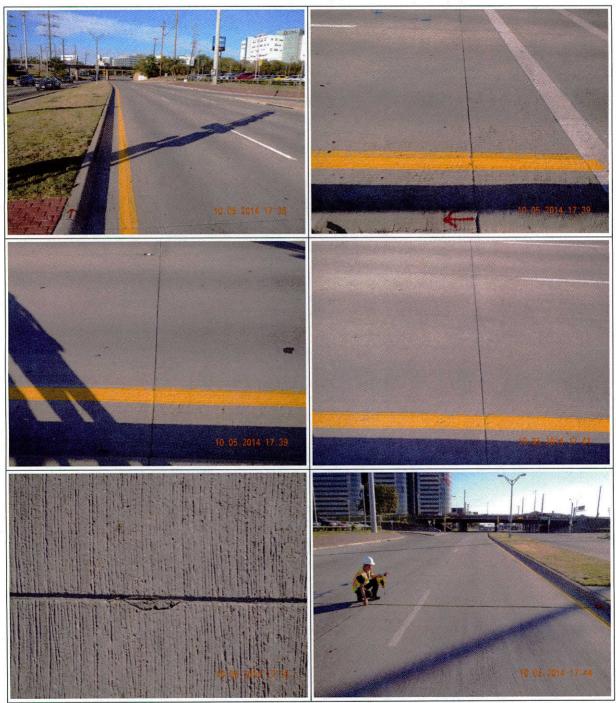
No.3 Inwood Rd (CSJ 8043-18-005)

Attribute	Information	Special Note
CSJ	8043-18-005	
County	Dallas	
Reference Marker		
GPS Coordinates		
Construction Year	2007	
Pavement Type	CPCD	
Slab thickness	8-in.	
Shoulder Type	Mono Curb	
Base Type	4-in ASB [TY-B]	
Subgrade Type	24-in. LTS	
Drainage Type		
Coarse Aggregate Type		
Con. Pavement Details

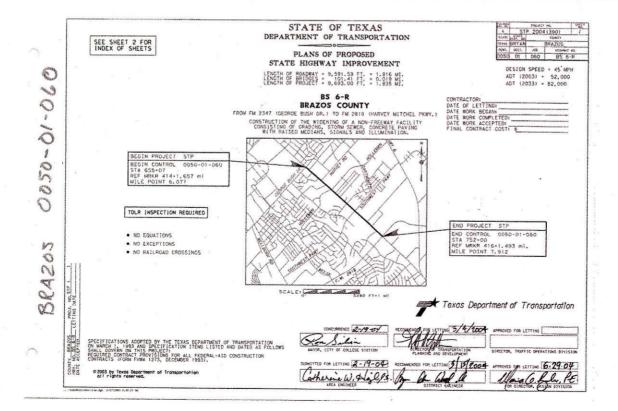
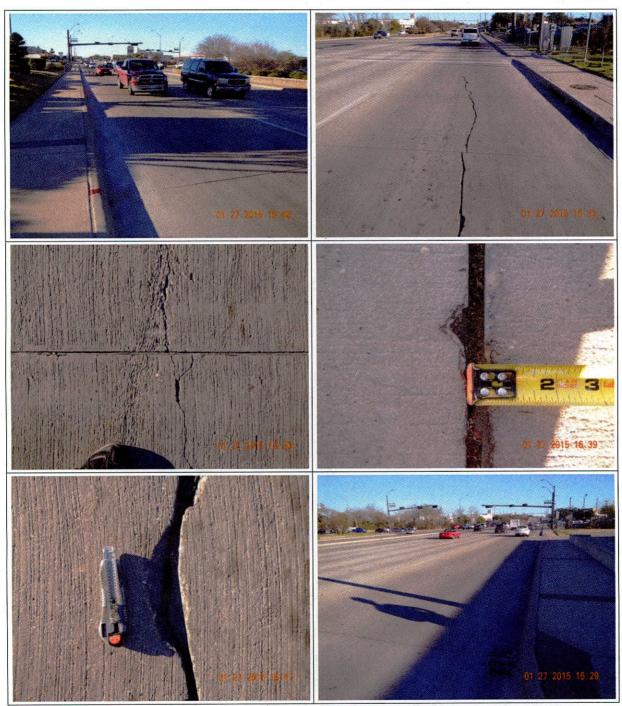
No.4 BS 6-R (CSJ 0050-01-060)

Attribute	Information	Special Note
CSJ	0050-01-060	
County	Brazos	
Reference Marker	RM 415+0.657 - RM 417+0.493	
GPS Coordinates		
Construction Year	2009	
Pavement Type	CPCD	
Slab thickness	8-in.	
Shoulder Type	TY-II Curb	
Base Type	1.5-in Bond Breaker	
Subgrade Type	Existing CPCD	
Drainage Type		
Coarse Aggregate Type		
Con. Pavement Details

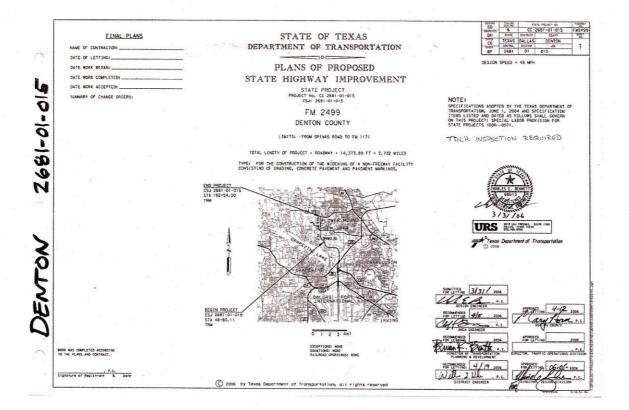
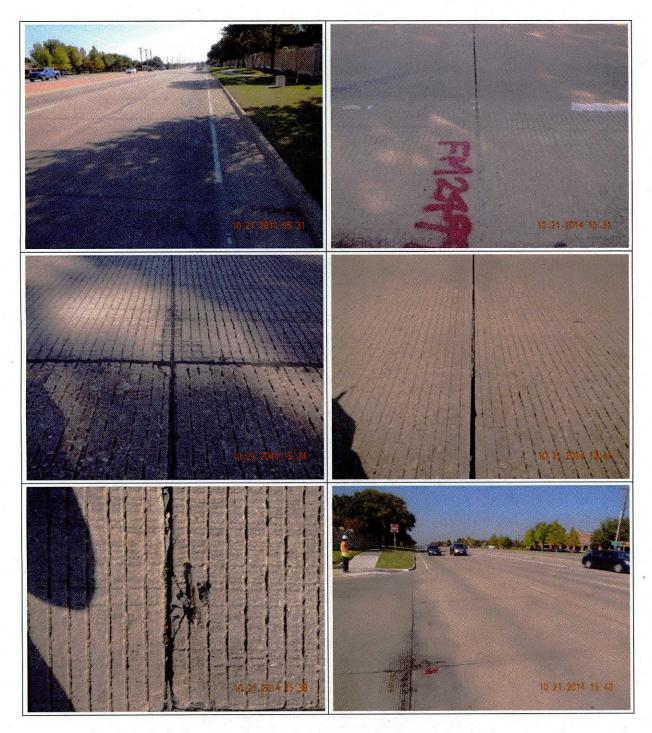
No.5 FM 2499 (CSJ 2681-01-015)

Attribute	Information	Special Note
CSJ	2681-01-015	
County	Denton	
Reference Marker	RM 246+0.7 - RM 246+0.7	
GPS Coordinates		
Construction Year	2008	
Pavement Type	CPCD	
Slab thickness	8-in.	
Shoulder Type	Curb	
Base Type	4-in ASB [TY-B]	
Subgrade Type	6-in. LTS	
Drainage Type		
Coarse Aggregate Type		
Con. Pavement Details

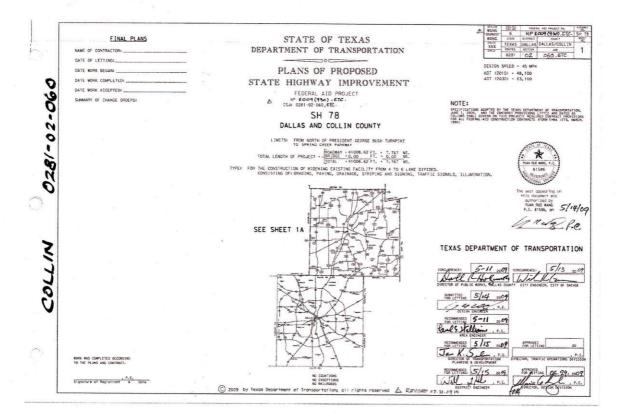
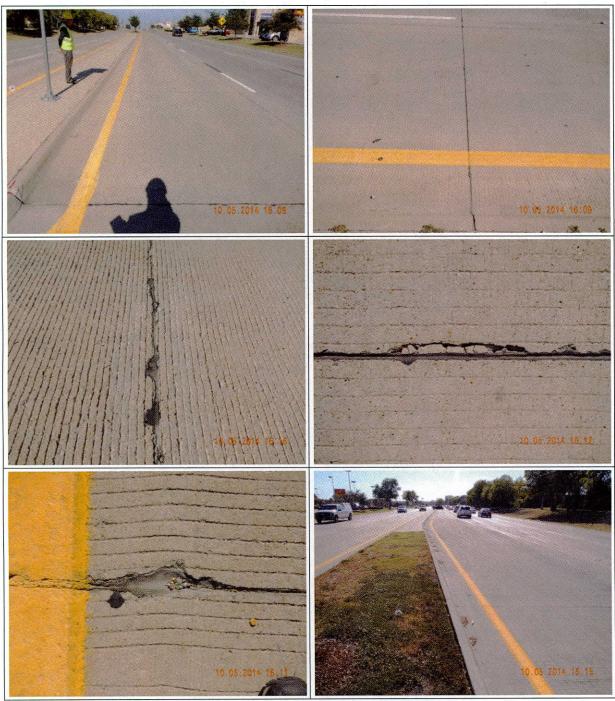
No.6 SH 78, (CSJ 0281-02-060)

Attribute	Information	Special Note
CSJ	0281-02-060	
County	Collin	
Reference Marker	RM 264+0.774 - RM 272+0.425	
GPS Coordinates		
Construction Year	2011	
Pavement Type	CPCD	
Slab thickness	9-in.	
Shoulder Type	TY-I Curb	
Base Type	4-in ASB	
Subgrade Type	12-in LTS	
Drainage Type		
Coarse Aggregate Type		
Con. Pavement Details

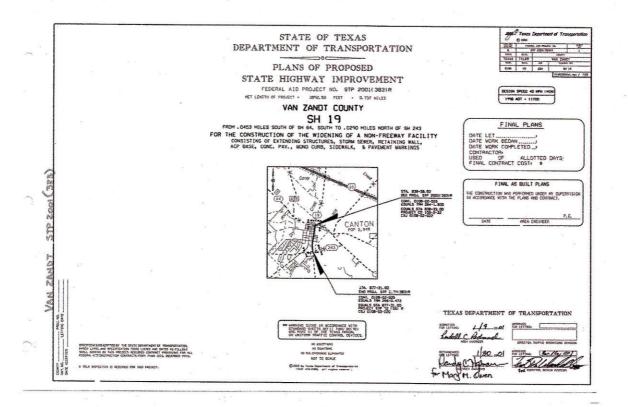
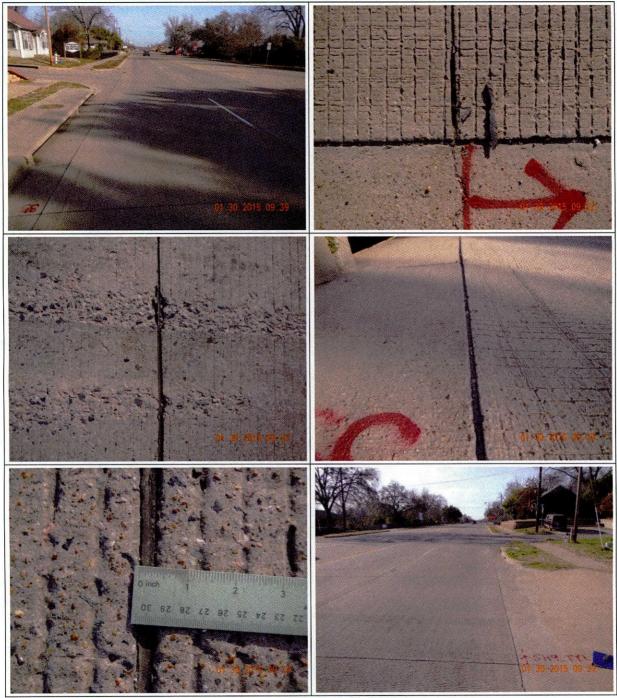
No.7 SH 19, (CSJ 0108-02-025)

Attribute	Information	Special Note
CSJ	0108-02-025	
County	Van Zandt	
Reference Marker	RM 285+0.805 - RM 286+0.473	
GPS Coordinates		
Construction Year	2003	
Pavement Type	CPCD	
Slab thickness	9-in.	
Shoulder Type	TY-I Curb	
Base Type	4-in ASB	
Subgrade Type		
Drainage Type		
Coarse Aggregate Type		
Con. Pavement Details

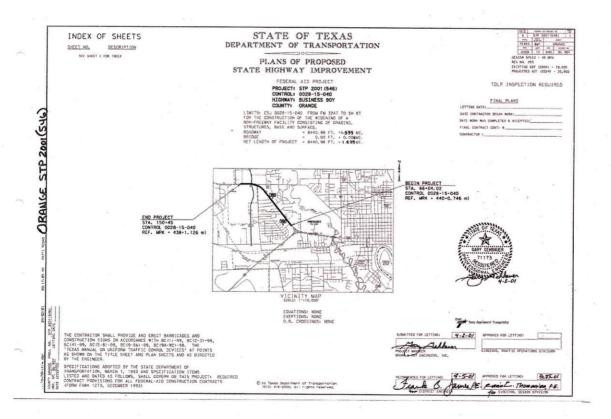
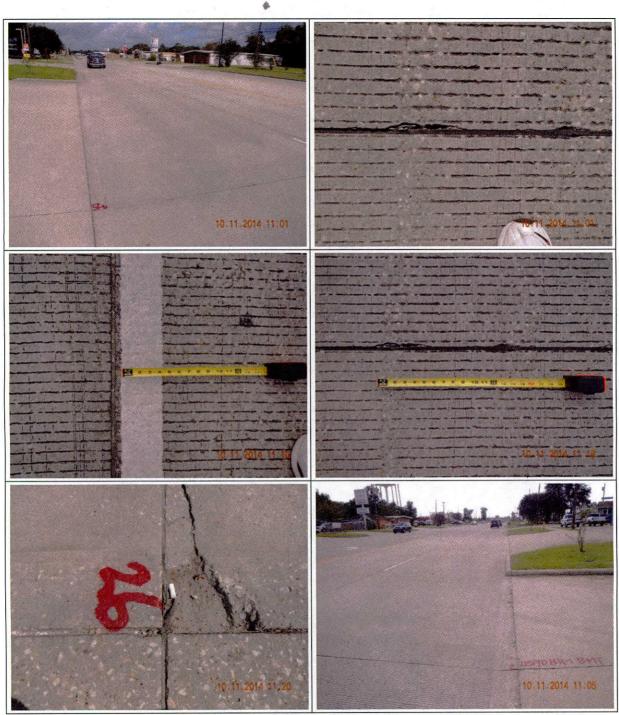
No.8 BU 90-Y, (CSJ 0028-15-040)

Attribute	Information	Special Note
CSJ	0028-15-040	
County	Orange	
Reference Marker	RM 439+0.126 - RM 440+0.746	
GPS Coordinates		
Construction Year	2005	
Pavement Type	CPCD	
Slab thickness	10-in.	
Shoulder Type	TY-P Mono Curb	
Base Type	1-in AC+6-in CSB	
Subgrade Type	6-in LTS	
Drainage Type		
Coarse Aggregate Type		
Con. Pavement Details

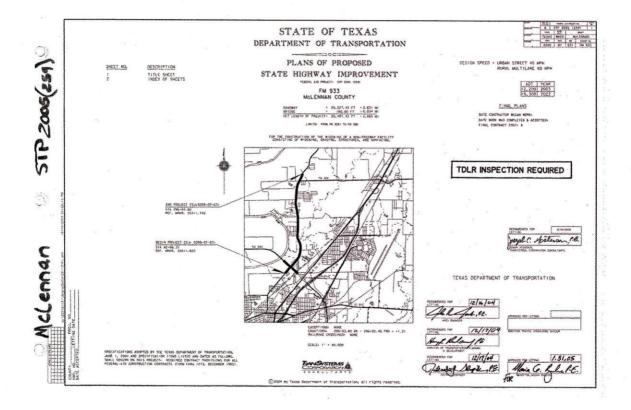
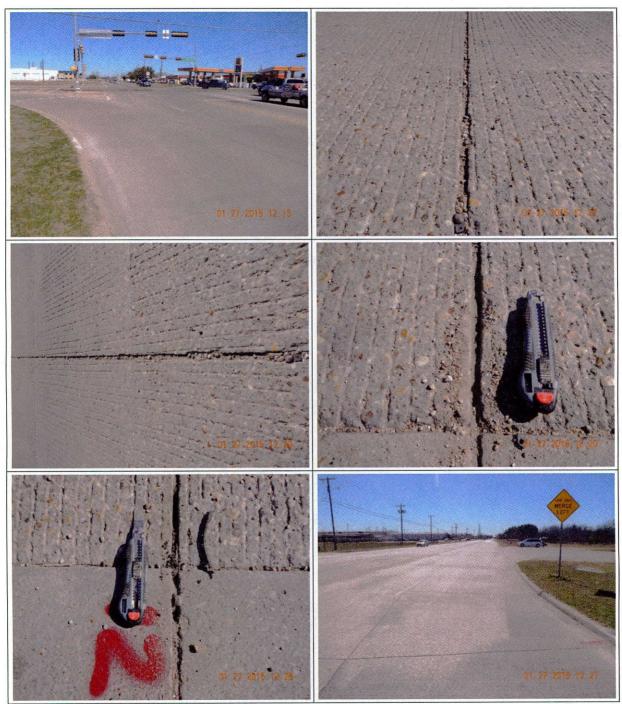
No.9 FM 933, (CSJ 0209-07-031)

Attribute	Information	Special Note
CSJ	0209-07-031	
County	McLennan	
Reference Marker	RM 353+0.740 - RM 357+0.603	
GPS Coordinates		
Construction Year	2009	
Pavement Type	CPCD	
Slab thickness	10-in.	
Shoulder Type	TY-II Mono Curb	• •
Base Type	6-in ASB [TY-B]	
Subgrade Type		
Drainage Type		
Coarse Aggregate Type		
Con. Pavement Details

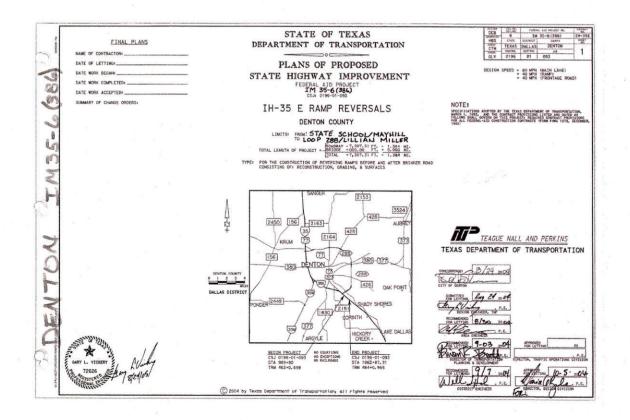
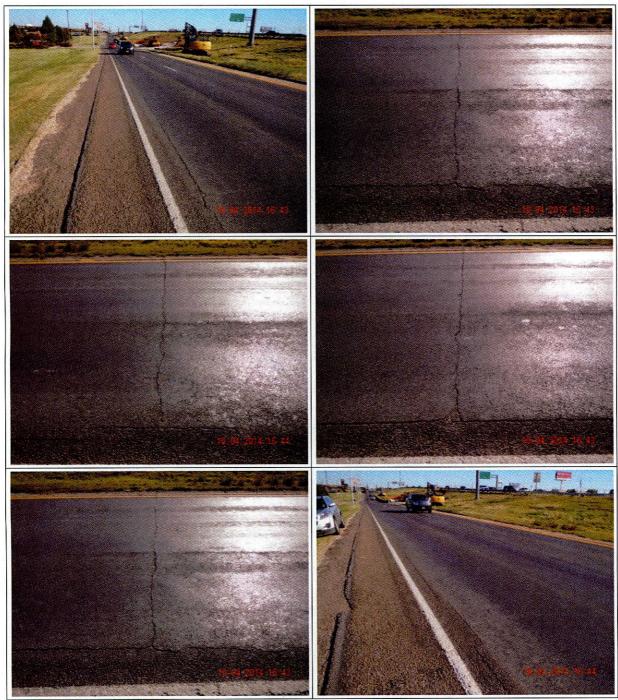
No.12 IH 35E, (CSJ 0196-01-093)

Attribute	Information	Special Note
CSJ	0196-01-093	
County	Denton	
Reference Marker	RM 463+0.698 - RM 464+0.966	
GPS Coordinates		
Construction Year	2006	
Pavement Type	CPCD	
Slab thickness	10-in.	
Shoulder Type	Tied Concrete	
Base Type	4-in ASB [TY-B]	
Subgrade Type	6-in CTS	
Drainage Type		
Coarse Aggregate Type		
Con. Pavement Details

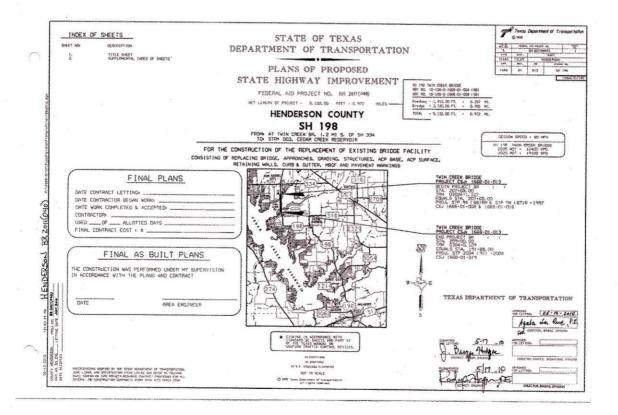
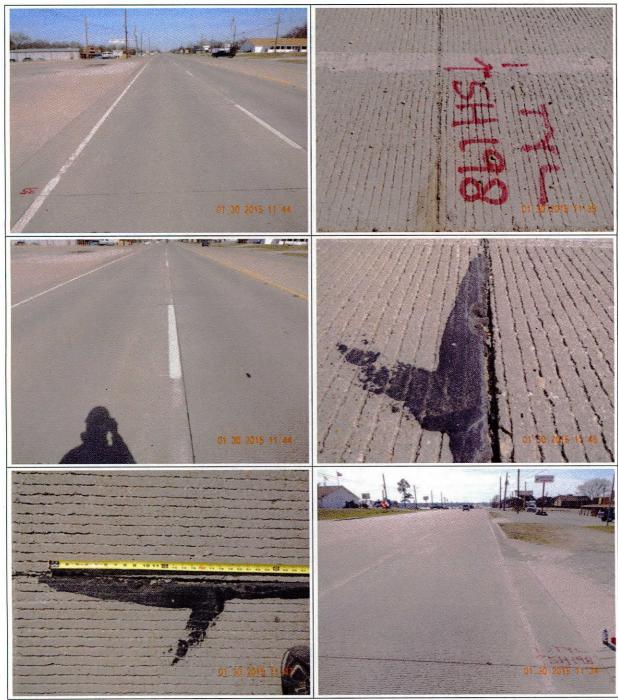
No.13 SH 198, (CSJ 1668-01-013)

Attribute	Information	Special Note
CSJ	1668-01-013	
County	Henderson	
Reference Marker	RM 303A+0.127 - RM 304+0.109	
GPS Coordinates		
Construction Year	2012	
Pavement Type	CPCD	
Slab thickness	9-in.	
Shoulder Type	TY-II Mono Curb	
Base Type	4-in ASB	
Subgrade Type	6-in LTS	
Drainage Type		
Coarse Aggregate Type		
Con. Pavement Details

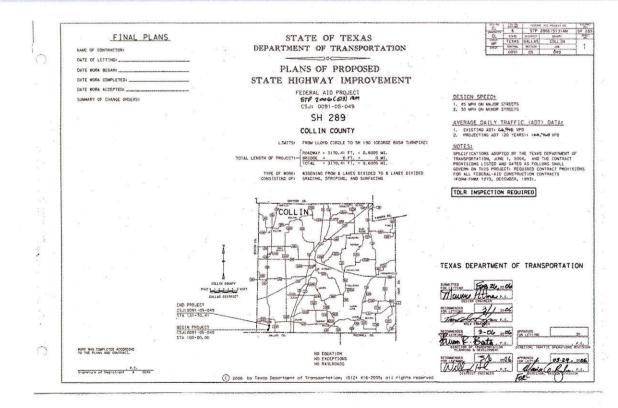
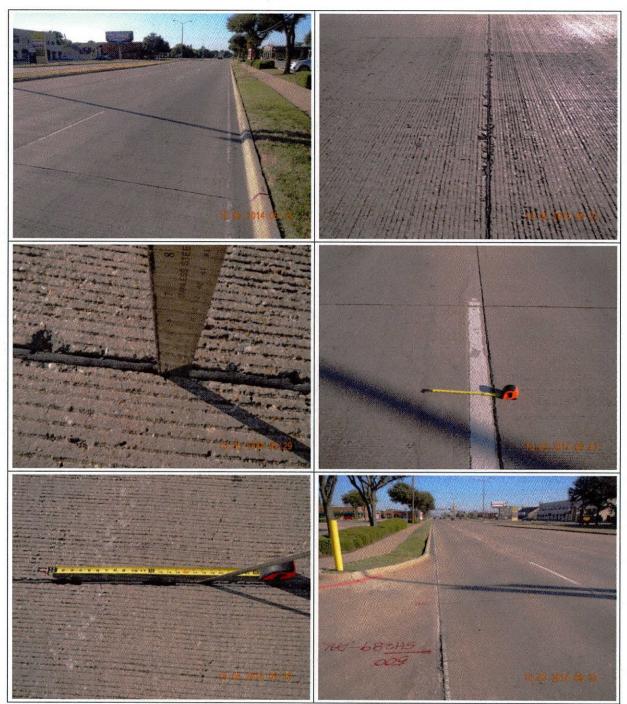
No.15 SH 289, (CSJ 0091-05-049)

Attribute	Information	Special Note
CSJ	0091-05-049	
County	Collin	
Reference Marker	RM 254 - RM 254+0.6005	
GPS Coordinates		
Construction Year	2007	
Pavement Type	CPCD	
Slab thickness	12-in.	
Shoulder Type	Curb	
Base Type	2-in ASB [TY-B]	
Subgrade Type	6-in LTS	
Drainage Type		
Coarse Aggregate Type		
Con. Pavement Details

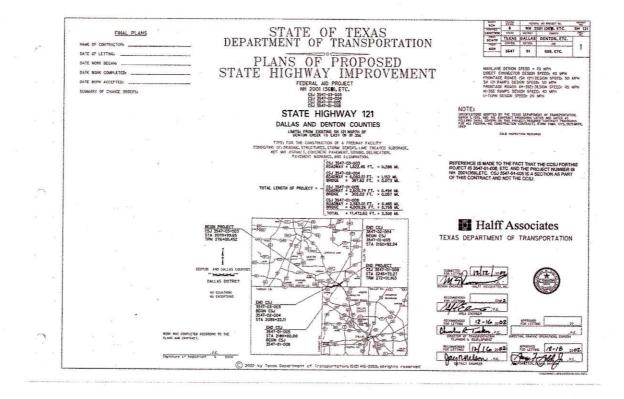
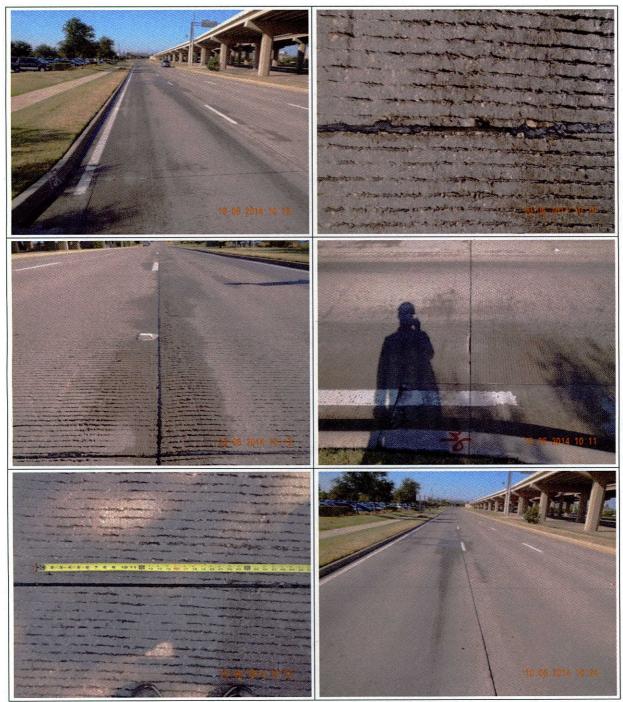
No.17 SH 121, (CSJ 3547-01-008)

Attribute	Information	Special Note
CSJ	3547-01-008	
County	Denton	
Reference Marker	RM 273+0.163 - RM 274+0.676	
GPS Coordinates		
Construction Year	2007	
Pavement Type	CPCD	
Slab thickness	11-in.	
Shoulder Type	Tied Concrete	
Base Type	4-in ASB	
Subgrade Type	6-in LTS	
Drainage Type		
Coarse Aggregate Type		
Con. Pavement Details

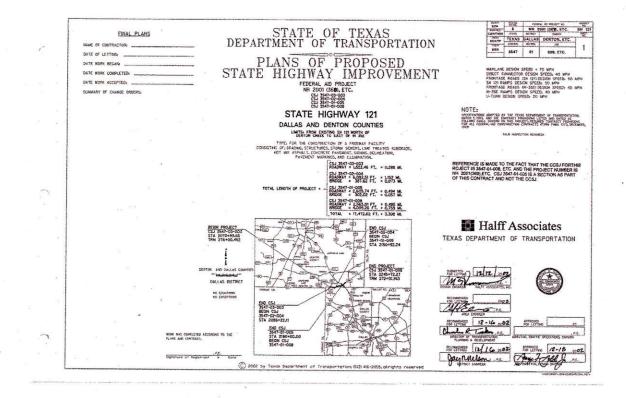
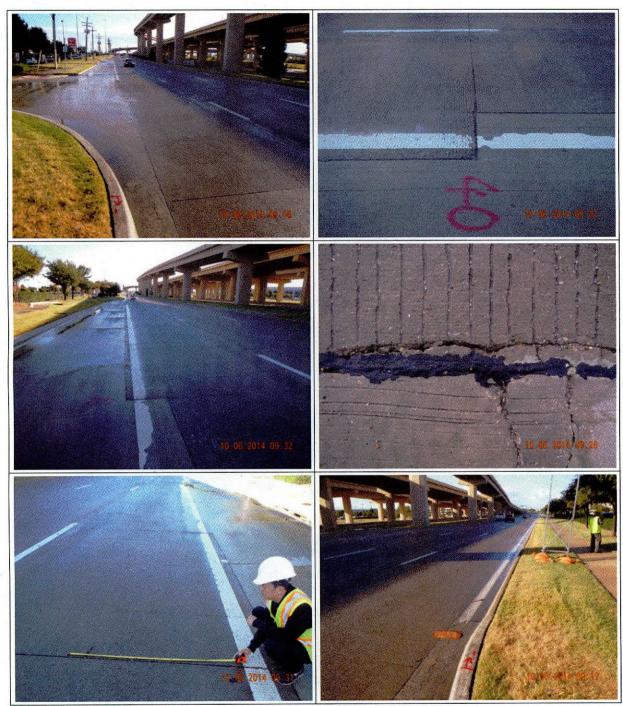
No.18 SH 121, (CSJ 3547-01-008)

Attribute	Information	Special Note
CSJ	3547-01-008	
County	Denton	
Reference Marker		
GPS Coordinates		
Construction Year		
Pavement Type	CPCD	
Slab thickness	10-in.	
Shoulder Type	TY-II Mono Curb	
Base Type	4-in ASB	
Subgrade Type	6-in LTS	
Drainage Type		
Coarse Aggregate Type		
Con. Pavement Details
