Pavement Repair Strategies for Selected Distresses in FM Roadways

Technical Report 0-6589-1

1. Report No. FHWA/TX-11/0-6589-1	2. Government Accession No.	3. Recipient's Catalog No.	
4. Title and Subtitle PAVEMENT REPAIR STRATEGIES FOR SELECTED DISTRESSES IN FM ROADWAYS		5. Report Date Published: June 2012

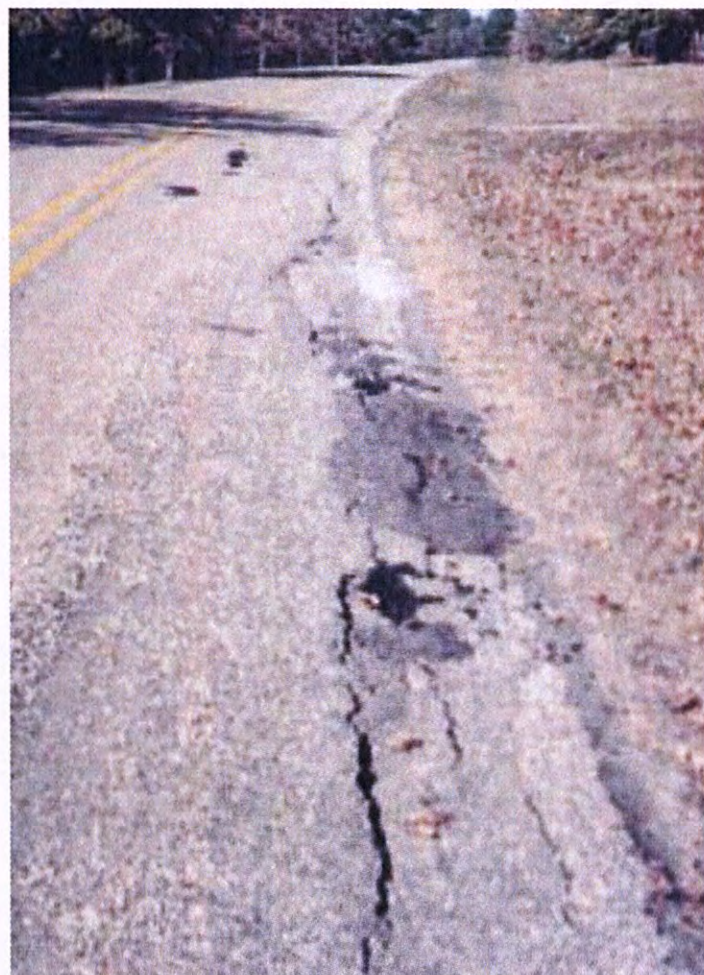
Figure 2.1. Longitudinal cracking and failure (Sebesta 2005).

Narrow Low volume roads, that lack lateral shoulder support, are experienced longitudinal cracking combined with rutting along the edge of the pavement. This type of narrow pavement constitute to significant. These types of distresses are referred to edge failure. Edge failures on narrow roads occur within 1–2 ft of the pavement edge in the form of longitudinal, fatigue and alligator cracking, rutting or a combination of these distresses. These failures can propagate toward the travel lane in the form of transverse cracks. Although these cracks are formed within a finite distance from the edge, they often propagate along the wheel paths and allow intrusion of moisture in the subgrade and base materials. Example of edge failures severity is shown in Figure 2.1 (Sebesta 2005).

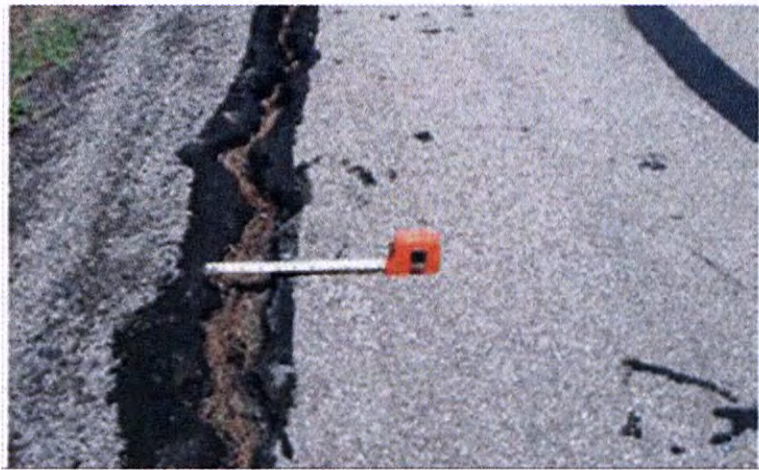
(a) Edge breaks due to loss of adhesion

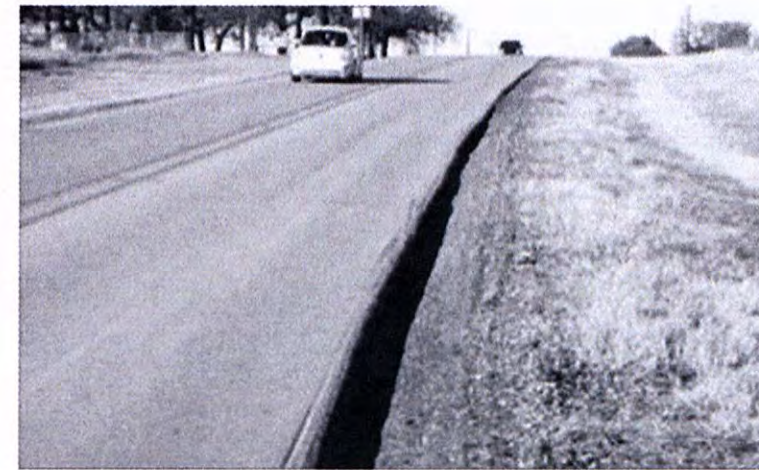
The causes of edge drop-offs include erosion caused by wind, rain or other environmental conditions. Lawson and Hossain (2004) conducted a study to investigate the causes of edge drop-off in Texas. They found that certain types of construction procedures often cause significant edge drop-off problems. They also remarked that edge drop-off occurs mainly in East Texas as a result of buildup of soil along the pavement edges. This problem occurs during the service life of pavement as vegetation adjacent to the pavement starts to encroach onto the pavement and cause a higher edge elevation than the pavement surface. As mentioned (Lawson

(b) Edge drop-off due to erosion

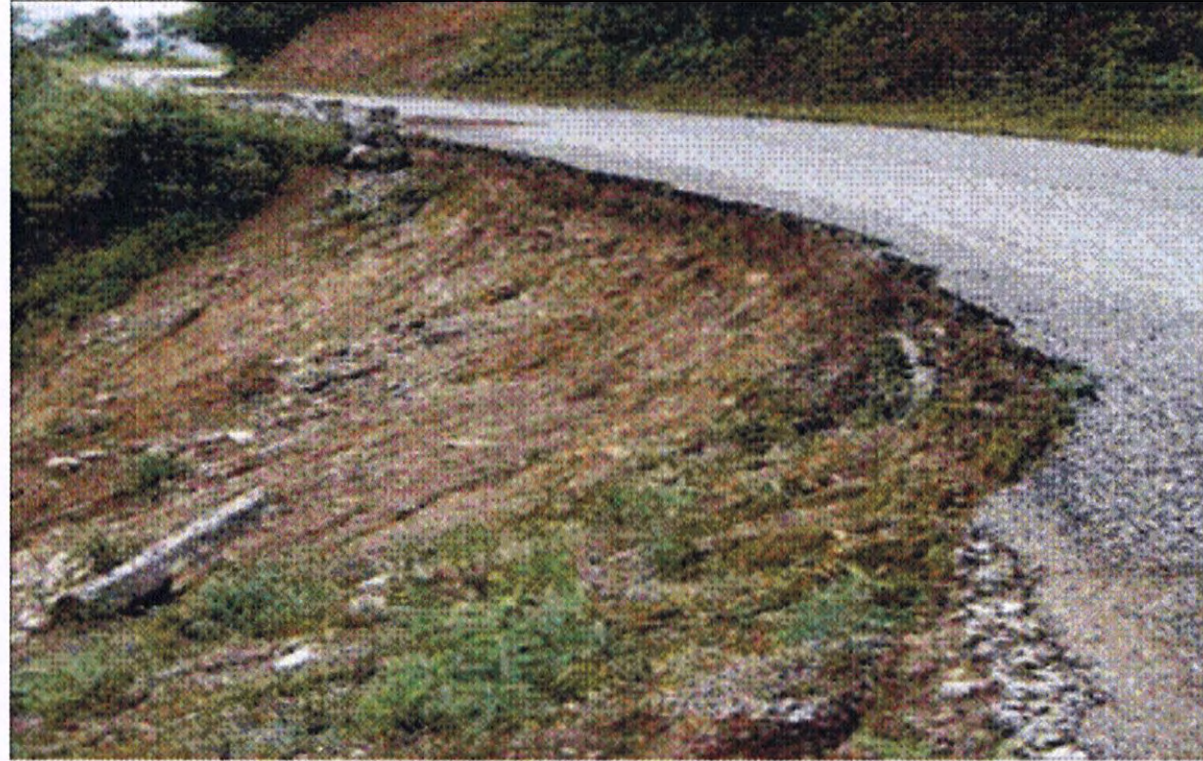
Figure 2.4. Edge Failure due to Slope Instability (Hearn et al. 2008).

Hearn et al. (2008) (Figures 2.4) correlates edge failure of roads ground movements at the edge of roads combined with existence higher wet season groundwater and water content in soils. Weathered rock masses at exposed steep roadside cuts also accelerate the ground movements at edges. These conditions are more common in roads at higher elevations. In addition, Heath et al. (1990) summarized the causes of edge slope instability, such as exceptional storms, seismic activity, erosion or the disturbances of materials due to road construction, and weak cohesive soils due to rapid weathering.

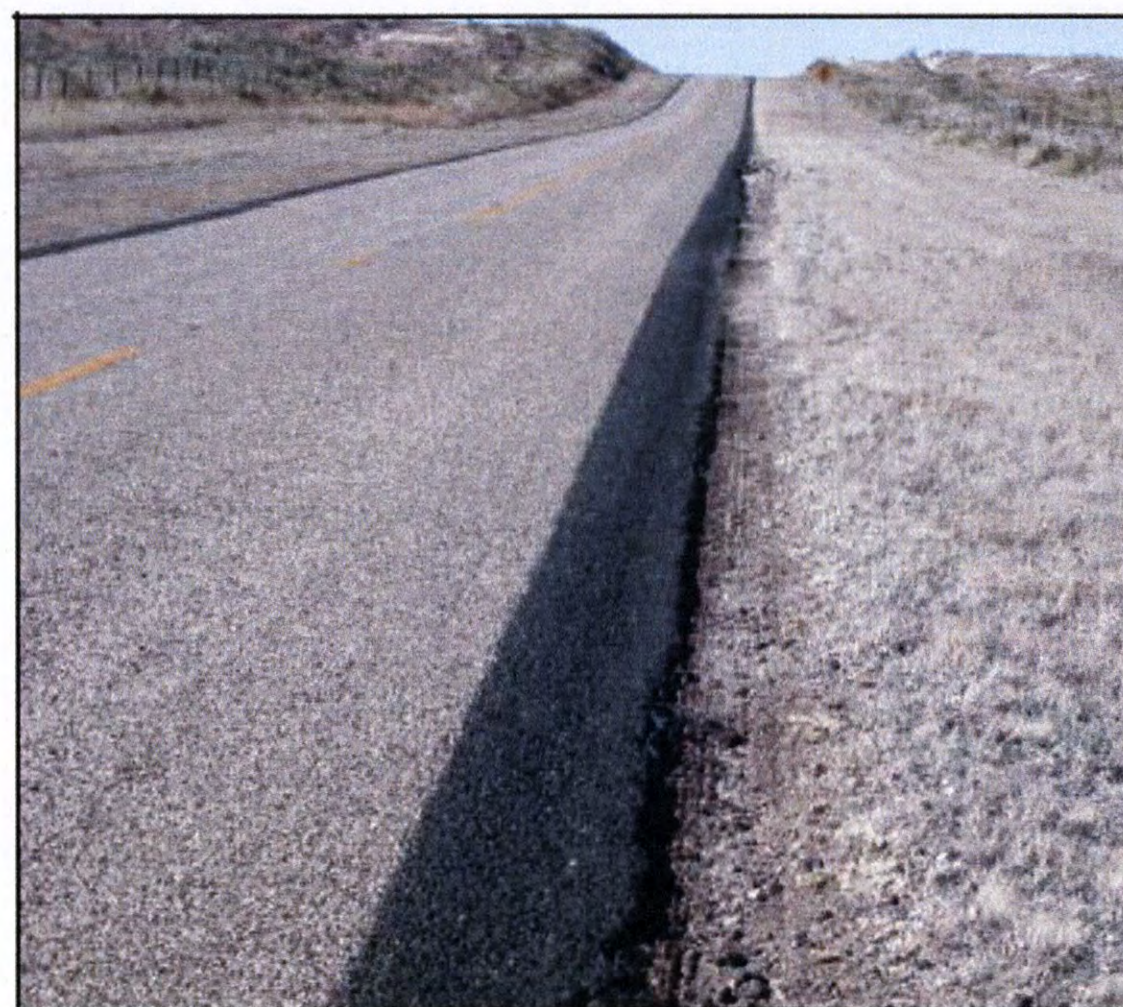
Figure 2.8. Pavement edge drop-off.

The research focused on best practices strategy to define and implement best practices for repair and stabilization of pavement naturally-occurring edge drop-offs on low-volume roads. Edge drop-off as defined in this project is the difference in vertical elevation between the paved surface and unpaved shoulder surface adjacent to it. This type of distresses has maintenance, safety and liability issues for TxDOT. This distress is affected by the narrow road width and absence of shoulders, traffic volume and type, and adverse environmental conditions (Figure 2.8).

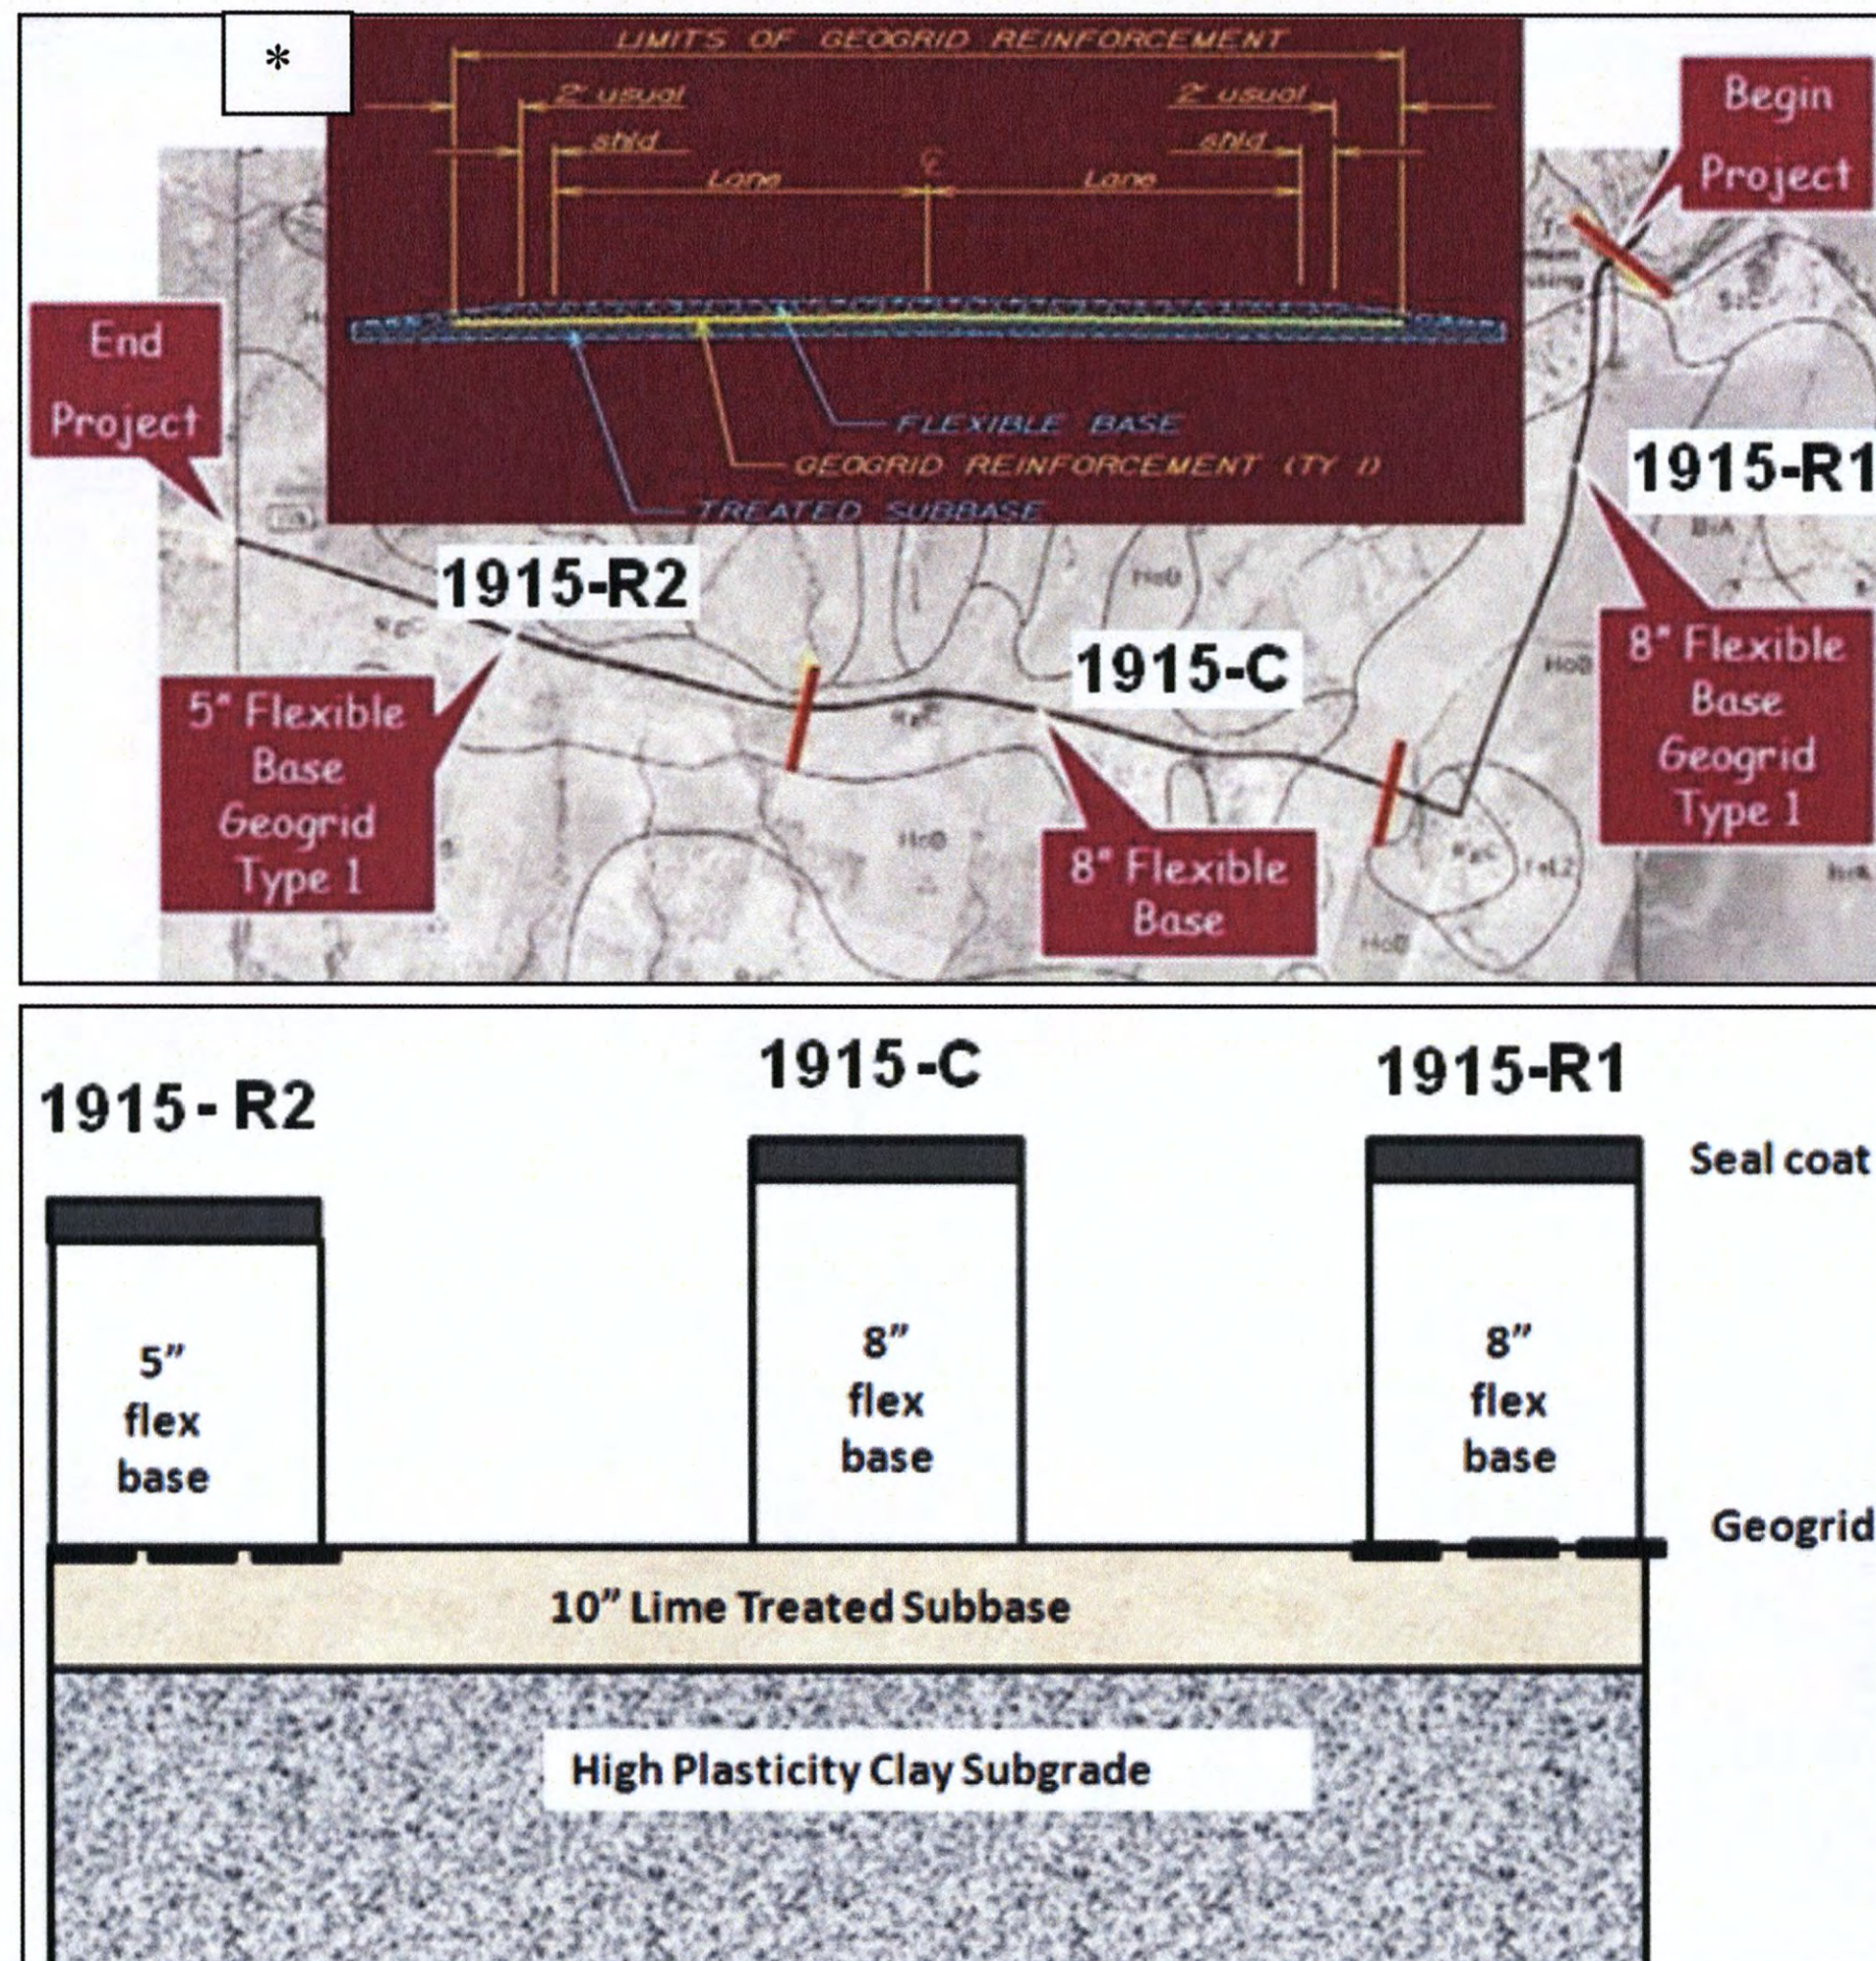
Figure 4.1. FM 1915 Test Sections Layout and Layers Thicknesses. (*Schematic courtesy of Darlene Goehl, P.E.).

The GPR data on sections 1915-R1 and 1915-C (Figure 4.1) showed higher variability in reflections compared to 1915-R2. With respect to layer thickness analysis, researchers estimated 1 in. of surface layer, 7 to 8 in. of base, and 8 to 10 in. of subbase layer from the GPR and the coring measurements. Details of field visual survey (Tables C-1 to C-3) along with captured GPR images (Figures C-1 to C-3) can be found in Appendix C. The results indicated that the control section (1915-C) exhibited more deteriorated areas with a higher number of distresses observed. However, geogrid reinforced section 1915-R1 also revealed severe longitudinal cracking. Section 1915-R2 was found to perform the best, as indicated by the shortest length of longitudinal cracking measured.

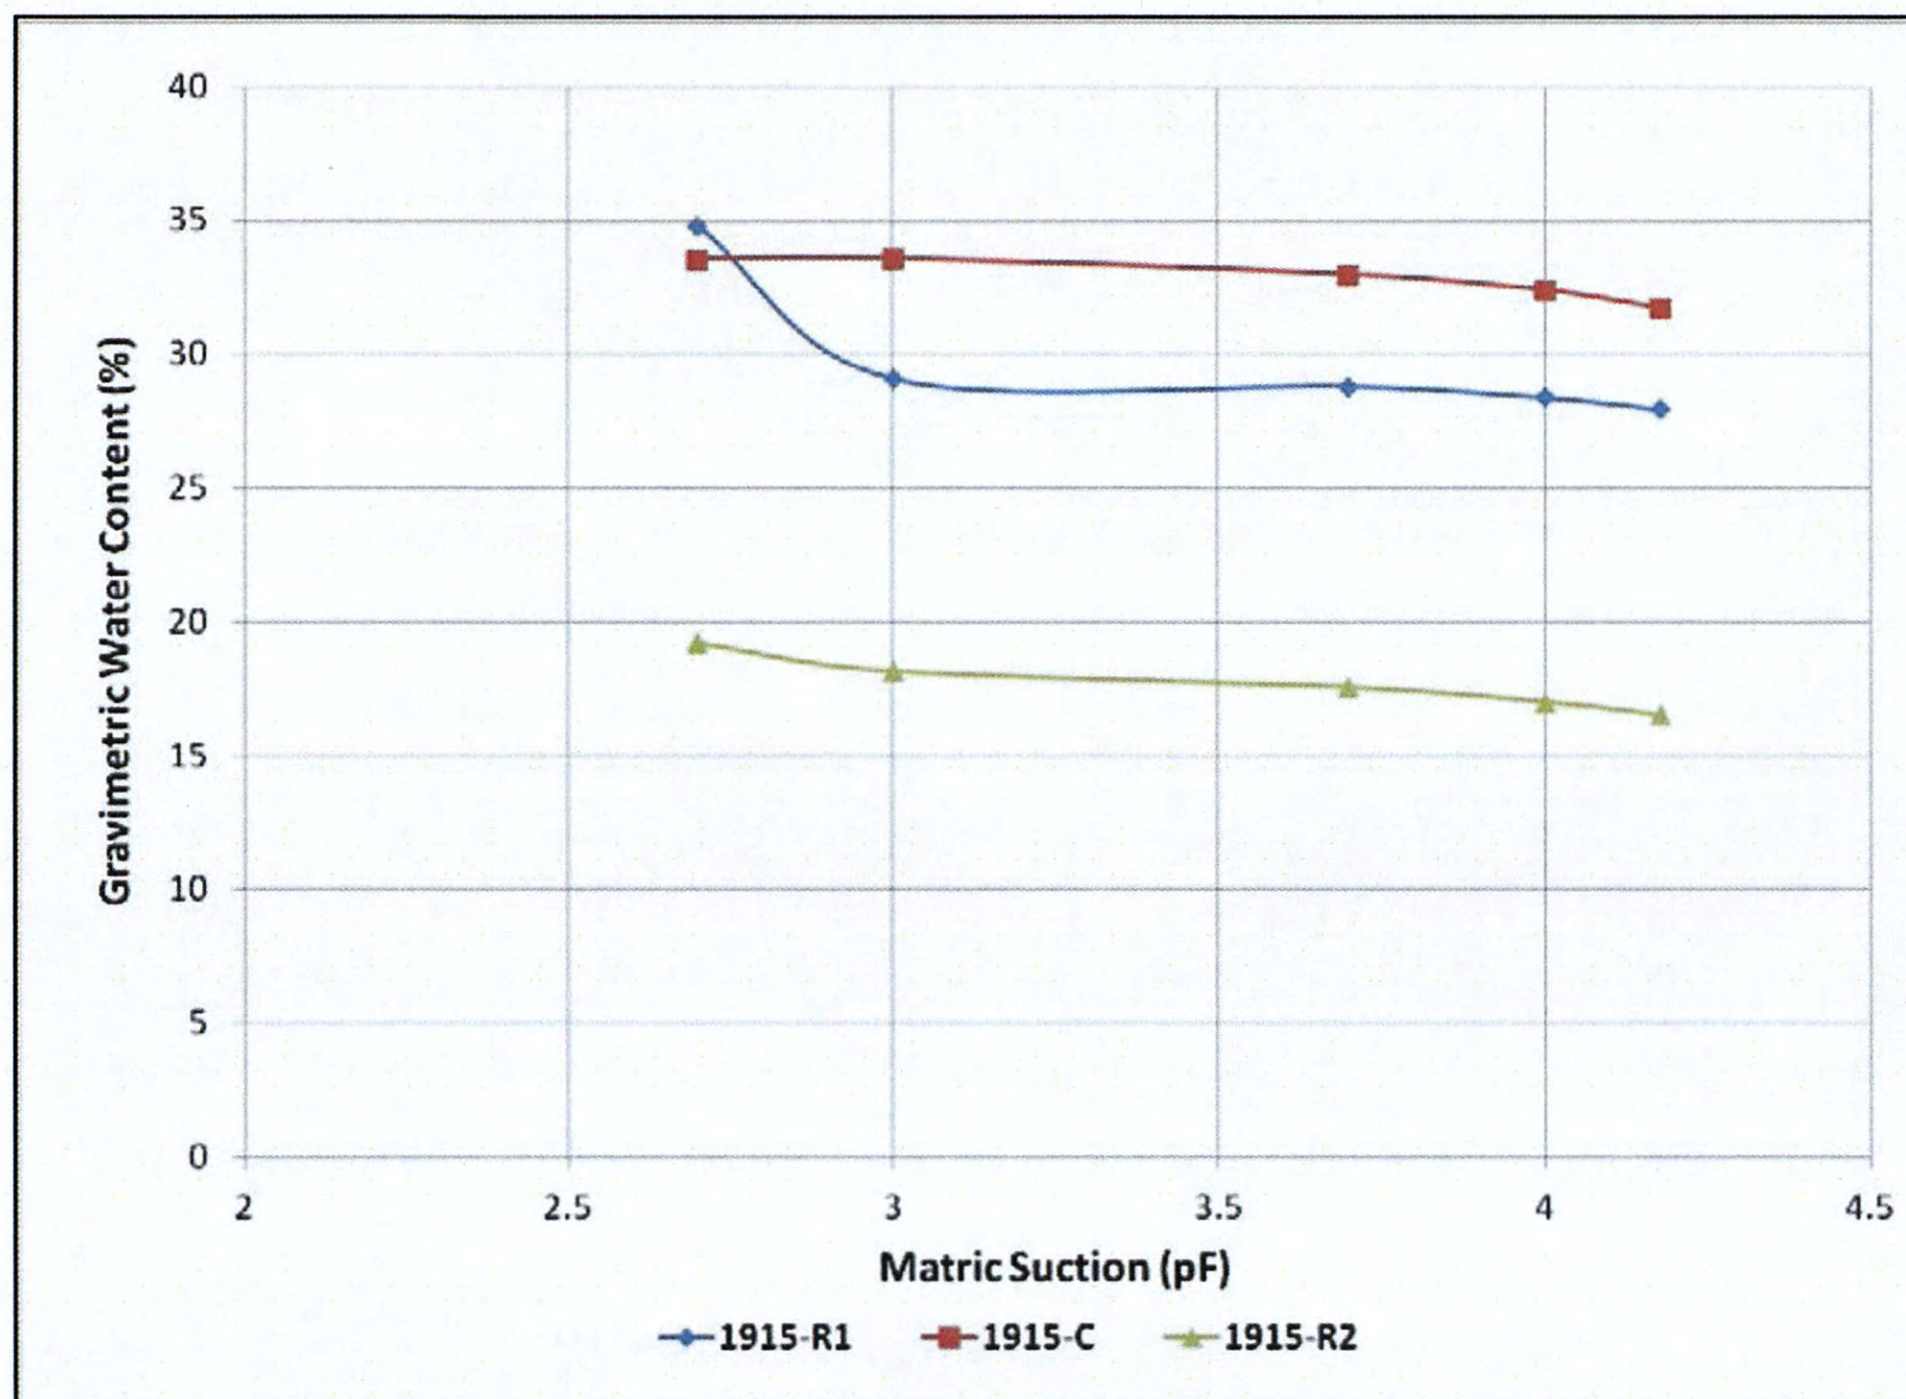
Figure 4.5. Soil Water Characteristic Curves of FM 1915 Subgrade.

The sulfate content was measured through a colorimeter following the Tex-145-E procedure. Chen et al. (2009) employed this test to identify cause of soil heaving. The test results showed that the sulfate content was not significant for all the tested soils. The pressure plate test (Figure 4.5) revealed that the variation of moisture content was not sensitive to the change of matric suction. This suggests that the soils tend to have a high capability of retaining water and a higher possibility to yield larger movement in case the soil encounters considerable amount of rainfall.

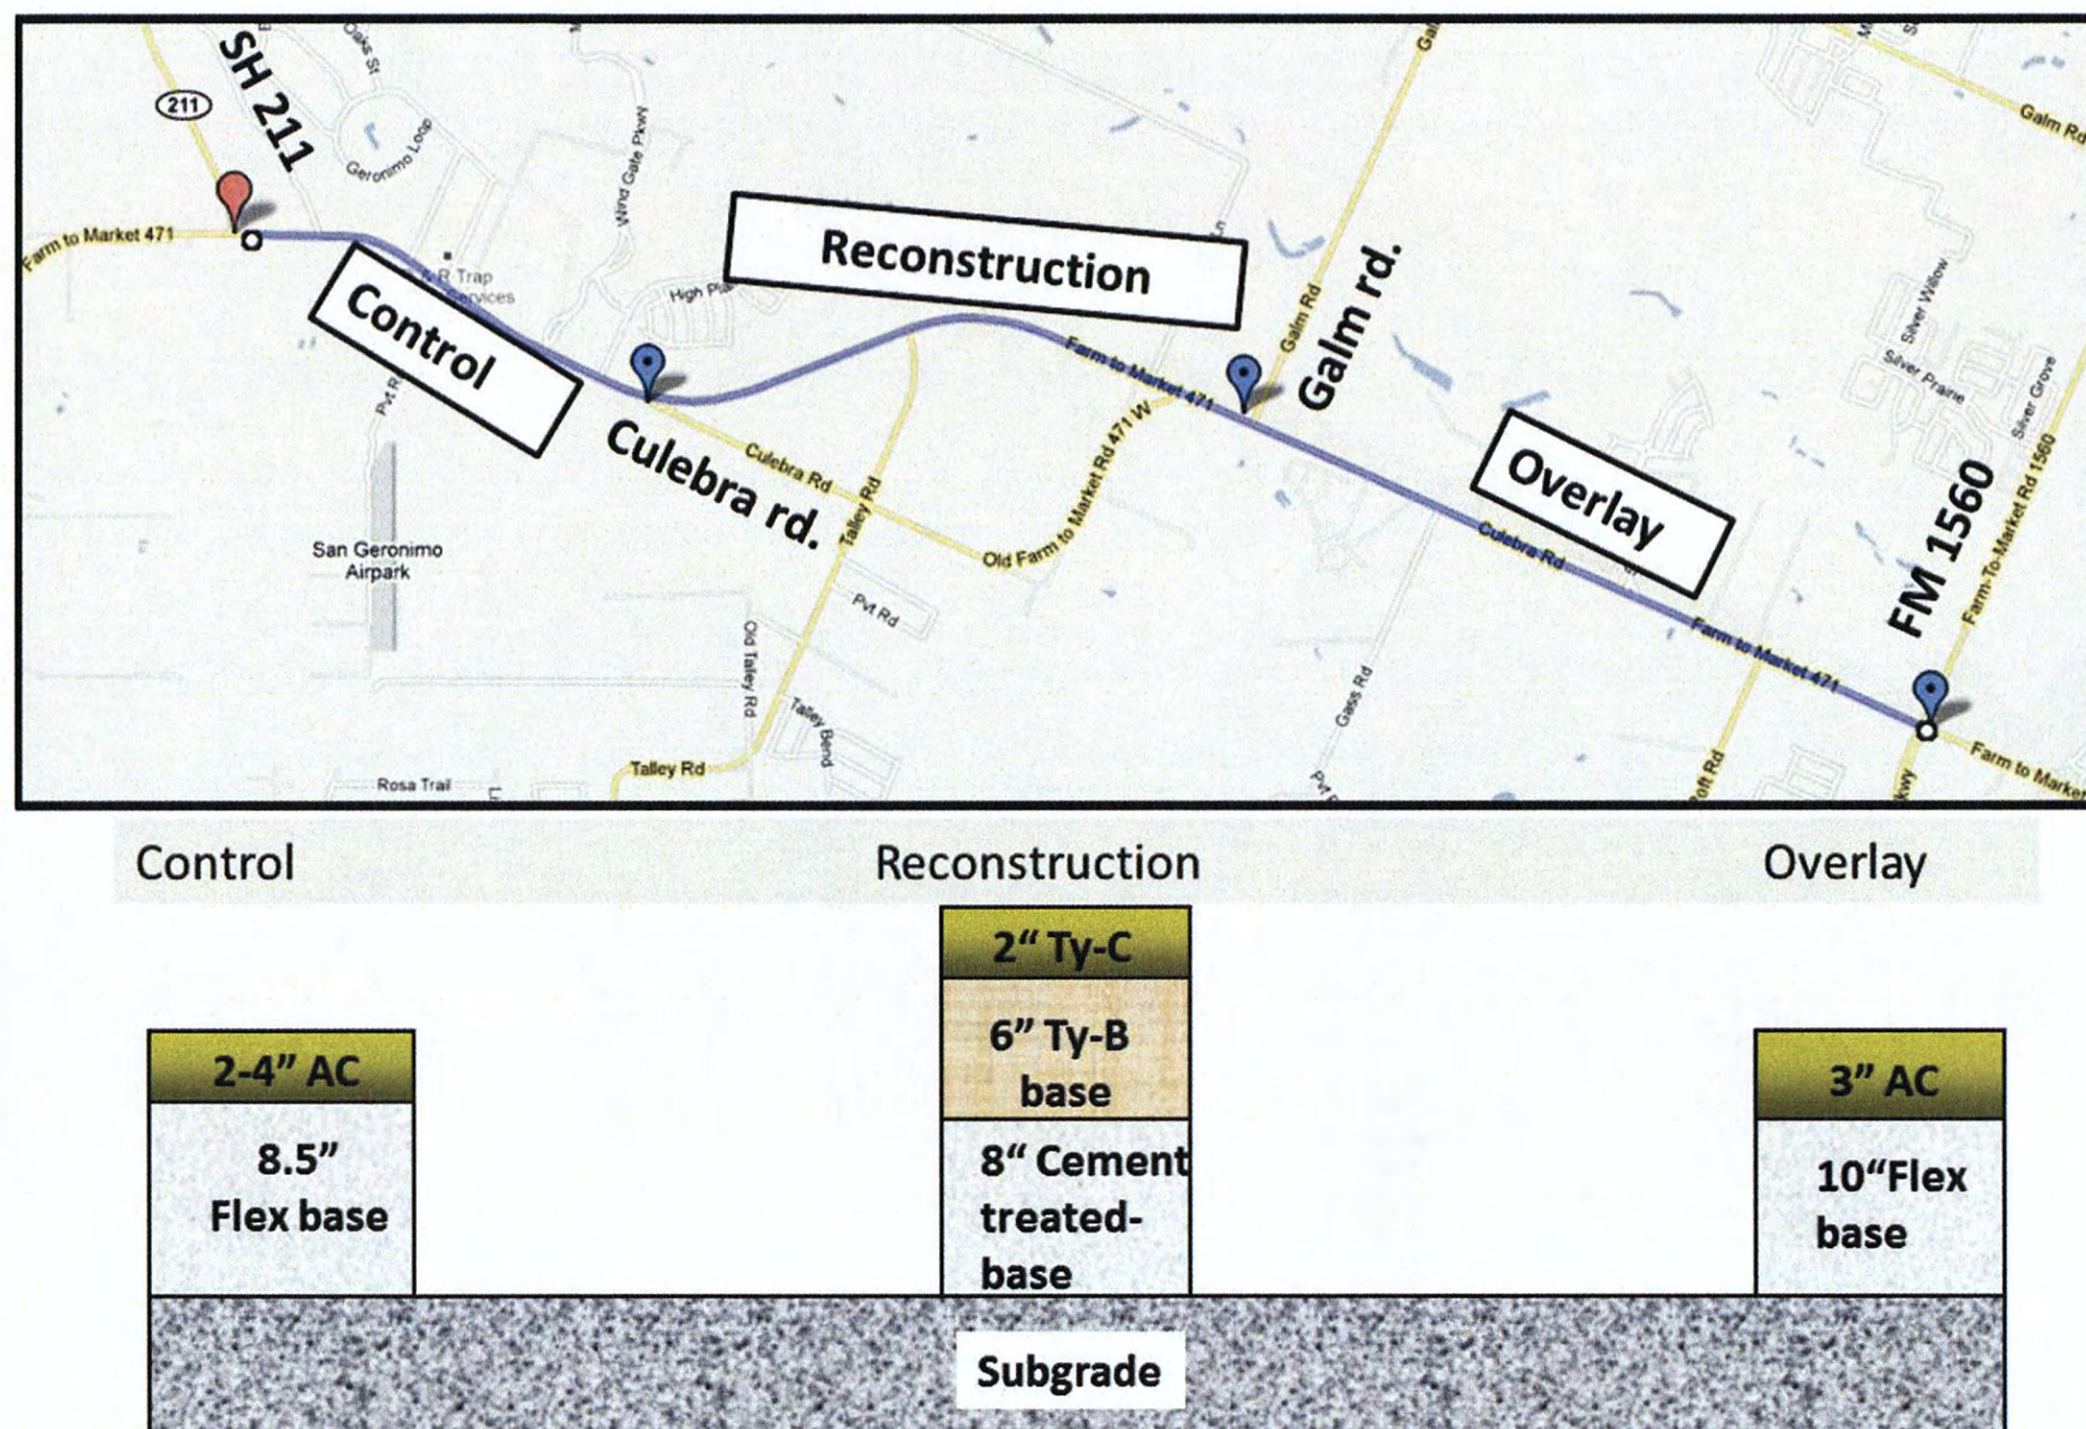
Figure 4.10. Selected Sections of FM 471.

The FM 471 site is a 5-mile long project bounded by FM 1560 and SH 211 in San Antonio District. The segment consists of three pavement sections (Figure 4.10). The control section starts at FM 211 (Station 866+92.54) and ends at Culebra rd. (Station 917+18.30). The reconstruction section starts from Culebra rd. and stretches up to Galm rd. (station 1078+98). The overlay section covers the remaining segment from Galm rd. until FM 1560. The reconstructed section was built to sustain the high ESALs loading incurred from the high percentage of hauling trucks going east toward the city. The overlay section was constructed to improve ride quality and skid resistance (see Figure 4.10).

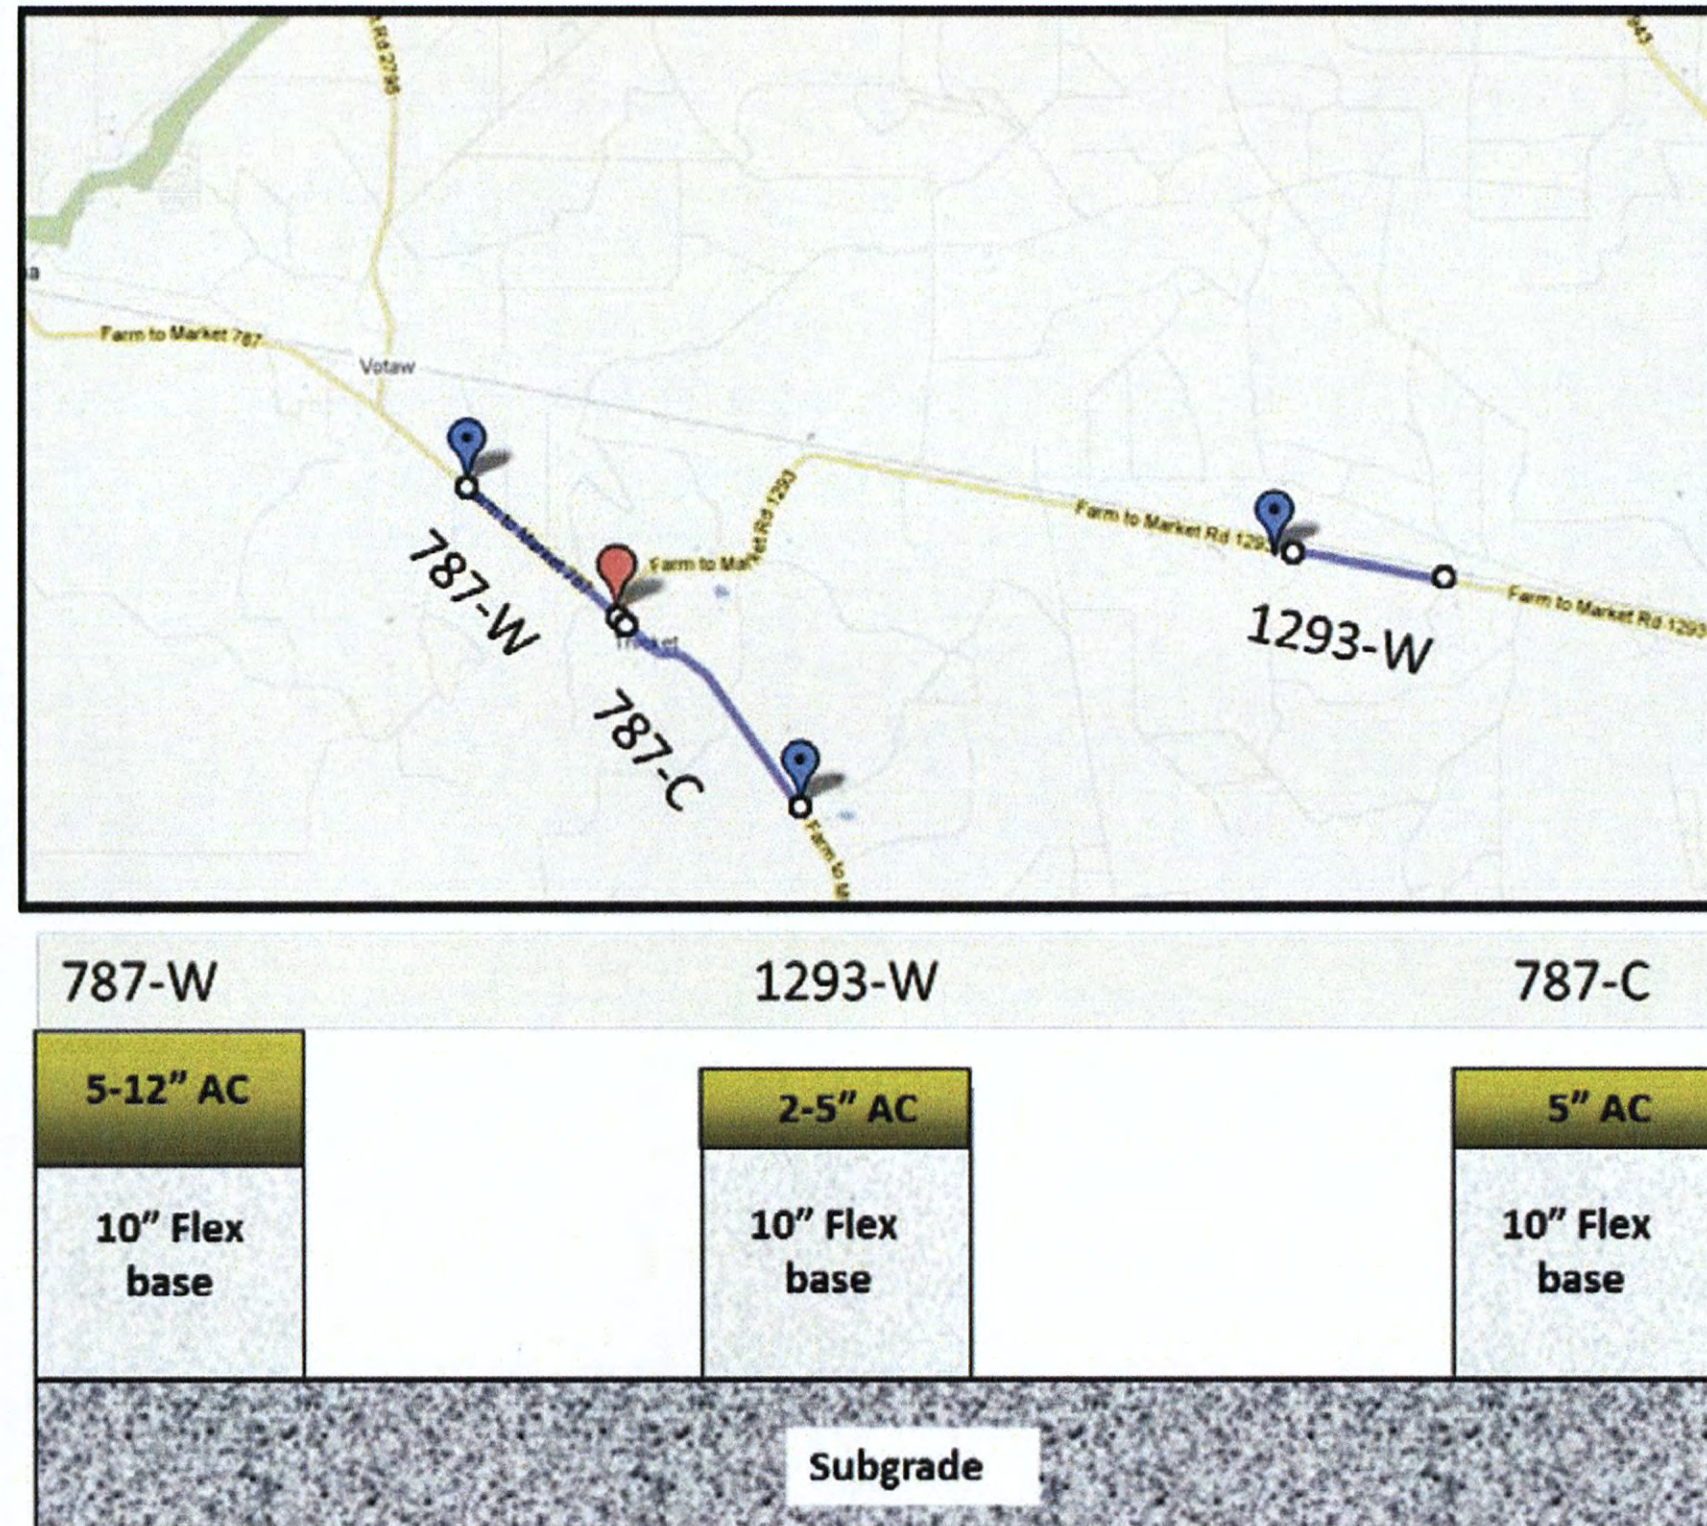
Figure 4.15. Test Sites Layout in Beaumont District.

This site is located at Kountze County in Beaumont District (Figure 4.15). The sites consists of three sections; the repaired section 1 is located on FM 1293 between reference marker (RM) 729 and 730, the control section 2 is located on FM 787 East between FM 1293 and Kervin Rd., and the repaired section 3 is on FM 787 West between FM 1293 and RM 726. This is an example of a widening job conducted by the district office to alleviate edge failures. A 3-ft shoulder was added to provide lateral support. About 10 in. of material was excavated and replaced with flexible base. The base was compacted, and then a prime coat was applied. Finally, the entire roadway was overlaid with 1.5 in asphalt surface.

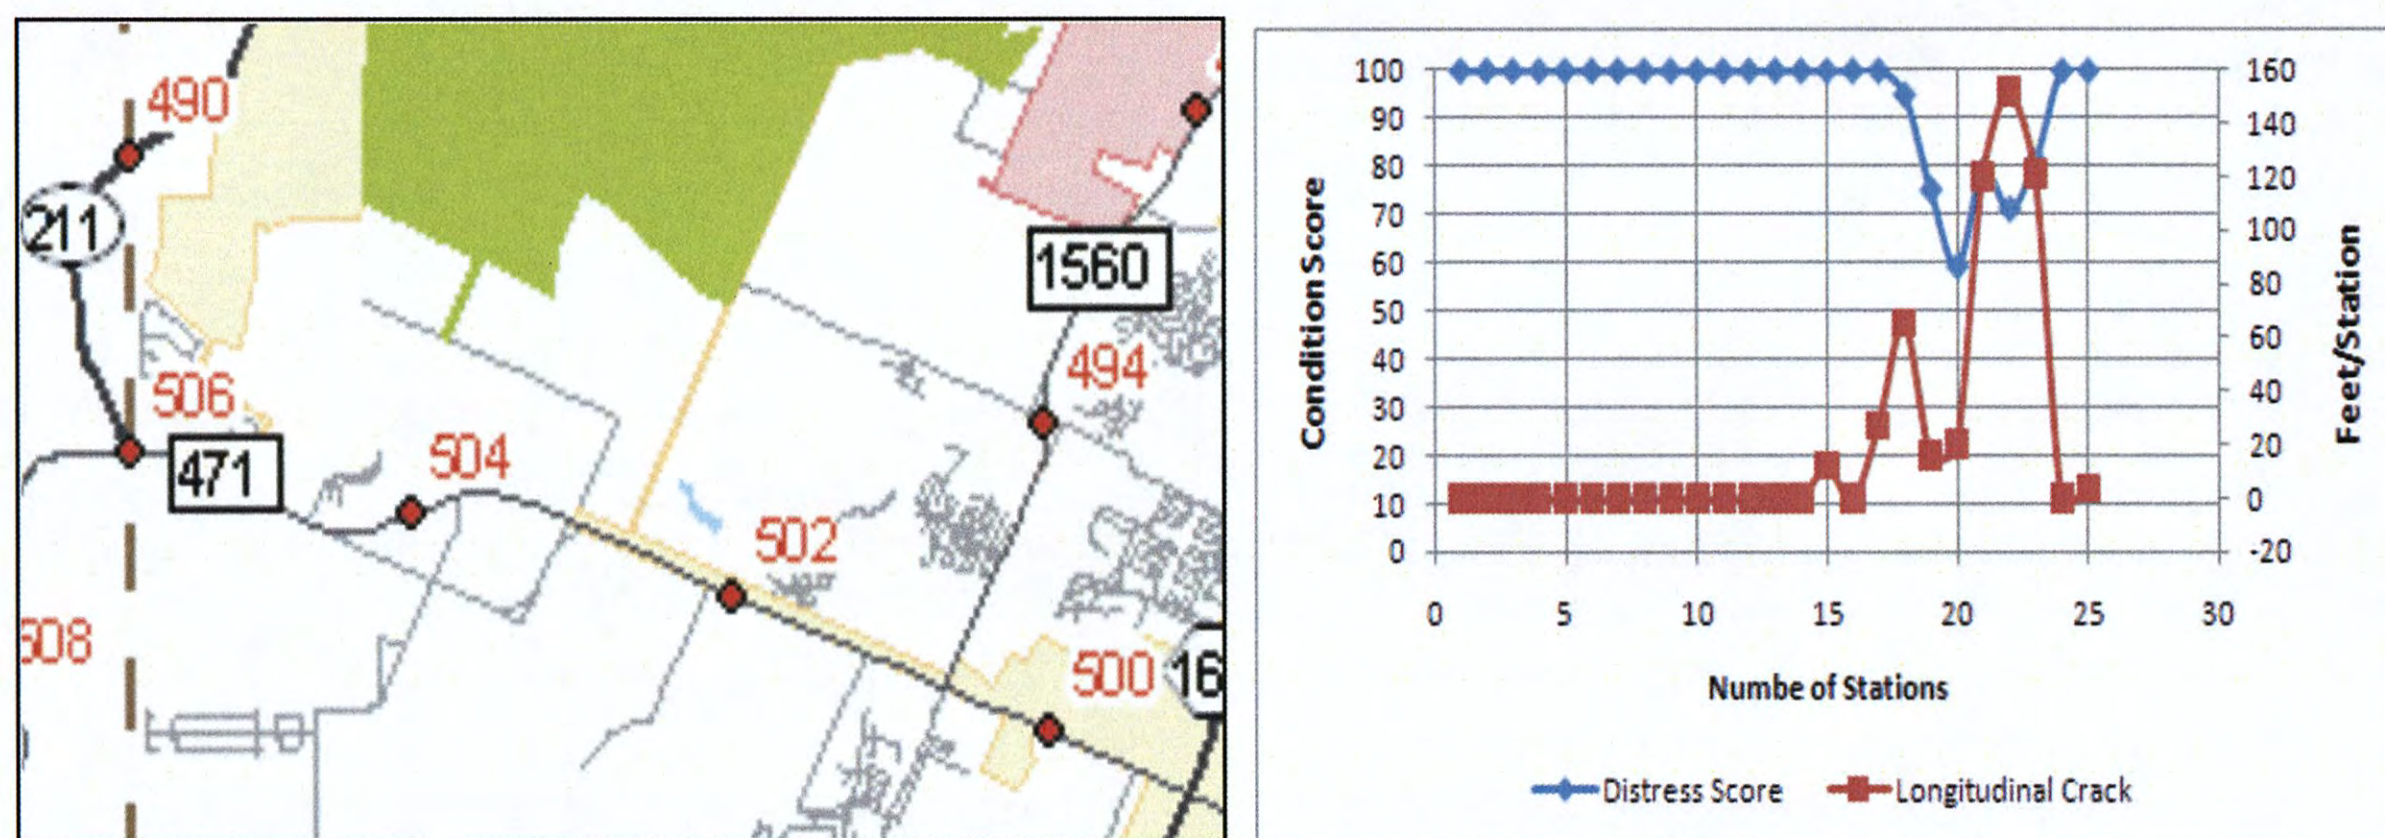
Figure 4.17. Plot of PMIS Data of FM 471.

An attempt to verify the sites performance with PMIS data of year 2010 is shown in Figures 4.17 to 4.20. The plots showed condition score and longitudinal crack data against the test segment. PMIS data was extracted based on the reference marker taken from the TxDOT statewide map system. The longitudinal crack here was shown in the average length in feet. The correlation between condition score and longitudinal crack seems reasonable. Also, the condition scores are in agreement with the visual inspection of the surface conditions. Figure 4.17 indicated the significant drop in condition score and increase in the longitudinal cracking in the control section (station 20-25). The effectiveness of the cement-treated base and overlay can also be noted (station 0-17). Figure 4.18 indicated the performance of the geogrid section (station zero) compared to the control (station 7-12). Figures 4.19-4.20 indicated the best performance among all sites in this study. Figure 4.21 indicated the effectiveness of the cement-treated base reconstruction section (station 0-6) versus the control lime-treated section (station 12-16).

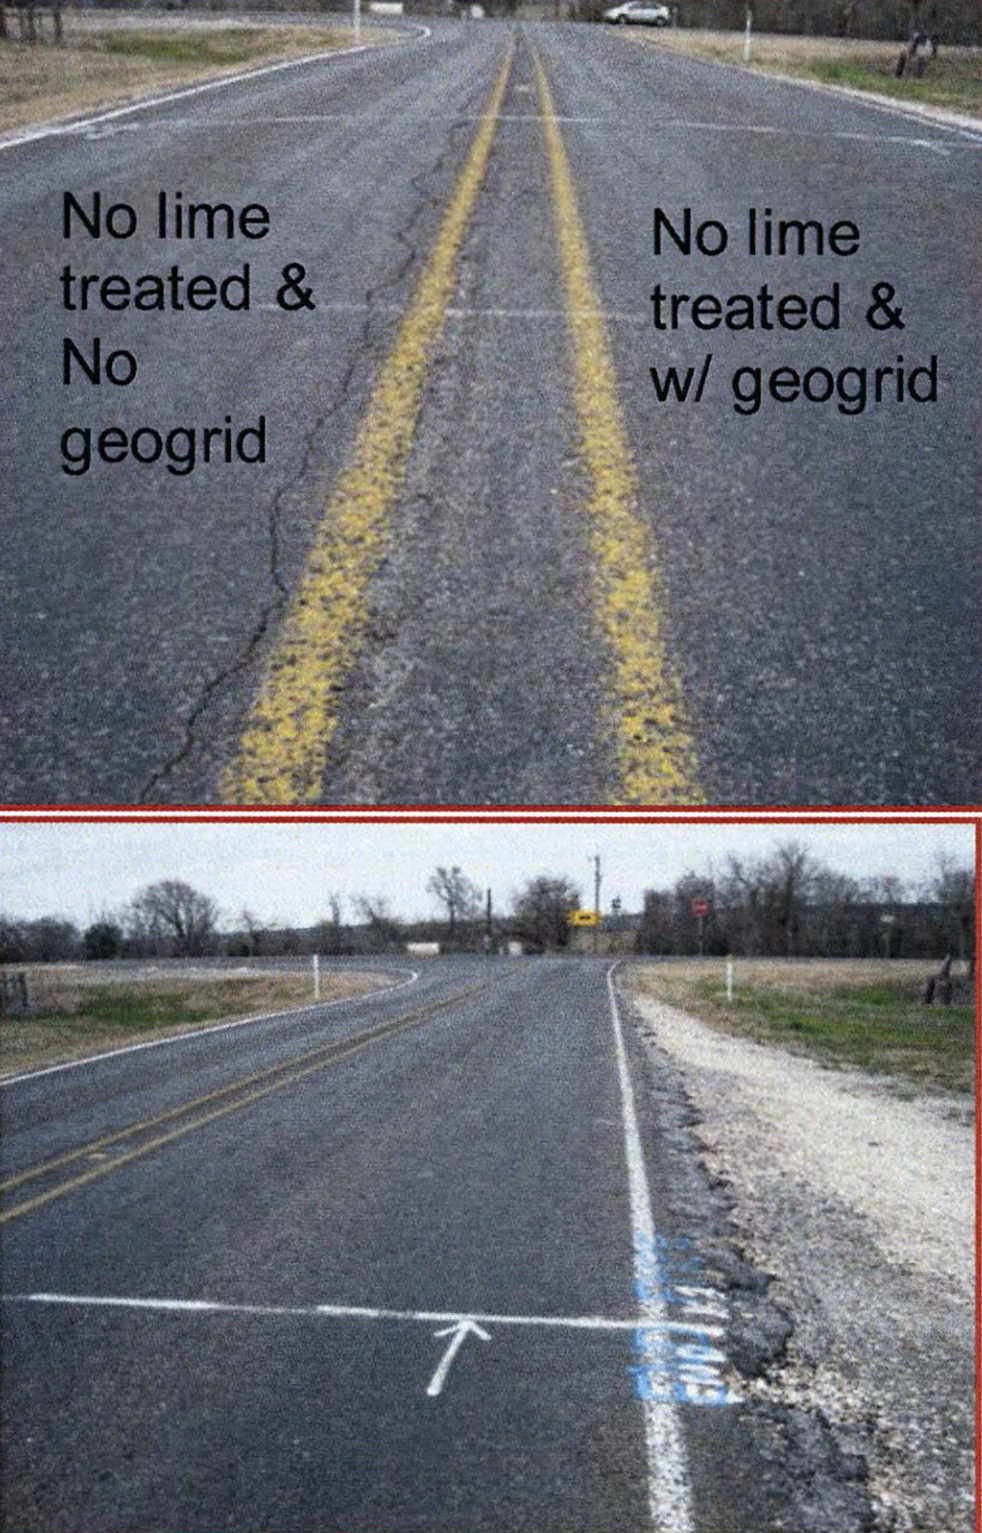
203+00 ~ 221+00	<p>Area surveyed: 1Wa/1Ea: No geosynthetic w/o lime treatment 2Wa/2Ea: Geogrid 1 w/o lime treatment 3Wa/3Ea: Geogrid 2 w/o lime treatment 4Wa/4Ea: Geotextile w/o lime treatment</p> <p>There are no edge cracks on both lanes; however, longitudinal cracks were found on a joint of both east and west bound lanes. The cracks length was about 27-ft with medium severity, initiated from 1Wa.</p>
