Treatments to Reduce the Frequency of Freeway Exit Sign Hits

Technical Report 0-6120-1

1. Report No. FHWA/TX-11/0-6120-1		2. Government Accession No.		3. Recipient's Catalog No.	
4. Title and Subtitle TREATMENTS TO REDUCE THE FREQUENCY OF FREEWAY EXIT SIGN HITS				5. Report Date January 2011 Published: June 2011

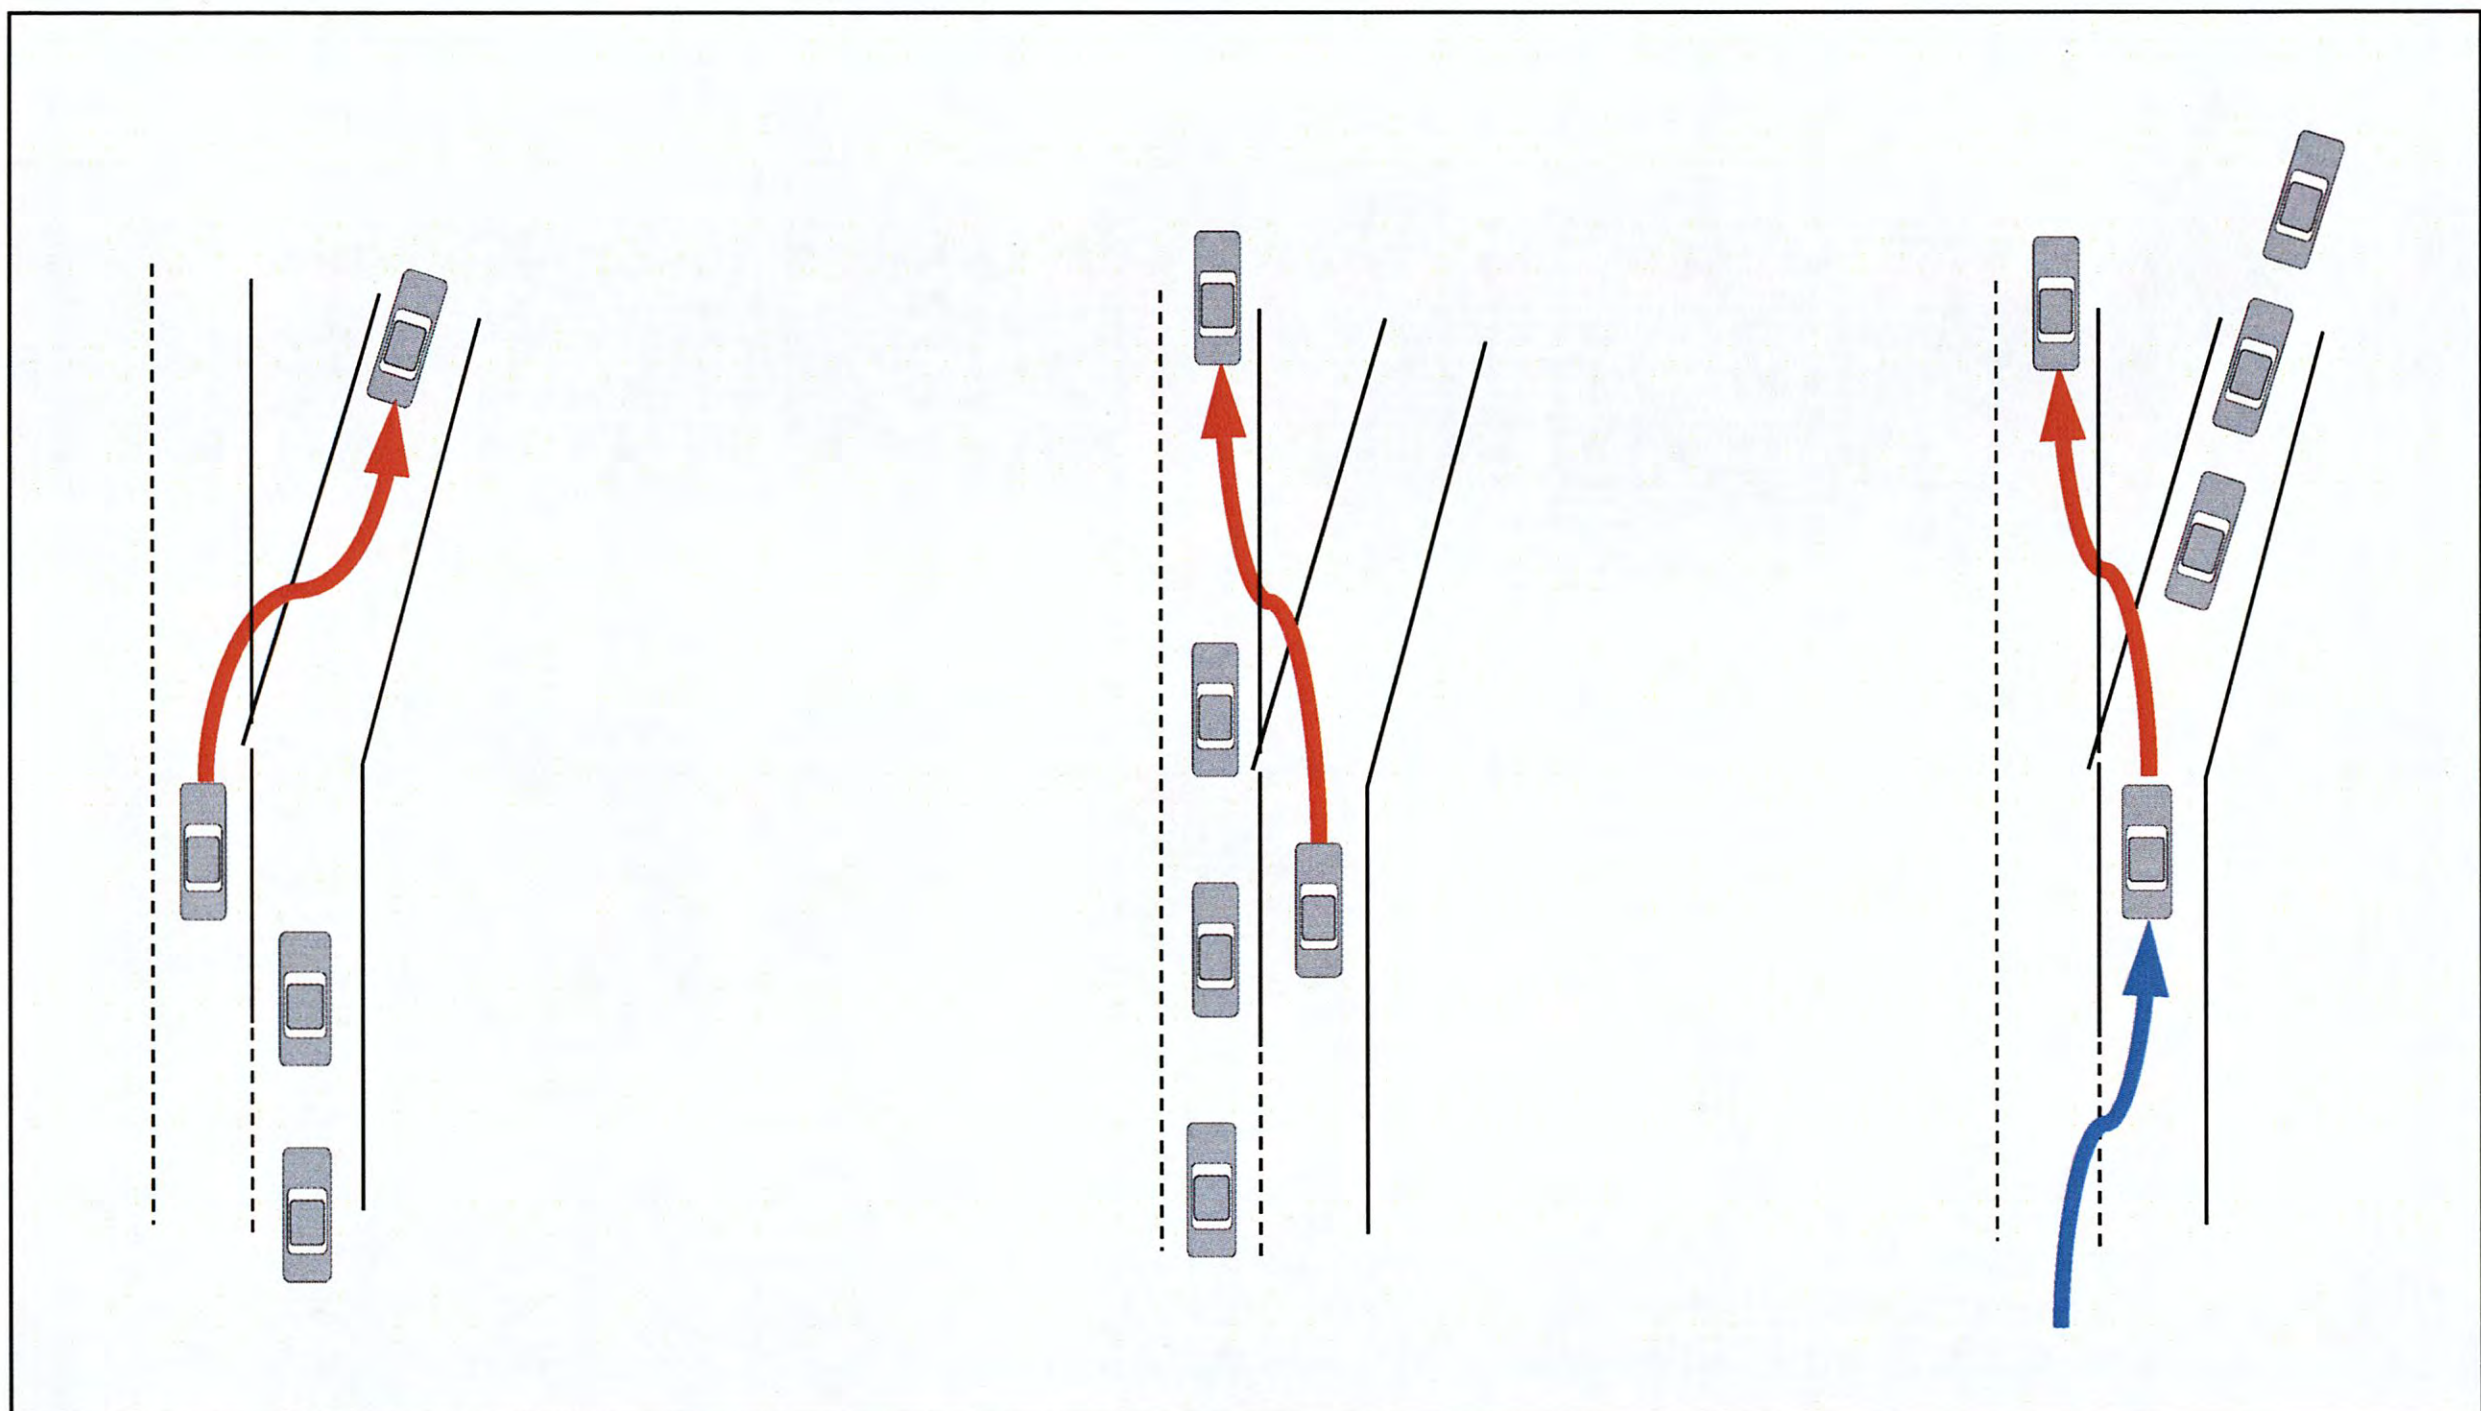
Figure 36. Erratic Maneuvers at Exit Gore.

The narrow time window of several days between sign hits and replacements did not make it possible to consider any accident records as safety measures in evaluating the safety impact of missing exit gore signs. Therefore, researchers took a different approach: they collected data on erratic vehicle maneuvers and used these as surrogate safety measures. The three most common erratic maneuvers that may be related to frequent exit gore sign hits are illustrated in Figure 36. In each case, vehicles cross the gore area to perform a late exit or late merge.

These erratic maneuvers may have several different reasons. For example, these may be related to inattentive driving, driver hesitation, late decision making. These maneuvers can also happen when drivers cannot find a sufficient gap in the weaving traffic stream to make a timely lane change for safe exiting or merging, and are forced to cross the gore area. In this study, researchers collected data on the frequency of all erratic maneuvers regardless of reason or cause.

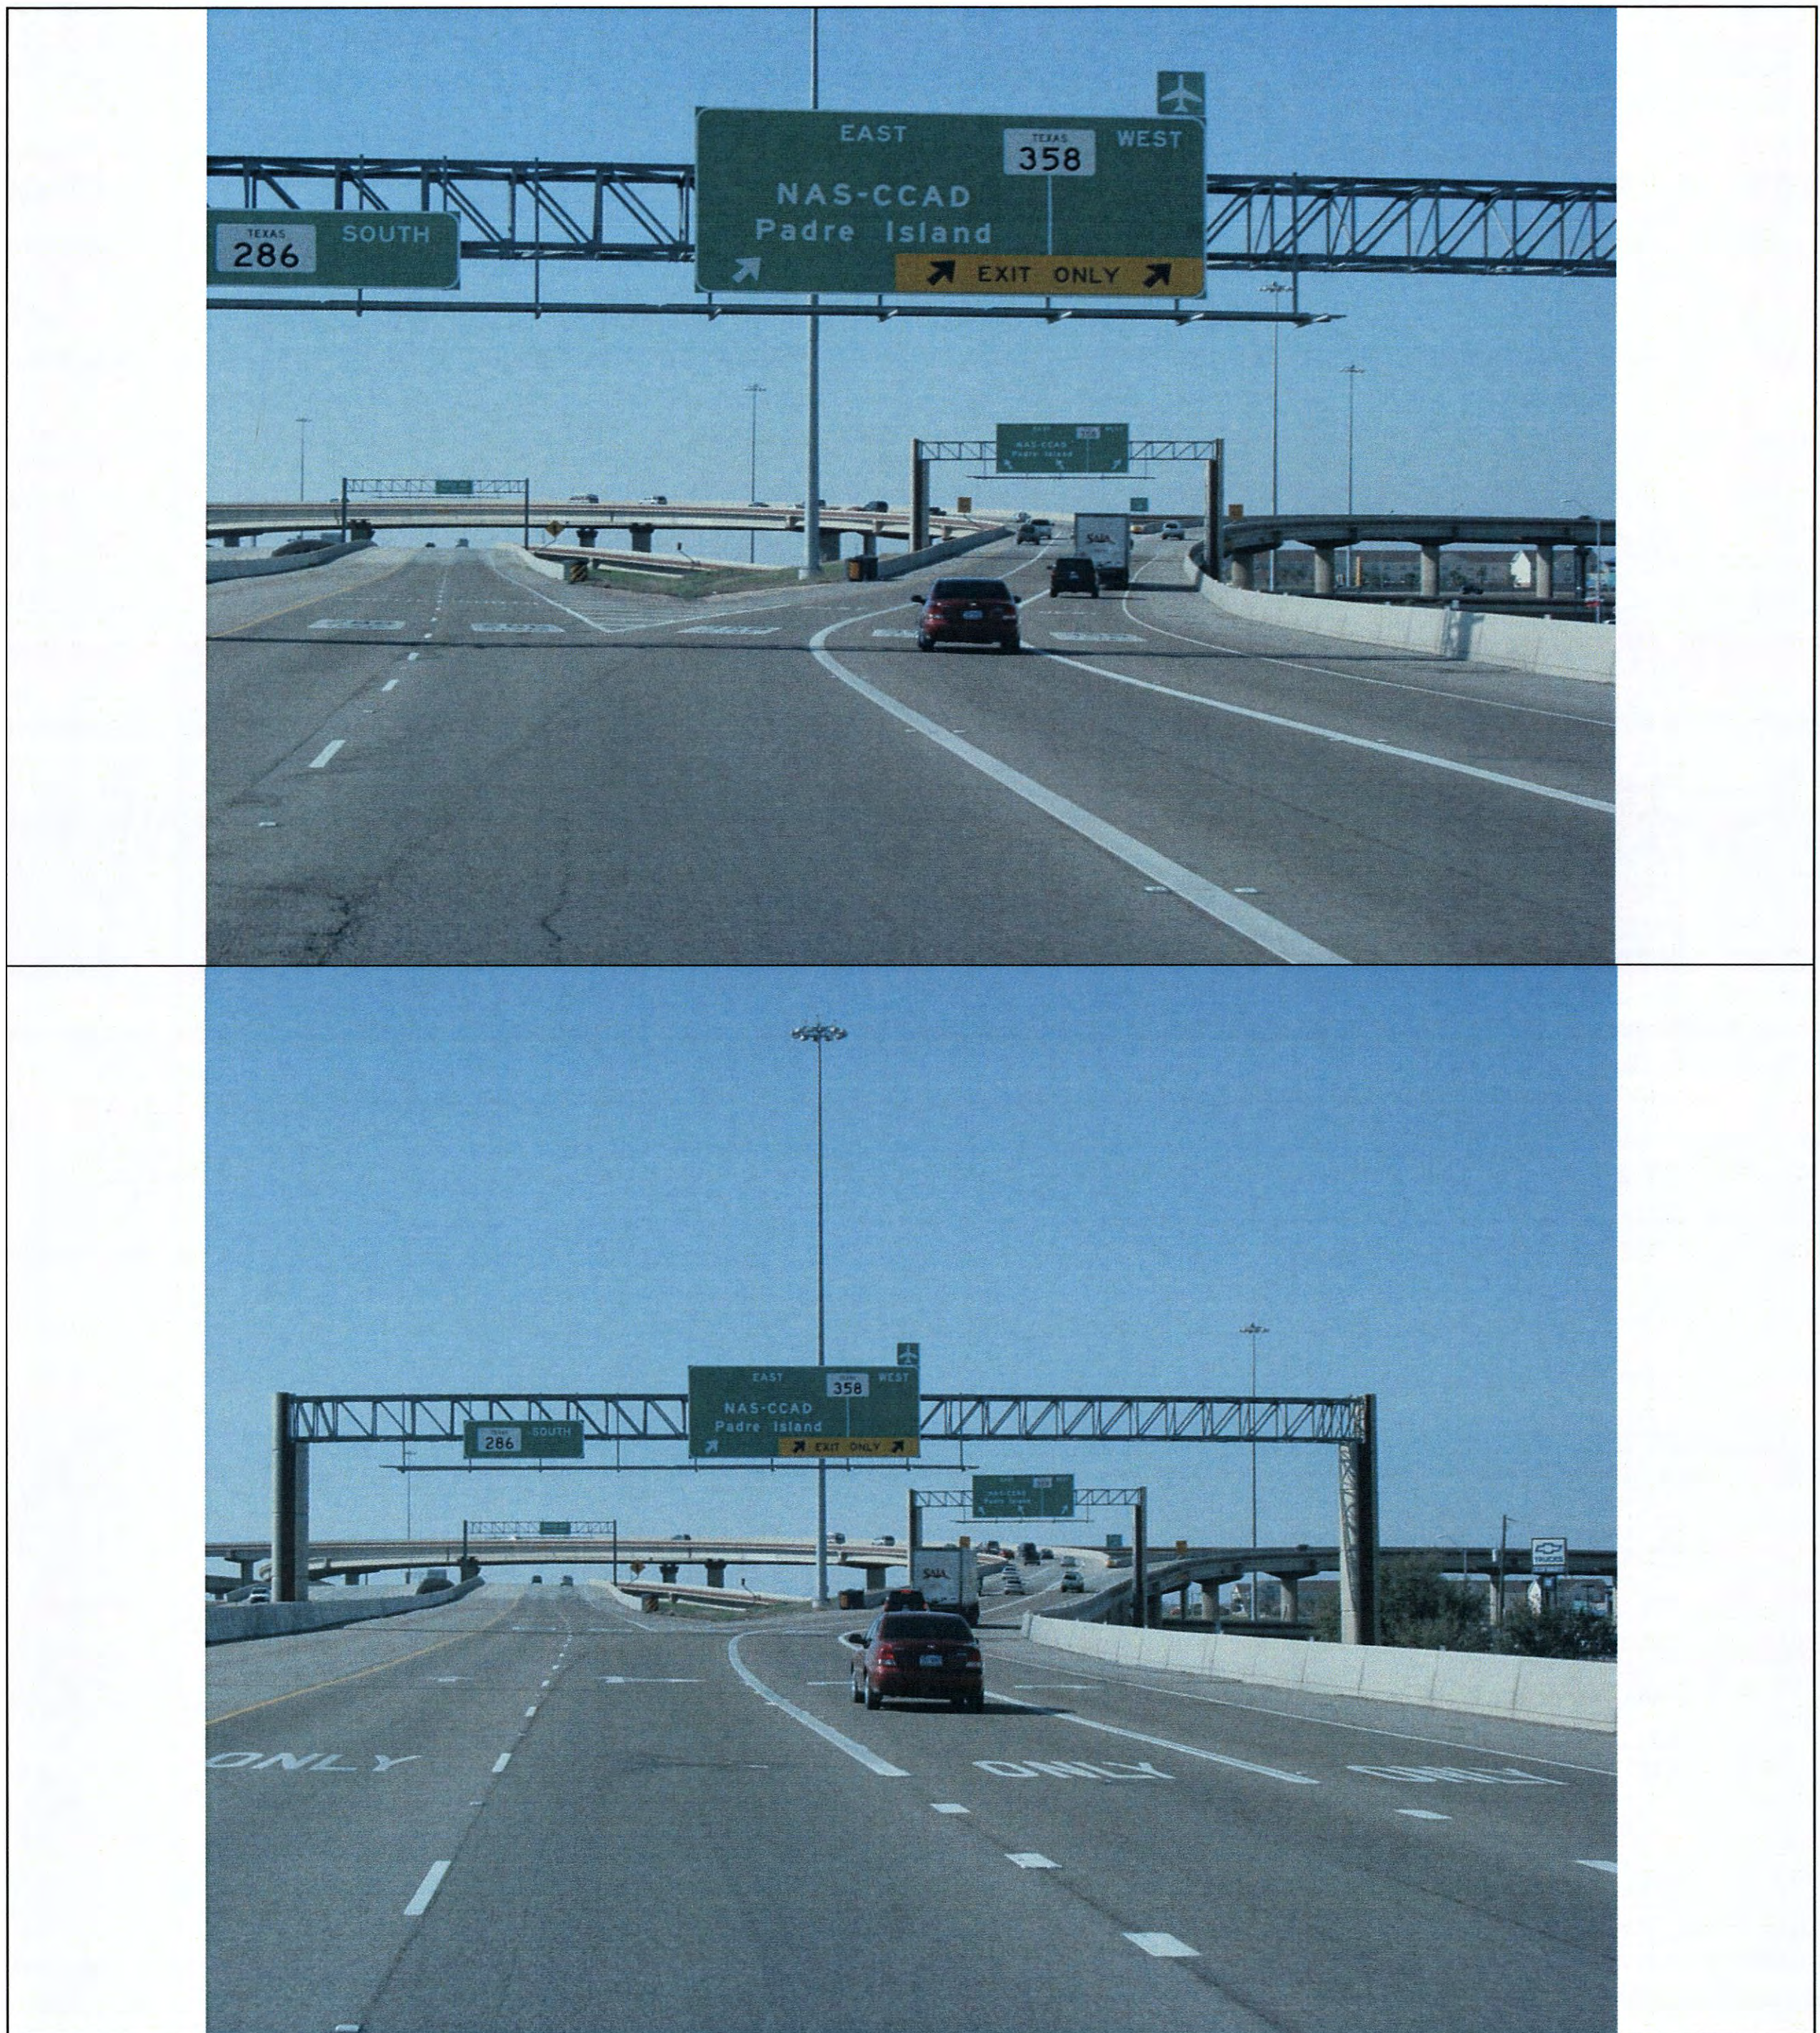
Figure 40. Approach to Southbound SH 286 Exit to SH 358 East at Start of Gore Area.

- This is a freeway to freeway direct connector ramp exit.
- There was no observed sight distance issue with this location.
- High operating speeds were observed on approach to the exit ramp.
- Very little visual clutter on approach.

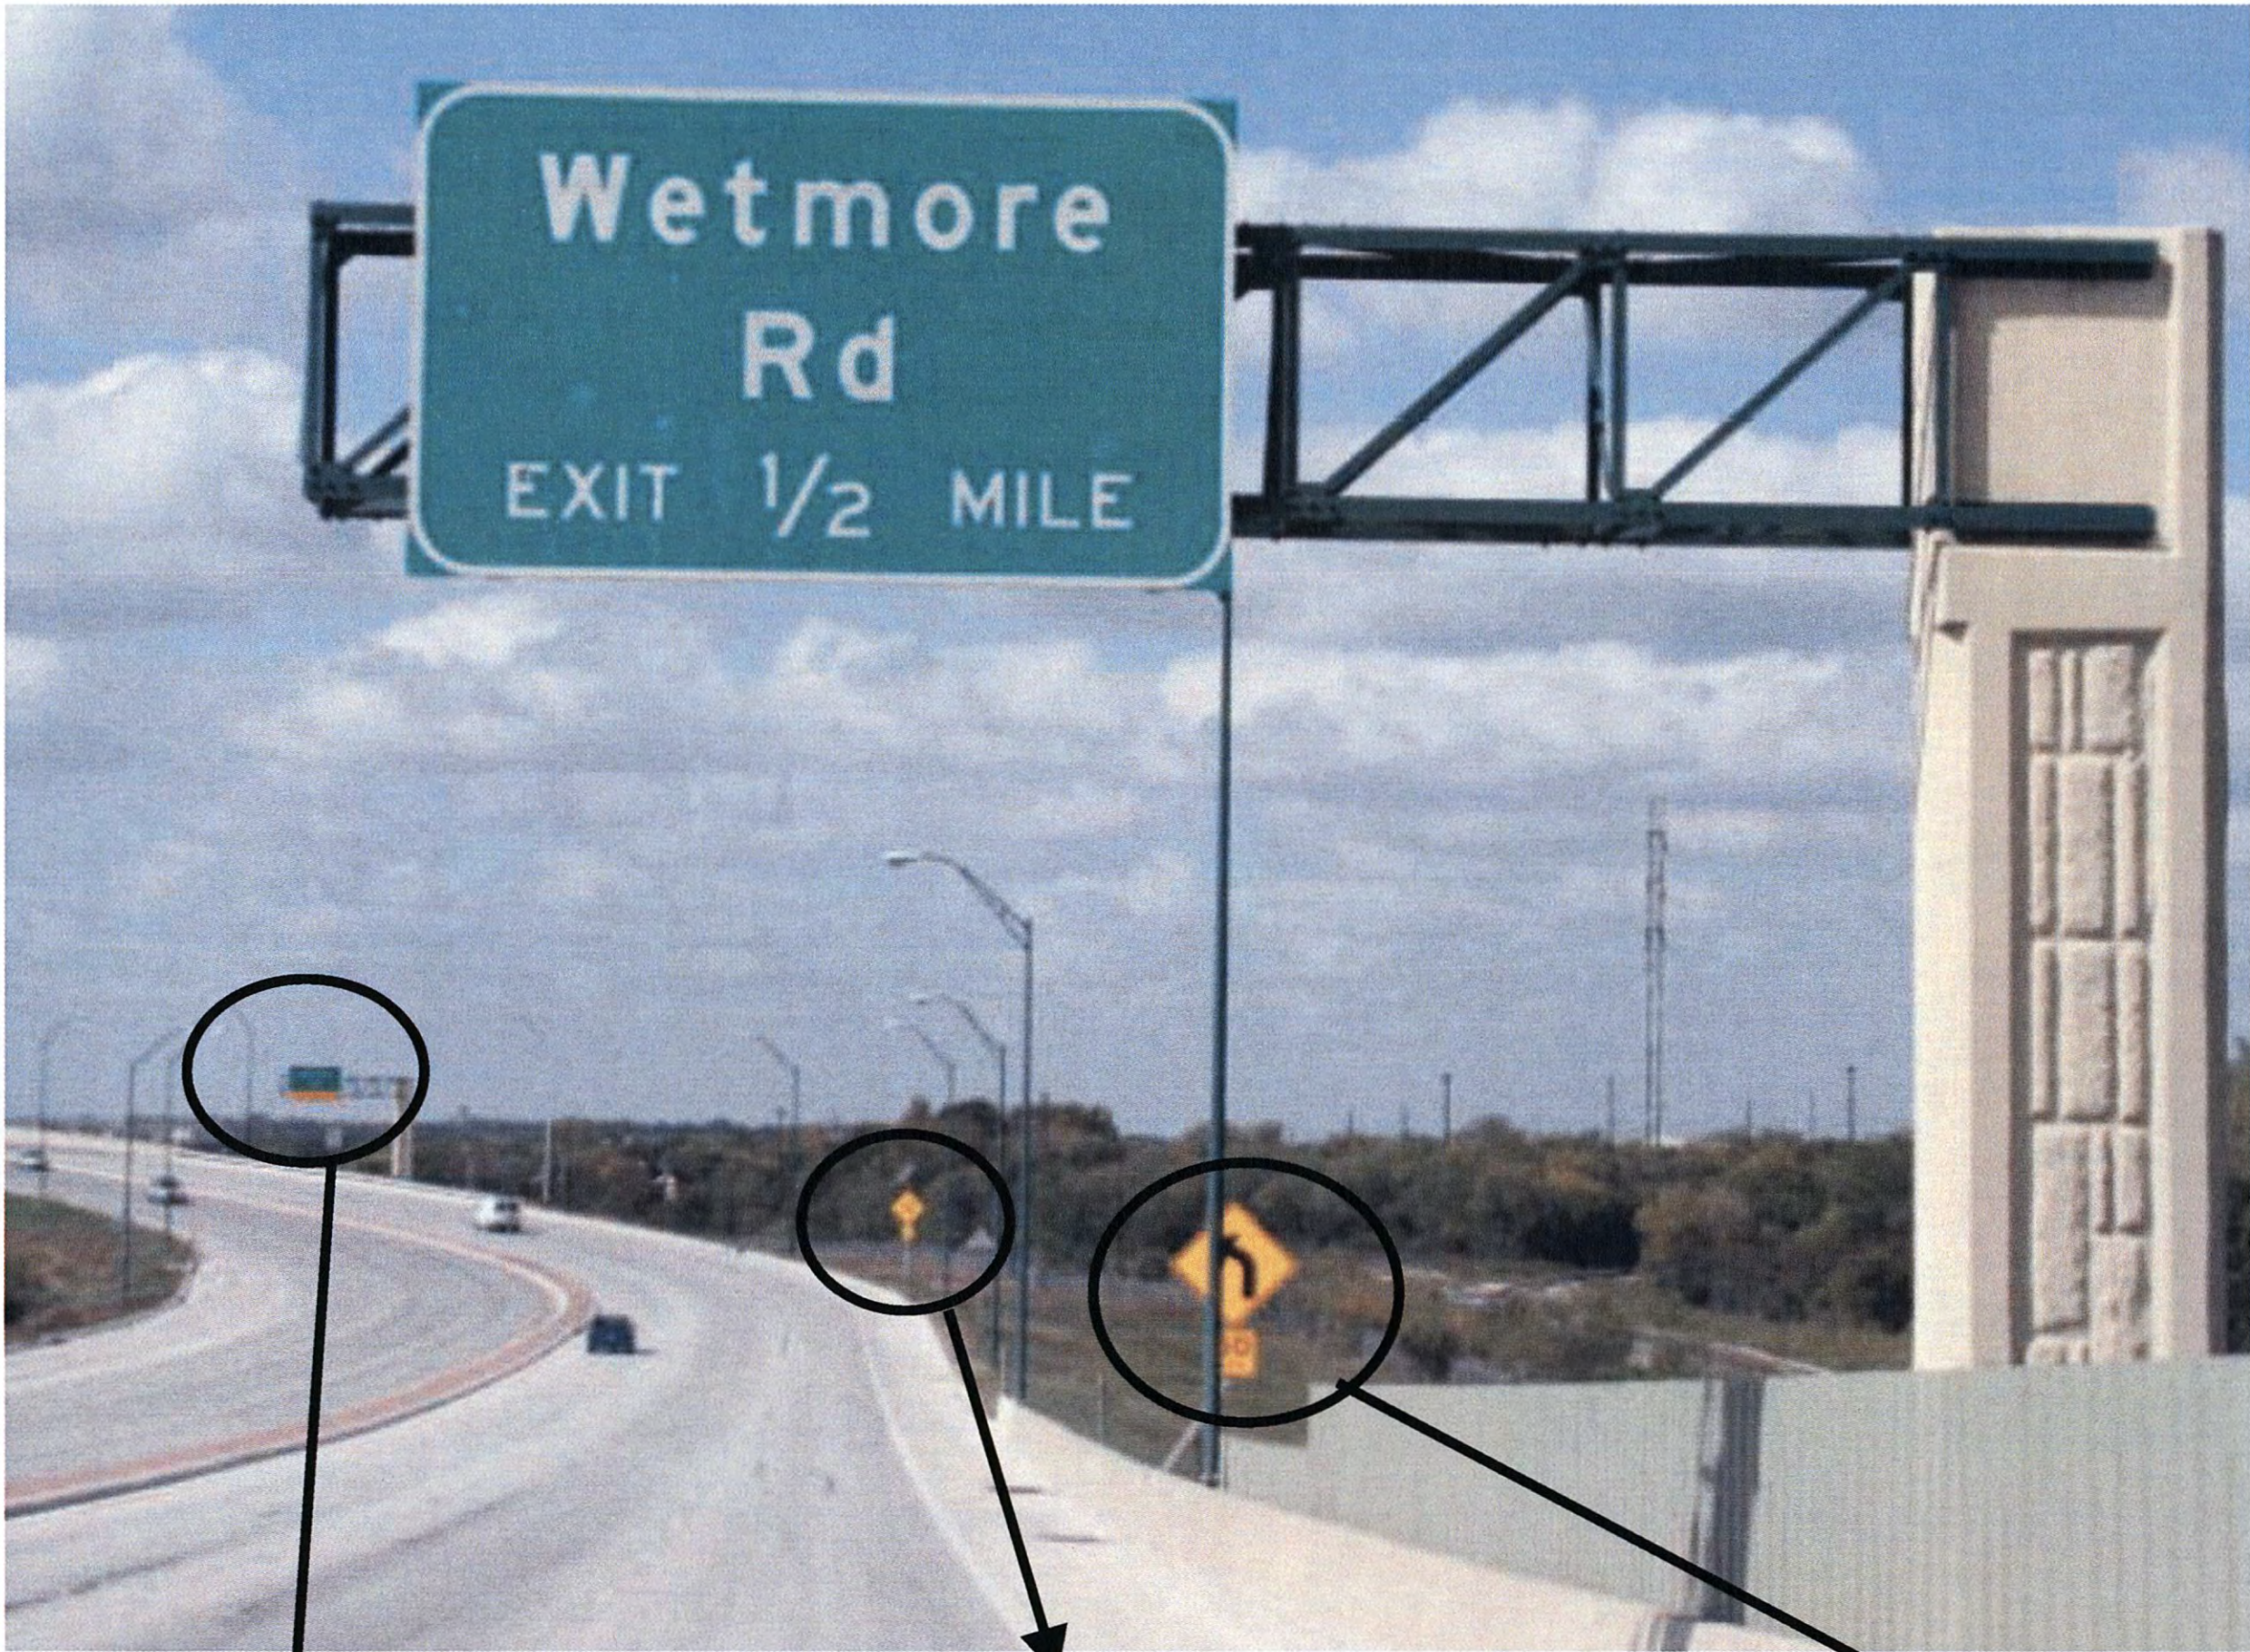
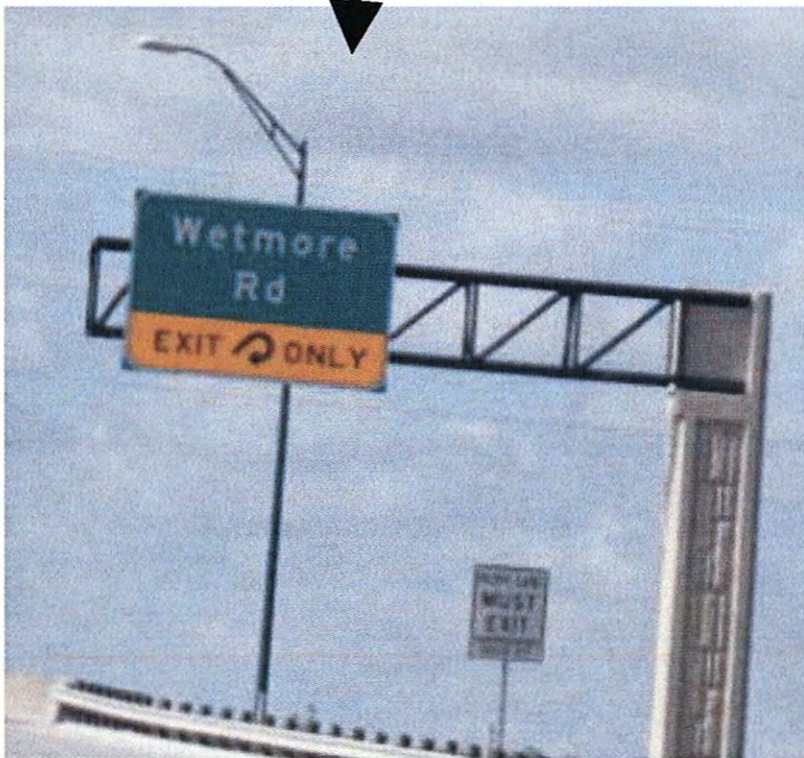
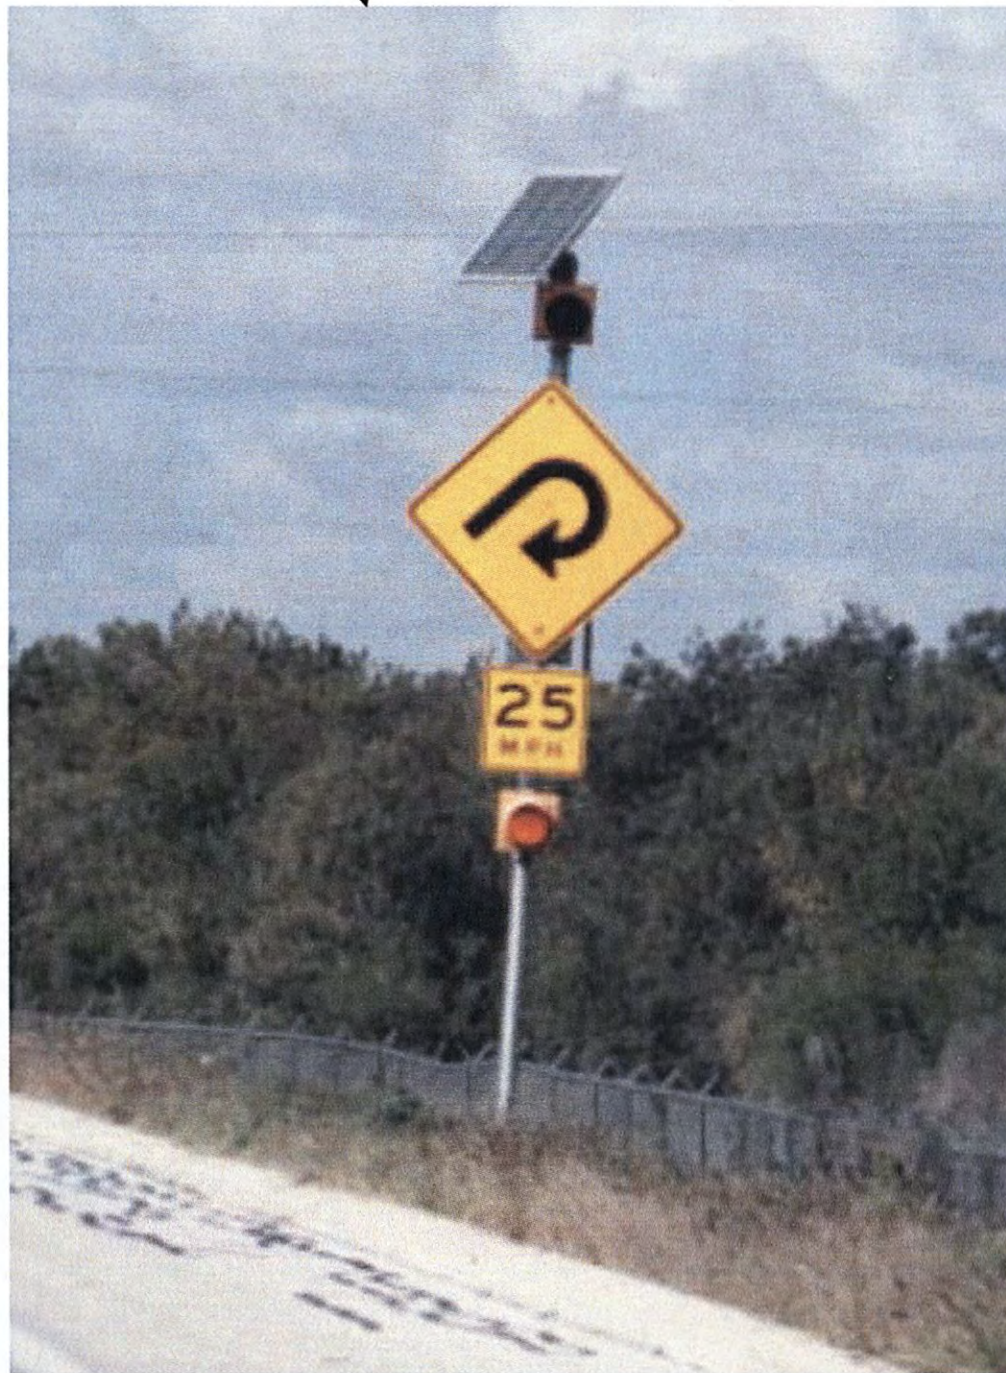
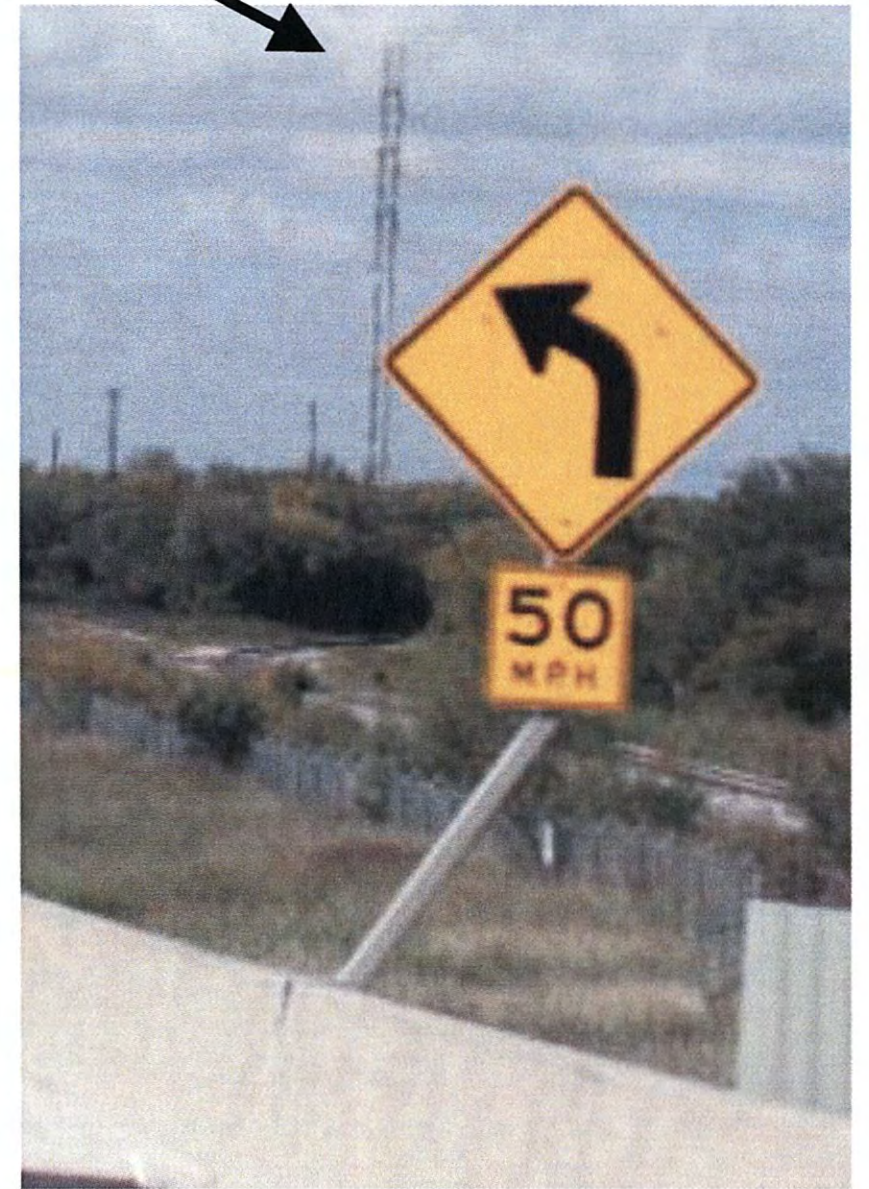
Figure 42. Sequence of Signing on Approach to Wetmore Exit on Westbound Wurzbach Parkway.

- Vertical and horizontal curves were observed on approach to exit.
- Steep grade on approach to the exit reduces sight distance significantly.
- Relatively high speeds were observed on approach to the exit.

- Advanced ramp advisory speed warning with flashers.
- Painted ramp speed on approach lane (see Figure 44).
- Rumble strips on approach lane.
- Removal of exit gore sign (not an option based on MUTCD).

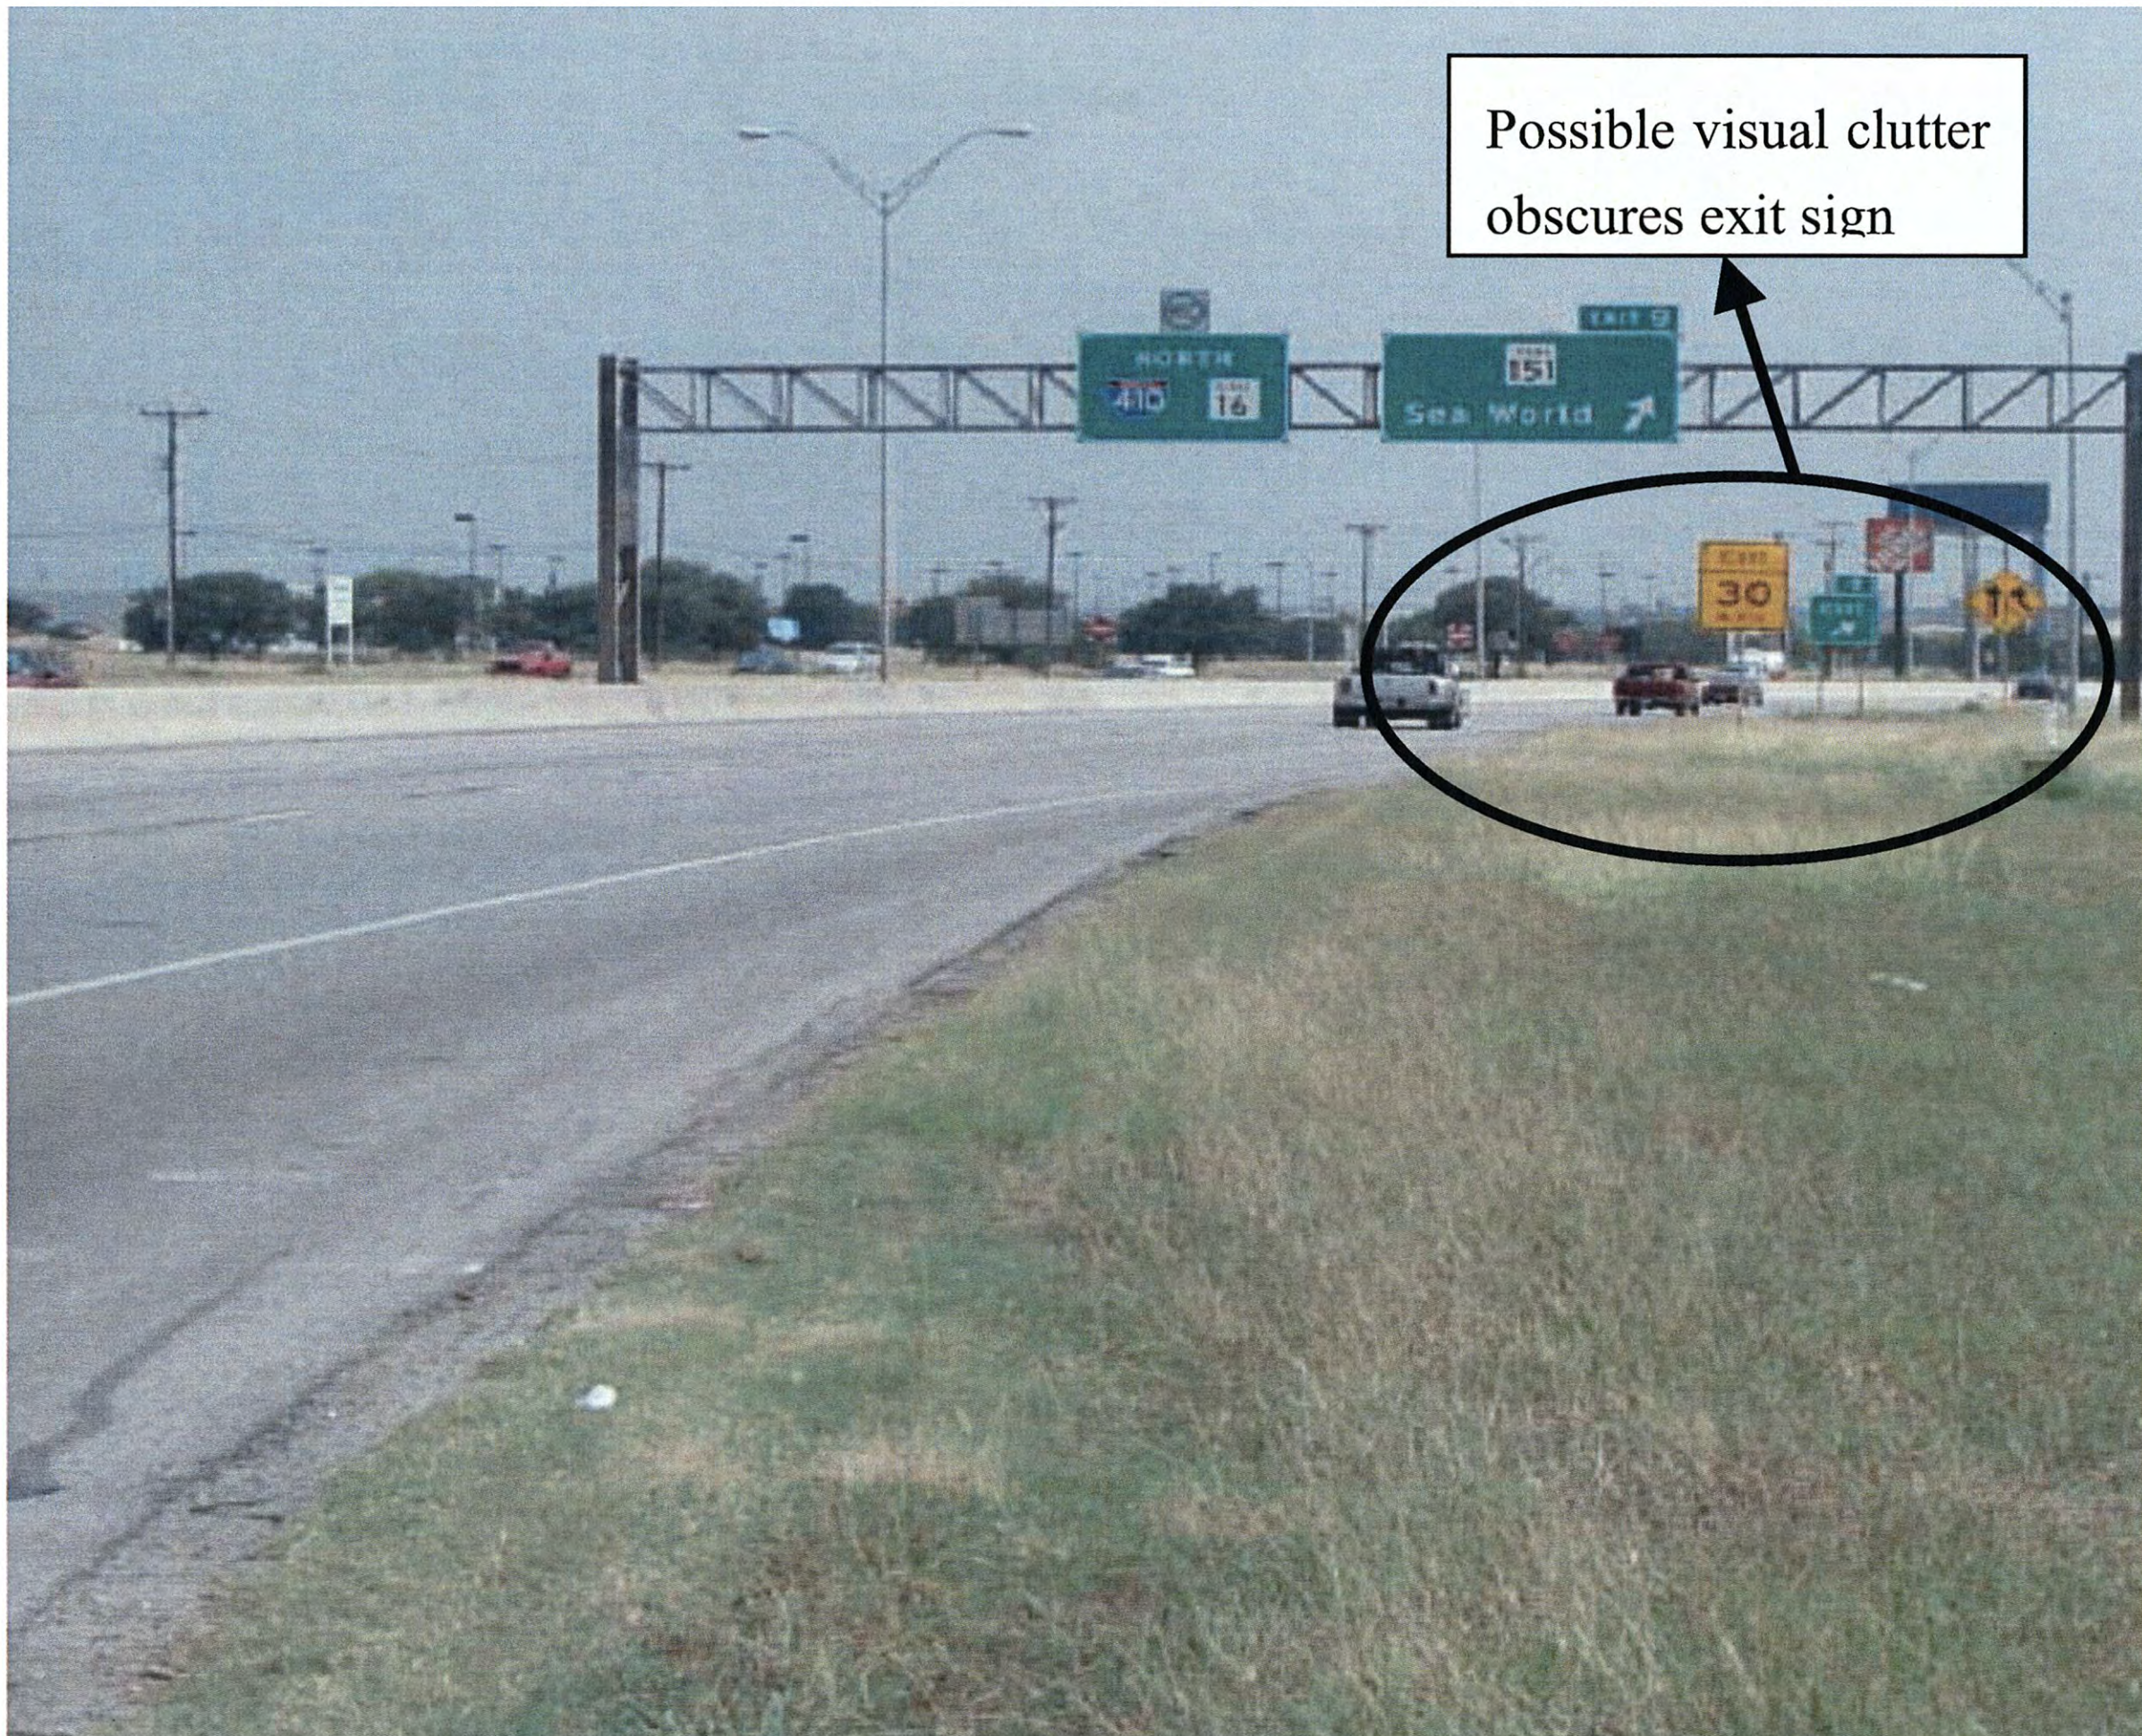
Figure 45. Approach to SH 151 Exit on Northbound IH 410.

- No obvious geometric deficiencies noted on site.
- High speeds were recorded for exiting traffic.
- Some visual clutter on approach to exit with numerous roadside signs (see Figure 45).
- Late maneuvering was a common observance.
