Treatments to Reduce the Frequency of Freeway Exit Sign Hits

Technical Report 0-6120-1

1. Report No. FHWA/TX-11/0-6120-1		2. Government Accession No.		3. Recipient's Catalog No.	
4. Title and Subtitle TREATMENTS TO REDUCE THE FREQUENCY OF FREEWAY EXIT SIGN HITS				5. Report Date January 2011 Published: June 2011

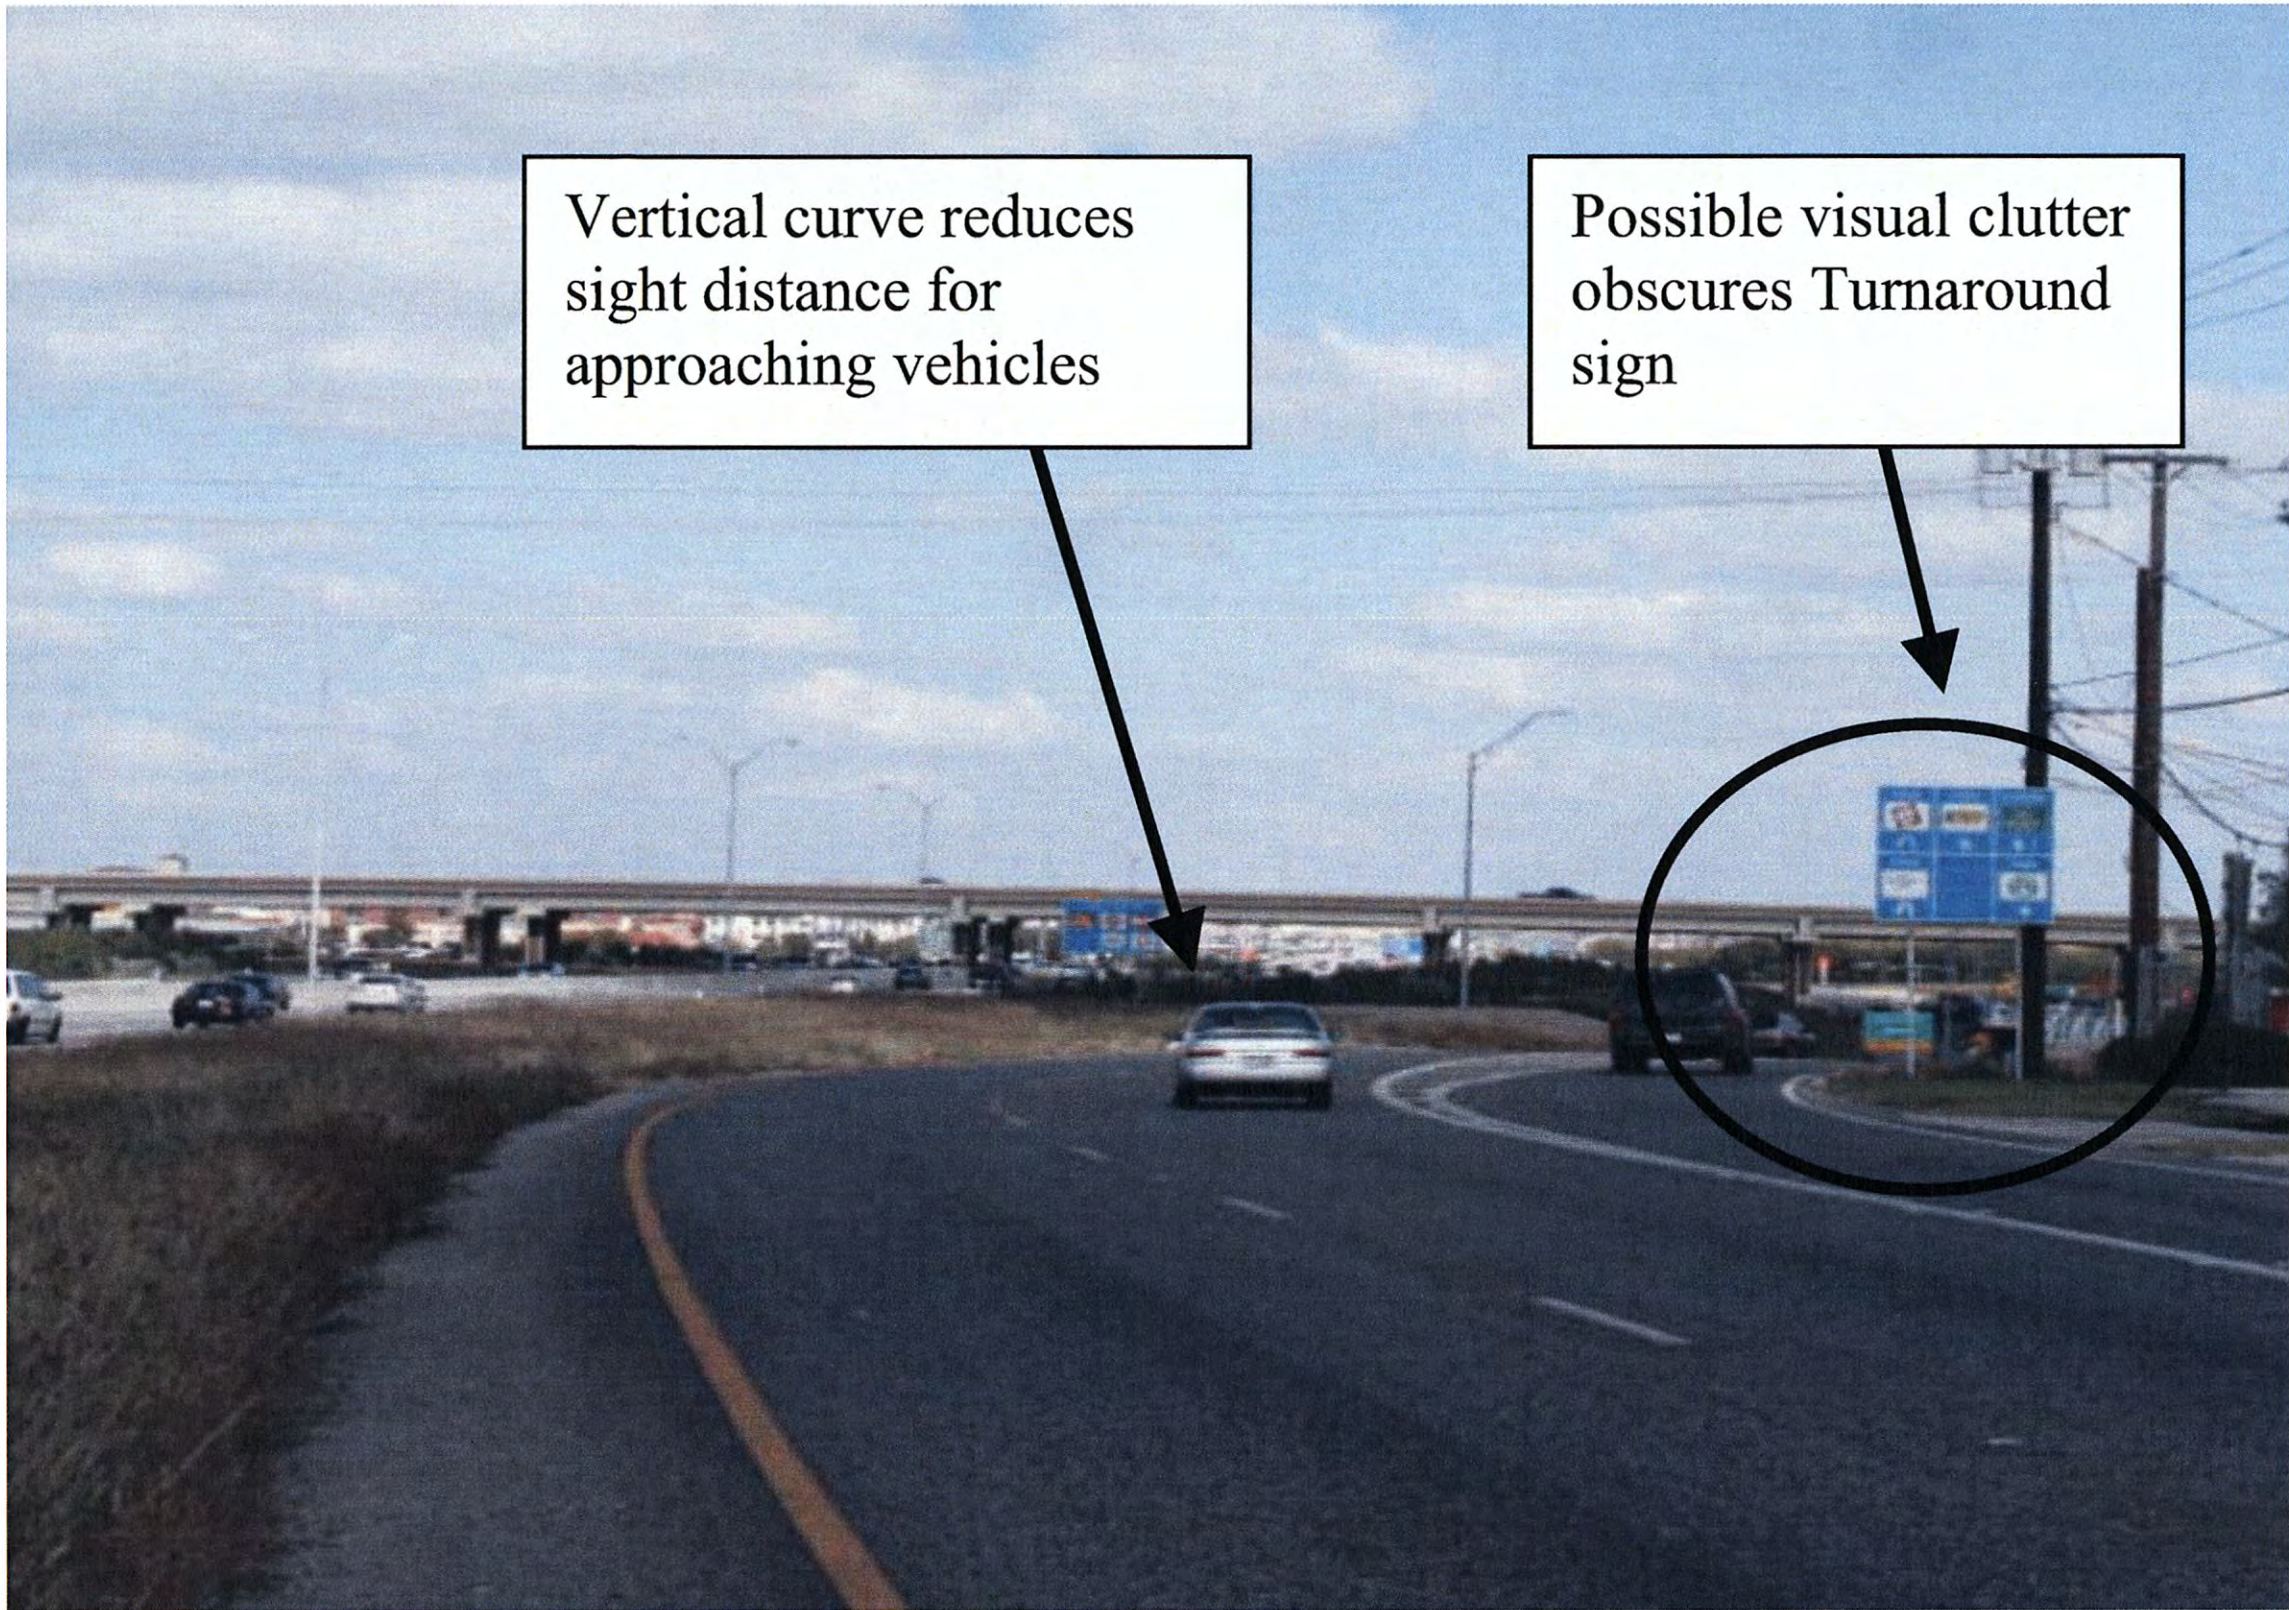
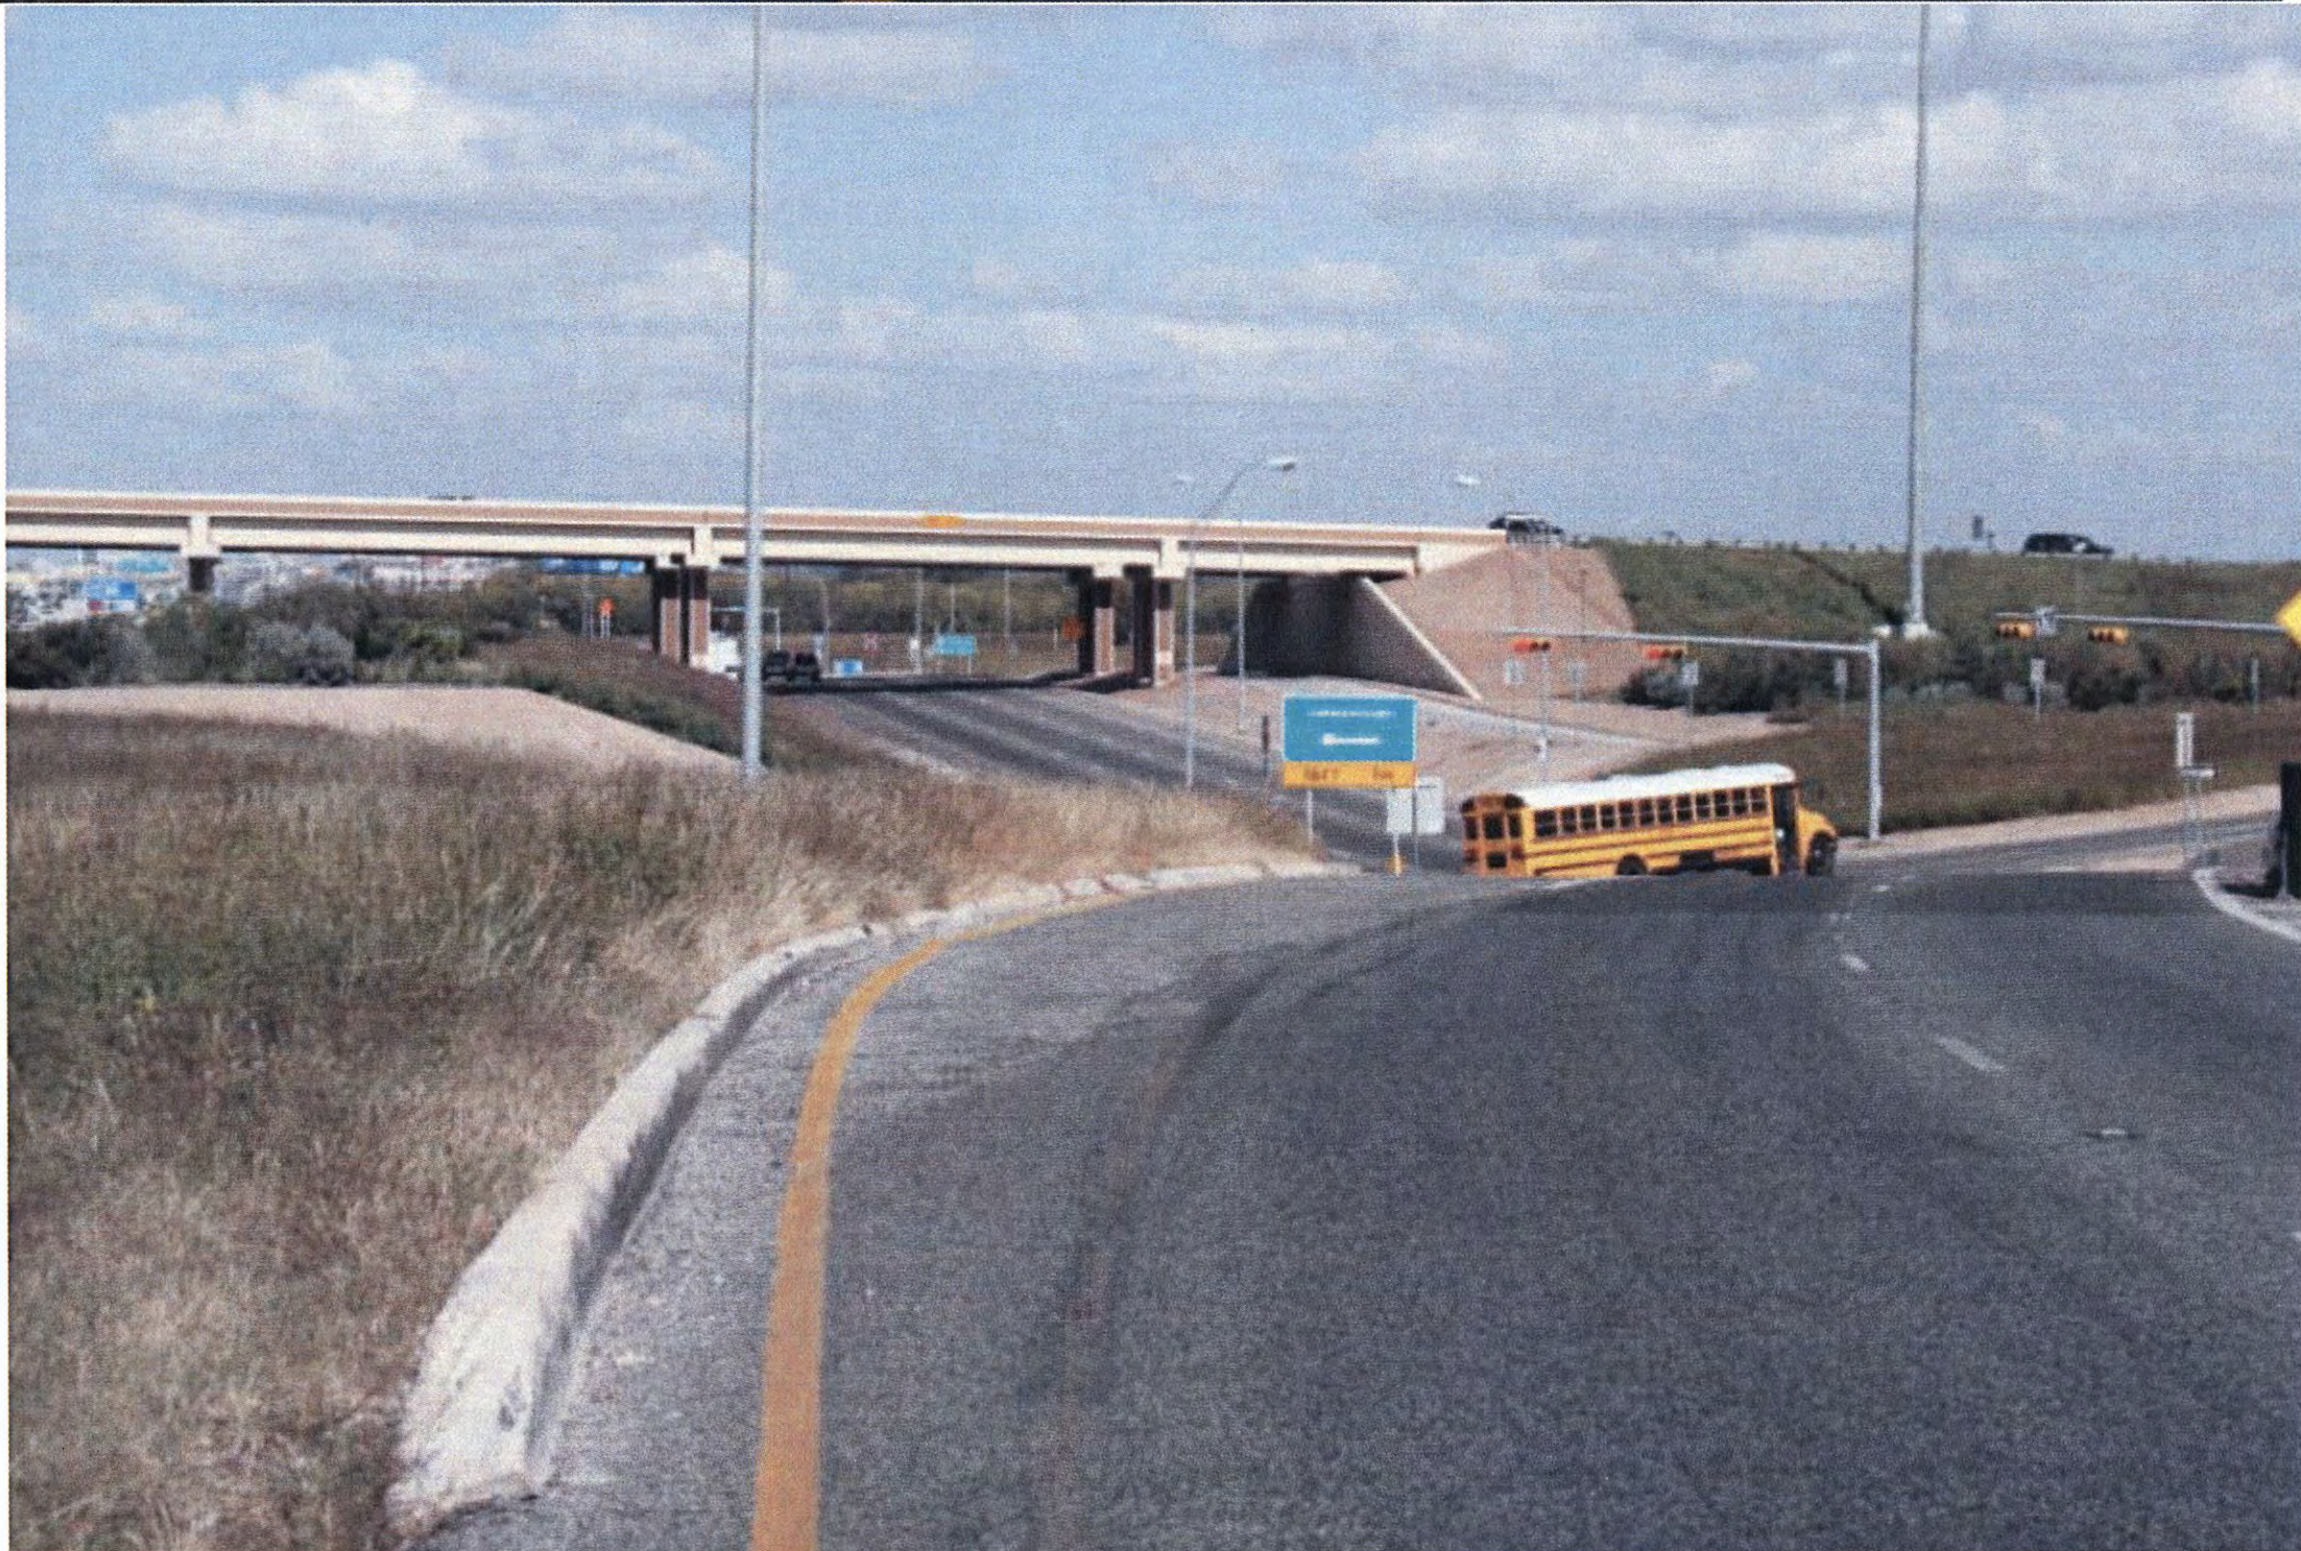
Figure 46. Northbound IH 410 Frontage Road Approach to U-Turn at SH 151.

- Vertical curve on approach to the frontage road intersection inhibits sight distance significantly, thus increasing driver response time to the sudden turnaround lane.
- It was easily observed from curb marks that drivers frequently overshoot the turnaround curve and jump the curb.

No existing measures were observed to have been taken at this location. However in the other direction, the U-turn sign had been completely removed after several hits.
