CRASH TEST AND EVALUATION OF THE TxDOT T631 BRIDGE RAIL

Test Report 9-1002-12-10

The objective of this research was to evaluate the impact performance of the new TxDOT Type T631 bridge rail. The TxDOT Type T631 bridge rail is intended to serve as a low-cost replacement for the TxDOT Type T6 bridge rail for *MASH* TL-2 applications. The TxDOT T631 bridge rail is intended for new construction. The crash testing was performed in accordance with the requirements of *MASH* TL-2.

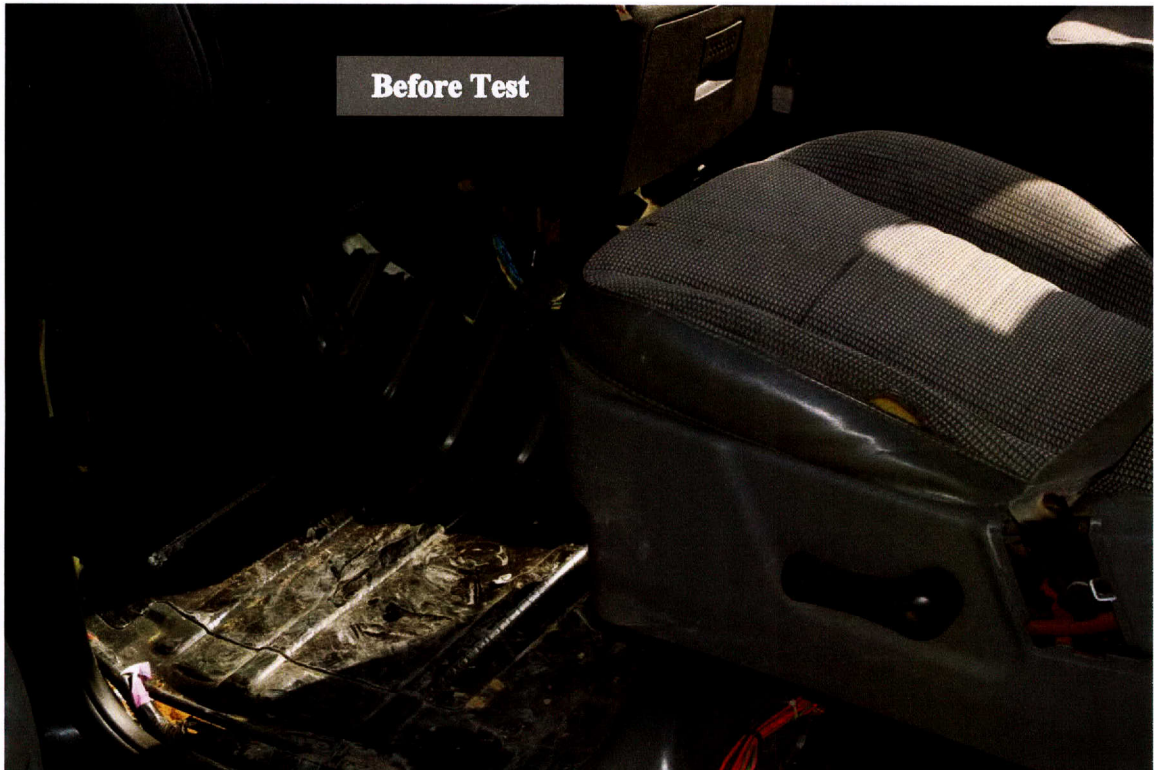
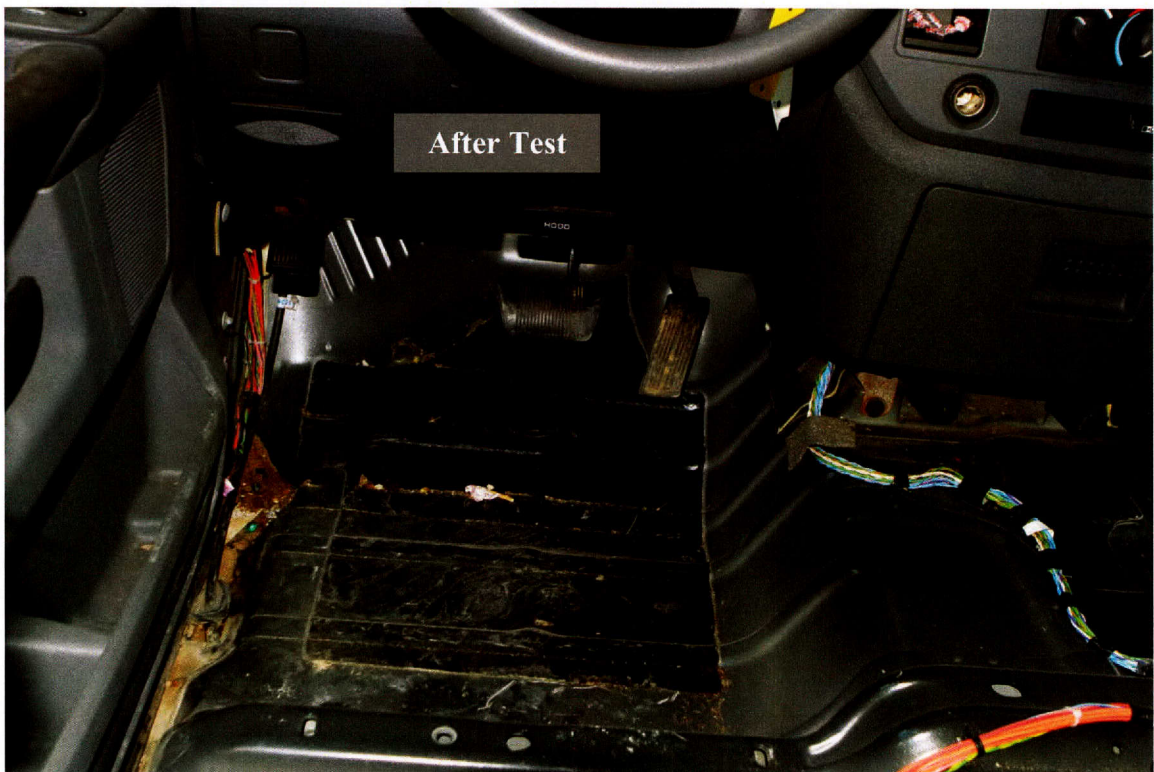
Figure 5.6. Interior of Vehicle for Test No. 490023-6-1a.

Figure 5.5 shows damage to the exterior of the vehicle. The left front wheel assembly broke from the upper and lower ball joints; the left upper and lower ball joints, A-arms, and left front tie rod end were deformed. Also damaged were the front bumper, left front fender, left front brake line, left front door, left front tire and wheel rim, left rear tire, left rear exterior bed, and the left rear bumper. Maximum exterior crush to the vehicle was 6 inches in the side plane at the left front corner at bumper height. No occupant compartment deformation or intrusion occurred. Figure 5.6 provides photographs of the interior of the vehicle. Tables C3 and C4 in Appendix C provide exterior crush and occupant compartment measurements.

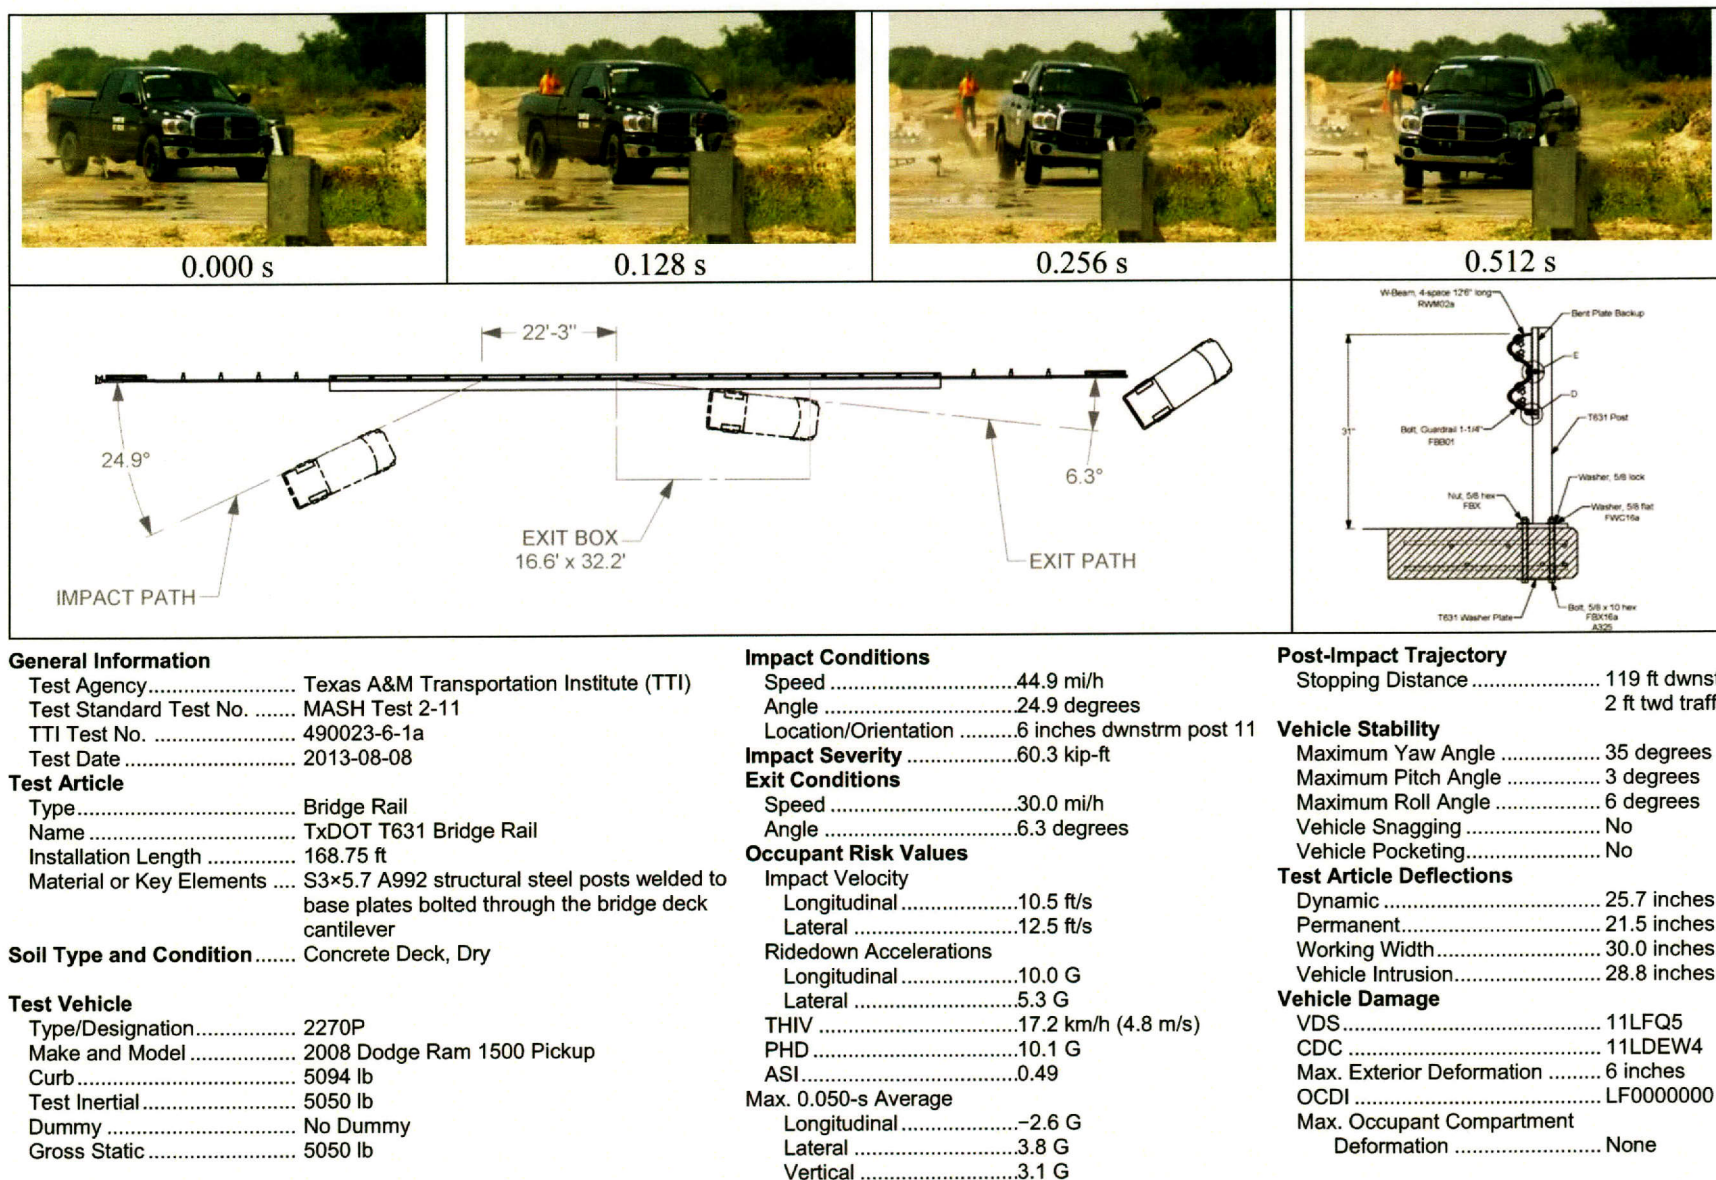
Figure 5.7. Summary of Results for MASH Test 2-11 on the T631 Bridge Rail.

Post 1 was pulled downstream 0.25 inch, and Posts 10 and 11 were leaning toward the field side 2 degrees and 20 degrees, respectively. Posts 12 through 14 were leaning downstream 90 degrees; there was a partial tear at the base, and the rail separated from the posts. Post 15 was leaning towards the field side 5 degrees and downstream 14 degrees, and the rail separated from the post. The vehicle contacted the installation a second time at the downstream terminal post and anchor. Figures 5.3 and 5.4 show damage to the installation. The vehicle was in contact with the bridge rail 22.25 ft. Maximum dynamic deflection of the bridge rail was 25.7 inches, and permanent deformation was 21.5 inches. Working width was 30.0 inches, and vehicle intrusion was 28.8 inches.

Results: The rail element separated from four posts but remained attached to the remaining installation; however, this detached element did not penetrate or show potential for penetrating the occupant compartment, or present a hazard to others in the area. (PASS)
No occupant compartment deformation or intrusion occurred. (PASS)

The TxDOT T631 bridge rail contained and redirected the 2270P vehicle. The vehicle did not penetrate, underride, or override the bridge rail. Maximum dynamic deflection was 25.7 inches. The rail element separated from four posts but remained attached to the remaining installation; however, this detached element did not penetrate or show potential for penetrating the occupant compartment, or present a hazard to others in the area. No occupant compartment deformation or intrusion occurred. The 2270P vehicle remained upright during and after the collision event. Maximum roll and pitch angles were 6 degrees and 3 degrees, respectively. Occupant risk factors were within the limits specified in *MASH*. The 2270P vehicle remained near the installation as it lost contact, and exited within the exit box criteria.

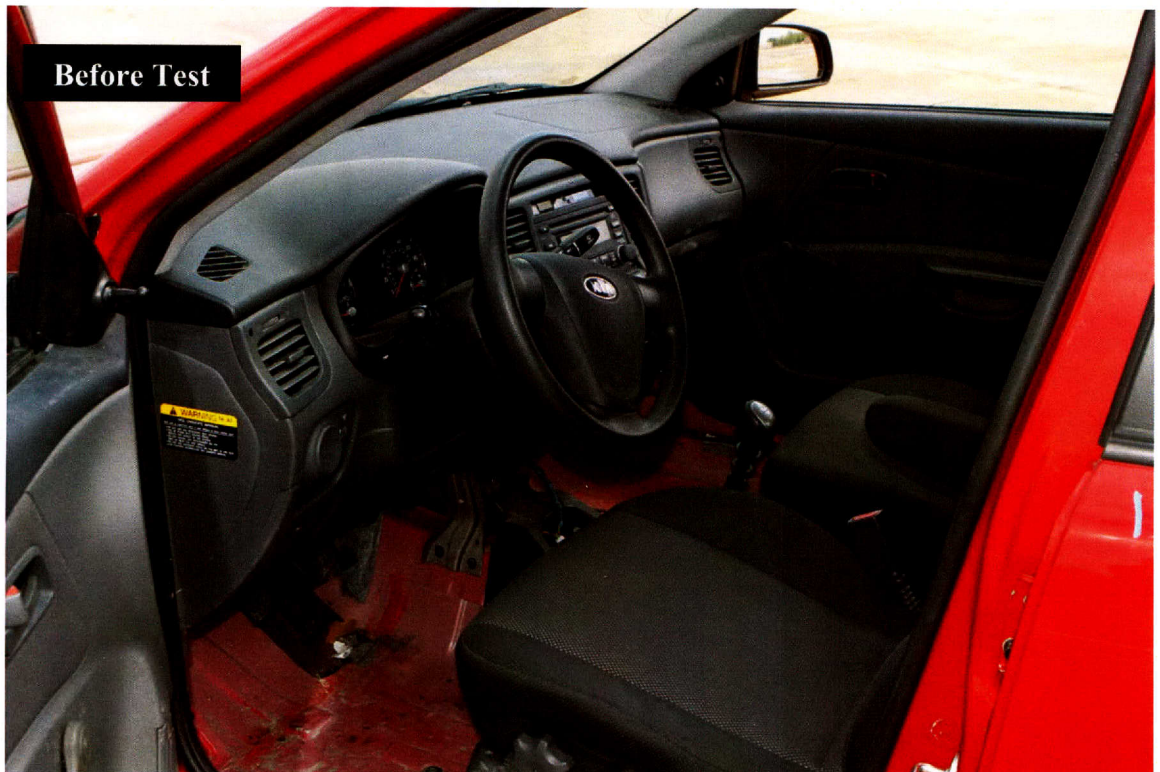
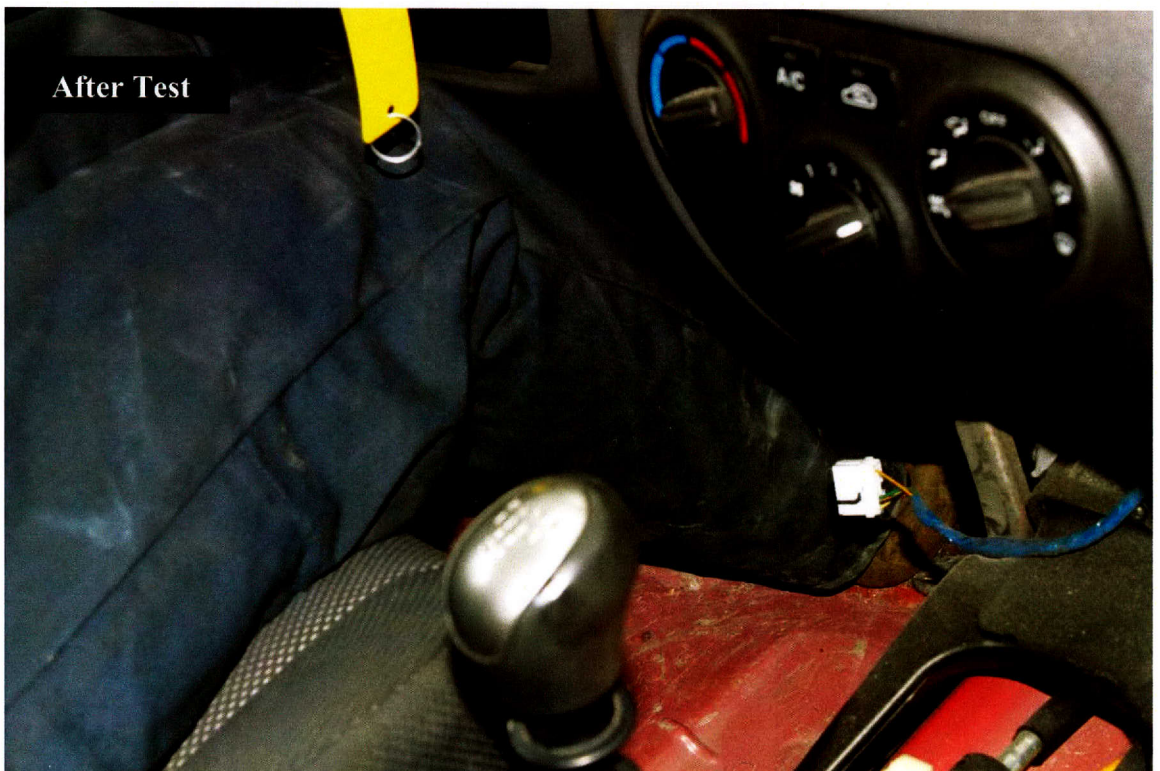
Figure 6.6. Interior of Vehicle for Test No. 490023-6-2.

Figure 6.5 shows damage to the 1100C vehicle. The left strut, strut tower, and left tie rod end were deformed. Also damaged were the front bumper, hood, left front fender, left front tire and wheel rim, and the left front door. Maximum exterior crush to the vehicle was 9.5 inches in the side plane at the left front corner at bumper height. No occupant compartment deformation or intrusion occurred. Figure 6.6 provides photographs of the interior of the vehicle. Tables D3 and D4 in Appendix D provide exterior crush and occupant compartment measurements.

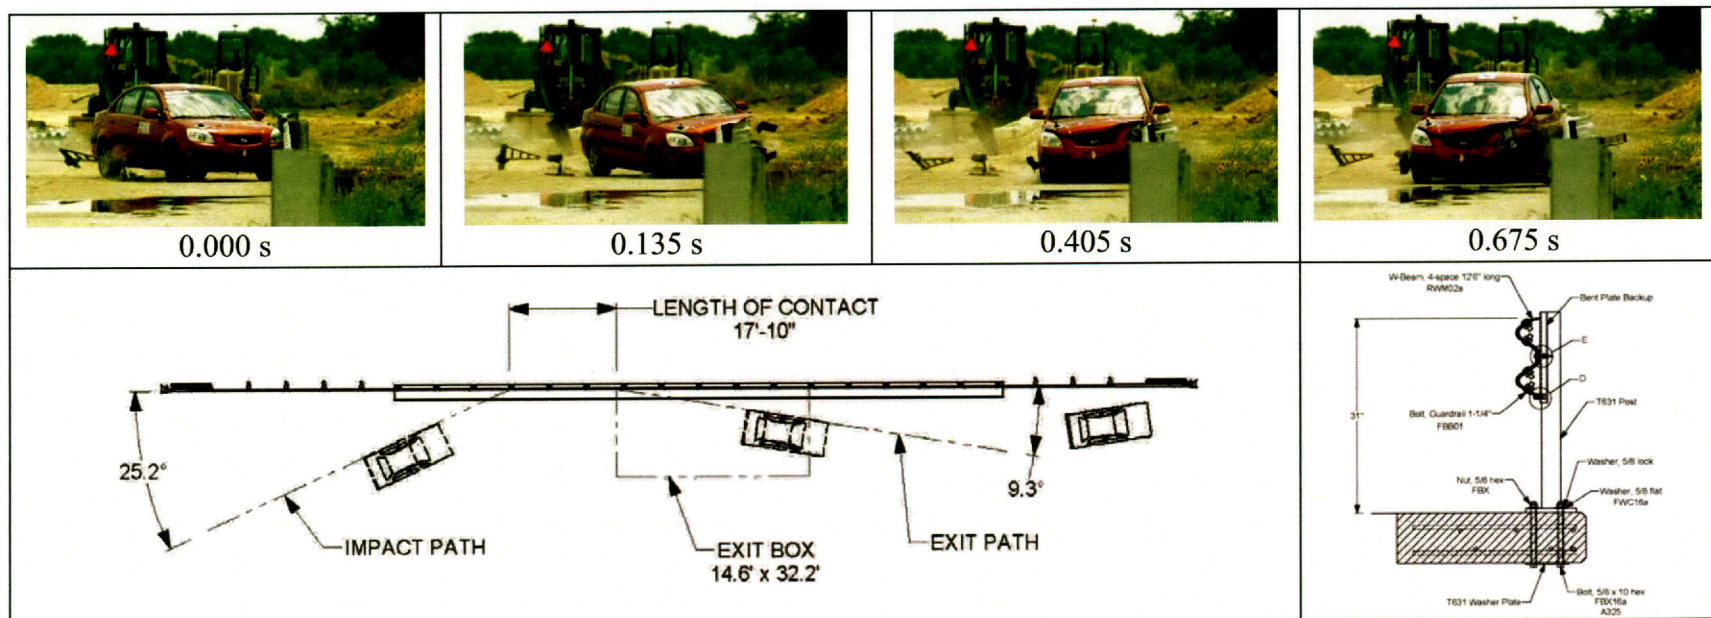
Post 9 was leaning towards the field side 4 degrees. Post 10 was leaning towards the field side 95 degrees and the front flange and webbing were torn. Post 11 was leaning downstream 85 degrees and towards the field side 10 degrees; the front flange was partially torn, and the backup plate released. Post 12 was leaning downstream 85 degrees and the back flange was partially torn. Post 12 was leaning downstream 8 degrees. Figures 6.3 and 6.4 show damage to the installation. The 1100C vehicle was in contact with the bridge rail 17.8 ft. Maximum dynamic deflection of the bridge rail during the test was 22.6 inches, and maximum permanent deformation was 15.0 inches. Working width was 25.5 inches, and vehicle penetration was 30.3 inches.

Results: The rail element separated from three posts but remained attached to the remaining installation; however, this detached element did not penetrate or show potential for penetrating the occupant compartment, or present a hazard to others in the area. (PASS)
No occupant compartment deformation or intrusion occurred. (PASS)

The TxDOT T631 bridge rail contained and redirected the 1100C vehicle. The vehicle did not penetrate, underride, or override the bridge rail. Maximum dynamic deflection was 22.6 inches. The rail element separated from three posts but remained attached to the remaining installation; however, this detached element did not penetrate or show potential for penetrating the occupant compartment, or present a hazard to others in the area. No occupant compartment deformation or intrusion occurred. The 1100C vehicle remained upright during and after the collision event. Maximum roll and pitch angles were 7 degrees and 3 degrees, respectively. Occupant risk factors were within the limits specified in *MASH*. The 1100C vehicle remained near the installation as it lost contact, and exited within the exit box criteria.

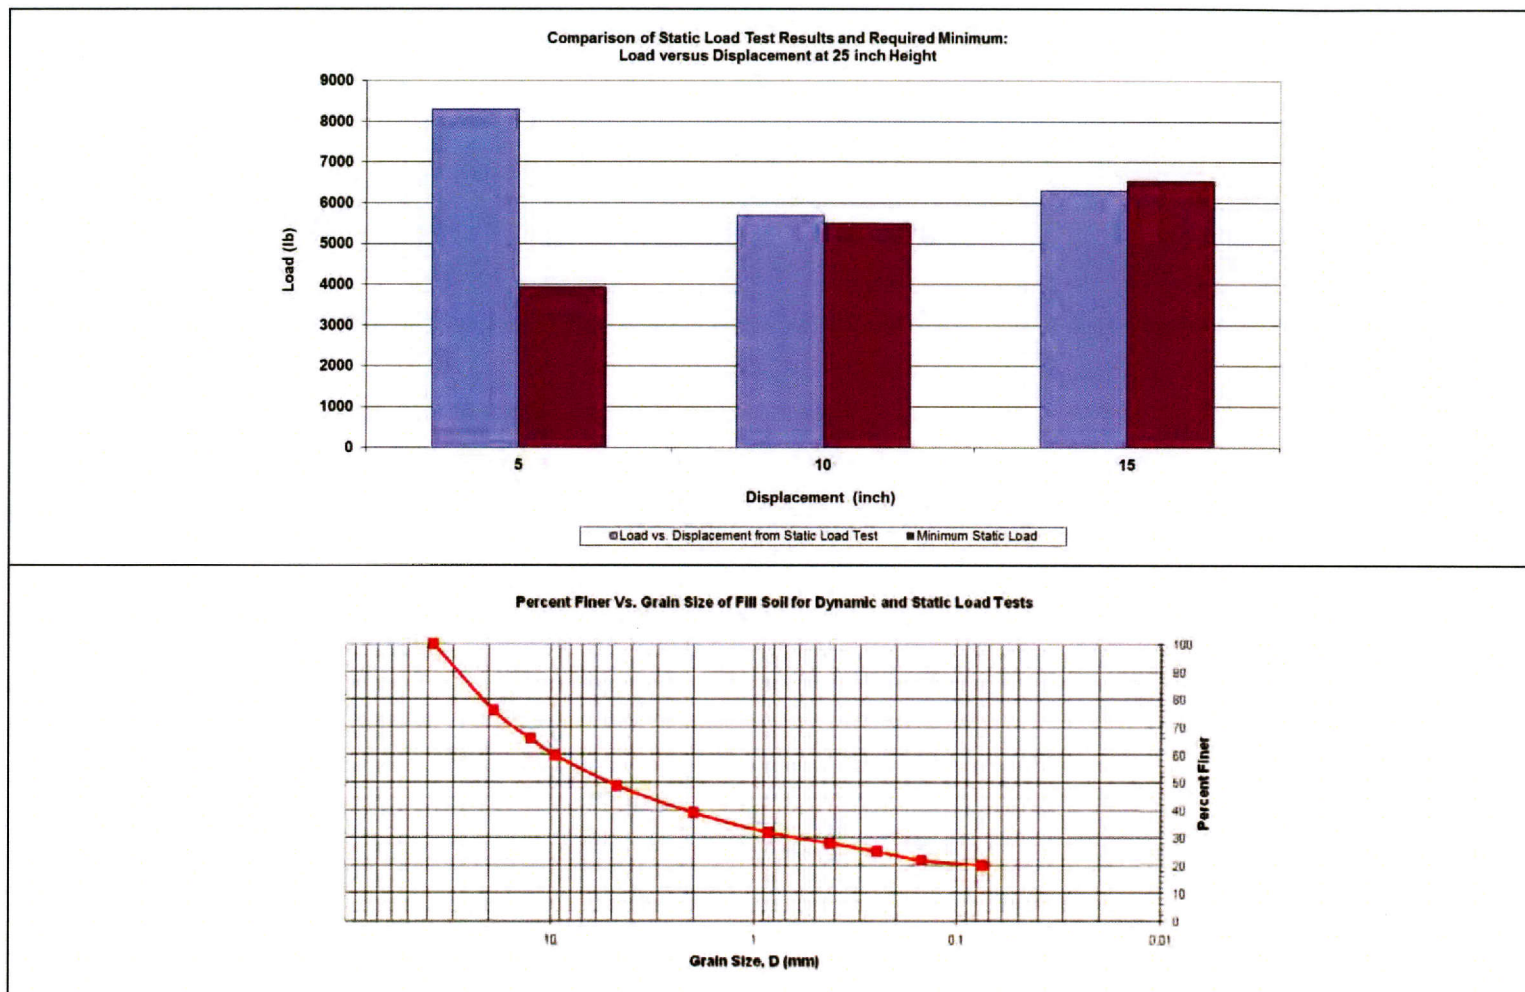
Figure C2. Test Day Static Soil Strength Documentation for Test No. 490023-6-1a.

On the day of Test No. 490023-1a, August 13, 2013, load on the post at deflections of 5 inches, 10 inches, and 15 inches was 8300 lbf, 5700 lbf, and 6300 lbf, respectively. The strength of the backfill material was slightly below minimum requirements at 15 inches (see Figure C2 in Appendix C); however, the soil was considered appropriate for testing. On the day of Test No. 490023-2, August 15, 2013, load on the post at deflections of 5 inches, 10 inches, and 15 inches was 7800 lbf, 8838 lbf, and 7926 lbf, respectively. The strength of the backfill material met minimum requirements (see Figure C3 in Appendix C).
