Temporary Large Guide Signs

Technical Report 0-6782-1

TEXAS A&M TRANSPORTATION INSTITUTE
COLLEGE STATION, TEXAS

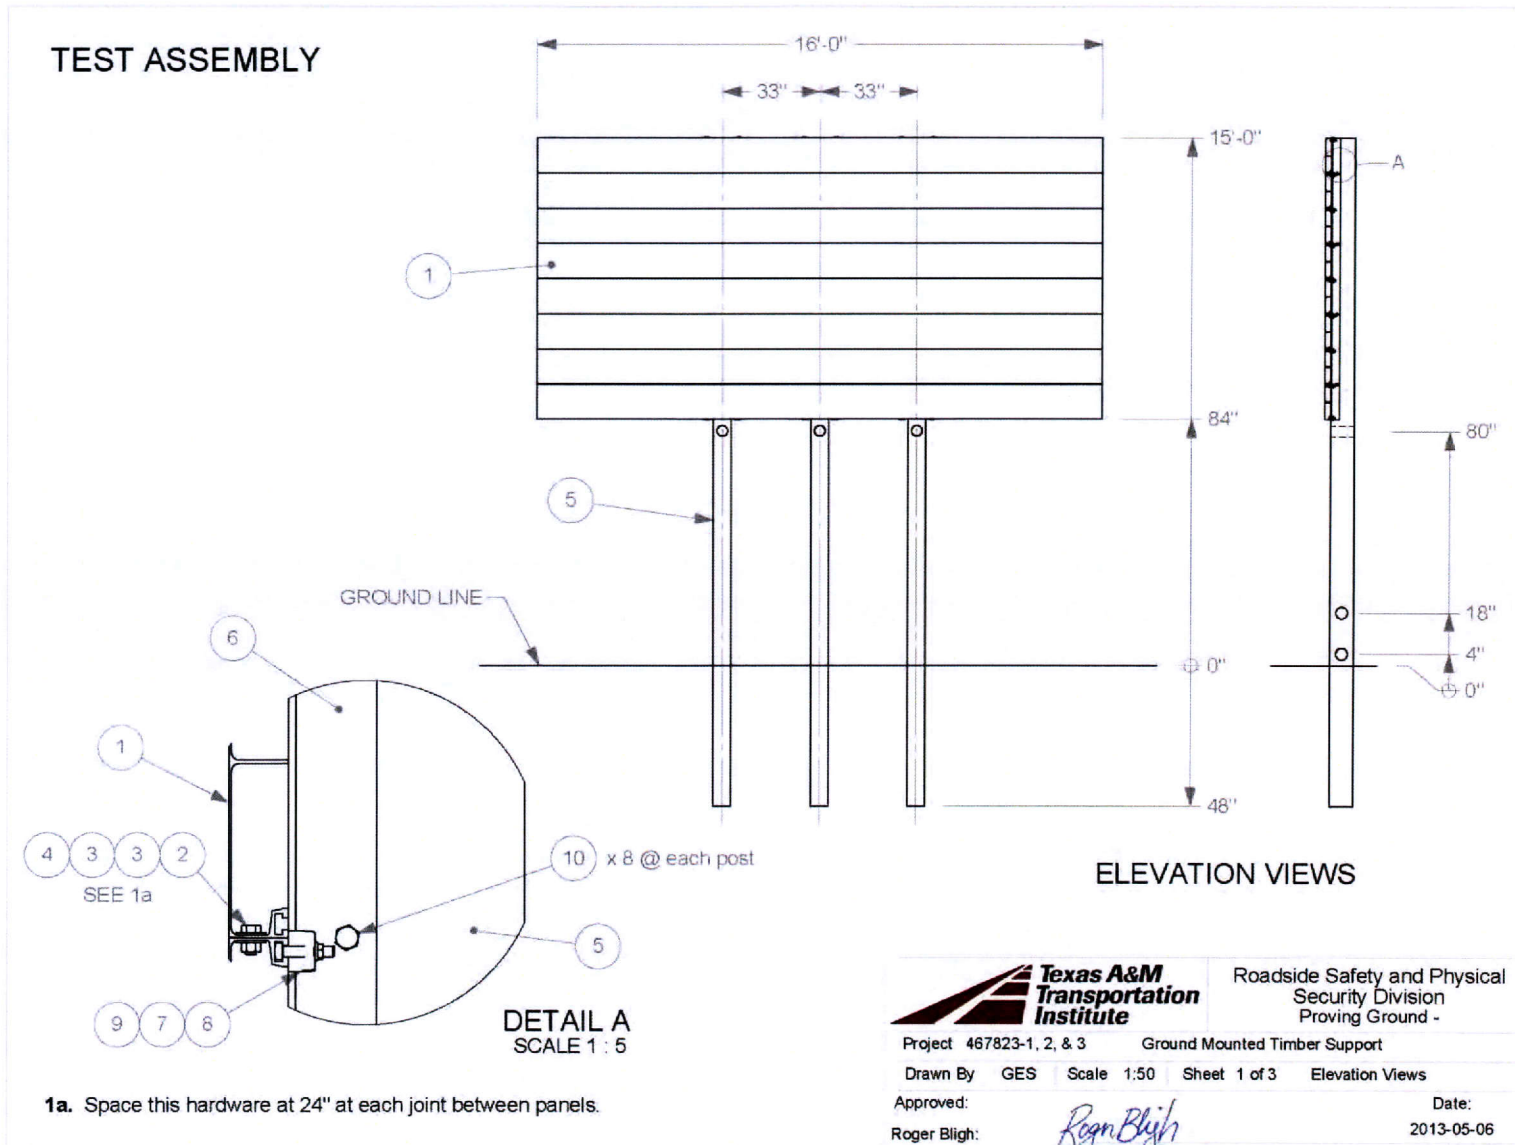
A connection between an extruded aluminum sign panel and wood support post was developed using standard clamp connection hardware as shown in Figure 2.3. A 3-inch \times 2-inch \times 1/4-inch steel angle is attached to each side of the wood support member. The length of the angle matches the vertical dimension of the extruded aluminum sign panel. One leg of each angle is placed flush with the sides of the wood support and attached using 1/2-inch diameter, 3-inch long lag screws spaced at approximately 2-ft intervals. The other leg of the angles is placed flush with the front face of the wood support post and extends perpendicularly outward from the post. The clamp connection hardware is used to clamp the extruded aluminum sign panel to the steel angle in a similar manner to the front flange of a steel post.

Figure 2.3. Recommended Design for Extruded Aluminum Sign Attached to Direct Embedded Wood Supports.

The researchers also developed connection details for connecting a plywood sign panel to the wood support posts (see page 3 of Figure 2.3). The recommended thickness for the plywood substrate sign panel is 5/8-inch. Aluminum wind beams run horizontally along the width of the plywood sign panel approximately 5 inches from the top and bottom edges of the sign panel. Interior wind beams are placed at maximum 4-ft spacing. The wind beams are secured to the plywood substrate using 5/16-inch diameter \times 1 1/4-inch long hex bolts. Aluminum plates measuring 3-inch wide \times 1/8-inch thick are placed along joints in the plywood sign substrate and secured using #10 \times 5/8-inch long pan head screws. The 3-inch \times 2-inch \times 1/4-inch steel angles are attached to the sides of each wood support member as described above. Square head bolts slide into a channel fabricated into the back side of the aluminum wind beams. The top bolt slides into a 1/2 inch wide \times 3/4-inch long slot cut into the edge of the angle and is secured with a nut. The remaining bolts are clamped to the edges of the angle in the same manner described above for the extruded aluminum sign substrate. The top bolt has a more positive connection because there are fewer clamps to attach the plywood substrate to the supports than the extruded aluminum substrate.

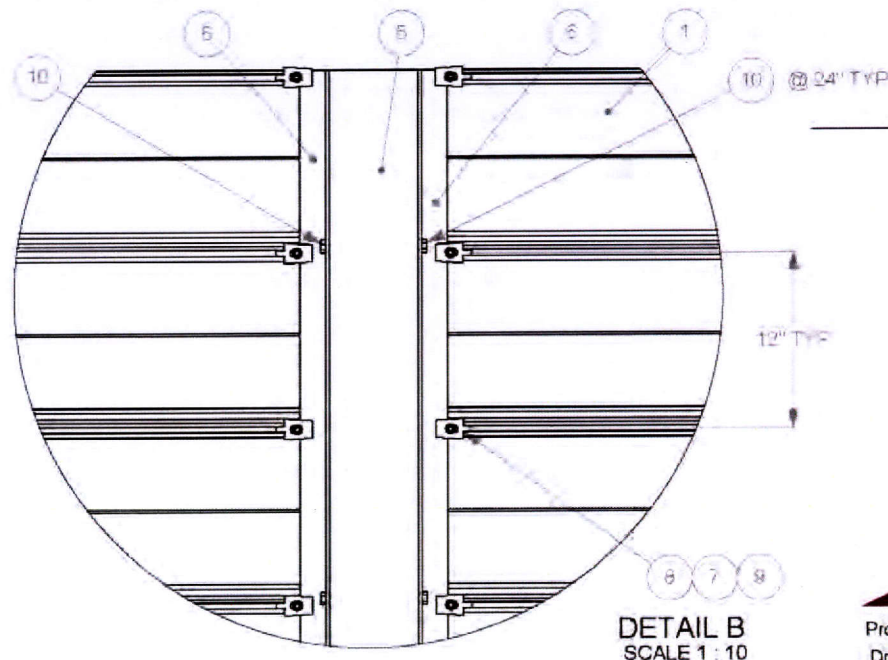
Project 467823-1, 2, & 3 Ground Mounted Timber Support 2013-05-06
Drawn By GES Scale 1:50 Sheet 2 of 3 Back View

Figure 2.3. Recommended Design for Extruded Aluminum Sign Attached to Direct Embedded Wood Supports (continued).

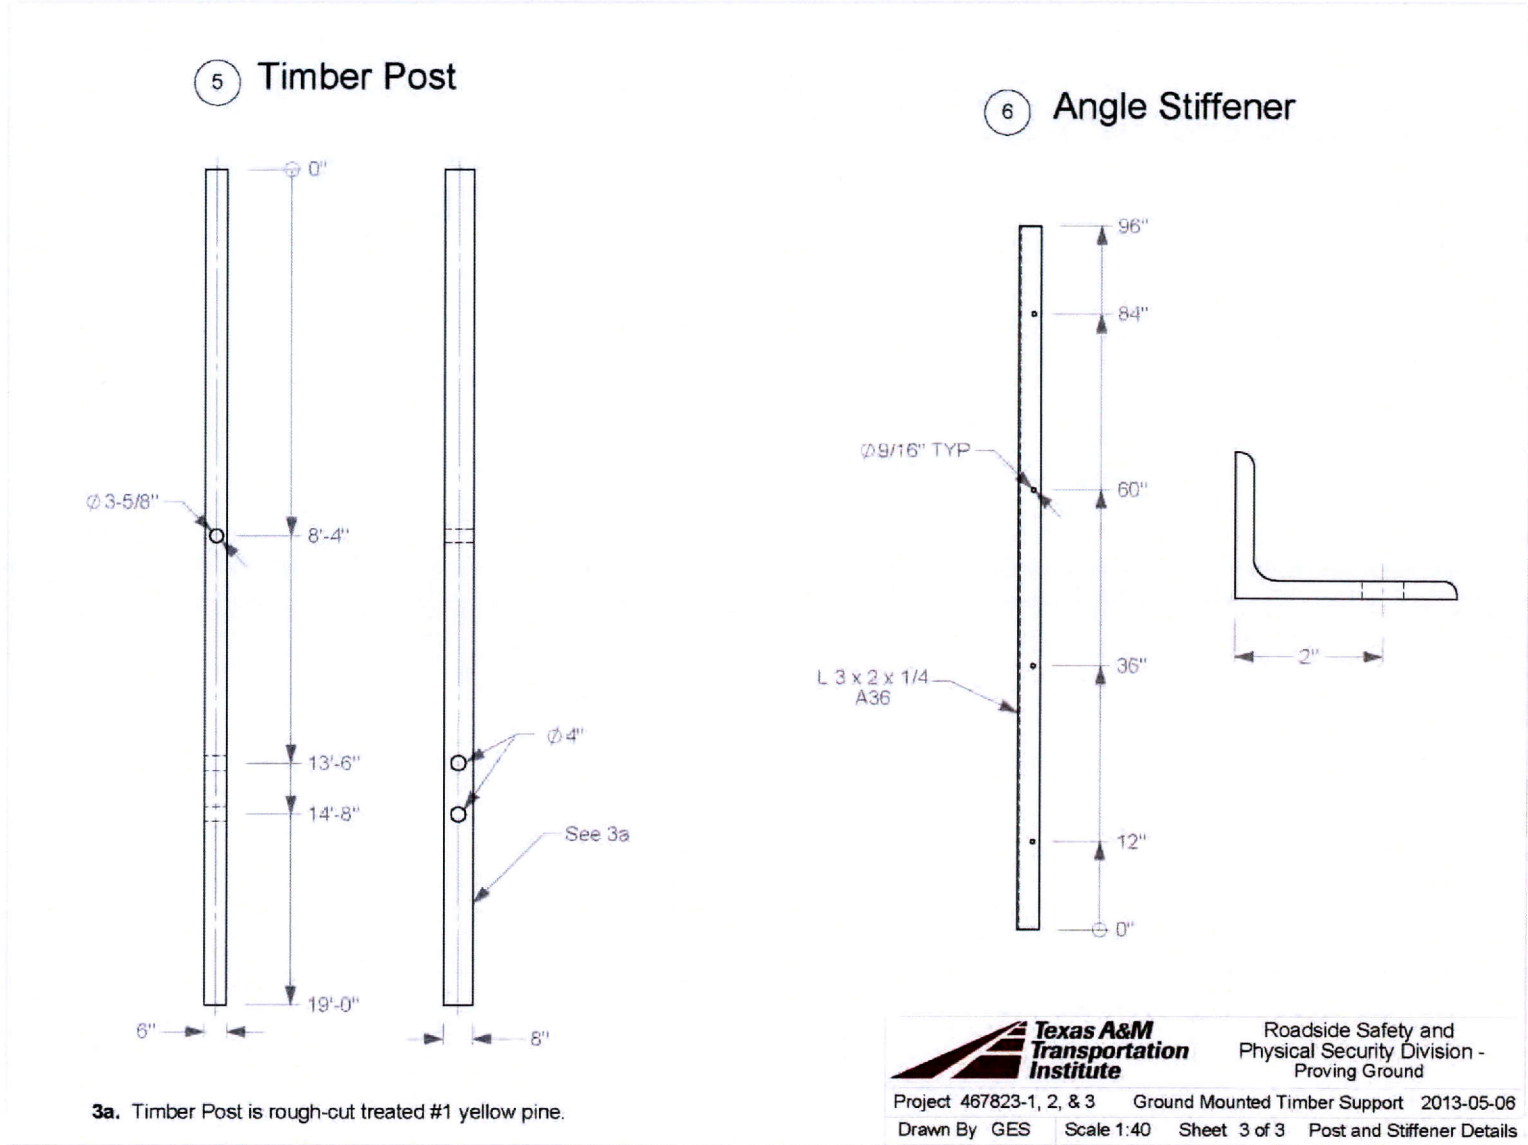
Figure 2.3. Recommended Design for Temporary Large Guide Sign with Direct Embedded Wood Supports (continued).

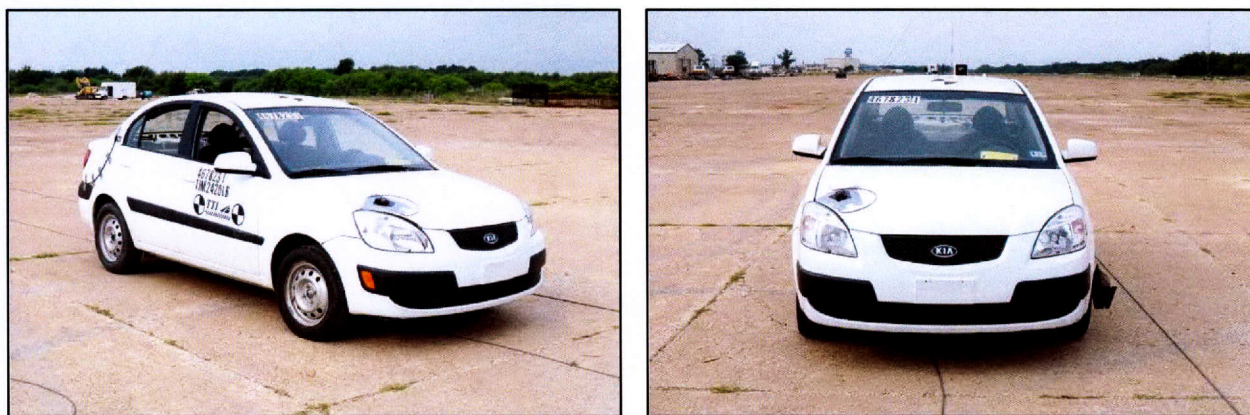
A 2008 Kia Rio, shown in Figure 4.3, was used for the crash test. Test inertia weight of the vehicle was 2443 lb, and its gross static weight was 2612 lb. The height to the lower edge of the vehicle bumper was 7.12 inches, and it was 21.0 inches to the upper edge of the bumper. Table B1 in Appendix B gives additional dimensions and information on the vehicle. The vehicle was directed into the installation using the cable reverse tow and guidance system and was released to be free-wheeling and unrestrained just prior to impact.

Figure 4.3. Vehicle before Test No. 467823-1.

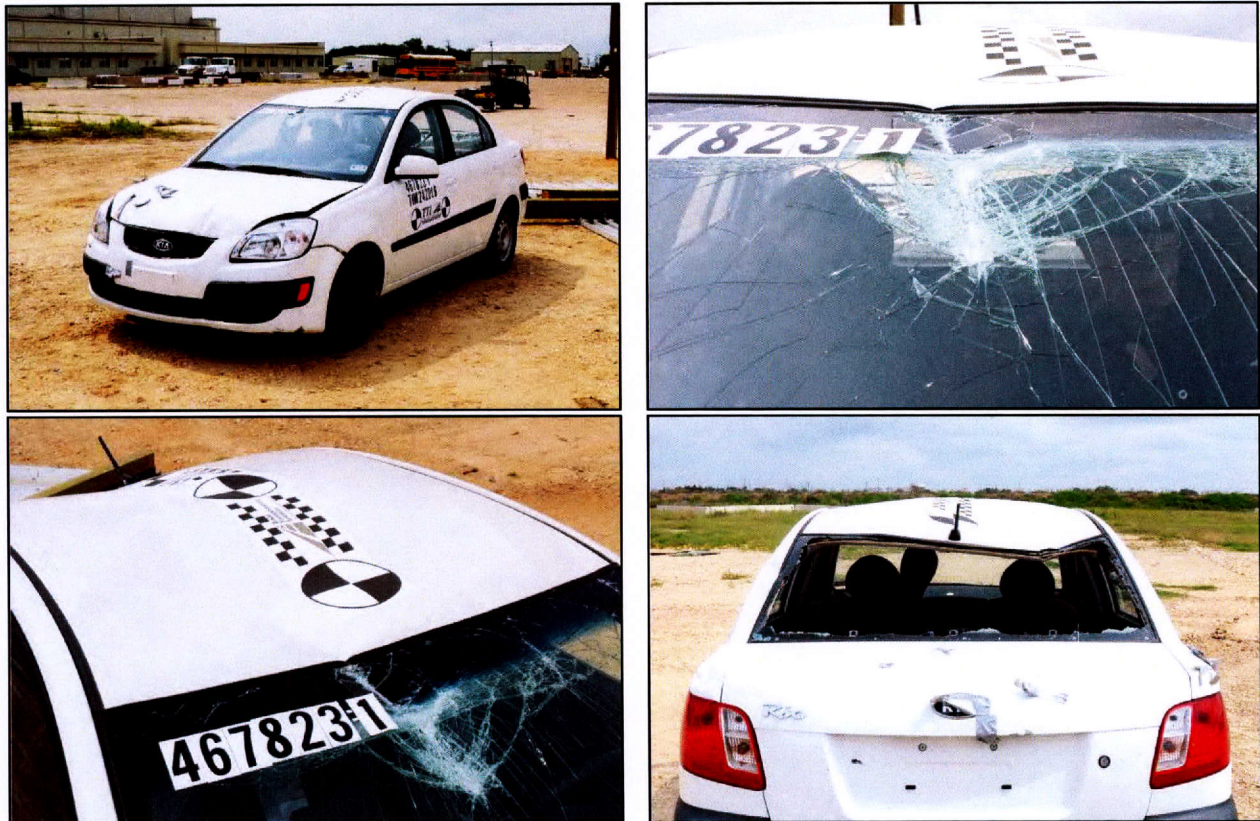
Figure 4.5 shows the damage sustained by the vehicle during the test, which included the front bumper, hood, windshield, right A-post, roof, left C-post, top of trunk lid, and left rear quarter panel. The hood was deformed 2.0 inches in the front plane just left of centerline of the

vehicle. The windshield shattered over an area of 12 inches \times 16 inches near the top center, and just above this area the roof was pushed downward towards the occupant compartment 1.75 inches. Just right of centerline of the roof over the rear passenger compartment was an area measuring 23 inches \times 24 inches that was deformed downward towards the occupant compartment. Maximum occupant compartment deformation was 3.5 inches in the roof over the right rear occupant compartment. Exterior crush and occupant compartment measurements can be found in Tables B2 and B3 of Appendix B.

Figure 4.5. Vehicle after Test No. 467823-1.

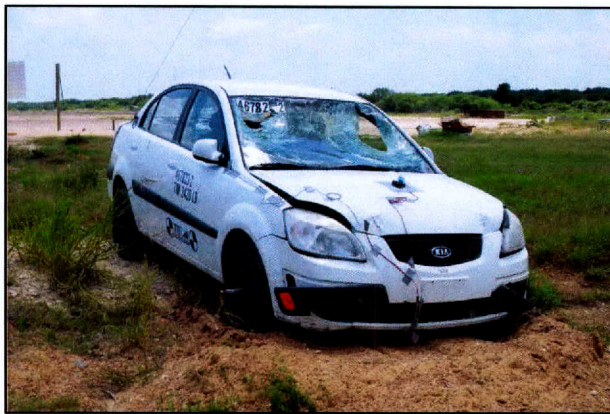
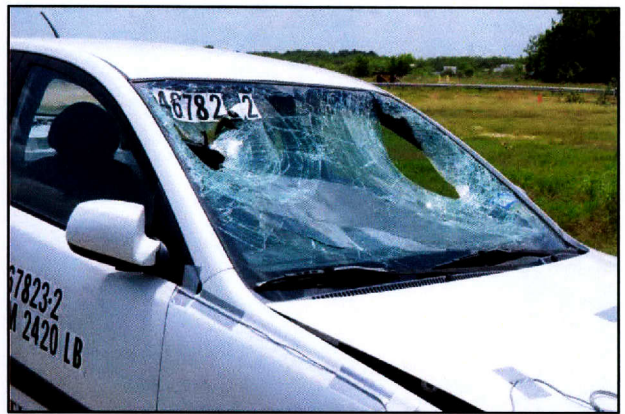
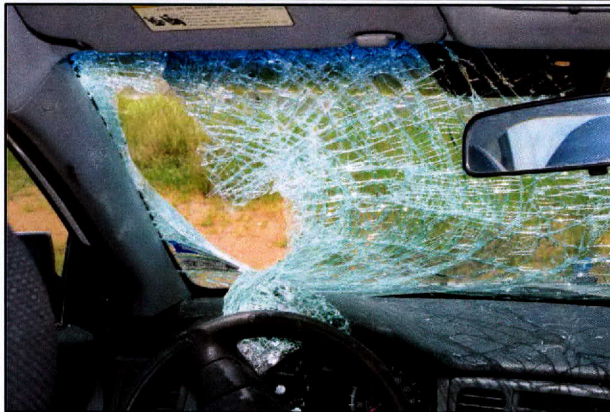
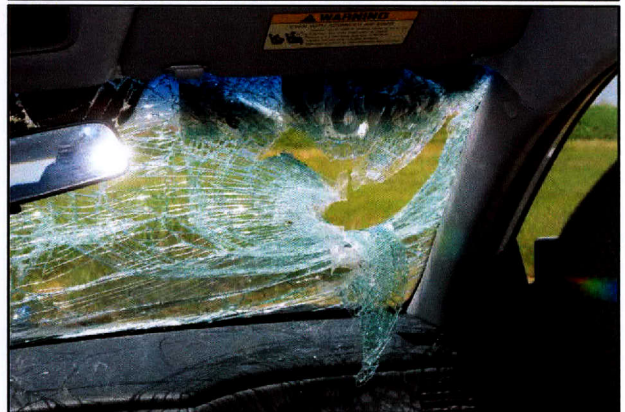
Figure 4.9 shows the damage sustained by the vehicle during the test, which included the front bumper, hood, and windshield. The front bumper was deformed inward 1.0 inch right of centerline of the vehicle. Both supports penetrated through the windshield and into the occupant compartment. The windshield had two holes: one on the driver side measuring 7 inches × 14 inches and one on the passenger side measuring 7 inches × 8 inches. Exterior crush and occupant compartment measurements can be found in Tables C2 and C3 of Appendix C.

Figure 4.9. Vehicle after Test No. 467823-2.

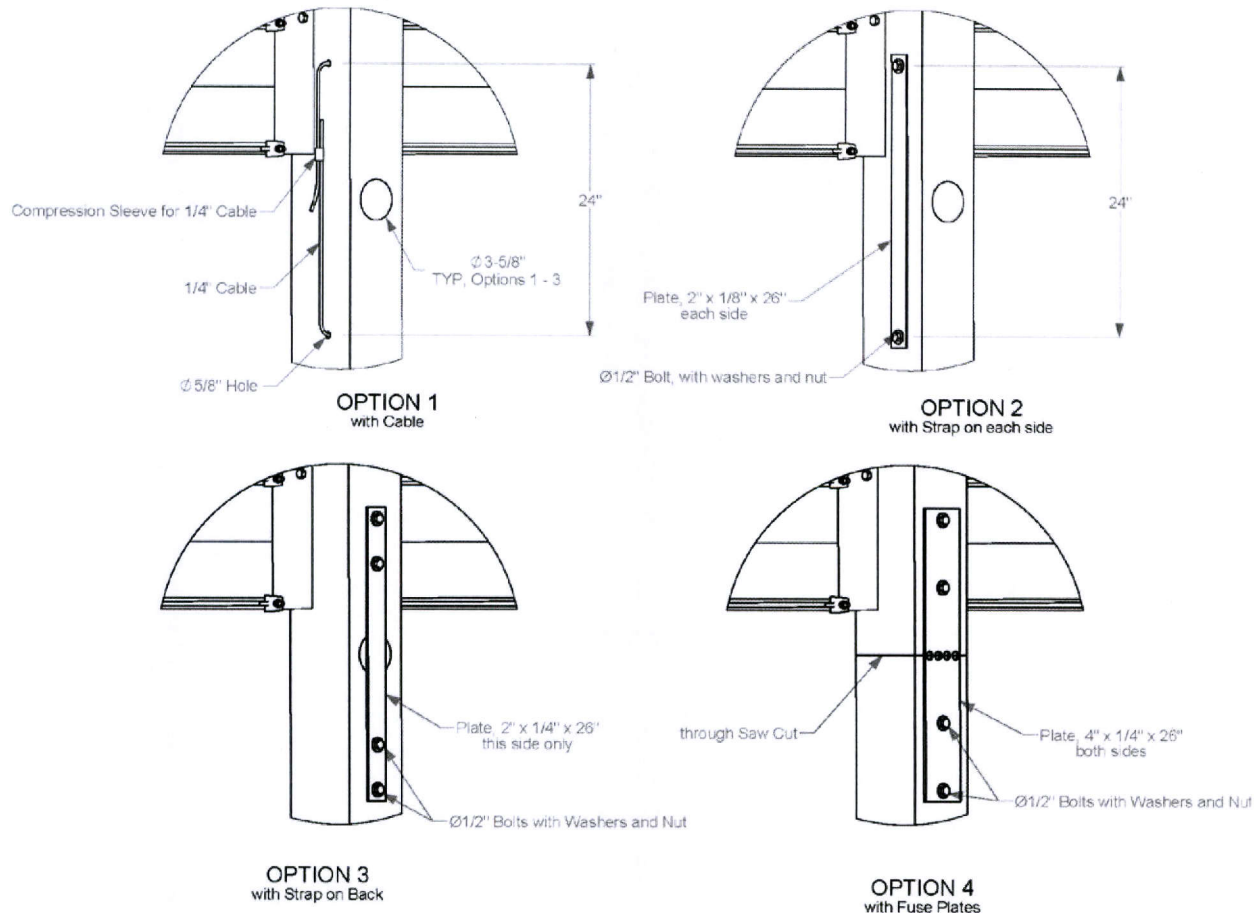
Figure 4.11 presents the design concepts considered. The research team recommended the option 1 design modification. It involves drilling a small hole through the wood support parallel to the sign panel above and below the weakening hole. A ¼-inch diameter cable is used to form a loop through the holes. Upon fracture of the support through the upper weakening hole, the cable will restrict rotation of the support toward the impacting vehicle.

Option 3 incorporates a steel strap on the back side of the wood support that spans across the upper weakening hole. After fracture of the support, the strap bends and acts as a hinge plate. This is analogous to the original design used on steel post guide signs in which the support was partially cut through the front flange and web. A fuse plate was placed across the front flange. When the fuse plate fractured during impact, the post rotated about a hinge formed at the back flange. In this wood support variation, the fracture of the support is controlled by the weakening hole, and the strap becomes the hinge. The drawback of this system is that it is

Figure 4.11. Design Options for Direct Embedded Wood Support Temporary Guide Sign System.

Option 4 is a fuse plate concept similar to that currently used on steel support systems. The wood support is saw cut through its entire cross section below the sign panel and is then reconnected by steel fuse plates on the front and back side of the posts. In this option, the fuse plate on the impact side fractures and the support rotates about the fuse plate on the opposite side of the post. The use of dual fuse plates makes this system bidirectional. Based on testing experience with steel post systems, the rear fuse plate may fracture during the impact sequence, but this would typically occur after the support hinges about the rear fuse plate and the vehicle has passed safely underneath the sign. This option is more complex and costly to fabricate and install than options 1 and 2.

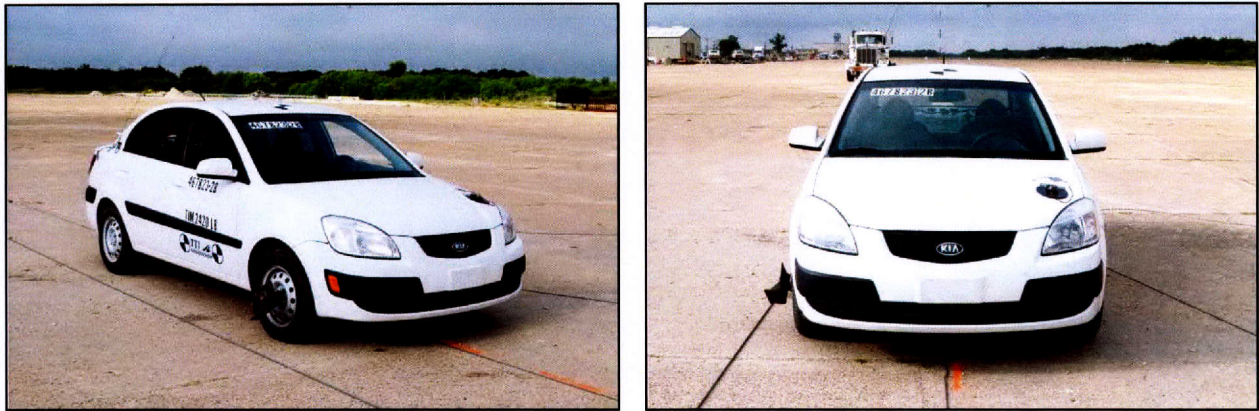
Figure 4.14 shows the 2006 Kia Rio used for the crash test. Test inertia weight of the vehicle was 2425 lb, and its gross static weight was 2604 lb. The height to the lower edge of the vehicle bumper was 7.12 inches, and the height to the upper edge of the bumper was 21.0 inches. Table E1 in Appendix E gives additional dimensions and information on the vehicle. The vehicle was directed into the installation using the cable reverse tow and guidance system and was released to be free-wheeling and unrestrained just prior to impact.

Figure 4.14. Vehicle before Test No. 467823-2b.

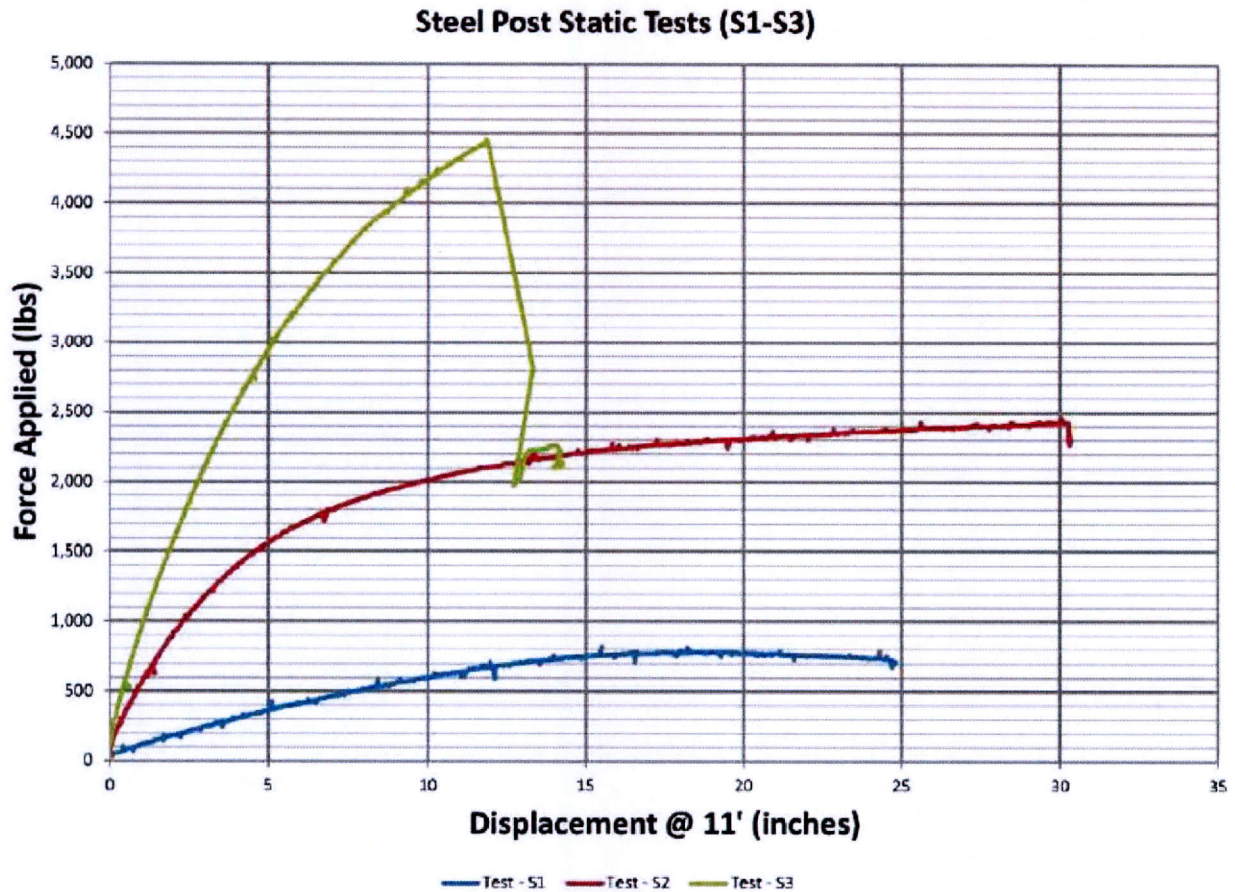
Figure 5.1. Static Test Results for S3×5.7 (Test S1), W6×9 (Test S2), and W8×18 (Test S3).

Figure 5.1 shows the force-deflection plots obtained from the static tests. In the test of the S3×5.7 foundation post, the post failed in lateral torsional buckling at a peak force of 0.82 kips. Given the force was applied at a height of 11 ft above grade, the resulting moment capacity is $0.82 \text{ kips} \times 11 \text{ ft} = 9.0 \text{ kip-ft}$. This value significantly exceeds the post capacity of 1.7 kip-ft.

In the test of the W6×9 post, the force-deflection curve was leveling off, and the test was halted due to significant deflection. The peak force at the time the test was halted was 2.46 kips. The corresponding moment capacity is 27.1 kip-ft, which is more than twice the post capacity of 11.8 kip-ft from Table 5.2.

In the test of the W8×18 foundation post, the test was halted when a weld on the slip base failed on the tension side of the post. The maximum force reached at time of failure was 4.45 kips. This corresponds to a moment capacity of 49.0 kip-ft, which exceeds the 36.4 kip-ft moment capacity of a W8×18 post section.

In summary, the measured static load capacity of all three foundation posts exceeded the calculated moment capacities of the corresponding steel support posts. This verifies the analytical procedure used to design the foundation posts and indicates the suitability of the foundation posts for the temporary installation of large guide signs.

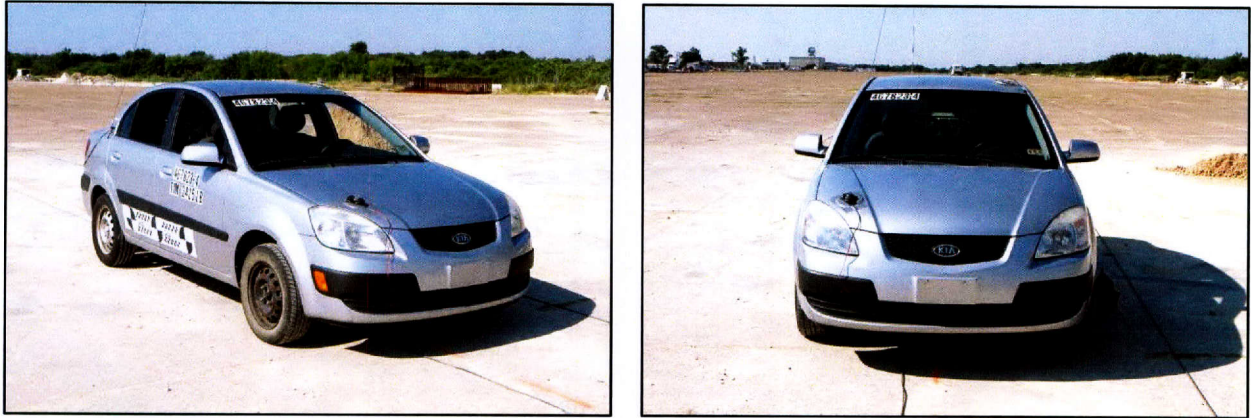
Figure 5.4. Vehicle before Test No. 467823-4.

Figure 5.4 shows the 2007 Kia Rio used for the crash test. Test inertia weight of the vehicle was 2425 lb, and its gross static weight was 2608 lb. The height to the lower edge of the vehicle bumper was 7.12 inches, and the height to the upper edge of the bumper was 21.0 inches. Table H1 in Appendix H gives additional dimensions and information on the vehicle. The vehicle was directed into the installation using the cable reverse tow and guidance system and was released to be free-wheeling and unrestrained just prior to impact.

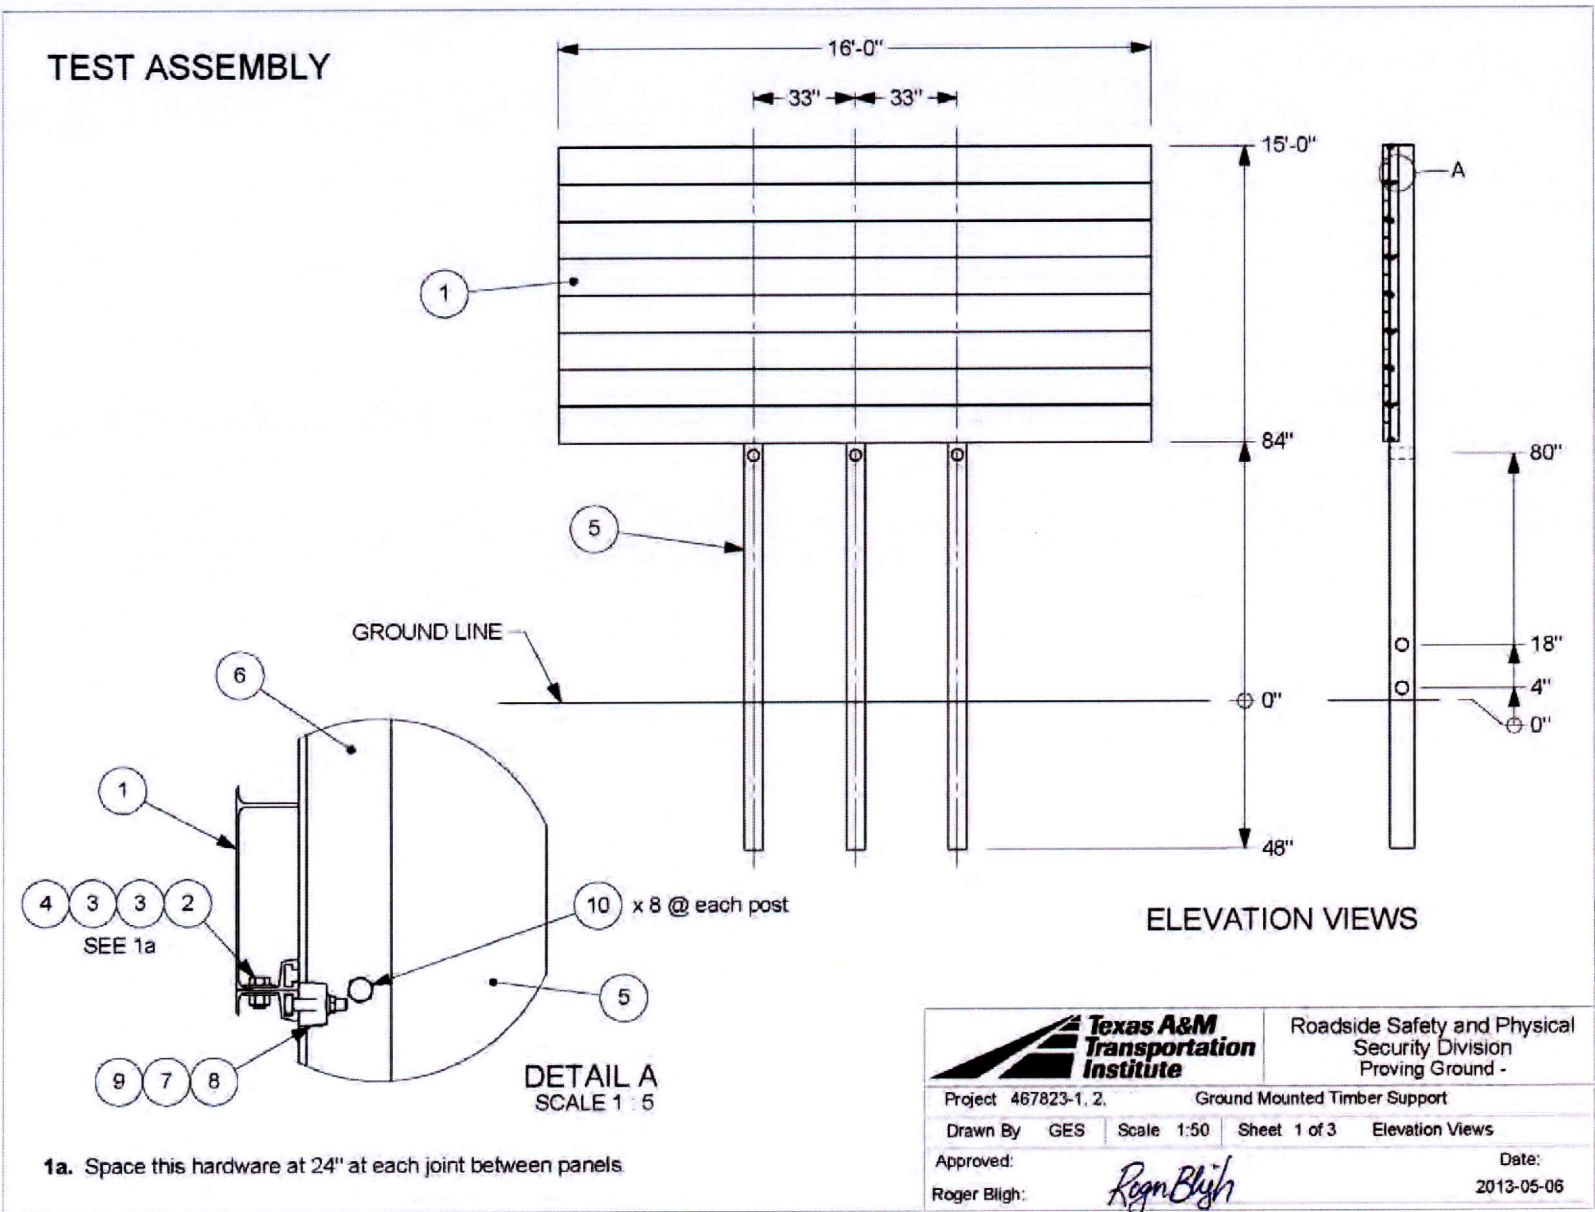
APPENDIX A. SUPPORT FOR DIRECT EMBEDDED WOOD SUPPORT TEMPORARY GUIDE SIGN SYSTEM

INSTALLATION PARTS			
#	PART NAME	DETAILS	QTY.
1	Aluminum Sign Panel, 12" x 16"	see TxDOT Drawing SMD (2-1) -08	8
2	Bolt, 3/8 x 3/4 hex	grade 2	56
3	Washer, 3/8 flat		112
4	Nut, 3/8 hex		56
5	Timber Post	sheet 3	3
6	Angle Stiffener	sheet 3	6
7	Bolt, 3/8 x 1-3/4 square head	see TxDOT Drawing SMD (2-1) -08	54
8	Sign Clip	see TxDOT Drawing SMD (2-1) -08	54
9	Nut, 3/8 flange		54
10	1/2 x 3 Lag Bolt	A307	24

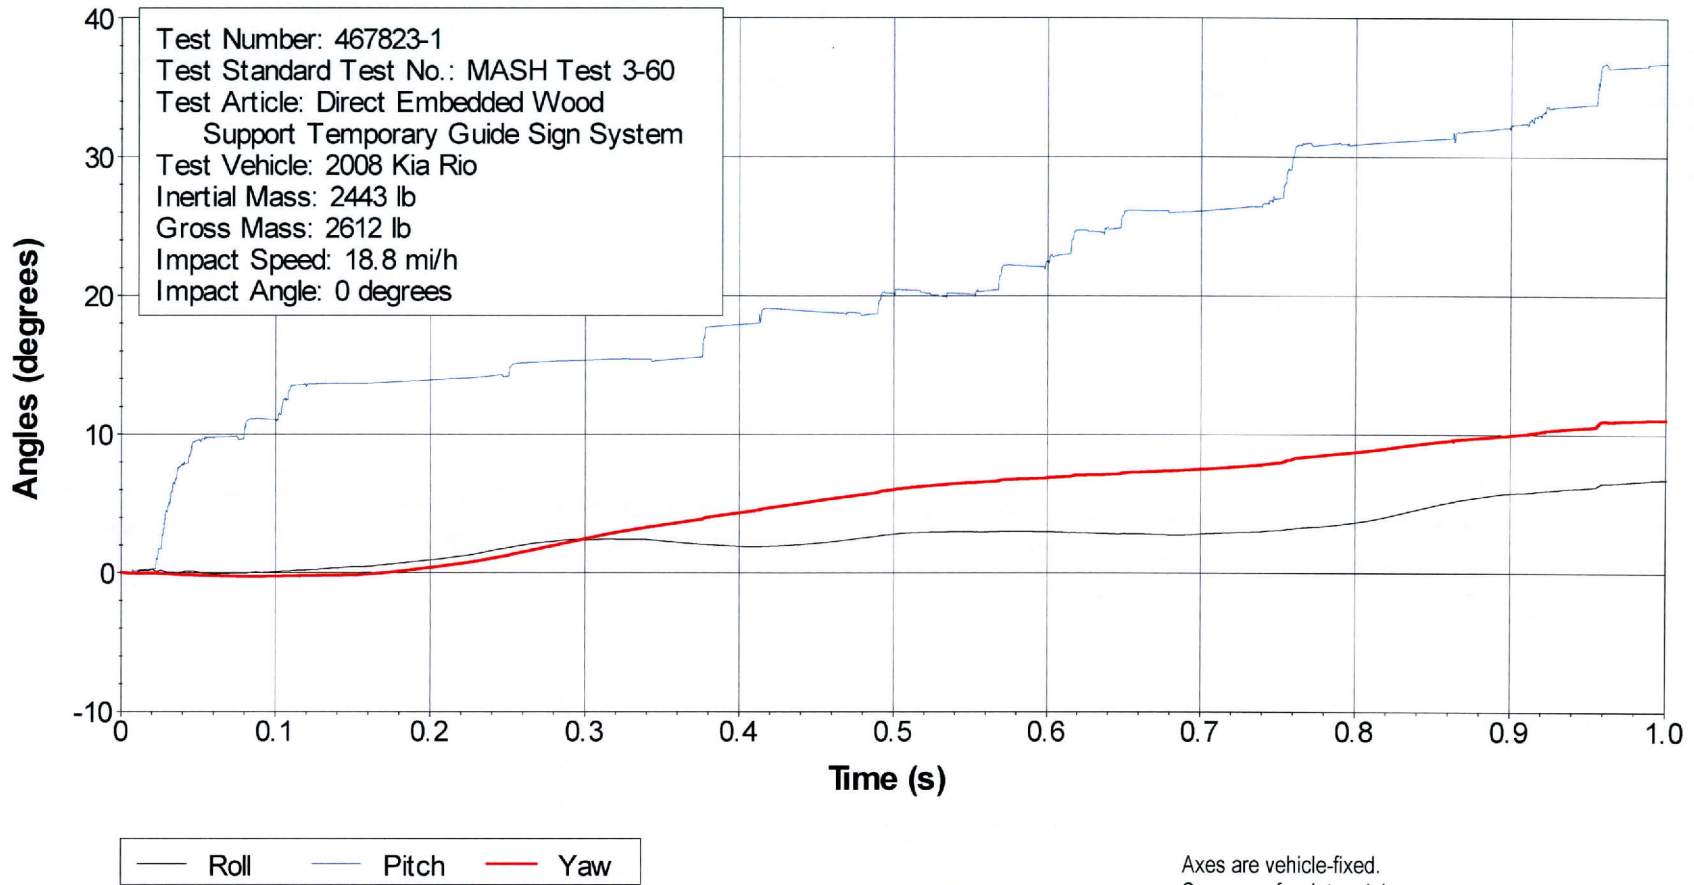
Figure B2. Vehicle Angular Displacements for Test No. 467823-1.

Test Number: 467823-1
 Test Standard Test No.: MASH Test 3-60
 Test Article: Direct Embedded Wood Support Temporary Guide Sign System
 Test Vehicle: 2008 Kia Rio
 Inertial Mass: 2443 lb
 Gross Mass: 2612 lb
 Impact Speed: 18.8 mi/h
 Impact Angle: 0 degrees

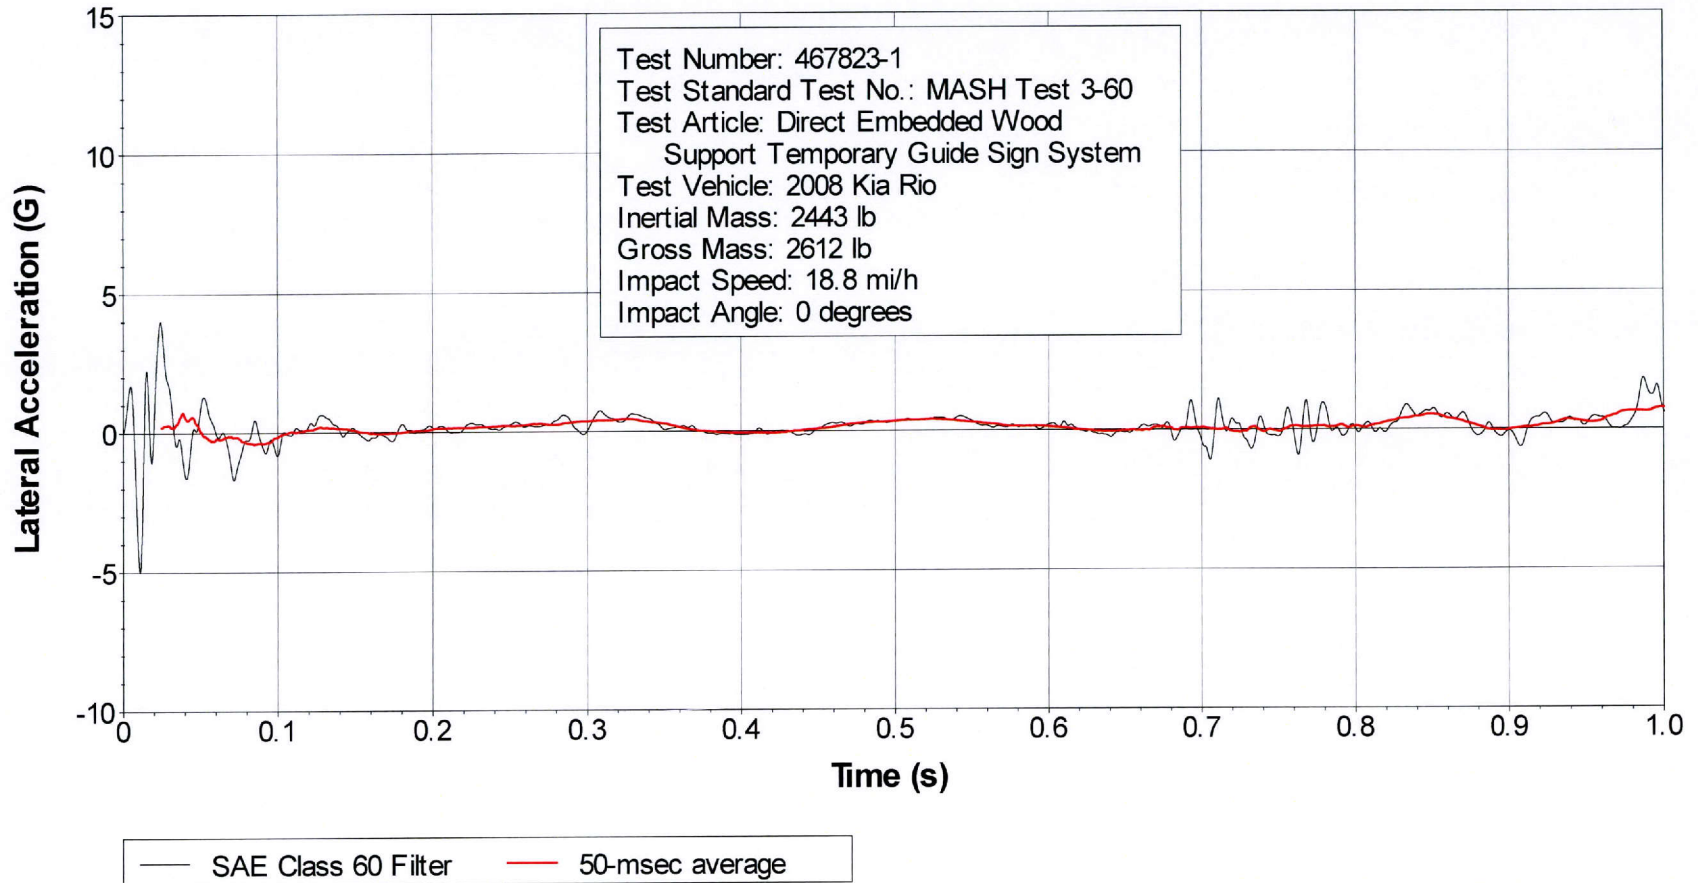
Figure B7. Vehicle Lateral Accelerometer Trace for Test No. 467823-1 (Accelerometer Located Rear of Center of Gravity).

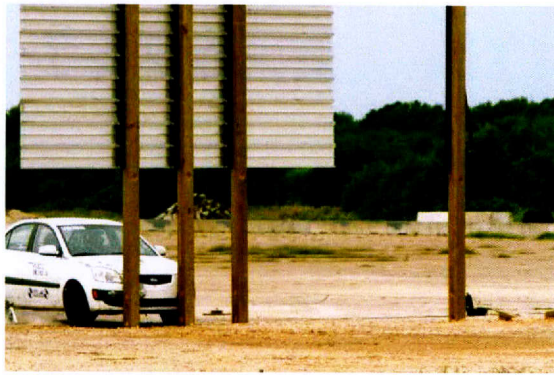
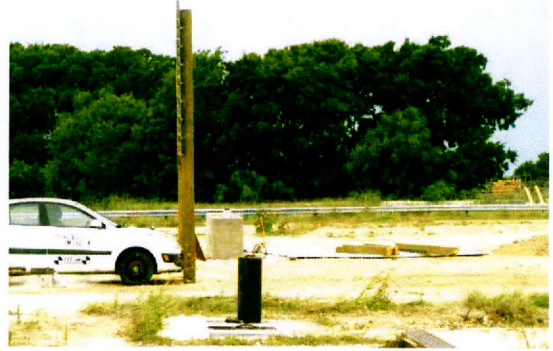
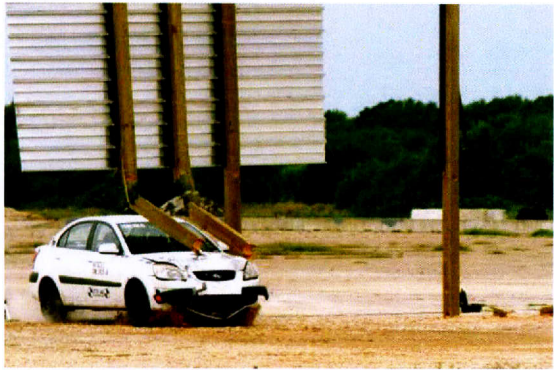
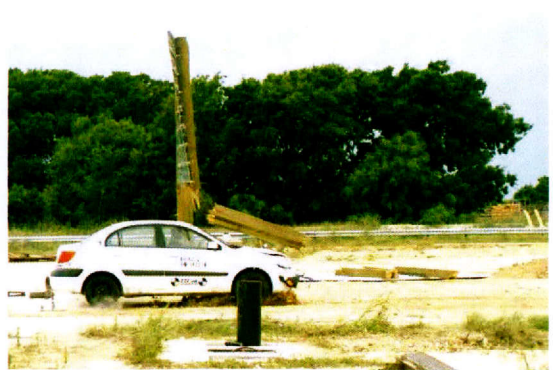
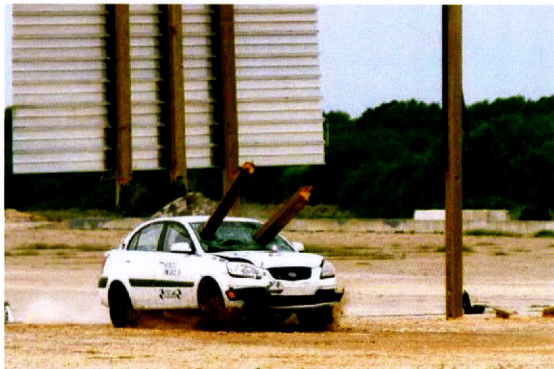
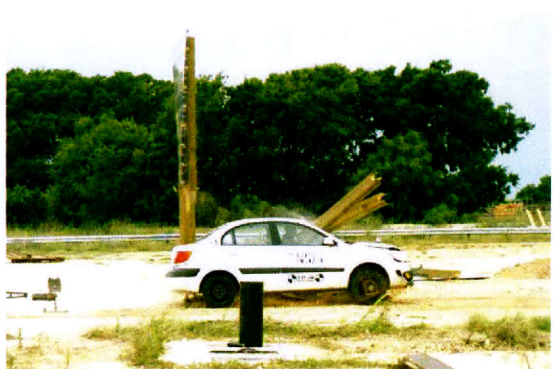
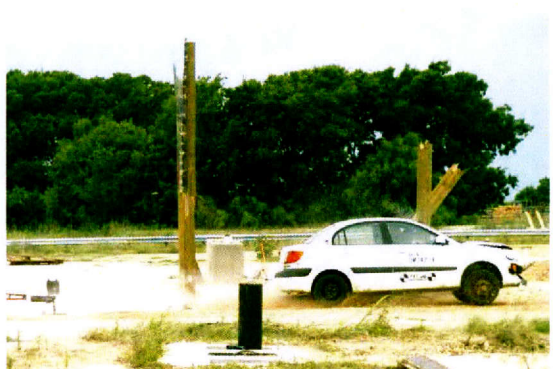
Figure C1. Sequential Photographs for Test No. 467823-2(Oblique and Perpendicular Views).

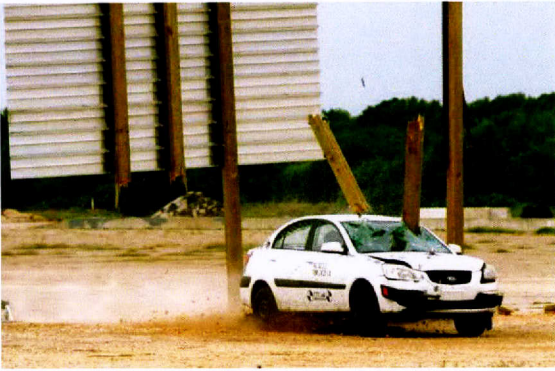
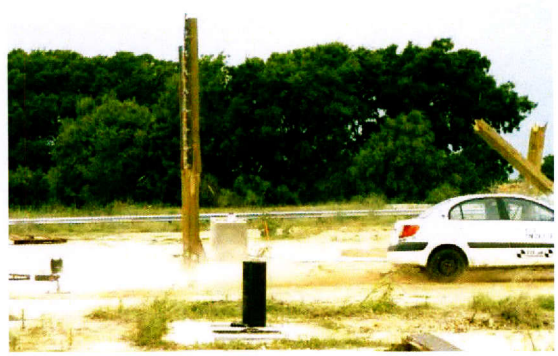
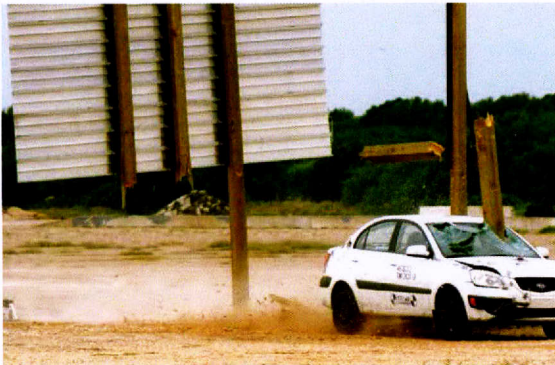
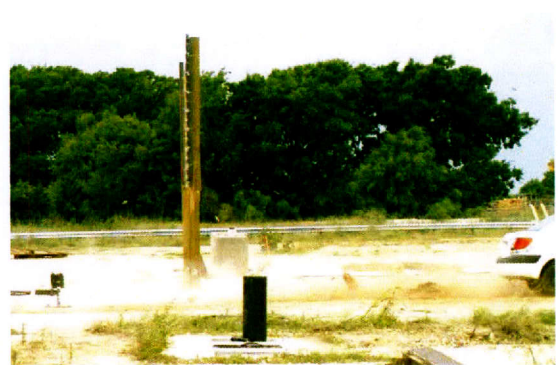
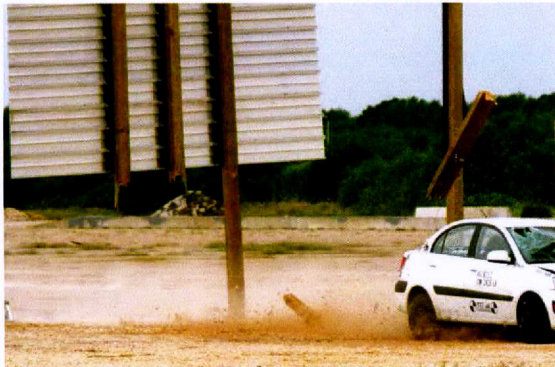
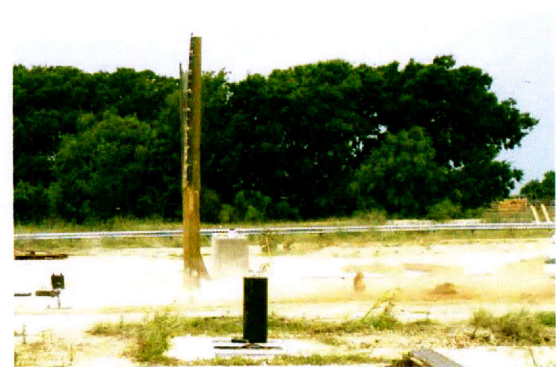
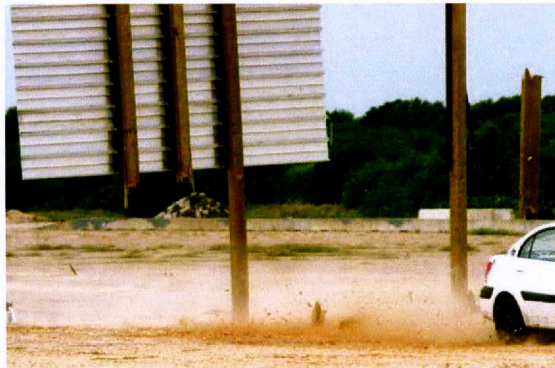
Figure C1. Sequential Photographs for Test No. 467823-2 (Oblique and Perpendicular Views) (Continued).

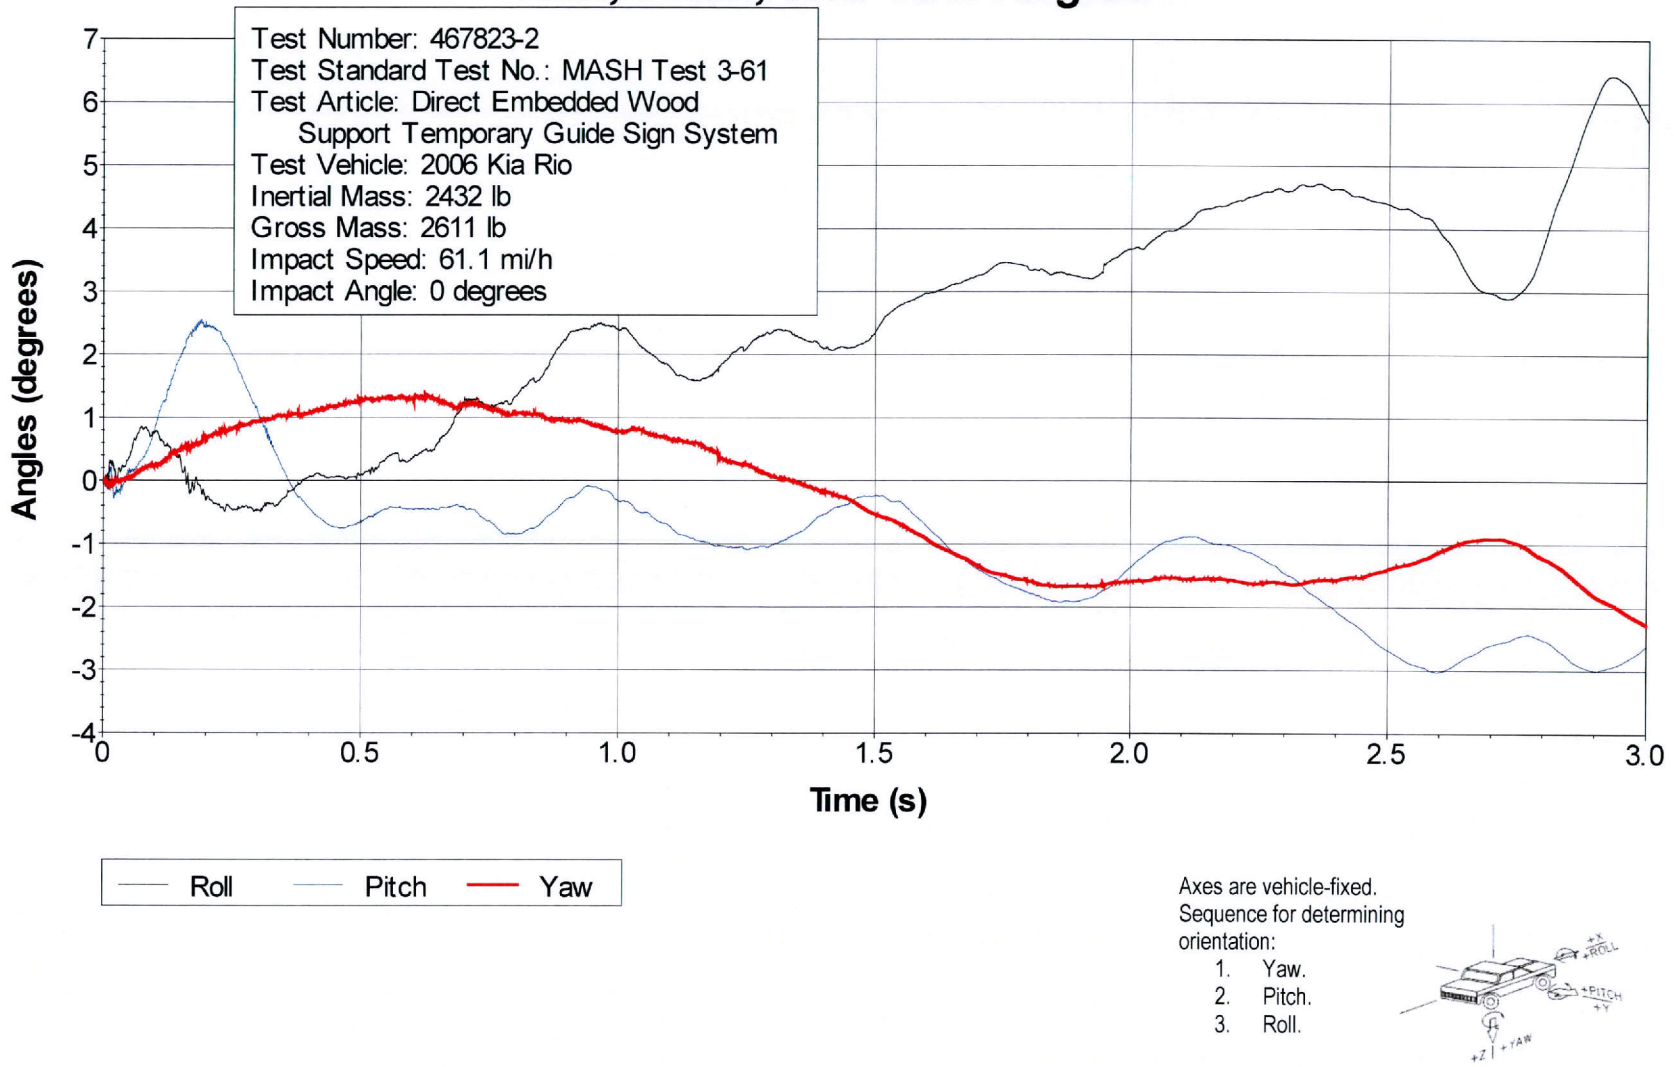
Figure C2. Vehicle Angular Displacements for Test No. 467823-2.
