Temporary Large Guide Signs

Technical Report 0-6782-1

TEXAS A&M TRANSPORTATION INSTITUTE
COLLEGE STATION, TEXAS

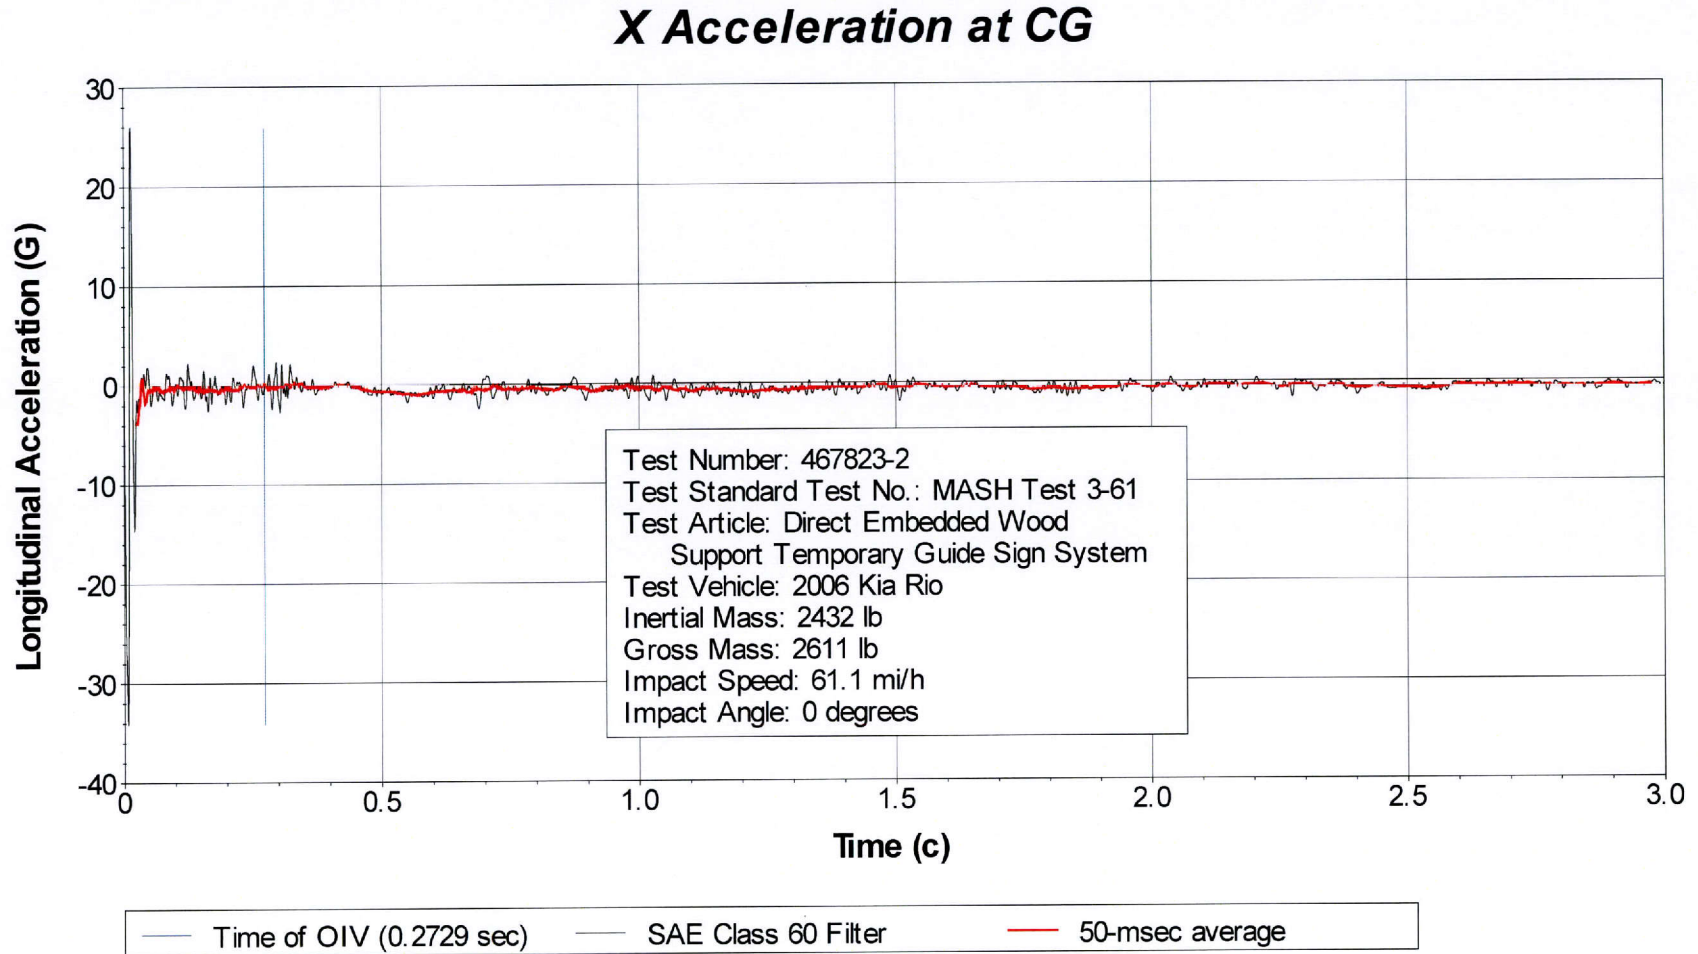
**Figure C3. Vehicle Longitudinal Accelerometer Trace for Test No. 467823-2
(Accelerometer Located at Center of Gravity).**

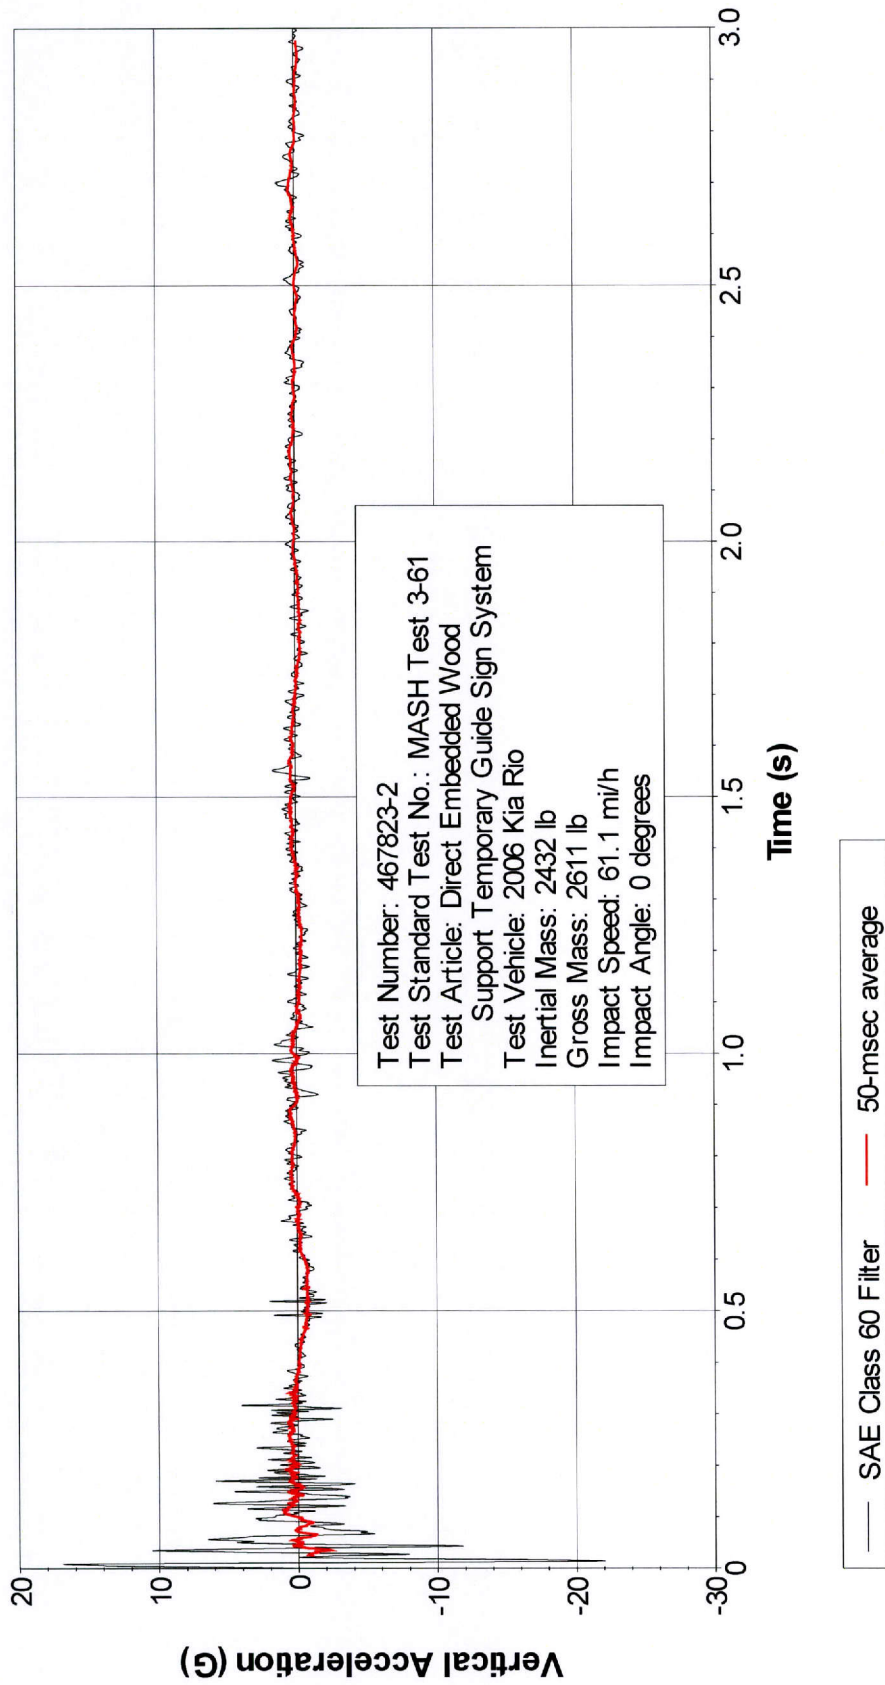
Figure C5. Vehicle Vertical Accelerometer Trace for Test No. 467823-2 (Accelerometer Located at Center of Gravity).

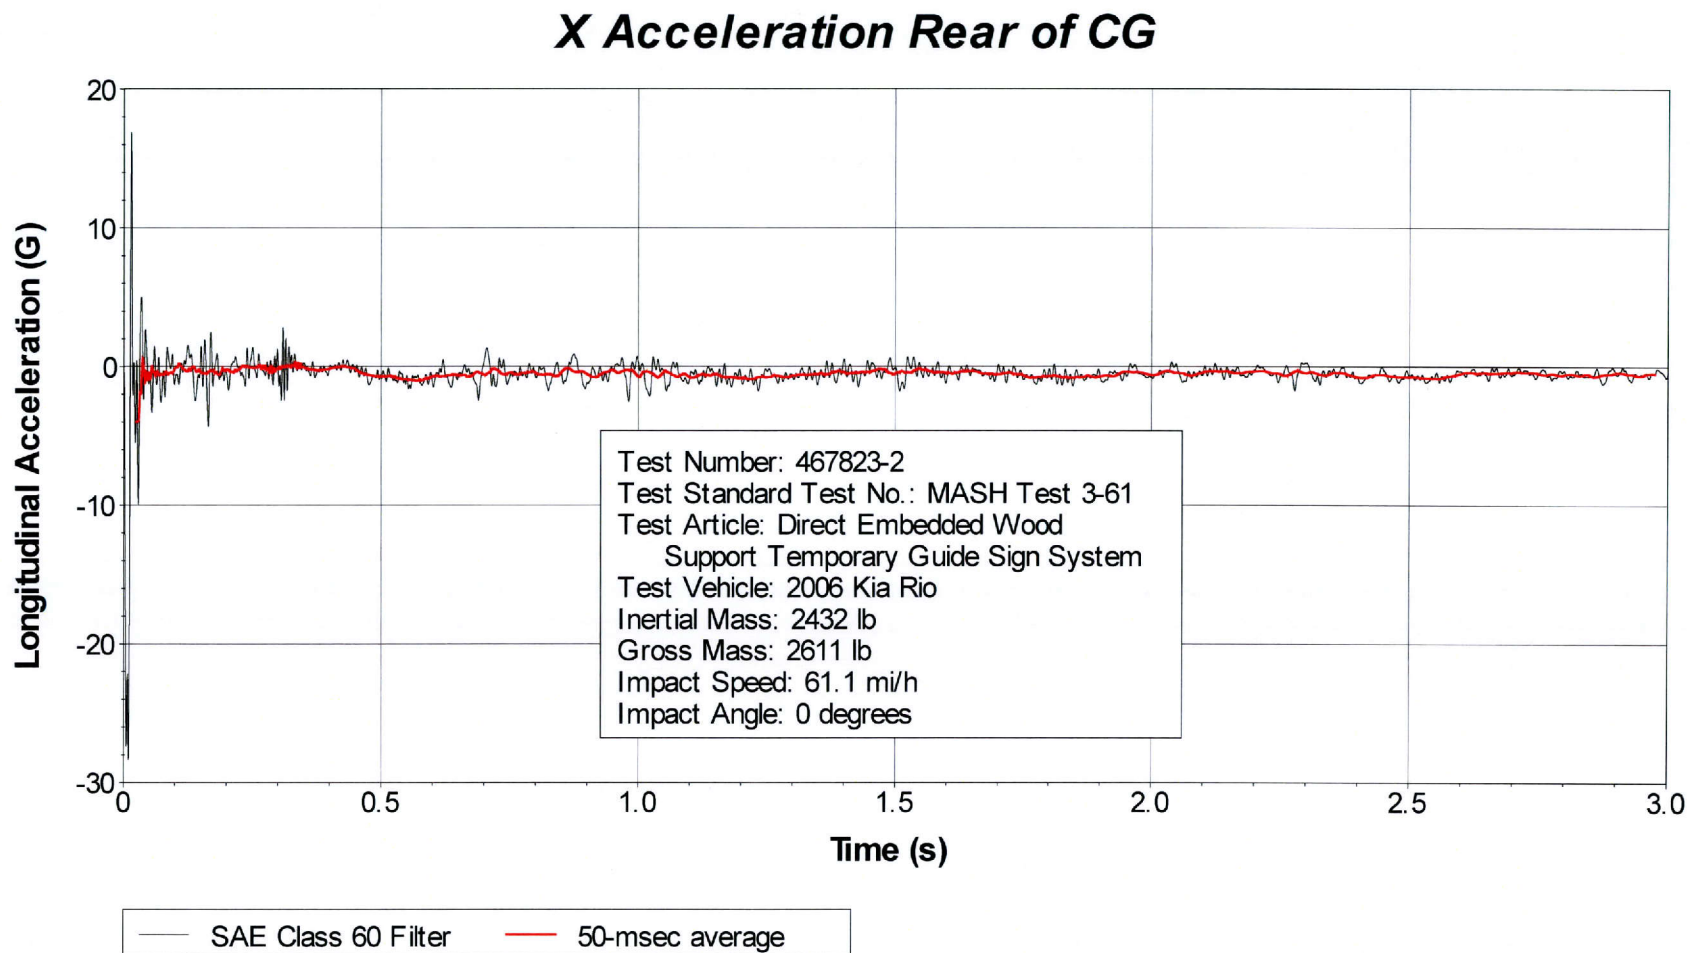
**Figure C6. Vehicle Longitudinal Accelerometer Trace for Test No. 467823-2
(Accelerometer Located Rear of Center of Gravity).**

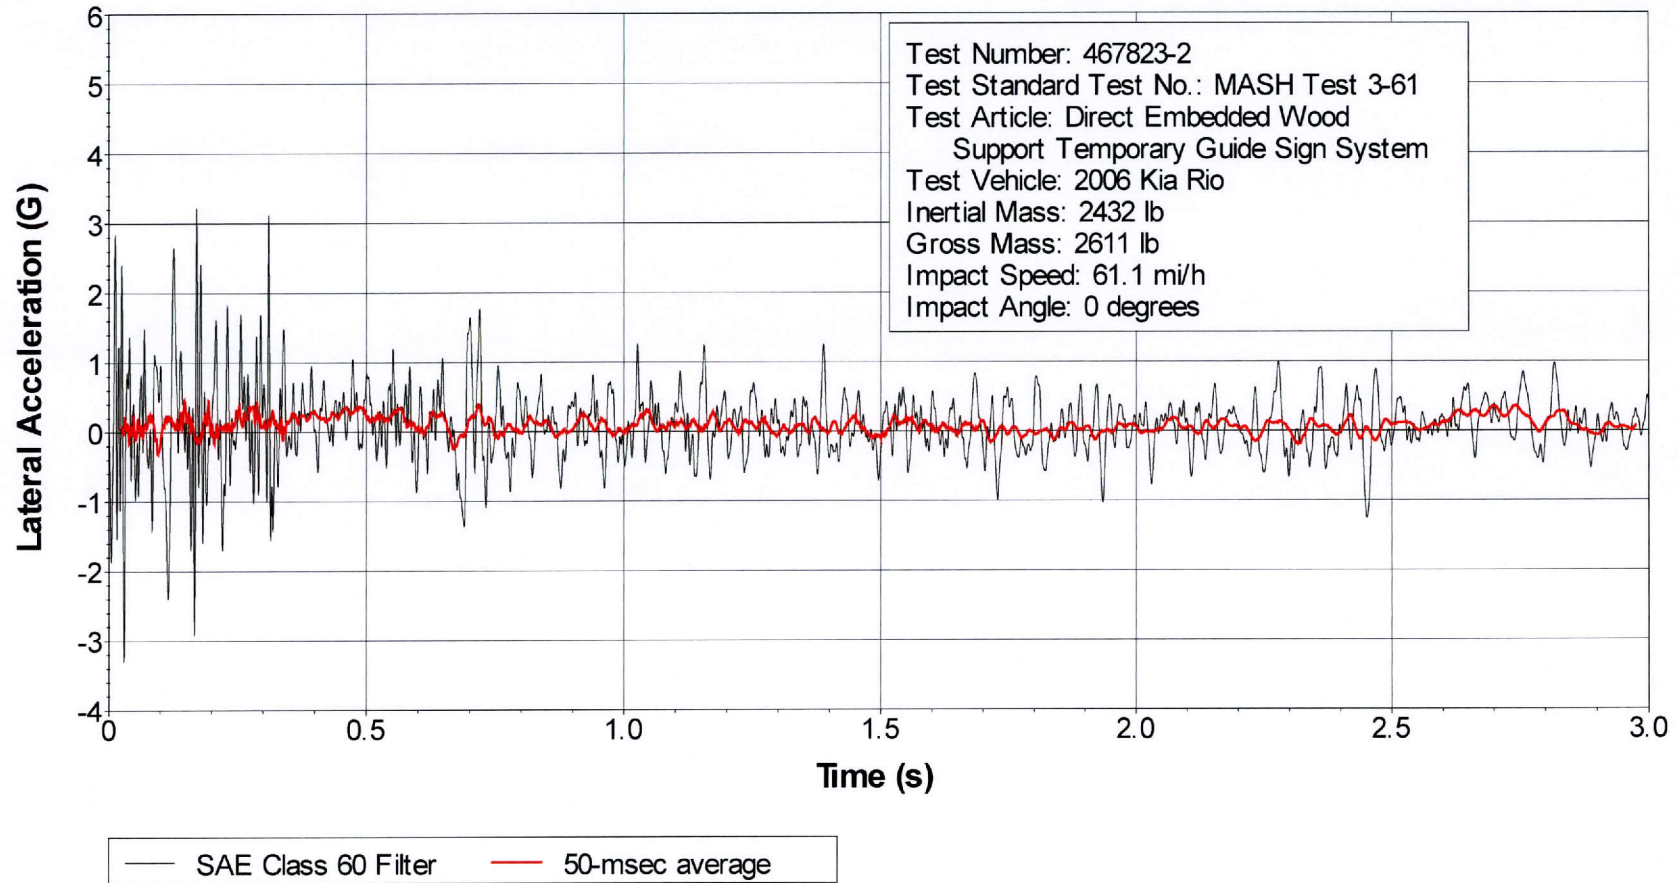
Figure C7. Vehicle Lateral Accelerometer Trace for Test No. 467823-2 (Accelerometer Located Rear of Center of Gravity).

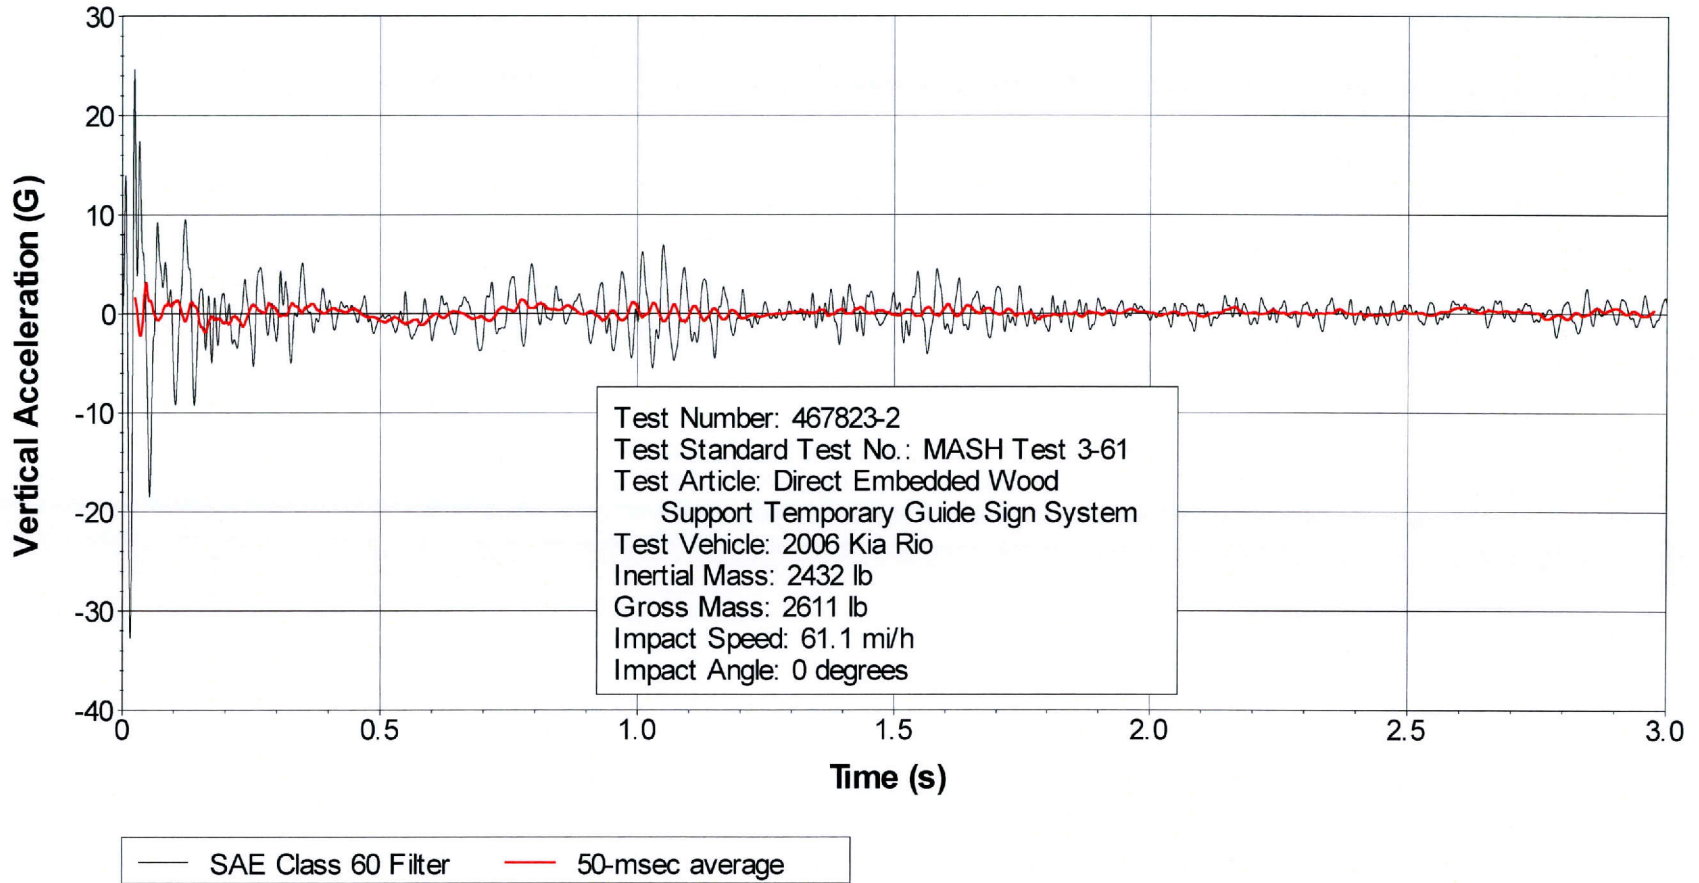
Figure C8. Vehicle Vertical Accelerometer Trace for Test No. 467823-2 (Accelerometer Located Rear of Center of Gravity).

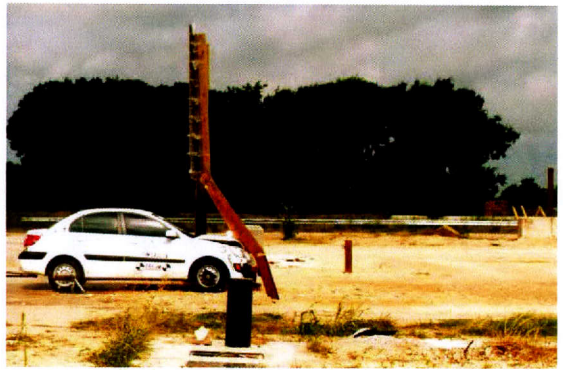
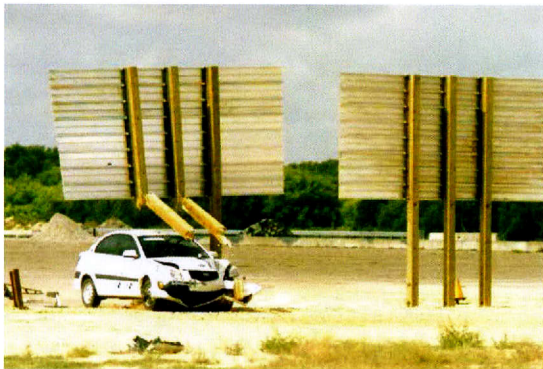
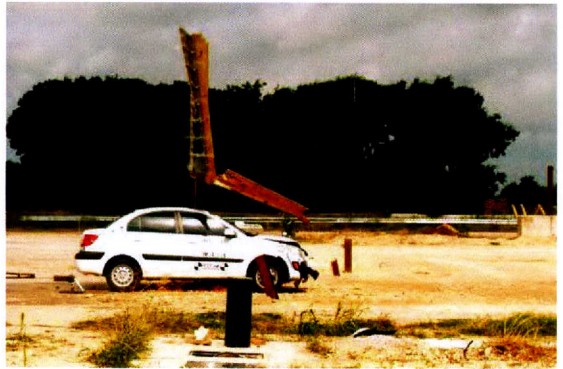
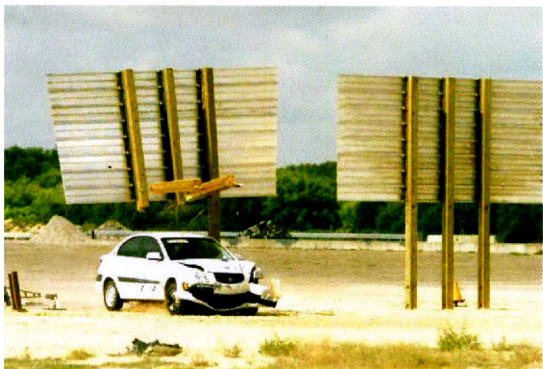
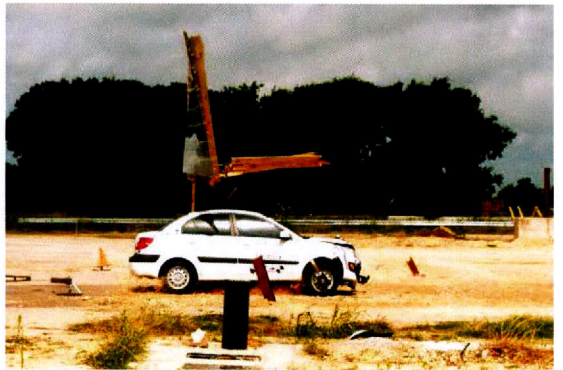
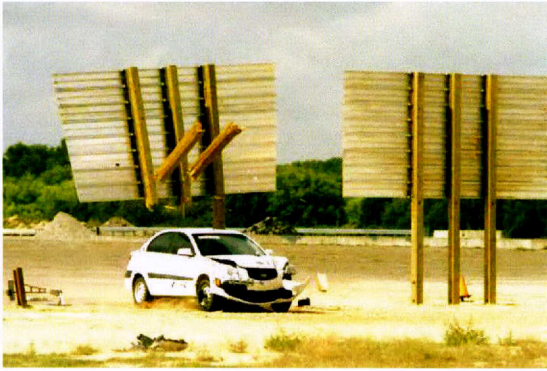
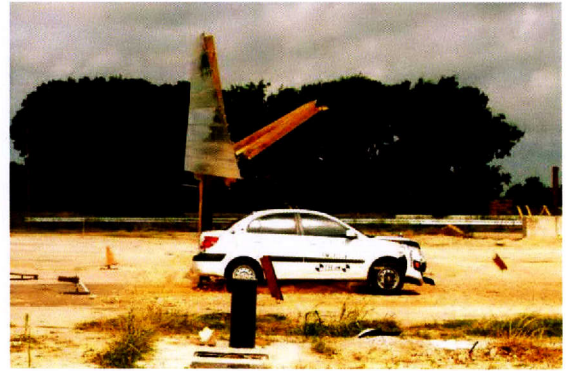
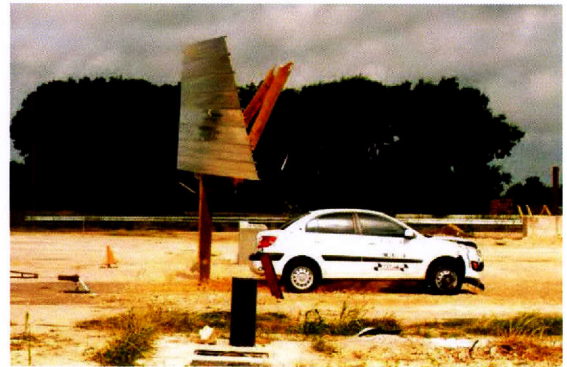
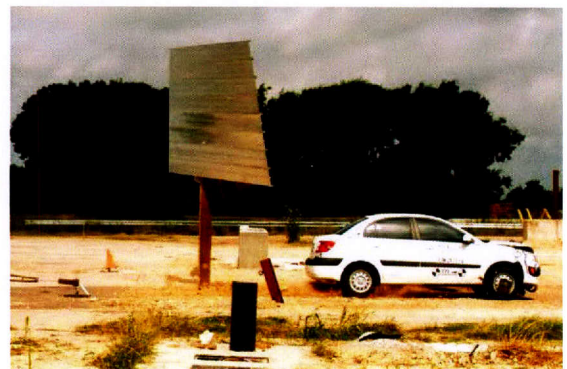
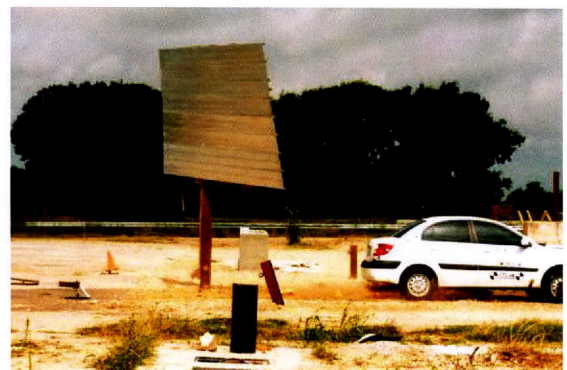
Figure E1. Sequential Photographs for Test No. 467823-2b(Oblique and Perpendicular Views).

Figure E1. Sequential Photographs for Test No. 467823-2b (Oblique and Perpendicular Views) (Continued).

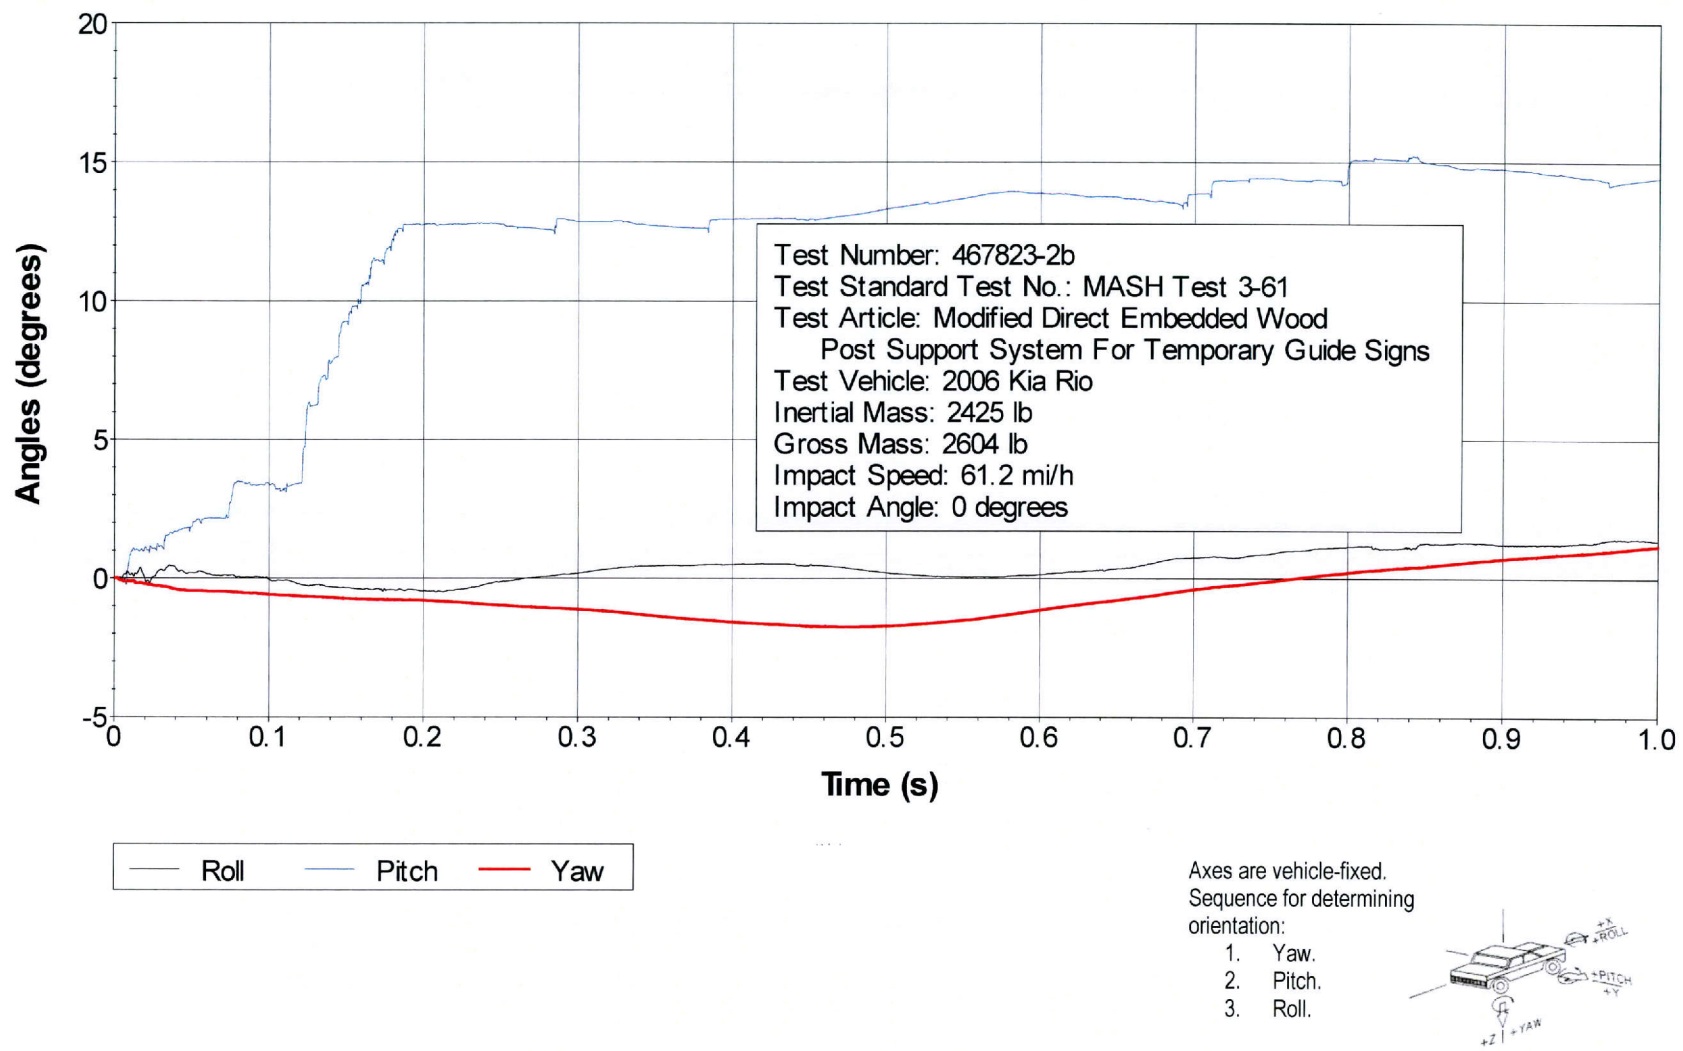
Figure E2. Vehicle Angular Displacements for Test No. 467823-2b.

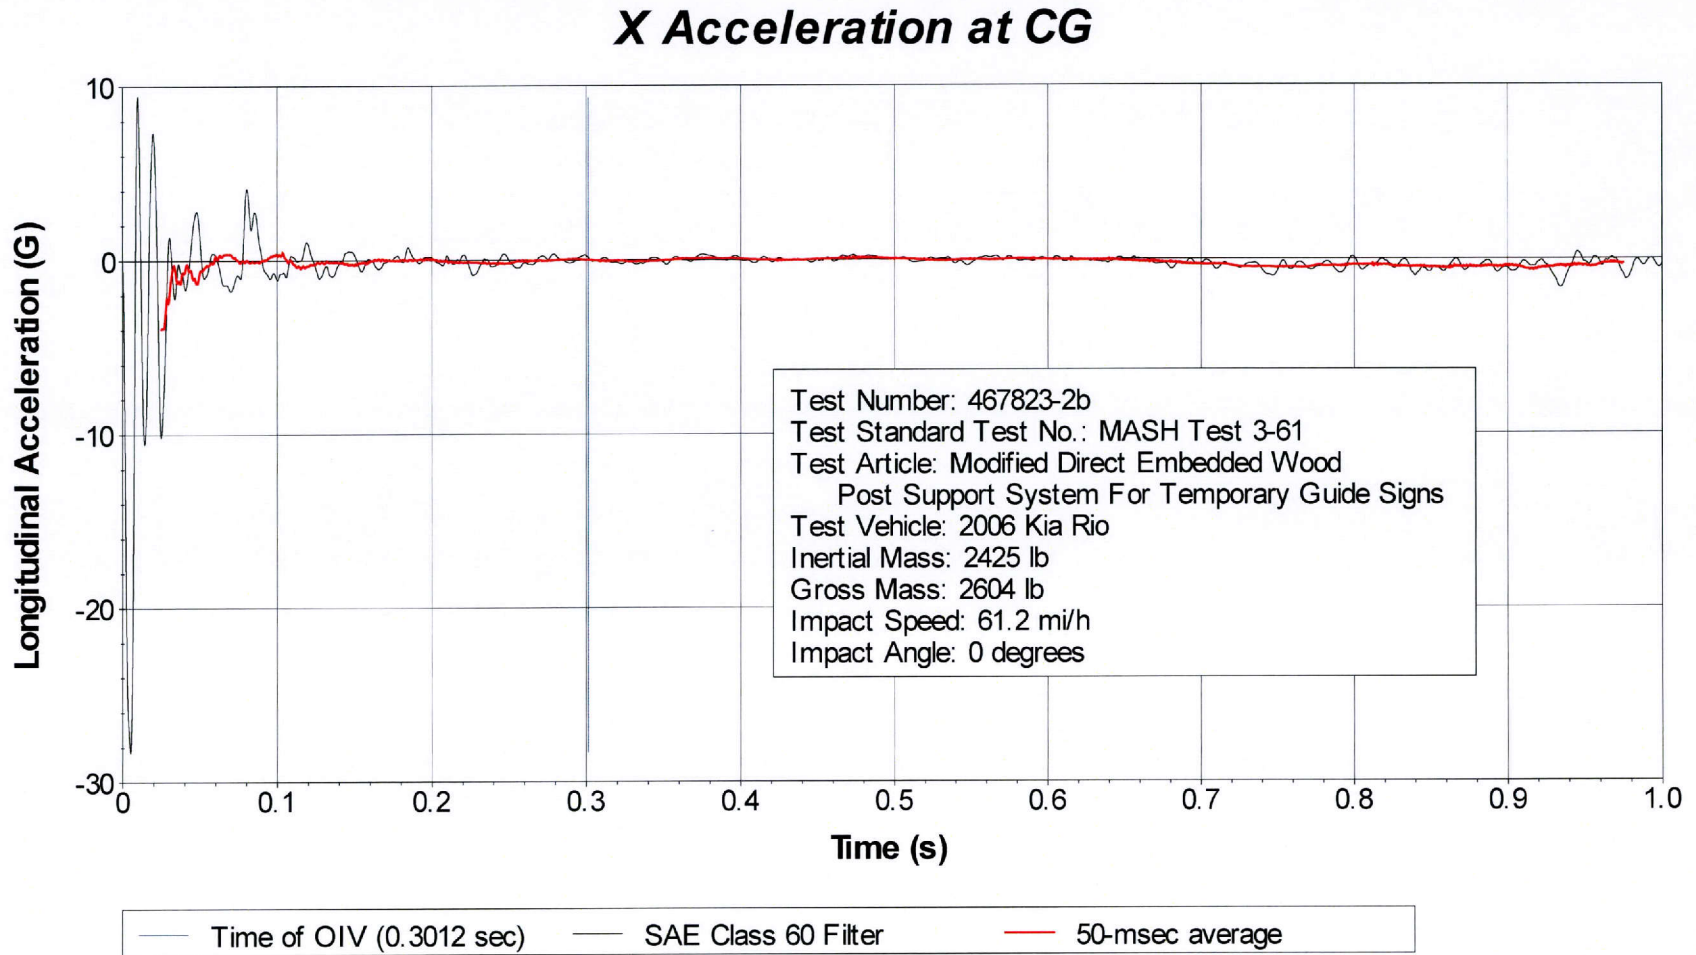
**Figure E3. Vehicle Longitudinal Accelerometer Trace for Test No. 467823-2b
 (Accelerometer Located at Center of Gravity).**

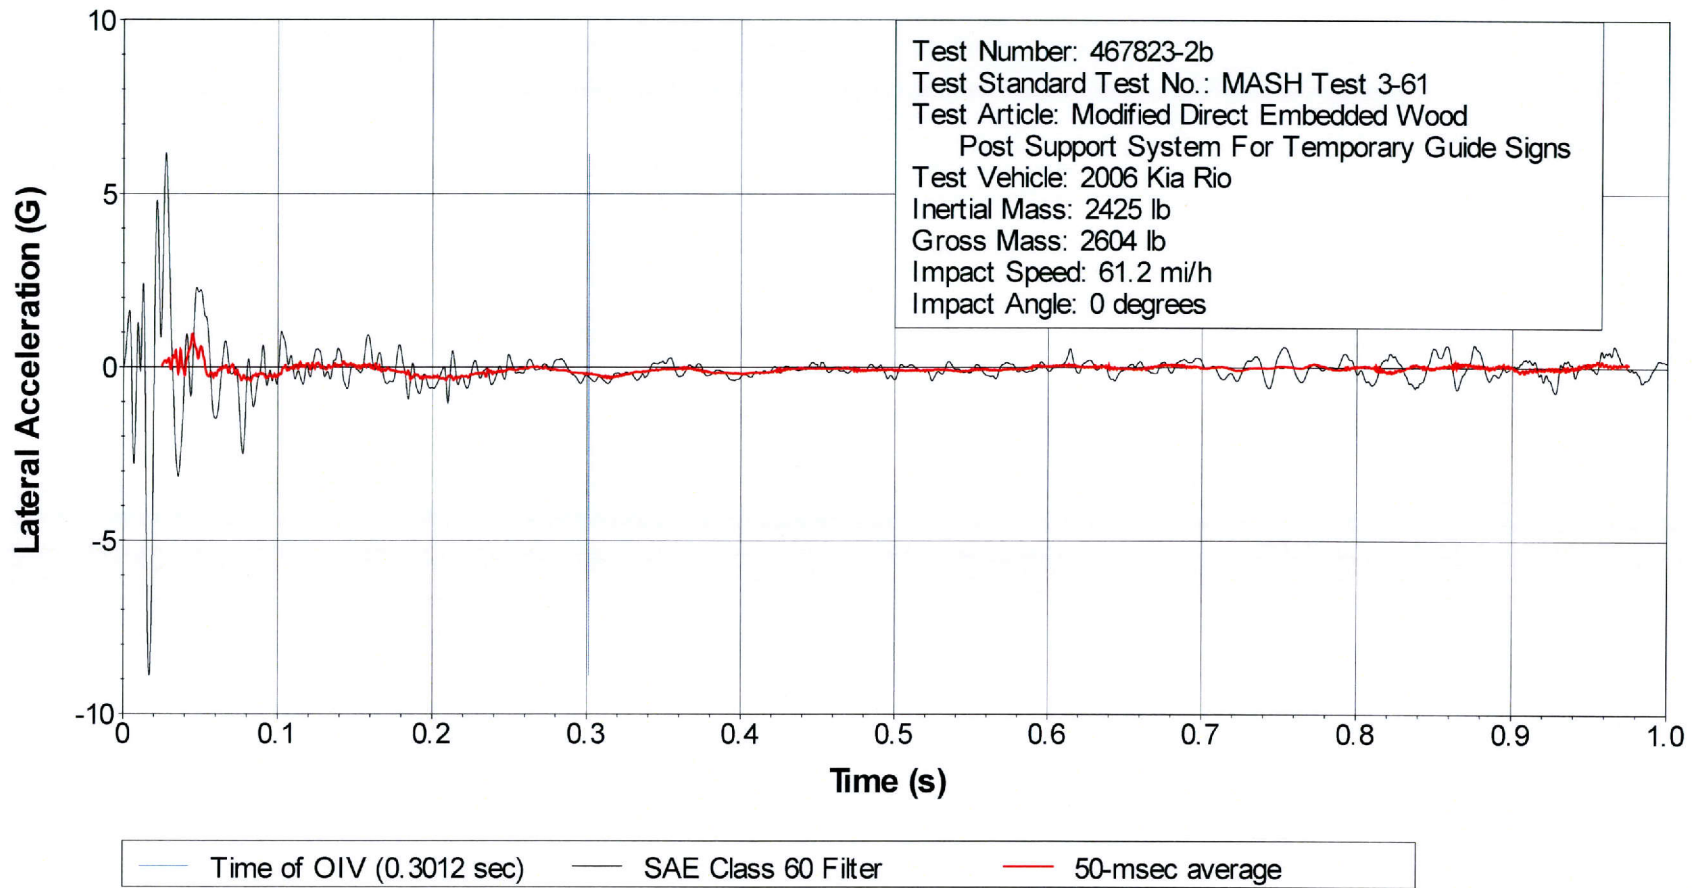
Figure E4. Vehicle Lateral Accelerometer Trace for Test No. 467823-2b (Accelerometer Located at Center of Gravity).

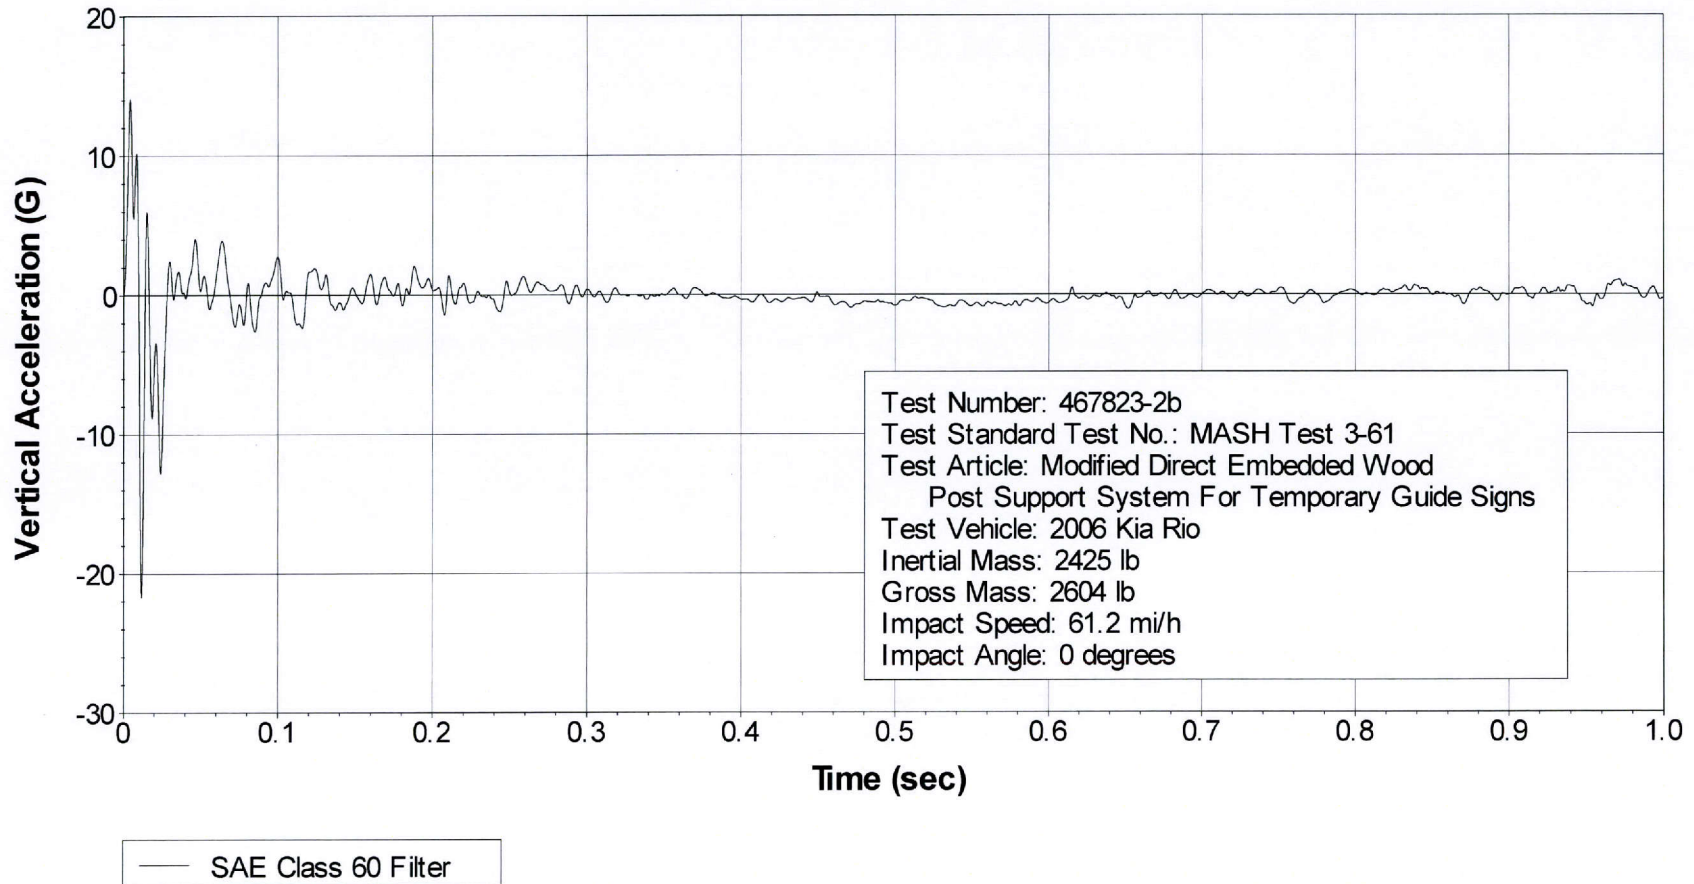
**Figure E5. Vehicle Vertical Accelerometer Trace for Test No. 467823-2b
(Accelerometer Located at Center of Gravity).**

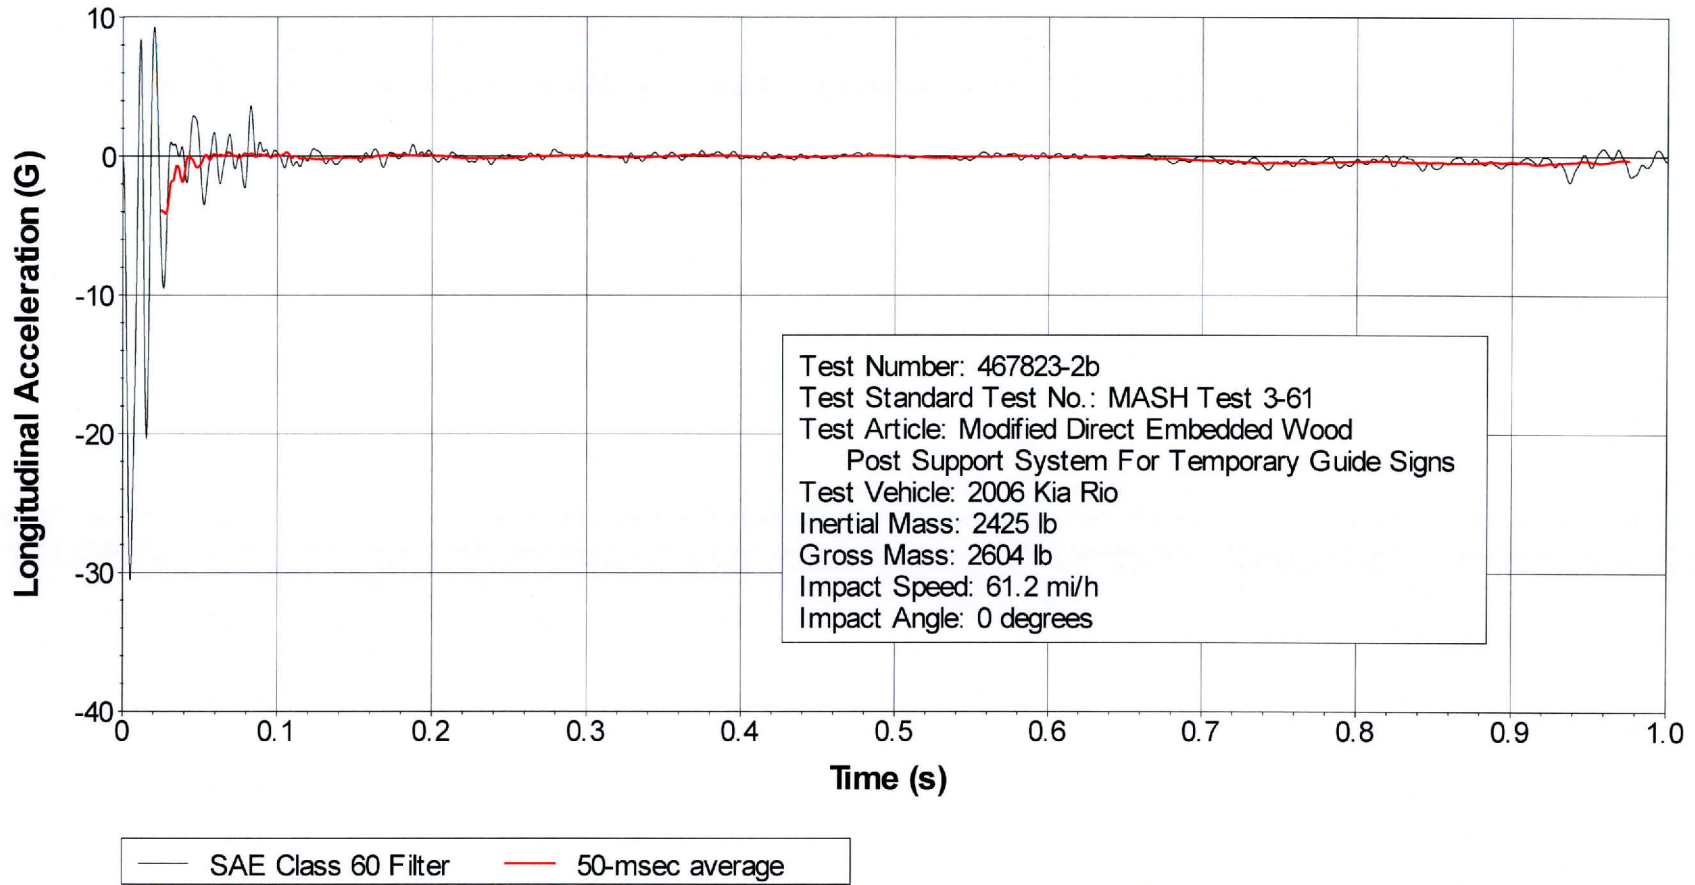
Figure E6. Vehicle Longitudinal Accelerometer Trace for Test No. 467823-2b (Accelerometer Located Rear of Center of Gravity).

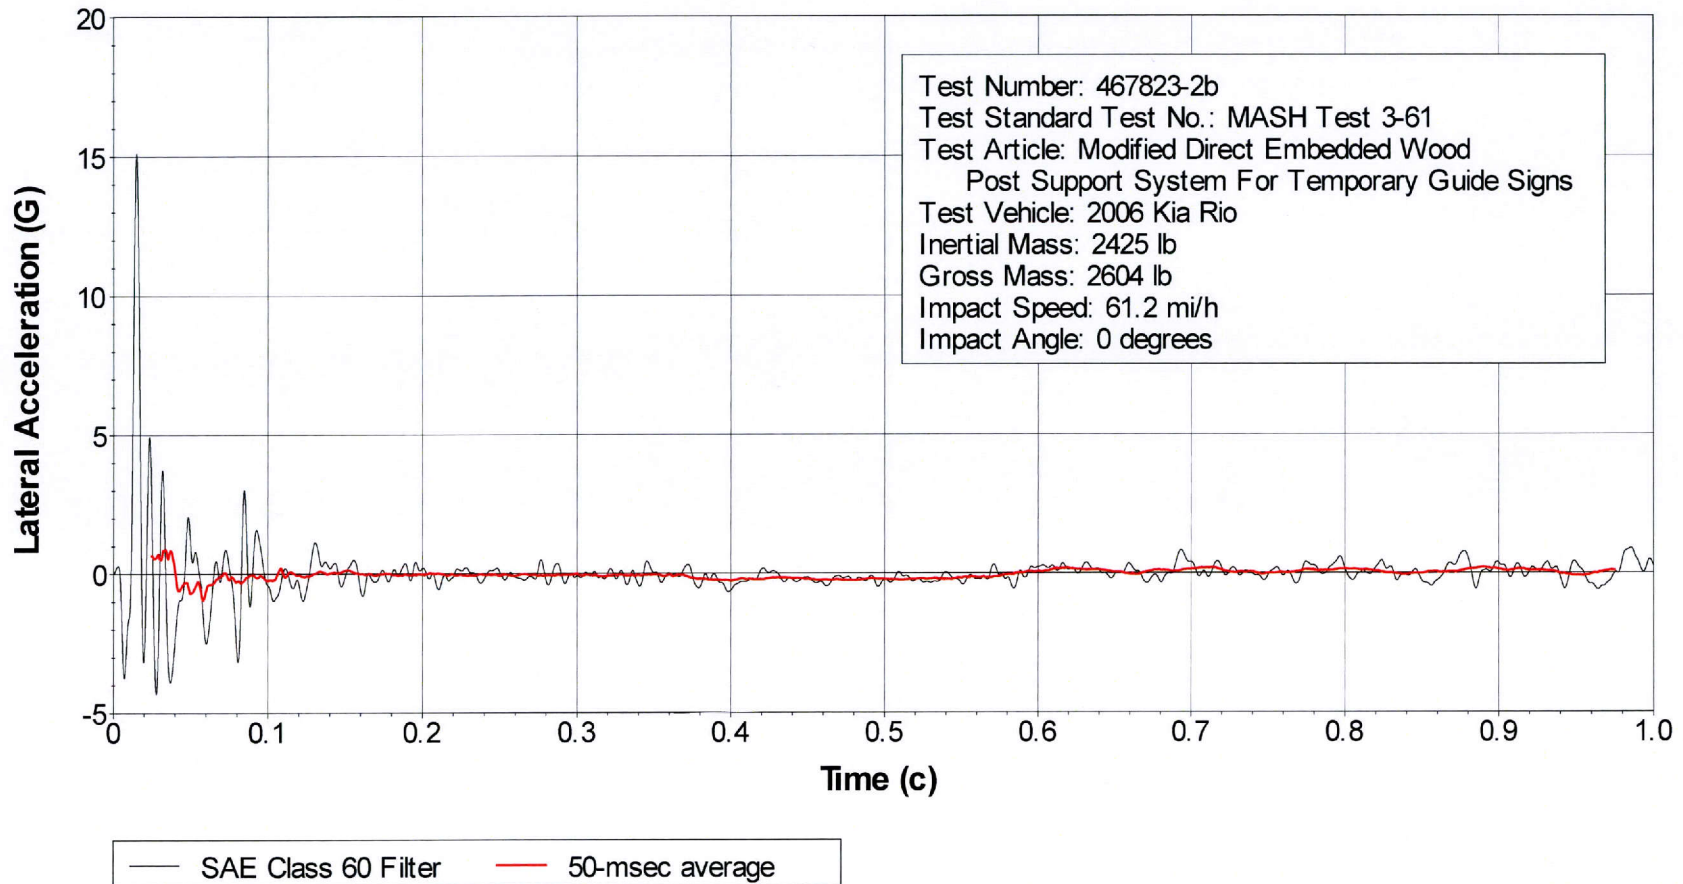
**Figure E7. Vehicle Lateral Accelerometer Trace for Test No. 467823-2b
 (Accelerometer Located Rear of Center of Gravity).**

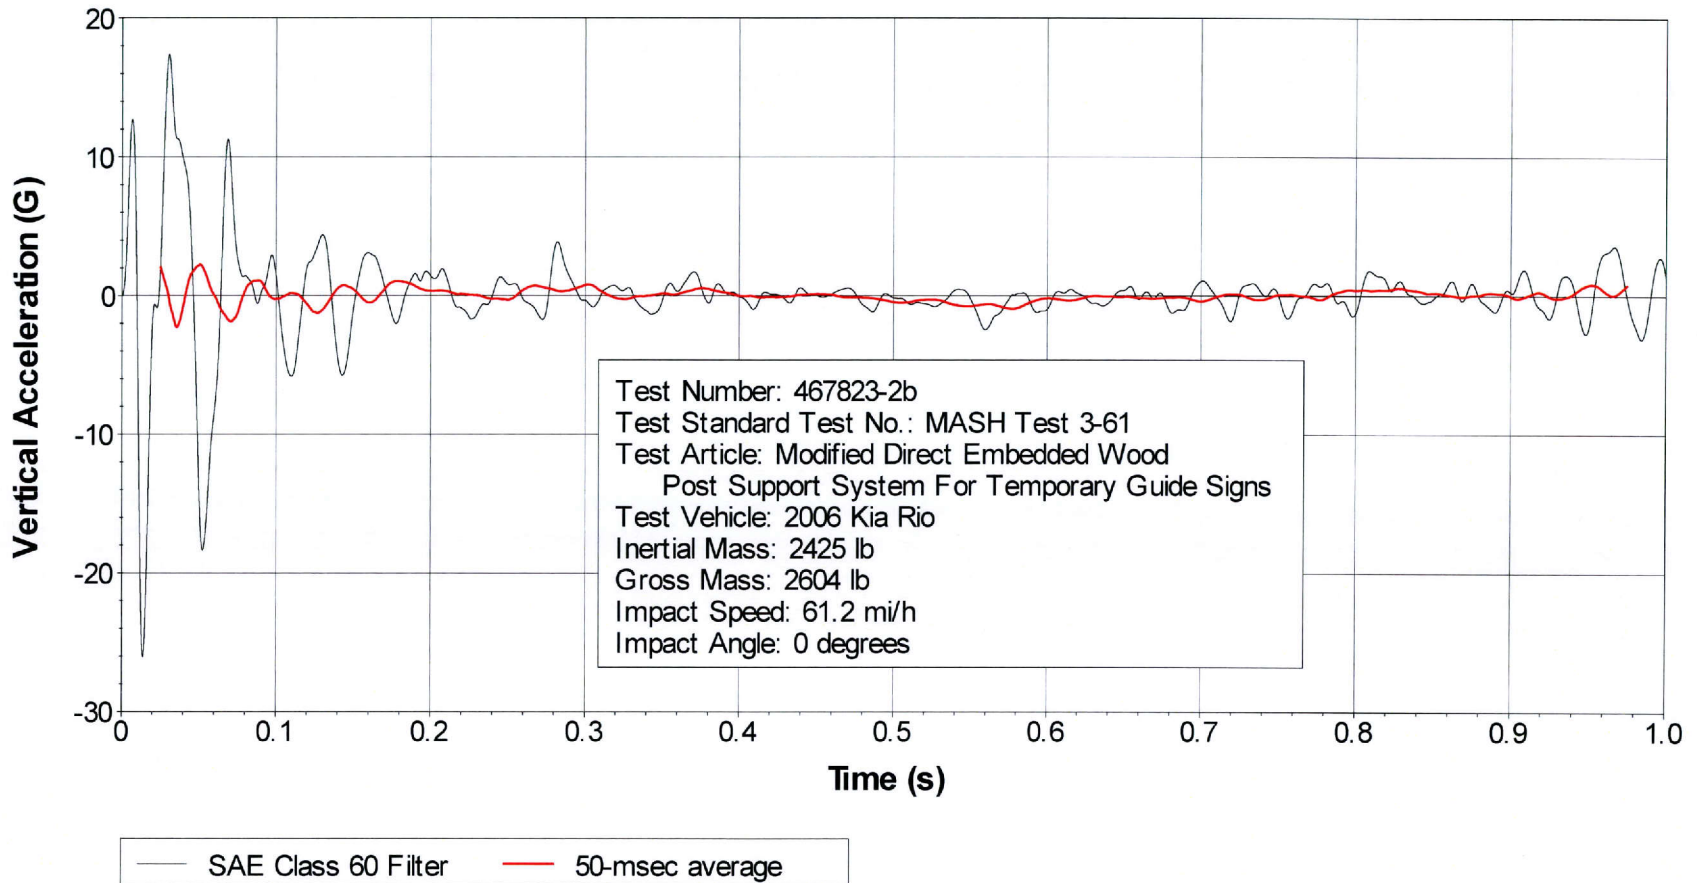
Figure E8. Vehicle Vertical Accelerometer Trace for Test No. 467823-2b (Accelerometer Located Rear of Center of Gravity).

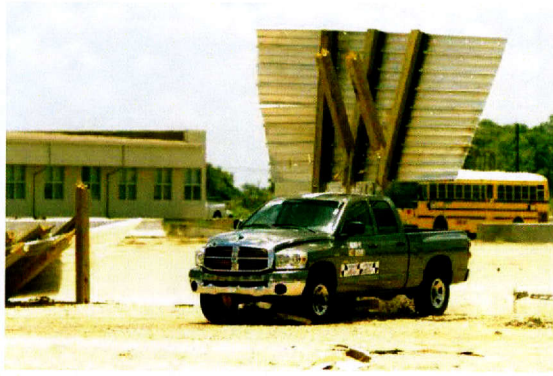
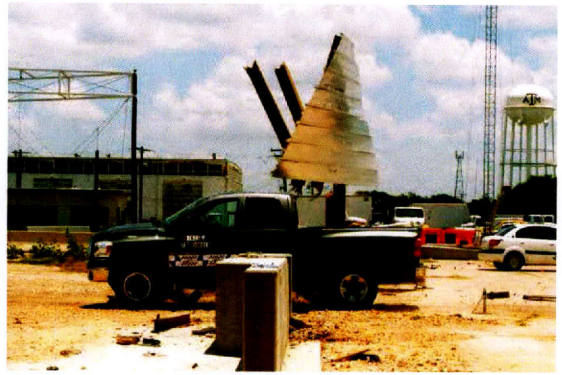
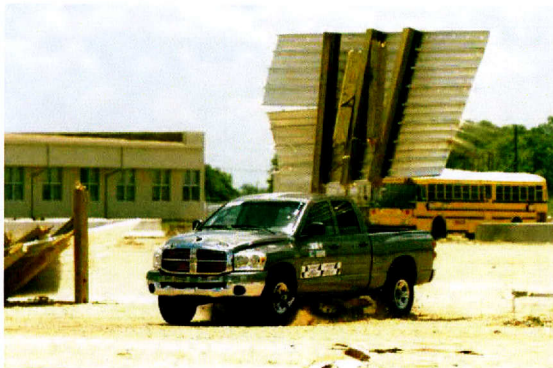
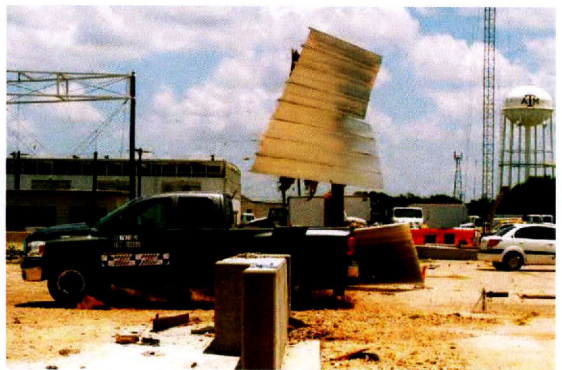
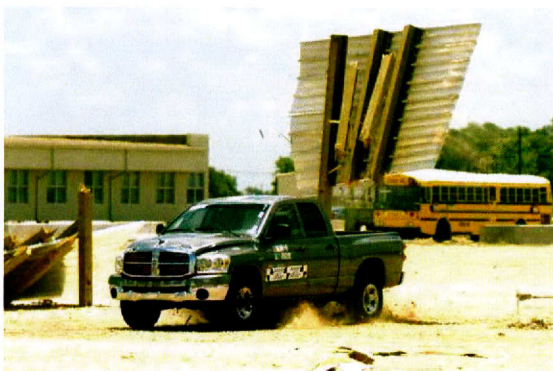
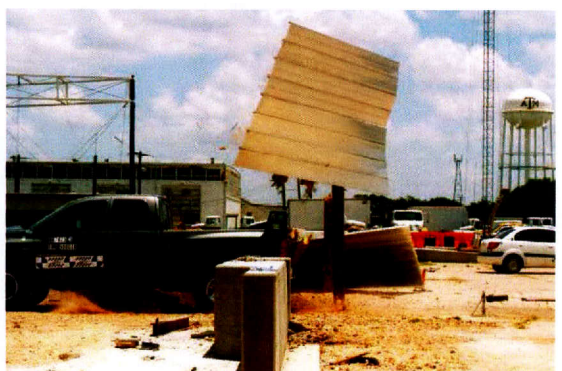
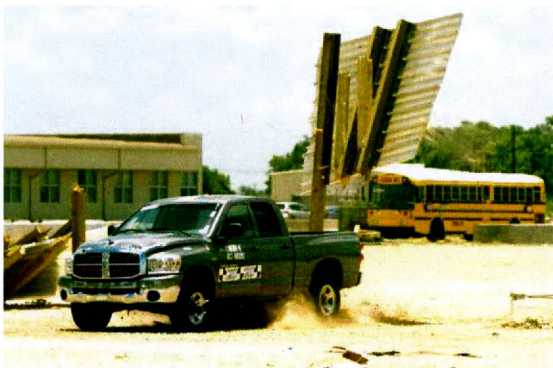
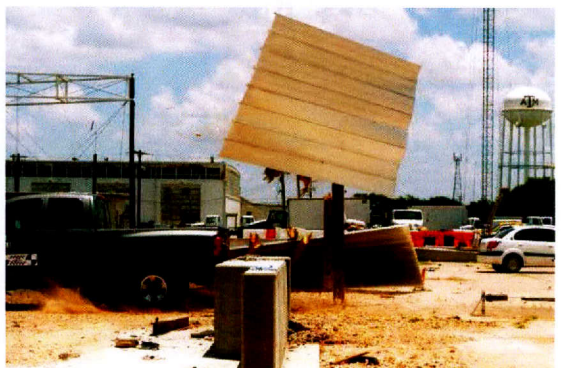
Figure F1. Sequential Photographs for Test No. 467823-3(Oblique and Perpendicular Views).

**Figure F1. Sequential Photographs for Test No. 467823-3
(Oblique and Perpendicular Views) (Continued).**
