Temporary Large Guide Signs

Technical Report 0-6782-1

TEXAS A&M TRANSPORTATION INSTITUTE
COLLEGE STATION, TEXAS

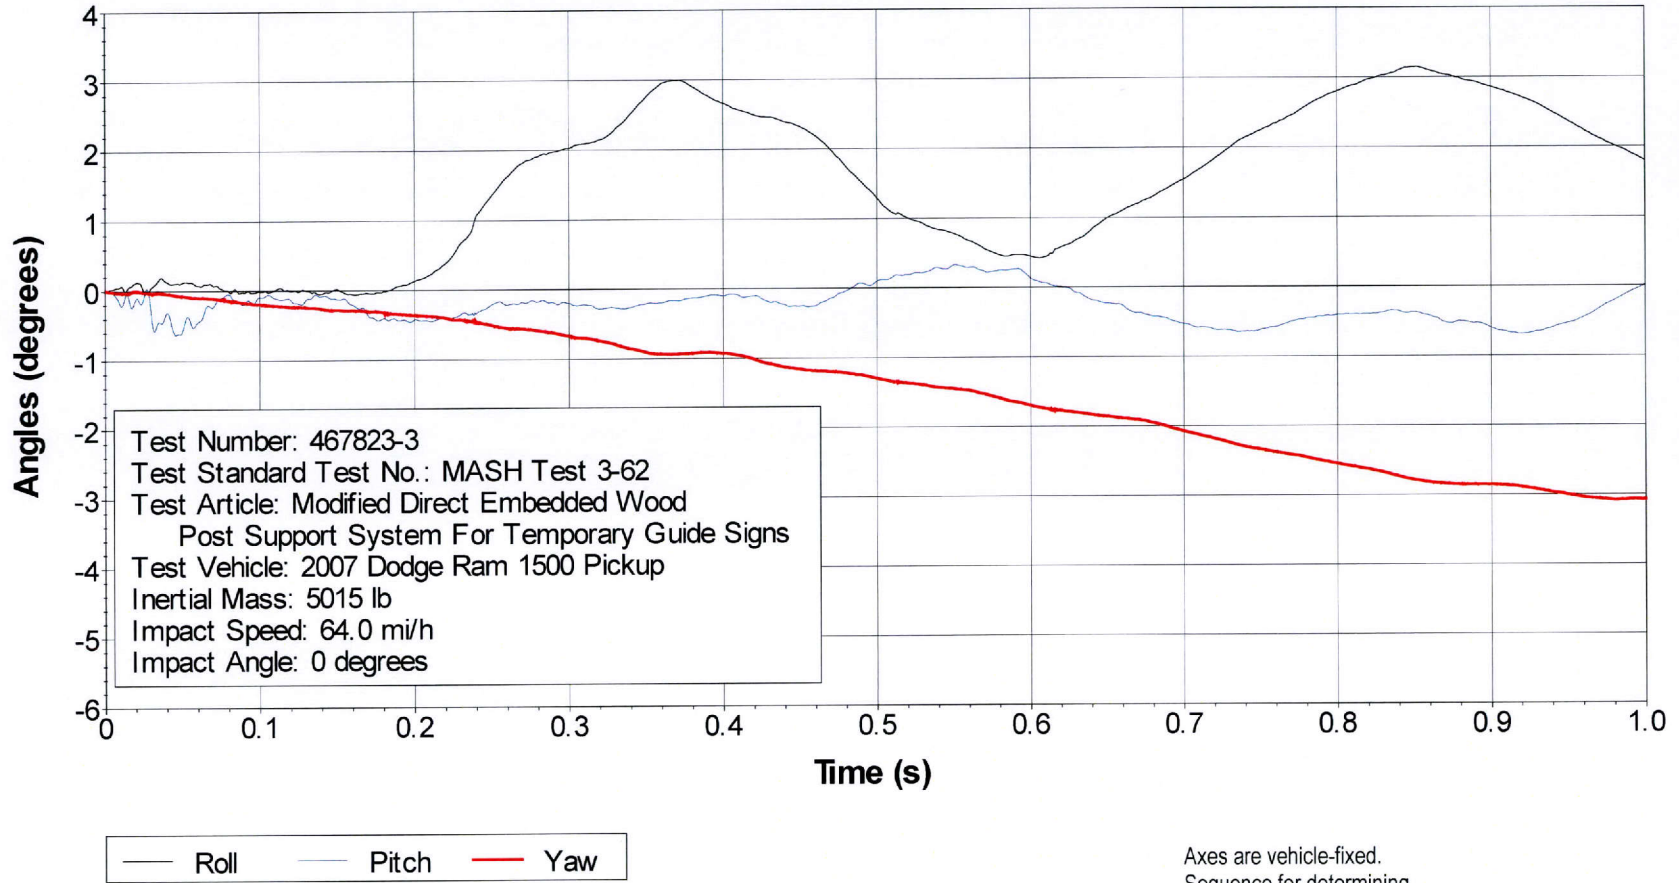
Axes are vehicle-fixed.
Sequence for determining orientation:

1. Yaw.
2. Pitch.
3. Roll.

Figure F2. Vehicle Angular Displacements for Test No. 467823-3.

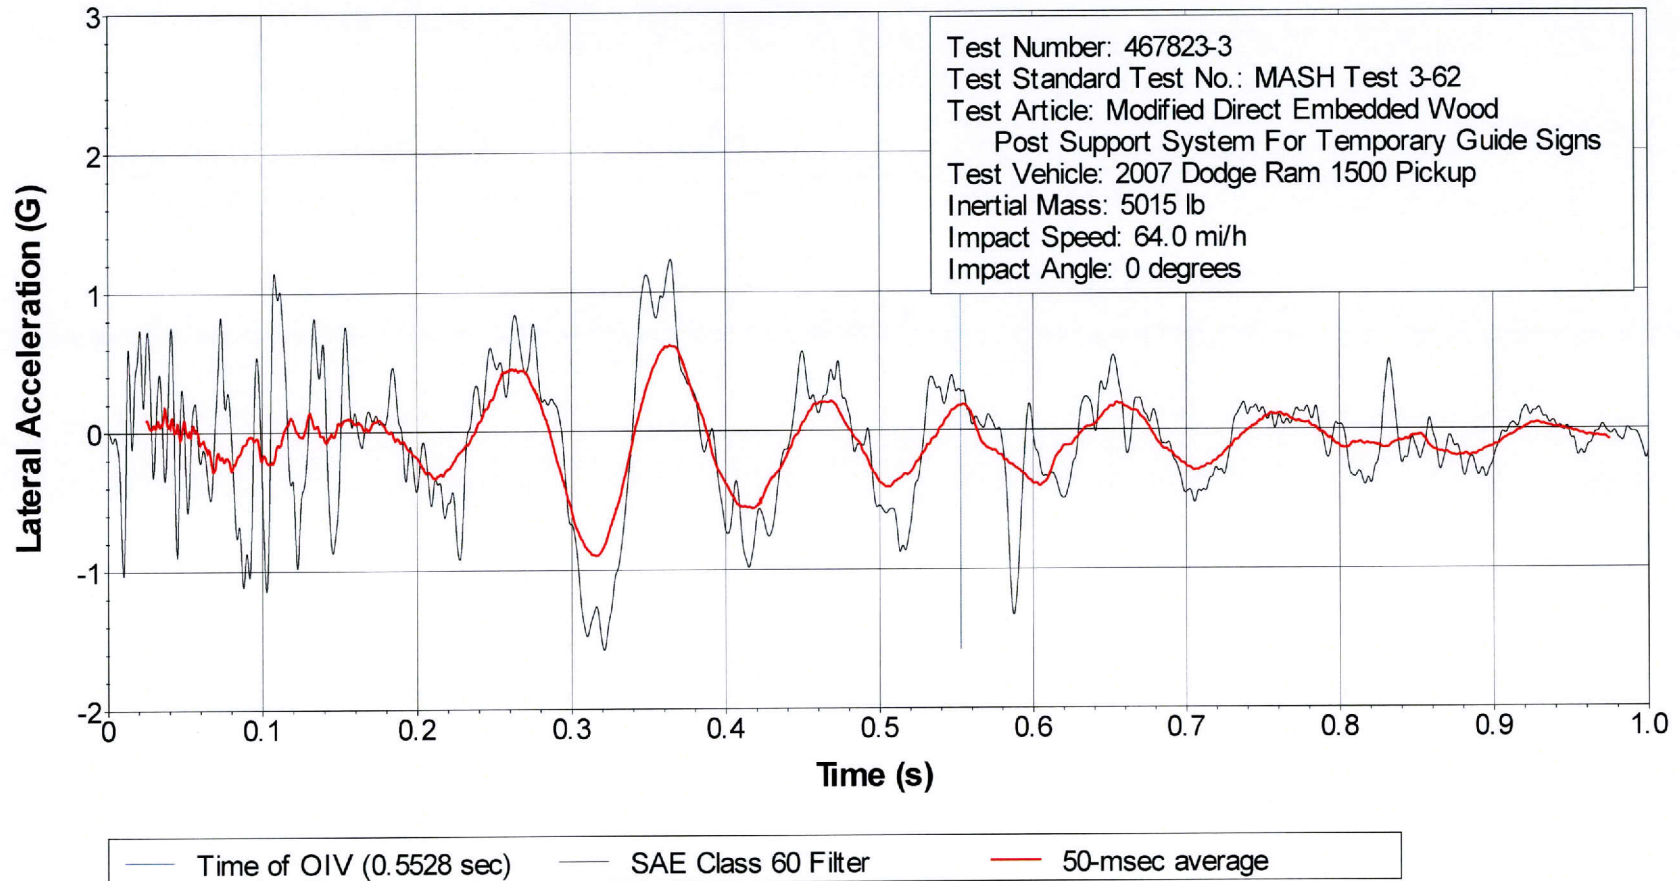
Figure F4. Vehicle Lateral Accelerometer Trace for Test No. 467823-3 (Accelerometer Located at Center of Gravity).

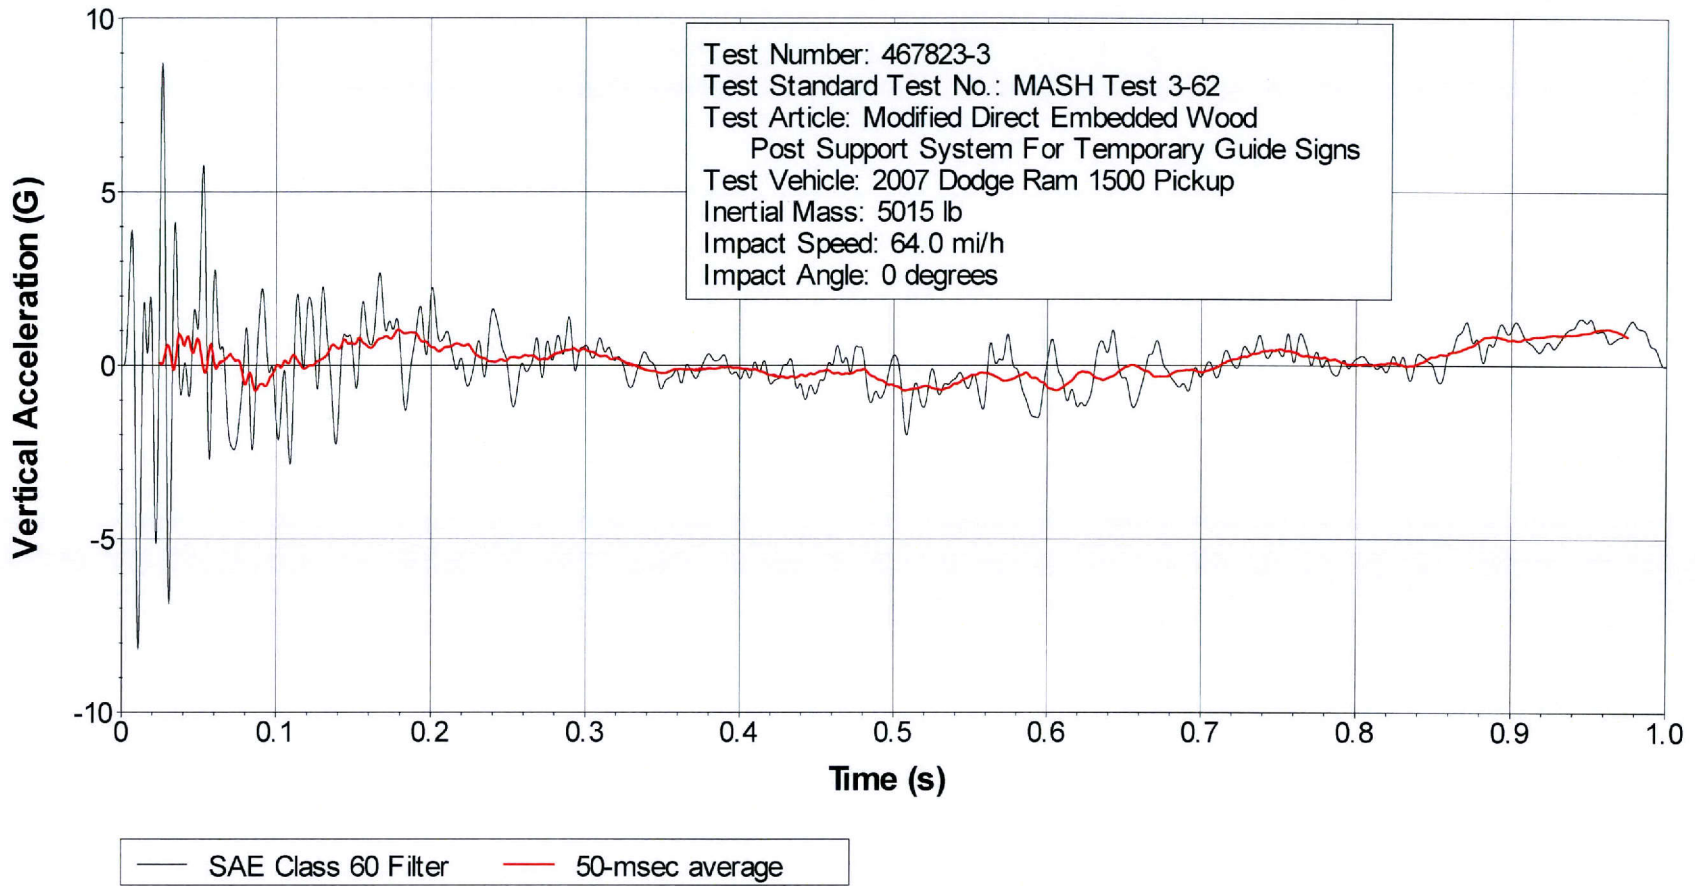
Figure F5. Vehicle Vertical Accelerometer Trace for Test No. 467823-3 (Accelerometer Located at Center of Gravity).

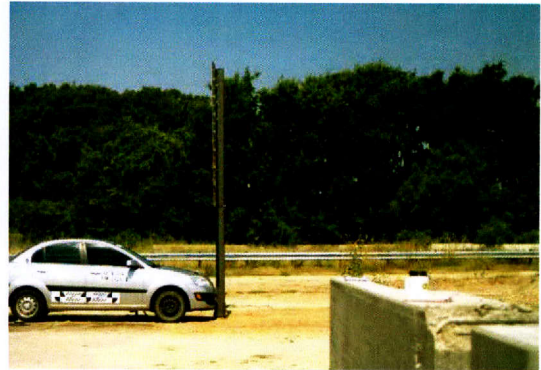
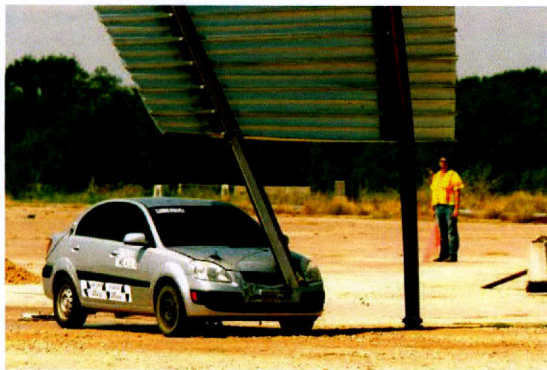
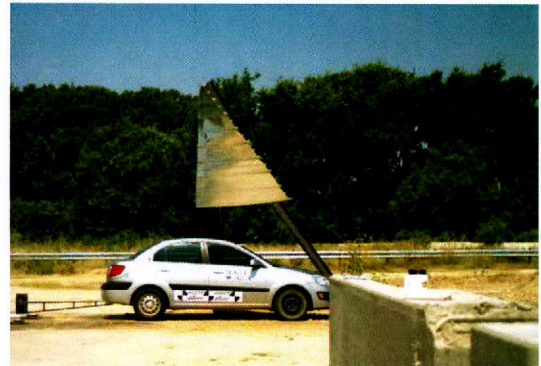
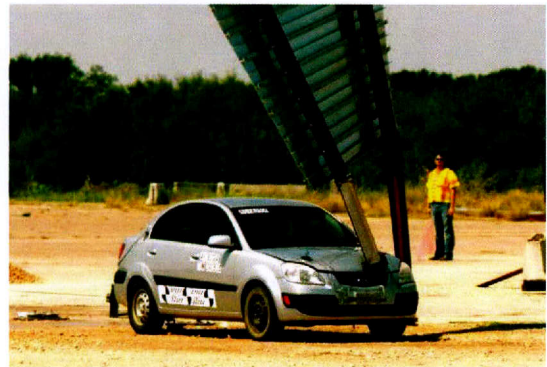
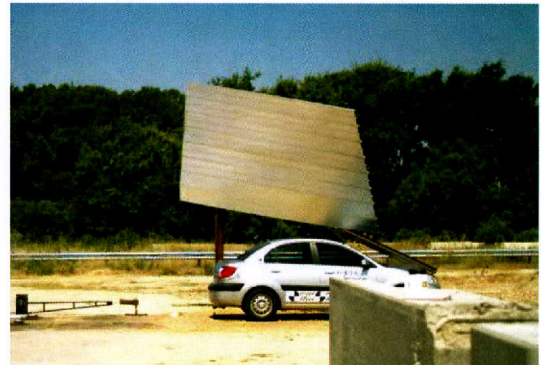
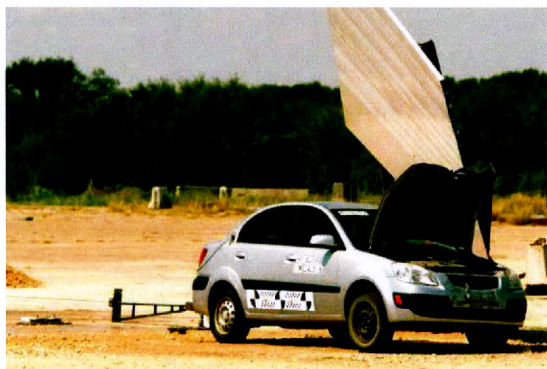
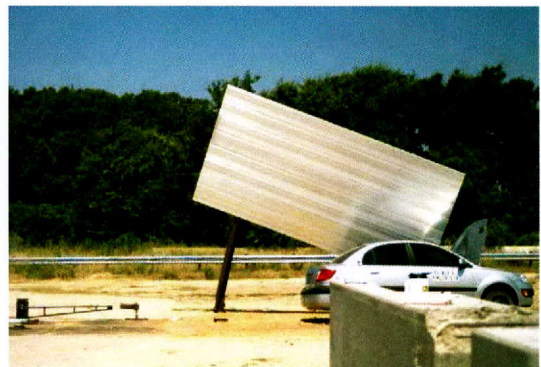
Figure H1. Sequential Photographs for Test No. 467823-4(Oblique and Perpendicular Views).

H.2 SEQUENTIAL PHOTOGRAPHS

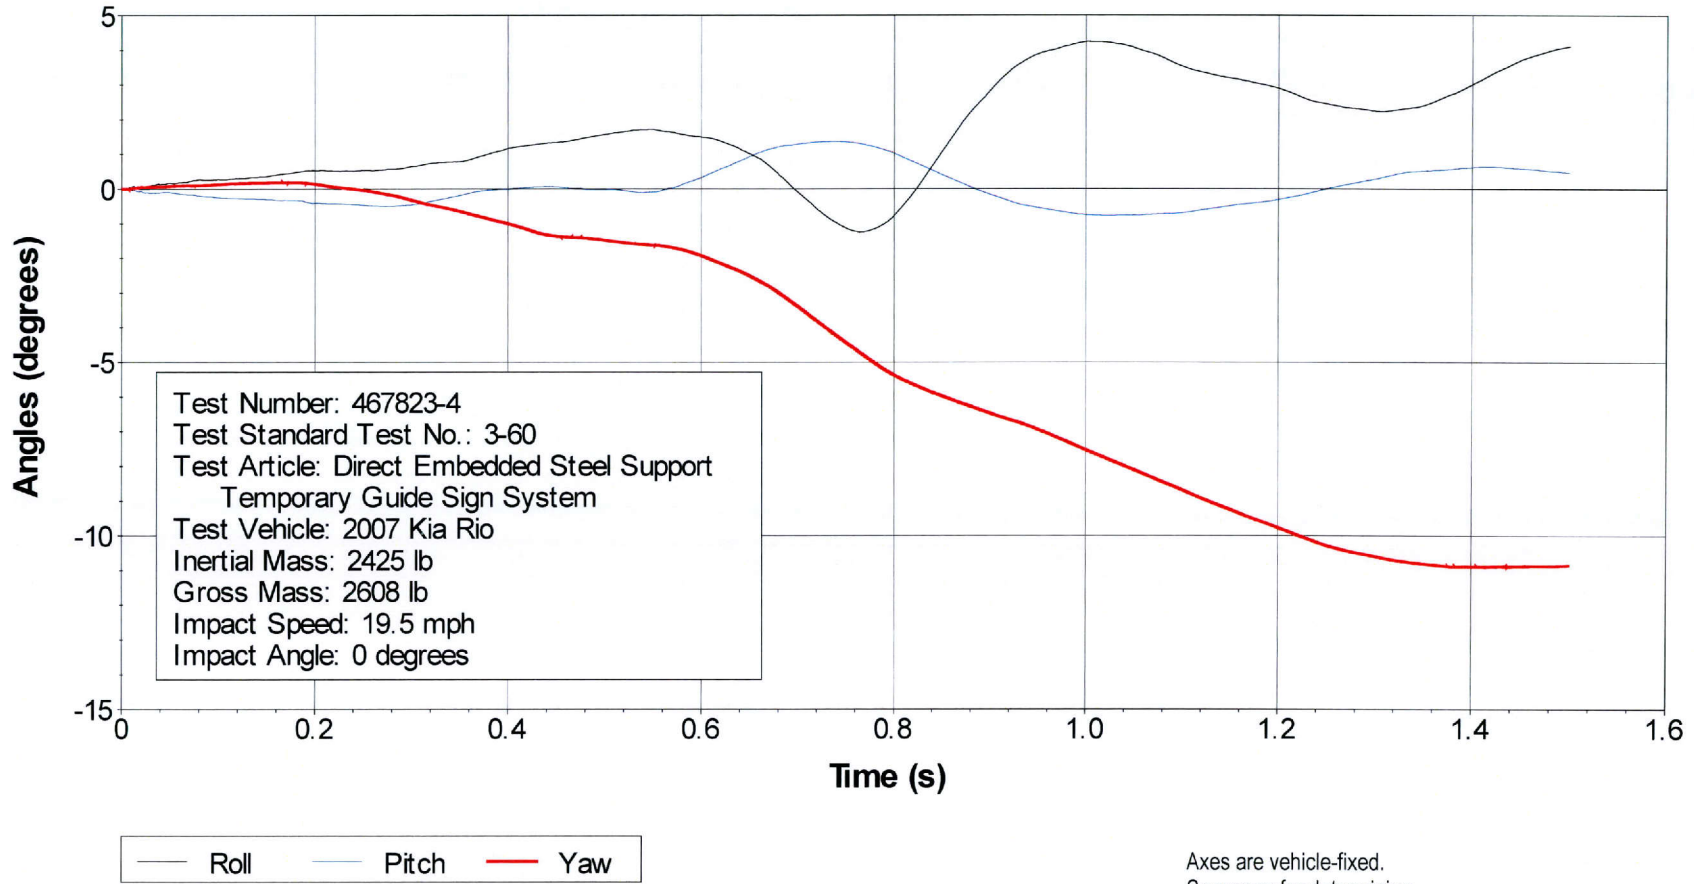
Figure H2. Vehicle Angular Displacements for Test No. 467823-4.

Roll, Pitch, and Yaw Angles

Axes are vehicle-fixed.
 Sequence for determining orientation:

1. Yaw.
2. Pitch.
3. Roll.

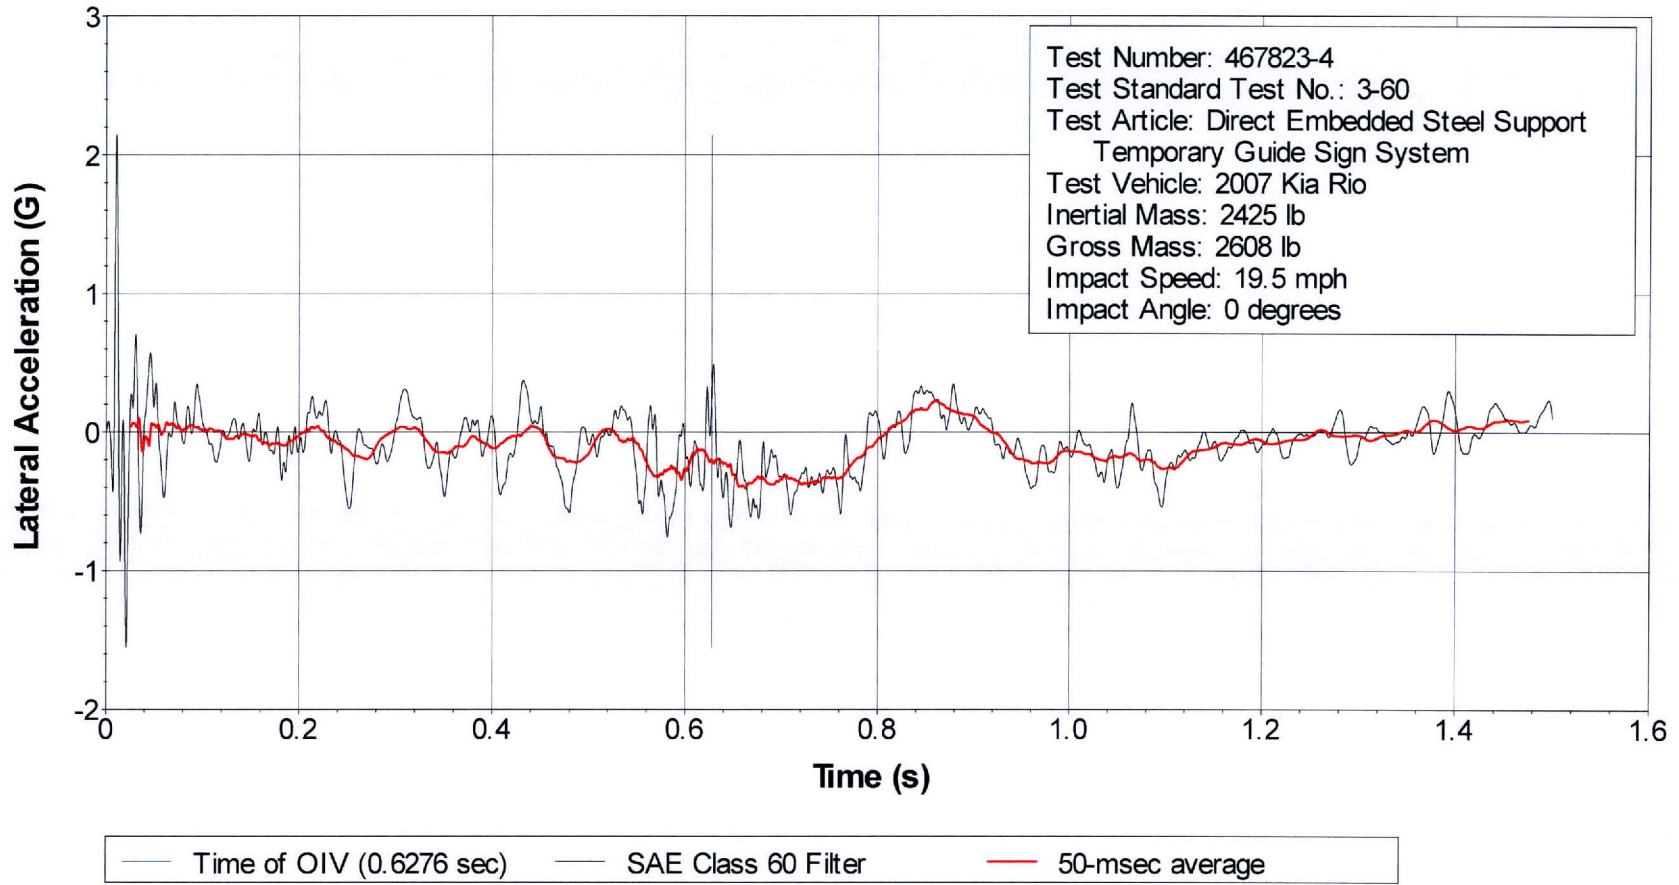
Figure H4. Vehicle Lateral Accelerometer Trace for Test No. 467823-4 (Accelerometer Located at Center of Gravity).

Y Acceleration at CG

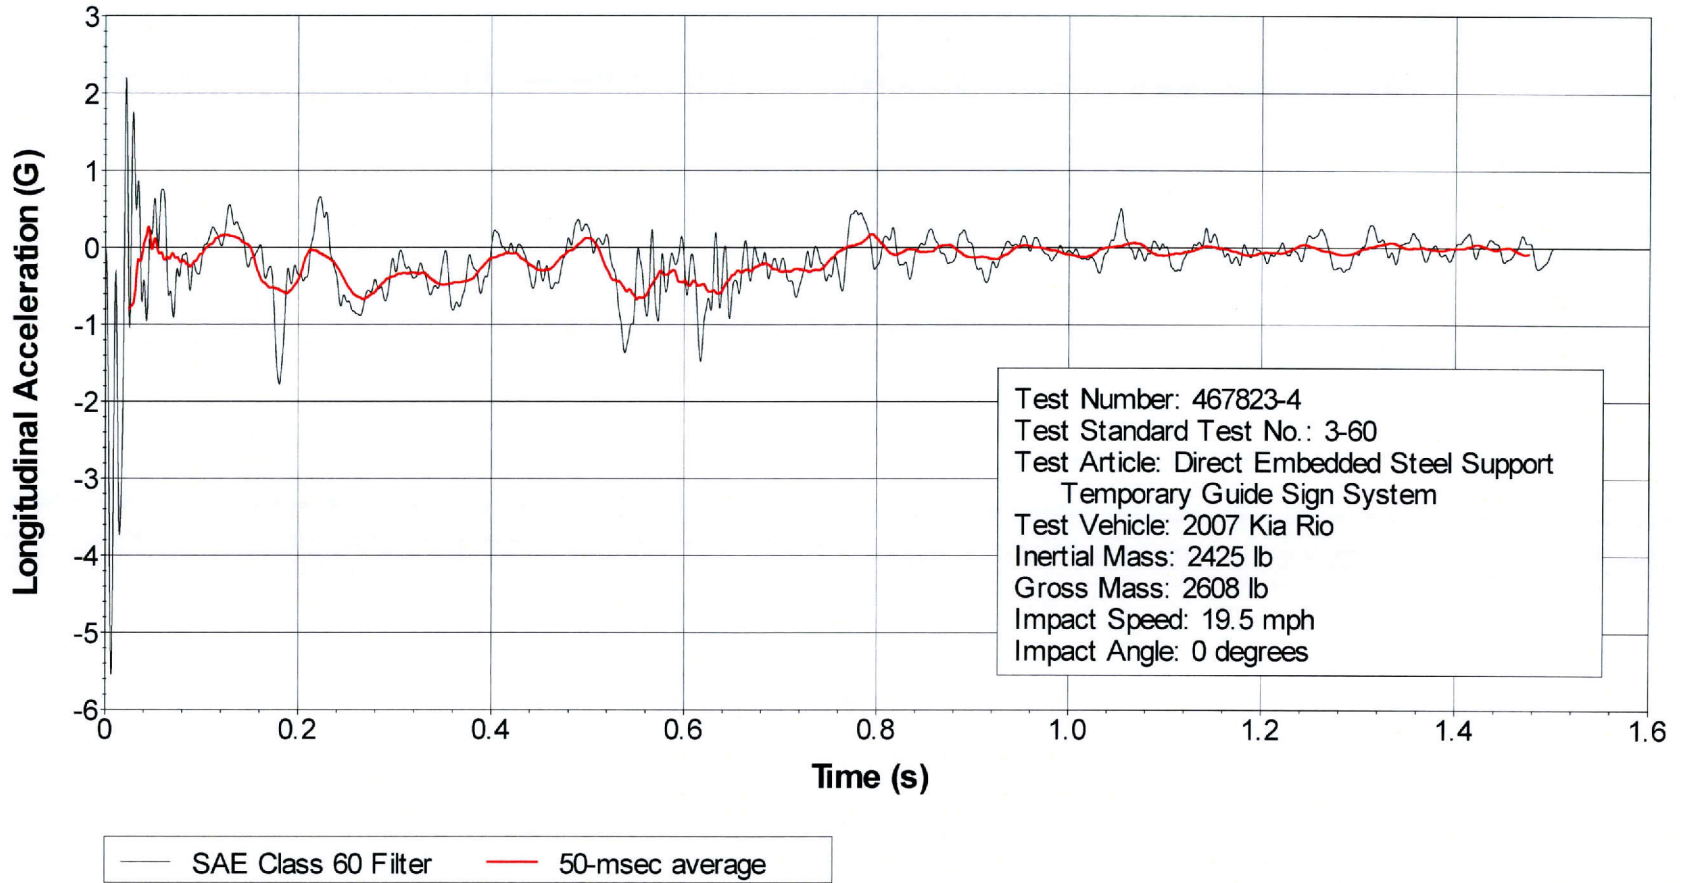
Figure H6. Vehicle Longitudinal Accelerometer Trace for Test No. 467823-4 (Accelerometer Located Rear of Center of Gravity).

X Acceleration Rear of CG

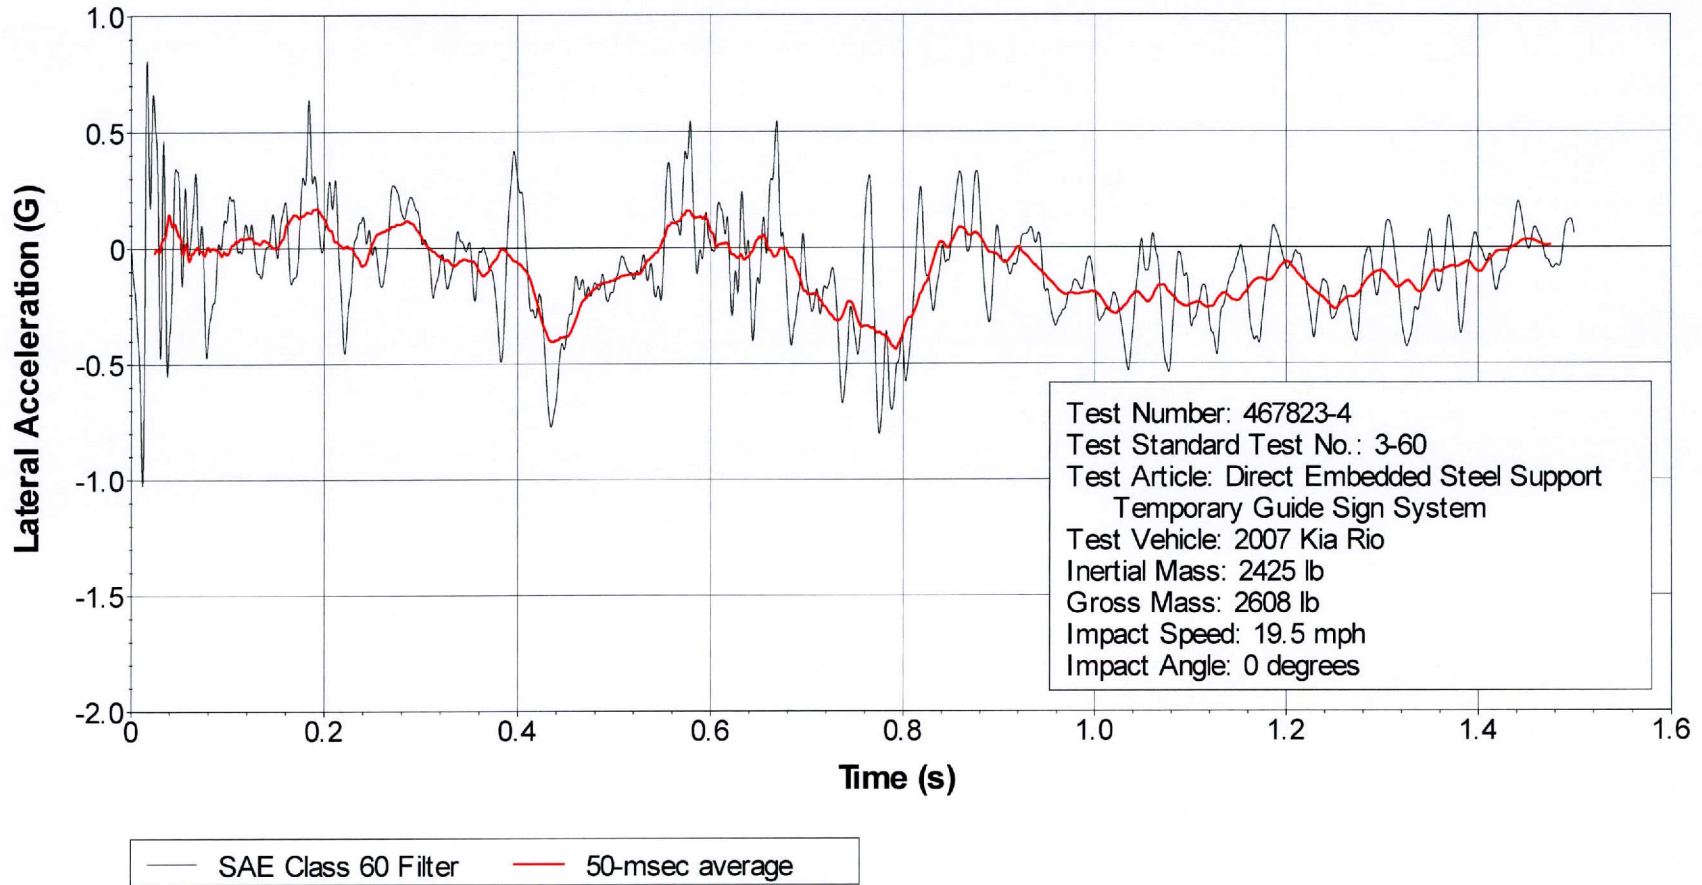
Figure H7. Vehicle Lateral Accelerometer Trace for Test No. 467823-4 (Accelerometer Located Rear of Center of Gravity).

Y Acceleration Rear of CG
