DEVELOPMENT AND EVALUATION OF A *MASH* TL-3 31-INCH W-BEAM MEDIAN BARRIER

Test Report 9-1002-12-8

TEXAS A&M TRANSPORTATION INSTITUTE
COLLEGE STATION, TEXAS

This project developed and evaluated a 31-inch tall W-beam median barrier that would meet the strength and safety performance criteria of *MASH* for TL-3 impact conditions.

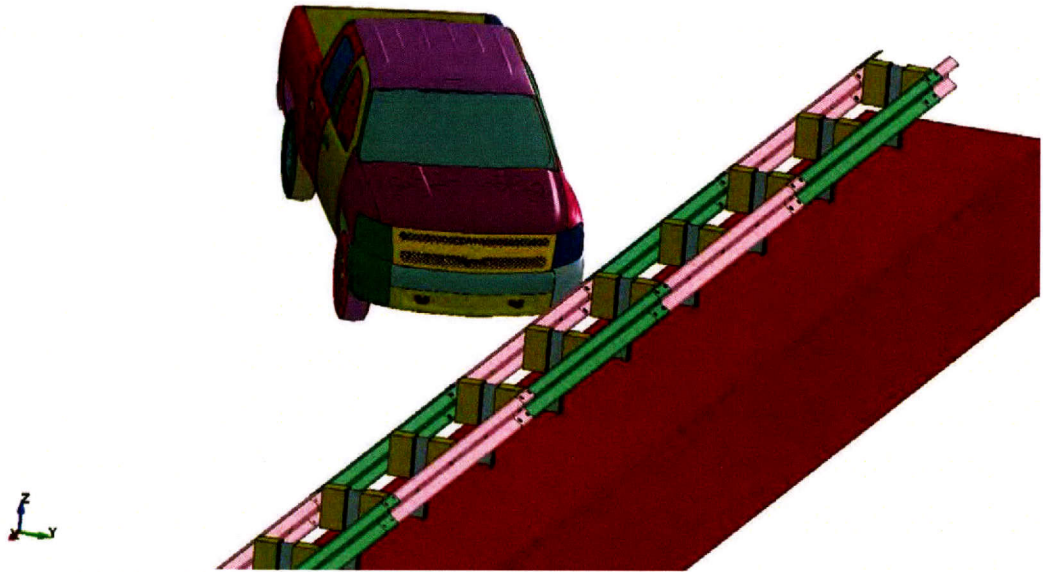
Figure 2.2. Finite Element Model of the 27-Inch Median Barrier.

The vehicle model used for simulation was the Chevrolet Silverado model, which was developed by NCAC. This vehicle model represents the *MASH* 2270P test vehicle. The finite element model for the *MASH* 1100C test vehicle was not available at the time this research was performed. Figure 2.2 shows the vehicle and 27-inch median W-beam barrier models.

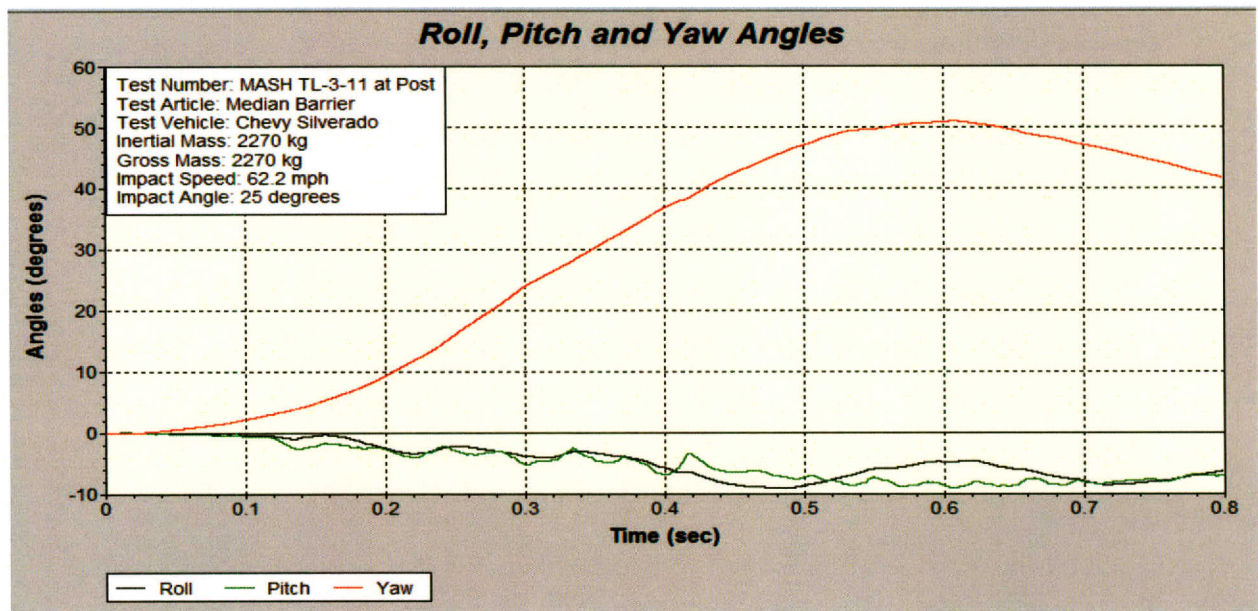
Figure 2.21. Roll, Pitch, and Yaw Angles for At-Post Impact.

Figure 2.21 provides the graph for angular displacements. A summary of results and sequential photos for this run are provided in Figure 2.22.

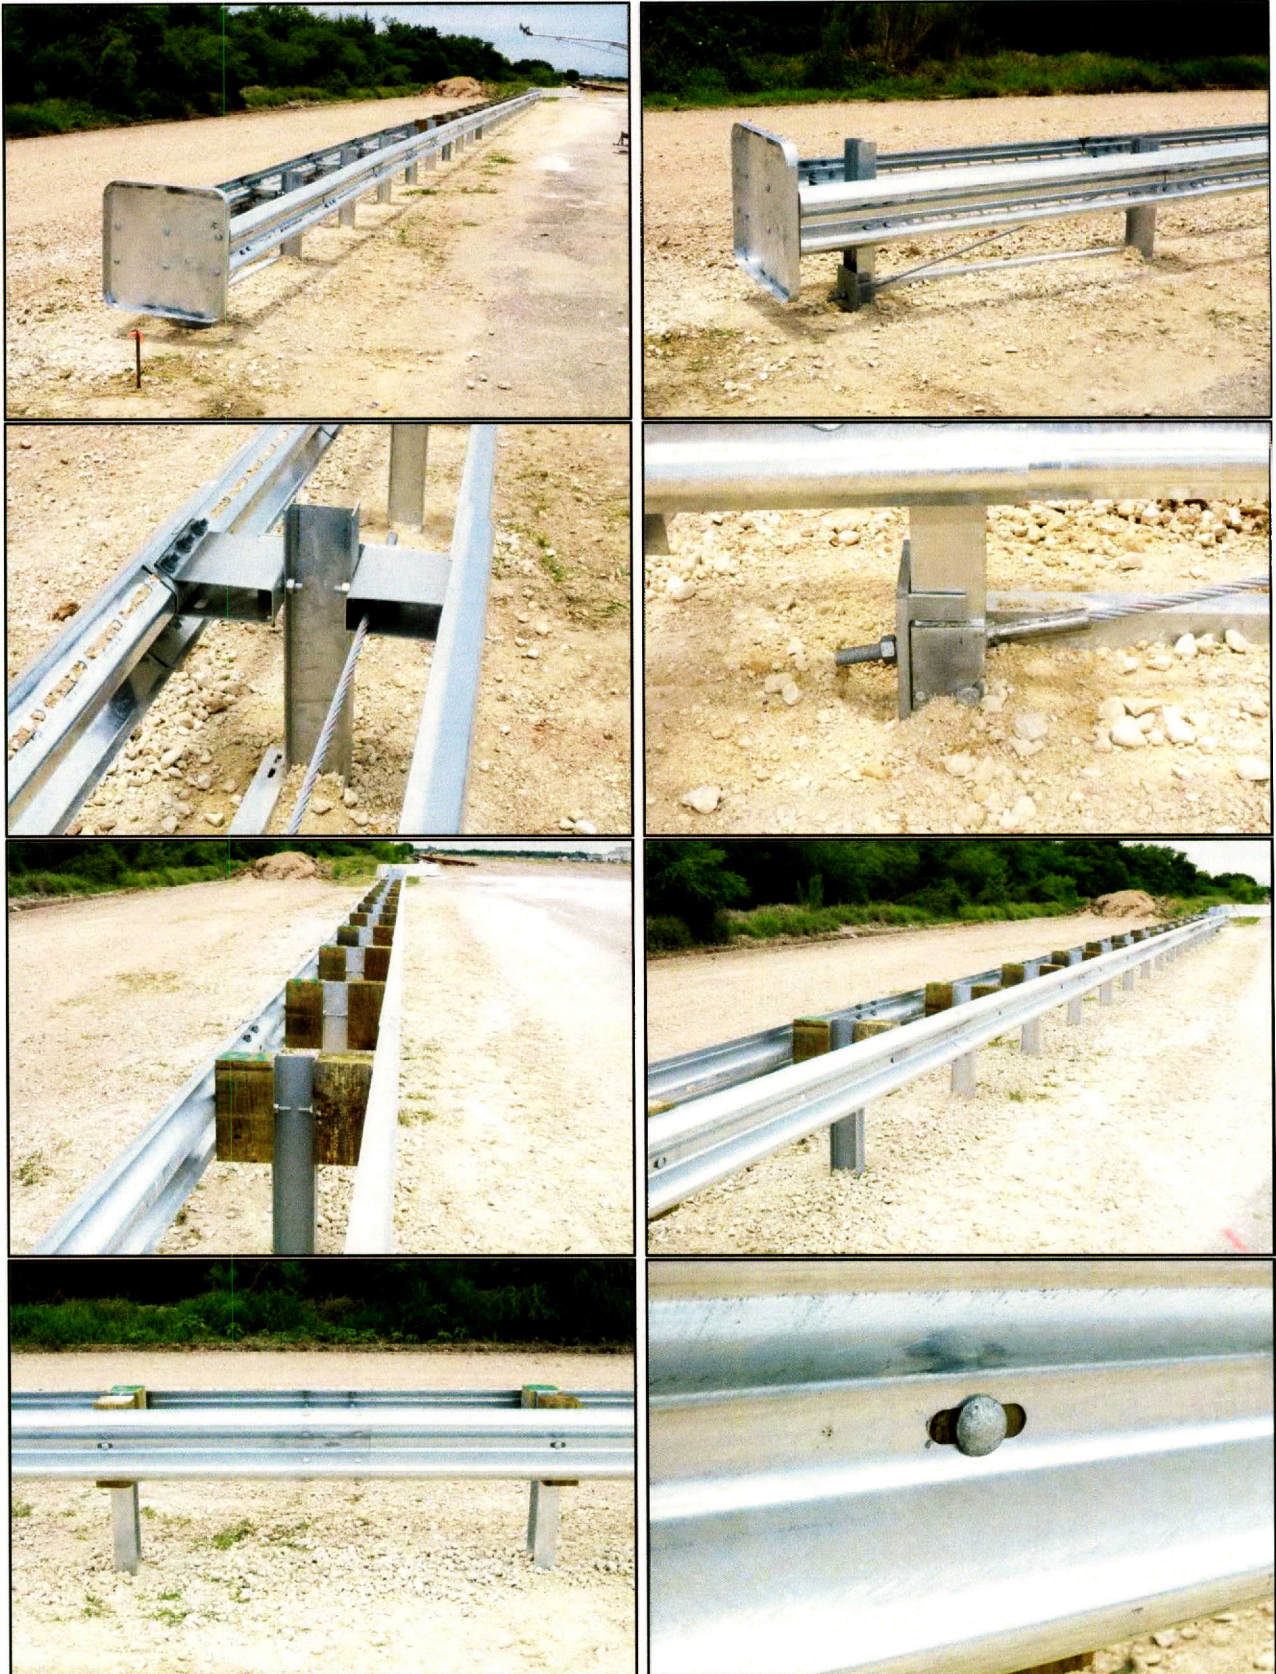
Figure 3.3. TxDOT 31-Inch W-Beam Median Barrier before Testing.

Figures 3.1 and 3.2 provide a layout and cross-section of the TxDOT 31-inch W-Beam Median Barrier. Photographs of the completed installation are shown in Figure 3.3. Appendix A presents more detailed information on the barrier.

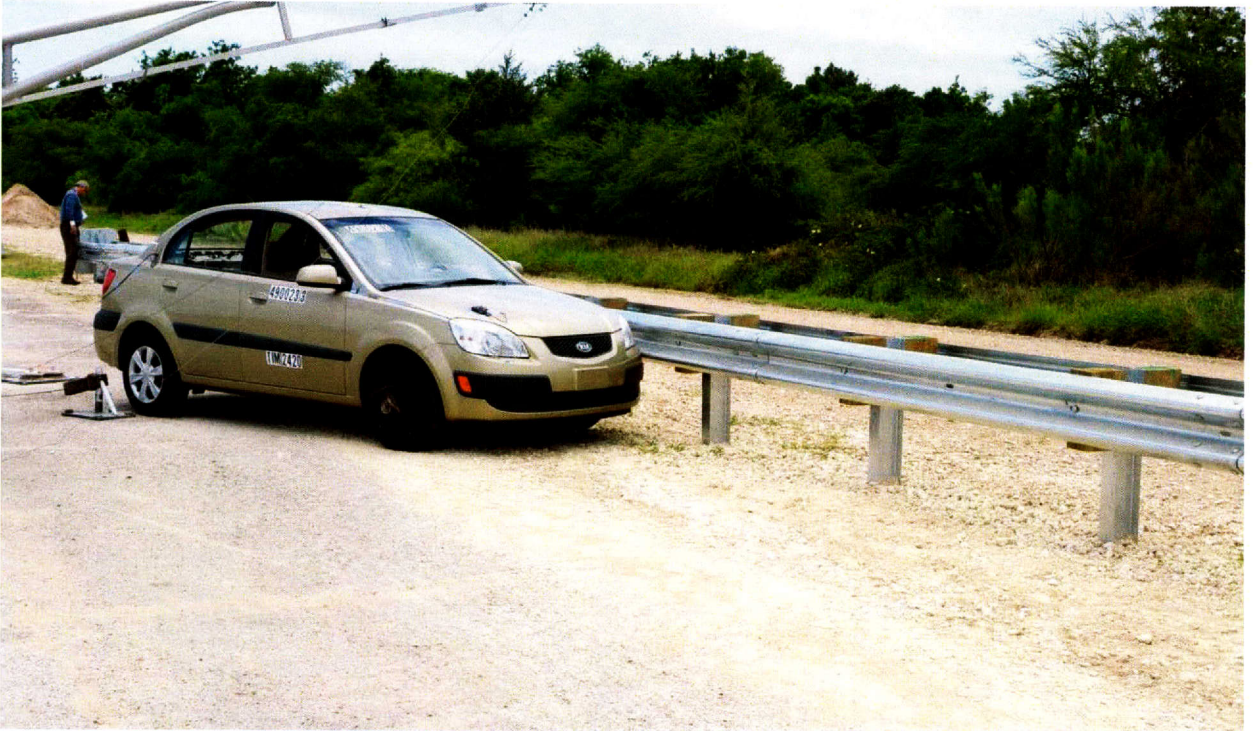
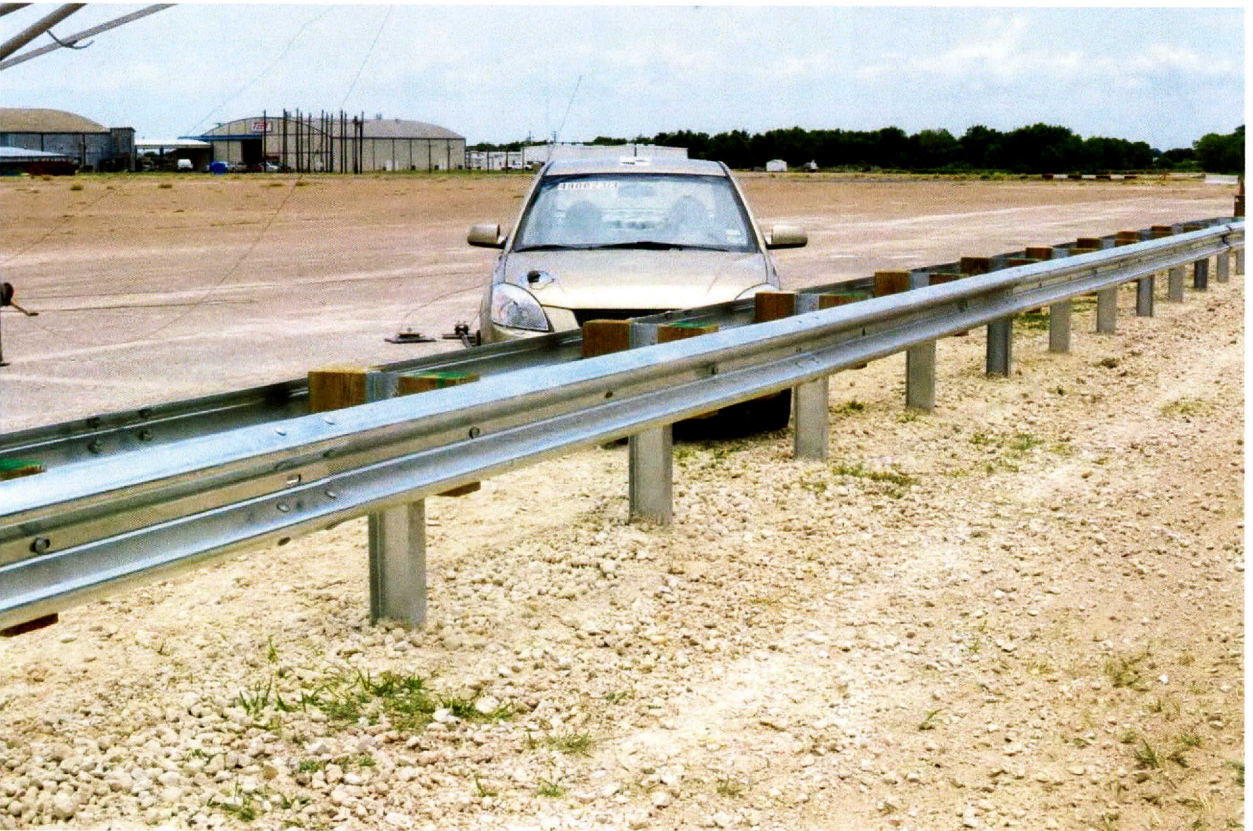
Figure 6.1. Vehicle/Installation Geometrics for Test No. 490023-3.

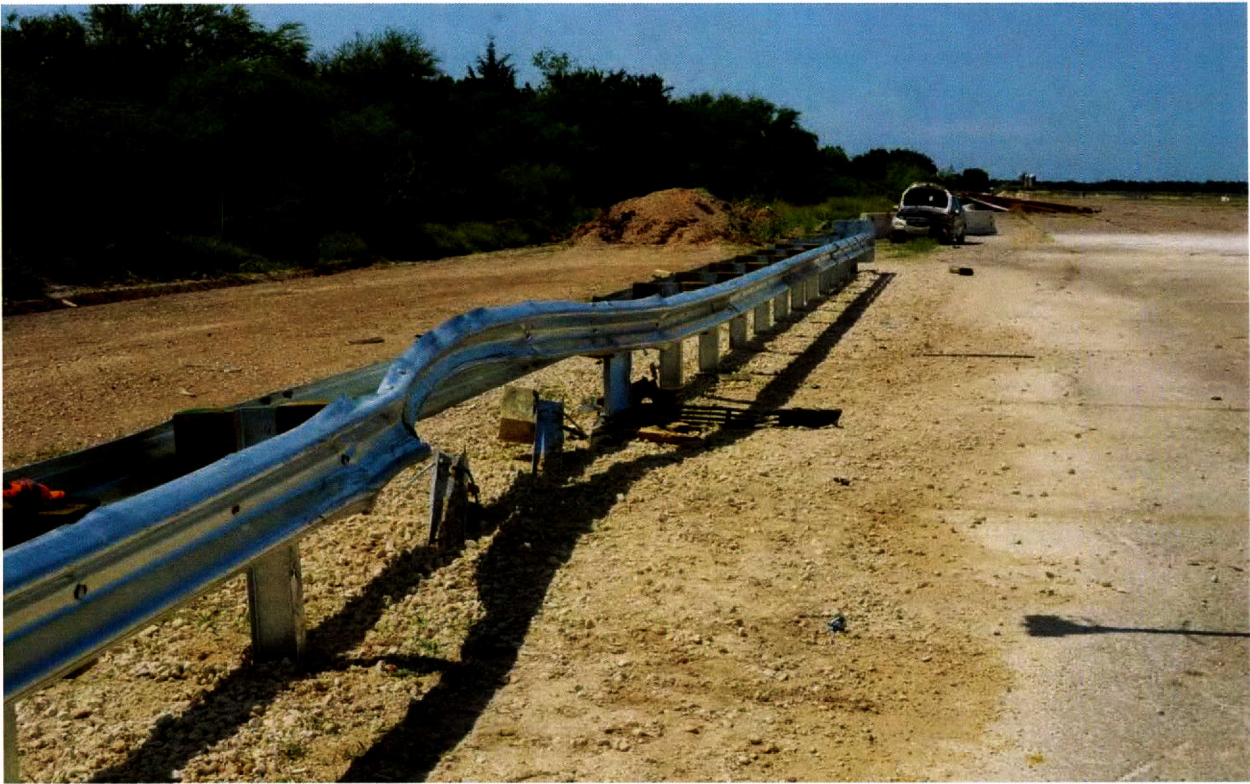
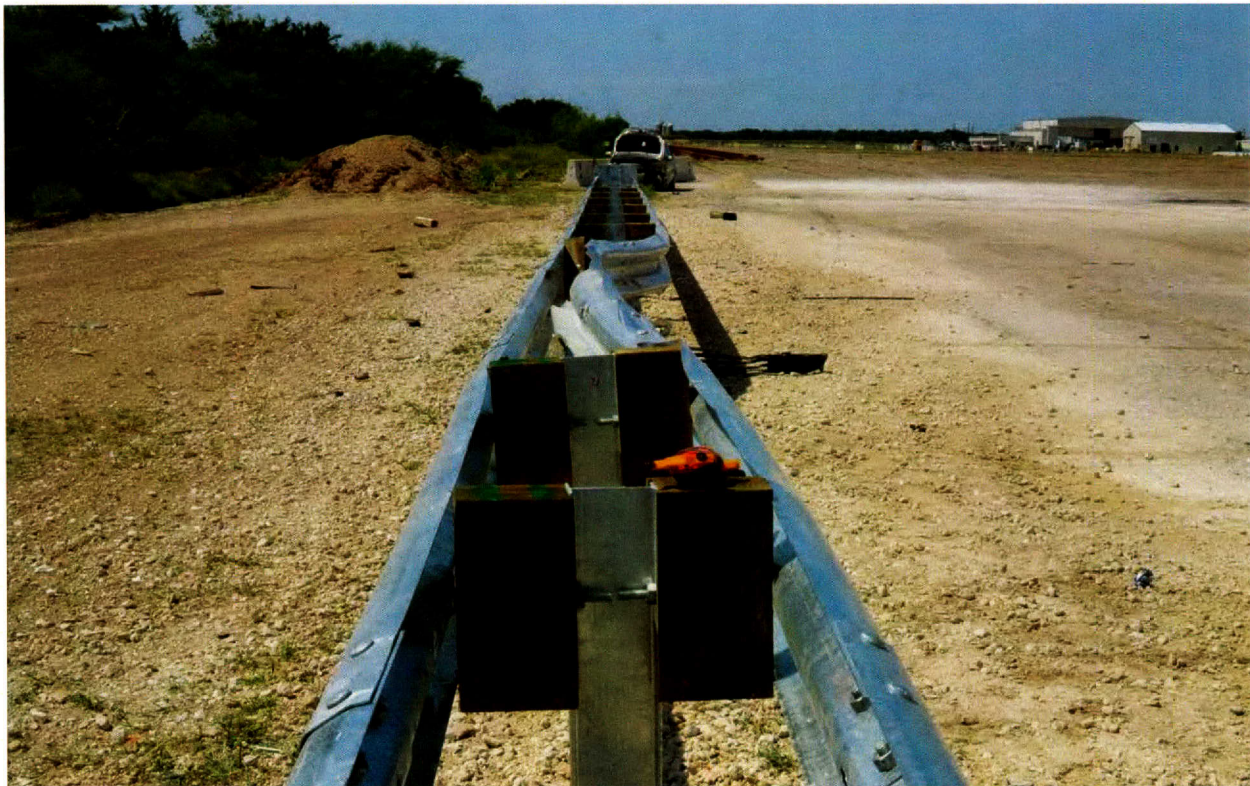
Figure 6.3. Vehicle/Installation Positions after Test No. 490023-3.

Figures 6.3 and 6.4 show damage to the TxDOT 31-inch W-Beam Median Barrier. No apparent movement was noted at post 1 or post 26 (the end posts). Post 11 and 12 were displaced through the soil toward the side opposite impact 0.25 inch and 1.75 inches, respectively. Posts 13 and 14 were leaning 70 degrees toward the side opposite impact and the rail element on the impact side separated from the posts. Both blockouts at post 13 separated from the post and the blockout on the side opposite impact separated from post 14. Post 15 rotated 45 degrees in the soil, the blockout on impact side separated from the post, and both rail elements separated from the post. The rail element on the impact side ruptured upward two-thirds of the width of the rail element at the upstream bolts on the splice between posts 12 and 13. The length of contact of the 1100C vehicle with the rail was 22.0 ft. Maximum permanent deformation of the rail was 20.25 inches between posts 13 and 14.

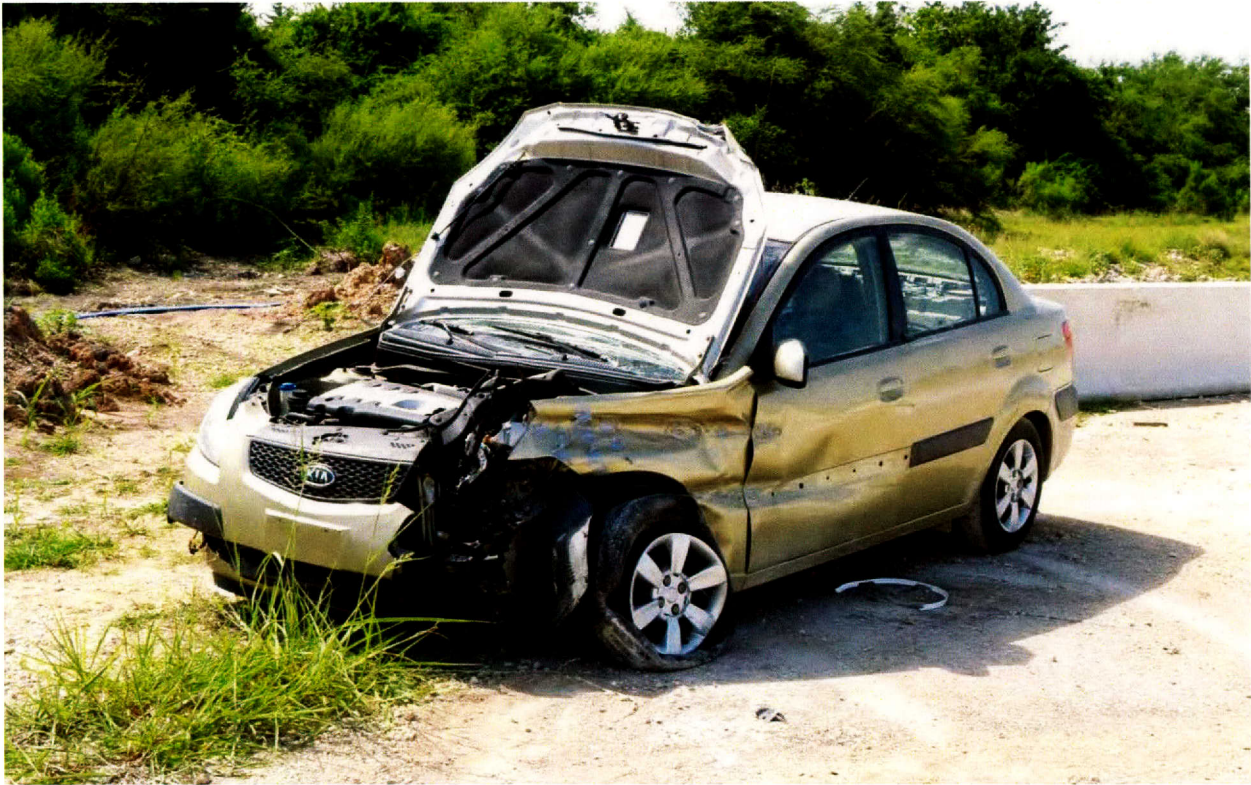
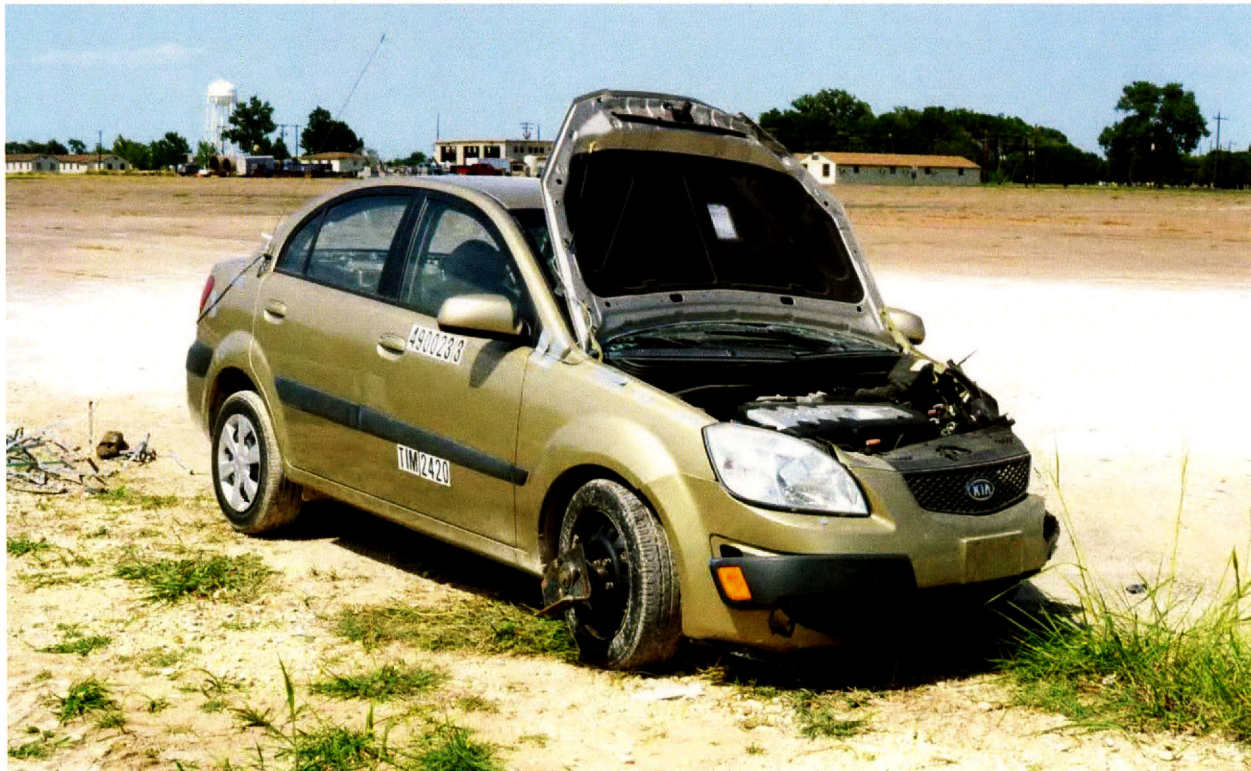
Figure 6.5. Vehicle after Test No. 490023-3.

Figure 6.5 shows damage to the 1100C vehicle. The front bumper, hood, radiator and support, left front strut and tower, left front tire and wheel rim, left front fender, and left front door were damaged. The hood was pushed into the windshield, which shattered the lower portion of the windshield. Maximum exterior crush to the 1100C vehicle was 13.0 inches in the side plane at the left front corner just above bumper height. No occupant compartment deformation was noted. Figure 6.6 provides photographs of the interior of the vehicle, and Tables D1 and D2 provide exterior and occupant compartment measurements.

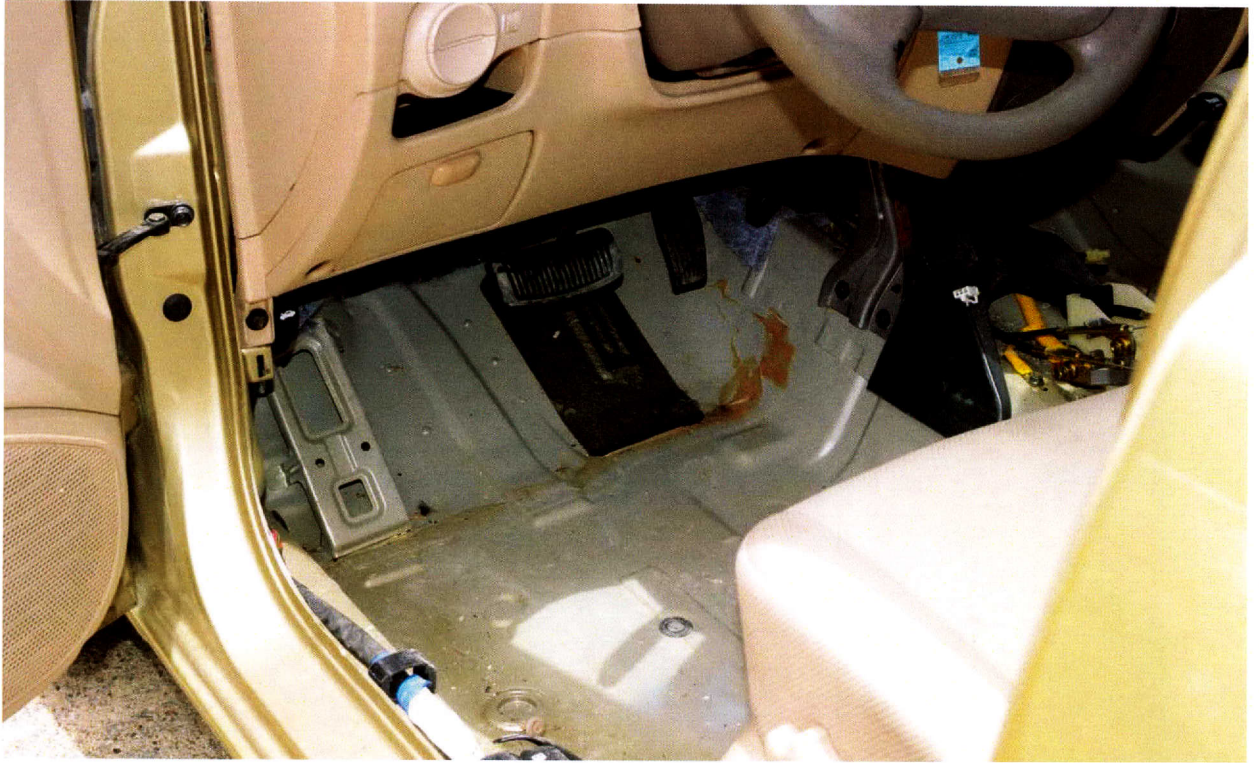
Figure 6.6. Interior of Vehicle for Test No. 490023-3.

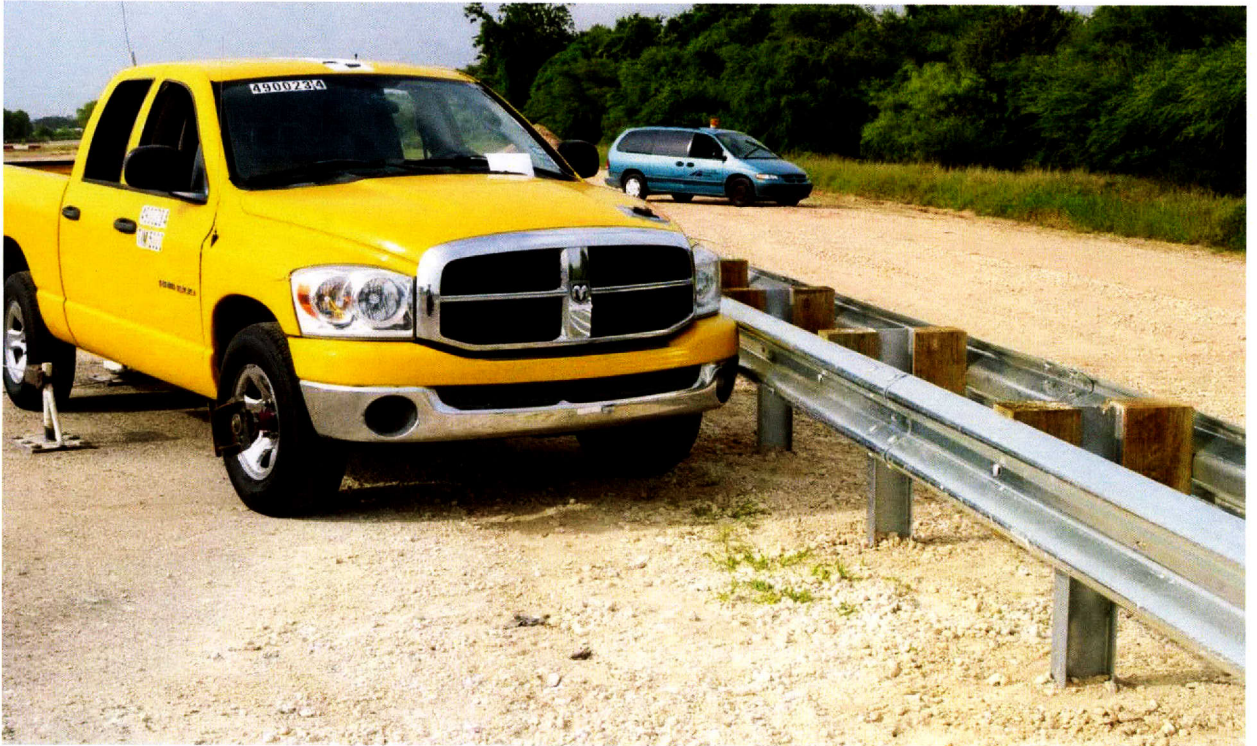
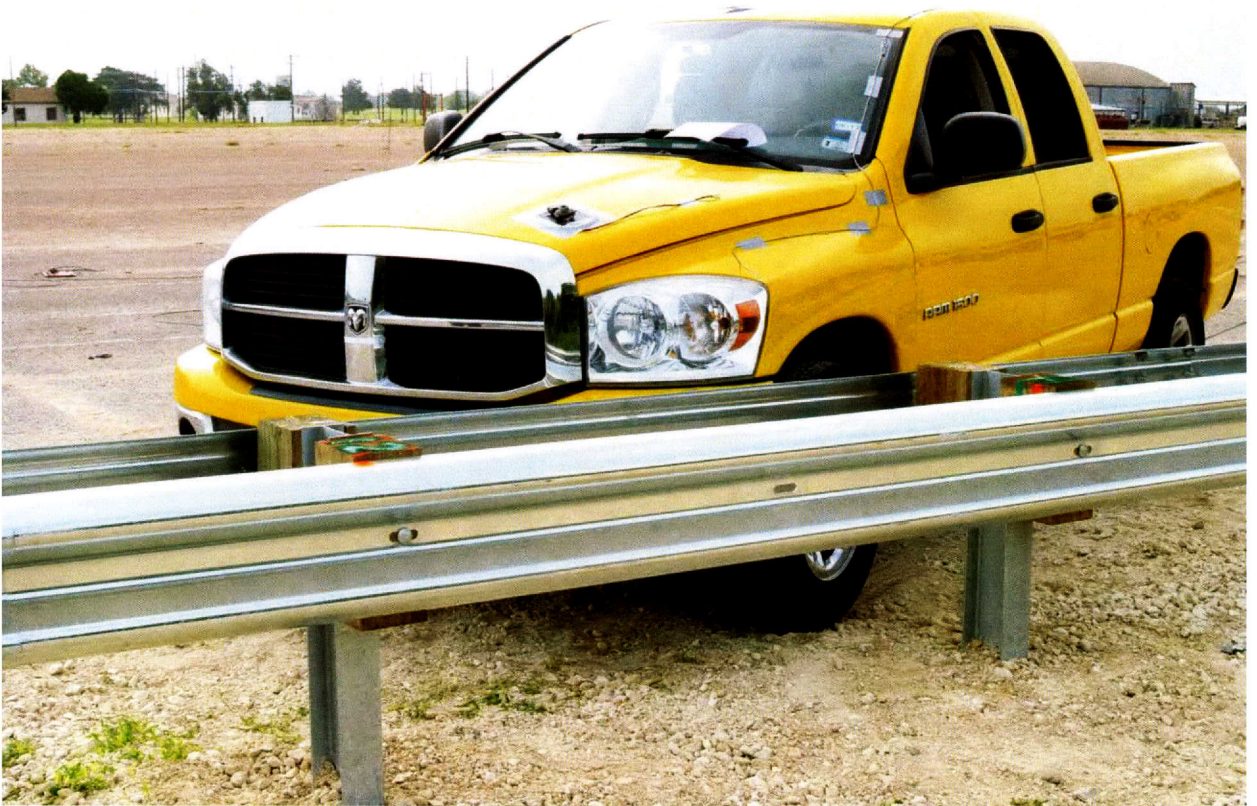
Figure 7.1. Vehicle/Installation Geometrics for Test No. 490023-4.

A 2007 Dodge Ram 1500 pickup truck, shown in Figures 7.1 and 7.2, was used for the crash test. Test inertia weight of the vehicle was 5014 lb, and its gross static weight was 5017 lb. The height to the lower edge of the vehicle bumper was 15.50 inches, and it was 28.00 inches to the upper edge of the bumper. The height to the vehicle's center of gravity was 28.50 inches. Tables E1 and E2 in Appendix E give additional dimensions and information on the vehicle. The vehicle was directed into the installation using the cable reverse tow and guidance system, and was released to be free-wheeling and unrestrained just prior to impact.

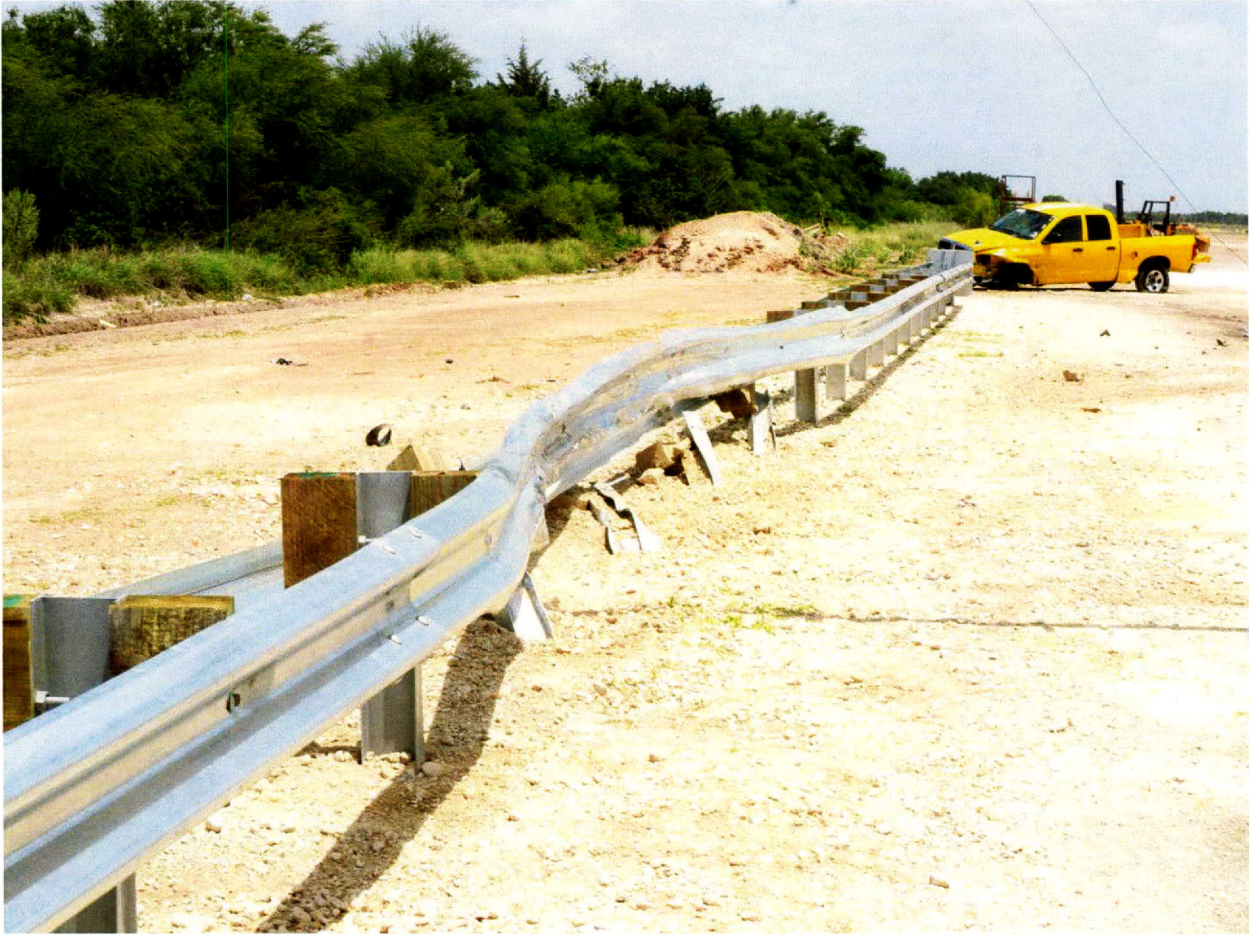
Figure 7.3. Vehicle/Installation Positions after Test No. 490023-4.

Figures 7.3 and 7.4 show damage to the TxDOT 31-inch W-Beam Median Barrier. Post 1 was displaced through the soil 0.5 inch at ground level on the upstream side, and no apparent movement was noted at post 26 (end posts). Posts 6 through 11 were slightly rotated, and post 11 was displaced through the soil 0.5 inch toward the side opposite impact. Post 12 was leaning downstream and toward the side opposite impact 45 degrees. Post 13 was leaning downstream 85 degrees and toward the side opposite impact 45 degrees. Posts 14 and 15 were leaning downstream 60 degrees. Post 16 was rotated slightly. The rail element on the impact side separated from posts 12 through 15, and the rail element on the side opposite impact released from posts 8 through 17. The blockouts on the impact side of posts 12 through 15 fractured and separated from the posts and rail element. The length of contact of the 2270P vehicle with the rail was 31.0 ft. Maximum permanent deformation of the rail was 29.5 inches between posts 13 and 14.

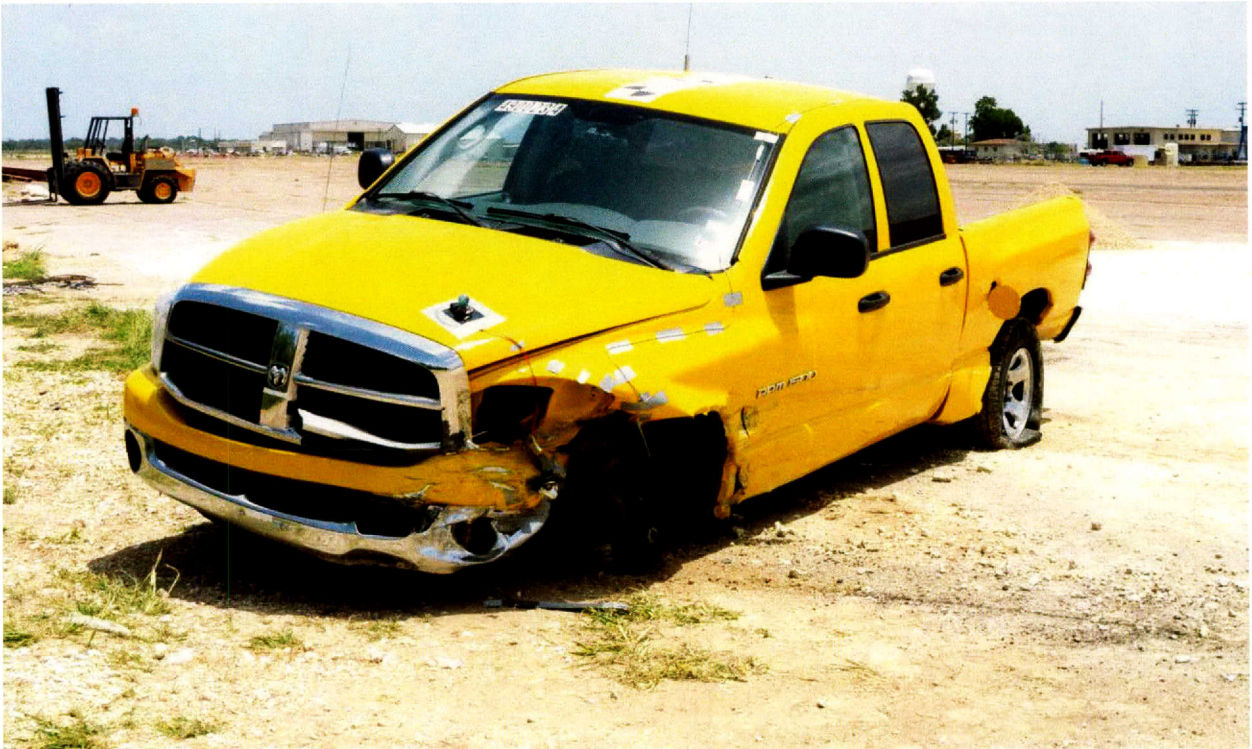
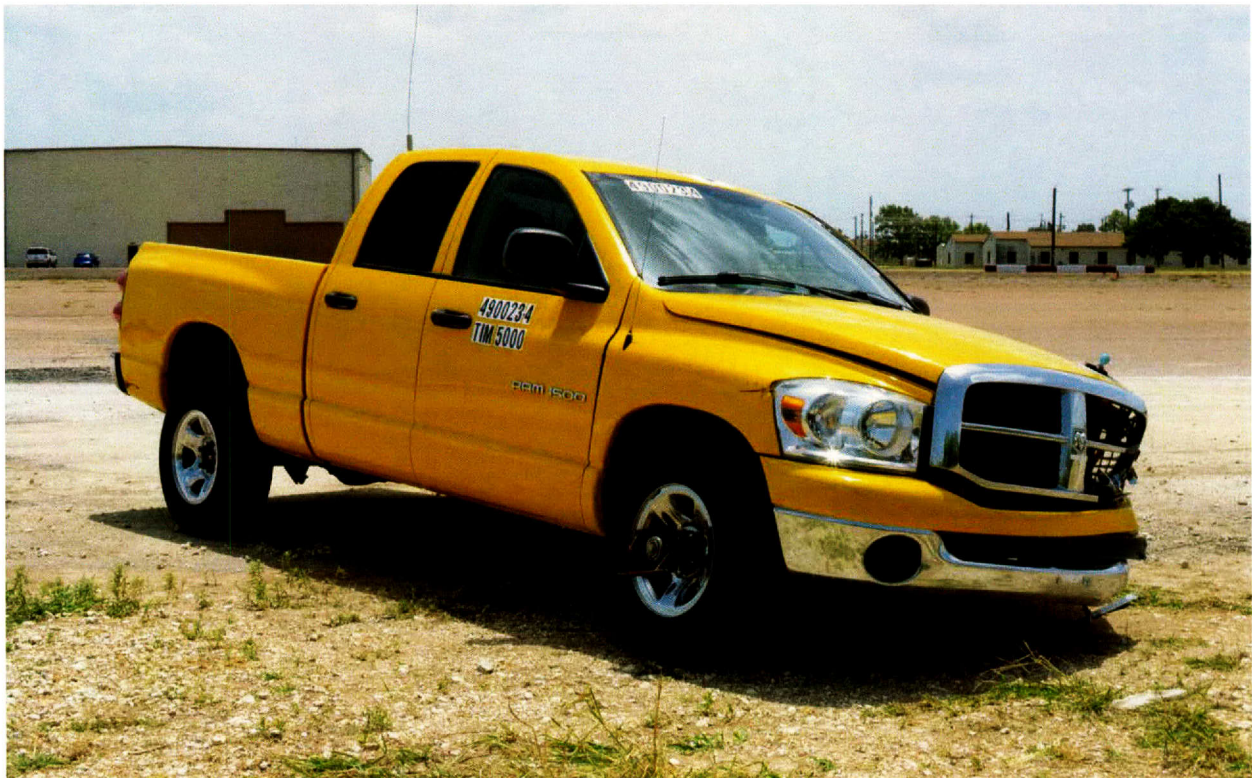
Figure 7.5. Vehicle after Test No. 490023-4.

Figure 7.5 shows damage to the 2270P vehicle. The left front tie rod, left front lower A-arm, left front frame rail, and left front hub assembly were deformed. Also damaged were the front bumper, grill, left front tire and wheel rim, left front fender, left front door, left rear door, left rear exterior bed, left rear tire, and rear bumper. Maximum exterior crush to the vehicle was 11.0 inches in the side plane at the left front corner just above bumper height. No occupant compartment deformation occurred. Figure 7.6 shows the interior of the vehicle before and after the test. Tables E3 and E3 in Appendix E present the measurements made on the vehicle.

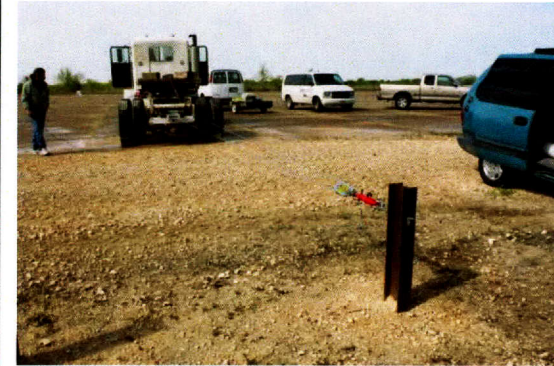
Static Load Setup

Table C2. Test Day Static Soil Strength Documentation for Test No. 490023-4.

Date.....	2013-06-18
Test Facility and Site Location	TTI Proving Ground – 3100 SH 47, Bryan, Tx
In Situ Soil Description (ASTM D2487)	Sandy gravel with silty fines
Fill Material Description (ASTM D2487) and sieve analysis	AASHTO Grade B Soil-Aggregate (see sieve analysis)
Description of Fill Placement Procedure	6-inch lifts tamped with a pneumatic compactor

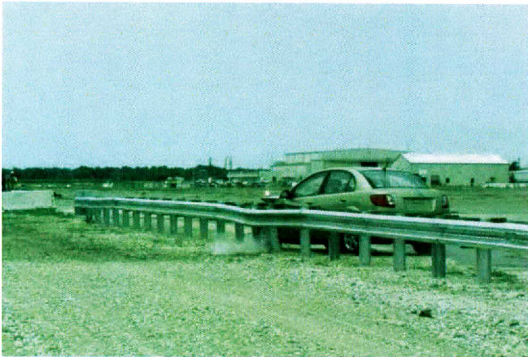
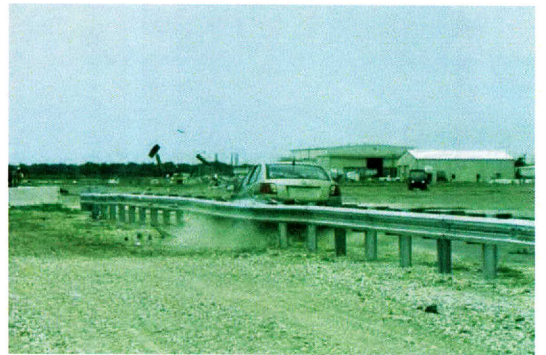
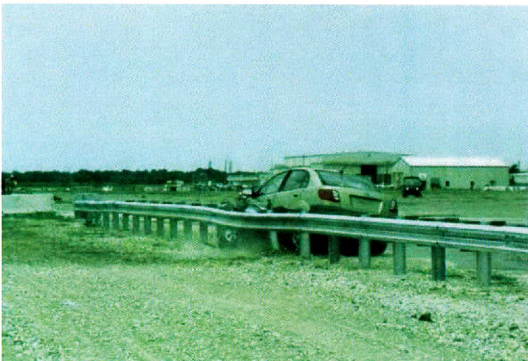
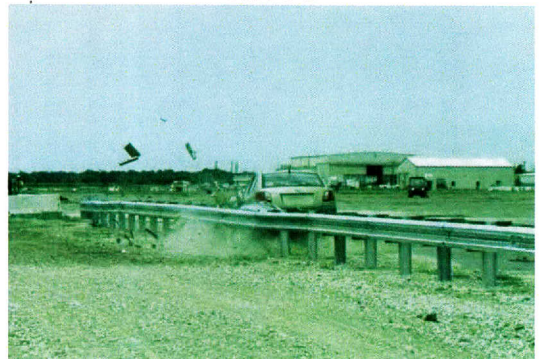
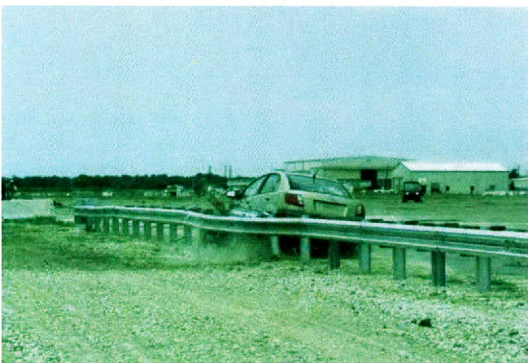
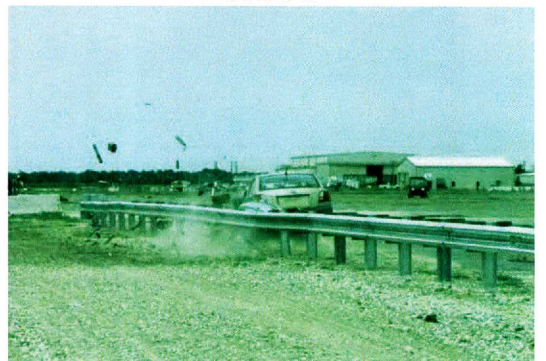
Figure D2. Sequential Photographs for Test No. 490023-3 (Rear View).

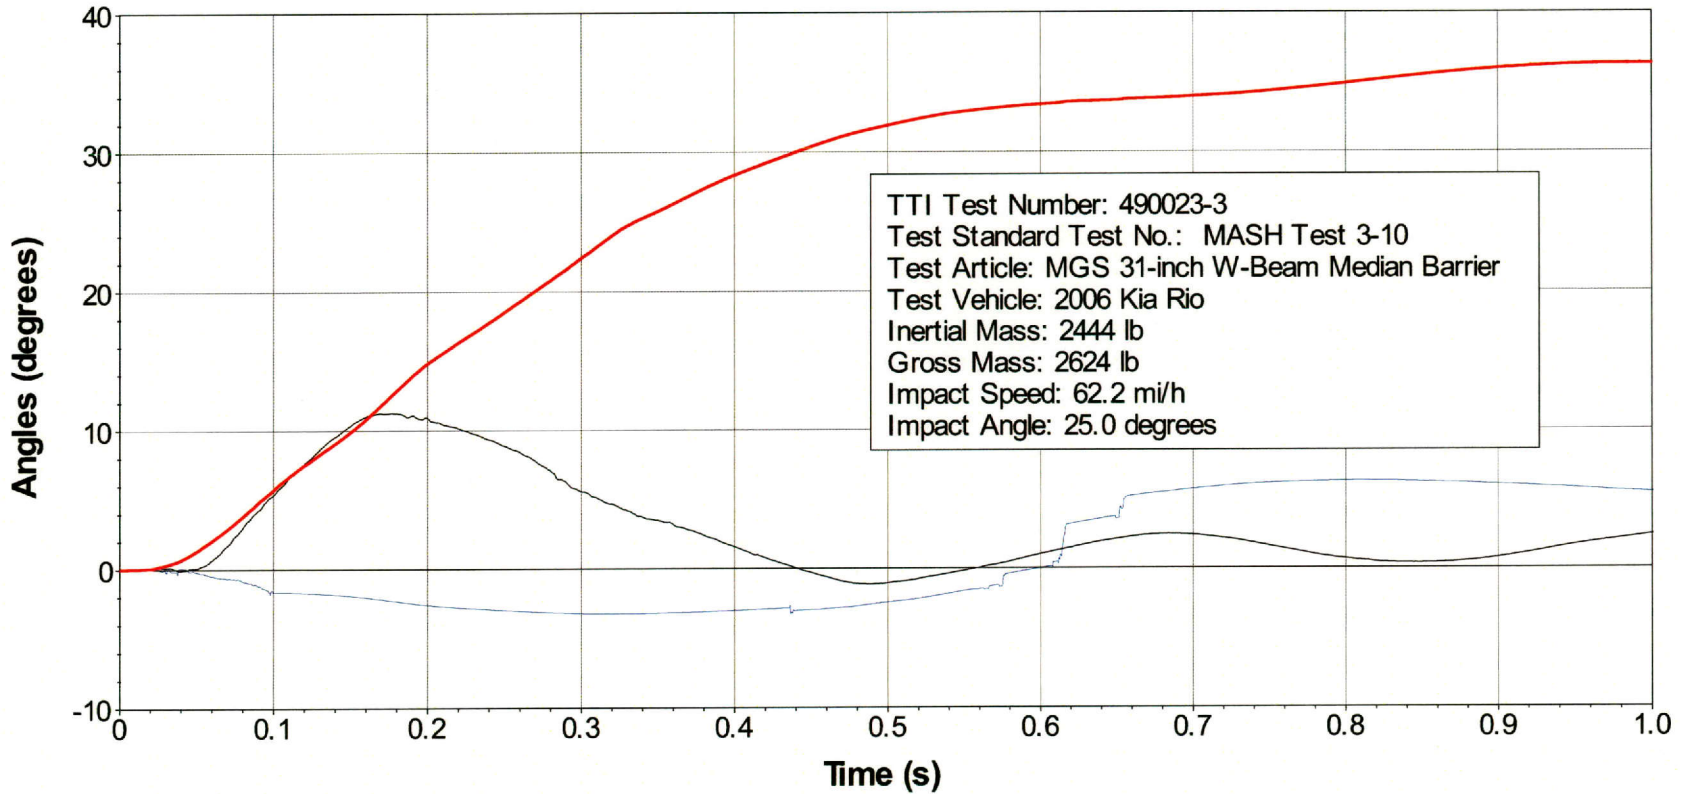
TTI Test Number: 490023-3
 Test Standard Test No.: MASH Test 3-10
 Test Article: MGS 31-inch W-Beam Median Barrier
 Test Vehicle: 2006 Kia Rio
 Inertial Mass: 2444 lb
 Gross Mass: 2624 lb
 Impact Speed: 62.2 mi/h
 Impact Angle: 25.0 degrees

Figure D3. Vehicle Angular Displacements for Test No. 490023-3.

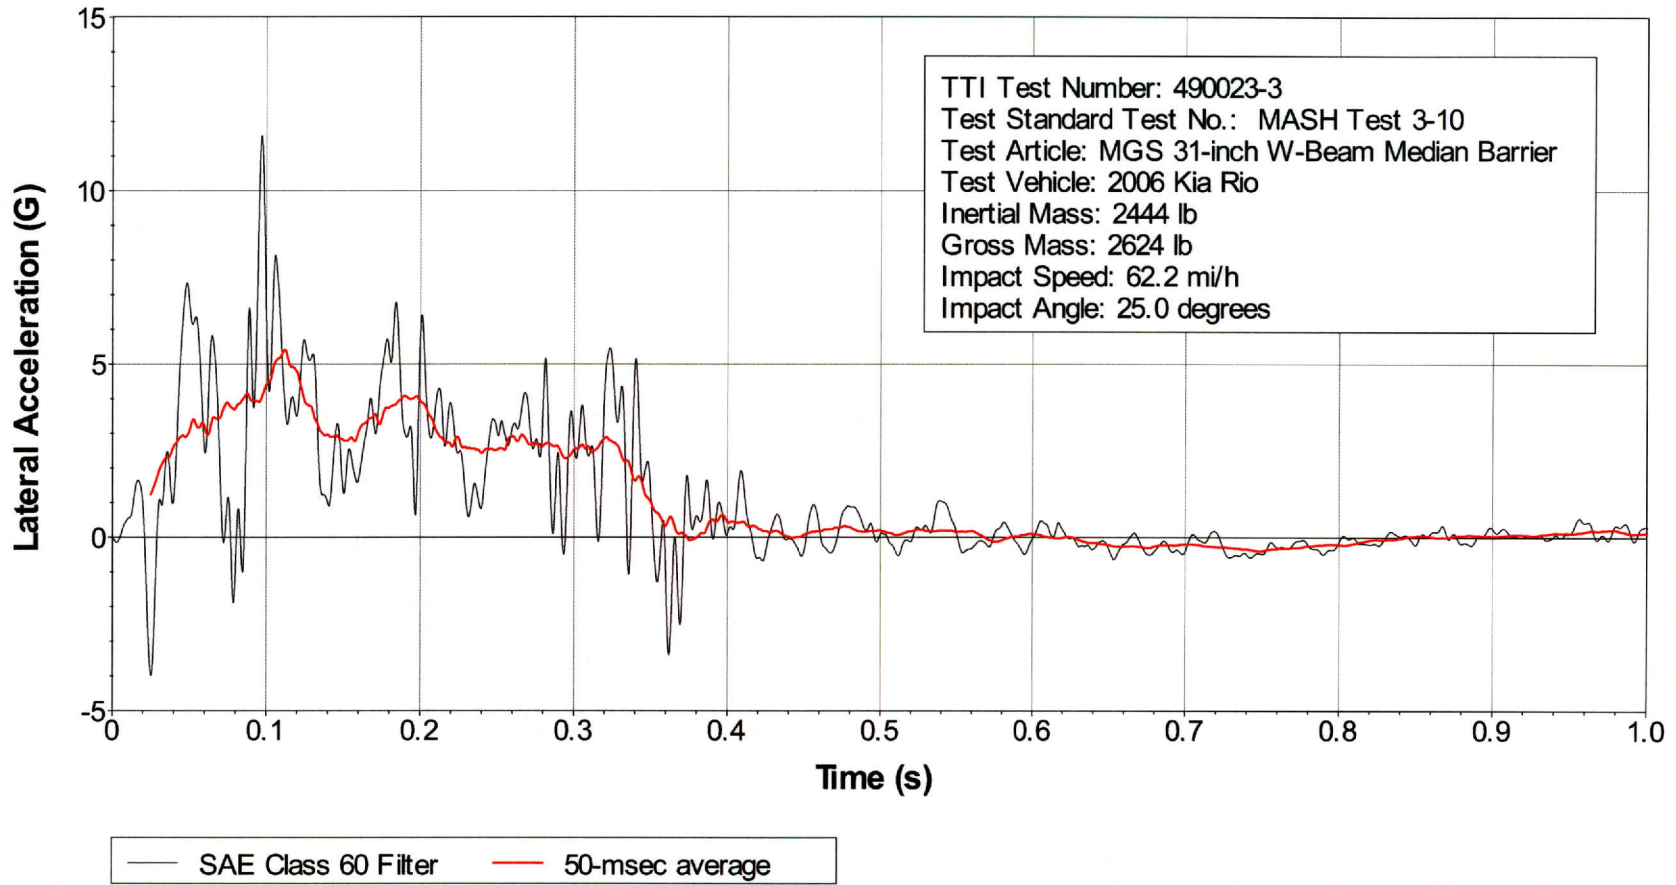
Figure D8. Vehicle Lateral Accelerometer Trace for Test No. 490023-3 (Accelerometer Located Rear of Center of Gravity).

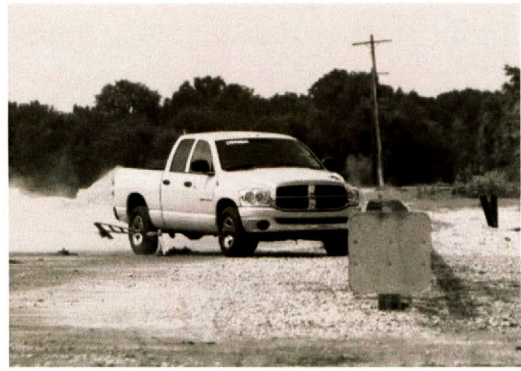
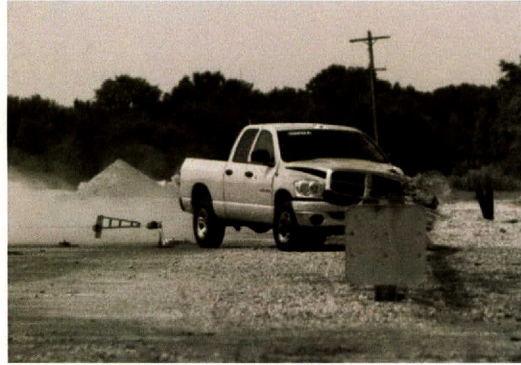
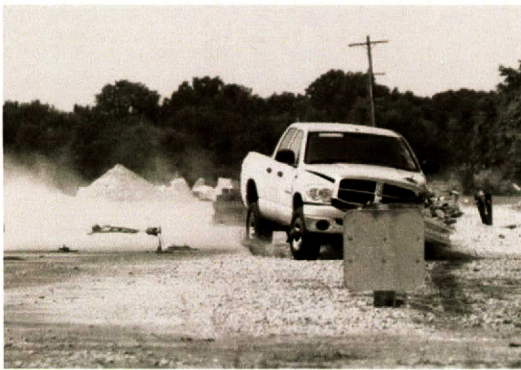
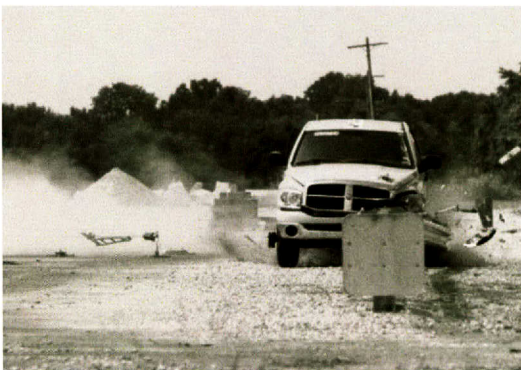
Figure E1. Sequential Photographs for Test No. 490023-4 (Overhead and Frontal Views).

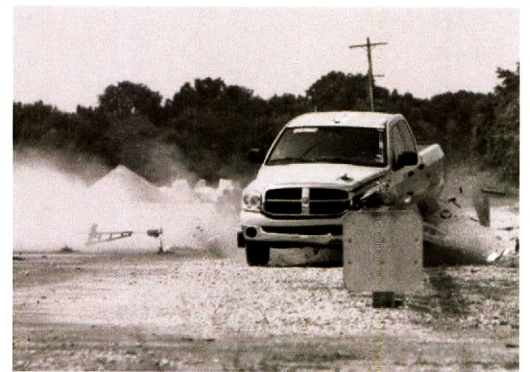
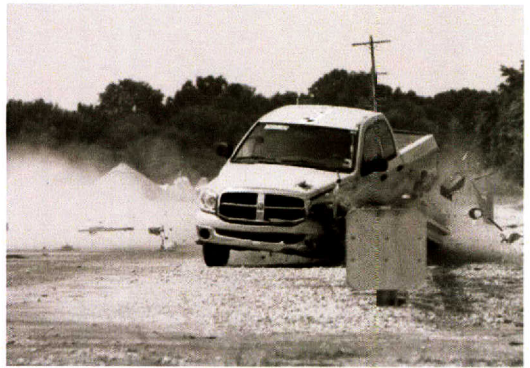
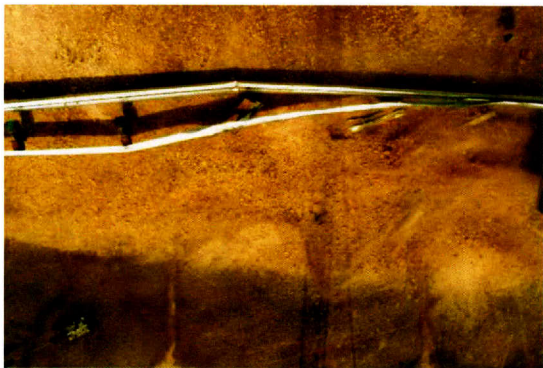
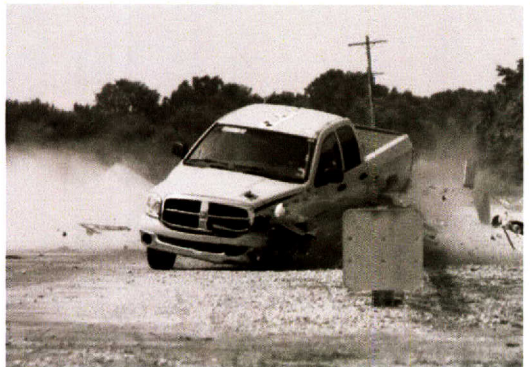
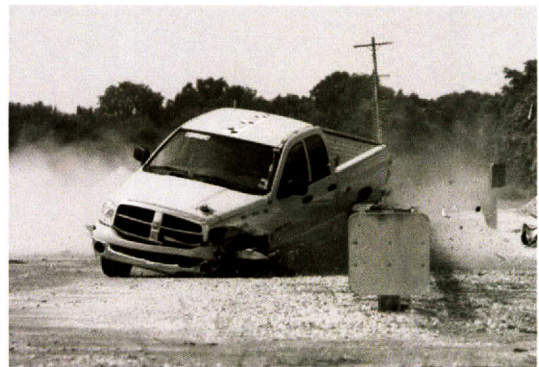
Figure E1. Sequential Photographs for Test No. 490023-4 (Overhead and Frontal Views) (continued).
