DEVELOPMENT AND EVALUATION OF A *MASH* TL-3 31-INCH W-BEAM MEDIAN BARRIER

Test Report 9-1002-12-8

TEXAS A&M TRANSPORTATION INSTITUTE
COLLEGE STATION, TEXAS

This project developed and evaluated a 31-inch tall W-beam median barrier that would meet the strength and safety performance criteria of *MASH* for TL-3 impact conditions.

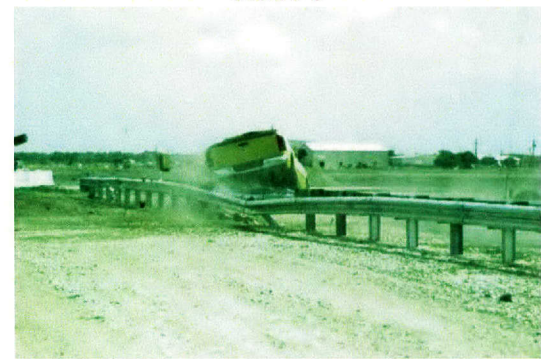
Figure E2. Sequential Photographs for Test No. 490023-4 (Rear View).
