# Improved Business Driveway Delineation in Urban Work Zones

Technical Report 0-6781-1

TEXAS A&M TRANSPORTATION INSTITUTE  
COLLEGE STATION, TEXAS

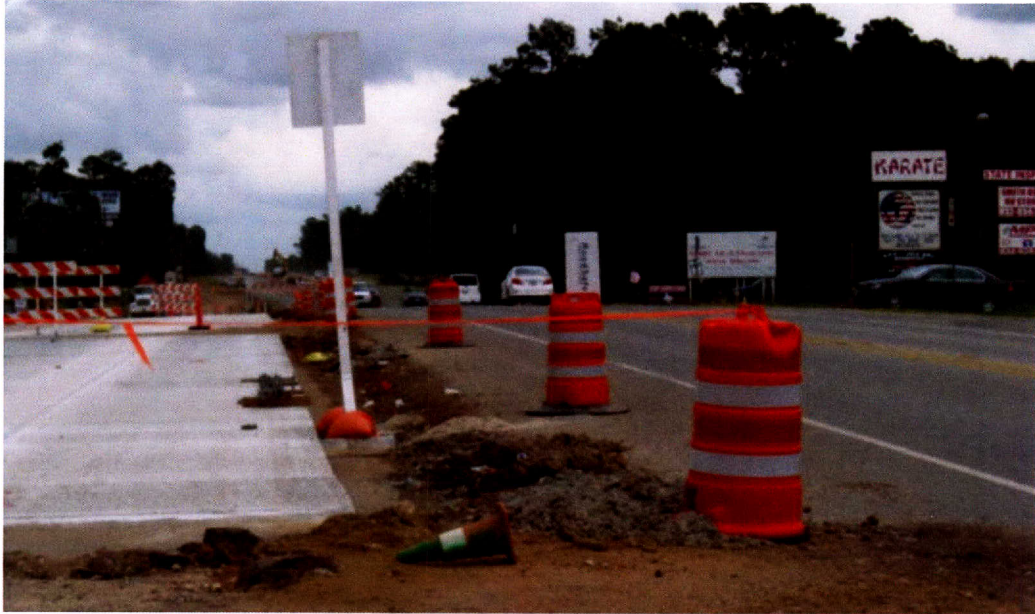
**Figure 2. Driver's View from a Passenger Car in a Driveway in a Texas Work Zone (3).**

Drums are the most common type of driveway delineation used in TxDOT work zones. Figure 2 shows a driver's view from a business driveway in a Texas work zone. In this case, the driver is able to look between the channelizing drums to see approaching traffic, but one can easily see that a closer spacing of these large channelizing drums in the vicinity of a business driveway may create negative impacts that far outweigh any improved delineation benefit.

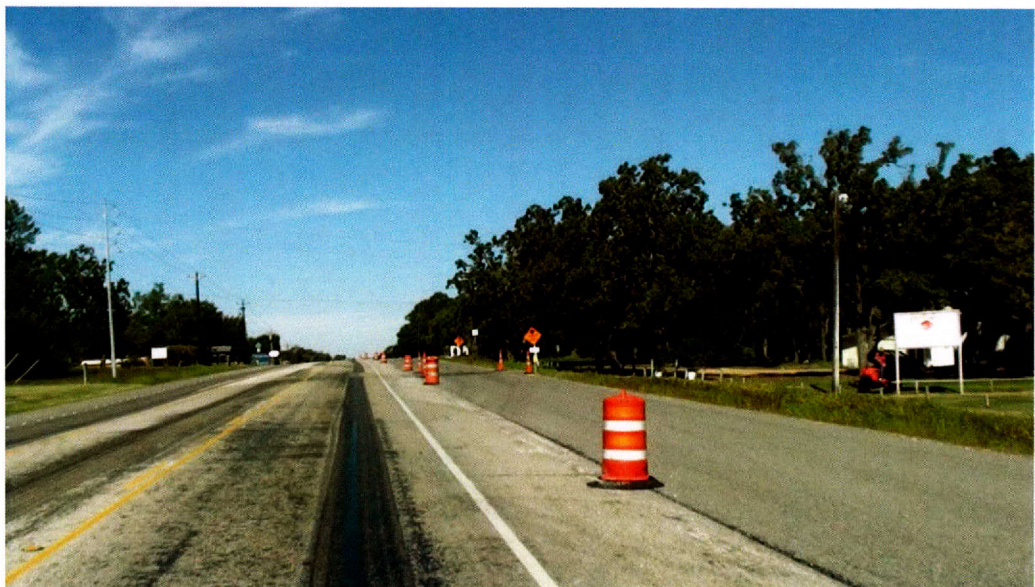
**Figure 3. Single Driveway with 42-Inch Tall Cones in a Rural Area.**

Depending upon the type, location, and duration of the work, many work zone driveways have no delineation and motorists simply select a gap in the main lane channelizing devices and turn into the business driveway. In other cases, the radii of the work zone driveways may be delineated with channelizing devices. Figure 3 shows 42-inch tall cones delineating a single driveway in a rural setting. In this scenario, the driveway is visible from a considerable distance.

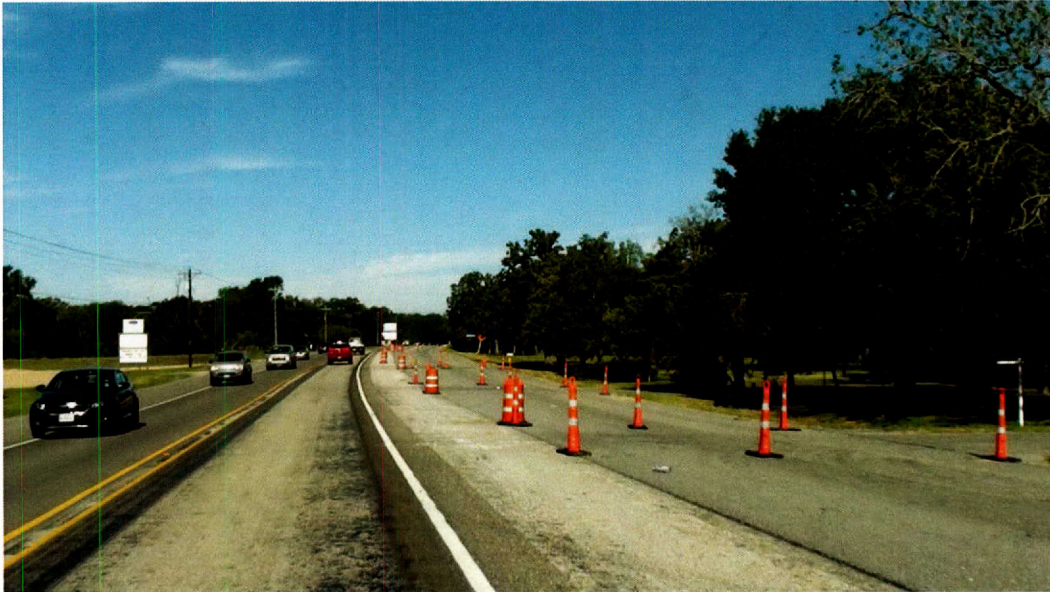
**Figure 4. Multiple Driveways with 42-Inch Tall Cones in a Rural Area.**

Figure 4 shows the same work zone driveway delineation treatment at several closely-spaced driveways. In this case, the 42-inch tall cones appear somewhat scattered and the proper turning gap may be more difficult to select, even in a rural area.

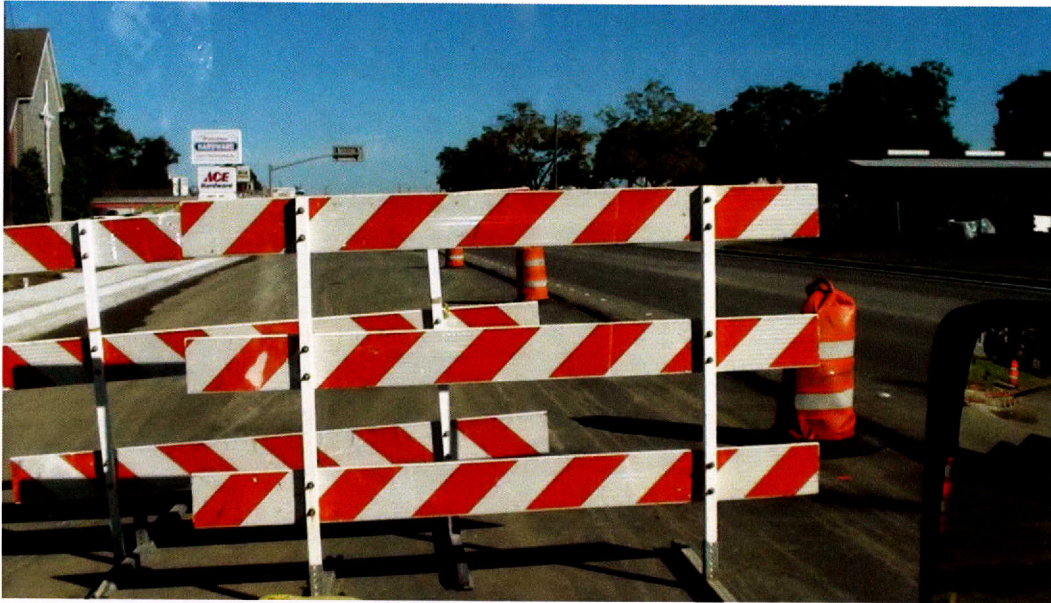
**Figure 5. Type 3 Barricades in a Texas Work Zone.**

Type 1 and type 3 barricades are frequently used in work zones for delineating business driveways. In addition to delineating, these devices are also used for closing roadways and serve to close off the portion of the roadway where driving is prohibited. Figure 5 shows type 3 barricades alongside a business driveway in a work zone from the perspective of a driver exiting the driveway. The primary concern of using type 3 barricades in this application is that they can block the view of oncoming traffic for motorists exiting the driveway.

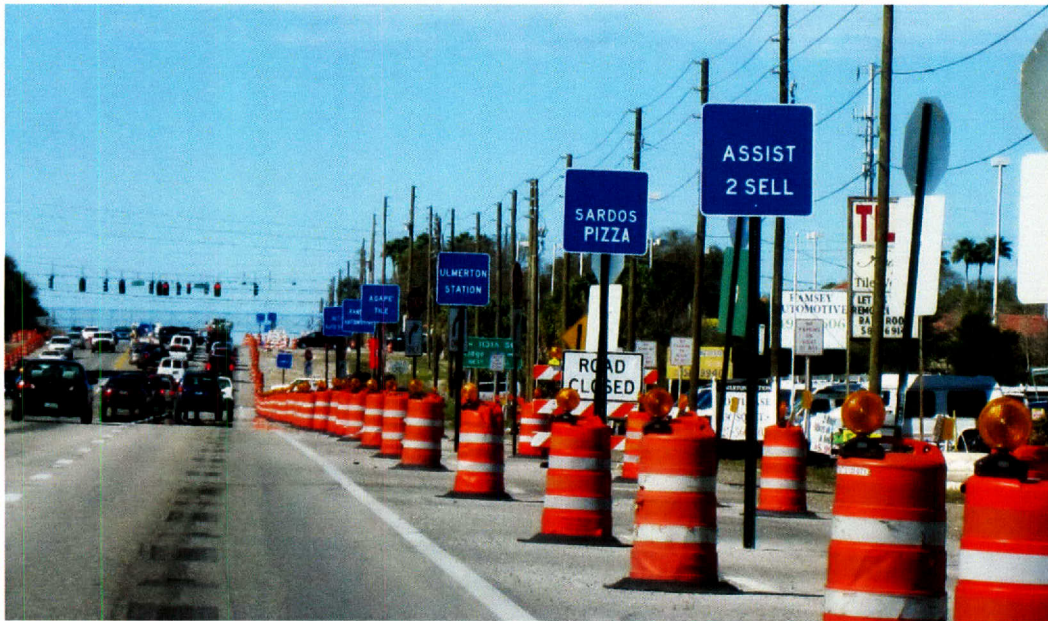
**Figure 7. Blue Driveway Signs in a Florida Work Zone.**

a cluttered and confusing appearance. Figure 7 shows similar signs in an urban work zone in Florida.

The effectiveness of these signs in terms of affecting driveway detection and turning behavior has not been researched. The researchers found inconsistent placement of these signs with respect to the driveway location in various work zones. The use of driveway signs results in an additional expense to TxDOT and the contractor; however, they are popular with local businesses.

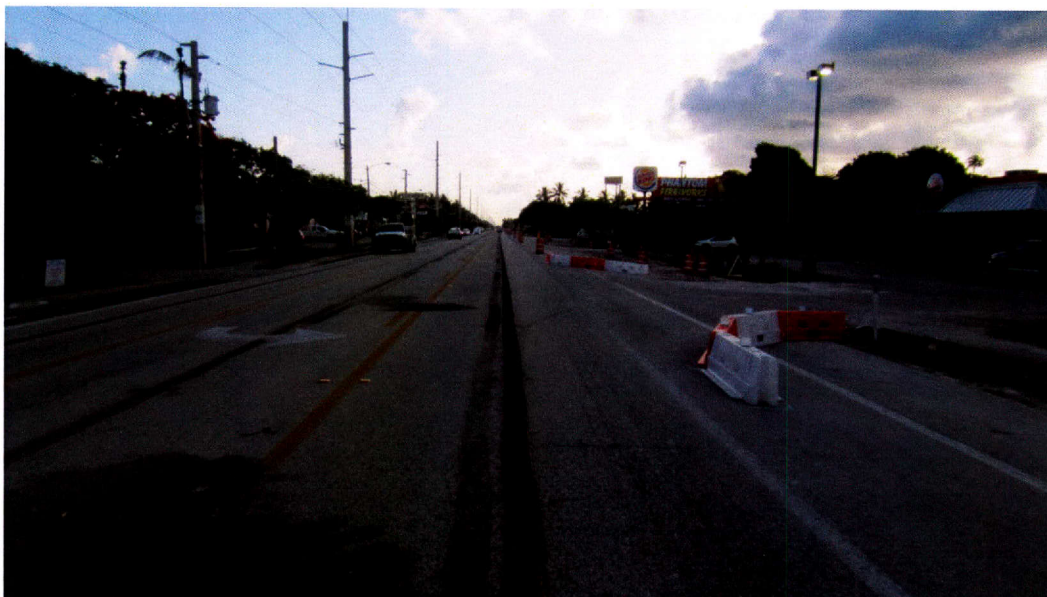
**Figure 8. Example Application of Low-Profile LCDs for Driveway Delineation.**

shows an example application of LCDs used for driveway delineation. This particular device was chosen because (a) it is only 18 inches in height and should not create sight distance restrictions, and (b) when connected together, the LCDs form a continuous line to improve positive guidance. The results of this research have not yet been published.

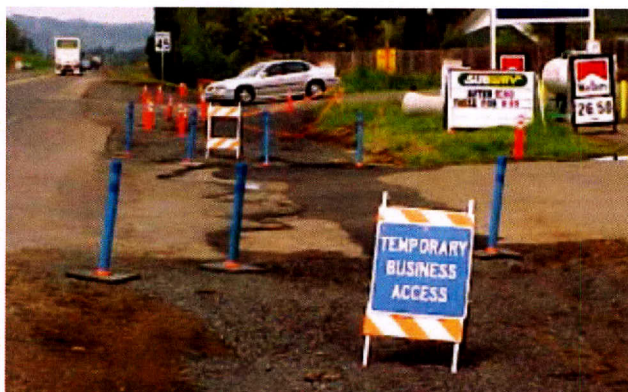
**Figure 10. Blue Delineation of Business Driveway in Oregon.**

work zone, while another work zone had the signs alone (without tubular markers). Figure 10 shows one of the driveways studied.

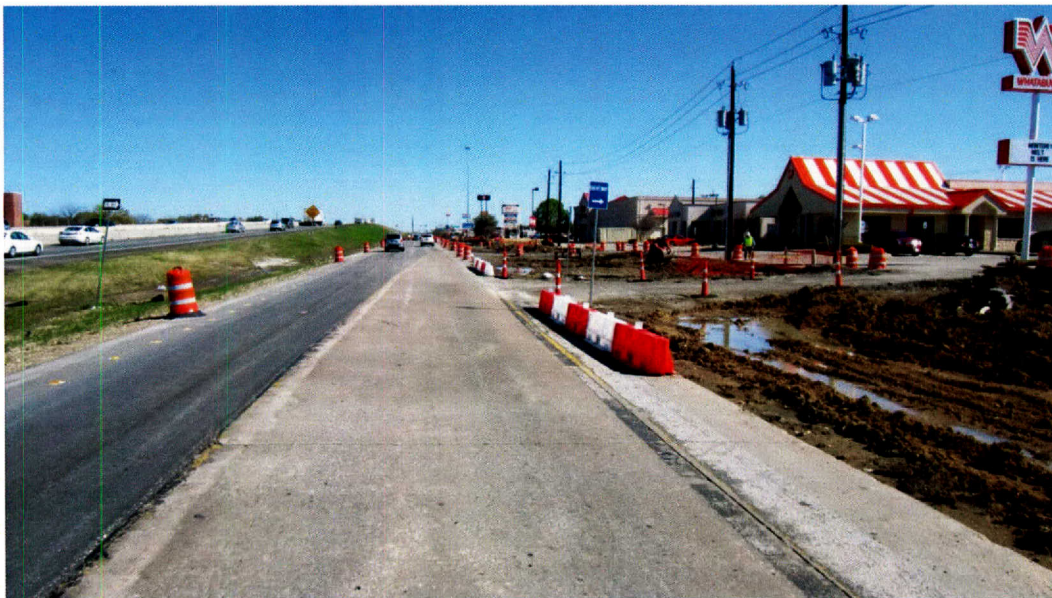
**Figure 14. Treatment F1.**

Treatment F1 consisted of 18-inch tall LCDs on the main lane with 42-inch tall cones on the driveway radii. Treatment F2 consisted of 42-inch tall cones on the main lane and 18-inch tall LCDs on the driveway radii. Treatment F3 consisted of 36-inch tall drums on both the main lane and the driveway radii. Treatment F3 is considered the standard driveway delineation technique that is widely used in TxDOT work zones.

The three treatments recommended for evaluation during the field evaluation are shown in Figure 14 through Figure 16. The F in the treatment number denotes a treatment used in the field study. The field evaluation consisted of a driver eye-tracking study, video observations of traffic operations at the driveway treatments, and interviews with owners, managers, and employees of businesses located near the driveway treatments.

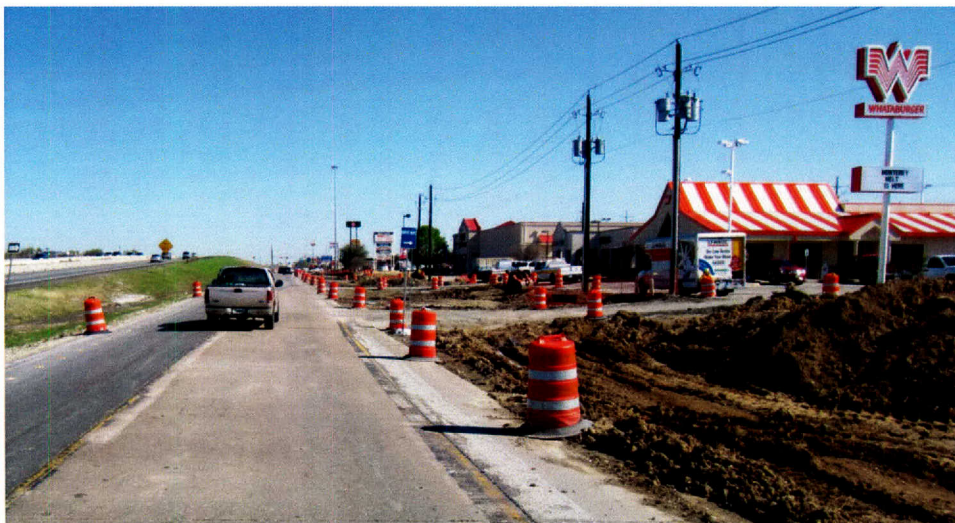
**Figure 17. Typical Work Zone Setup at McKinney Driveways.**

The purpose of the driver eye-tracking study was to determine how drivers respond to the different treatments with regard to their visual attention. This study was performed at two different locations. During the weeks of March 18, 2014, and April 7, 2014, the researchers used the work zone located on US 75 in McKinney, Texas. At this work zone, the northbound frontage road had a mixture of low profile barrier and drums in different segments. In the segment located from Rockhill Road to University Drive (US 380), the right lane was closed and several business driveways were located within the closure, including numerous restaurants and retail stores. The driveway throats were approximately 20–30 ft wide and the length of the driveway (also the width of the construction area) was approximately 40-65 ft. Figure 17 shows an example of the typical work zone traffic control found in the McKinney work zone.

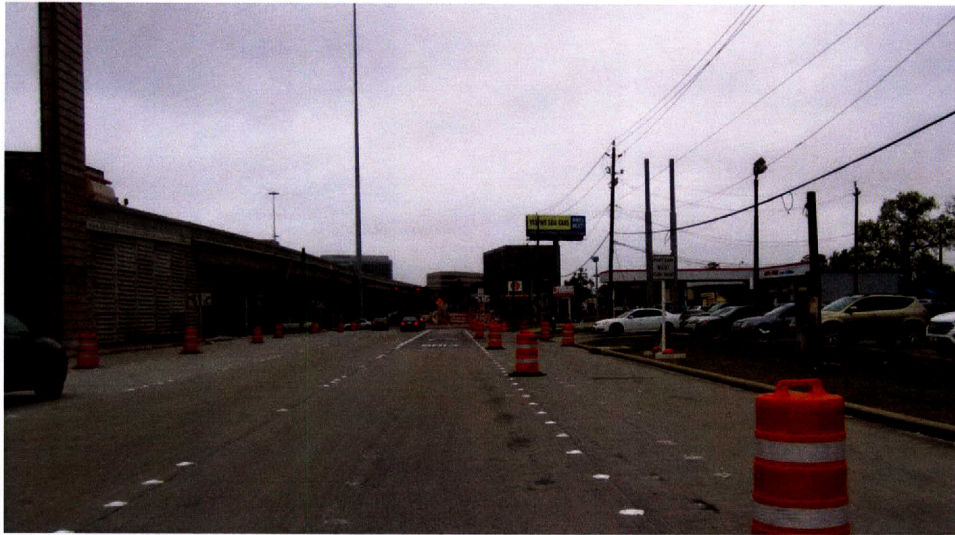
**Figure 18. Typical Work Zone Setup at Houston Driveways.**

During the week of March 25, 2014, the researchers used the work zone located on IH 610 near the US 290 interchange in Houston, Texas. At this work zone, the westbound frontage road between Ella Boulevard and T. C. Jester, as well as sections of T. C. Jester, had drums delineating the right lane closures. The driveway throats were approximately 30–40 ft wide and the length of the driveways (also the width of the lane closure) were considerably smaller than the McKinney driveways. Figure 18 shows an example of the typical work zone traffic control found in the Houston work zone.

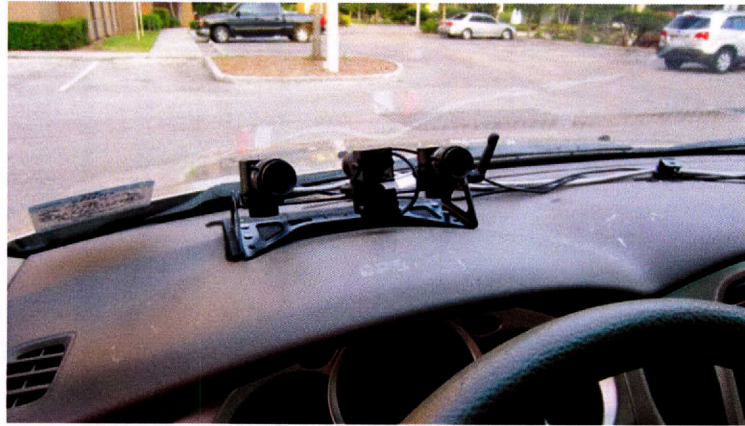
**Figure 19. FaceLAB™ IR Transmitters and Cameras.**

After completing consent paperwork, each participant drove one of two GPS-instrumented 2009 Ford Explorers through the work zone where the treatments were deployed. The vehicles were equipped with a faceLAB™ eye-tracking system, which was used to record driver glances via in-vehicle video cameras. Figure 19 shows the faceLAB™ dash-mounted eye-tracking infrared (IR) transmitters and cameras. The transmitters emitted a very low level of light and did not impact the driving task. The left and right cameras recorded pupil information for each eye, respectively, which was used to estimate the location of the driver's glances. Although not shown in the figure, a forward scene camera was also mounted behind the vehicles' rear-view mirror and was used to capture the view out the front of the vehicle. The forward scene view was then overlaid with the eye movement of the participant to gauge where within the road scene each participant's attention was drawn. All of this information was recorded by equipment located in the back seat of the vehicle. Two researchers were in the vehicle with the participant at all times. One researcher provided instructions for the participant, while the other operated the data collection equipment.

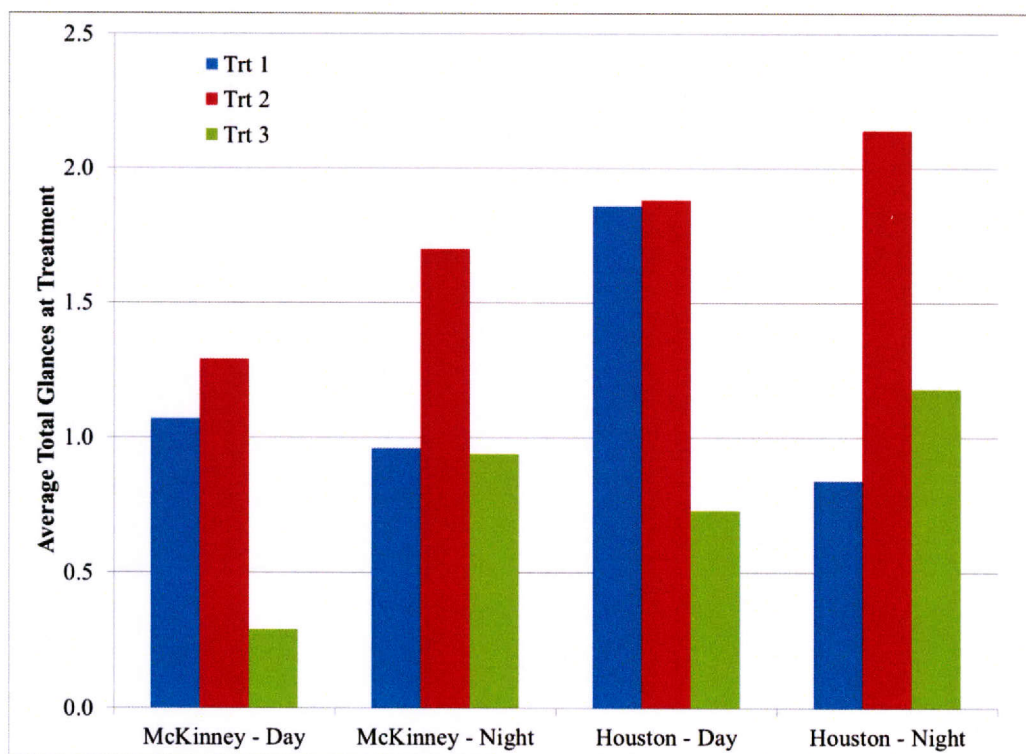
**Figure 21. Average of Total Treatment Glance Times.**

Although the McKinney and Houston nighttime data indicated that the treatment was the primary factor in time spent glancing at treatments, the daytime data showed an element of randomness and no demonstration of a significant effect caused by the treatment.

In further review of the treatment total glance times in Figure 21, the researchers felt that longer treatment glances were favorable, since more time looking at the treatment was indicative of the success of treatment in attracting attention to the actual driveway location and the driver's focus on the task of properly negotiating the driveway turn. Overall, the researchers found that glance durations were longer for Treatment F2 at night at both McKinney and Houston. The

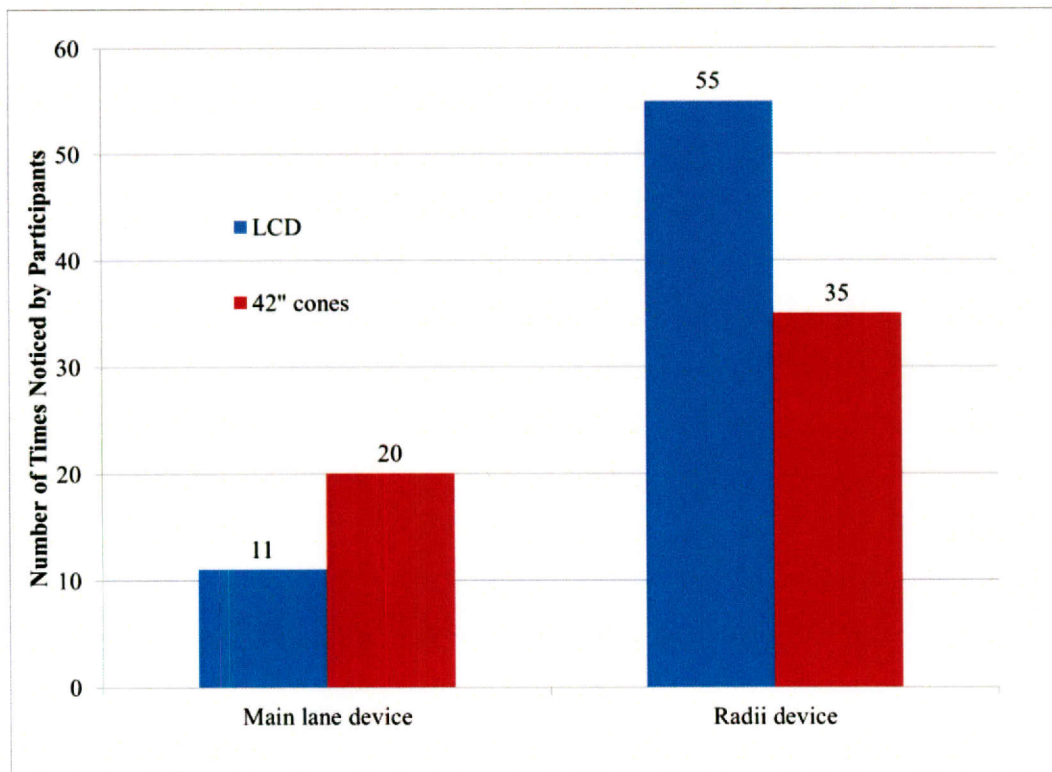
**Figure 22. Number of Times Traffic Control Features Were Noticed by Participants.**

After each participant turned into each driveway opening, they were asked to stop the vehicle for a brief discussion. The researcher asked if they noticed anything different about the driveway and, if so, what did they notice. Once the researcher recorded the participant responses on the data collection form, the participant was then instructed to proceed to the next driveway and this routine was repeated for the remaining driveways. The question was primarily aimed at determining if Treatments F1 and F2 would be noticed more when used in lieu of Treatment F3 (the standard drum configuration). Data were analyzed only for the 116 participants who successfully made a turn into the correct driveway and noticed the 42-inch tall cones or LCDs in either Treatment F1 or F2. Treatment F3 was not included in the analysis because there was essentially nothing different to notice. If the 42-inch tall cones or the LCDs were noticed by the participant, the researchers noted whether those devices were located along the main lane or in the radii of the driveway. Figure 22 shows the results.

Although the data set was too small for computing statistics, the researchers did notice some interesting trends. Recall that Treatment F1 had LCDs on the main lane and 42-inch tall cones on the driveway radii, and that Treatment F2 had 42-inch tall cones on the main lane and LCDs on the driveway radii. When the LCDs were placed on the radii (i.e., Treatment F2), they were noticed five times more often than when they were placed on the main lane. When the 42-inch tall cones were placed on the radii, as in Treatment F1, they were also noticed considerably more than when they were placed on the main lane. This may be indicative of the devices in the radii playing a larger role in driver perception and recognition than when they are placed along the main lane.

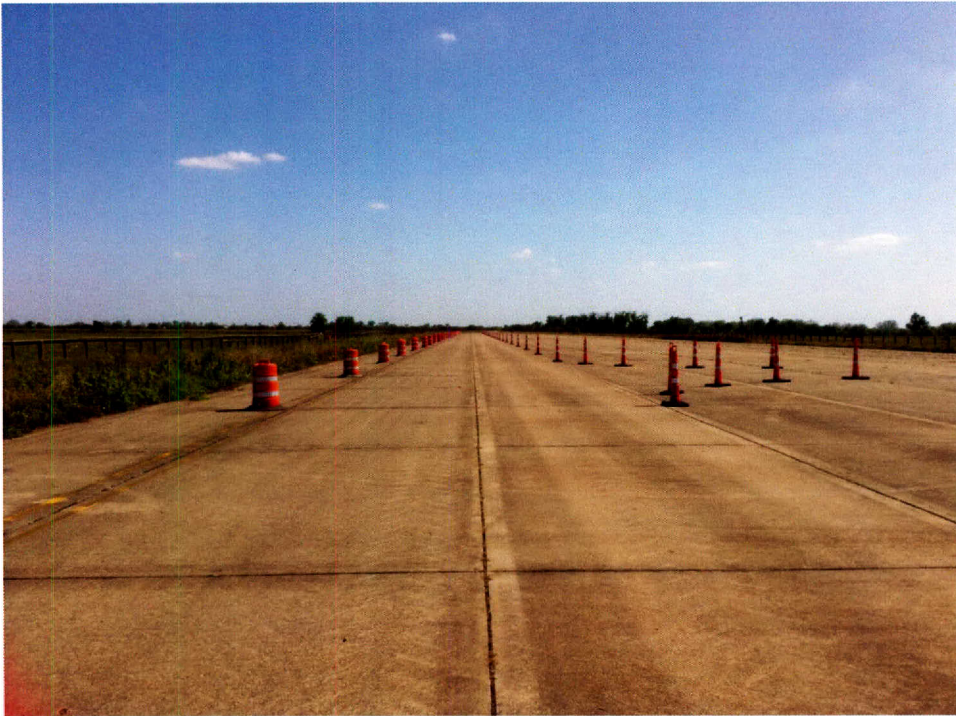
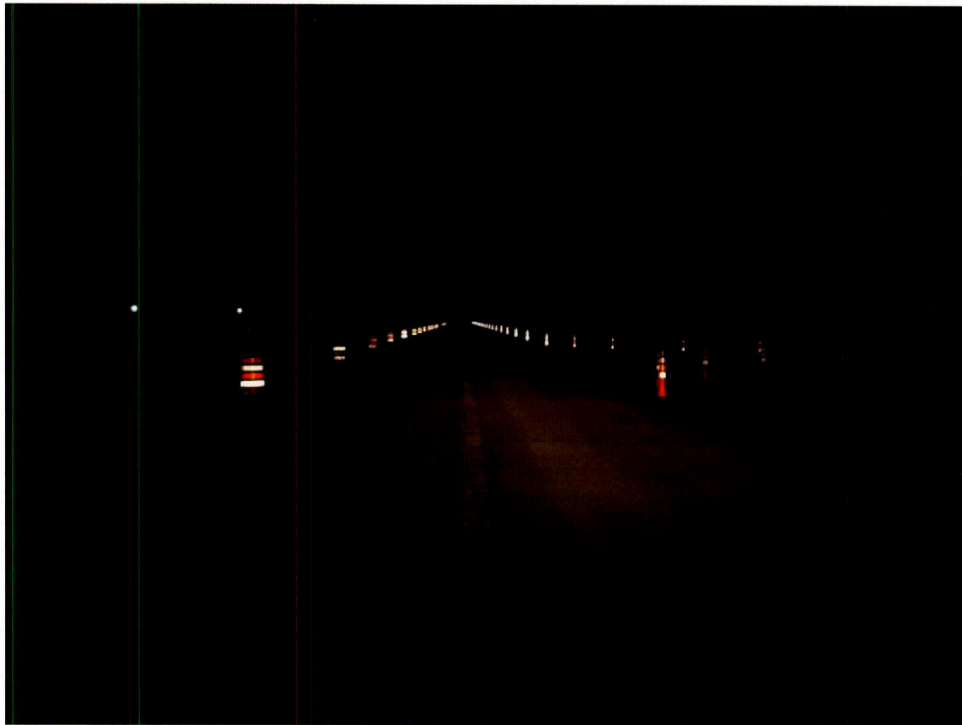
**Figure A-23. Treatment 1: 42-Inch Cones on Main Lane with 42-Inch Cones on Driveway.**

**Figure A-32. Treatment 1: 42-Inch Cones on Main Lane with 42-Inch Cones on Driveway.**

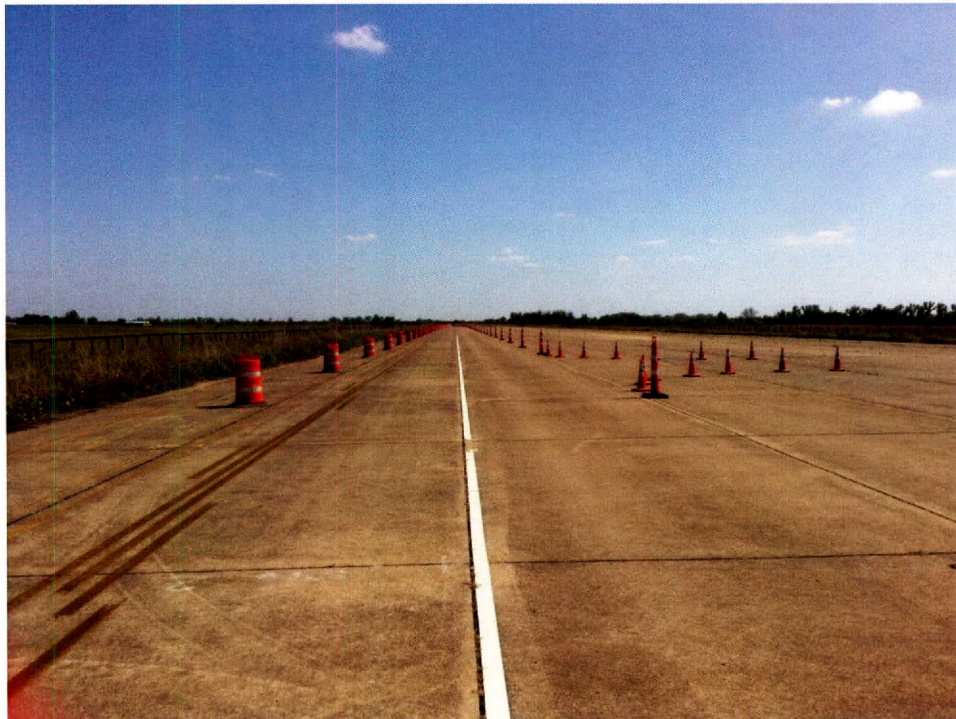
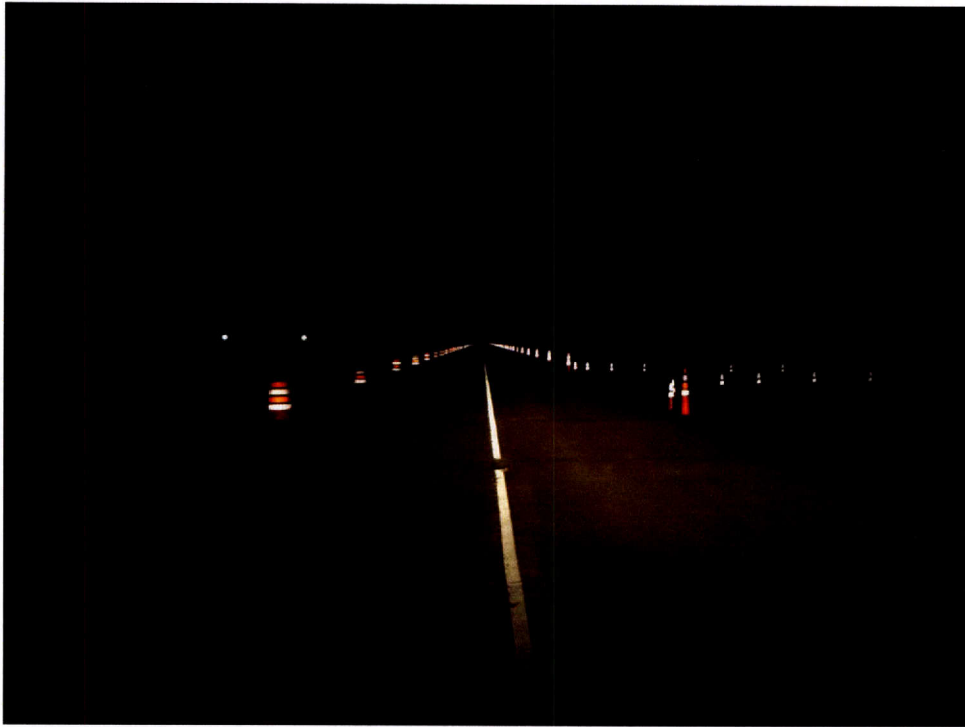
**Figure A-24. Treatment 2: 42-Inch Cones on Main Lane with 28-Inch Cones on Driveway.**

**Figure A-33. Treatment 2: 42-Inch Cones on Main Lane with 28-Inch Cones on Driveway.**

Treatments C2 and C7 both include the use of 28-inch tall cones on the driveway. The average performance measures for these treatments were typically in the bottom half of the results tables for both night and day conditions. Based on their relatively poor performance, coupled with the fact that they are currently not allowed by TxDOT in nighttime work zones, the researchers could not justify pursuing these treatments. Thus, they were eliminated from further consideration.

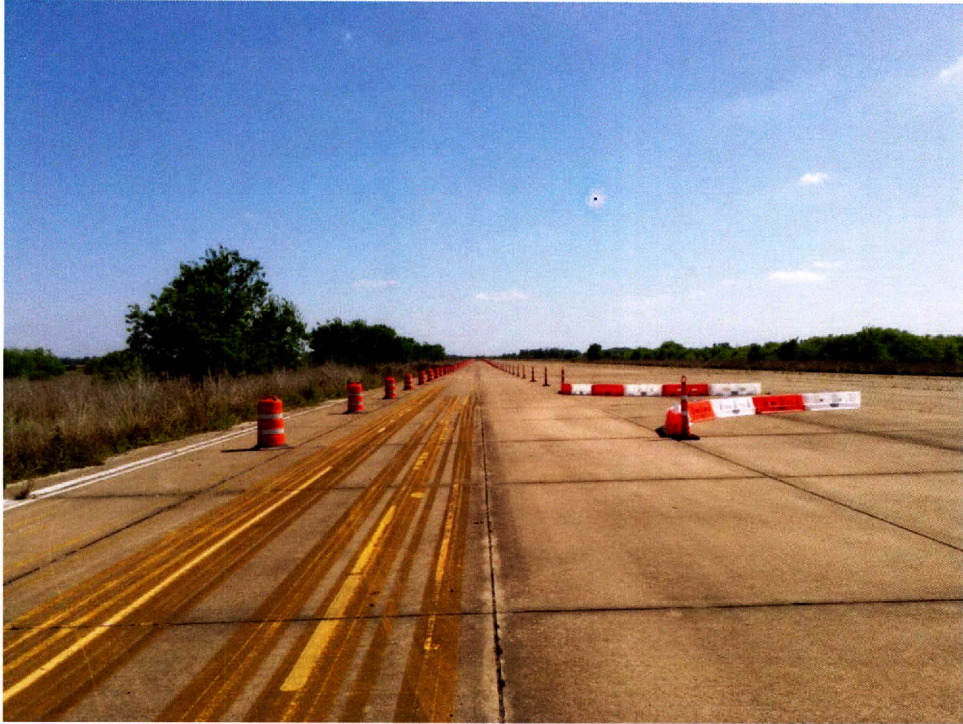
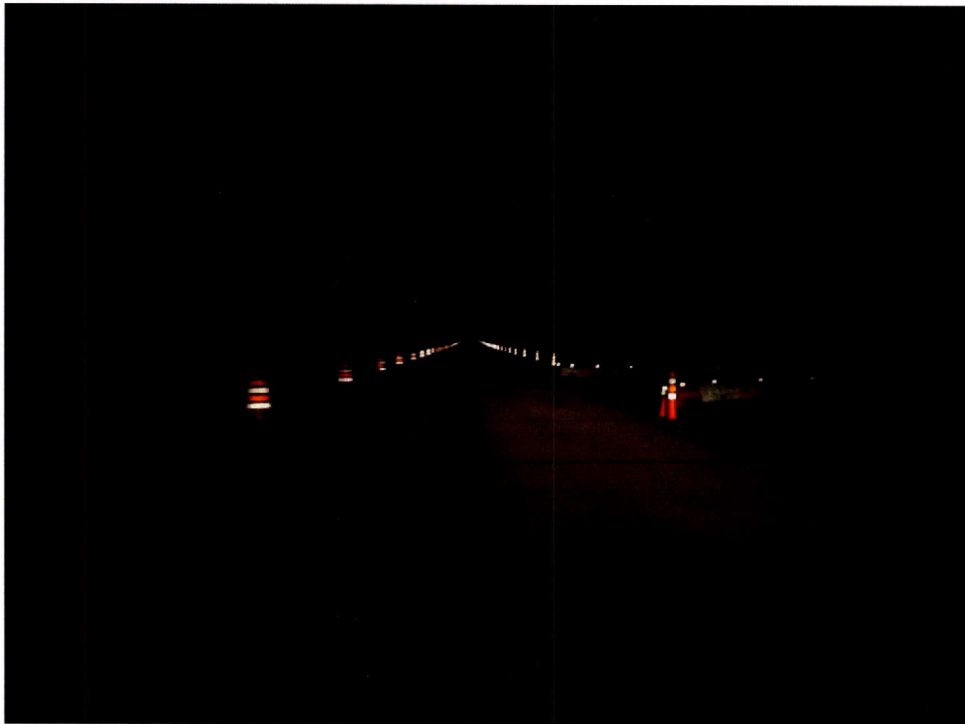
**Figure A-25. Treatment 3: 42-Inch Cones on Main Lane with 18-Inch LCDs on Driveway.**

**Figure A-34. Treatment 3: 42-Inch Cones on Main Lane with 18-Inch LCDs on Driveway.**

The remaining, high-performing devices included Treatments C3 and C6. Both of these treatments had good visibility characteristics in both night and day conditions. Treatment C3 combined 42-inch tall cones on the main lane with 18-inch tall LCDs in the driveway. Treatment C6 used 18-inch tall LCDs along the main lane with 42-inch tall cones in the driveway. For both treatments, the difference in retroreflectivity at night is helpful to motorists. During daytime, the size and shape differences provide good visual cues for motorists.

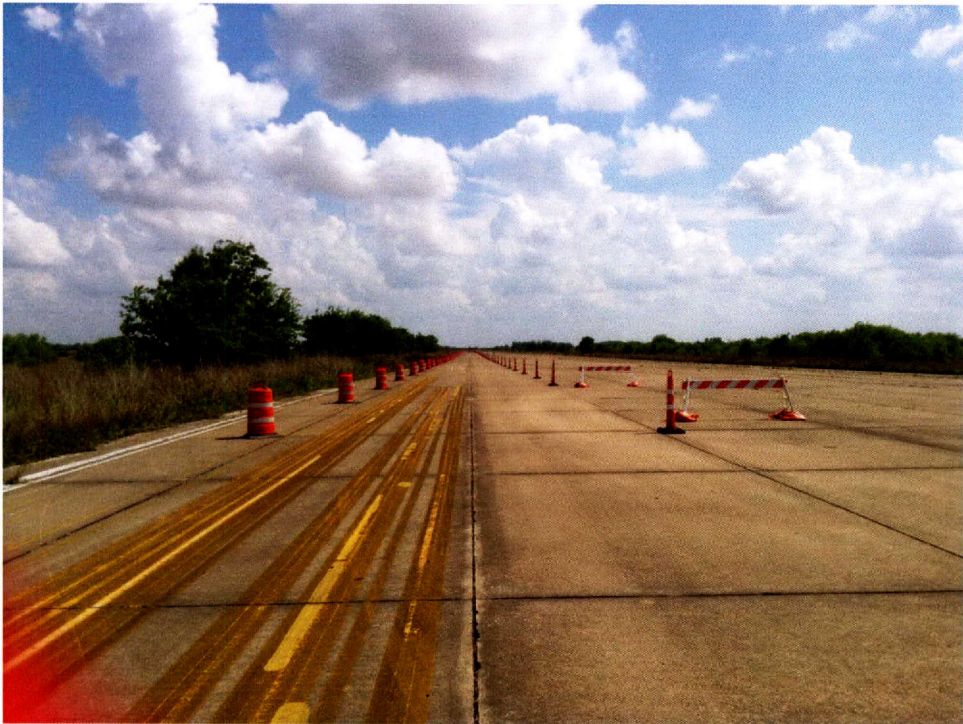
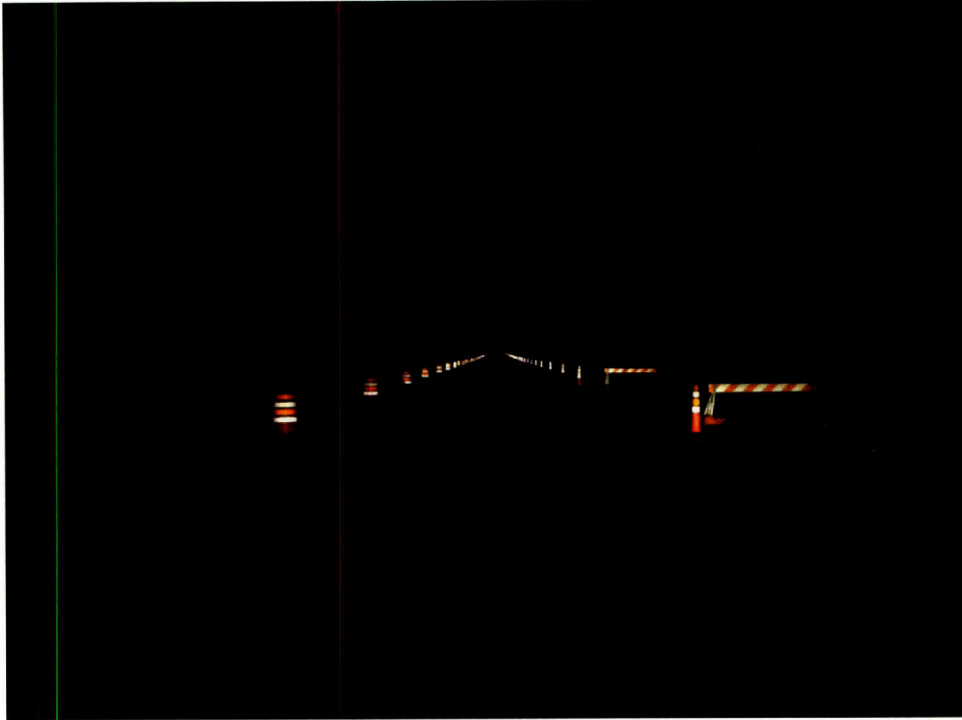
**Figure A-26. Treatment 4: 42-Inch Cones on Main Lane with 36-Inch Type I Barricades on Driveway.**

**Figure A-35. Treatment 4: 42-Inch Cones on Main Lane with 36-Inch Type I Barricades on Driveway.**

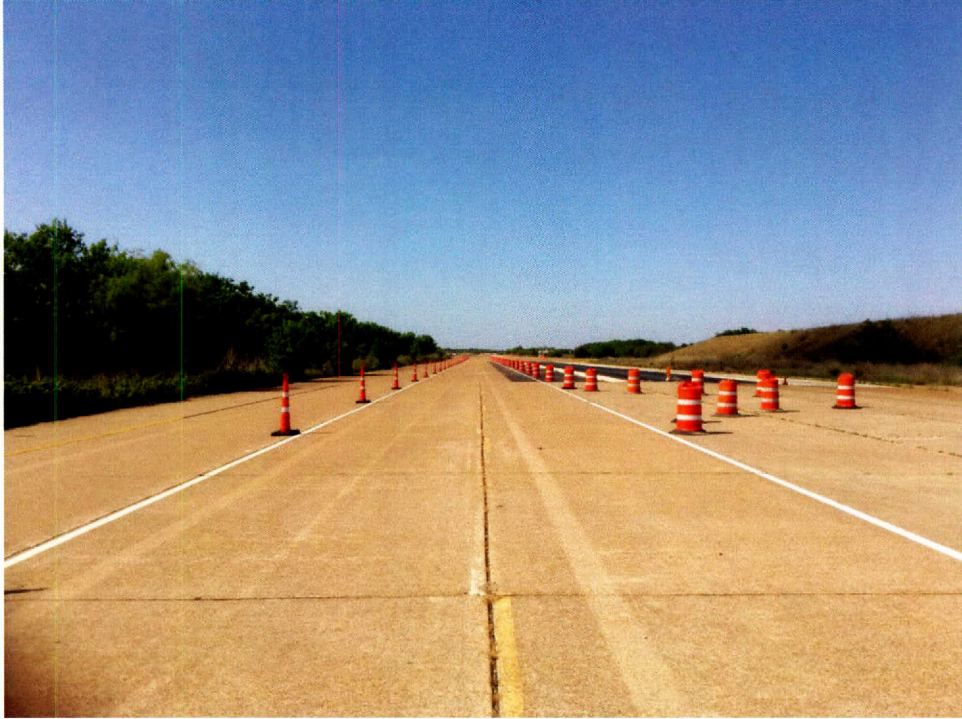
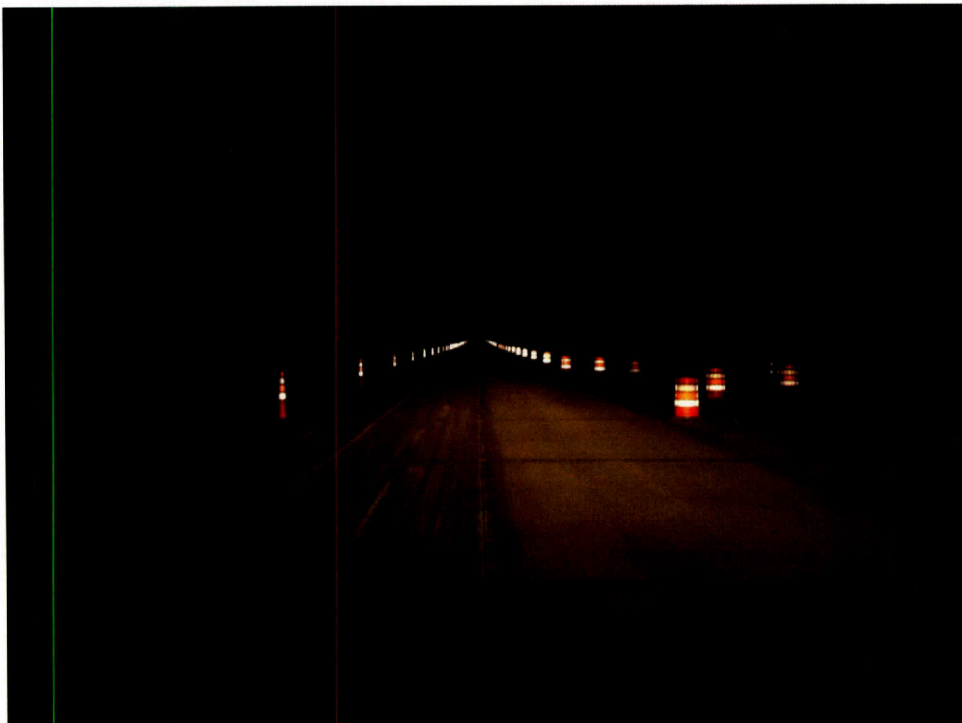
**Figure A-27. Treatment 5: Drums on Main Lane with Drums on Driveway.**

**Figure A-36. Treatment 5: Drums on Main Lane with Drums on Driveway.**

Initially it was felt that providing a treatment which included a device change in the driveway throat area would help drivers locate the driveway sooner. Three treatments tested did not have a device change (Treatments C1, C5, and C8), and the results appear to support the researchers' hypothesis. Treatment C5, which was included as the baseline treatment, performed poorly in all measures, and Treatments C1 and C8 traded low spots between the measures. Thus, the researchers recommend eliminating these three treatments from further consideration.

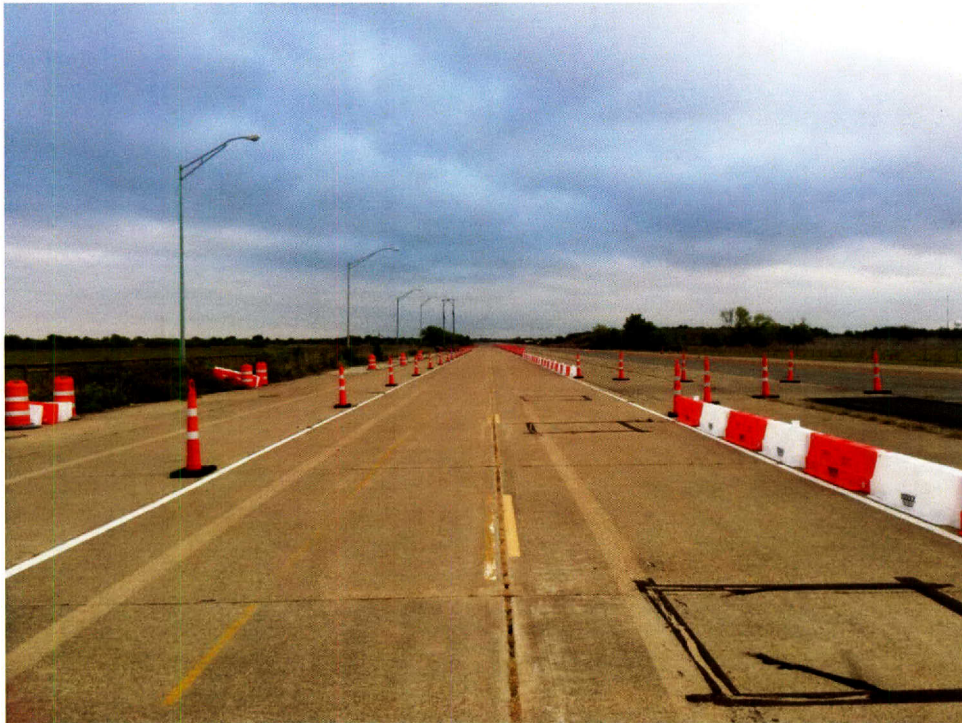
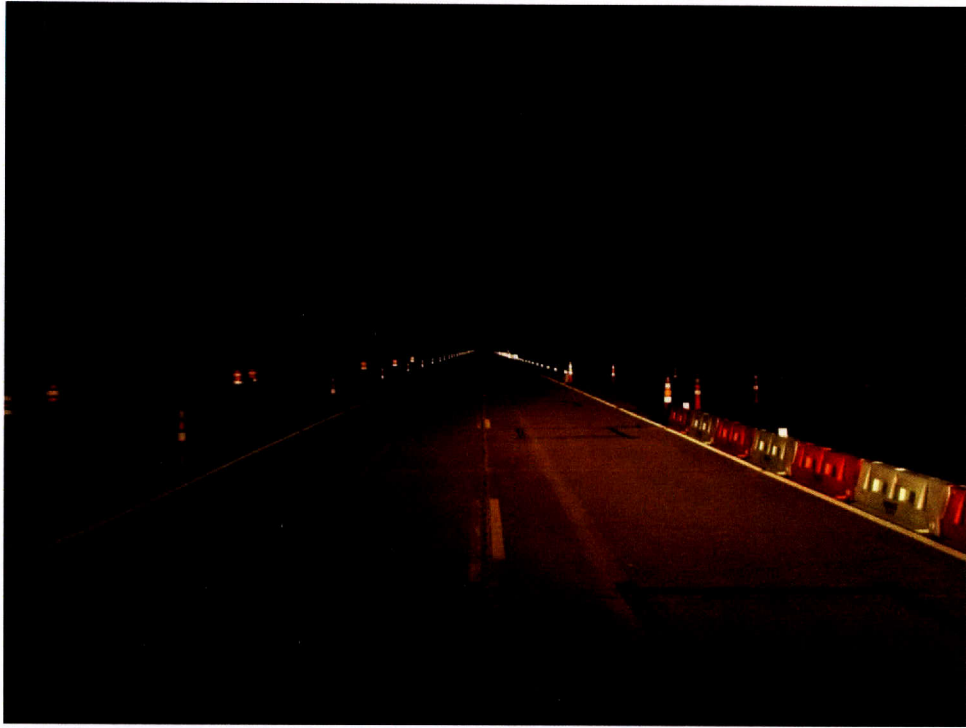
**Figure A-28. Treatment 6: 18-Inch LCDs on Main Lane with 42-Inch Cones on Driveway.**

**Figure A-37. Treatment 6: 18-Inch LCDs on Main Lane with 42-Inch Cones on Driveway.**

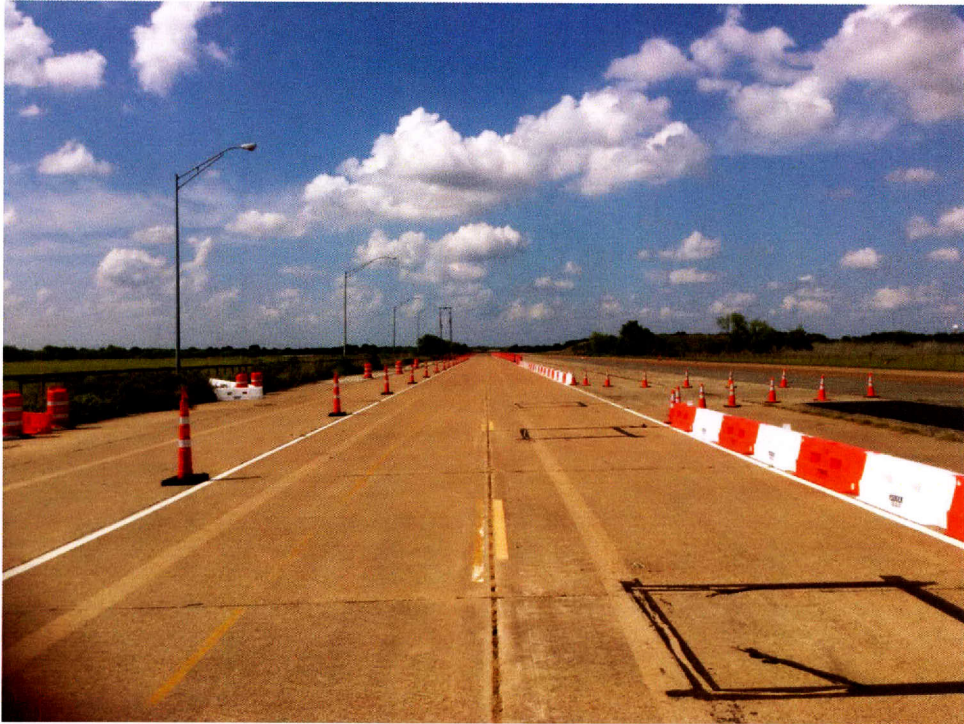
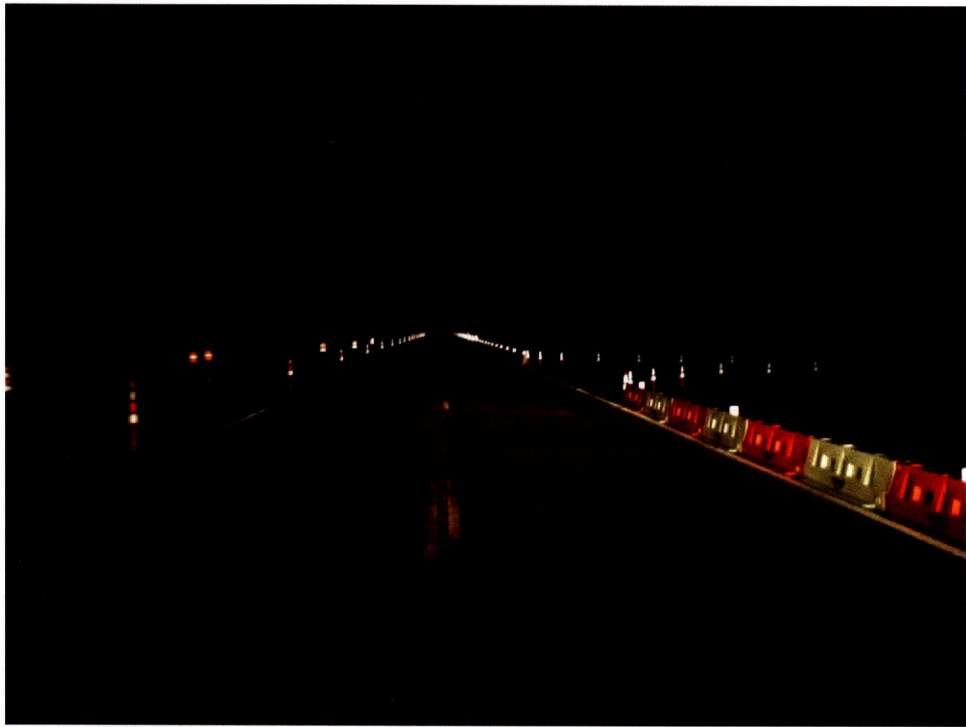
**Figure A-29. Treatment 7: 18-Inch LCDs on Main Lane with 28-Inch Cones on Driveway.**

**Figure A-38. Treatment 7: 18-Inch LCDs on Main Lane with 28-Inch Cones on Driveway.**

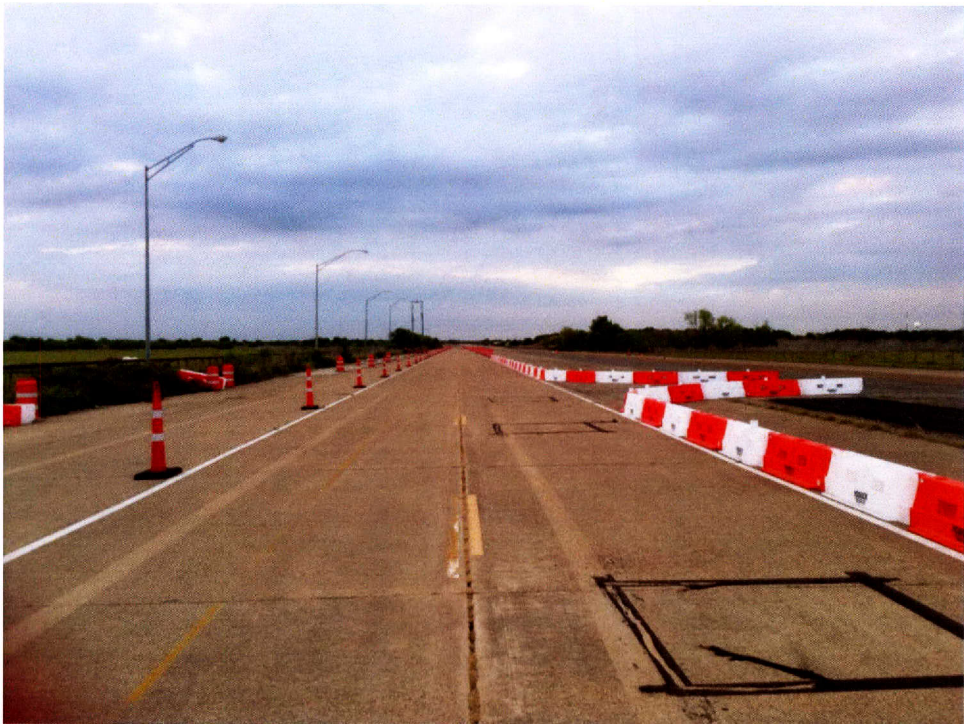
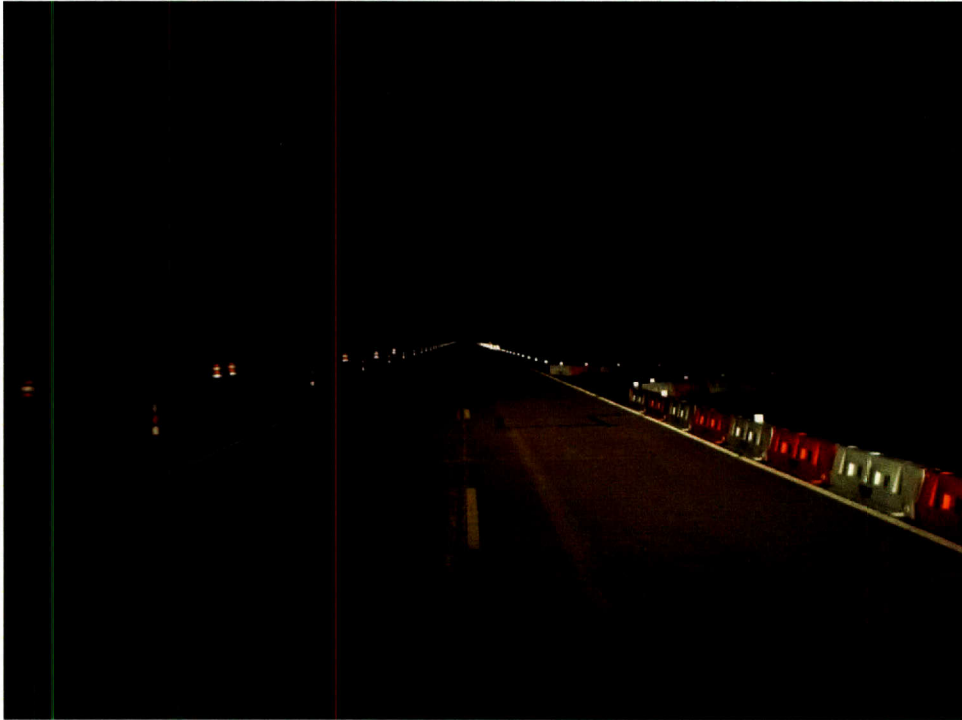
**Figure A-30. Treatment 8: 18-Inch LCDs on Main Lane with 18-Inch LCDs on Driveway.**

**Figure A-39. Treatment 8: 18-Inch LCDs on Main Lane with 18-Inch LCDs on Driveway.**

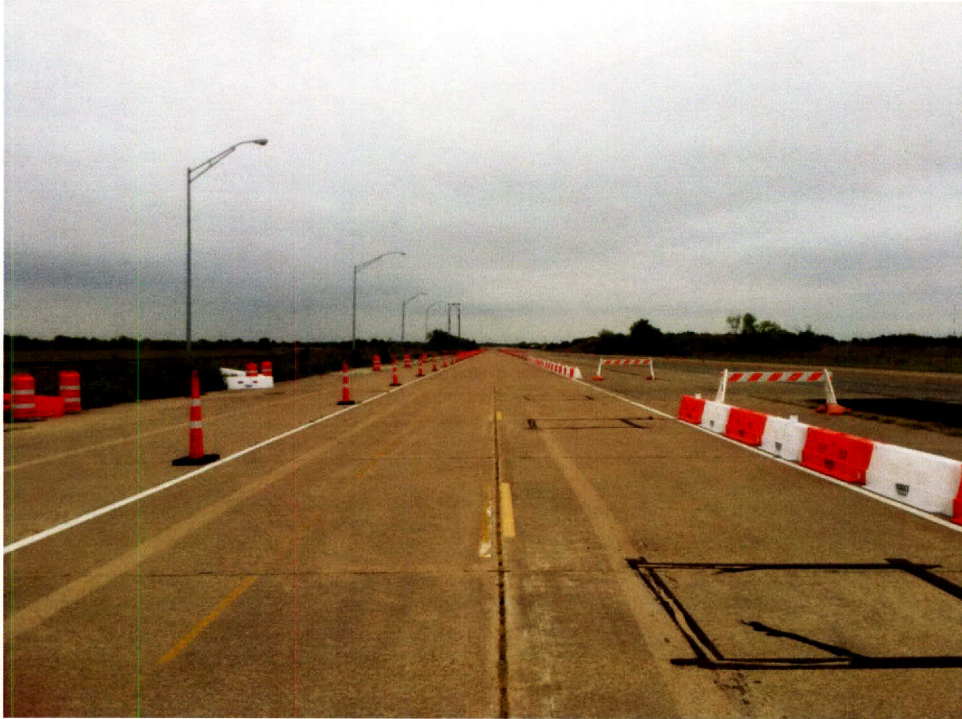
**Figure A-31. Treatment 9: 18-Inch LCDs on Main Lane with 36-Inch Type I Barricades on Driveway.**

**Figure A-40. Treatment 9: 18-Inch LCDs on Main Lane with 36-Inch Type I Barricades on Driveway.**
